# VersaLink® B600/B610 Printer and B605/B615 Multifunction Printer Service Manual

Xerox® VersaLink® B600 Family MFP Service Manual

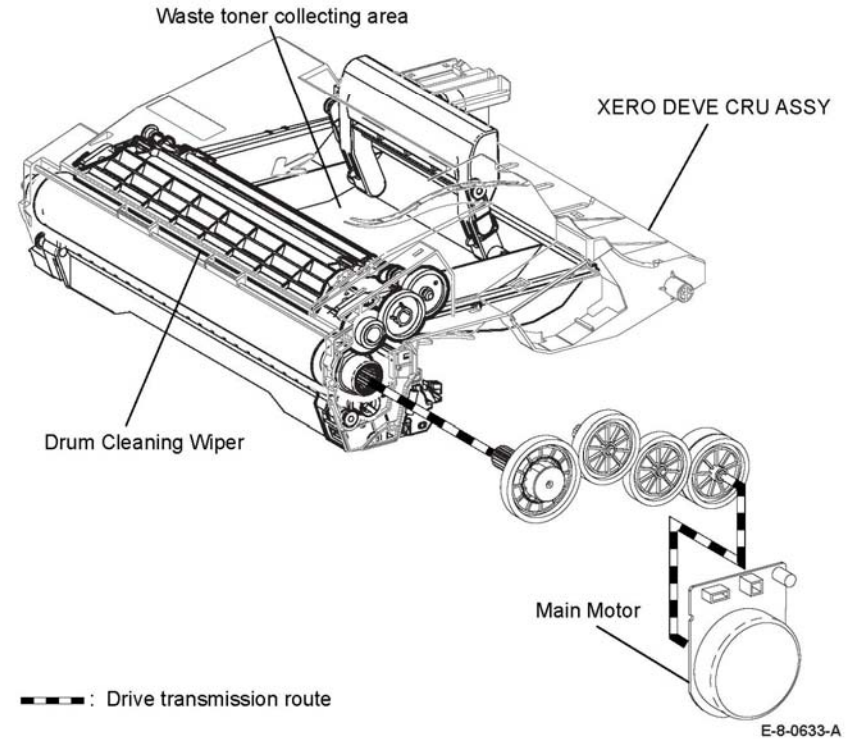
The excess toner generated by the drum cleaning is fed to the waste toner collection area by the drum cleaning wiper in the drum cartridge as shown [Figure 5](#). The drum cleaning wiper is driven by the main motor.

Figure 5 Waste toner collection

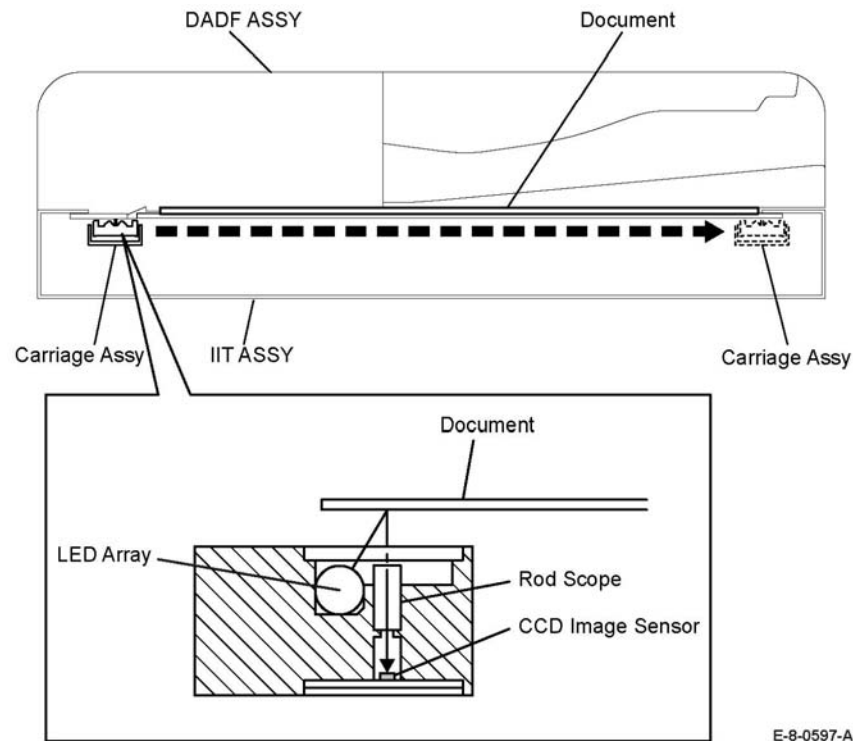
The scanner assembly consists of the Image Input Terminal (IIT) and the Duplex Automatic Document Feeder (DADF). The CIS assembly in the Image Input Terminal scans the front side of the document and the CIS assembly in the Duplex Automatic Document feeder scans the back side of the document.

The carriage assembly consists of components such as the CIS Image sensor for converting image to data, the LED Array for illuminating the original, and the rod scope for converting the original image to a full-size erect image.

Figure 1 Scanning at platen (IIT) assembly

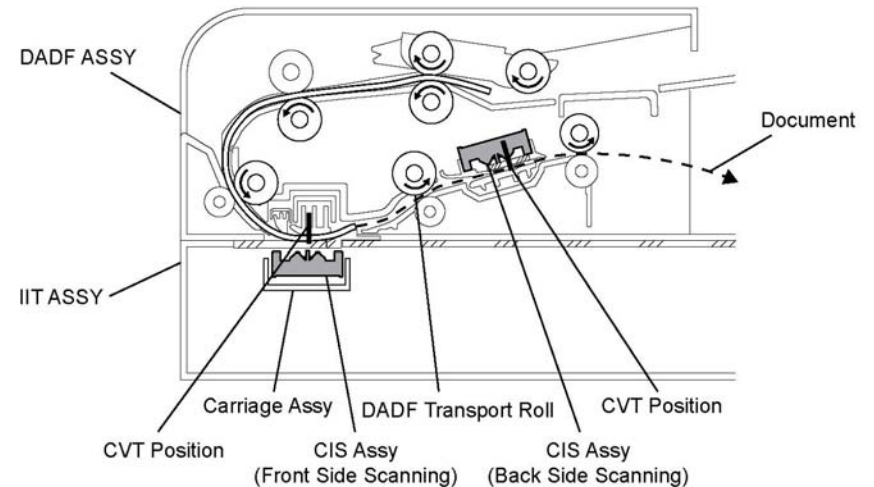
The CIS assembly on the IIT assembly reads the front side of the document, and the CIS assembly on the DADF assembly reads the back side of the document. These two scanning parts are arranged to interpose the paper path from both sides, allowing both sides of the document to be scanned without rotation.

The document is fed by the torque from the DADF motor at the speed corresponding to the set magnification. The document passes the scanner home position; Constant Velocity Transport (CVT) of the carriage assembly in the IIT, and the reflected image is read by the CIS image sensor.

Figure 2 Scanning at DADF assembly

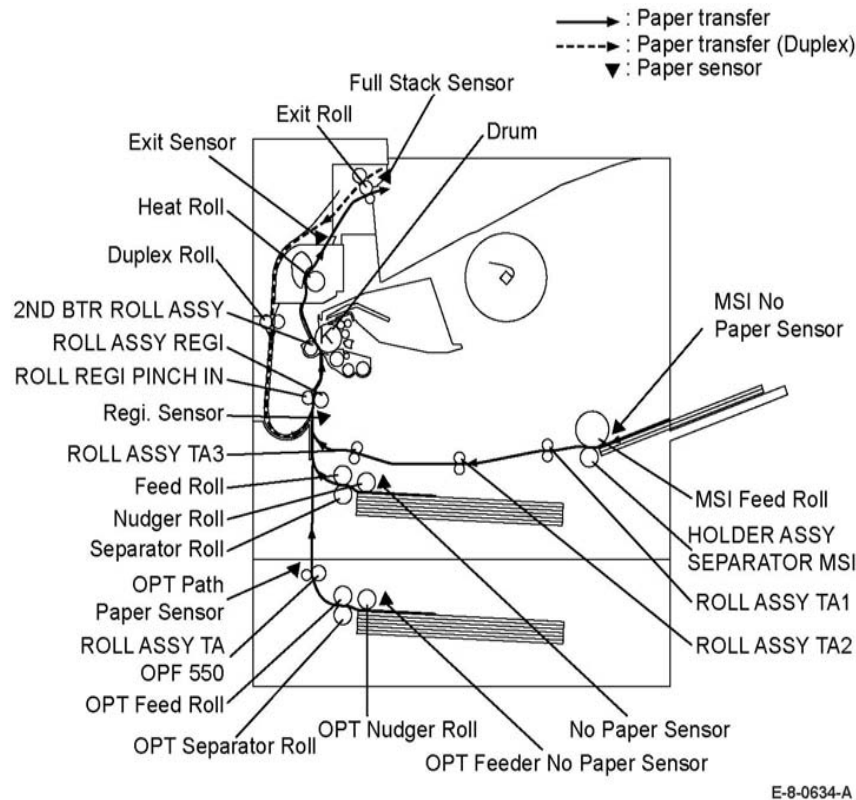
Figure 1 shows the paper feed layout when the tray module is installed, and the components associated with feeding the paper.

Figure 1 Paper path layout

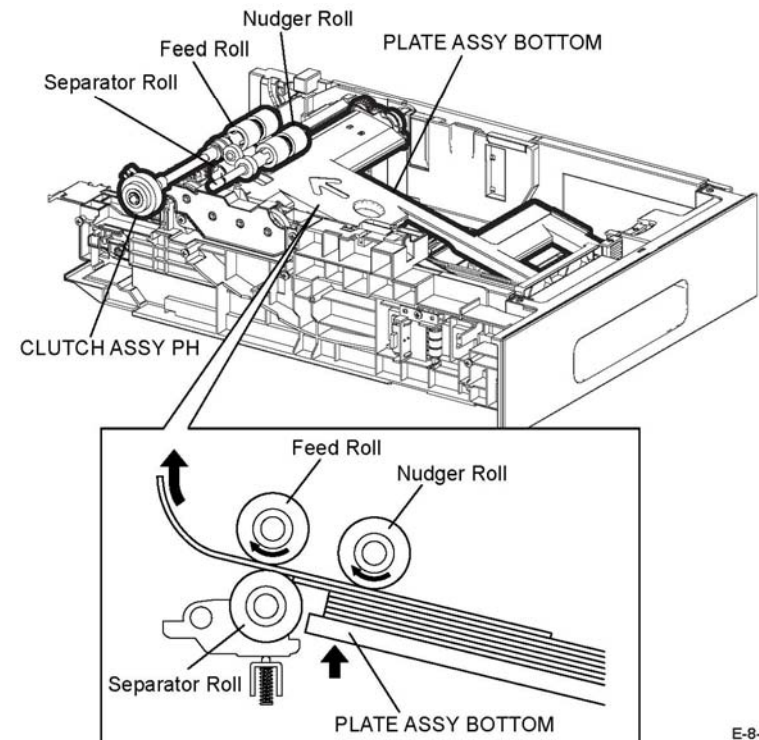
- The nudger roll and the feed roll are rotated by the main motor via the clutch assembly PH.

- The separator roll, pressed from underneath by the spring pressure and forced against the feed roll, fans a sheet by the rotation friction.
- When the sheet is lapped over, the break force of the torque limiter combined with the separator roll, separates and feeds the top sheet.
- The plate assembly bottom is the mechanism driven with the gear located on the side of the paper cassette.
- Unless the interlock gear is unlocked, the plate assembly bottom keeps the state that it is not lowered or elevated from the arbitrary position. The sheet is fed at this position.
- As paper is fed and the stack of paper decreases by several sheets, the nudger roll lowers down and the lever unlocks the gear, which elevates the plate assembly bottom.

Figure 2 Feeding from paper cassette

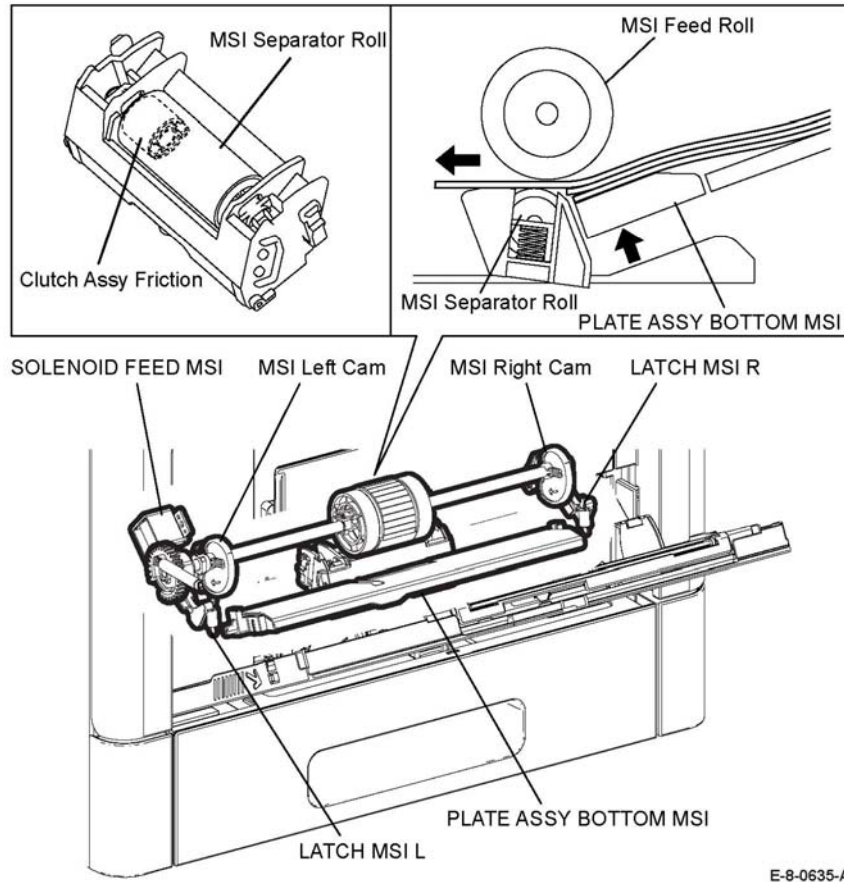
Normally, when only one sheet is fed, both the MSI feed roll and MSI separator roll rotate to allow the sheet to pass. However, when two sheets are fed concurrently, only the MSI feed roll rotates and the MSI separator roll is locked. This allows the upper sheet to pass by being separated from the lower sheet that is stopped by the friction with the MSI Separator roll at rest.

The MSI separator roll is pushed toward the MSI feed roll by spring pressure, and controlled by the torque limiter (clutch assembly friction) with which it is coupled.

Figure 3 Feeding from the bypass tray

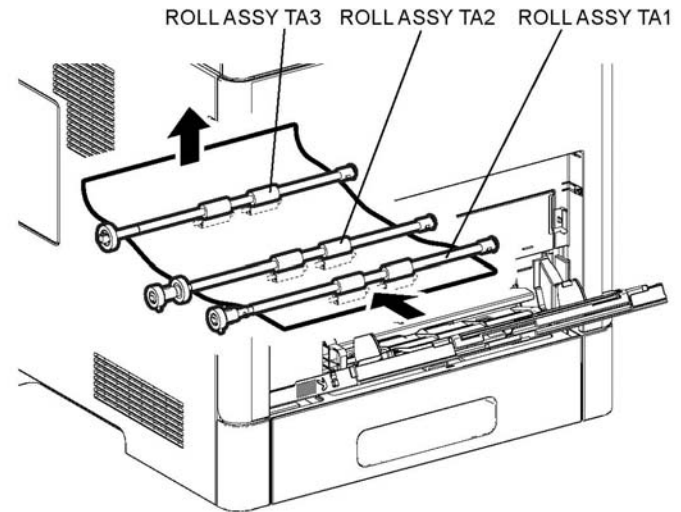
The sheet fed from the MSI is fed to the registration section by the roll assembly TA1, roll assembly TA2, and roll assembly TA3 driven by the main motor. Refer to Figure 4.

Figure 4 Feeding through the takeaway rolls

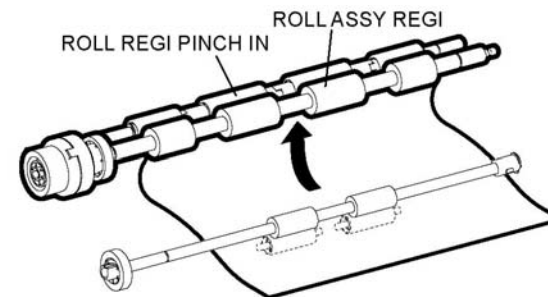
The sheet fed from the paper cassette is passed through the chute directly and fed to the registration section. Refer to Figure 5.

Figure 5 Feeding to the registration section

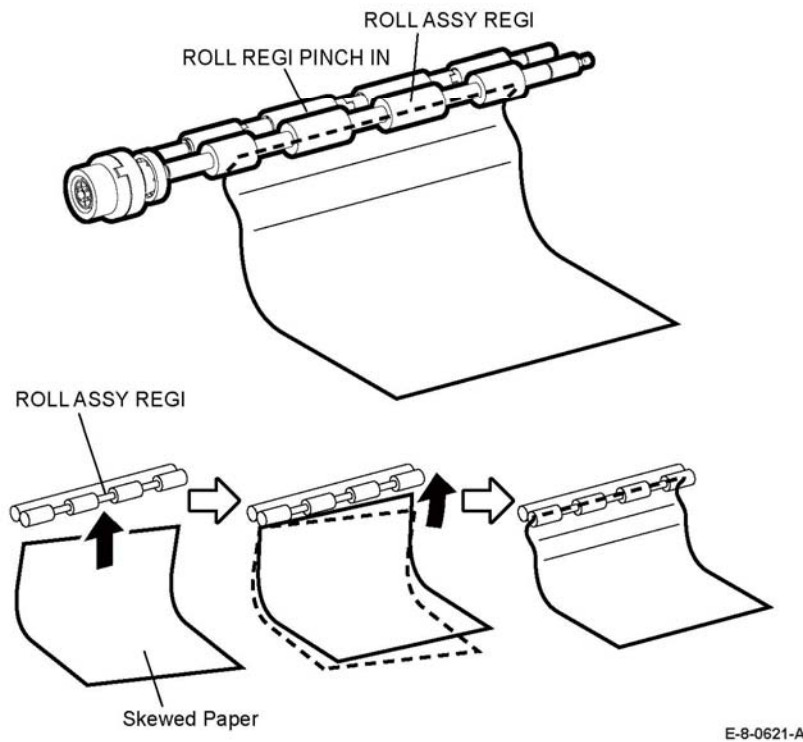
By thrusting the edge of the sheet fed out of the MSI or tray against the locked roll assembly regi, the sheet's lead edge position is corrected. Refer to [Figure 6](#).

Figure 6 Sheet leading edge position correction

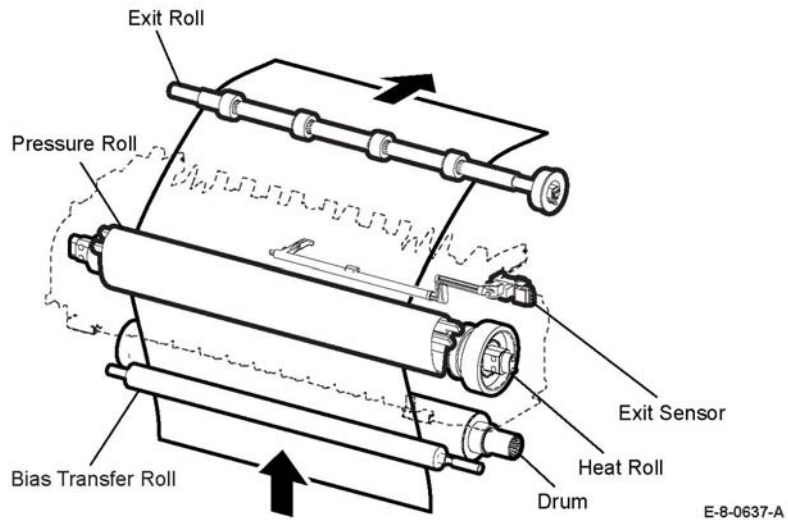
On the sheet passed through the registration section, the toner image on the drum is transferred by the drum and bias transfer roll, rotated by the main motor drive. The sheet is then fed to the exit section where the toner image is fused by the heat roll, rotated by the main motor. Refer to Figure 7. The main motor drive is transmitted to the exit clutch, and the exit roll is rotated in the sheet exit direction. The printed sheet is ejected from the printer. The exit sensor detects when the sheet completely exits the printer.

Figure 7 Feeding through the transfer/fusing/exit

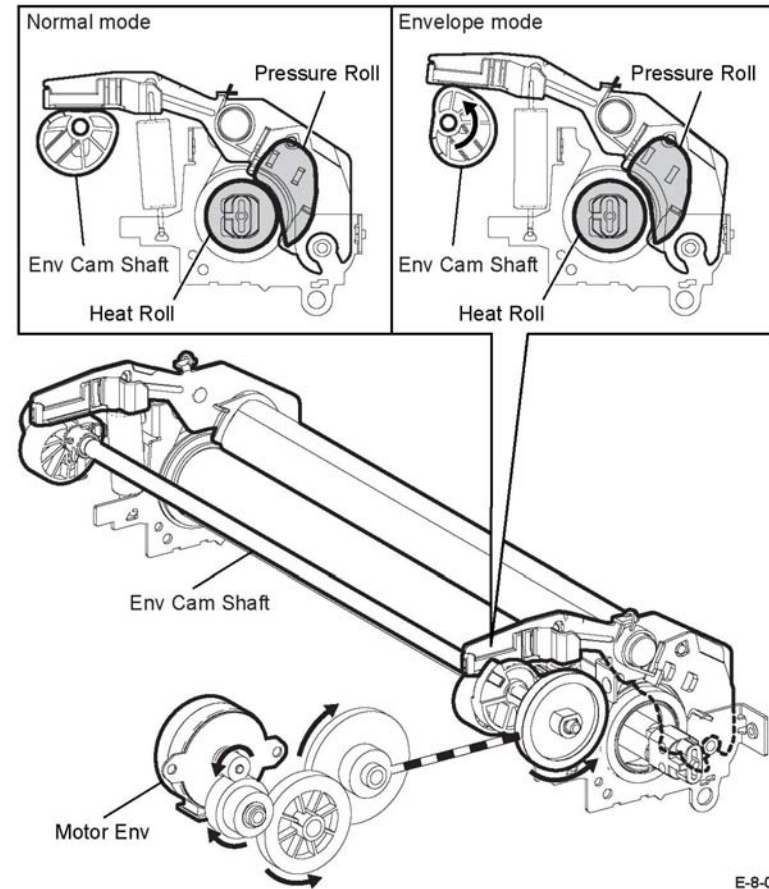
For printing envelopes, the envelope drive motor rotates the envelope cam shaft to switch into the envelope mode. In the envelope mode, the pressure roll moves away from the heat roll, which reduces the pressure. Refer to Figure 8.

Figure 8 Feeding through envelope mode

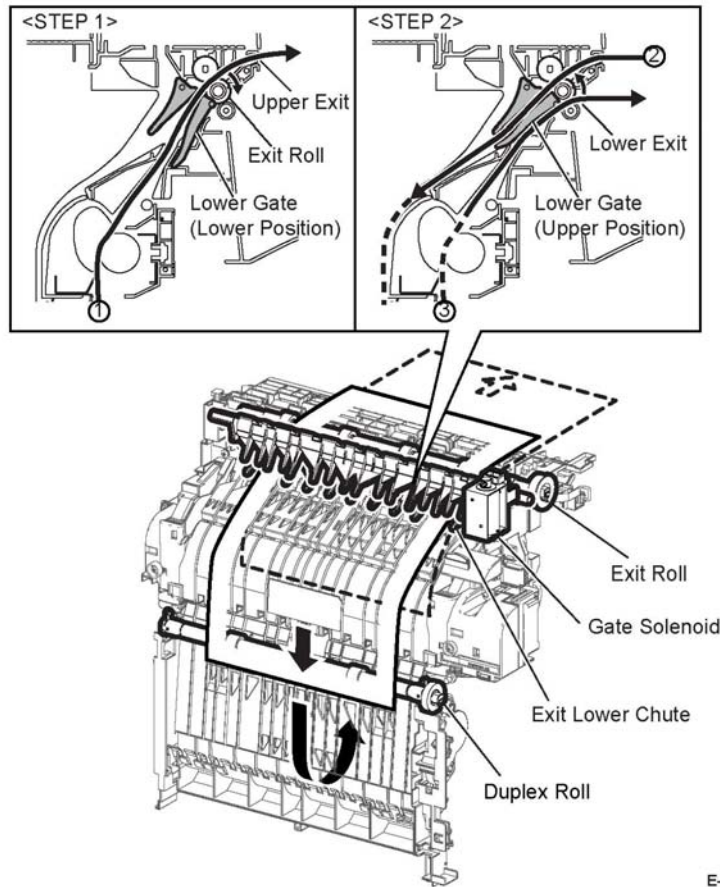
The main motor drive is transferred to the exit clutch, which rotates the exit roll forward. The sheet is fed to the duplex assembly along the lower gate, which is shifted to the upper position by the gate solenoid.

The duplex roll is driven by the PH motor which feeds the sheet to the registration position. After the sheet passes the heat roll and side 2 printing has completed, the sheet is output to the lower exit. The exit roll rotates forward and the lower gate is at the upper position. Refer to [Figure 9](#).

Figure 9 Feeding through the duplexer

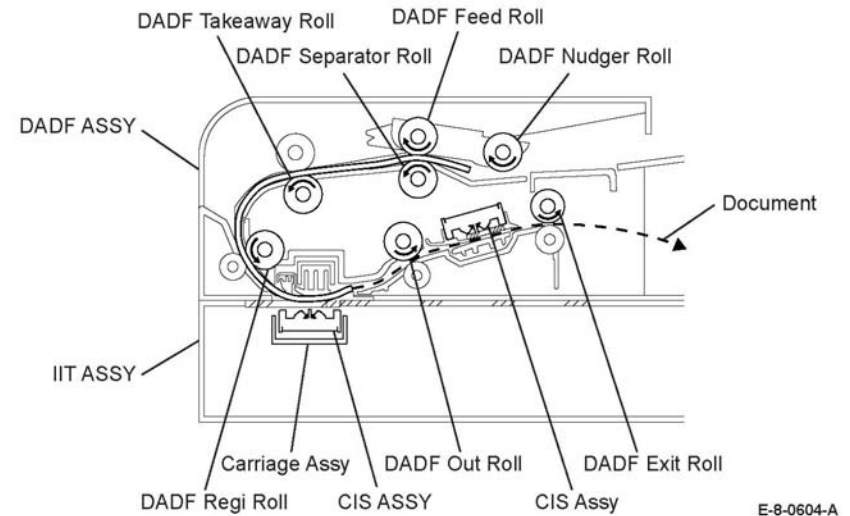
Inside the DADF, the sheet is fed by the DADF takeaway roll rotated by the DADF motor, aligned by the DADF registration roll rotated by the DADF motor, and fed to the scanner home (CVT: Constant Velocity Transport) position in the carriage assembly, and is scanned (simplex). Then, the sheet is fed by the DADF transport roll rotated by the DADF motor to the CVT position, and is scanned (duplex).

After being scanned, the sheet is ejected by the DADF exit roll rotated by the DADF motor to the DADF's document output tray.

Figure 10 Feeding through the DADF

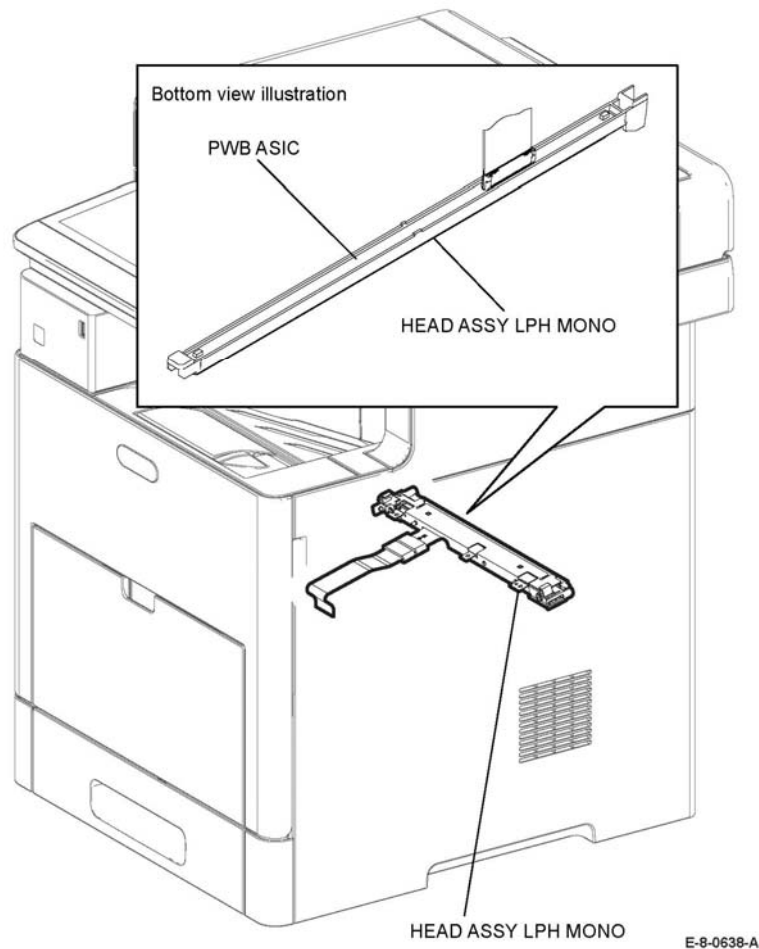
Figure 1 shows the Laser Print Head (LPH) assembly. (PL 2.1 Item 1)

Figure 1 LPH function

An exposure device for creating an electrostatic latent image on the drum surface.

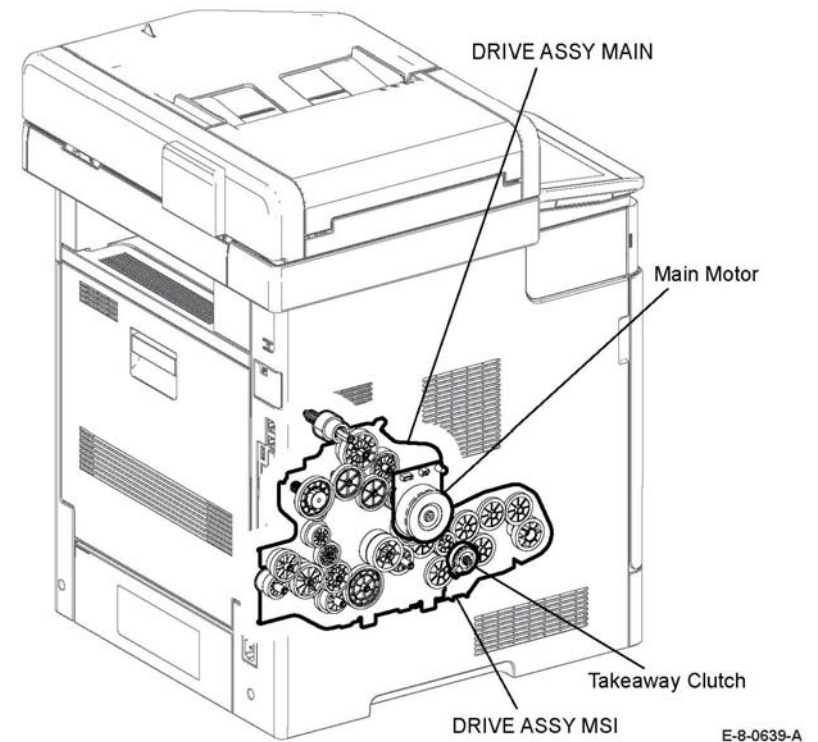
Figure 2 shows the drive assembly. (PL 3.1 Item 1)

Figure 2 Drive function

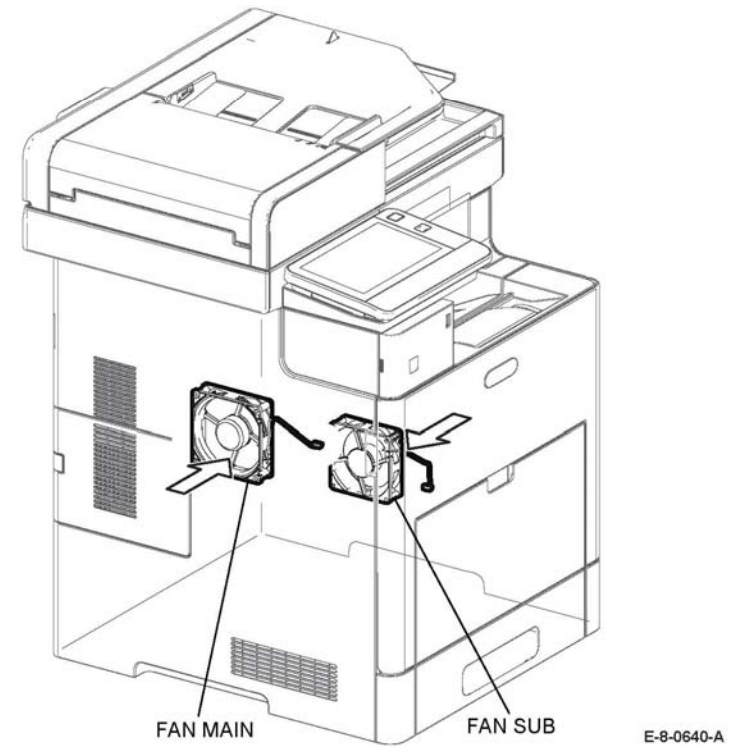
Figure 3 shows the air flow (MFP shown).

Figure 3 Air flow

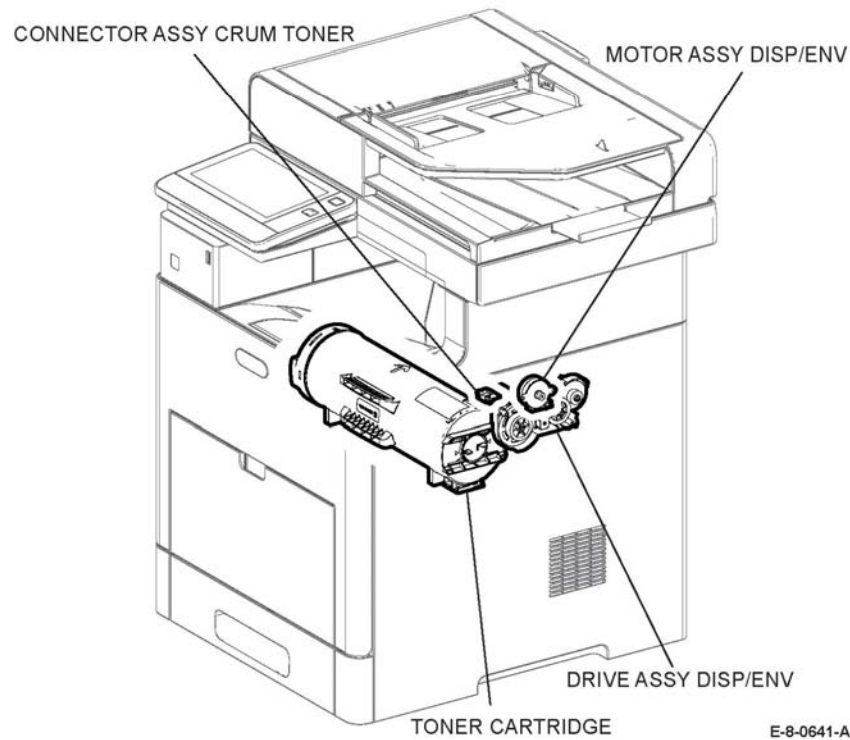
Figure 4 shows the toner dispensing system.

Figure 4 Toner dispensing function

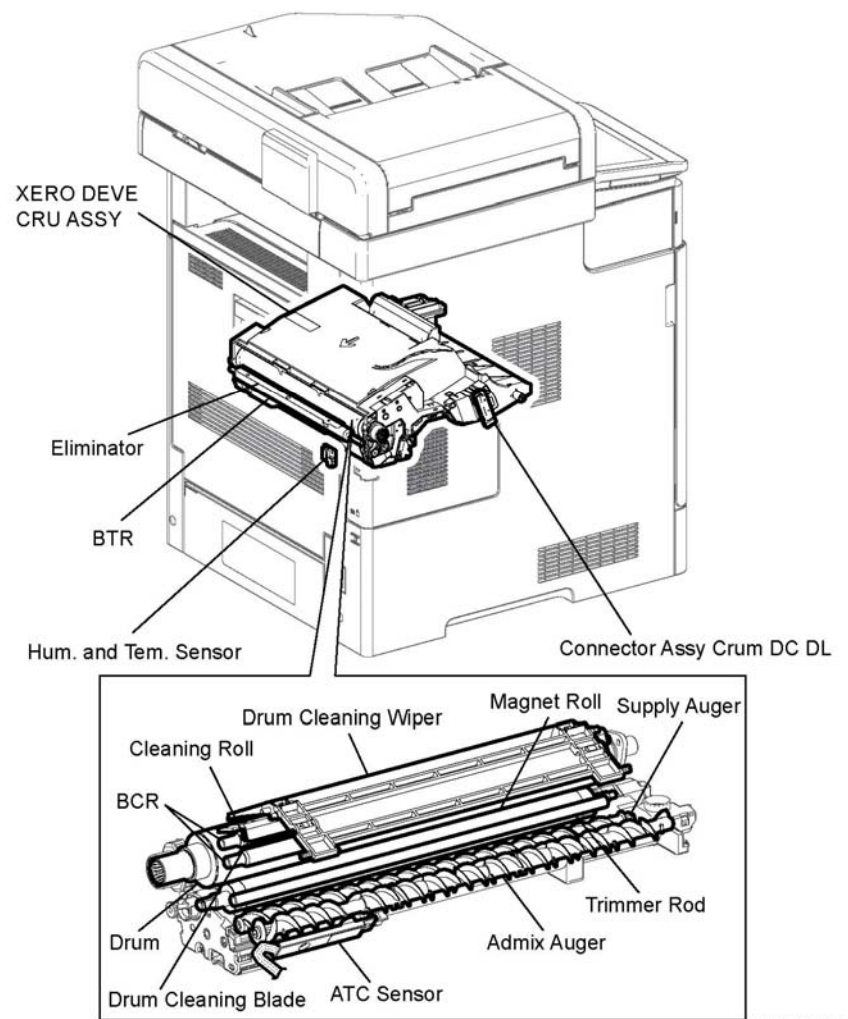
Figure 5 shows the xerographics and transfer systems.

Figure 5 Xerographics and transfer functions

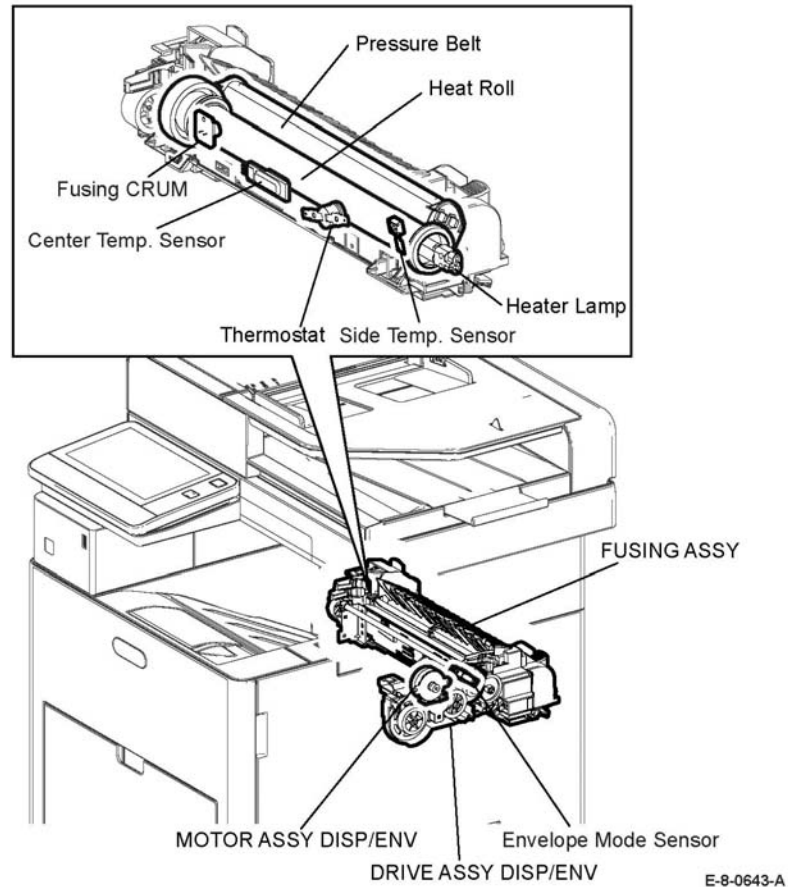
Figure 6 shows the fusing function.

Figure 6 Fuser function

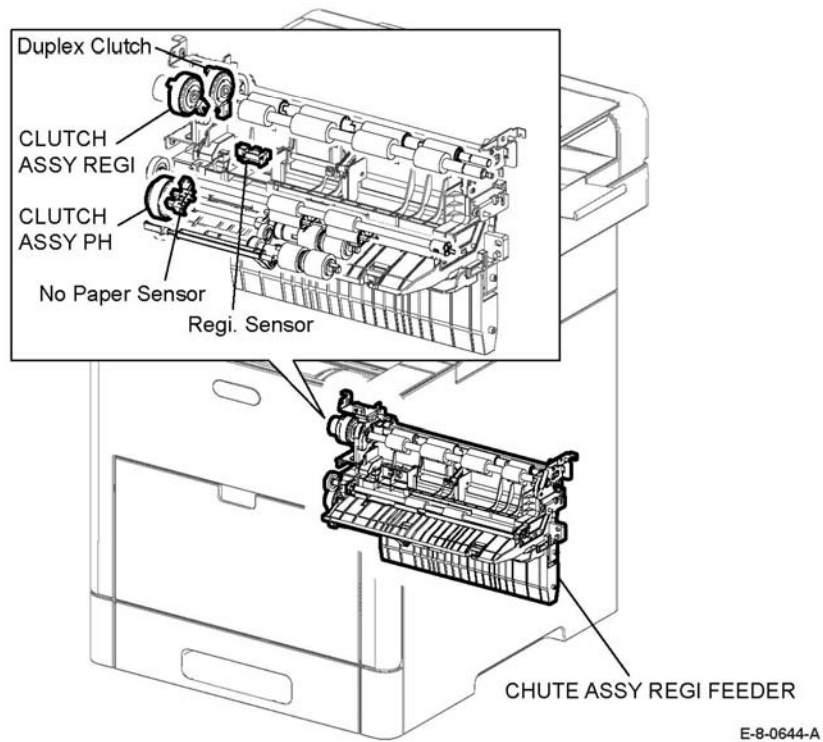
Figure 7 shows the paper transport system.

Figure 7 Paper transport function

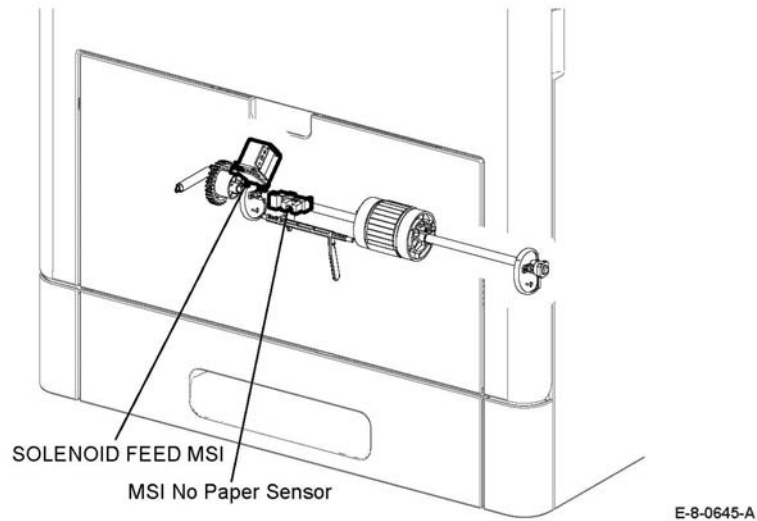
Figure 8 shows the bypass function.

Figure 8 Bypass function

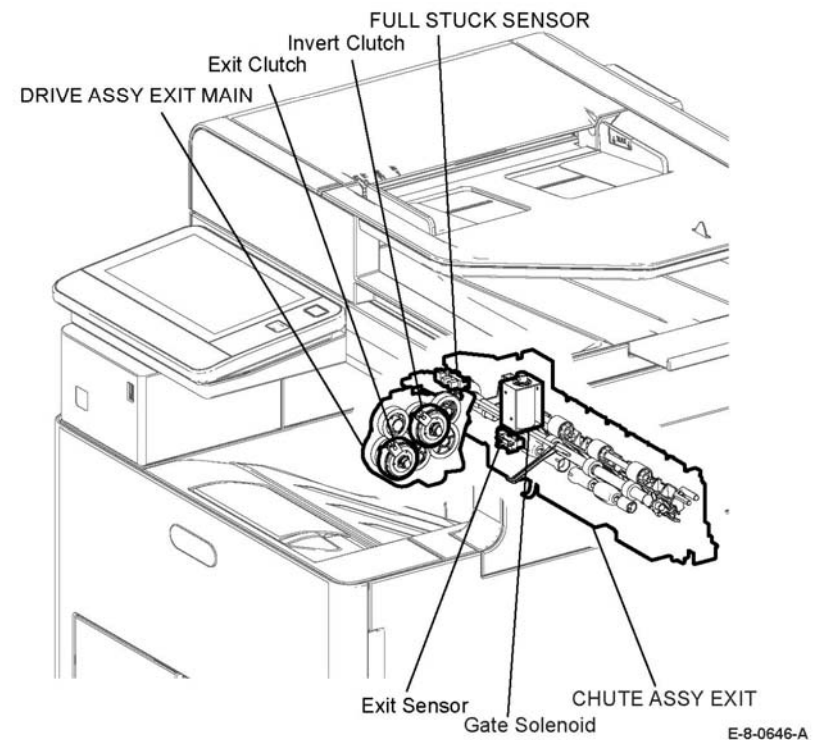
Figure 9 shows the exit function.

Figure 9 Exit Function

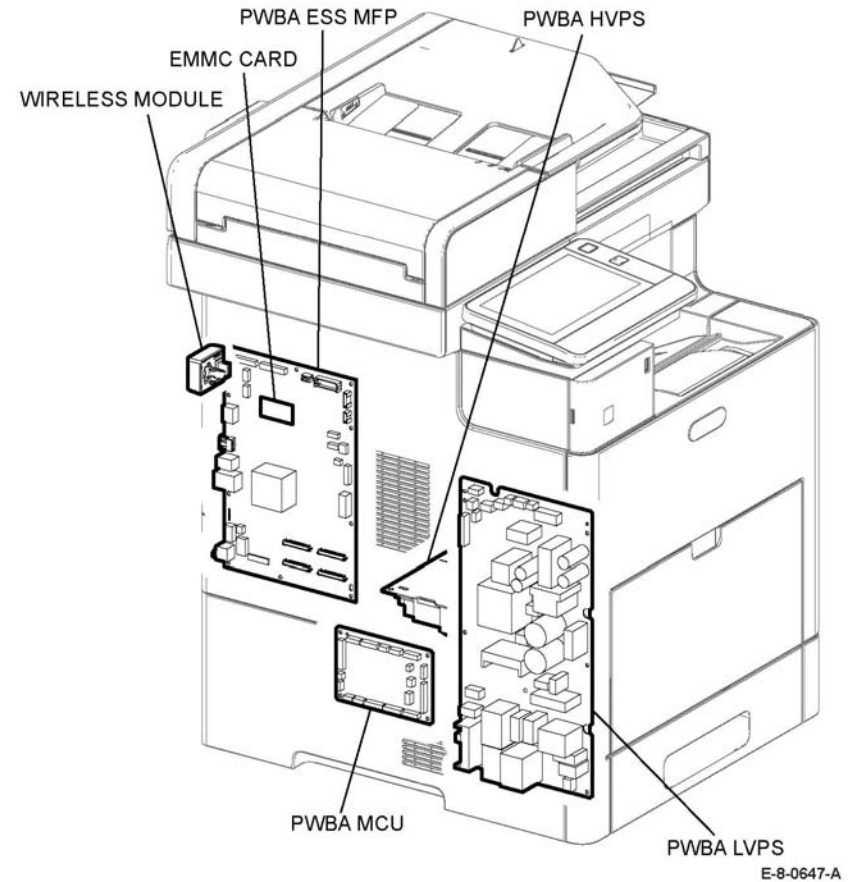
Figure 10 shows the electrical function. (MFP shown)

Figure 10 Electrical function

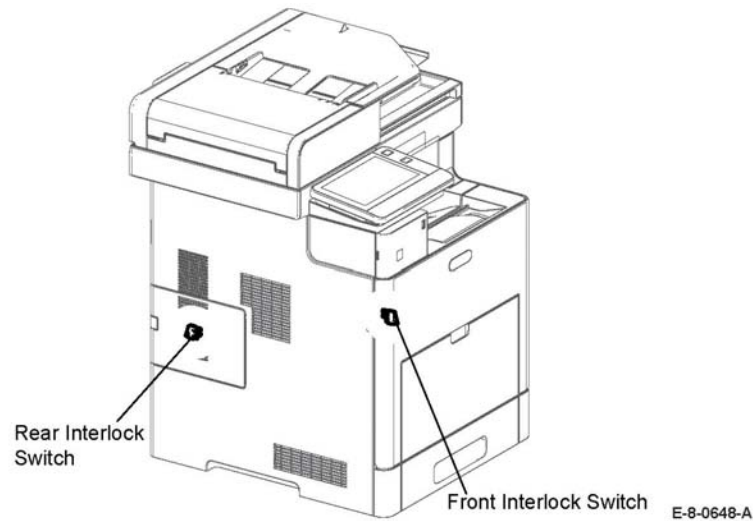
Figure 11 shows the interlock function.

Figure 11 Interlock function

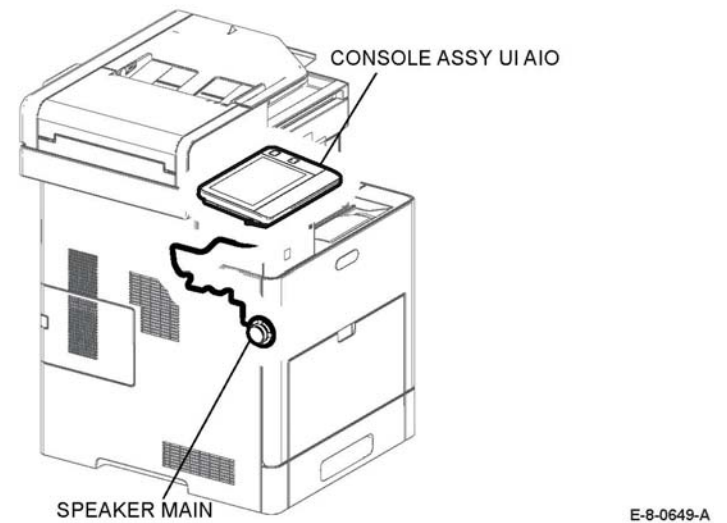
Figure 12 shows the UI function for the MFP standard printer.

Figure 12 UI function (B605/B615) MFP Std.

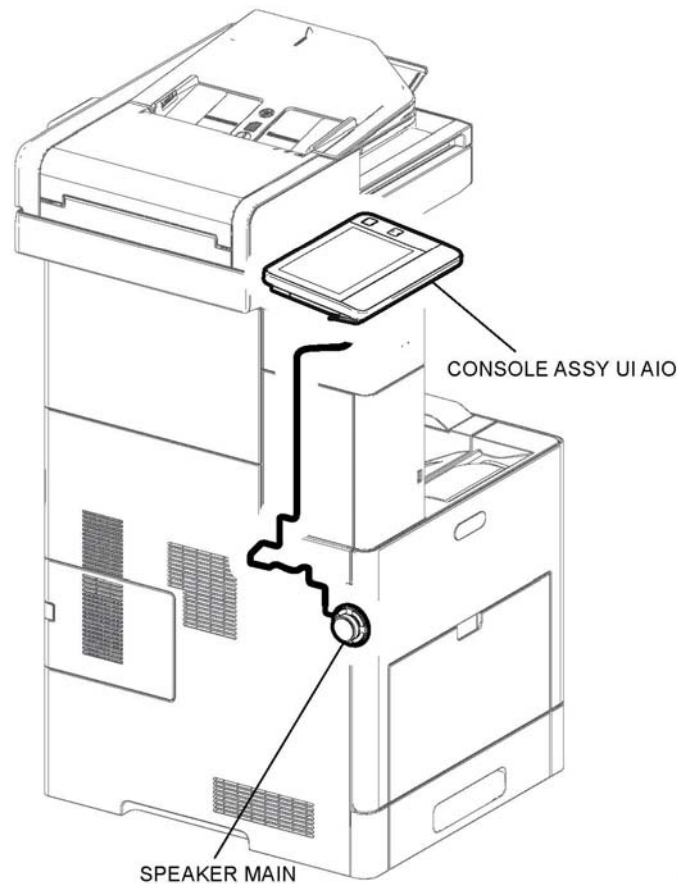
Figure 13 shows the UI function for the MFP\_Tall configuration.

Figure 13 UI function (B615) MFP\_Tall

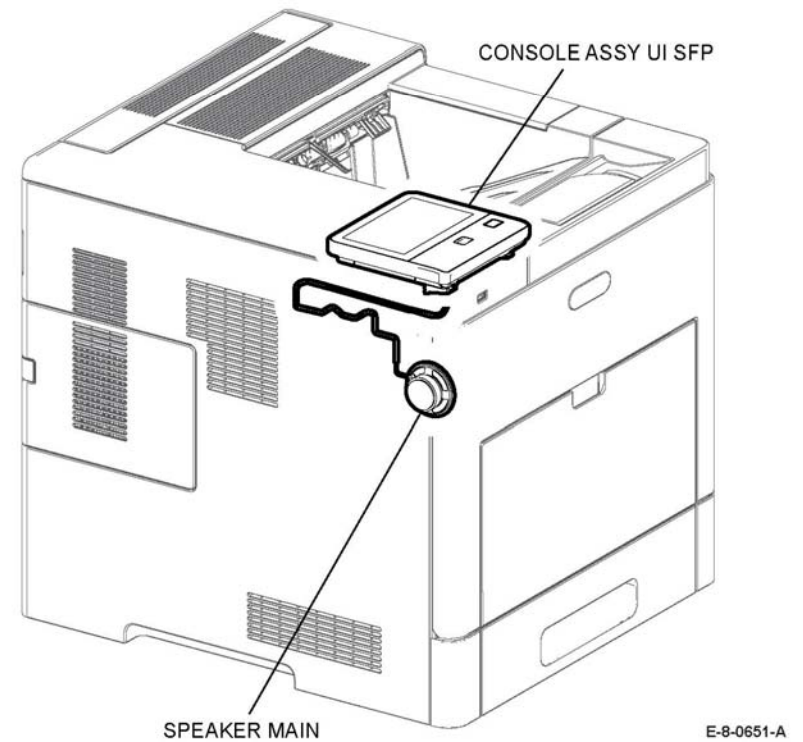
Figure 14 shows the UI function for the SFP.

Figure 14 UI function (B600/B610) SFP

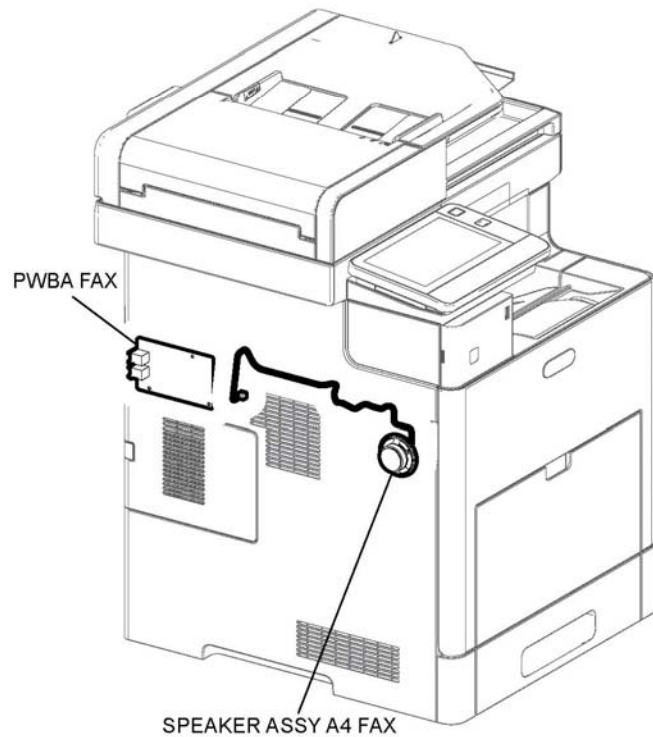
Figure 15 shows the fax function. (MFP standard shown)

Figure 15 Fax function (MFP Std.)

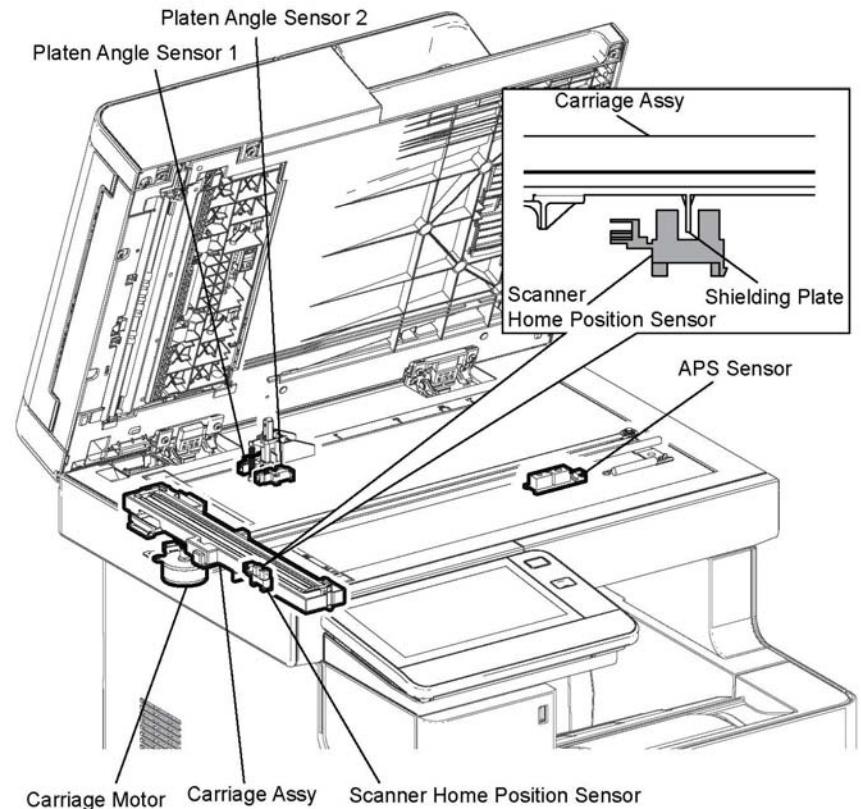
Figure 16 shows the scanner function. (MFP only)

Figure 16 Scanner IIT function (MFP)

- Platen angle sensor  
Detects whether the platen is open or closed.
- APS sensor  
Detects the document size on the platen glass.

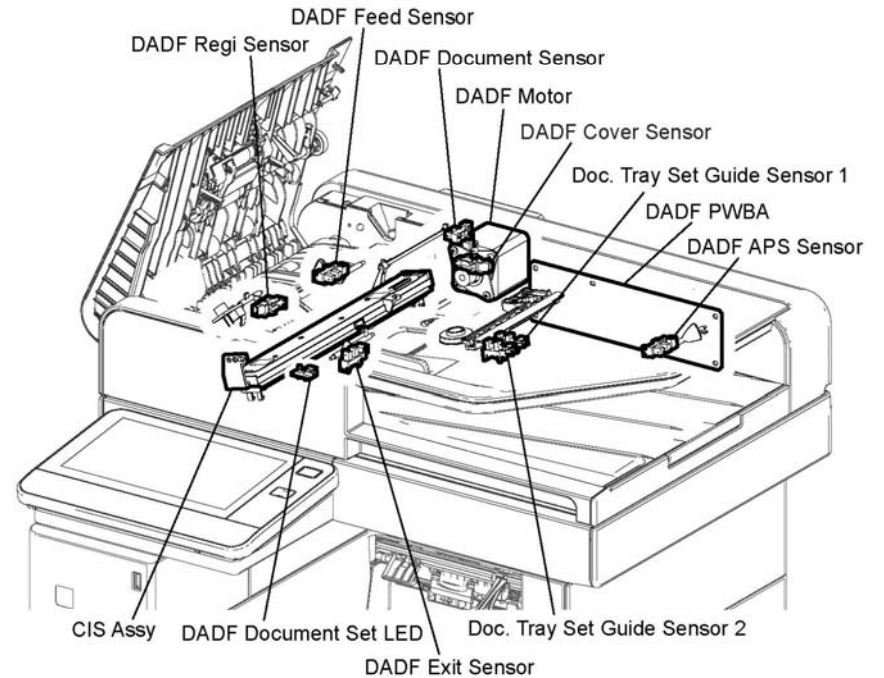
#### Scanner DADF Assembly Function (Figure 17 / PL 50.1 Item 1)

**Figure 17 Scanner DADF function**

- CIS array assembly  
Scans the image on the back side of the document in the duplex mode.
- DADF Board  
Controls the entire DADF system.
- DADF exit sensor  
Detects a sheet passing through the paper path around the exit.
- DADF Document set LED  
LED is on when a document is placed on the tray. LED is off when the document is removed
- Document tray set guide sensor 1/2  
Detects the paper width set on the DADF feeder, and turns on and off depending on position of the side guide.
- DADF APS sensor  
Detects the paper length set on the DADF feeder, and turns on and off depending on the position of the side guide.

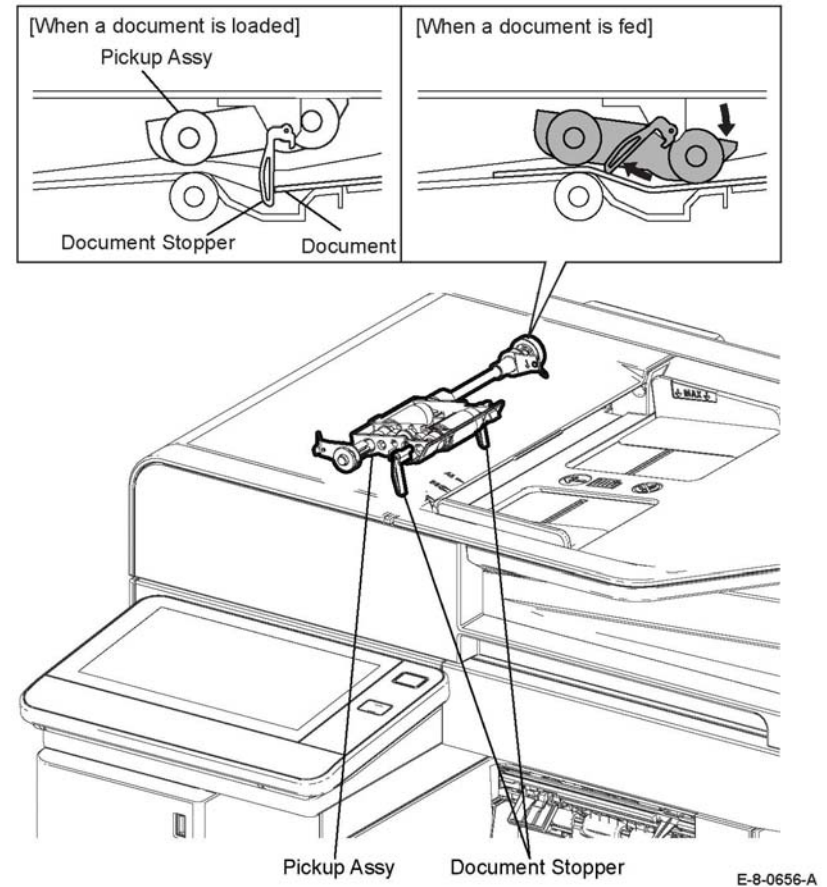
**Figure 18 Document stopper function**

- When a document is loaded in the DADF, the document stopper is locked to prevent the document from being moved forward.
- When the DADF starts feeding, the front portion of the pickup assembly is lowered. This unlocks the document stopper that blocks the document. When the document stopper is pressed by the lead edge of the document in the feed direction, the document is fed. When the paper feed is completed, the pickup assembly returns to its original position.

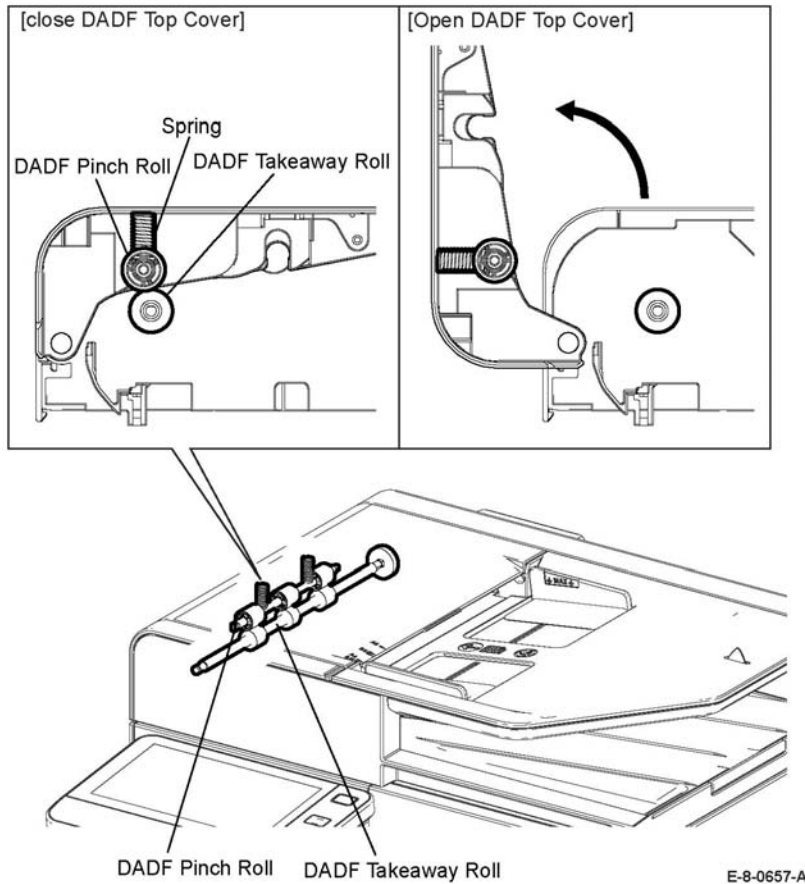
Figure 19 DADF Pinch roll function

- The DADF pinch roll is normally pressed against the direction of the DADF takeaway roll by the spring pressure. Documents are fed between the DADF pinch roll and the DADF takeaway roll to the CVT window by the rotation of the DADF takeaway roll. A document that jams between the DADF pinch roll and the DADF takeaway roll, is hard to retrieve due to the high spring pressure of DADF pinch roll. To retrieve jammed documents, open the DADF top cover to release the spring pressure. This creates clearance between the DADF pinch roll and the DADF takeaway roll.

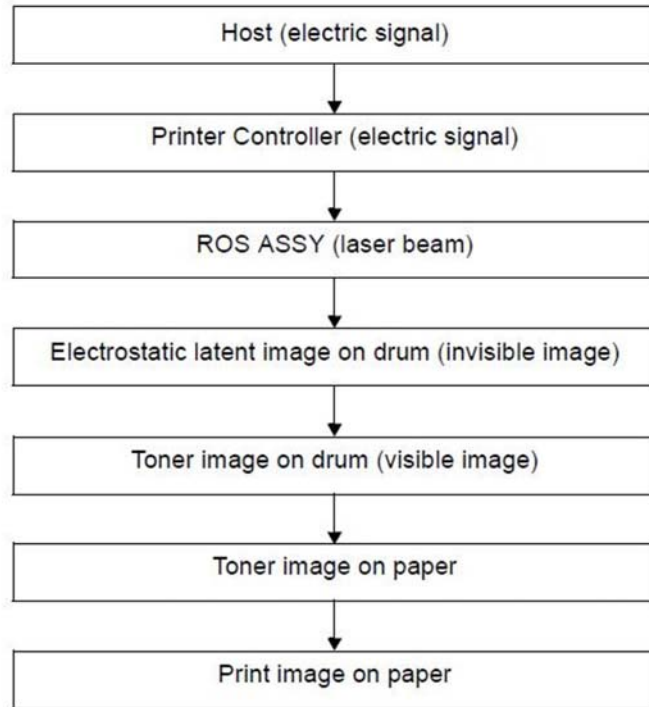
Figure 1 shows the flow of the print data (electric signal) from the printer controller as it becomes a printed image.

Figure 1 Data Flow (IOT)

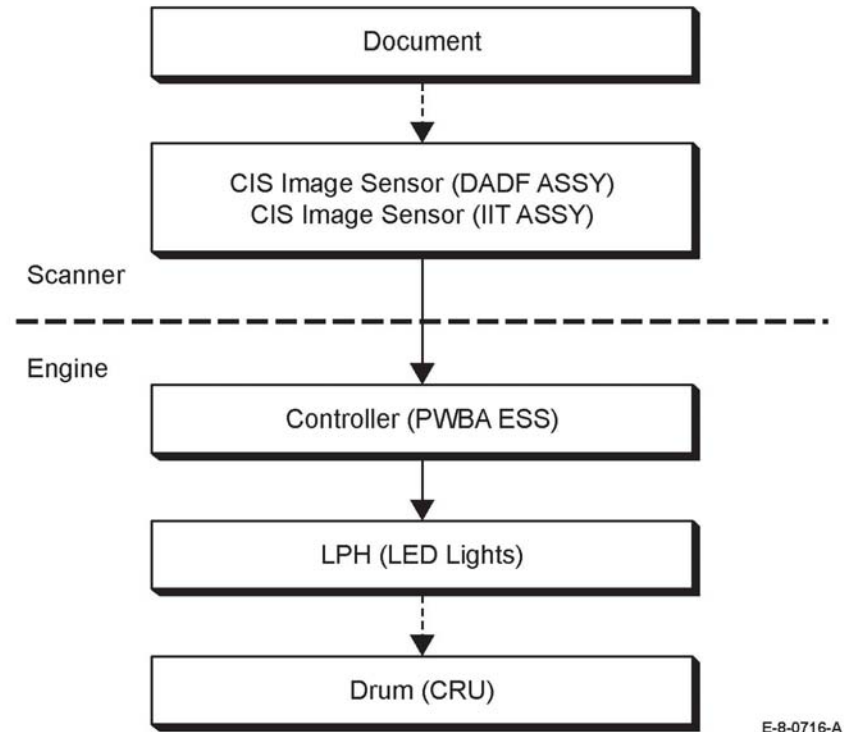
The image data from the document set on the IIT or DADF goes through the following components before it is printed at the engine. Refer to Figure 2.

Figure 2 Data Flow (Scanner)

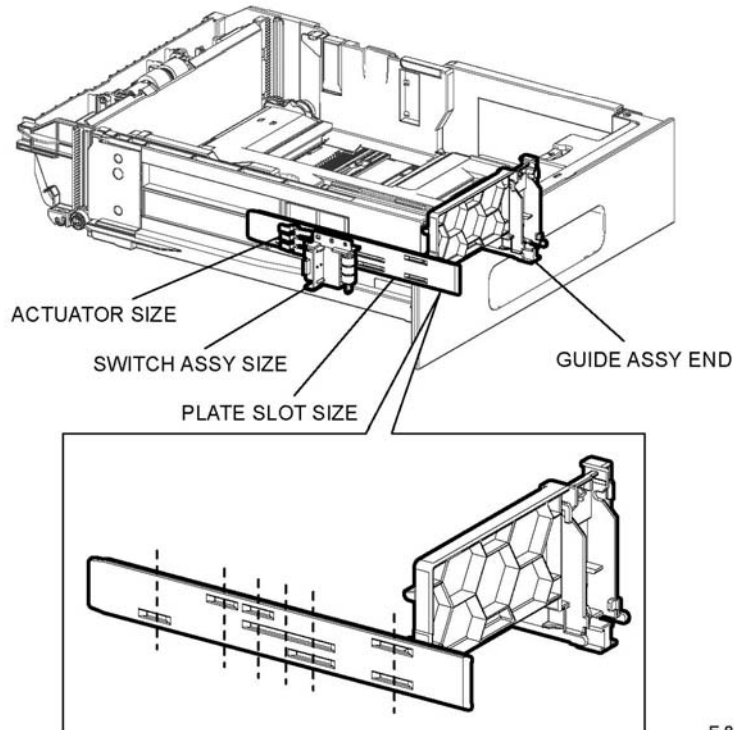
Load paper in the paper cassette, and adjust the left guide assembly, right guide assembly, and end guide assembly to the paper size. Linked with the end guide assembly, the position of the size slot plate is changed, and the three size actuators on the side of the cassette depress the size switch assembly. The detected paper size corresponds to the combination of actuators depressing the size switch. Refer to [Figure 1](#).

Figure 1 Option feeder size switch
