# VersaLink® B600/B610 Printer and B605/B615 Multifunction Printer Service Manual

Xerox® VersaLink® B600 Family MFP Service Manual

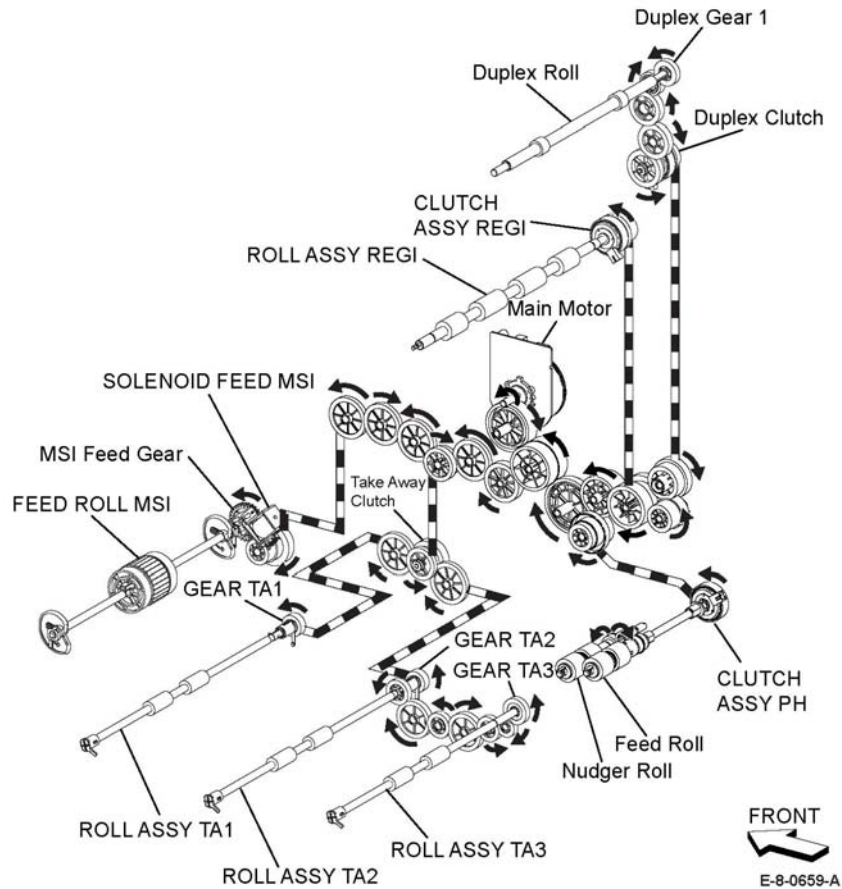
Figure 1 shows the drive transmission from the MSI section to the registration section, where the rolls and gears are driven by the main motor.

Figure 1 Paper feed (MSI to registration)

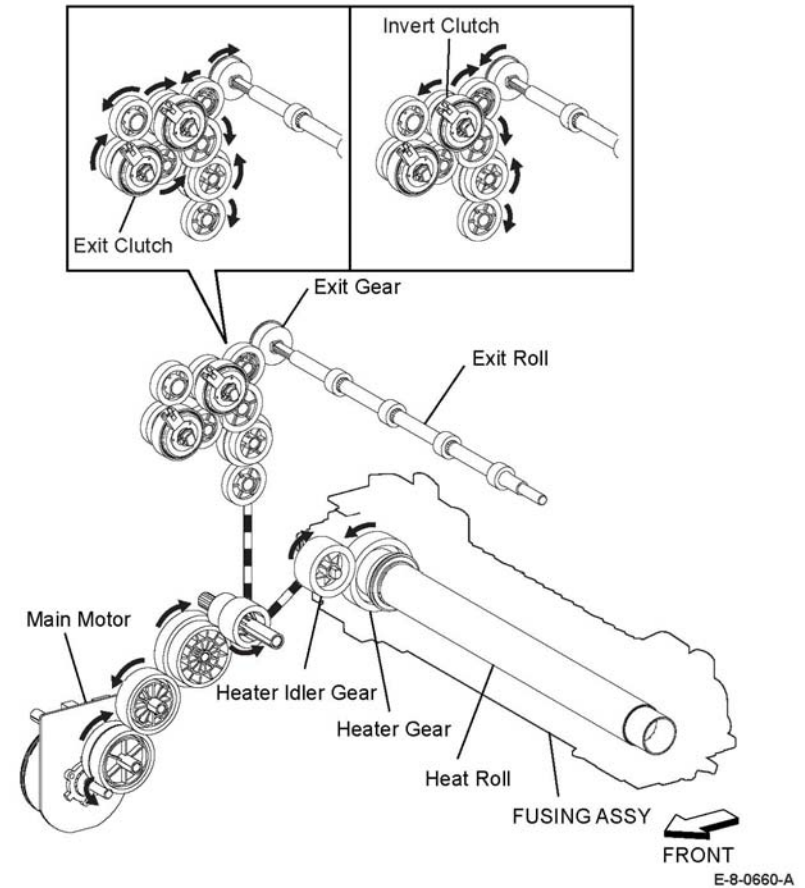
Figure 2 shows the drive transmission from the fuser section to the exit section where the rolls and gears are driven by the main motor.

Figure 2 Paper feed (fuser to exit)

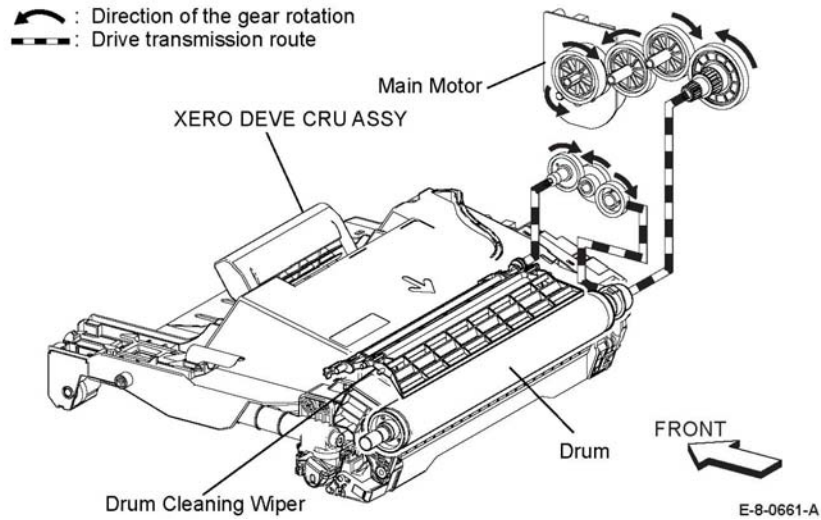
Figure 3 shows the drive transmission of the drum, where the rolls and gears are driven by the main motor.

Figure 3 Drum

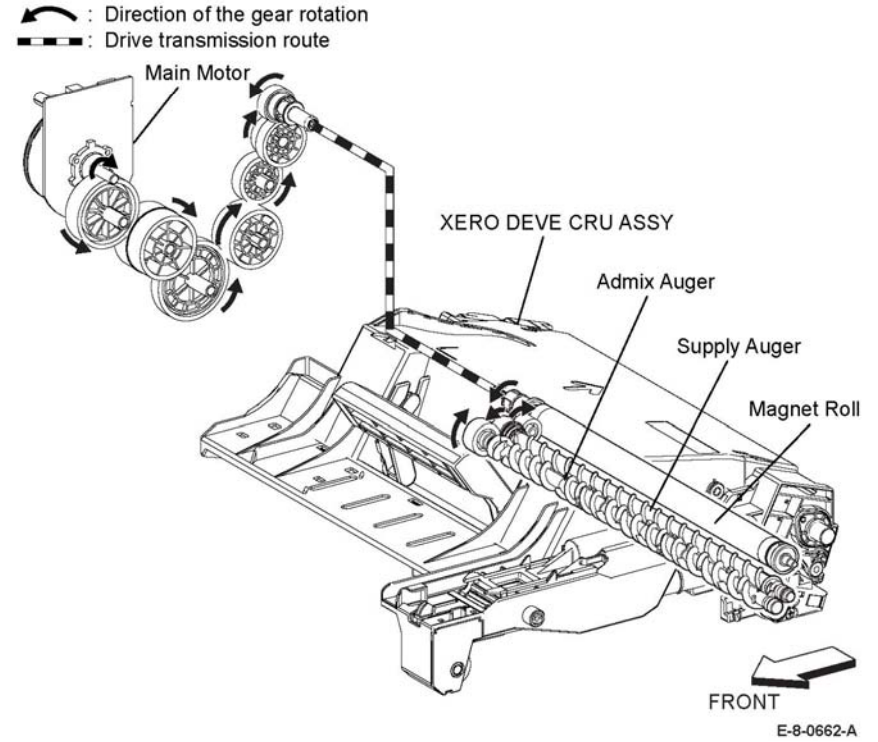
Figure 4 shows the drive transmission of the development feed components, where the rolls and gears are driven by the main motor.

Figure 4 Development feed

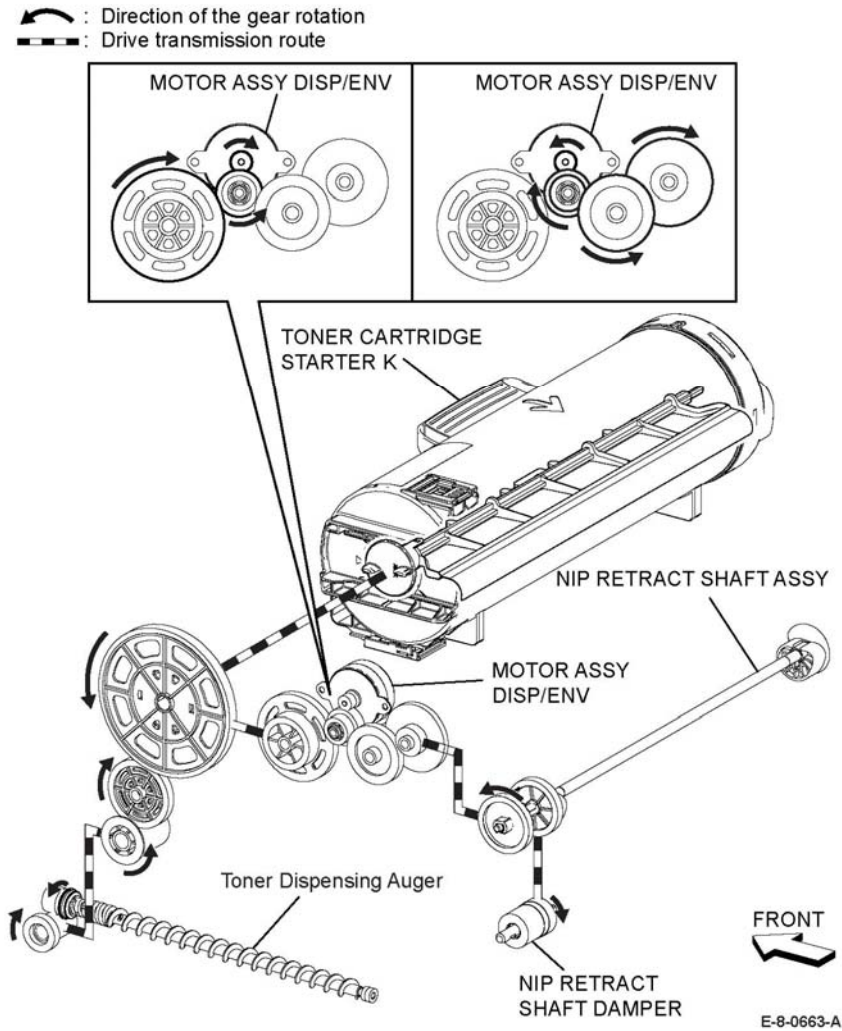
Figure 5 describes the drive transmission of the toner dispensing and nip retracting where the rolls and gears are driven by the motor assembly disp./env.

Figure 5 Toner dispensing and nip retracting

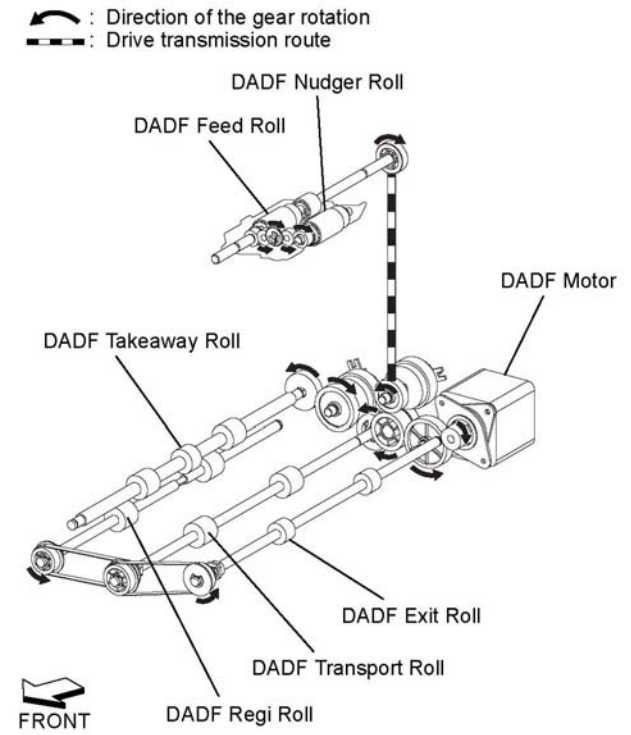
Figure 6 shows the drive transmission route from the DADF motor to each roller.

Figure 6 DADF motor

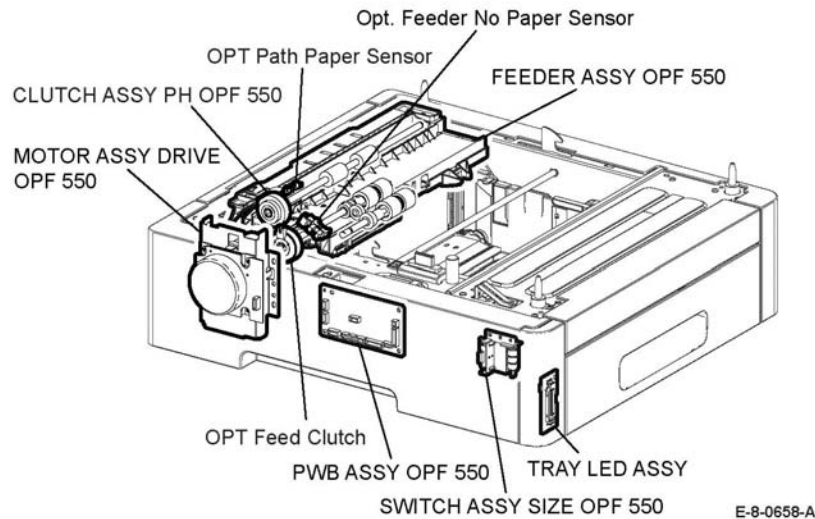
The options are documented in their respective installation instructions. Refer to [Figure 1](#) for the option feeder functions.

Figure 1 Option feeder functions

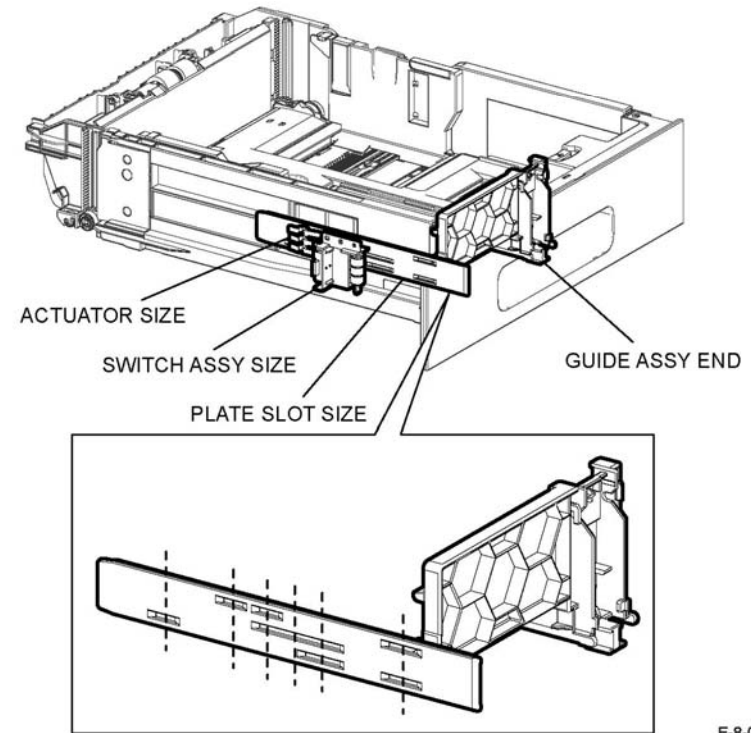
The option feeder size switch shown in [Figure 2](#), detects paper size, and presence or absence of paper in the 550 paper cassette.

Figure 2 Option feeder size switch
