708P91372
February 2017

Xerox® VersaLink® C400 Color Printer & C405 Color Multifunction Printer Service Manual

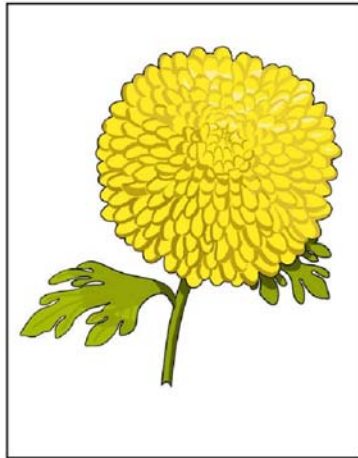
Figure 1 Undertone in one color

The overall image density for one color is too light, [Figure 1](#).

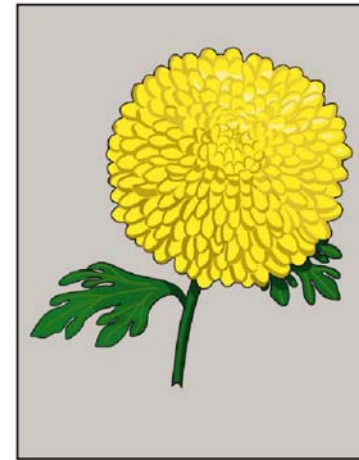
Figure 1 Background defect

There is toner contamination on all or part of the page, [Figure 1](#). The contamination appears as a very light single or multi-color dusting or fog.

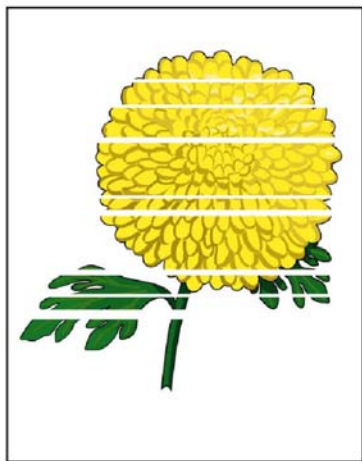
Figure 1 Horizontal bands

Use this procedure to correct defects that appear as areas of horizontal bands, [Figure 1](#).

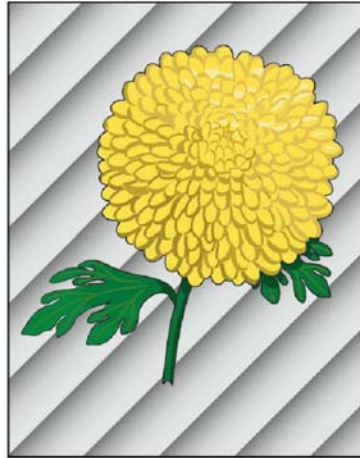
Figure 1 Auger marks

Auger marks appear across output, [Figure 1](#).

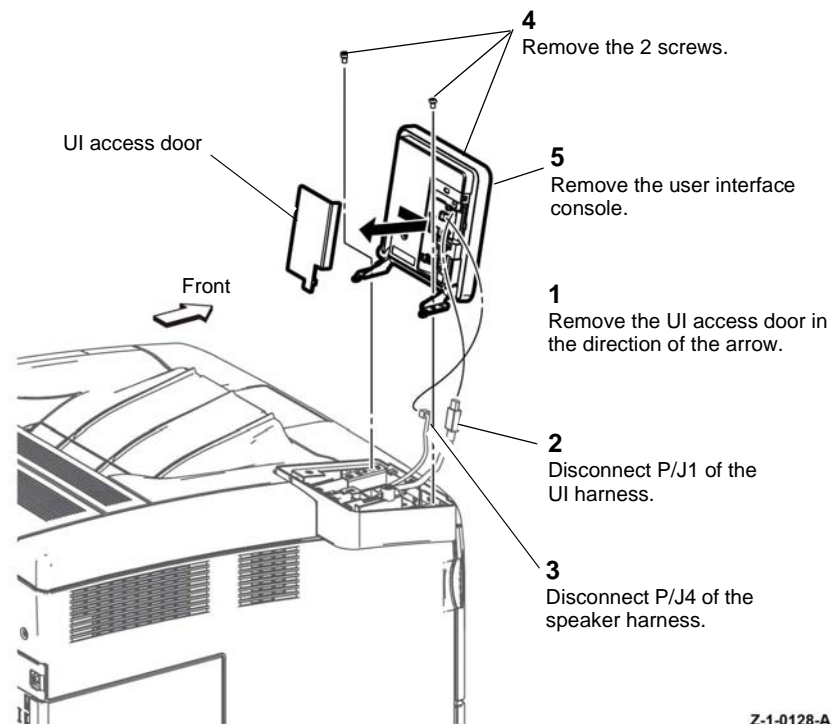
Figure 2 User interface console C400

2. Remove the user interface console, [Figure 2](#)

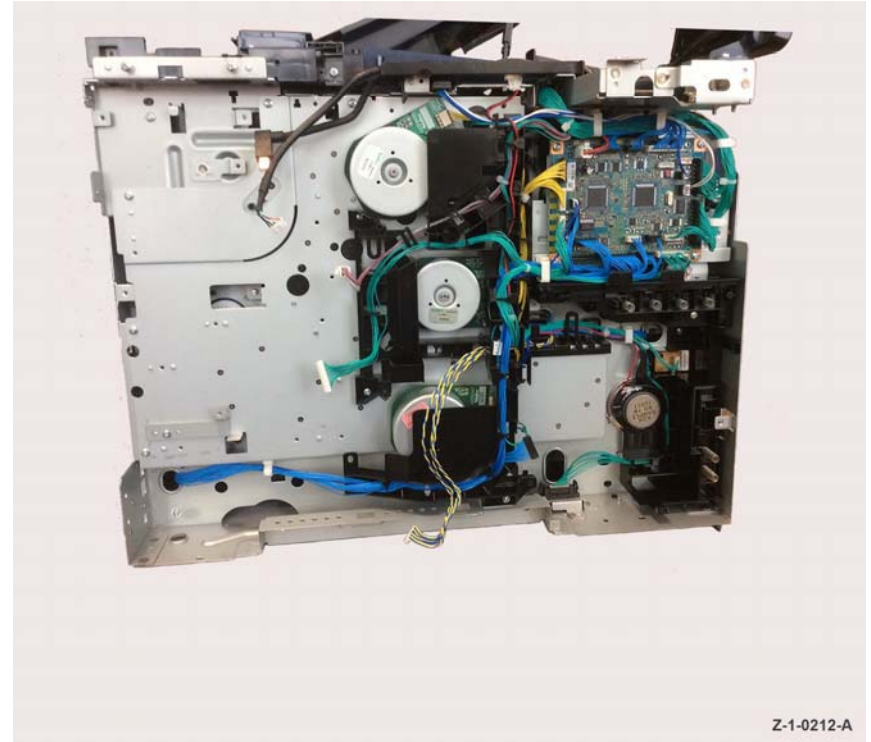
Z-1-0212-A

4. If necessary refer to [Figure 9](#) for routing of the harnesses.

Figure 9 Harness routing

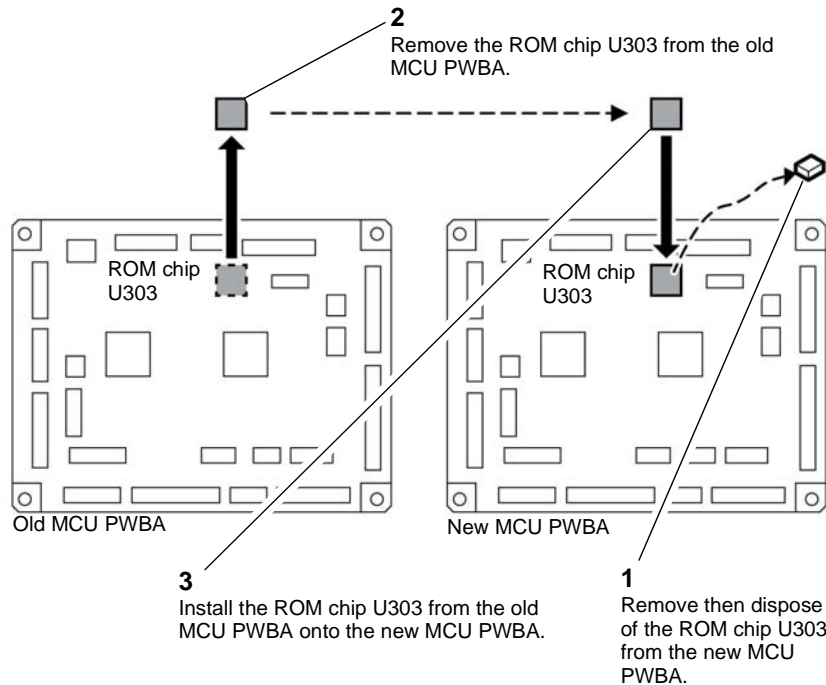
1. Replacement is the reverse of the removal procedure.
2. Before installing a new MCU PWBA, swap the ROM chip U303 from the old MCU PWBA for the ROM chip U303 on the new MCU PWBA, [Figure 3](#).

Figure 3 Swap the U303 ROM chip

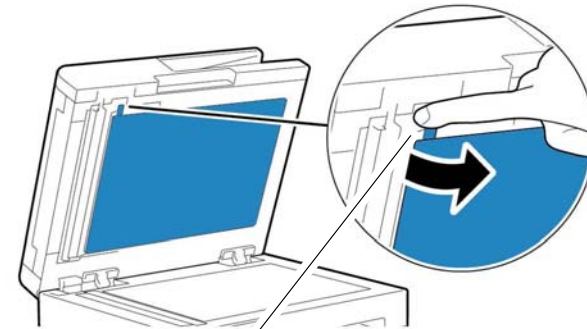
Z-1-0222-A

2. Prepare to clean the white reference strip of the side 2 scanner, Figure 2.

Pull the tab to open the DADF chute cover, then hold it open.

Figure 2 Open the DADF chute

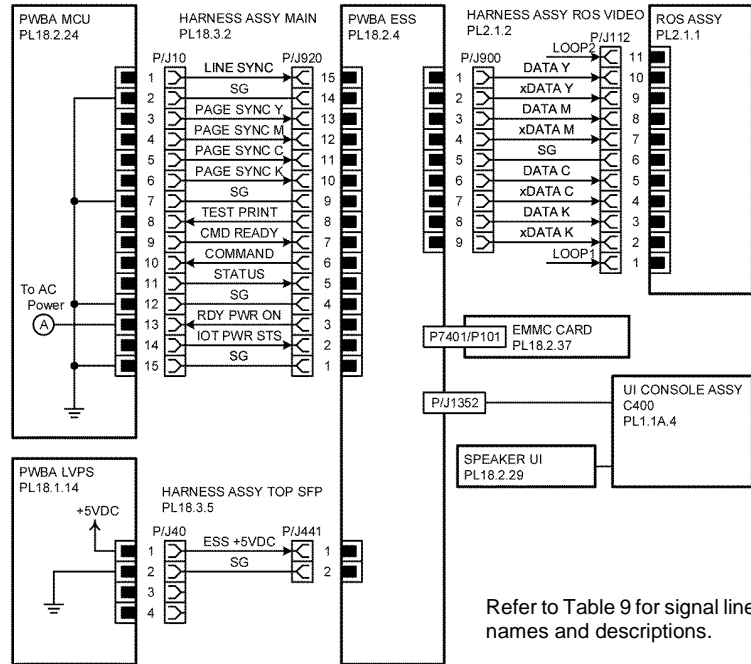
WD 10 Controller C400

Signal line name	Description
LINE SYNC PAGE SYNC Y PAGE SYNC M PAGE SYNC C PAGE SYNC K TEST PRINT CMD READY COMMAND STA- TUS RDY PWR ON IOT PWR STS	Control signal of the PWBA ESS
DATA Y xDATA Y DATA M xDATA M DATA C xDATA C DATA K xDATA K	Image data of each color (Y/M/C/K)

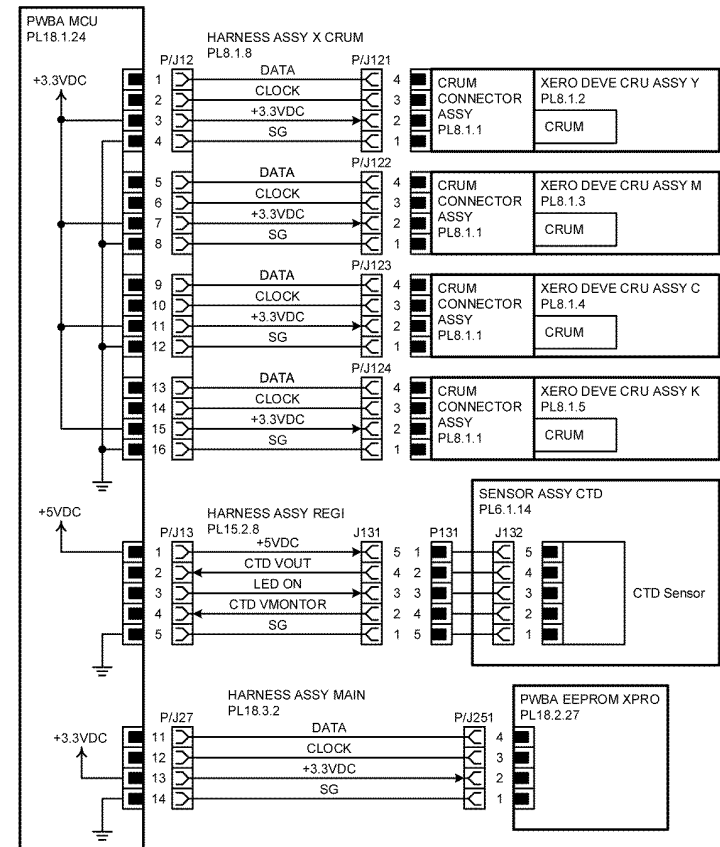
Figure 13 Wiring diagram 13

WD 13 Xerographics

Signal line name	Description
DATA	Control signal of the XERO DEVE CRU ASSY Y/M/C/K and the PWBA EEPROM
CLOCK	
CTD VOUT	Toner patch density data measured by the CTD Sensor
LED ON	LED lighting signal of the CTD Sensor
CTD VMONTOR	Voltage monitor signal of the CTD Sensor

Xerographics	Figure 13 Table 11	Wiring Diagram 13: Interconnection Wiring; Xerographics. Connections of Xero deve CRU ASSY Y with PWBA MCU. Connections of Xero deve CRU ASSY M with PWBA MCU. Connections of Xero deve CRU ASSY C with PWBA MCU. Connections of Xero deve ASSY K with PWBA MCU. Connections of CTD Sensor with PWBA MCU. Connections of PWBA EEPROM XPRO with PWBA MCU.
Developer	Figure 14 Table 12	Wiring Diagram 14: Interconnection Wiring; Developer. Connections of toner cartridge Y with PWBA MCU. Connections of toner cartridge M with PWBA MCU. Connections of toner cartridge C with PWBA MCU. Connections of toner cartridge K with PWBA MCU. Connections of toner dispense motor (Y, M) with PWBA MCU. Connections of toner dispense motor (C, K) with PWBA MCU. Connections of front cover sensor with PWBA MCU.
Exit	Figure 15 Table 13	Wiring Diagram 15: Interconnection Wiring; Exit. Connections of exit sensor with PWBA MCU. Connections of stack full sensor with PWBA MCU. Connections of exit Clutch 1 with PWBA MCU. Connections of exit Clutch 2 with PWBA MCU.

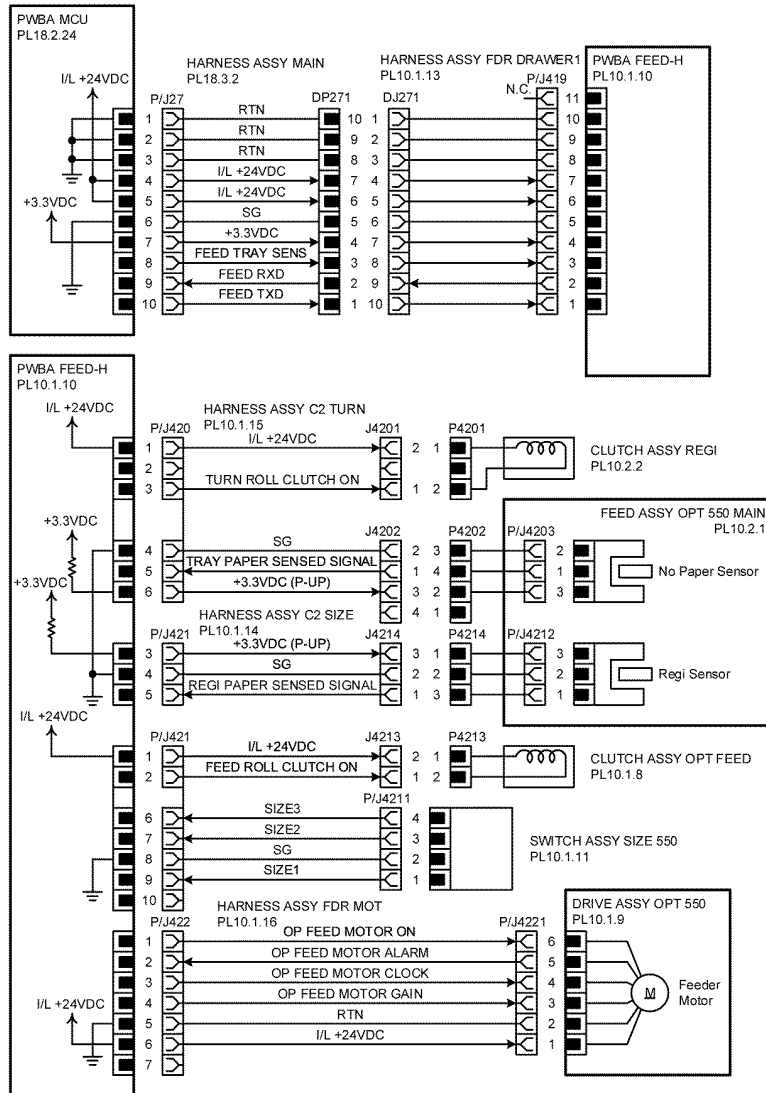
Figure 16 Wiring diagram 16

Signal line name	Description
FEED TRAY SENSFEED RXDFEED TXD	Control signal of the PWBA FEED
TURN ROLL CLUTCH ON	ON/OFF signal of the Turn Roll Clutch
TRAY PAPER SENSED SIGNAL	Detect signal of paper inside the optional tray by the C2 No Paper Sensor
REGI PAPER SENSED SIGNAL	Detect signal of paper in the Registration section of the optional tray by the C2 Regi Sensor
FEED ROLL CLUTCH ON	ON/OFF signal of the C2 Feed Clutch
SIZE3SIZE2SIZE1	Detect signal of a paper size inside the optional tray by the SWITCH ASSY SIZE
OP FEED MOTOR ONOP FEED MOTOR ALARMOP FEED MOTOR CLOCKOP FEED MOTOR GAIN	Drive control signal of the Option Feeder Motor

Optional 550 cassette	Figure 16 Table 14	Wiring Diagram 16: Interconnection Wiring; 550 Feeder. Connections of feeder PWBA with PWBA MCU. Connections of registration clutch assembly with 550 Option feeder PWBA. Connections of 550 Option main feed assembly with 550 Option feeder PWBA. Connections of 550 Option feed clutch assembly with 550 Option feeder PWBA. Connections of 550 Option size switch assembly with 550 Option feeder PWBA. Connections of 550 Option drive assembly with 550 Option feeder PWBA.
Scanner	Figure 17	Wiring Diagram 17: Interconnection Wiring; Scanner. Connections of scanner assembly with PWBA ESS. Connections of scanner assembly with UI console. Connections of PWBA ESS with PWBA USB HUB. Connections of UI console with PWBA USB HUB.

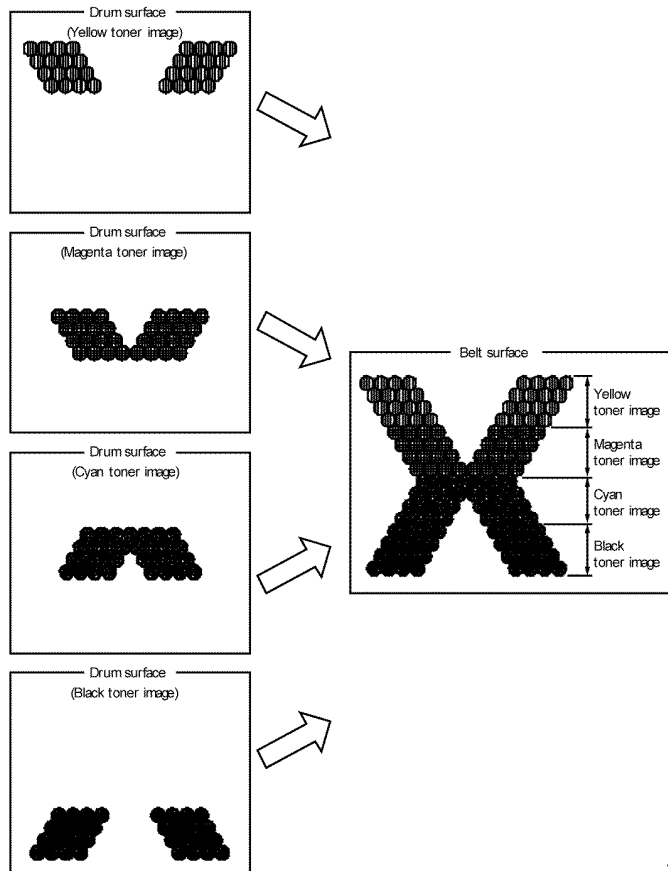
Figure 9 Drum to IBT transfer

The 1st BTR is a metal roll, to which the positive voltage from the High Voltage Power Supply (HVPS) is applied. The 1st BTR positively charges the backside of the IBT with the voltage generated by the contact resistance with the IBT. The toner images on the drums are transferred to the IBT due to the attracting force generated between the negative polarity of the toner image and the positive polarity on the IBT, [Figure 9](#).

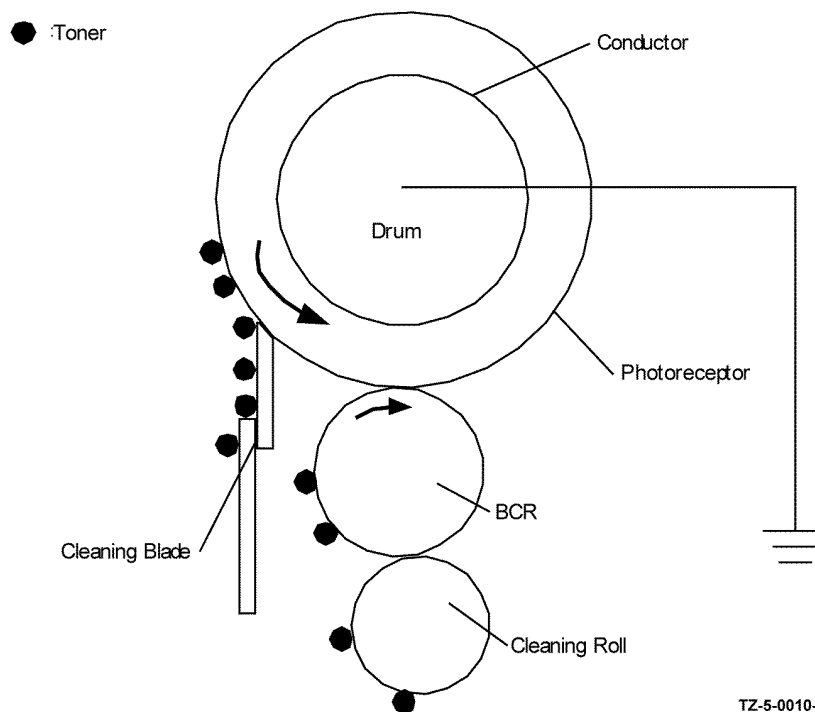
Figure 10 Drum and BCR cleaning

The remaining toner is roiled by a cleaning roll (made of spongy material) in contact with the BCR surface, and then collected to the drum. The toner returned to the drum is scraped off by the drum cleaning blade, [Figure 10](#).

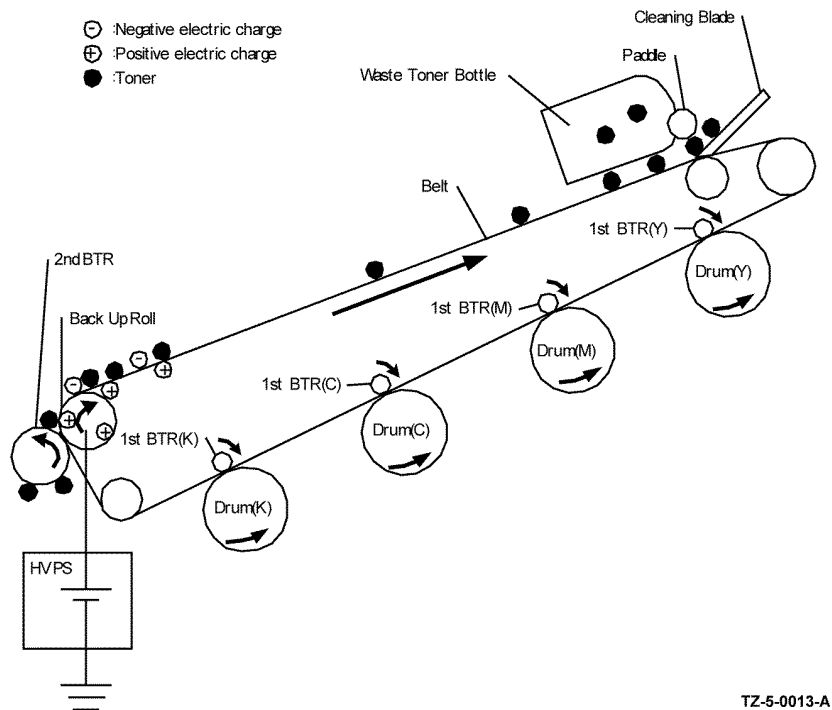
The excess toner deposited on the 2nd BTR in the secondary transfer process soils the back-sides of the subsequent sheets. To prevent this trouble, the excess toner on the 2nd BTR is transferred back onto the IBT using the attracting force generated by the back up roll. The back up roll is positioned opposite the 2nd BTR and is positively polarized by DC voltage from the HVPS. The excess toner remaining on the IBT is scraped off by the belt cleaning Blade that is in contact with the IBT, and is then collected into the waste box assembly, **Figure 13**. Refer to **NOHAD & Waste Toner**.

Figure 13 IBT and 2nd BTR cleaning

The excess toner that was not transferred to the print medium in the secondary transfer process remains on the IBT surface. To prevent the excess toner from causing trouble in the subsequent processes, the toner is scraped off by a cleaning blade in contact with the IBT surface, and then is collected into the waste box assembly, refer to [Figure 13](#).

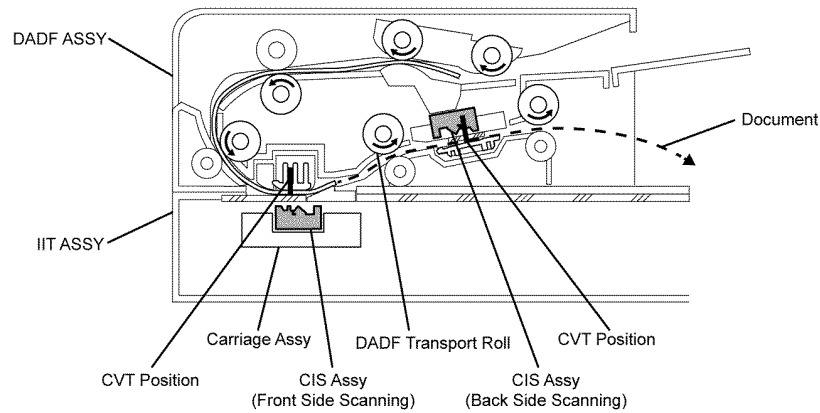
As documents are fed at a speed corresponding to the set magnification a Contact Image Sensor (CIS) assembly in the IIT reads the front of the document, and a CIS assembly in the DADF reads the back of the document. These two scanning parts are arranged so as to interpose the paper path from both sides, and this allows both sides of the document to be scanned without rotation, [Figure 2](#).

Document feeding starts from the document feeder tray of the DADF. As the DADF nudger roll and the DADF feed roll rotate a document is nipped and then fed between the DADF feed roll and the retard pad into the DADF document path. The document continues transportation via the DADF takeaway roll. Aligned by the DADF regi roll the document is then transported over the CVT (Constant Velocity Transport) window of the IIT, allowing the reflected image to be scanned (simplex image) by the CIS assembly mounted on the carriage assembly that is stationed in the scanner home position. The document is then transported via the DADF transport roll and DADF exit roll passed the CIS assembly within the DADF (for duplex images the back of the document is scanned at this point via this CIS assembly) to the DADF document output tray. All DADF rolls are rotated by torque from the DADF motor, [Figure 2](#).

Figure 2 DADF scanning

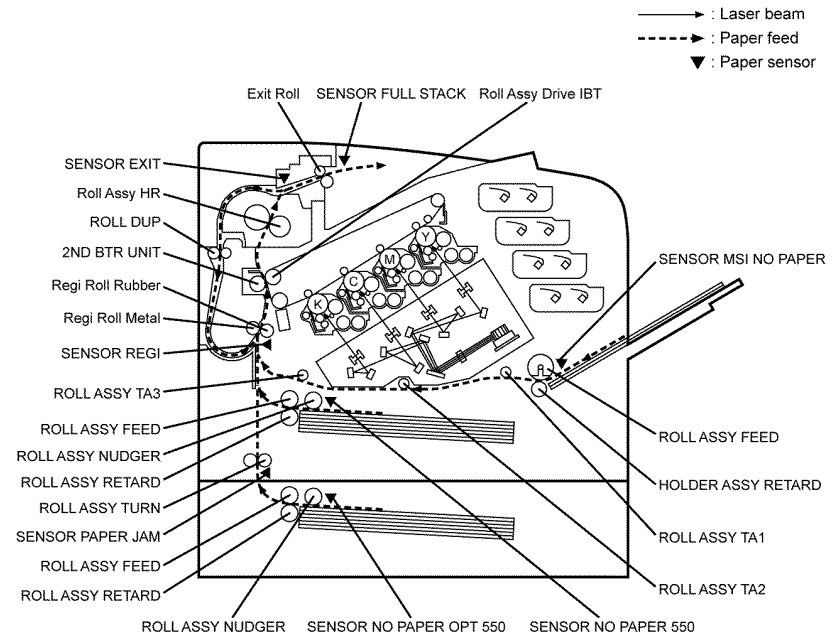
[Figure 1](#) illustrates the paper feed layout with the 550 optional cassette assembly installed, and the components relevant to paper feed.

Figure 1 Paper path

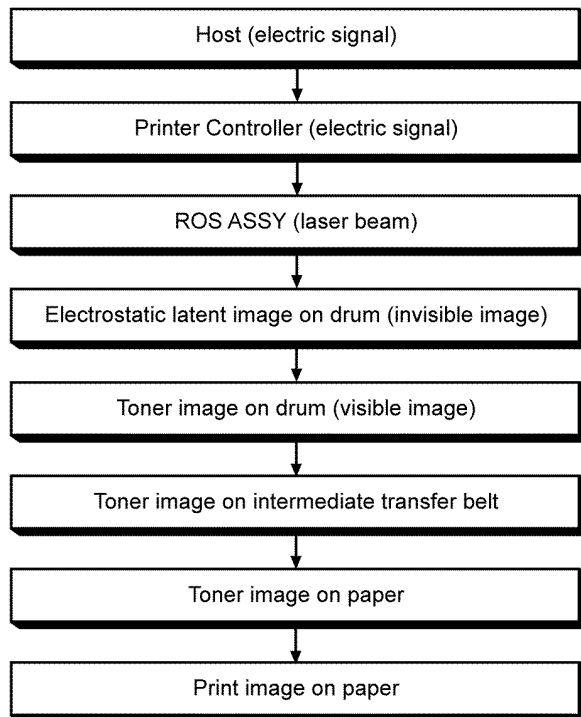
TZ-5-0046-A

The print data (electrical signals) from the print controller flows as shown below before it is turned into a print, [Figure 1](#).

Figure 1 Print data flow
