VersaLink[®] C8000/C9000 Printer

Service Manual

VersaLink C9000 Family Service Manual

705P01418

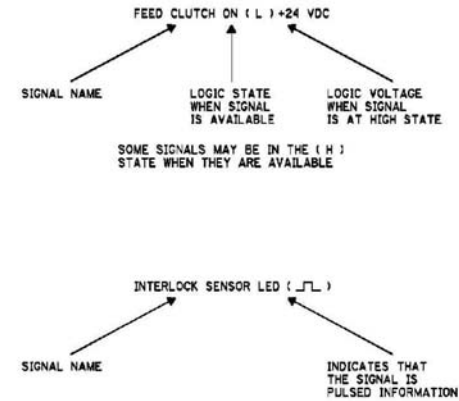
TF-1-0629-A

[Figure 1](#) shows the signal nomenclature used in the BSDs.

Figure 1 Signal Nomenclature

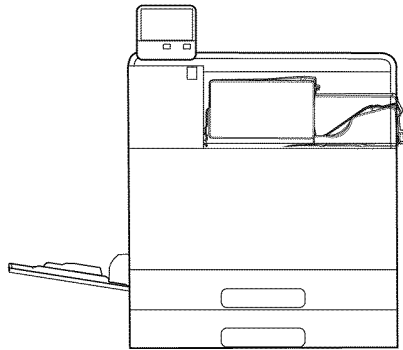
F-1-0631-A

Figure 1 Desktop printer

- Xerox® VersaLink® C8000/C9000 desktop, [Figure 1](#).
- Xerox® VersaLink® C8000/C9000 with 2TM and office finisher LX, [Figure 2](#).
- Xerox® VersaLink® C8000 with HCF, TTM and office finisher LX with booklet maker, [Figure 3](#).

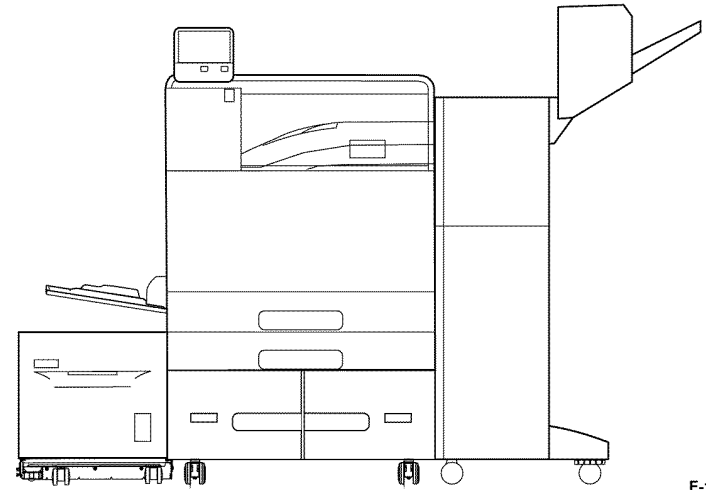
F-1-0633-A

Figure 3 With HCF, TTM and LX finisher with booklet maker

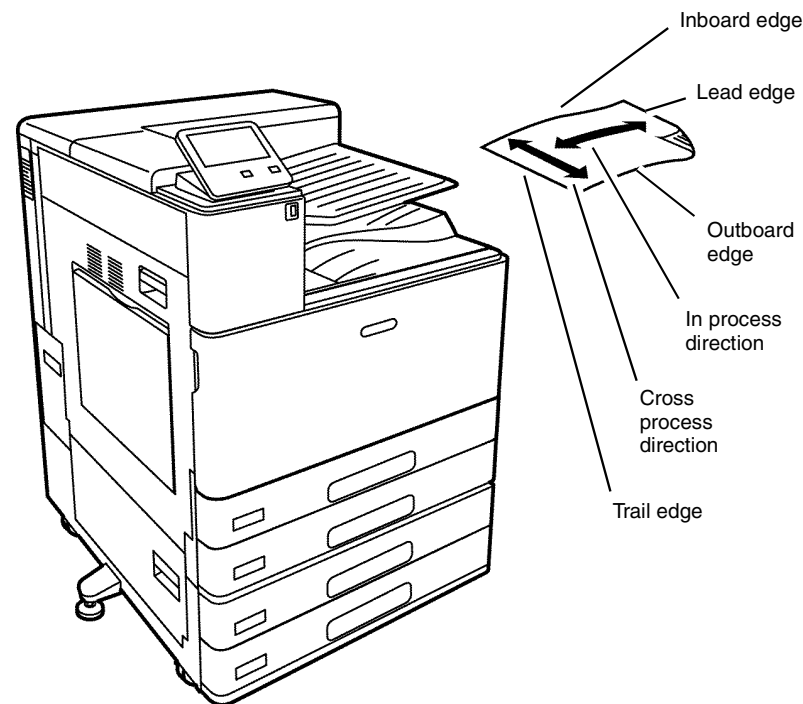
F-1-0634-A

Figure 1 Print definitions

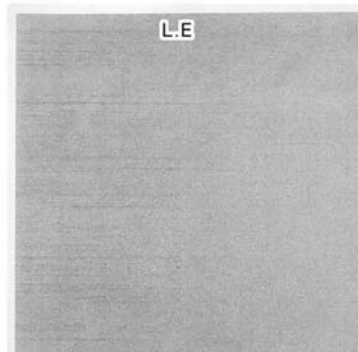
F-1-0635-A

Perform this RAP if dark lines appear in the cross process direction on half-tone images. This is a unique phenomenon of a charged DC by BCR. Refer to [Figure 1](#).

Figure 1 Example

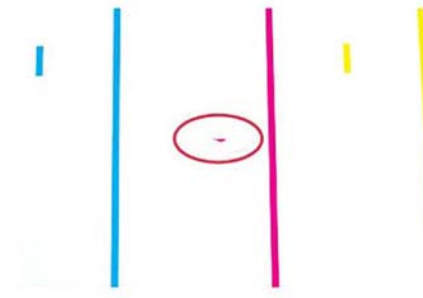
F-1-0636-A

Perform this RAP if the prints have contamination consisting of random spatters of toner in sizes of a few millimeters. Refer to [Figure 1](#).

Figure 1 Example

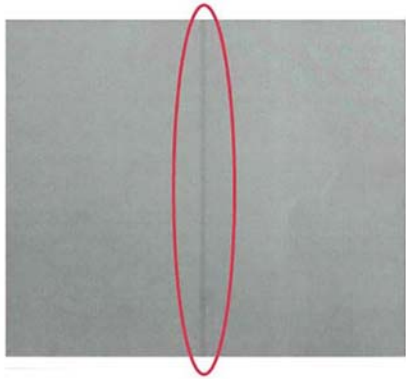
F-1-0637-A

This change in speed changes the difference in relative speed between the photoreceptor and the IBT belt surface in the K-color primary transfer section, hence creating a smear (distorted image). This occurs in the BW mode for heavyweight paper

Figure 1 Example

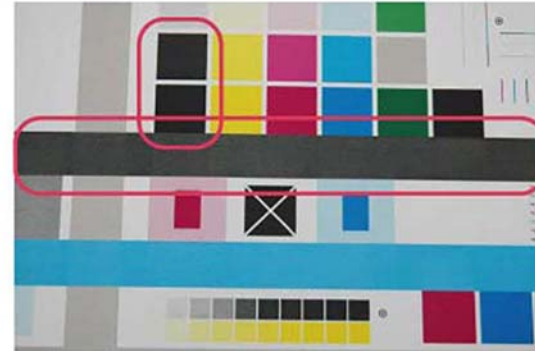
F-1-0638-A

Perform this RAP if blacks appear poor. When apparent on paper that is not flat or has poor hue, the toner may not have been transferred properly due to the irregular paper surface, creating a rough transferred image. This occurs in modes other than transparencies Refer to [Figure 1](#).

Figure 1 Example

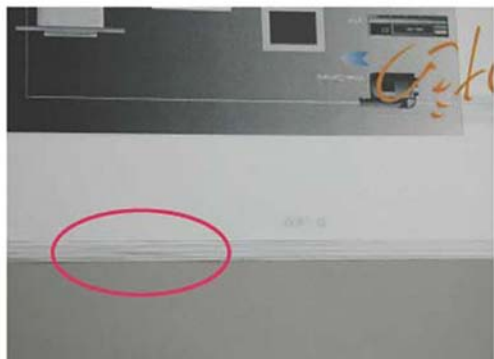
F-1-0639-A

- Lead Edge: Paper lead edge contacts the belt when it is transported from registration to Transfer.
- Trail Edge: The tail edge of paper that loops between the transfer-fusing sections, at the release of the secondary transfer nip, moves opposite to the feed direction and contacts the BTR surface, or bounds up and contacts the belt

Figure 1 Example

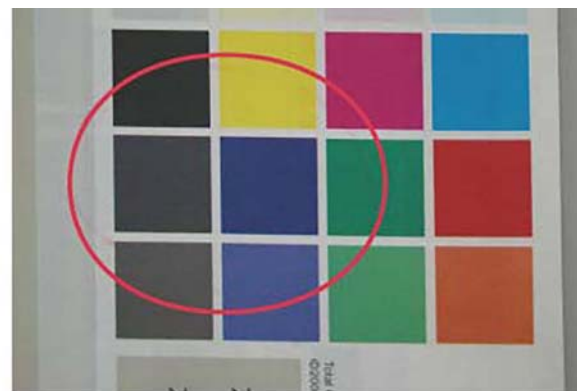
F-1-0640-A

Since the resistance in the secondary transfer section also increases by lower humidity or over time, the required electrical field may not be attained, especially in the early mornings (low humidity environment).

Figure 1 Example

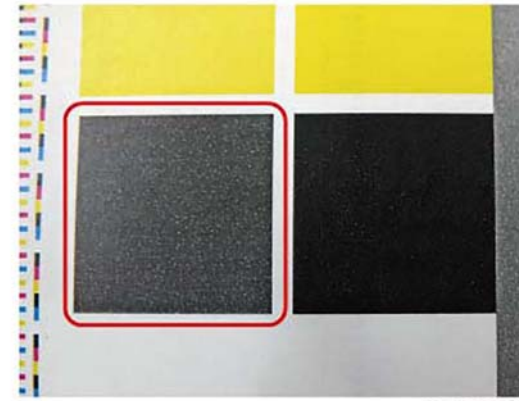
Perform this RAP if side 2 has small white spots. In the early morning of a low humidity environment, the resistance of the secondary transfer is high. Refer to Figure 1.

Figure 1 Example

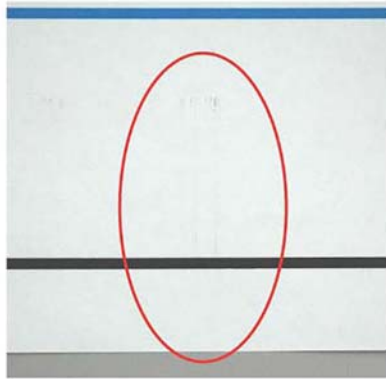
F-1-0642-A

At Cin50% and Cin30%, the lines in the process direction have reversed black and white colors. Width is approximately 1mm. Refer to [Figure 1](#).

Figure 1 Example

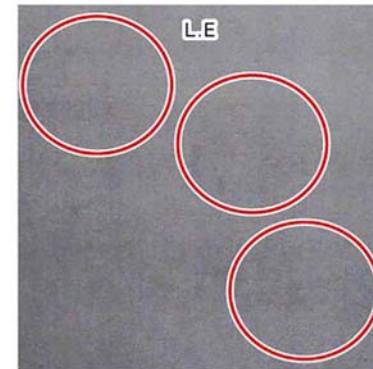
F-1-0643-A

If the adhesion of the toner to the paper is weak and the amount of electricity removal is big, the toner scatters and a round shaped pattern appears continuously in the vertical direction.

Figure 1 Example

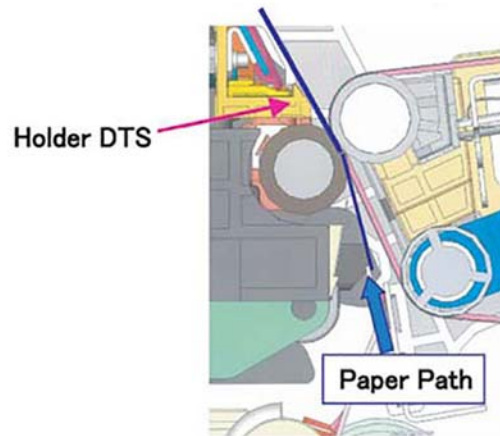
F-1-0644-A

Figure 1 Paper path

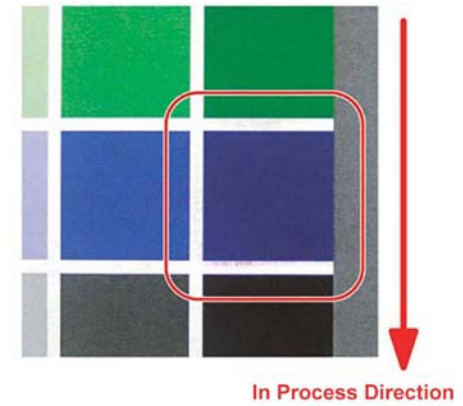
F-1-0645-A

Figure 2, Heat haze example.

Figure 2 Heat haze example

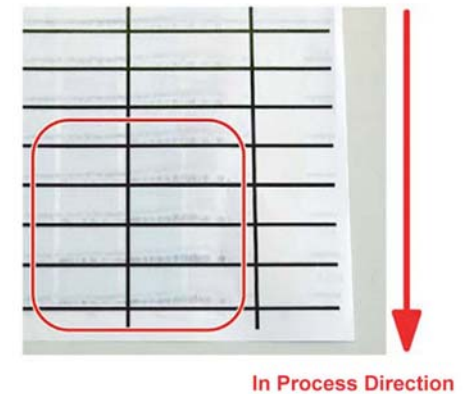
F-1-0646-A

Figure 3, Mock heat haze (line/text image).

Figure 3 Mock heat haze example: line/text

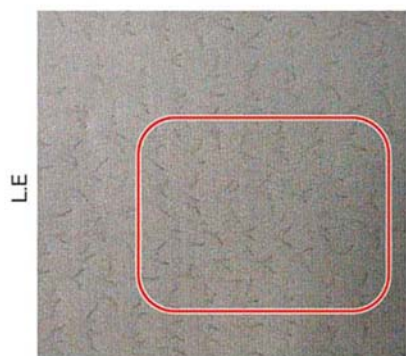
F-1-0647-A

Figure 4, Mock heat haze (halftone image).

Figure 4 Mock head haze example: halftone

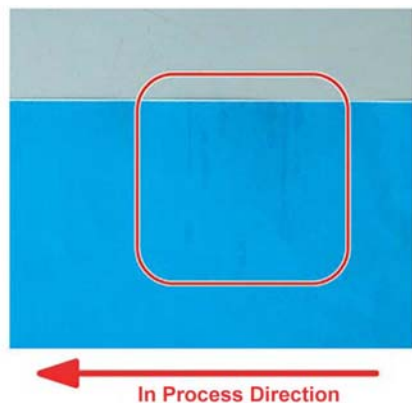
F-1-0648-A

As system resistance of the primary transfer is high, the charge voltage of the primary transfer to the toner on the Photoreceptor is increased, causing kiss-shaped discharge marks. Refer to Figure 1.

Figure 1 Example

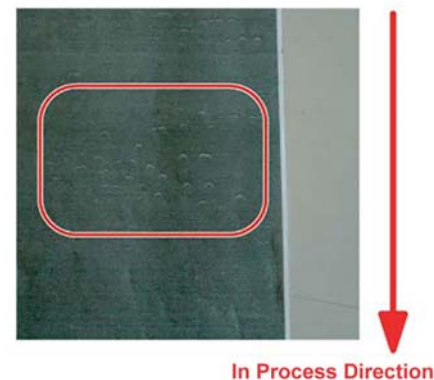
F-1-0649-A

Perform this RAP when the prints have a semicircular arc pattern. Refer to Figure 1.

Figure 1 Example

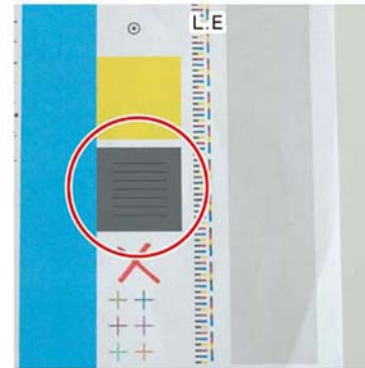
F-1-0650-A

Transfer defect occurred due to lack of electric charge in the toner before the secondary transfer.

Figure 1 Example

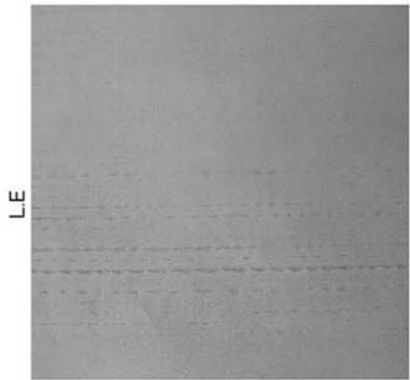
F-1-0651-A

The paper loop amount between the secondary transfer and fusing unit is large, and the rib of the holder DTS is friction-charged by being strongly rubbed against, and toner is attracted by static, causing streaks to be generated at intervals of the rib pitch.

Figure 1 Example

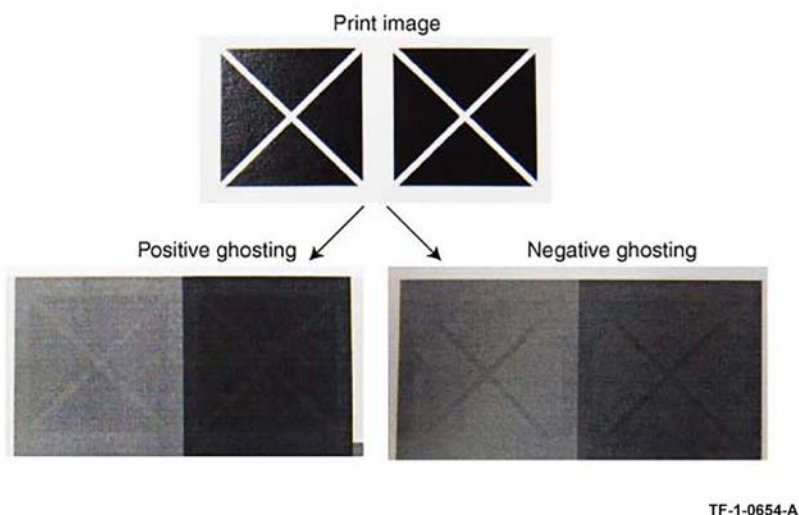
As DC charging has weak charging capability compared to AC charging, ghosting may worsen with the environment or paper. Refer to [Figure 1](#).

Figure 1 Example

Positive ghosting: The print appears darker after halftone of one rotation (94.5mm/3.7 inches) of the photoreceptor.

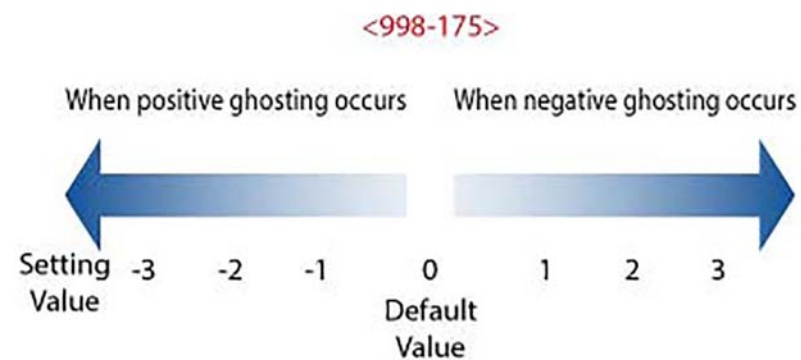
1. Enter [dC612](#) Print Test Pattern. Print a suitable test pattern. Identify if the ghosting is positive or negative.
2. Refer to [Figure 2](#). Enter [dC131](#). Perform the steps that follow:
 - For positive ghosting, reduce the value of NVM 998-175.
 - For negative ghosting, increase the value NVM 998-175.

Figure 2 NVM 998-175 setting

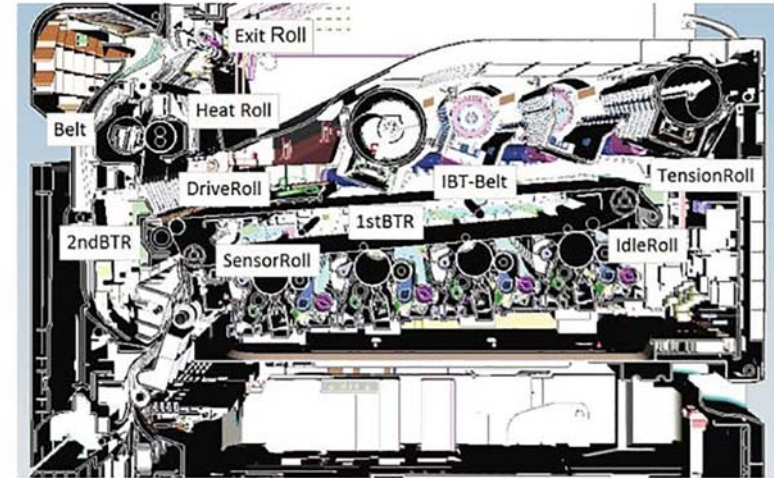
TF-1-0656-A

Repeated defects can be caused by a variety of issues in the print engine. Refer to [Figure 1](#).

Figure 1 Print engine

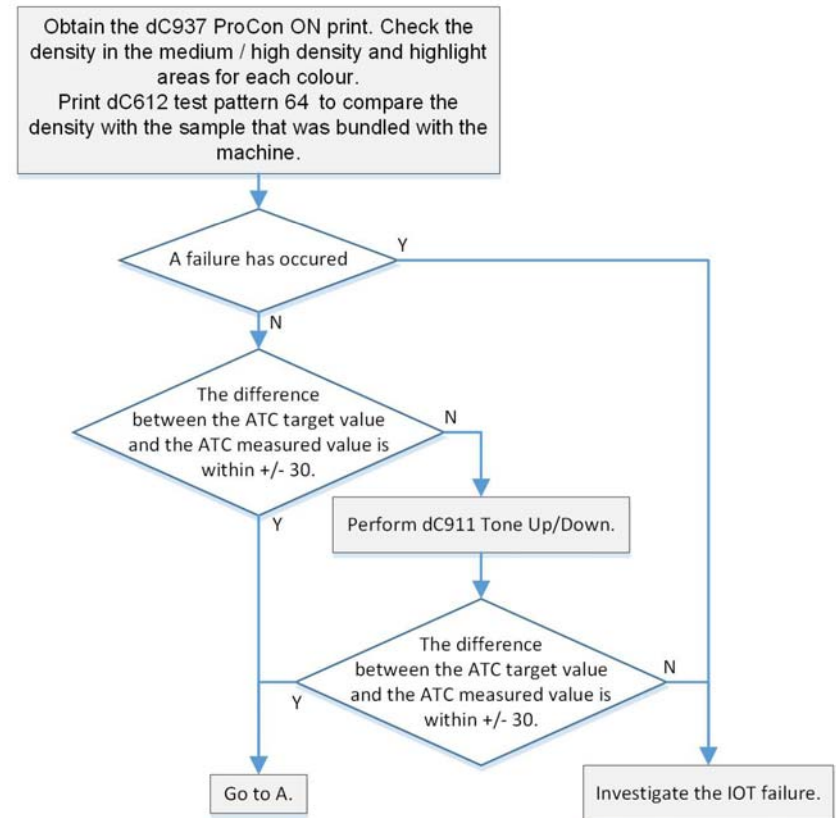
TF-1-0692-A

During a service call, when a problem with the image quality has been determined or when there is a request from the customer regarding image quality, perform the adjustment according to the following flow, [Figure 1](#), [Figure 2](#) and [Figure 3](#).

Figure 1 IQ call flow (1 of 3)

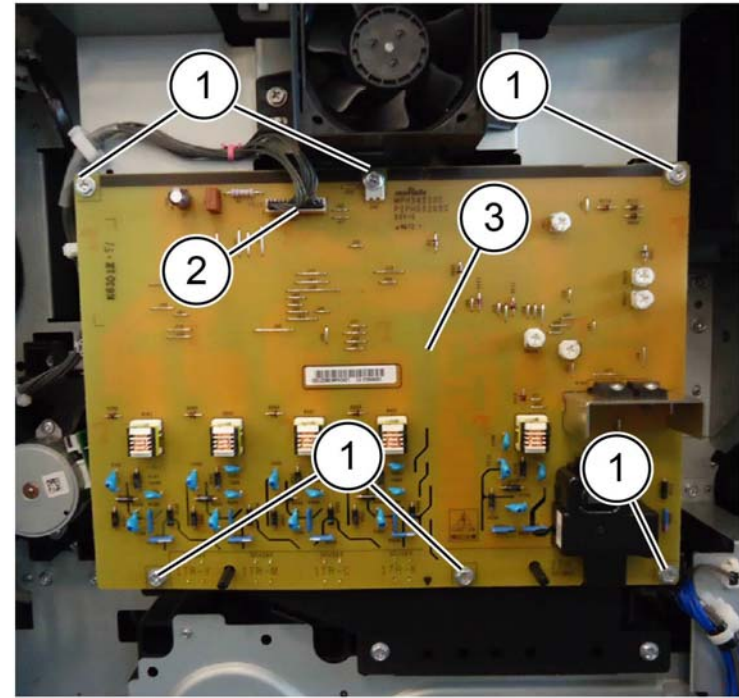
F-1-0092-A

1. Open the video contact chassis assembly, [PL 3.10 Item 2](#), [GP 32](#).
2. Remove the HVPS, [Figure 2](#):
 - a. Remove five screws (1).
 - b. Disconnect the connector (2).
 - c. Remove the HVPS (3).

Figure 2 HVPS removal

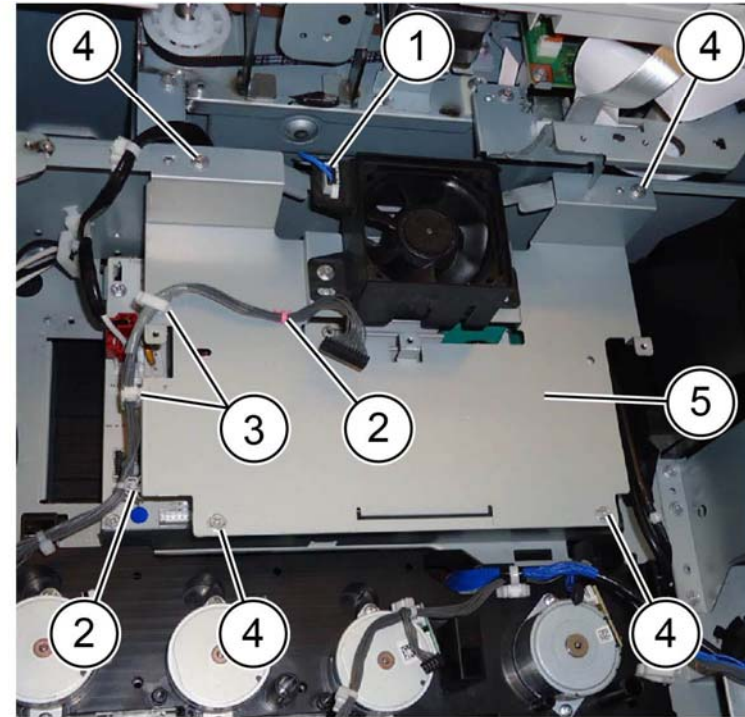
F-1-0093-A

1. Open the video contact chassis assembly, [PL 3.10 Item 2](#), [GP 32](#).
2. Remove the BTR HVPS PWB, [REP 1.1](#).
3. Remove the bracket: [Figure 2](#).
 - a. Disconnect the connector (1).
 - b. Remove two cable ties (2).
 - c. Open two clamps (3), then move the harness out of the way.
 - d. Remove four screws (4).
 - e. Remove the bracket (5).

Figure 2 Bracket removal

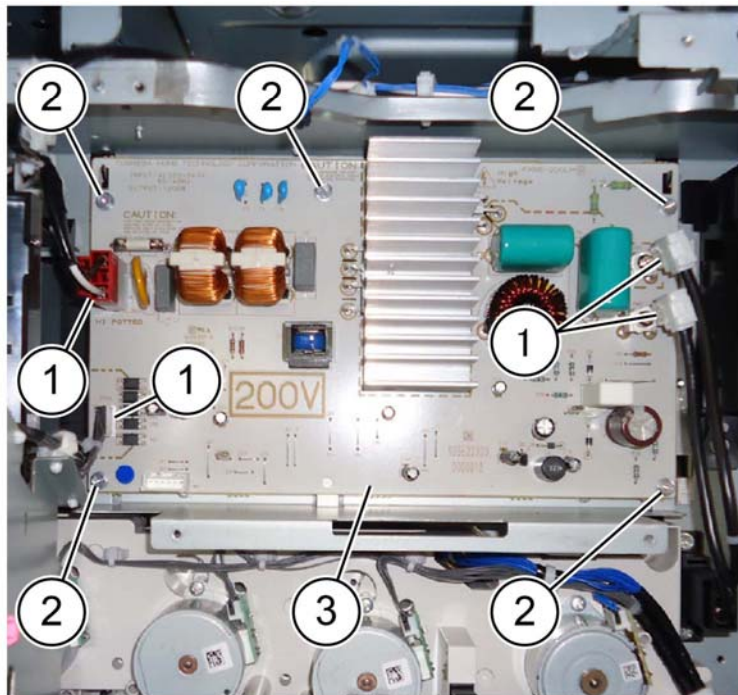
F-1-0161-A

4. Remove the fuser heater power supply: [Figure 3](#).
 - a. Disconnect four connectors (1).
 - b. Remove five screws (2).
 - c. Remove the fuser heater power supply (3).

Figure 3 Power supply removal

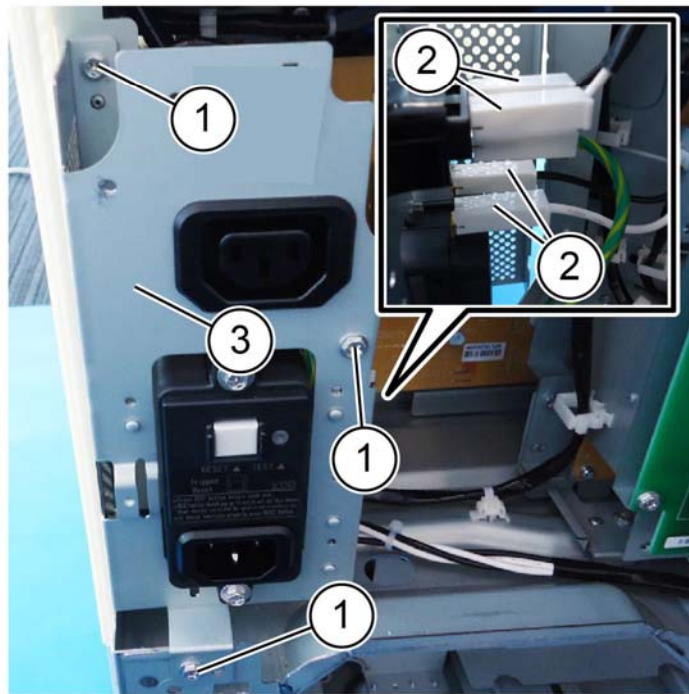
F-1-0162-A

4. Remove the items that follow, [Figure 2](#):
 - a. Remove three screws (1).
 - b. Disconnect four connectors (2).
 - c. Lift the GFI chassis assembly (3) off the frame hook then remove.

Figure 2 GFI chassis assembly removal

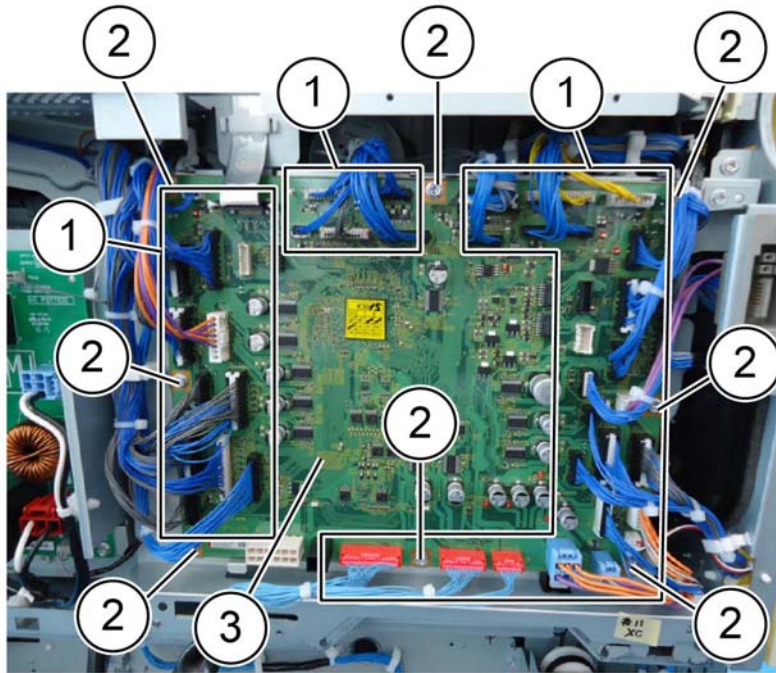
F-1-0094-A

4. Remove the motor drive PWB, [Figure 2](#):
 - a. Disconnect all connectors (1).
 - b. Remove eight screws (2).
 - c. Remove the motor drive PWB (3).

Figure 2 Drive PWB removal

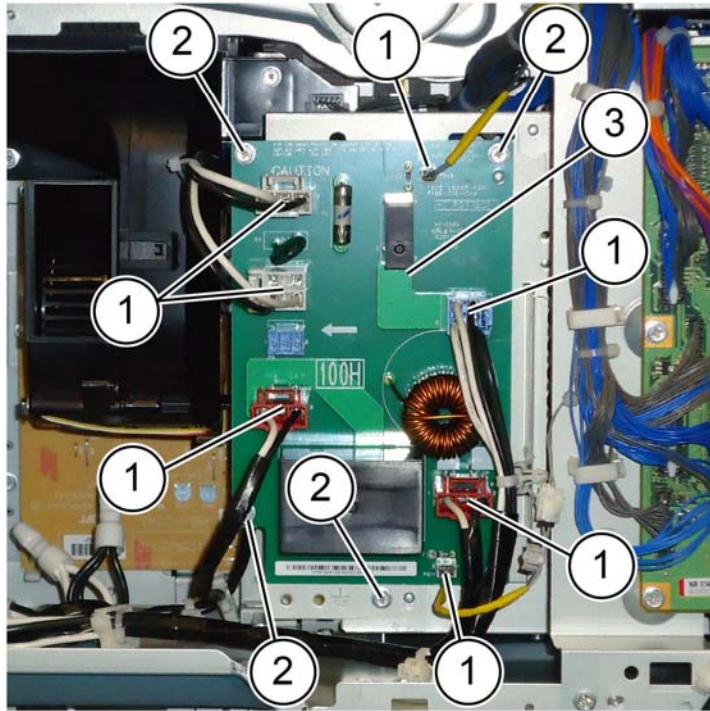
F-1-0095-A

4. Remove the AC drive PWB: [Figure 2](#).
 - a. Disconnect seven connectors (1).
 - b. Remove four screws (2).
 - c. Remove the AC drive PWB (3).

Figure 2 AC drive PWB removal

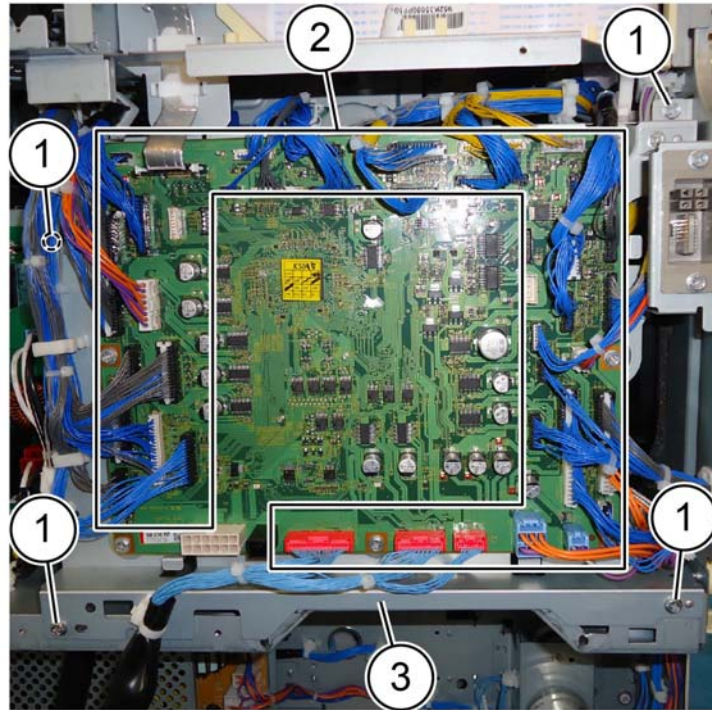
F-1-0096-A

4. Remove the motor drive chassis assembly, [Figure 2](#):
 - a. Remove four screws (1).
 - b. Disconnect all connectors (2).
 - c. Remove the motor drive chassis assembly (3).

Figure 2 Motor drive chassis assembly removal

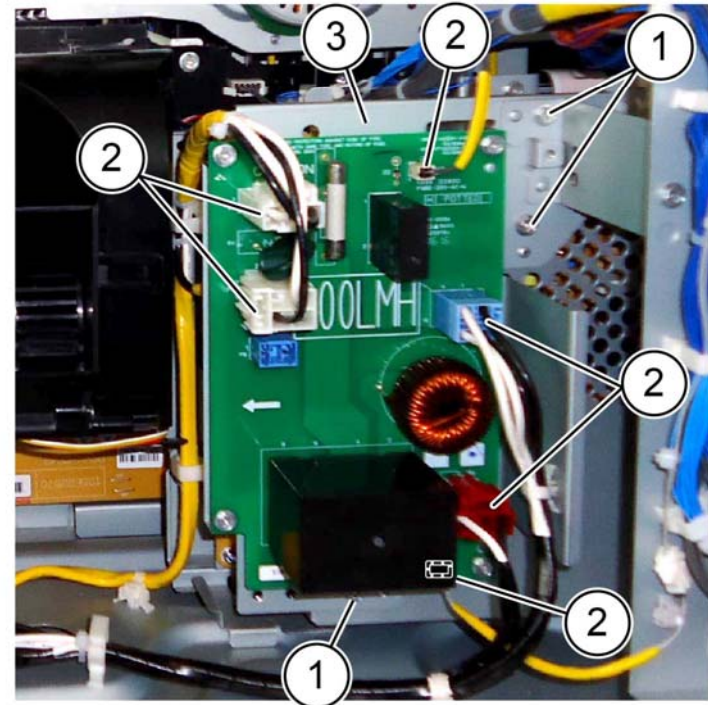
F-1-0097-A

5. Remove the AC Bracket, [Figure 3](#).
 - a. Remove three screws (1).
 - b. Disconnect six connectors (2).
 - c. Remove the AC bracket (3).

Figure 3 AC bracket removal

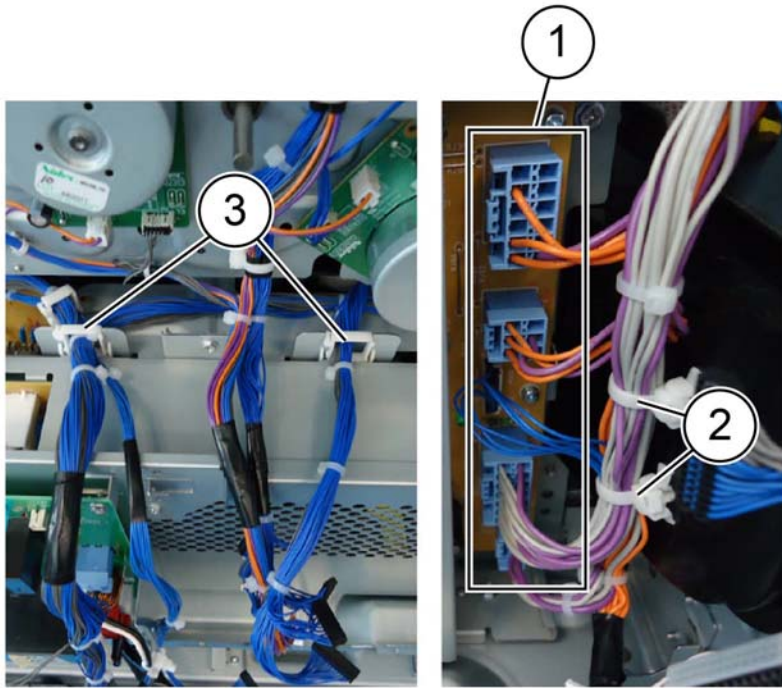
Figure 4 Disconnect the harness

6. Disconnect the LVPS harnesses, [Figure 4](#).
 - a. Disconnect three connectors (1).
 - b. Remove two wire ties (2).
 - c. Release the harness from two clamps, then move the harness away from the LVPS (3).

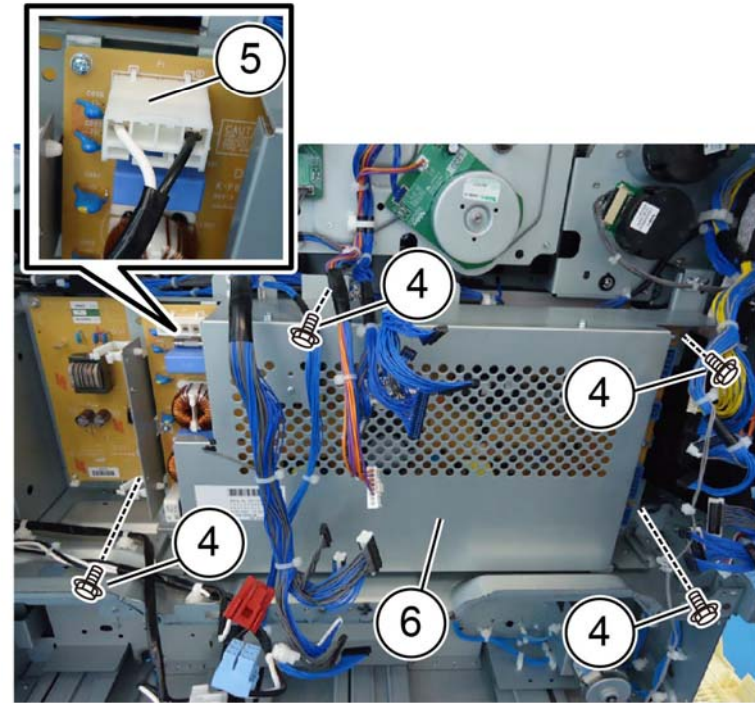
Figure 5 LVPS removal

7. Remove the LVPS, [Figure 5](#).
 - a. Remove four screws (4).
 - b. Disconnect the connector (5).
 - c. Remove the LVPS (6).

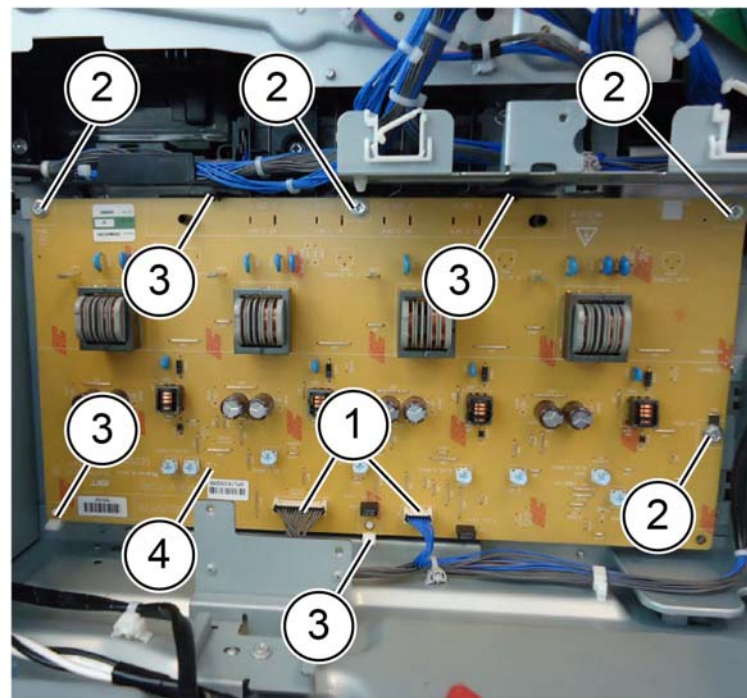
Figure 2 HVPS developer bias removal

1. Remove the LVPS, [REP 1.6](#).
2. Remove the AC drive PWB, [REP 1.5](#).
3. Remove HVPS developer bias, [Figure 2](#):
 - a. Disconnect two connectors (1).
 - b. Remove four screws (2).
 - c. Release two hooks at the top, lean the HVPS developer bias forward to clear the hooks (3).
 - d. Lift then remove the HVPS developer bias PWB (4).

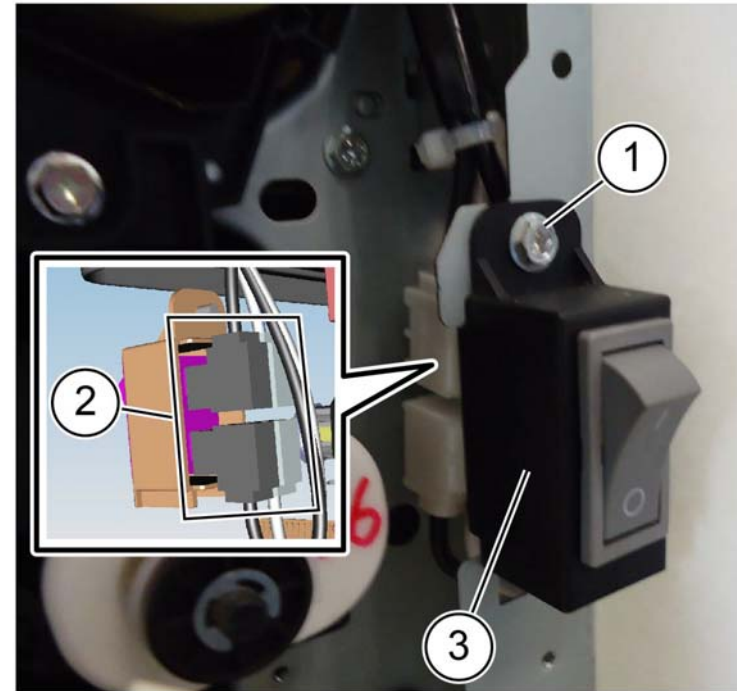
Figure 2 Main power switch removal

2. Remove the main power switch, [Figure 2](#):
 - a. Remove the screw (1).
 - b. Disconnect the main power switch from the connector (2).
 - c. Remove the main power switch (3).

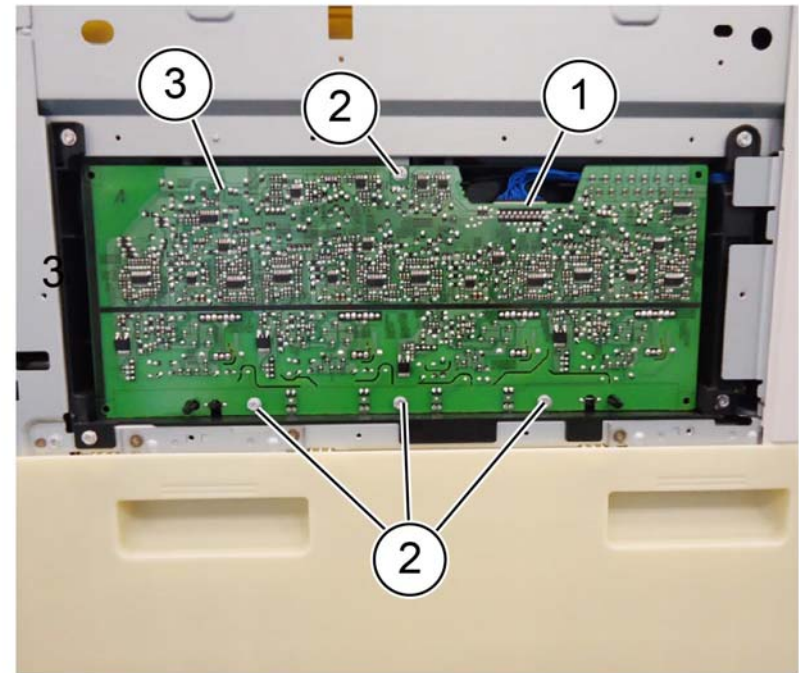
Figure 2 BCR HVPS removal

1. Remove the upper right front cover, [PL 28.15 Item 1](#).
2. Remove the BCR HVPS cover, [PL 1.20 Item 2](#).
3. Remove the BCR HVPS, [Figure 2](#):
 - a. Remove the connector (1).
 - b. Remove four screws (2).
 - c. Remove the BCR HVPS (3).

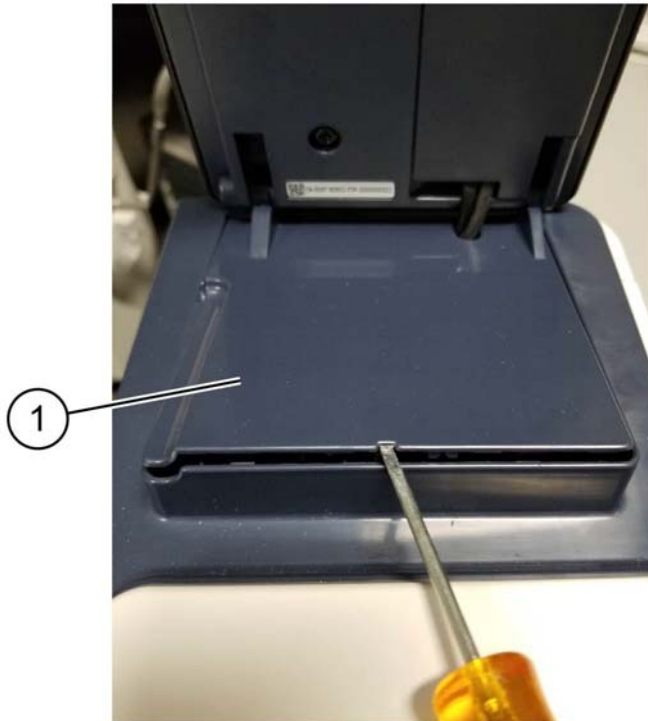
Figure 1 UI top cover removal

1. Remove the UI top cover (1), [PL 2.05 Item 3, Figure 1](#).

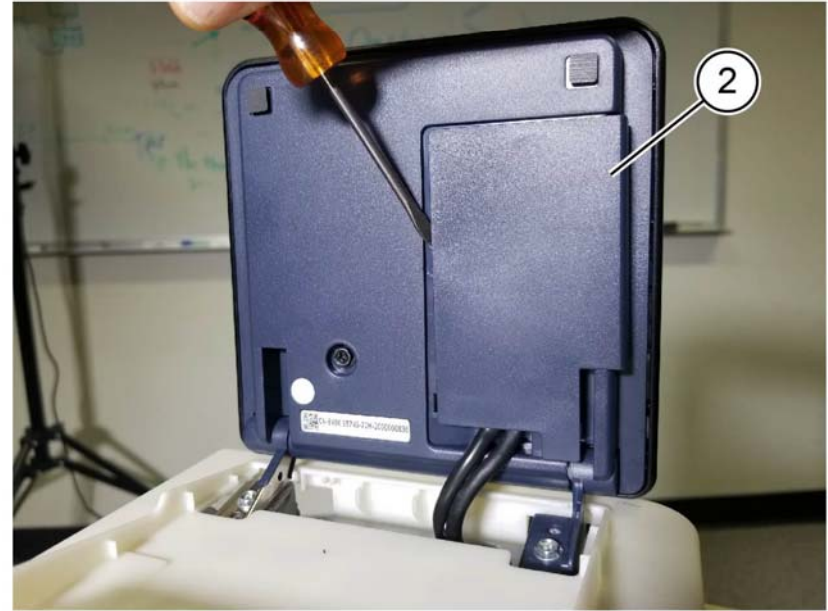
Figure 2 Cable cover removal

2. Remove the cable cover (2), [Figure 2](#).

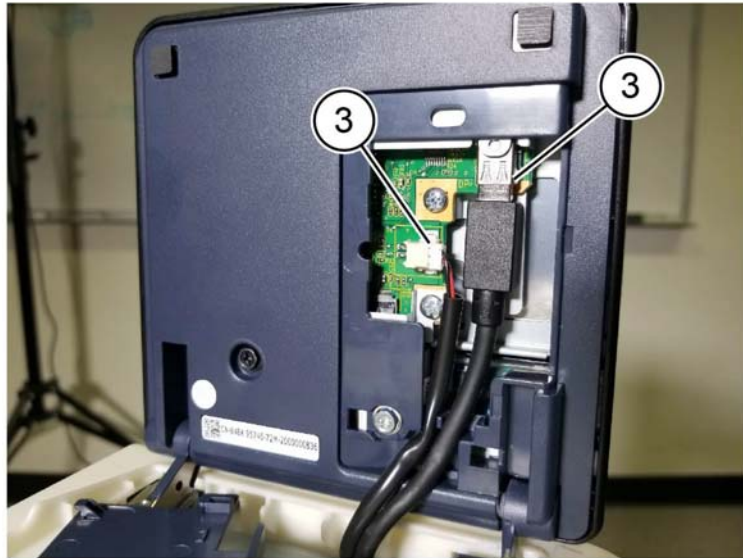
Figure 3 UI and speaker connections

3. Disconnect the UI and speaker connectors (3), [Figure 3](#).

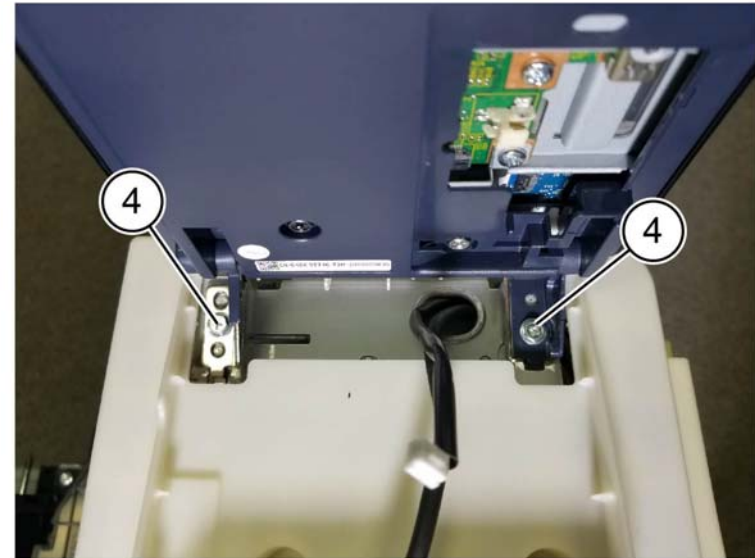
Figure 4 UI console assembly removal

4. Remove two screws (4), then remove the UI console assembly, [Figure 4](#).

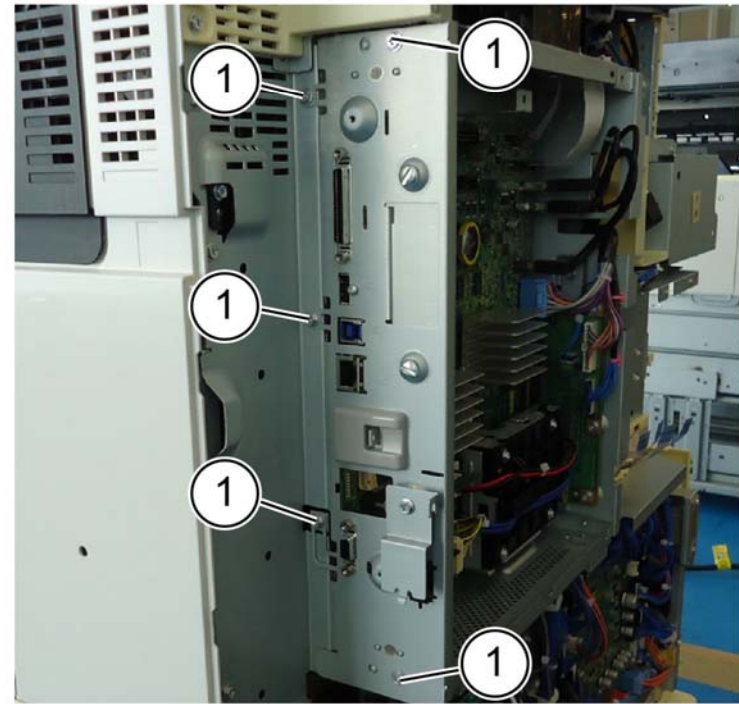
Figure 2 Screw removal

1. Remove the ESS rear cover, [PL 28.15 Item 4](#).
2. Remove the controller cover assembly kit, [PL 3.10 Item 1](#).
3. Disconnect all external connectors from the controller PWB assembly, [PL 3.05 Item 1](#).
4. Remove five screws (1), [Figure 2](#).

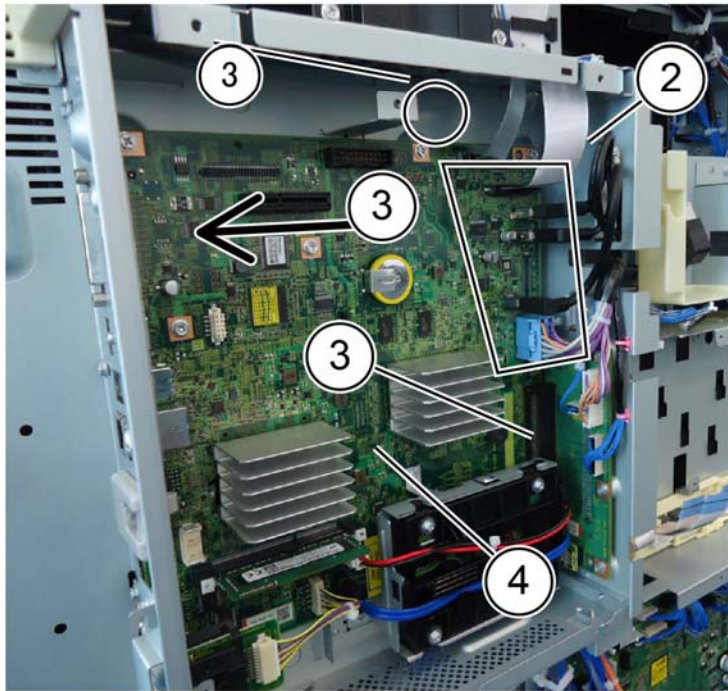
Figure 3 Controller PWB assembly removal

5. Remove the controller PWB assembly, [Figure 3](#):
 - a. Disconnect six connectors (2).
 - b. Slide the case left in the direction of the arrow, disengage the stopper, then disconnect the controller PWB from the back plane PWB (3).
 - c. Remove the controller PWB assembly (4).

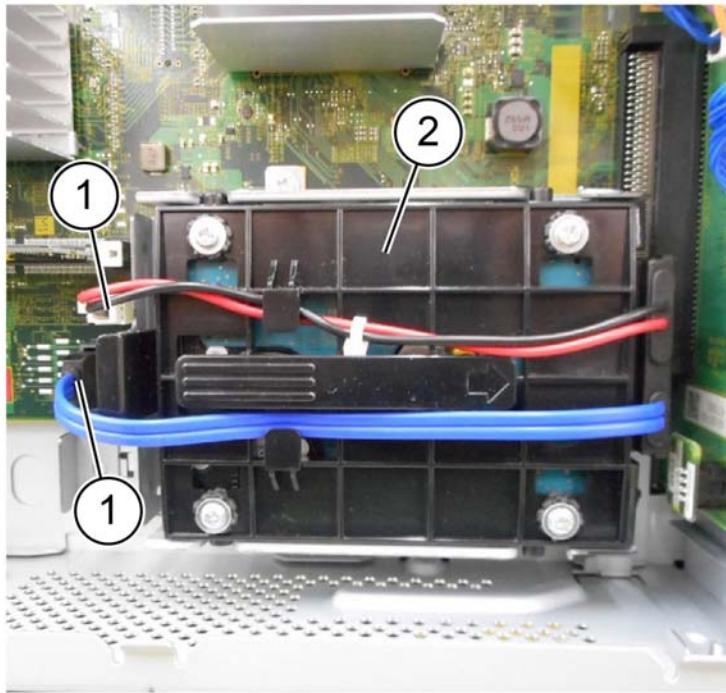
Figure 2 HDD removal

2. Remove the HDD, [Figure 2](#):
 - a. Disconnect two connectors (1).
 - b. Release the hook and remove the HDD, [PL 3.05 Item 9](#) (2).

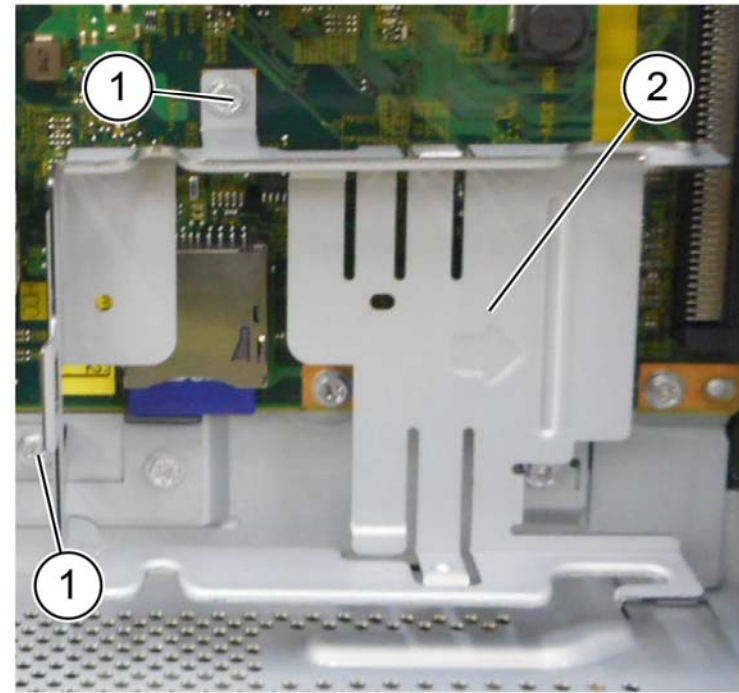
Figure 3 HDD bracket removal

3. Remove the HDD bracket, [Figure 3](#):
 - a. Remove two screws (1).
 - b. Remove the HDD bracket (2).

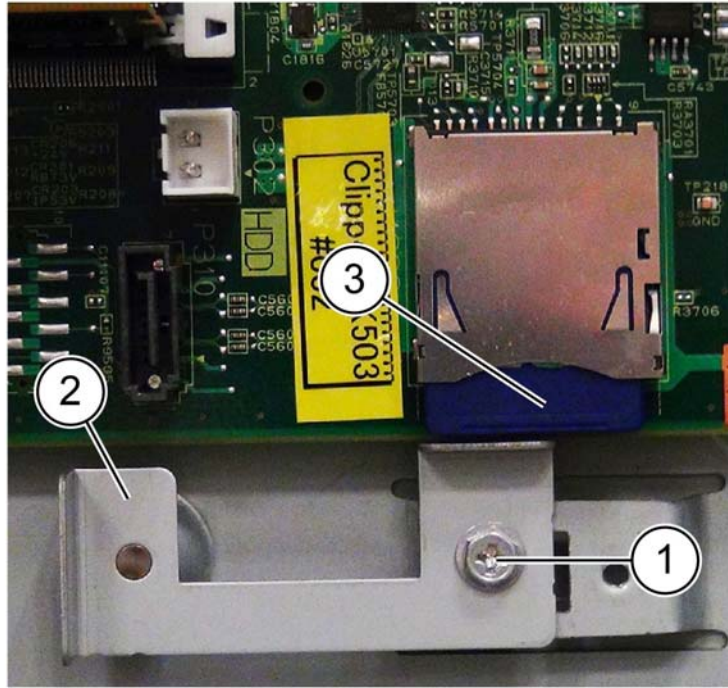
Figure 4 SD card removal

4. Remove the SD memory card, [Figure 4](#):
 - a. Remove the screw (1).
 - b. Remove the SD card clip (2).
 - c. Remove the SD memory card (3).

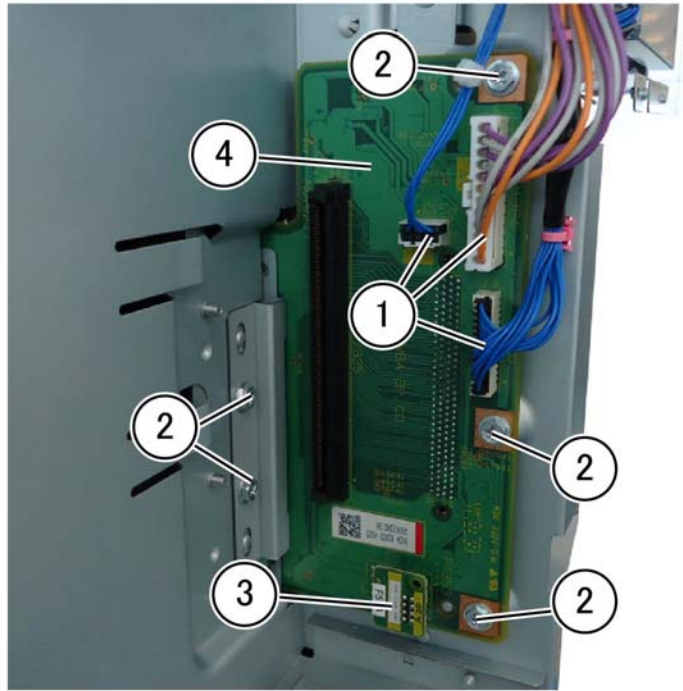
Figure 2 Back plane PWB removal

2. Remove the back plane PWB, **Figure 2**:
 - a. Disconnect three connectors (1).
 - b. Remove five screws (2).
 - c. Remove the SEEP ROM (3).
 - d. Remove the back plane PWB (4).

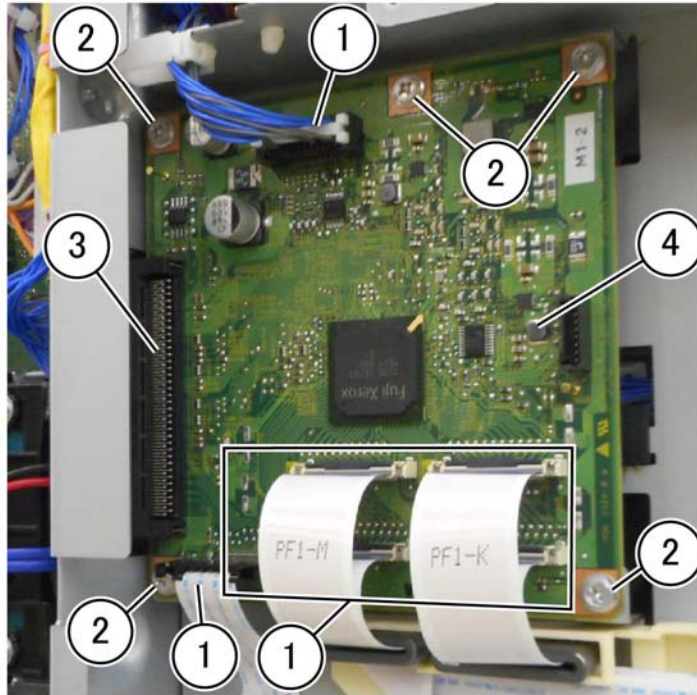
Figure 2 Halftone PWB removal

3. Remove the halftone PWB, [Figure 2](#):
 - a. Disconnect six connectors (1).
 - b. Remove five screws (2).
 - c. Disconnect the back plane PWB (3).
 - d. Remove the halftone PWB, [PL 3.15 Item 4](#) (4).

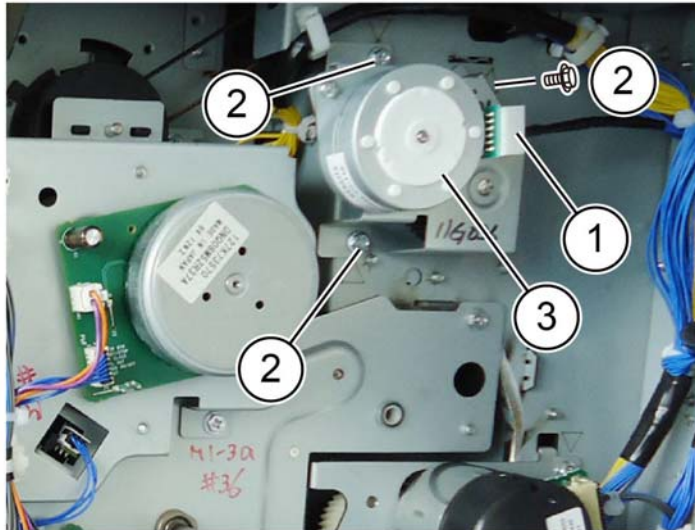
Figure 1 Retract motor assembly removal

1. Open the video contact chassis, [GP 32](#).
2. Remove the retract motor assembly, [PL 10.05 Item 1, Figure 1](#):
 - a. Disconnect the connector (1).
 - b. Remove three screws (2).
 - c. Remove the retract motor assembly (3).

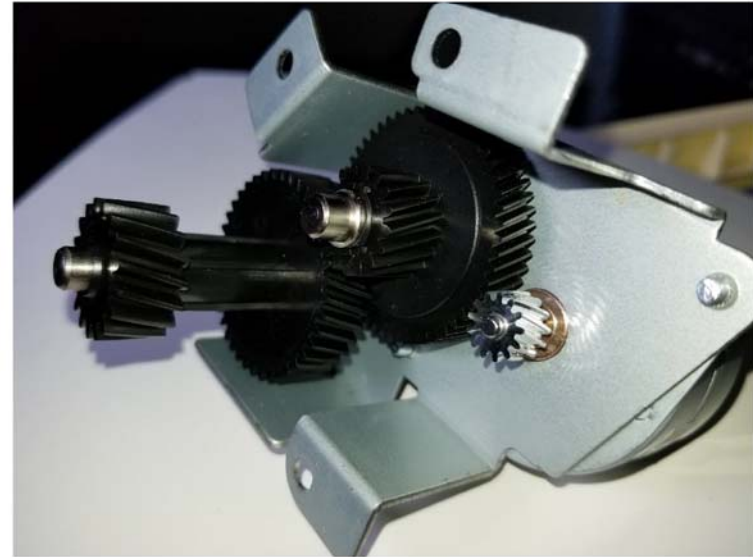
Figure 2 Proper gear alignment

When replacing the retract motor assembly verify the gears are replaced on the shaft in the correct manner, [Figure 2](#).

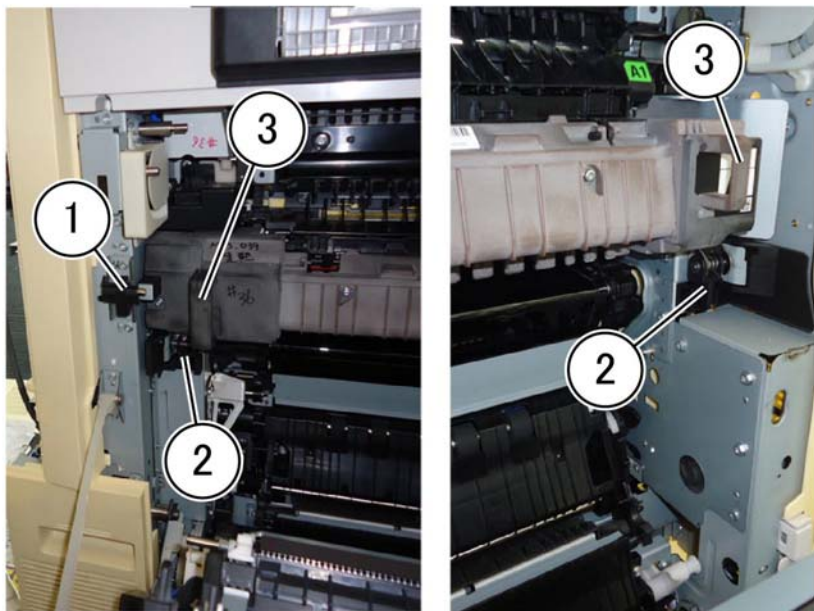
Figure 1 Fuser removal

1. Open the left cover assembly, [PL 80.75 Item 21](#).
2. Remove the fuser, [PL 10.05 Item 14, Figure 1](#):
 - a. Lift the lock (1) at the rear of the fuser up and slide left to unlock the fuser.
 - b. Push two locks (2) to the inside to release the fuser.
 - c. Remove the fuser (3).

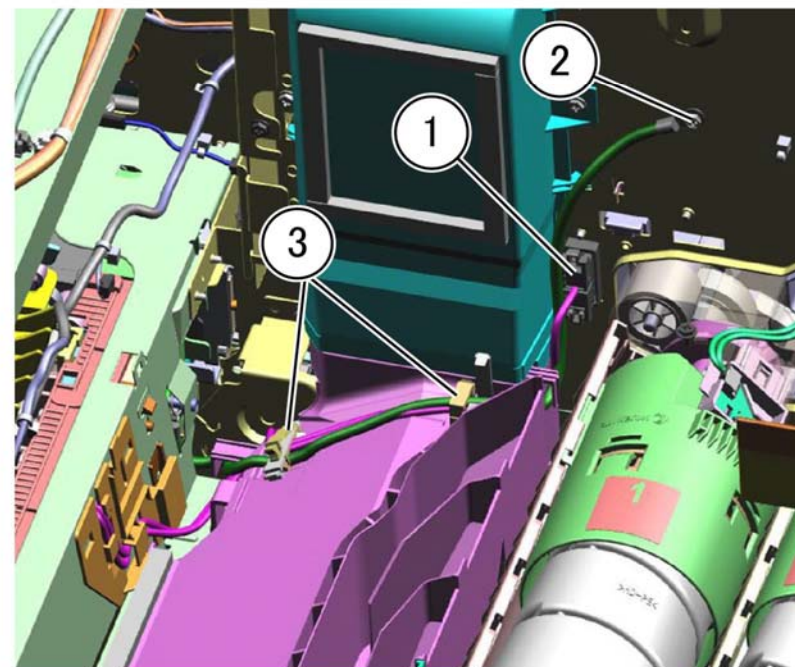
Figure 1 Disconnect wiring

1. Open the left cover assembly, [PL 80.75 Item 21](#).
2. Remove the fuser, [REP 10.2](#).
3. Remove the top rear cover, [PL 28.10 Item 10](#).
4. Disconnect the fuser heater coil wiring, [Figure 1](#):
 - a. Disconnect the connector (1).
 - b. Remove the screw on the ground wire (2).
 - c. Remove the harness from the guide (3).
