VersaLink[®] C8000/C9000 Printer

Service Manual

VersaLink C9000 Family Service Manual

705P01418

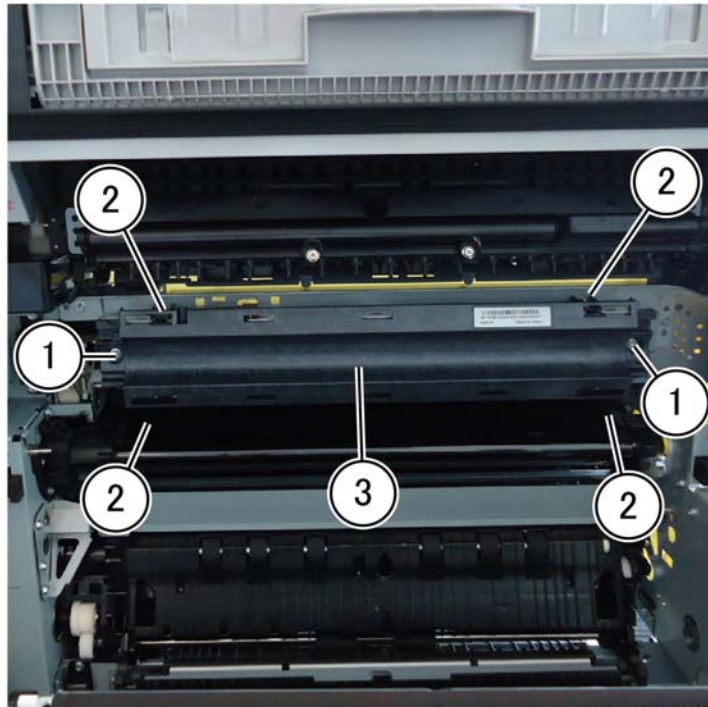
Figure 2 Coil assembly removal

5. Remove the fuser heater coil, [Figure 2](#):
 - a. Remove two screws (1).
 - b. Release four hooks (2).
 - c. Remove the fuser heater coil (3).

NOTE: While removing the fuser heater coil, carefully thread the fuser heater coil harness through the frame to not damage the harness insulation.

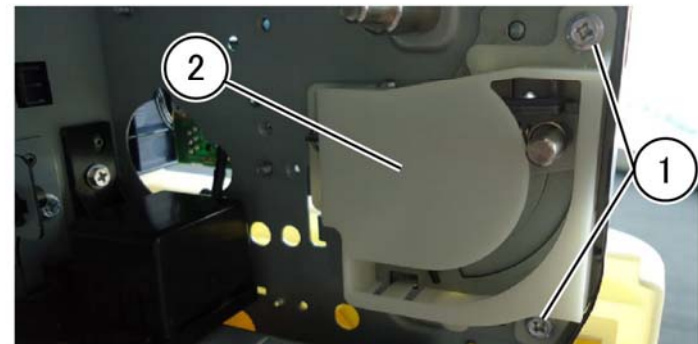
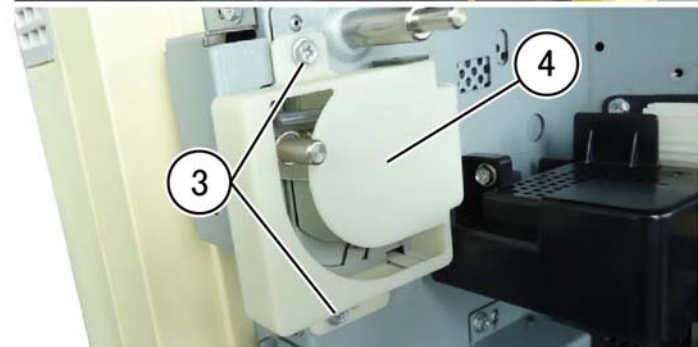
Figure 1 Rear toggle lever assembly removal

1. Remove the controller cover assembly, [PL 3.10 Item 1](#).
2. Remove the right upper cover, [PL 28.10 Item 11](#).
3. Remove the exit 2 transport assembly, [REP 10.8](#).
4. Remove the front toggle lever assembly and rear toggle lever assembly, [Figure 1](#):
 - a. Remove two screws (1).
 - b. Remove the front toggle lever assembly (2).
 - c. Remove two screws (3).
 - d. Remove the rear toggle lever assembly (4)

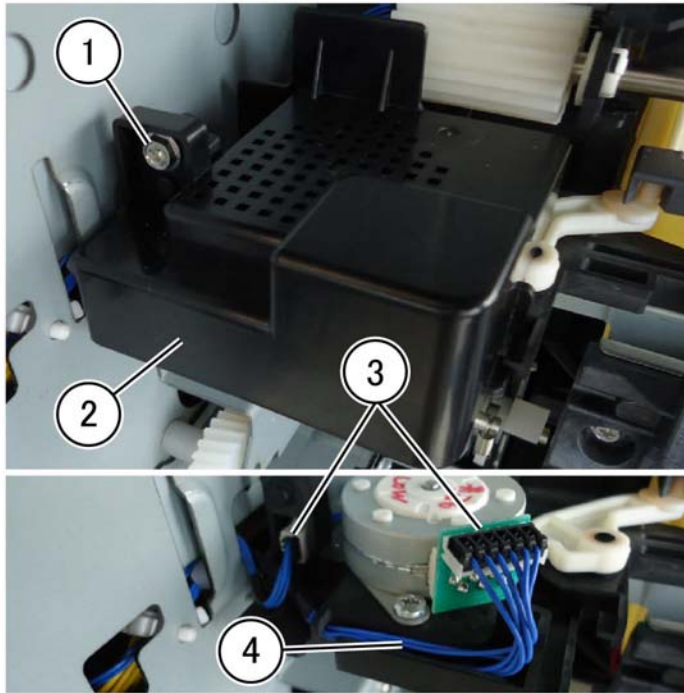
Figure 2 Harness removal

5. Remove the motor cover and remove the harness, **Figure 2**:
 - a. Remove the screw (1).
 - b. Remove the motor cover (2).
 - c. Disconnect two connectors (3).
 - d. Remove the harness from exit 1 transport. assembly (4).

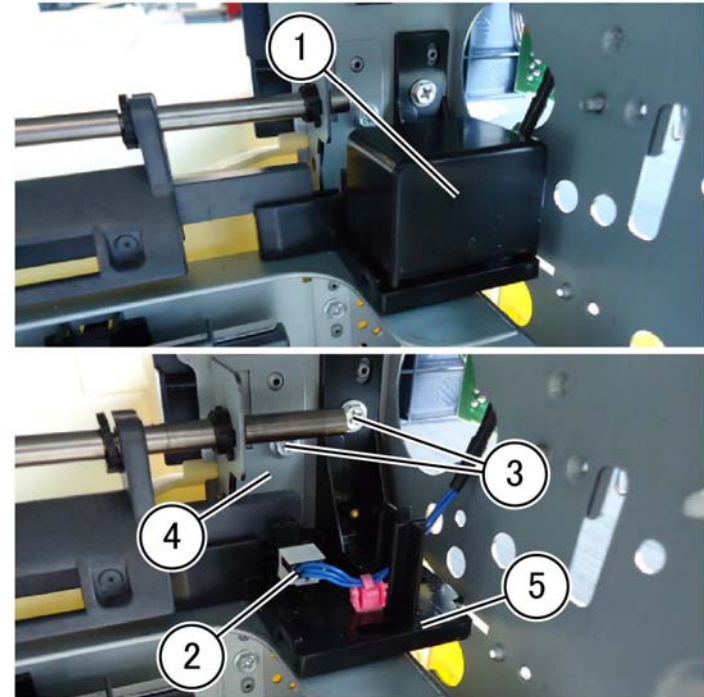
Figure 3 Front guide removal

6. Remove the bracket and front guide, **Figure 3**:
 - a. Remove the sensor cover (1).
 - b. Disconnect the connector (2).
 - c. Remove two screws (3).
 - d. Remove the bracket (4).
 - e. Remove the front guide (5).

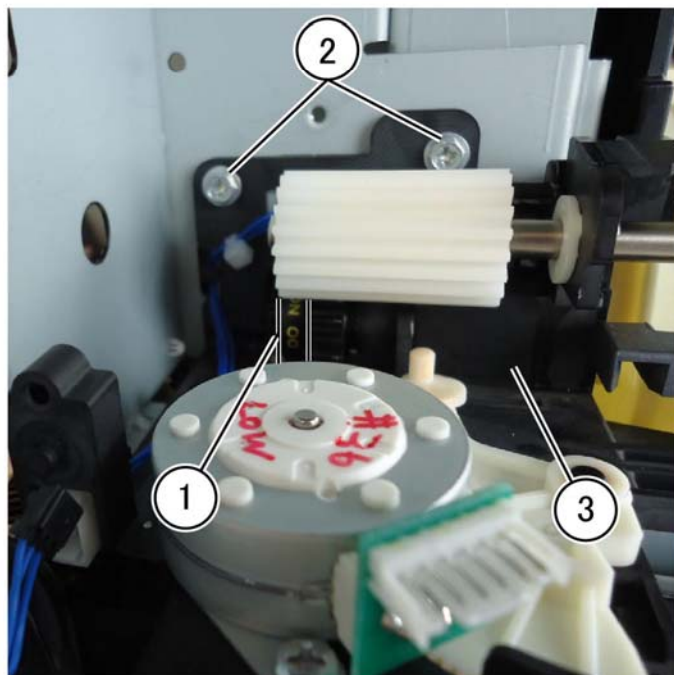
Figure 4 Exit 1 transport assembly removal

7. Remove the exit 1 transport assembly, [Figure 4](#):
 - a. Remove the belt (1).
 - b. Remove two screws (2).
 - c. Remove the exit 1 transport assembly (3).

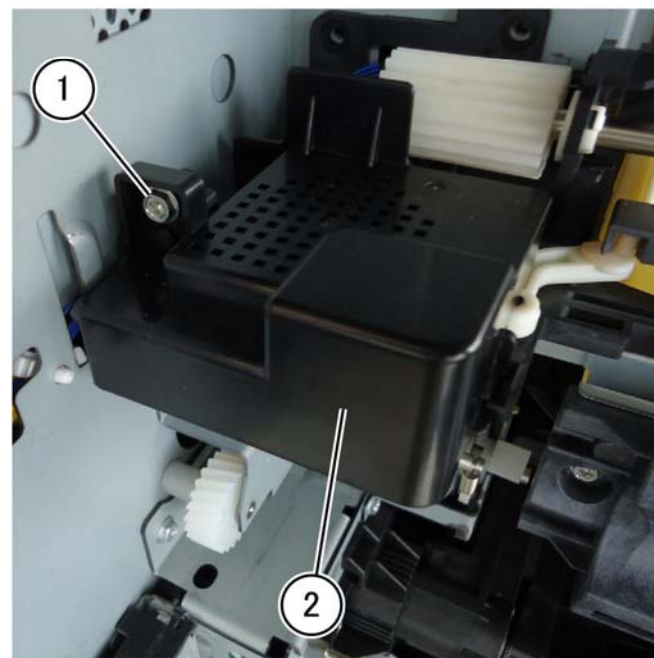
Figure 1 Motor cover removal

1. Remove the exit 2 transport assembly, refer to [REP 10.8](#).
2. Remove the motor cover, [Figure 1](#):
 - a. Remove the screw (1).
 - b. Remove the motor cover (2).

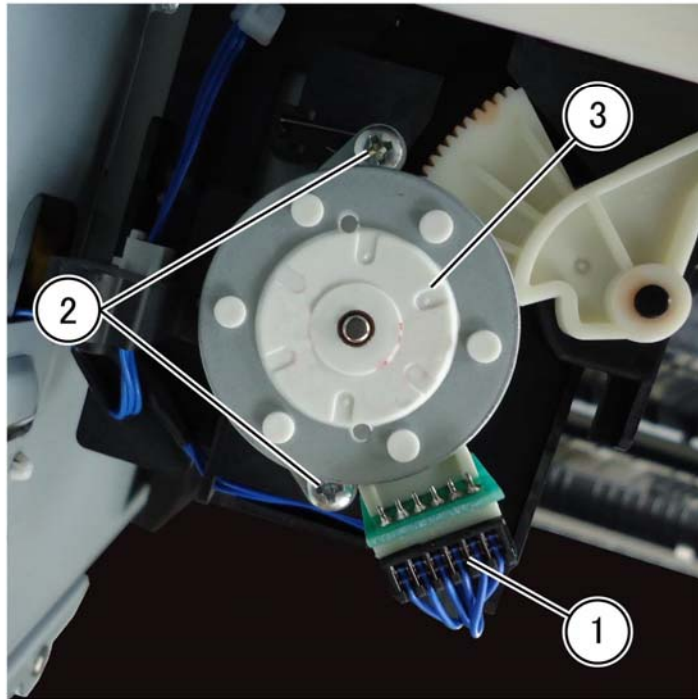
Figure 2 Exit 1 OTC removal

3. Remove the exit 1 oct motor, [Figure 2](#):
 - a. Disconnect the connector (1).
 - b. Remove two screws (2).
 - c. Remove the exit 1 oct motor (3).

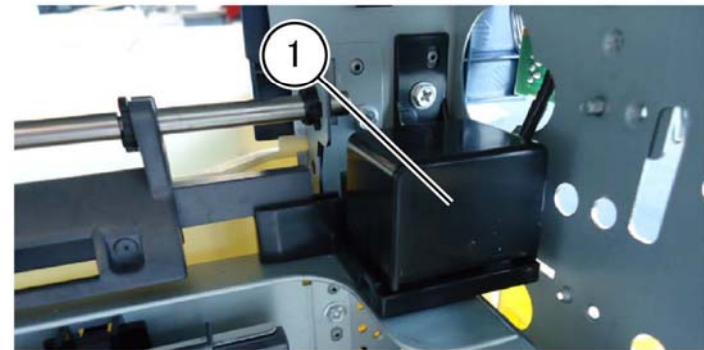
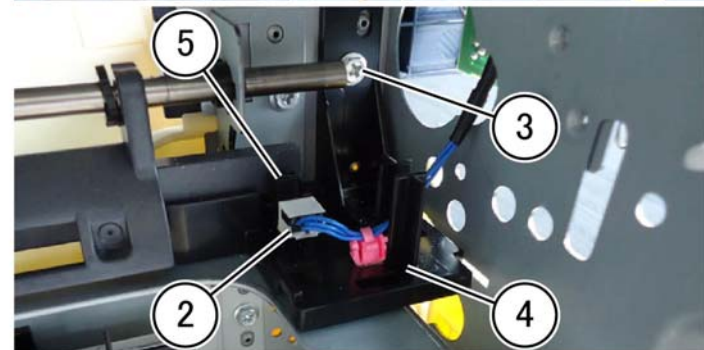
Figure 1 Exit 1 OCT home position sensor removal

1. Remove the exit 2 transport assembly, refer to [REP 10.8](#).
2. Remove the exit 1 OCT home position sensor, [Figure 1](#):
 - a. Remove the sensor cover (1).
 - b. Disconnect the connector (2).
 - c. Remove the screw (3).
 - d. Remove the front guide (4).
 - e. Remove the exit 1 oct home position sensor (5).

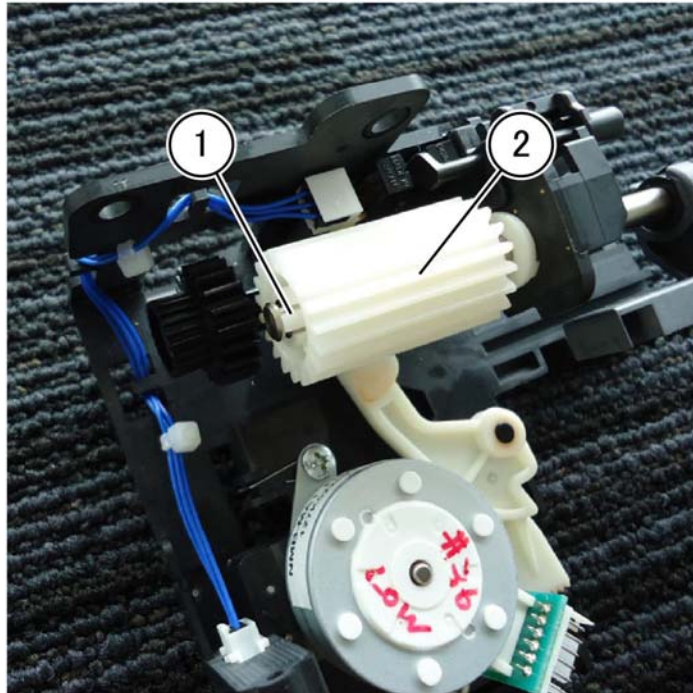
Figure 1 Exit 1 drive gear removal

1. Remove the exit 2 transport assembly, refer to [REP 10.8](#).
2. Remove the gear, [Figure 1](#):
 - a. Release the latch (1).
 - b. Remove exit 1 drive gear, [PL 10.10 Item 10](#).

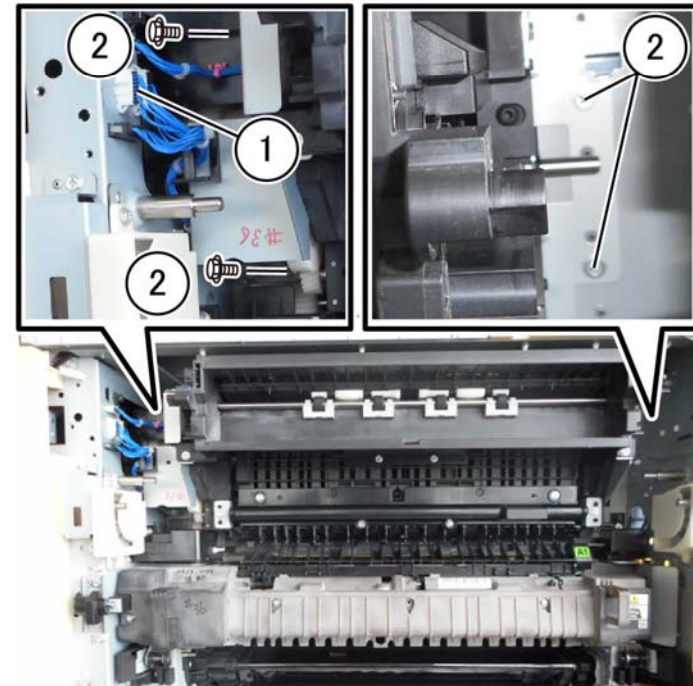
Figure 1 Exit 2 transport assembly removal

1. Open the left cover assembly, [PL 80.70](#).
2. Remove the two screws and remove the left top cover, [PL 10.15 Item 1](#).
3. Remove the exit 2 transport assembly, [PL 10.15 Item 2, Figure 1](#):
 - a. Disconnect four connectors (1).
 - b. Remove four screws (2).
 - c. Remove the exit 2 transport assembly.

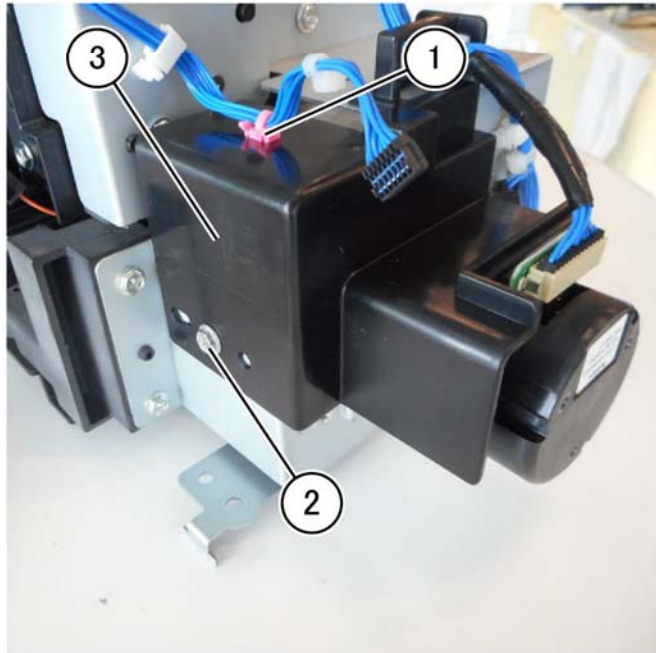
Figure 1 Harness guide removal

1. Remove the exit 2 transport assembly, [REP 10.8](#).
2. Remove the harness guide: [Figure 1](#).
 - a. Remove the clamp (1).
 - b. Remove the screw (2).
 - c. Remove the harness guide (3).

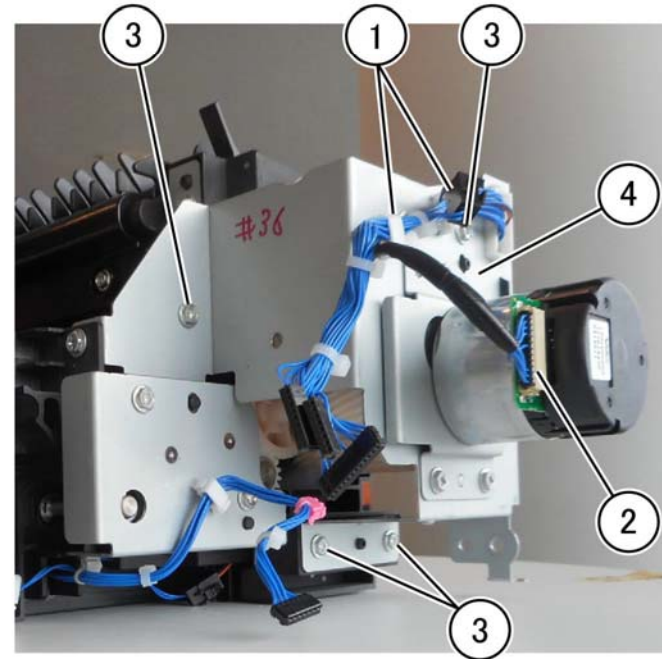
Figure 2 Exit 2 drive assembly

3. Remove the exit 2 drive assembly: [Figure 2](#).
 - a. Remove two clamps (1).
 - b. Disconnect the connector (2) and release the harness clamps from the case.
 - c. Remove four screws (3).
 - d. Remove the exit 2 drive assembly, [PL 10.25 Item 2](#) (4).

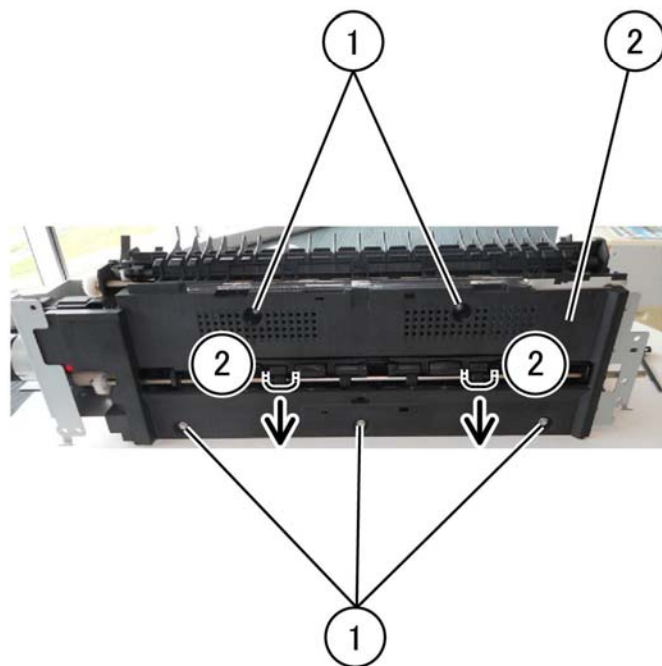
Figure 1 Exit 2 guide assembly

1. Remove the exit 2 transport assembly, [REP 10.8](#).
2. Remove the exit 2 guide assembly: [Figure 1](#).
 - a. Remove five screws (1).
 - b. Remove the guard exit and the exit guide assembly (2).

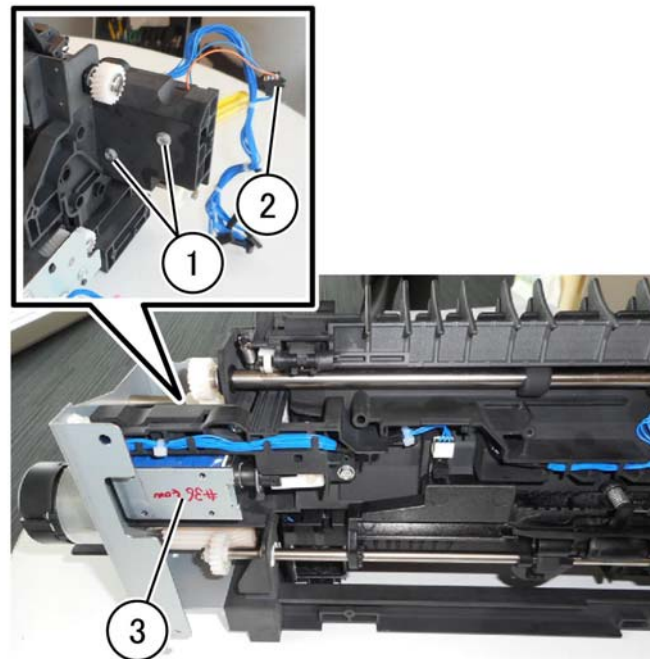
Figure 2 Exit 2 gate solenoid

4. Remove the exit 1 gate solenoid: [Figure 2](#).
 - a. Remove two screws (1).
 - b. Disconnect the connector (2).
 - c. Remove the exit 1 gate solenoid, [PL 10.25 Item 11](#) (3).

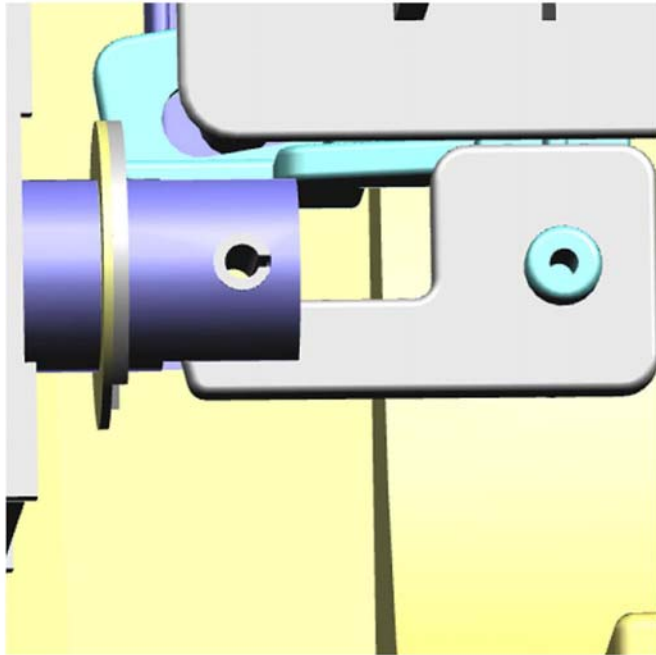
Figure 3 Leading edge in groove

1. The replacement is the reverse of the removal procedure.
2. Install with the leading edge in the groove, [Figure 3](#).

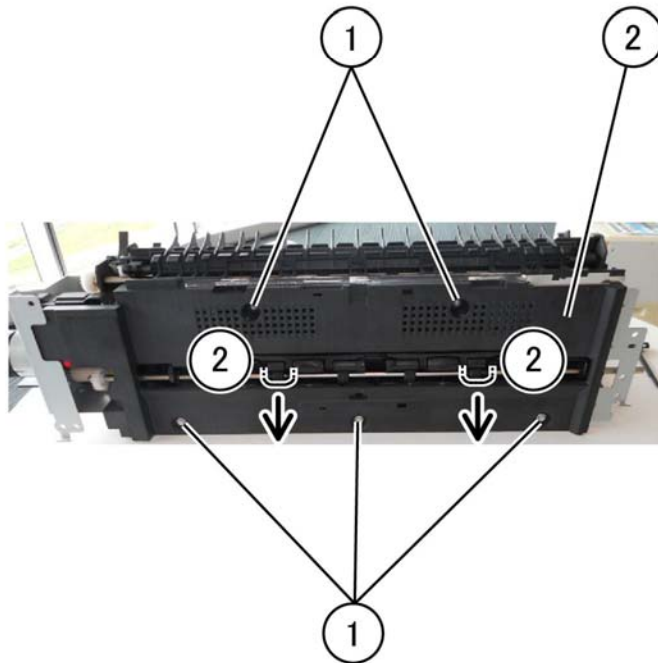
Figure 1 Exit guide assembly removal

1. Remove the exit 2 transport assembly, [REP 10.8](#).
2. Remove the exit 2 guide assembly, [PL 10.25 Item 6, Figure 1](#):
 - a. Remove five screws (1).
 - b. Remove the guard exit and the exit guide assembly (2).

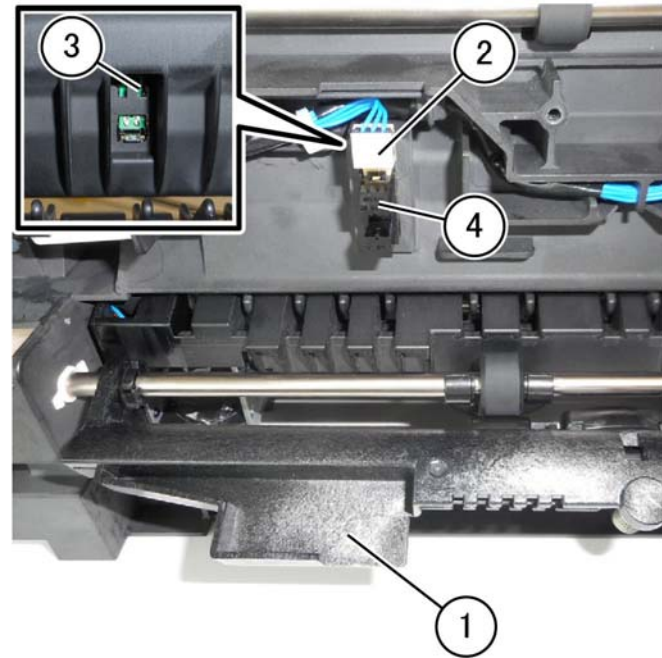
F-1-0226-A

3. Remove the exit 2 OCT home position sensor, [PL 10.25 Item 14, Figure 2](#):
 - a. Position the exit 2 chute assembly face down. (1).
 - b. Disconnect the harness (2).
 - c. Release the sensor from the hook. (3).
 - d. Remove the 2 OCT home position sensor (4).

Figure 2 Exit 2 OCT home position sensor removal

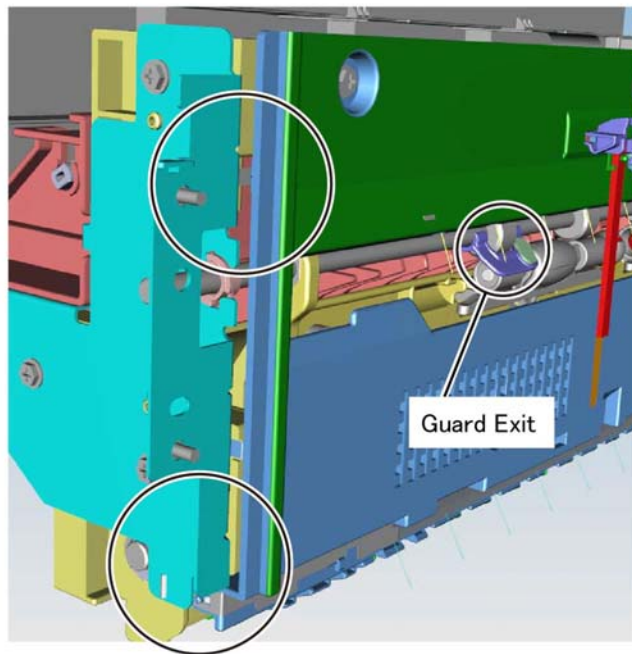
F-1-0228-A

1. Install the exit 2 guide assembly aligned with the bracket, [Figure 3](#).
2. Install the guard exit in the direction shown, [Figure 3](#).

Figure 3 Exit 2 guide reassembly

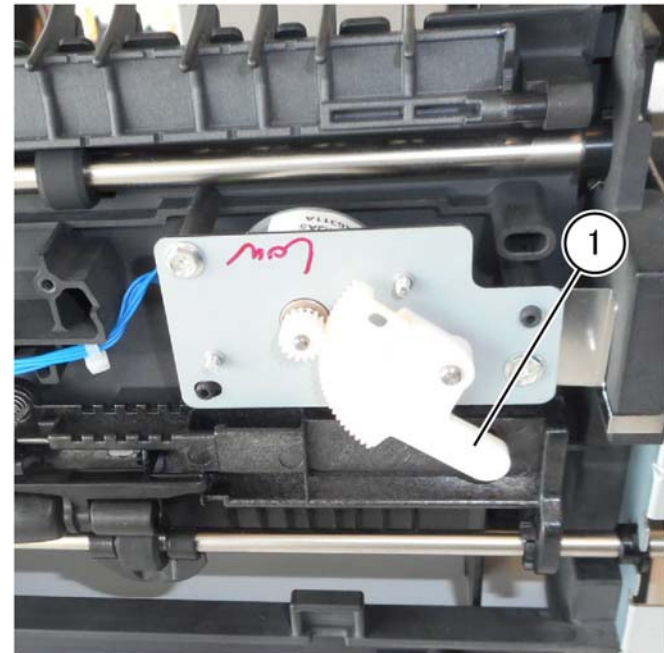
F-1-0229-A

1. Remove the exit 2 transport assembly, [REP 10.8](#) and then remove the exit 2 guide assembly, [PL 10.25 Item 6](#), [REP 10.11](#).
2. Remove the offset gear, [PL 10.25 Item 16](#), [Figure 1](#).

Figure 1 Offset gear removal

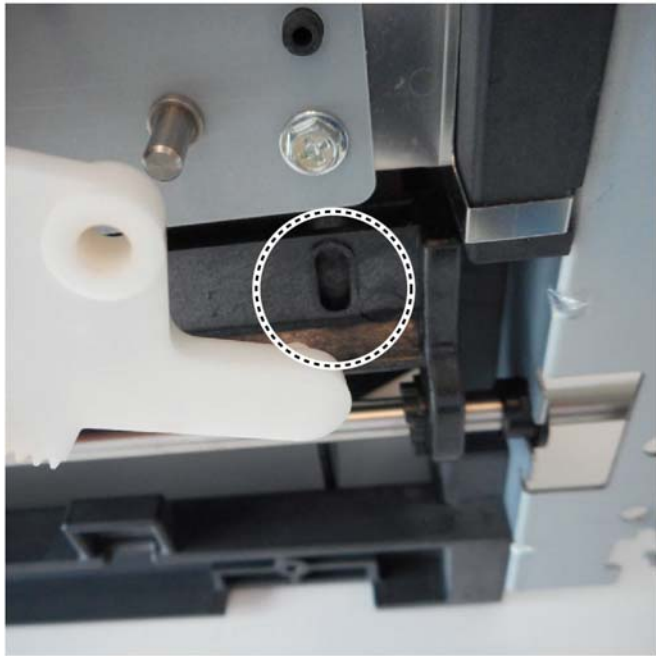
F-1-0231-A

1. Install the offset gear with the peg in the recess of the gear arm, [Figure 2](#).

Figure 2 offset gear leading edge in groove

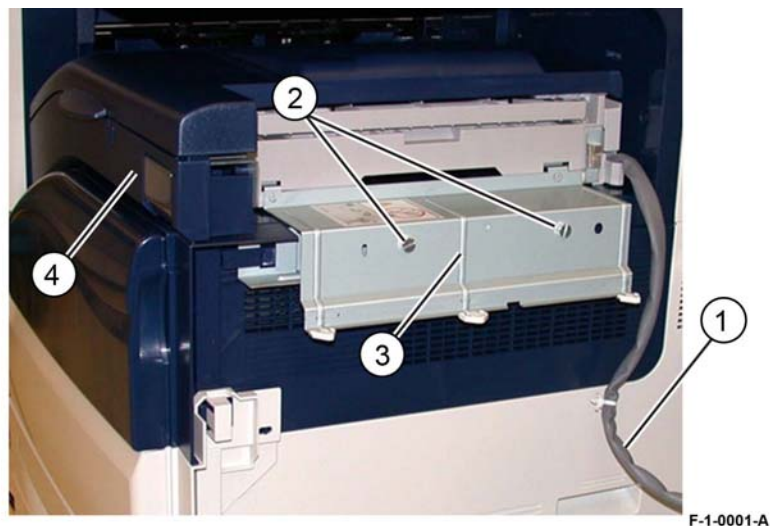
1. Undock the finisher, [REP 13.5](#).
2. Remove the horizontal transport assembly, [Figure 1](#):
 - a. Disconnect the harness (1).
 - b. Remove two screws (2).
 - c. Remove the docking plate (3).
 - d. Remove the horizontal transport (4).

Figure 1 Horizontal transport removal

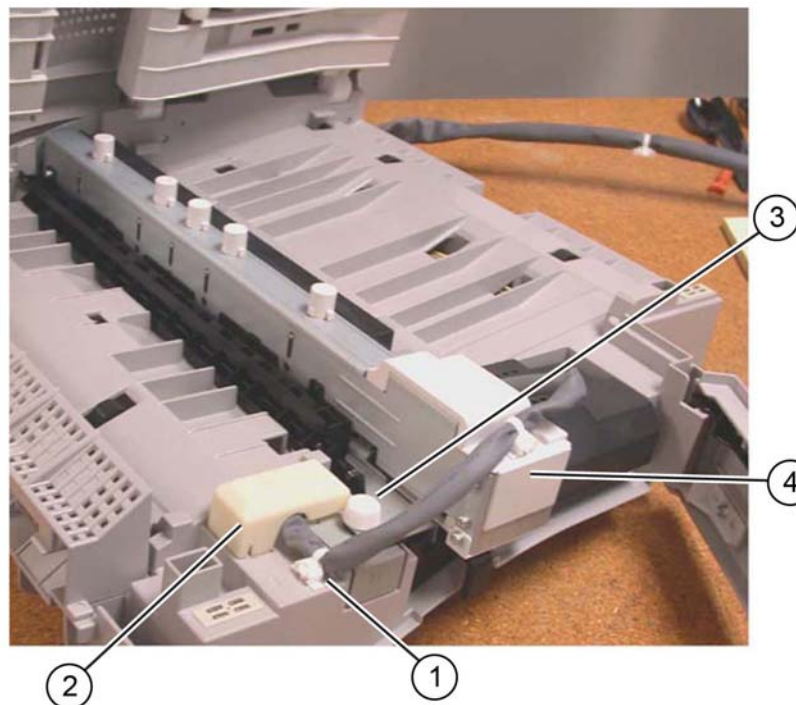
1. Hold open the horizontal transport top cover.
2. Open the horizontal transport front cover.
3. Remove the hole punch assembly, [Figure 1](#):
 - a. Release the cable clamp (1).
 - b. Remove the connector cover (2), then disconnect the connector.
 - c. Remove the thumbscrew (3).
 - d. Remove the hole punch assembly (4).

Figure 1 Hole punch assembly removal

NOTE: For clarity, the horizontal transport is shown removed from the machine in [Figure 1](#).

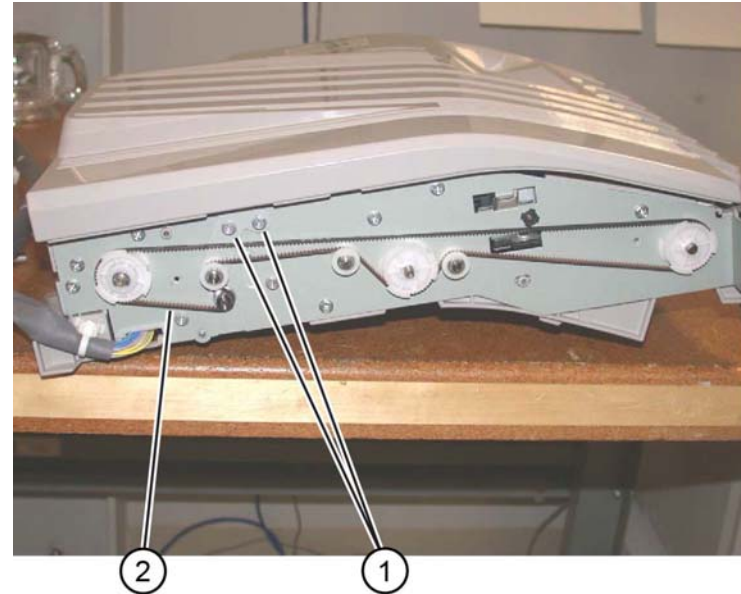
F-1-0003-A

1. Remove the horizontal transport assembly, [REP 13.1](#).
2. Remove the horizontal transport rear cover, [PL 13.06](#) Item 9.
3. Remove the horizontal transport belt, [PL 13.08](#) Item 22, [Figure 1](#):
 - a. Loosen two screws to release the belt tension (1).
 - b. Remove the belt (2).

Figure 1 Belt removal

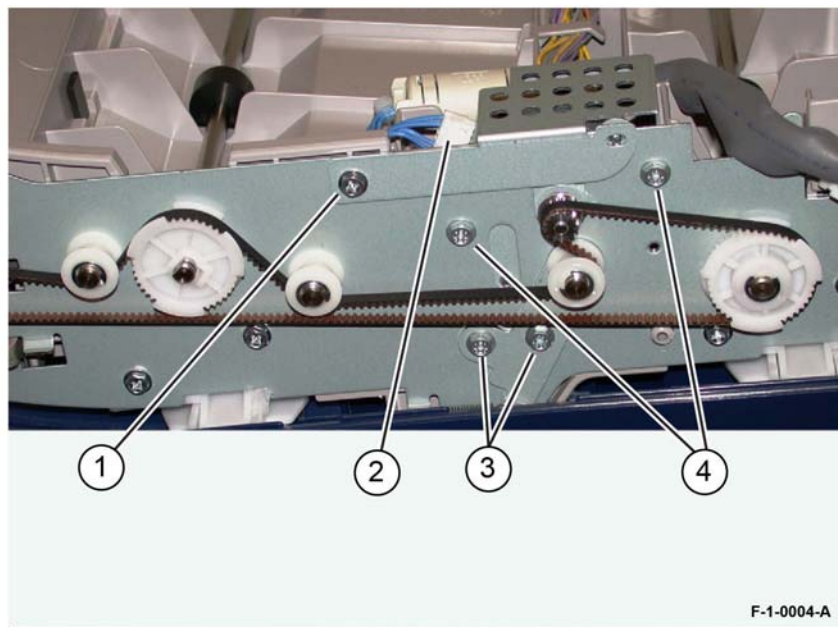
1. Remove the horizontal transport assembly, [REP 13.1](#).
2. Remove the horizontal transport rear cover, [PL 13.06 Item 9](#).
3. Place the horizontal transport top down on a work surface.
4. Remove the horizontal transport motor, [PL 13.08 Item 13, Figure 1](#):
 - a. Remove the screw, then the shield (1).
 - b. Disconnect the connector (2).
 - c. Loosen two screws to release the belt tension (3).
 - d. Remove two screws (4), then remove the horizontal transport motor.

Figure 1 Motor removal

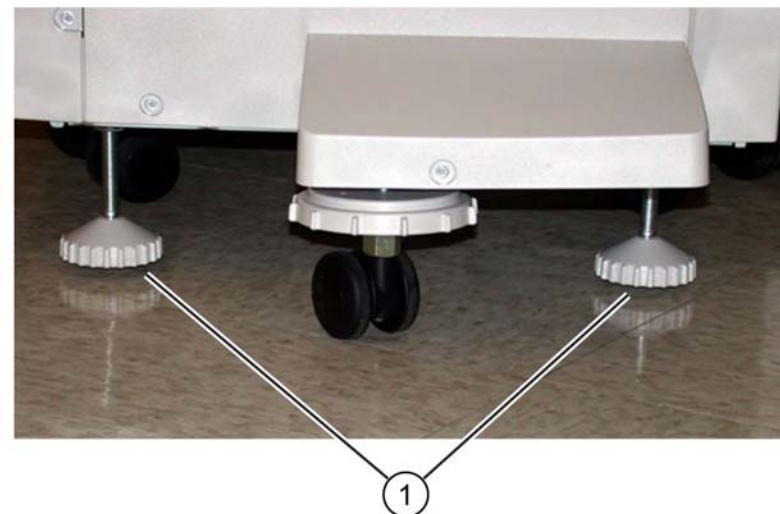
F-1-0005-A

2. Raise the feet (1) to free the finisher, [Figure 1](#).

Figure 1 Finisher feet

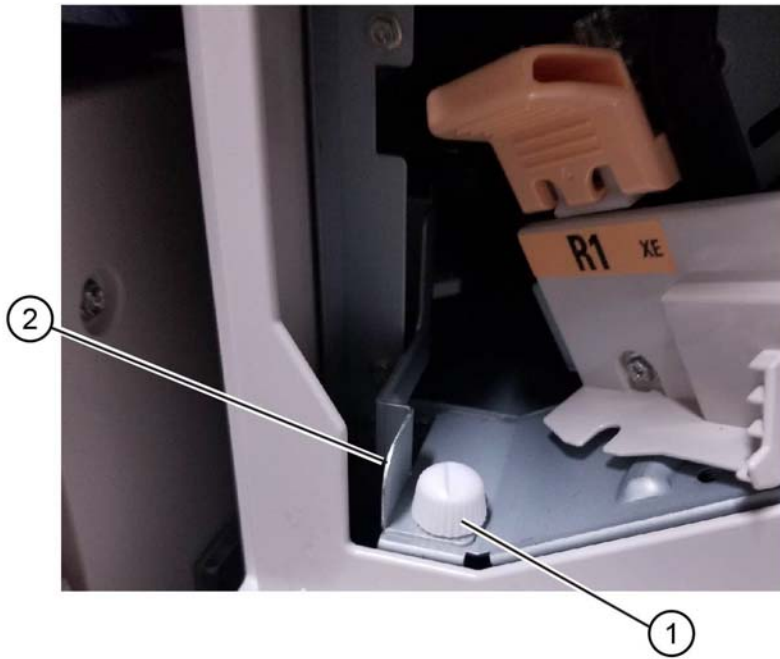
F-1-0705-A

4. Undock the finisher, [Figure 2](#):
 - a. Remove the thumb screw (1).
 - b. Pull the docking plate lever (2) forwards to detach the finisher.

Figure 2 Finisher undocking

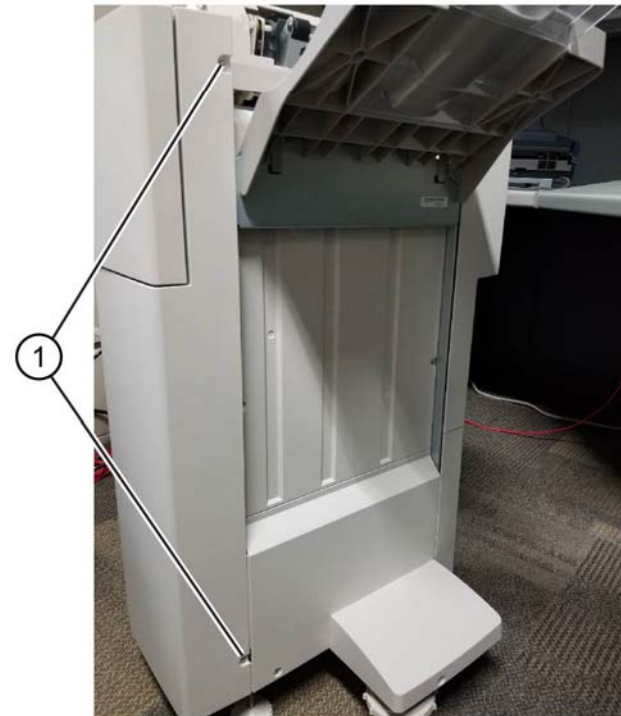
F-1-0706-A

2. Remove the booklet maker, [REP 13.31](#).
3. Open the finisher front door, [PL 13.10 Item 5](#).
4. Start to remove the front cover, remove one screw (1), [Figure 1](#).

Figure 1 Preparation 1 of 3

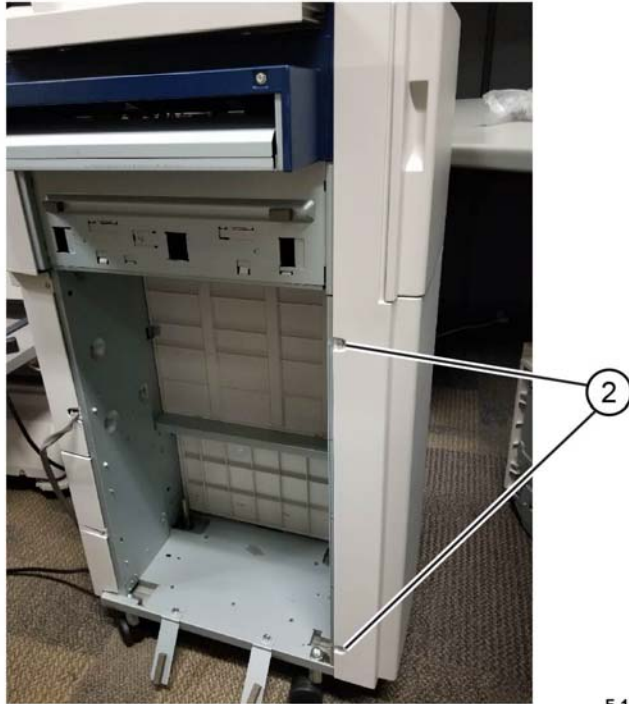
F-1-0707-A

5. Continue to remove the front cover, remove two screws (2), [Figure 2](#).

Figure 2 Cover removal 2 of 3

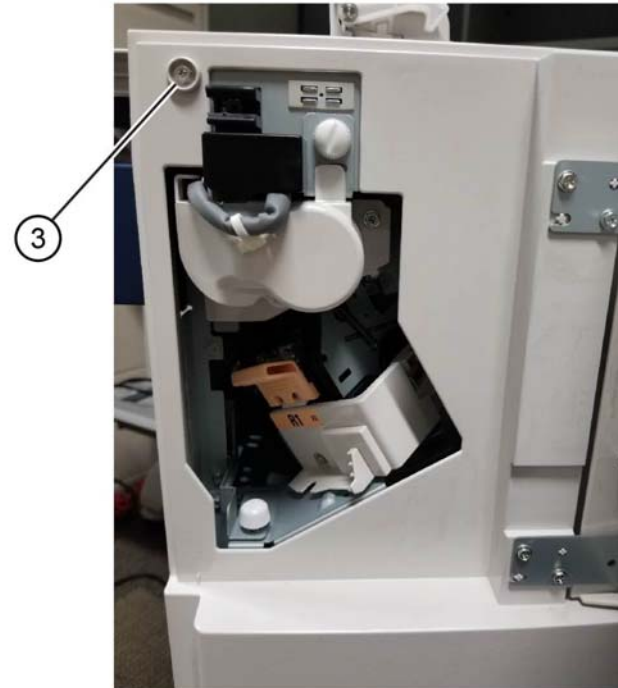
F-1-0708-A

6. Remove the front cover, [Figure 3](#):
- Remove one screw (3).
 - Remove the front cover.

Figure 3 Cover removal 3 of 3

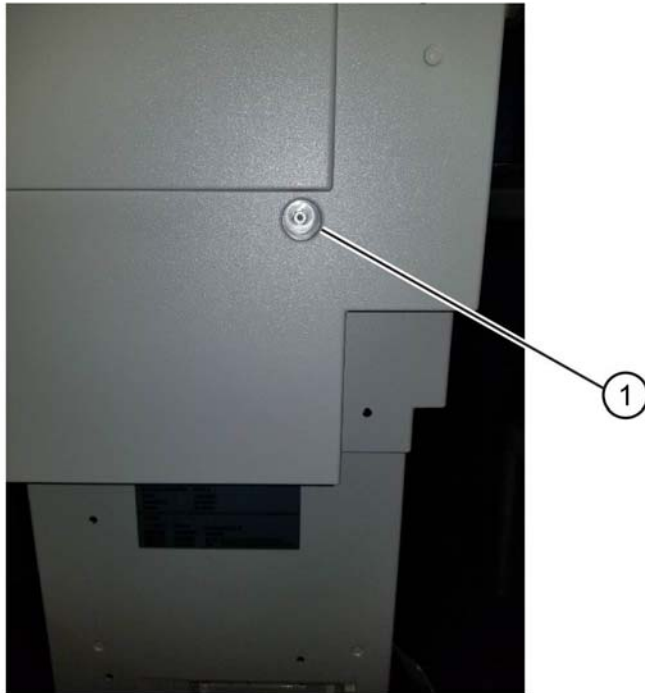
F-1-0709-A

1. Undock the finisher, [REP 13.5](#).
2. Remove the booklet maker, [REP 13.31](#).
3. Start to remove the cover, remove one screw (1), [Figure 1](#).

Figure 1 Cover removal 1 of 4

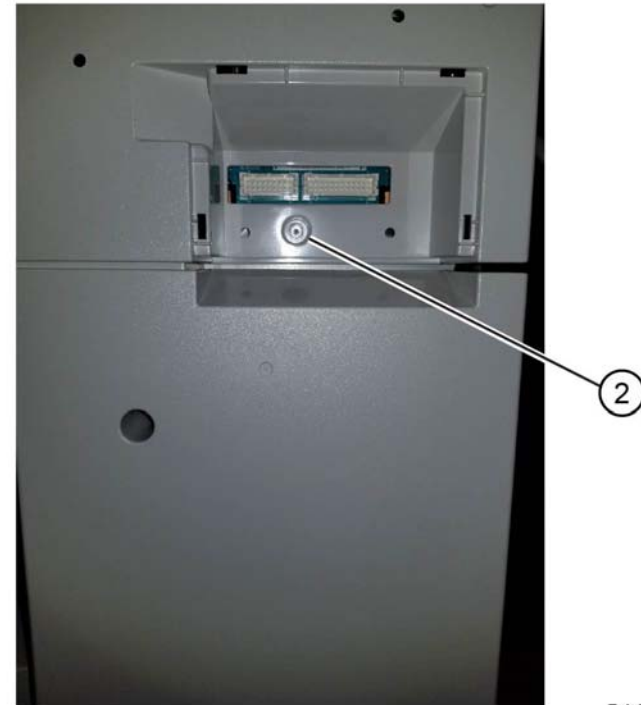
F-1-0710-A

4. Continue to remove the cover, remove one screw (2), [Figure 2](#).

Figure 2 Cover removal 2 of 4

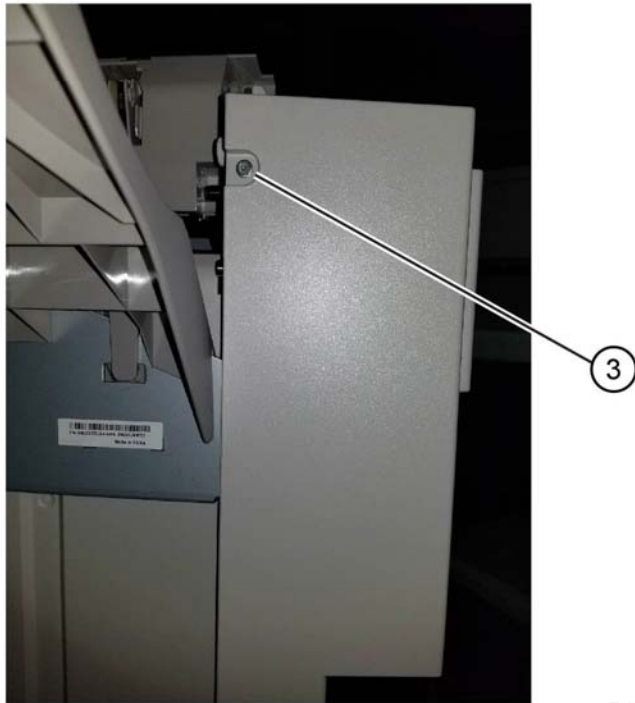
F-10711-A

5. Continue to remove the cover, remove one screw (3), [Figure 3](#).

Figure 3 Cover removal 3 of 4

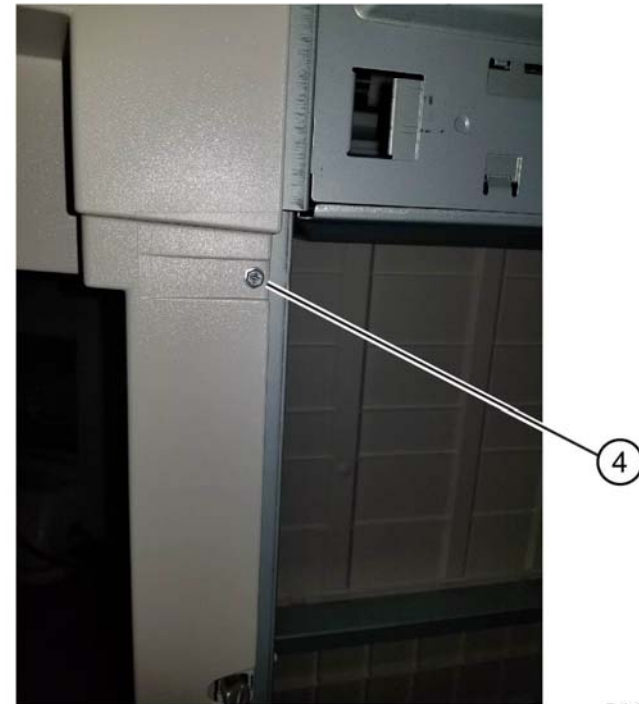
F-1-0712-A

6. Remove the rear upper cover, [Figure 4](#):
- Remove one screw (4).
 - Remove the cover.

Figure 4 Cover removal 4 of 4

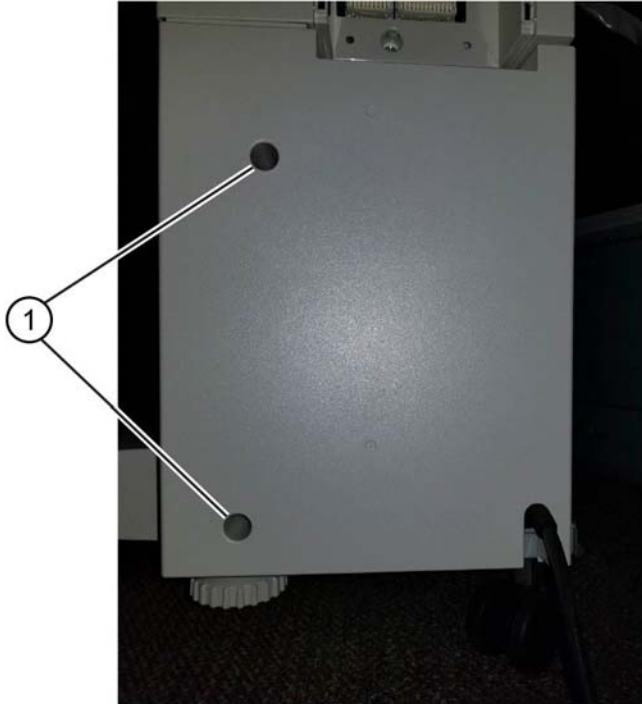
F-1-0713-A

1. Undock the finisher, [REP 13.5](#).
2. Prepare to remove the cover, remove two screws (1), [Figure 1](#).

Figure 1 Preparation

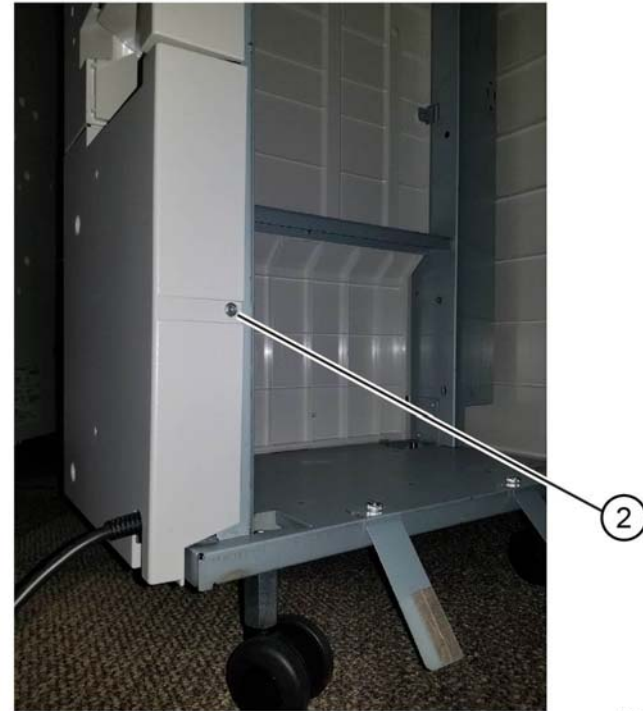
F-1-0714-A

3. Remove the rear lower cover, [Figure 2](#):
 - a. Remove one screw (2).
 - b. Remove the cover.

Figure 2 Cover removal

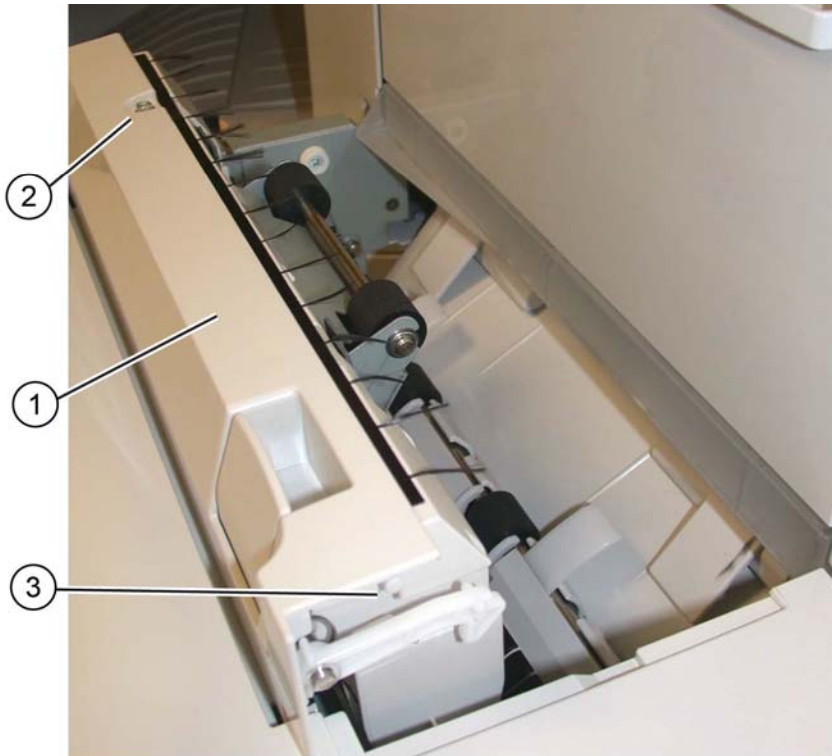
F-1-0006-A

1. Remove the top right cover, [PL 13.26 Item 1](#), [Figure 1](#):
 - a. Unlatch the eject cover (1), then move it to the left.
 - b. Remove the retaining screw (2).
 - c. Push the latch (3) through the hole in the cover.
 - d. Remove the cover by moving it to the left.

Figure 1 Eject cover removal

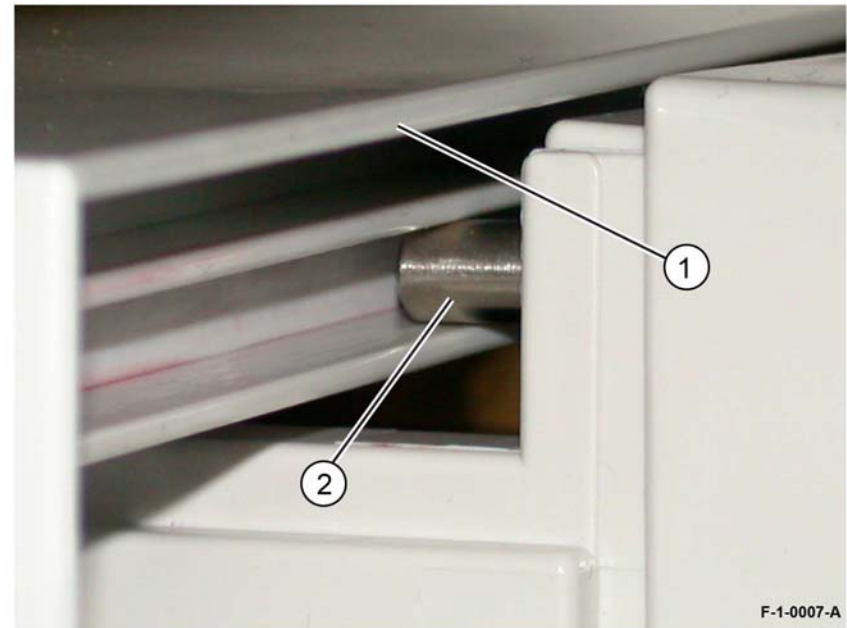
F-1-0007-A

1. Align the top right cover (1) with the pins (2) on both sides, then slide it to the right, [Figure 2](#).

NOTE: The left side of the cover will be captured by the pins and cannot be lifted up.

Figure 2 Eject cover alignment

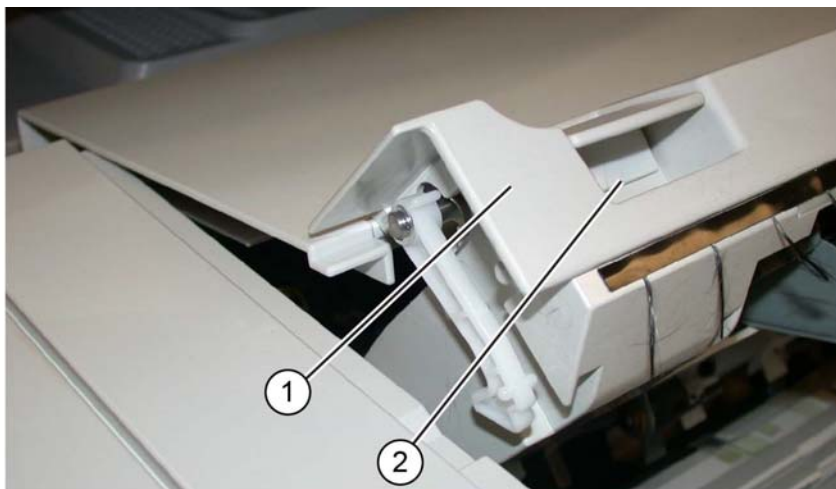
F-1-0008-A

2. Position the top right cover (1) so that the latch (2) is inserted in the hole, [Figure 3](#).

NOTE: The Latch must be outside the hole.

Figure 3 Inserting the Latch

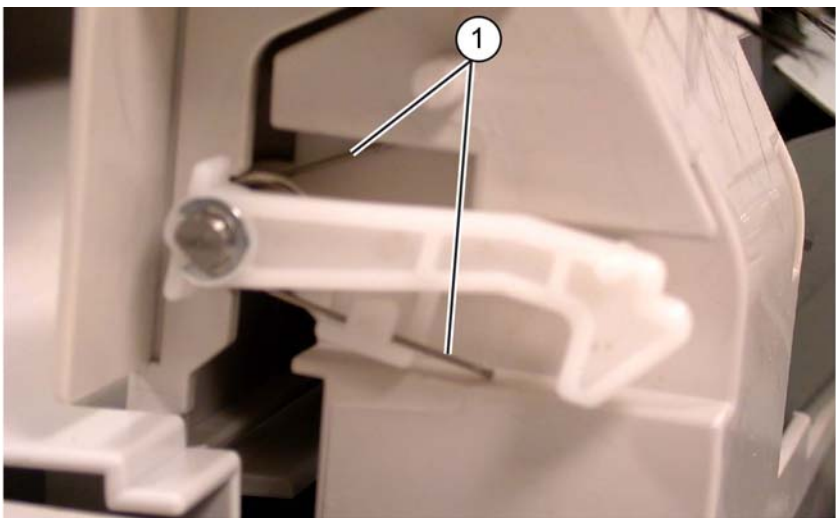
F-1-0009-A

3. Position the latch spring (1) as shown, [Figure 4](#).

Figure 4 Latch spring position

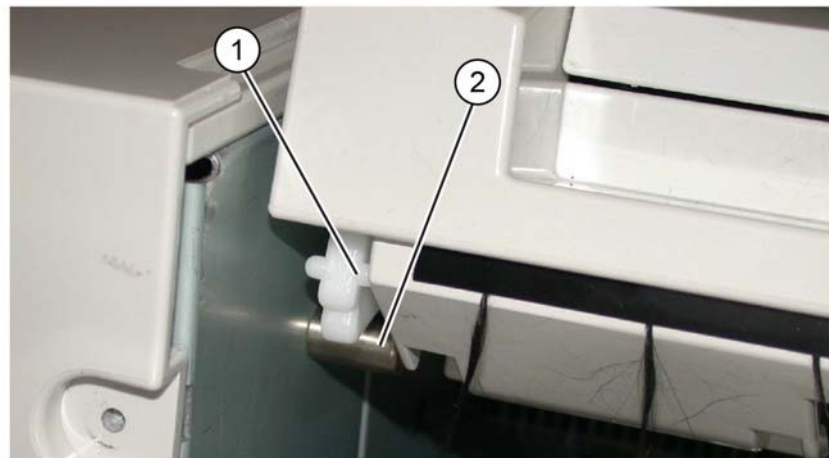
F-1-0010-A

4. Position the latch hook (1) and latch pin (2) as shown, [Figure 5](#).

Figure 5 Hook and pin positioning

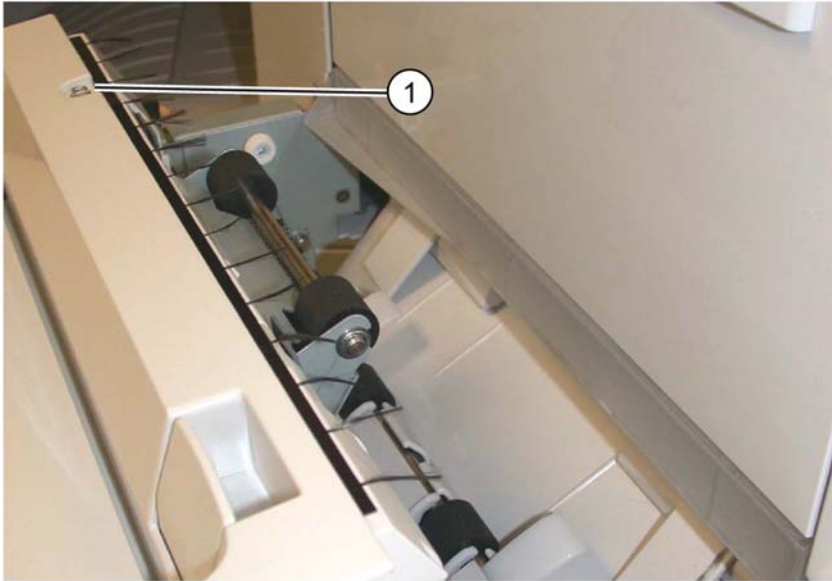
F-1-0011-A

5. Install the retaining screw (1), Figure 6.

Figure 6 Retaining screw

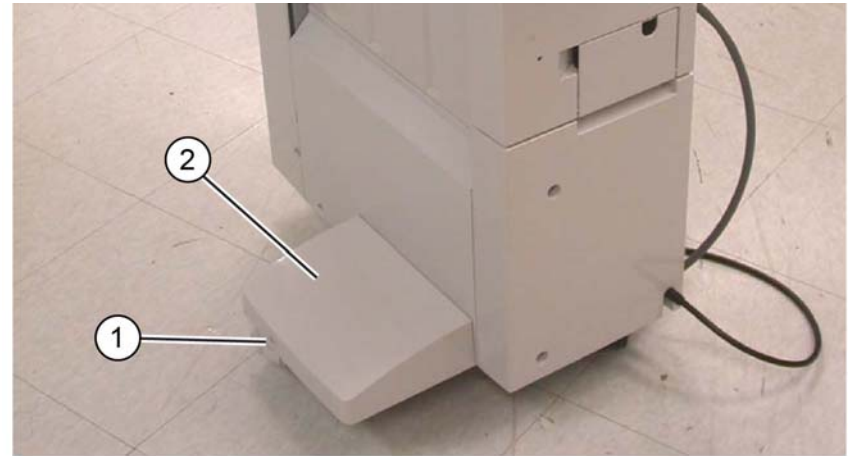
F-1-0012-A

1. Remove the screw (1), then the foot cover (2), Figure 1.

Figure 1 Foot cover removal

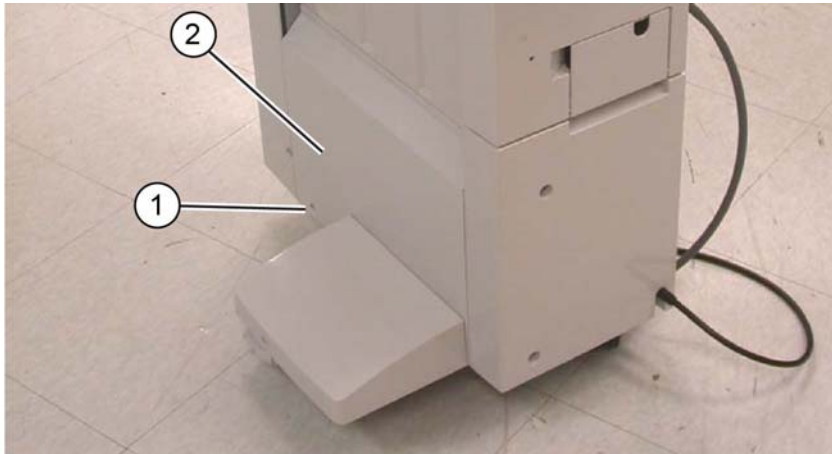
F-1-0013-A

1. Remove the foot cover, [REP 13.10](#).
2. Remove the two screws (1), then the stacker lower cover (2), [Figure 1](#).

Figure 1 Stacker lower cover removal

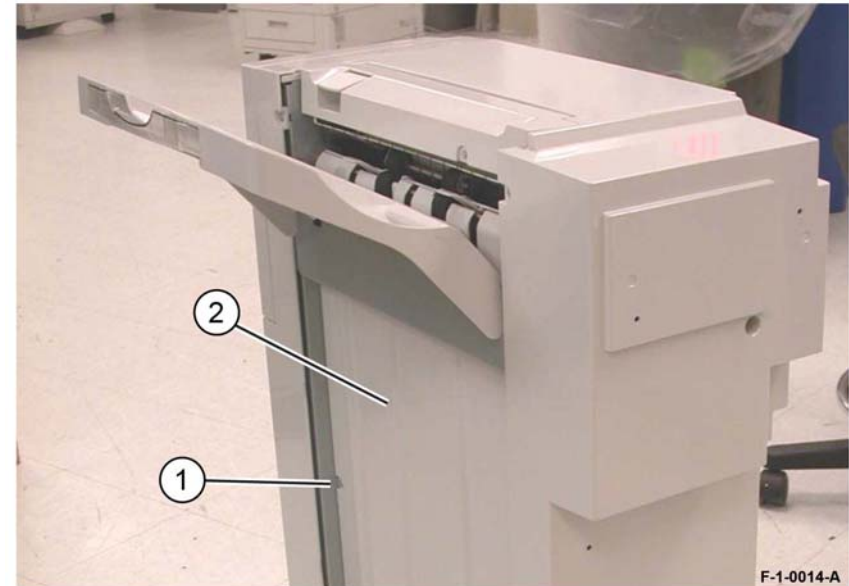
F-1-0014-A

1. Remove the stacker tray, [REP 13.20](#).
2. Remove the stacker lower cover, [REP 13.11](#).
3. Remove six screws (1), then the stacker upper cover (2), [PL 13.15 Item 33, Figure 1](#).

Figure 1 Stacker upper cover removal
