VersaLink[®] C8000/C9000 Printer

Service Manual

VersaLink C9000 Family Service Manual

705P01418

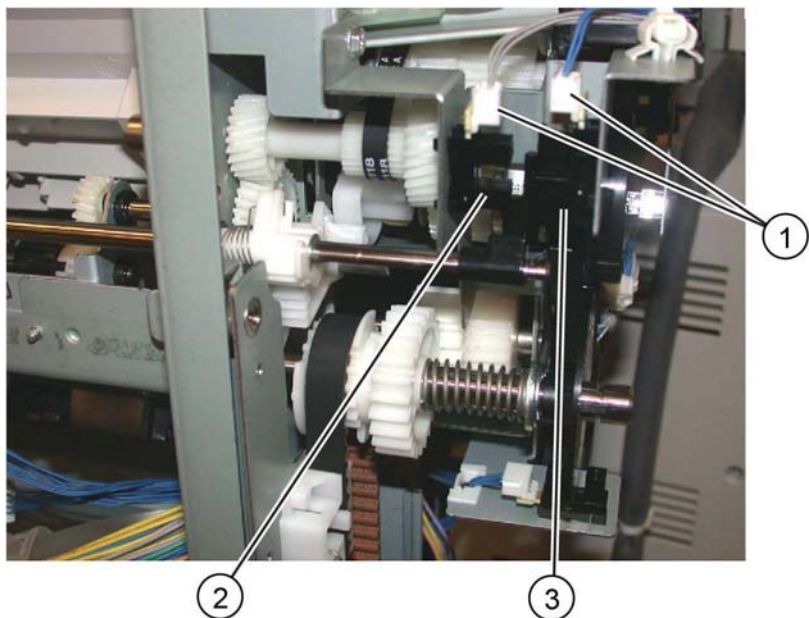
F-1-0015-A

1. Remove the rear upper cover, [REP 13.7](#).
2. Remove the relevant stack height sensor, [PL 13.27 Item 16, Figure 1](#):
 - a. Disconnect the relevant connector (1).
 - b. Remove either stack height sensor 1 (2) or stack height sensor 2 (3).

Figure 1 Sensor removal

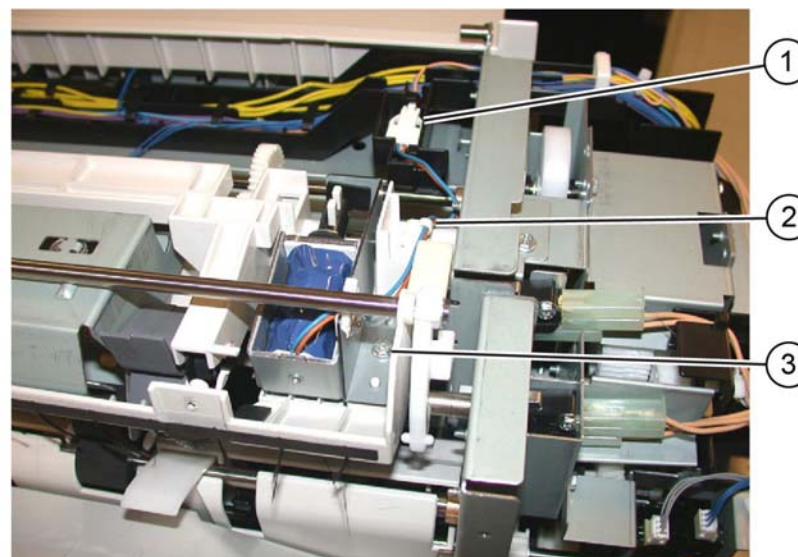
F-1-0016-A

1. Remove the top right cover, [REP 13.9](#).
2. Remove the sub paddle solenoid assembly, [PL 13.26 Item 8, Figure 1](#):
 - a. Disconnect the connector (1).
 - b. Release the harness from the clamps (2).
 - c. Remove the screw (3), then the sub paddle solenoid assembly.

Figure 1 Solenoid assembly removal

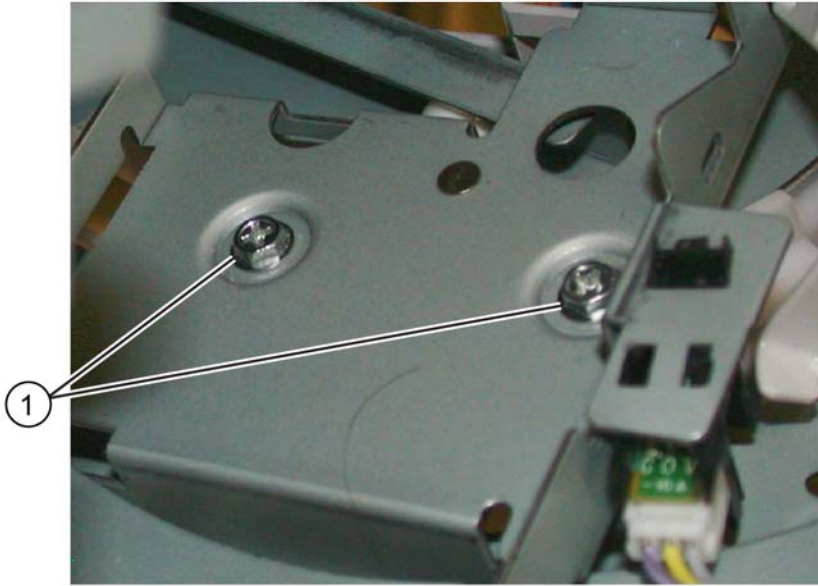
F-1-0017-A

1. Remove the finisher stapler assembly, [REP 13.16](#).
2. Remove two screws (1), [Figure 1](#).

Figure 1 Screw removal

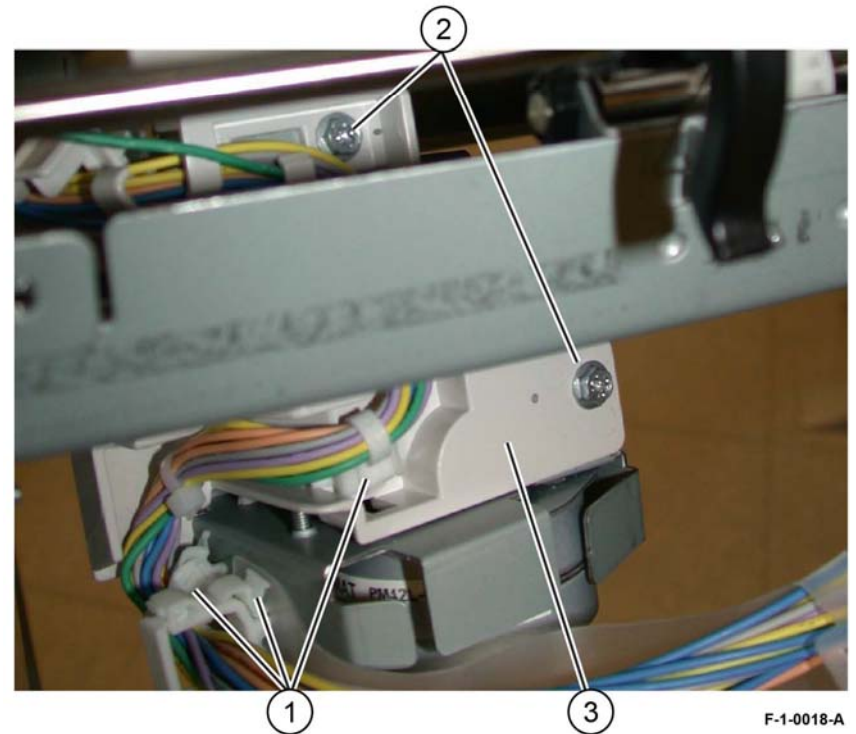
F-1-0018-A

3. Remove the wire guide, [Figure 2](#):
 - a. Pull out the cable clamps (1), then remove the wires from the wire guide.
 - b. Remove two screws (2).
 - c. Remove the wire guide (3).

Figure 2 Wire guide removal

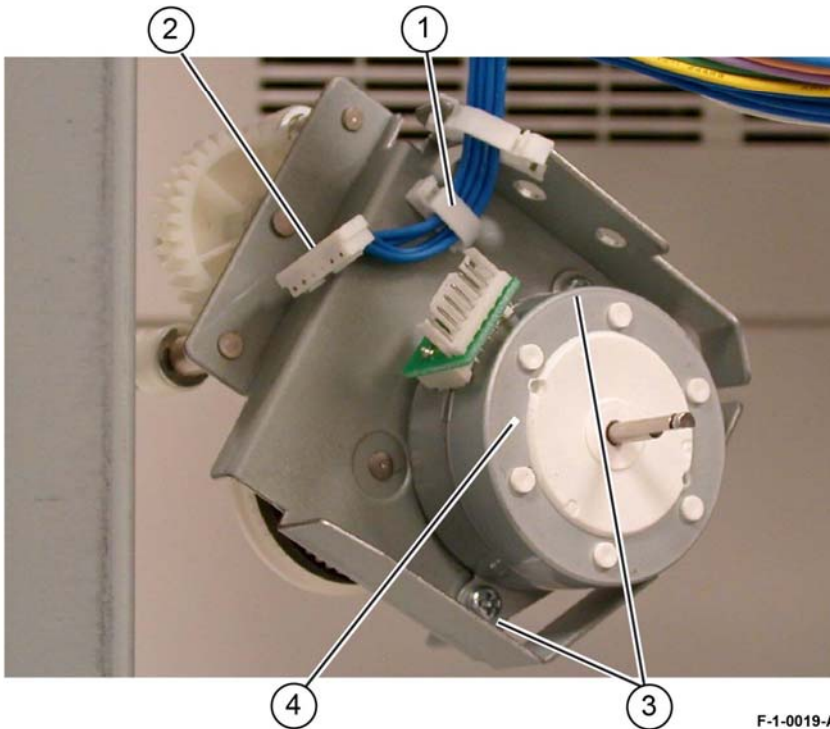
F-1-0019-A

4. Remove the stapler move motor, [Figure 3](#):
 - a. Release the wires from the cable clamp (1).
 - b. Disconnect the connector (2).
 - c. Remove two screws (3).
 - d. Remove the stapler motor (4).

Figure 3 Stapler motor removal

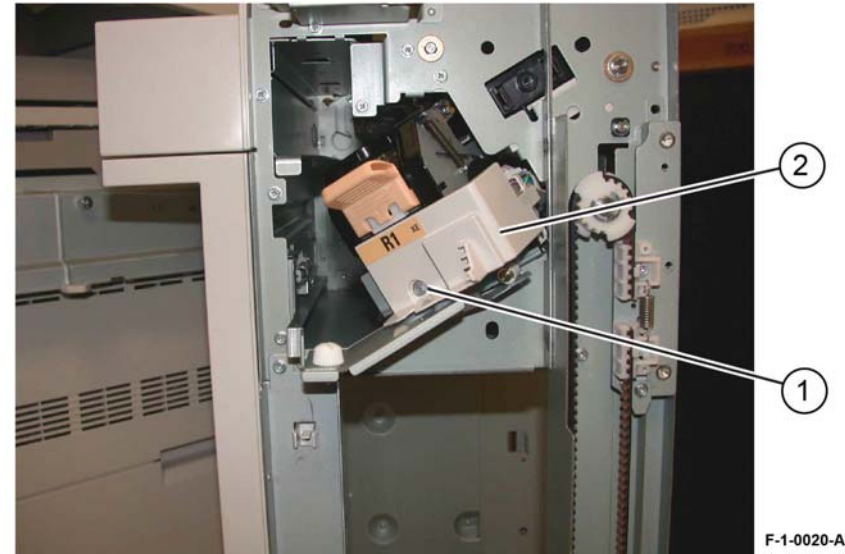
F-1-0020-A

1. Remove the crease assembly, [REP 13.18](#).
2. Remove the front cover assembly, [REP 13.6](#).
3. Remove the stapler cover, [Figure 1](#):
 - a. Remove the screw (1).
 - b. Remove the stapler cover (2).

Figure 1 Stapler cover removal

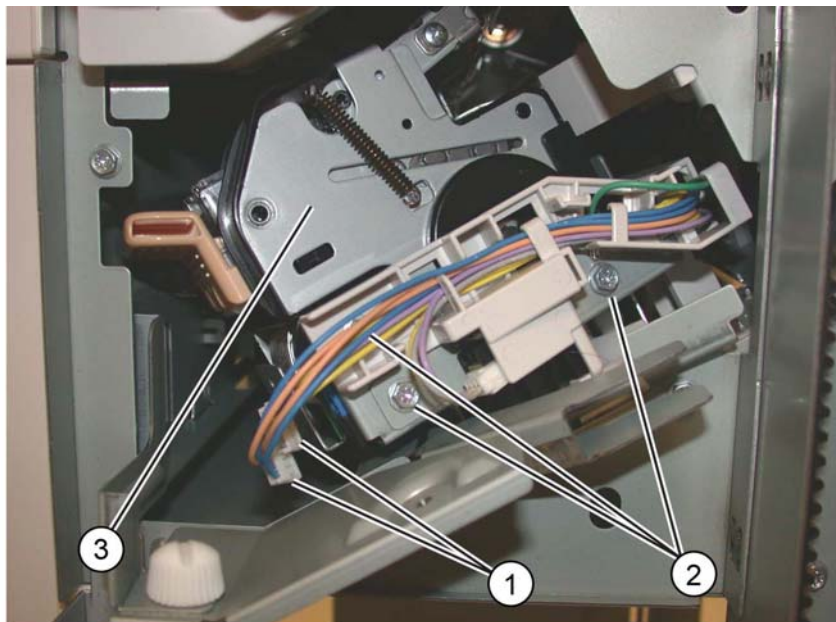
F-1-0021-A

4. Remove the stapler assembly, [PL 13.20 Item 4, Figure 2](#):
 - a. Disconnect the connectors (1).
 - b. Remove three screws (2).
 - c. Remove the stapler assembly (3).

Figure 2 Stapler assembly removal

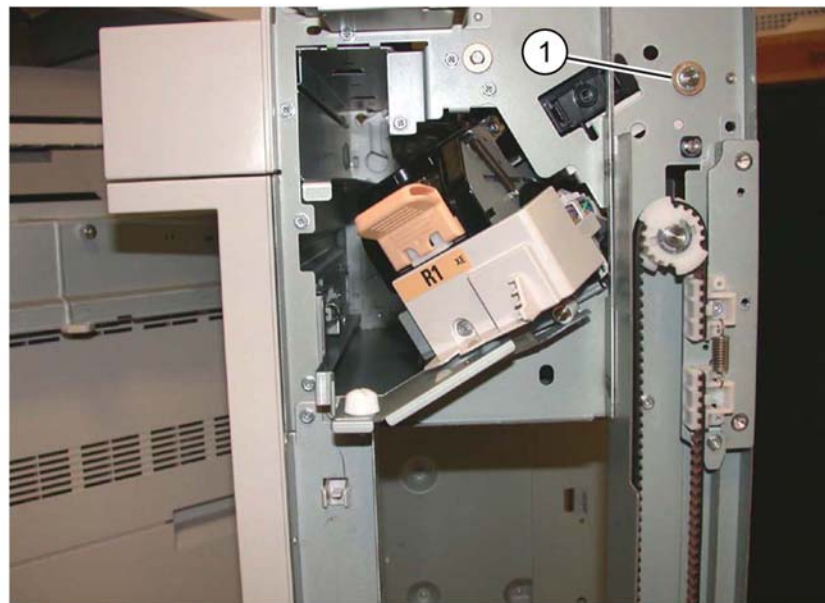
F-1-0022-A

1. Undock the finisher, [REP 13.5](#).
2. Remove the front cover, [REP 13.6](#).
3. Remove the rear upper cover, [REP 13.7](#).
4. Remove the foot cover, [REP 13.10](#).
5. Remove the stacker lower cover, [REP 13.11](#).
6. Remove the stacker tray, [REP 13.20](#).
7. Remove the stacker upper cover, [REP 13.12](#).
8. Remove the top right cover, [REP 13.9](#).
9. Remove the E-clip and bearing from the end of the shaft (1), [Figure 1](#).

Figure 1 E-clip and bearing removal

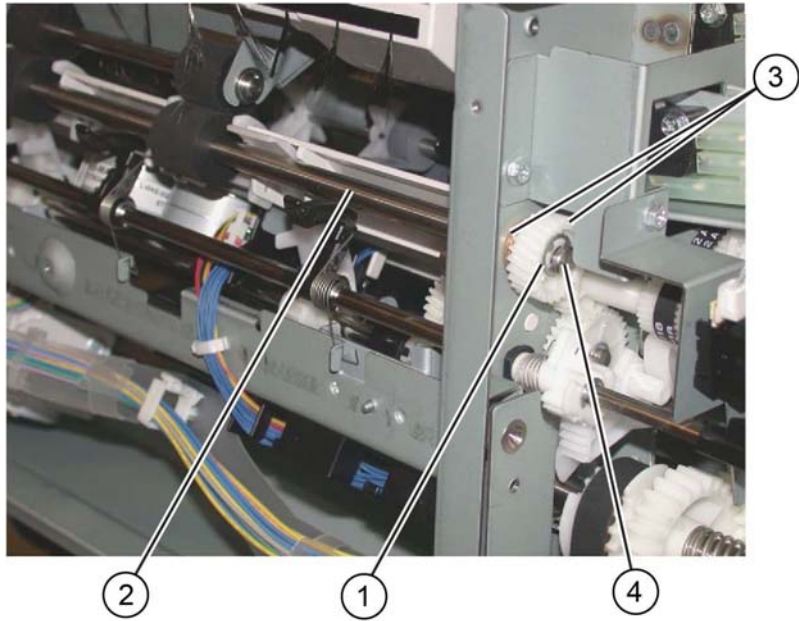
F-1-0023-A

10. Remove the eject roller, **Figure 2**:
 - a. Remove the E-clip (1).
 - b. Slide the eject roller shaft (2) toward the front.
 - c. Remove the gear and bearing (3).
 - d. Remove the eject roll shaft (4) from the finisher.

Figure 2 Eject roll shaft removal

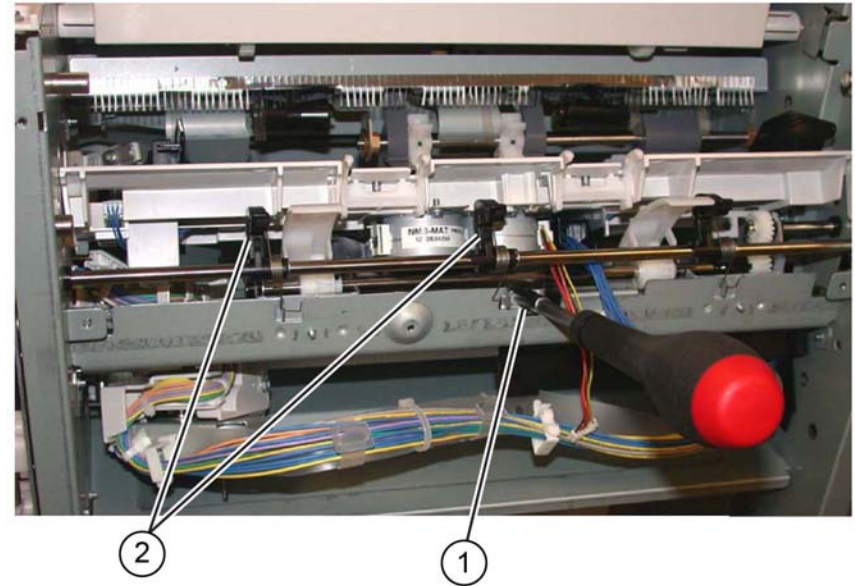
F-1-0024-A

11. Remove the compiler tray screw (1), **Figure 3**.
NOTE: Note the position of the set clamp holders (2).

Figure 3 Compiler tray screw removal

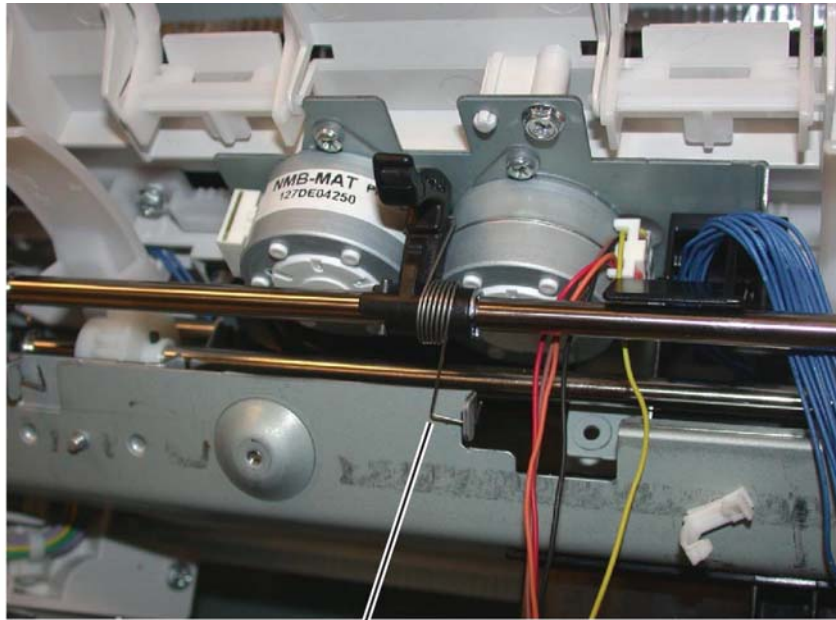
F-1-0025-A

12. Disengage the three springs (1) from the set clamp holders, [Figure 4](#).

Figure 4 Set clamp holder springs

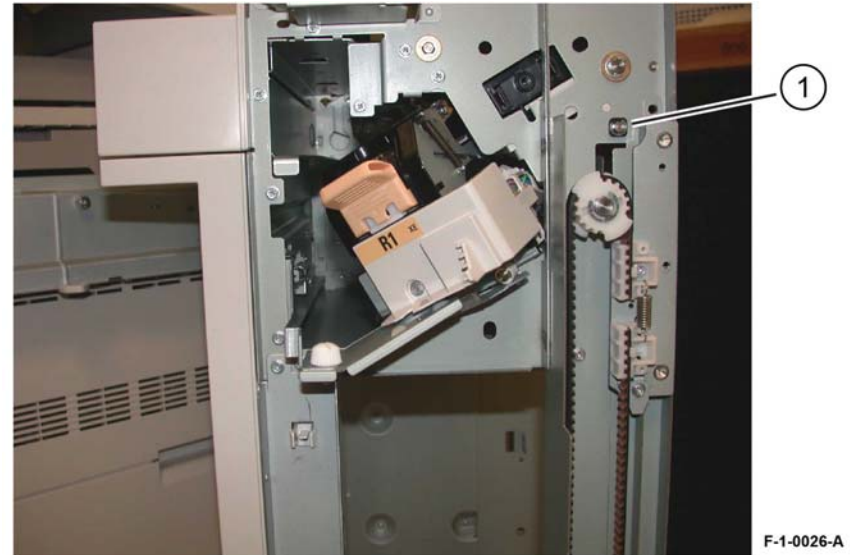
F-1-0026-A

13. Remove the front E-clip and the bearing (1) from the set clamp shaft assembly, [Figure 5](#).

Figure 5 Front E-clip removal

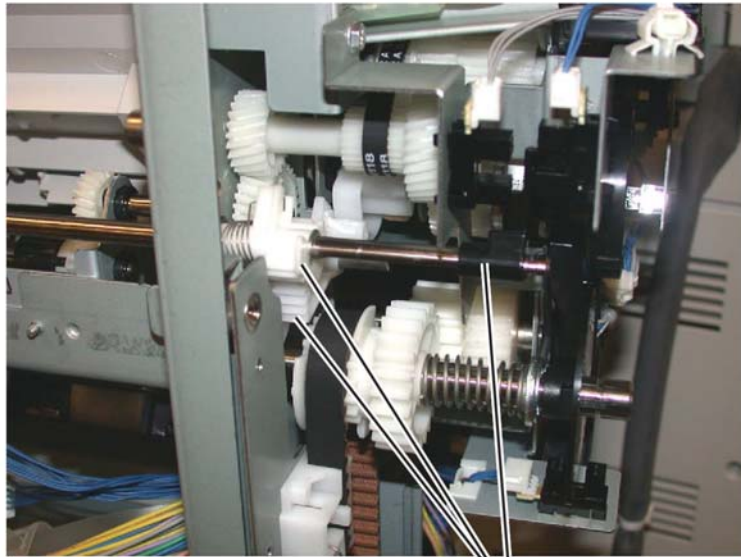
Figure 6 Gear orientation

14. Note the position and orientation of the set clamp shaft gear and the cam gear that it engages (1). When installing the set clamp shaft, these gears must engage in the same manner, [Figure 6](#).

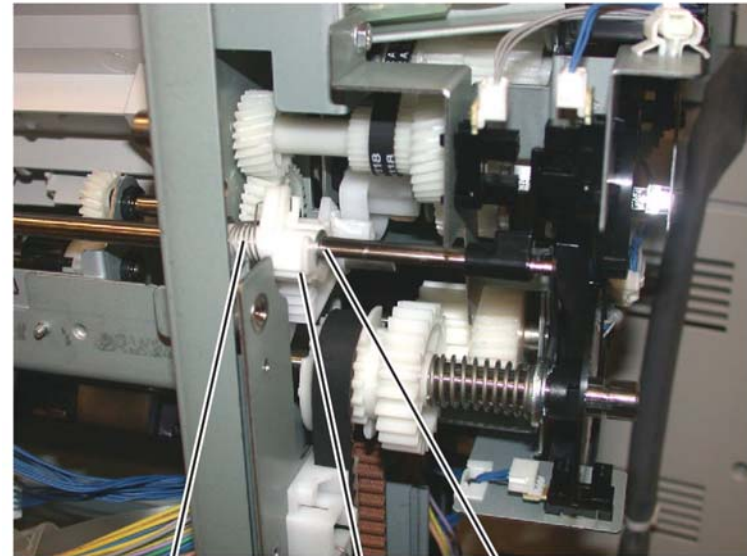
Figure 7 Preparation

15. Prepare to remove the set clamp shaft, [PL 13.25 Item 9, Figure 7](#):
- Remove the rear E-clip (1) from the set clamp shaft
 - Slide the gear (2) away from the frame.
 - Disconnect the spring (3) from the gear.

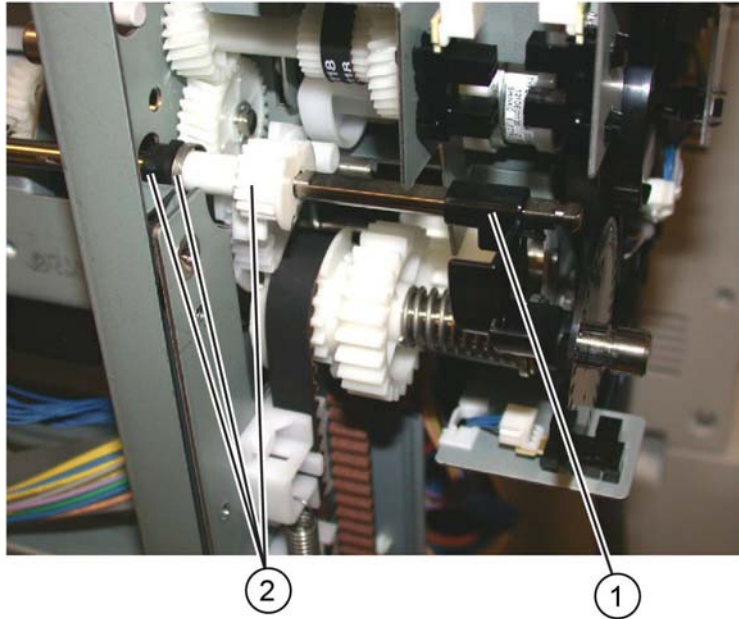
Figure 8 Flag removal

16. Slide the gear, spring and the bearing away from the frame, **Figure 8**:
 - a. Unlock, then remove the flag (1).
 - b. Slide the gear, spring and the bearing (2) away from the frame.

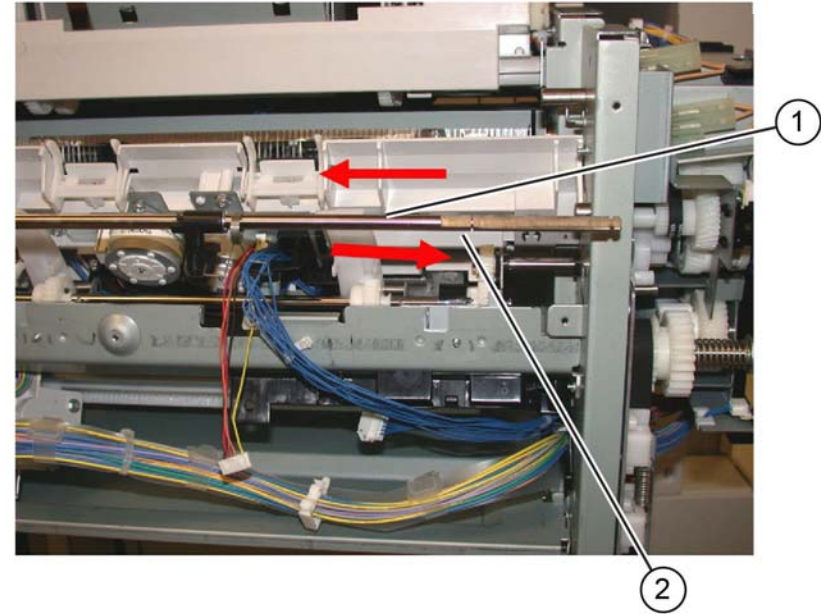
Figure 9 Set clamp shaft removal

17. Remove the set clamp shaft, **Figure 9**:
 - a. Slide the shaft toward the front (1).
 - b. Slide the shaft toward the rear, then remove (2).

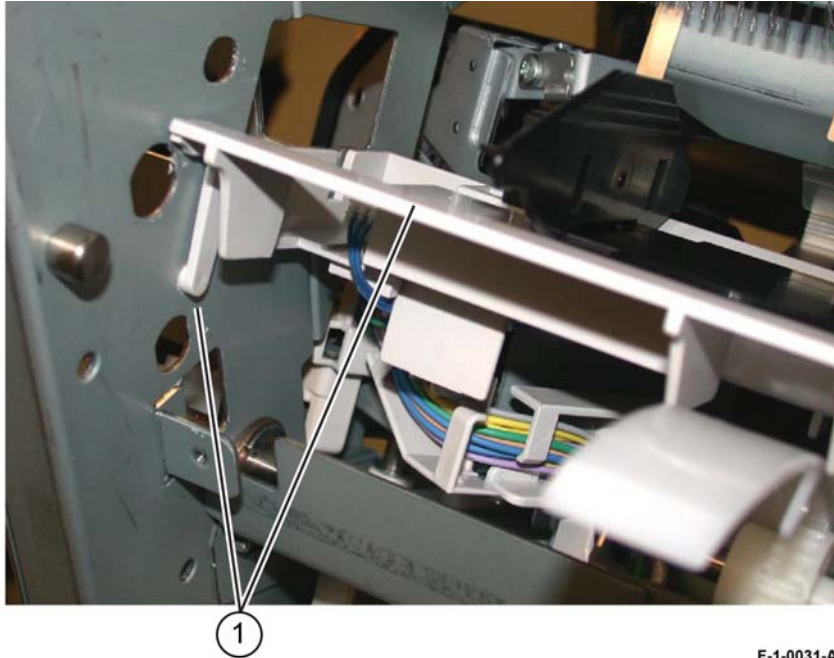
Figure 10 Tray assembly removal

18. Remove the compiler tray assembly (1), [Figure 10](#).

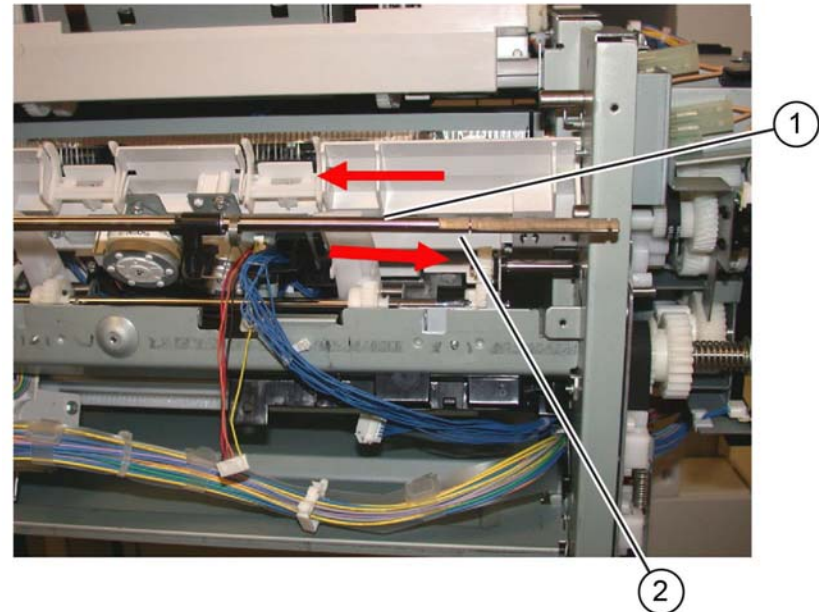
Figure 11 Set clamp shaft installation

1. Route the harness through the wire guides and connect the proper connectors to the no paper sensor, [PL 13.28 Item 9](#), tamper home sensors, [PL 13.28 Item 8](#), and the tamper motors, [PL 13.28 Item 6](#).
2. Place the compiler tray assembly into position.
3. Install the set clamp shaft front end into the front frame, [Figure 11](#):
 - a. Insert the front end of the shaft into the front frame (1).
 - b. Slide the shaft toward the front until the rear end of the shaft can be inserted into the rear frame (2).

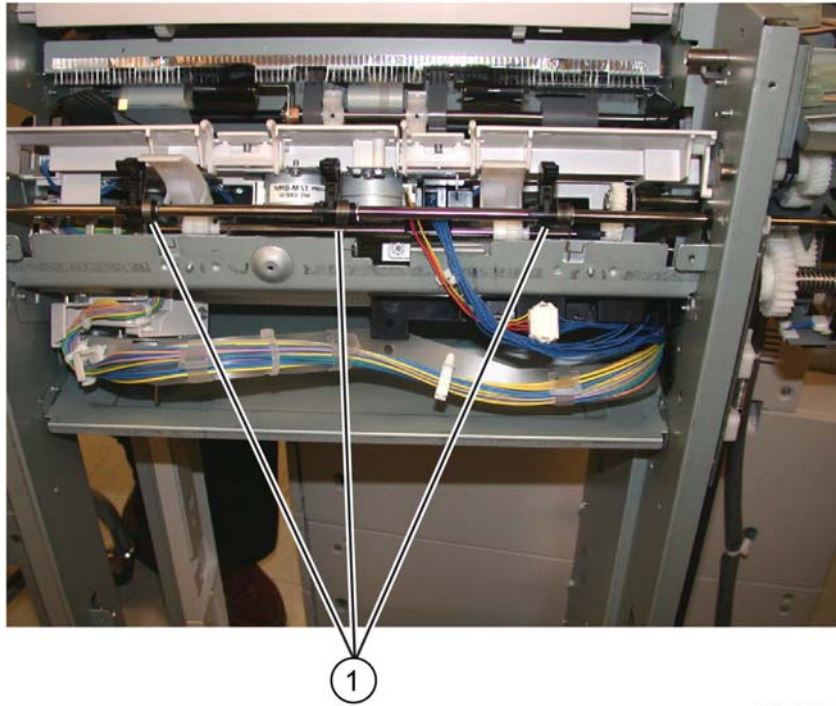
Figure 12 Replacement preparation

4. Slide the three set clamp holders with springs (1) into the correct location on the shaft, [Figure 12](#).

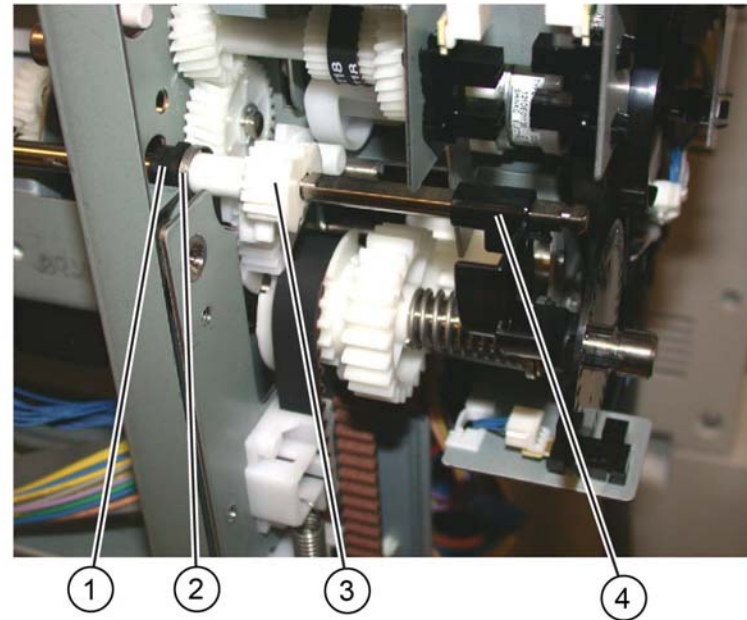
Figure 13 Parts installation

5. Install the bearing, spring and gear onto the rear end of the set clamp shaft, [Figure 13](#):
 - a. Install the bearing (1).
 - b. Install the spring (2).
 - c. Install the gear (3).
 - d. Install the stack height sensor flag (4) onto the rear end of the shaft as shown.

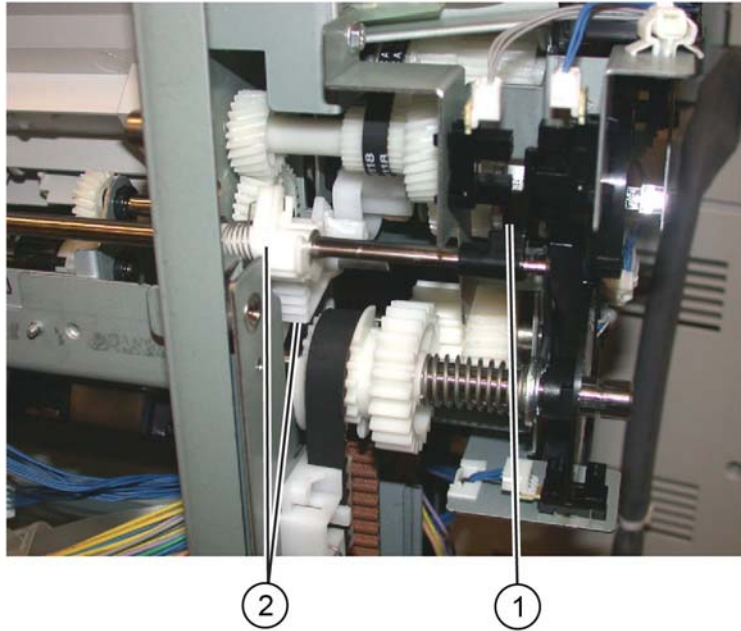
Figure 14 Parts alignment

6. Rotate the set clamp shaft until the stack height sensor flag (1) is in the correct position, then correctly align both gears (2), **Figure 14**.

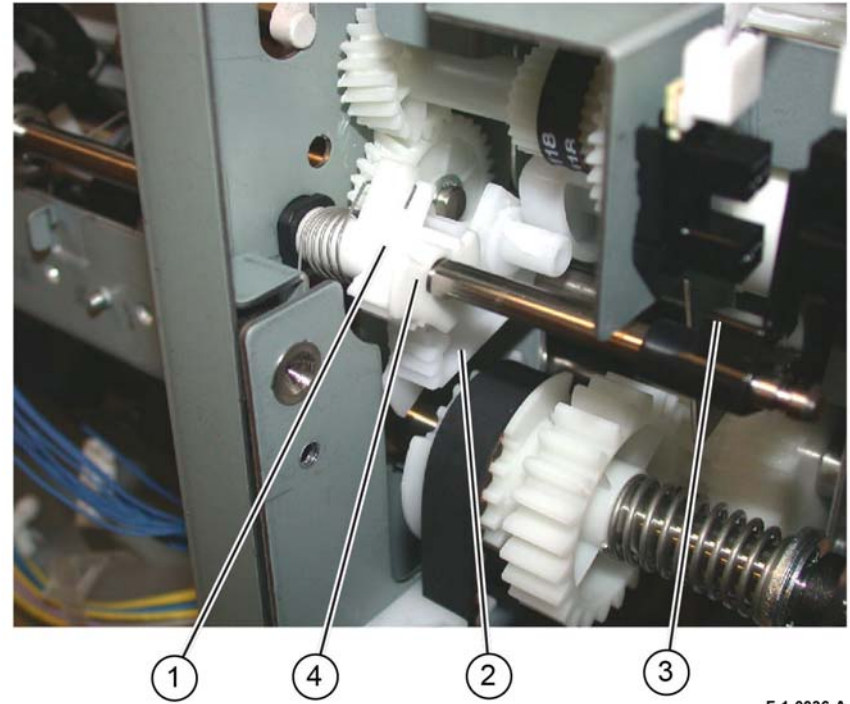
Figure 15 Parts positioning

8. Ensure that the shaft gear (1), pinion gear (2) and the stack height sensor flag (3) are positioned as shown in **Figure 15**, then install the E-clip (4).

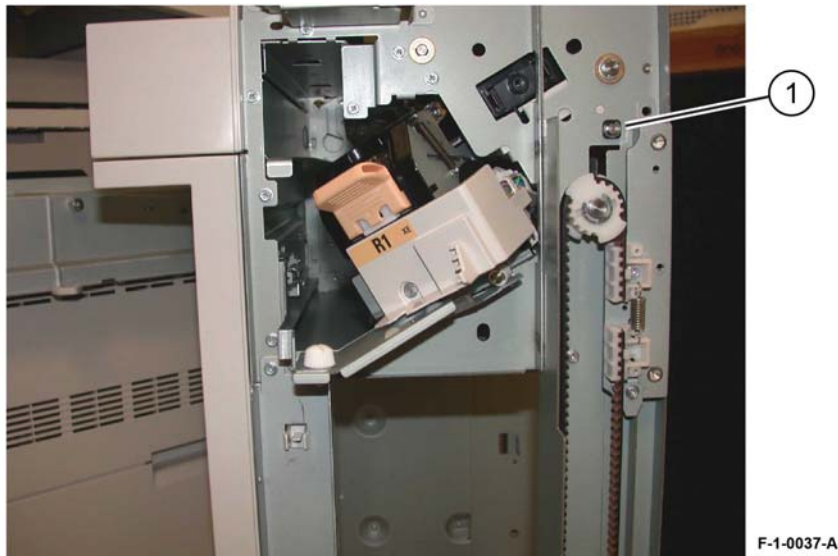
Figure 16 Bearing and E-clip

9. Install the bearing onto the end of the set clamp shaft, then install the E-clip (1), [Figure 16](#).

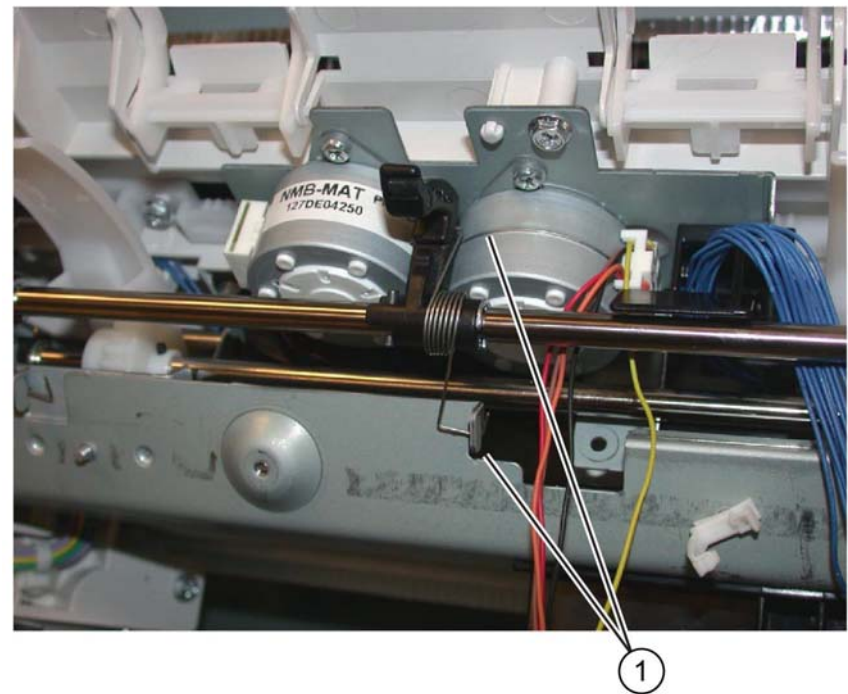
Figure 17 Set clamp holder springs

10. Ensure that the set clamp holder springs (1) are connected, [Figure 17](#).

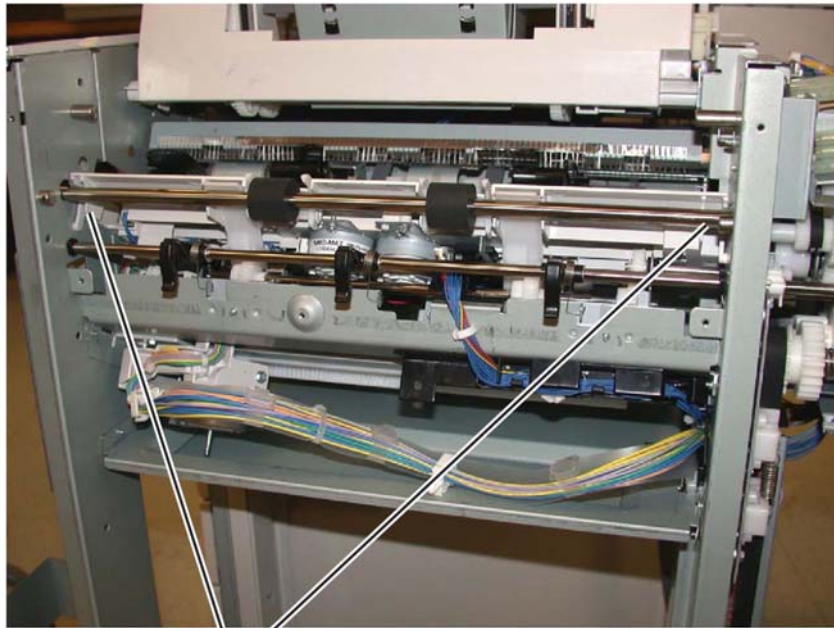
Figure 18 Eject roll shaft installation

11. Install the eject roll shaft (1) into position in the front and rear frame, [Figure 18](#).

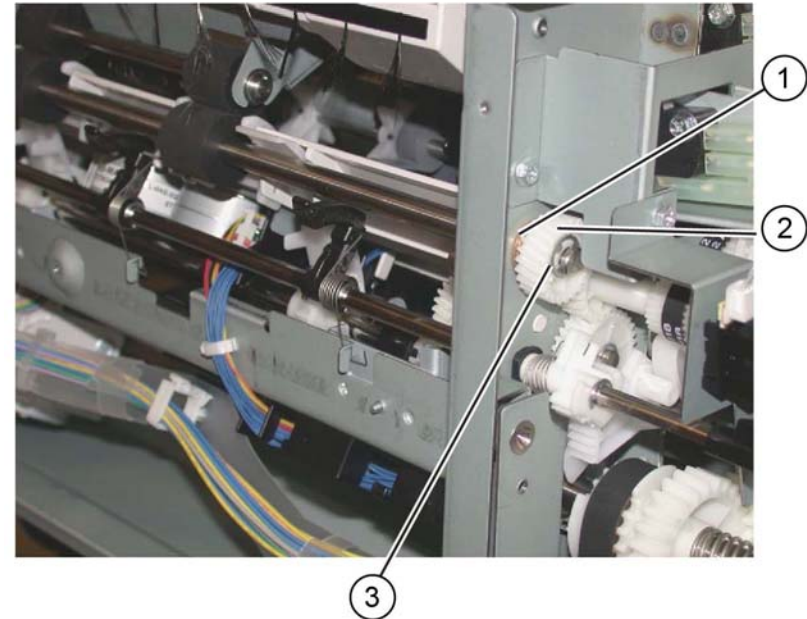
Figure 19 Rear components

12. Install the bearing (1), gear (2) and E-clip (3) onto the rear of the eject roll shaft, [Figure 19](#).

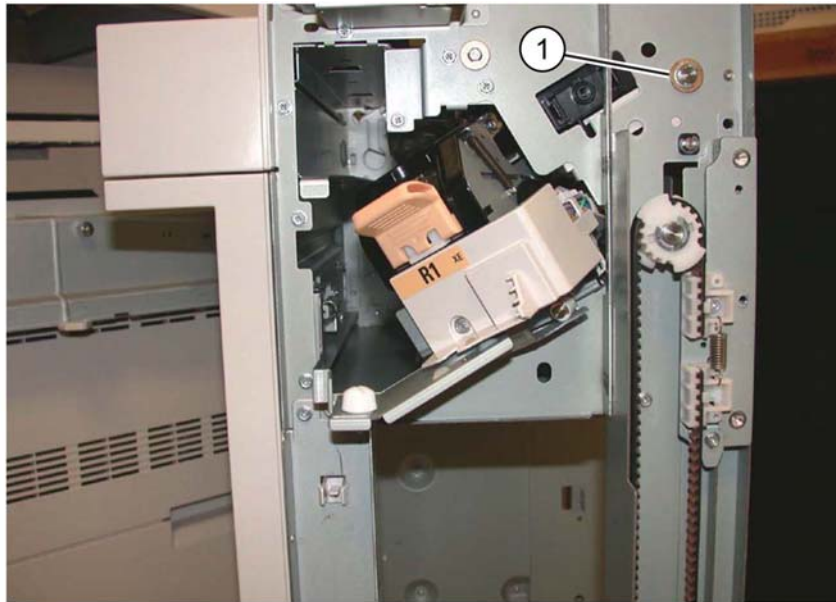
Figure 20 Front components

13. Install the bearing and E-clip onto the front of the eject roll shaft (1), [Figure 20](#).

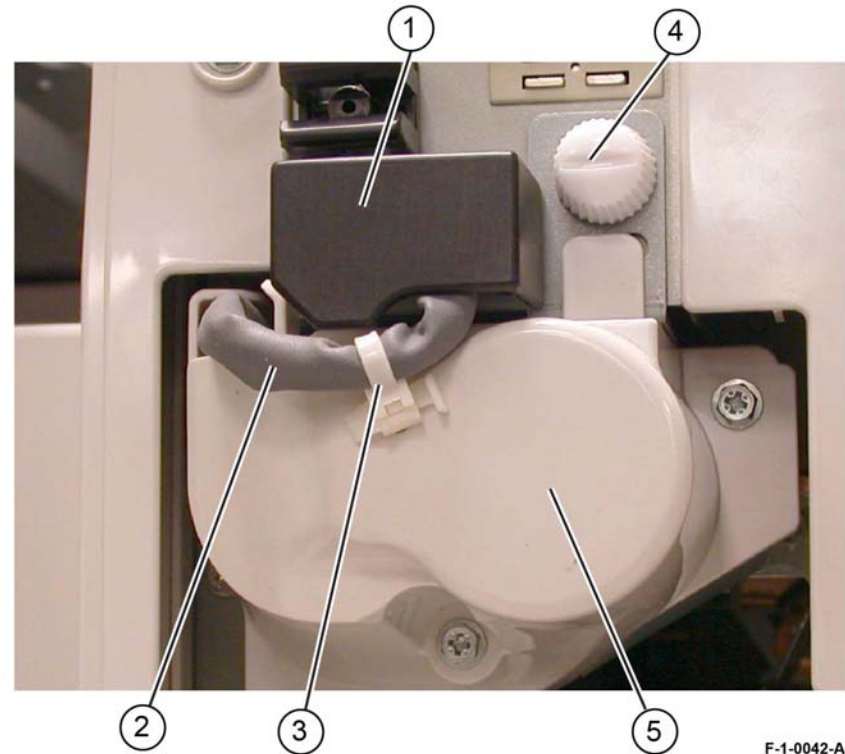
Figure 1 Crease assembly removal

NOTE: Pull out the cable tie (3) to obtain additional slack in the cable.

- d. Remove the thumbscrew (4).
 - e. Pull out the crease assembly (5).

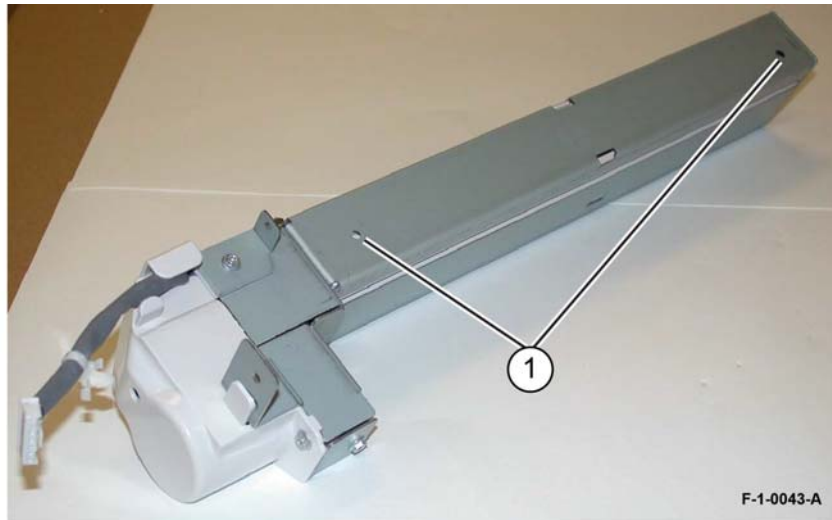
Figure 2 Crease assembly

NOTE: Ensure the locating pins (1) are correctly engaged, [Figure 2](#).

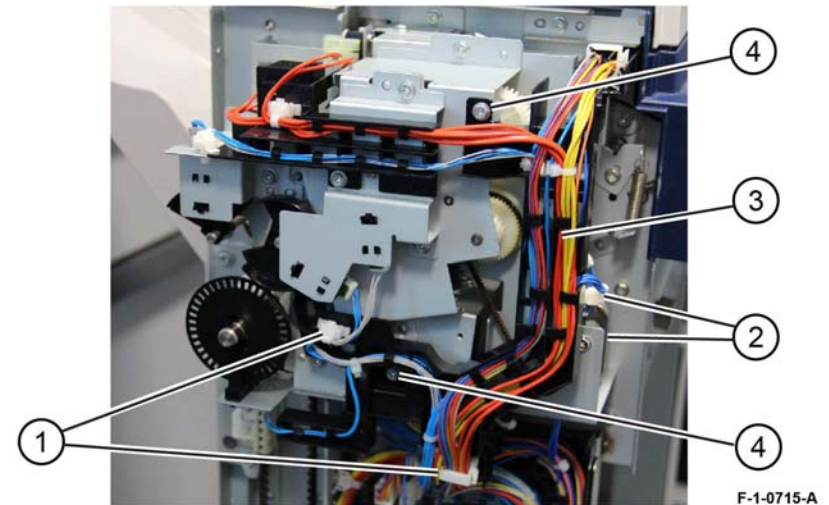
Figure 1 Main harness release

1. Undock the finisher, [REP 13.5](#).
2. Remove the booklet maker, [REP 13.31](#).
3. Remove the finisher rear upper cover, [REP 13.7](#).
4. Remove the main harness guide, [Figure 1](#).
 - a. Release two harness retainers (1).
 - b. Release the harness retainer and disconnect the motor (2).
 - c. Release the harness from the guide (3).
 - d. Remove two screws, then remove the harness guide (4).

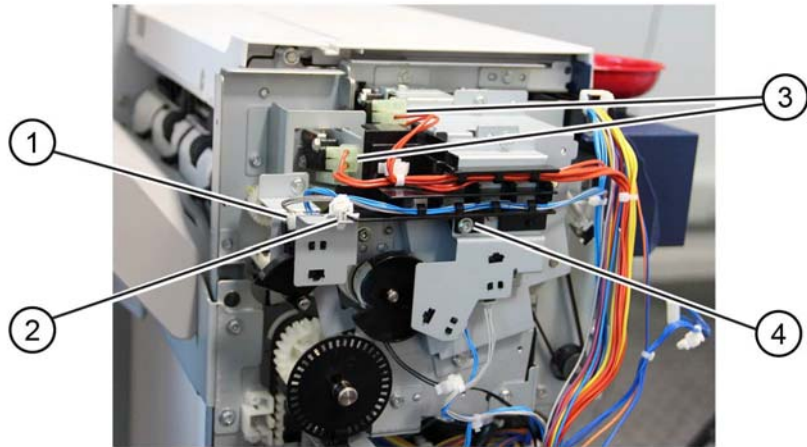
Figure 2 Upper harness guide release

5. Release the upper harness guide [Figure 2](#).
 - a. Disconnect two sensors (1).
 - b. Release the harness retainer (2).
 - c. Disconnect two switches (3).
 - d. Remove one screw to release the harness guide (4).
 - e. Allow the harness and guide to hang to the right side.

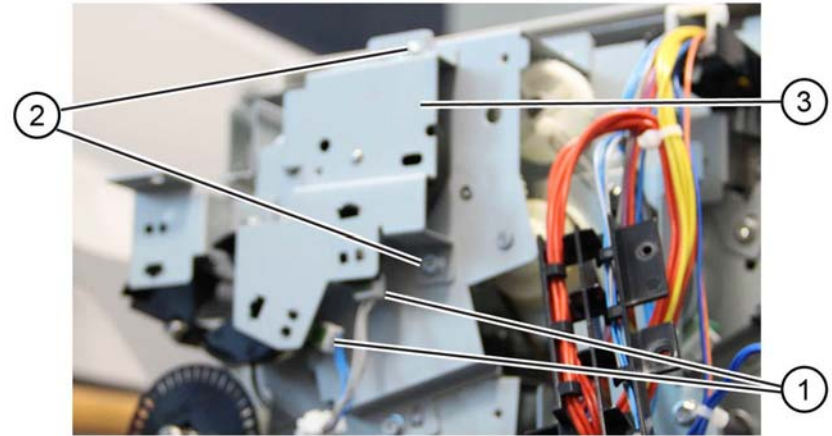
Figure 3 Sensor bracket removal

6. Remove the sensor bracket, [Figure 3](#).
 - a. Disconnect two sensors (1).
 - b. Remove two screws (2).
 - c. Remove the sensor bracket (3).

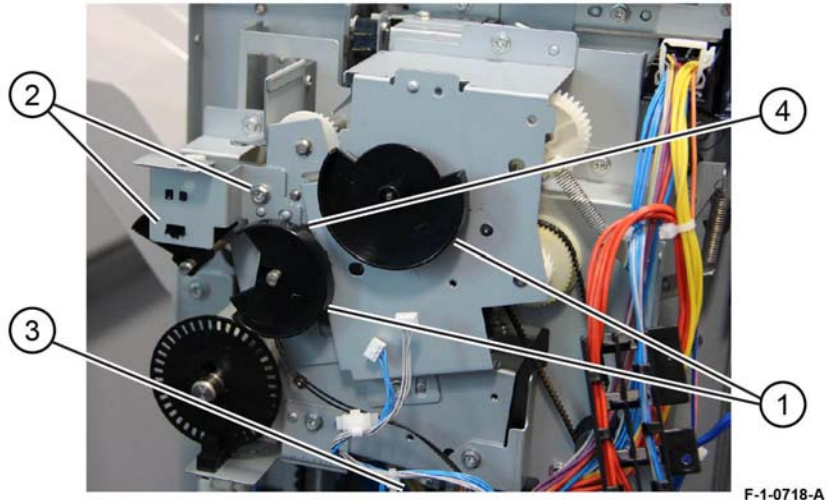
Figure 4 Clutch removal

7. Remove the clutch, **Figure 4**.
 - a. Remove two timing wheels (1).
 - b. Remove the screw and sensor bracket (2).
 - c. Disconnect the clutch harness at the in-line connector (3).
 - d. Remove the clutch (4).

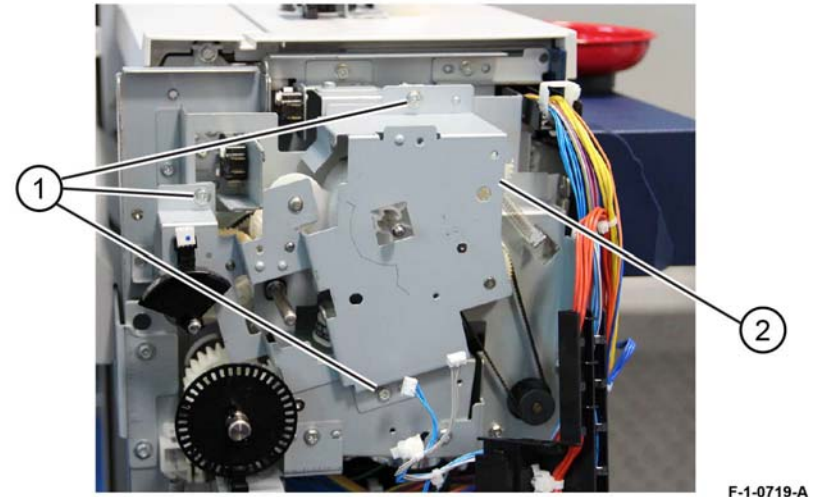
Figure 5 Bracket removal

8. Remove the bracket, **Figure 5**.
 - a. Remove three screws (1).
 - b. Remove the bracket (2).

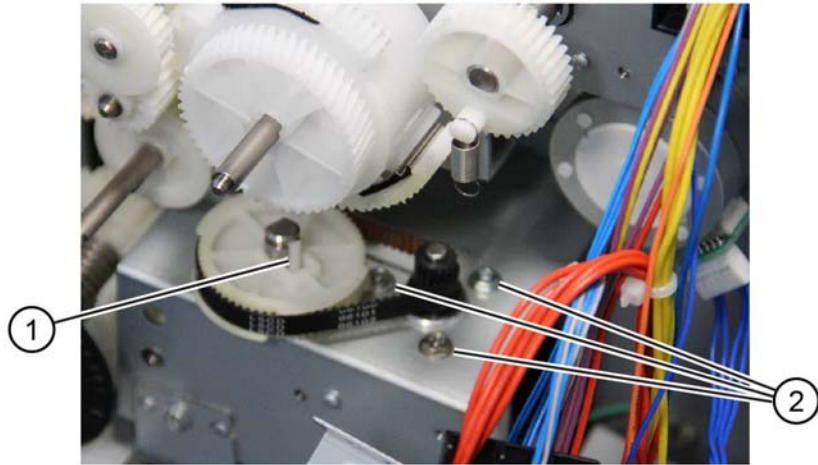
Figure 6 Motor removal

9. Remove the motor, [Figure 6](#).
 - a. Release the locking arm, then slide the belt and pulley off of the motor shaft (1).
 - b. Remove three screws (2).
 - c. Remove the motor from the bracket, then disconnect the motor harness from the PWB.

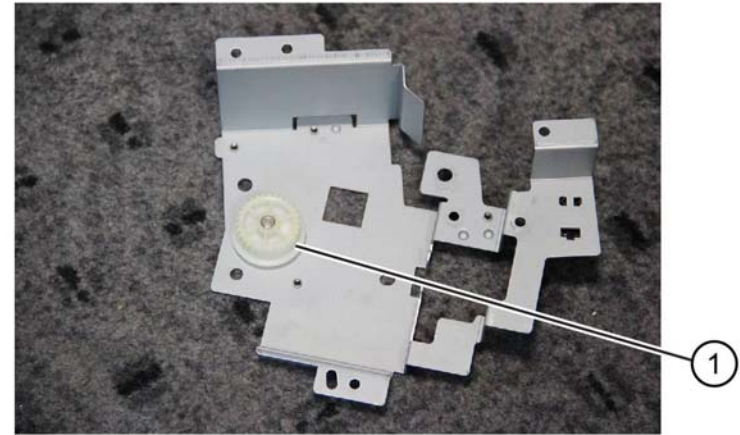
Figure 7 Idler pulley

NOTE: When reinstalling the bracket ensure the idler gear (1) is installed on the stub shaft, [Figure 7](#).

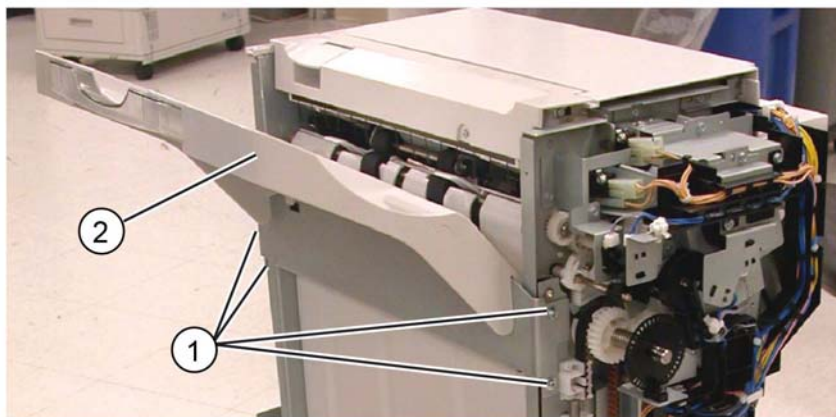
Figure 1 Stacker tray removal

1. If installed, remove the booklet maker assembly, [REP 13.31](#).
2. Remove the front cover assembly, [REP 13.6](#).
3. Remove the rear upper cover, [REP 13.7](#).
4. Remove the stacker tray, [PL 13.20 Item 15](#), [Figure 1](#):
 - a. Remove four screws (1).
 - b. Remove the stacker tray (2).

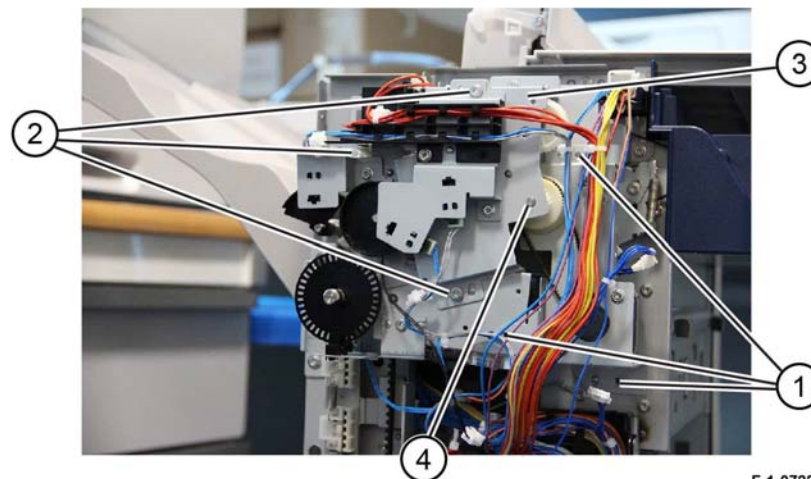
Figure 1 Motor bracket removal

1. Go to [REP 13.19](#), perform steps 1 to 5. Continue at 2 of this repair.
2. Remove the motor bracket assembly, [Figure 1](#).
 - a. Remove three screws (1).
 - b. Loosen three screws about 4 turns (2).
 - c. Pull the large bracket (3) away to release the shaft of the motor bracket assembly (4), then remove the motor bracket assembly.

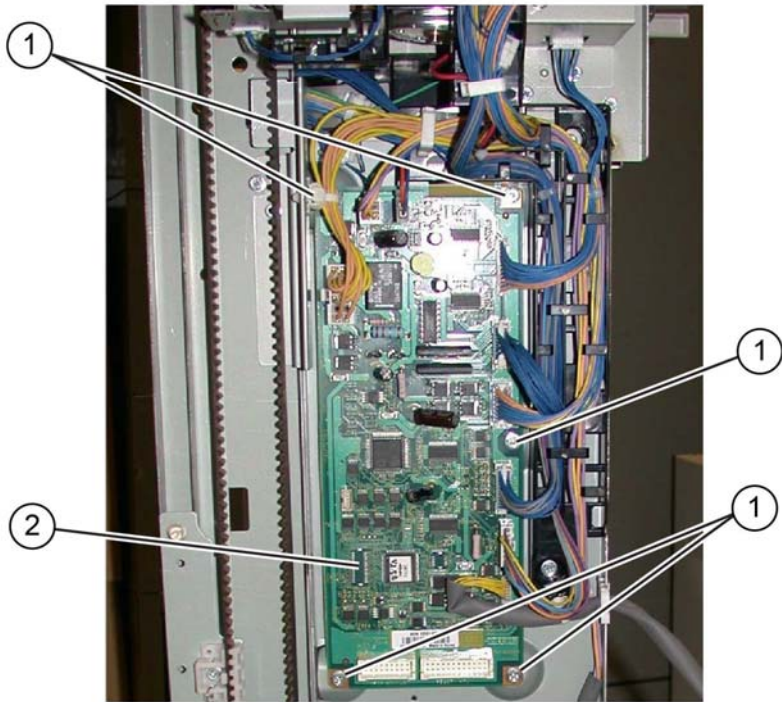
Figure 2 Finisher PWB removal

3. Remove the finisher PWB, [PL 13.45 Item 2, Figure 2](#):
 - a. Disconnect all connectors from the finisher PWB.
 - b. Remove the five screws (1).
 - c. Remove the finisher PWB (2).

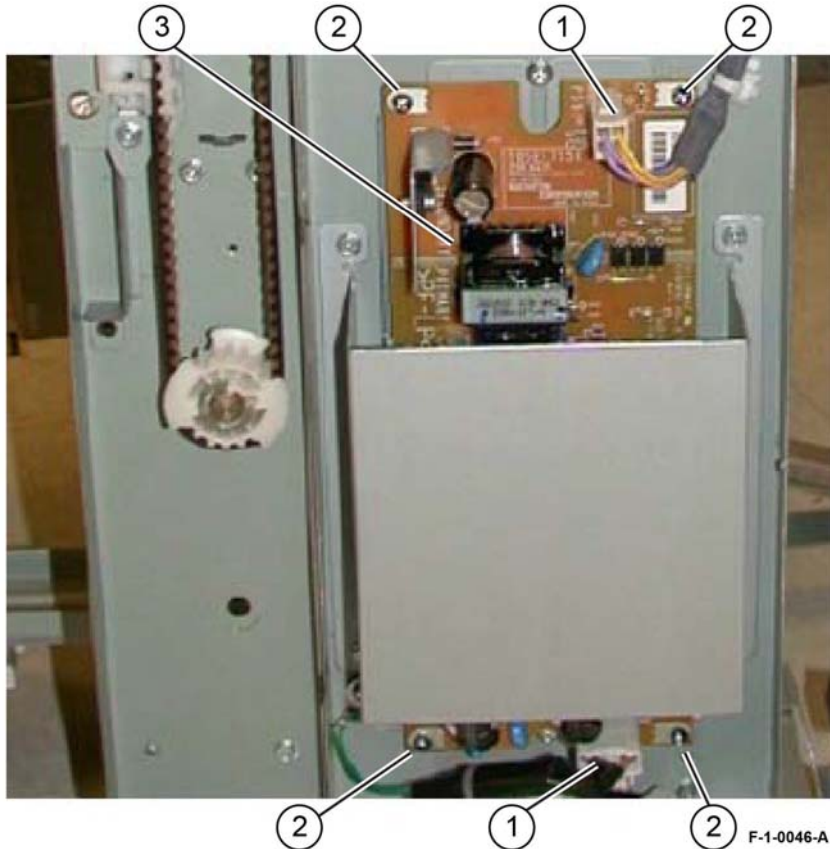
Figure 2 Finisher LVPS removal

2. Remove the finisher LVPS, PL 13.45 Item 14, Figure 2:
 - a. Disconnect two connectors (1).
 - b. Remove four screws (2).
 - c. Remove the finisher LVPS (3).

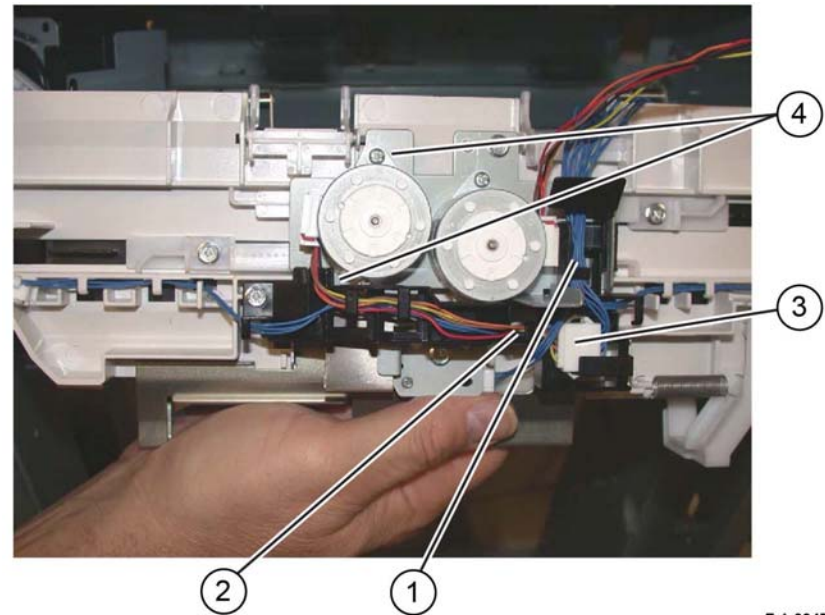
Figure 1 Tamper motor removal

1. Remove the compiler tray, REP 13.17.
2. Place the compiler tray upside down on a work surface.
3. Remove the tamper motor, PL 13.28 Item 6, Figure 1:
 - a. Release the harness (1) from the harness guide.
 - b. Remove the screw (2), then the harness guide.
 - c. Disconnect the tamper motor connector (3).
 - d. Remove both screws to remove the tamper motor.

NOTE: Figure 1 shows the removal of the rear tamper motor.
