VersaLink[®] C8000/C9000 Printer

Service Manual

VersaLink C9000 Family Service Manual

705P01418

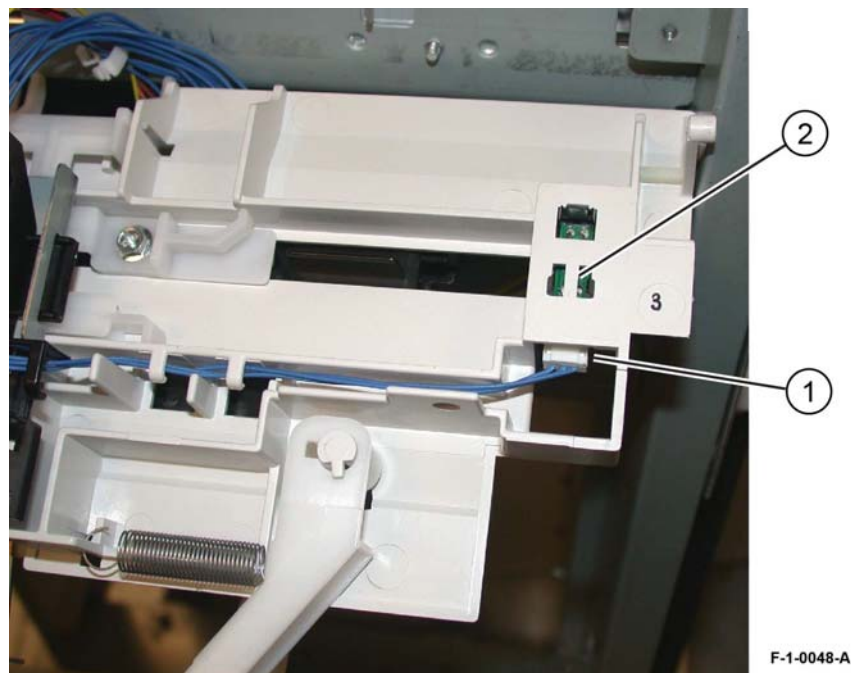
Figure 1 Tamper home sensor removal

1. Remove the compiler tray assembly, [REP 13.17](#).
2. Place the compiler tray upside down on a work surface.
3. Remove the front or rear tamper home sensor, [PL 13.28 Item 8, Figure 1](#):
 - a. Disconnect the connector (1).
 - b. Remove the front or rear tamper home sensor (2).

NOTE: Removal of the rear tamper home sensor is shown in [Figure 1](#).

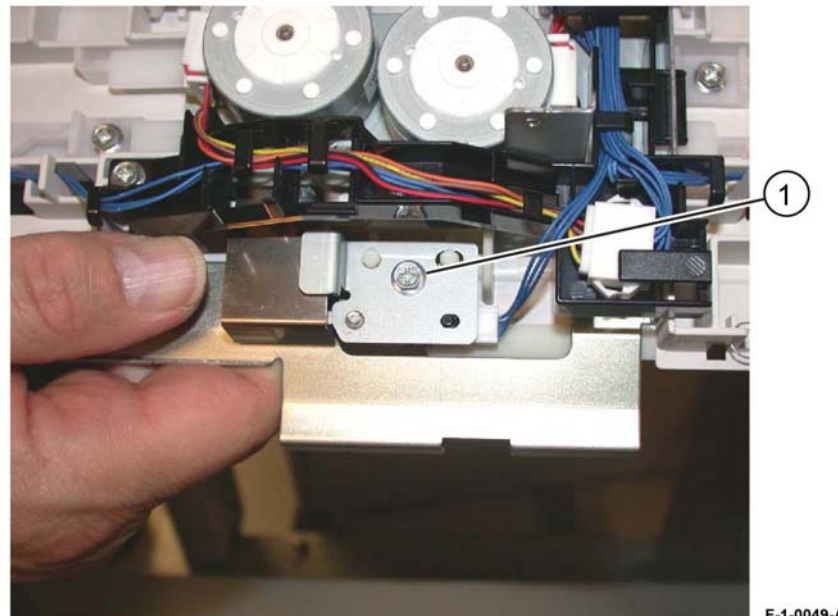
Figure 1 Bracket removal

1. Remove the compiler tray assembly, [REP 13.17](#).
2. Place the compiler tray upside down on a work surface.
3. Remove the screw (1) that secures the bracket, [Figure 1](#).

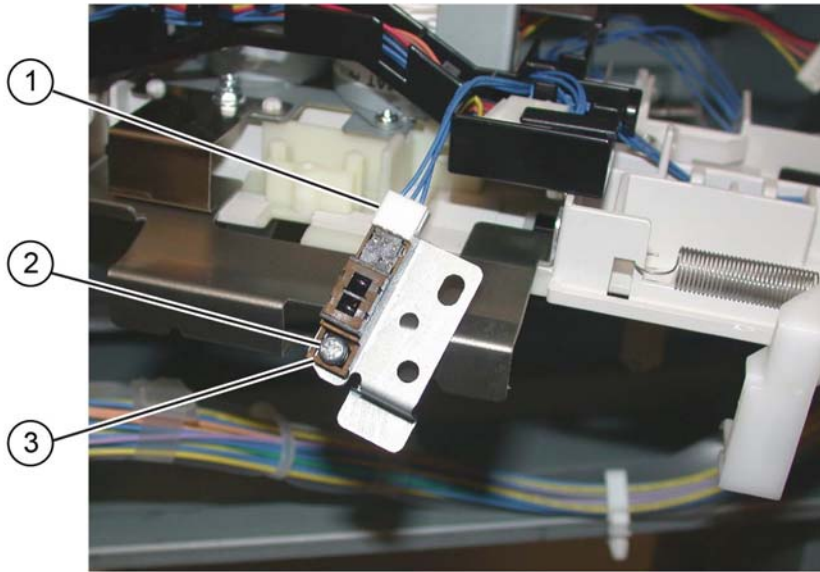
Figure 2 No paper sensor removal

4. Remove the compiler no paper sensor, [PL 13.28 Item 9](#), [Figure 2](#):
 - a. Disconnect the connector (1).
 - b. Remove the screw (2).
 - c. Remove the compiler tray no paper sensor (3).

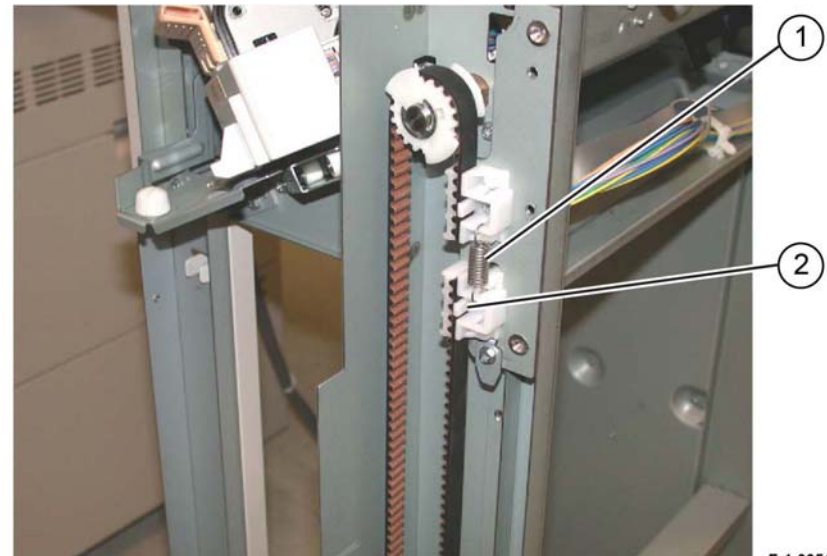
Figure 1 Carriage assembly removal

1. Enter [dC330](#), code 12-060 stacker motor up, to fully raise the stacker tray.
2. Remove the finisher front cover, [REP 13.6](#).
3. Remove the rear upper cover, [REP 13.7](#).
4. Remove the rear lower cover, [REP 13.8](#).
5. Remove the stacker tray, [REP 13.20](#).
6. Removing the carriage assembly, [Figure 1](#):
 - a. Disconnect, then remove the spring (1).
 - b. Use a flat bladed screwdriver to release the belt clamp latch (2).
 - c. Remove the stacker belt and carriage assembly.

NOTE: The carriage bearings (2 each assembly) are not fastened to the shafts. Ensure the bearings are retained when the carriage assembly is removed.

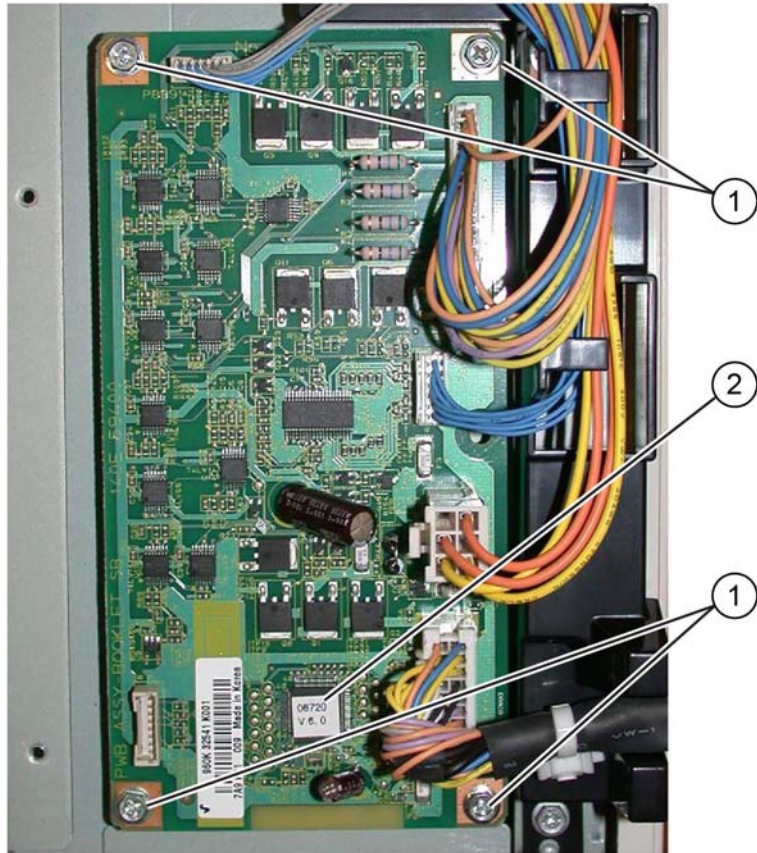
Figure 2 Booklet PWB removal

2. Remove the booklet PWB, PL 13.70 Item 4, Figure 2:
 - a. Disconnect the connectors from the booklet PWB.
 - b. Remove four screws (1).
 - c. Remove the booklet PWB (2).

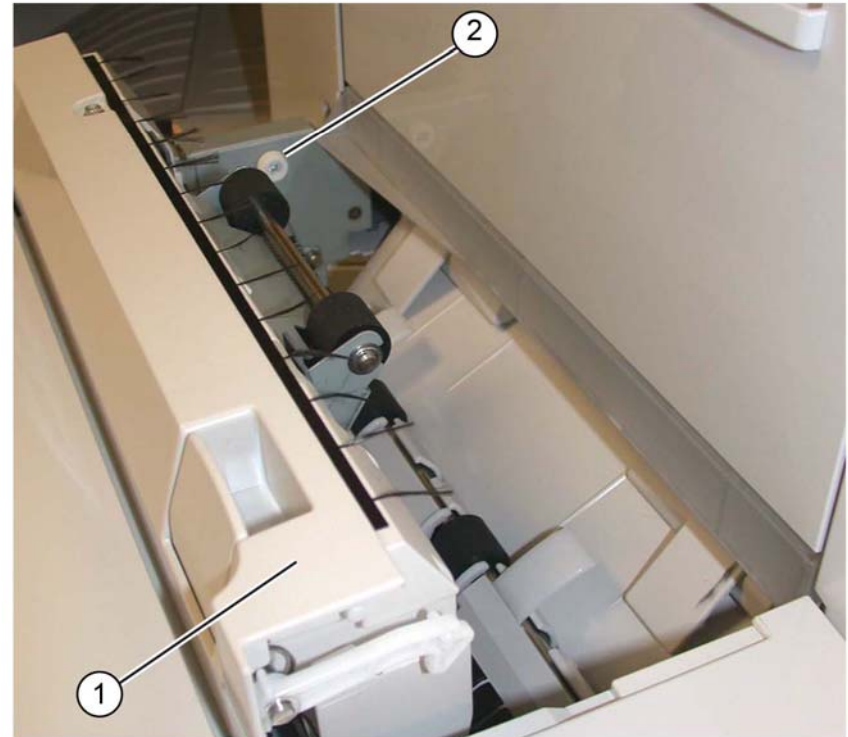
Figure 1 Preparation

1. Prepare to remove the booklet maker assembly, Figure 1:
 - a. Unlatch the top right cover (1), then move it all the way to the left.
 - b. Remove the front and rear thumbscrews (2).

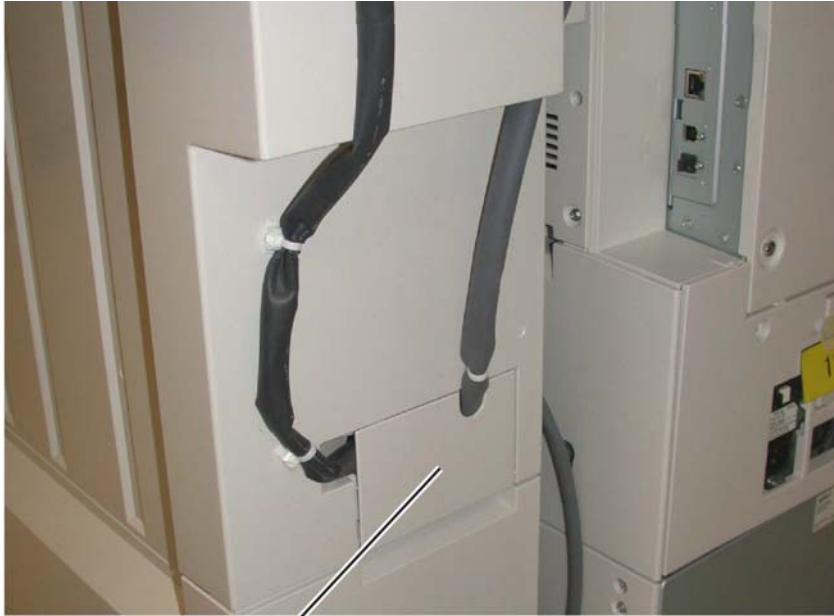
Figure 2 Connector cover

2. Remove the connector cover (1), [Figure 2](#).

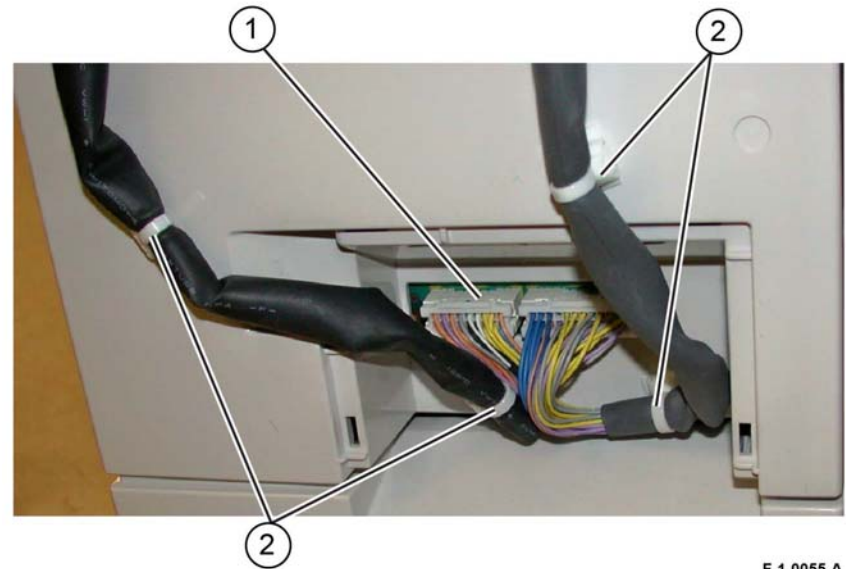
3. Disconnect the booklet maker assembly from the finisher, [Figure 3](#):
 - a. Disconnect the connector (1).
 - b. Pull out the four cable ties (2).

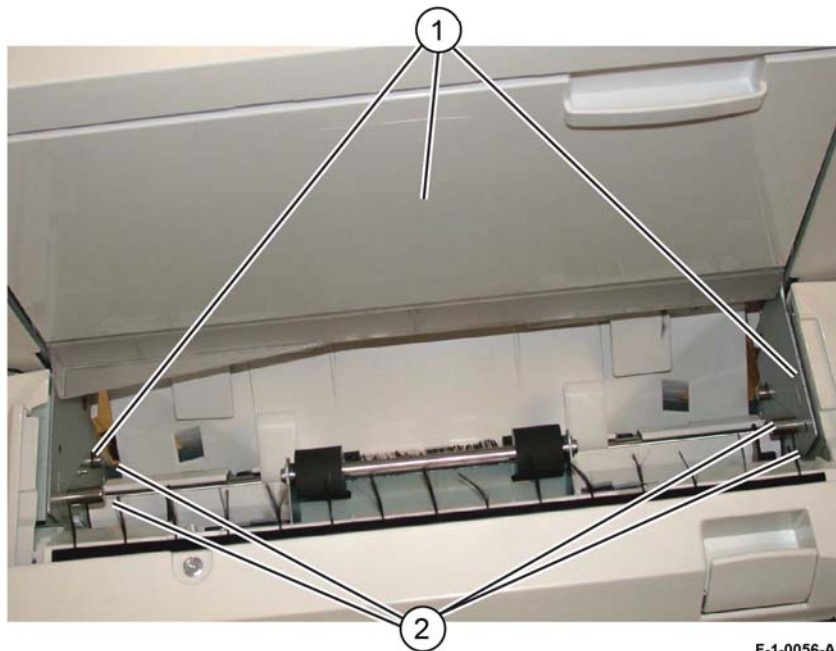
Figure 4 Removal

4. Lift the booklet maker assembly (1) off the four locating pins (2), then remove, [Figure 4](#).

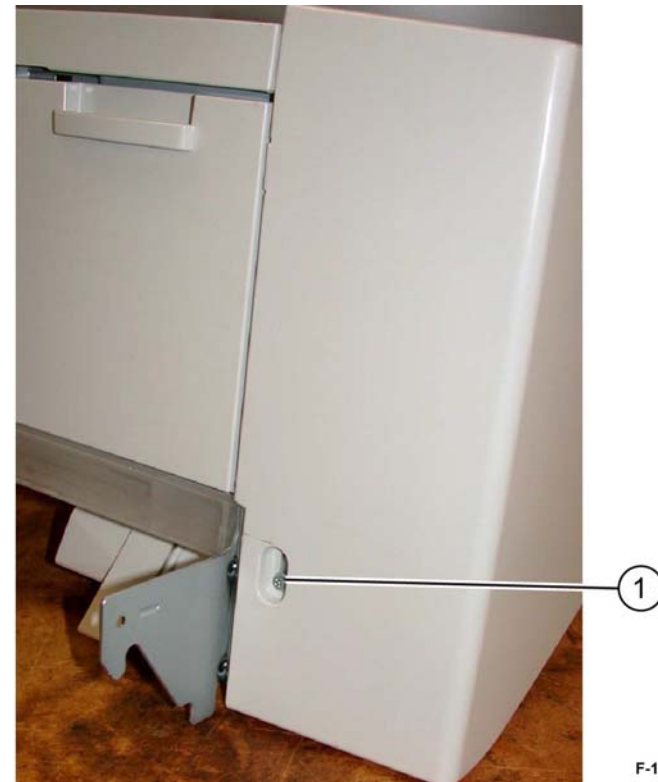
Figure 1 Screw removal

1. Remove the booklet maker assembly from the finisher, [REP 13.31](#).
2. Remove the screw (1), [Figure 1](#).

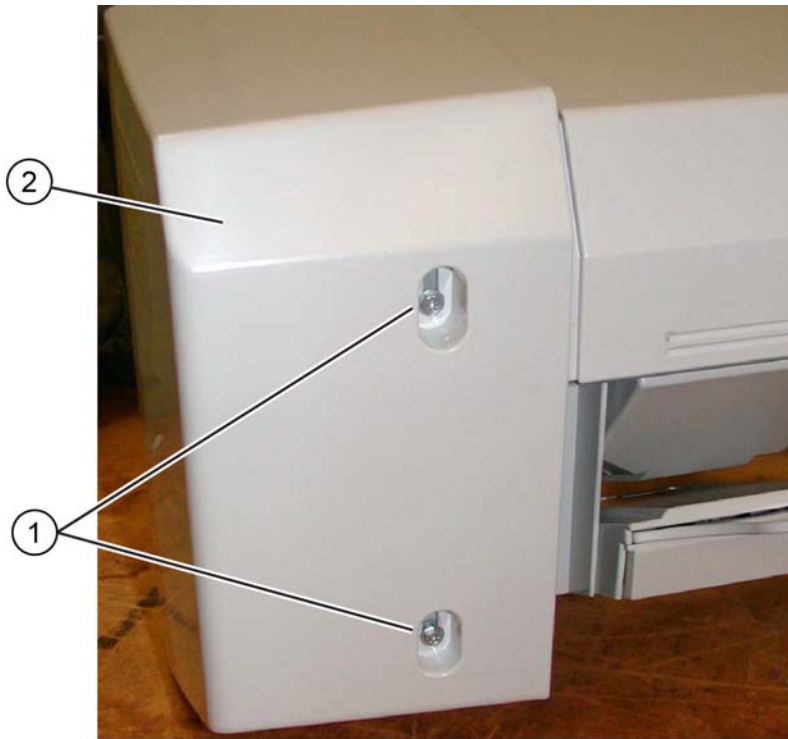
Figure 2 Booklet front cover removal

3. Remove two screws (1), then remove the front cover (2), [PL 13.50 Item 3, Figure 2](#).

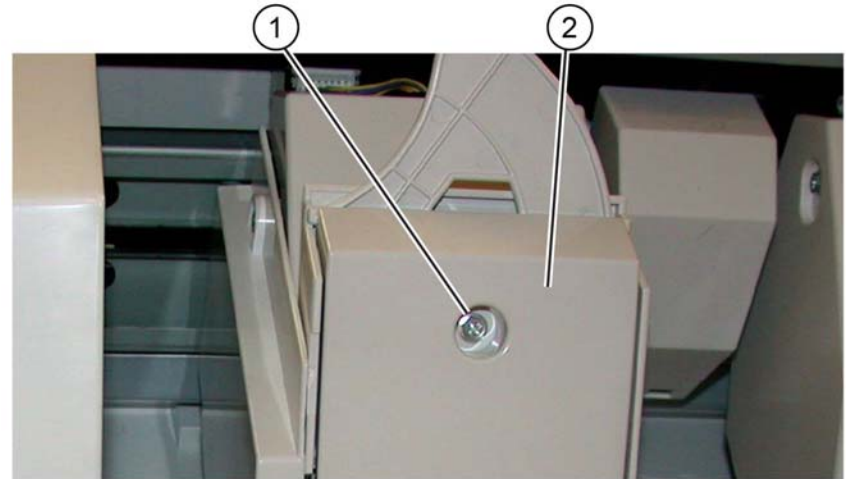
Y N

Install a new finisher PWB, PL 13.45 Item 2.

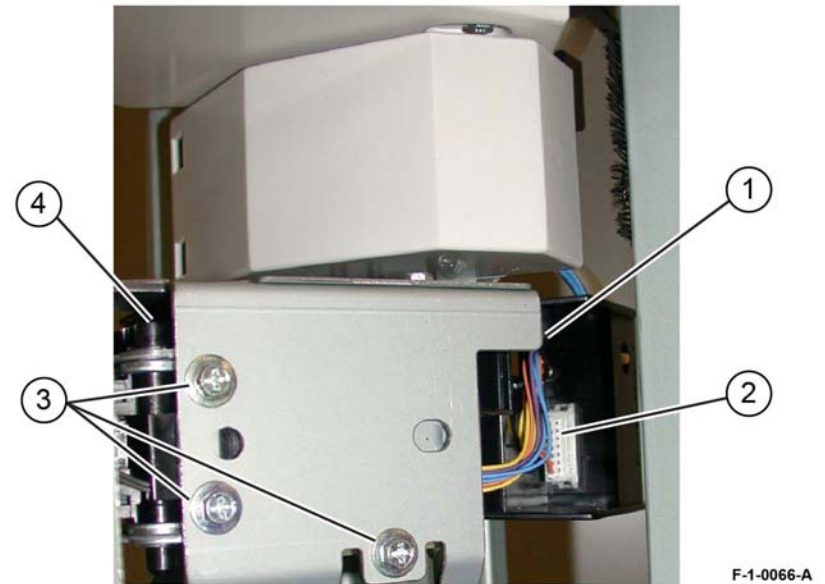
Ensure that the electricity to the machine is switched off while performing tasks that do not need electricity. Refer to GP 10. Disconnect the power cord. Electricity can cause death or injury. Moving parts can cause injury.

012-223 The front tamper home sensor is not turned off within the specified time.

WARNING

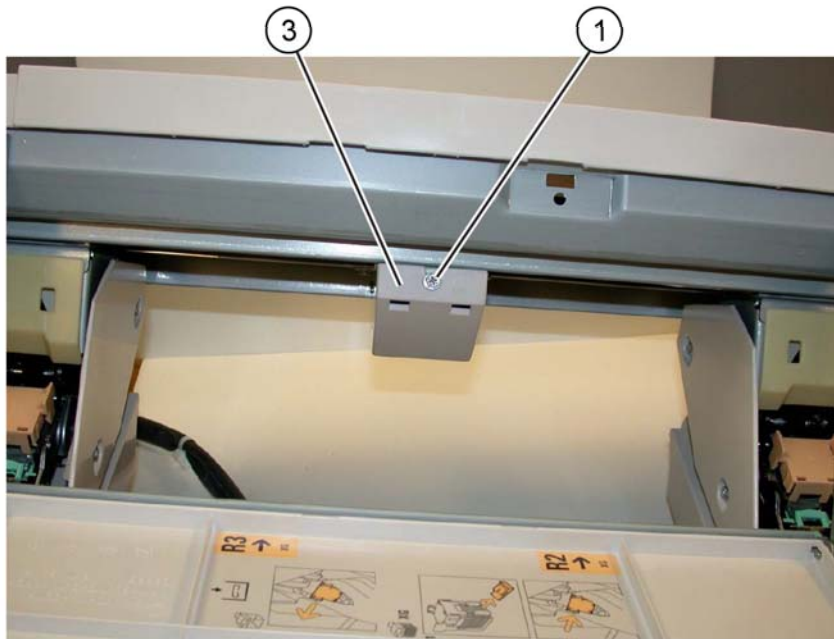
Y N

Reconnect or repair as necessary.

Install a new finisher PWB, PL 13.45 Item 2.

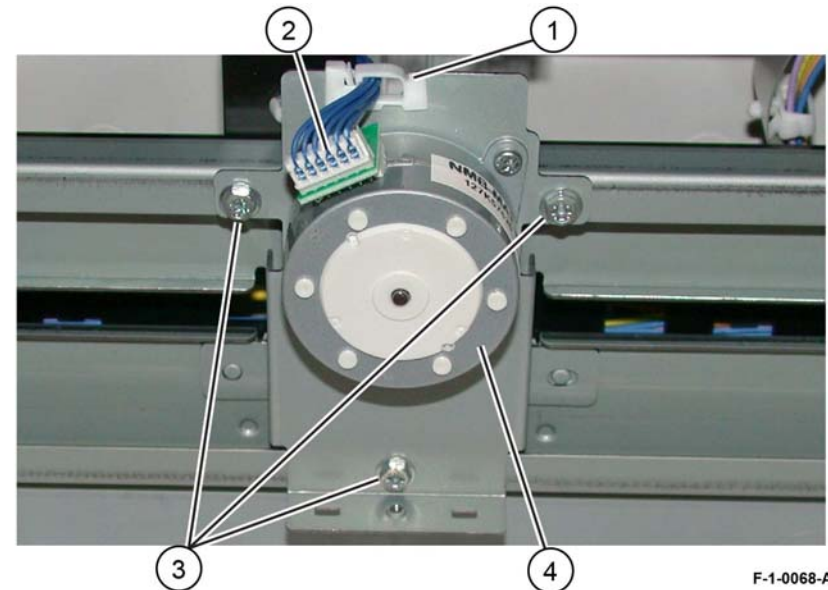
Install a new front tamper home sensor, PL 13.28 Item 8.

Measure the voltage between P/J8884 pin 5 on the finisher PWB and ground. Manually operate the tamper mechanism to actuate the front tamper home sensor. **The voltage changes.**

Install a new finisher PWB, PL 13.45 Item 2.

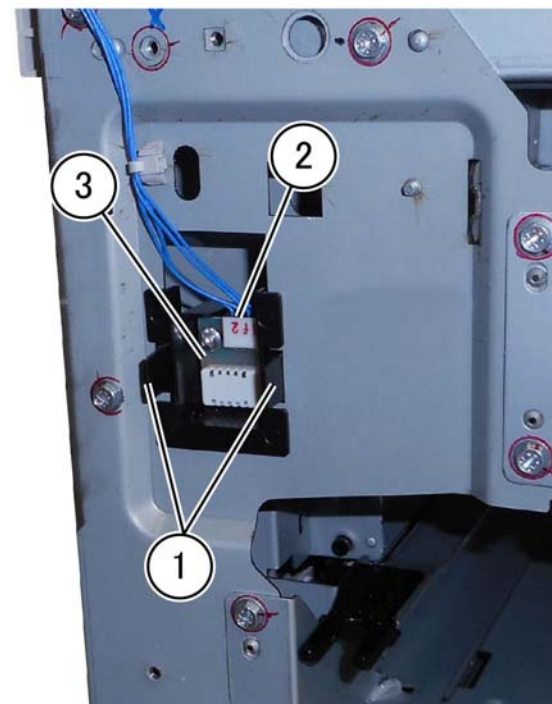
F-1-0254-A

1. Remove the front cover assembly, [PL 28.05 Item 8](#).
2. Remove tray 1 and tray 2.
3. Remove the left cover assembly if necessary, [PL 80.65 Item 1](#), [REP 80.21](#).
4. Remove the tray inner cover, [PL 28.10 Item 2](#).
5. Remove the temp/humidity sensor, [PL 40.10 Item 5: Figure 1](#).
 - a. Release the hook (1).
 - b. Disconnect the connector, (2).
 - c. Remove the temp/humidity sensor (3).

Figure 1 Temp/humidity sensor removal

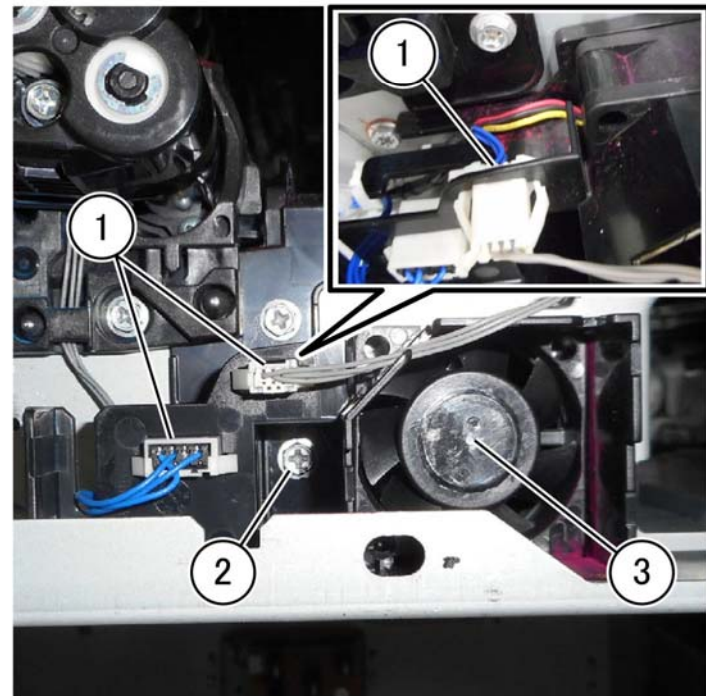
F-1-0255-A

1. Remove the front cover assembly, [PL 28.05 Item 8](#).
2. Remove the waste toner transport assembly, [PL 90.15 Item 1](#).
3. Remove the inner lower cover, [PL 28.05 Item 2](#).
4. Remove the inner hinge cover assembly, [PL 28.05 Item 4](#).
5. Remove the drum assemblies, [REP 90.1](#).
6. Remove the duct assembly, [PL 40.10 Item 7, Figure 1](#).
 - a. Disconnect three connectors (1).
 - b. Remove the screw (2).
 - c. Remove the duct assembly (3).

Figure 1 Duct assembly removal

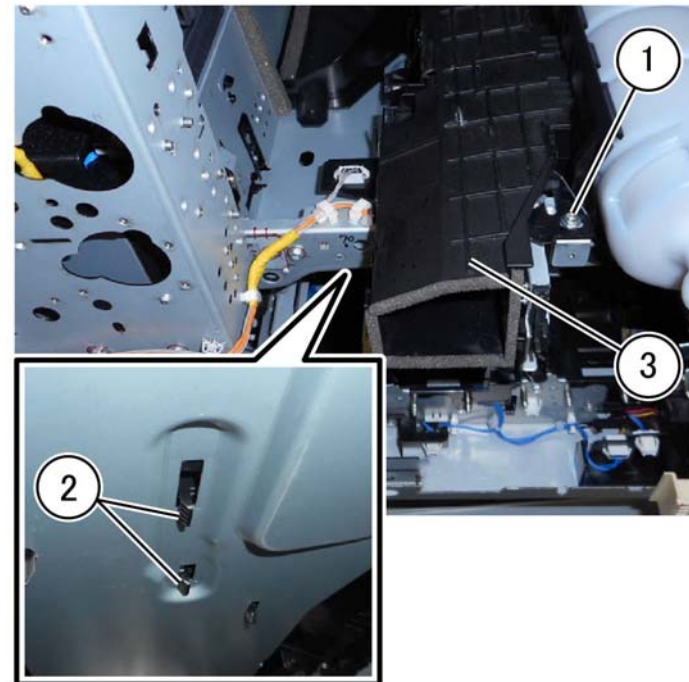
F-1-0256-A

1. Remove the front cover assembly, [PL 28.05 Item 8](#).
2. Remove the waste cartridge, [PL 90.15 Item 6](#).
3. Remove the waste toner transport assembly, [PL 90.15 Item 1](#).
4. Remove the inner cover assembly, [PL 28.05 Item 1](#).
5. Remove the inner lower cover, [PL 28.05 Item 2](#).
6. Remove the top cover, [PL 28.10 Item 9](#).
7. Remove the toner cartridge cooling fan assembly, [PL 40.10 Item 12: Figure 1](#).
 - a. Remove the screw (1).
 - b. Release the hook on the bottom (2).
 - c. Remove the toner cartridge cooling fan assembly (3).

Figure 1 Toner cartridge cooling fan assembly removal

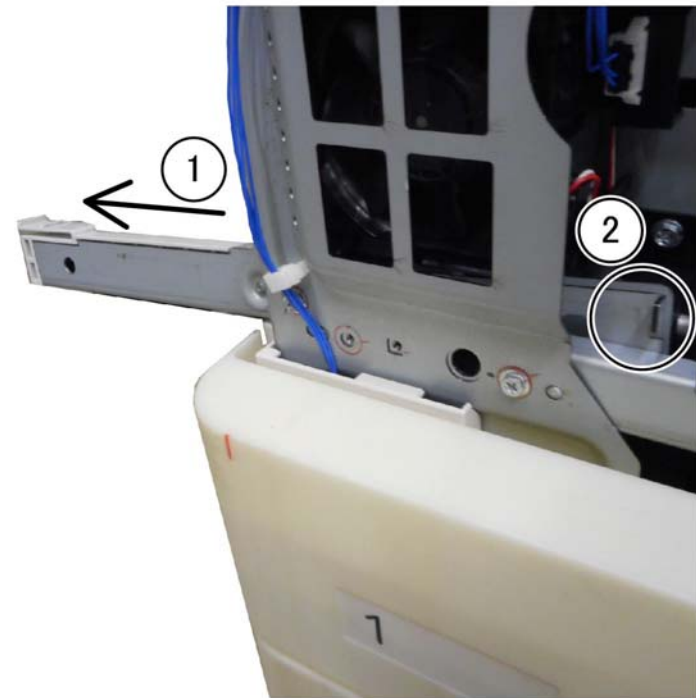
F-1-0257-A

1. Remove the front cover assembly, [PL 28.05 Item 8](#).
2. Remove the inner left cover assembly, [PL 28.05 Item 5](#).
3. Remove the duct, [PL 40.10 Item 1](#).
4. Remove the front handle: [Figure 1](#).
 - a. Move the handle in the direction of the arrow.
 - b. move the handle so that it is released from the stop and remove the handle from the machine (2).

Figure 1 Front handle removal

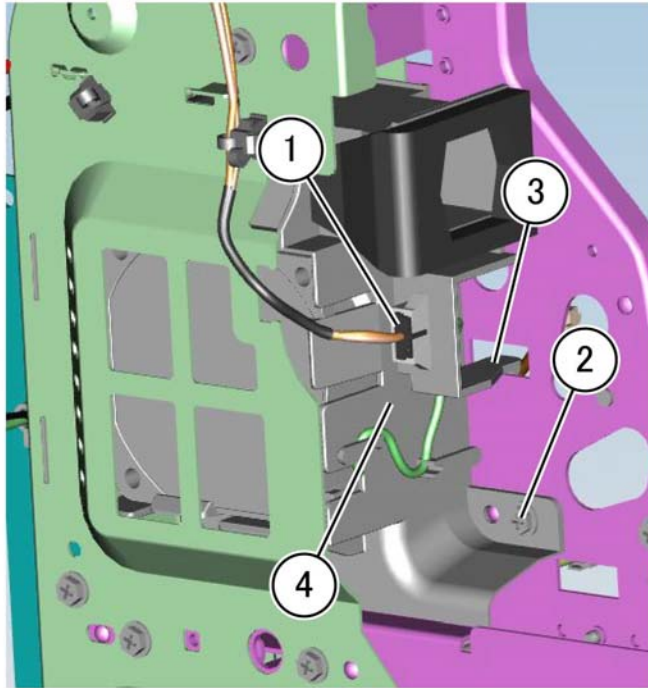
F-1-0258-A

5. Remove the front left marking fan assembly, PL 40.10 Item 13: Figure 2.
 - a. Disconnect the connector (1).
 - b. Remove the screw (2).
 - c. Release the hook (3).
 - d. Remove the front left marking fan assembly (4).

Figure 2 Front/Left marking fan assembly removal

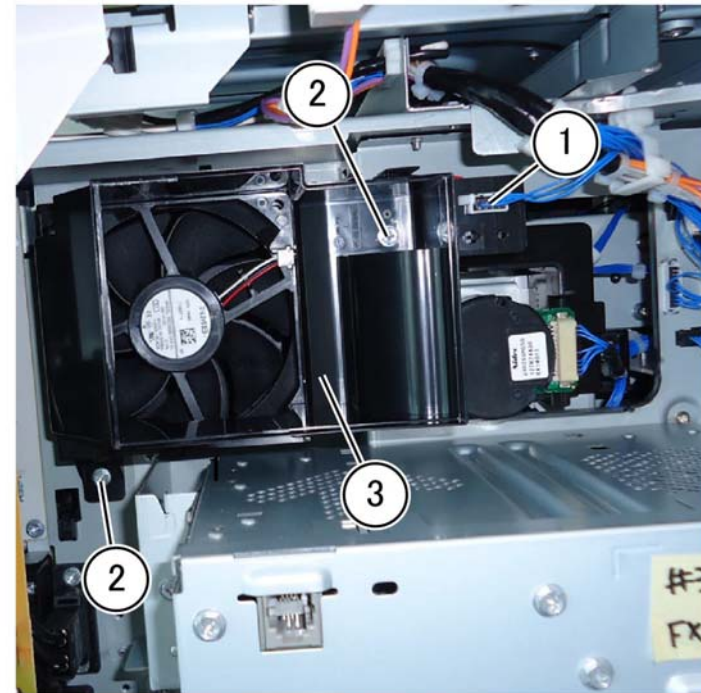
F-1-0259-A

1. Remove the controller cover assembly, PL 3.10 Item 1.
2. Remove the MCU cover, PL 28.15 Item 10.
3. Remove the lower rear cover, PL 28.15 Item 8.
4. Remove the rear fuser duct assembly, PL 40.15 Item 1: Figure 1.
 - a. Disconnect the connector (1).
 - b. Remove two screws (2).
 - c. Remove the rear duct (3).

Figure 1 Rear duct removal

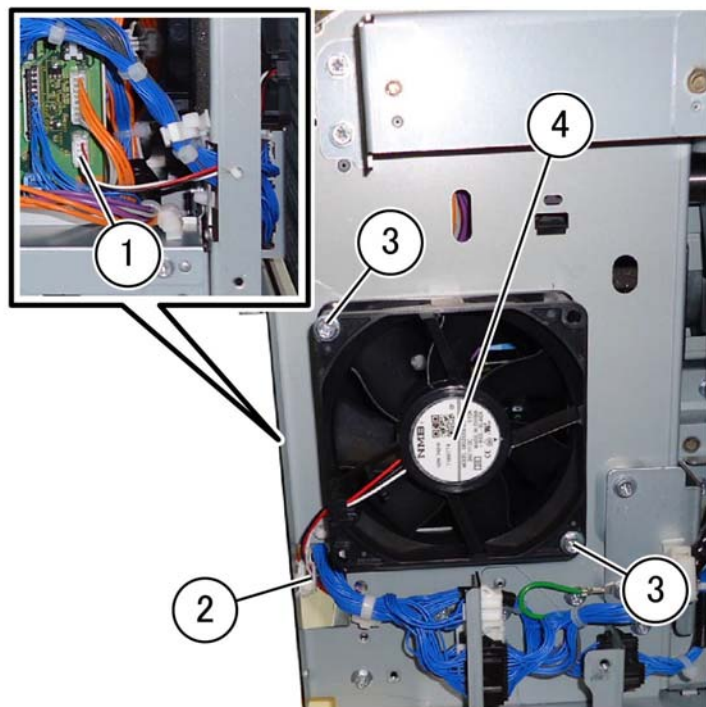
F-1-0260-A

1. Remove the lower rear cover, [PL 28.15 Item 8](#).
2. Remove the left lower cover, [PL 28.10 Item 4](#).
3. Remove the LVPS fan assembly, [PL 40.15 Item 4: Figure 1](#).
 - a. Disconnect the connector (1).
 - b. Release the clamp (2).
 - c. Remove two screws (3).
 - d. Remove the LVPS Fan (4).

Figure 1 LVPS fan removal

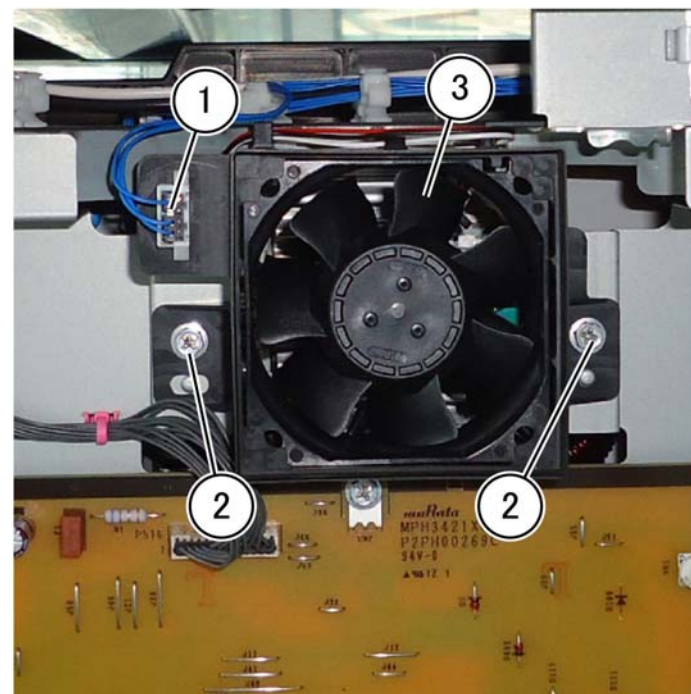
F-1-0261-A

1. Open the video contact chassis assembly, [GP 32](#).
2. Remove the upper rear cover, [PL 28.15 Item 5](#).
3. Remove the IHPS, intake duct assembly, [PL 40.15 Item 8: Figure 1](#).
 - a. Disconnect the connector (1).
 - b. Remove the screw (2).
 - c. Remove the IHPS intake duct assembly (3).

Figure 1 IHPS intake duct assembly removal

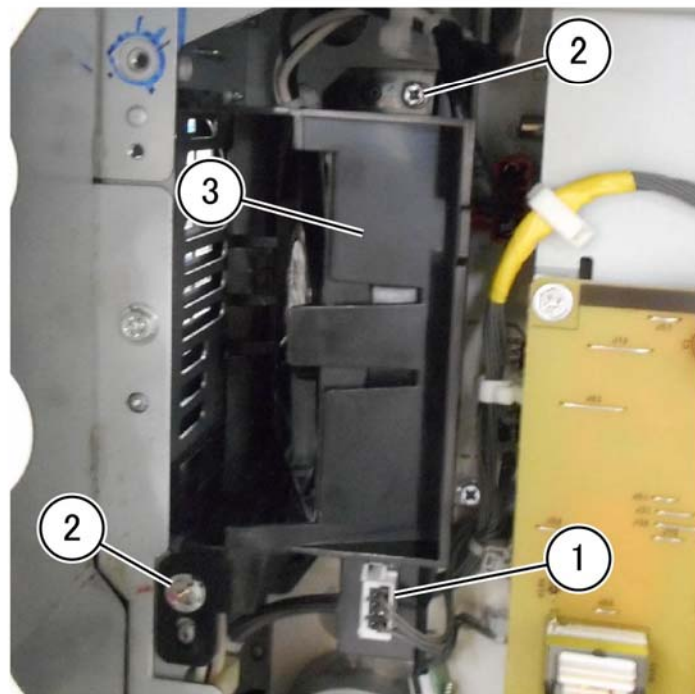
F-1-0262-A

1. Open the video contact chassis assembly, [GP 32](#).
2. Remove the upper rear cover, [PL 28.15 Item 5](#).
3. Remove the toner cartridge exhaust fan assembly, [PL 40.15 Item 9: Figure 1](#).
 - a. Disconnect the connector (1).
 - b. Remove two screws (2).
 - c. Remove the toner cartridge exhaust fan assembly (3).

Figure 1 Toner cartridge exhaust fan assembly removal

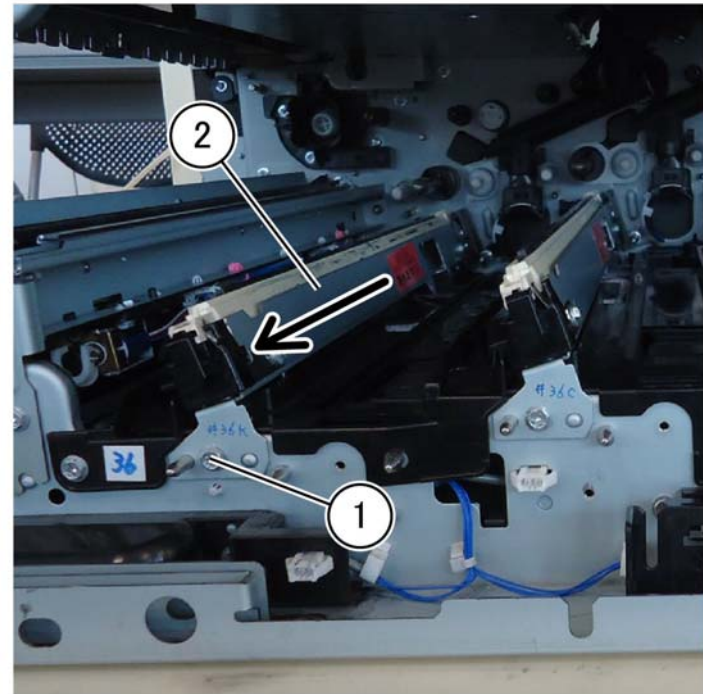
F-1-0241-A

4. Remove the screw (1) securing the LPH then move the LPH fully to the front, [Figure 2](#).

Figure 2 Remove the screw

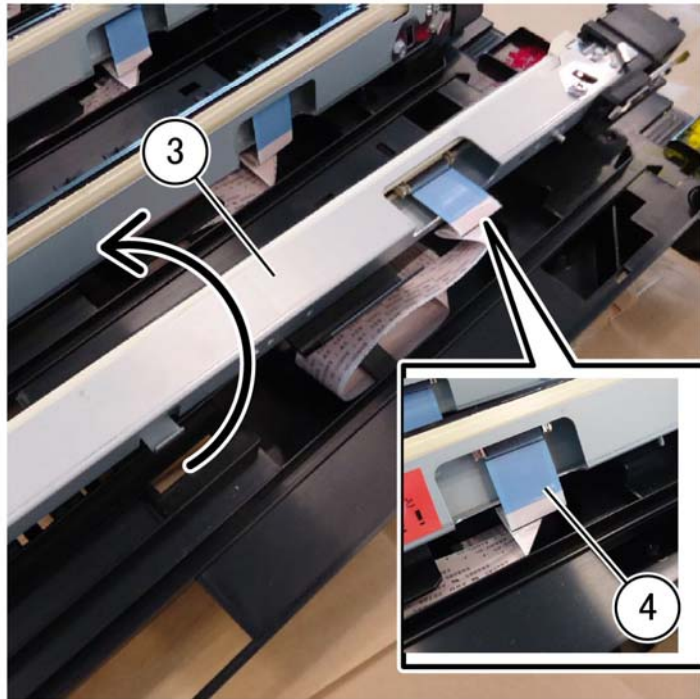
F-1-0242-A

5. Roll the LPH (3) in the direction of the arrow to expose the FFC cable (4), [Figure 3](#).

Figure 3 FFC cable

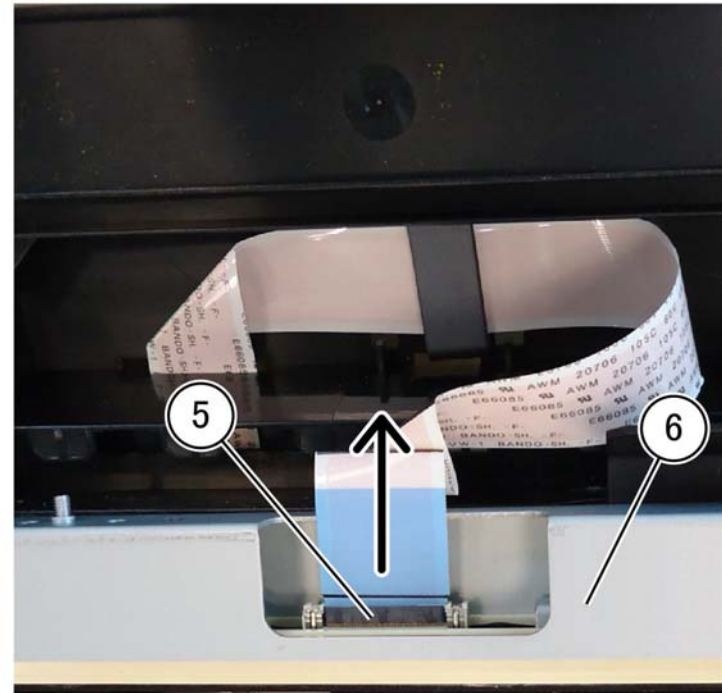
F-1-0243-A

6. Press the release latch on the connector (5), remove the FFC cable from the LPH in the direction of the arrow, then remove the LPH (6), [Figure 4](#).

Figure 4 LPH removal

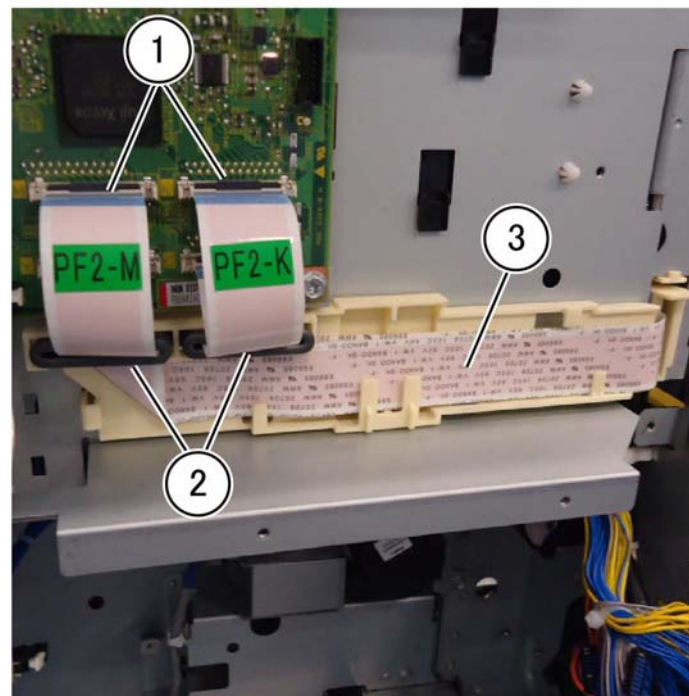
F-1-0244-A

10. Release the FFC cable from the half tone PWB: [Figure 2](#).
 - a. Disconnect four FFC cables on the half tone PWB (1).
 - b. Remove four ferrites (2).
 - c. Release the FFC cable assembly from the harness guide (3).

Figure 2 Disconnect the FFC cables

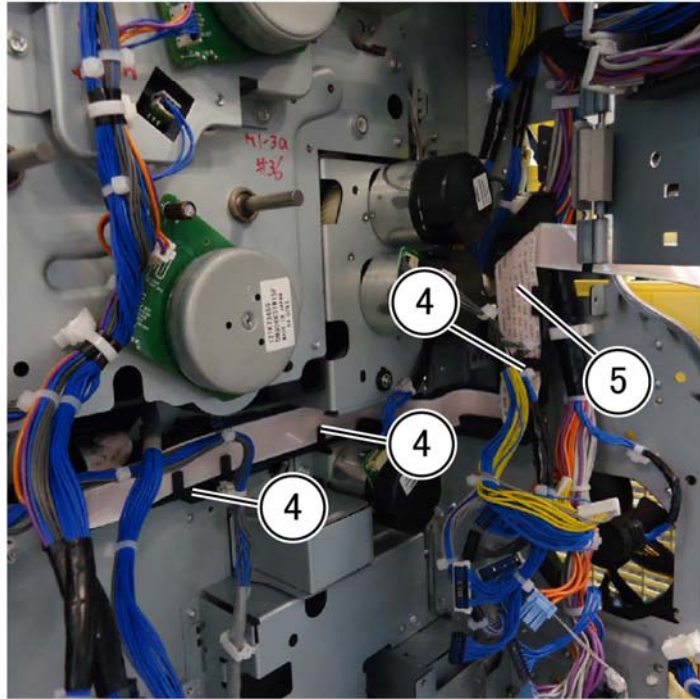
F-1-0245-A

11. Release the FFC cables from the harness guide, (4) and (5): [Figure 3](#).

Figure 3 Unharness the FFC cables

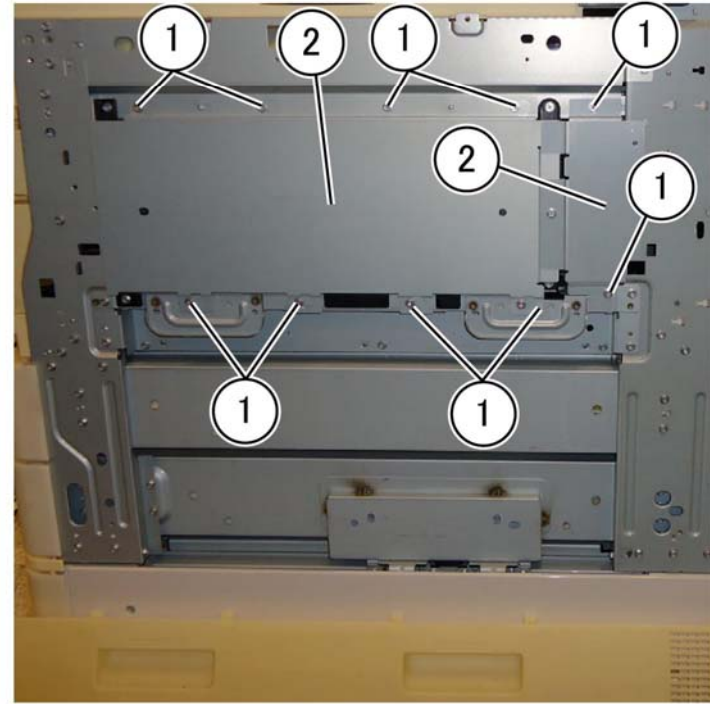
F-1-0246-A

12. Remove 10 screws (1) then remove the BCR HVPS cover assembly [PL 1.20 Item 2](#), and cover, [PL 1.20 Item 3 \(2\)](#), [Figure 4](#).

Figure 4 Cover assembly and cover

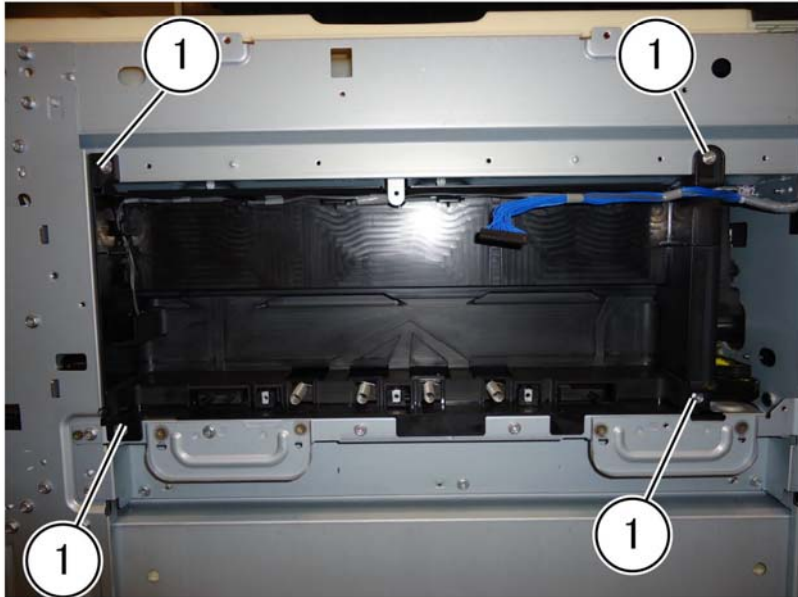
F-1-0247-A

14. Remove four screws (1), [Figure 5](#).

Figure 5 Remove four screws

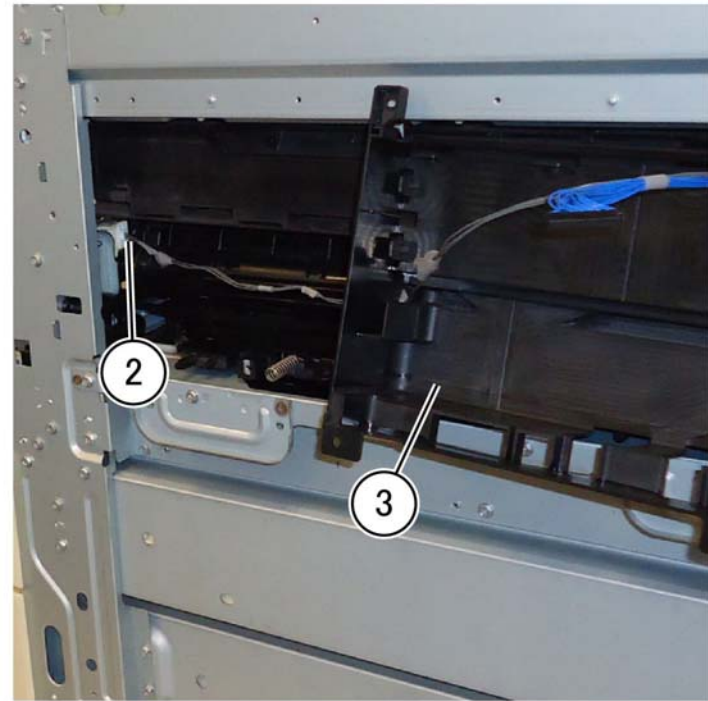
F-1-0248-A

15. Move the conductor assembly, [PL 1.20 Item 5 \(3\)](#), to the rear, disconnect the connector (2), then remove the conductor assembly (3), [Figure 6](#).

Figure 6 BCR housing removal

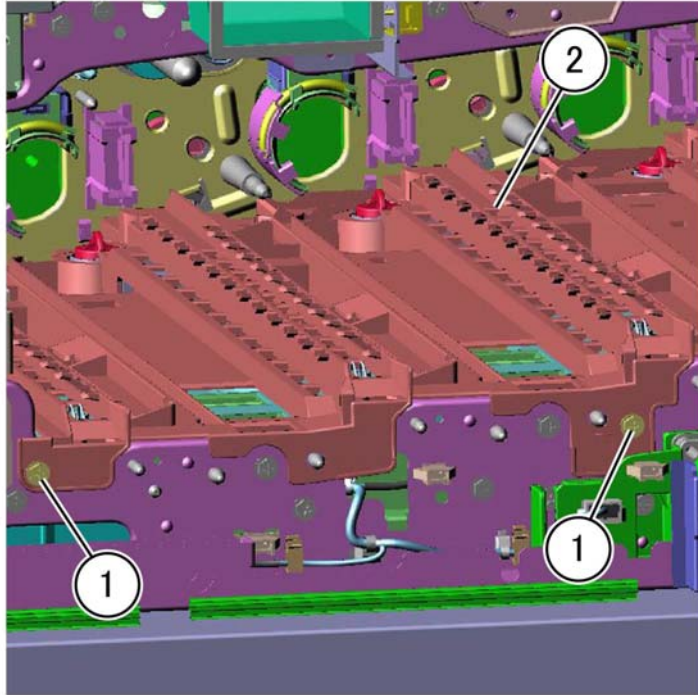
F-1-0249-A

16. Remove two screws (1) then remove the marking guide, PL 90.25 Item 1 (2), Figure 7.

Figure 7 Marking guide removal

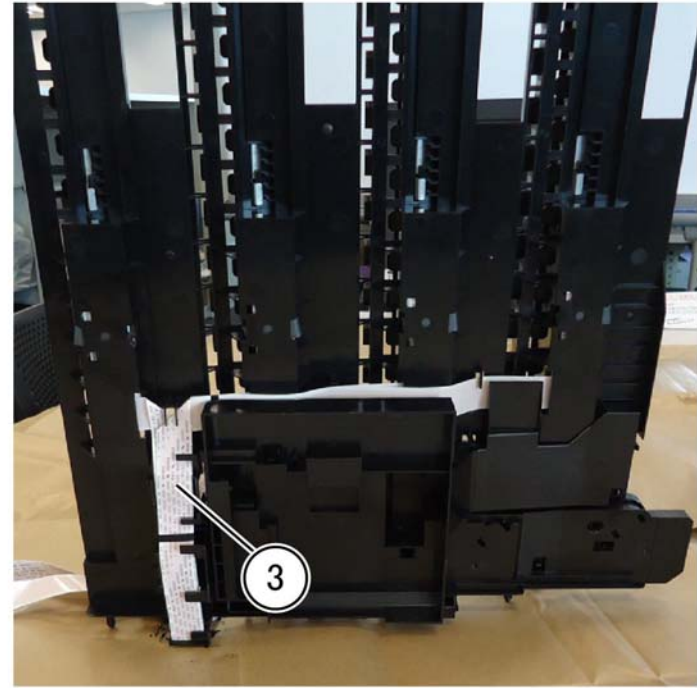
F-1-0250-A

17. Remove the FFC cable assembly, PL 60.05 Item 7 and PL 60.05 Item 8 from the marking guide PL 90.25 Item 1, Figure 8.

Figure 8 FFC cable assembly removal

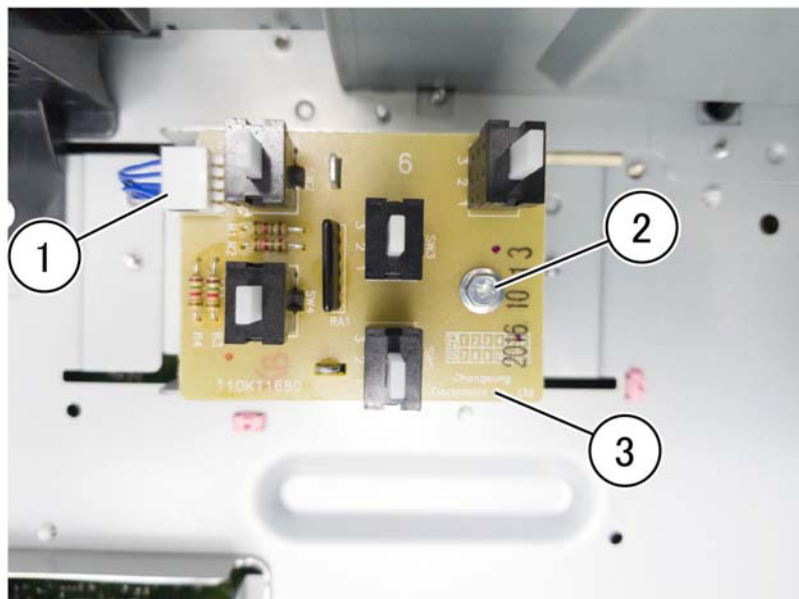
F-1-0411-A

1. Remove tray 1 and tray 2 to gain access to the inside-rear of the machine.
2. Remove the failed paper size sensor, [PL 70.05 Item 3: Figure 1](#).
 - a. Disconnect the connector (1).
 - b. Remove the screw (2).
 - c. Remove the failed paper size sensor (3).

Figure 1 Tray 1/2 paper size sensor

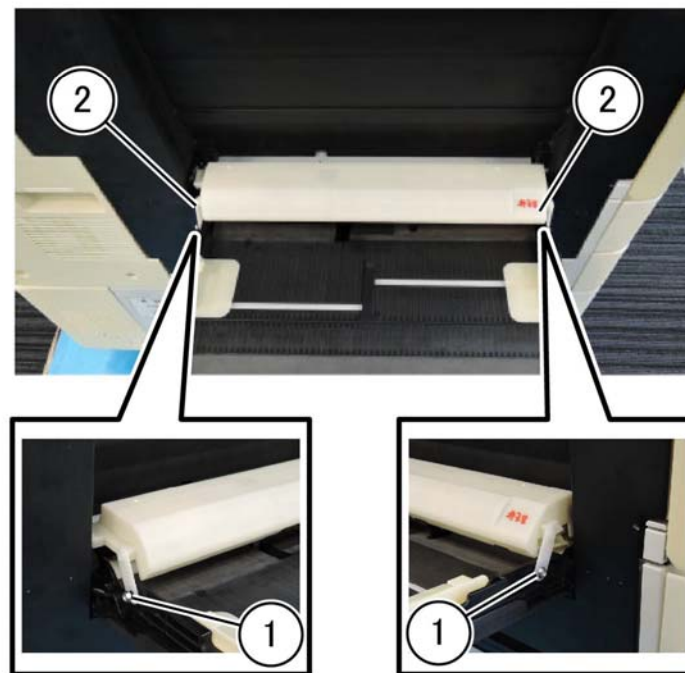
F-1-0263-A

1. Separate the bypass tray from the lower frame assembly: [Figure 1](#).
 - a. Remove two screws (1).
 - b. Release the tray link cover from the lower frame assembly (2).

Figure 1 Tray link cover

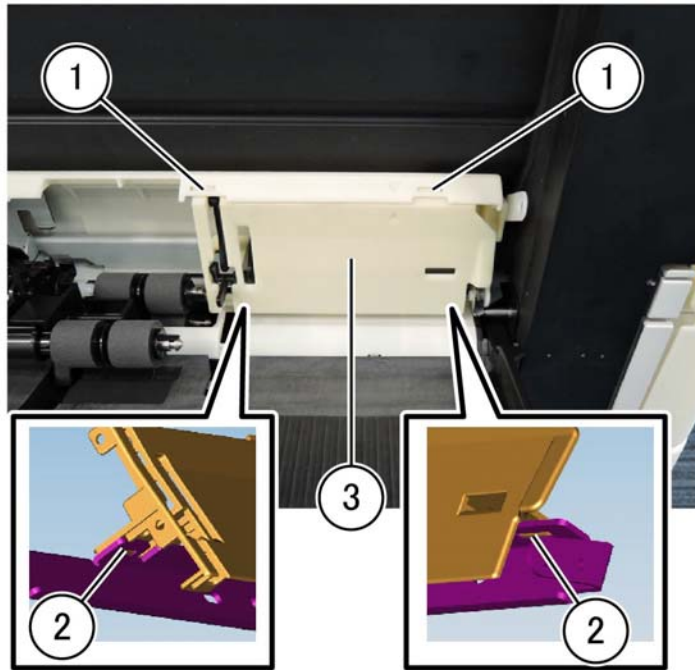
F-1-0264-A

2. Remove the top chute assembly, [Figure 2](#).
 - a. Release four latches (1) then (2).
 - b. Remove the top chute assembly (3).

Figure 2 Top chute assembly

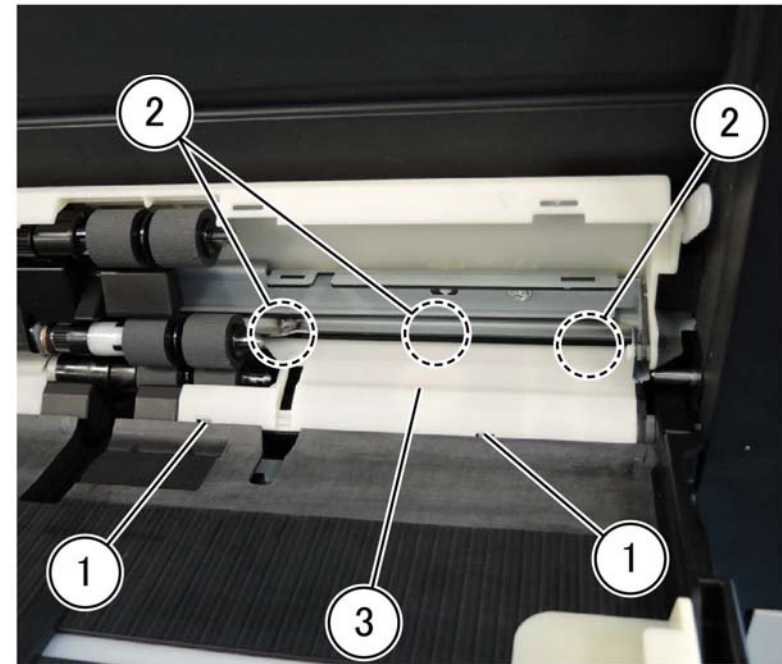
F-1-0265-A

3. Remove the chute front: [Figure 3](#).
 - a. Release five hooks (1) then (2).
 - b. Remove the chute front (3).

Figure 3 Chute front removal

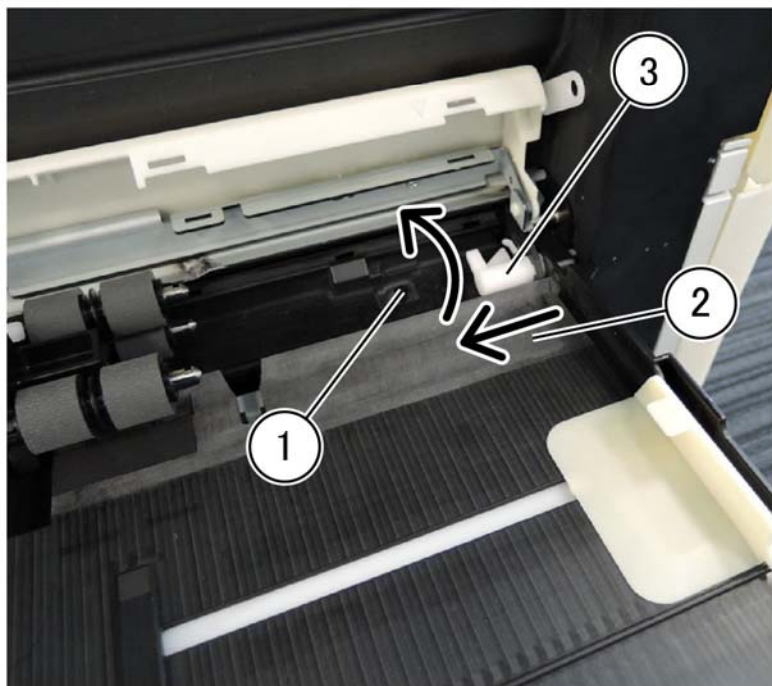
F-1-0266-A

4. Remove the pivot, [PL 70.50 Item 1: Figure 4](#).
 - a. Rotate the pivot in the direction of the arrow (1).
 - b. Slide the pivot in the direction of the arrow (2).
 - c. Remove the pivot (3).

Figure 4 Pivot removal

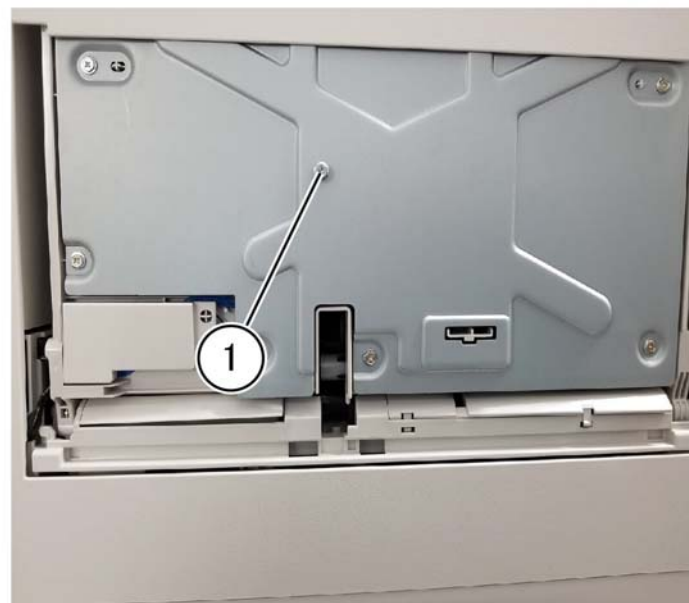
F-1-0267-A

1. Remove the pivot, [REP 70.2](#).
2. Unlock the bypass tray from the left cover, lift the extension tray up to expose the back of the bypass tray, then insert a screw in the hole (1) to keep the extension tray lifted, [Figure 1](#).

Figure 1 Extension tray lifted

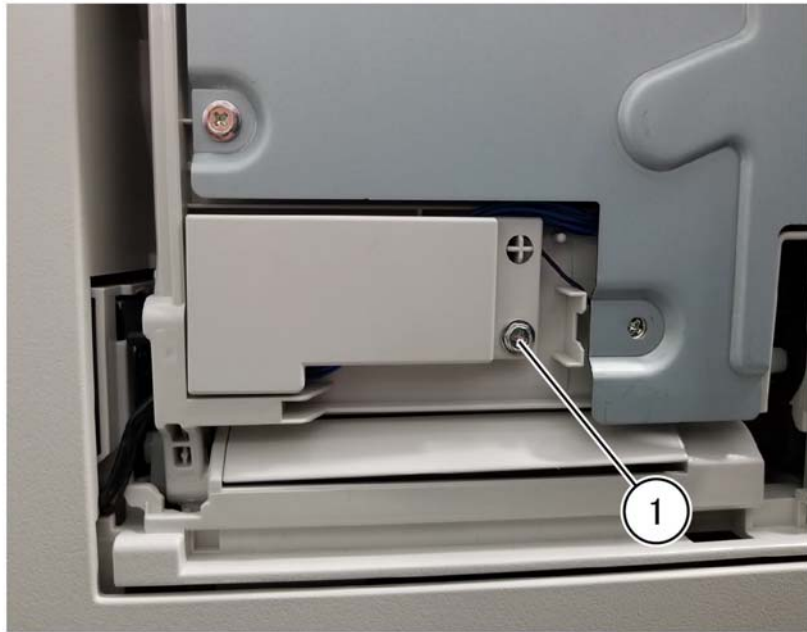
F-1-0356-A

3. Remove the screw (1) then remove the connector cover, [Figure 2](#).

Figure 2 Connector cover removal
