VersaLink[®] C8000/C9000 Printer

Service Manual

VersaLink C9000 Family Service Manual

705P01418

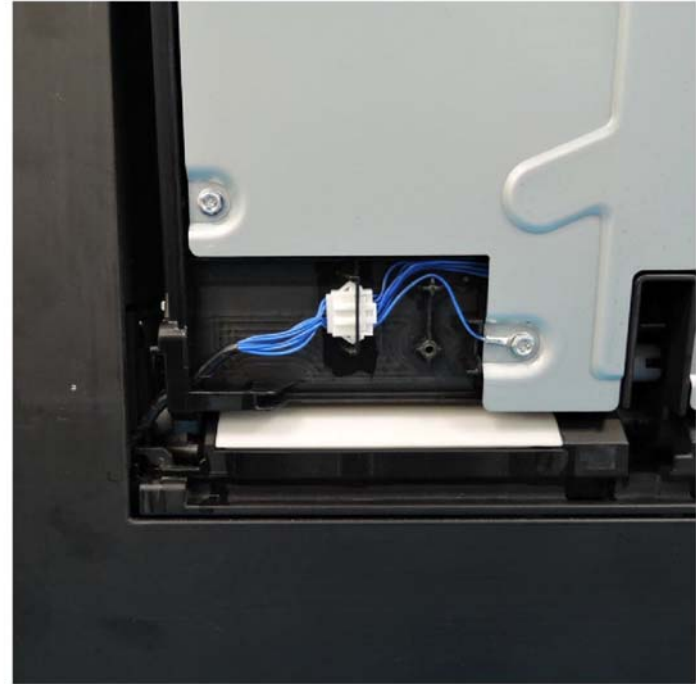
F-1-0268-A

4. Disconnect the no paper harness connector, [Figure 3](#).

Figure 3 No paper harness connector

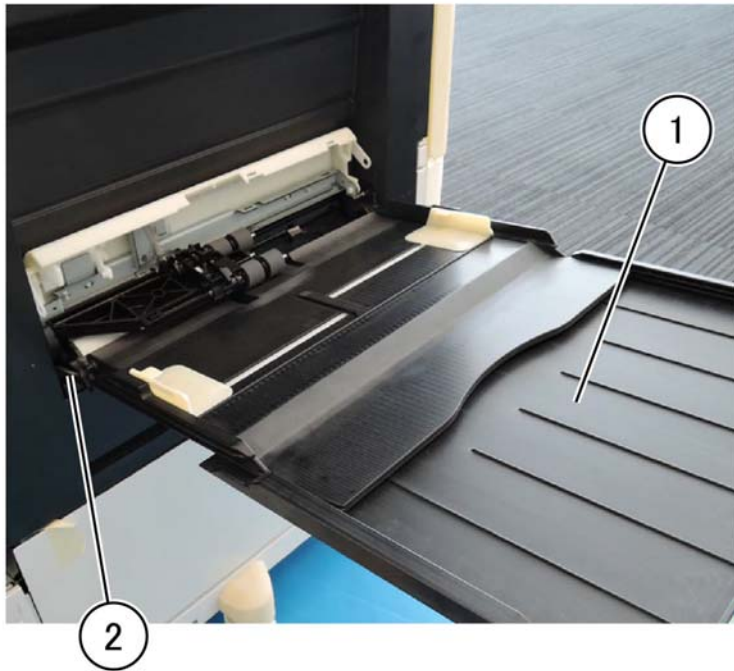
F-1-0269-A

- Lower the extension tray (1) and feed the no paper harness through the hole of the bypass tray (2), [Figure 4](#).
- Lift the extension tray (2) to 75 degrees, remove the link part (3) of the bypass tray from the main unit, then remove the bypass tray (4), [Figure 5](#).

Figure 4 Release the harness

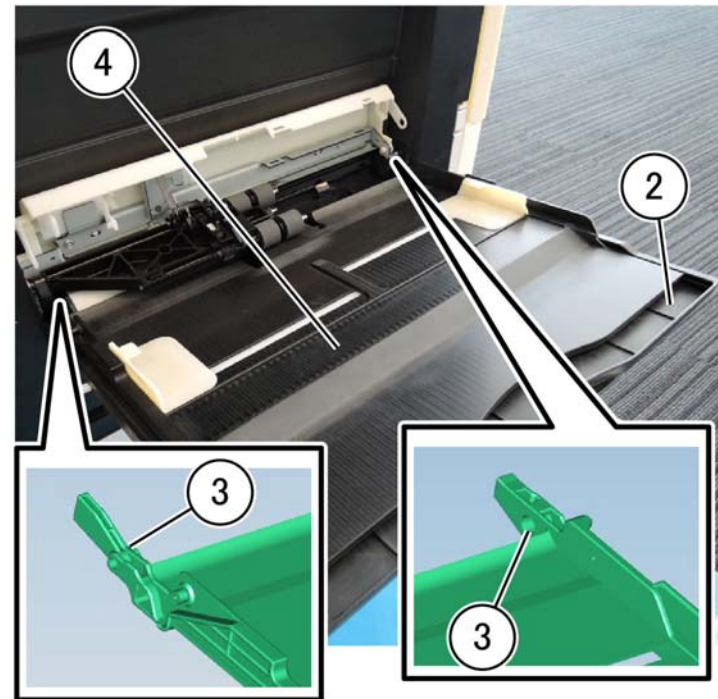
F-1-0270-A

Figure 5 Bypass tray removal

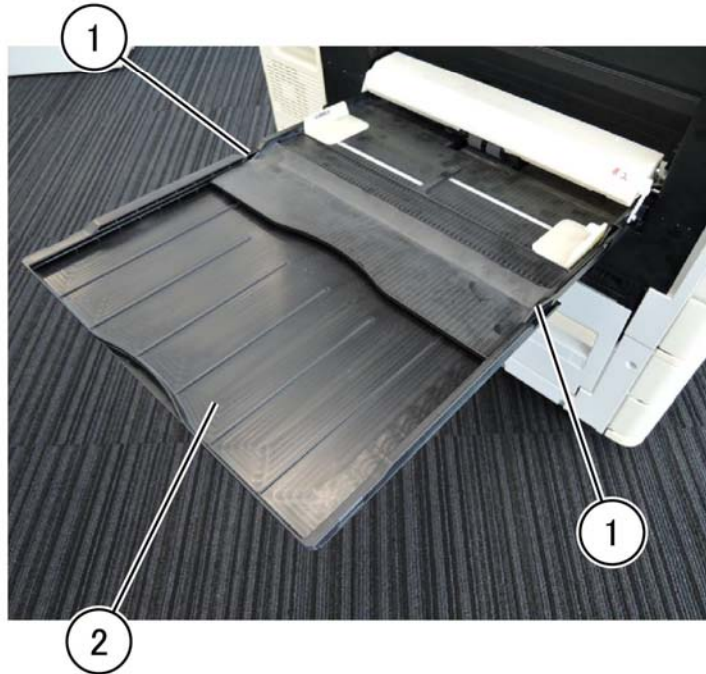
F-1-0271-A

1. Fully extend the extension tray.
2. Using firm pressure, pull the extension tray (2) from the bypass tray (1) to remove: [Figure 1](#).

Figure 1 Extension tray removal

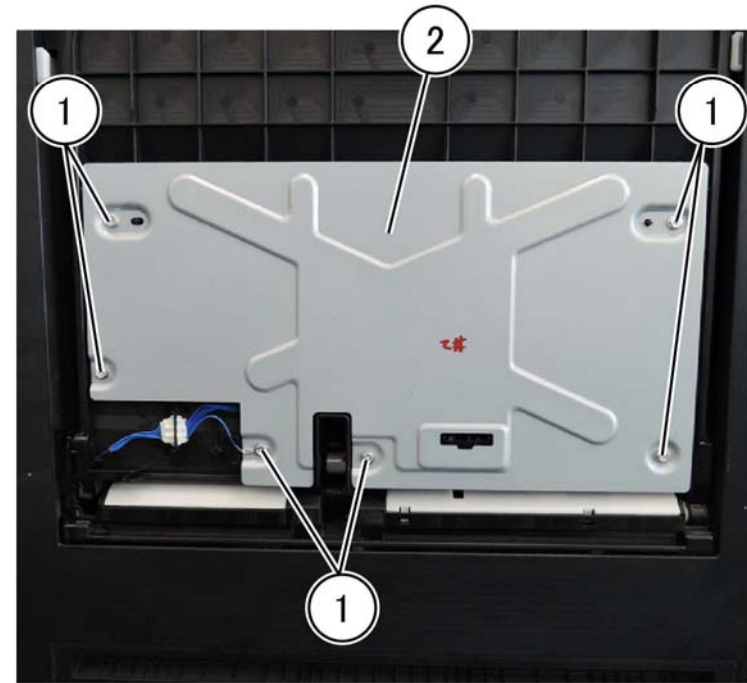
F-1-0272-A

3. Lift the bypass tray, remove six screws (1), then remove the tray plate (2), [Figure 2](#).

Figure 2 Tray plate removal

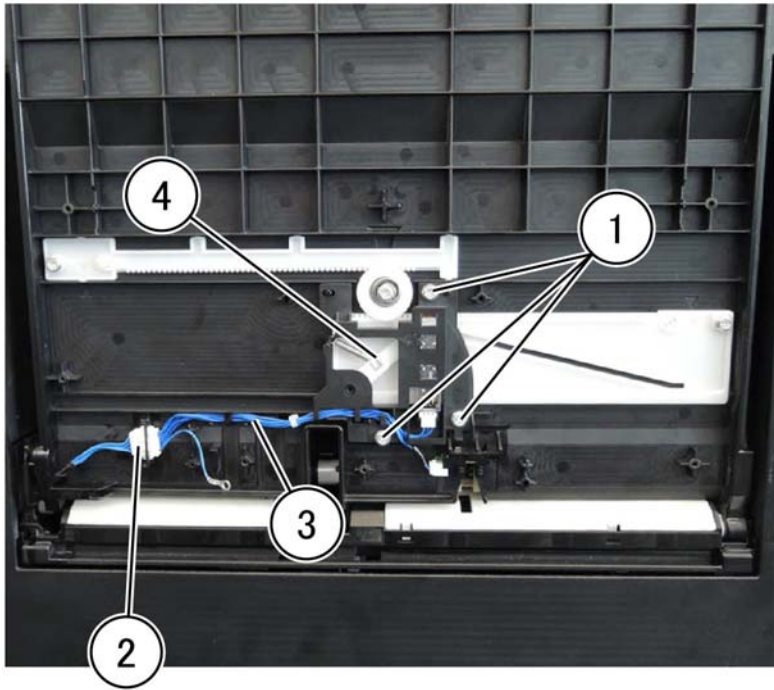
F-1-0273-A

4. Remove the MSI paper size sensor assembly, PL 70.55 Item 1: Figure 3.
 - a. Remove three screws (1).
 - b. Disconnect the connector (2).
 - c. Release the harness (3).
 - d. Release the bypass tray paper size sensor assembly (4).
 - e. Disconnect the paper size sensor.
 - f. Remove the bypass tray paper size sensor assembly.

Figure 3 Assembly removal

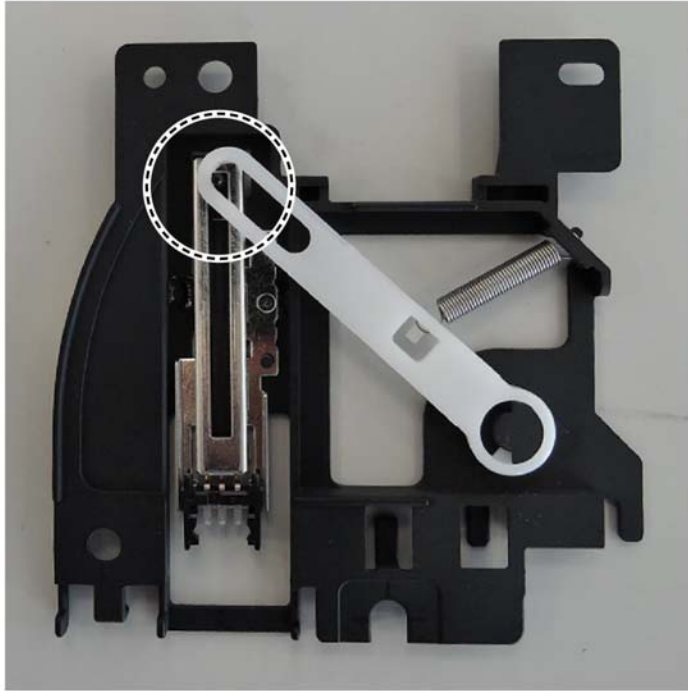
F-1-0274-A

1. When installing the bypass tray paper size sensor assembly, put the pin into the long hole of the link, [Figure 4](#).

Figure 4 Pin and link location

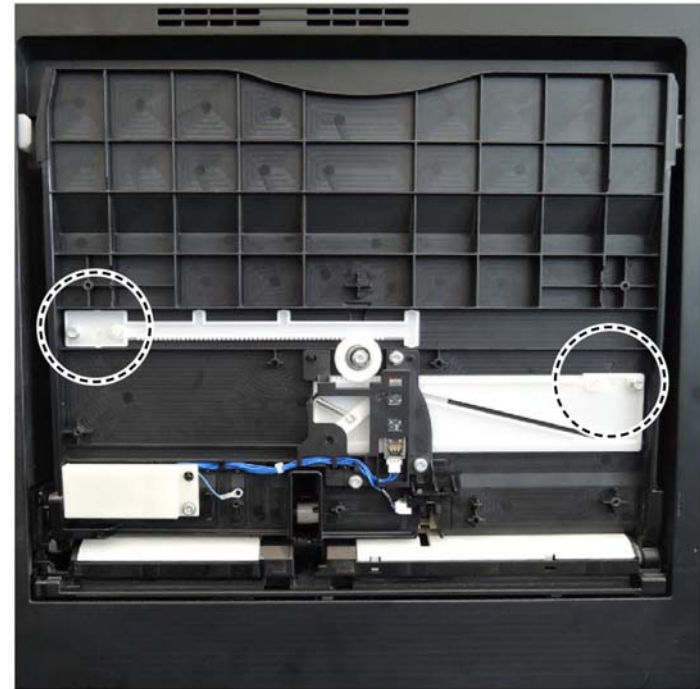
F-1-0275-A

2. When installing the gear, align the marks on the front/rear rack to the marks on the bypass tray, [Figure 5](#).

Figure 5 Gear alignment

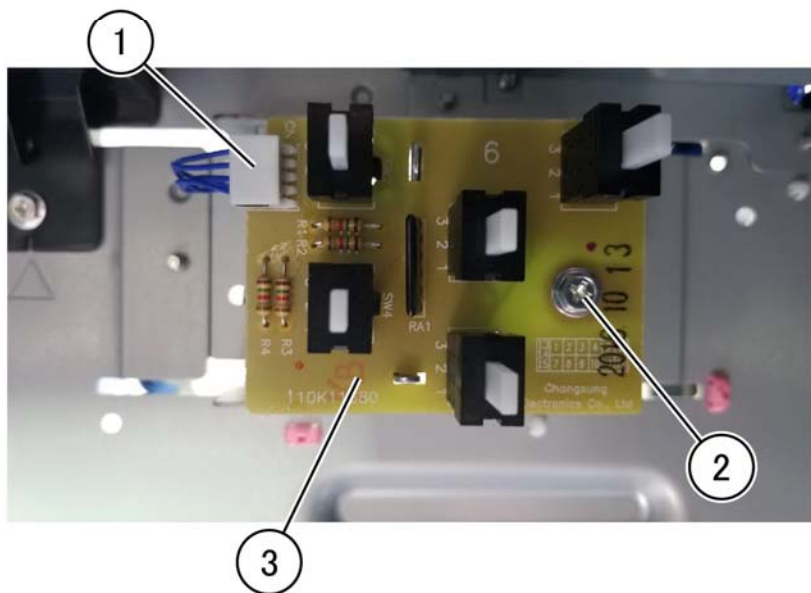
F-1-0357-A

1. Remove 2TM tray 3 and tray 4, [PL 70.20 Item 1](#).
2. Remove the malfunctioning paper size sensor, [PL 70.20 Item 12: Figure 1](#).
 - a. Disconnect the connector (1).
 - b. Remove the screw (2).
 - c. Remove the paper size sensor (3).

Figure 1 2TM paper size sensor removal

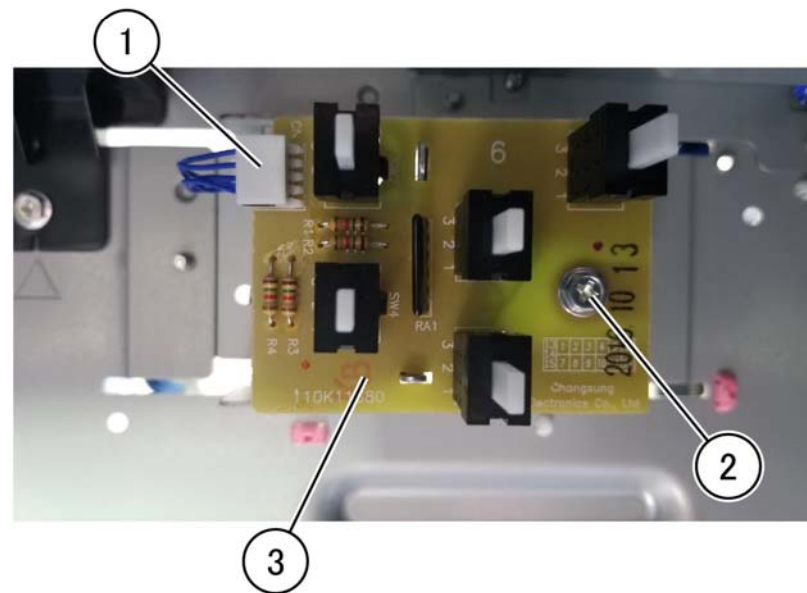
F-1-0358-A

1. Remove the transport stopper, [PL 70.35 Item 20](#) or [PL 70.35 Item 21](#).
2. Remove TTM tray 3 or tray 4, [PL 70.35 Item 1](#) or [PL 70.35 Item 2](#).
3. Remove the malfunctioning paper size sensor, [PL 70.35 Item 22: Figure 1](#).
 - a. Disconnect the connector (1).
 - b. Remove the screw (2).
 - c. Remove the paper size sensor (3).

Figure 1 TTM Paper size sensor removal

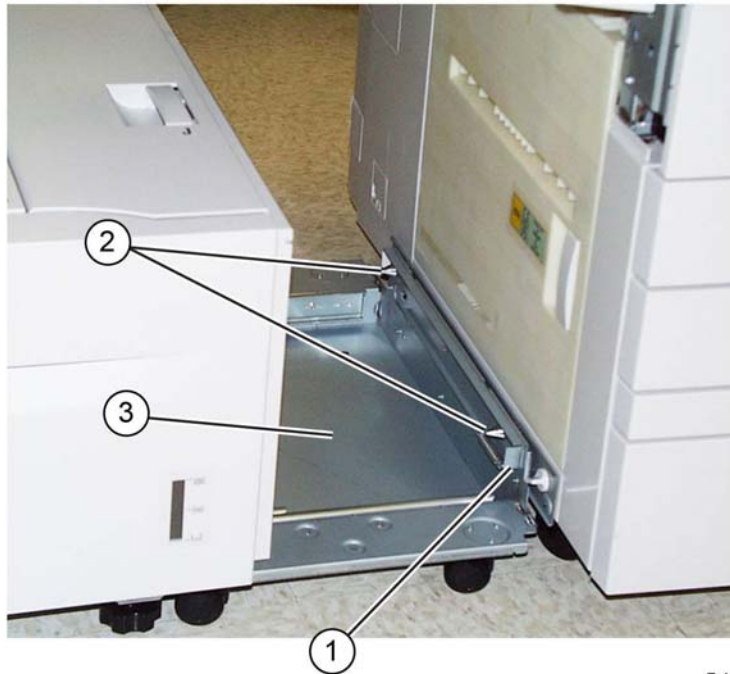
F-1-0758-A

1. Disconnect the HCF cable from the machine.
2. Unscrew the wing screw, then slide the HCF away from the machine.
3. Release the docking latch spring lever (1) on the right side of the docking base, [Figure 1](#).

Figure 1 Docking base

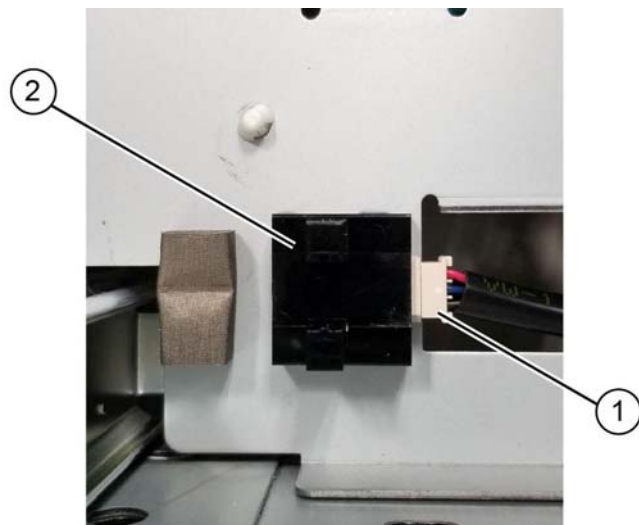
F-1-0759-A

3. Disconnect the connector (1), then remove the tray set sensor (2), PL 70.75 Item 3, Figure 2:

Figure 2 Tray set sensor removal

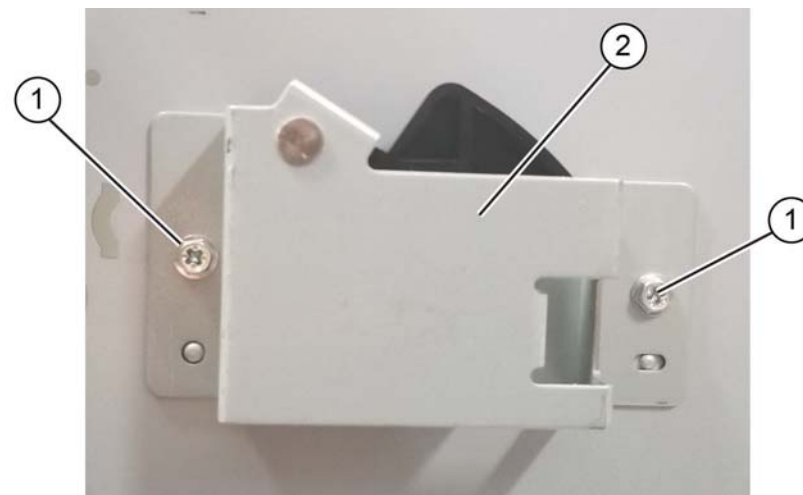
F-1-0760-A

1. Undock the HCF, REP 70.7.
2. Tray latch assembly removal, Figure 1:
 - a. Lay the HCF on the left side.
 - b. Open the tray to gain access to the tray bottom and tray latch assembly, PL 70.80 Item 1.
 - c. Remove two screws (1), then remove the tray latch assembly (2).

Figure 1 Tray latch assembly removal

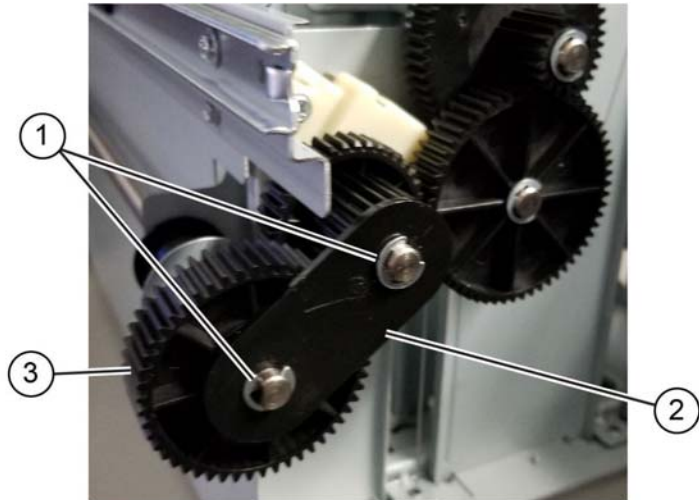
F-1-0761-A

1. Undock the HCF, [REP 70.7](#).
2. Remove the HCF tray, [REP 70.8](#).
3. Remove the lift gear, [Figure 1](#):
 - a. Remove two E-clips (1) then remove the plate (2).
 - b. Remove the lift gear [PL 70.85 Item 24](#) (3).

Figure 1 Lift gear removal

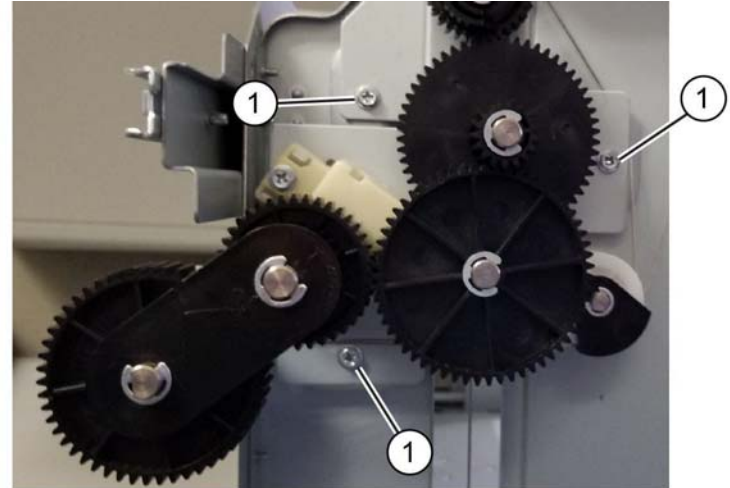
F-1-0762-A

1. Remove the HCF lift gear, [REP 70.11](#).
2. Remove three screws (1), then remove the gear bracket assembly, [PL 70.85 Item 17](#), [Figure 1](#).

Figure 1 Gear bracket assembly removal

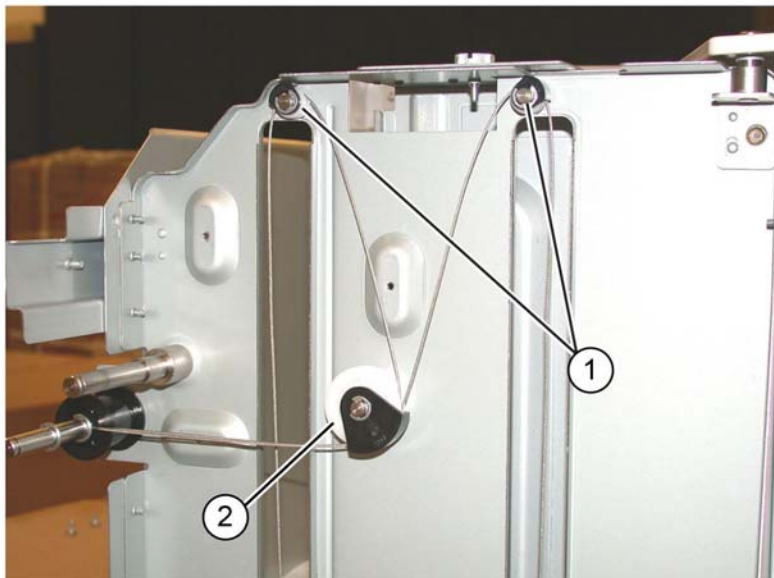
F-1-0763-A

1. Remove the HCF gear bracket assembly, [REP 70.11](#).
2. Remove two E-clips the two short wire guides and two pulleys (1), then the E-clip the long wire guide and pulley (2), [Figure 1](#).

Figure 1 Guides and pulleys removal

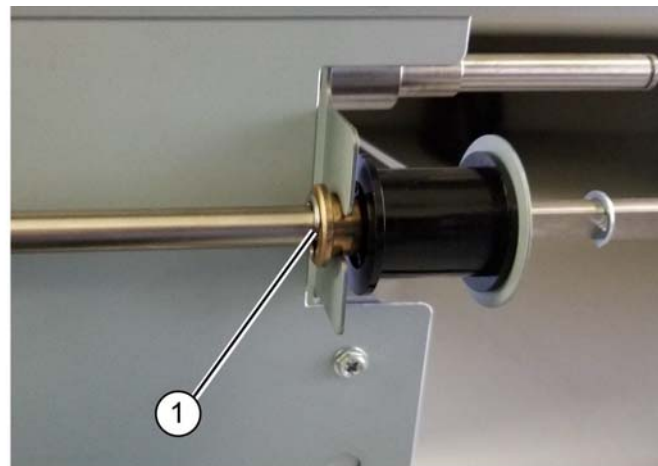
F-1-0764-A

3. Remove the E-clip (1), [Figure 2](#):

Figure 2 E-clip removal

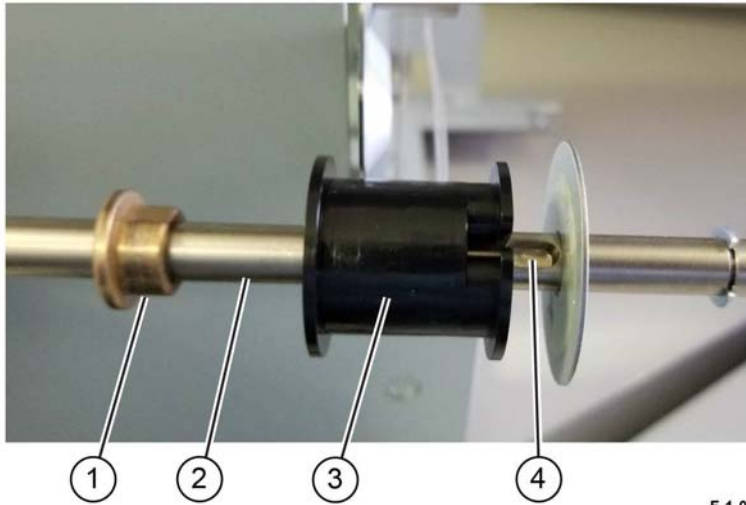
F-1-0765-A

- Slide the bearing (1) left, away from the frame, releasing the lift shaft (2) from the HCF frame, slide the pulley (3) to the rear, releasing the cable ends from the lift shaft (4), [Figure 3](#).

Figure 3 Releasing the cable ends

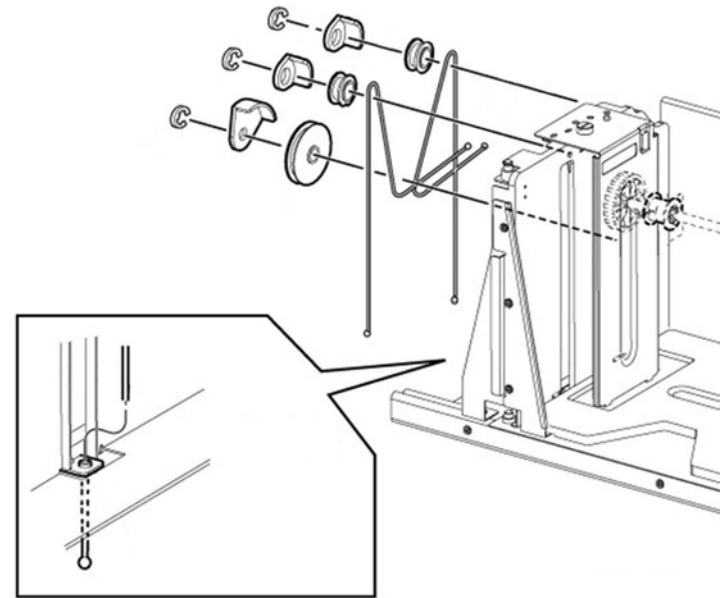
F-1-0766-A

Replacement is the reverse of the removal procedure. Refer to [Figure 4](#).

Figure 4 Replacement

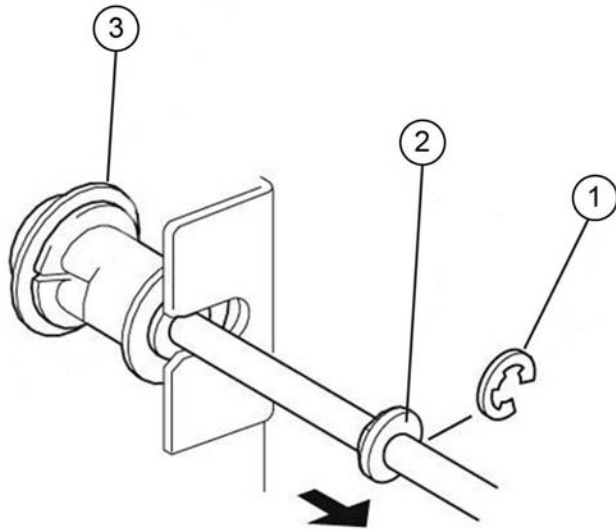
F-1-0767-A

1. Remove the HCF tray front cover, [PL 70.50 Item 7](#).
2. Free movement of the front tray cable pulley, [Figure 1](#):
 - a. Remove the E-ring (1) on the lift shaft.
 - b. Slide the bearing (2) to the rear on the lift shaft.
 - c. Front tray cable pulley (3), [PL 70.85 Item 4](#).

Figure 1 Tray cable pulley

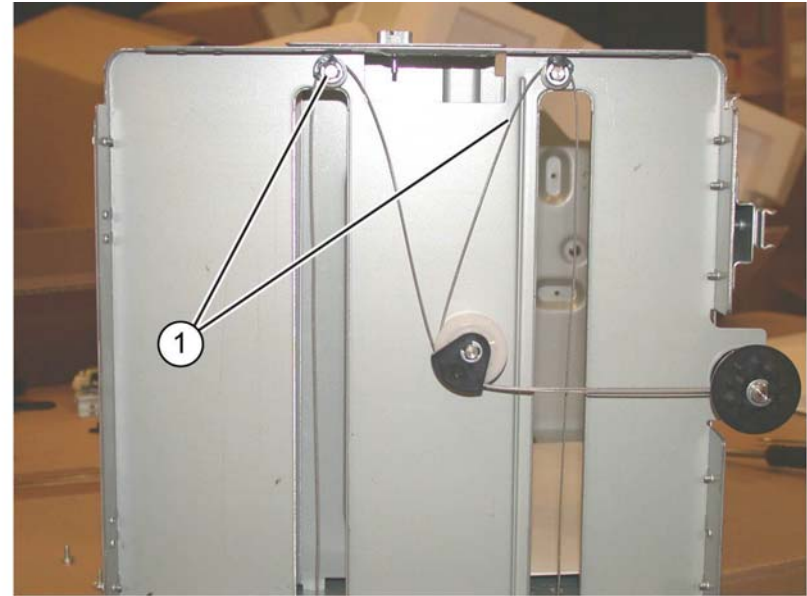
F-1-0768-A

3. Prepare to remove the tray front cables. Remove two E-rings, wire guides and pulleys (1) from the front of the HCF tray, [Figure 2](#).

Figure 2 Preparation

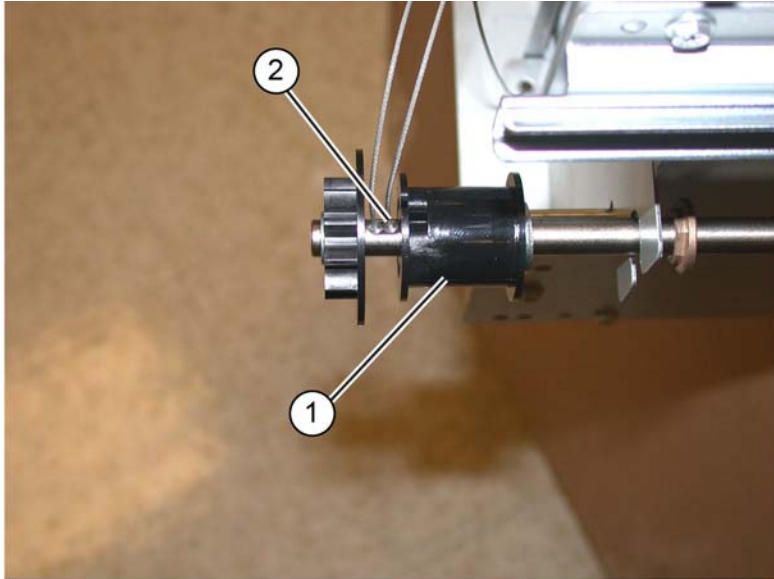
F-1-0769-A

4. Slide the pulley (1) to the right to release the rear lift cable ends (2), [Figure 3](#).

Figure 3 Releasing the cable ends

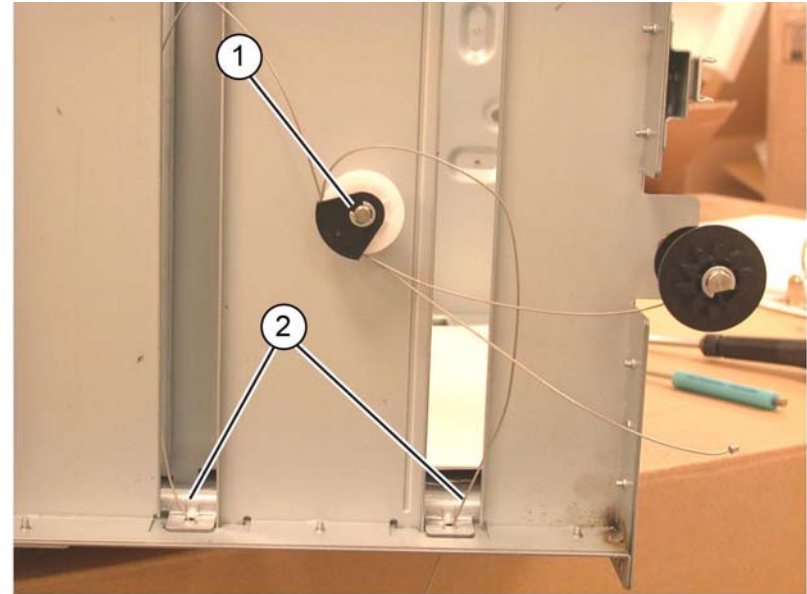
F-1-0770-A

5. Remove the front tray cables, [Figure 4](#):
- Remove the E-ring, wire guide and pulley (1).
 - Remove the cables (2).

Figure 4 Front cables removal

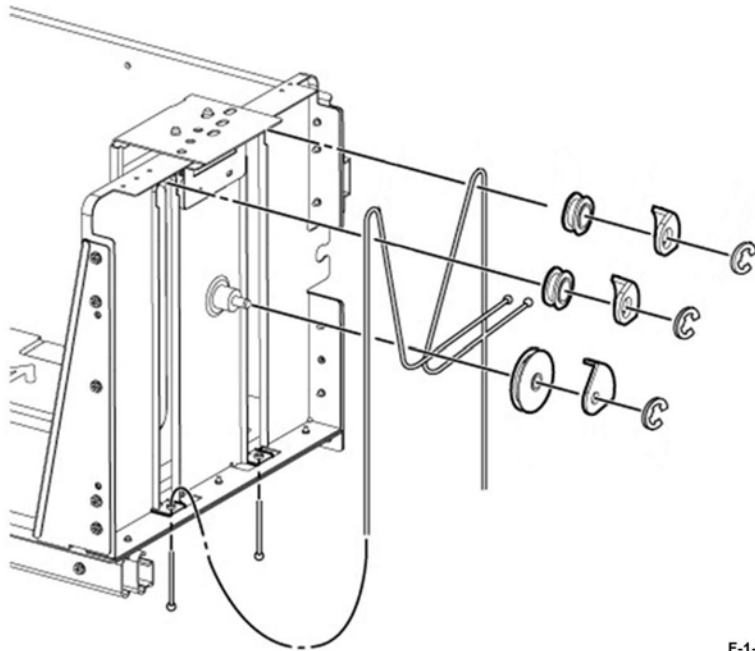
F-1-0771-A

Replacement is the reverse of the removal procedure. Refer to [Figure 5](#).

NOTE: When reinstalling the HCF tray front cover, raise the gear on the indicator shaft so that it meshes with the adjoining lift shaft gear.

Figure 5 Replacement

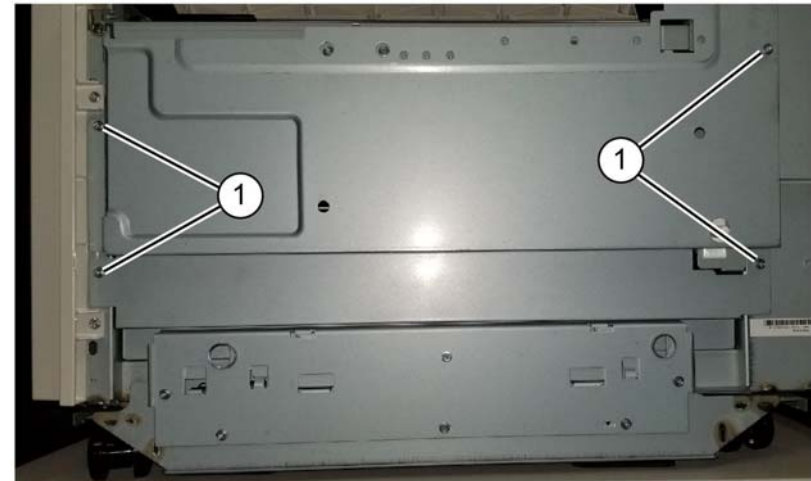
F-1-0772-A

1. Undock the HCF, [REP 70.7](#).
2. Remove the right cover, [PL 70.75 Item 7](#).
3. Remove the front right cover, [PL 70.75 Item 8](#).
4. Remove four screws (1) to remove the inner right cover, [Figure 1](#).

Figure 1 Inner right cover removal

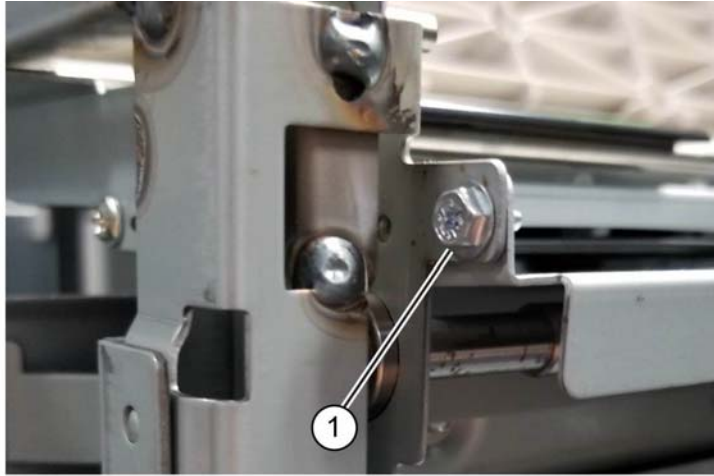
F-1-0773-A

5. Remove the lower chute, [PL 70.90 Item 24](#):
 - a. Remove the lower chute front screw (1), [Figure 2](#).

Figure 2 Front screw removal

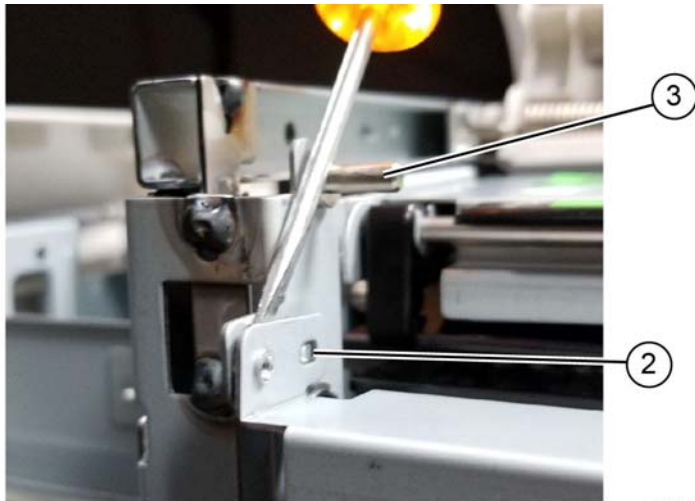
F-1-0774-A

- b. Gently pry the chute from the HCF frame to get over the set notch (2), then lift the chute front out of the way of the front cover latch pin (3), [Figure 3](#).

Figure 3 Chute front release

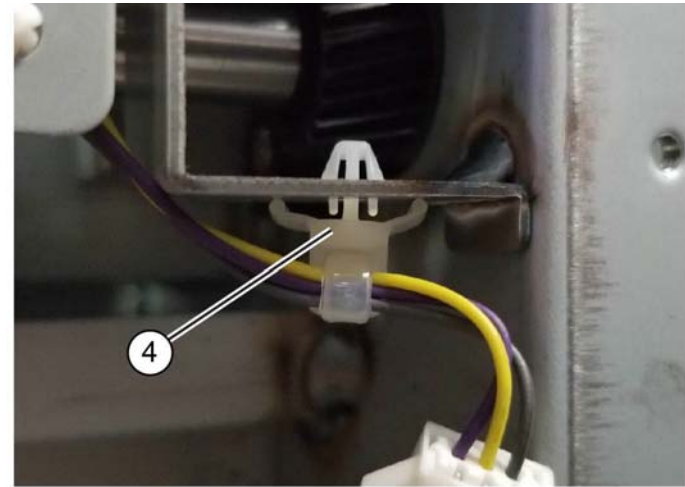
F-1-0775-A

- c. Release the cable clamp from the frame (4), [Figure 4](#).

Figure 4 Cable clamp

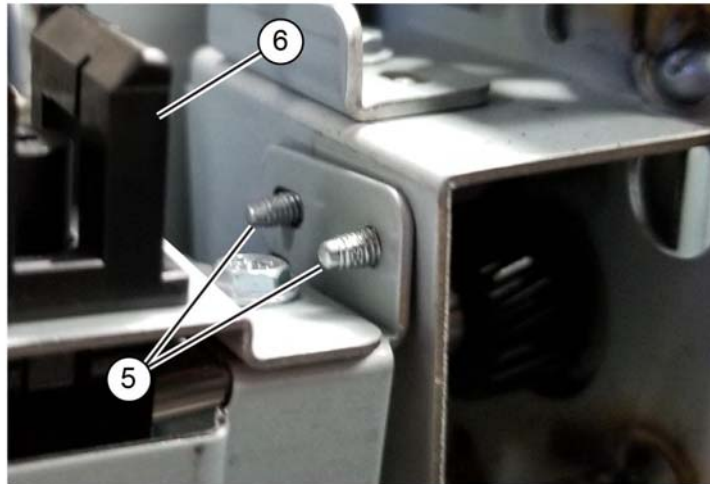
F-1-0776-A

- d. Move the lower chute forward off the two screw shafts (5), then remove the lower chute (6), [PL 70.90 Item 24, Figure 5](#).

Figure 5 Rear screws

NOTE: The two screw shafts are not securing the chute to the machine frame, only holding the rear side of the chute in-place. Do not attempt to remove the two screws.

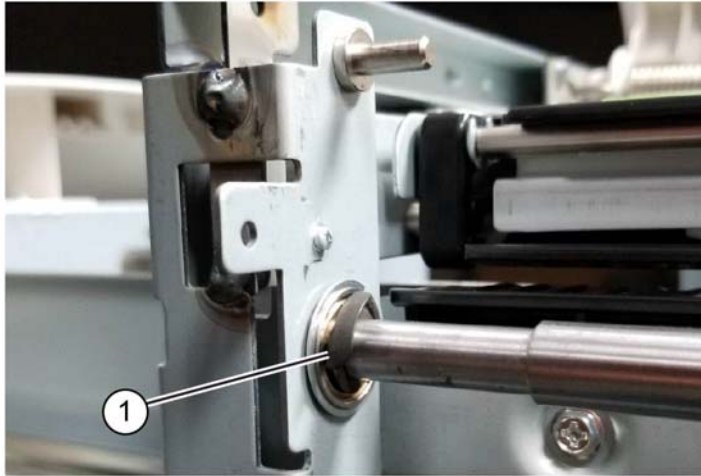
F-1-0777-A

6. Release the takeaway roll from the frame, [PL 70.90 Item 18](#).
a. Remove the K-clip (1), [Figure 6](#).

Figure 6 K-clip removal

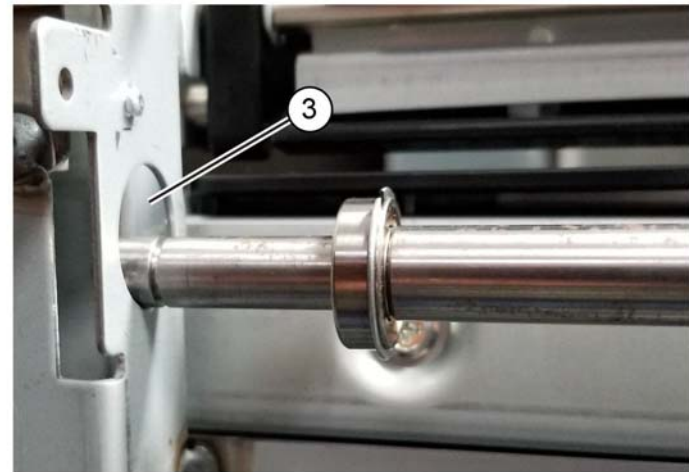
F-1-0778-A

- c. Slide the bearing end of the takeaway roll forward (left) into the shaft hole (3), [Figure 8](#).

Figure 8 Shaft hole

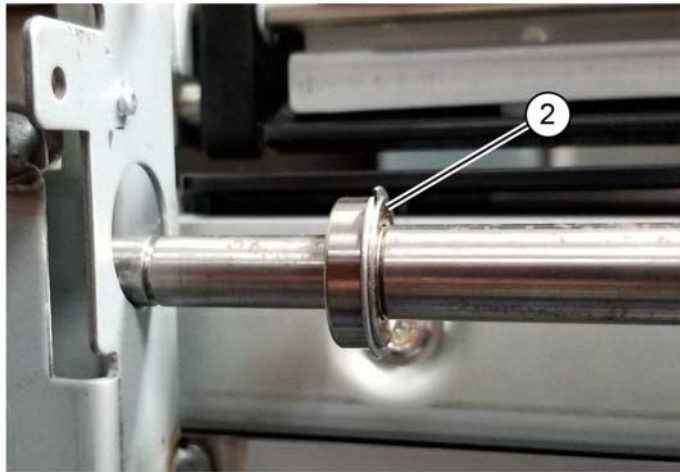
F-1-0778-A

- b. Slide the bearing (2) to the rear (right) onto the takeaway roll, [Figure 7](#).

Figure 7 Slide bearing to the rear (right)

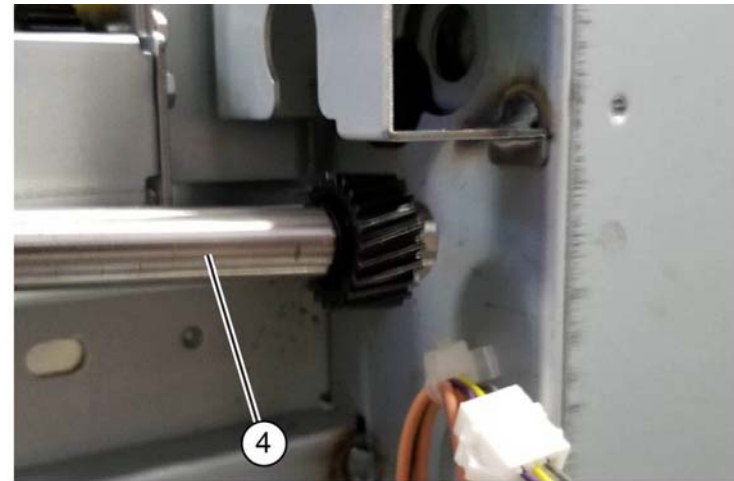
- d. Drop the takeaway roll (4) through the notch in HCF frame, then remove the takeaway roll, [PL 70.90 Item 18](#), [Figure 9](#).

Figure 9 Takeaway roll removal

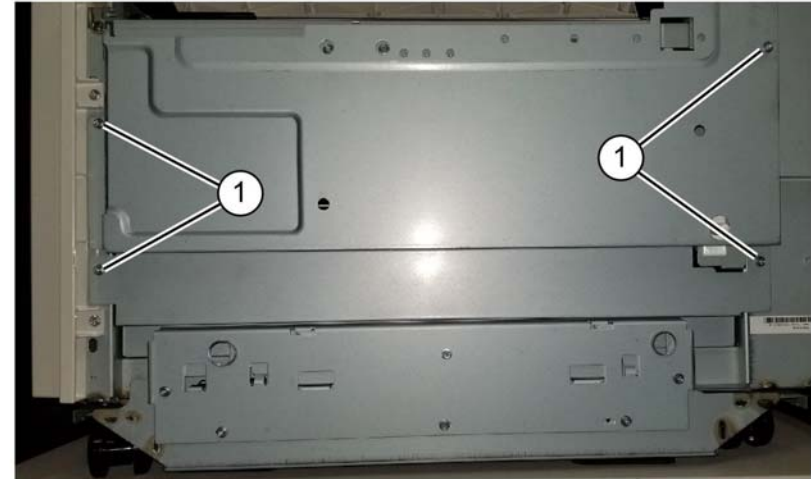
1. Undock the HCF, [REP 70.7](#).
2. Remove the right cover, [PL 70.75 Item 7](#).
3. Remove four screws (1), then remove the inner right cover, [Figure 1](#).

Figure 1 Inner right cover removal

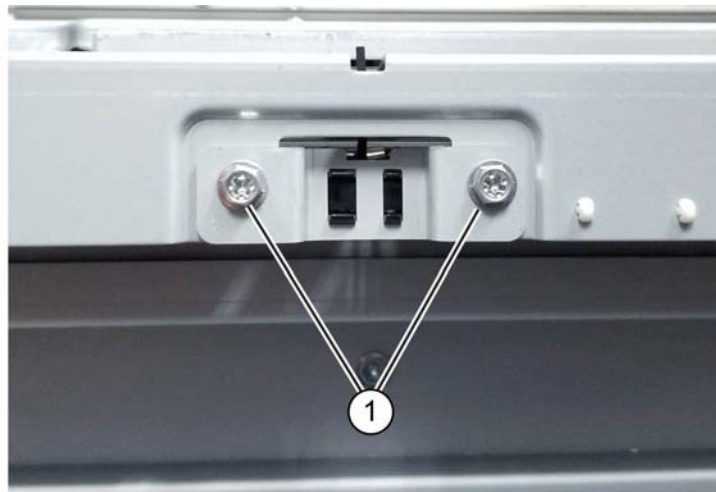
4. Remove two screws (1) holding the feed out sensor bracket, [Figure 2](#).

Figure 2 Screw removal

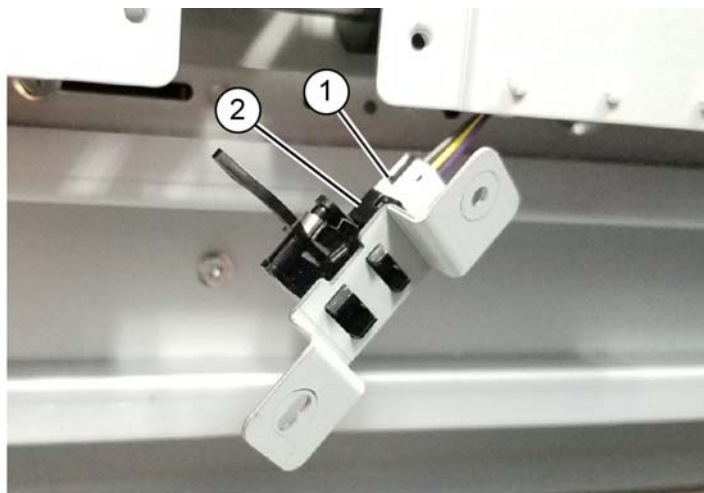
5. Disconnect the connector (1), then remove the feed out sensor (2), [PL 70.90 Item 25](#) from the bracket, [Figure 3](#).

Figure 3 Feed out sensor removal

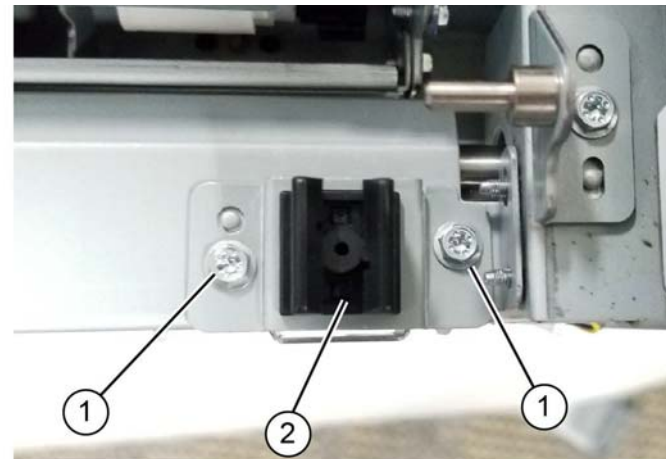
1. Remove two screws (1), lift the transport interlock switch (2) from the frame hole, [Figure 1](#).

Figure 1 Screw removal

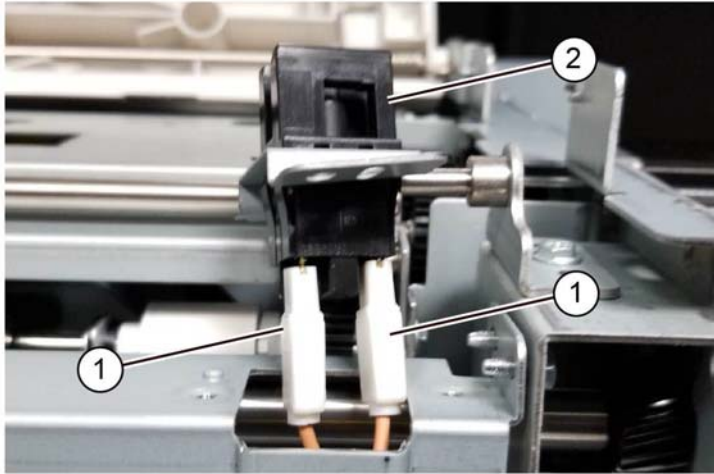
2. Disconnect two connectors (1), then remove the transport interlock switch (2), PL 70.90 Item 26, from the bracket, Figure 2.

Figure 2 Transport interlock switch removal

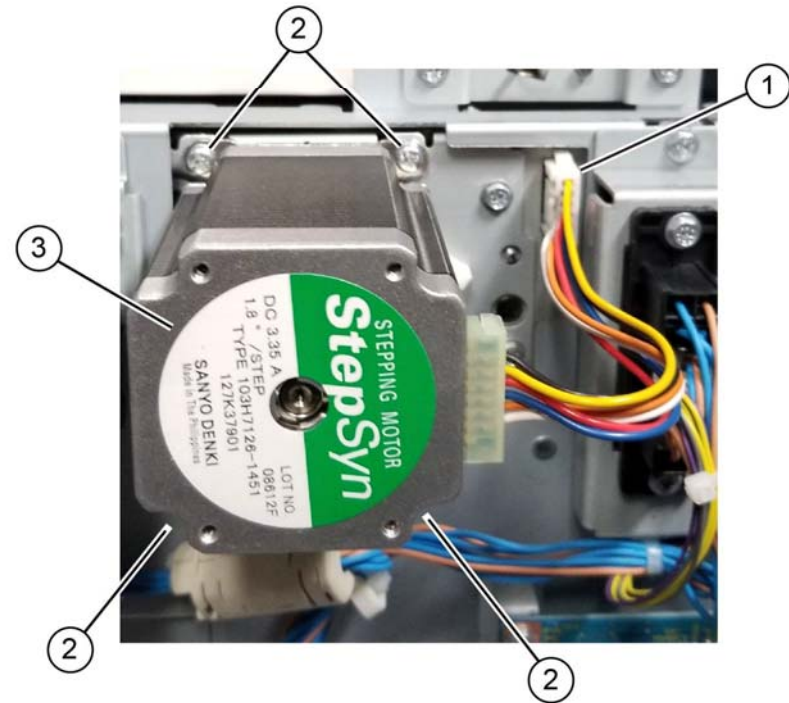
1. Undock the HCF, REP 70.7.
2. Remove the rear cover, PL 70.75 Item 10.
3. Disconnect the connector (1), remove four screws (2), then remove the takeaway motor (3), PL 70.95 Item 7, Figure 1.

Figure 1 Takeaway motor removal

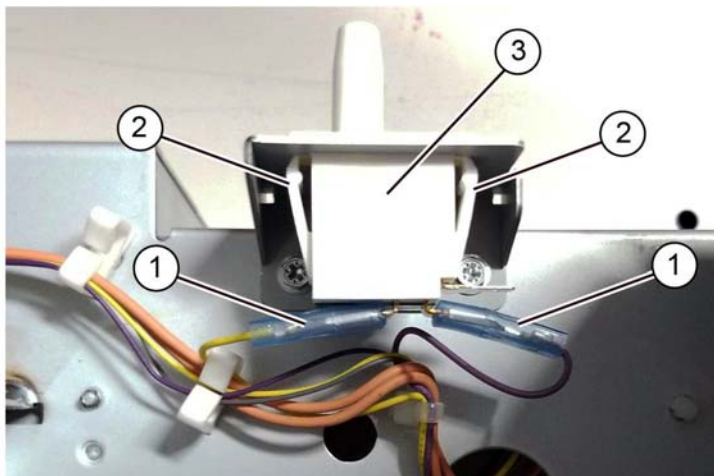
1. Undock the HCF, [REP 70.7](#).
2. Remove the HCF tray, [REP 70.8](#).
3. Disconnect two connectors (1), then squeeze the locks on each side of the slide out switch (2), then remove the slide out switch (3), [PL 70.95 Item 8](#) from the bracket, [Figure 1](#).

Figure 1 Slide out switch removal

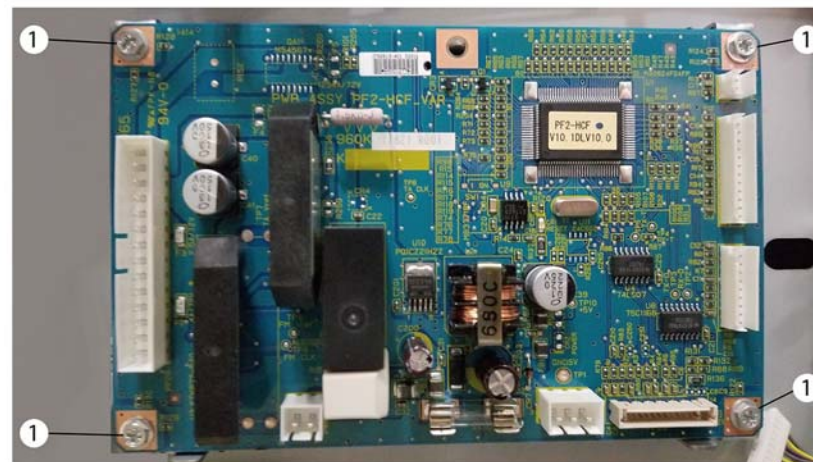
1. Print a Configuration Report, then verify the software is the latest version. Upgrade the software as necessary, [GP 4](#).
2. Undock the HCF, [REP 70.8](#).
3. Remove the rear cover, [PL 70.75 Item 10](#).
4. Disconnect all connectors from the HCF PWB, [PL 70.95 Item 9](#).
5. Remove fore screws (1), then remove the HCF PWB, [PL 70.95 Item 9](#), [Figure 2](#).

Figure 2 HCF PWB removal

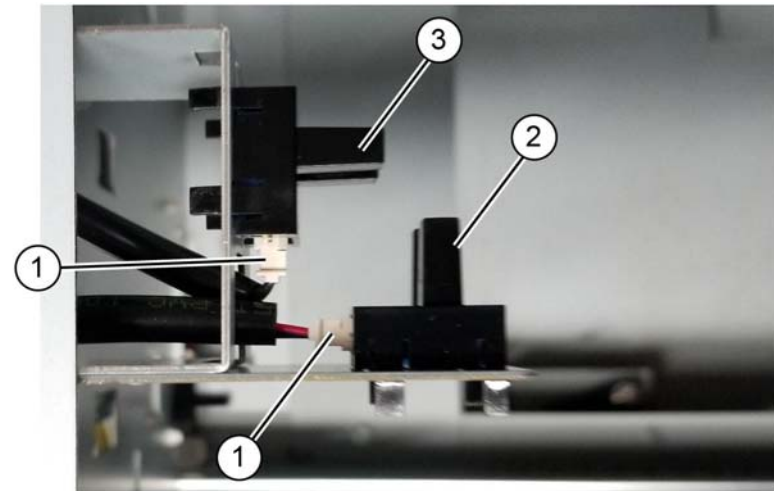
1. Undock the HCF, [REP 70.7](#).
2. Open the HCF tray, [PL 70.75](#).
3. Remove the rear cover, [PL 70.75 Item 10](#).
4. Remove the left top cover, [PL 70.75 Item 7](#).
5. Disconnect the connector (1), then remove the appropriate size sensor; (2) HCF paper sensor (Letter) (Q78-202), (3) HCF paper sensor (A4) (Q78-203), [PL 70.95 Item 13, Figure 1](#).

Figure 1 Size sensor removal

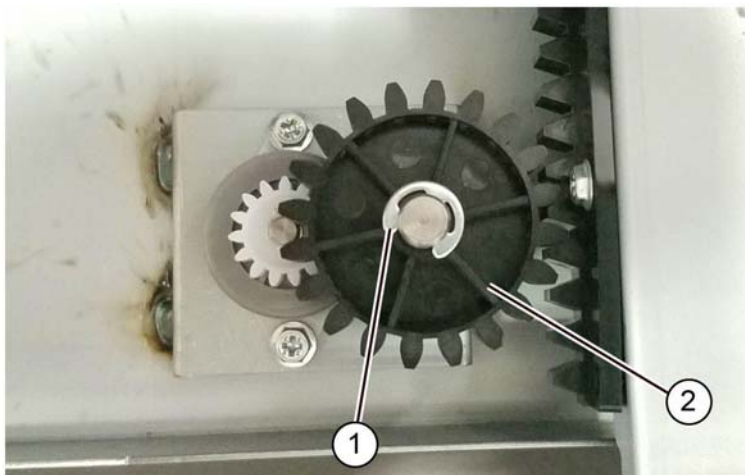
1. Undock the HCF, [REP 70.7](#).
2. Remove the HCF tray, [REP 70.8](#).
3. Remove the wing screw to release the slide mechanism, then slide the HCF open to gain access to the pinion, [PL 70.95 Item 17](#) and damper, [PL 70.95 Item 16](#).
4. Remove the Pinion: [Figure 1](#):
 - a. Remove the E-clip (1), then remove the pinion (2), [PL 70.95 Item 17](#).

Figure 1 Pinion removal

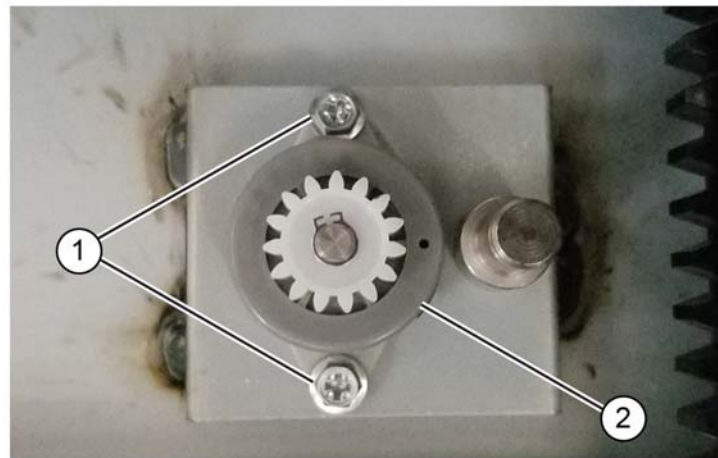
5. Remove the damper, [Figure 2](#).
 - a. Remove two screws (1), then remove the damper (2), [PL 70.95 Item 16](#).

Figure 2 Damper removal

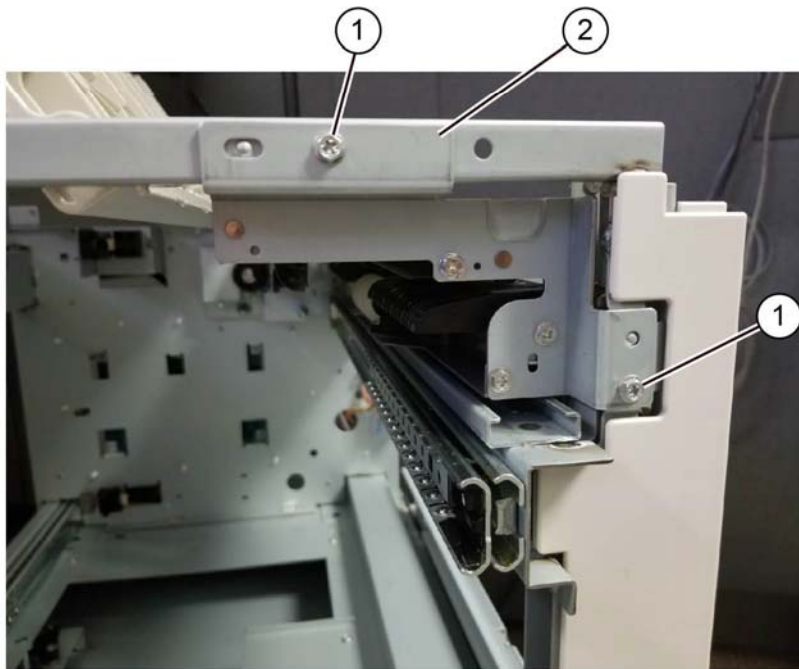
1. Undock the HCF, [REP 70.7](#).
2. Remove the tray, [REP 70.8](#).
3. Remove the left top cover, [PL 70.75 Item 6](#).
4. Open the top cover, [PL 70.90 Item 7](#).
5. Remove two screws (1) securing the front frame, [PL 80.100 Item 13](#), to the HCF frame, [Figure 1](#).

Figure 1 Feeder securing screws

1. Align the guide pins of the frame with the adjacent holes in the feedhead frame pushing the feedhead assembly into the connector until fully seated.
2. The remainder of the replacement is the reverse of the removal procedure

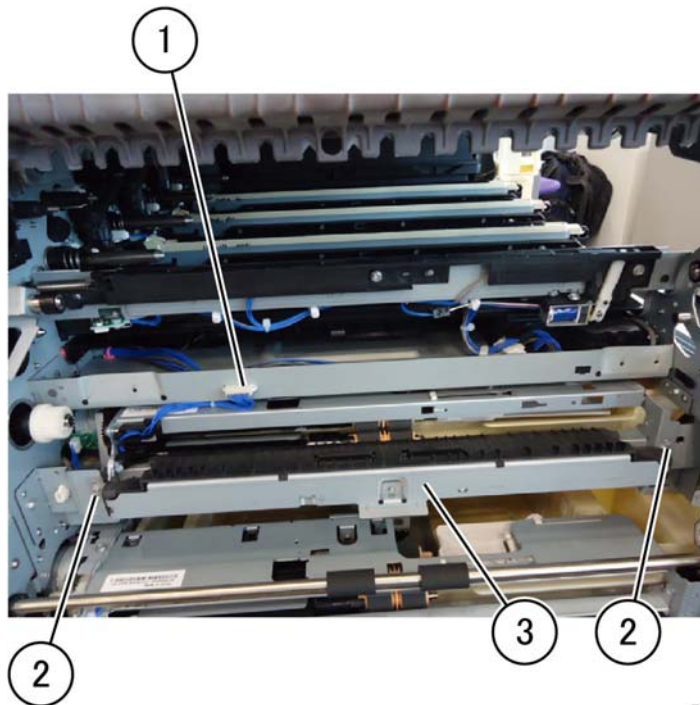
1. Remove tray 1 and tray 2, [PL 70.05 Item 1](#) and [PL 70.05 Item 2](#).
2. Remove the left cover assembly, [REP 80.18](#).
3. Remove the chute, [PL 70.50 Item 11](#).
4. Remove the tray 1 feedhead assembly, [PL 80.05 Item 1](#), [Figure 1](#).
 - a. Disconnect the connector (1).
 - b. Remove two screws (2).
 - c. Remove the tray 1 feedhead assembly (3).

Figure 1 Tray 1 feedhead assembly removal

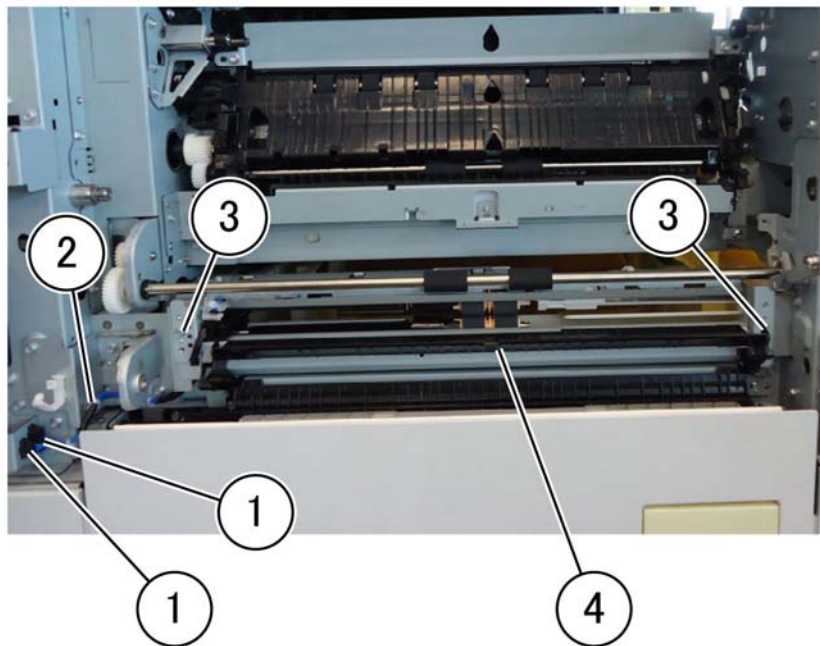
1. Remove tray 1 and tray 2, [PL 70.05 Item 1](#) and [PL 70.05 Item 2](#).
2. Remove the left cover assembly, [REP 80.18](#).
3. Remove the chute, [PL 70.50 Item 11](#).
4. Remove the tray 2 feedhead assembly, [PL 80.05 Item 2](#), [Figure 1](#).
 - a. Disconnect two connectors (1).
 - b. Remove the harness tie (2).
 - c. Remove two screws (3).
 - d. Remove the tray 2 feedhead assembly (4).

Figure 1 Tray 2 feedhead assembly removal

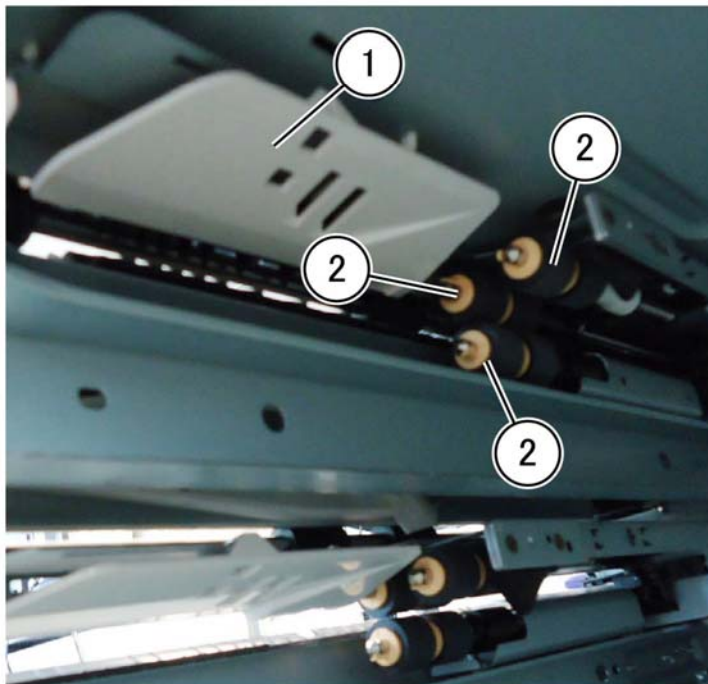
1. Remove tray 1 and tray 2, [PL 70.05 Item 1](#) and [PL 70.05 Item 2](#).
2. Remove the feed, nudger, and retard roll, [PL 80.10](#) and [PL 80.15](#), [Figure 1](#).
 - a. Move the chute to the front (1).
 - b. Remove the feed, nudger, and retard roll (2).

Figure 1 Tray 1/2 feed roll kit removal

NOTE: The feed roll kit replacement procedure is the same for tray 1 and tray 2. The feed rolls are replaced as a set, [PL 80.10 Item 11](#), [PL 80.15 Item 10](#).
