VersaLink[®] C8000/C9000 Printer

Service Manual

VersaLink C9000 Family Service Manual

705P01418

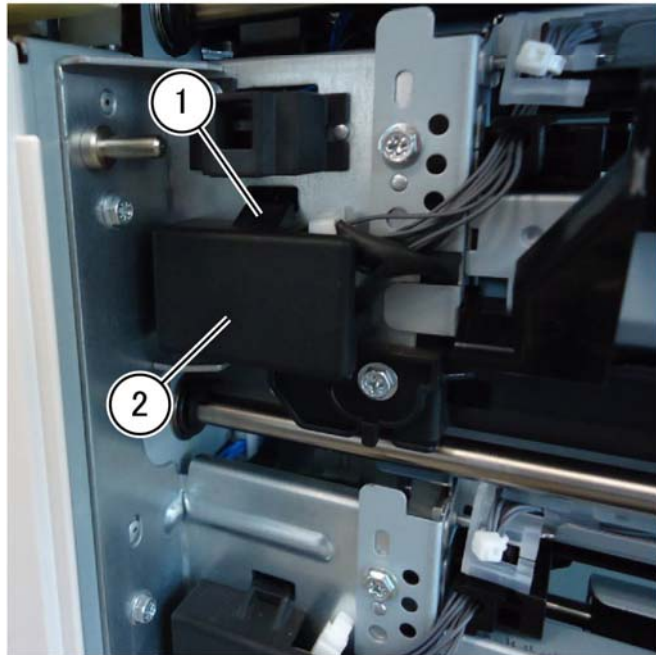
3. Remove the feed out chute, [PL 80.20 Item 11](#), upper position.
4. Remove the connector cover [PL 80.20 Item 9](#), [Figure 1](#).
 - a. Release the hook (1).
 - b. Remove the connector cover (2), [PL 80.20 Item 9](#) upper position.

Figure 1 Connector cover removal

NOTE: The feedhead 1 assembly and the feedhead 2 assembly, [PL 80.20 Item 10](#) are identified by (1) and (2). Refer to the upper position for assemblies that are in both positions.

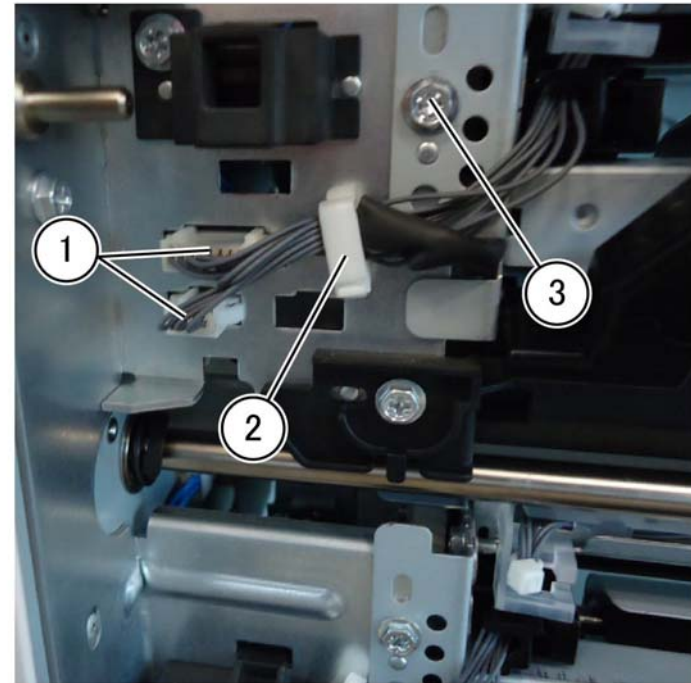
5. Disconnect the 2TM feedhead 1 assembly: [Figure 2](#).
 - a. Disconnect two connectors (1).
 - b. Open the clamp (2), then move the harness out of the way.
 - c. Remove the screw at the rear (3).

Figure 2 Rear screw removal

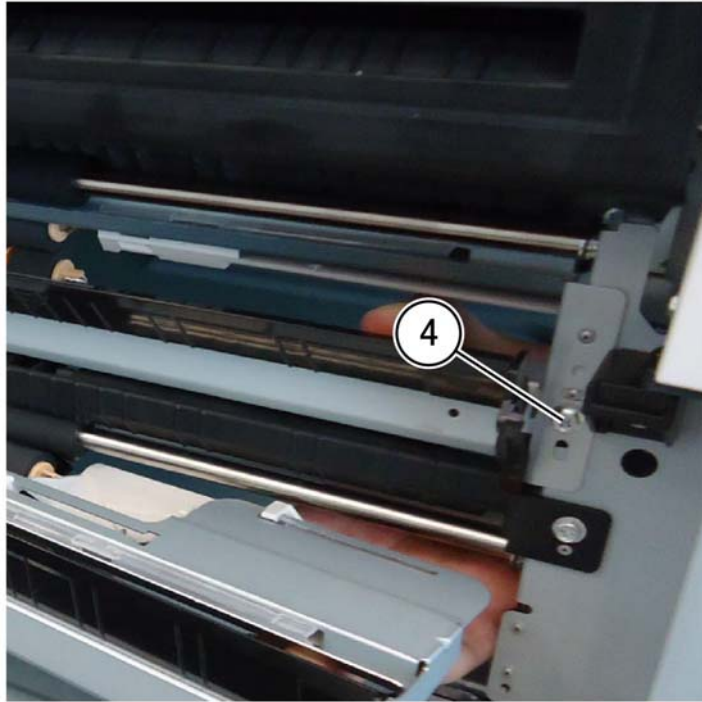
- Remove the screw at the front (4), [Figure 3](#).

Figure 3 Front screw removal

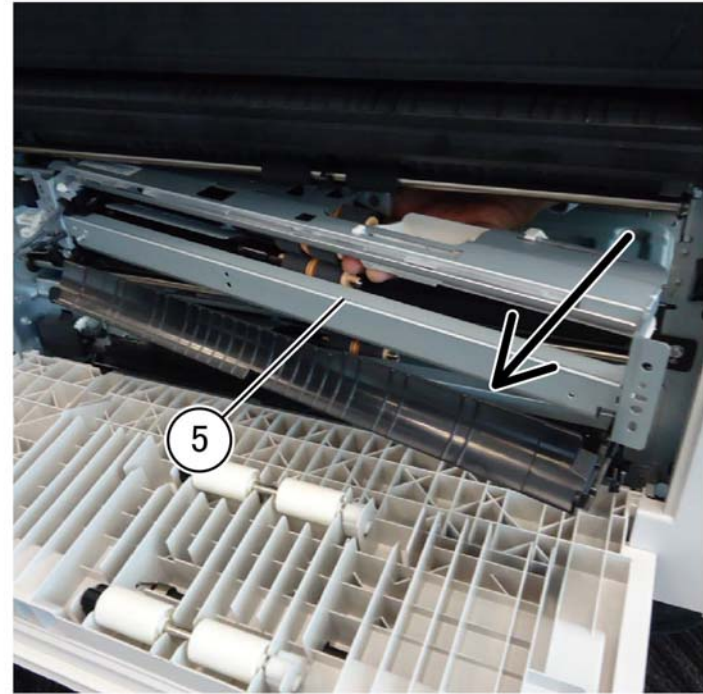
- Remove the 2TM feedhead 1 assembly (5) in the direction of the arrow, [PL 80.20 Item 10](#) upper position, [Figure 4](#).

Figure 4 2TM feedhead 1 assembly removal

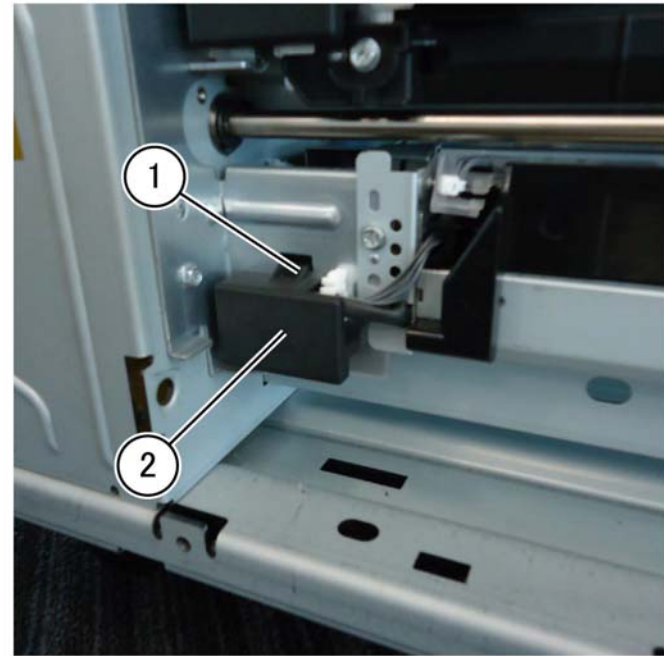
6. Remove the connector cover: [Figure 1](#).
 - a. Release the hook (1).
 - b. Remove the connector cover (2).

Figure 1 Connector cover removal

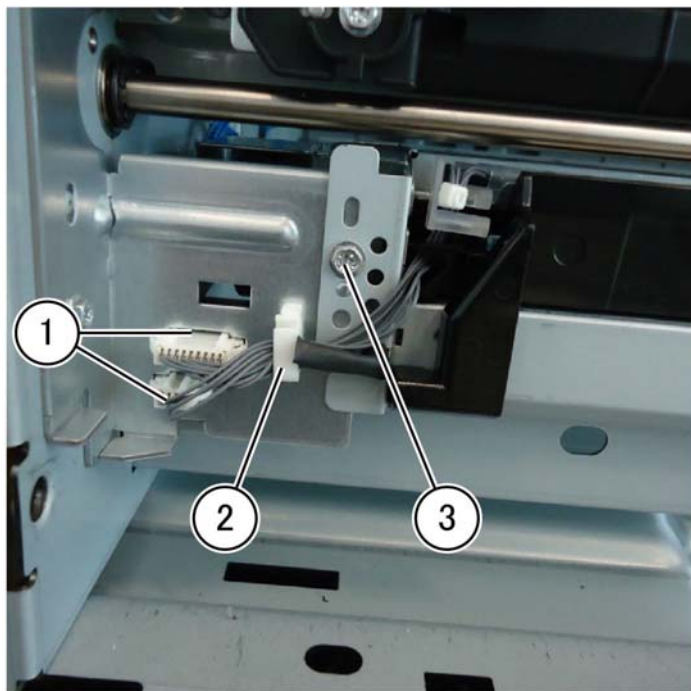
7. Disconnect the 2TM feedhead 2 assembly: [Figure 2](#).
 - a. Disconnect two connectors (1).
 - b. Open the clamp (2), then move the harness out of the way.
 - c. Remove the screw at the rear (3).

Figure 2 Rear screw removal

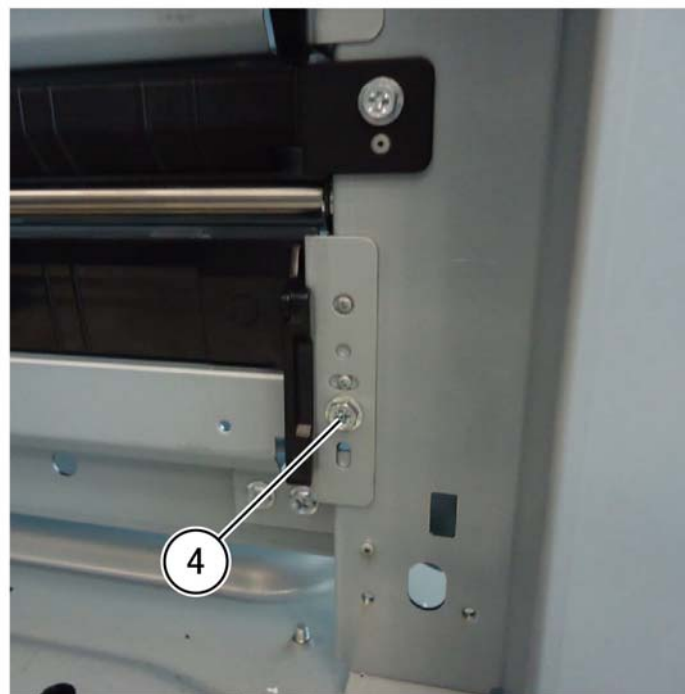
8. Remove the screw at the front (4), [Figure 3](#).

Figure 3 Front screw removal

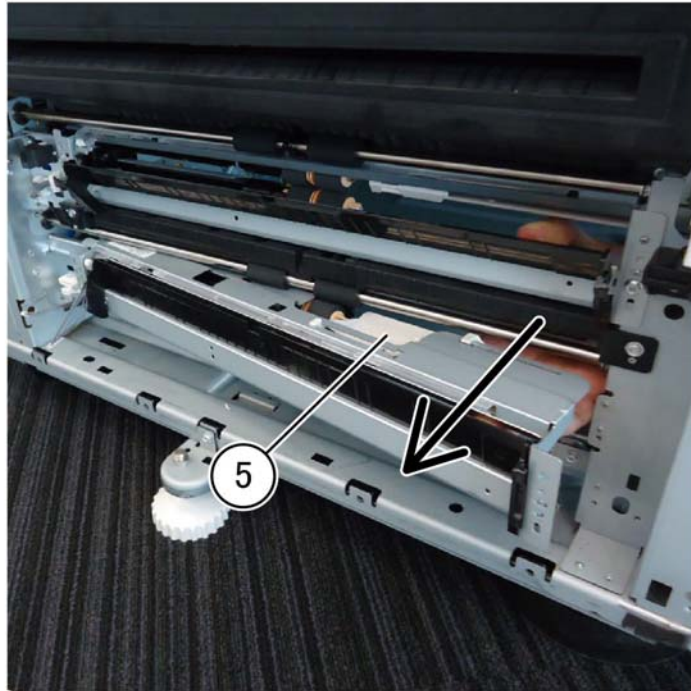
10. Remove the 2TM feedhead 2 assembly (5) in the direction of the arrow, PL 80.20 Item 10 lower position, Figure 4.

Figure 4 2TH feeder 2 assembly removal

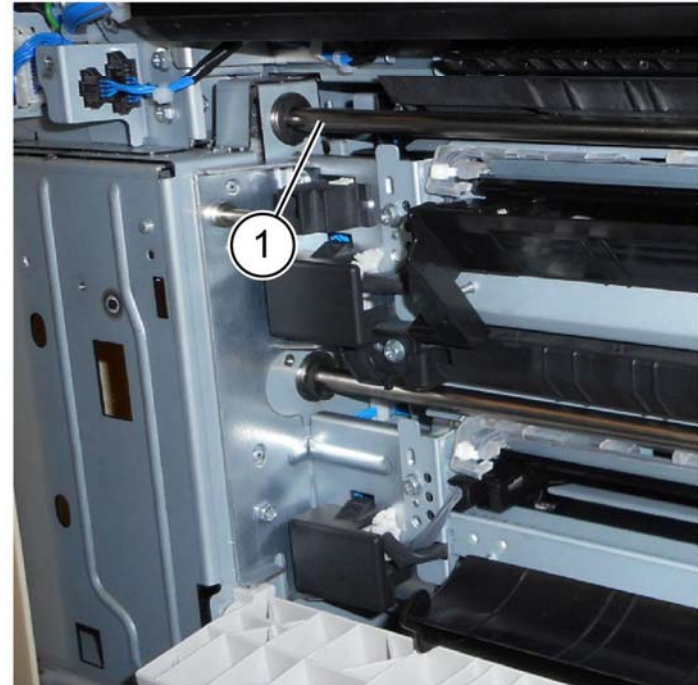
1. Open the 2TM left cover assembly, PL 80.20 Item 1.
2. Remove the k-clip (1), Figure 1.

Figure 1 K-clip removal

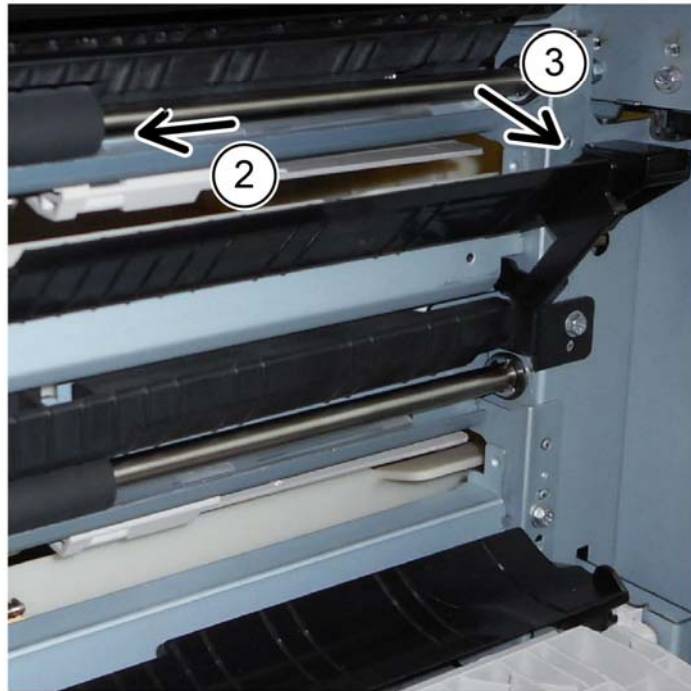
3. Remove the takeaway roll assembly, [PL 80.25 Item 1, Figure 2](#).
 - a. Slide the takeaway roll assembly to the rear (2).
 - b. Lift the actuator and lay the shaft out of the way.
 - c. Slide forward, then pull out from the front to remove (3).

Figure 2 Takeaway roll assembly removal

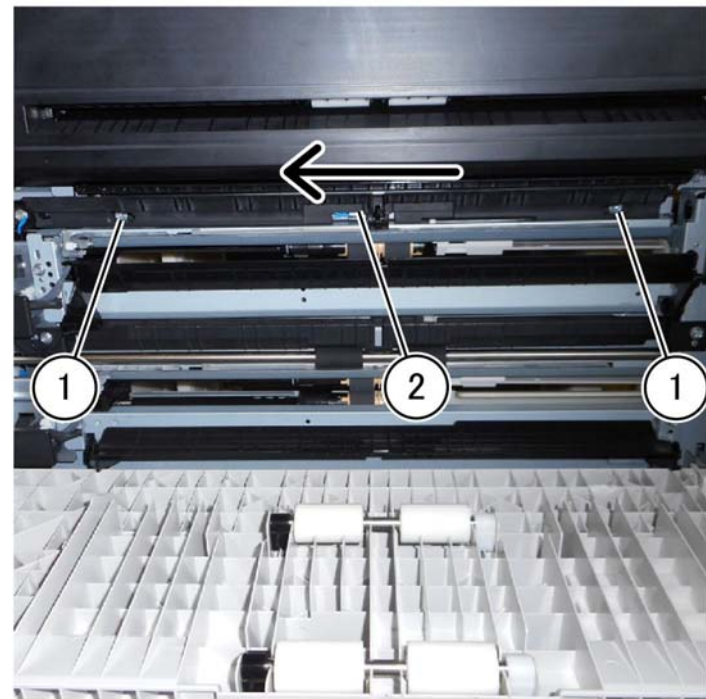
1. Remove the 2TM feedhead 1 assembly, [REP 80.4](#).
2. Remove the upper takeaway roll assembly, [REP 80.6](#).
3. Remove the tray 3 chute assembly, [PL 80.25 Item 3, Figure 1](#).
 - a. Remove two screws (1).
 - b. Release the boss, above left and slide to the rear to remove the tray chute assembly (2),
 - c. Release two hooks, then remove the switch from the actuator.

Figure 1 Tray 3 chute assembly removal

NOTE: This procedure describes the removal of 2TM tray 3 chute assembly, [PL 80.25 Item 3](#), tray 4 chute assembly is similar, [PL 80.25 Item 8](#).

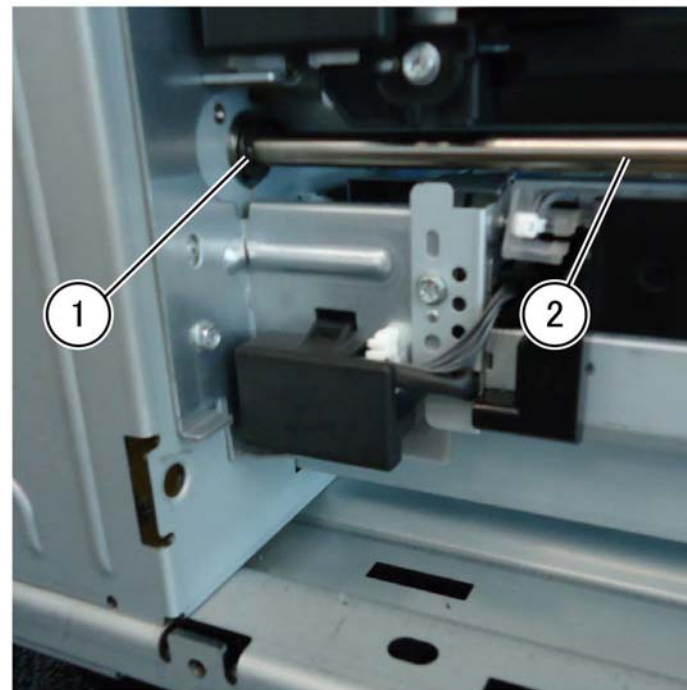
1. Open the 2TM left cover assembly, [PL 80.20 Item 1](#).
2. Remove the 2TM takeaway roll assembly, [Figure 1](#).
 - a. Remove the k-clip (1).
 - b. Slide the 2TM takeaway roll assembly to the rear and remove (2).

Figure 1 2TM takeaway roll assembly

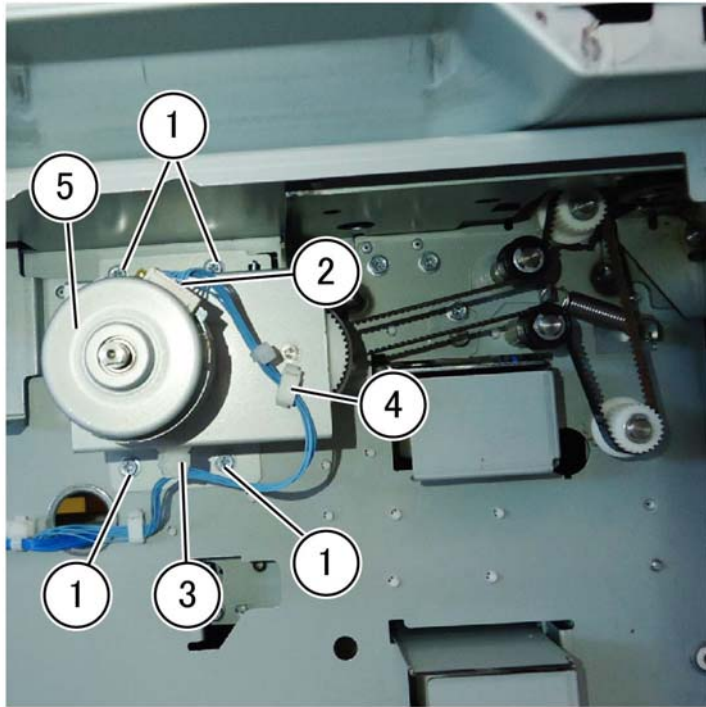
1. Remove the rear cover, [PL 70.20 Item 11](#).
2. Remove the 2TM takeaway motor assembly, [PL 80.30 Item 1, Figure 1](#).
 - a. Remove four screws (1).
 - b. Disconnect the connector (2),
 - c. Remove the c-clip (3).
 - d. Release the harness from the clamp (4).
 - e. Remove the 2TM takeaway motor assembly (5).

Figure 1 Takeaway motor assembly removal

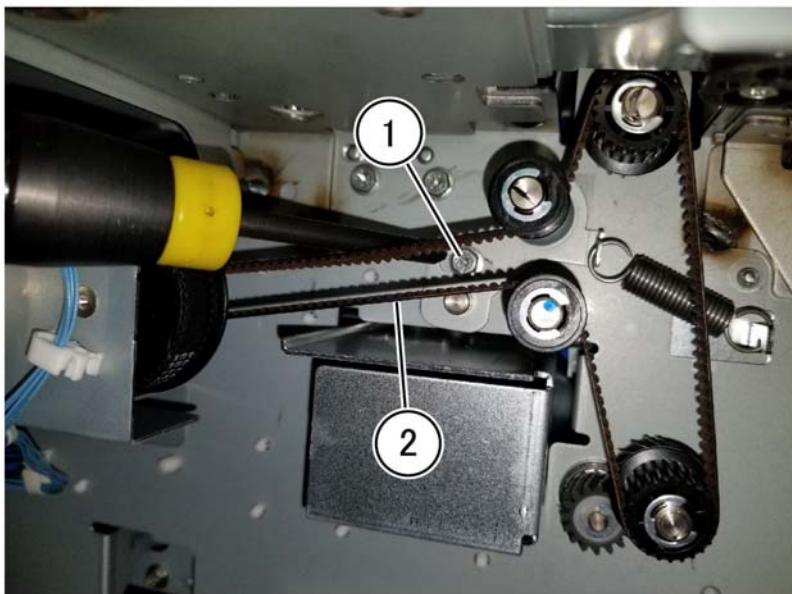
1. Remove the 2TM takeaway motor assembly, [REP 80.8](#).
2. Remove the 2TM belt, [PL 80.30 Item 2](#), [Figure 1](#).
 - a. Loosen the tensioning screw (1).
 - b. Remove the 2TM belt (2).

Figure 1 2TM belt

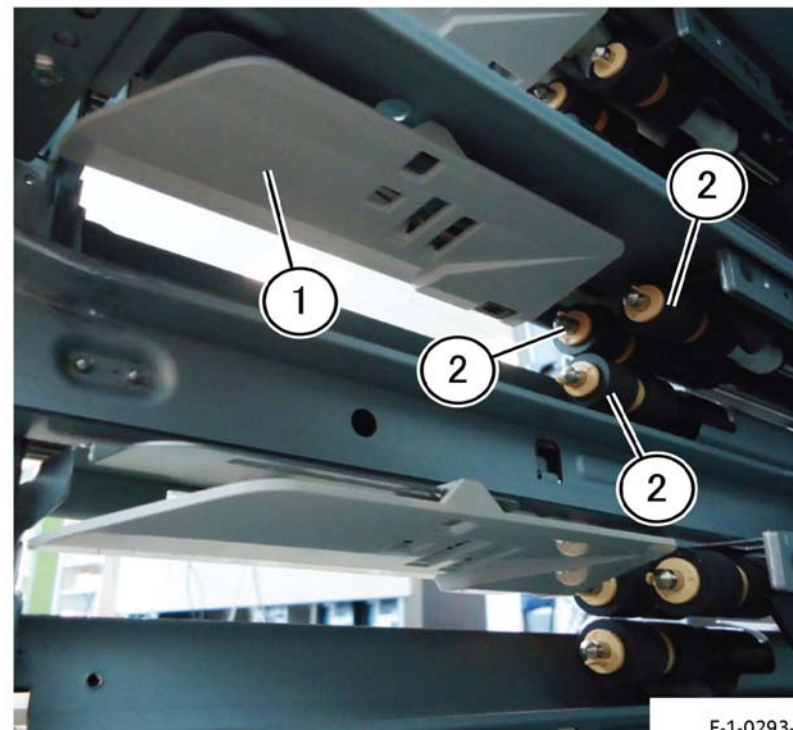
1. Remove the tray 3 & 4 assembly, [PL 70.20 Item 1](#).
2. Remove the feed, nudger, and retard roll, [PL 80.35](#), [Figure 1](#).
 - a. Move the chute to the front (1).
 - b. Remove the feed, nudger, and retard roll (2).

Figure 1 2TM feed roll kit removal

NOTE: The feed roll kit replacement procedure is the same for tray 3 and tray 4. The feed rolls are replaced as a set, [PL 80.35 Item 13](#).

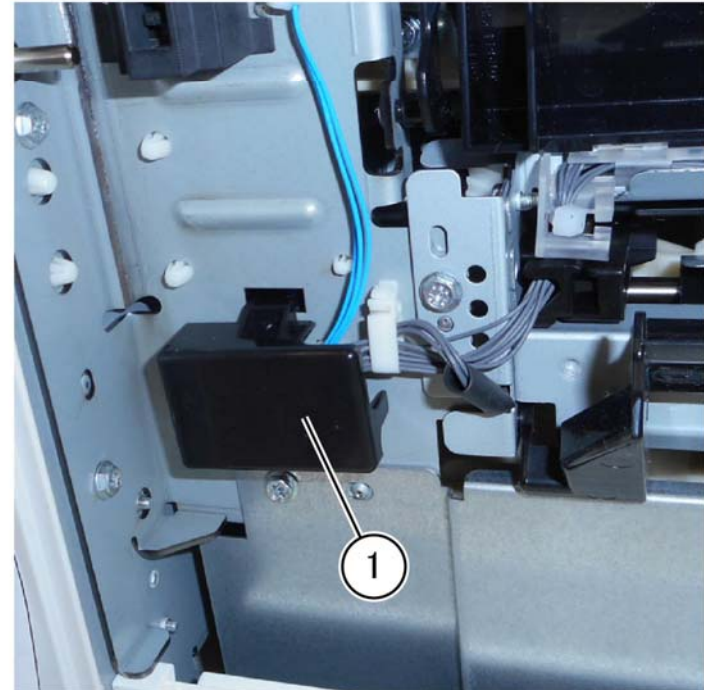
1. Open the TTM left cover assembly, [PL 70.35 Item 16](#).
2. Remove the connector cover (1), [Figure 1](#).

Figure 1 Connector cover removal

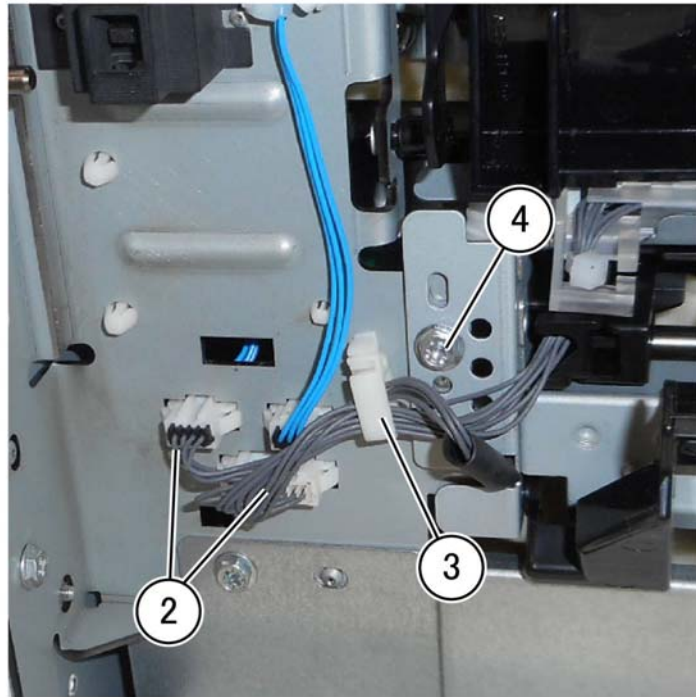
3. Disconnect two connectors (2), open the clamp (3), then remove the screw (4), [Figure 2](#).

Figure 2 Rear side removal

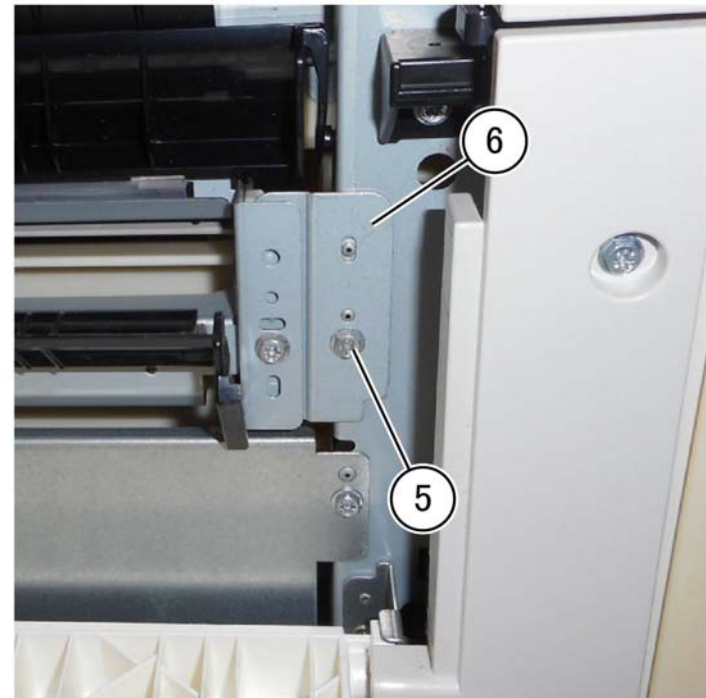
F-1-0296-A

4. Remove the screw (5), then remove the TTM tray 3 feedhead assembly (6) [PL 80.40 Item 3](#), [Figure 3](#).

Figure 3 Front side removal

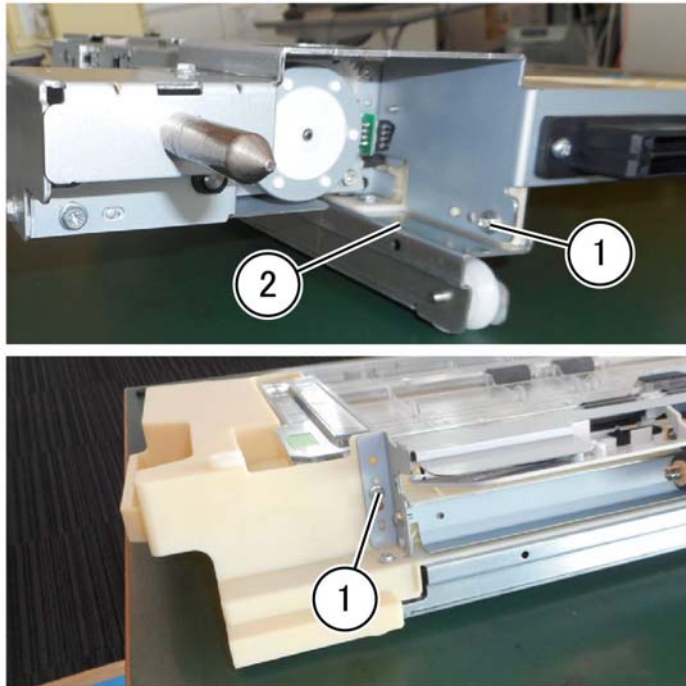
F-1-0297-A

1. Remove the TTM Tray 3 Assembly, [PL 70.35 Item 1](#).
2. Remove the TTM Tray 4 Assembly, [PL 70.35 Item 2](#).
3. Remove the TTM Transport Assembly, [PL 80.40 Item 6](#).
4. Remove the TTM tray 4 feedhead assembly, [PL 80.40 Item 7, Figure 1](#).
 - a. Remove two screws (1).
 - b. Remove the TTM tray 4 feedhead assembly (2).

Figure 1 TTM tray 4 feedhead assembly removal

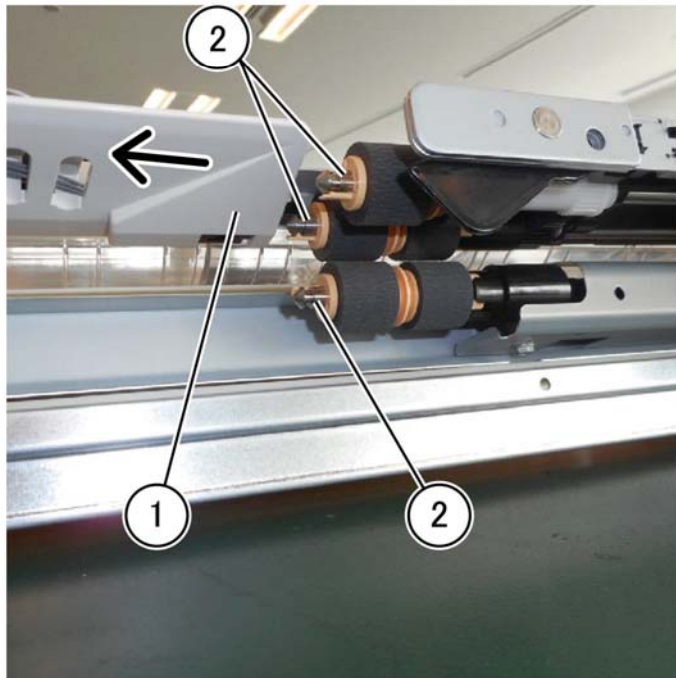
F-1-0299-A

1. Remove TTM tray 3 assembly, [PL 70.35 Item 1](#).
2. Remove TTM tray 4 assembly, [PL 70.35 Item 2](#).
3. If replacing the rolls for tray 4 remove the tray 4 feedhead assembly, [REP 80.15](#).
4. Remove the feed, nudger, and retard roll, [PL 80.50](#) and [PL 80.55](#), [Figure 1](#).
 - a. Move the chute to the front (1).
 - b. Remove the feed, nudger, and retard roll (2).

Figure 1 TTM feed roll kit removal

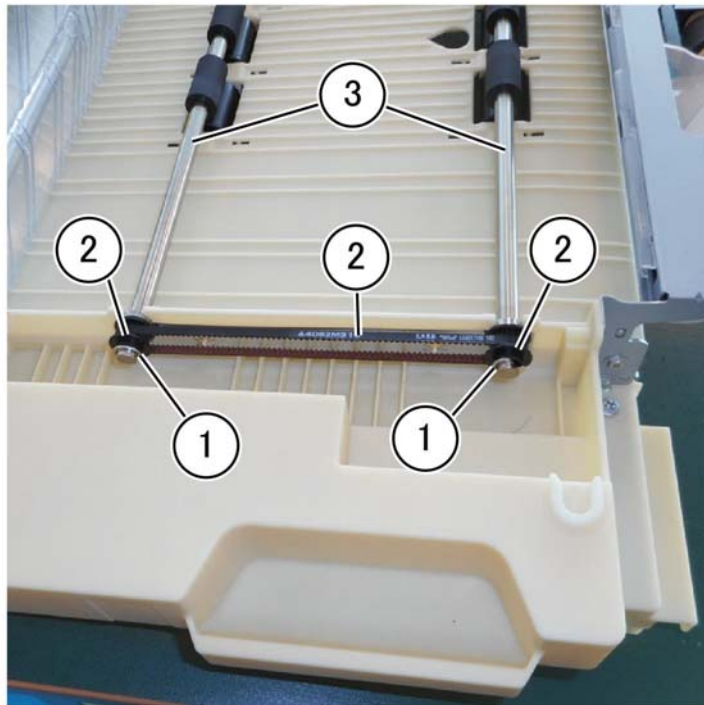
F-1-0300-A

- a. Move two e-rings (1).
- b. Remove two pulleys and the belt (2).
- c. Remove the transport roll assembly (3).

Figure 1 Transport roll assembly removal

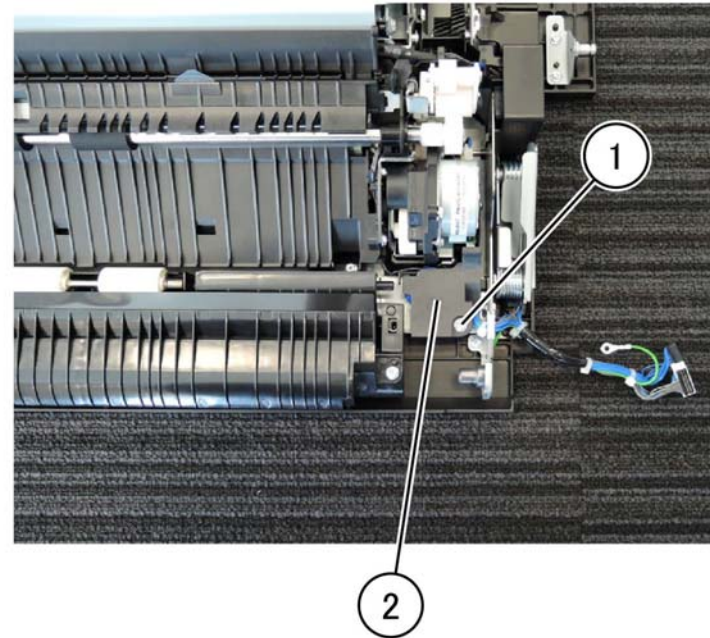
F-1-0301-A

1. Remove the left cover assembly, **REP 80.21**.
2. Remove the bypass tray, **REP 70.3**.
3. Remove the bypass feedhead assembly.
 - a. Remove the screw (1), then remove the harness guide (2), **Figure 1**.

Figure 1 Transport roll assembly removal

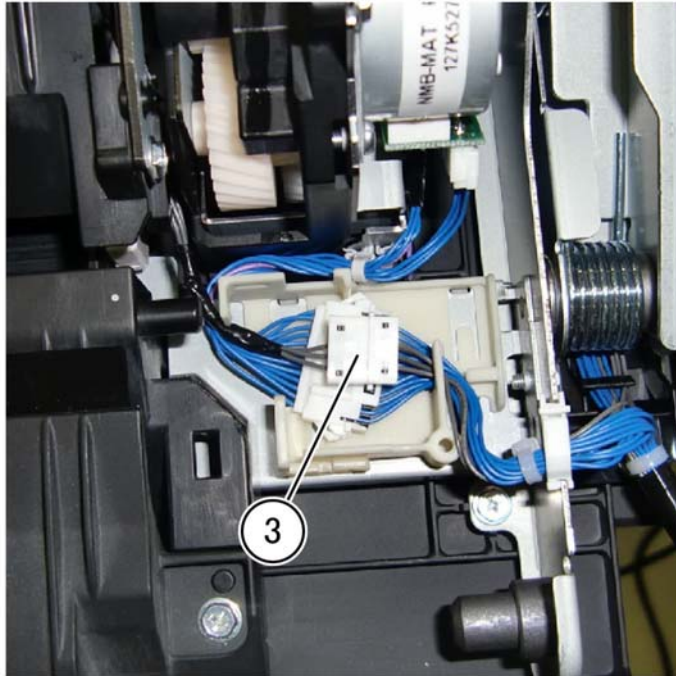
F-1-0302-A

- b. Disconnect the connector (3), [Figure 2](#).

Figure 2 Connector

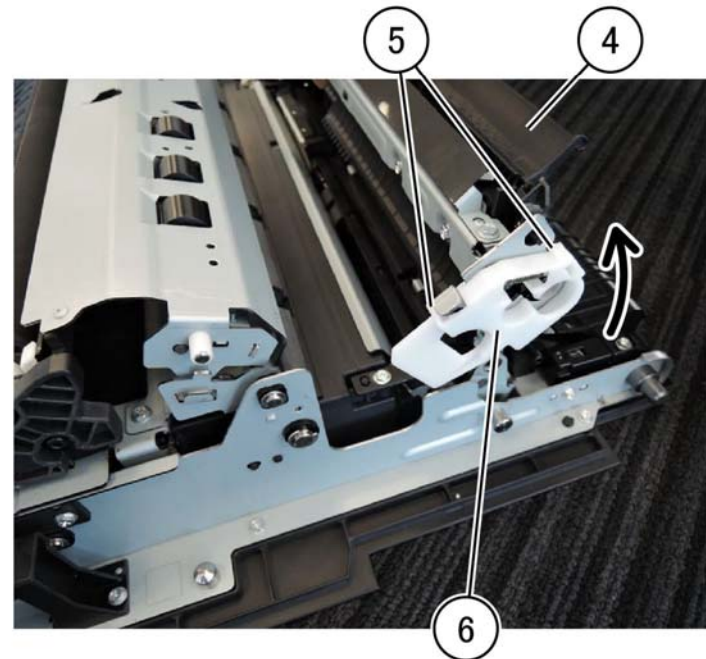
F-1-0303-A

- c. Lift the bypass takeaway assembly (4) in the direction of the arrow, Remove two claws (5), than remove the knob (6), [Figure 3](#).

Figure 3 Knob removal

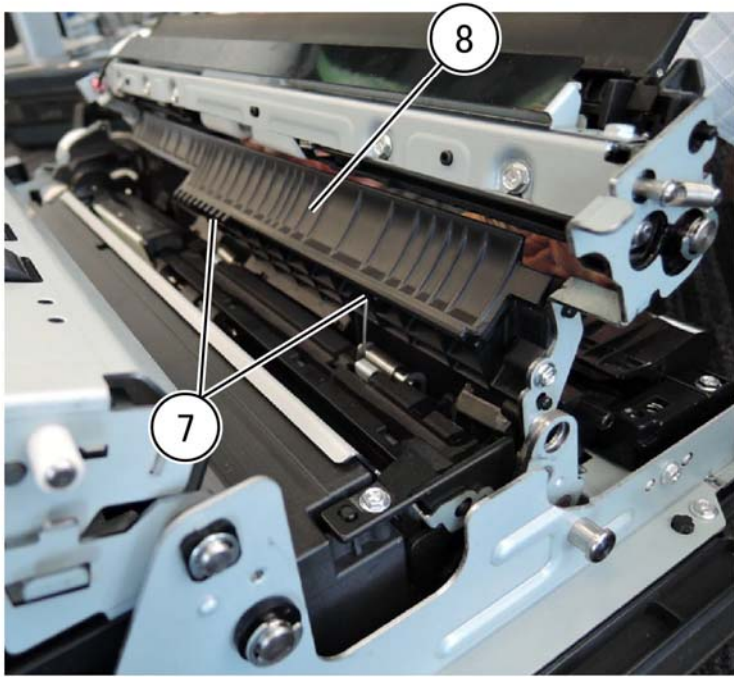
F-1-0304-A

- d. Push in and move left to release two springs (7) and remove from the bypass takeaway assembly, then remove the bypass takeaway assembly (8) PL 70.50 Item 4, Figure 4.

Figure 4 Bypass takeaway assembly removal

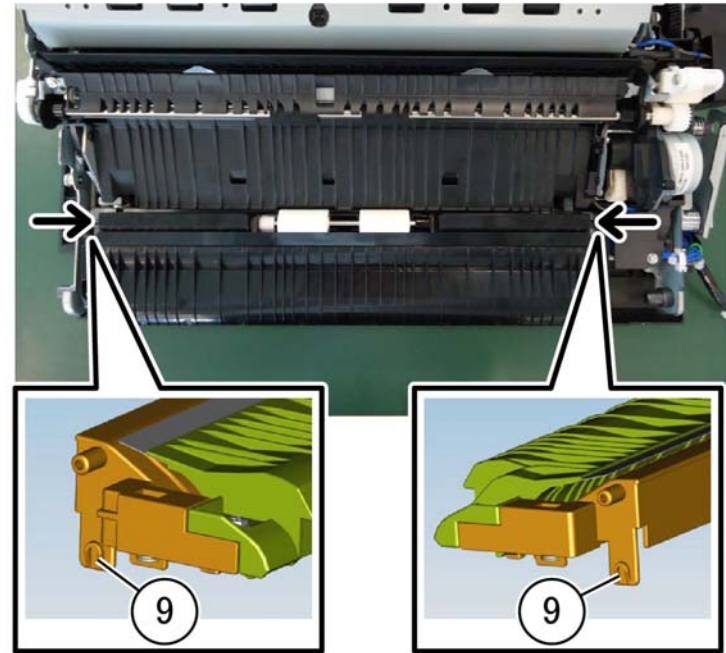
F-1-0305-A

- e. Press the left lower chute assembly tabs in the direction of the arrows to release the tab pins (9), then lift the left chute assembly, Figure 5.

Figure 5 Left lower chute pins

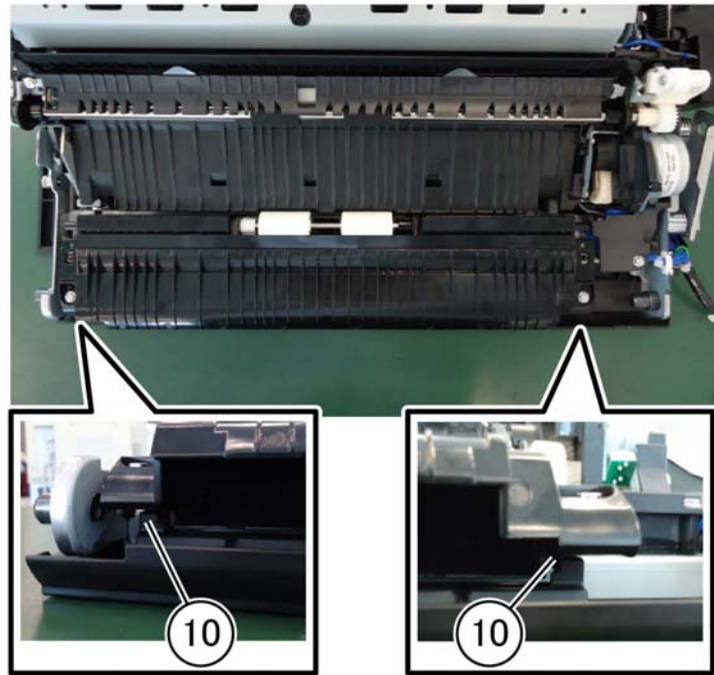
F-1-0306-A

- f. Remove two screws (10) holding the miller plate, then remove the left lower chute assembly, [Figure 6](#).

Figure 6 Left lower chute assembly removal

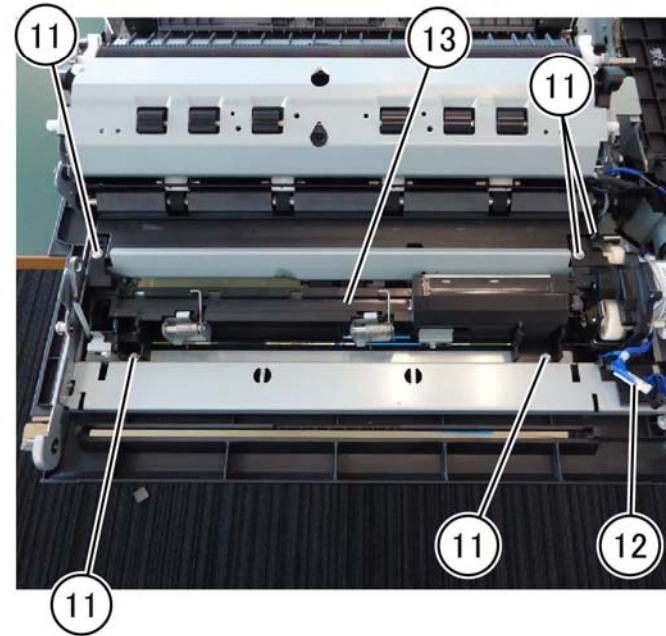
F-1-0307-A

- g. Remove five screws (11), disconnect the connector (12), then remove the bypass feeder kit (13), [PL 70.50 Item 17, Figure 7](#).

Figure 7 Bypass feeder kit removal

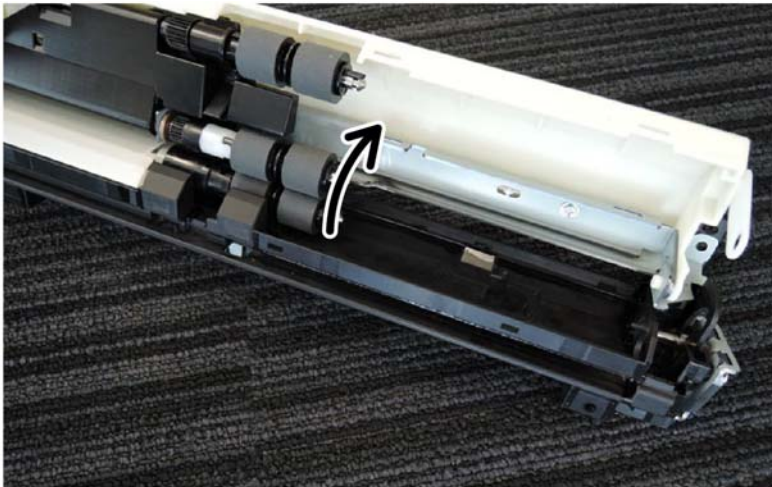
F-1-0308-A

1. Remove the bypass feedhead assembly, [REP 80.19](#).
2. Remove the bypass tray roll kit.
 - a. Lift the top cover of the upper frame assembly in the direction of the arrow (1), [Figure 1](#).

Figure 1 Lift the cover

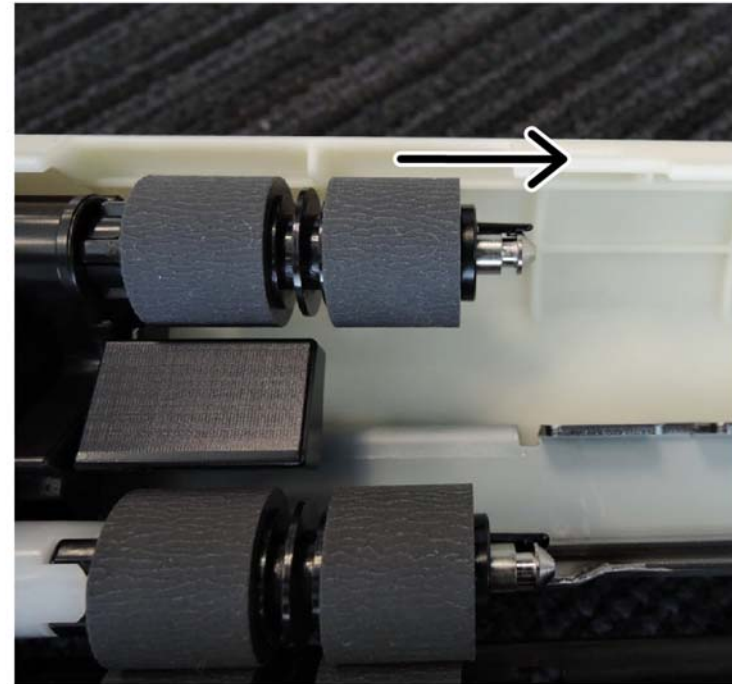
F-1-0309-A

- b. Release the hooks of the feed, nudge, and retard rolls, [PL 80.20](#), then slide and remove in the direction of the arrow (2), [Figure 2](#).

Figure 2 Roll removal

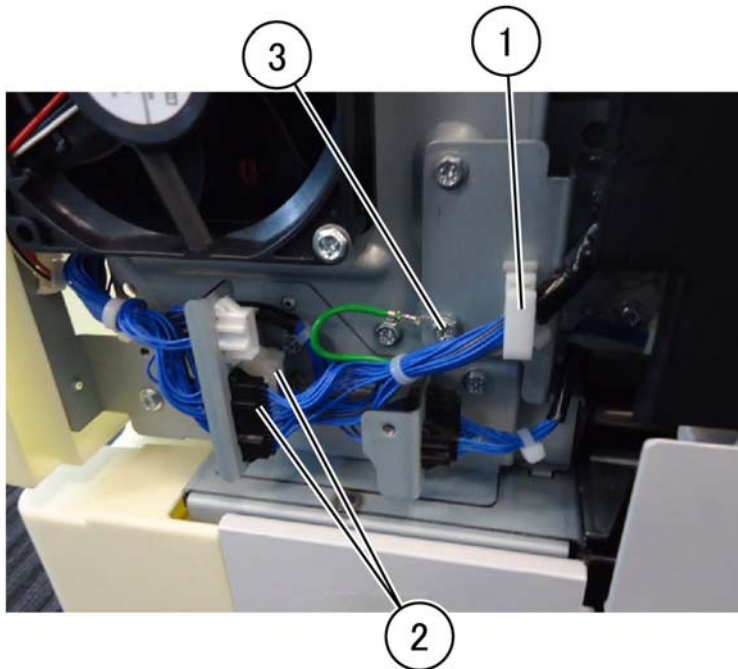
F-1-0310-A

1. Remove the lower left cover, [PL 28.10 Item 4](#).
2. Disconnect the left cover assembly harness: [Figure 1](#).
 - a. Release the clamp (1).
 - b. Disconnect two connectors (2).
 - c. Remove the screw securing the ground wire (3).

Figure 1 Disconnect the harness

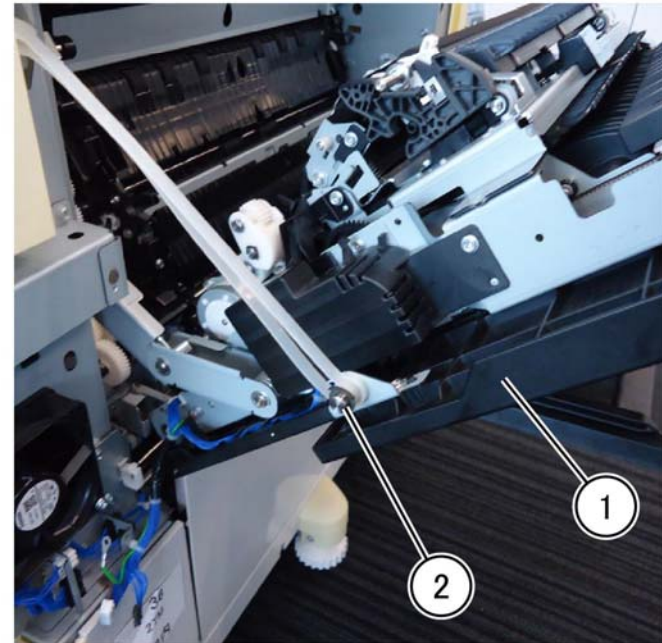
F-1-0311-A

3. Remove the left cover assembly.
 - a. Open the left cover (1), then remove the KL-clip (2) securing the rear left support bracket, [PL 80.65 Item 5, Figure 2](#).

Figure 2 KL-clip removal

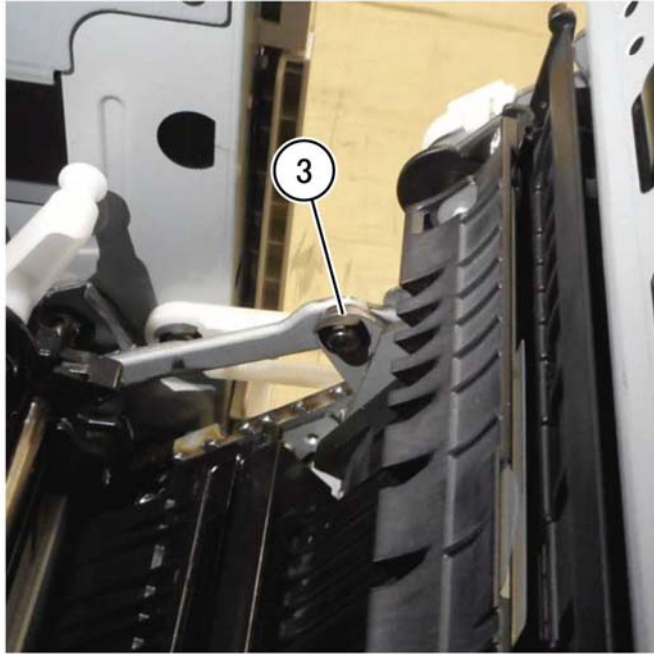
F-1-0312-A

- b. Remove the EL-clip (3), then release the front support from the pin, [Figure 3](#).

Figure 3 E-clip removal

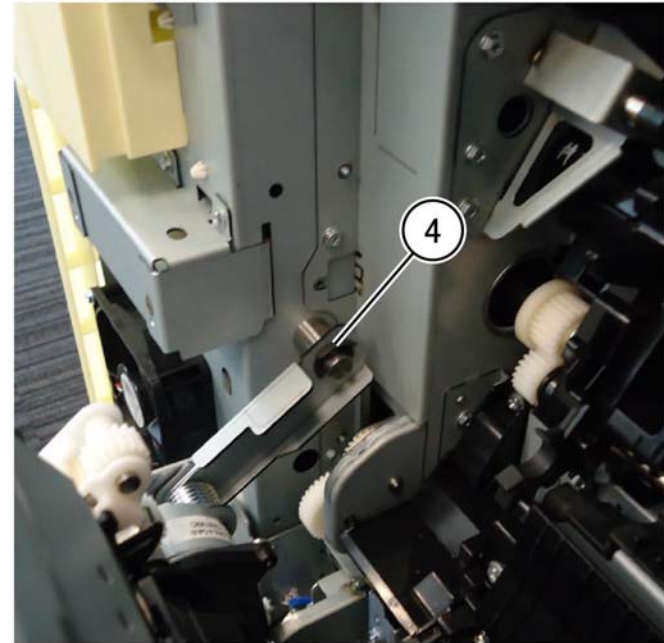
F-1-0313-A

- c. Remove the KL-clip (4) securing the link assembly, then release the link assembly from the pin, [Figure 4](#).

Figure 4 Release the link assembly

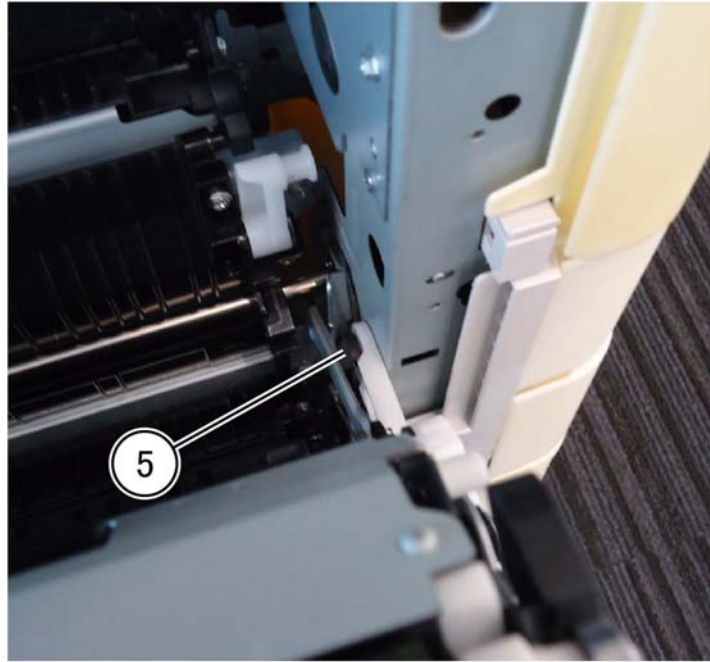
F-1-0314-A

- d. Remove the KL-clip (5), then securing the front support to the IOT frame, [Figure 5](#).

Figure 5 KL-clip removal

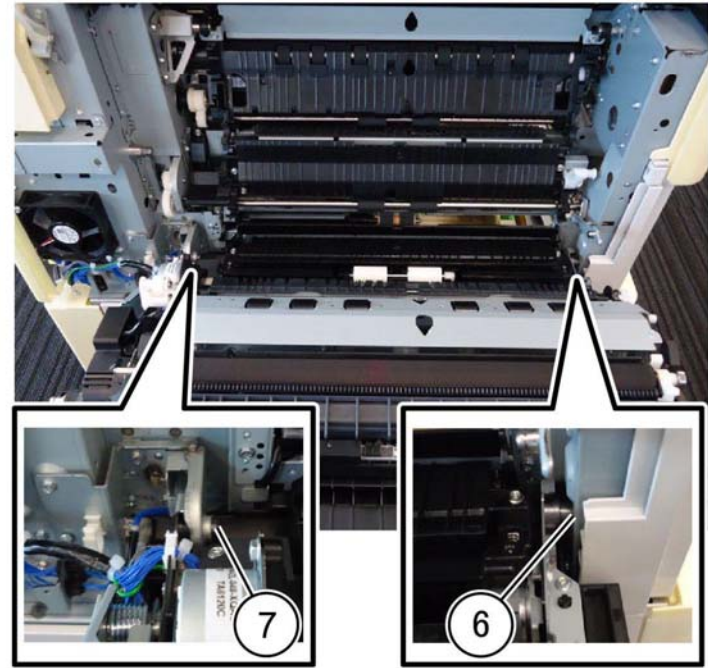
F-1-0315-A

- e. Open the left cover assembly 15 degrees from horizontal. Slide the left cover assembly to the rear of the machine to clear the front hinge (6) and pull out, then slide the left cover assembly forward to release the pin in the rear (7) and remove the left cover assembly, [Figure 6](#).

Figure 6 Left cover assembly removal

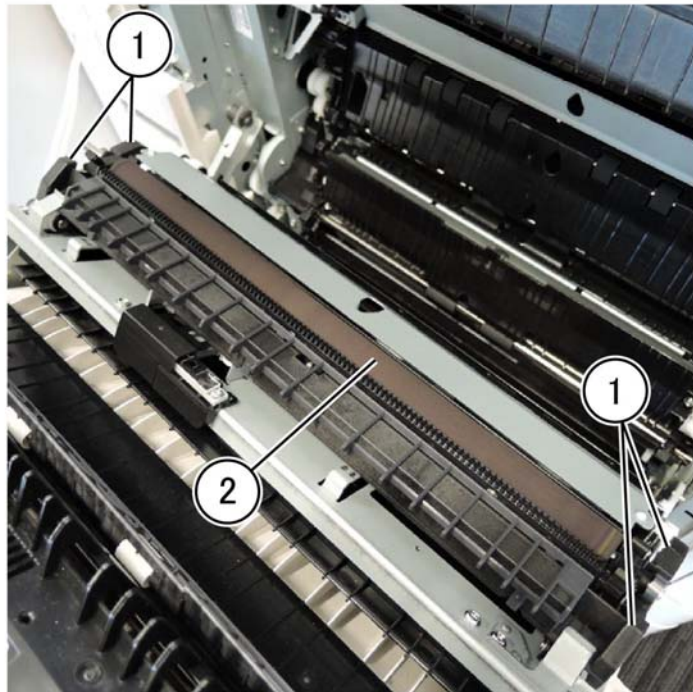
F-1-0316-A

- a. Release four hooks (1), then remove the 2nd BTR roll (2), [Figure 1](#).
[Figure 2](#)

Figure 1 2nd BTR roll removal

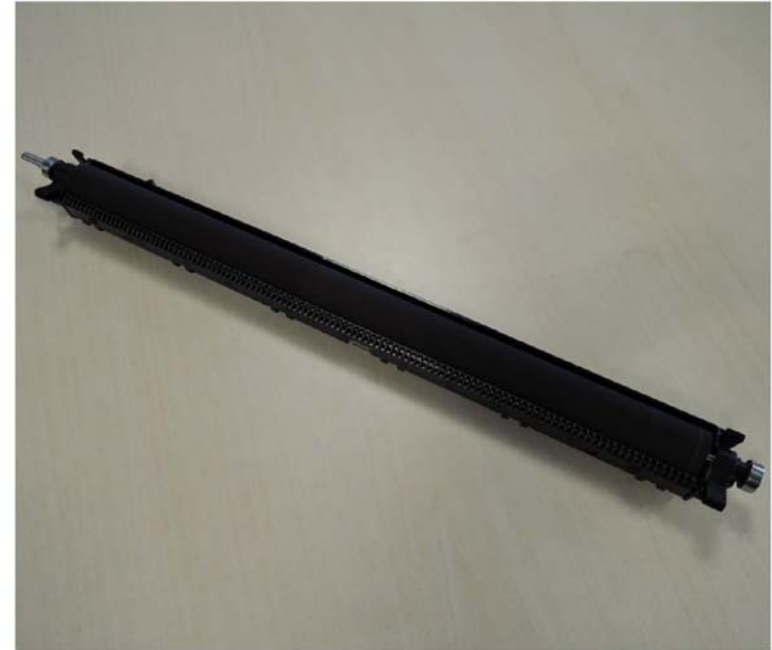
F-1-0317-A

Figure 2 2nd BTR roll removed

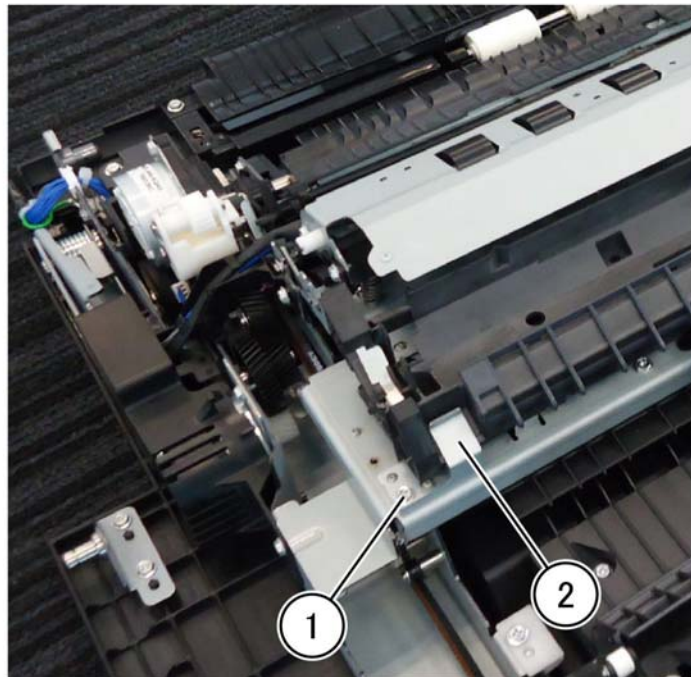
F-1-0318-A

1. Open the left cover assembly, [PL 80.65 Item 1](#).
2. Remove the fusing link: [Figure 1](#).
 - a. Remove the screw (1).
 - b. Remove the bracket (2).

Figure 1 Bracket removal

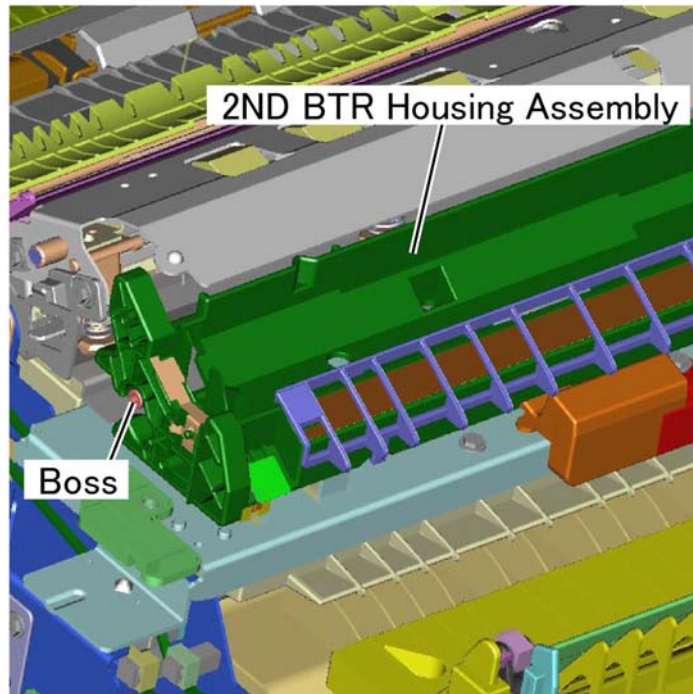
F-1-0319-A

3. Release the boss securing the 2nd BTR housing assembly, PL 80.70 Item 5, Figure 2.

Figure 2 Boss location

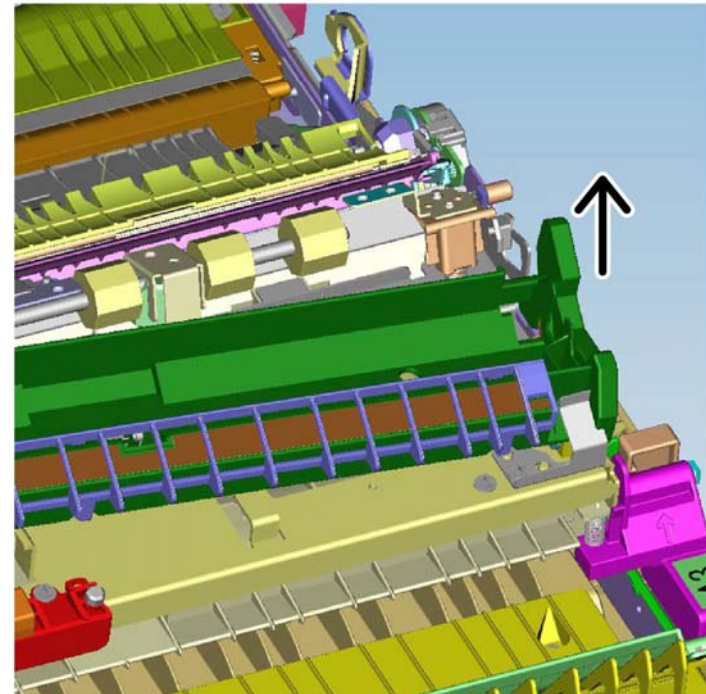
F-1-0320-A

4. Slide the 2nd BTR housing assembly in the direction of the arrow to remove, Figure 3.

Figure 3 2nd BTR housing assembly removal

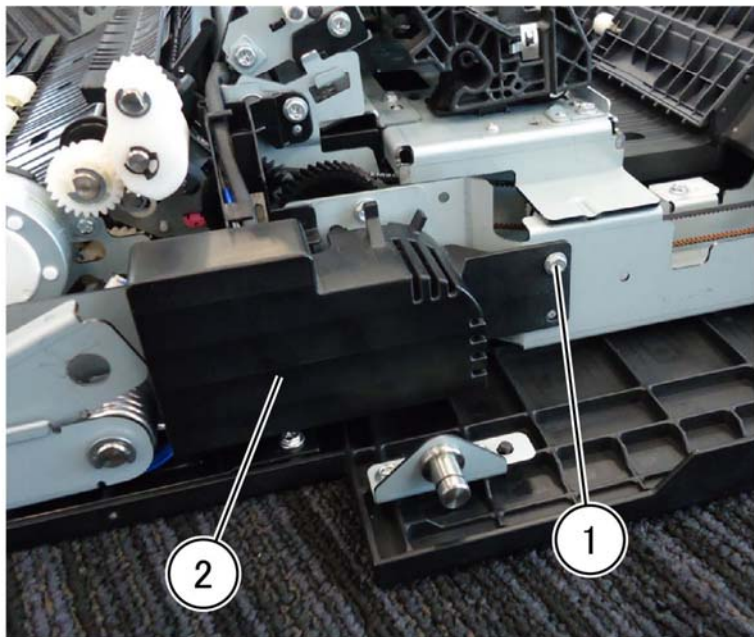
F-1-0321-A

1. Remove the 2nd BTR housing assembly, [REP 80.23](#).
2. Remove the screw (1), then remove the duplex motor cover (2), [Figure 1](#).

Figure 1 Duplex motor cover removal

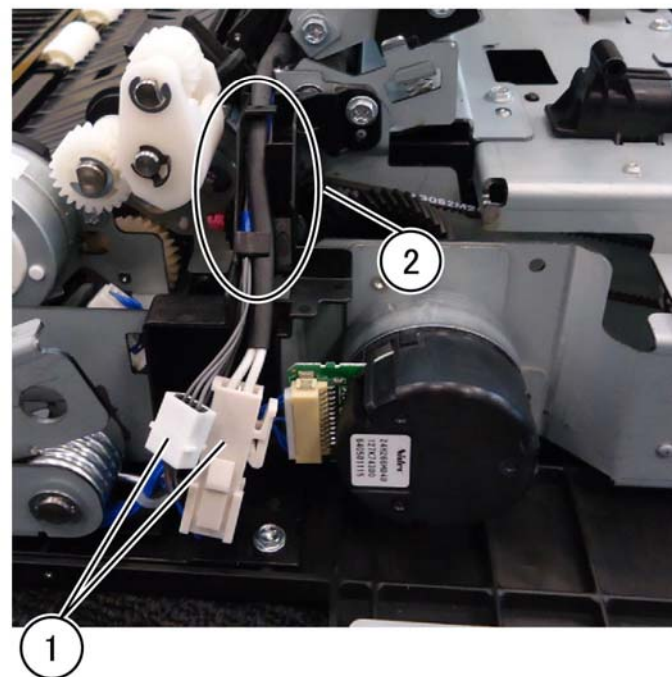
F-1-0322-A

3. Disconnect two connectors (1), then release the harness from the harness guide (2), [Figure 2](#).

Figure 2 Release the harness
