VersaLink[®] C8000/C9000 Printer

Service Manual

VersaLink C9000 Family Service Manual

705P01418

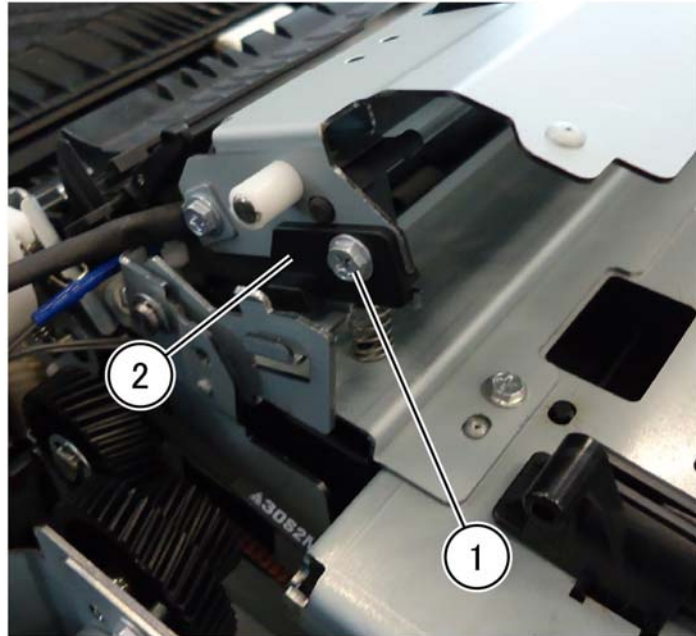
F-1-0323-A

4. Remove the duplex inner chute assembly, PL 80.80, Figure 3.
 - a. Remove the screw (1).
 - b. Remove the plate (2).

Figure 3 Plate removal

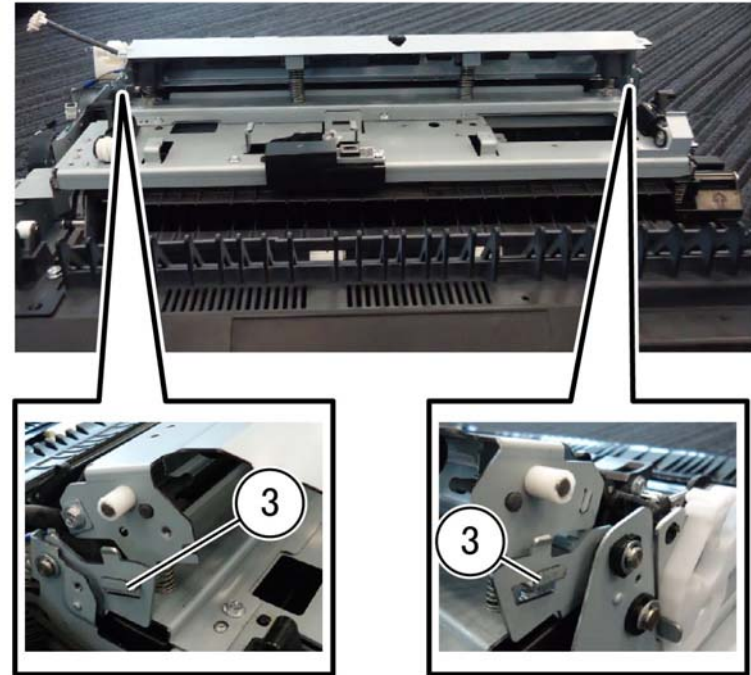
F-1-0324-A

5. Release the two registration chute pins (3), Figure 4.

Figure 4 Pin release

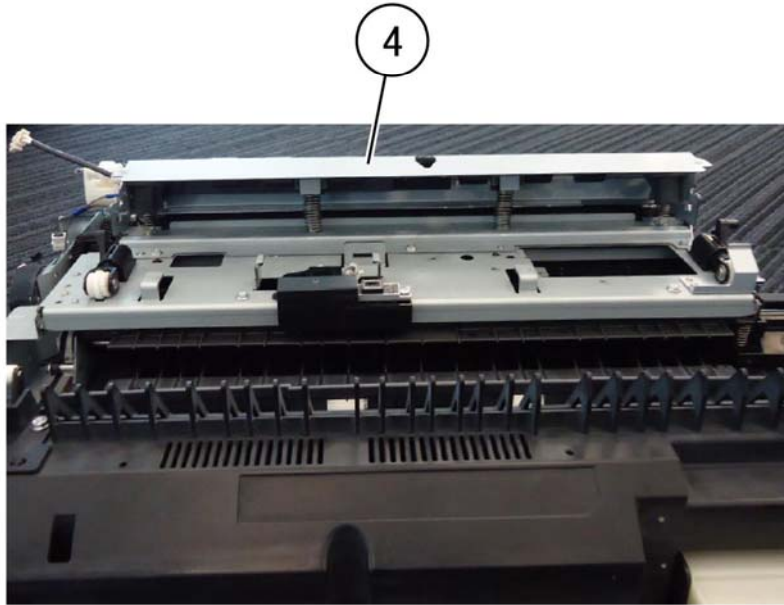
F-1-0325-A

6. Lift then remove the registration chute (4), [Figure 5](#).

Figure 5 Registration chute removal

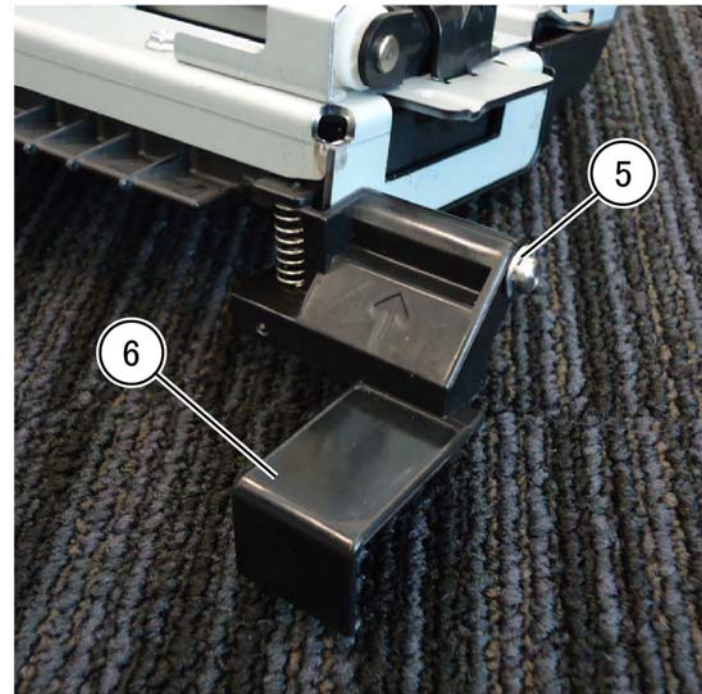
F-1-0326-A

7. Remove the e-clip (5), then remove the handle (6), [Figure 6](#).

Figure 6 Handle removal

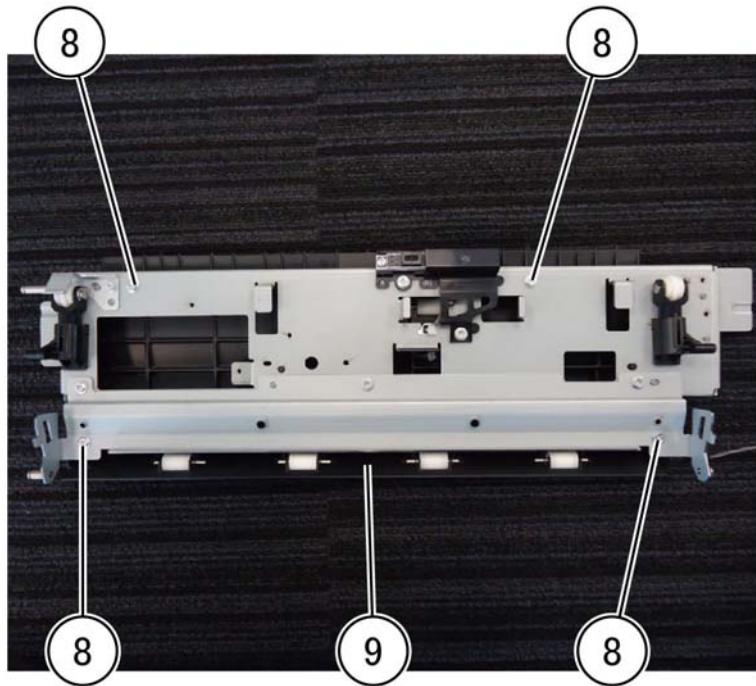
F-1-0327-A

9. Remove four screws (8), then remove the registration tie plate (9), [Figure 7](#).

Figure 7 Tie plate removal

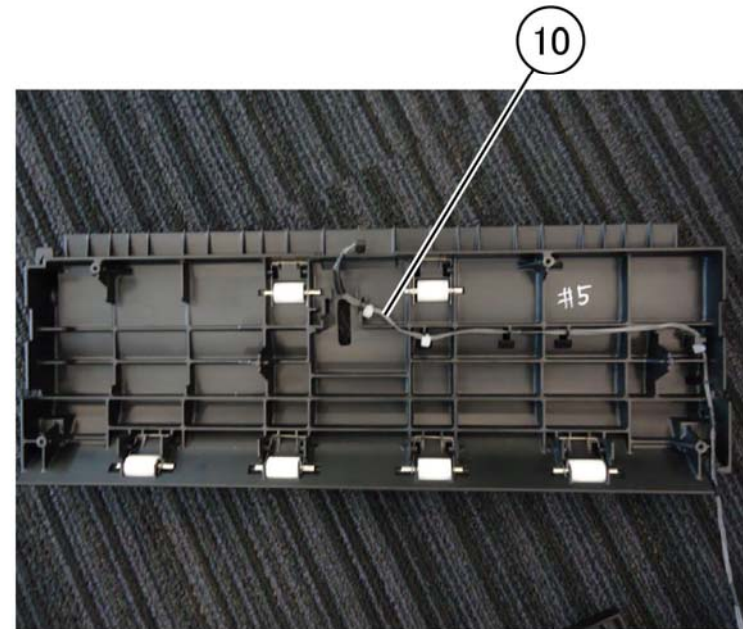
F-1-0328-A

10. Turn the duplex inner chute assembly over, then remove the wire harness (10), [Figure 8](#).

Figure 8 Wire harness removal

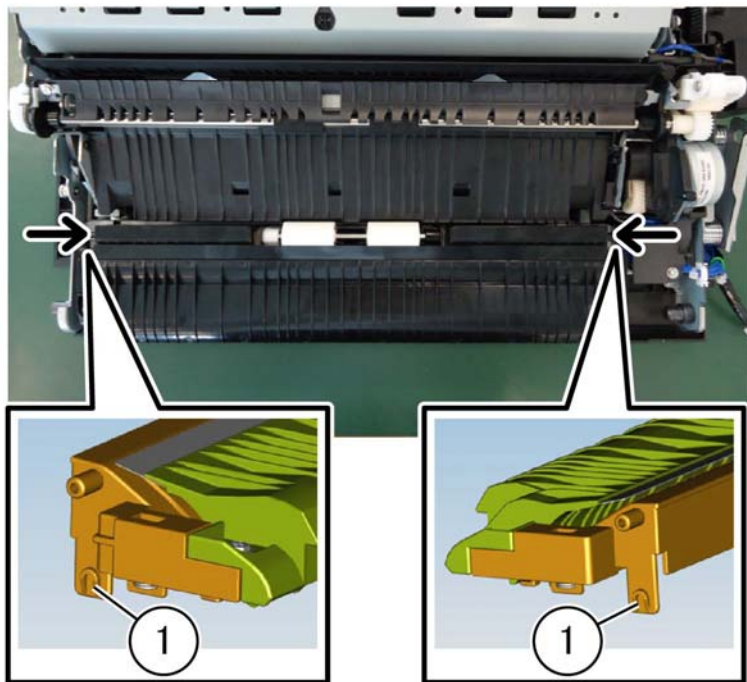
F-1-0329-A

1. Open the left cover assembly, [PL 80.65 Item 1](#). If it is necessary to remove the left cover assembly refer to [REP 80.21](#).
2. Press in on the lower chute assembly (1) in the direction of the arrows, then lift the lower chute assembly, [Figure 1](#).

Figure 1 Duplex motor cover removal

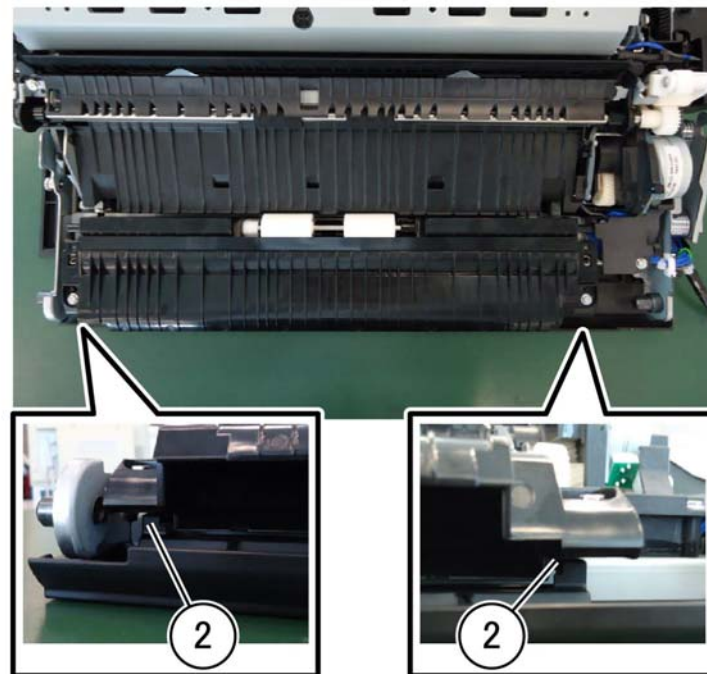
F-1-0330-A

3. Release two tabs (2) attaching the left transport chassis to the lower chute assembly, then remove the lower chute assembly, [Figure 2](#).

Figure 2 Lower chute assembly removal

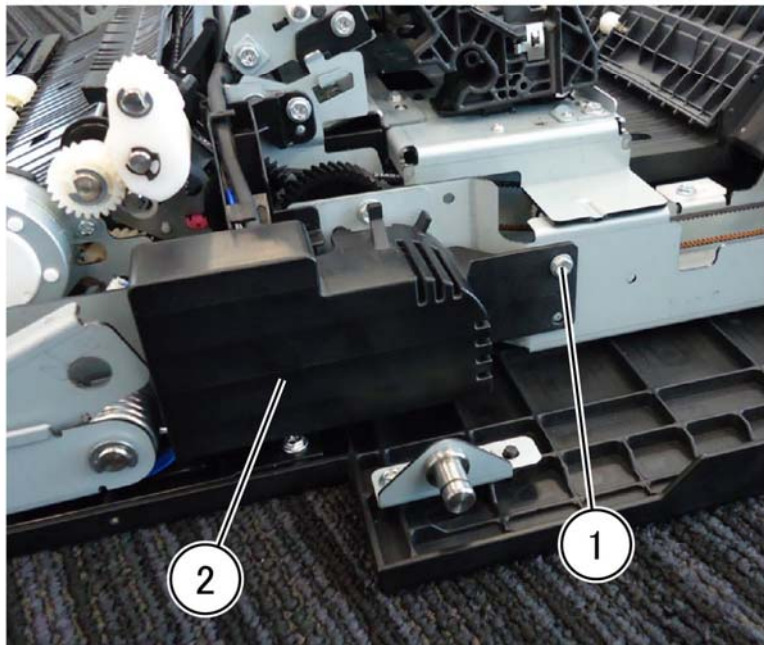
F-1-0331-A

1. Remove the 2nd BTR housing assembly, [REP 80.23](#).
2. Remove the screw (1), then remove the duplex motor cover (2), [Figure 1](#).

Figure 1 Registration sensor removal

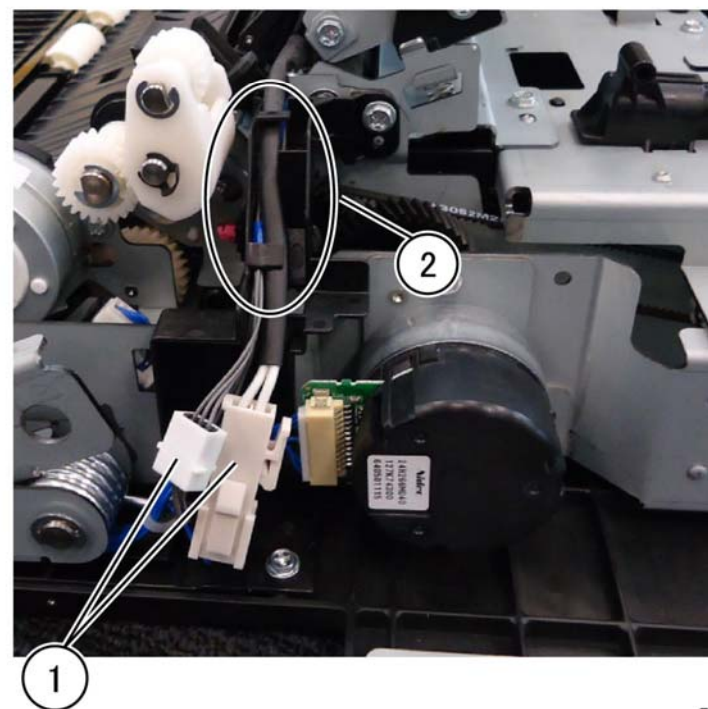
F-1-0332-A

3. Disconnect two connectors (1), then release the harness from the harness guide (2), [Figure 2](#).

Figure 2 Release the harness

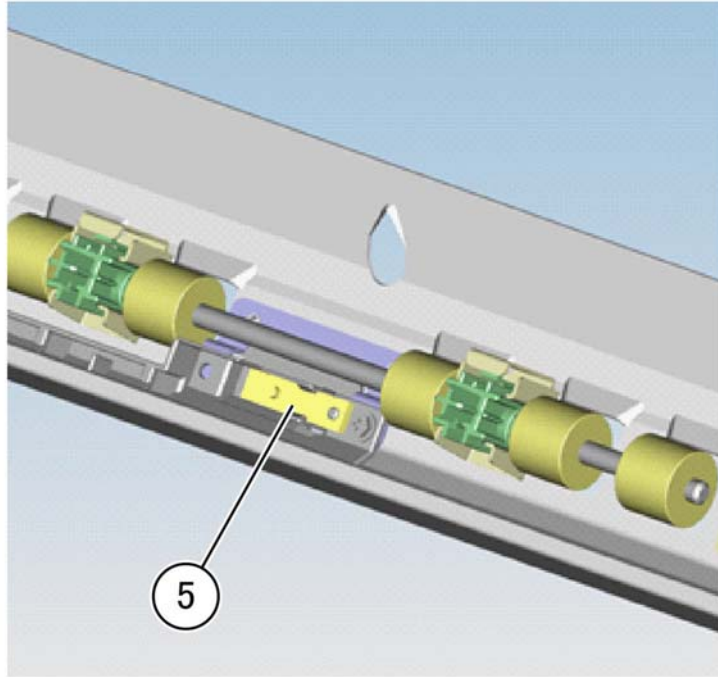
F-1-0333-A

5. Remove the registration sensor (1), [Figure 3](#).

Figure 3 Registration sensor removal

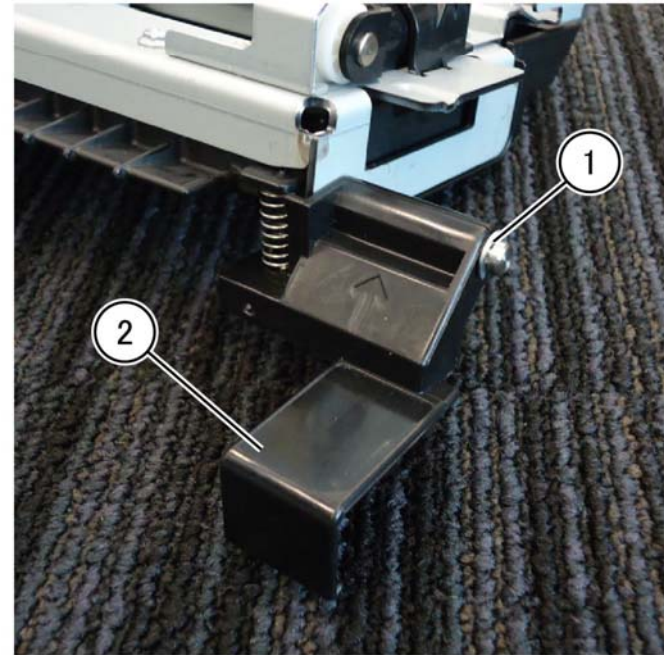
F-1-0334-A

1. Open the left cover assembly, [PL 80.65 Item 1](#).
2. Remove the e-clip (1), then remove the handle (2), [PL 80.80 Item 6, Figure 1](#).

Figure 1 Disconnect the harness

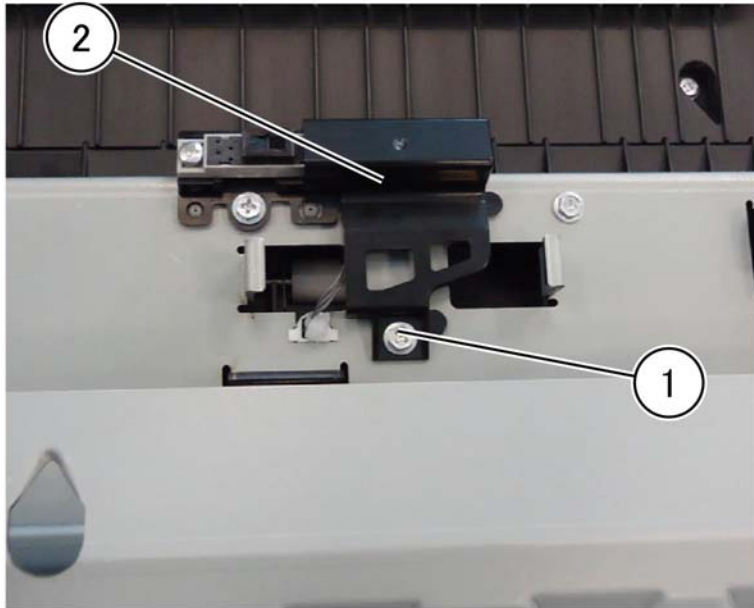
F-1-0335-A

1. Remove the 2ND BTR housing assembly, [REP 80.23](#).
2. Remove the harness cover: [Figure 1](#).
 - a. Remove the screw (1).
 - b. Remove the harness cover (2).

Figure 1 Harness cover removal

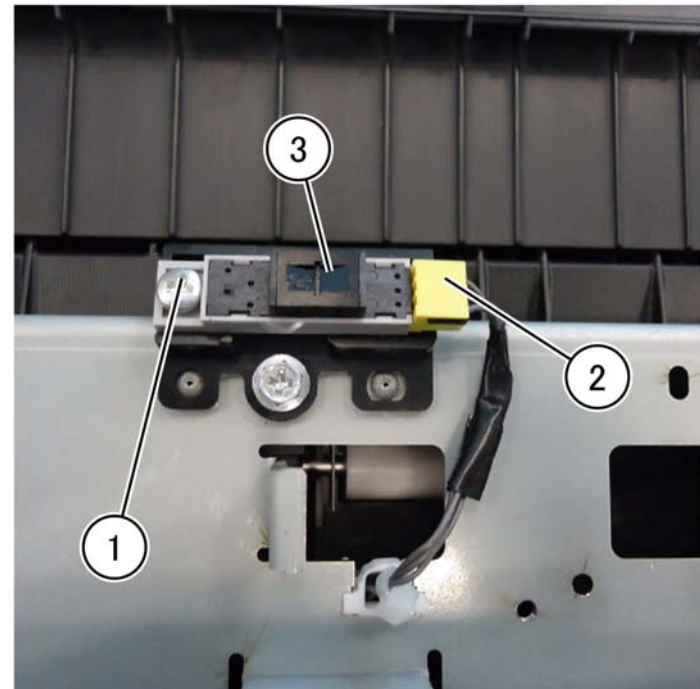
F-1-0336-A

3. Remove the POB jam sensor, [PL 80.80 Item 9, Figure 2](#).
 - a. Remove the screw (1).
 - b. Disconnect the connector (2).
 - c. Remove the POB jam sensor (3).

Figure 2 POB jam sensor removal

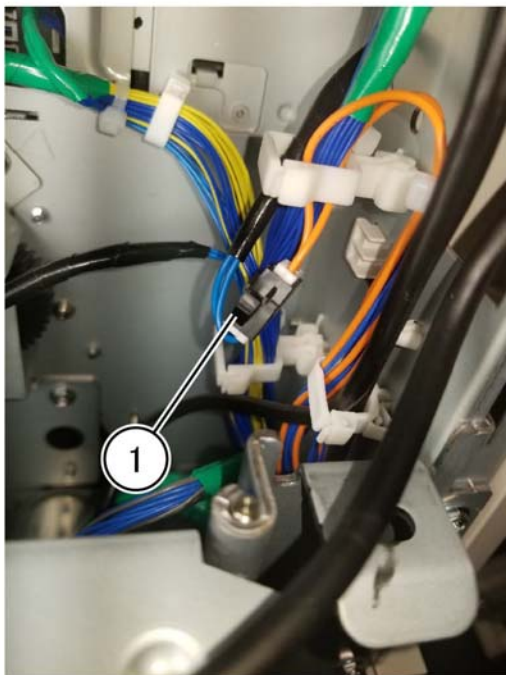
1. Open the video contact chassis assembly, [GP 32](#).
2. Open the left cover assembly, [PL 80.65 Item 1](#).
3. Disconnect the connector behind the video contact chassis assembly (1), [Figure 1](#).

Figure 1 Connector location

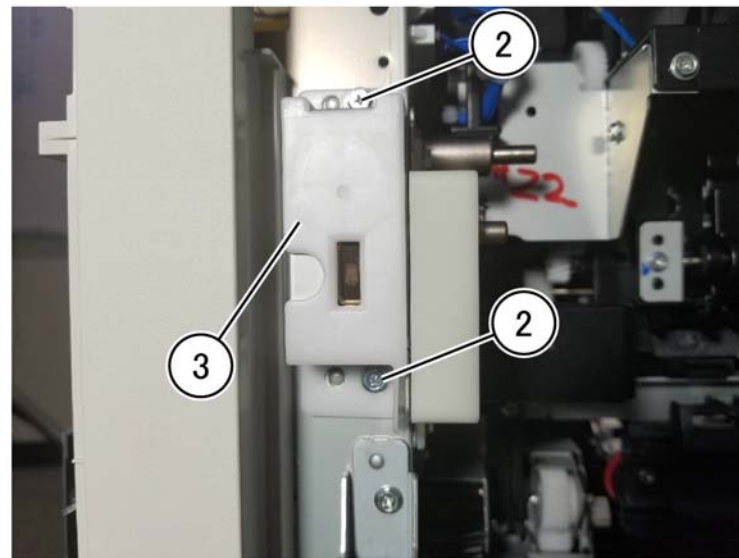
4. Remove two screws (2) then remove the interlock switch assembly (3) [PL 80.65 Item 9](#), [Figure 2](#).

Figure 2 Interlock switch assembly removal

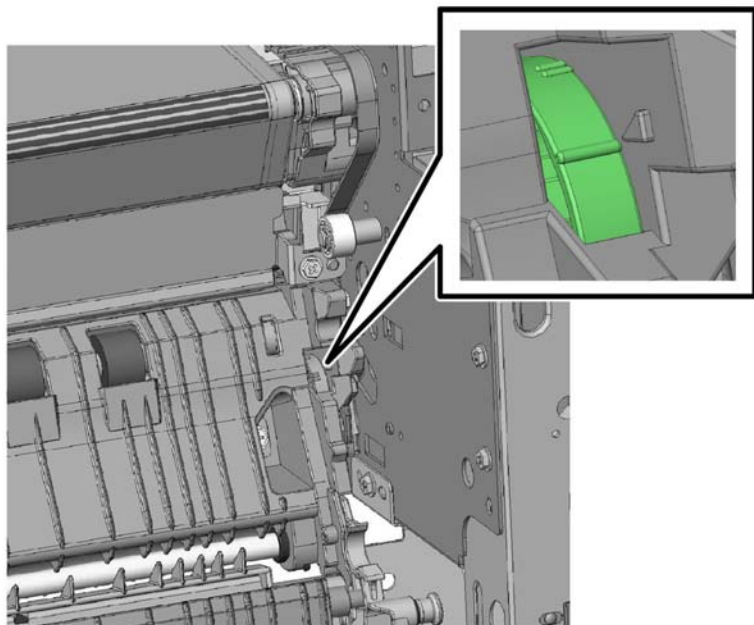
1. Open the left cover assembly, [PL 80.65 Item 1](#).
2. Mark the position of the adjustment camshaft on the front side of the registration transport assembly, [PL 80.90 Item 1](#), before beginning removal, [Figure 1](#).

Figure 1 Mark the adjust camshaft location

3. Set the position of the adjustment cam on the front side to the mark made before removal, Figure 1.
4. Loosen the two screws (1) of the registration transport assembly, Figure 3.

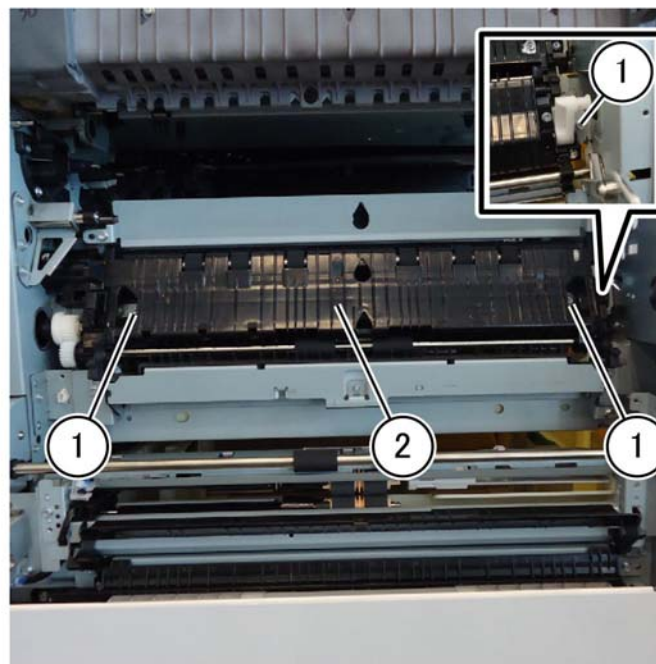
3. Remove the registration transport assembly, [PL 80.90 Item 1](#), [Figure 2](#).
 - a. Remove three screws (1).
 - b. Slide the registration transport assembly (2) left towards the shaft hole.
 - c. Lift the right side up then disengage the registration transport assembly from the pin.
 - d. Roll the top of the registration transport assembly back to release the registration transport assembly from the pin.
 - e. Pull the right-side out to release the shaft from the hole in the chassis and remove the registration transport assembly.

Figure 2 Registration transport assembly removal

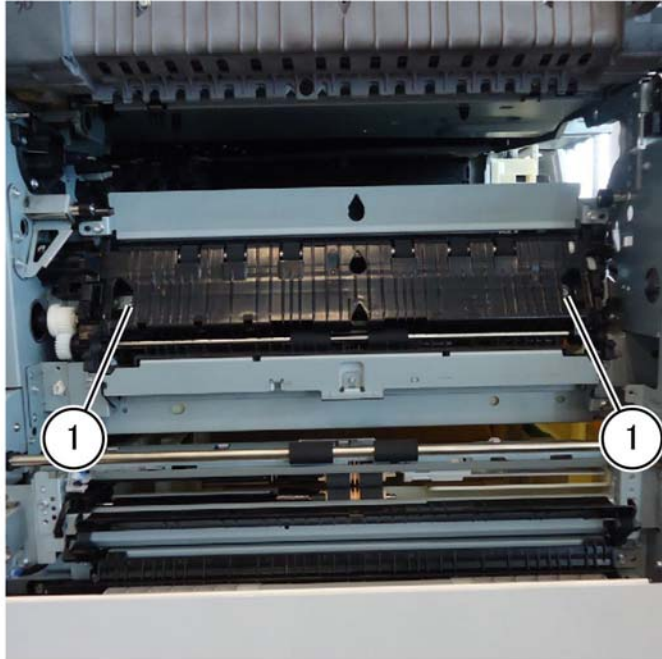
Figure 3 Registration transport assembly screws

- Tighten the two screws (1) of the registration transport assembly left loose, [Figure 3](#).
NOTE: If paper wrinkles are generated, refer to [RAP IQ2 IOT defects rap, transfer wrinkle](#). Check for moisture in the paper, replace with new paper as needed.

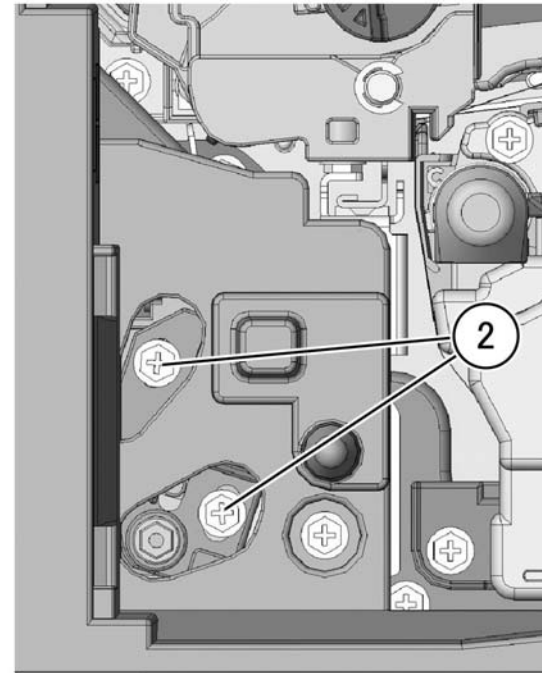
5. Remove the waste cartridge, PL 90.15 Item 6, then loosen two screws (2) securing the skew adjust block, Figure 4.

Figure 4 Adjust block screws

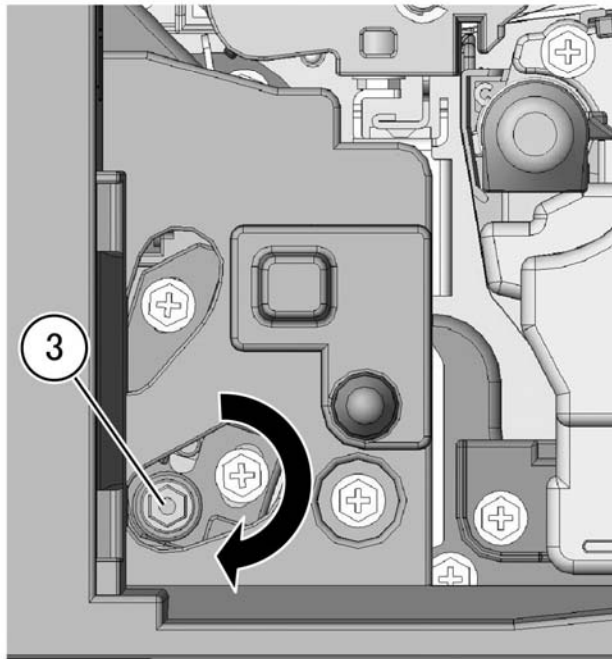
- Turn the adjustment camshaft while observing the front of the registration transport assembly to verify the registration transport assembly rises as the adjustment camshaft turns, [Figure 5](#).

Figure 5 Adjust camshaft turn location

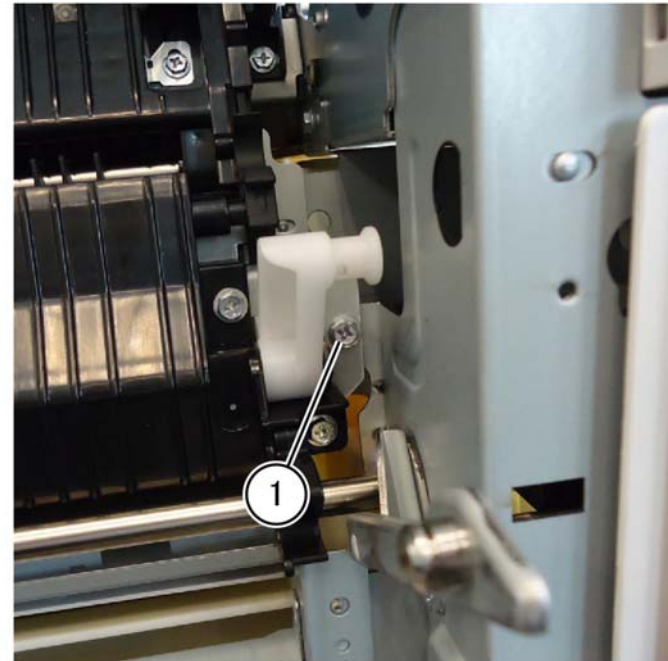
- Remove the left cover assembly, [REP 80.21](#).
- Remove the screw (1), [Figure 1](#).

Figure 1 Screw removal

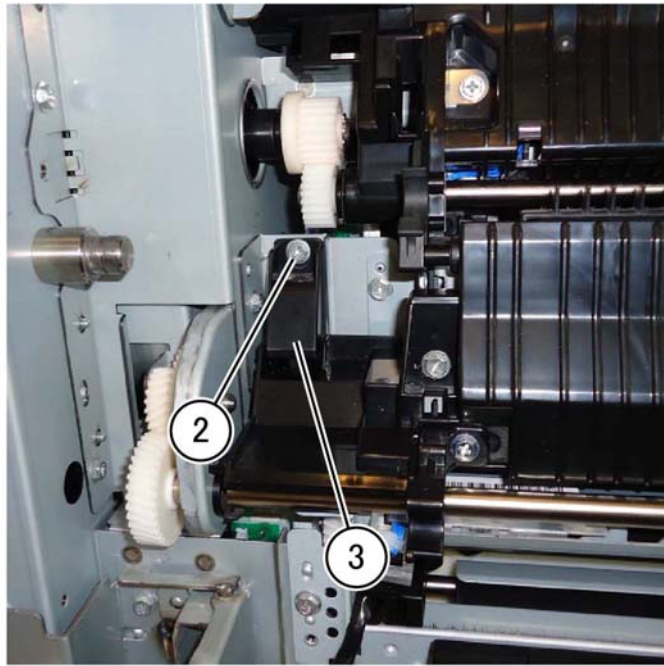
3. Remove the screw (2), then remove connector cover (3), [Figure 2](#).

Figure 2 Connector cover removal

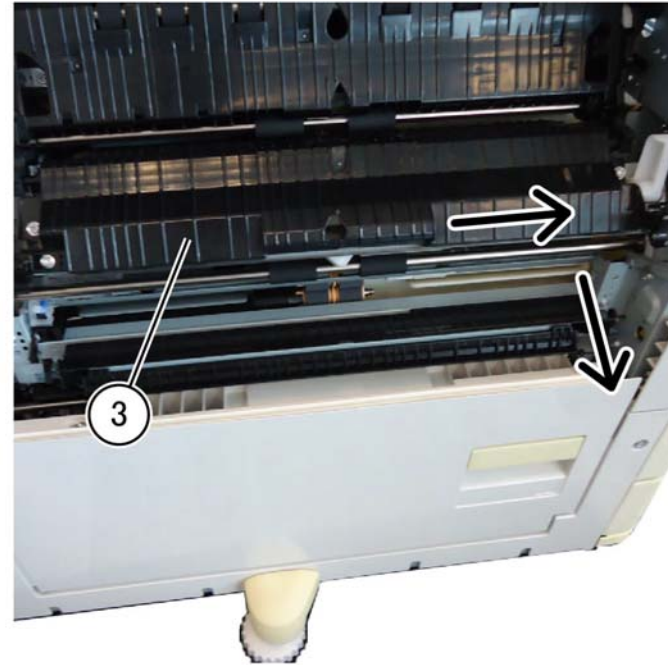
4. Slide the chute assembly (3), [PL 80.90 Item 4](#), in the direction of the right-arrow, then remove the chute assembly in the direction of the out-arrow, [Figure 3](#).

Figure 3 Chute assembly removal

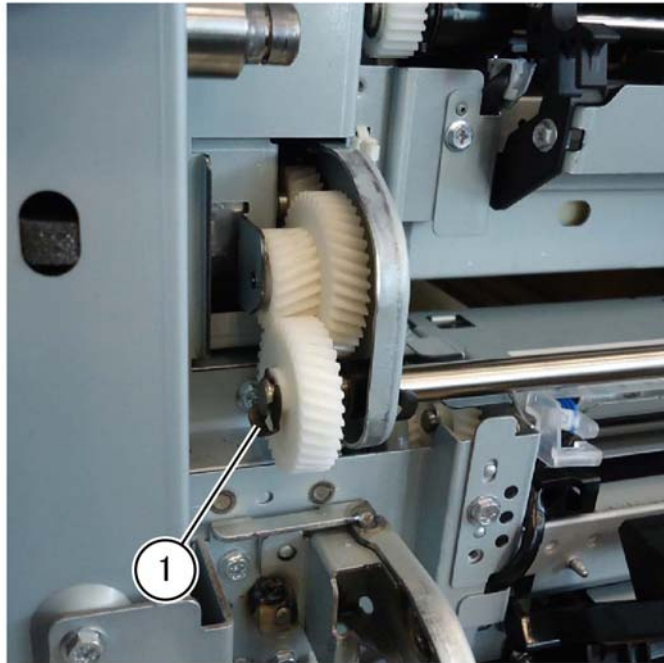
1. Remove the left cover assembly, [REP 80.21](#).
2. Remove the chute assembly [REP 80.31](#).
3. Remove the k-clip (1) holding the gear on the end the shaft towards the rear of the machine, then remove the gear, [Figure 1](#).

Figure 1 K-clip and gear removal

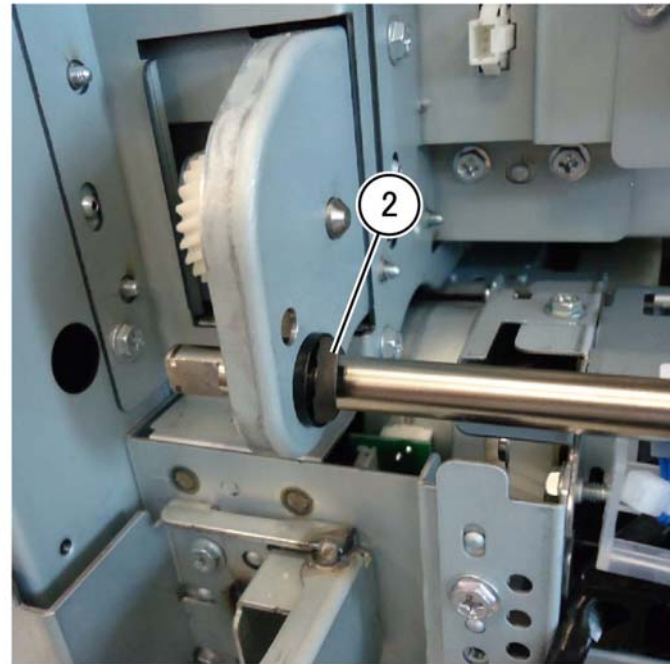
4. Remove the k-clip on the inside of the bracket (2), [Figure 2](#).

Figure 2 Connector cover removal

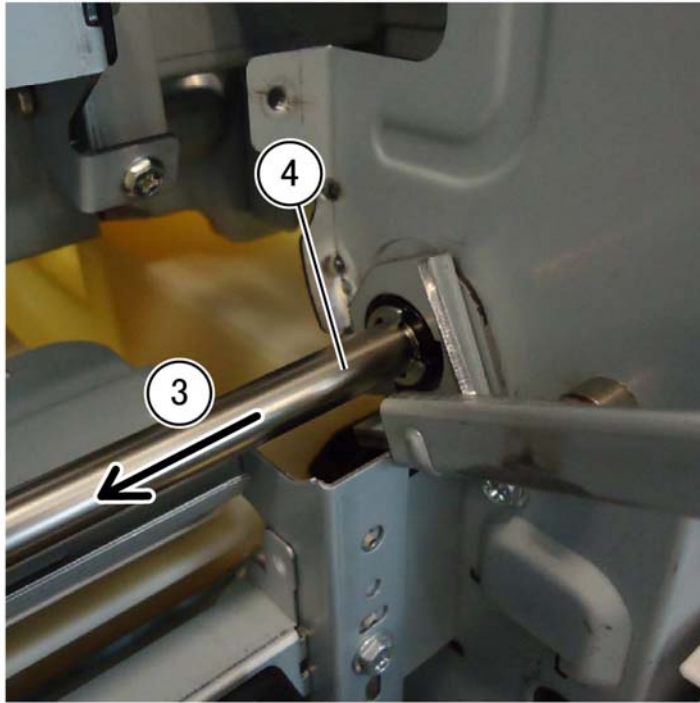
- Slide the takeaway roll assembly (4), PL 80.90 Item 7, in the direction of the arrow towards the rear of the machine (3), then remove the takeaway roll assembly, Figure 3.

Figure 3 Takeaway roll assembly removal

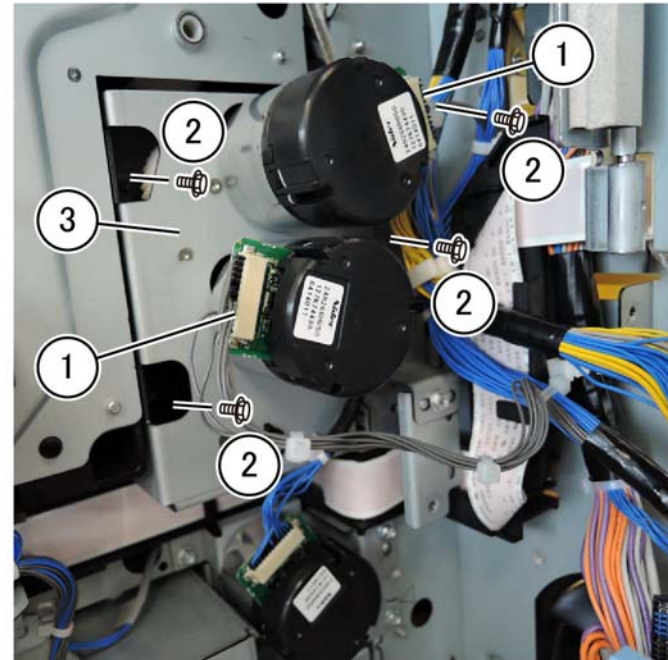
- Remove the lower rear cover, PL 28.15 Item 8.
- Open the video contact chassis assembly, GP 32.
- Remove the motor drive PWB, REP 1.4.
- Remove the registration drive assembly, PL 80.95 Item 1: Figure 1.
 - Disconnect two connectors (1).
 - Remove the five screws (2).
 - Remove the cable tie from the frame.
 - Remove the registration drive assembly (3).

Figure 1 Registration drive assembly removal

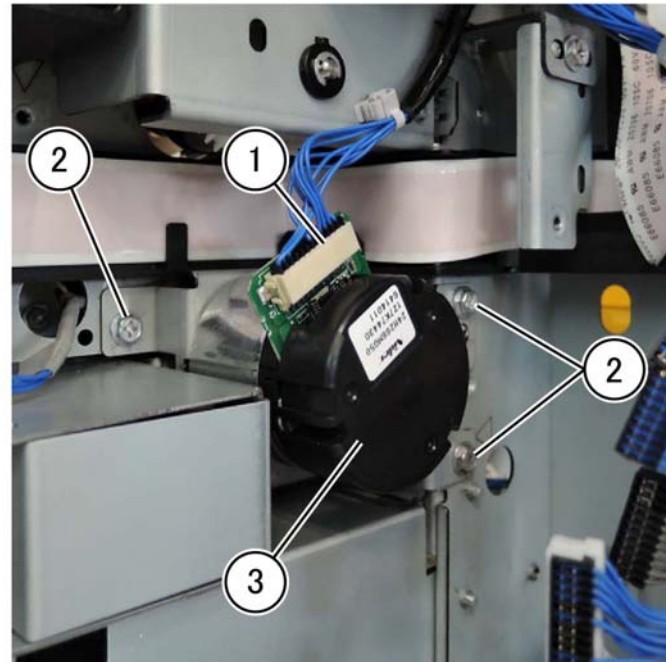
1. Remove the motor drive PWB, [REP 1.5](#).
2. Remove the AC drive PWB, [REP 1.5](#).
3. Remove the LVPS, [REP 1.6](#).
4. Remove the takeaway motor 2 drive assembly, [PL 80.95 Item 15: Figure 1](#).
 - a. Disconnect the connector (1).
 - b. Remove the three screws (2).
 - c. Remove the drive assembly (3).

Figure 1 Takeaway motor 2 drive removal

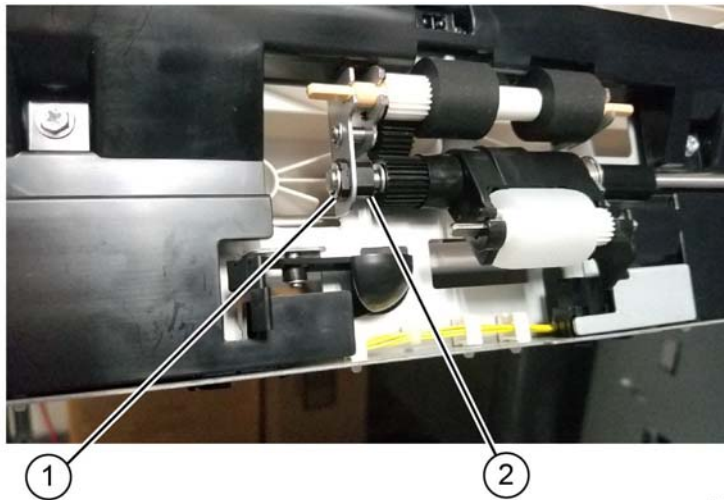
1. Open the top cover, [PL 70.90 Item 7](#).
2. Release the green lever opening the upper feeder assembly, [PL 80.105 Item 1](#).
3. Remove the nudger roll, [PL 80.105 Item 23](#).
4. Remove the feed shaft, ball bearing, and feed gear: [Figure 1](#).
 - a. Remove the E-clip (1) and bearing (2), [PL 80.105 Item 10](#).
 - b. Slide the remaining feed shaft assembly (3) to the right (rear), then remove the feed shaft assembly, [PL 80.105 Item 4](#).

Figure 1 Feed shaft assembly removal

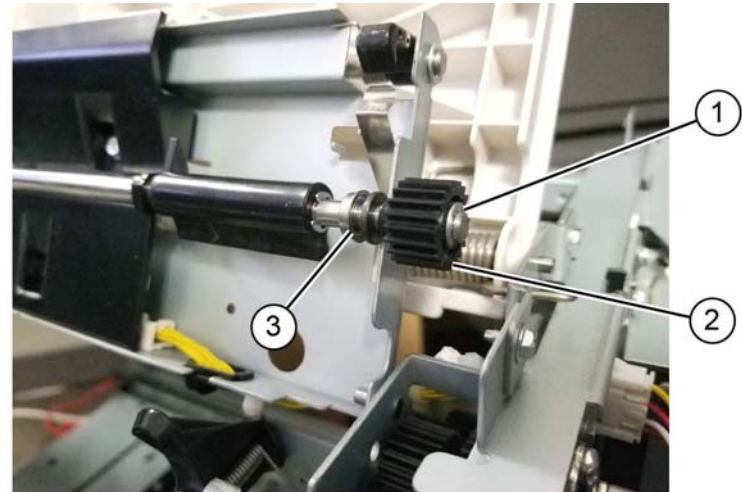
5. Remove the ball bearing and feed gear, [Figure 2](#):
 - a. Remove the E-clip (1).
 - b. Remove the feed gear (2).
 - c. Remove the ball bearing (3).

Figure 2 Ball bearing and feed gear removal

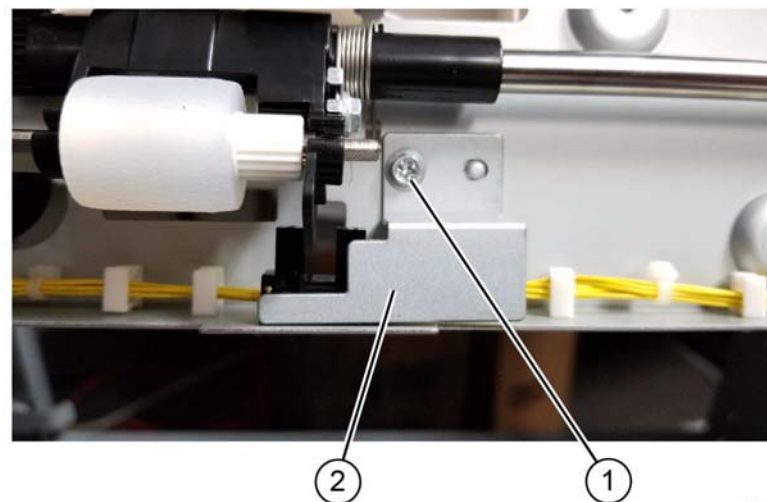
1. Open the top cover, [PL 70.90 Item 7](#).
2. Lift the upper feed assembly lever, [PL 80.105 Item 9](#), to open the upper feed assembly, gaining access to the underside components.
3. Remove the rear upper chute, [PL 80.105 Item 14](#).
4. Remove the upper chute, [PL 80.105 Item 15](#).
5. Remove one screw (1), then remove the sensor cover (2), [Figure 1](#).

Figure 1 Sensor cover removal

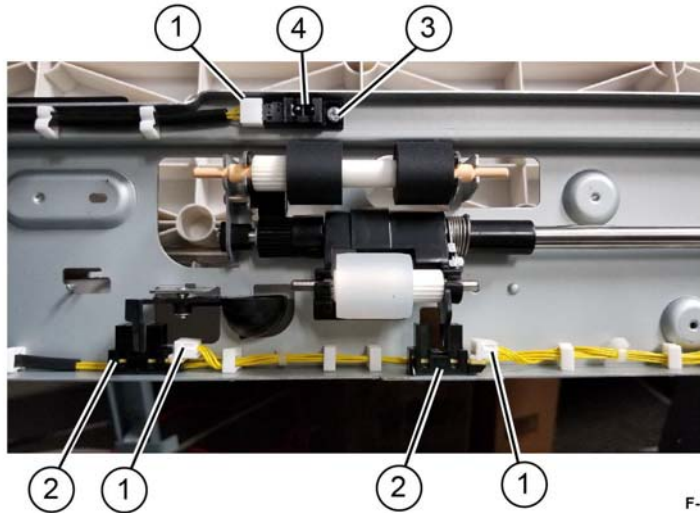
- Disconnect the connectors (1), level sensor and no paper sensor (2), PL 80.105 Item 19, then one screw (3) securing the pre feed sensor (4), PL 80.105 Item 20, Figure 2.

Figure 2 Sensor removal

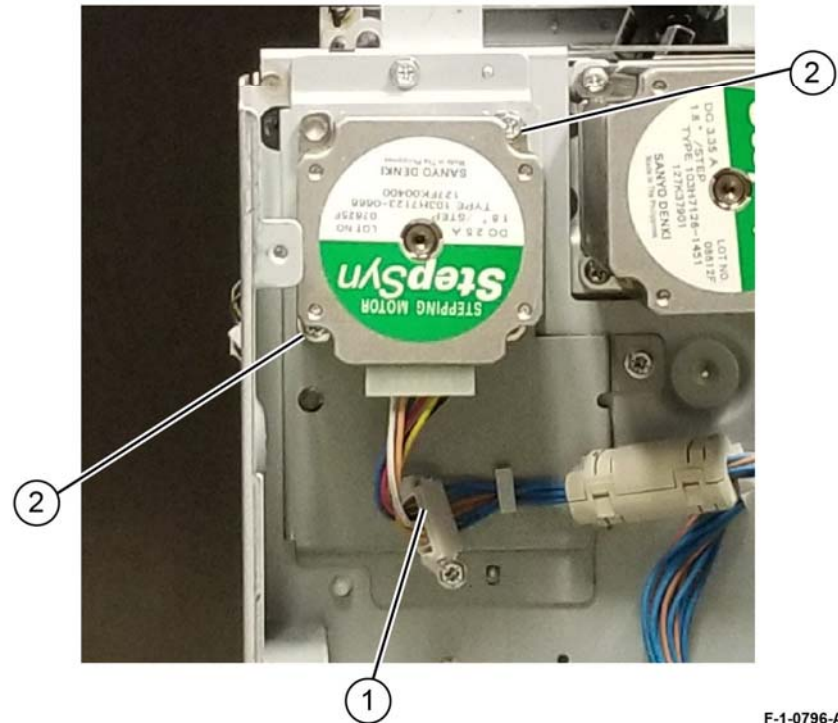
- Undock the HCF, [REP 70.7](#).
- Remove rear cover, [PL 70.75 Item 10](#).
- Disconnect the motor harness (1) from the HCF electrical harness, remove two screws (2), then remove the HCF feed lift motor (3), [PL 80.100 Item 23, Figure 1](#).

Figure 1 HCF feed lift motor removal

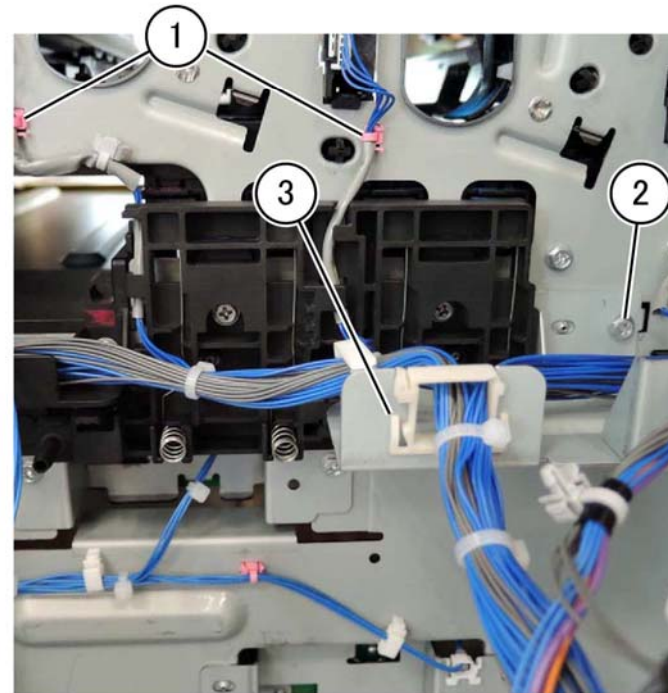
10. Remove the harness bracket: [Figure 1](#).
 - a. Release two cable ties (1).
 - b. Release the LED head harness from the guide (3).
 - c. Remove the screw (2) then remove the harness bracket.

Figure 1 Harness bracket removal

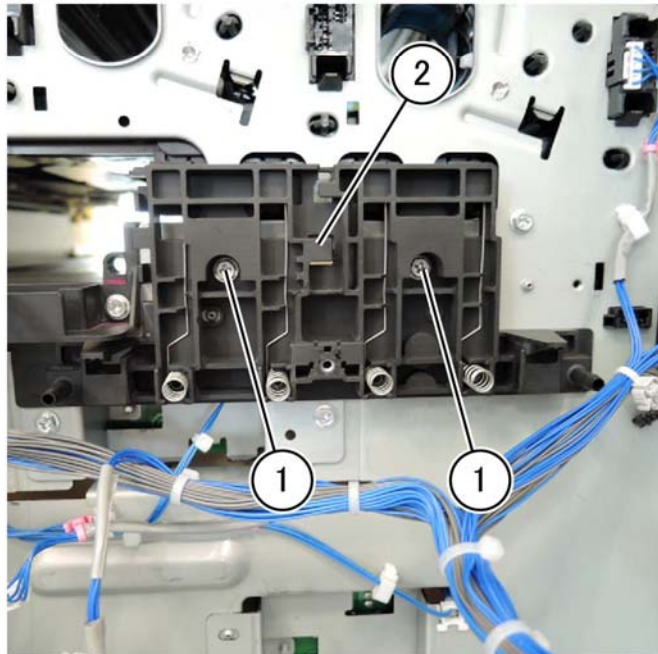
Take care not to damage the springs or allow the springs to fall out of the conductor housing assembly.

- a. Remove two screws (1).
- b. Remove the conductor housing assembly (2).

Figure 2 Conductor housing assembly removal

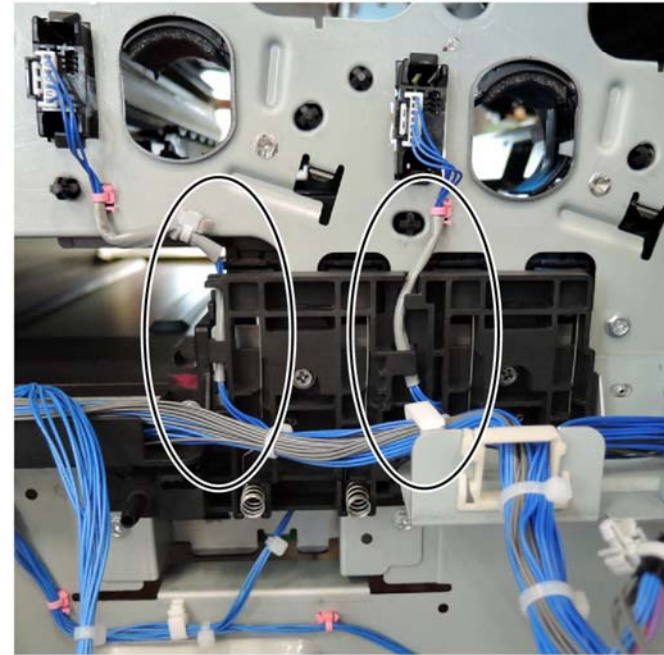
1. During replacement properly route the LED head harnesses, Figure 3.

Figure 3 LED head harness routing

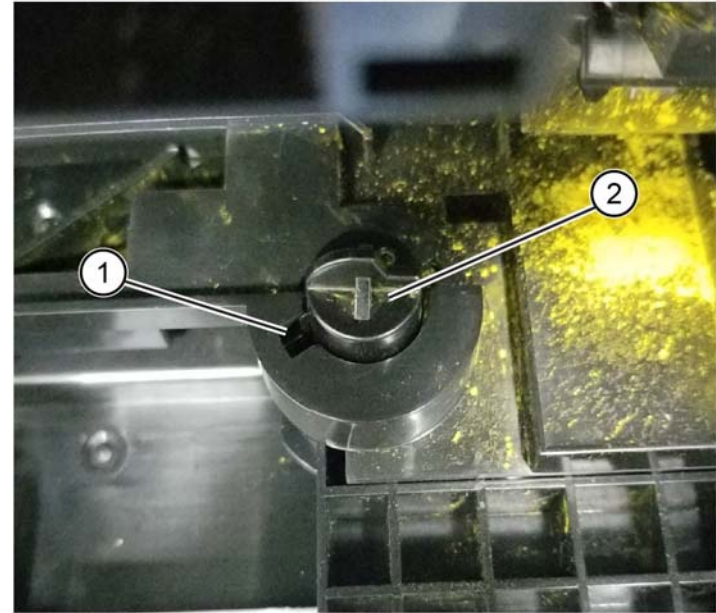
- To access the plunger it is not necessary to remove the FCC cables [PL 60.05 Item 7](#) and [PL 60.05 Item 8](#) from the marking guide, [PL 90.25 Item 1](#).
 - The plunger is mounted on the developer conductor housing assembly, [PL 90.05 Item 2](#), part of the FCC cable assembly, [PL 60.05 Item 9](#).
2. Remove the plunger, [PL 90.05 Item 3](#), [Figure 1](#).
 - a. Press down on the plunger, turn clockwise to align the groove to the pin (1) unlocking the plunger (2).
 - b. Remove the plunger (2).

Figure 1 Plunger removal

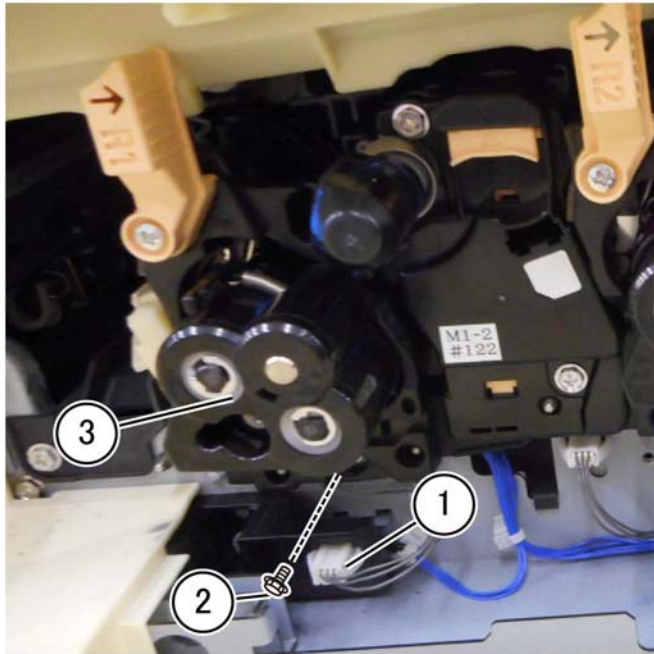
1. Remove the front cover assembly, [PL 28.05 Item 8](#).
2. Remove the waste toner transport assembly, [PL 90.15 Item 1](#).
3. Remove the inner lower cover, [PL 28.05 Item 2](#).
4. Remove the drum assembly, [REP 90.11](#).
5. Remove the developer assembly: [Figure 1](#).
 - a. Disconnect the connector (1).
 - b. Remove the screw (2).
 - c. Remove the developer assembly (3).

Figure 1 Developer assembly removal

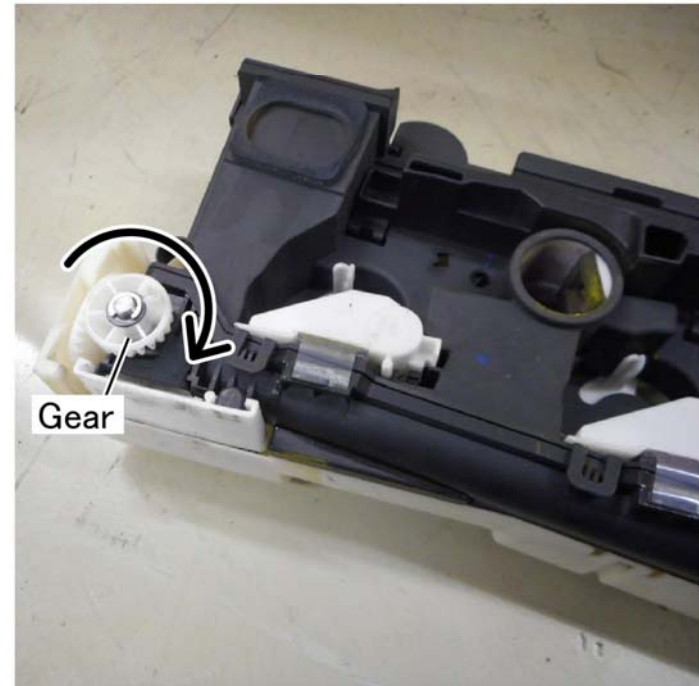
1. Using a toner vacuum on the output port, clean the inside of the waste toner transport assembly, [PL 90.15 Item 1, Figure 2](#).

NOTE: Rotate the gear in the direction of the arrow (clockwise) to assist ejection of the toner during cleaning.

Figure 2 Rotate the gear

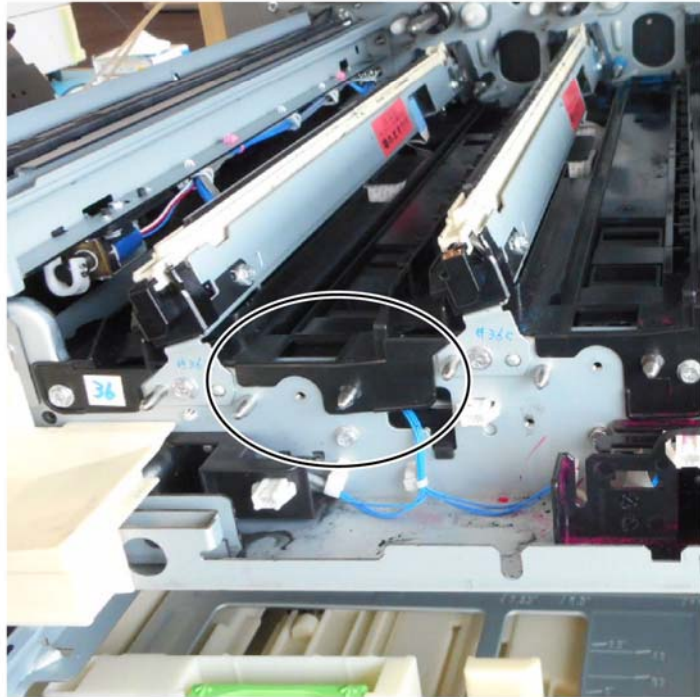
3. Inspect and clean the frame of all toner before installing the developer assembly, [Figure 3](#).

Figure 3 Frame inspection

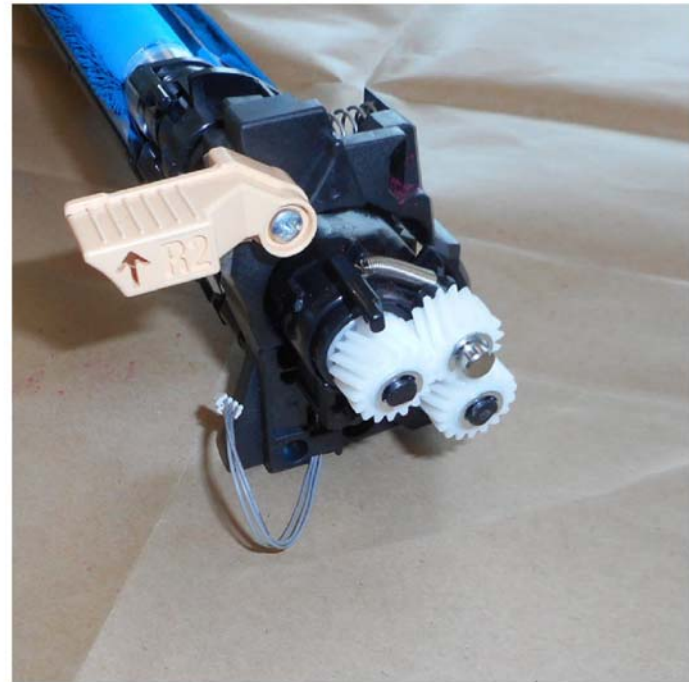
4. Inspect and clean all toner from the developer assembly gear before installing or banding and excessive wear of the gear will occur, [Figure 4](#).

Figure 4 Gear inspection

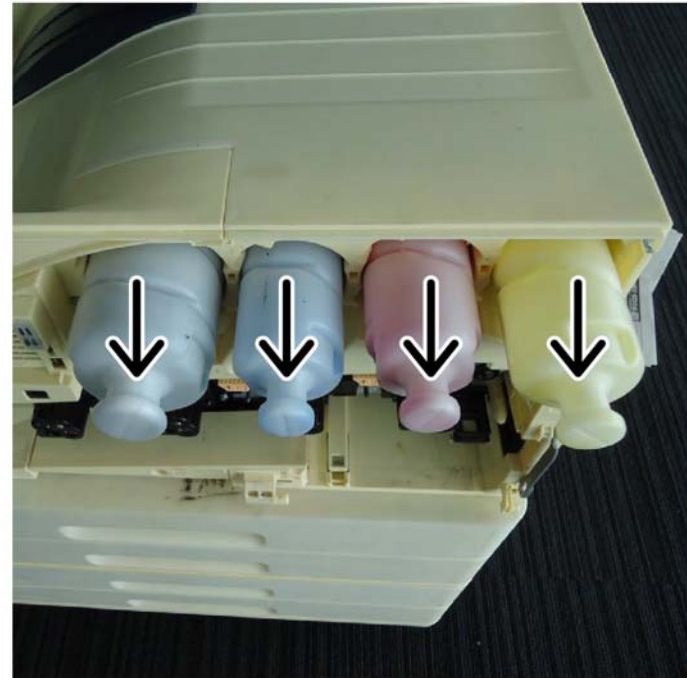
1. Pull out the toner cartridge to the extent indicated in **Figure 1**.

Figure 1 Toner cartridge

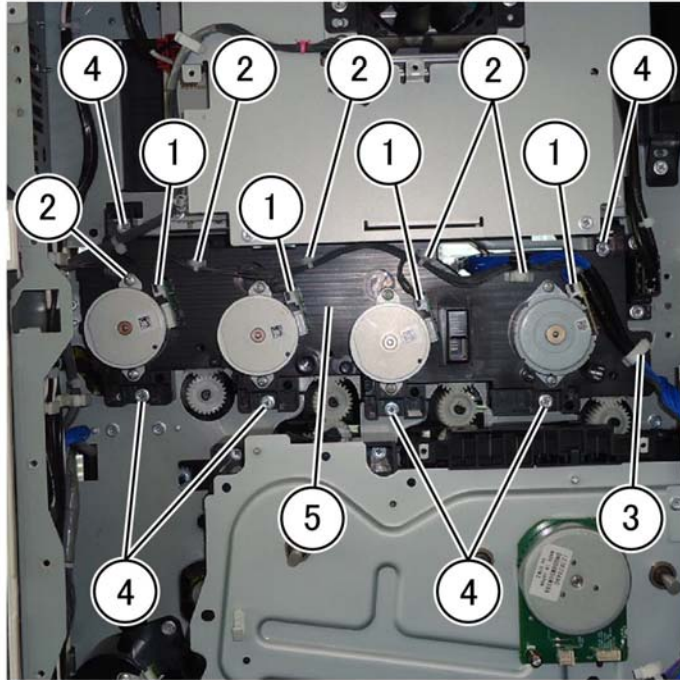
6. Remove the toner dispense motor assembly, [PL 90.10 Item 1](#), [Figure 2](#).
 - a. Disconnect four connectors (1).
 - b. Remove five clips (2).
 - c. Open the clamp (3), then remove the harness.
 - d. Remove six screws (4).
 - e. Remove the toner dispense motor assembly (5).

Figure 2 Toner dispense motor assembly removal
