VersaLink[®] C8000/C9000 Printer

Service Manual

VersaLink C9000 Family Service Manual

705P01418

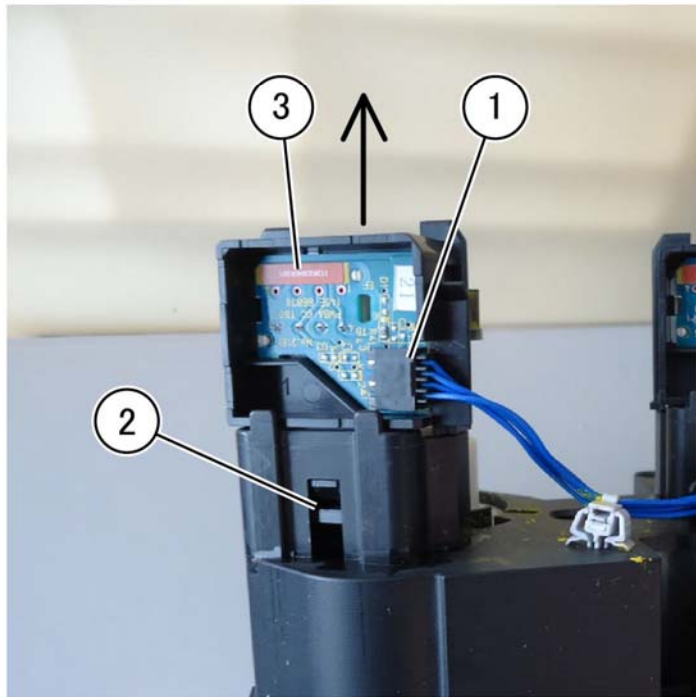
10. Remove the toner CRUM connector assembly: [Figure 1](#).
 - (1) Disconnect the connector (1).
 - (2) Release the hook (2), and slide in the direction of the arrow.
 - (3) Remove the toner crum connector assembly (3).

Figure 1 Toner crum connector assembly removal

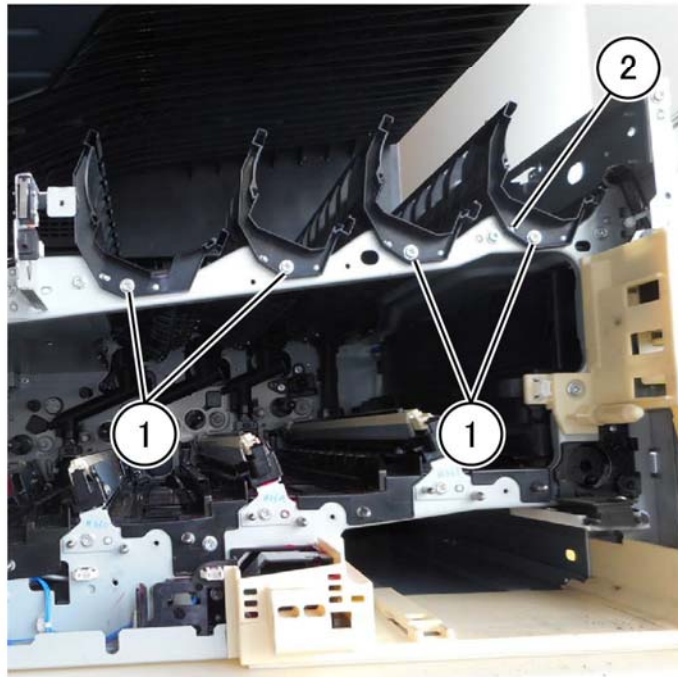
- (1) Remove four screws (1).
- (2) Remove the dispenser assembly (3).

NOTE: Always remove in the order (Y,M,C,K).

Figure 1 Dispenser assembly removal

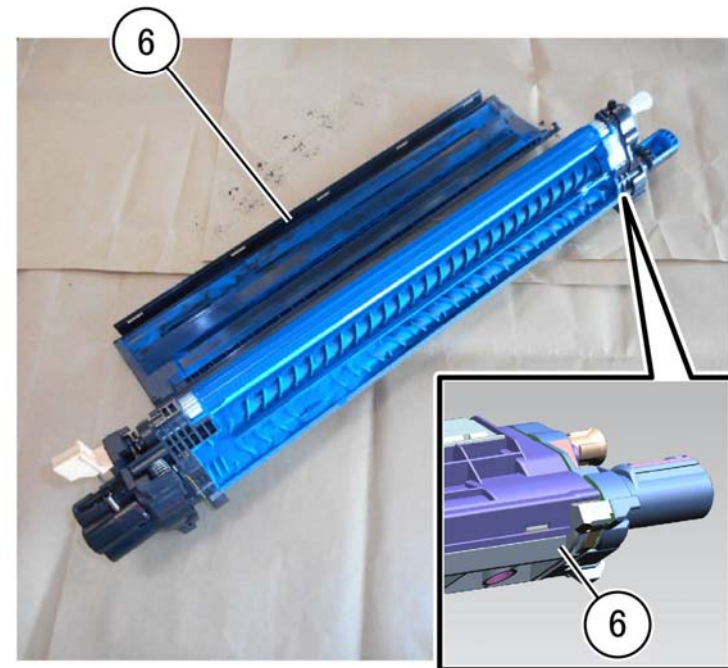
1. Prepare the black paper or black bag.
2. Remove the front cover assembly, [PL 28.05 Item 8](#).
3. Remove the waste cartridge, [PL 90.15 Item 6](#).
4. Remove the inner lower cover, [PL 28.05 Item 2](#).
5. Remove the drum assembly, [REP 90.11](#).
6. Remove the developer assembly, [REP 90.3](#).
7. Release the snap fit and remove the upper cover (6), [Figure 1](#).

Figure 1 Upper cover removal

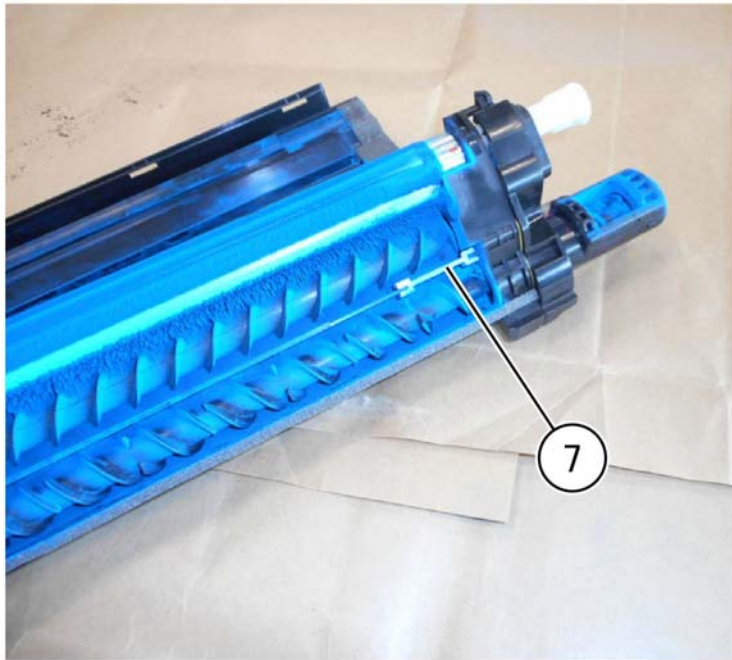
F-1-0373-A

8. Remove the triumph plate (7), [Figure 2](#).

Figure 2 Triumph plate removal

10. Install the triumph plate back into the developer housing assembly, [Figure 2](#).

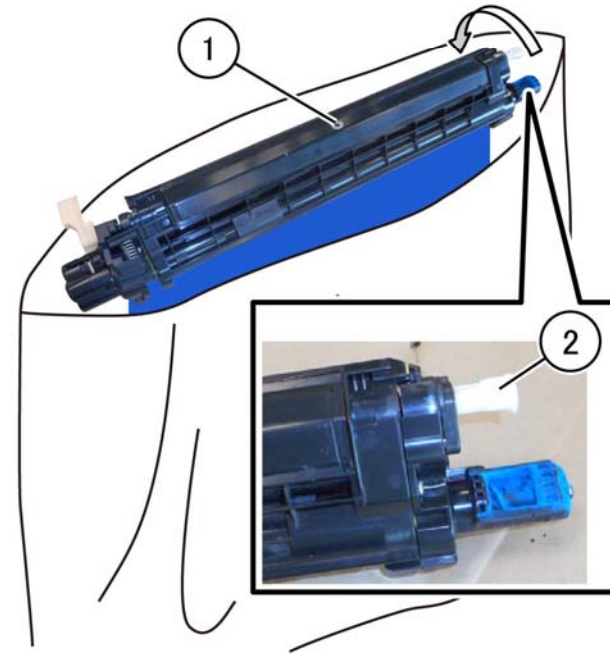
F-1-0374-A

9. Place the developer housing assembly (1) into the plastic bag shipped with the developer, turn the developer housing assembly upside down, then rotate the gear (2) clockwise to eject the developer into the bag, [Figure 3](#).

Figure 3 Eject old developer

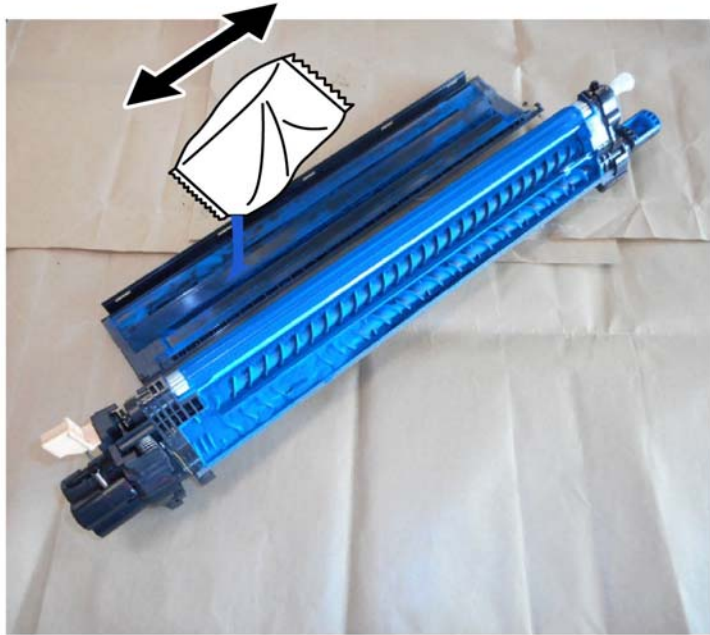
F-1-0375-A

11. Open the bag of new developer carefully, then slowly add new developer to the magnetic roller side, [Figure 4](#).

Figure 4 Add new developer

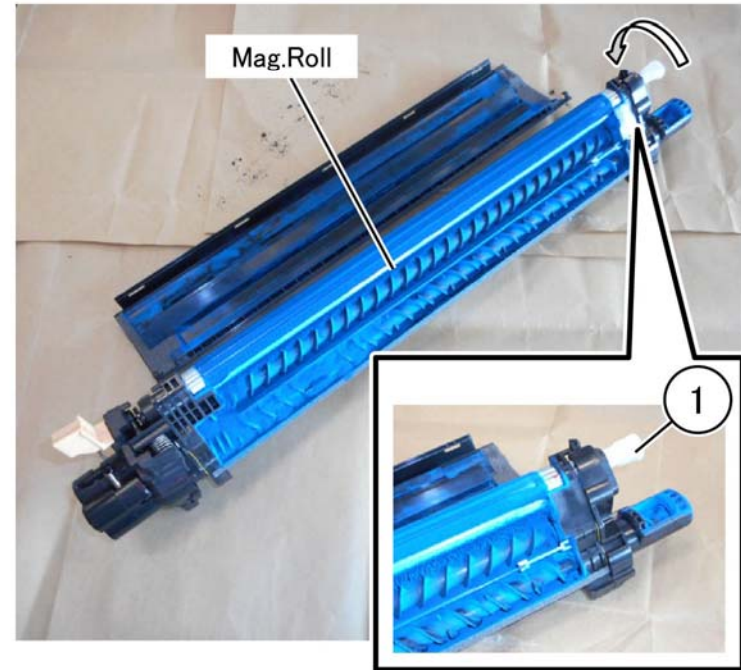
F-1-0376-A

12. Rotate the gear (1) to the right (clockwise) to evenly distribute the developer on the magnetic roller, [Figure 5](#).

Figure 5 Rotate the gear

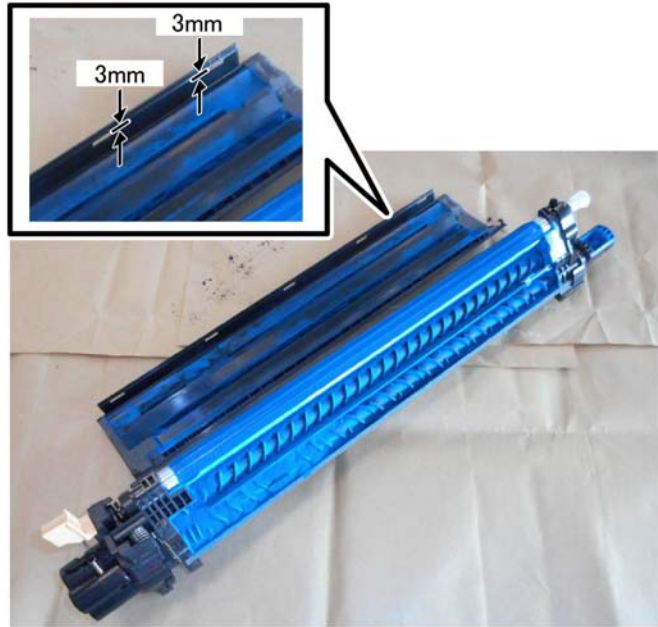
F-1-0377-A

NOTE: Do not fill developer past the line inside the housing, approximately 3mm, below the upper cover installation slot, [Figure 6](#).

Figure 6 Fill line

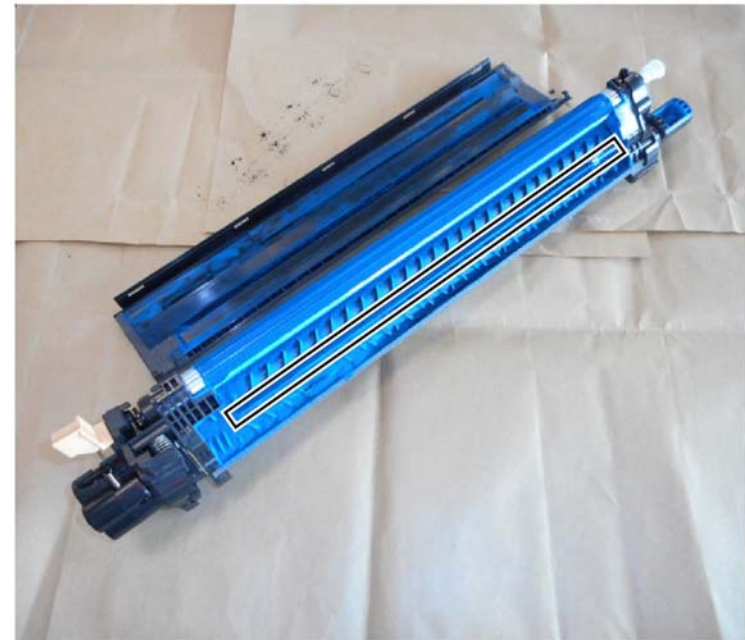
F-1-0378-A

13. Clean any developer or toner from the location indicated by the black dashed area outlined in [Figure 7](#).

Figure 7 Clean housing area

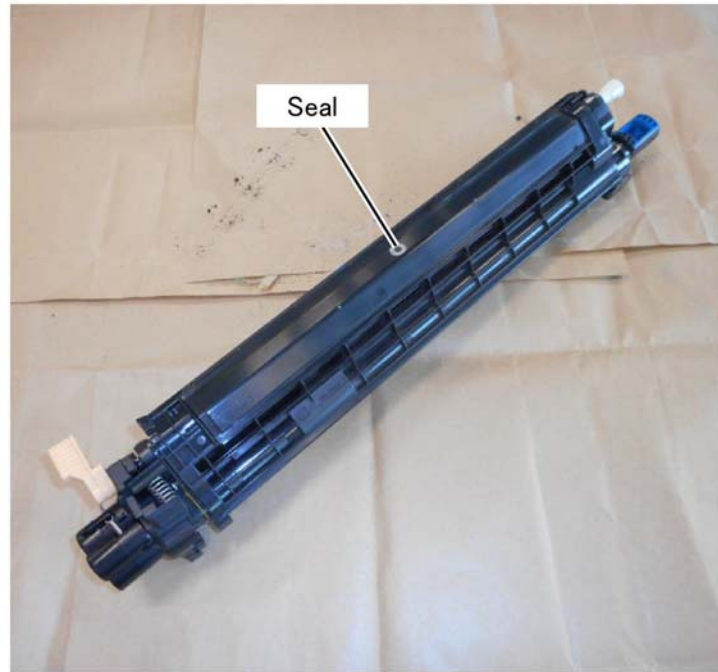
F-1-0379-A

14. Inspect and clean all developer or toner from the seal on the upper cover, [Figure 8](#).

Figure 8 Clean the seal

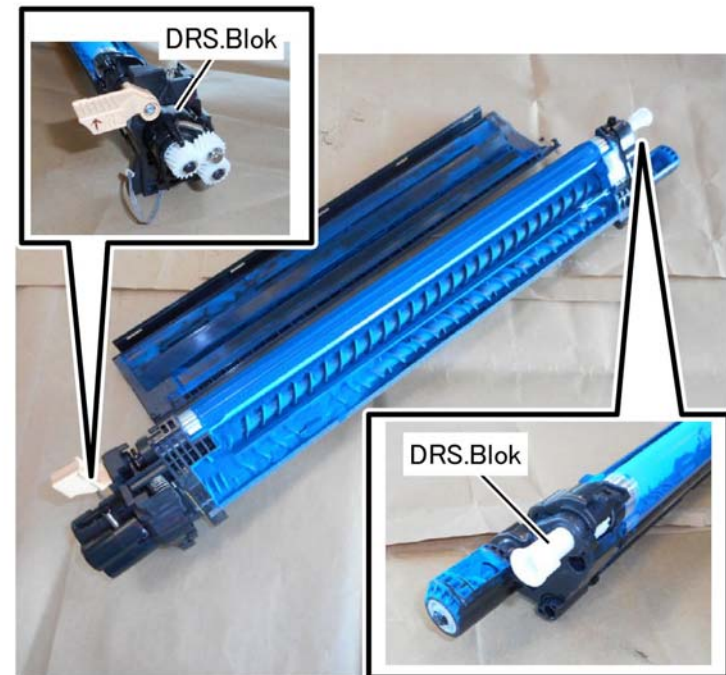
F-1-0380-A

16. Turn the developer housing over, inspect and clean all developer or toner from the DRS block located in [Figure 9](#).

Figure 9 Clean the DRS block

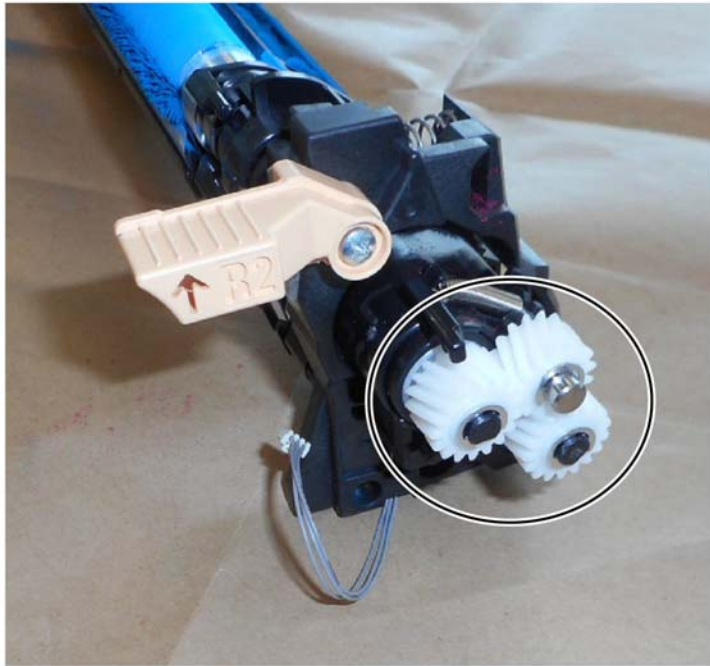
F-1-0381-A

17. Inspect and clean all developer or toner from the gear by turning the gear clockwise, [Figure 10](#).

Figure 10 Clean the gear

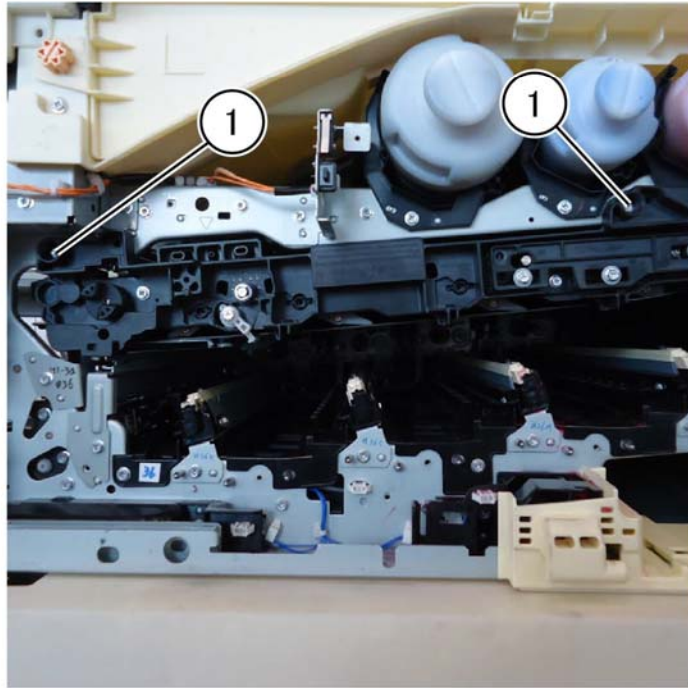
F-1-0382-A

7. Remove the IBT belt assembly, PL 90.30 Item 1.
 - a. Remove two screws (1), Figure 1.

Figure 1 Remove two screws

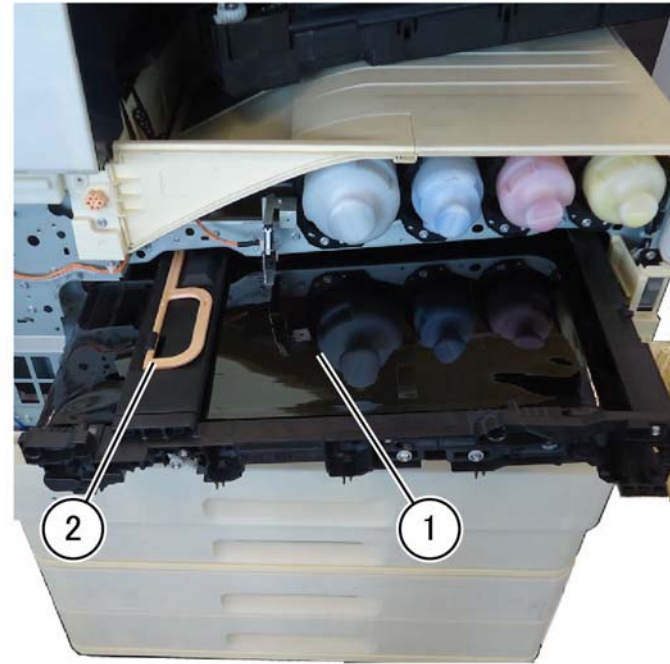
F-1-0383-A

- b. Pull the IBT belt assembly (1) out to full stop, grasp the IBT belt assembly handle (2), then remove the IBT belt assembly (1), Figure 2.

NOTE: A stopper mechanism is in place to prevent the IBT belt assembly from falling out of the machine. The stopper mechanism is configured to release when the handle is lifted.

Figure 2 IBT belt assembly removal

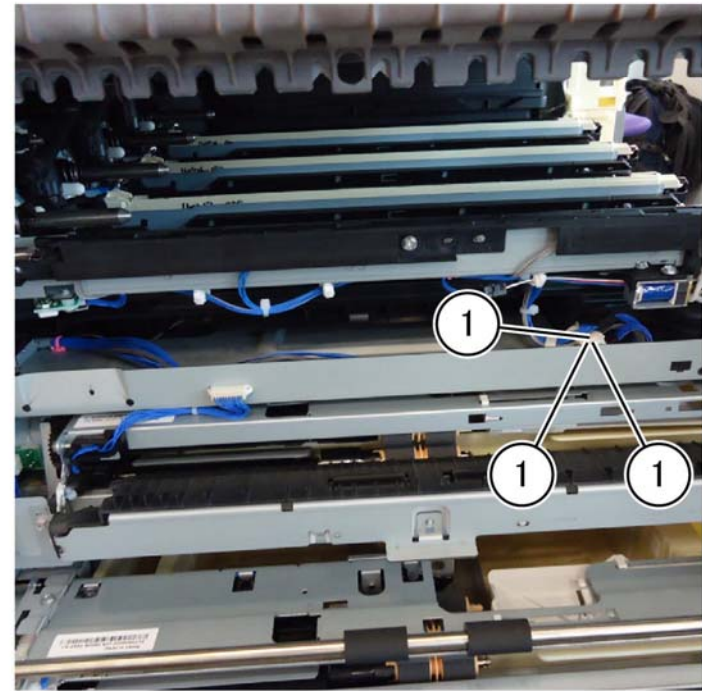
F-1-0384-A

10. Remove the MOB/ADC assembly, [PL 90.30 Item 4](#).
 - a. Disconnect three connectors (1), [Figure 1](#).

Figure 1 Connectors location

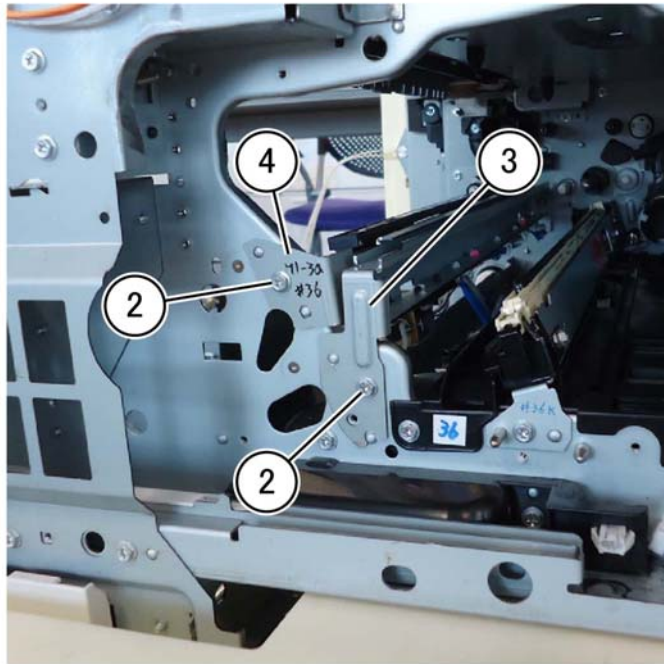
F-1-0385-A

- b. Remove two screws (2), remove the lower guide-IBT (3), then remove the MOB/ADC assembly (4), [Figure 2](#).

Figure 2 MOB/ADC assembly removal

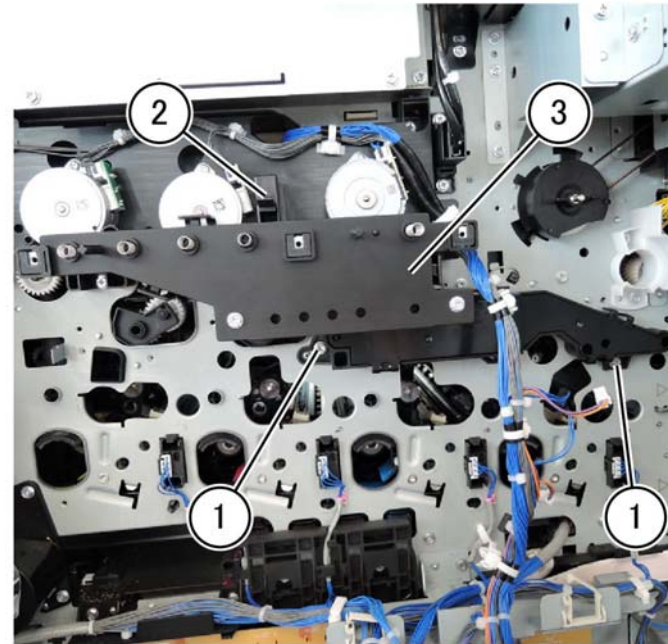
F-1-0386-A

1. Remove the BTR HVPS PWB, [REP 1.1](#).
2. Remove the conductor housing assembly: [Figure 1](#).
 - a. Remove two screws (1).
 - b. Release the hook (2).
 - c. remove the upper conductor housing assembly, [PL 90.30 Item 7](#), (3).

Figure 1 Conductor housing assembly removal

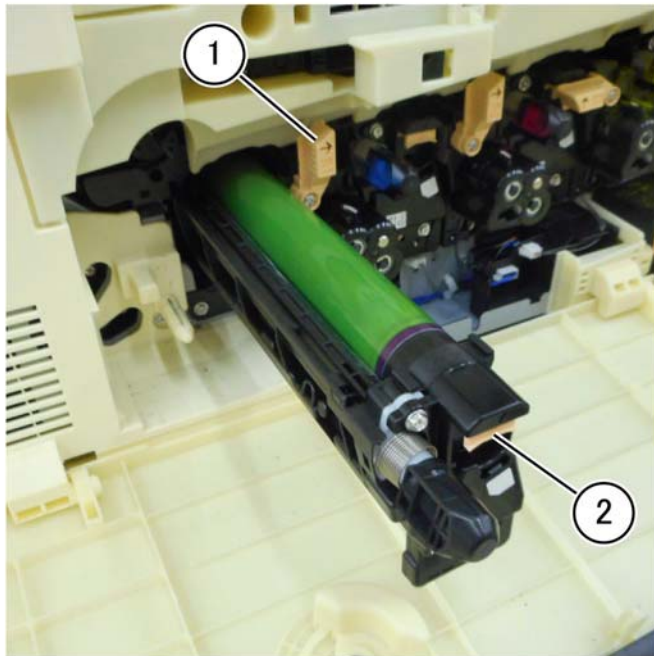
F-1-0387-A

1. Remove the front cover assembly, [PL 28.05 Item 8](#).
2. Remove the waste cartridge, [PL 90.15 Item 1](#).
3. Remove the inner lower cover, [PL 28.05 Item 2](#).
4. Remove the drum assembly, [PL 90.15, Figure 1](#).
 - a. Raise the developer assembly lever (1).
 - b. Raise the hook and remove the drum assembly (2).

Figure 1 Drum assembly removal

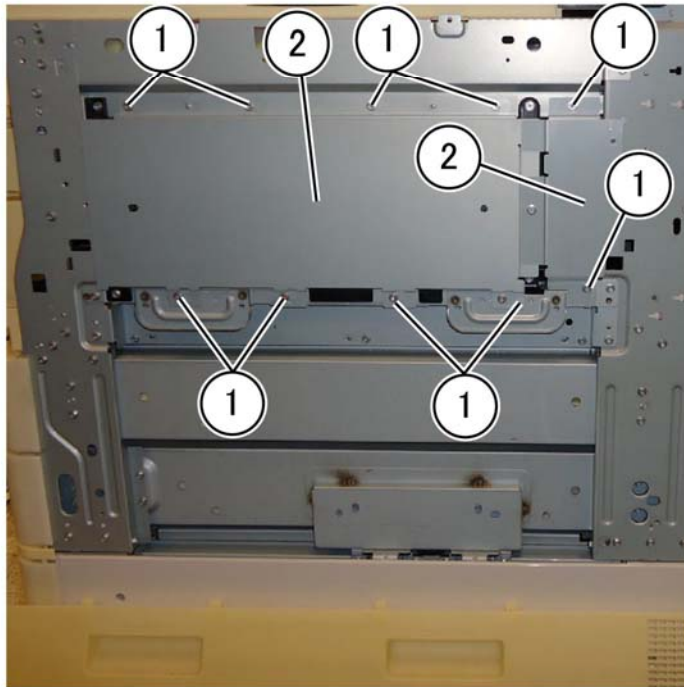
F-1-0388-A

1. Remove the four developer assemblies, [REP 90.3](#).
2. Remove the upper right front cover, [PL 28.15 Item 1](#).
3. Remove the cover assembly and cover: [Figure 1](#).
 - a. Remove ten screws (1).
 - b. Remove the cover assembly and cover (2).

Figure 1 Drum assembly removal

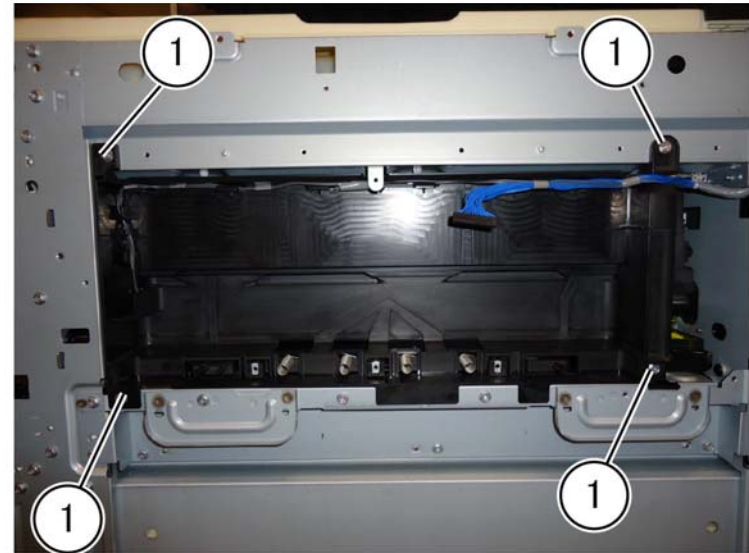
F-1-0389-A

5. Remove the conductor assembly: [Figure 2](#).
 - a. Remove four screws (1).

Figure 2 Screw location

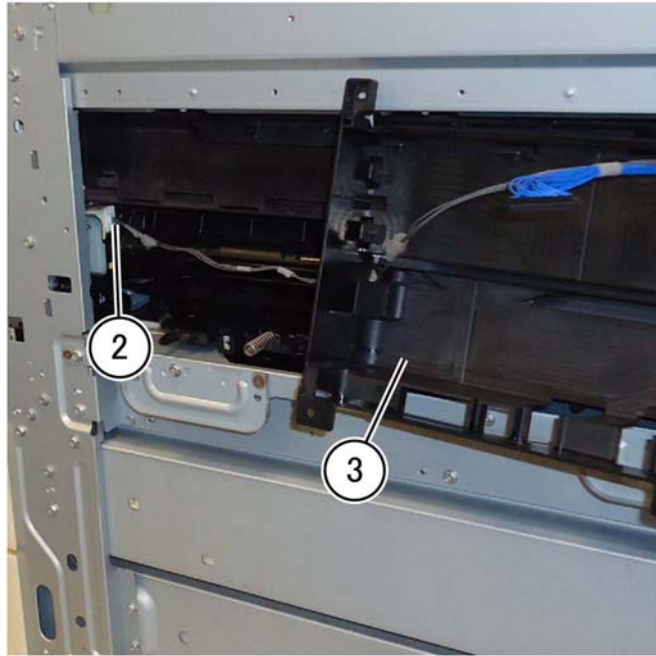
F-1-0390-A

- b. Disconnect the connector (2) and remove the conductor housing assembly (3), [Figure 3](#).
6. Remove two screws (1), then remove the gear housing assembly (2), [Figure 4](#).

Figure 3 Conductor housing removal

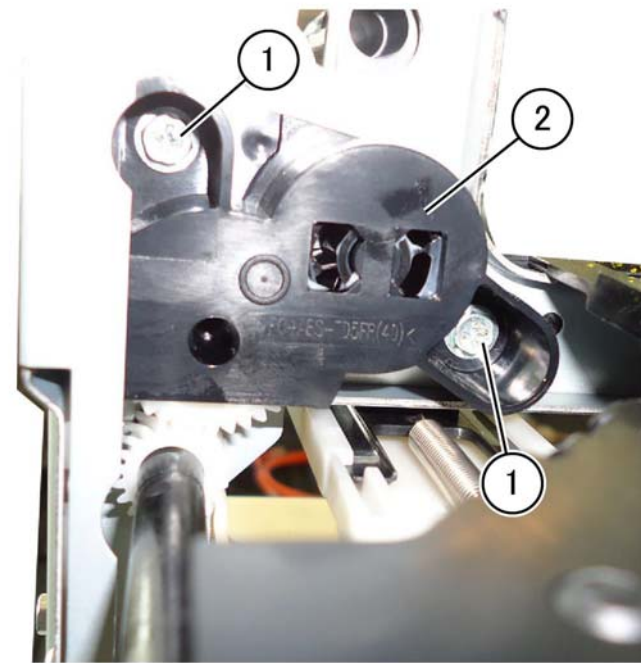
F-1-0391-A

Figure 4 Gear housing assembly removal

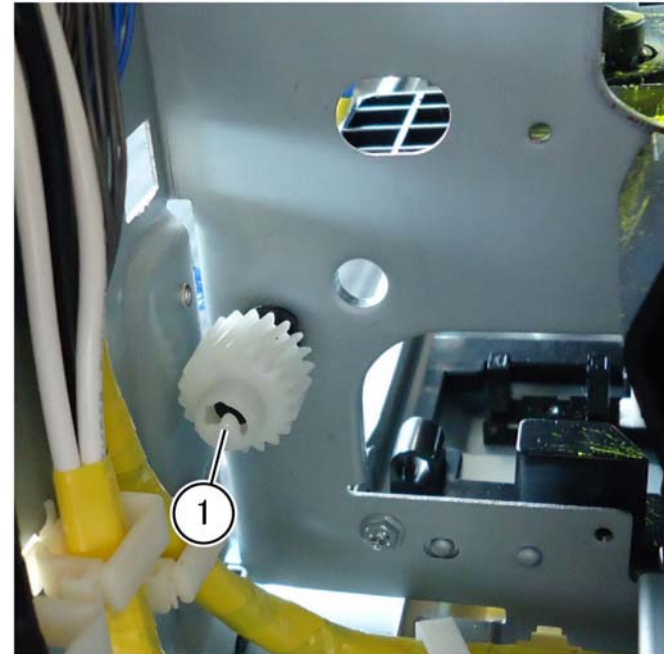
F-1-0392-A

13. Release the latch inside the rear gear (1), then remove the gear and sleeve bearing, [Figure 1](#).

Figure 1 Rear gear removal

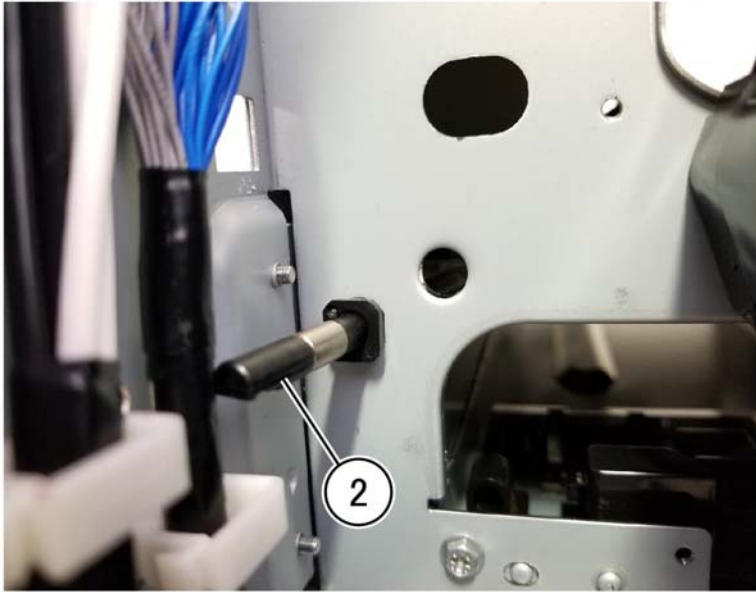
F-1-0393-A

14. Grasp the rear-end of the drive shaft (2), PL 90.20 Item 2, pulling the front-end of the drive shaft through the frame hole, then remove the drive shaft from the front, Figure 2.

Figure 2 Drive shaft rear-end

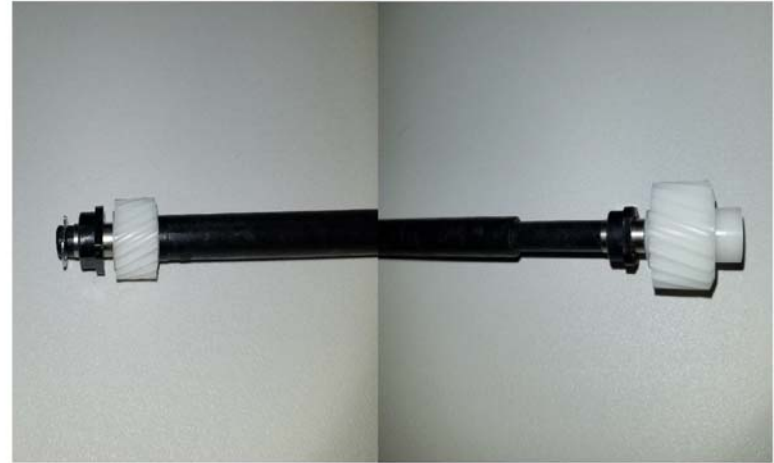
F-1-0394-A

NOTE: The flanged end of the sleeve bearing seats against the gear on both ends, Figure 3. The shaft of the sleeve bearing seats inside the frame hole, Figure 4.

Figure 3 Sleeve bearing to gear position

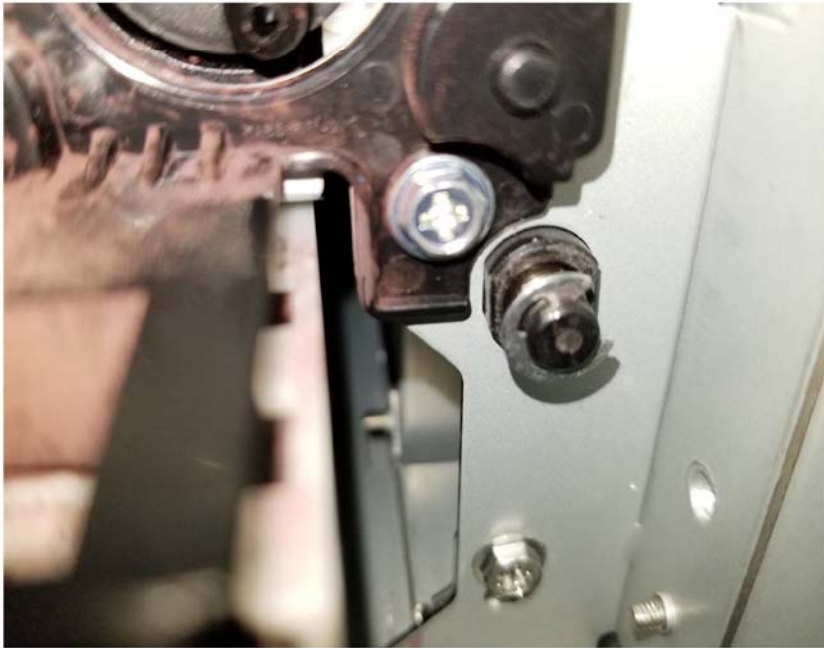
F-1-0395-A

Figure 4 Sleeve bearing in the frame

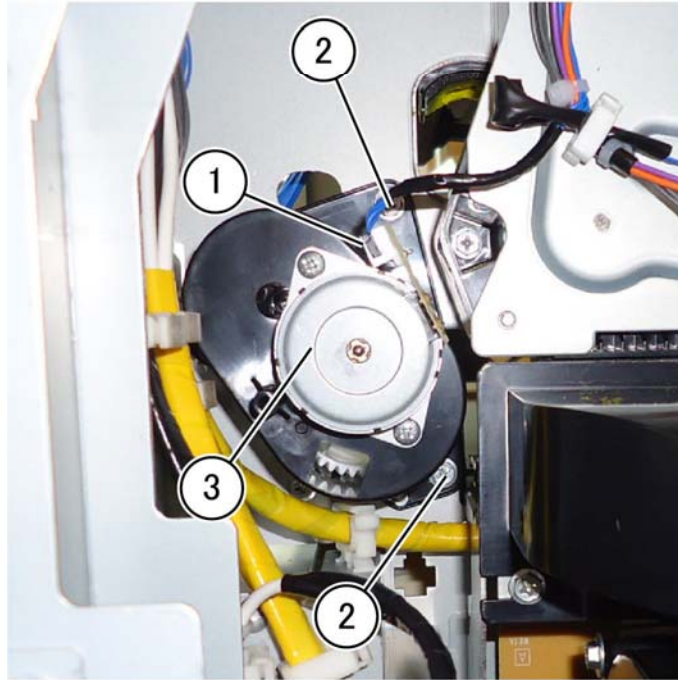
F-1-0396-A

Use extreme caution when disconnecting the connector from the motor. The connector PWB is very fragile and will break easily.

- a. Disconnect the connector (1).
- b. Remove two screws (2).
- c. Remove the agitator motor assembly (3).

Figure 1 Agitator motor assembly removal

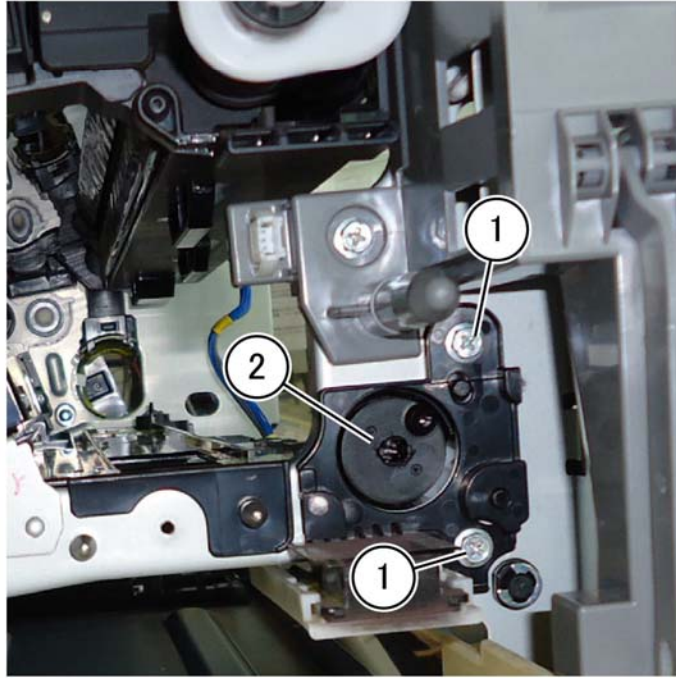
F-1-0397-A

9. Remove the joint pipe assembly, [PL 90.20 Item 11, Figure 1](#).
 - a. Remove two screws (1).
 - b. Remove the joint pipe assembly (2).

Figure 1 Joint pipe assembly removal

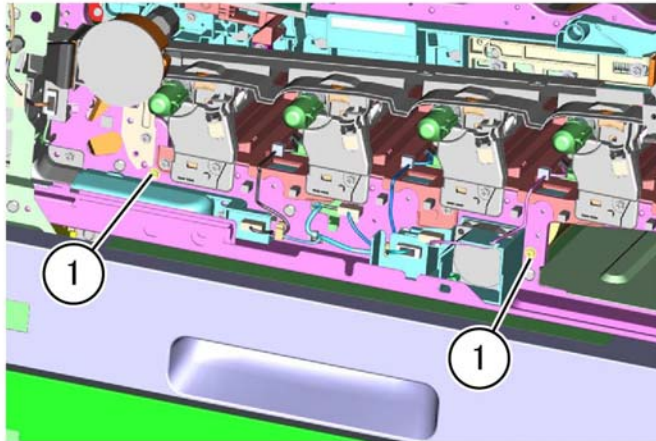
F-1-0398-A

1. Remove the front cover assembly, [PL 28.05 Item 8](#).
2. Remove the waste toner assembly, [PL 90.15 Item 1](#).
3. Remove the inner lower cover, [PL 28.05 Item 2](#).
4. Remove the drum assembly, [REP 90.11](#).
5. Remove the developer assembly, [REP 90.3](#).
6. Remove the FFC cable assembly, [REP 60.2](#).
7. Remove two screws (1), [Figure 1](#).

Figure 1 Screw removal

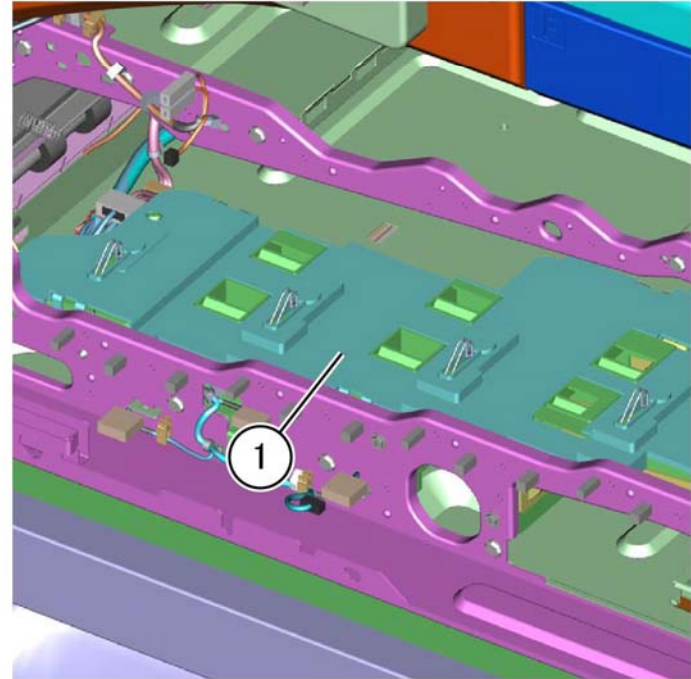
F-1-0399-A

- Remove the housing assembly (2), PL 90.25 Item 2, Figure 2.

Figure 2 Housing assembly removal

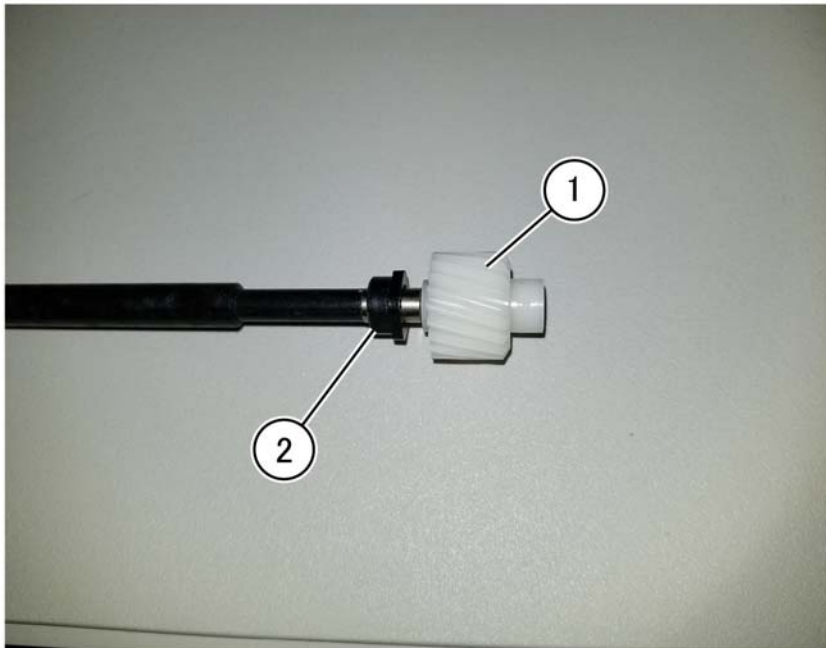
F-1-0400-A

1. Remove the drive shaft, [REP 90.13](#).
2. Remove the rear sleeve bearing, [PL 90.20 Item 3, Figure 1](#).
 - a. Release the gear latch, then remove the helical gear (1) and sleeve bearing (2).

NOTE: During replacement, the bearing flange seats against the gear.

Figure 1 Rear sleeve bearing removal

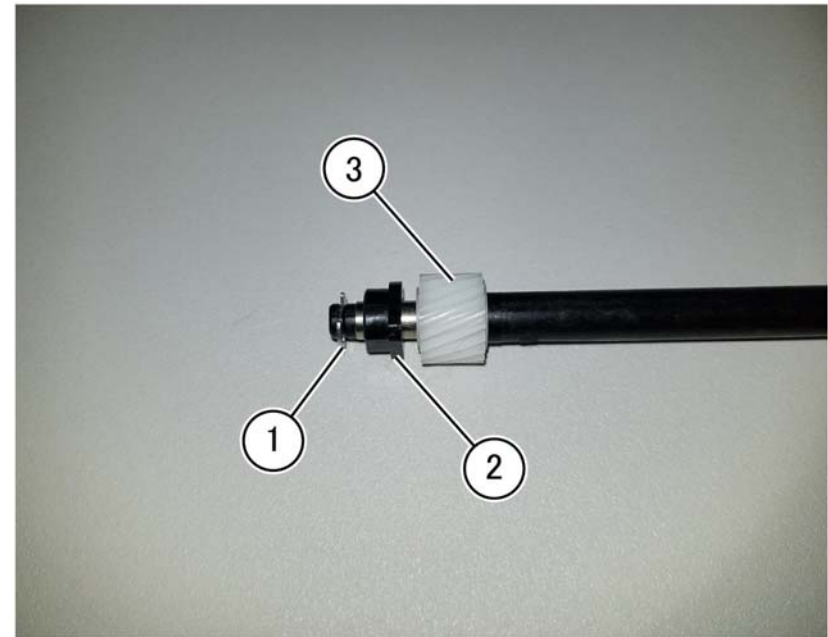
F-1-0401-A

3. Remove the front sleeve bearing, [PL 90.20 Item 3, Figure 2](#).
 - a. Remove the e-clip (1).
 - b. Remove the sleeve bearing (2) leaving the gear (3) on the drive shaft.

Figure 2 Front sleeve bearing alignment

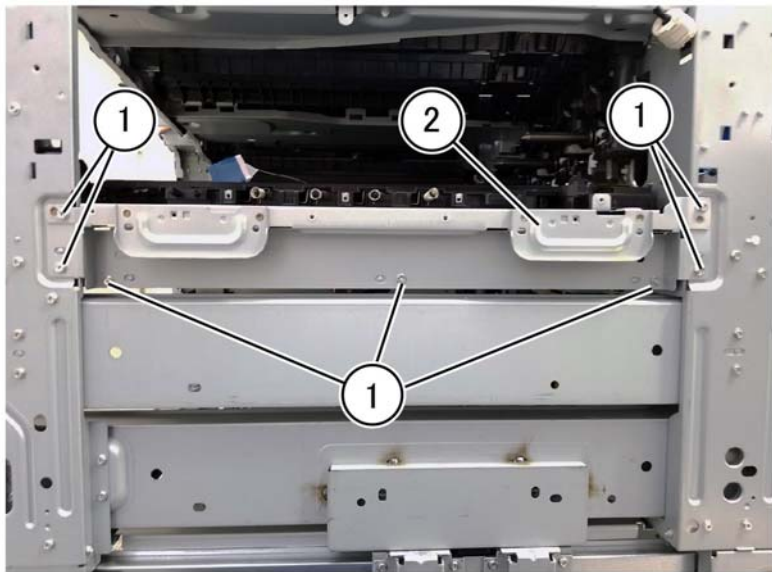
F-1-0402-A

1. Remove the BCR HVPS PWB, [REP 1.9](#).
2. Remove the lower right front cover, [PL 28.15 Item 2](#).
3. Remove the upper right rear cover, [PL 28.15 Item 3](#).
4. Remove the conductor assembly, [PL 1.20 Item 5](#).
5. Remove seven screws (1), then remove the handle assembly (2), [Figure 1](#).

Figure 1 Handle assembly removal

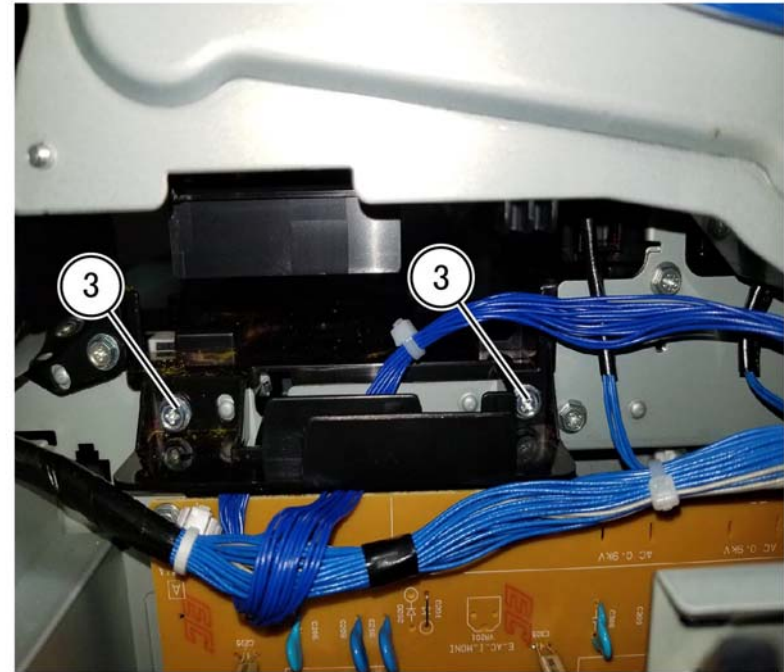
F-1-0403-A

8. Remove two screws (3) securing the cartridge guide, [Figure 2](#).

Figure 2 Cartridge guide screws

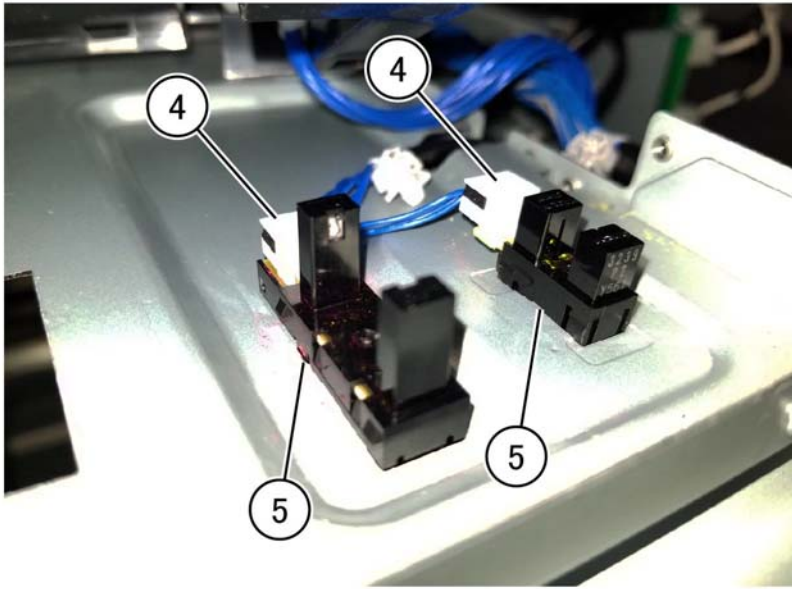
F-1-0404-A

10. Disconnect the connector (4) of the failed sensor, release the sensor housing hooks of the failed sensor (5), then remove the sensor, [PL 90.20 Item 6](#) or [PL 90.20 Item 7](#), [Figure 3](#).

Figure 3 Sensor removal

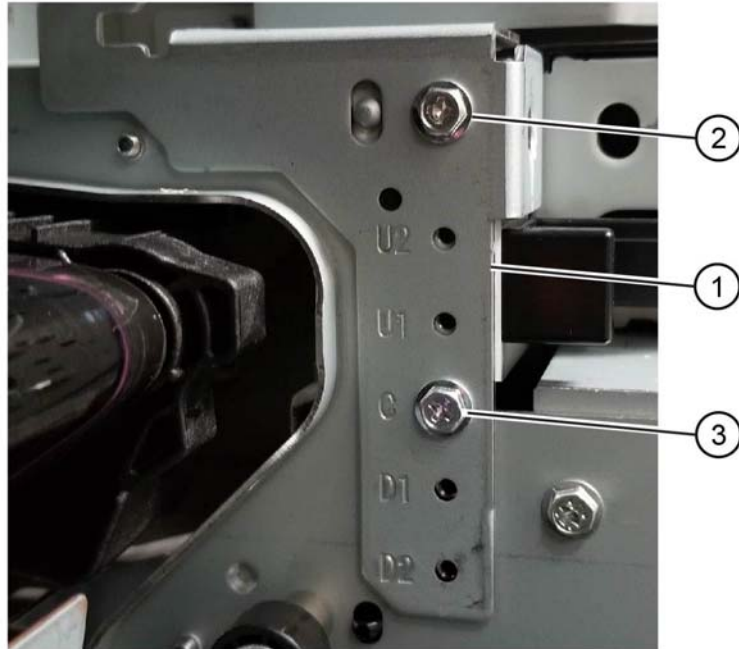
F-1-0678-A

1. Remove the fuser, [PL 10.05 Item 14](#).
2. Adjustment bracket (1), [Figure 1](#).
 - a. Loosen the top screw (2).
 - b. Remove the screw in location C (3).

Figure 1 Loosen adjustment bracket

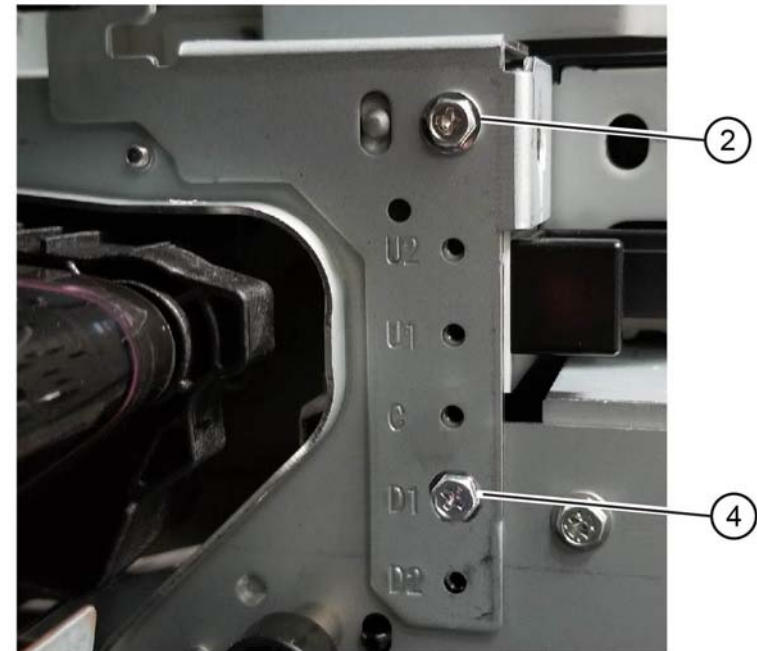
F-1-0679-A

3. Left side of the paper is wrinkled, go to Step 4. Right side of the paper is wrinkled, go to Step 5.
4. Adjust the position of the bracket for left side wrinkle.
 - a. Begin adjustment inserting the screw removed from location C into the hole marked D1 (4) and tighten both D1 (4) and the top screw (2), [Figure 2](#).

Figure 2 Initial left side adjustment

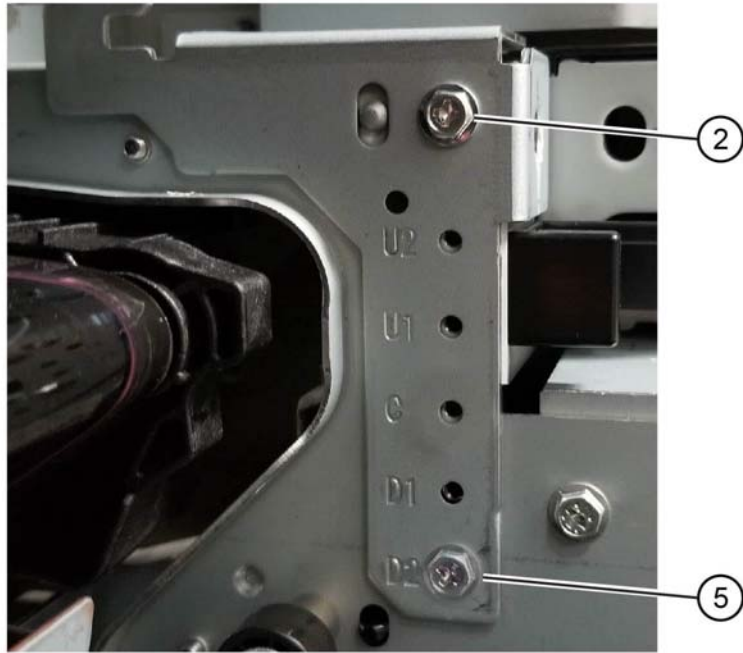
F-1-0680-A

- b. After testing if more adjustment is required, loosen the top screw (2), remove the screw from D1 (4), install into the hole marked D2 (5), tighten the top screw (2), [Figure 3](#).

Figure 3 Subsequent left side adjustment

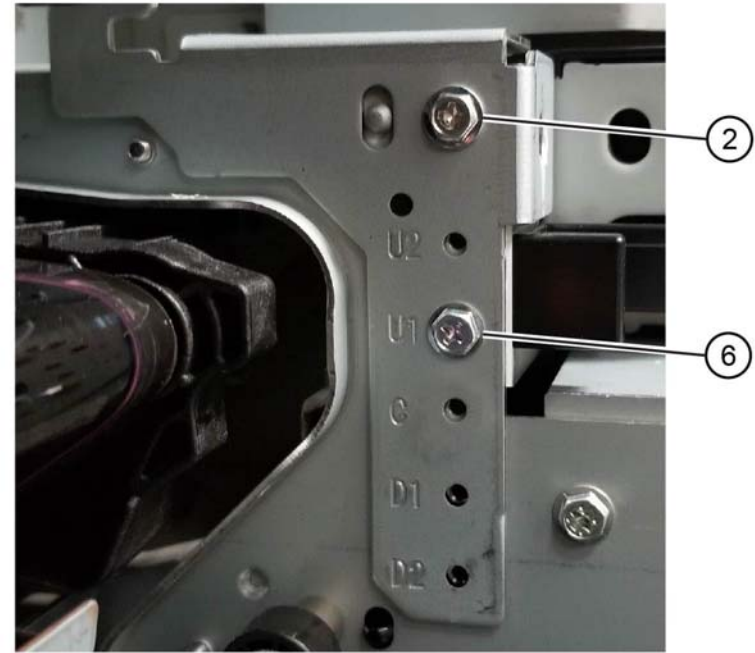
F-1-0681-A

5. Adjust the position of the bracket for right side wrinkle.
- a. Begin adjustment inserting the screw removed from location C into the hole marked U1 (6) and tighten both U1 (6) and the top screw (2), [Figure 4](#).

Figure 4 Initial right side adjustment

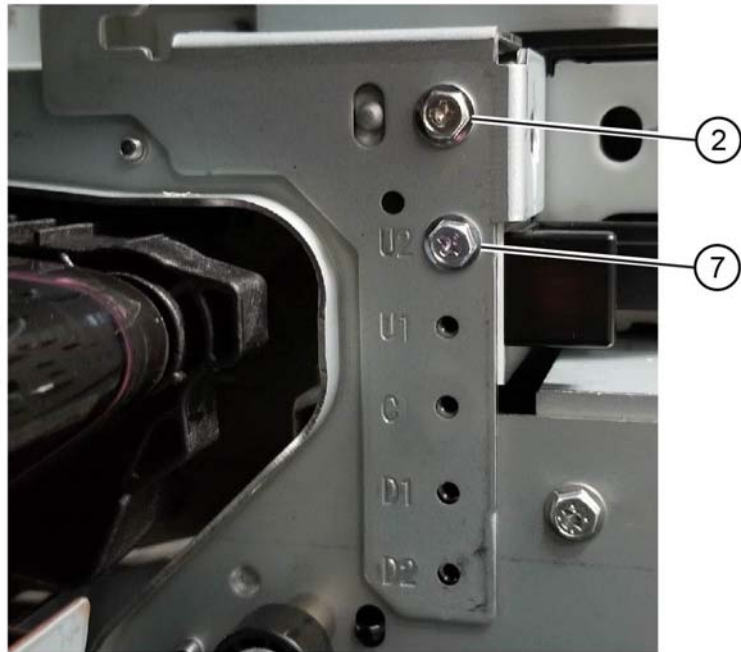
F-1-0682-A

- b. After testing if more adjustment is required, loosen the top screw (2), remove the screw from U1, install into the hole marked U2 (7), tighten the top screw (2), **Figure 5**.

Figure 5 Subsequent right side adjustment

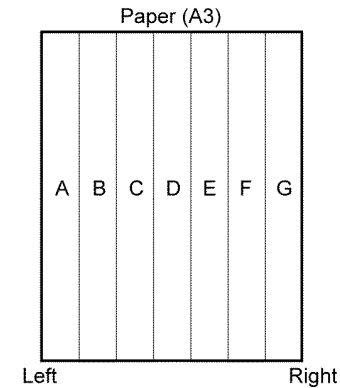
TF-1-0675-A

To supply a process of adjusting the LPH exposure amount to correct uneven density in the process direction due to various causes in the vicinity of the drum for each YMCK color individually.

The LPH Exposure Amount Adjustment can be performed as a negative correction within the range of 0 to -17(%)

Figure 1 Correction areas

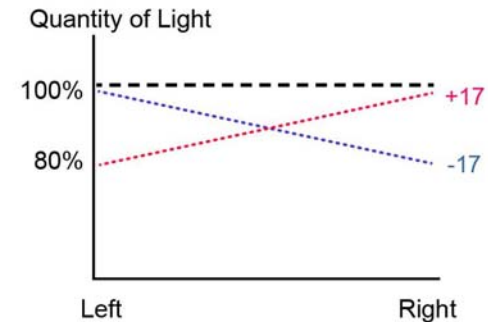
TF-1-0676-A

Figure 2 IN/OUT density correction

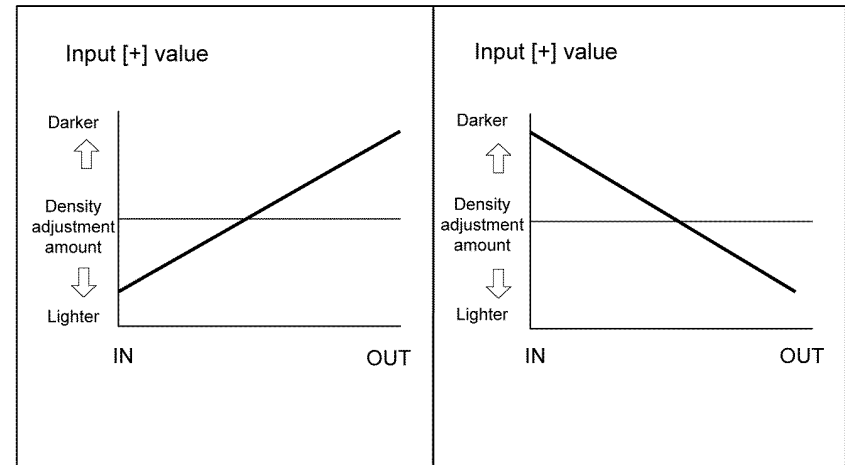
Figure 4 Density adjustment

1. Adjust the density distribution based on the printout sample. (Adjustment amount is -17~17) The greater the value, the greater the adjustment amount. [Figure 4.](#)

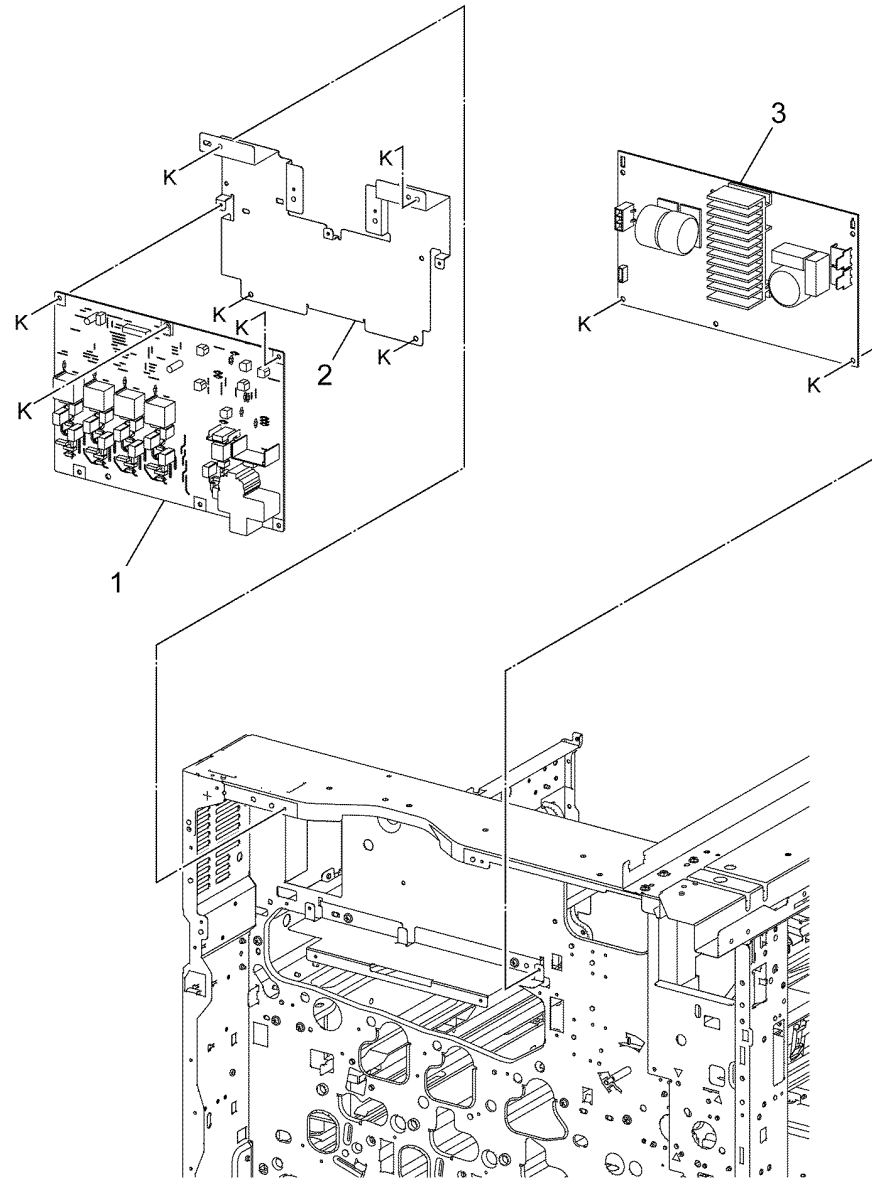
PL 1.05 Electrical - Rear (1 of 3)

Item	Part	Description
1	105E23240	BTR HVPS PWB (REP 1.1)
2	-	Bracket (Not Spared)
3	105E23001	Fuser heater power supply (110V) (REP 1.2)
-	105E22322	Fuser heater power supply (220V) (REP 1.2)
