VersaLink[®] C8000/C9000 Printer

Service Manual

VersaLink C9000 Family Service Manual

705P01418

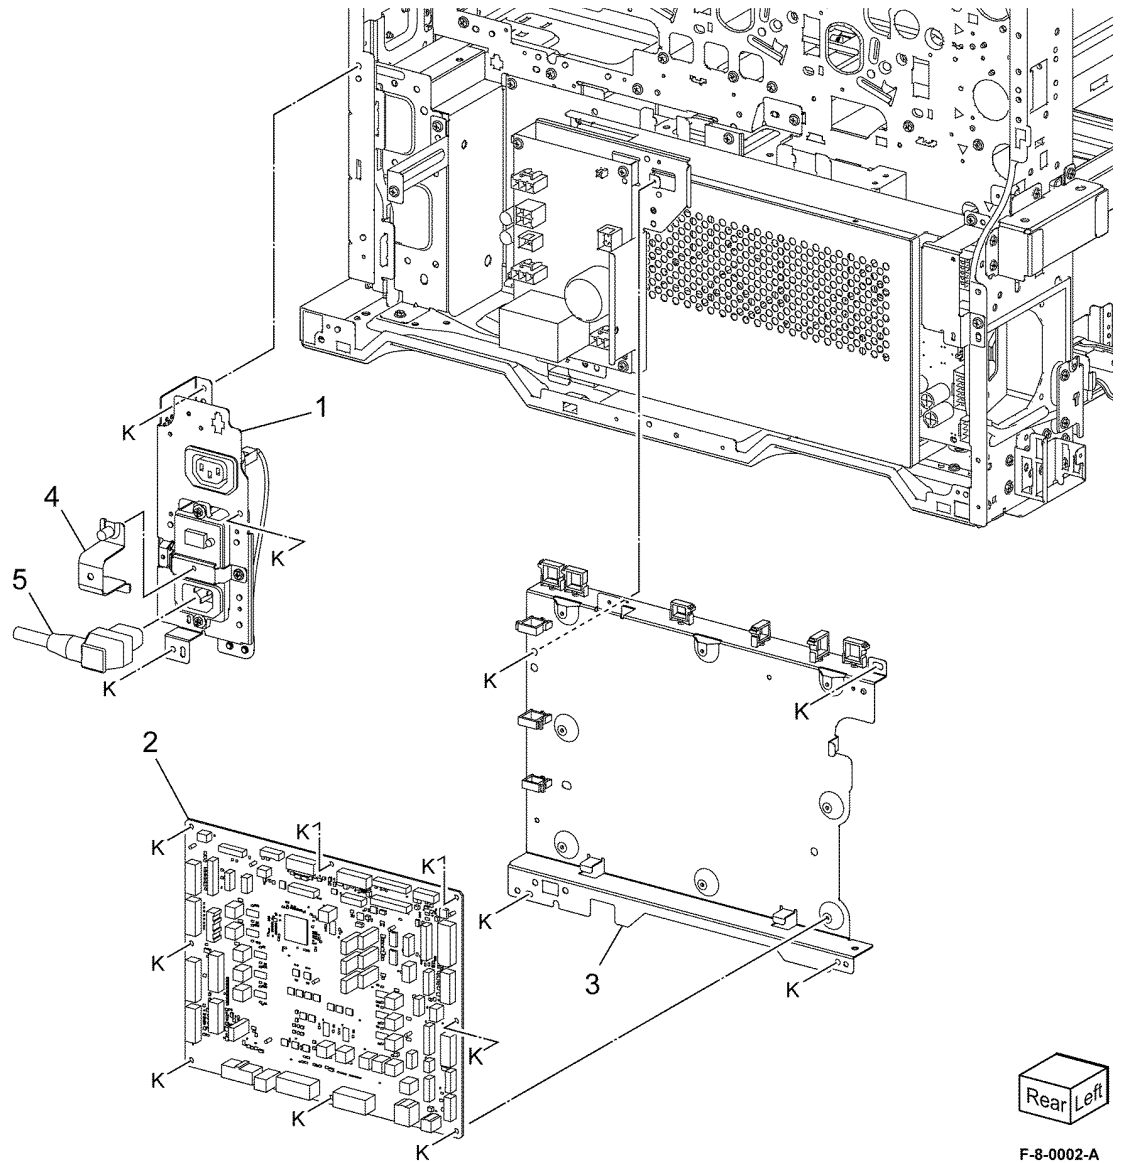
PL 1.10 Electrical - Rear (2 of 3)

Item	Part	Description
1	101K69950	GFI chassis assembly (REP 1.3)
2	960K81545	Motor drive PWB (REP 1.4)
3	-	Motor drive chassis assembly (Not Spared)
4	-	Power cord bracket (Not Spared)
5	-	Power cord (Not Spared)

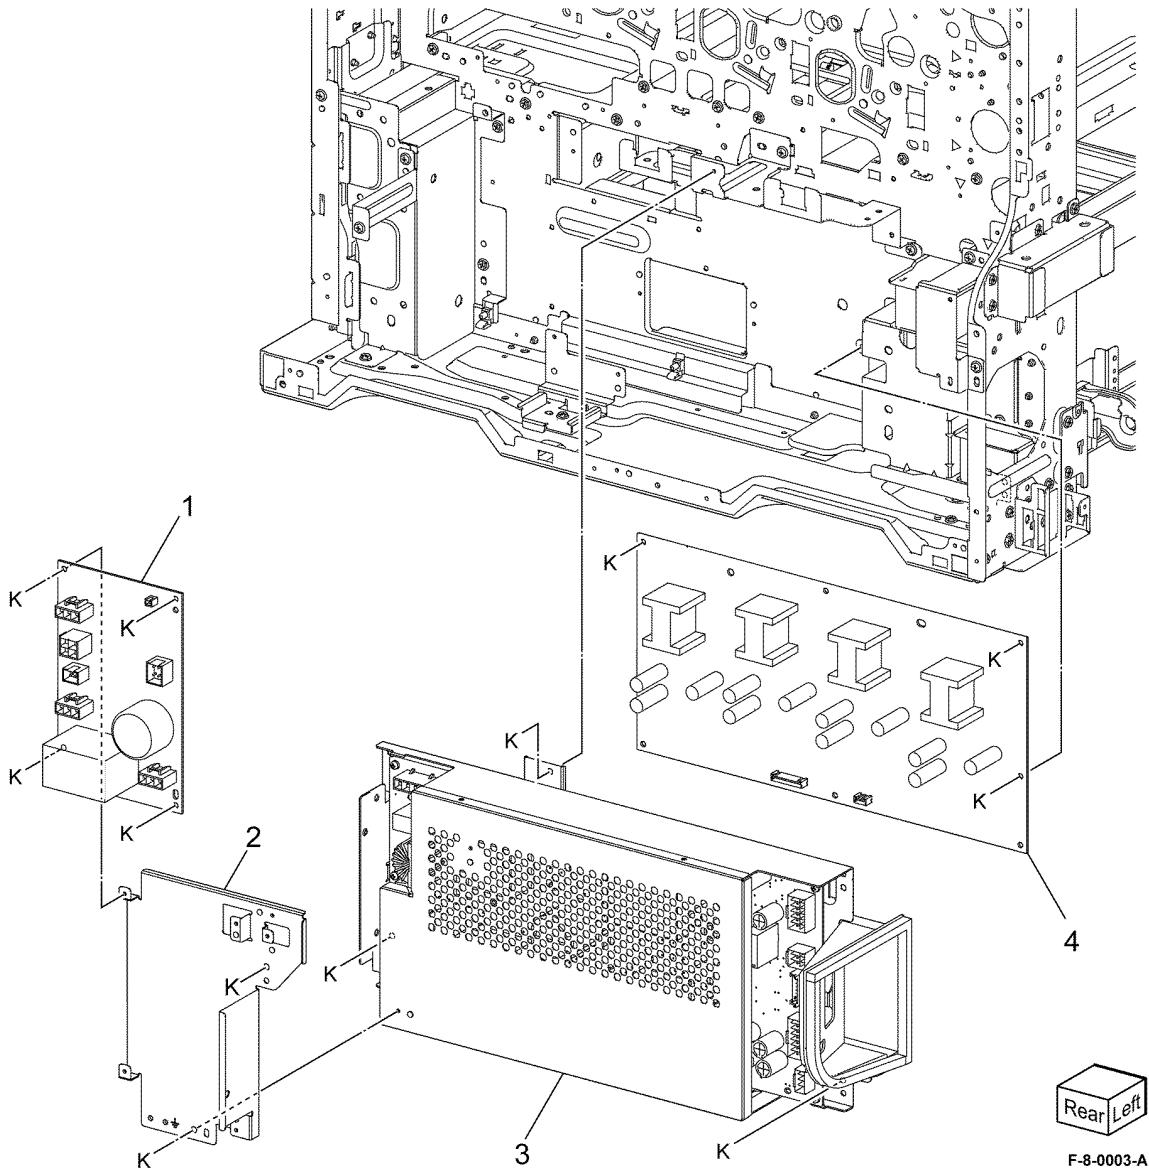
PL 1.15 Electrical - Rear (3 of 3)

Item	Part	Description
1	105K32890	AC drive PWB (110V) (REP 1.5)
-	105K33530	AC drive PWB (110V) (REP 1.5) (alternative)
-	105K32900	AC drive PWB (220V) (REP 1.5)
-	105K33540	AC drive PWB (220V) (REP 1.5) (alternative)
2	-	AC bracket (Not Spared)
3	112K91350	LVPS (REP 1.6)
4	105E22572	Developer bias HVPS PWB (REP 1.7)

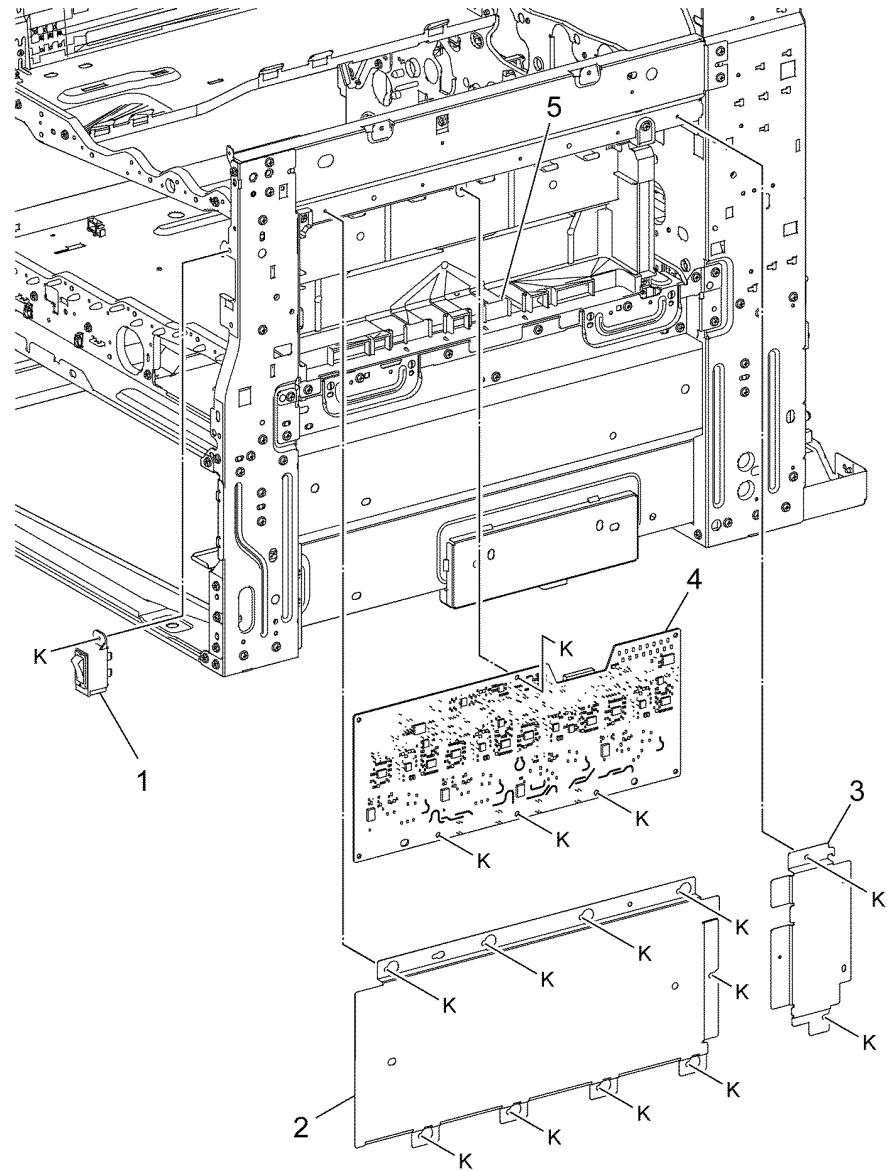
PL 1.20 Electrical - Front/Right

Item	Part	Description
1	049K35050	Main power switch (REP 1.8)
2	-	BCR HVPS cover (Not Spared)
3	-	Cover (Not Spared)
4	105E23230	BCR HVPS PWB (REP 1.9)
5	-	Conductor assembly (Not Spared)

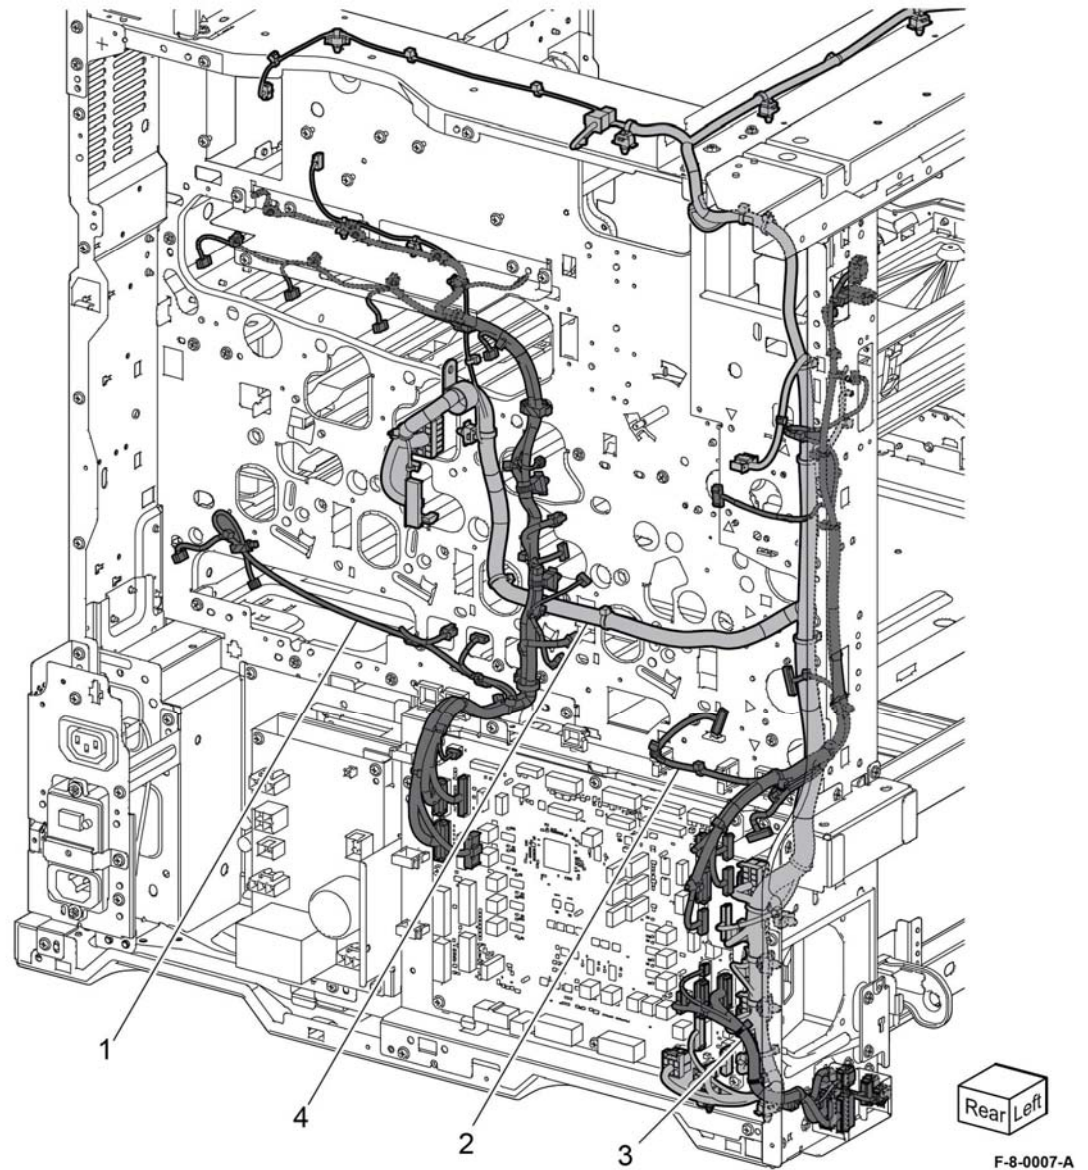
PL 1.25 Wire Harness

Item	Part	Description
1	—	Drive harness (Not Spared)
2	—	PH drive harness (Not Spared)
3	—	LH harness (Not Spared)
4	—	DC power harness (Not Spared)

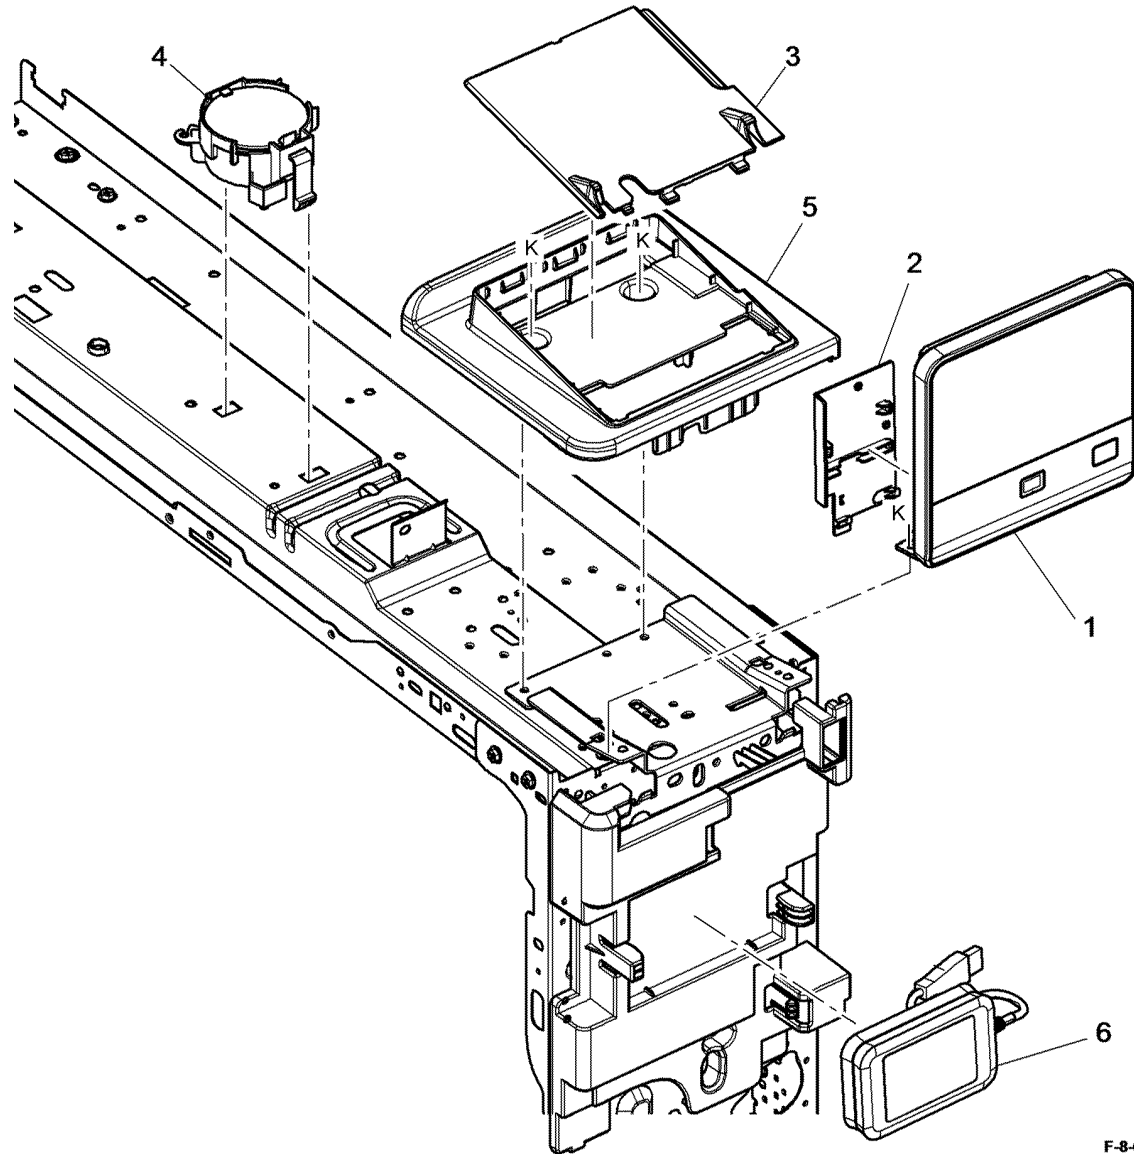
PL 2.05 User Interface

Item	Part	Description
1	948K19282	UI console assembly (REP 2.1)
2	822E32001	Cable cover (REP 2.1)
3	822E48500	UI top cover
4	-	Speaker assembly (Not Spared)
5	822E48510	UI base cover
6	-	Card reader assembly (Not Spared)

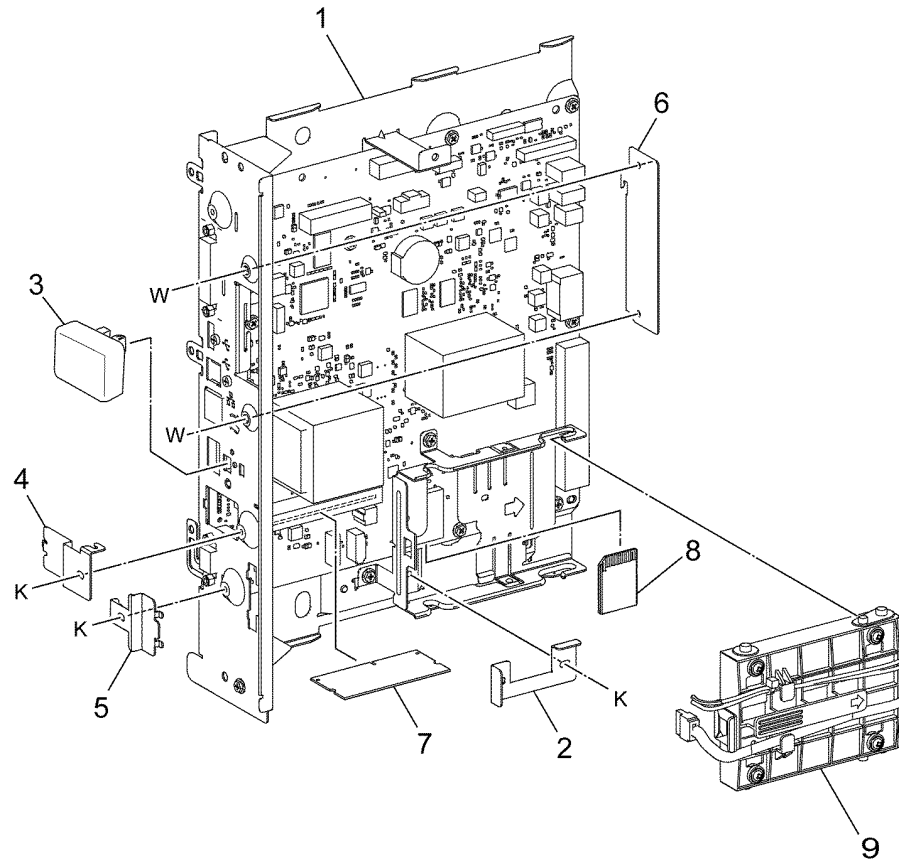
PL 3.05 Control Unit (ESS PWB)

Item	Part	Description
1	101K69280	Controller PWB assembly (REP 3.1)
2	–	SD card clip (Not Spared)
3	101K72680	Wi-fi dongle
4	–	Blanking cover (Not Spared)
5	–	SIM card blanking cover (Not Spared)
6	–	PCI blanking cover (Not Spared)
7	133K28271	DIMM (4GB)
8	540K22511	SD memory card (REP 3.2)
9	101K73920	HDD

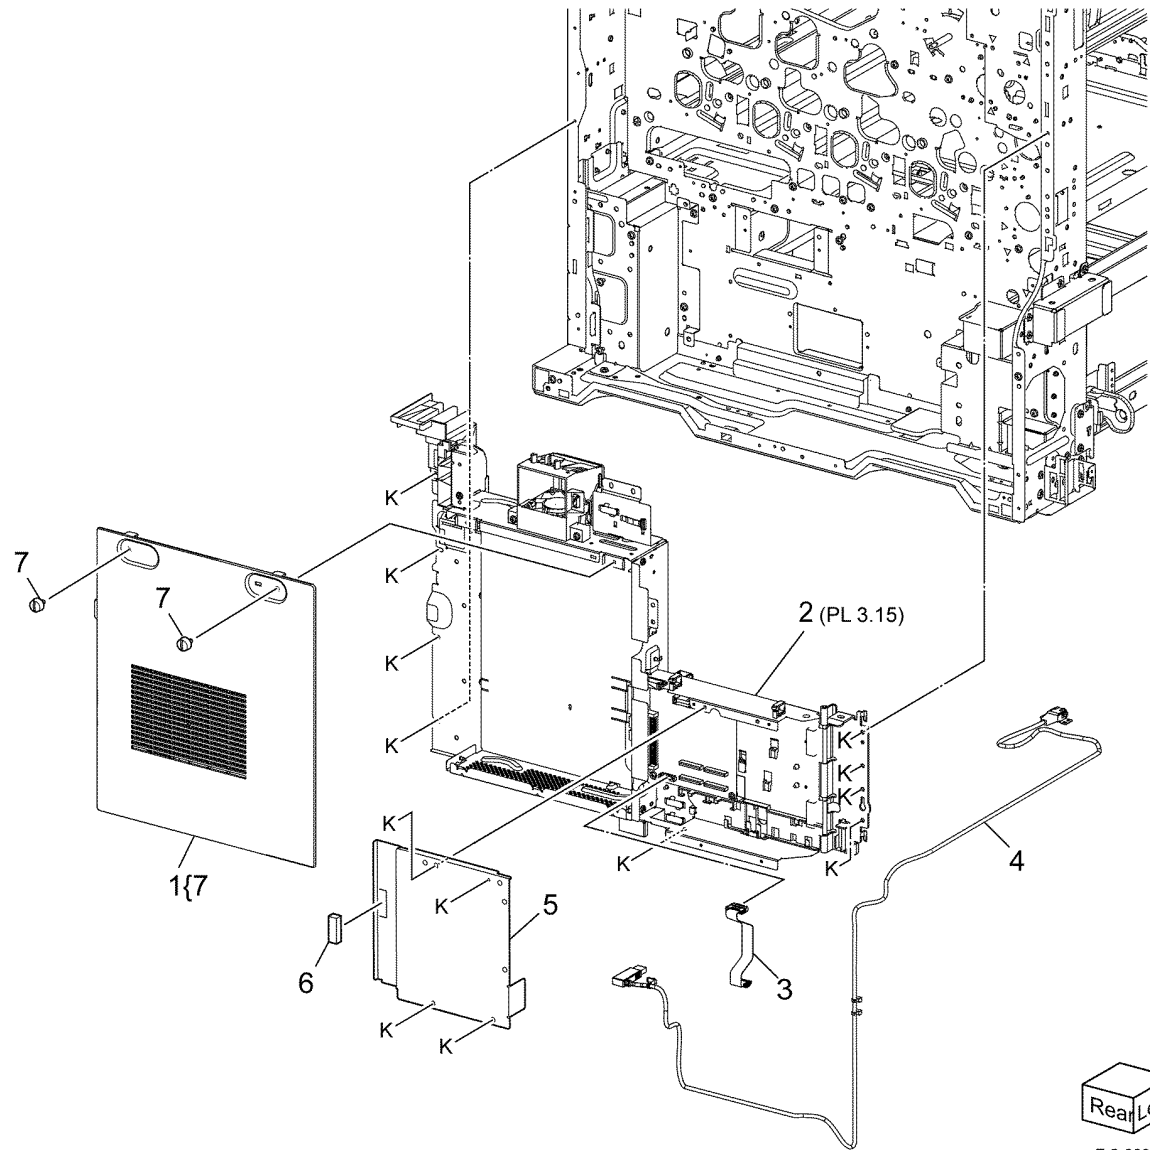
PL 3.10 Video Contact Chassis Unit

Item	Part	Description
1	607K11840	Controller cover assembly kit
2	-	Video contact chassis assembly (Not Spared)
3	117K49232	Motor drive ribbon cable
4	117K49390	USB cable
-	117K50010	USB cable (alternative)
-	117K49210	USB cable (alternative)
5	-	DFE cover (Not Spared)
6	-	Shield gasket (Not Spared)
7	-	Thumbscrew (P/O PL 3.10 Item 1)

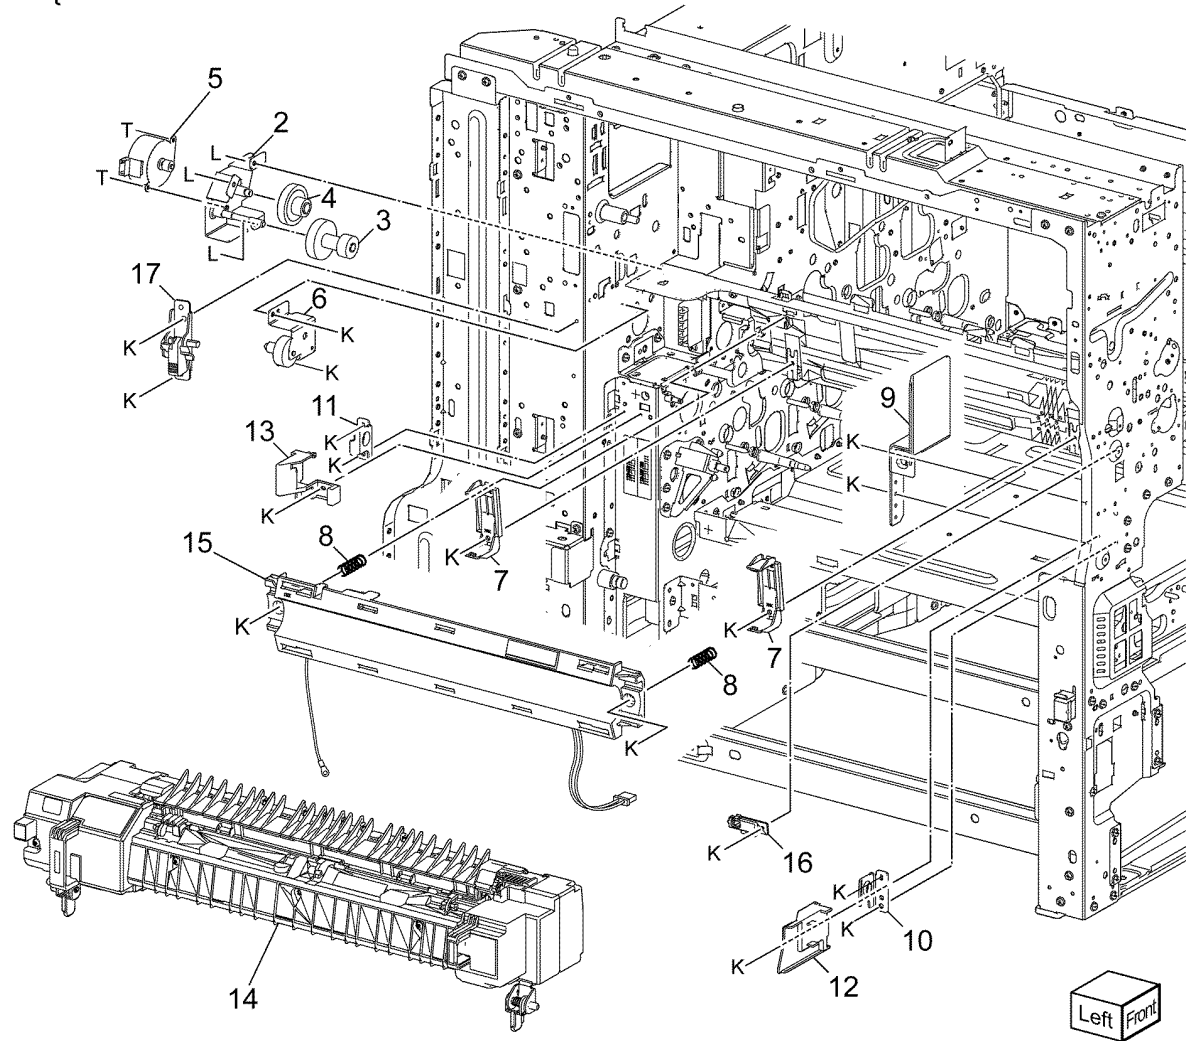
PL 10.05 Fuser

Item	Part	Description
1	007K21640	Retract motor assembly (REP 10.1)
2	-	Motor bracket (P/O PL 10.05 Item 1)
3	-	Gear (17/40T) (P/O PL 10.05 Item 1)
4	-	Gear (17/54T) (P/O PL 10.05 Item 1)
5	-	Roll latch motor (P/O PL 10.05 Item 1)
6	007K21650	Retract gear assembly
7	-	Support (Not Spared)
8	-	Spring (Not Spared)
9	-	Adjust plate (Not Spared)
10	-	Front fuser bracket (Not Spared)
11	-	Rear fuser bracket (Not Spared)
12	-	Front stopper lever (Not Spared)
13	-	Rear stopper lever (Not Spared)
14	115R00143	Fuser (110/220V) (REP 10.2)
15	-	Fuser heater coil - see below for variants
-	104K91373	110V (REP 10.3)
-	104K91393	220V (REP 10.3)
16	-	Holder (Not Spared)
17	-	Stopper lever assembly (Not Spared)

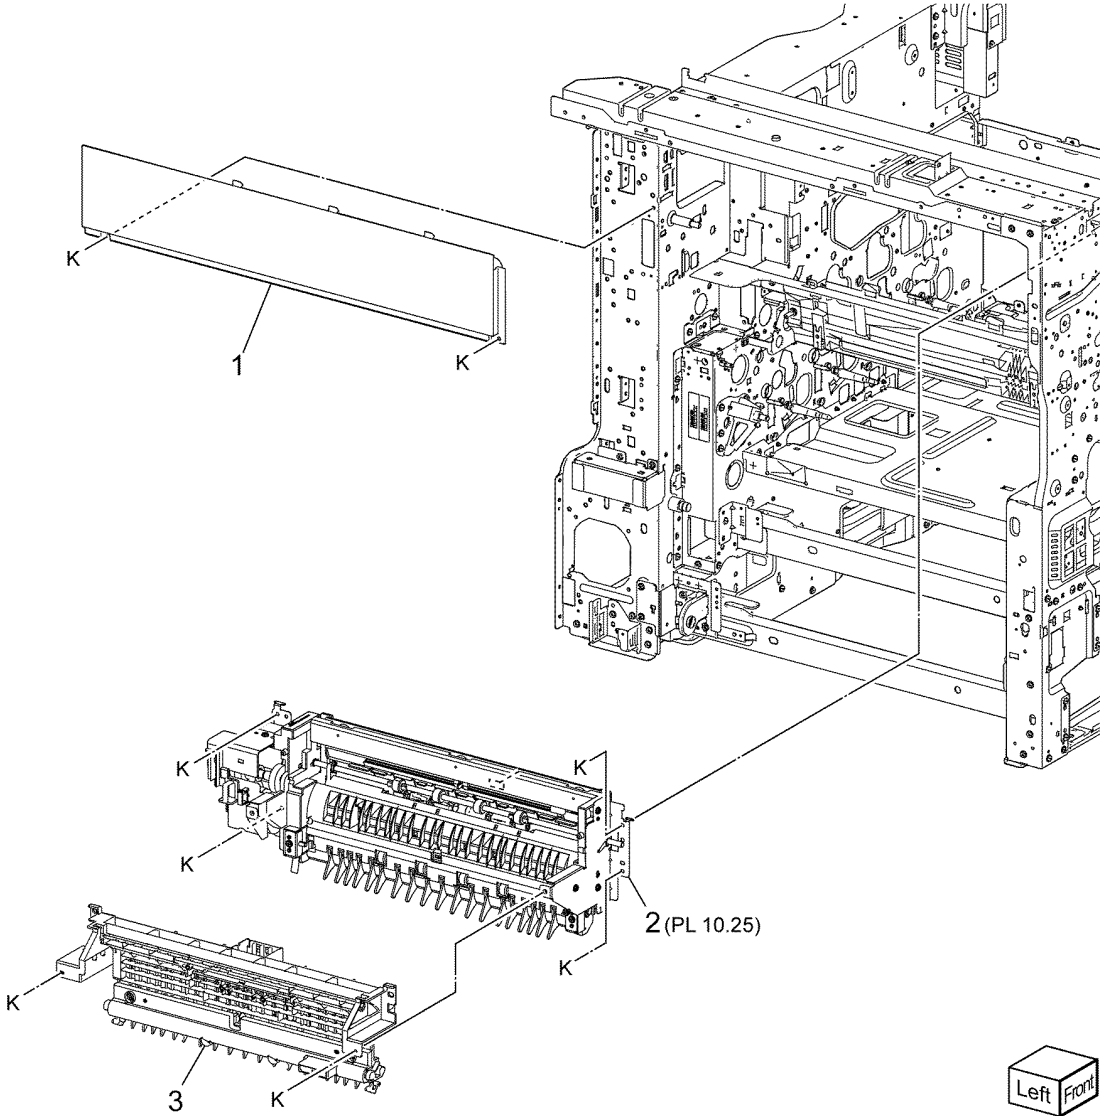
PL 10.15 Exit 2 Transport Components

Item	Part	Description
1	822E33800	Left top cover
2	859K10296	Exit 2 transport assembly (REP 10.8)
3	-	Top chute assembly (Not Spared)

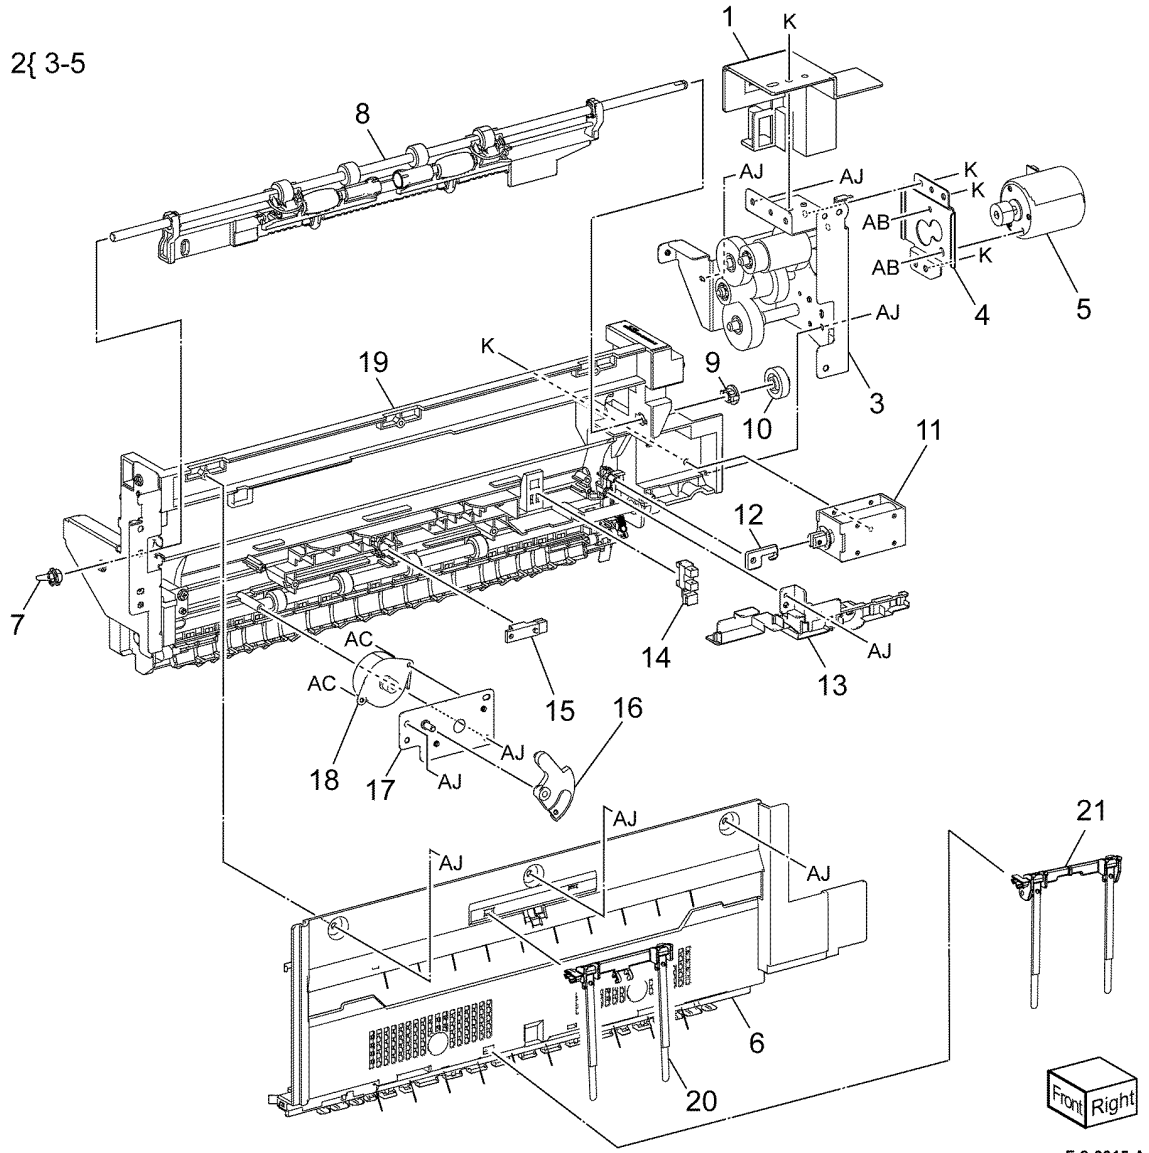
PL 10.25 Exit 2 Transport Assembly

Item	Part	Description
1	-	Harness guide (P/O PL 10.15 Item 2)
2	-	Exit 2 drive assembly (P/O PL 10.15 Item 2) (REP 10.9)
3	-	Exit 2 drive bracket assembly (P/O PL 10.25 Item 2)
4	-	Motor bracket (P/O PL 10.25 Item 2)
5	-	Exit 2 drive motor (MOT77-060) (P/O PL 10.25 Item 2)
6	-	Exit 2 guide assembly (P/O PL 10.15 Item 2)
7	-	Bearing (P/O PL 10.15 Item 2)
8	-	Exit 2 chute assembly (P/O PL 10.15 Item 2)
9	-	Bearing (P/O PL 10.15 Item 2)
10	-	Gear (P/O PL 10.15 Item 2)
11	-	Exit 1 gate solenoid (SOL77-003) (P/O PL 10.15 Item 2) (REP 10.10)
12	-	Link (P/O PL 10.15 Item 2)
13	-	Harness guide (P/O PL 10.15 Item 2)
14	-	Exit 2 OCT home position sensor (Q77-110) (P/O PL 10.15 Item 2) (REP 10.11)
15	-	Exit 2 sensor (Q77-113) (P/O PL 10.15 Item 2)
16	-	Offset gear (P/O PL 10.15 Item 2) (REP 10.12)
17	-	Motor bracket (P/O PL 10.15 Item 2)
18	-	Exit 2 OCT motor (MOT77-045) (P/O PL 10.15 Item 2)
19	-	Exit 2 transport chassis (P/O PL 10.15 Item 2)

20	036K92441	Exit 2 bail arm assembly
21	036K92431	Exit 1 bail arm assembly

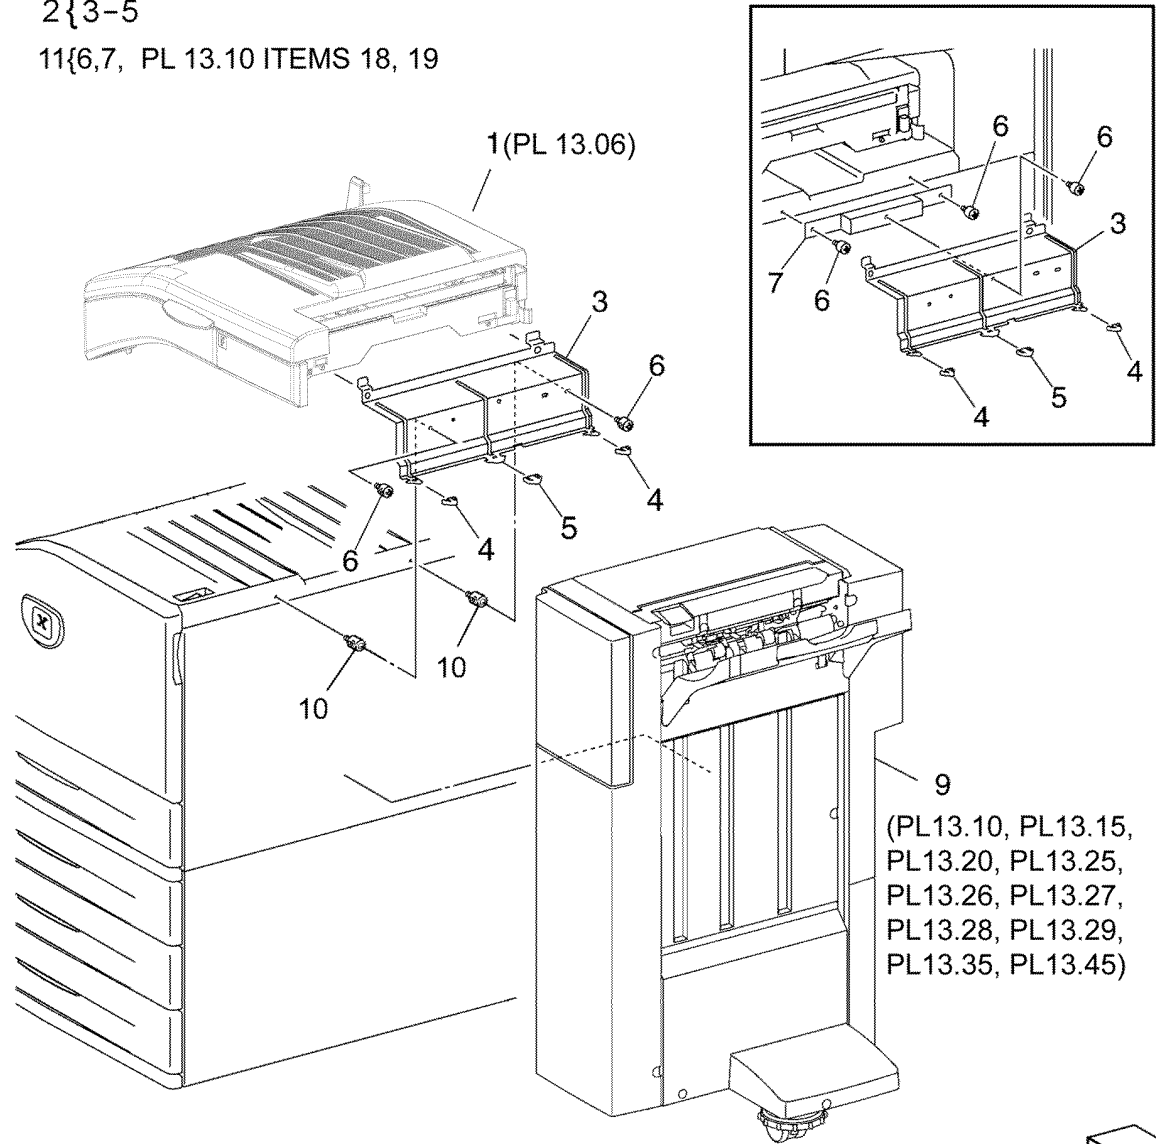
PL 13.05 Office Finisher LX - Horizontal Transport Assembly (1 of 5)

Item	Part	Description
1	859K04770	Horizontal transport assembly (REP 13.1)
2	068K59494	Docking plate assembly
3	-	Docking plate (P/O PL 13.05 Item 2)
4	-	Side guide (P/O PL 13.05 Item 2)
5	-	Center guide (P/O PL 13.05 Item 2)
6	026K81200	Thumb screw
7	868E51550	Docking bracket
8	-	Not used
9	-	Finisher LX assembly (Not Spared) (REP 13.5)
10	-	HTU spacer (Not Spared)
11	-	Gap kit

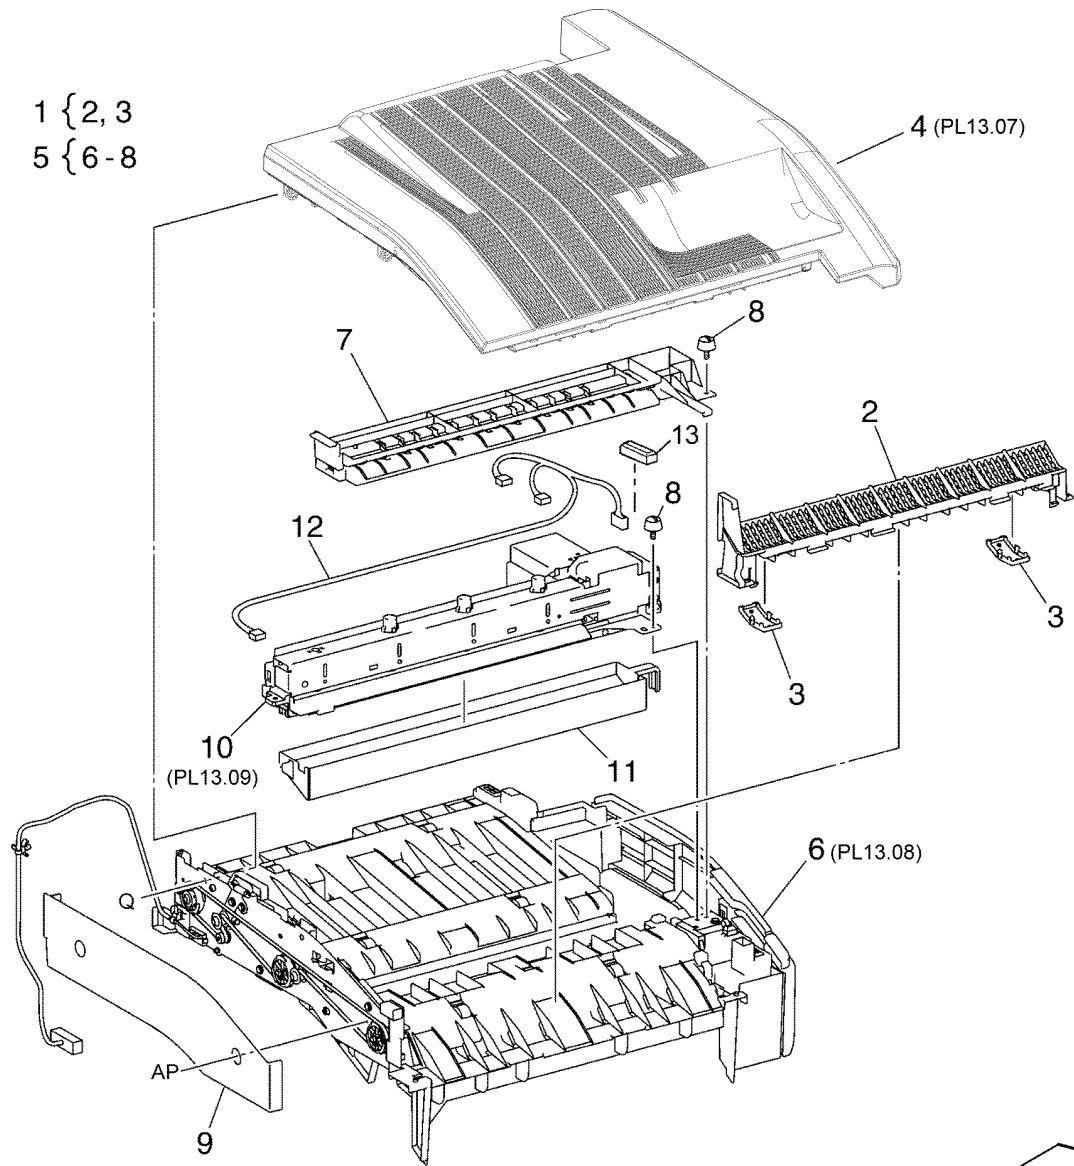
PL 13.06 Office Finisher LX - Horizontal Transport Assembly (2 of 5)

Item	Part	Description
1	-	Left cover assembly (Not Spared)
2	-	Left cover (P/O PL 13.06 Item 1)
3	-	Paper guide (P/O PL 13.06 Item 1)
4	-	Top cover assembly (Not Spared)
5	-	Lower chute assembly (Not Spared)
6	-	Lower chute assembly (P/O PL 13.06 Item 5)
7	-	Chute assembly (P/O PL 13.06 Item 5)
8	026K81200	Thumb screw
9	-	Rear cover (Not Spared)
10	180K00393	Punch assembly (2/3 Hole) (REP 13.2, ADJ 13.1)
-	180K00403	Punch assembly (2/4 Hole) (REP 13.2, ADJ 13.1)
11	695K19403	Punch box
12	-	Wire harness (Not Spared)
13	-	Connector cover (Not Spared)

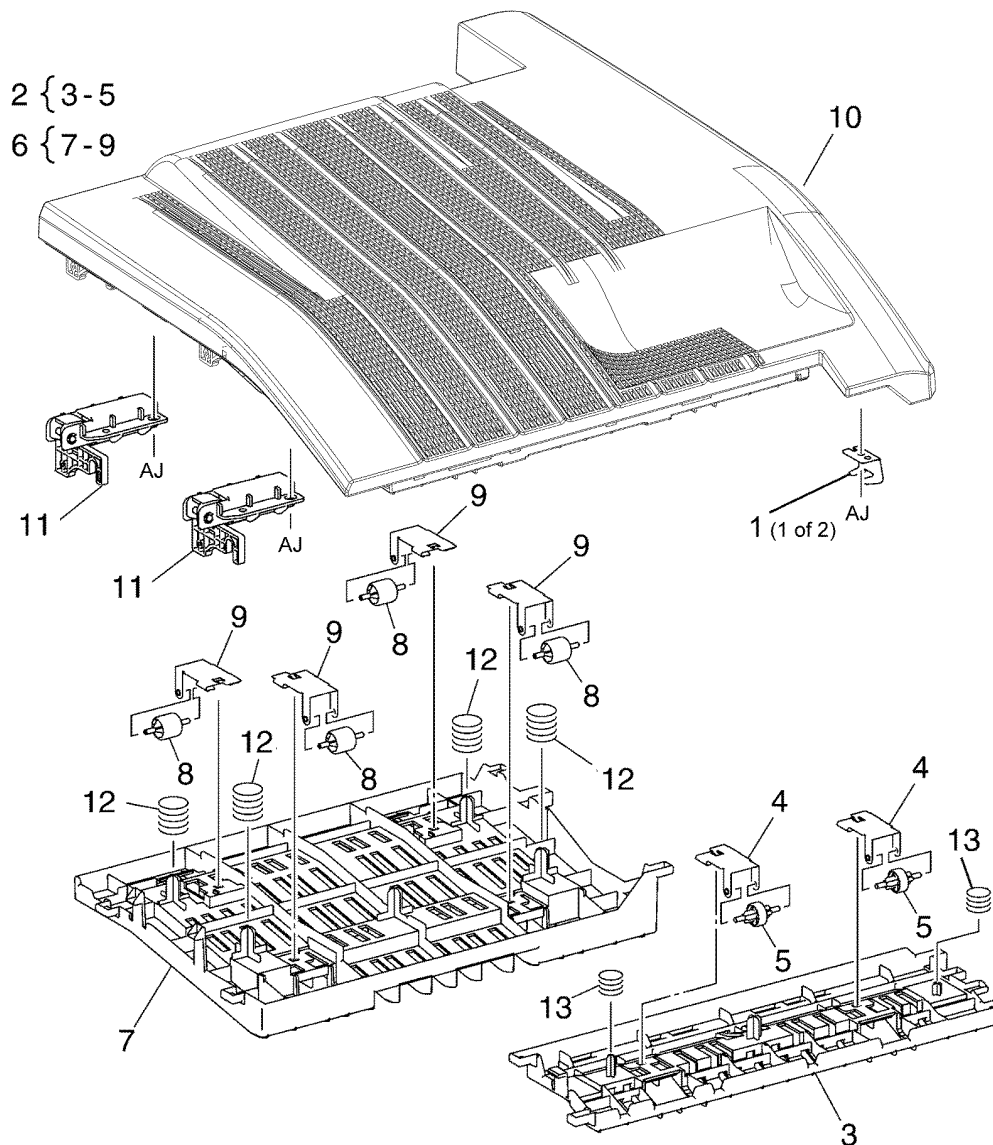
PL 13.07 Office Finisher LX - Horizontal Transport Assembly (3 of 5)

Item	Part	Description
1	-	Bracket (P/O PL 13.06 Item 4)
2	054K50020	Left chute assembly
3	-	Left chute (P/O PL 13.07 Item 2)
4	-	Pinch spring (P/O PL 13.07 Item 2)
5	-	Pinch roller (P/O PL 13.07 Item 2)
6	054K35246	Right chute assembly
7	-	Right chute (P/O PL 13.07 Item 6)
8	-	Nip roll (P/O PL 13.07 Item 6)
9	-	Nip spring (P/O PL 13.07 Item 6)
10	-	Top cover (Not Spared)
11	-	Horizontal transport counter balance (Not Spared)
12	-	Spring (Not Spared)
13	-	Spring (Not Spared)

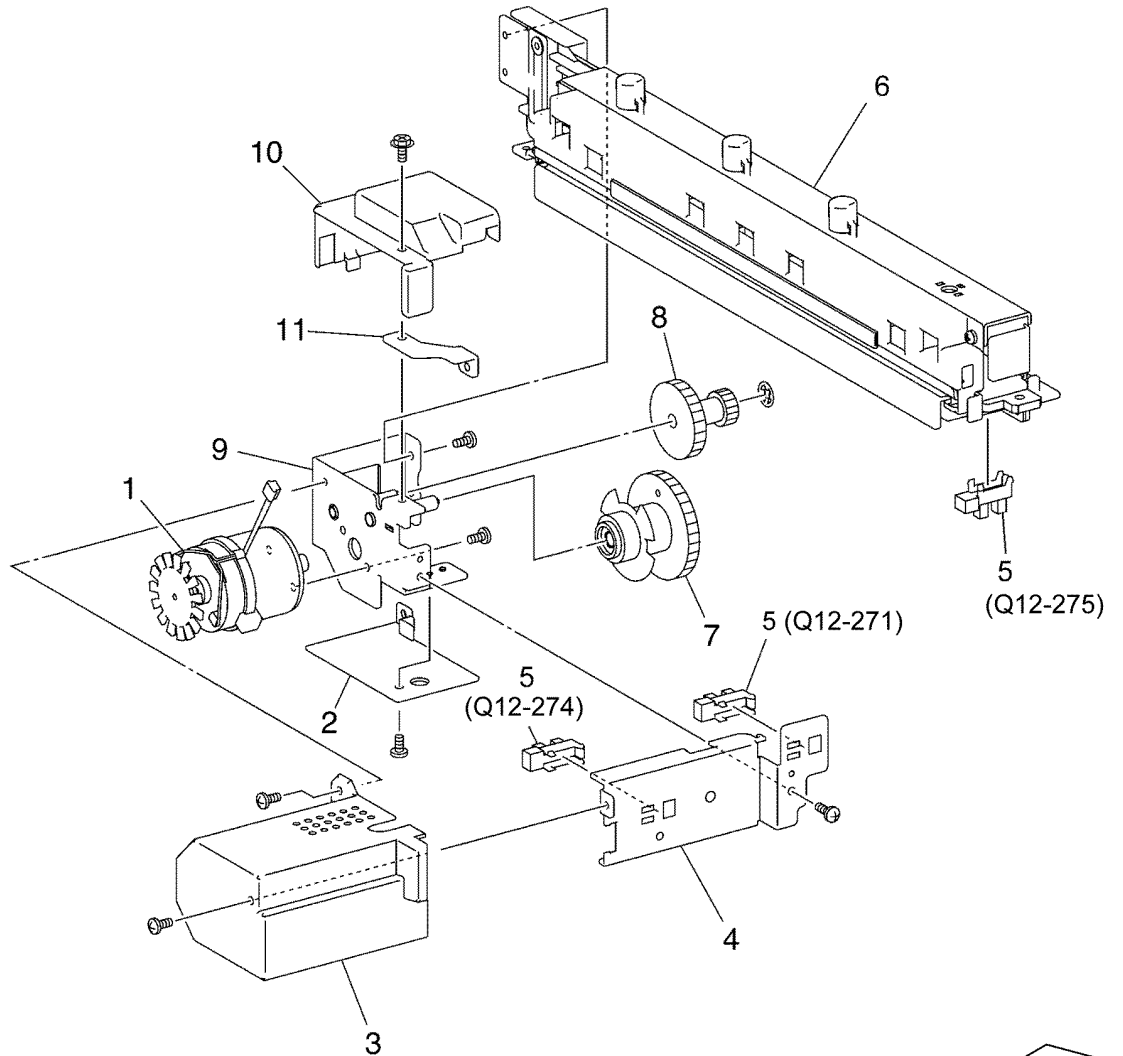
PL 13.09 Office Finisher LX - Horizontal Transport Assembly (5 of 5)

Item	Part	Description
1	-	Punch motor (MOT12-074) (P/O PL 13.06 Item 10)
2	-	Punch lower cover (P/O PL 13.06 Item 10)
3	-	Punch motor cover (P/O PL 13.06 Item 10)
4	-	Sensor bracket (P/O PL 13.06 Item 10)
5	930W00111	Punch encoder sensor (Q12-274)/ Punch home sensor (Q12-271)/ Punch box set sensor (Q12-275)
6	-	Punch frame assembly (P/O PL 13.06 Item 10)
7	-	Encoder/gear assembly (P/O PL 13.06 Item 10)
8	-	Gear (P/O PL 13.06 Item 10)
9	-	Motor bracket (P/O PL 13.06 Item 10)
10	-	Punch top cover (P/O PL 13.06 Item 10)
11	-	Bracket (P/O PL 13.06 Item 10)

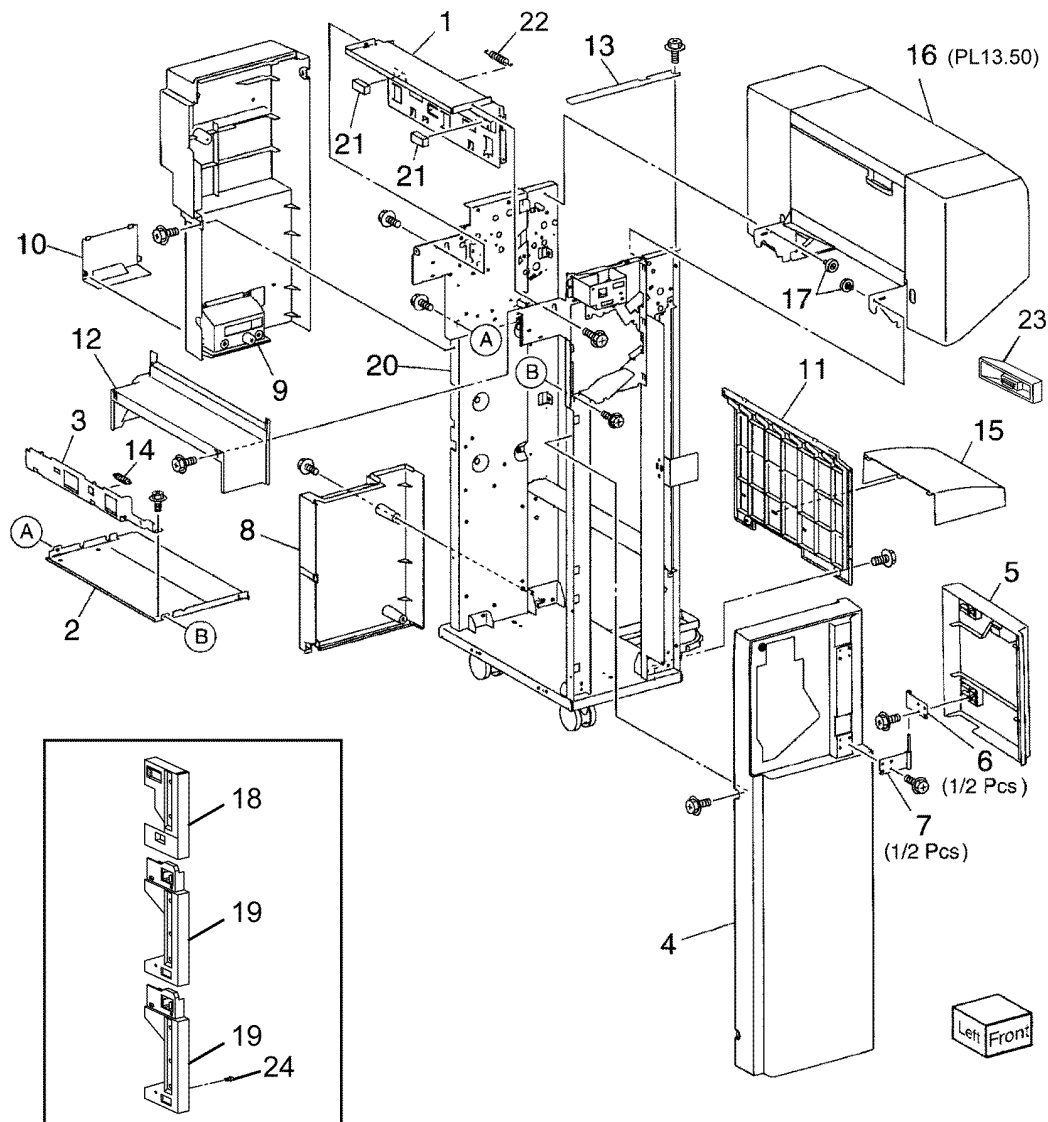
PL 13.10 Office Finisher LX Covers

Item	Part	Description
1	848E22730	Plate
2	-	Lower plate (Not Spared)
3	-	Docking lever (Not Spared)
4	848E75671	Front cover (REP 13.6)
5	848K57230	Front door
6	-	Bracket (Not Spared)
7	-	Hinge (Not Spared)
8	-	Rear lower cover (Not Spared) (REP 13.8)
9	-	Rear upper cover (Not Spared) (REP 13.7)
10	-	Connector cover (Not Spared)
11	848E75711	Stacker lower cover (REP 13.11)
12	-	LH cover (Not Spared)
13	-	Cover (Not Spared)
14	-	Spring (Not Spared)
15	-	Foot cover (Not Spared) (REP 13.10)
16	801K30704	Booklet maker assembly (REP 13.31)
17	-	Thumb screw (Not Spared)
18	-	Upper adjust cover (Not Spared)
19	-	Lower adjust cover (Not Spared)
20	-	Base frame assembly (Not Spared)
21	835E43650	Gasket
22	-	Extension spring (Not Spared)
23	-	Paper guide (Not Spared)
24	-	Thumb screw (Not Spared)

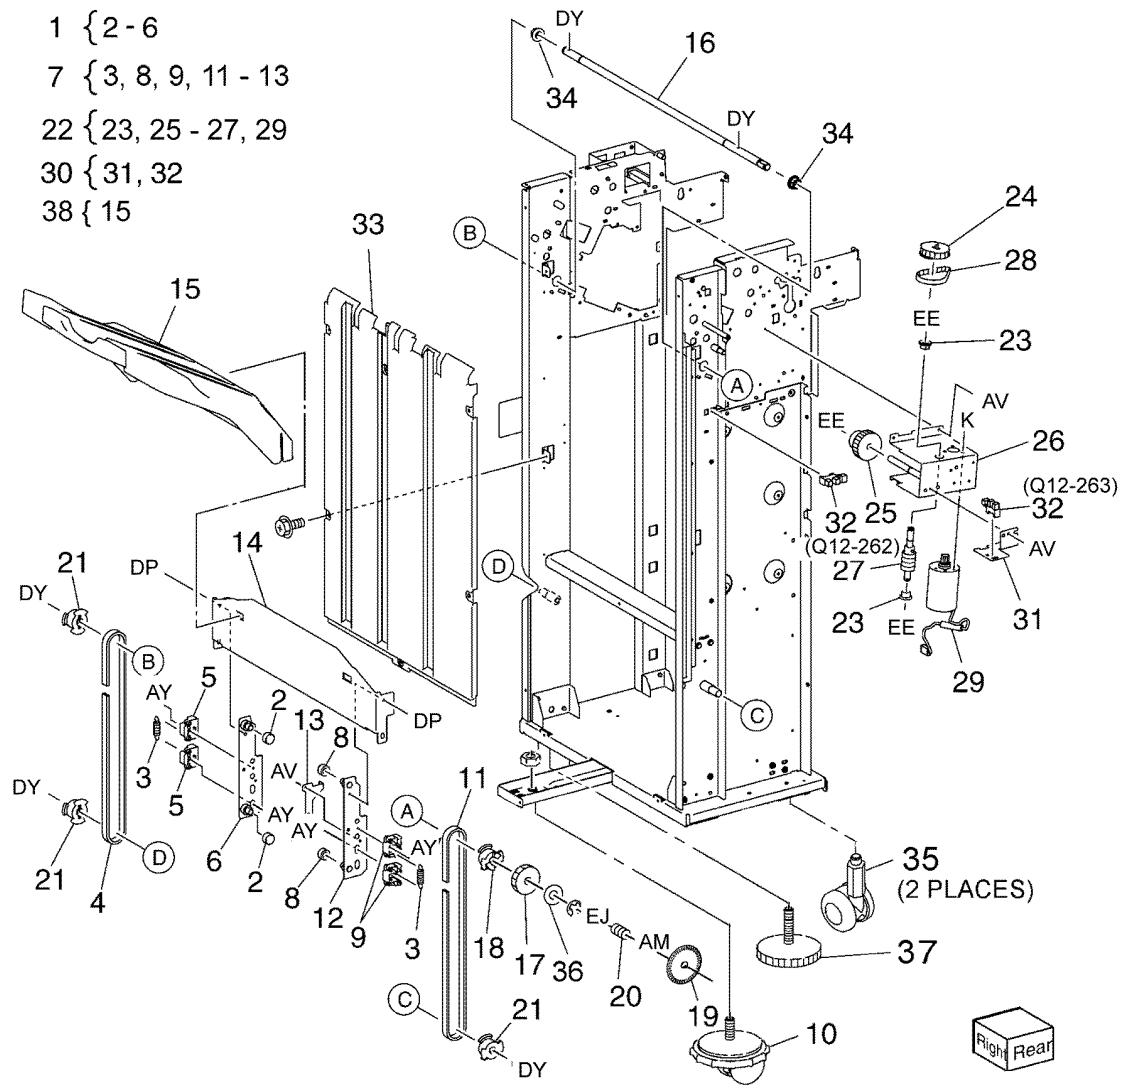
PL 13.15 Office Finisher LX Stacker

Item	Part	Description
1	-	Front carriage assembly (Not Spared) (REP 13.29)
2	-	Bearing (P/O PL 13.15 Item 1)
3	-	Spring (P/O PL 13.15 Item 1)
4	-	Front stacker belt (P/O PL 13.15 Item 1)
5	-	Clamp (P/O PL 13.15 Item 1)
6	-	Front carriage assembly (P/O PL 13.15 Item 1)
7	-	Rear carriage assembly (REP 13.29)
8	-	Bearing (P/O PL 13.15 Item 7)
9	-	Clamp (Not Spared)
10	-	Knob caster assembly (Not Spared)
11	-	Rear stacker belt (P/O PL 13.15 Item 7)
12	-	Rear carriage (P/O PL 13.15 Item 7)
13	-	Actuator (P/O PL 13.15 Item 7)
14	-	Carriage tray (Not Spared)
15	-	Stacker tray (REP 13.20)
16	-	Shaft (Not Spared)
17	-	Gear (Not Spared)
18	-	Pulley (Not Spared)
19	146E90651	Encoder
20	-	Spring (Not Spared)
21	-	Pulley (18T) (Not Spared)
22	068K58304	Stacker elevator motor assembly
23	-	Bearing (P/O PL 13.15 Item 22)
24	-	Pulley (60T) (Not Spared)
25	-	Gear (15T/37T) (P/O PL 13.15 Item 22)
26	-	Motor bracket (P/O PL 13.15 Item 22)

27	-	Worm shaft (P/O PL 13.15 Item 22)
28	-	Belt (Not Spared)
29	-	Stacker elevator motor (MOT12-060) (P/O PL 13.15 Item 22) (REP 13.19)
30	-	Stacker encoder sensor assembly (Not Spared)
31	-	Bracket (P/O PL 13.15 Item 30)
32	930W00111	Stacker encoder sensor (Q12-263)/stacker paper sensor (Q12-262)
33	-	Stacker upper cover (Not Spared) (REP 13.12)
34	-	Bearing (Not Spared)
35	017K96450	Caster assembly
36	-	Washer (Not Spared)
37	017K94901	Adjustable foot assembly
38	607K04580	Stacker tray kit
