VersaLink[®] C8000/C9000 Printer

Service Manual

VersaLink C9000 Family Service Manual

705P01418

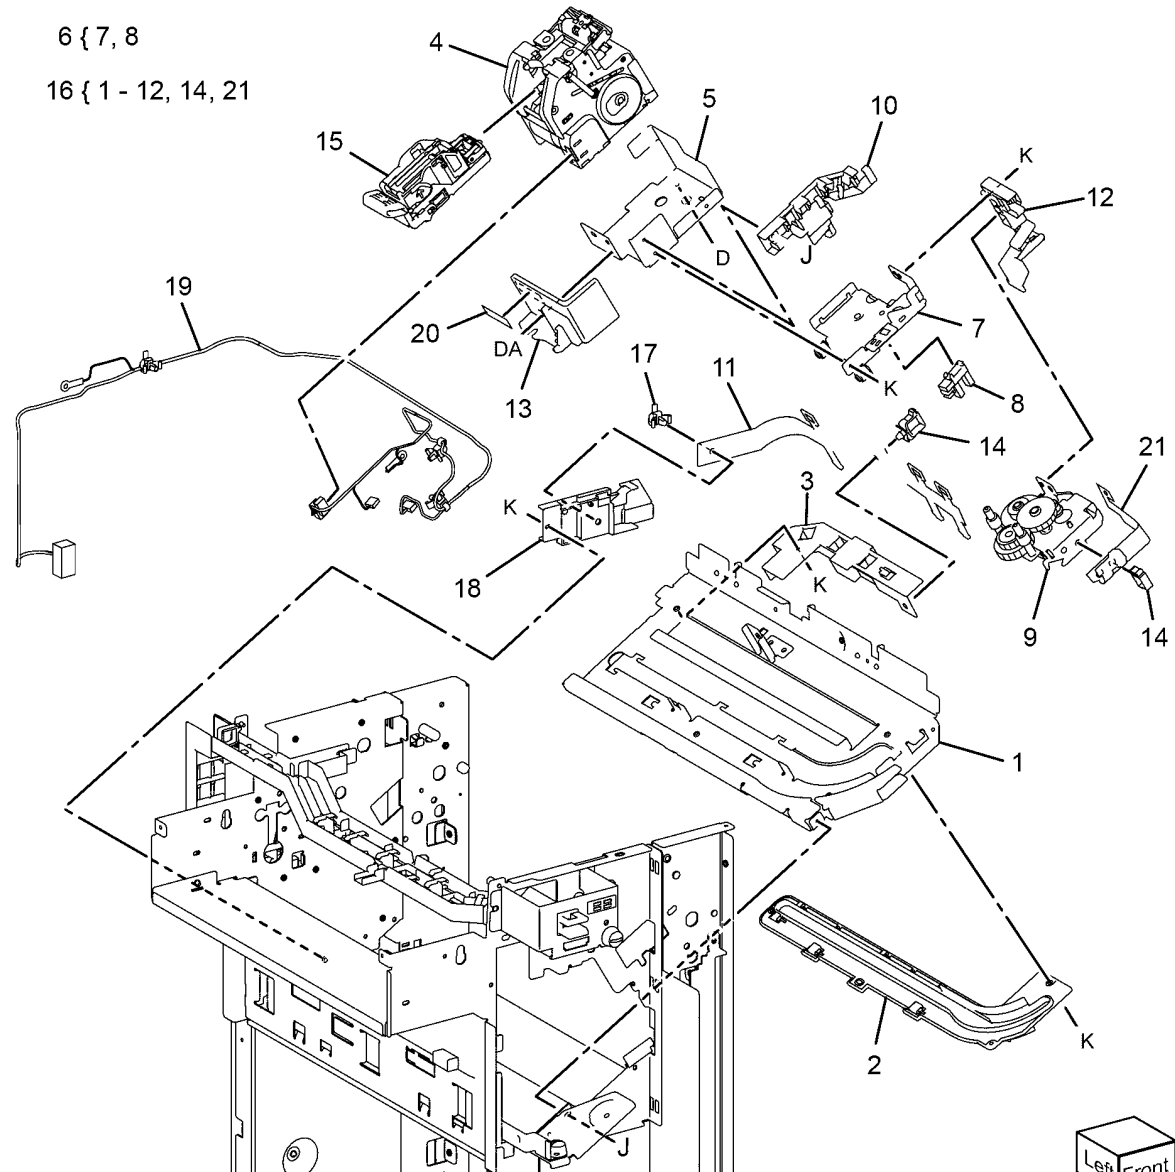
PL 13.20 Office Finisher LX Stapler

Item	Part	Description
1	-	Base frame (P/O PL 13.20 Item 16)
2	-	Rail (P/O PL 13.20 Item 16)
3	-	Harness guide (P/O PL 13.20 Item 16)
4	029K93260	Stapler assembly (REP 13.16)
5	-	Holder (P/O PL 13.20 Item 16)
6	-	Stapler move position sensor assembly (Not Spared)
7	-	Bracket (P/O PL 13.20 Item 6)
8	130E94940	Stapler move position sensor (Q12-241)
9	068K58811	Stapler move motor assembly (MOT12-046) (REP 13.15)
10	-	Harness guide (P/O PL 13.20 Item 16)
11	-	Harness support guide (P/O PL 13.20 Item 16)
12	-	Harness guide (P/O PL 13.20 Item 16)
13	-	Stapler cover (Not Spared)
14	-	Clamp (P/O PL 13.20 Item 16)
15	-	Stapler cartridge (See NOTE)
16	801K64900	Stapler unit
17	-	Cable band (Not Spared)
18	-	Harness guide (Not Spared)
19	952K35890	Wire harness
20	-	Label (Not Spared)
21	-	Stapler move motor bracket (P/O PL 13.20 Item 9)

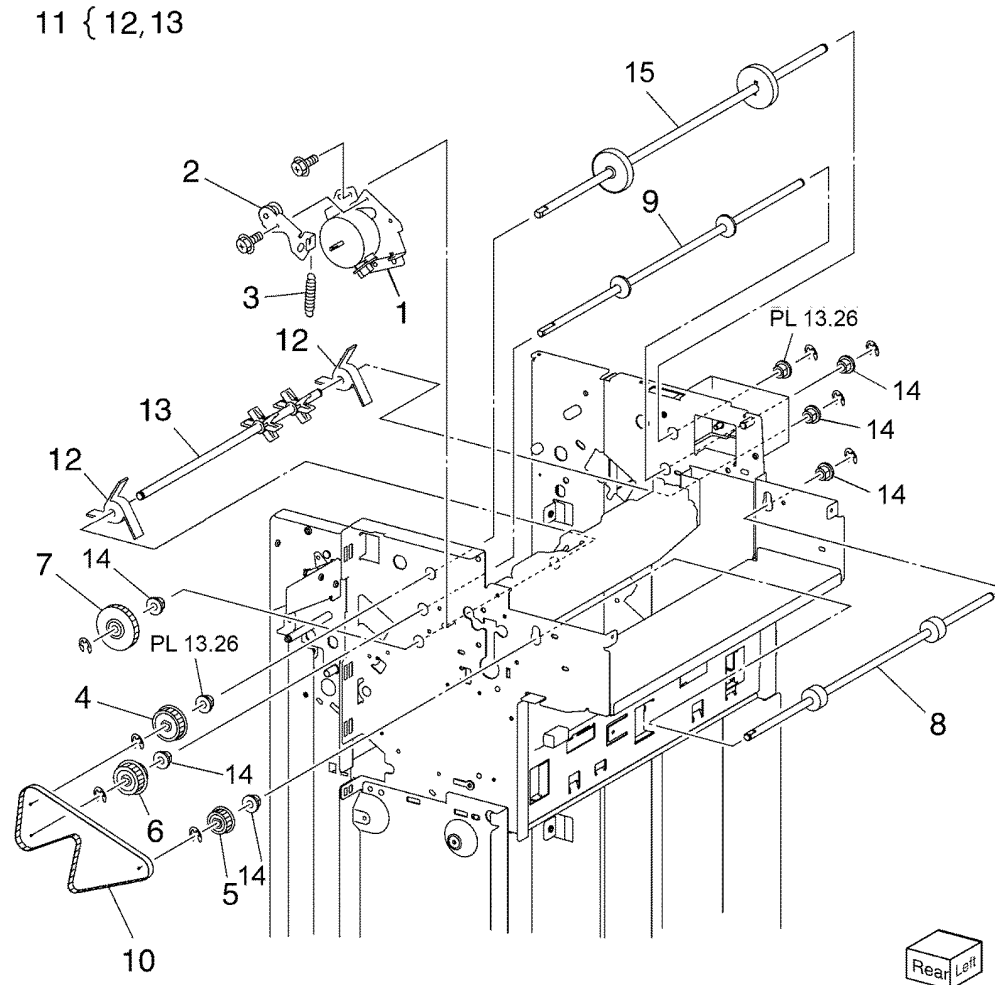
PL 13.29 Office Finisher LX Ejector (5 of 5)

Item	Part	Description
1	068K58823	Transport motor (MOT12-013)
2	-	Tension roller assembly (Not Spared)
3	-	Spring (Not Spared)
4	-	Pulley (30T) (Not Spared)
5	-	Pulley (41T) (Not Spared)
6	-	Gear/Pulley (27T/30T) (Not Spared)
7	-	Gear (Not Spared)
8	059K55082	Entrance roller
9	059K55092	Exit roller
10	-	Transport belt (Not Spared) (REP 13.21)
11	006K98010	Paddle shaft assembly
12	-	Cyclone paddle (P/O PL 13.29 Item 11)
13	-	Paddle shaft (P/O PL 13.29 Item 11)
14	413W75959	Bearing
15	-	Eject drive shaft (REF: PL 13.26 Item 28)

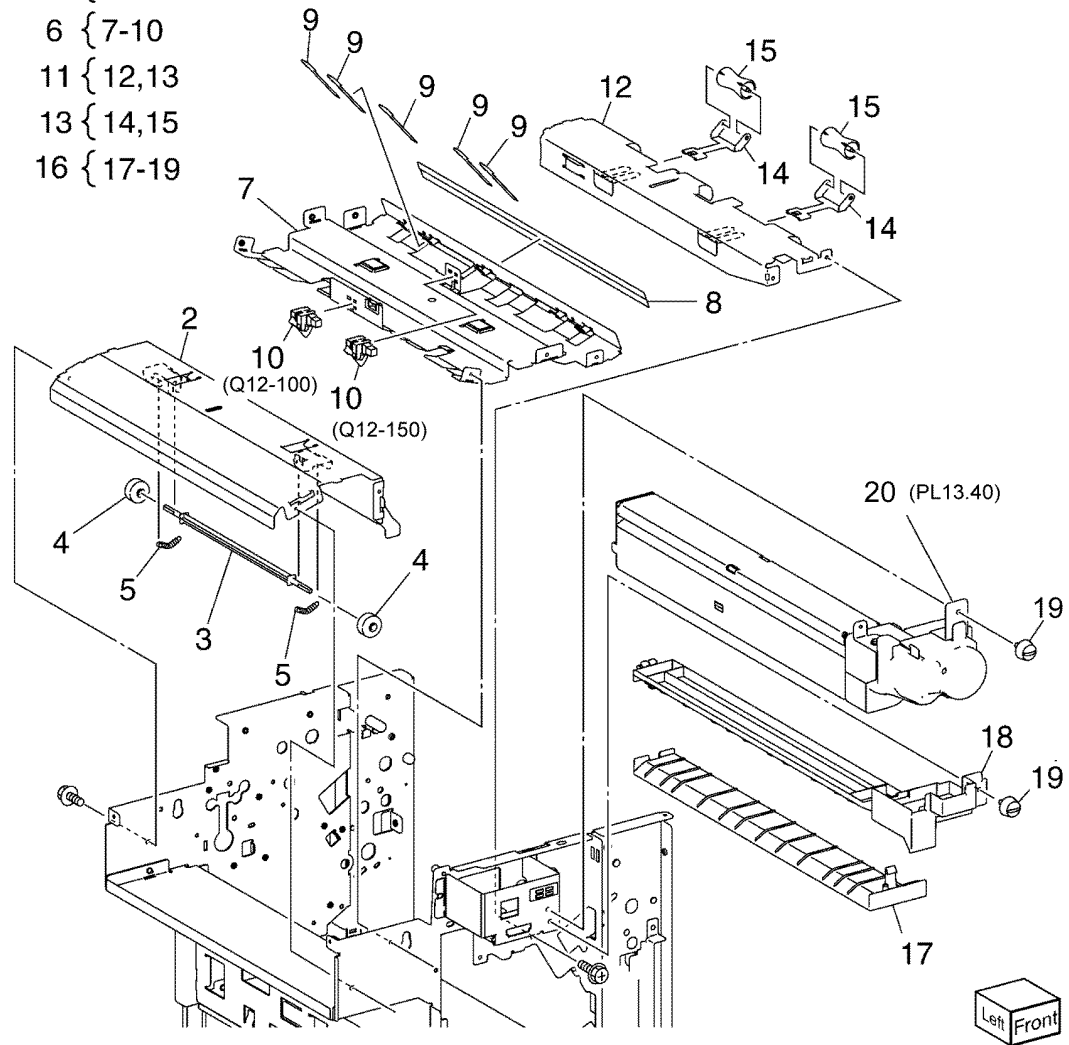
PL 13.35 Office Finisher LX Exit and Folder Assembly

Item	Part	Description
1	054K35532	Lower chute assembly
2	-	Lower chute (P/O PL 13.35 Item 1)
3	-	Shaft (P/O PL 13.35 Item 1)
4	-	Nip roll (P/O PL 13.35 Item 1)
5	-	Spring (P/O PL 13.35 Item 1)
6	054K35540	Exit upper chute assembly
7	-	Exit upper chute (P/O PL 13.35 Item 6)
8	-	Static eliminator (P/O PL 13.35 Item 6)
9	-	Paper guide (P/O PL 13.35 Item 6)
10	130K88311	Compiler exit sensor (Q12-150)/ Finisher entrance sensor (Q12-100)
11	054K48531	Exit lower chute assembly
12	-	Exit lower chute (P/O PL 13.35 Item 11)
13	-	Nip roll assembly (P/O PL 13.35 Item 11)
14	-	Spring (P/O PL 13.35 Item 13)
15	-	Nip roll (P/O PL 13.35 Item 13)
16	607K03960	Chute assembly
17	-	Lower chute (P/O PL 13.35 Item 16)
18	-	Upper chute (P/O PL 13.35 Item 16)
19	026K81200	Thumb screw
20	695K18692	Crease assembly (Option) (REP 13.18)

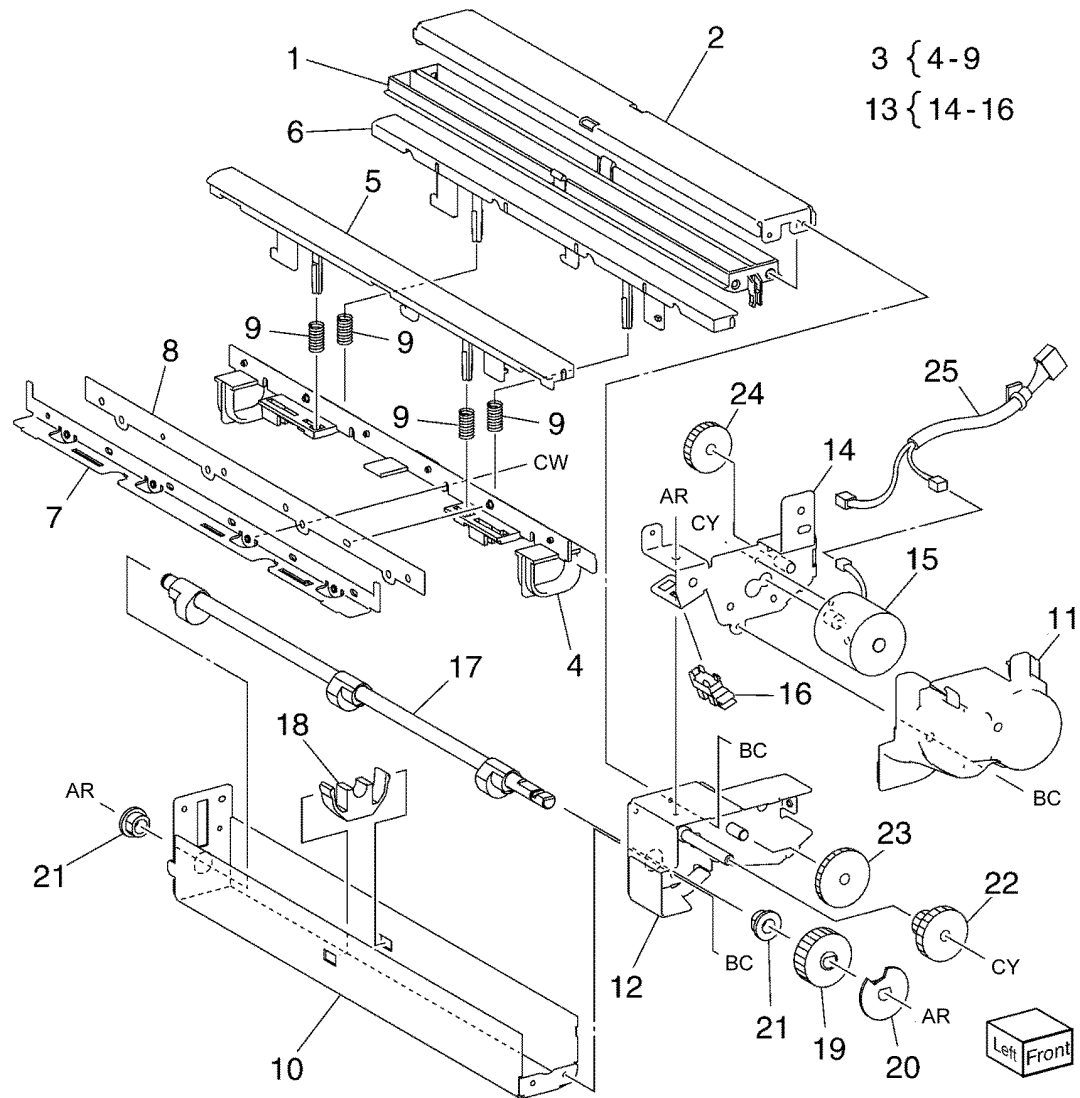
PL 13.40 Office Finisher LX Folder Assembly

Item	Part	Description
1	-	Upper chute (P/O PL 13.35 Item 20)
2	-	Upper plate (P/O PL 13.35 Item 20)
3	-	Knife assembly (P/O PL 13.35 Item 20)
4	-	Blade holder (P/O PL 13.40 Item 3)
5	-	Lower holder 1 (P/O PL 13.40 Item 3)
6	-	Lower holder 2 (P/O PL 13.40 Item 3)
7	-	Bracket (P/O PL 13.40 Item 3)
8	-	Blade (P/O PL 13.40 Item 3)
9	-	Spring (P/O PL 13.35 Item 2)
10	-	Frame (P/O PL 13.35 Item 20)
11	-	Front cover (Not Spared)
12	-	Bracket (P/O PL 13.35 Item 20)
13	-	Knife motor assembly (P/O PL 13.35 Item 20)
14	-	Motor bracket (P/O PL 13.40 Item 13)
15	-	Knife motor (MOT13-022) (P/O PL 13.40 Item 13)
16	930W00111	Folder home sensor (Q12-101)
17	-	Cam shaft assembly (P/O PL 13.35 Item 20)
18	-	Guide (P/O PL 13.35 Item 20)
19	-	Gear (28T/8T) (P/O PL 13.35 Item 20)
20	-	Encoder (P/O PL 13.35 Item 20)
21	-	Bearing (P/O PL 13.35 Item 20)
22	-	Gear (12T/27T) (P/O PL 13.35 Item 20)
23	-	Gear (12T/30T) (P/O PL 13.35 Item 20)

24	-	Gear (12T/51T) (P/O PL 13.35 Item 20)
25	-	Wire harness (P/O PL 13.35 Item 20)

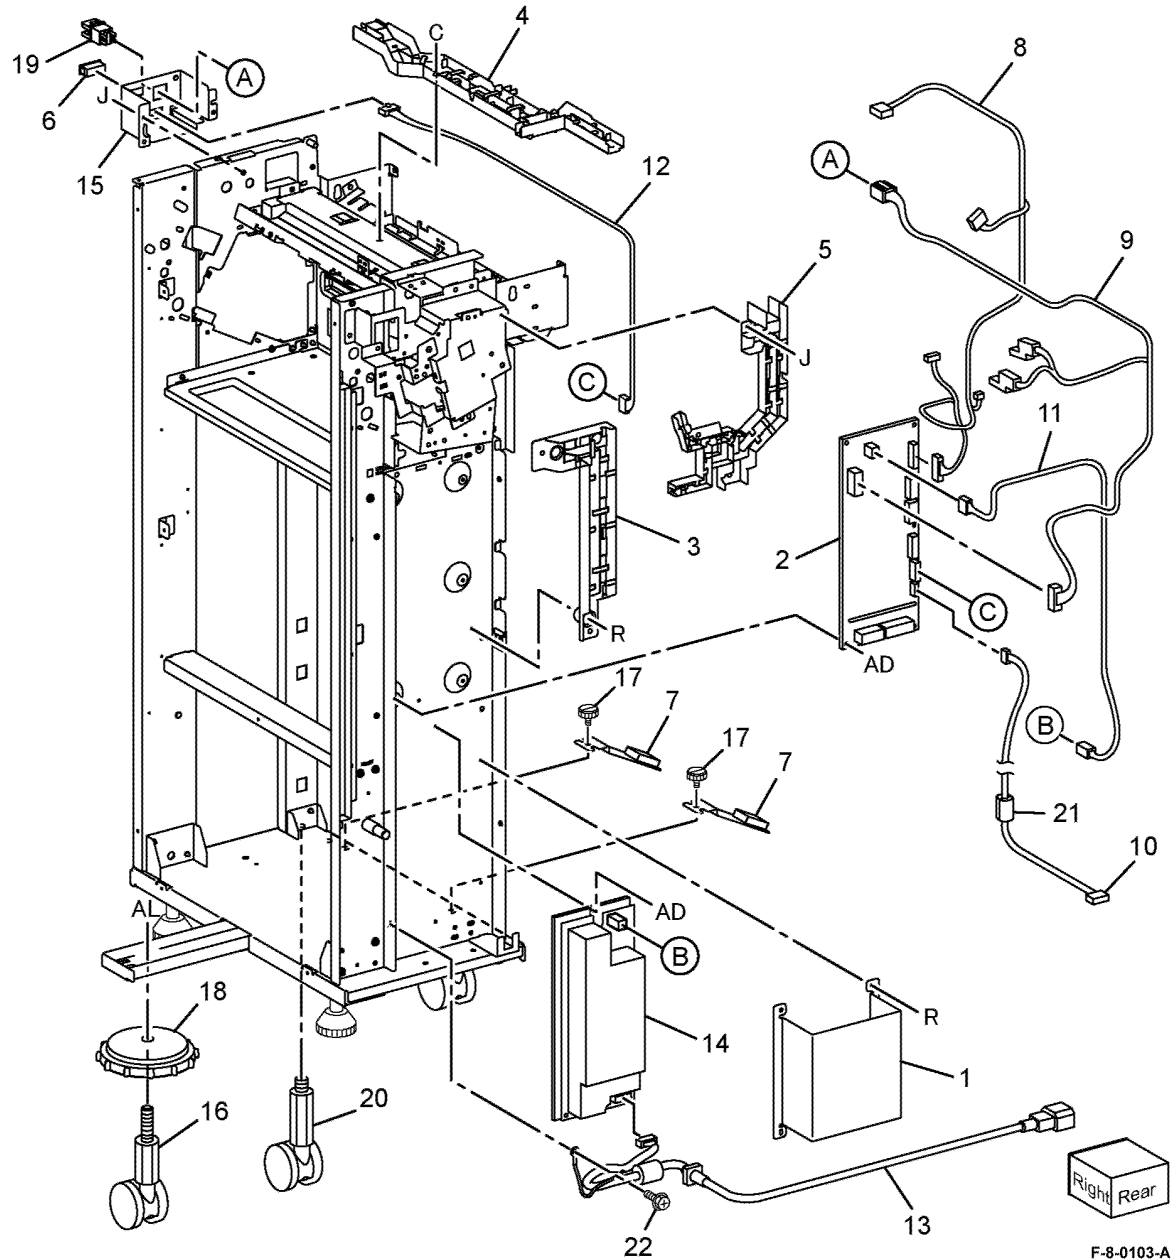
PL 13.45 Office Finisher LX Folder Electrical

Item	Part	Description
1	-	LVPS cover (Not Spared)
2	960K96561	Finisher PWB (REP 13.23)
3	-	Harness guide (Not Spared)
4	-	Harness guide (Not Spared)
5	-	Harness guide (Not Spared)
6	-	Magnet (Not Spared)
7	-	Gasket plate assembly (Not Spared)
8	-	Wire harness (Not Spared)
9	-	Wire harness (Not Spared)
10	962K60482	Wire harness (IF)
11	962K60493	Wire harness (LVPS)
12	962K60594	Wire harness (IF)
13	962K60511	Power cable
14	105E22590	Finisher LVPS (REP 13.24)
15	-	Bracket (Not Spared)
16	-	Caster (Not Spared)
17	-	Thumb Screw (Not Spared)
18	-	Knob (Not Spared)
19	110E97990	Finisher front door interlock switch (S12-302)
20	017K96450	Caster
21	-	Core (Not Spared)
22	-	Screw (Not Spared)

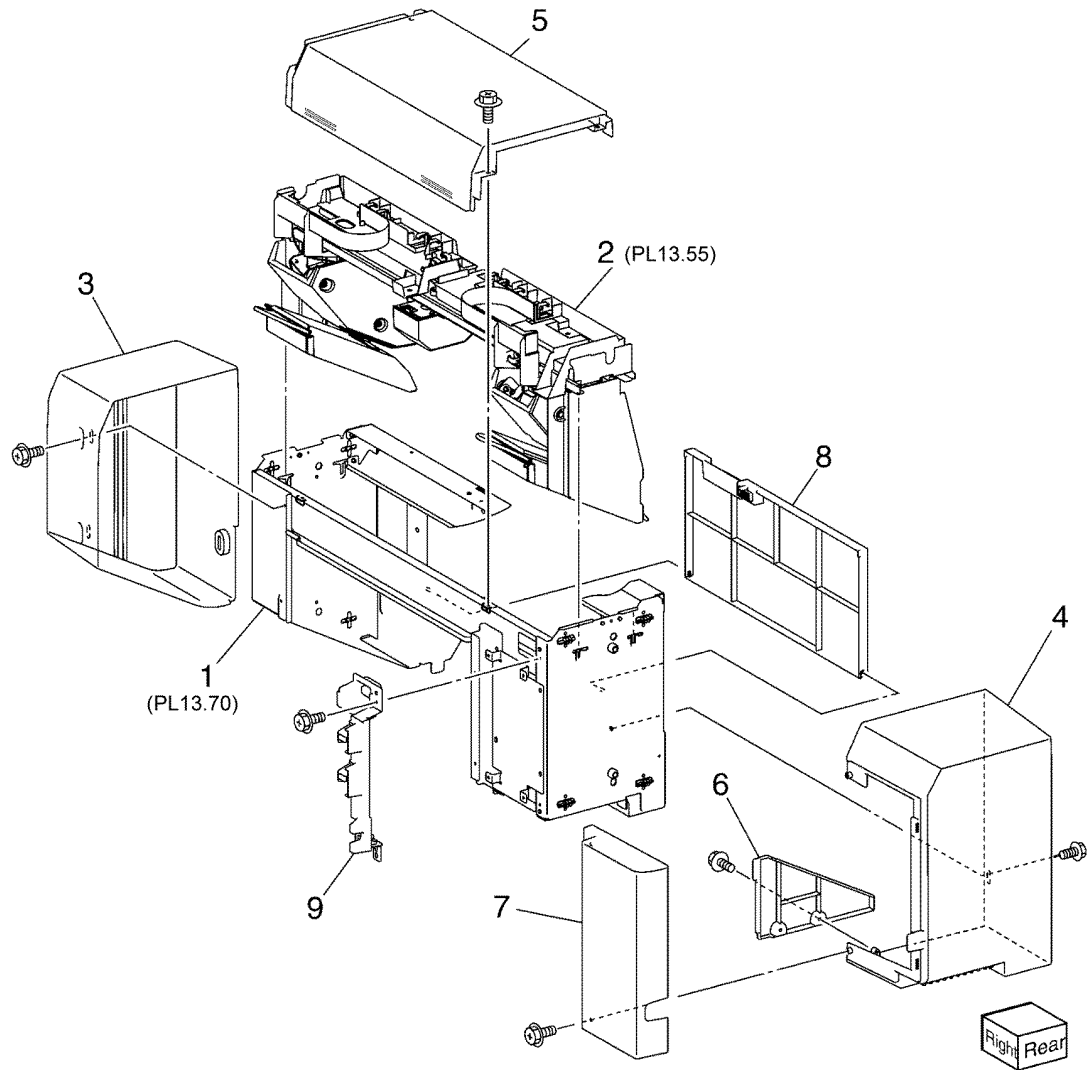
F-8-0104-A

PL 13.50 Office Finisher LX Booklet Cover

Item	Part	Description
1	-	Frame assembly (Not Spared)
2	-	Booklet stapler assembly (Not Spared) (ADJ 13.1)
3	-	Front cover (Not Spared)(REP 13.32)
4	-	Rear cover (Not Spared) (REP 13.33)
5	-	Top cover (Not Spared) (REP 13.34)
6	-	Side cover (Not Spared)
7	-	PWB cover (Not Spared) (REP 13.35)
8	-	Left cover (Not Spared) (REP 13.36)
9	-	Harness guide (Not Spared)

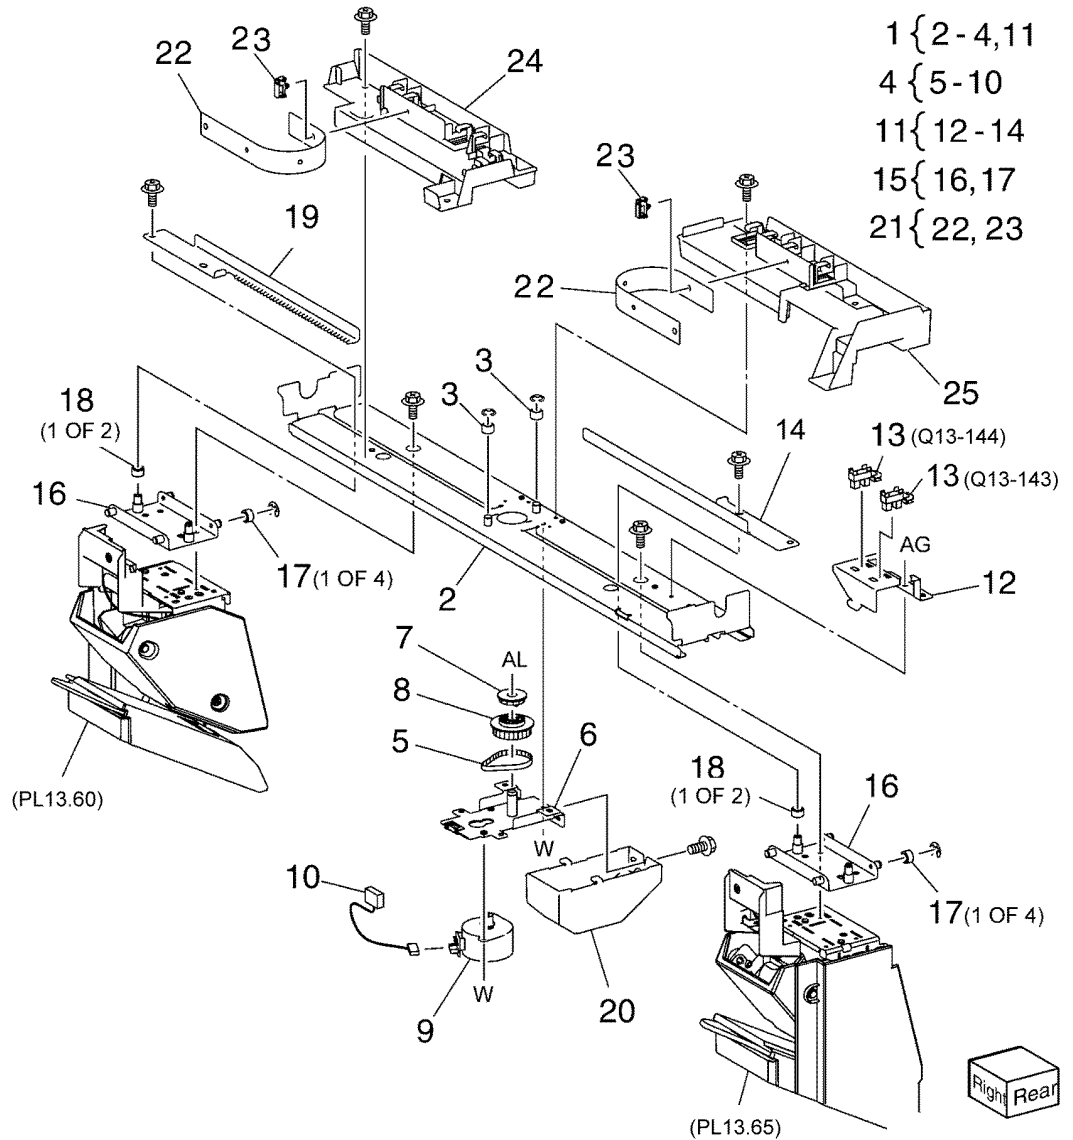
F-8-0105-A

PL 13.55 Office Finisher LX Booklet Stapler Assembly

Item	Part	Description
1	-	Front carriage rail (Not Spared)
2	-	Frame (P/O PL 13.55 Item 1)
3	-	Core (P/O PL 13.55 Item 1)
4	127K57052	Booklet stapler move motor assembly
5	-	Belt (P/O PL 13.55 Item 4)
6	-	Bracket (P/O PL 13.55 Item 4)
7	-	Gear (12T) (P/O PL 13.55 Item 4)
8	-	Pulley (50T) (P/O PL 13.55 Item 4)
9	-	Booklet stapler move motor (MOT13-028) (P/O PL 13.55 Item 4) (REP 13.38)
10	-	Wire harness (P/O PL 13.55 Item 4)
11	-	Sensor bracket assembly (P/O PL 13.55 Item 1)
12	-	Sensor bracket (P/O PL 13.55 Item 11)
13	930W00111	Booklet stapler move position sensor (Q13-143)/Booklet stapler move home sensor (Q13-144)
14	-	Rear rack gear (Not Spared)
15	-	Carriage assembly (Not Spared)
16	-	Carriage (P/O PL 13.55 Item 15)
17	-	Core (P/O PL 13.55 Item 15)
18	-	Core (Not Spared)
19	-	Front rack gear (Not Spared)
20	-	Motor cover (Not Spared)
21	-	Harness guide assembly (Not Spared)
22	-	Harness strap (P/O PL 13.55 Item 21)

23	-	Locking clamp (P/O PL 13.55 Item 21)
24	-	Harness guide (front) (Not Spared)
25	-	Harness guide (rear) (Not Spared)

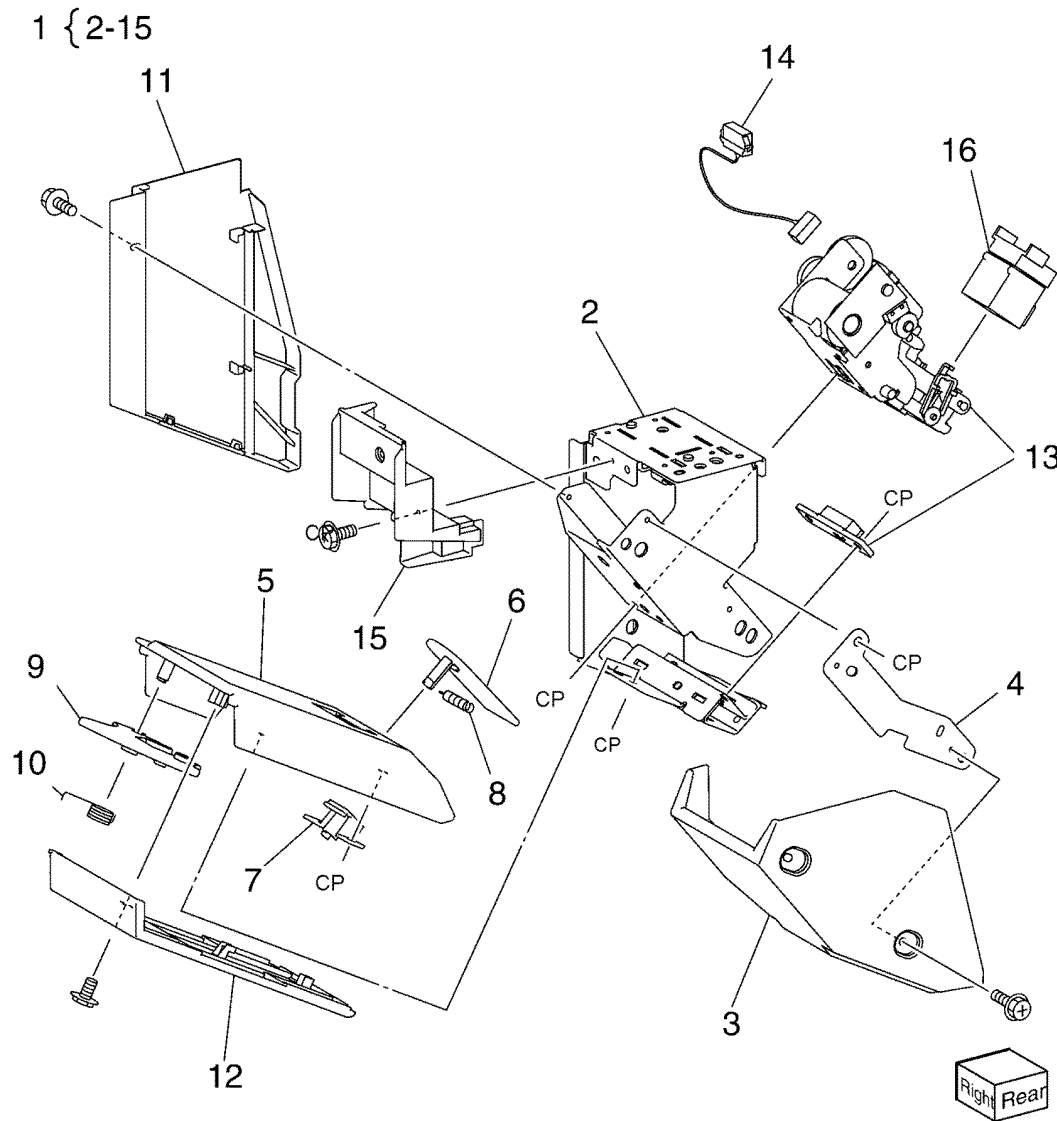
F-8-0106-A

PL 13.60 Office Finisher LX Booklet Front Stapler Assembly

Item	Part	Description
1	029K92491	Booklet front stapler assembly
2	-	Bracket (P/O PL 13.60 Item 1)
3	-	Rear cover (P/O PL 13.60 Item 1)
4	-	Bracket (P/O PL 13.60 Item 1)
5	-	Chute (P/O PL 13.60 Item 1)
6	-	Sub chute (P/O PL 13.60 Item 1)
7	-	Support (P/O PL 13.60 Item 1)
8	-	Spring (P/O PL 13.60 Item 1)
9	-	Exit sub chute (P/O PL 13.60 Item 1)
10	-	Spring (P/O PL 13.60 Item 1)
11	-	Front cover (P/O PL 13.60 Item 1)
12	-	Lower cover (P/O PL 13.60 Item 1)
13	-	Booklet stapler assembly (P/O PL 13.60 Item 1) (REP 13.37, ADJ 13.1)
14	-	Wire harness (P/O PL 13.60 Item 1)
15	-	Guide (P/O PL 13.60 Item 1)
16	-	Booklet staple cassette assembly

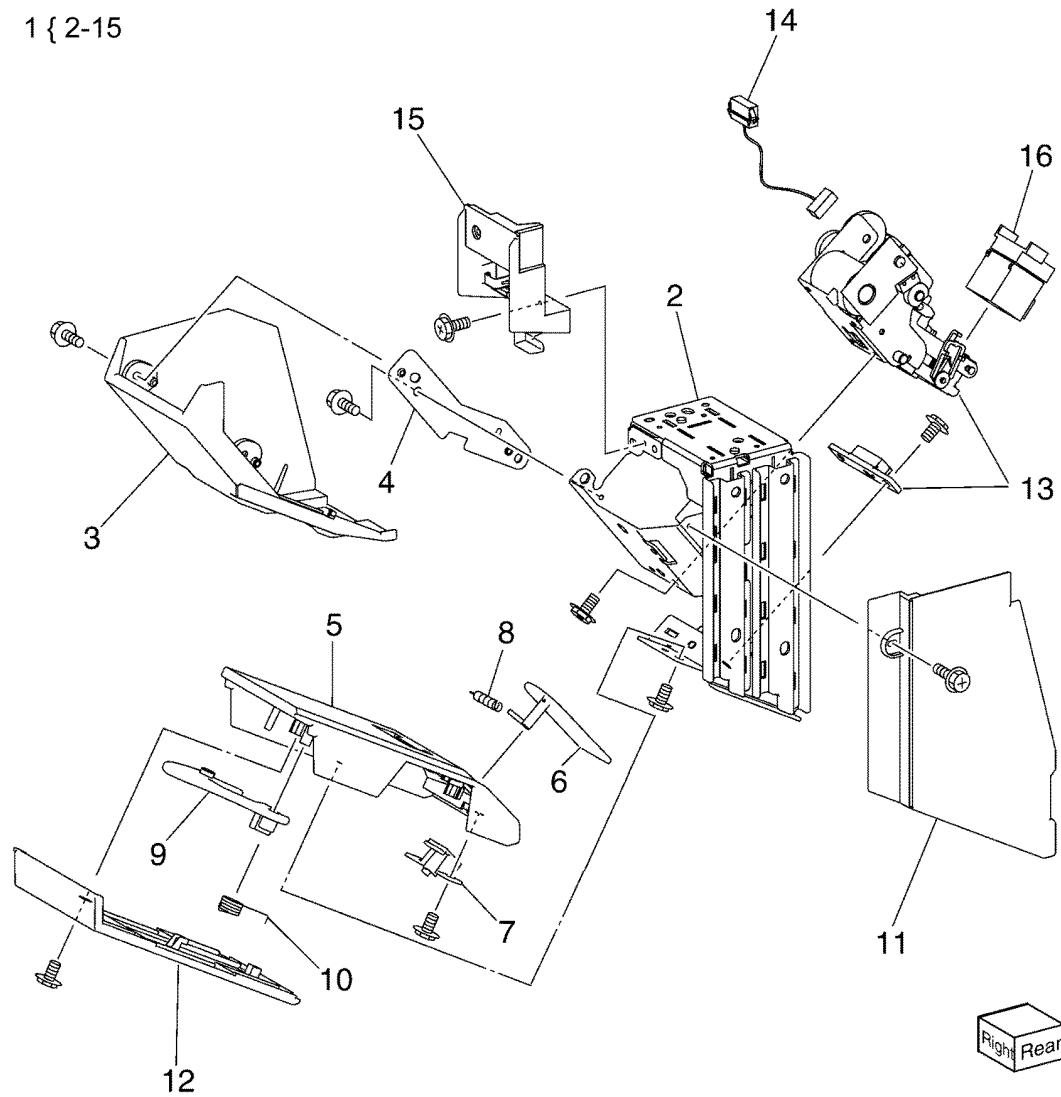
F-8-0107-A

PL 13.65 Office Finisher LX Booklet Rear Stapler Assembly

Item	Part	Description
1	029K92501	Booklet rear stapler assembly
2	-	Bracket (P/O PL 13.65 Item 1)
3	-	Rear cover (P/O PL 13.65 Item 1)
4	-	Bracket (P/O PL 13.65 Item 1)
5	-	Chute (P/O PL 13.65 Item 1)
6	-	Sub chute (P/O PL 13.65 Item 1)
7	-	Support (P/O PL 13.65 Item 1)
8	-	Spring (P/O PL 13.65 Item 1)
9	-	Sub chute (P/O PL 13.65 Item 1)
10	-	Spring (P/O PL 13.65 Item 1)
11	-	Front cover (P/O PL 13.65 Item 1)
12	-	Lower cover (P/O PL 13.65 Item 1)
13	-	Booklet stapler assembly (P/O PL 13.65 Item 1) (REP 13.37, ADJ 13.1)
14	-	Wire harness (P/O PL 13.65 Item 1)
15	-	Guide (P/O PL 13.65 Item 1)
16	-	Booklet staple cassette assembly

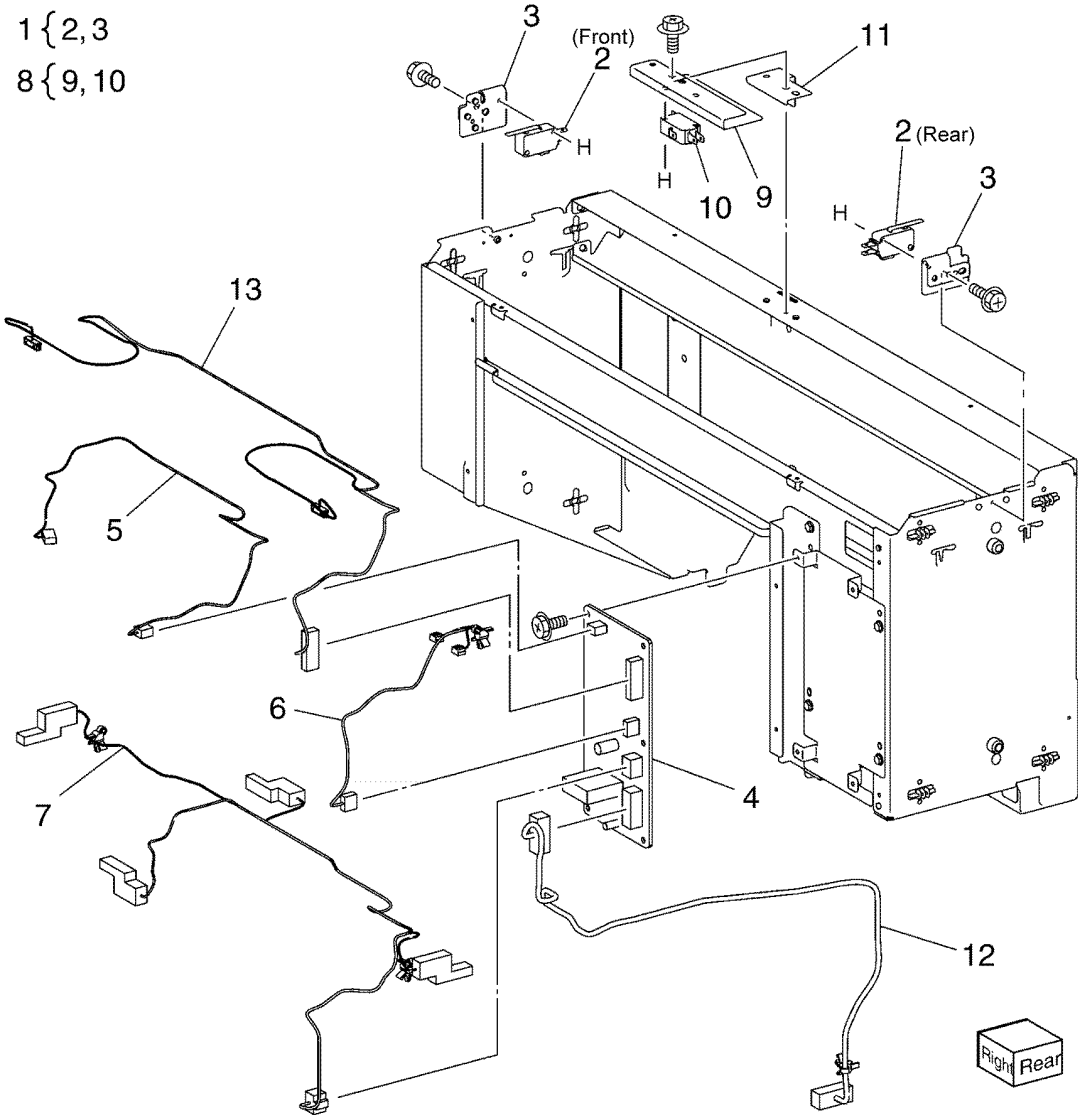
F-8-0108-A

PL 13.70 Office Finisher LX Booklet Electrical

Item	Part	Description
1	068K58351	Stapler rear safety switch/stapler front safety switch
2	-	Booklet stapler safety switch assembly (P/O PL 13.70 Item 1)
3	-	Bracket (P/O PL 13.70 Item 1)
4	960K32545	Booklet PWB (REP 13.30)
5	-	Wire harness (Not Spared)
6	-	Wire harness (Not Spared)
7	-	Wire harness (Not Spared)
8	068K58361	Booklet stapler cover switch assembly
9	-	Bracket (P/O PL 13.70 Item 8)
10	-	Booklet cover open switch (S13-300) (P/O PL 13.70 Item 8)
11	-	Plate (Not Spared)
12	-	Wire harness (Not Spared)
13	-	Wire harness (Not Spared)

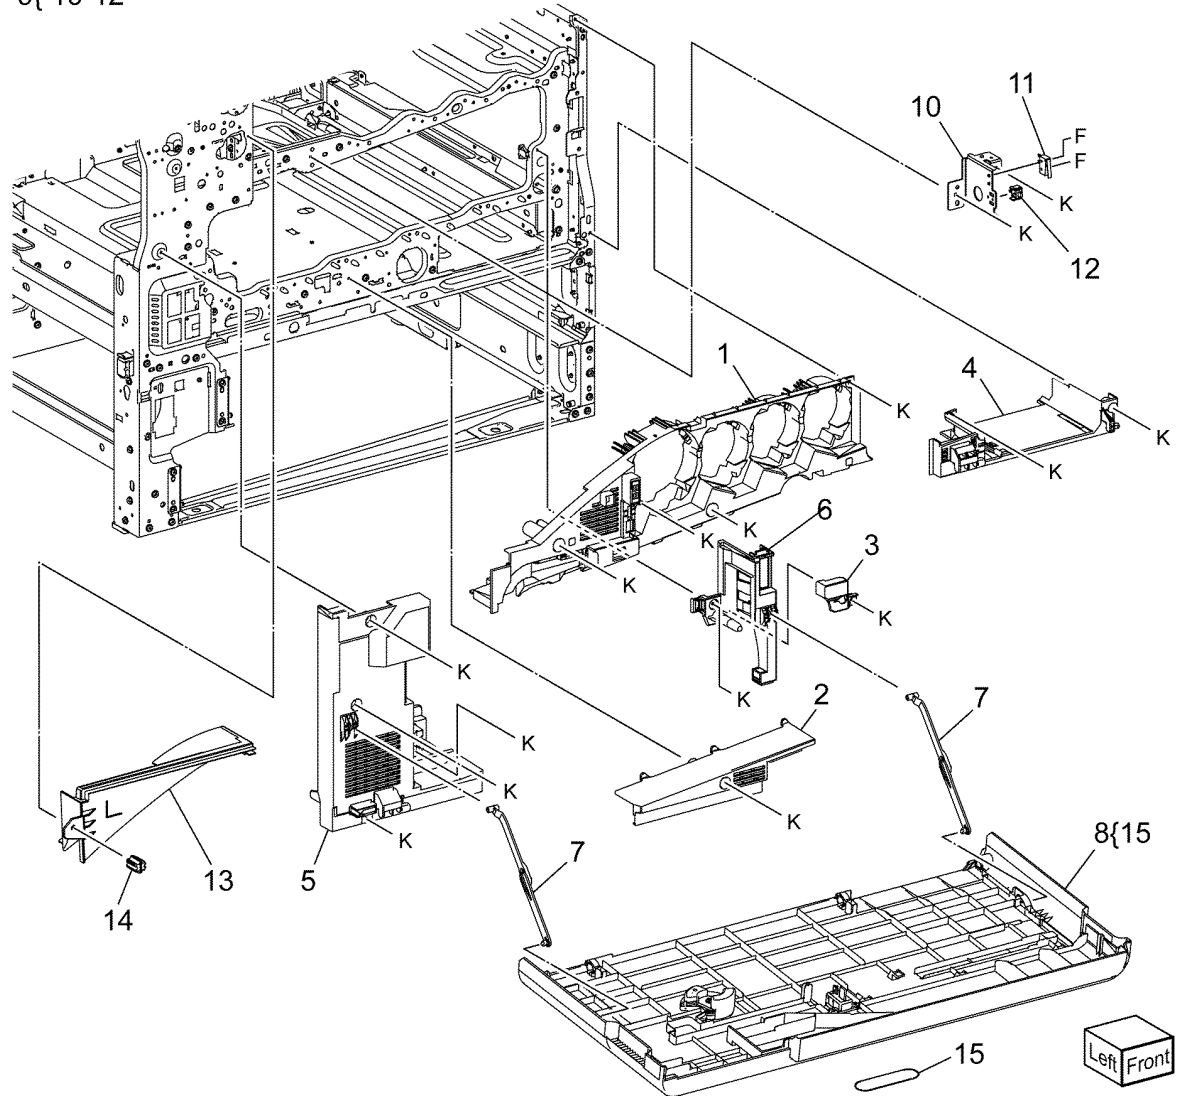
F-8-0116-A

Item	Part	Description
1	-	Inner cover assembly (Not Spared)
2	-	Inner lower cover (Not Spared)
3	-	Inner right cap cover (Not Spared)
4	-	Inner hinge cover assembly (Not Spared)
5	-	Inner left cover (Not Spared)
6	-	Inner right cover (Not Spared)
7	674K05081	Front cover strap kit
8	948K13110	Front cover assembly
9	110K18350	Front cover interlock switch assembly (S77-303)
10	-	Bracket (P/O PL 28.05 Item 9)
11	-	Front cover interlock switch (P/O PL 28.05 Item 9)
12	-	Front cover open switch (P/O PL 28.05 Item 9)
13	-	Inner upper cover (Not Spared)
14	-	Knob (Not Spared)
15	-	Logo badge (P/O PL 28.05 Item 8)

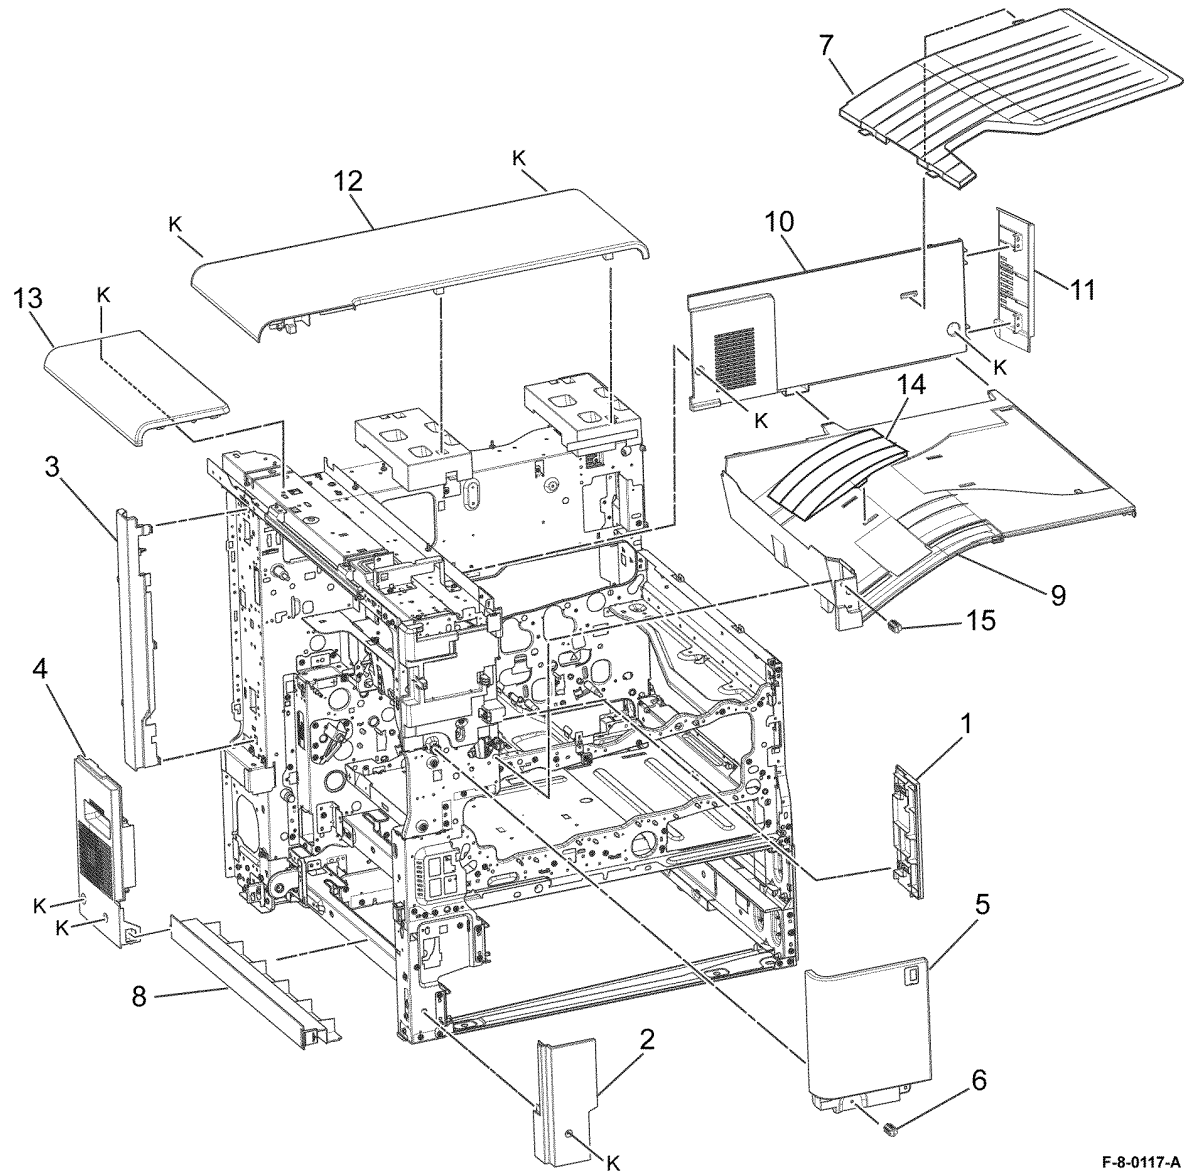
F-8-0117-A

PL 28.10 Covers (2 of 3)

Item	Part	Description
1	–	Front exit cover (Not Spared)
2	–	Tray inner cover (Not Spared)
3	822E25072	Upper left cover
4	822E25112	Lower left cover
5	822E46761	Pillar cover
6	–	Thumbscrew (Not Spared)
7	050E32924	Exit 2 tray
8	–	Bottom left cover (Not Spared)
9	822E24855	Top cover
10	–	Top rear cover (Not Spared)
11	822E46741	Right upper cover
12	822E46701	Upper top cover
13	822E46680	Top left cover
14	050K79510	Add tray
15	–	Thumbscrew (Not Spared)

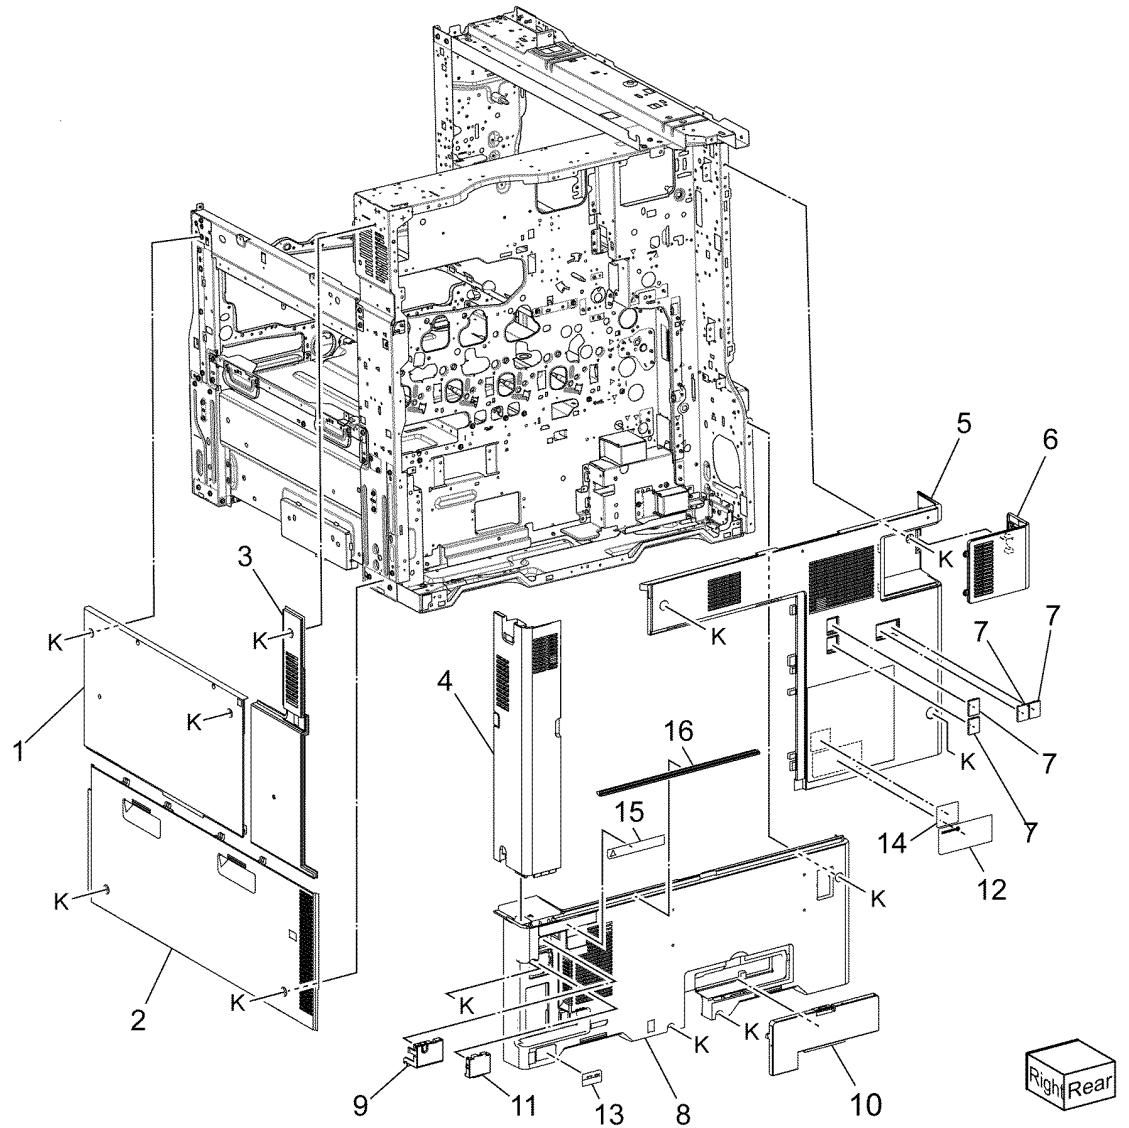
F-8-0118-A

PL 28.15 Covers (3 of 3)

Item	Part	Description
1	822E25191	Upper right front cover
2	822E25133	Lower right front cover
3	822E33951	Upper right rear cover
4	822E25311	ESS rear cover
5	822E25321	Upper rear cover
6	822E25420	Left rear cover
7	-	Cap cover (Not Spared)
8	822E25443	Lower rear cover
9	-	EPSV cover (Not Spared)
10	822E25601	MCU cover
11	-	Outlet cover (Not Spared)
12	-	Label (Date) (Not Spared)
13	-	Label (GFI) (Not Spared)
14	-	Label (Warning) (Not Spared)
15	-	Label (Earth) (Not Spared)
16	-	Gasket (Not Spared)

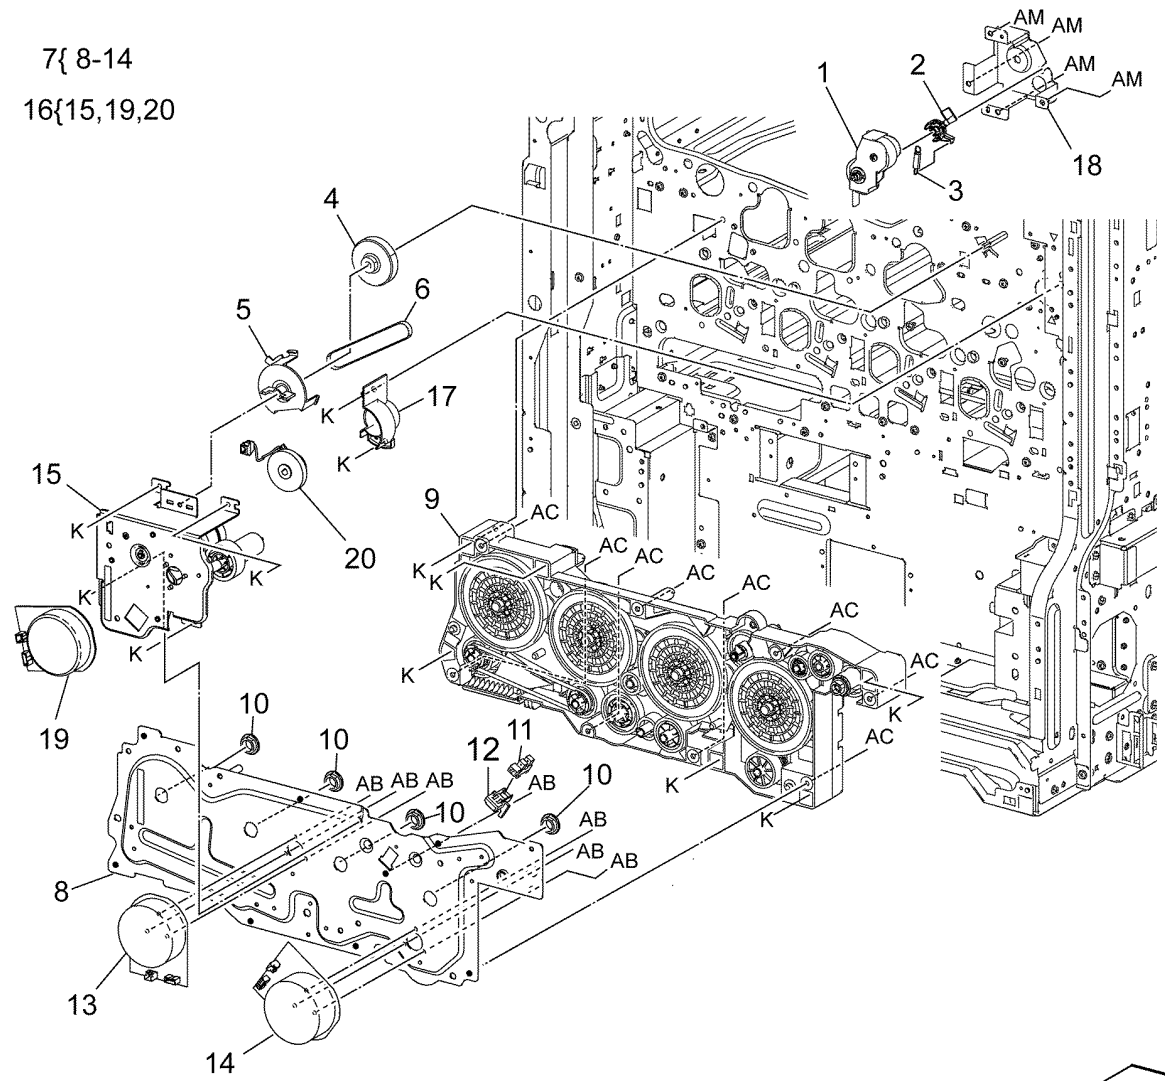
F-8-0123-A

-	423W10355	Drive belt (alternative)
7	007K22595	Main drive assembly (MOT42-018) (REP 40.1)
8	-	Drum drive bracket assembly (P/O PL 40.05 Item 7)
9	-	Drum drive housing assembly (P/O PL 40.05 Item 7)
10	-	Bearing (P/O PL 40.05 Item 7)
11	930W00121	BTR contact/retract sensor (Q94-200)
12	-	Sensor bracket (P/O PL 40.05 Item 7)
13	-	Drum/developer (C, M, Y) motor (MOT42-007) (P/O PL 40.05 Item 7)
14	-	Drum/developer (K)/ IBT motor (MOT42-001) (P/O PL 40.05 Item 7)
15	-	Fuser drive bracket assembly (P/O PL 40.05 Item 16)
16	007K21444	Fuser drive assembly (REP 40.2)
17	-	Gear lever (Not Spared)
18	-	Bracket (Not Spared)
19	-	Fuser unit drive motor (P/O PL 40.05 Item 16)
20	-	BTR contact/retract clutch assembly (P/O PL 40.05 Item 16)

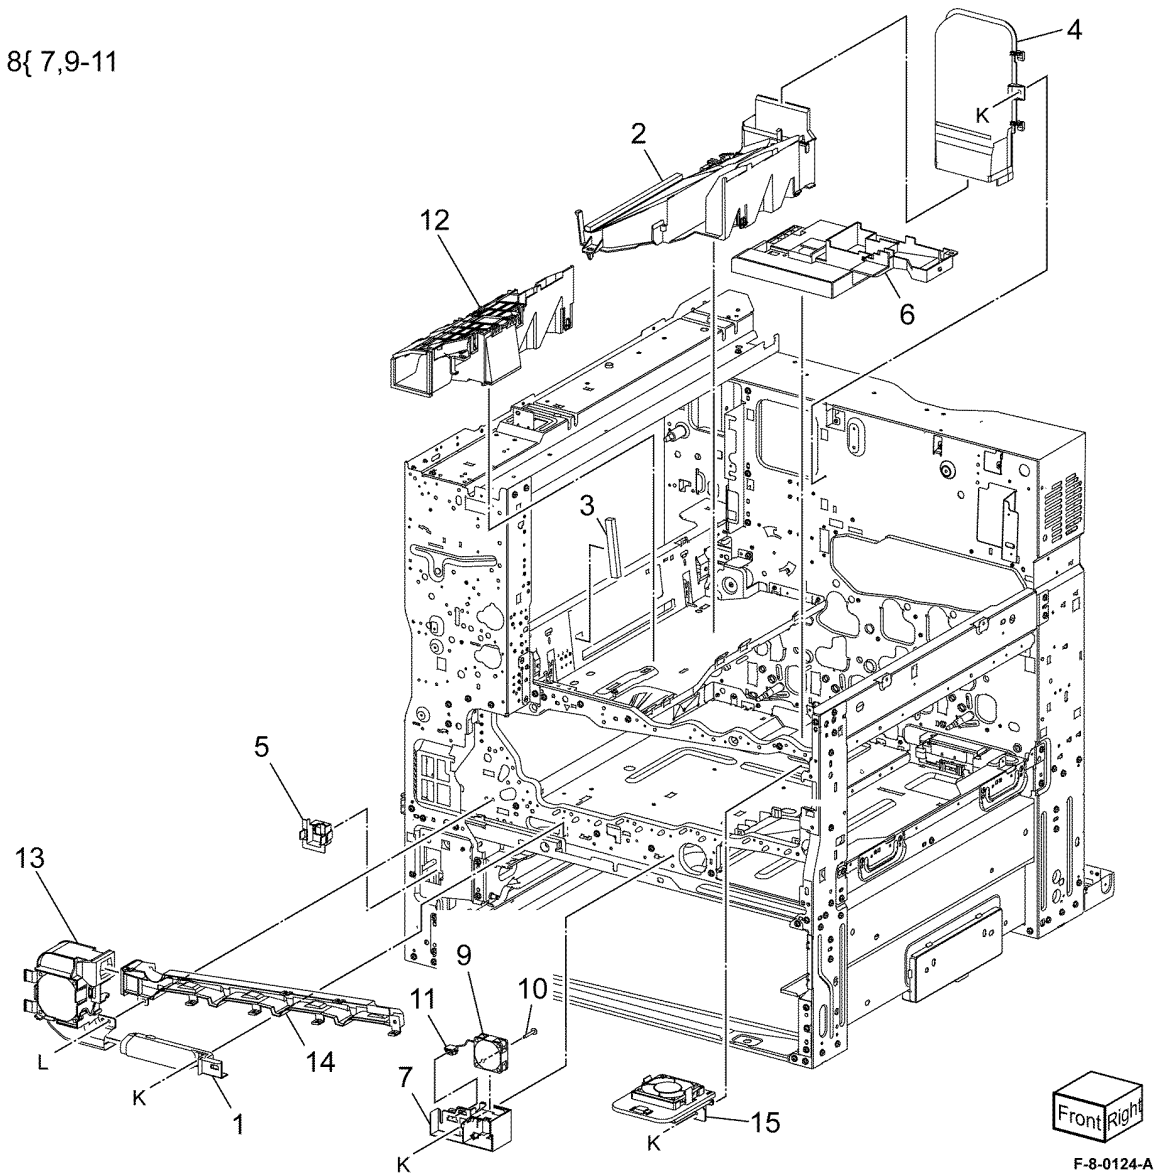
PL 40.10 NOHAD (front)

Item	Part	Description
1	–	Duct (Not Spared)
2	–	Fuser duct assembly (Not Spared)
3	–	Fuser seal (Not Spared)
4	–	Fuser duct (Not Spared)
5	930K00500	Temp/Humidity sensor (external) (REP 40.3)
6	–	Rear duct (Not Spared)
7	–	P1 duct (P/O PL 40.10 Item 8)
8	–	Duct assembly (Not Spared) (REP 40.4)
9	127K69610	Front/right marking fan
10	–	Screw (P/O PL 40.10 Item 8)
11	–	Connector (P/O PL 40.10 Item 8)
12	127K74190	Toner cartridge cooling fan assembly (REP 40.5)
13	054K55030	Front/Left marking fan assembly (MOT42-067) (REP 40.6)
14	–	Front duct (Not Spared)
15	054K55060	Marking fan duct assembly (MOT42-025)

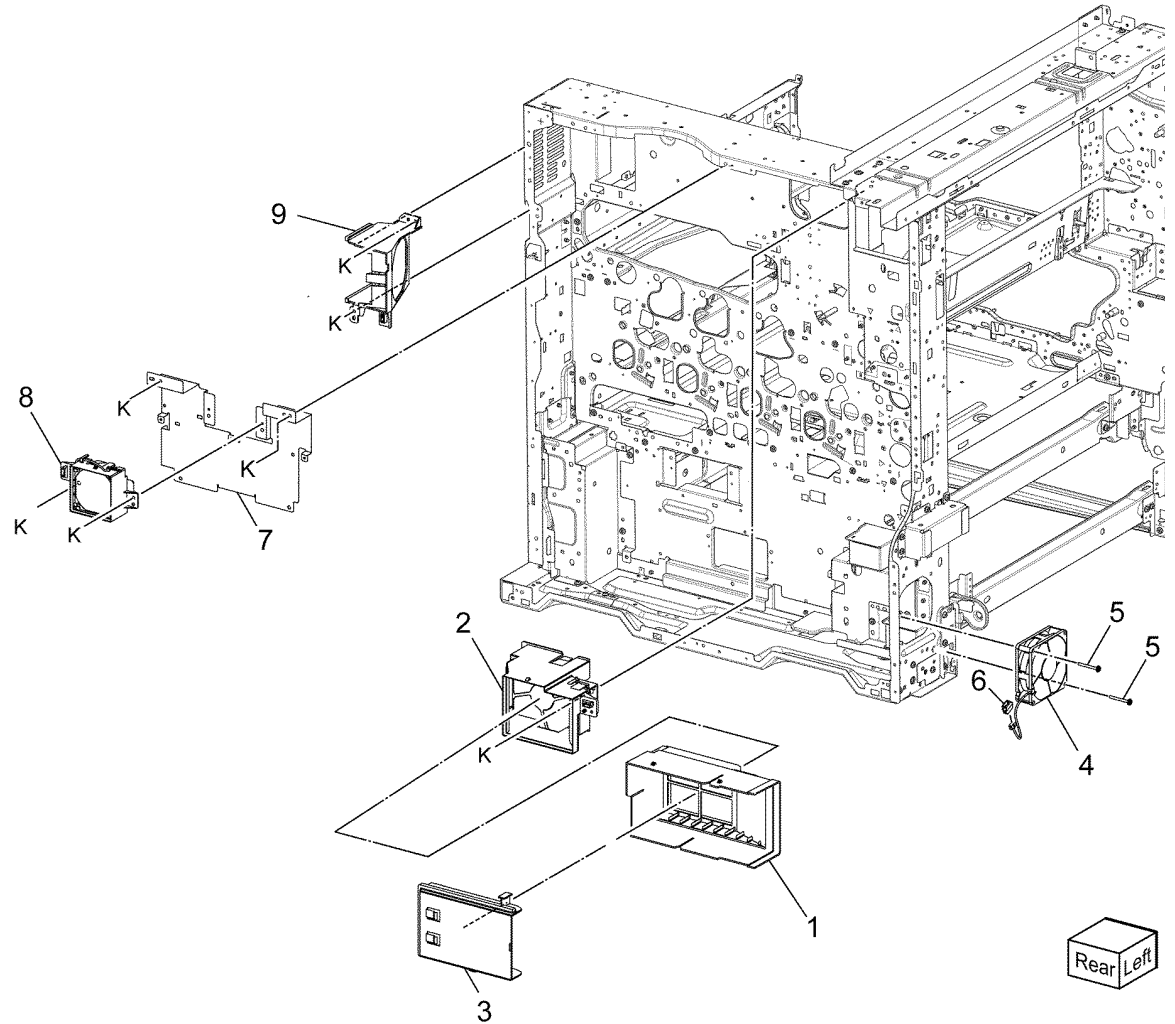
F-8-0125-A

PL 40.15 NOHAD (rear)

Item	Part	Description
1	–	Rear fuser duct assembly (Not Spared) (REP 40.7)
2	054K55050	Fuser unit exhaust fan assembly (MOT42-058)
3	815K16761	Side plate
4	127K74210	LVPS fan assembly (MOT42-052) (REP 40.8)
5	–	Screw (P/O PL 40.15 Item 4)
6	–	Connector (P/O PL 40.15 Item 4)
7	–	Bracket (P/O PL 40.15 Item 8)
8	054K55210	IHPS intake duct assembly (MOT42-069) (REP 40.9)
9	054K54990	Toner cartridge exhaust fan assembly (REP 40.10)
