VersaLink[®] C8000/C9000 Printer

Service Manual

VersaLink C9000 Family Service Manual

705P01418

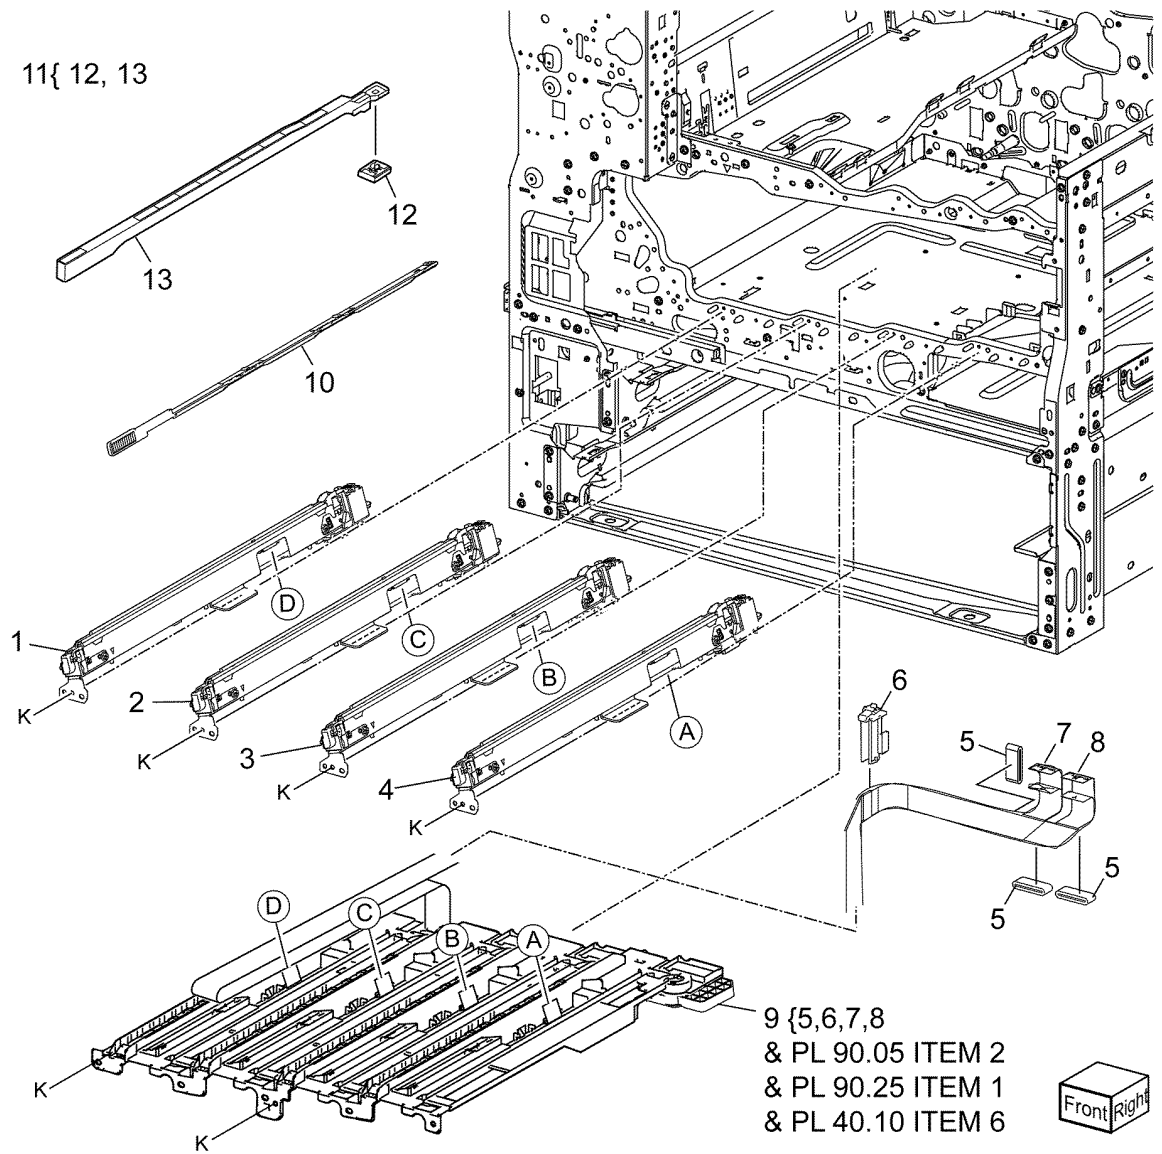
PL 60.05 LPH Module

Item	Part	Description
1	930K00722	LPH assembly (K) (REP 60.1)
2	-	LPH assembly (C) (REP 60.1)
3	-	LPH assembly (M) (REP 60.1)
4	-	LPH assembly (Y) (REP 60.1)
5	-	Core ferrite (P/O PL 60.05 Item 9)
6	-	FFC guide (P/O PL 60.05 Item 9)
7	-	FFC cable (P/O PL 60.05 Item 9)
8	-	FFC cable (P/O PL 60.05 Item 9)
9	607K10570	FFC cable assembly kit (REP 60.2)
10	042K94930	LPH cleaner
11	-	Cleaner assembly kit
12	-	Cleaner base assembly (P/O PL 60.05 Item 11)
13	-	Cleaner rod (P/O PL 60.05 Item 11)

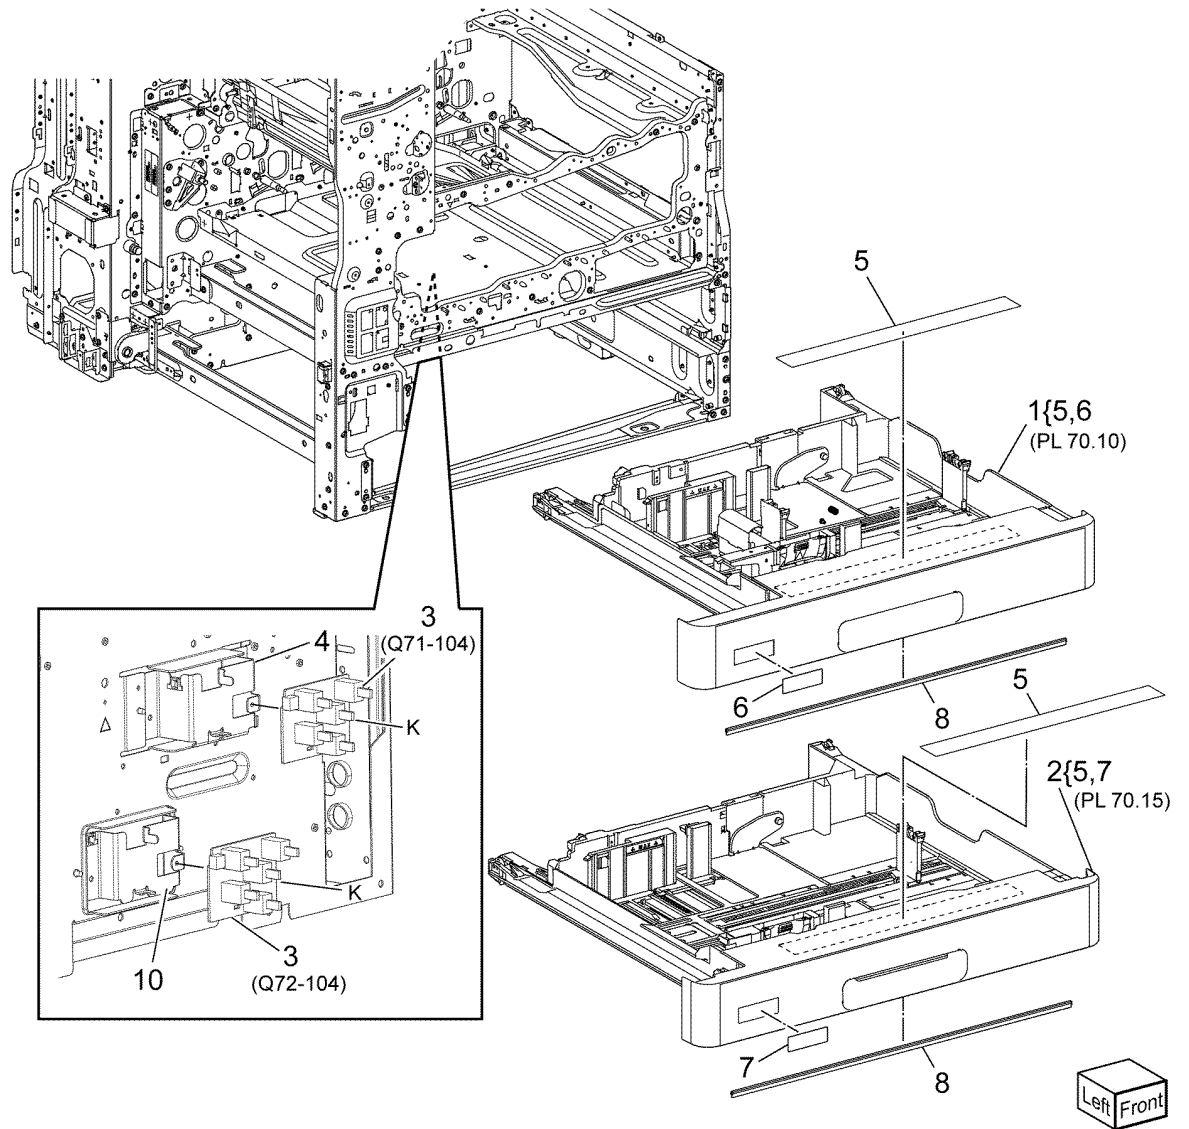
F-8-0127-A

PL 70.05 Tray 1 & 2 Assembly

Item	Part	Description
1	607K10600	Tray 1 assembly
2	607K10610	Tray 2 assembly
3	110K12100	Tray 1 paper size sensor (Q71-104) / Tray 2 paper size sensor (Q72-104) (REP 70.1)
-	110K17951	Tray 1 paper size sensor (Q71-104) (REP 70.1) / Tray 2 paper size sensor (Q72-104) (REP 70.1) (Alternative)
4	-	Bracket (Not Spared)
5	-	Label (instruction) (P/O PL 70.05 Item 1 & PL 70.05 Item 2)
6	-	Label (No. 1) (P/O PL 70.05 Item 1)
7	-	Label (No. 2) (P/O PL 70.05 Item 2)
8	-	Gasket (Not Spared)
9	-	Not used
10	-	Bracket (Not Spared)

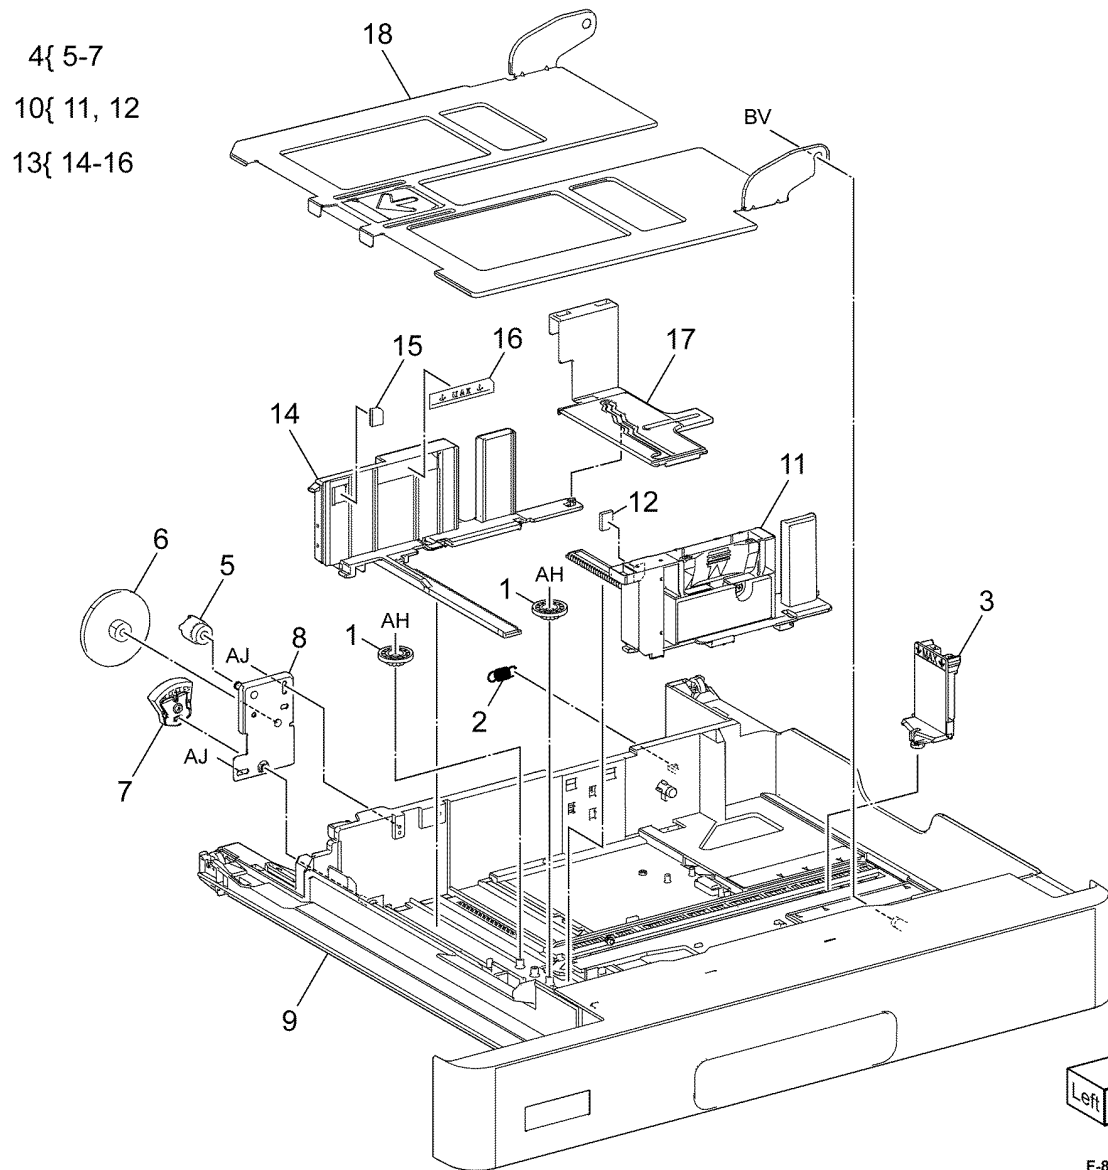
F-8-0128-A

PL 70.10 Tray 1 Assembly

Item	Part	Description
1	-	Pinion (P/O PL 70.05 Item 1)
2	-	Spring (P/O PL 70.05 Item 1)
3	-	End guide (Not Spared)
4	-	Tray gear assembly (Not Spared)
5	-	Gear (13) (P/O PL 70.10 Item 4)
6	-	Gear (13/60) (P/O PL 70.10 Item 4)
7	-	Gear assembly (P/O PL 70.10 Item 4)
8	-	Bracket (P/O PL 70.05 Item 1)
9	-	Cassette assembly (P/O PL 70.05 Item 1)
10	-	Front side guide assembly (Not Spared)
11	-	Front side guide (P/O PL 70.10 Item 10)
12	-	Pad (P/O PL 70.10 Item 10)
13	-	Rear side guide assembly (Not Spared)
14	-	Rear side guide (P/O PL 70.10 Item 13)
15	-	Pad (P/O PL 70.10 Item 13)
16	-	Label (MAX) (P/O PL 70.10 Item 13)
17	-	Side actuator (P/O PL 70.05 Item 1)
18	-	Lift plate (P/O PL 70.05 Item 1)

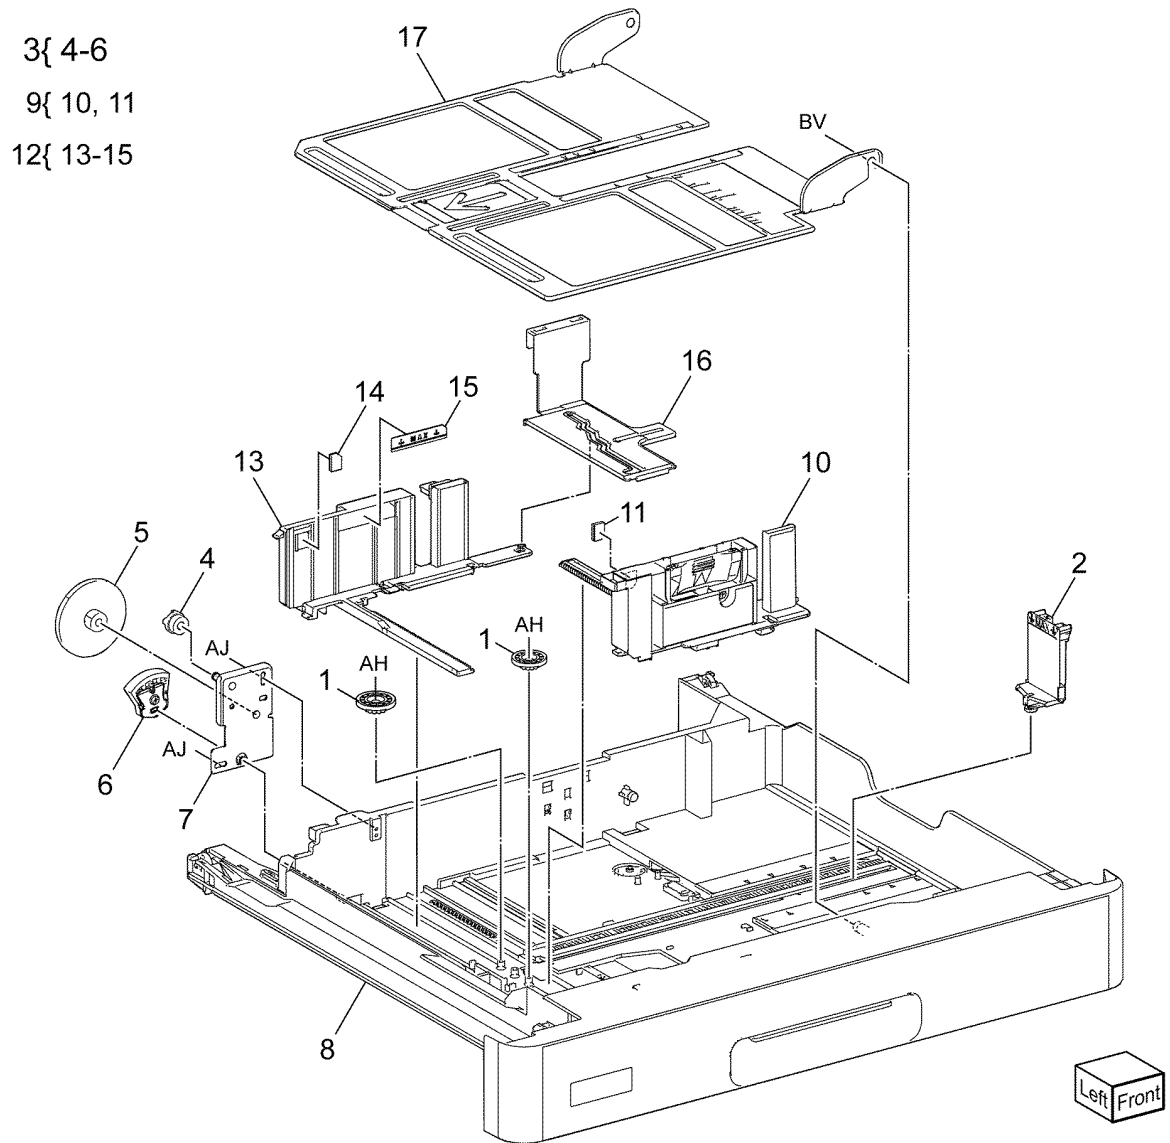
F-8-0129-A

PL 70.15 Tray 2 Assembly

Item	Part	Description
1	-	Pinion (P/O PL 70.05 Item 2)
2	-	End guide kit (Not Spared)
3	-	Tray gear kit (Not Spared)
4	-	Gear (13) (P/O PL 70.15 Item 3)
5	-	Gear (13/60) (P/O PL 70.15 Item 3)
6	-	Gear assembly (P/O PL 70.15 Item 3)
7	-	Bracket (P/O PL 70.05 Item 2)
8	-	Cassette assembly (P/O PL 70.05 Item 2)
9	-	Front side guide kit (Not Spared)
10	-	Front side guide (P/O PL 70.15 Item 9)
11	-	Pad (P/O PL 70.15 Item 9)
12	-	Rear side guide kit (Not Spared)
13	-	Rear side guide (P/O PL 70.15 Item 12)
14	-	Pad (P/O PL 70.15 Item 12)
15	-	Label (MAX) (P/O PL 70.15 Item 12)
16	-	Side actuator (P/O PL 70.05 Item 2)
17	-	Lift plate (P/O PL 70.05 Item 2)

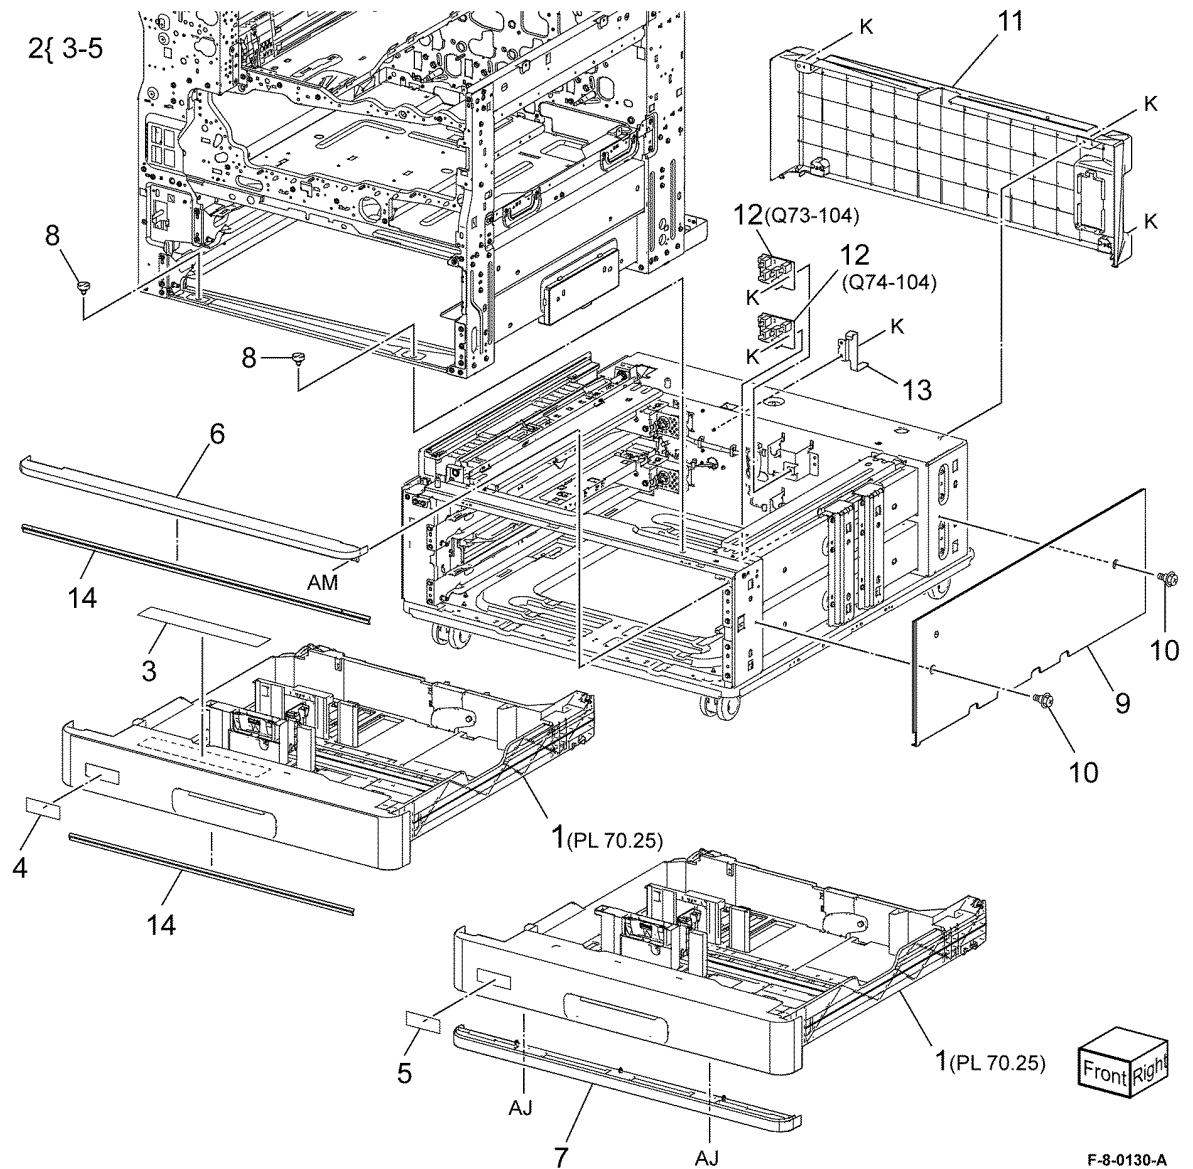
F-8-0130-A

PL 70.20 2TM Components

Item	Part	Description
1	-	Tray 3 & 4 assembly (REF:PL 70.25)
2	-	2TM tray label kit (P/O PL 31.05 Item 7)
3	-	Label (instruction) (P/O PL 31.05 Item 7)
4	-	Label (No. 3) (P/O PL 31.05 Item 7)
5	-	Label (No. 4) (P/O PL 31.05 Item 7)
6	-	Top cover (Not Spared)
7	822E41111	Foot cover
8	-	Docking screw (Not Spared)
9	822E41071	Right cover
10	-	Shoulder screw (Not Spared)
11	822E41013	Rear cover
12	110K12100	Tray 3 paper size sensor (Q73-104) / Tray 4 paper size sensor (Q74-104) (REP 70.5)
-	110K17951	Tray 3 paper size sensor (Q73-104)/ Tray 4 paper size sensor (Q74-104) (alternative) (REP 70.5)
13	-	Joint bracket (Not Spared)
14	-	Gasket (Not Spared)

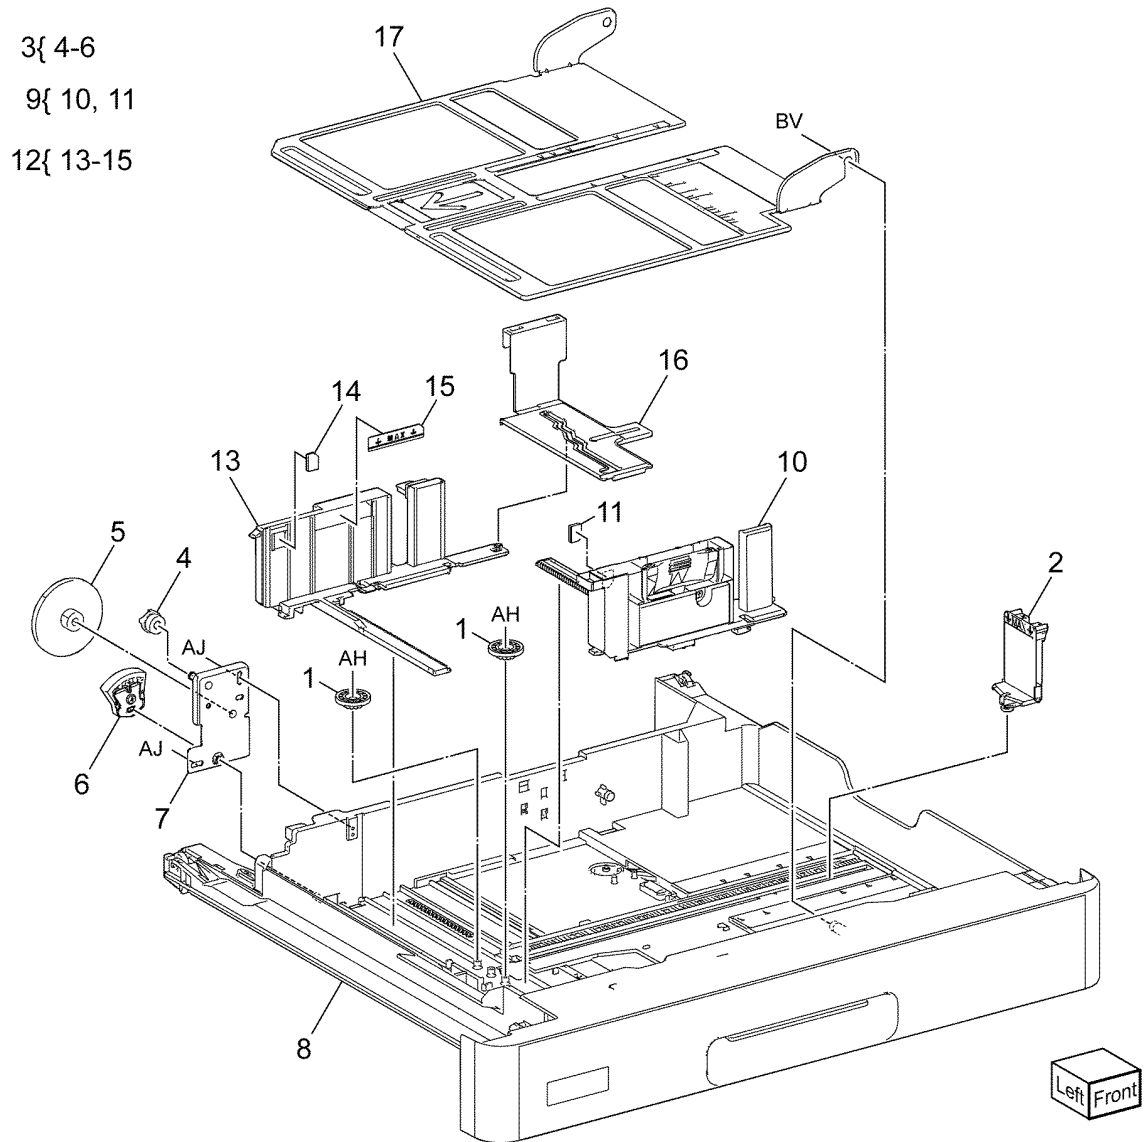
F-8-0131-A

PL 70.25 2TM Tray 3/4 Assembly

Item	Part	Description
1	-	Pinion (P/O PL 70.20 Item 1)
2	-	End guide (P/O PL 70.20 Item 1)
3	-	Tray gear kit (Not Spared)
4	-	Gear (13) (P/O PL 70.25 Item 3)
5	-	Gear (13/60) (P/O PL 70.25 Item 3)
6	-	Gear assembly (P/O PL 70.25 Item 3)
7	-	Bracket (P/O PL 70.20 Item 1)
8	-	Cassette assembly (P/O PL 70.20 Item 1)
9	-	Front side guide kit (Not Spared)
10	-	Front side guide (P/O PL 70.25 Item 9)
11	-	Pad (P/O PL 70.25 Item 9)
12	-	Rear side guide kit (Not Spared)
13	-	Rear side guide (P/O PL 70.25 Item 12)
14	-	Pad (P/O PL 70.25 Item 12)
15	-	Label (MAX) (P/O PL 70.25 Item 12)
16	-	Side actuator (P/O PL 70.20 Item 1)
17	-	Lift plate (P/O PL 70.20 Item 1)

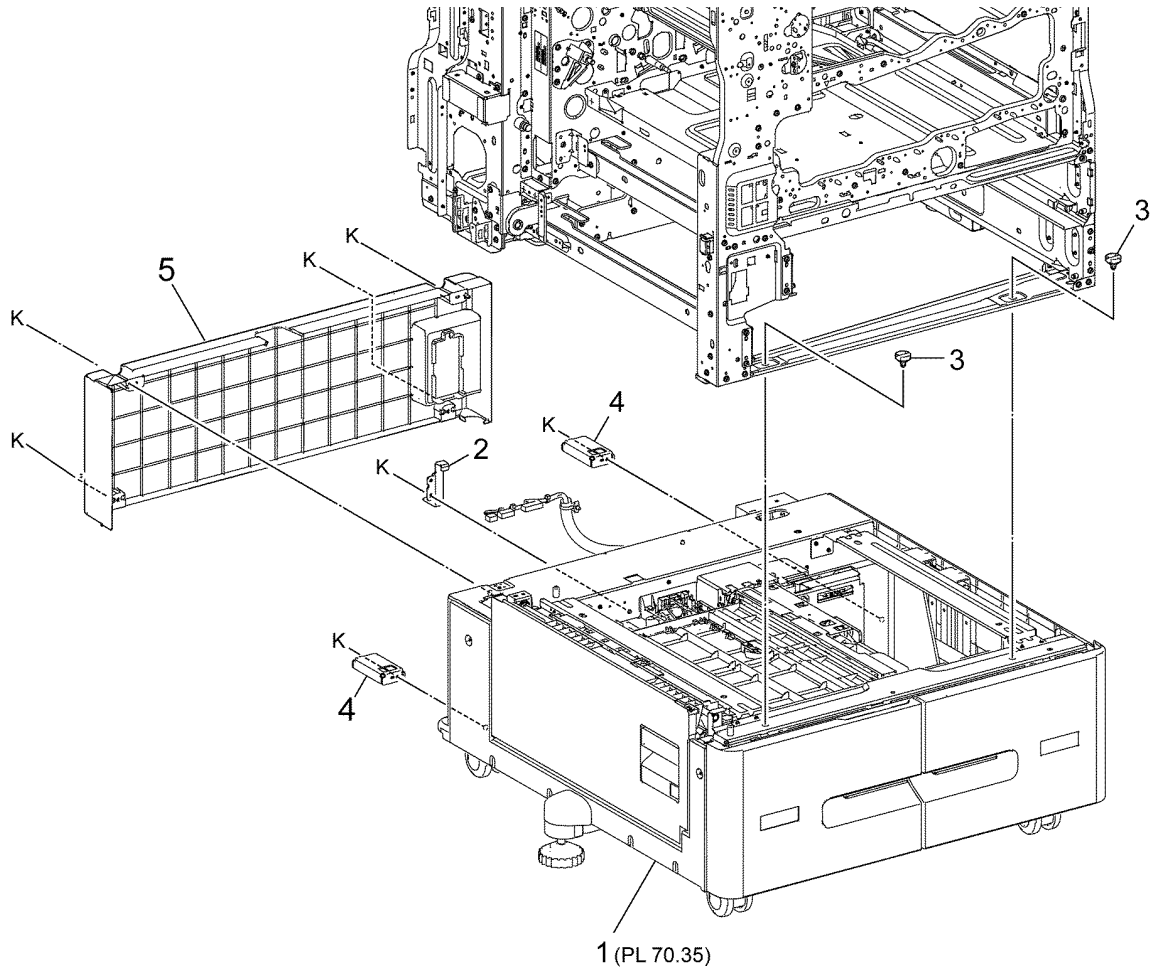
F-8-0132-A

PL 70.30 TTM Components

Item	Part	Description
1	—	TTM module
2	—	Joint bracket (Not Spared)
3	—	Docking screw (Not Spared)
4	—	Cover bracket (Not Spared)
5	822E41013	Rear cover

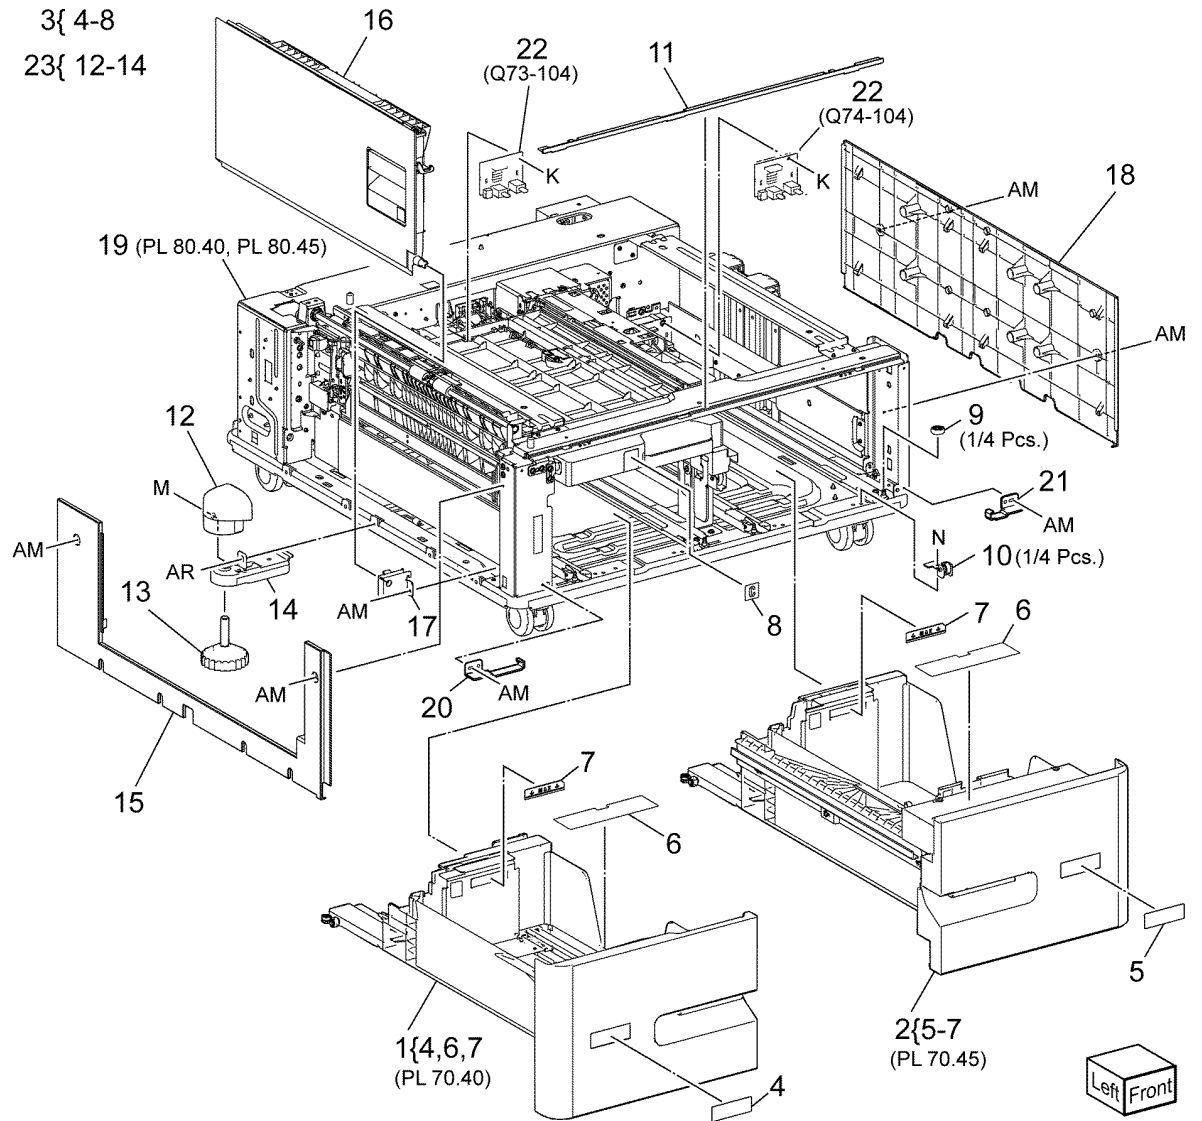
F-8-0133-A

PL 70.35 TTM Covers and Tray 3/4 Assembly

Item	Part	Description
1	607K10491	TTM Tray 3 assembly
2	607K10500	TTM Tray 4 assembly
3	-	Not used
4	-	Label (No. 3) (P/O PL 70.35 Item 1)
5	-	Label (No. 4) (P/O PL 70.35 Item 2)
6	-	Label (instruction) (P/O PL 70.35 Item 1 & PL 70.35 Item 2)
7	-	Label (MAX) (P/O PL 70.35 Item 1 & PL 70.35 Item 2)
8	-	Label (C) (Not Spared)
9	-	Upper roller (Not Spared)
10	-	Roller bracket assembly (Not Spared)
11	-	Top cover (Not Spared)
12	-	Foot cover (P/O PL 70.35 Item 23)
13	-	Adjuster foot (P/O PL 70.35 Item 23)
14	-	Foot bracket (P/O PL 70.35 Item 23)
15	822E41053	Left cover
16	948K12040	Left door assembly
17	-	Pivot bracket (Not Spared)
18	822E41071	Right cover
19	-	TTM frame assembly (Not Spared)
20	-	Left stopper (Not Spared)
21	-	Right stopper (Not Spared)
22	110K17960	Tray 3 paper size sensor (Q73-104)/ Tray 4 paper size sensor (Q74-104) (REP 70.6)

-	110K15040	Tray 3 paper size sensor (Q73-104)/ Tray 4 paper size sensor (Q74-104) (alternative) (REP 70.6)
-	110K11820	Tray 3 paper size sensor (Q73-104)/ Tray 4 paper size sensor (Q74-104) (alternative) (REP 70.6)
23	607K11480	Adjuster foot assembly

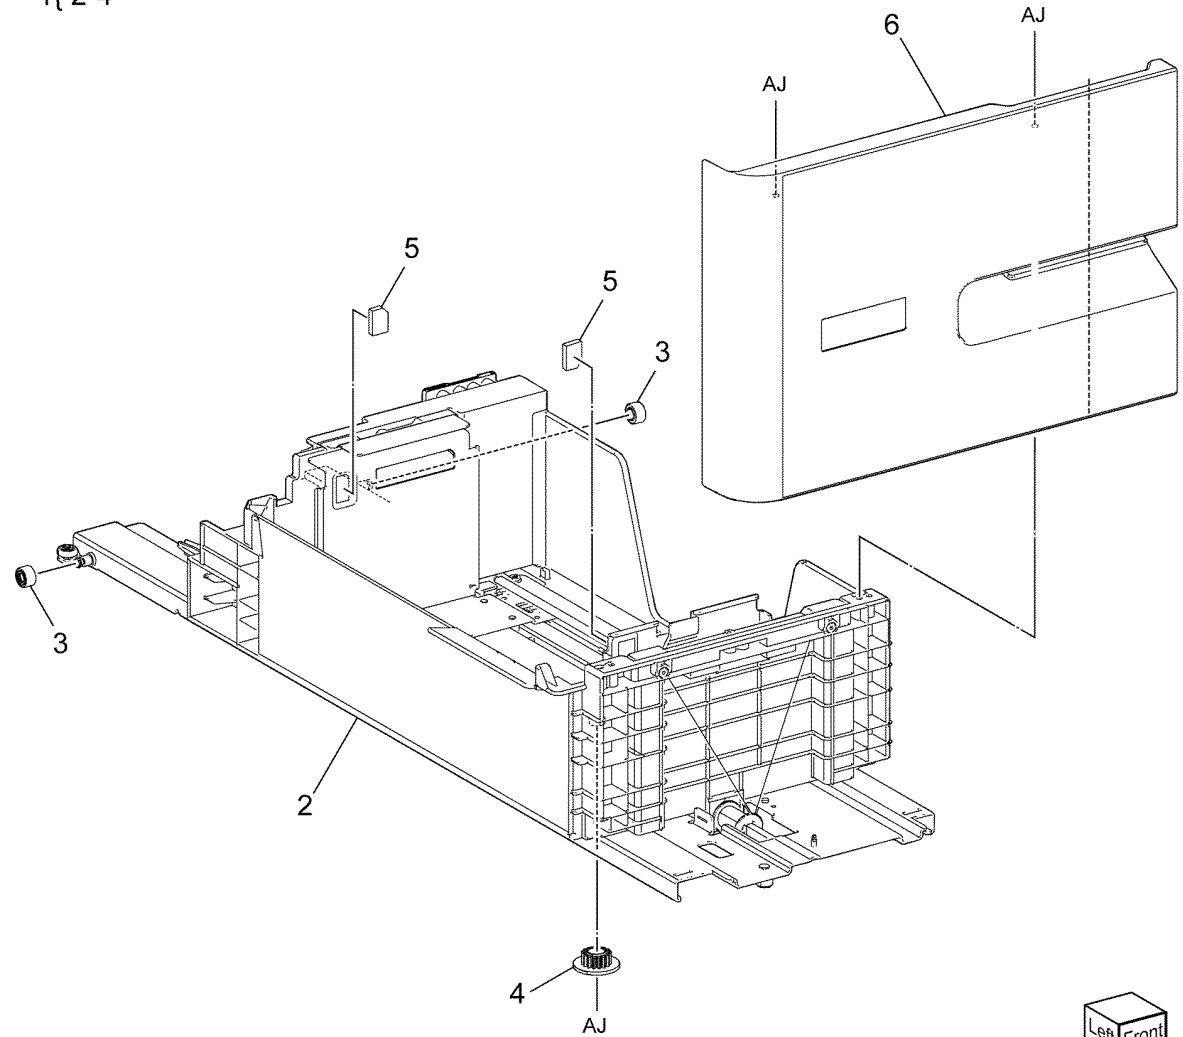
F-8-0134-A

Item	Part	Description
1	-	Tray 3 chassis assembly
2	-	Tray 3 chassis (P/O PL 70.40 Item 1)
3	-	Upper roller (P/O PL 70.40 Item 1)
4	-	Pinion (P/O PL 70.40 Item 1)
5	-	Pad (P/O PL 70.35 Item 1)
6	-	Tray 3 cover assembly (P/O PL 70.35 Item 1)

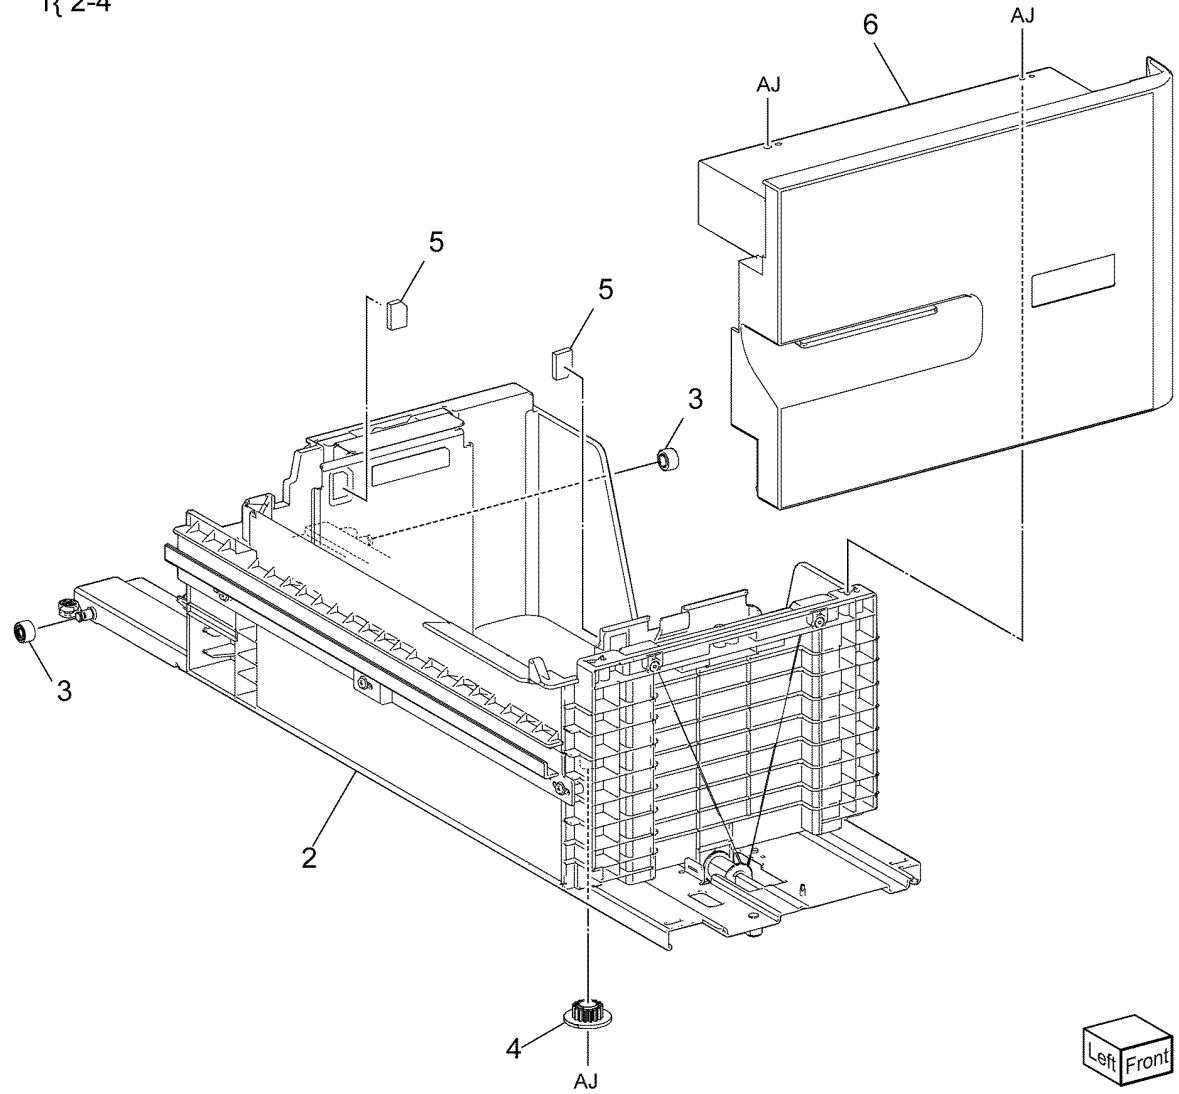
F-8-0135-A

PL 70.45 TTM Tray 4 Assembly

Item	Part	Description
1	-	Tray 4 chassis assembly (P/O PL 70.35 Item 2)
2	-	Tray 4 chassis (P/O PL 70.45 Item 1)
3	-	Upper roller (P/O PL 70.45 Item 1)
4	-	Pinion (P/O PL 70.45 Item 1)
5	-	Pad (P/O PL 70.35 Item 2)
6	-	Tray 4 cover assembly (P/O PL 70.35 Item 2)

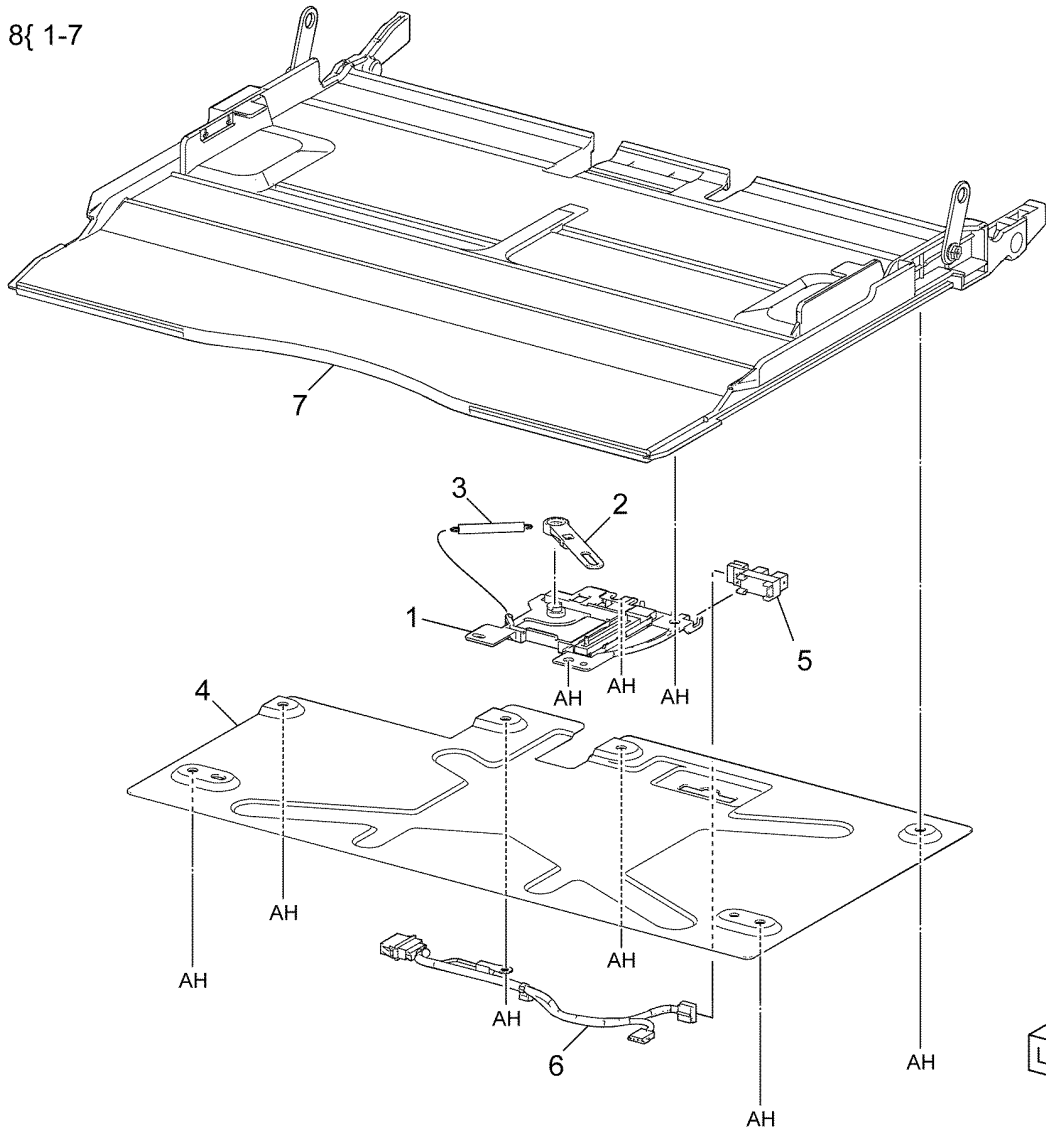
F-8-0139-A

Item	Part	Description
1	-	Paper size sensor assembly (P/O PL 70.55 Item 8) (REP 70.4)
2	-	Link (P/O PL 70.55 Item 8)
3	-	Spring (P/O PL 70.55 Item 8)
4	-	Tray plate (P/O PL 70.55 Item 8)
5	-	No paper sensor (Q75-101) (P/O PL 70.55 Item 8)
6	-	No paper sensor harness (P/O PL 70.55 Item 8)
7	-	Bypass tray (P/O PL 70.55 Item 8)
8	-	Bypass tray assembly (P/O PL 70.50 Item 16) (REP 70.3)

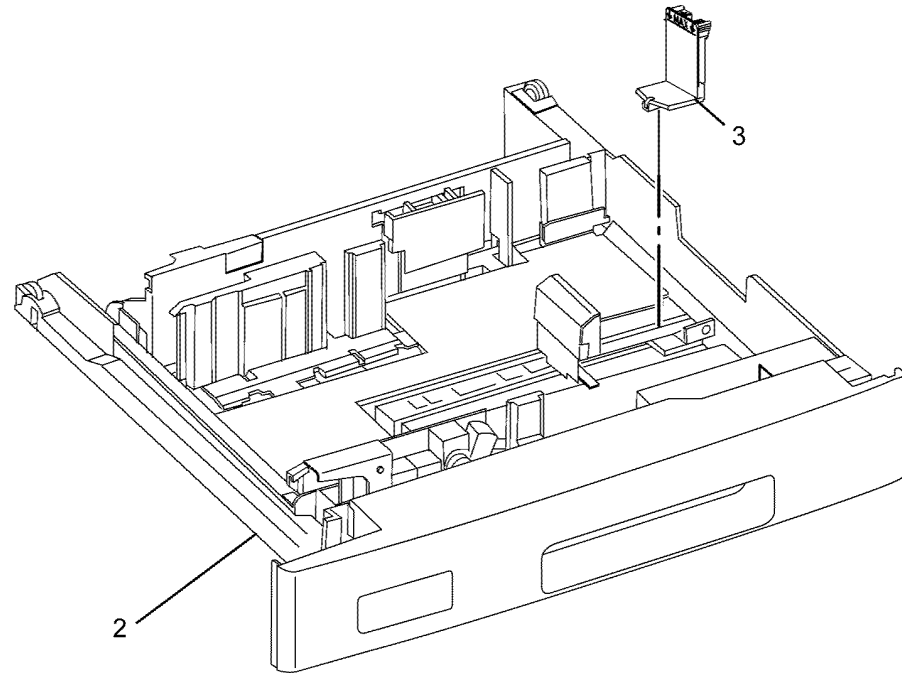
F-8-0140-A

PL 70.70 Envelope Tray

Item	Part	Description
1	050K76591	Envelope tray assembly
2	-	Envelope tray (P/O PL 70.70 Item 1)
3	-	End guide (P/O PL 70.70 Item 1)

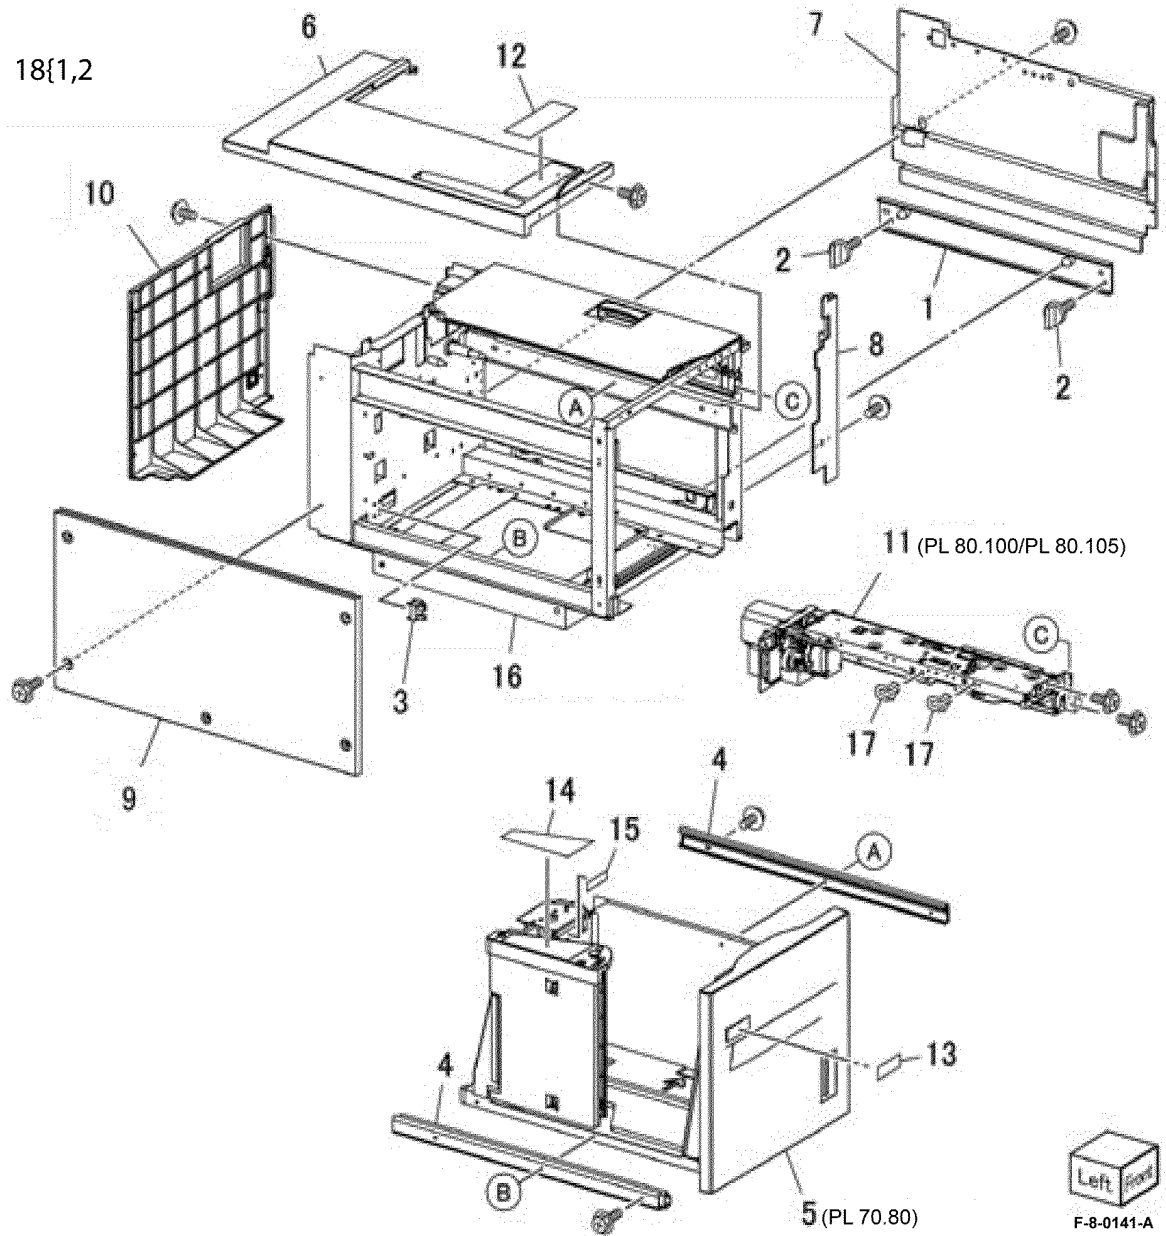
PL 70.75 HCF Unit

Item	Part	Description
1	–	Joint plate (P/O PL 70.75 Item 18)
2	003K91881	Knob
3	130K55590	Tray set sensor (Q78-204)(REP 70.9)
4	801K15701	Tray rail
5	050K51976	HCF tray (REP 70.7, REP 70.8)
6	–	Left top cover (Not Spared)
7	–	Right cover (Not Spared)
8	–	Front right cover (Not Spared)
9	–	Left cover (Not Spared)
10	–	Rear cover (Not Spared)
11	–	HCF feed head (REF: PL 80.100 & PL 80.105) (REP 70.23)
12	–	Label (Top) (Not Spared)
13	–	Label (Tray number) (Not Spared)
14	–	Label (End) (Not Spared)
15	–	Label (Size) (Not Spared)
16	–	Frame assembly (Not Spared)
17	–	Plate assembly (Not Spared)
18	604K23830	HCF docking plate

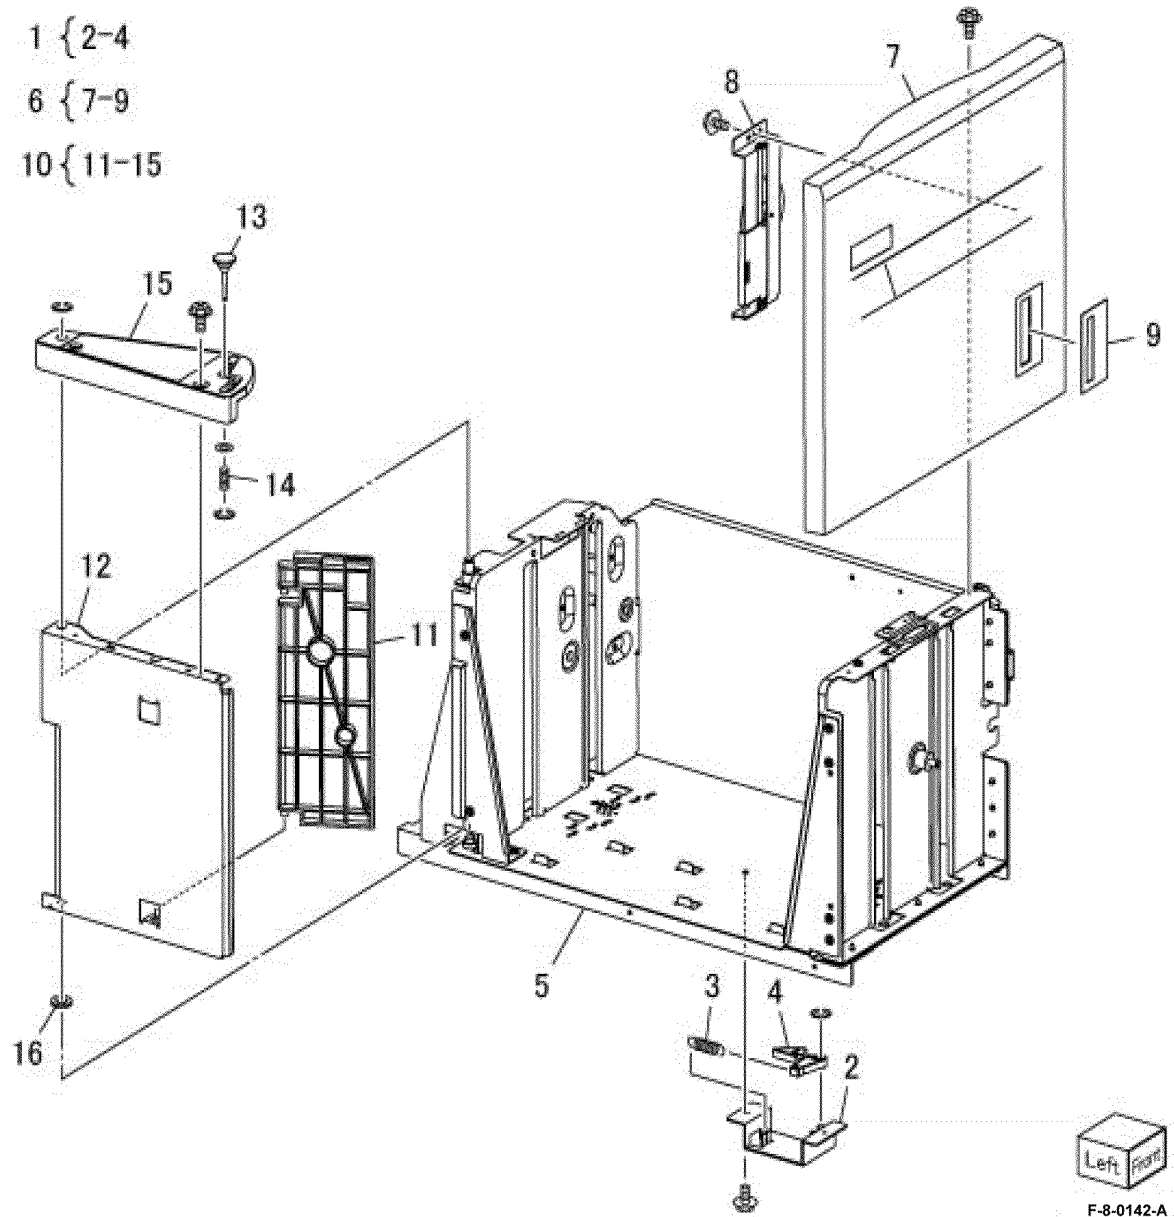
PL 70.80 HCF Tray 6 (1 of 2)

Item	Part	Description
1	003K13592	Tray latch assembly (REP 70.10)
2	-	Bracket (P/O PL 70.80 Item 1)
3	-	Spring (P/O PL 70.80 Item 1)
4	-	Latch lever (P/O PL 70.80 Item 1)
5	-	Tray
6	-	Front cover assembly
7	-	Front cover (P/O PL 70.80 Item 6)
8	-	Gear bracket (P/O PL 70.80 Item 6)
9	-	Label (Gauge) (P/O PL 70.80 Item 6)
10	-	Frame
11	-	Plate (P/O PL 70.80 Item 10)
12	-	Bracket (P/O PL 70.80 Item 10)
13	-	Pin (P/O PL 70.80 Item 10)
14	-	Spring (P/O PL 70.80 Item 10)
15	-	Top plate (P/O PL 70.80 Item 10)
16	-	Wave washer (Not Spared)

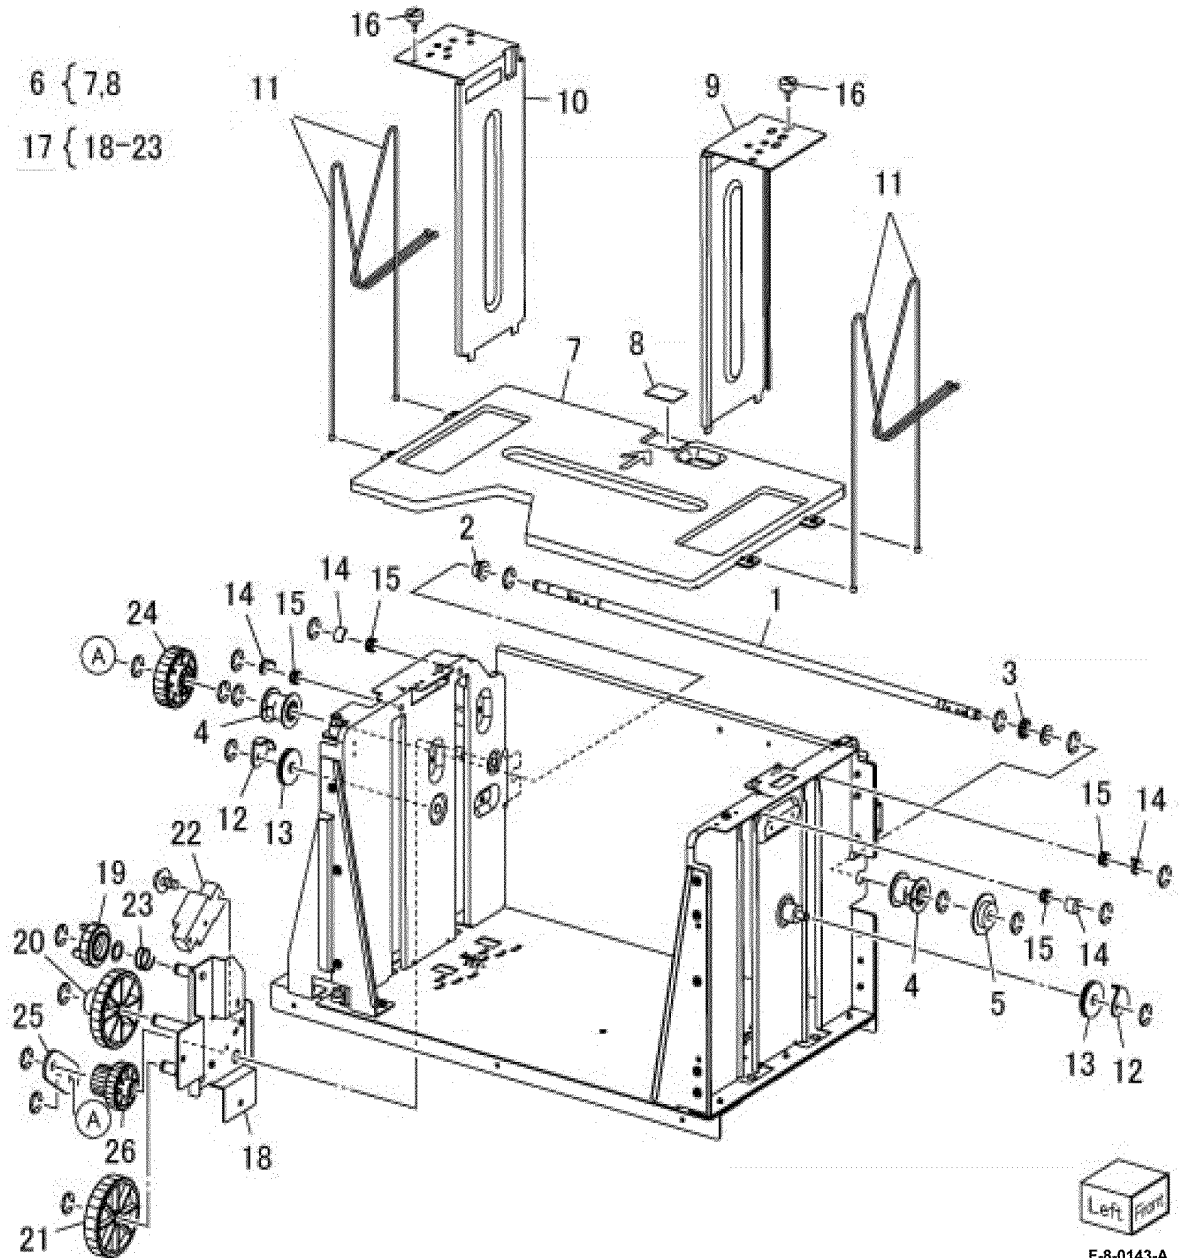
PL 70.85 HCF Tray 6 (2 of 2)

Item	Part	Description
1	-	Lift shaft (P/O PL 70.75 Item 5)
2	-	Bearing (P/O PL 70.75 Item 5)
3	-	Bearing (P/O PL 70.75 Item 5)
4	020E37620	Pulley
5	-	Gear (P/O PL 70.75 Item 5)
6	-	Bottom plate assembly (P/O PL 70.75 Item 5)
7	-	Bottom plate (P/O PL 70.85 Item 6)
8	019E58620	Pad
9	-	Front side guide (P/O PL 70.75 Item 5)
10	-	Rear side guide (P/O PL 70.75 Item 5)
11	604K19981	Cable and pulley kit (REP 70.13)
12	032E22410	Long wire guide
13	-	Pulley (P/O PL 70.75 Item 5)
14	-	Short wire guide (P/O PL 70.75 Item 5)
15	-	Pulley (P/O PL 70.75 Item 5)
16	-	Screw (P/O PL 70.75 Item 5)
17	015K65532	Gear bracket assembly (REP 70.12)
18	-	Gear bracket (P/O PL 70.85 Item 17)
19	-	Contact gear (P/O PL 70.85 Item 17)
20	-	Gear (P/O PL 70.85 Item 17)
21	-	Gear (P/O PL 70.85 Item 17)
22	-	Brake (P/O PL 70.85 Item 17)
23	-	Spring (P/O PL 70.85 Item 17)
24	807E04500	Lift gear (REP 70.11)
25	-	Plate (P/O PL 70.75 Item 5)
26	-	Gear (P/O PL 70.75 Item 5)
