VersaLink[®] C8000/C9000 Printer

Service Manual

VersaLink C9000 Family Service Manual

705P01418

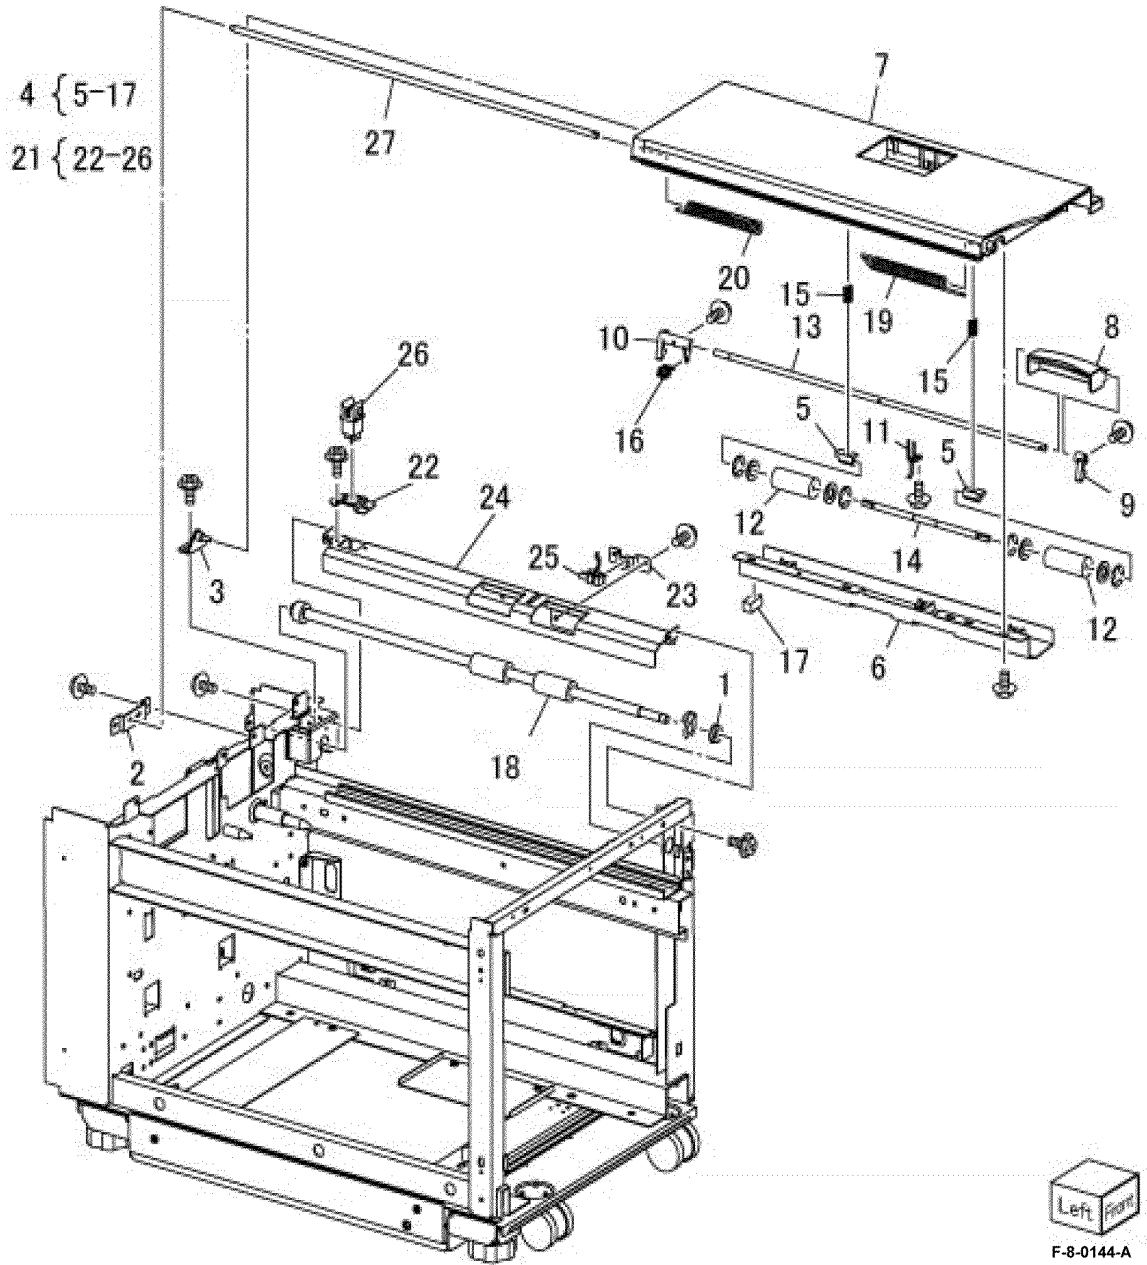
PL 70.90 HCF Top Cover Unit

Item	Part	Description
1	013E17100	Bearing
2	-	Bracket (Not Spared)
3	-	Pivot bracket (Not Spared)
4	-	Transport cover assembly
5	-	Bearing (P/O PL 70.90 Item 4)
6	-	Upper chute (P/O PL 70.90 Item 4)
7	-	Top cover (P/O PL 70.90 Item 4)
8	-	Knob (P/O PL 70.90 Item 4)
9	-	Latch (P/O PL 70.90 Item 4)
10	-	Latch (P/O PL 70.90 Item 4)
11	-	Spring (P/O PL 70.90 Item 4)
12	059E01430	Pinch roller
13	-	Shaft (P/O PL 70.90 Item 4)
14	-	Shaft (P/O PL 70.90 Item 4)
15	-	Spring (P/O PL 70.90 Item 4)
16	-	Spring (P/O PL 70.90 Item 4)
17	-	Gasket (P/O PL 70.90 Item 4)
18	059K36260	Takeaway roll (REP 70.15)
19	-	Spring (Left) (Not Spared)
20	-	Spring (Right) (Not Spared)
21	-	Lower chute assembly (Not Spared)
22	-	Bracket (P/O PL 70.90 Item 21)
23	-	Bracket (P/O PL 70.90 Item 21)
24	-	Lower chute (P/O PL 70.90 Item 21)
25	130K88150	Feed out sensor (Q78-101) (REP 70.16)
26	110E94770	Transport interlock switch (S78-300) (REP 70.17)
27	-	Pivot shaft (Not Spared)

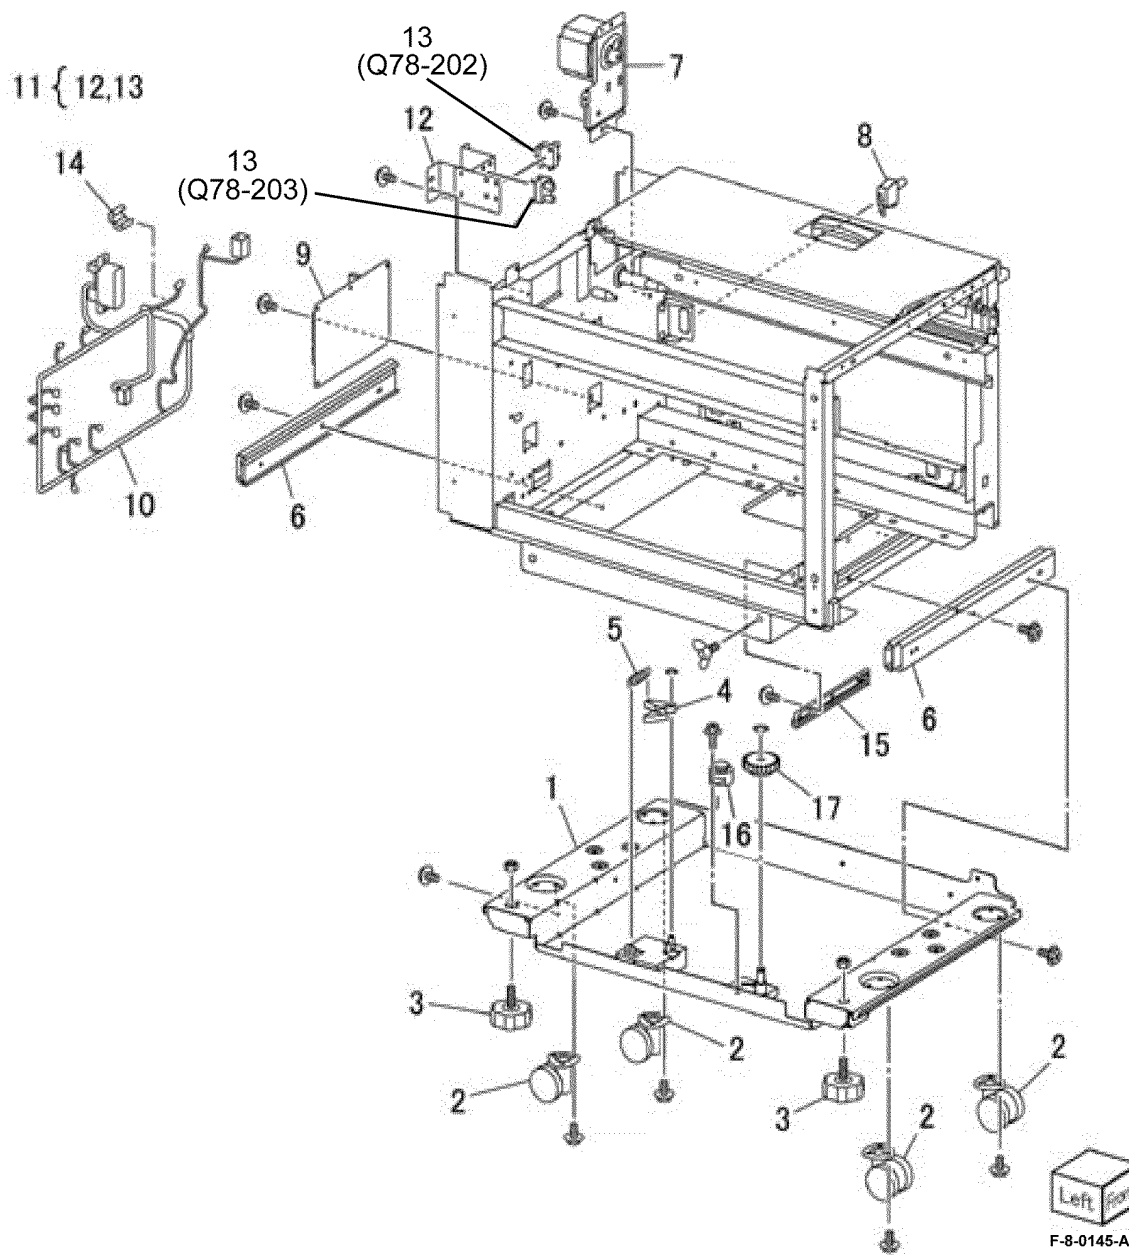
PL 70.95 HCF Electrical and Rail

Item	Part	Description
1	-	Plate (Not Spared)
2	017E92820	Rack caster
3	017E97191	Foot
4	-	Latch lever (Not Spared)
5	-	Spring (Not Spared)
6	801K15690	Rail
7	127K47152	Takeaway motor (MOT78-007) (REP 70.18)
8	110E10381	Slide out switch (S78-301)(REP 70.19)
9	960K88140	HCF PWB (REP 70.20)
10	-	Wire harness (Not Spared)
11	130K55590	HCF Size Sensor Assembly (REP 70.21)
12	-	Bracket (P/O PL 70.95 Item 11)
13	-	HCF paper sensor (Letter) (Q78- 202) / HCF paper sensor (A4) (Q78-203) (P/O PL 70.95 Item 11)
14	-	Core (Not Spared)
15	-	Gear rack (Not Spared)
16	004K03000	Damper (REP 70.22)
17	807E32730	Pinion (REP 70.22)

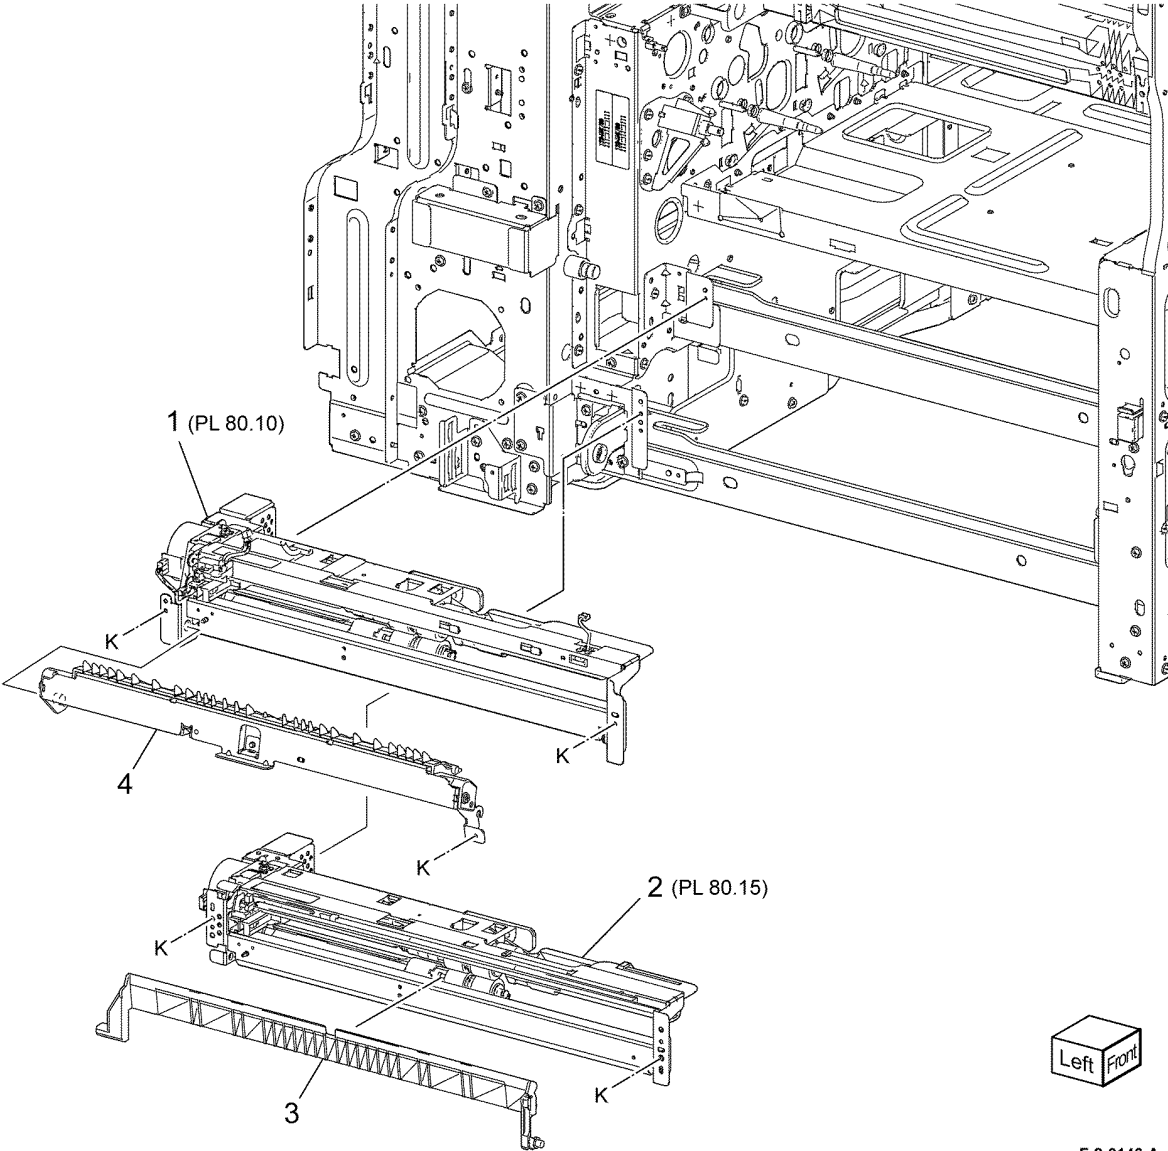
PL 80.05 Tray 1 & 2 Feedhead Assembly

Item	Part	Description
1	859K14361	Tray 1 feedhead assembly (REP 80.1)
2	859K14380	Tray 2 feedhead assembly (REP 80.2)
3	054E36442	Feed out chute
4	054K55444	Feedhead chute assembly

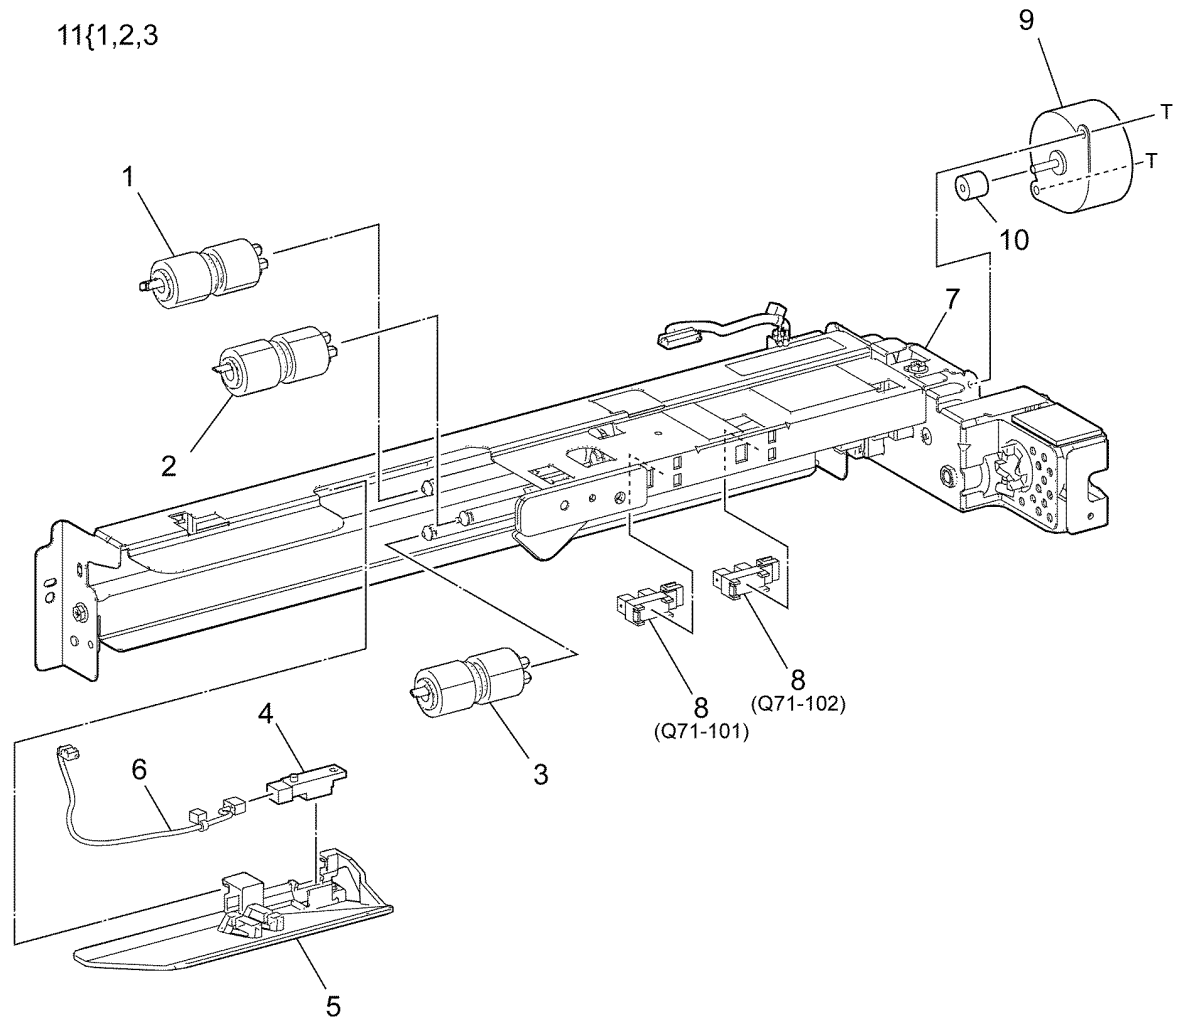
PL 80.10 Tray 1 Feedhead Assembly

Item	Part	Description
1	-	Feed roll (P/O PL 80.10 Item 11) (REP 80.3)
2	-	Nudger roll (P/O PL 80.10 Item 11) (REP 80.3)
3	-	Retard roll (P/O PL 80.10 Item 11) (REP 80.3)
4	930W00211	Tray 1 pre-feed sensor (Q71-105)
5	-	Chute (P/O PL 80.10 Item 7)
6	-	Wire harness (P/O PL 80.10 Item 7)
7	-	Feedhead assembly (P/O PL 80.05 Item 1)
8	-	Tray 1 no paper sensor (Q71-101)/ Tray 1 level sensor (Q71-102) (P/ O PL 80.05 Item 1)
9	-	Tray 1 feed /lift motor (MOT71-001) (P/O PL 80.05 Item 1)
10	-	Gear (P/O PL 80.10 Item 9)
11	109R00790	Tray 1-4 feed rolls

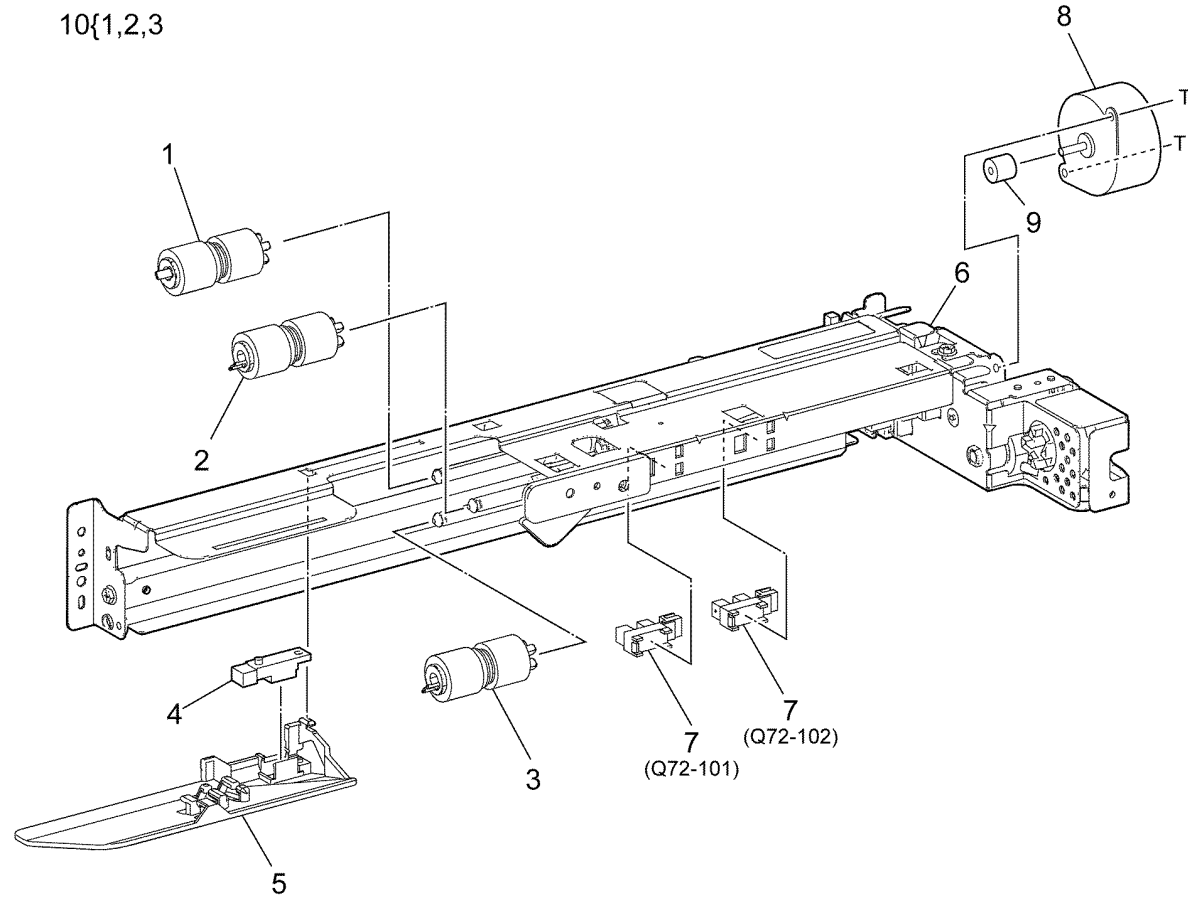
PL 80.15 Tray 2 Feedhead Assembly

Item	Part	Description
1	-	Feed roll (P/O PL 80.15 Item 10) (REP 80.3)
2	-	Nudger roll (P/O PL 80.15 Item 10) (REP 80.3)
3	-	Retard roll (P/O PL 80.15 Item 10) (REP 80.3)
4	930W00211	Tray 2 pre-feed sensor (Q72-105)
5	-	Chute (P/O PL 80.15 Item 6)
6	-	Feedhead assembly (P/O PL 80.05 Item 2)
7	-	Tray 2 no paper sensor (Q72-101) / Tray 2 level sensor (Q72-102) (P/O PL 80.05 Item 2)
8	-	Tray 2 feed/lift motor (MOT72-001) (P/O PL 80.05 Item 2)
9	-	Gear (P/O PL 80.15 Item 8)
10	109R00790	Tray 1-4 feed rolls

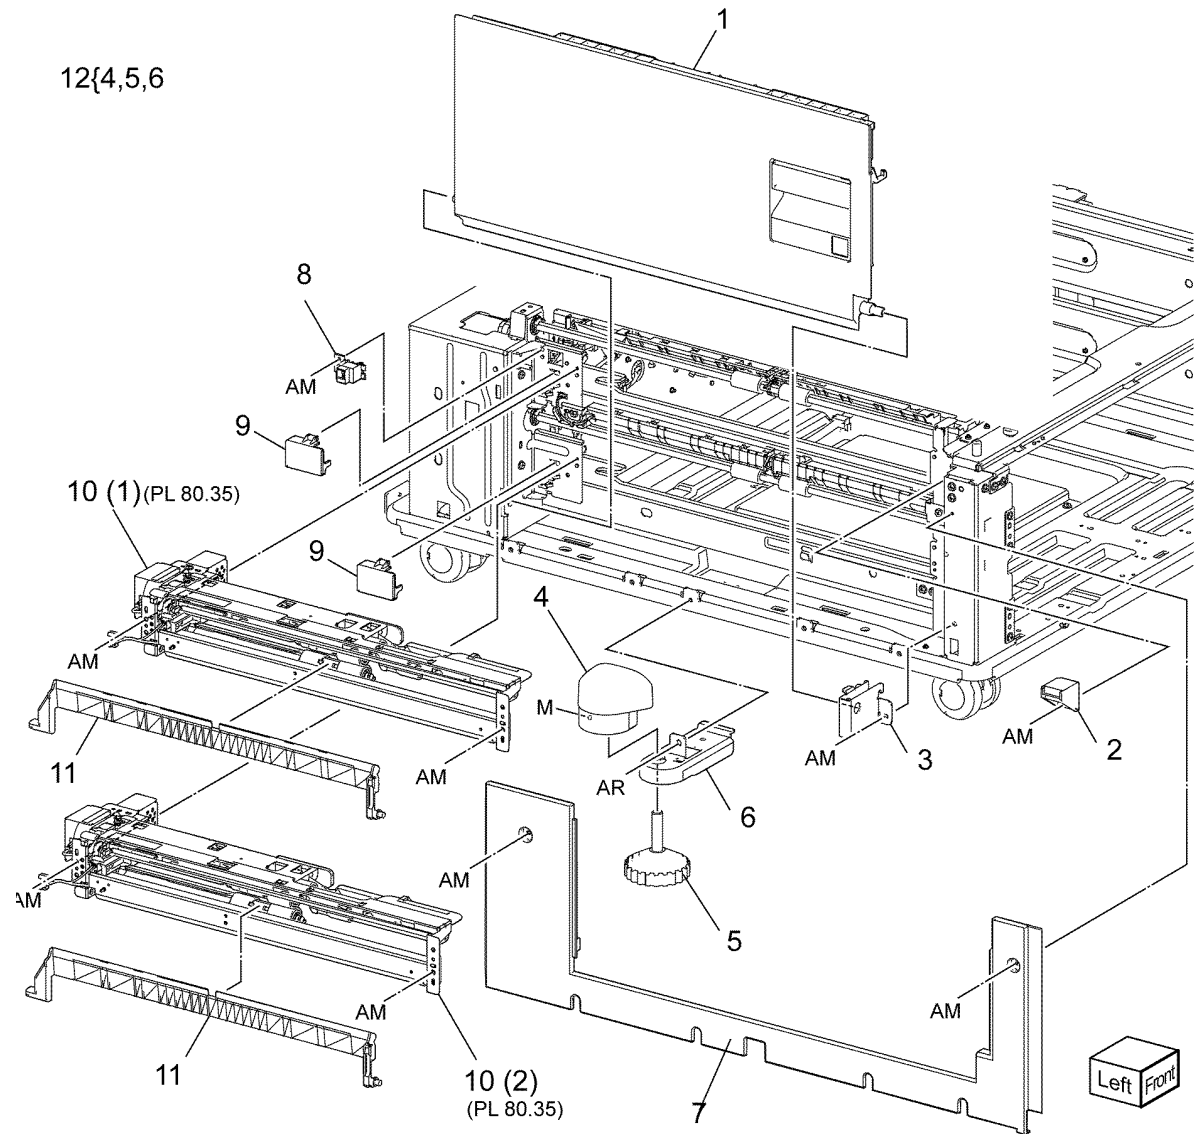
PL 80.20 2TM Left Cover Feedhead Assembly

Item	Part	Description
1	948K12050	Left door assembly
2	-	Latch holder (Not Spared)
3	-	Pivot bracket (Not Spared)
4	-	Foot cover (P/O PL 80.20 Item 12)
5	-	Adjuster foot (P/O PL 80.20 Item 12)
6	-	Foot bracket (P/O PL 80.20 Item 12)
7	822E41053	Left cover
8	948K01810	2TM left door interlock switch (S77-306)
9	822E27982	Connector cover
10	859K04741	2TM feedhead 1 assembly (REP 80.4)/ 2TM feedhead 2 assembly (REP 80.5) (REF: PL 80.35)
11	054E36442	Feed out chute
12	607K11480	Adjuster foot assembly

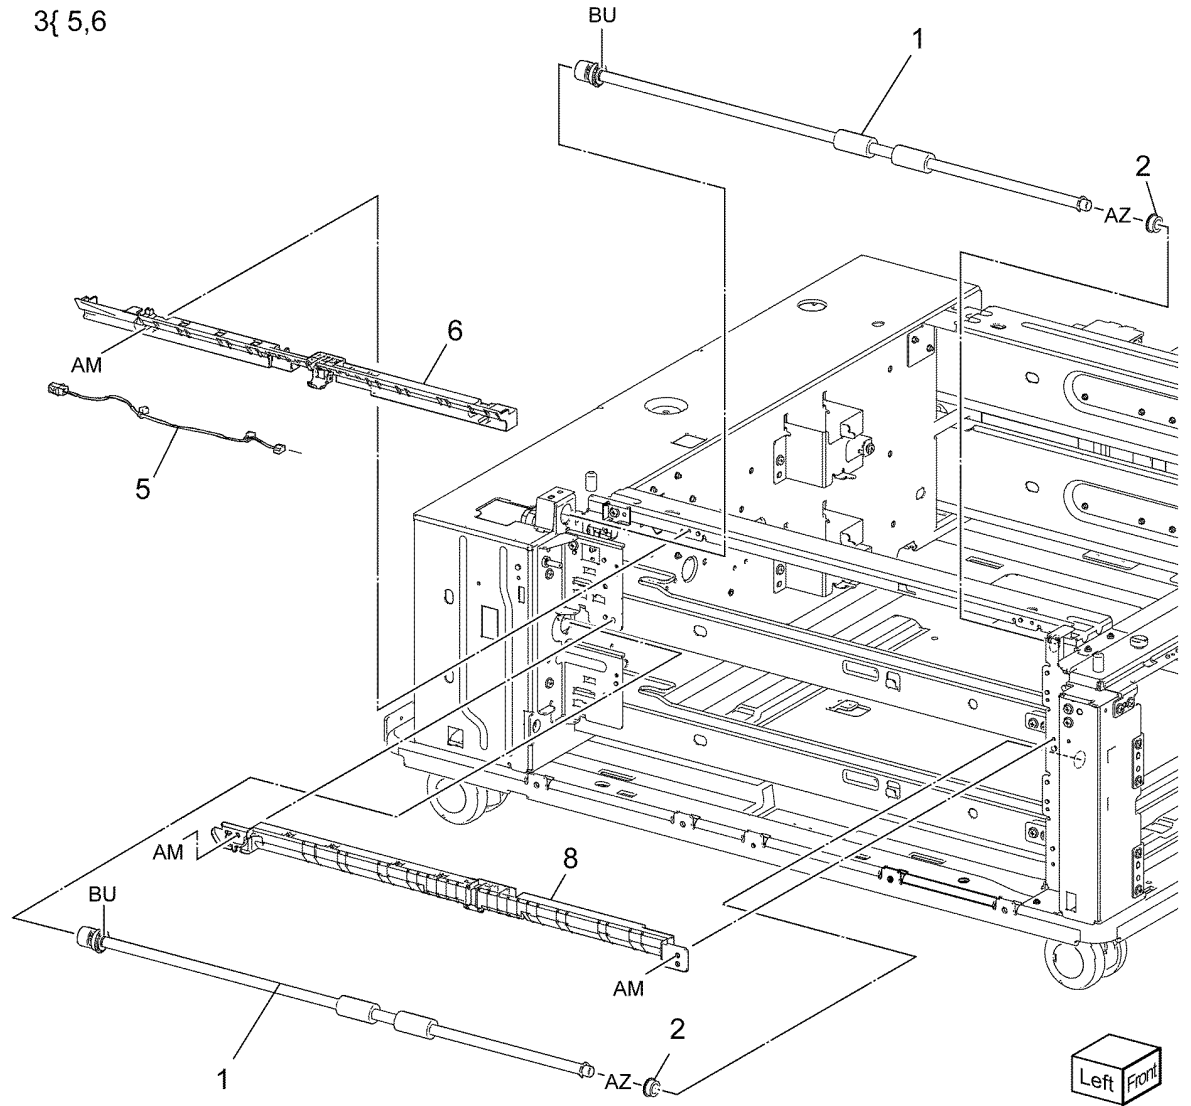
PL 80.25 2TM Takeaway Assembly

Item	Part	Description
1	859K07790	Takeaway roll assembly (upper) (REP 80.6)/ Takeaway roll assembly (lower) (REP 80.8)
2	413W88650	Bearing
3	054K55191	Tray 3 chute assembly (REP 80.7)
4	-	Not used
5	-	Tray 3 feed out sensor harness (P/ O PL 80.25 Item 3)
6	-	Tray 3 chute (P/O PL 80.25 Item 3)
7	-	Not used
8	-	Tray 4 chute assembly (Not Spared)

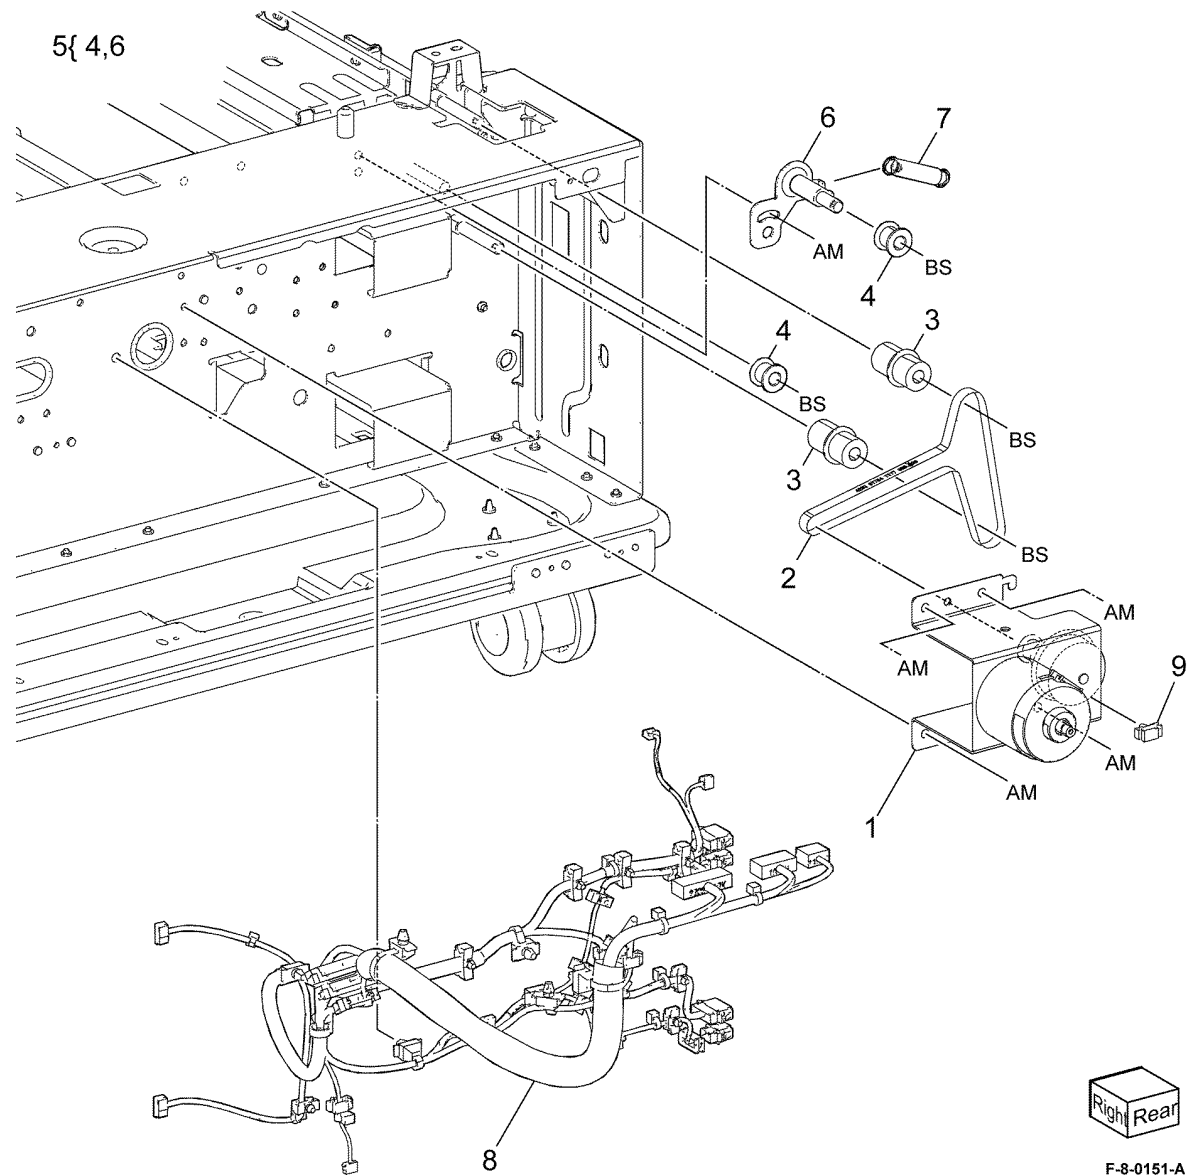
PL 80.30 2TM Drive Assembly

Item	Part	Description
1	049K41791	Takeaway motor assembly (REP 80.9)
2	423W37754	Belt (REP 80.10)
3	-	Pulley (24T) (Not Spared)
4	-	Roller (P/O PL 80.30 Item 5)
5	-	Tension bracket assembly (Not Spared)
6	-	Tension bracket (P/O PL 80.30 Item 5)
7	-	Spring (Not Spared)
8	-	Wire harness assembly (Not Spared)
9	-	Clamp (Not Spared)

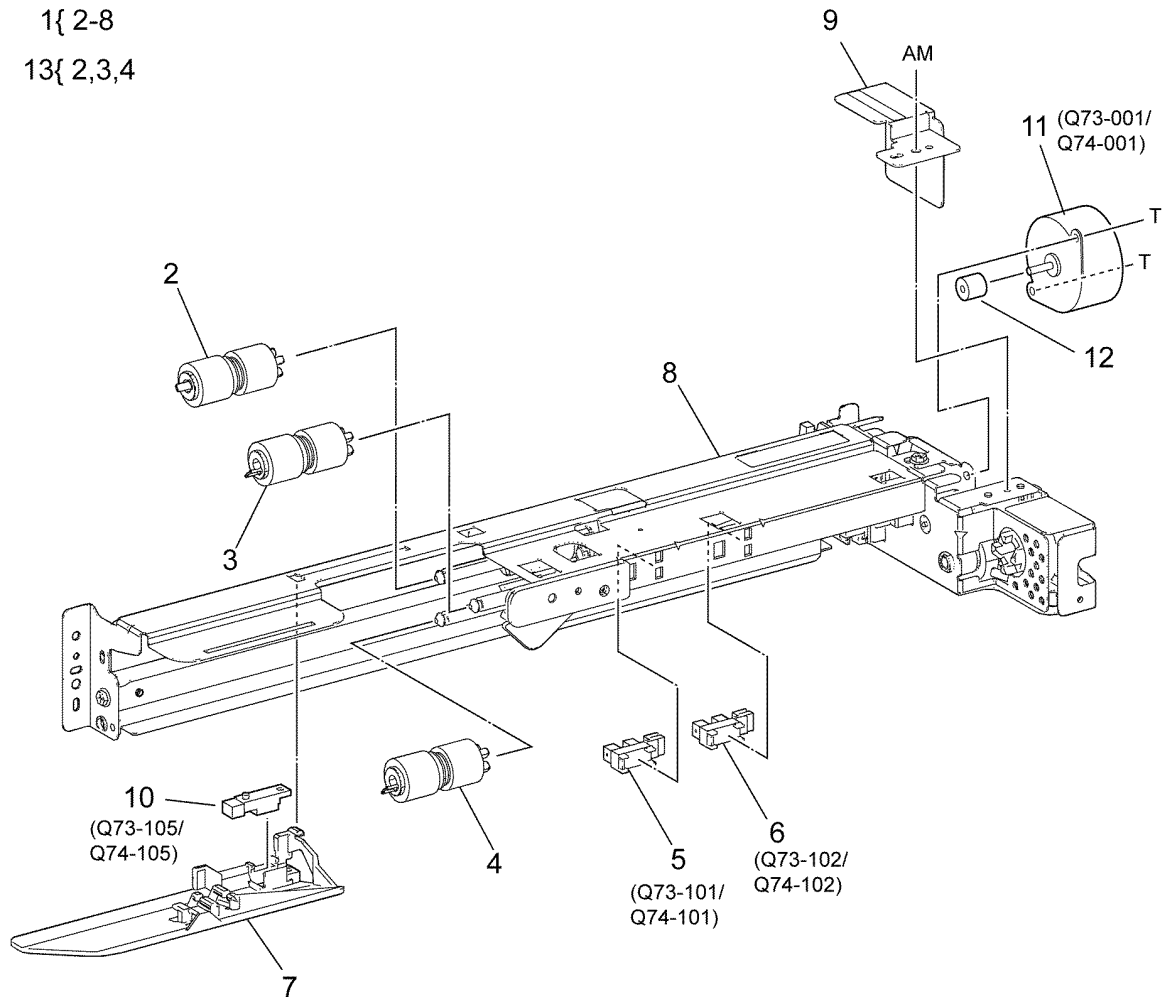
PL 80.35 2TM Tray 3 & 4 Feedhead Assembly

Item	Part	Description
1	-	Feedhead assembly (REF: PL 80.40 Item 3 & PL 80.40 Item 7)
2	-	Feed roll (P/O PL 80.35 Item 13) (REP 80.12)
3	-	Nudger roll (P/O PL 80.35 Item 13) (REP 80.12)
4	-	Retard roll (P/O PL 80.35 Item 13) (REP 80.12)
5	-	Tray 3 no paper sensor (Q73-101)/ Tray 4 no paper sensor (Q74-101) (P/O PL 80.20 Item 10)
6	-	Tray 3 level sensor (Q73-102)/ Tray 4 level sensor (Q74-102) (P/O PL 80.20 Item 10)
7	-	Chute (P/O PL 80.35 Item 1)
8	-	Feedhead frame (P/O PL 80.35 Item 1)
9	-	Bracket (Not Spared)
10	930W00211	Tray 3 pre-feed sensor (Q73-105)/ Tray 4 pre-feed sensor (Q74-105)
11	-	Tray 3 lift motor (MOT73-001)/Tray 4 lift motor (MOT74-001) (P/O PL 80.35 Item 1)
12	-	Gear (P/O PL 80.35 Item 11)
13	109R00790	Tray 1-4 feed rolls

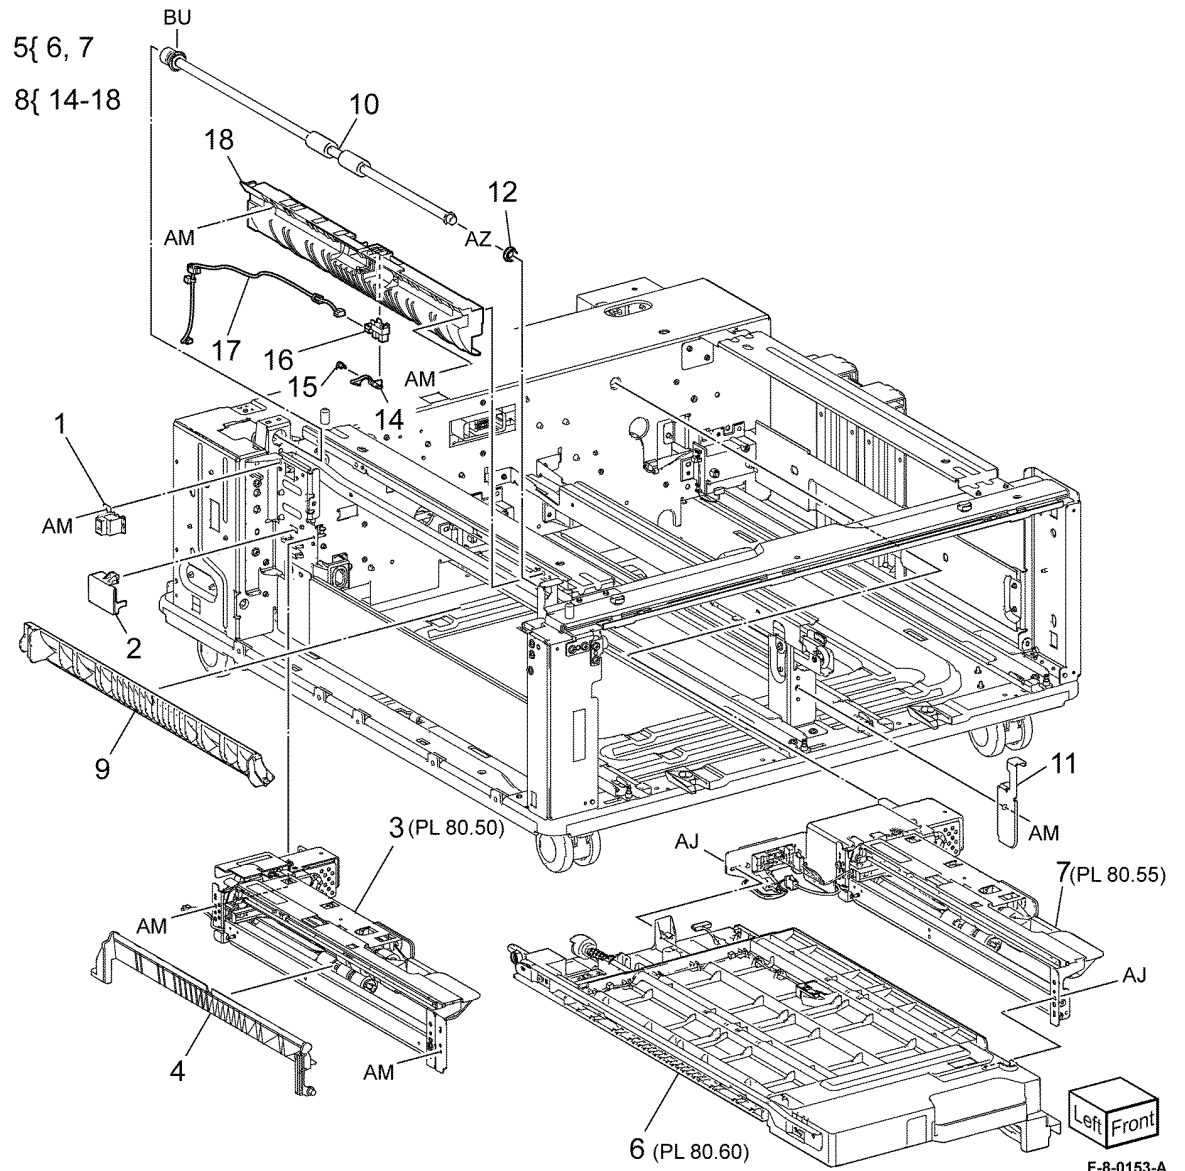
PL 80.40 TTM Transport assembly / Tray 3 & 4 Feedhead Assembly

Item	Part	Description
1	948K01810	TTM left door interlock switch (S77-306)
2	—	Connector cover (Not Spared)
3	859K02411	Tray 3 feedhead assembly (REP 80.14)
4	054E33803	Feed out chute
5	859K02862	Transport assembly (REF: PL 80.60)
6	—	TTM transport assembly (P/O PL 80.40 Item 5)
7	859K02931	Tray 4 feedhead assembly (REP 80.15)
8	054K56450	Takeaway chute assembly
9	054E39560	Transport feed chute
10	859K07790	Takeaway roll assembly
11	—	Transport stopper (Not Spared)
12	413W88650	Bearing
13	—	Not used
14	—	Actuator (P/O PL 80.40 Item 8)
15	—	Spring (P/O PL 80.40 Item 8)
16	—	Feed out sensor 3 (Q73-103) (P/O PL 80.40 Item 8)
17	—	Harness assembly (P/O PL 80.40 Item 8)
18	—	Takeaway chute (P/O PL 80.40 Item 8)

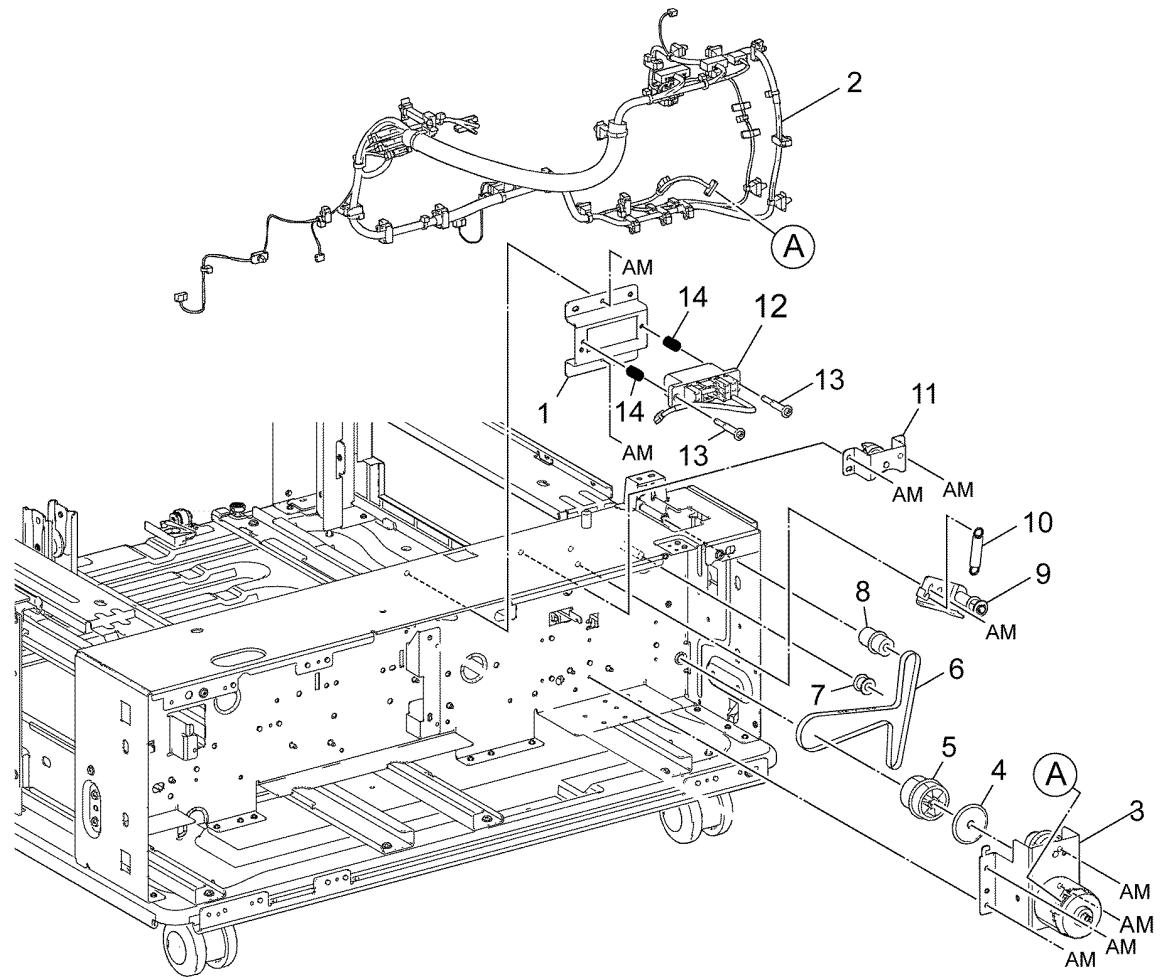
PL 80.45 TTM Drive Assembly

Item	Part	Description
1	-	Connector bracket (Not Spared)
2	-	Wire harness (Not Spared)
3	049K31871	Takeaway motor assembly (MOT77-035)
4	-	Collar (Not Spared)
5	-	Pulley (48T) (Not Spared)
6	423W85054	Belt
7	-	Roller (Not Spared)
8	-	Pulley (Not Spared)
9	-	Tension bracket assembly (Not Spared)
10	-	Spring (Not Spared)
11	-	Transport bracket assembly (Not Spared)
12	-	Drawer harness (Not Spared)
13	-	Shoulder screw (Not Spared)
14	-	Spring (Not Spared)

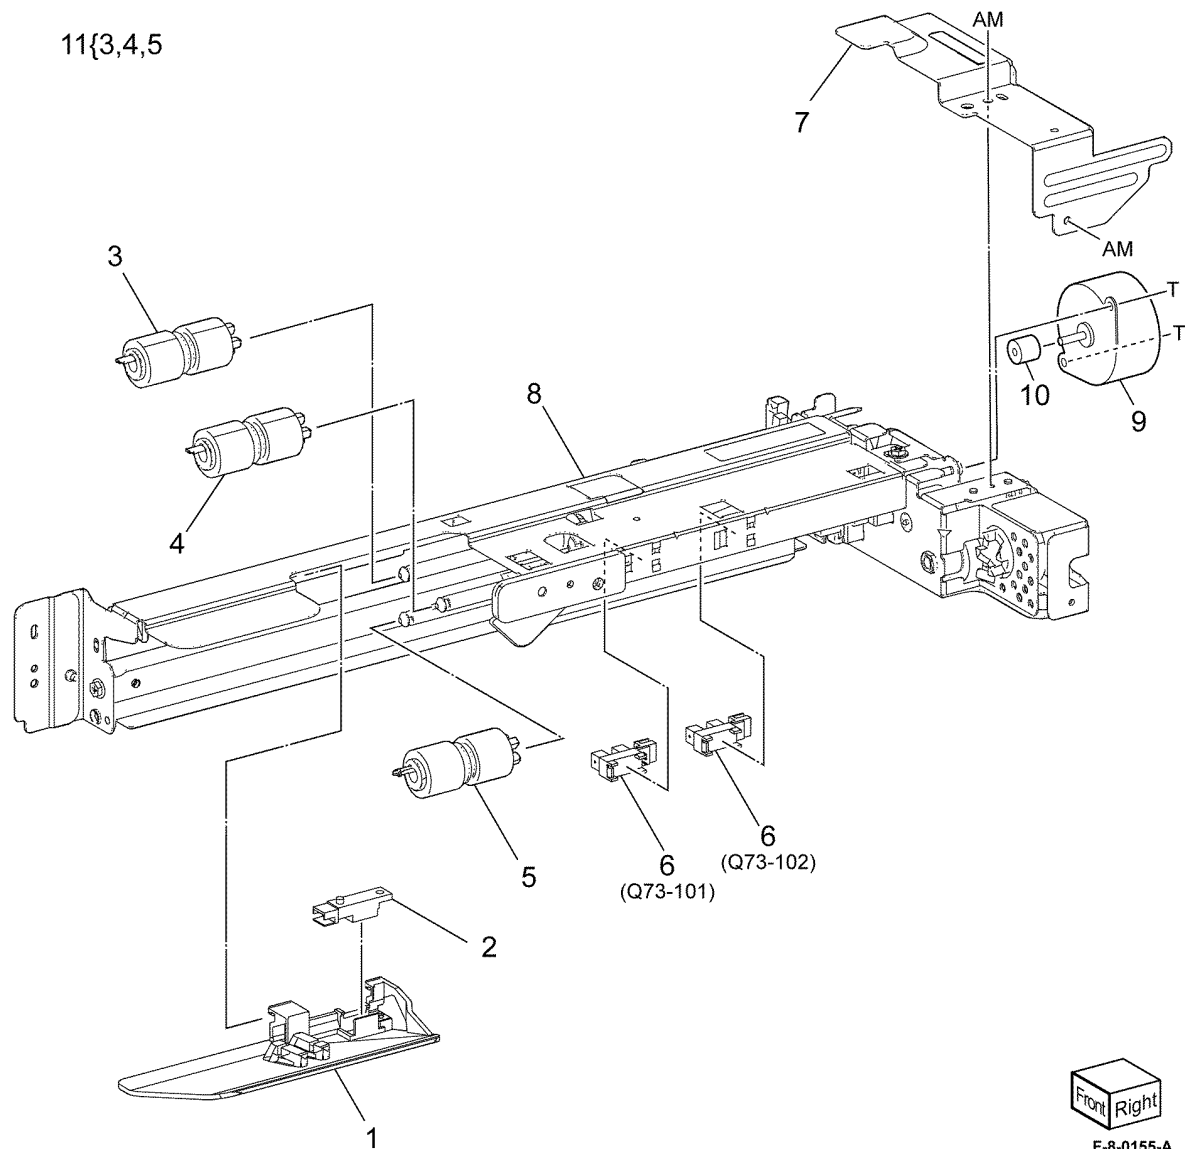
PL 80.50 TTM Tray 3 Feedhead Assembly

Item	Part	Description
1	-	Chute (P/O PL 80.40 Item 3)
2	930W00211	Tray 3 pre-feed sensor (Q73-105)
3	-	Feed roll (P/O PL 80.50 Item 11) (REP 80.16)
4	-	Nudger roll (P/O PL 80.50 Item 11) (REP 80.16)
5	-	Retard roll (P/O PL 80.50 Item 11) (REP 80.16)
6	-	Tray 3 no paper sensor (Q73-101)/ Tray 3 level sensor (Q73-102) (P/ O PL 80.40 Item 3)
7	-	Feedhead cover (P/O PL 80.40 Item 3)
8	-	Feedhead frame (P/O PL 80.40 Item 3)
9	-	Tray 3 feed/lift motor (MOT73-001) (P/O PL 80.40 Item 3)
10	-	Gear (P/O PL 80.50 Item 9)
11	109R00790	Tray 1-4 feed rolls

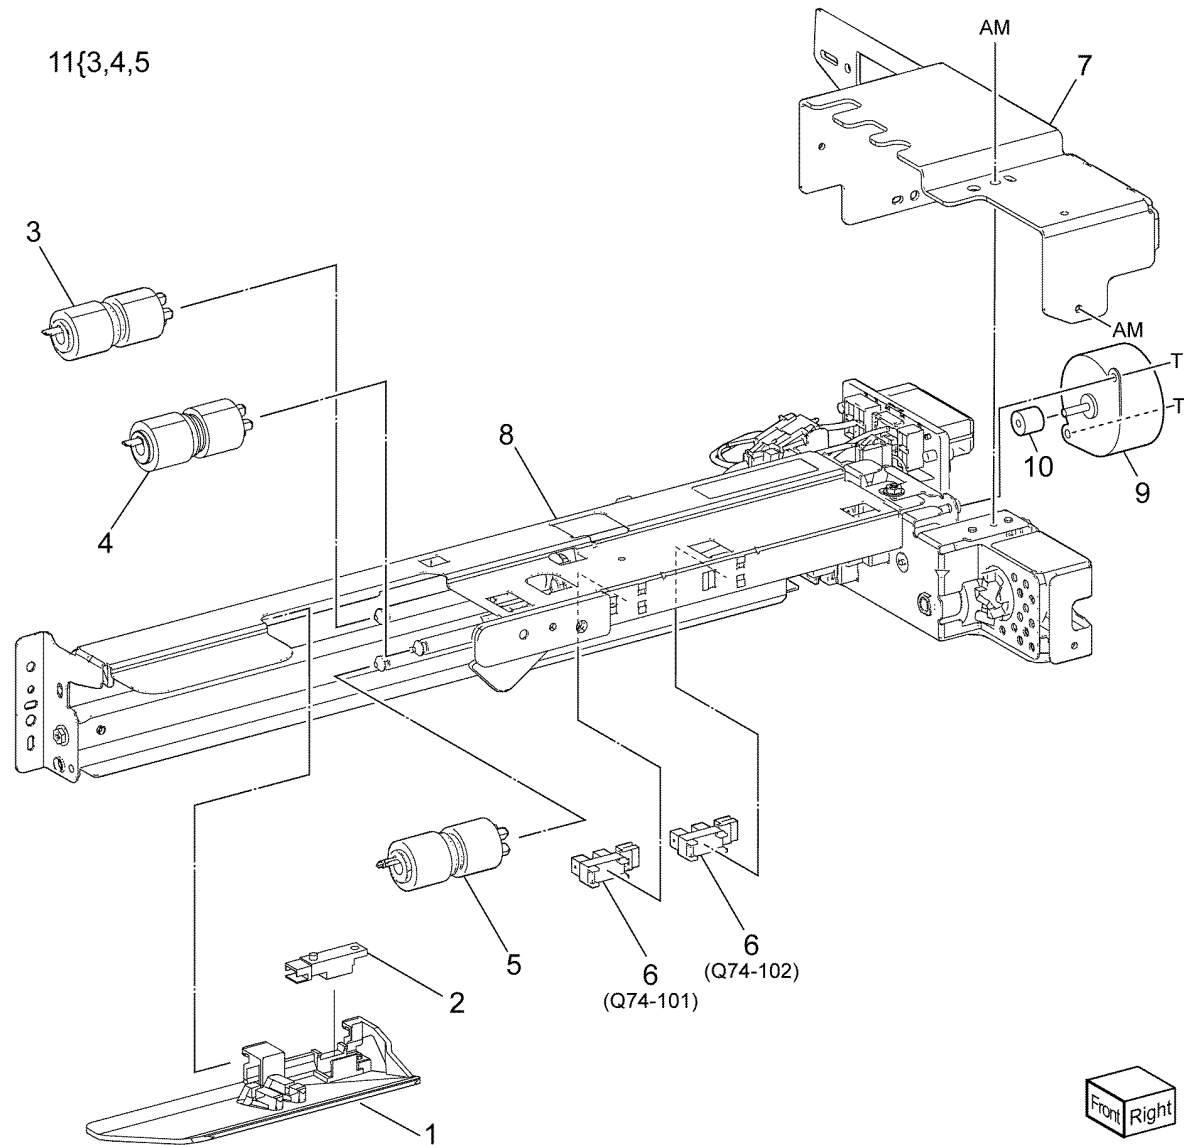
PL 80.55 TTM Tray 4 Feedhead Assembly

Item	Part	Description
1	-	Chute (P/O PL 80.40 Item 7)
2	930W00211	Tray 4 pre-feed sensor (Q74-105)
3	-	Feed roll (P/O PL 80.55 Item 11) (REP 80.16)
4	-	Nudger roll (P/O PL 80.55 Item 11) (REP 80.16)
5	-	Retard roll (P/O PL 80.55 Item 11) (REP 80.16)
6	-	Tray 4 no paper sensor (Q74-101)/ Tray 4 level sensor (Q74-102) (P/ O PL 80.40 Item 7)
7	-	Feedhead cover (P/O PL 80.40 Item 7)
8	-	Feedhead frame (P/O PL 80.40 Item 7)
9	-	Tray 4 feed/lift motor (MOT74-001) (P/O PL 80.40 Item 7)
10	-	Gear (P/O PL 80.55 Item 9)
11	109R00790	Tray 1-4 feed rolls

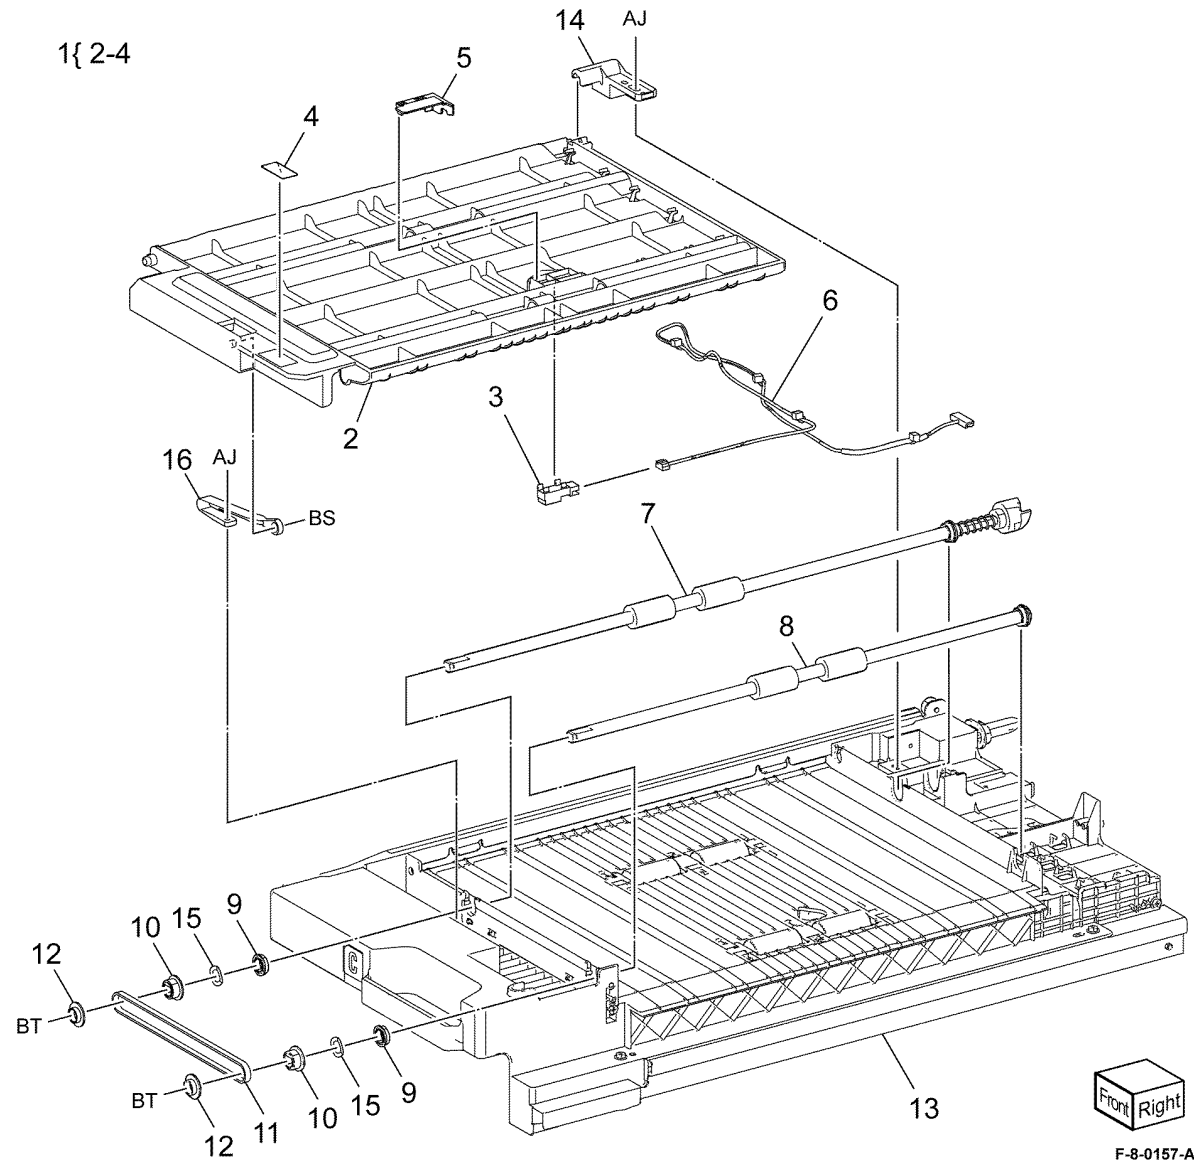
PL 80.60 TTM Transport Assembly

Item	Part	Description
1	-	Upper chute transport kit (REF: PL 80.40 Item 5)
2	-	Upper chute transport (P/O PL 80.60 Item 1)
3	-	Feed out sensor 4 (Q74-103) (P/O PL 80.60 Item 1)
4	-	Label (Transport) (P/O PL 80.60 Item 1)
5	-	Feed out sensor cover (Not Spared)
6	-	Feed out sensor harness (Not Spared)
7	-	Transport roll assembly (Not Spared) (REP 80.17)
8	-	Transport roll (Not Spared)
9	-	Bearing (Not Spared)
10	-	Pulley (Not Spared)
11	-	Belt (Not Spared)
12	-	Collar (Not Spared)
13	-	Lower chute transport (Not Spared)
14	-	Rear jam clearance handle (Not Spared)
15	-	Washer (Not Spared)
16	-	Front jam clearance handle (Not Spared)

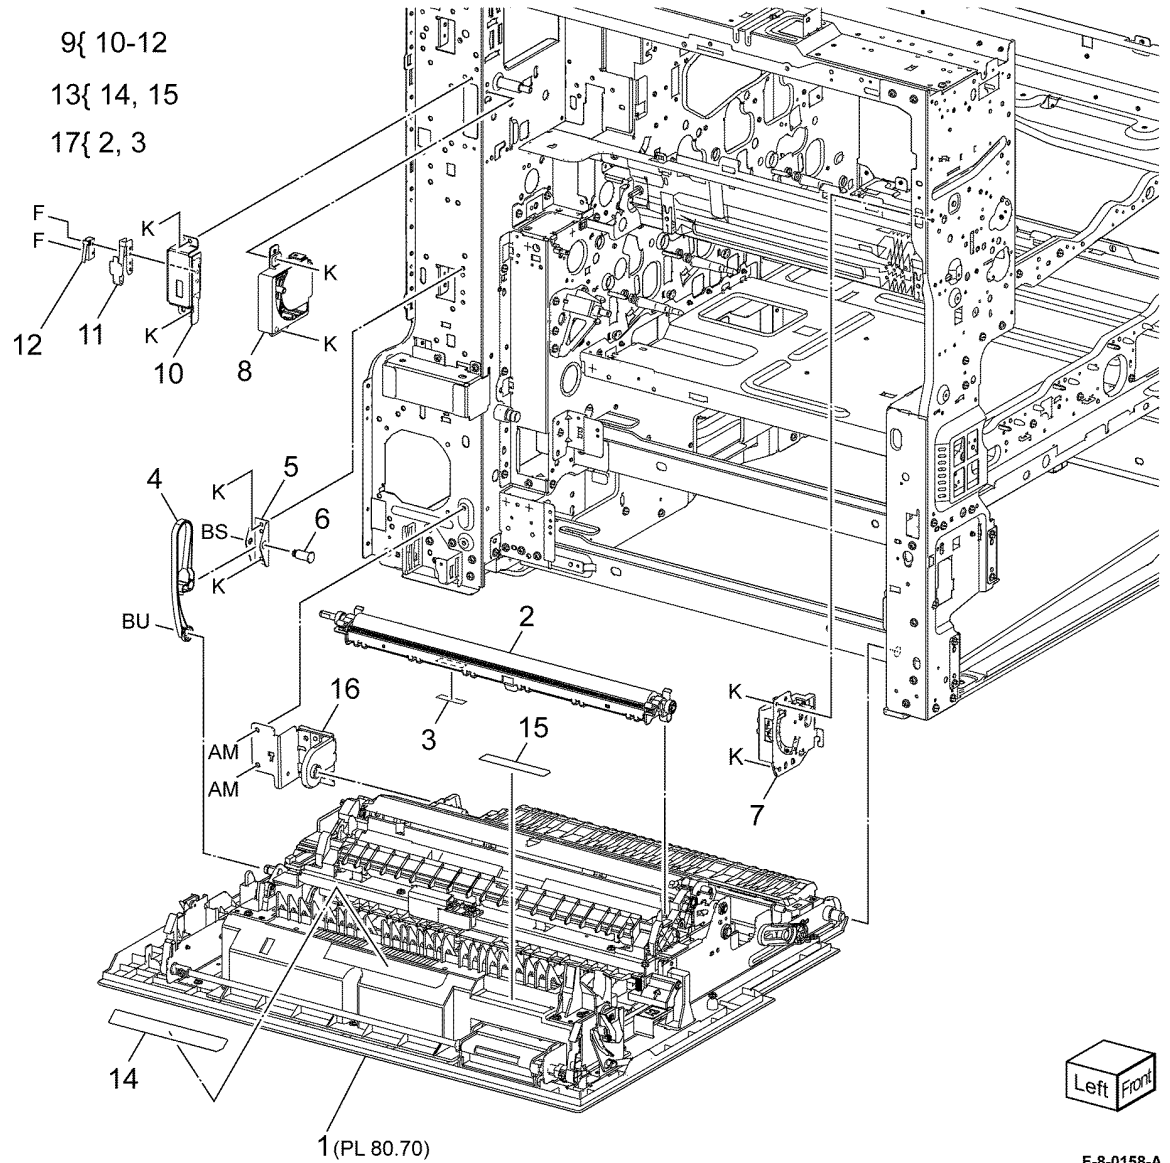
PL 80.65 Left Cover Components

Item	Part	Description
1	859K14042	Left cover assembly (REP 80.21)
2	-	2nd BTR roll assembly (P/O PL 80.65 Item 17) (REP 80.22)
3	-	Label (P/O PL 80.65 Item 17)
4	869E24730	Rear left support
5	-	Support bracket (Not Spared)
6	-	Shaft (Not Spared)
7	-	Front lever assembly (Not Spared)
8	-	Rear lever assembly (Not Spared)
9	110K18150	Interlock switch assembly (S77-300) (REP 80.29)
10	-	Switch bracket (P/O PL 80.65 Item 9)
11	-	Switch plate (P/O PL 80.65 Item 9)
12	-	Left cover interlock switch (P/O PL 80.65 Item 9)
13	-	Caution label kit (Not Spared)
14	-	Label (Finger caution) (P/O PL 80.65 Item 1)
15	-	Label (Caution) (P/O PL 80.65 Item 1)
16	-	Rear bracket (Not Spared)
17	116R00015	2nd BTR assembly
