VersaLink[®] C8000/C9000 Printer

Service Manual

VersaLink C9000 Family Service Manual

705P01418

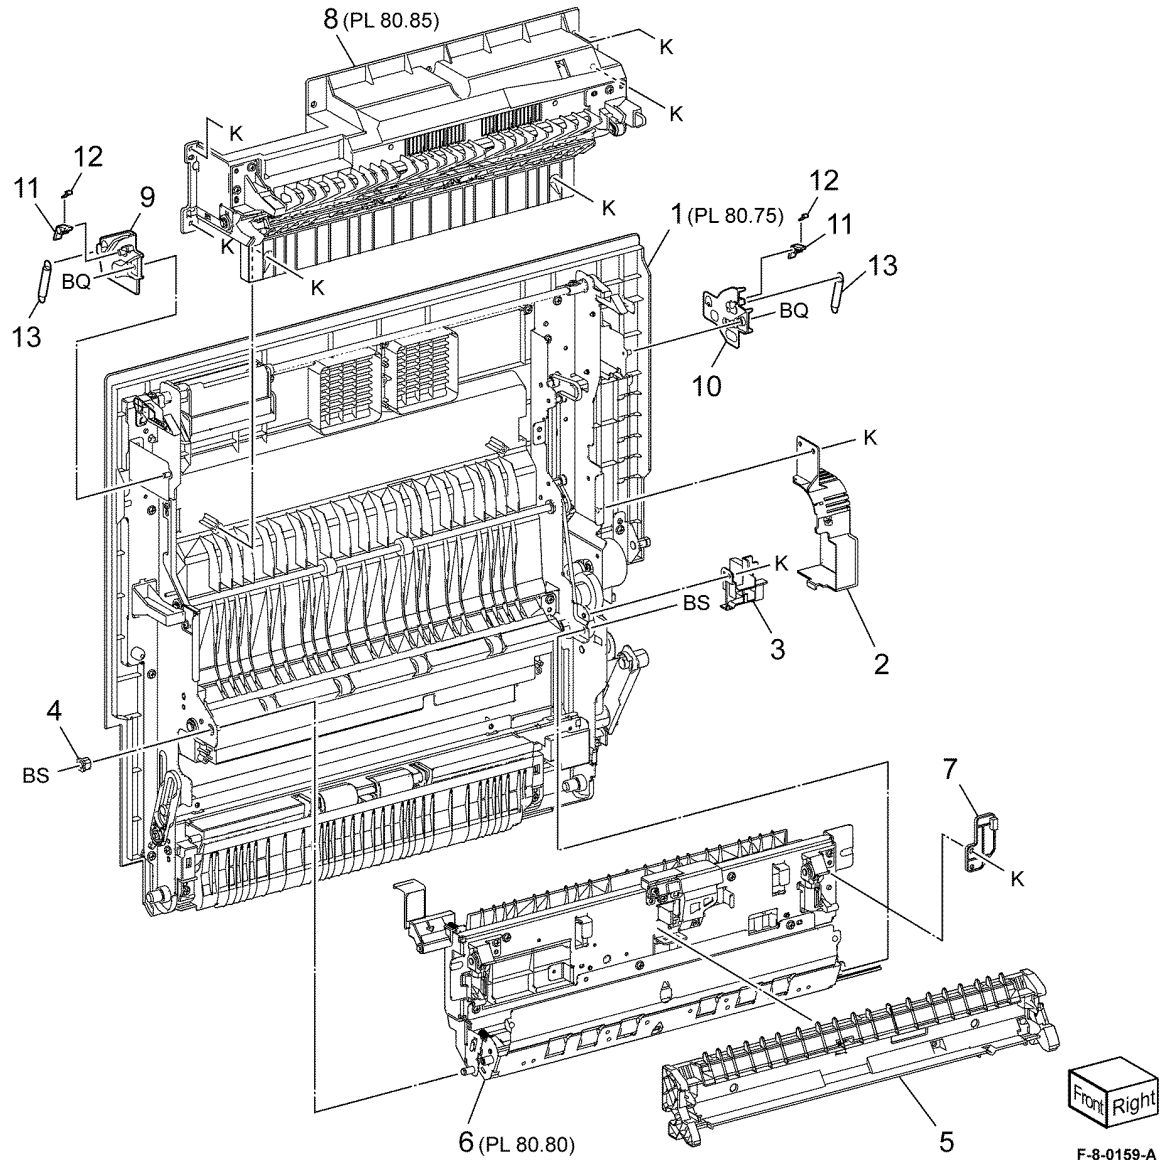
PL 80.70 Left Cover Transport Components

Item	Part	Description
1	-	Left cover assembly (REF: PL 80.75)
2	-	Duplex motor cover
3	-	Harness guide
4	-	Bearing
5	-	2nd BTR housing assembly (REF: PL 80.65 Item 17) (REP 80.23)
6	-	Duplex inner chute assembly (REF: PL 80.80) (REP 80.24)
7	-	Link (P/O PL 80.70 Item 6)
8	-	Duplex chute assembly (REF: PL 80.85)
9	-	Front toggle guide
10	-	Rear toggle guide
11	-	Toggle gate
12	-	Spring
13	-	Toggle spring

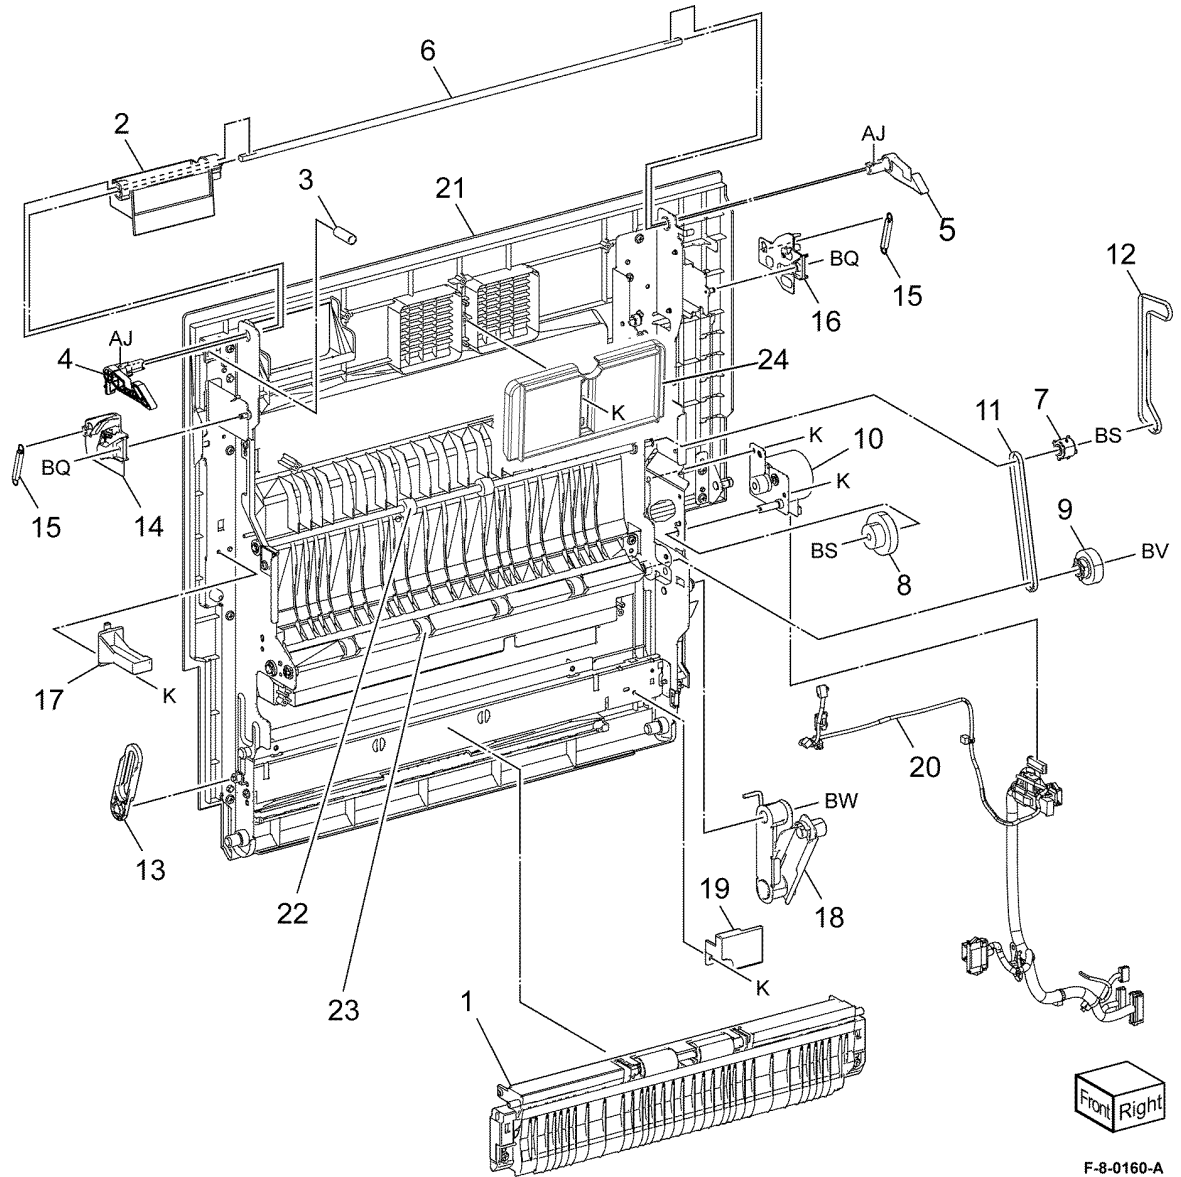
PL 80.75 Left Cover Transport Assembly

Item	Part	Description
1	-	Lower chute assembly (REP 80.25)
2	-	Handle
3	-	Spring
4	-	Front latch
5	-	Rear latch
6	-	Shaft
7	-	Pulley
8	-	Gear
9	-	Gear/pulley
10	-	Duplex motor and bracket assembly (MOT77-071)
11	-	Belt
12	-	Belt
13	-	Front support
14	-	Front toggle guide assembly
15	-	Spring
16	-	Rear toggle guide assembly
17	-	Close stopper
18	-	Link assembly
19	-	Connector cover
20	-	Harness assembly
21	-	Left cover assembly
22	-	Mid duplex roll assembly
23	-	Lower duplex roll assembly
24	-	Vent cover

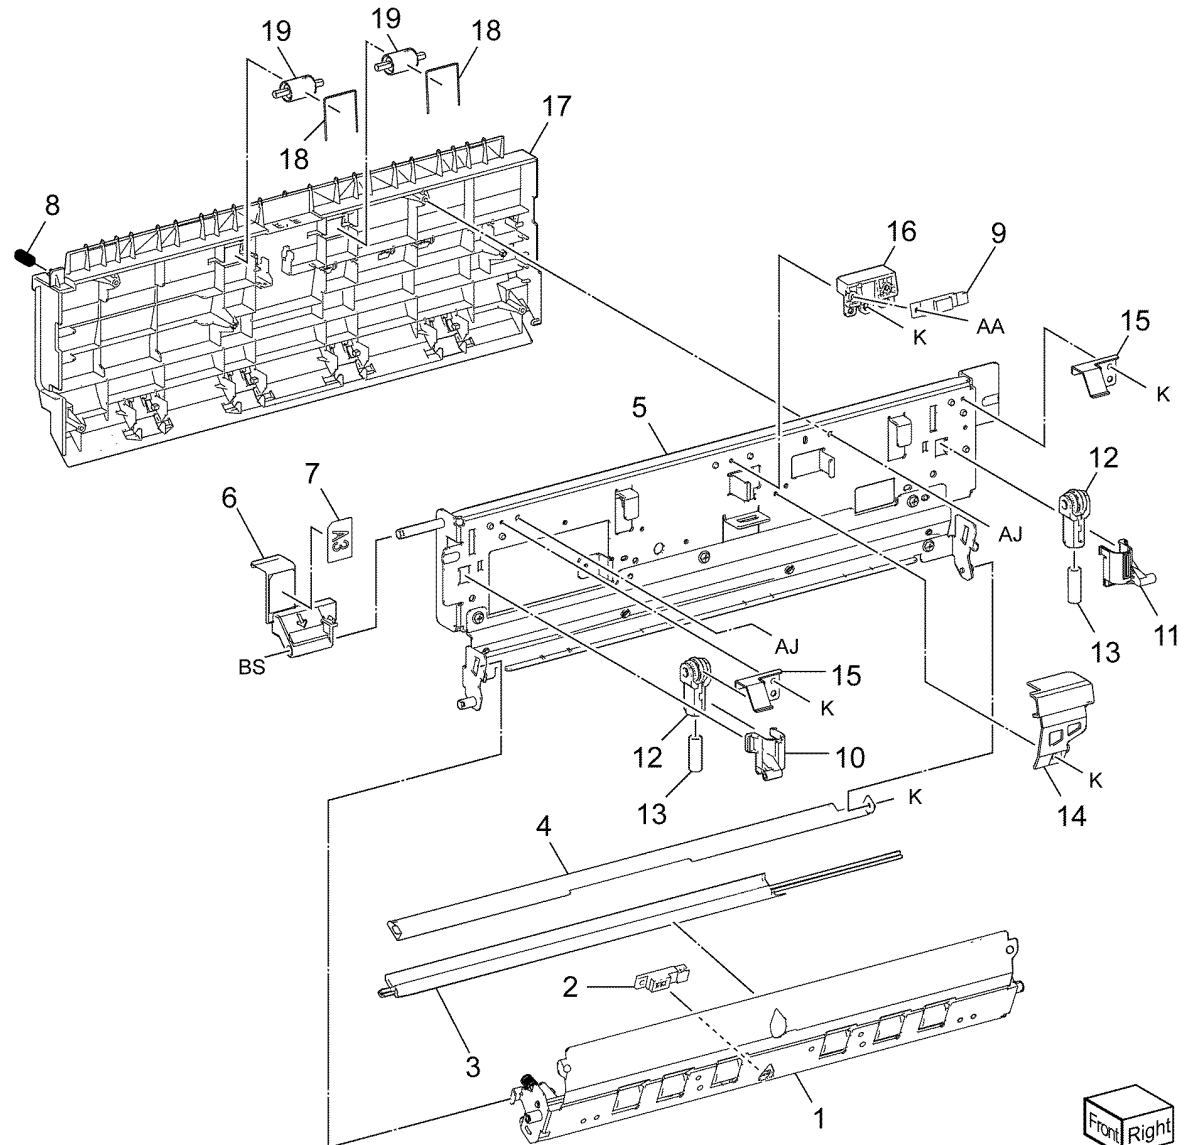
PL 80.80 Duplex Inner Chute Assembly

Item	Part	Description
1	-	Registration chute assembly
2	-	Registration sensor (Q77-103) (REP 80.26)
3	-	Registration heater assembly
4	-	Registration heater bracket
5	-	Registration tie plate
6	-	Handle (REP 80.27)
7	-	Label (A3)
8	-	Spring
9	-	POB jam sensor (Q94-201) (REP 80.28)
10	-	Front spring housing
11	-	Rear spring housing
12	-	2nd roller assembly
13	-	Spring
14	-	Harness cover
15	-	BTR bracket
16	-	POB jam sensor holder
17	-	Duplex inner chute
18	-	Pinch spring
19	-	Pinch roller

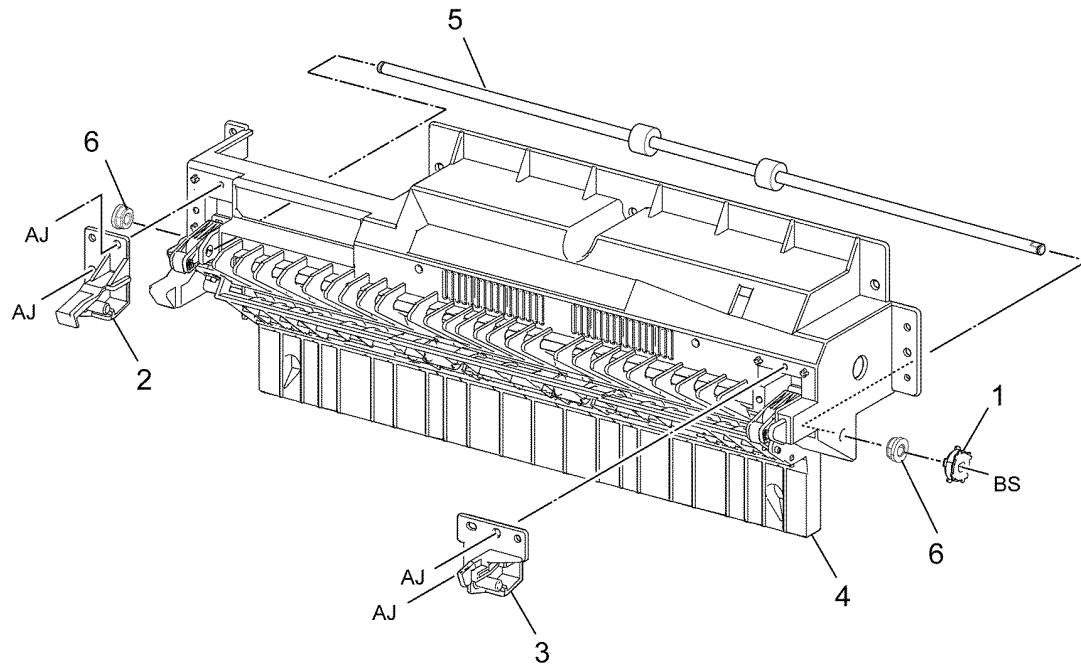
PL 80.85 Duplex Chute Assembly

Item	Part	Description
1	—	Pulley
2	—	Front holder assembly
3	—	Rear holder assembly
4	—	Duplex chute housing assembly
5	—	Upper duplex roll assembly
6	—	Bearing

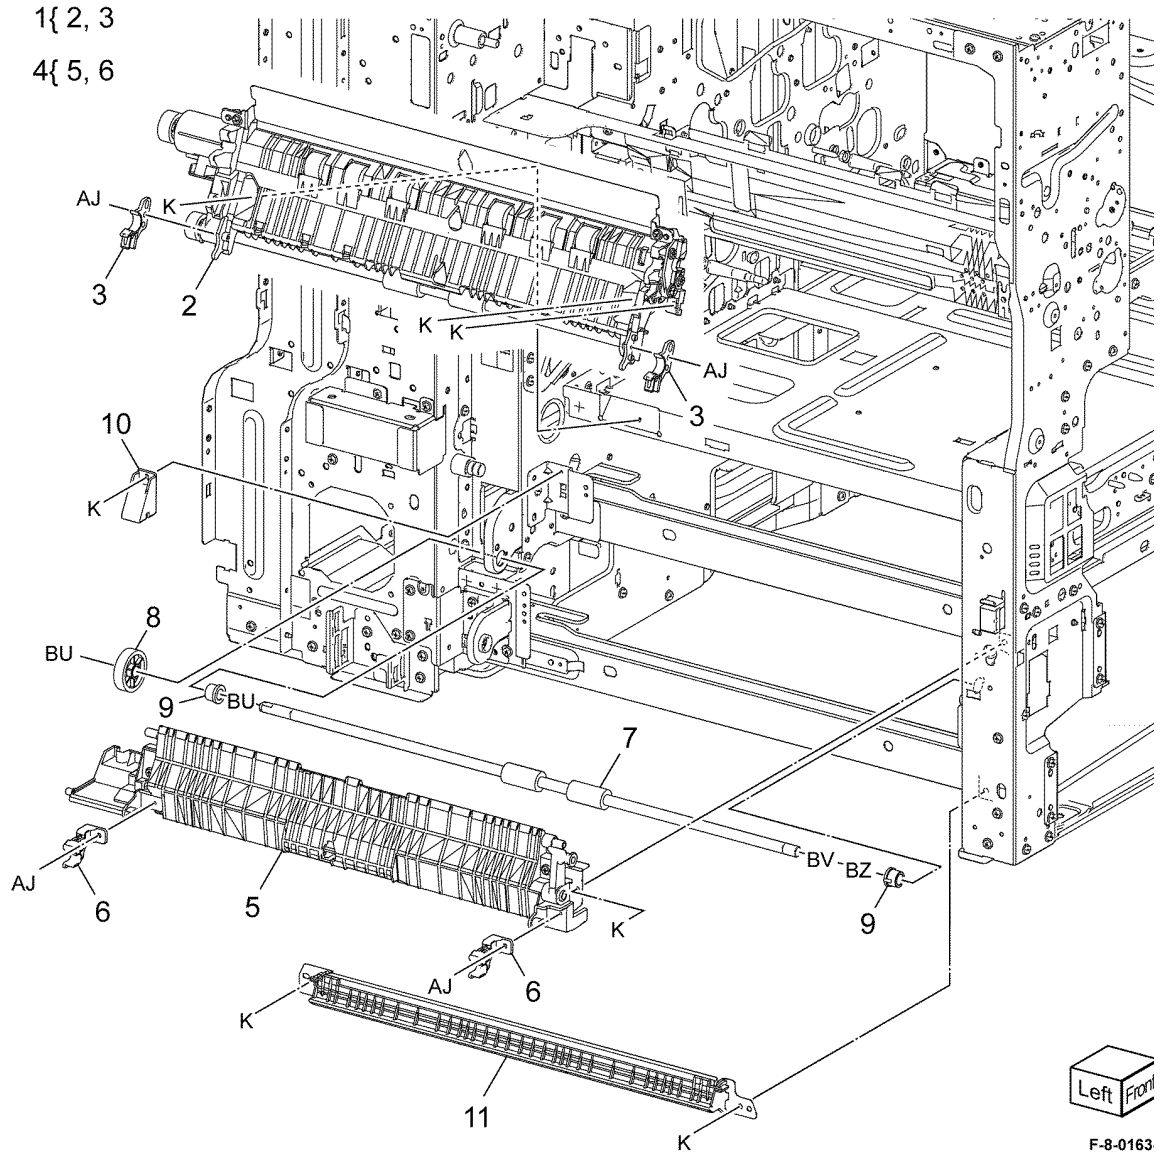
PL 80.90 Registration Transport Assembly

Item	Part	Description
1	859K03317	Registration transport assembly (REP 80.30)
2	-	Registration transport (P/O PL 80.90 Item 1)
3	-	Chute holder (P/O PL 80.90 Item 1)
4	-	Chute assembly (Not Spared) (REP 80.31)
5	-	Chute (P/O PL 80.90 Item 4)
6	-	Chute guide (P/O PL 80.90 Item 4)
7	859K07200	Takeaway roll 2 assembly (REP 80.32)
-	859K02290	Takeaway roll 2 assembly (alternative)(REP 80.32)
8	807E52000	Drive gear
9	013E46820	Bearing
10	-	Connector cover (Not Spared)
11	-	Upper chute assembly (Not Spared)

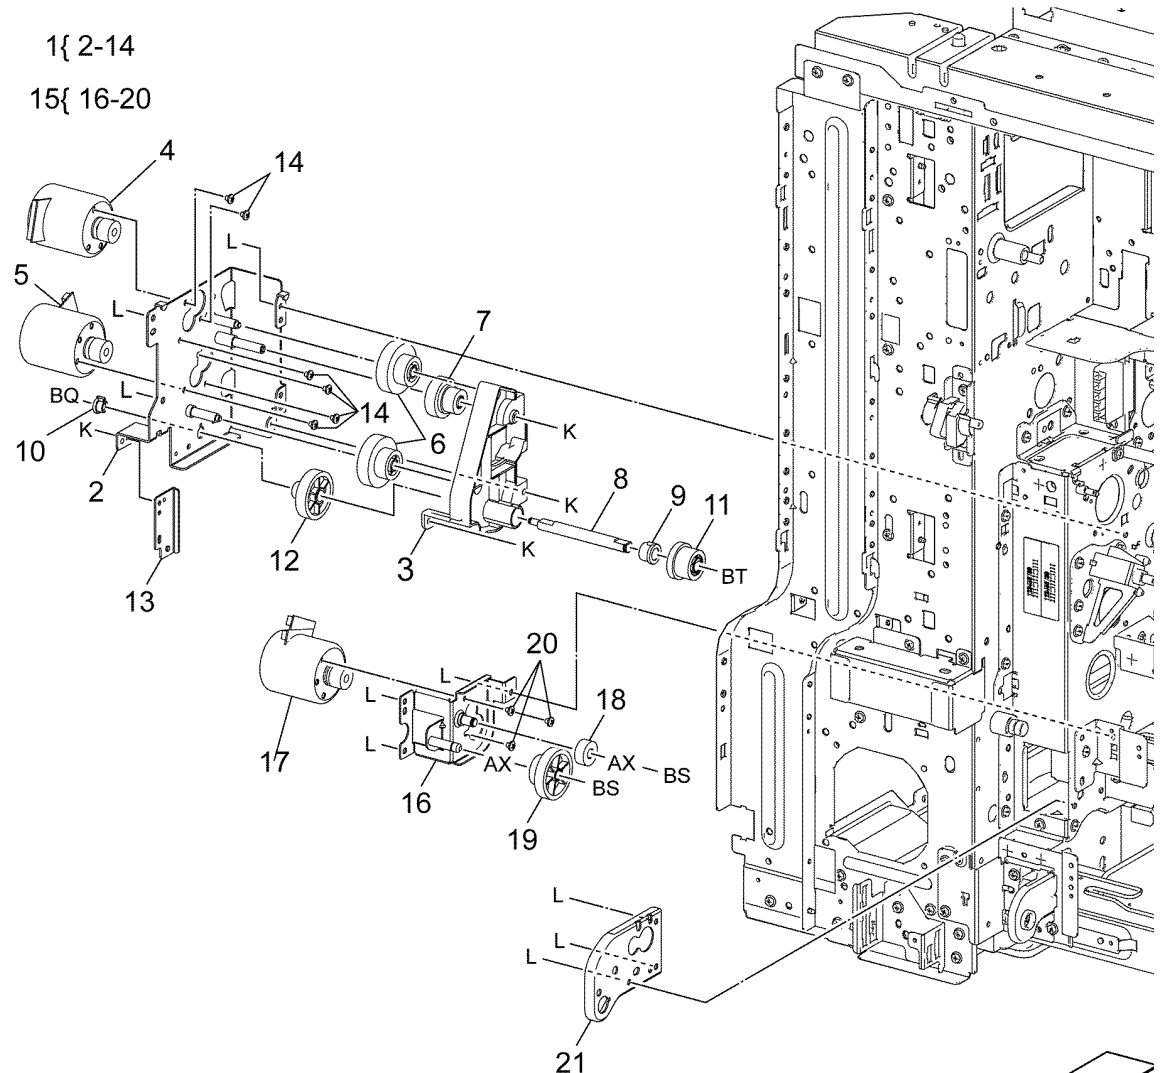
PL 80.95 Registration Drive Assembly

Item	Part	Description
1	007K22002	Registration drive assembly (REP 80.33)
2	-	Motor bracket (P/O PL 80.95 Item 1)
3	-	Block (P/O PL 80.95 Item 1)
4	-	Registration motor (MOT77-055) (P/O PL 80.95 Item 1)
5	-	Takeaway motor 1 (MOT77-050) (P/O PL 80.95 Item 1)
6	-	Gear (39/22) (P/O PL 80.95 Item 1)
7	-	Gear (30/18) (P/O PL 80.95 Item 1)
8	-	Shaft (P/O PL 80.95 Item 1)
9	-	Bearing
10	-	Bearing (P/O PL 80.95 Item 1)
11	-	Gear (37) (P/O PL 80.95 Item 1)
12	-	Gear (25) (P/O PL 80.95 Item 1)
13	-	Bracket (P/O PL 80.95 Item 1)
14	-	Screw (P/O PL 80.95 Item 1)
15	007K22022	Takeaway drive assembly (REP 80.34)
16	-	Takeaway motor 2 bracket (P/O PL 80.95 Item 15)
17	-	Takeaway motor 2 (MOT77-051) (P/O PL 80.95 Item 15)
18	-	Gear (18) (P/O PL 80.95 Item 15)
19	-	Gear (Z39/22) (P/O PL 80.95 Item 15)
20	-	Screw (P/O PL 80.95 Item 15)
21	-	Drive bracket (Not Spared)

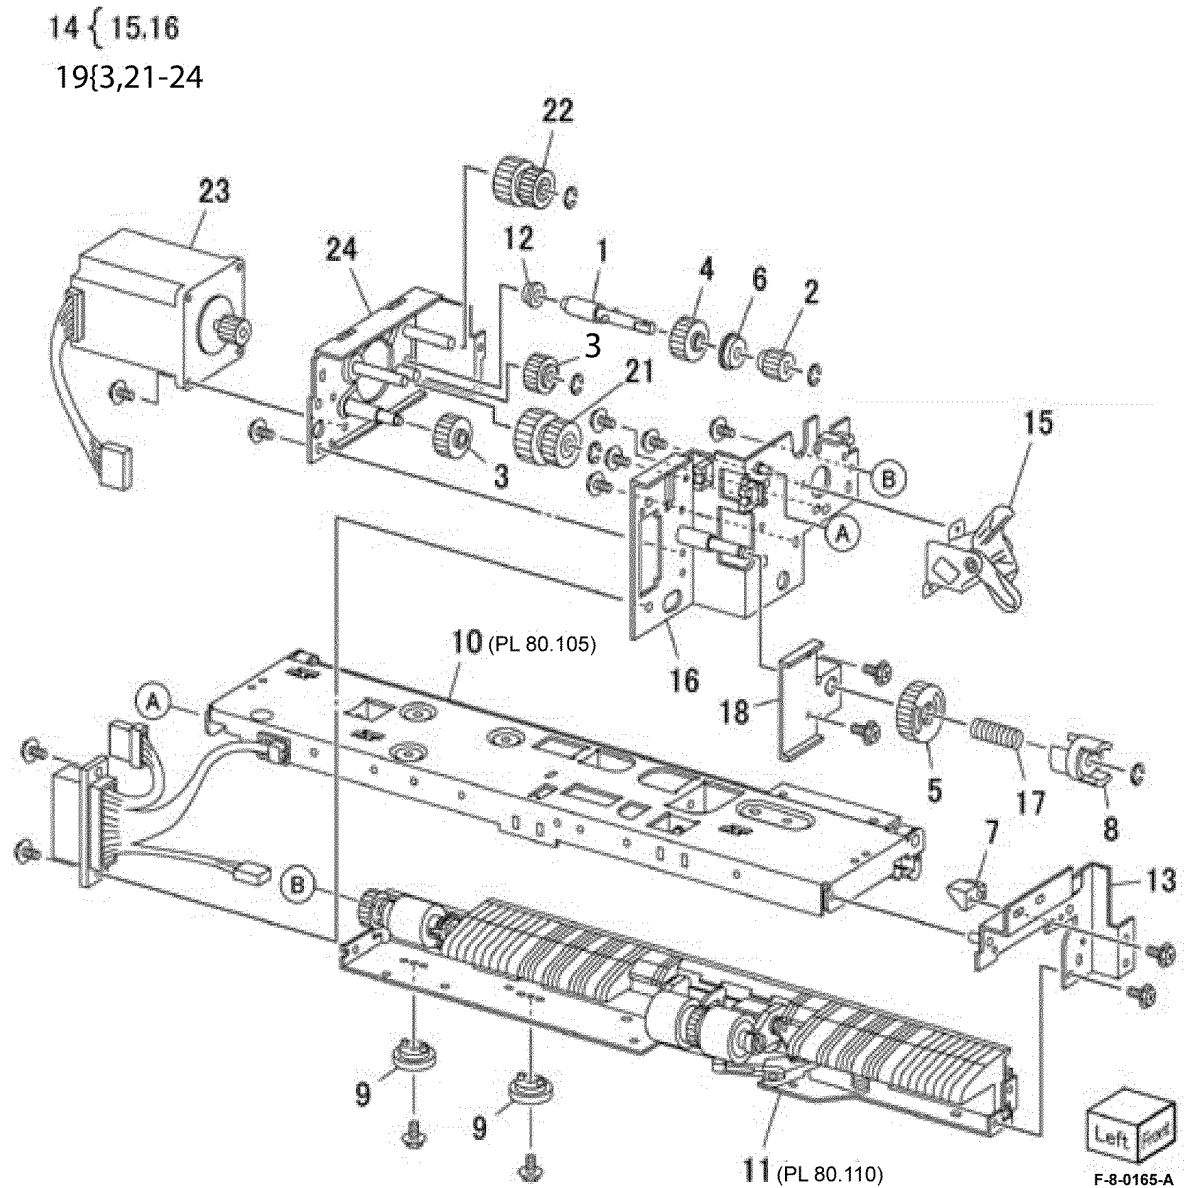
PL 80.100 HCF Feeder (1 of 3)

Item	Part	Description
1	-	Shaft (P/O PL 70.75 Item 11)
2	007E78760	Gear (19T)
3	007E78770	Gear (25T)
4	007E78780	Gear (25T)
5	007E78790	Gear (40T)
6	013E25530	Bearing
7	-	Block (P/O PL 70.75 Item 11)
8	-	Spacer (P/O PL 70.75 Item 11)
9	019E56470	Holder
10	-	Upper feeder assembly (P/O PL 70.75 Item 11)
11	-	Lower feeder assembly (P/O PL 70.75 Item 11)
12	413W66250	Ball bearing
13	-	Front frame (P/O PL 70.75 Item 11)
14	-	Rear frame assembly (P/O PL 70.75 Item 11)
15	-	Link assembly (P/O PL 80.100 Item 14)
16	-	Rear frame (P/O PL 80.100 Item 14)
17	-	Spring (P/O PL 70.75 Item 11)
18	-	Bracket (P/O PL 70.75 Item 11)
19	-	Drive gear assembly (P/O PL 70.75 Item 11)
21	007K88520	Gear (23T/27T)
22	007K88530	Gear (31T/36T)
23	127K37901	HCF feed lift motor (MOT78-003) (REP 80.39)
24	-	Motor frame (P/O PL 80.100 Item 19)

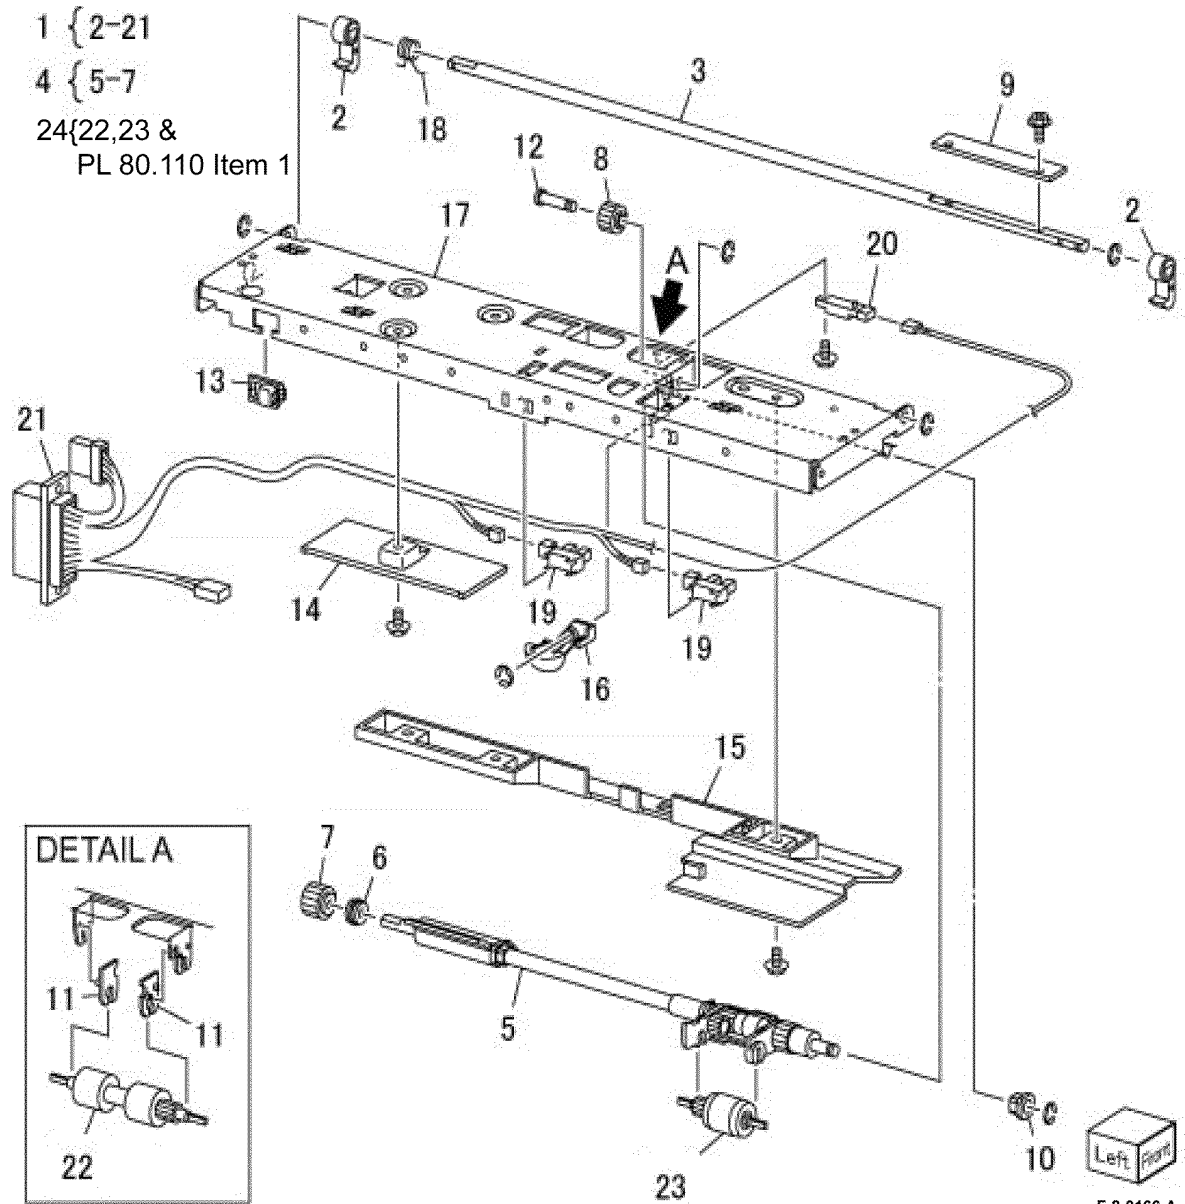
PL 80.105 HCF Feeder (2 of 3)

Item	Part	Description
1	-	Upper feeder assembly (P/O PL 70.75 Item 11)
2	003E59570	Latch (REP 80.37)
3	-	Shaft latch (P/O PL 80.105 Item 1)
4	006K23124	Feed shaft assembly (REP 80.36)
5	-	Feed shaft (P/O PL 80.105 Item 4)
6	413W66250	Ball bearing (REP 80.36)
7	-	Gear (20T) (P/O PL 80.105 Item 4)
8	007E78180	Feed gear (25T) (REP 80.36)
9	-	Lever (P/O PL 80.105 Item 1)
10	-	Bearing (P/O PL 80.105 Item 1)
11	-	Spacer (P/O PL 80.105 Item 1)
12	-	Pin drive (P/O PL 80.105 Item 1)
13	-	Guide (P/O PL 80.105 Item 1)
14	-	Rear upper chute (P/O PL 80.105 Item 1)
15	-	Upper chute (P/O PL 80.105 Item 1)
16	120E21900	Actuator
17	-	Upper Frame (P/O PL 80.105 Item 1)
18	-	Spring (P/O PL 80.105 Item 1)
19	930W00112	HCF level sensor / HCF no paper sensor (REP 80.38)
20	930W00211	HCF pre feed sensor (REP 80.38)
21	-	Wire harness (P/O PL 80.105 Item 1)
22	-	Feed roll (P/O PL 80.105 Item 24)
23	-	Nudger roll (P/O PL 80.105 Item 24)

24	116R00017	Tray 6 feed rolls

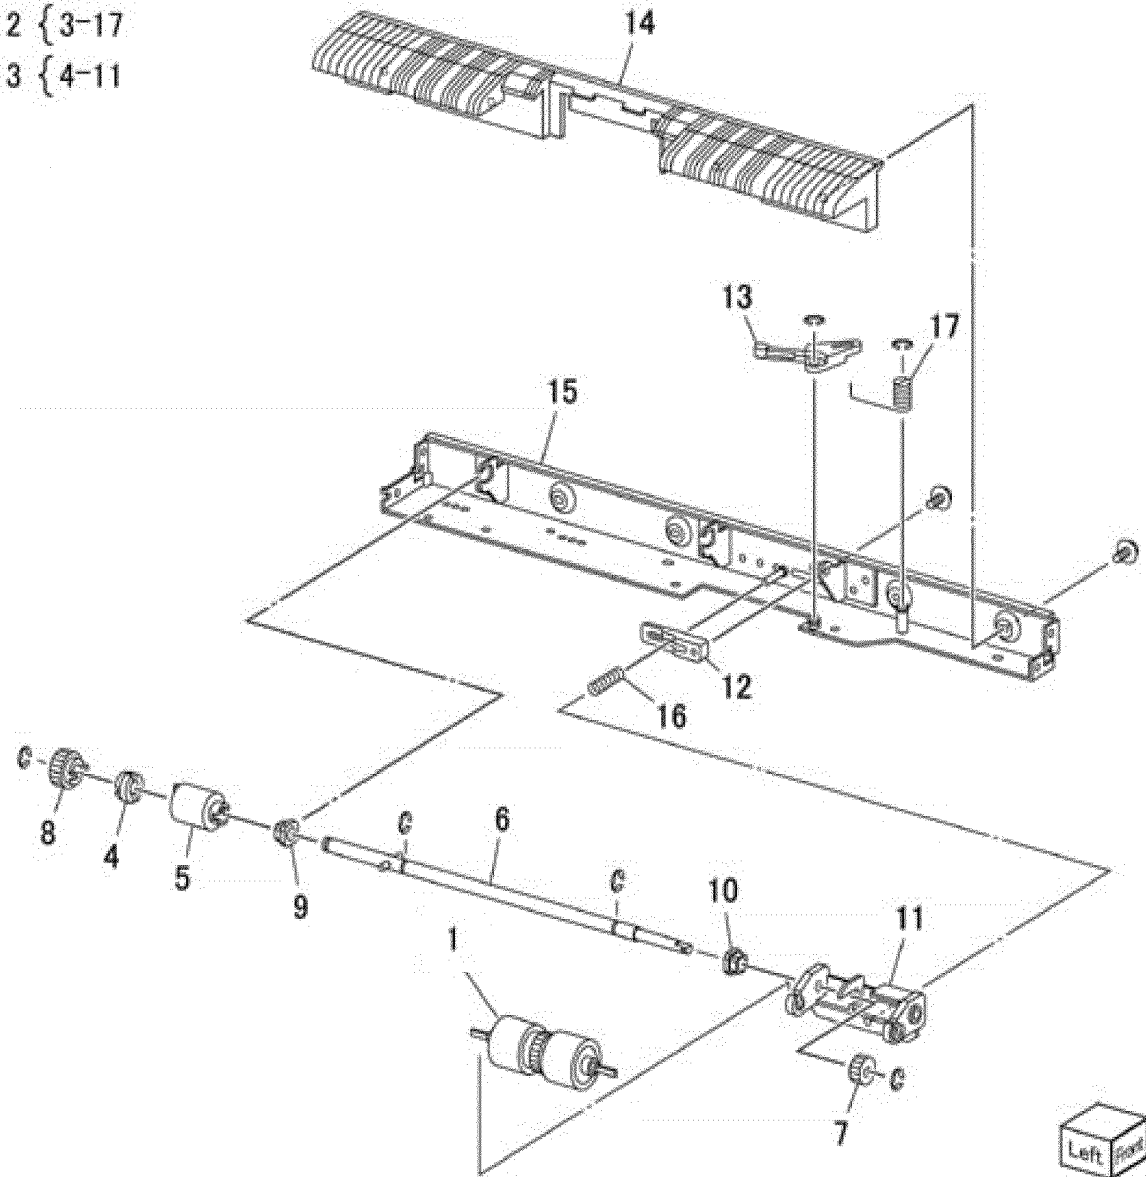
PL 80.110 HCF Feeder (3 of 3)

Item	Part	Description
1	-	Retard roll (P/O PL 80.105 Item 24)
2	-	Lower feeder assembly (P/O PL 70.75 Item 11)
3	-	Retard shaft assembly (P/O PL 80.110 Item 2)
4	-	Collar (P/O PL 80.110 Item 3)
5	005K06701	Friction clutch
6	-	Shaft (P/O PL 80.110 Item 3)
7	007E78170	Gear (15T)
8	007E89760	Gear (22T)
9	013E23600	Bearing
10	013E23610	Bearing
11	-	Retard bracket (P/O PL 80.110 Item 3)
12	-	Slide (P/O PL 80.110 Item 2)
13	-	Lever (P/O PL 80.110 Item 2)
14	-	Lower chute (P/O PL 80.110 Item 2)
15	-	Lower frame (P/O PL 80.110 Item 2)
16	-	Spring (P/O PL 80.110 Item 2)
17	-	Spring (P/O PL 80.110 Item 2)

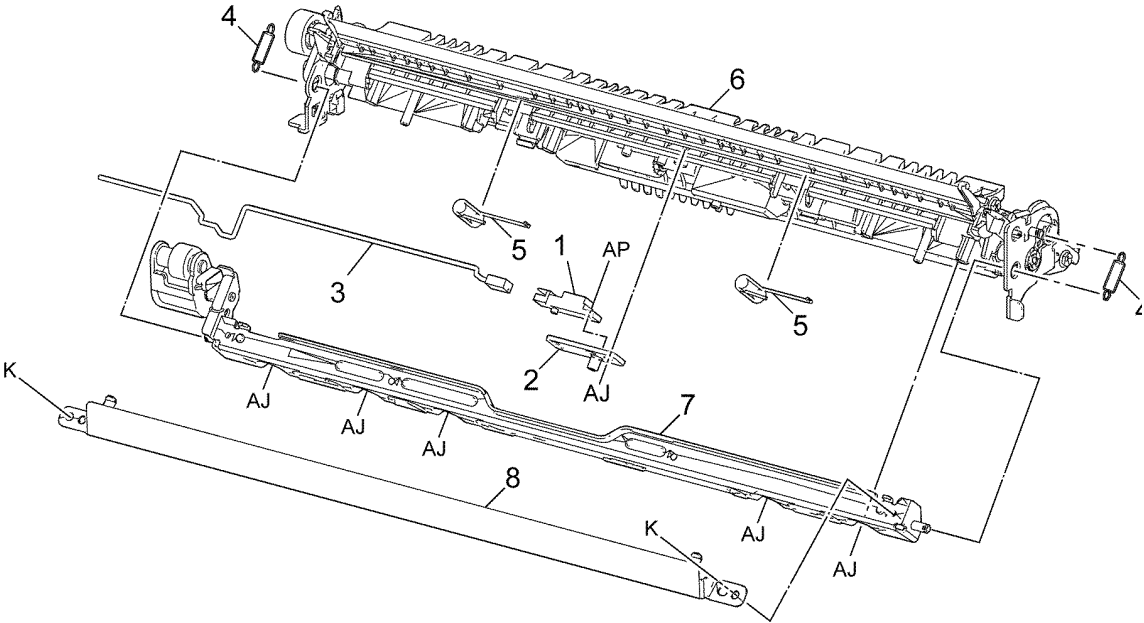
PL 80.115 Bypass Tray Takeaway Assembly

Item	Part	Description
1	930W00211	Feed out sensor (Q77-104)
2	-	Feed out sensor holder
3	-	Feed out sensor harness
4	-	Spring
5	-	Spring
6	-	Pinch chute
7	-	Tie plate
8	-	Miler plate

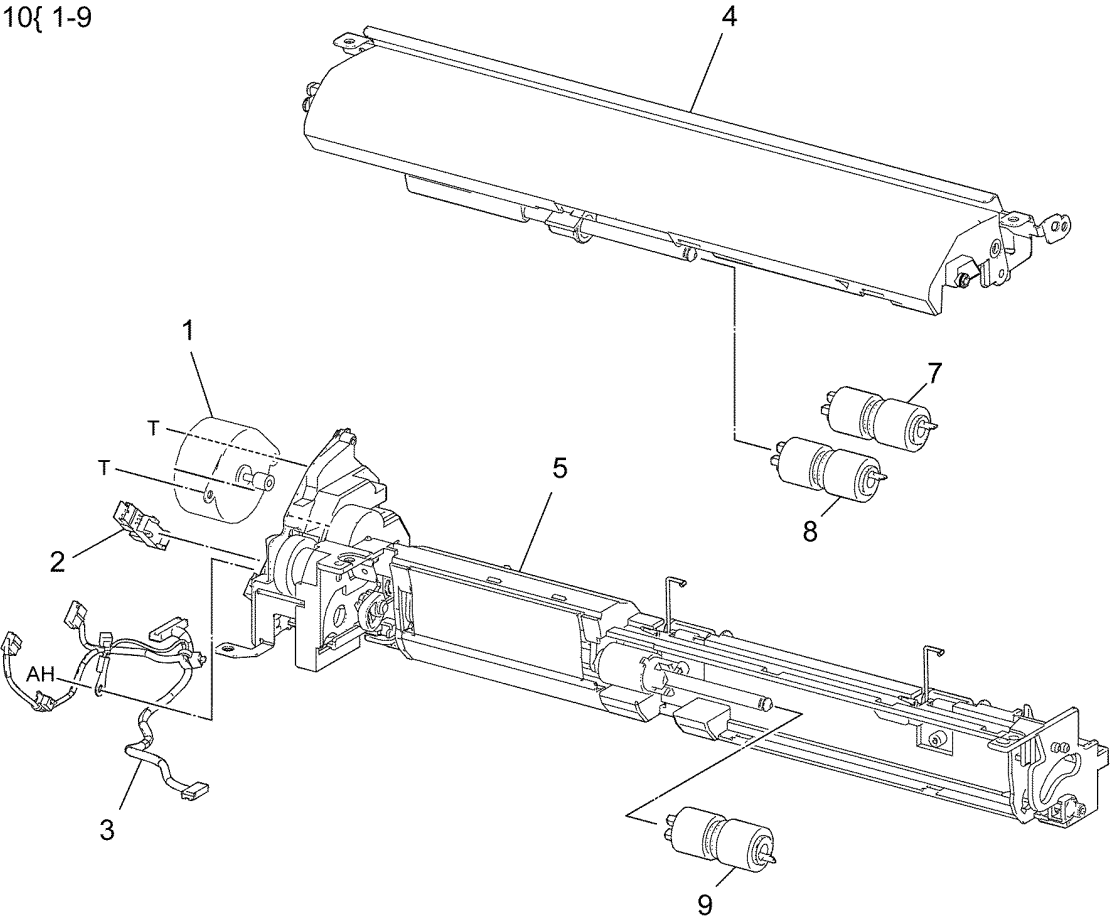
PL 80.120 Bypass Tray Feedhead Assembly

Item	Part	Description
1	-	Bypass tray feed/lift motor (MOT75-003) (P/O PL 80.120 Item 10)
2	-	Bypass tray nudger position sensor (Q75-102) (P/O PL 80.120 Item 10)
3	-	Harness assembly (P/O PL 80.120 Item 10)
4	-	Upper feedhead assembly (P/O PL 80.120 Item 10)
5	-	Lower frame (P/O PL 80.120 Item 10)
6	116R00016	Bypass tray roll kit (REP 80.20)
7	-	Feed roll (P/O PL 80.120 Item 6)
8	-	Nudger roll (P/O PL 80.120 Item 6)
9	-	Retard roll (P/O PL 80.120 Item 6)
10	-	Bypass tray feedhead assembly (P/O PL 70.50 Item 17) (REP 80.19)

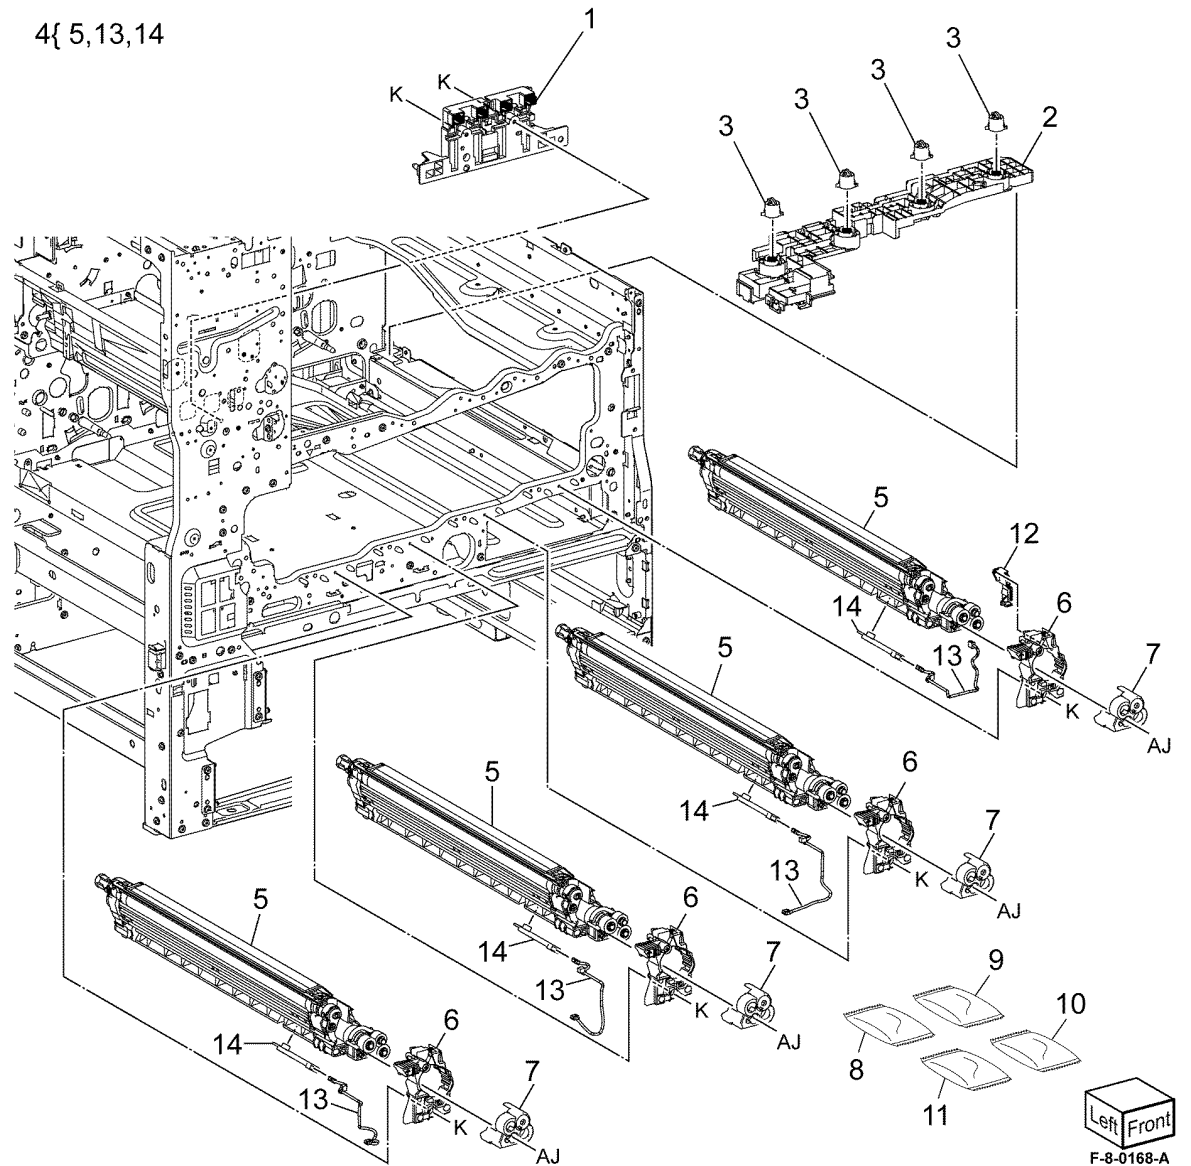
PL 90.05 Developer Unit

Item	Part	Description
1	948K01510	Conductor housing assembly (REP 90.1)
2	948K01530	Developer conductor housing assembly
3	010E96730	Plunger (REP 90.2)
4	948K13033	Developer housing kit (See NOTE)
5	-	Developer assembly (P/O PL 90.05 Item 4) (REP 90.3)
6	-	Developer plate assembly (Not Spared)
7	-	Gear cover (Not Spared)
8	607K12421	Developer material (Y) (REP 90.7)
9	607K12411	Developer material (M) (REP 90.7)
10	607K12401	Developer material (C) (REP 90.7)
11	607K12391	Developer material (K) (REP 90.7)
12	-	Harness guide (Not Spared)
13	-	Wire harness (P/O PL 90.05 Item 4)
14	-	ATC sensor (P/O PL 90.05 Item 4)

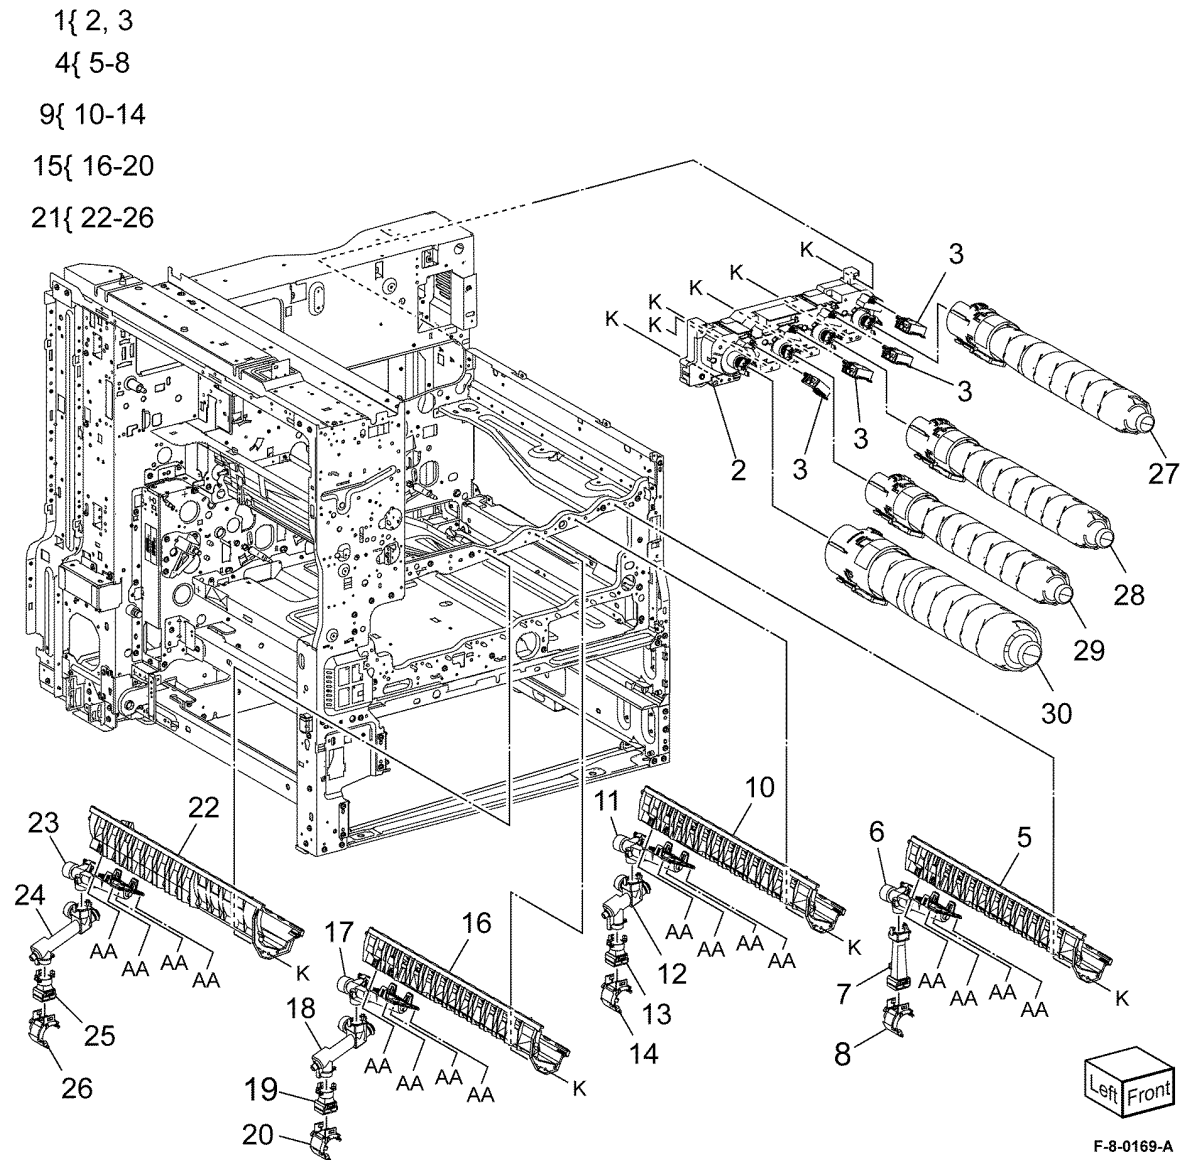
PL 90.10 Toner Dispense

Item	Part	Description
1	007K23170	Toner dispense motor assembly (MOT92-005) (REP 90.4)
2	-	Drive assembly (P/O PL 90.10 Item 1)
3	019K16490	Toner CRUM connector assembly (REP 90.5)
4	094K94141	Dispenser assembly (Y) (REP 90.6)
5	-	Toner guide assembly (P/O PL 90.10 Item 4)
6	-	Main pipe (Y) (P/O PL 90.10 Item 4)
7	-	Lower pipe (Y) (P/O PL 90.10 Item 4)
8	-	Shutter (Y) (P/O PL 90.10 Item 4)
9	094K94151	Dispenser assembly (M) (REP 90.6)
10	-	Toner guide assembly (M) (P/O PL 90.10 Item 9)
11	-	Main pipe (M) (P/O PL 90.10 Item 9)
12	-	Sub pipe (M) (P/O PL 90.10 Item 9)
13	-	Lower pipe (M) (P/O PL 90.10 Item 9)
14	-	Shutter (M) (P/O PL 90.10 Item 9)
15	094K94161	Dispenser assembly (C) (REP 90.6)
16	-	Toner guide assembly (C) (P/O PL 90.10 Item 15)
17	-	Main pipe (C) (P/O PL 90.10 Item 15)
18	-	Sub pipe (C) (P/O PL 90.10 Item 15)
19	-	Lower pipe (C) (P/O PL 90.10 Item 15)
20	-	Shutter (C) (P/O PL 90.10 Item 15)
21	094K94171	Dispenser assembly (K) (REP 90.6)

22	-	Toner guide assembly (K) (P/O PL 90.10 Item 21)
23	-	Main pipe (K) (P/O PL 90.10 Item 21)
24	-	Sub pipe (K) (P/O PL 90.10 Item 21)
25	-	Lower pipe (K) (P/O PL 90.10 Item 21)
26	-	Shutter (K) (P/O PL 90.10 Item 21)
27	-	Toner cartridge (Y) (REF: PL 25.10 Item 1)
28	-	Toner cartridge (M) (REF: PL 25.05 Item 2)
29	-	Toner cartridge (C) (REF: PL 25.05 Item 1)
30	-	Toner cartridge (K) (REF: PL 25.10 Item 2)

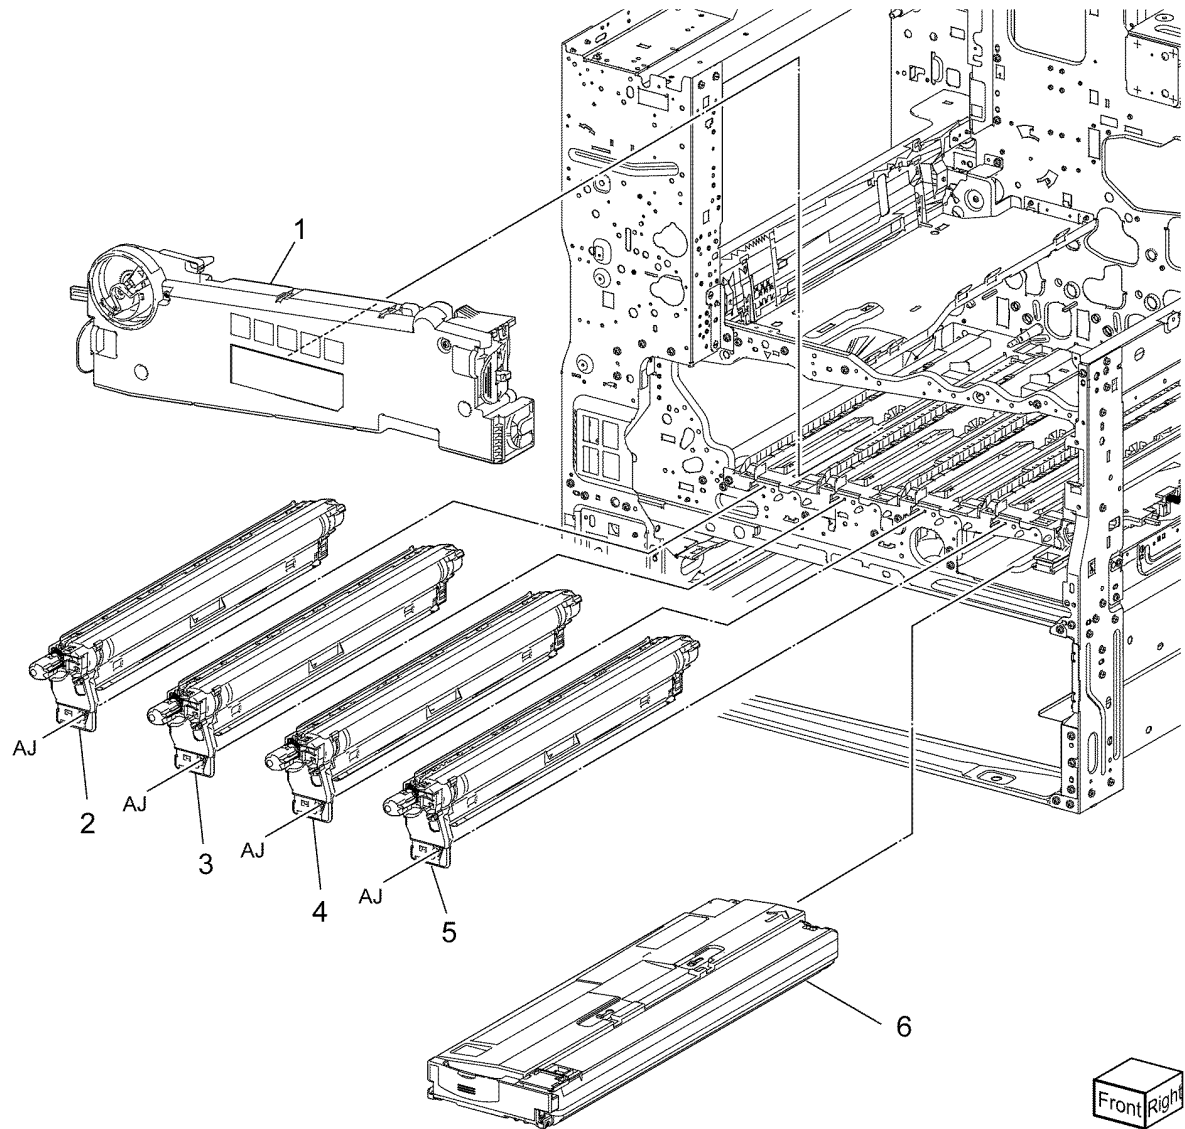
PL 90.15 Xerographic Components

Item	Part	Description
1	948K00016	Waste toner transport assembly
2	-	Drum assembly (K) (NOTE) (REP 90.11)
3	-	Drum assembly (C) (NOTE) (REP 90.11)
4	-	Drum assembly (M) (NOTE) (REP 90.11)
5	-	Drum assembly (Y) (NOTE) (REP 90.11)
6	108R01504	Waste cartridge

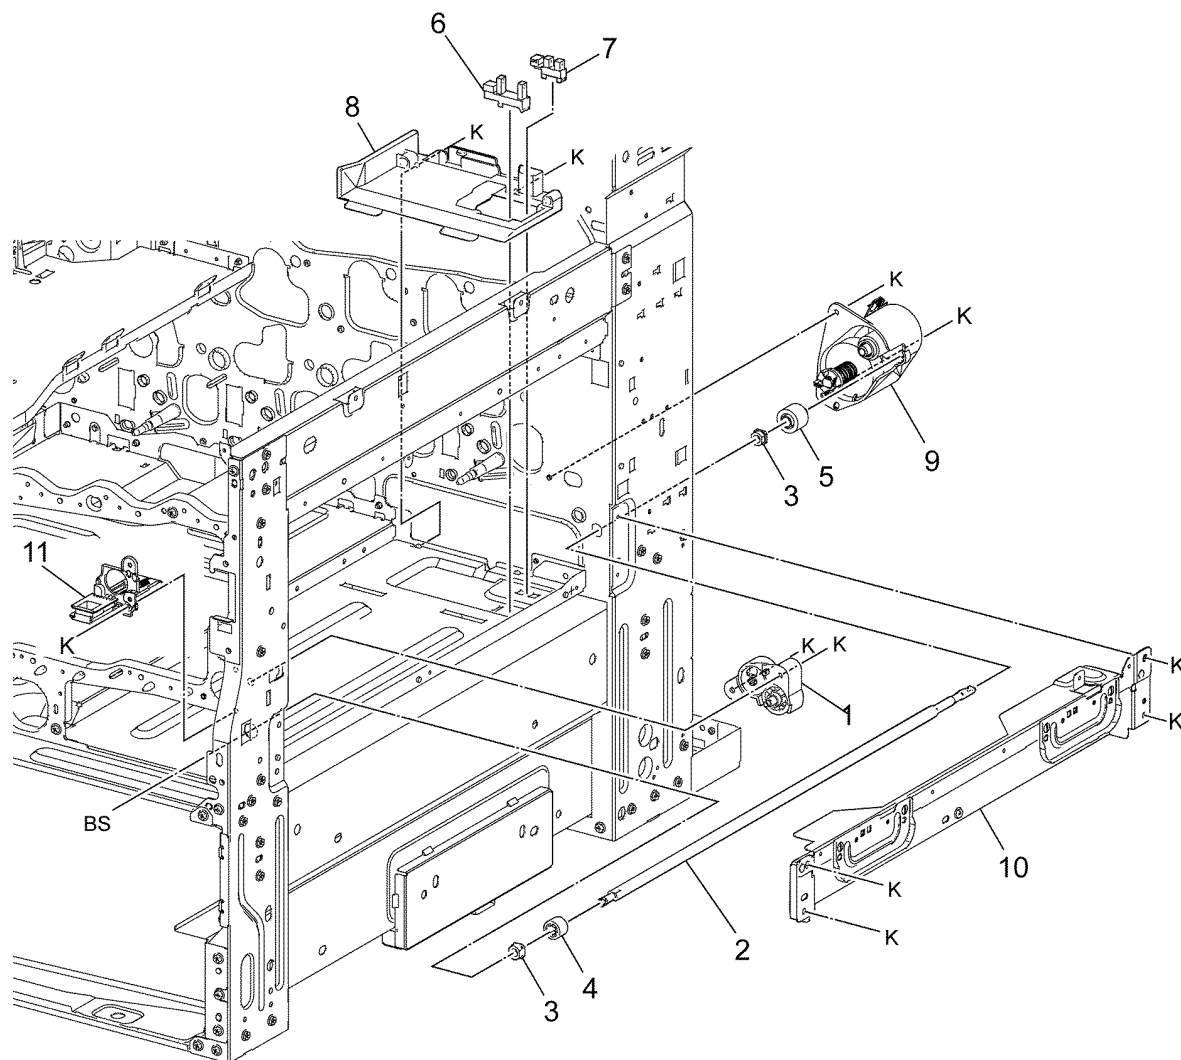
F-8-0171-A

PL 90.20 Xerographic Assembly (1 of 2)

Item	Part	Description
1	948K02890	Gear housing assembly (REP 90.12)
2	-	Drive shaft (Not Spared) (REP 90.13)
3	413W11660	Sleeve bearing (REP 90.17)
4	807E52060	Gear
5	807E51980	Helical gear
6	930W00511	Waste toner bottle full sensor (Q91-201) (REP 90.18)
7	130E81600	Waste toner bottle position sensor (Q91-200) (REP 90.18)
8	-	Bottle guide (Not Spared)
9	948K00350	Agitator motor assembly (MOT91-006) (REP 90.14)
10	-	Handle assembly (Not Spared)
11	052K14000	Joint pipe assembly (REP 90.15)

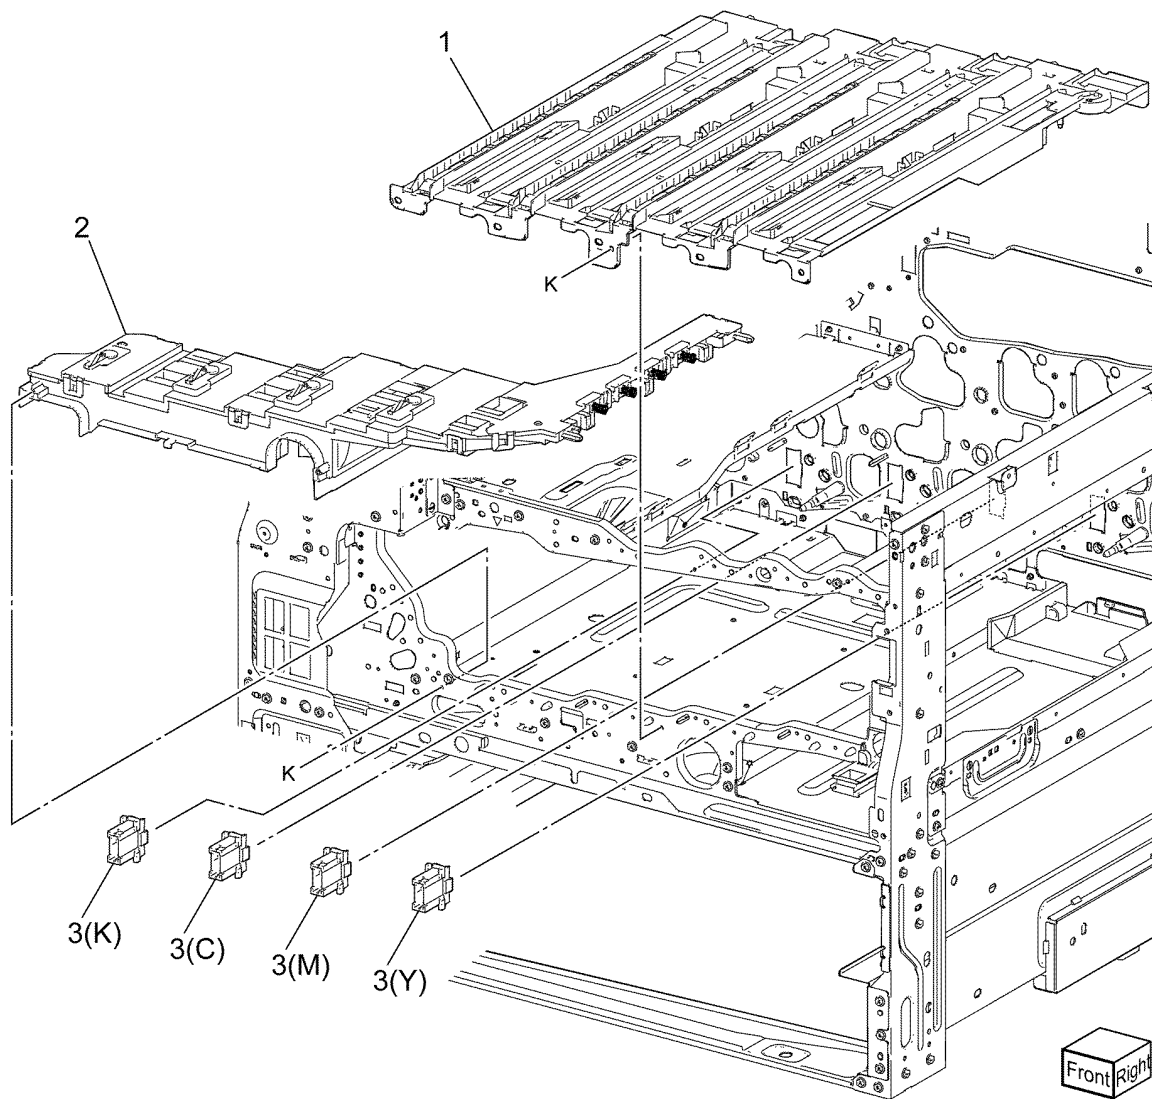
F-8-0172-A

PL 90.25 Xerographic Assembly (2 of 2)

Item	Part	Description
1	-	Marking guide (P/O PL 60.05 Item 1)
2	948K00060	Housing assembly (REP 90.16)
3	113E48880	Drum CRUM connector
