VersaLink[®] C8000/C9000 Printer

Service Manual

VersaLink C9000 Family Service Manual

705P01418

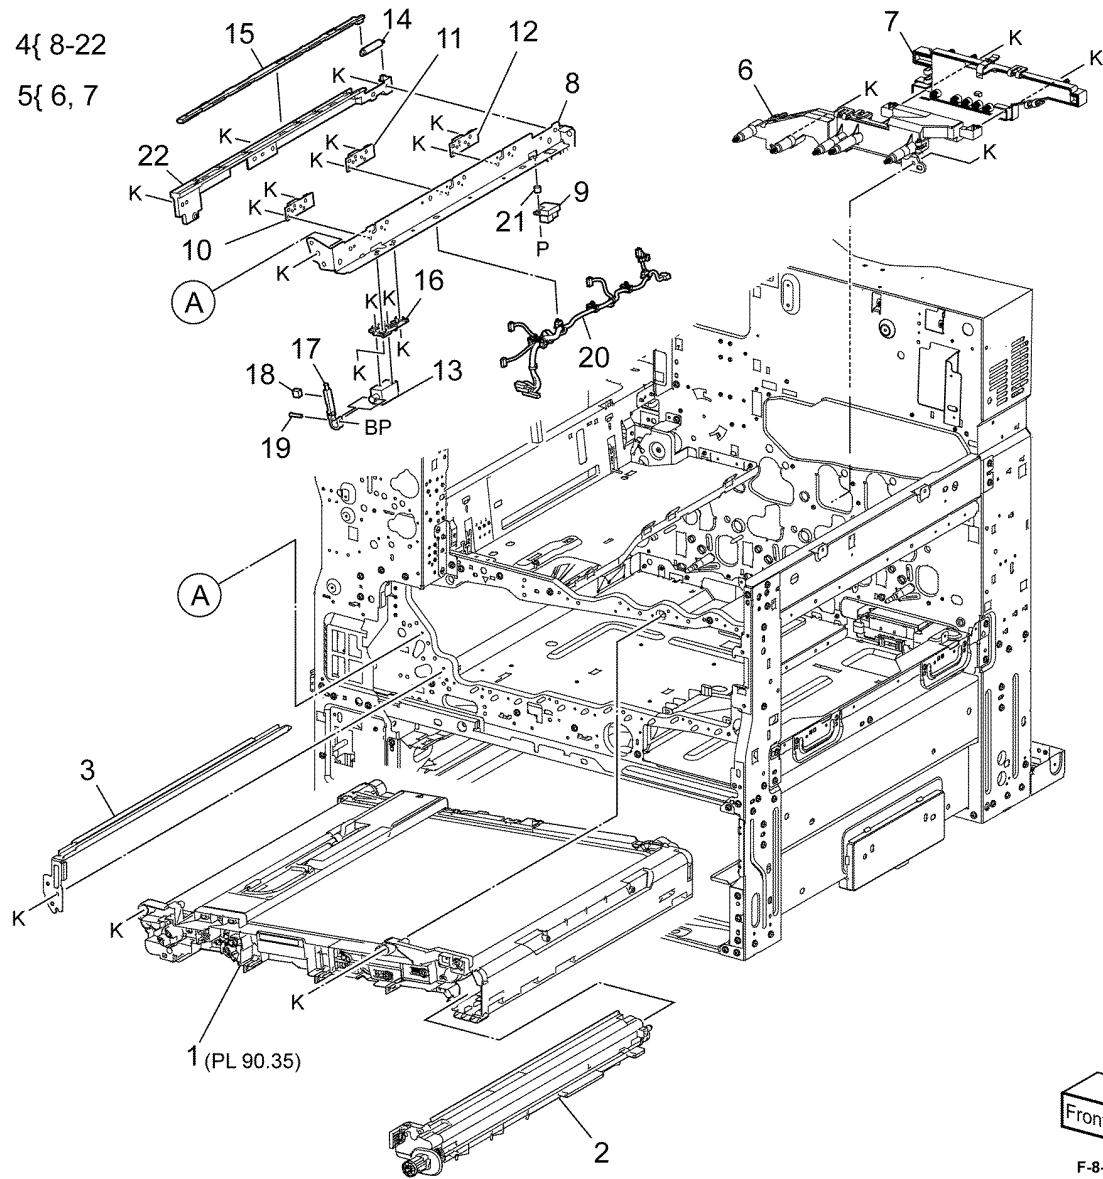
F-8-0173-A

PL 90.30 IBT Belt Unit Components

Item	Part	Description
1	064K02536	IBT belt assembly (REP 90.8)
2	104R00256	IBT belt cleaner assembly
3	-	IBT lower guide (Not Spared)
4	930K02752	MOB/ADC Assembly (REP 90.9)
5	948K01955	Conductor housing assembly (REP 90.10)
6	-	Lower conductor housing assembly (P/O PL 90.30 Item 5)
7	-	Upper conductor housing assembly (P/O PL 90.30 Item 5)
8	-	Bracket (P/O PL 90.30 Item 4)
9	-	Temp/Humidity sensor (internal) (P/O PL 90.30 Item 4)
10	-	Front MOB sensor (P/O PL 90.30 Item 4)
11	-	ADC sensor (Q92-029) (P/O PL 90.30 Item 4)
12	-	Rear MOB sensor (P/O PL 90.30 Item 4)
13	-	Shutter solenoid (P/O PL 90.30 Item 4)
14	-	Spring (P/O PL 90.30 Item 4)
15	-	Shutter (P/O PL 90.30 Item 4)
16	-	Solenoid holder (P/O PL 90.30 Item 4)
17	-	Arm (P/O PL 90.30 Item 4)
18	-	Cushion (P/O PL 90.30 Item 4)
19	-	Pin (P/O PL 90.30 Item 4)
20	-	MOBC harness assembly (P/O PL 90.30 Item 4)
21	-	Humidity spacer (P/O PL 90.30 Item 4)
22	-	Cover (P/O PL 90.30 Item 4)

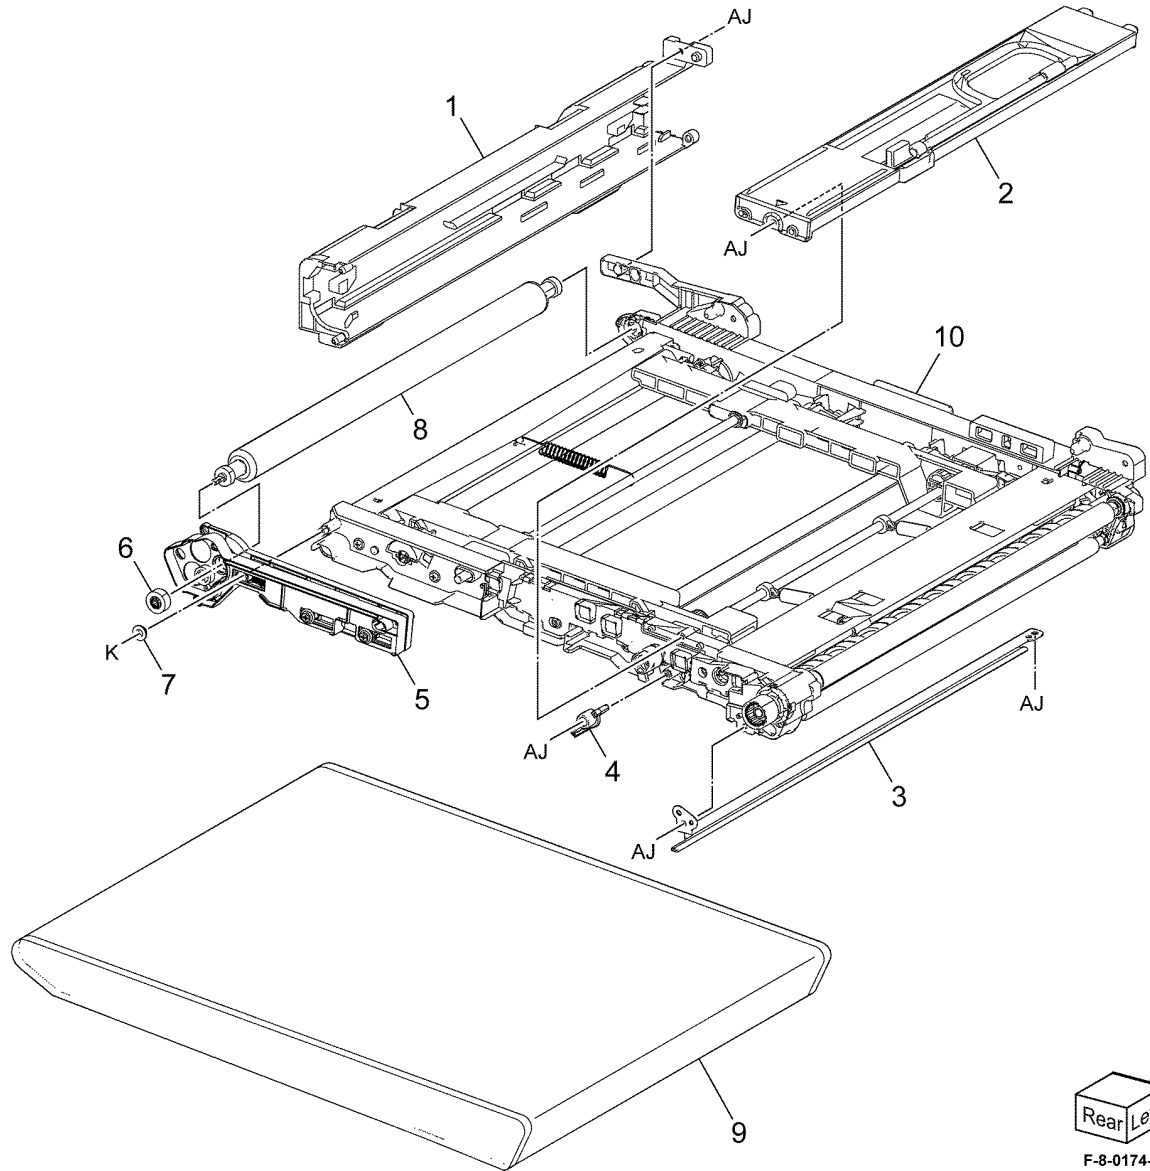
PL 90.35 IBT Belt Unit Assembly

Item	Part	Description
1	-	Cleaner housing guide
2	-	Handle holder
3	-	IBT upper guide
4	-	Belt arm
5	-	Tension holder assembly
6	-	Tension gear
7	-	Tension collar
8	-	Tension roller assembly
9	-	IBT belt
10	-	IBT handle unit

NOTE: All parts are part of PL 90.30 Item 1.

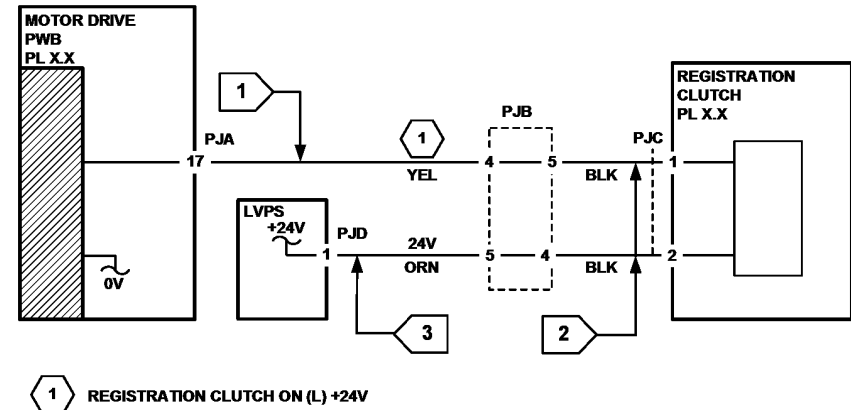
TF-1-0180-A

- Check that the signal changes on the ESS PWB (Flag 1) when the component control code for the clutch or solenoid is entered.
- Disconnect PJC (Flag 2). Check that +24V is measured when the component control code for the clutch or solenoid is entered.
- Disconnect PJD (Flag 3). Check for +24V on the LVPS.
- Check the wiring and the connectors for the clutch or solenoid circuit.

Figure 1 Wiring diagram

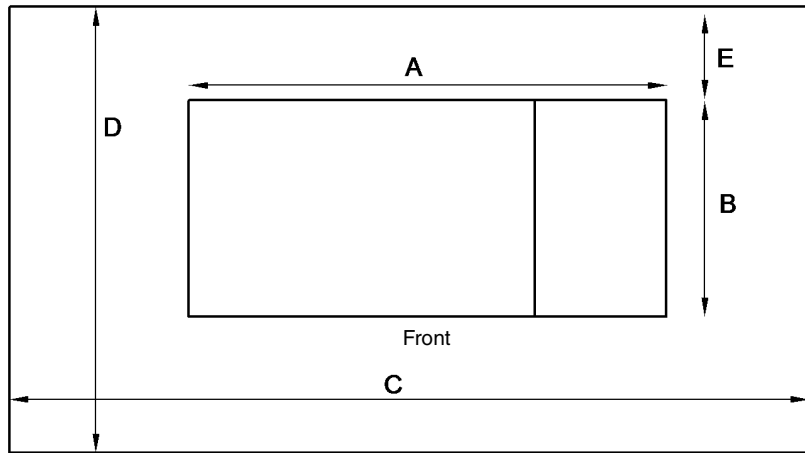
F-1-0586-A

Figure 1 represents a plan view of a machine installation and is to be read in conjunction with Table 1. The dimensions A and B outline a footprint of the machine within the boundary of safe operation, dimensions C and D. The dimension E indicates the area required for airflow/work space at the rear of the machine.

Figure 1 Installation plan

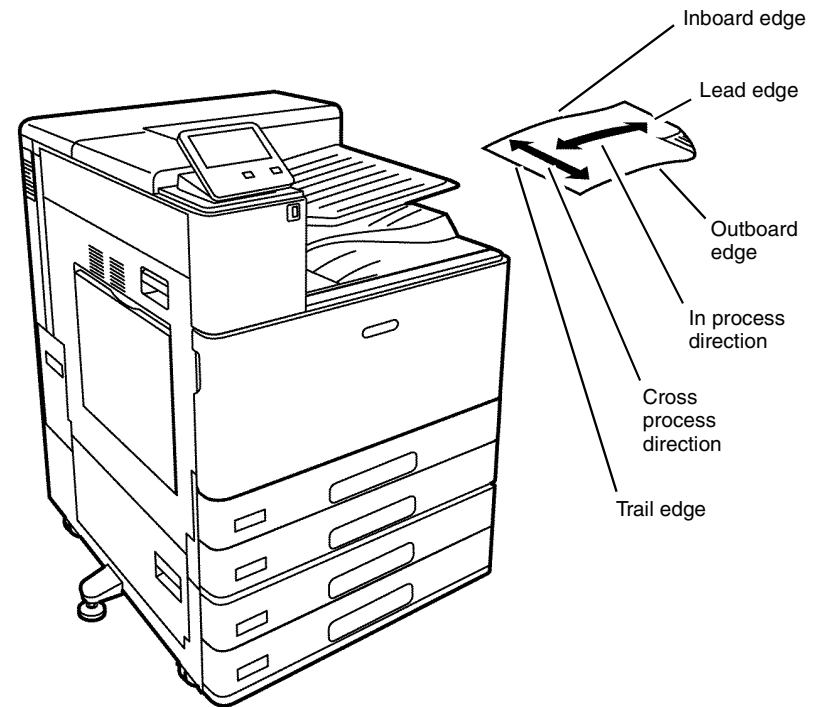
F-1-0668-A

- **Inboard edge** - can also be described as the top edge or side edge.
- **In process direction** - can also be described as the slow scan direction.
- **Cross process direction** - can also be described as the fast scan direction.

Figure 1 Print/copy orientation definitions

Refer to Figure 1. Be aware of the points that follow:

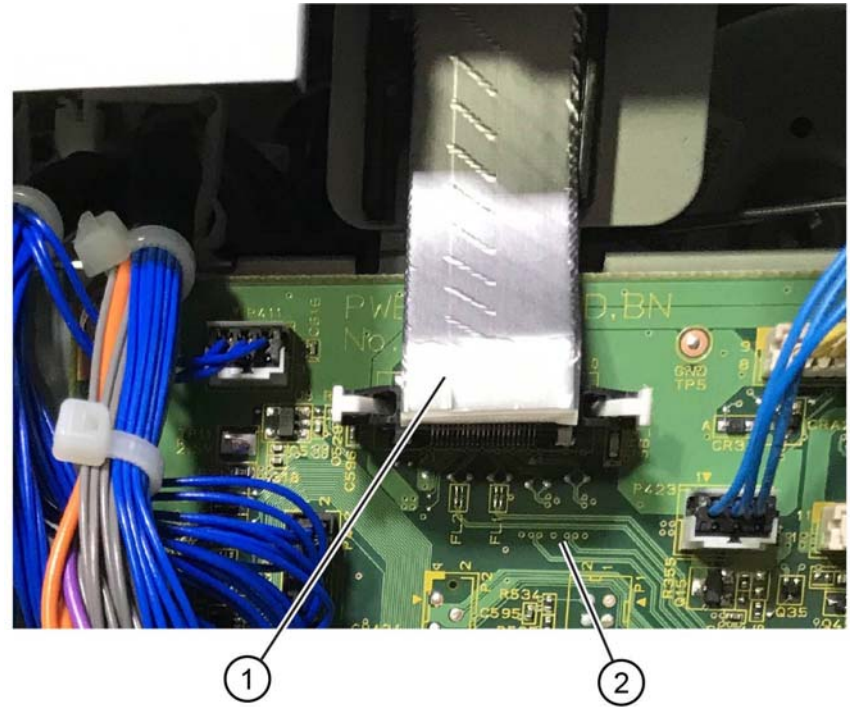
F-1-0670-A

2. Open the video contact chassis assembly, [PL 3.10 Item 2](#).
 - a. Disconnect the motor drive ribbon cable (1) from the motor drive PWB (2), [Figure 2](#).

Figure 2 Ribbon cable disconnect

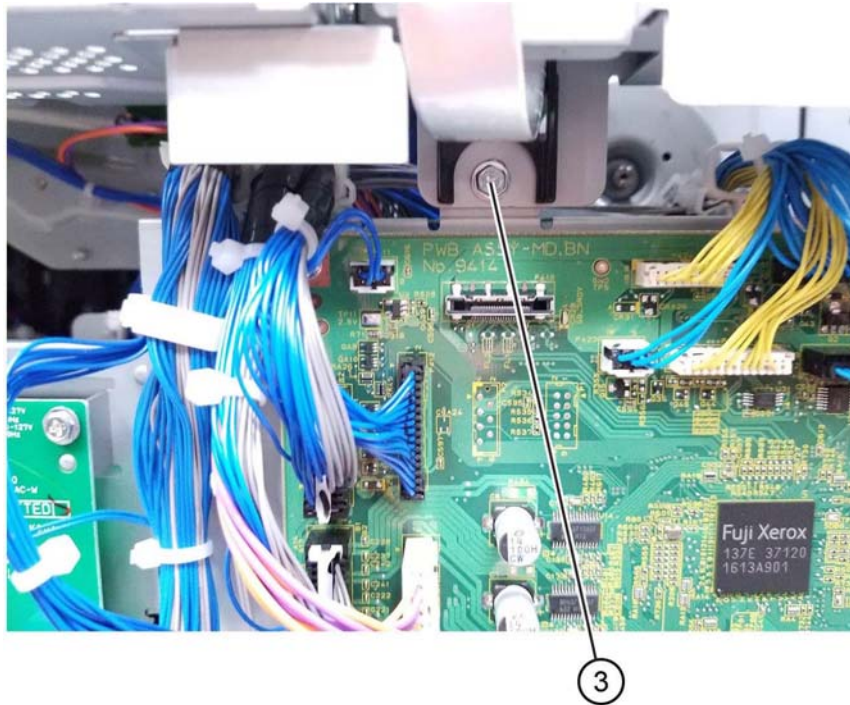
F-1-0671-A

- b. Remove one screw (3) from behind the motor drive ribbon cable and above the motor drive PWB, [Figure 3](#).

Figure 3 Screw removal

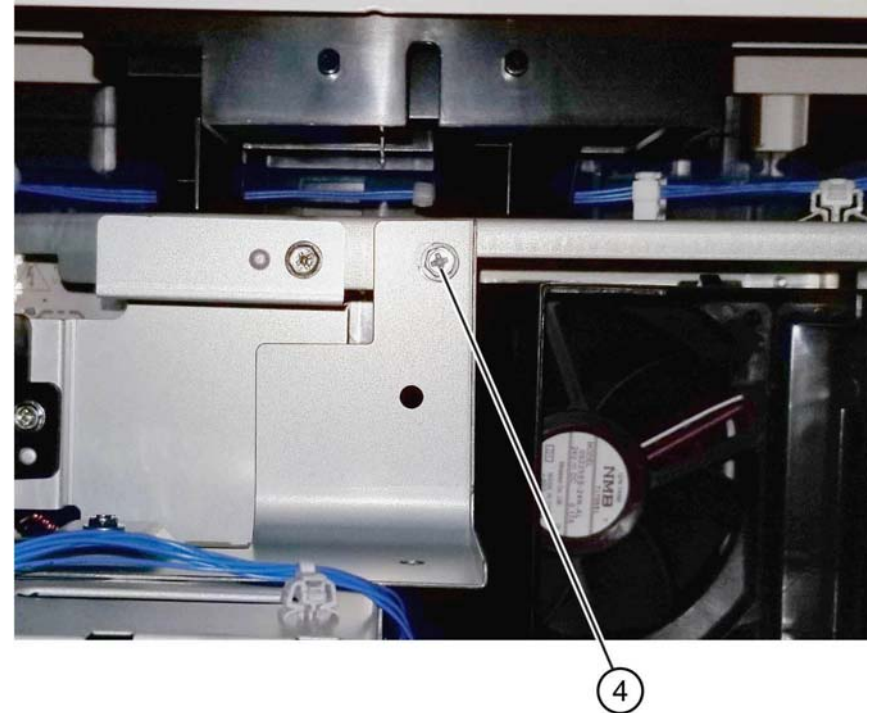
F-1-0672-A

- c. Remove one screw (4) above the video contact control chassis assembly, [Figure 4](#).

Figure 4 Screw removal

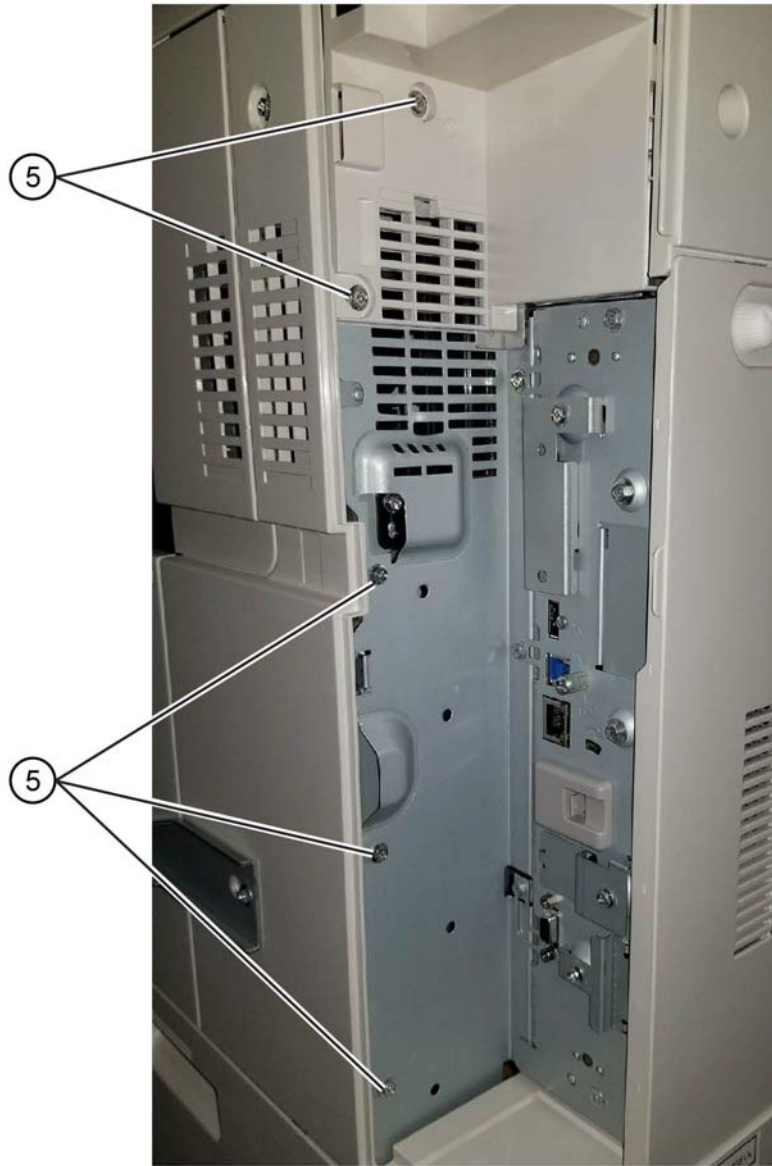
F-1-0673-A

d. Remove five screws (5), Figure 5.

Figure 5 Screw removal

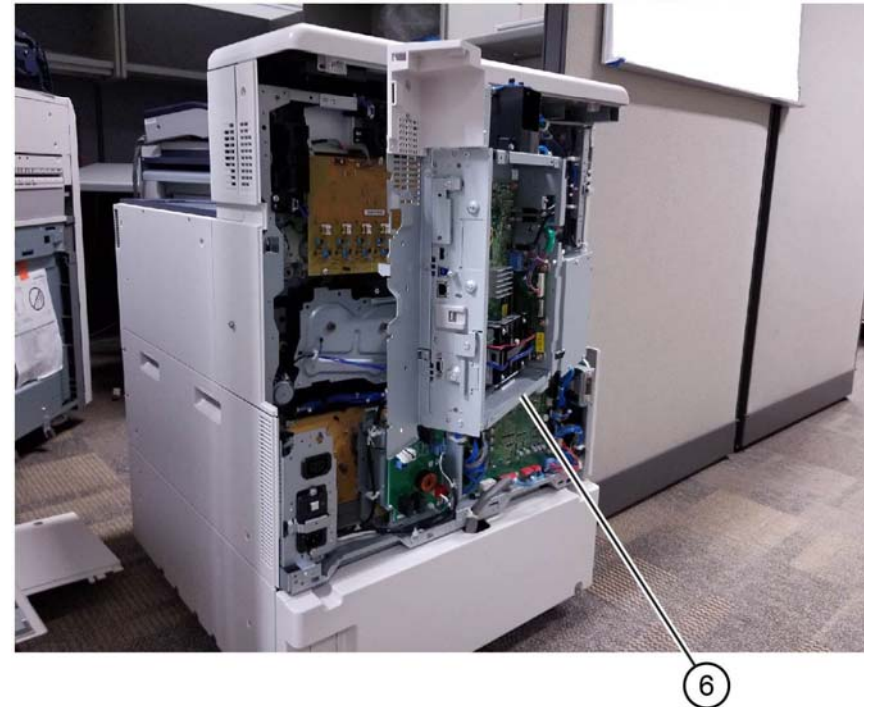
F-1-0674-A

e. Open the video contact chassis unit (6), Figure 6.

Figure 6 Video contact chassis unit open

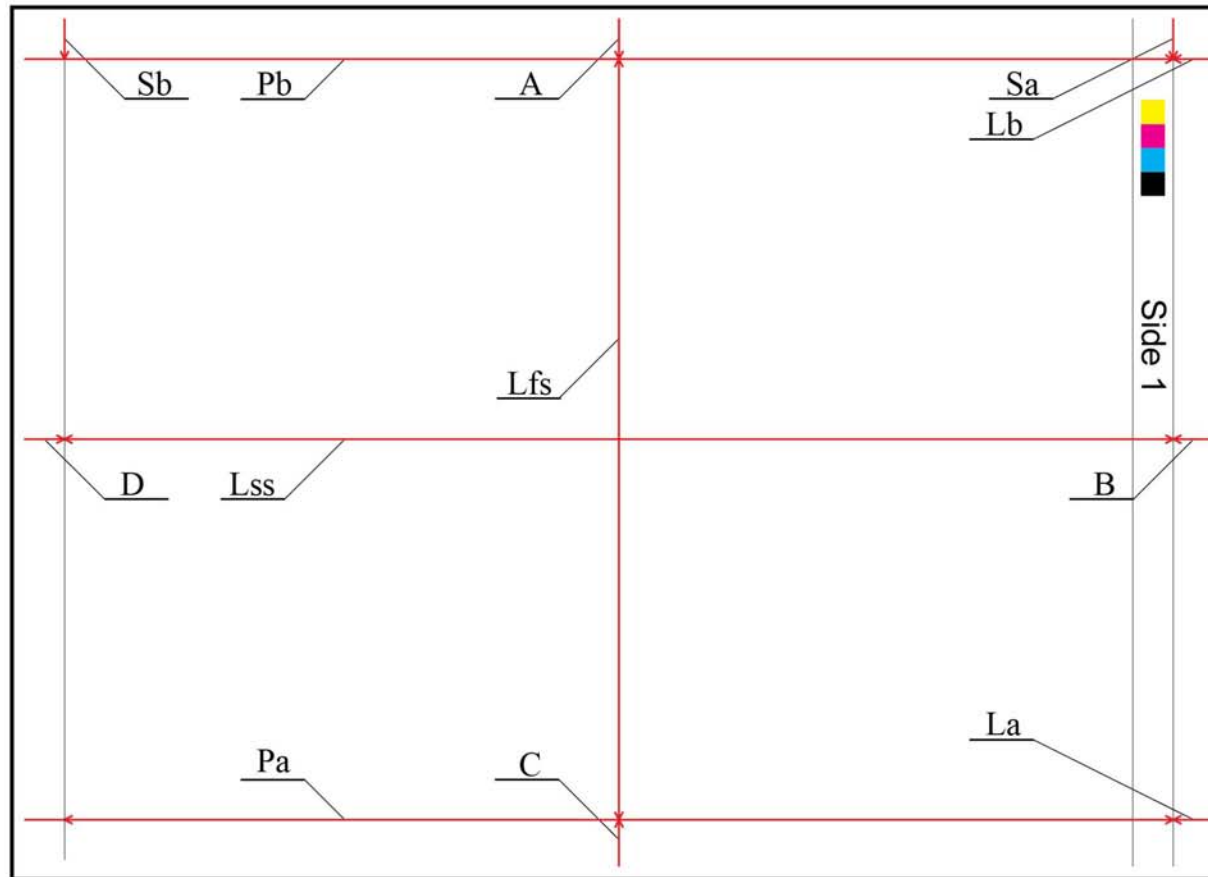
F-1-0696-A

For adjustment items other than the Side 1/Side 2 Registration, successive adjustments can be performed using the output result of 1 chart sheet. Refer to [Figure 1](#) and [Figure 2](#).

Figure 1 Registration test pattern side 1

Print the Adjustment Test Pattern (containing the record of measurement (length) locations of the various alignment components) that is stored in the controller and then follow the instructions on the UI screen to input the result of measurements from the measurement locations on the printout via the UI screen to send the misalignment to the IOT and adjust the alignment component.

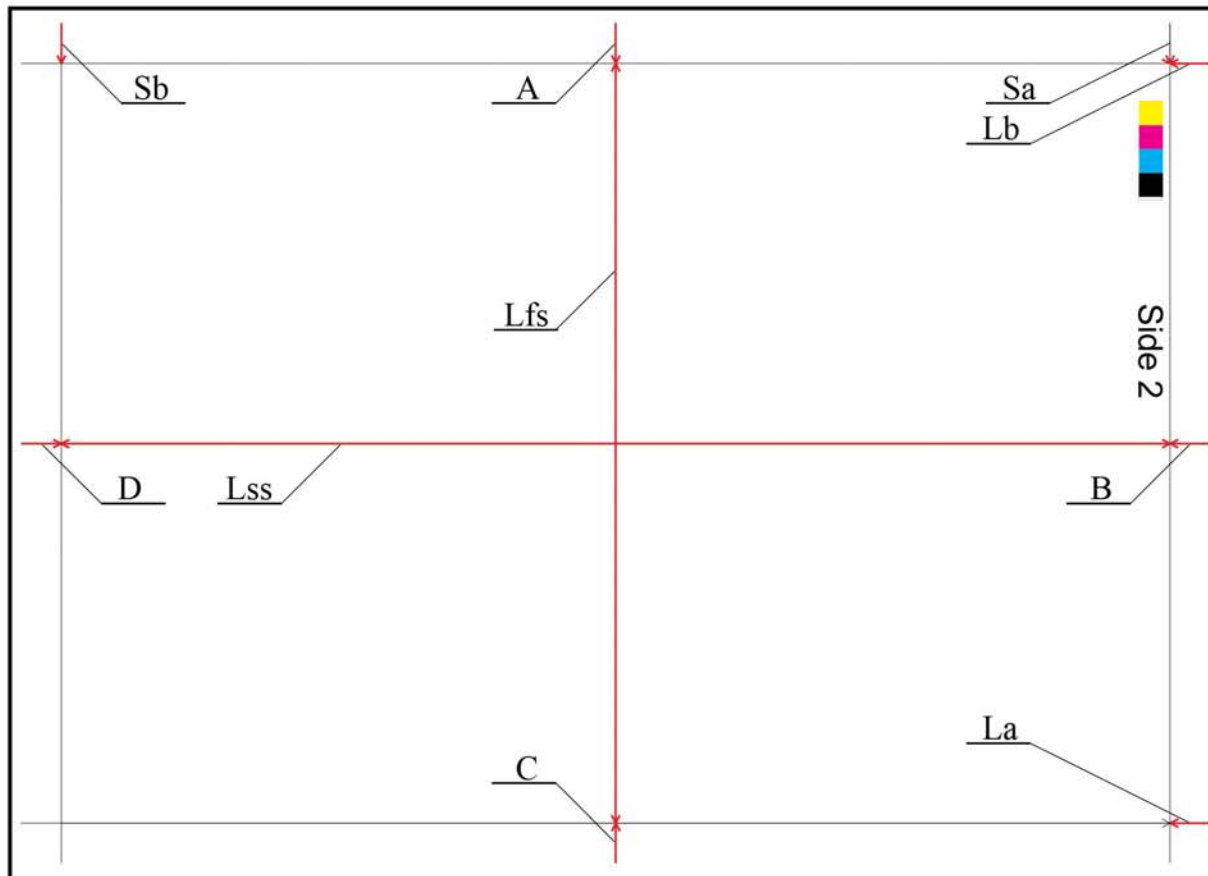
F-1-0697-A

Figure 2 Registration test pattern side 2

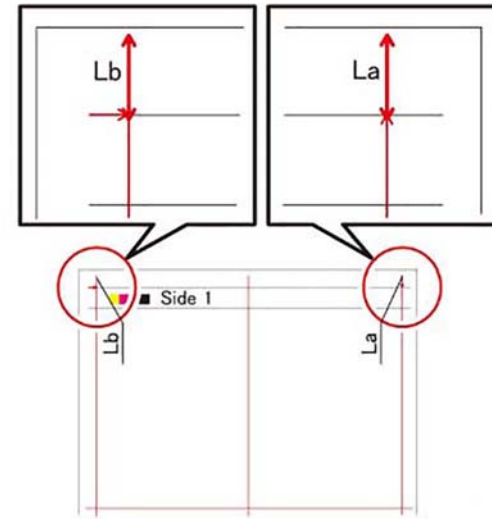
F-1-0746-A

2. Measure **La** and **Lb** on Side 1 of the measurement chart, [Figure 7](#).

Figure 7 Side 1 La and Lb measurement

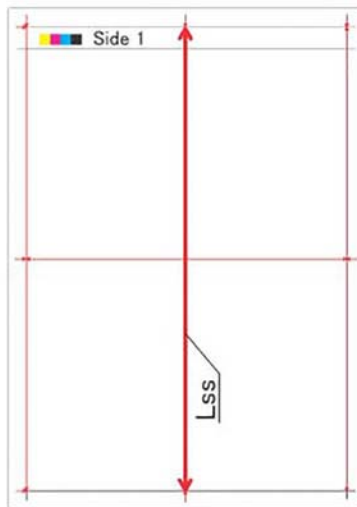
F-1-0735-A

2. Measure **Lss** on **Side 1** of the measurement chart, [Figure 13](#).

Figure 13 Side 1 Lss measurement

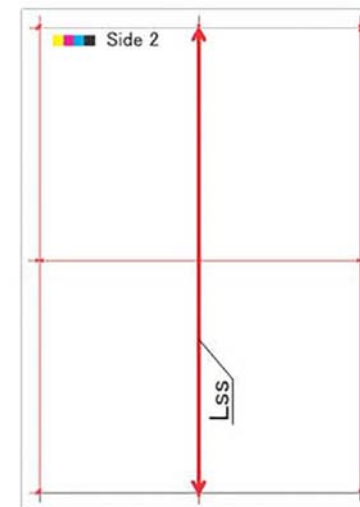
F-1-0749-A

4. Measure **Lss** on **Side 2** of the measurement chart. [Figure 15](#).

Figure 15 Side 2 Lss measurement

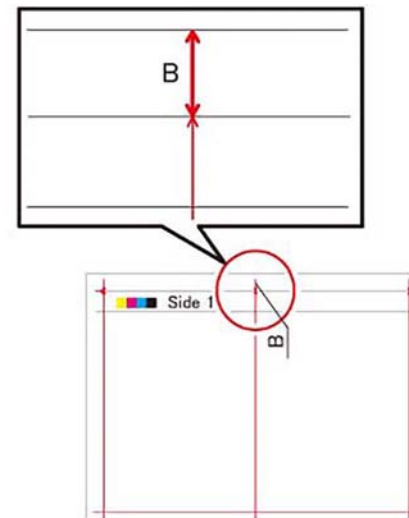
Figure 18 Lead edge side 1 measurement

2. Measure **B** on **Side 1** of the measurement chart, [Figure 18](#).

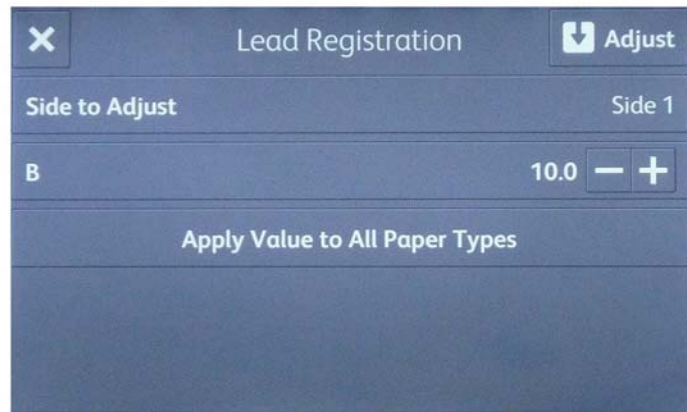
Figure 19 Lead Registration Side 1 input

3. Select **Side 1**, input the measured value, and select **Adjust**. [Figure 19](#).

4. Select **Apply Value to All Paper Types**, [Figure 19](#).
5. Measure **B** on **Side 2** of the measurement chart. [Figure 20](#).

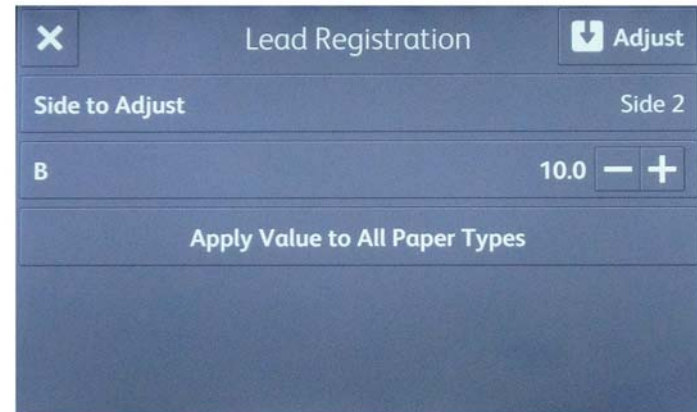
Figure 21 Lead Registration Side 2 input

6. Select **Side 2**, input the measured value, and select **Adjust**. [Figure 21](#).

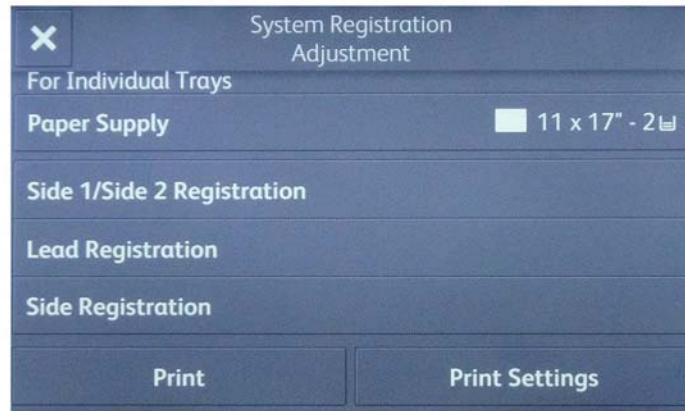
Figure 22 Side edge registration selection

1. Select **Paper Supply** for the correct tray, then select **Side Registration**. [Figure 22](#).

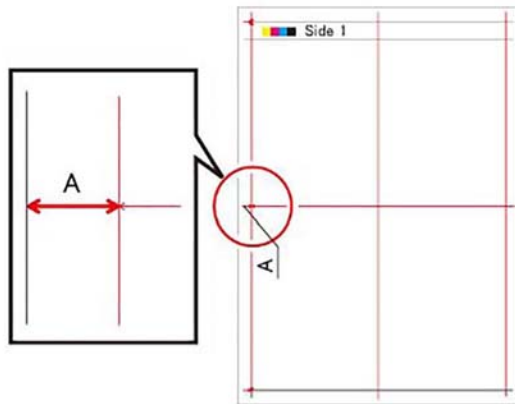
Figure 23 Side 1 Side Registration measurement

2. Measure **A** on **Side 1** of the measurement chart. [Figure 23](#).

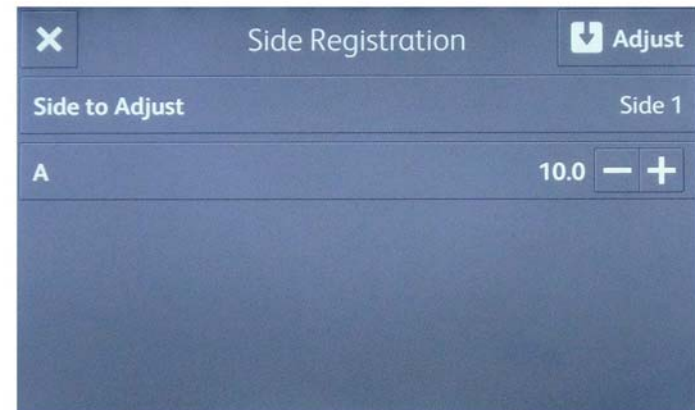
Figure 24 Side 1 Side Registration input

3. Select **Side 1**. Input the measured value, then select **Adjust**. [Figure 24](#).

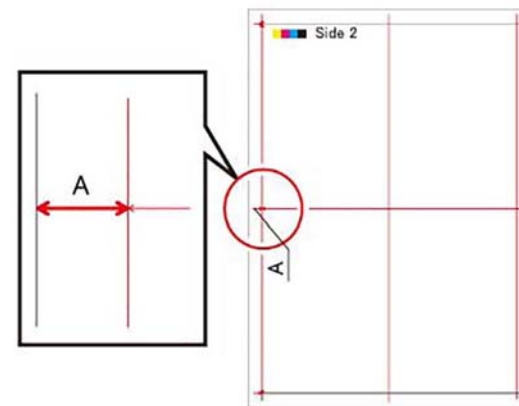
Figure 25 Side 2 Side Registration measurement

4. Measure **A** on **Side 2** of the measurement chart. [Figure 25](#).

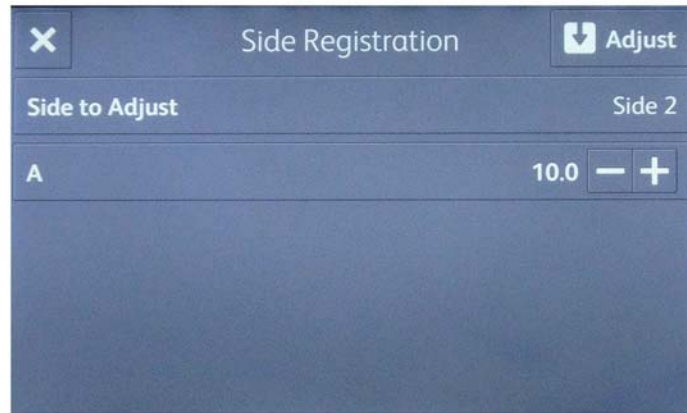
Figure 26 Side 2 Side Registration adjustment

5. Select **Side 2**, input the measured value, then select **Adjust**. [Figure 26](#).

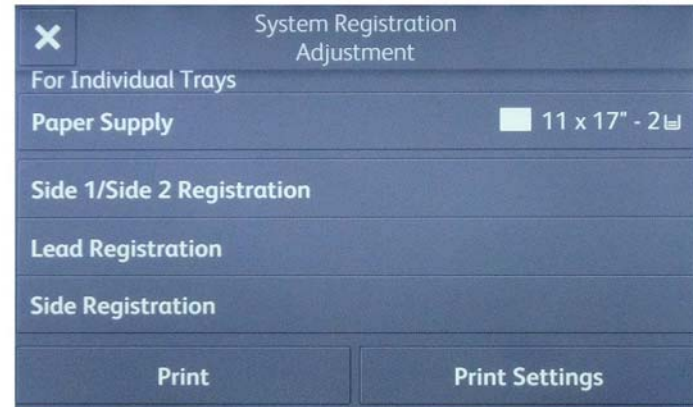
Figure 27 Side 1/Side 2 Registration selection

1. Select **Paper Supply** for the appropriate tray, select **Print** to print a measurement page, then **Side 1/Side 2 Registration** to perform adjustments, [Figure 27](#).

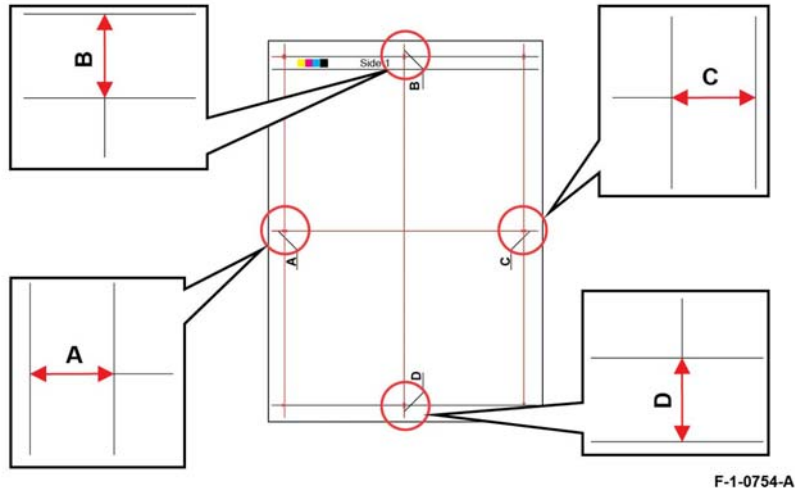
Figure 28 Side 1/Side 2 Registration measurement

2. Measure **A** to **D** on **Side 1** and **Side 2** of the measurement chart. [Figure 28](#).

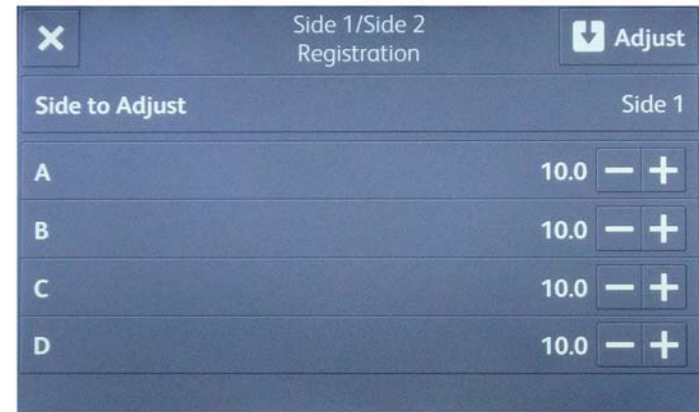
Figure 29 Side 1/Side 2 Registration adjustment

3. Enter the measured values for **A** to **D** on **Side 1** and **Side 2** of the measurement chart, then select **Adjust**. [Figure 29](#).

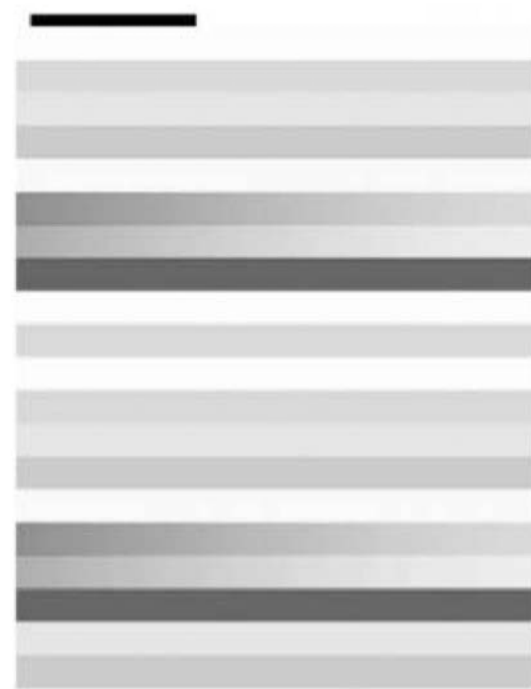
Figure 1 Test pattern

1. Load A3 paper into Tray 1.
2. Enter Diagnostics, **GP 1**.
3. Select **dC931, Density Uniformity Adjustment**.
4. Select **Print Settings**.
5. Specify **Tray 1 - A3**.
6. Select **Full Color**, then **OK**.
7. Select **Print Sample**, **Figure 1**:
 - The Print Sample will be printed out in the order of Primary color, Secondary color, and Process color.
8. Check the Print Sample for incorrect color density.
9. Adjustment:
 - a. Select **Color** (Yellow, Magenta, Cyan, or Black).
 - b. Select **Shape**, 1 ~ 6.
 - c. Select **Level**, -17 ~ +17.
 - d. Select **Inboard/Outboard**, -17 ~ +17.
 - e. Select **Print Sample**.

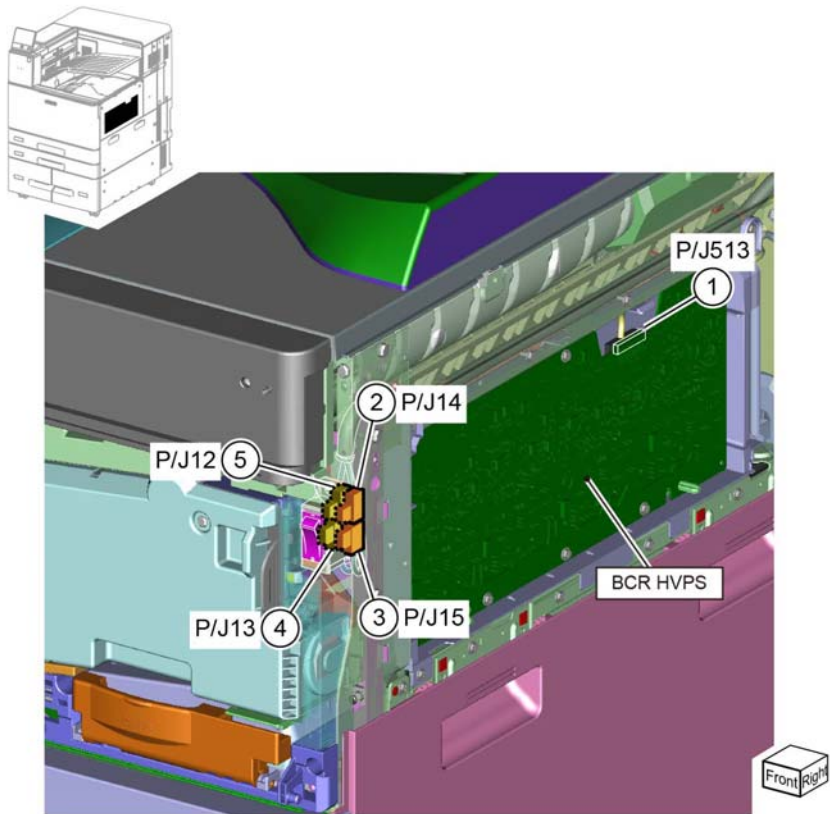
Figure 1 Main Power Switch/BCR HVPS

Main Power Switch / BCR HVPS

Location: PL 1.20

- Back plane PWB, [Figure 25](#).
- BCR HVPS, [Figure 1](#).
- BTR HVPS, [Figure 18](#).
- Bypass tray, [Figure 6](#).
- Controller PWB, [Figure 23](#).
- Developer bias HVPS/LVPS, [Figure 16](#).

- LPH/toner cartridge CRUM, [Figure 3](#).
- LX finisher horizontal transport, [Figure 26](#).
- Machine left side, [Figure 20](#).
- Main power switch, [Figure 1](#).

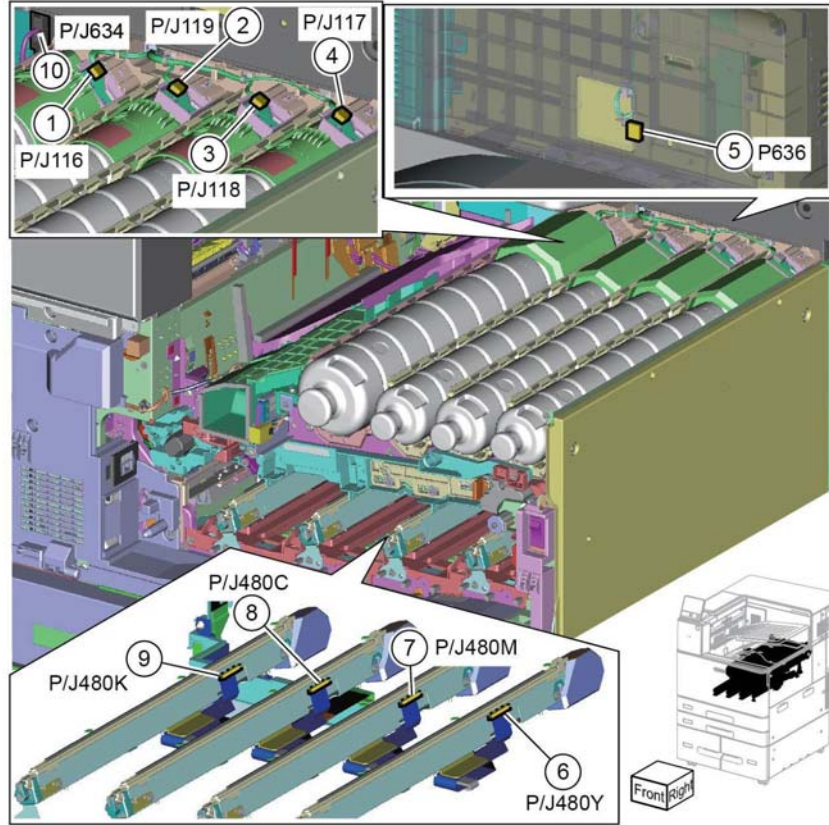
Figure 3 LPH/Toner Cartridge CRUM

LPH/Toner Cartridge CRUM

Location: PL 60.05, PL 90.10

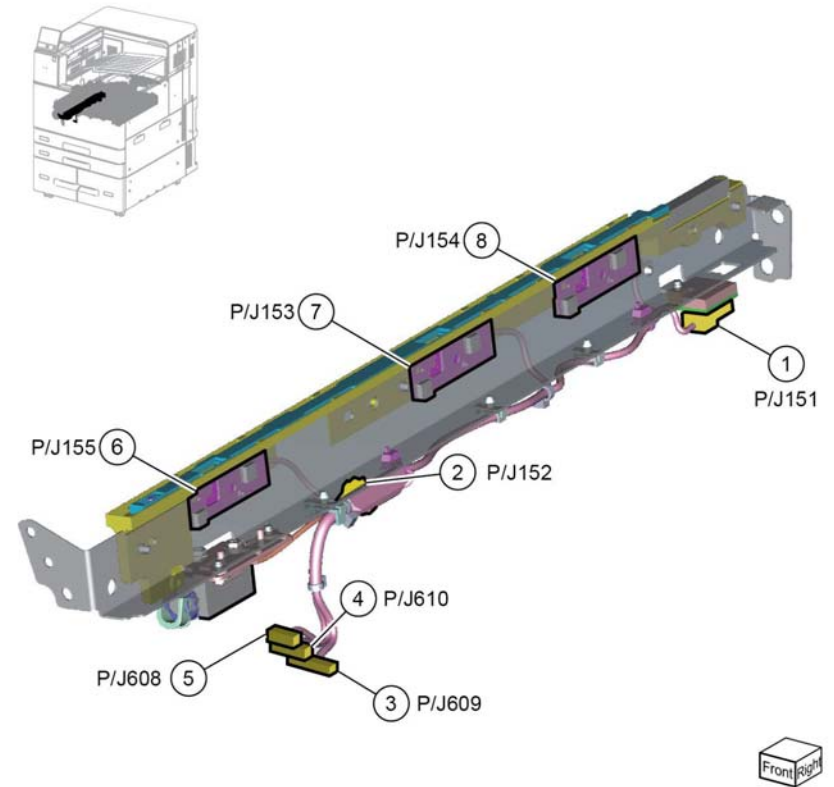
Figure 4 MOB Assembly

MOB Assembly

Location: PL 90.30

- MOB assembly, [Figure 4](#).
- Motor drive PWB, [Figure 2](#).
- NOHAD, [Figure 14](#).
- Office finisher LX front, [Figure 27](#).
- Office finisher LX rear, [Figure 28](#).

P/J123	Figure 9	7	Tray module (2TM) 2 of 2
P/J124	Figure 17	12	IOT front location/ATC sensor
P/J125	Figure 17	13	IOT front location/ATC sensor
P/J126	Figure 17	14	IOT front location/ATC sensor
P/J127	Figure 17	15	IOT front location/ATC sensor
P/J129	Figure 20	2	Machine left side
P/J132	Figure 20	10	Machine left side
P/J133	Figure 20	11	Machine left side
P/J134	Figure 6	10	Bypass tray
P/J135	Figure 22	11	Exit 1 and 2
P/J136	Figure 22	10	Exit 1 and 2
P/J138	Figure 22	15	Exit 1 and 2
P/J139	Figure 22	13	Exit 1 and 2
J140	Figure 13	4	Drum/developer/fuser drives
P/J141	Figure 22	1	Exit 1 and 2
P/J142	Figure 22	3	Exit 1 and 2
P/J143	Figure 22	2	Exit 1 and 2
P/J151	Figure 4	1	MOB assembly
P/J152	Figure 4	2	MOB assembly

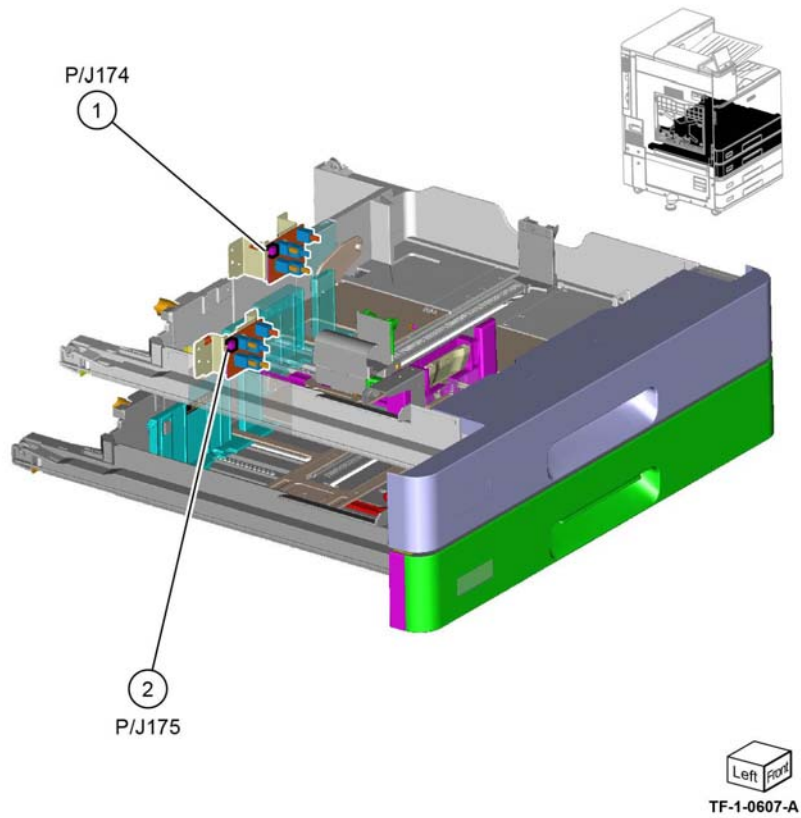
Figure 5 Tray 1, 2 Paper Size Sensors

Tray 1 and 2 Paper Size Sensors

Location: PL 70.05

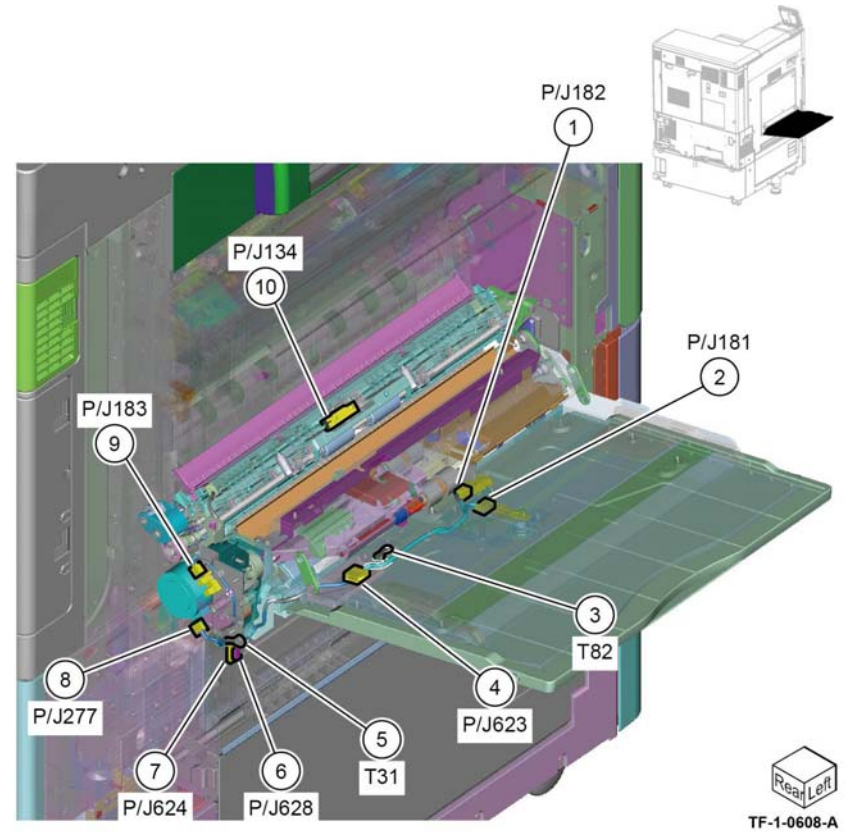
Figure 6 Bypass Tray

Bypass Tray

Location: PL 80.120

Connector No.	Figure No.	Item No.	Connector Location
P/J623	Figure 10	9	Tray module (TTM) 1 of 3
P/J623	Figure 6	4	Bypass tray
P/J624	Figure 8	7	Tray module (2TM) 1 of 2
P/J624	Figure 10	10	Tray module (TTM) 1 of 3
P/J624	Figure 6	7	Bypass tray
P/J625	Figure 8	5	Tray module (2TM) 1 of 2
P/J625	Figure 10	8	Tray module (TTM) 1 of 3
P/J625	Figure 20	7	Machine left side
P/J626	Figure 20	6	Machine left side
P/J628	Figure 6	6	Bypass tray
P/J629	Figure 20	4	Machine left side
P/J630	Figure 20	5	Machine left side
P/J631	Figure 22	6	Exit 1 and 2
P/J632	Figure 22	4	Exit 1 and 2
P/J633	Figure 22	14	Exit 1 and 2
P/J634	Figure 22	5	Exit 1 and 2
J634	Figure 21	5	Fuser
P/J634	Figure 3	10	LPH/toner cartridge CRUM
P634	Figure 18	2	BTR HVPS/fuser power supply
P636	Figure 3	5	LPH/toner cartridge CRUM
P/J638	Figure 22	7	Exit 1 and 2
DP800	Figure 32	10	HCF top
DP800	Figure 16	3	Developer bias HVPS/LVPS
J1312	Figure 23	4	Controller PWB

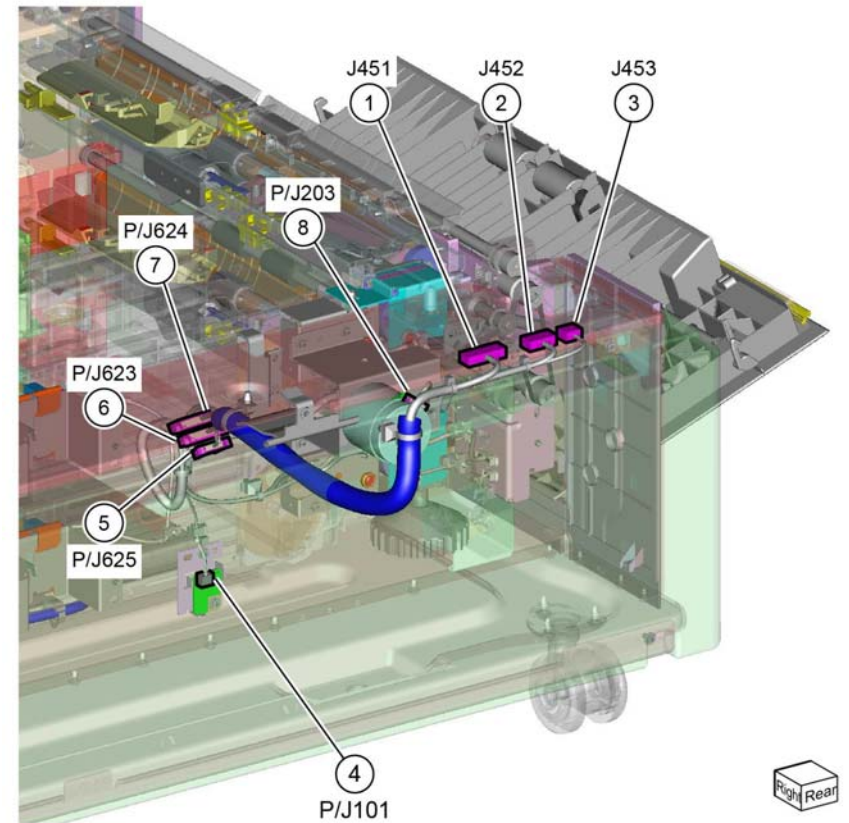
Figure 8 Tray Module (2TM) 1 of 2

Tray Module (2TM) 1 of 2

Location: PL 80.25

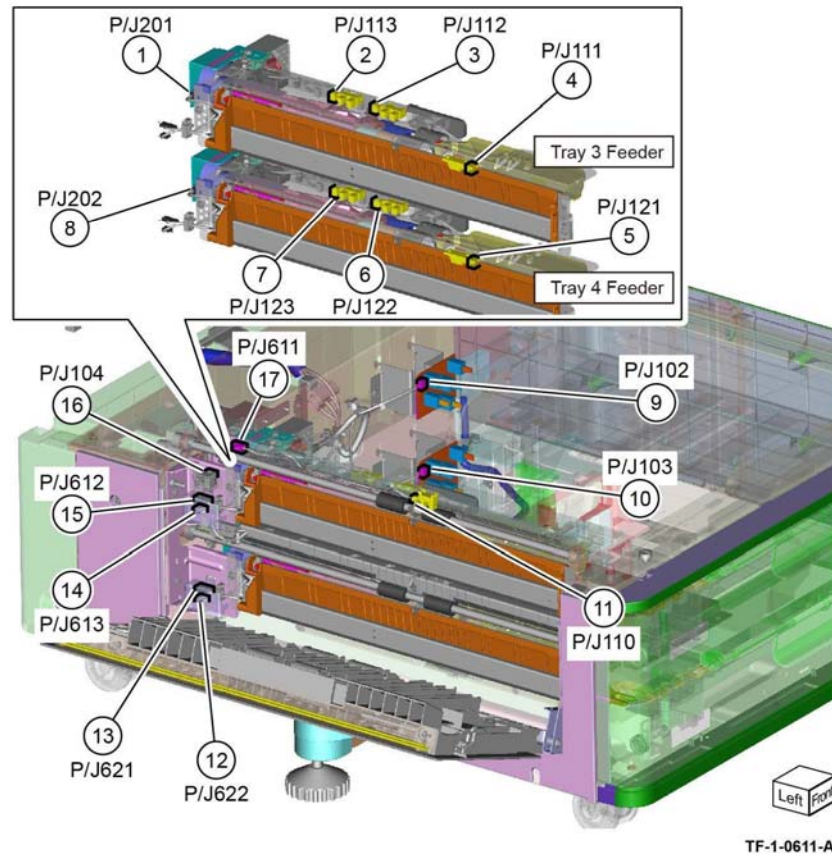
Figure 9 Tray Module (2TM) 2 of 2

Tray Module (2TM) 2 of 2

Location: PL 80.20

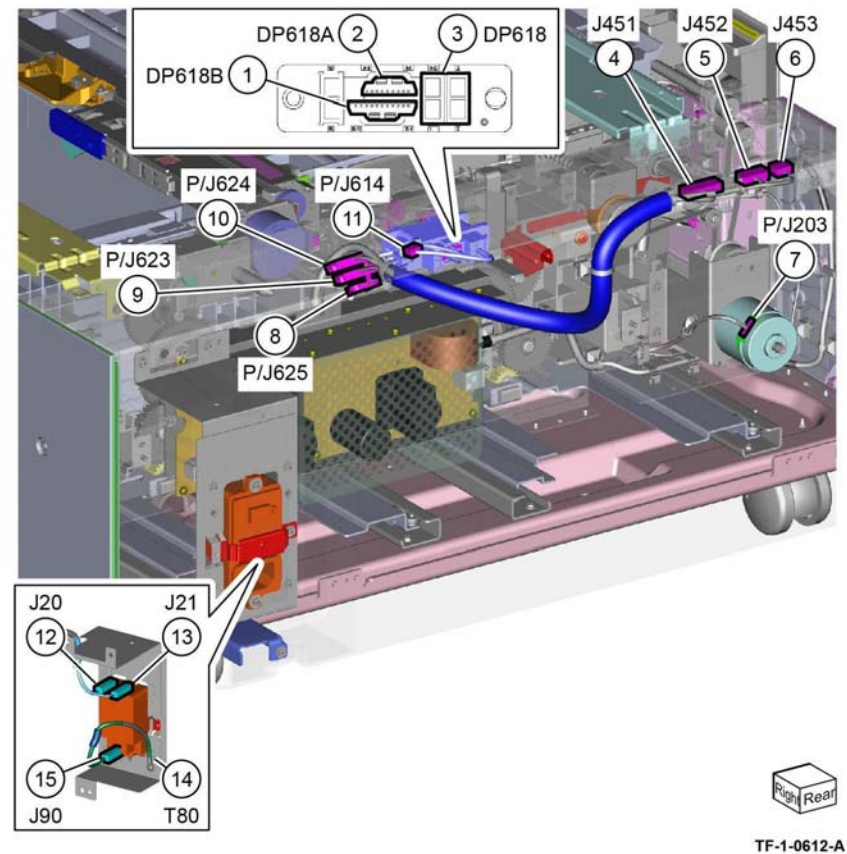
Figure 10 Tray Module (TTM) 1 of 3

Tray Module (TTM) 1 of 3

Location: PL 70.30, PL 70.35

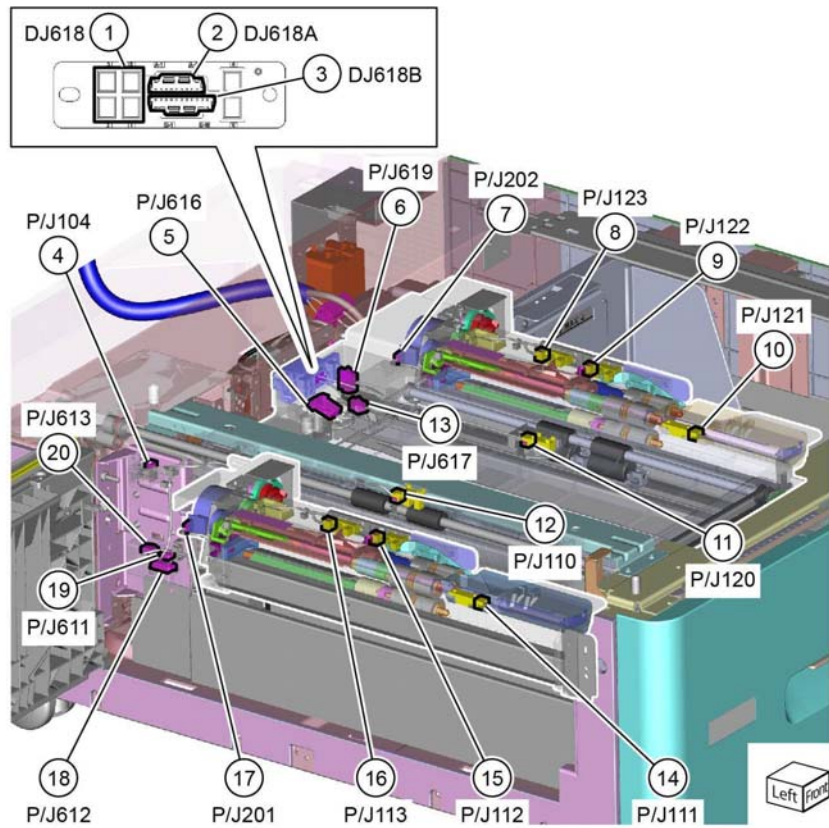
Figure 11 Tray Module (TTM) 2 of 3

Tray Module (TTM) 2 of 3

Location: PL 70.30, PL 70.35

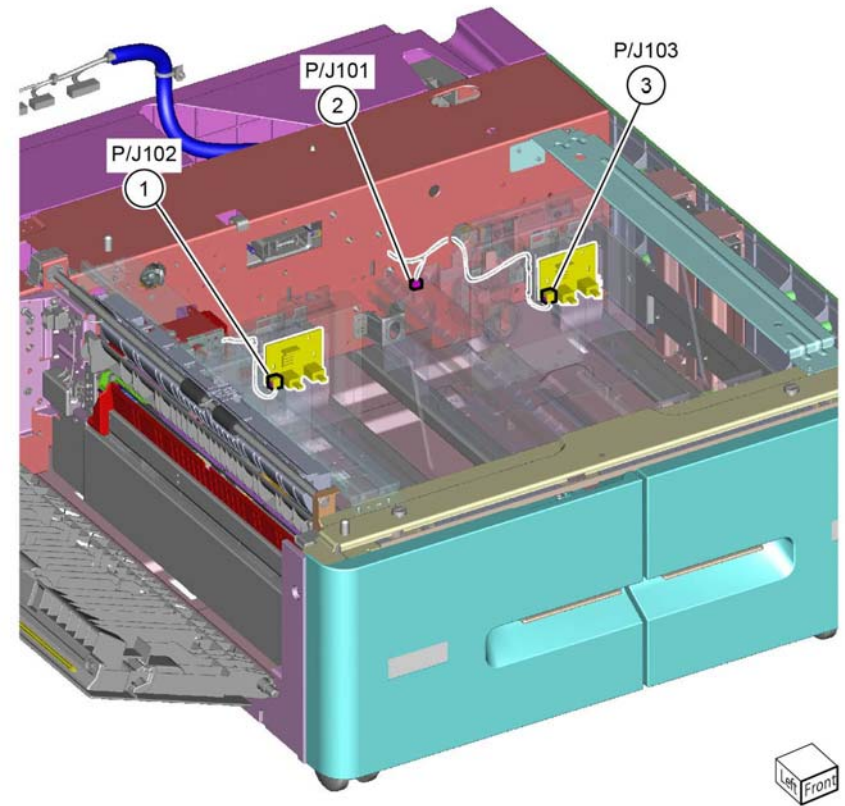
Figure 12 Tray Module (TTM) 3 of 3

Tray Module (TTM) 3 of 3

Location: PL 70.30, PL 70.35
