VersaLink[®] C8000/C9000 Printer

Service Manual

VersaLink C9000 Family Service Manual

705P01418

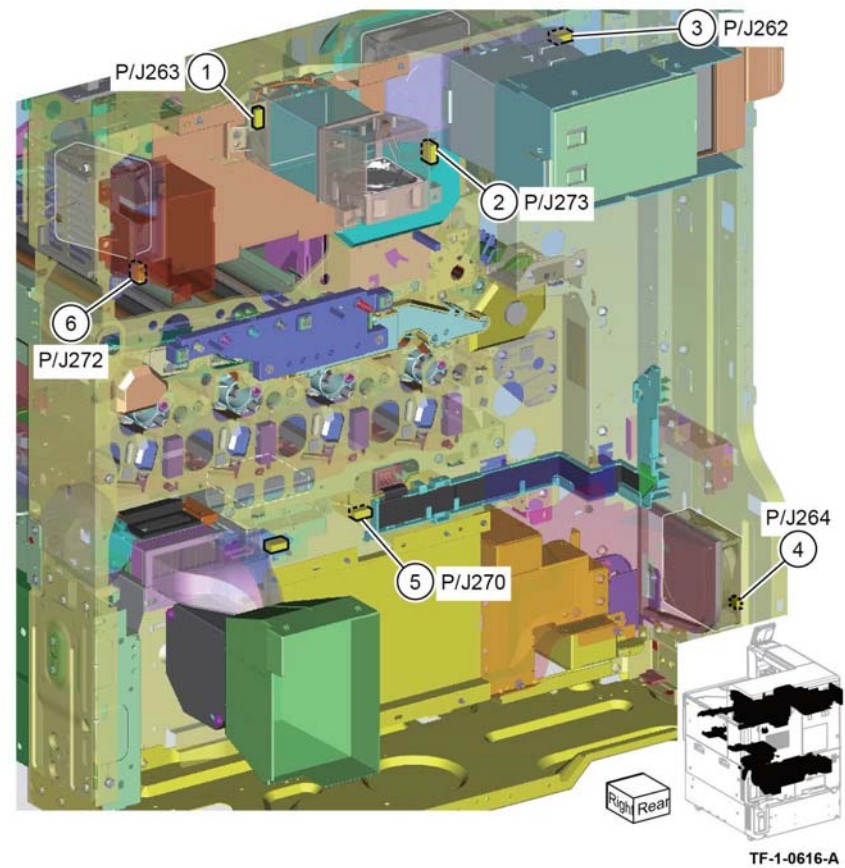
Figure 14 NOHAD

NOHAD

Location: PL 40.10, PL 40.15

- MOB assembly, [Figure 4](#).
- Motor drive PWB, [Figure 2](#).
- NOHAD, [Figure 14](#).
- Office finisher LX front, [Figure 27](#).
- Office finisher LX rear, [Figure 28](#).

Connector No.	Figure No.	Item No.	Connector Location
P/J222	Figure 19	3	Dispense motor/GFI
P/J223	Figure 19	4	Dispense motor/GFI
P/J225	Figure 13	3	Drum/developer/fuser drives
P/J226	Figure 22	16	Exit 1 and 2
P/J231	Figure 7	2	Registration, tray 1/2 feeder
P/J232	Figure 7	1	Registration, tray 1/2 feeder
P/J233	Figure 7	3	Registration, tray 1/2 feeder
P/J234	Figure 20	3	Machine left side
P/J235	Figure 22	12	Exit 1 and 2
P/J236	Figure 22	8	Exit 1 and 2
P/J237	Figure 22	9	Exit 1 and 2
P/J240	Figure 13	1	Drum/developer/fuser drives
P/J261	Figure 17	9	IOT front location/ATC sensor
P/J262	Figure 14	3	NOHAD
P/J263	Figure 14	1	NOHAD
P/J264	Figure 14	4	NOHAD
P/J265	Figure 17	2	IOT front location/ATC sensor
P/J267	Figure 17	1	IOT front location/ATC sensor
P/J270	Figure 14	5	NOHAD
P/J270	Figure 15	6	Drum CRUM
P/J272	Figure 14	6	NOHAD
P/J273	Figure 14	2	NOHAD
P/J275	Figure 7	4	Registration, tray 1/2 feeder
P/J276	Figure 7	15	Registration, tray 1/2 feeder

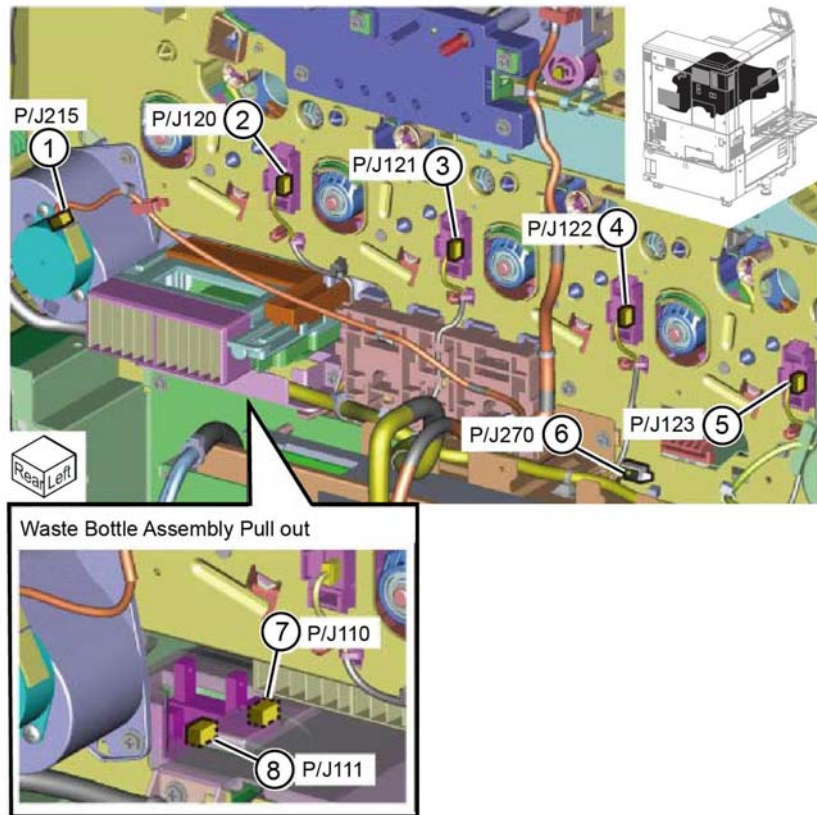
Figure 15 Drum CRUM

Drum CRUM

Location: PL 90.25

- Dispense motor/GFI, [Figure 19](#).
- Drum CRUM, [Figure 15](#).
- Drum/developer/fuser drives, [Figure 13](#).
- Exit 1 and 2, [Figure 22](#).
- Fuser, [Figure 21](#).

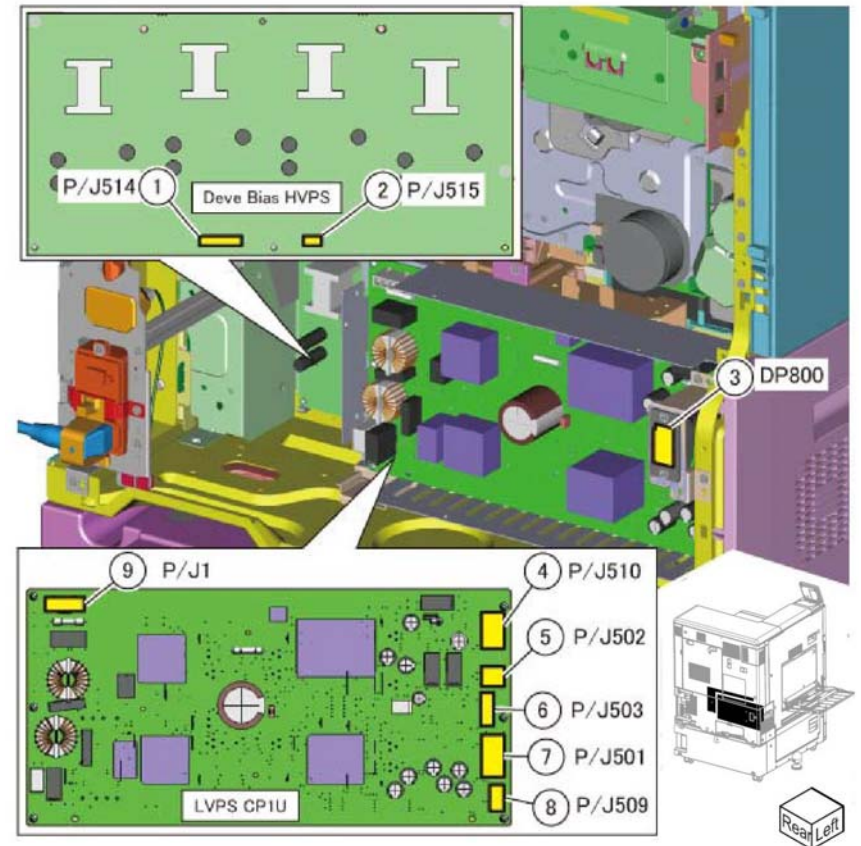
Figure 16 Developer Bias HVPS/LVPS

Developer Bias HVPS/LVPS

Location: PL 1.15

- Back plane PWB, [Figure 25](#).
- BCR HVPS, [Figure 1](#).
- BTR HVPS, [Figure 18](#).
- Bypass tray, [Figure 6](#).
- Controller PWB, [Figure 23](#).
- Developer bias HVPS/LVPS, [Figure 16](#).

Connector No.	Figure No.	Item No.	Connector Location
P/J623	Figure 10	9	Tray module (TTM) 1 of 3
P/J623	Figure 6	4	Bypass tray
P/J624	Figure 8	7	Tray module (2TM) 1 of 2
P/J624	Figure 10	10	Tray module (TTM) 1 of 3
P/J624	Figure 6	7	Bypass tray
P/J625	Figure 8	5	Tray module (2TM) 1 of 2
P/J625	Figure 10	8	Tray module (TTM) 1 of 3
P/J625	Figure 20	7	Machine left side
P/J626	Figure 20	6	Machine left side
P/J628	Figure 6	6	Bypass tray
P/J629	Figure 20	4	Machine left side
P/J630	Figure 20	5	Machine left side
P/J631	Figure 22	6	Exit 1 and 2
P/J632	Figure 22	4	Exit 1 and 2
P/J633	Figure 22	14	Exit 1 and 2
P/J634	Figure 22	5	Exit 1 and 2
J634	Figure 21	5	Fuser
P/J634	Figure 3	10	LPH/toner cartridge CRUM
P634	Figure 18	2	BTR HVPS/fuser power supply
P636	Figure 3	5	LPH/toner cartridge CRUM
P/J638	Figure 22	7	Exit 1 and 2
DP800	Figure 32	10	HCF top
DP800	Figure 16	3	Developer bias HVPS/LVPS
J1312	Figure 23	4	Controller PWB

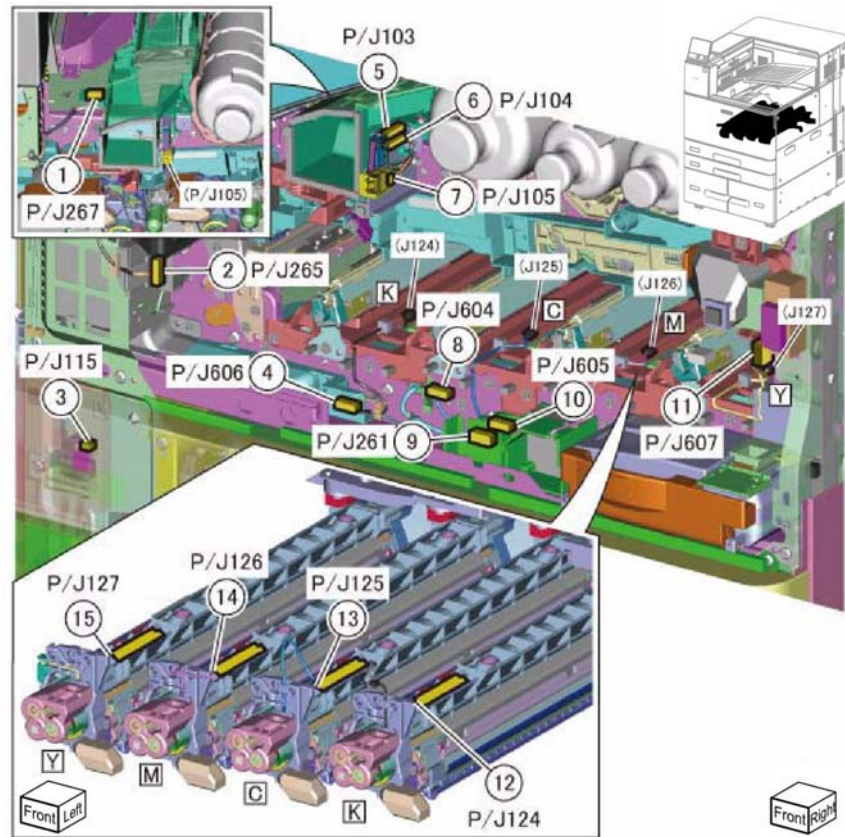
Figure 17 IOT Front Location/ATC Sensor

IOT Front Location / ATC Sensor

Location: PL 90.10, PL 90.15

P/J123	Figure 9	7	Tray module (2TM) 2 of 2
P/J124	Figure 17	12	IOT front location/ATC sensor
P/J125	Figure 17	13	IOT front location/ATC sensor
P/J126	Figure 17	14	IOT front location/ATC sensor
P/J127	Figure 17	15	IOT front location/ATC sensor
P/J129	Figure 20	2	Machine left side
P/J132	Figure 20	10	Machine left side
P/J133	Figure 20	11	Machine left side
P/J134	Figure 6	10	Bypass tray
P/J135	Figure 22	11	Exit 1 and 2
P/J136	Figure 22	10	Exit 1 and 2
P/J138	Figure 22	15	Exit 1 and 2
P/J139	Figure 22	13	Exit 1 and 2
J140	Figure 13	4	Drum/developer/fuser drives
P/J141	Figure 22	1	Exit 1 and 2
P/J142	Figure 22	3	Exit 1 and 2
P/J143	Figure 22	2	Exit 1 and 2
P/J151	Figure 4	1	MOB assembly
P/J152	Figure 4	2	MOB assembly

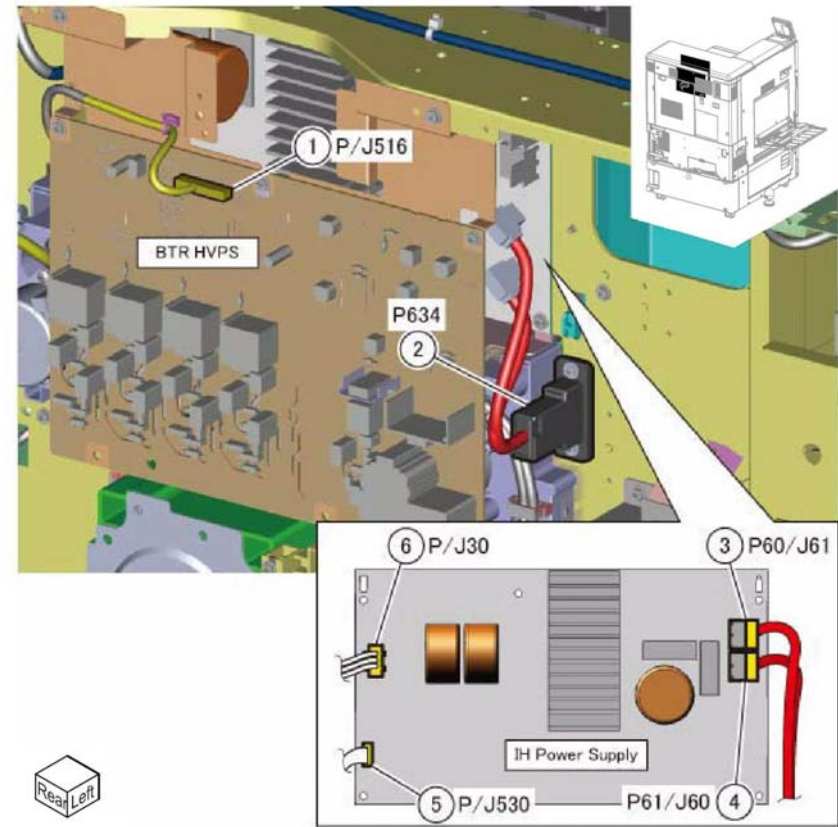
Figure 18 BTR HVPS/Fuser Power Supply

BTR HVPS/Fuser Heater Power Supply

Location: PL 1.05

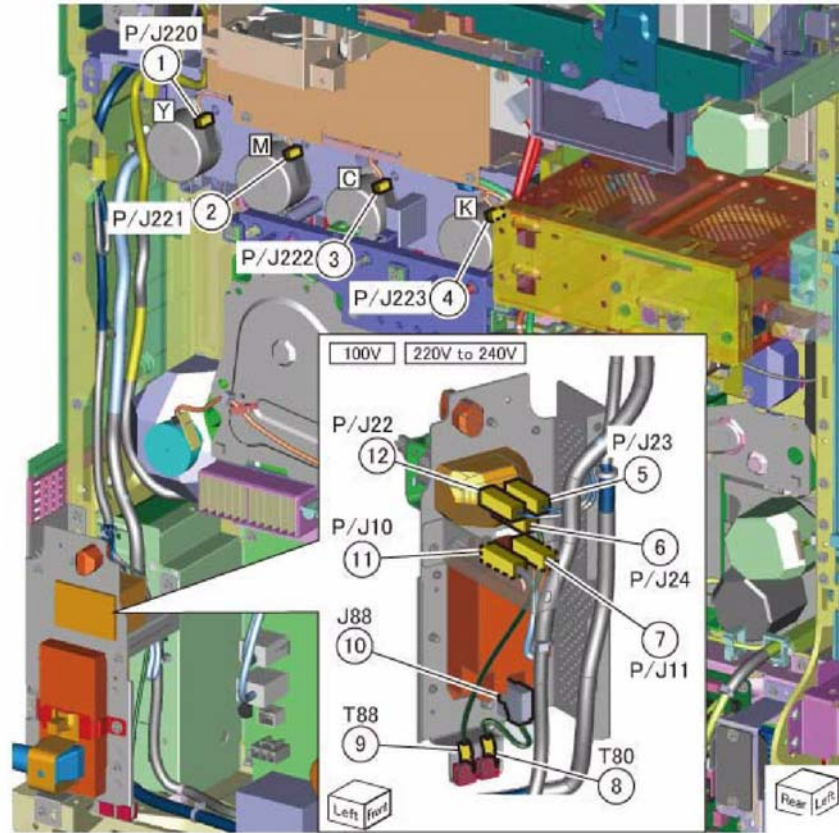
Figure 19 Dispense Motor/GFI

Dispense Motor/GFI

Location: PL 1.10, PL 90.10

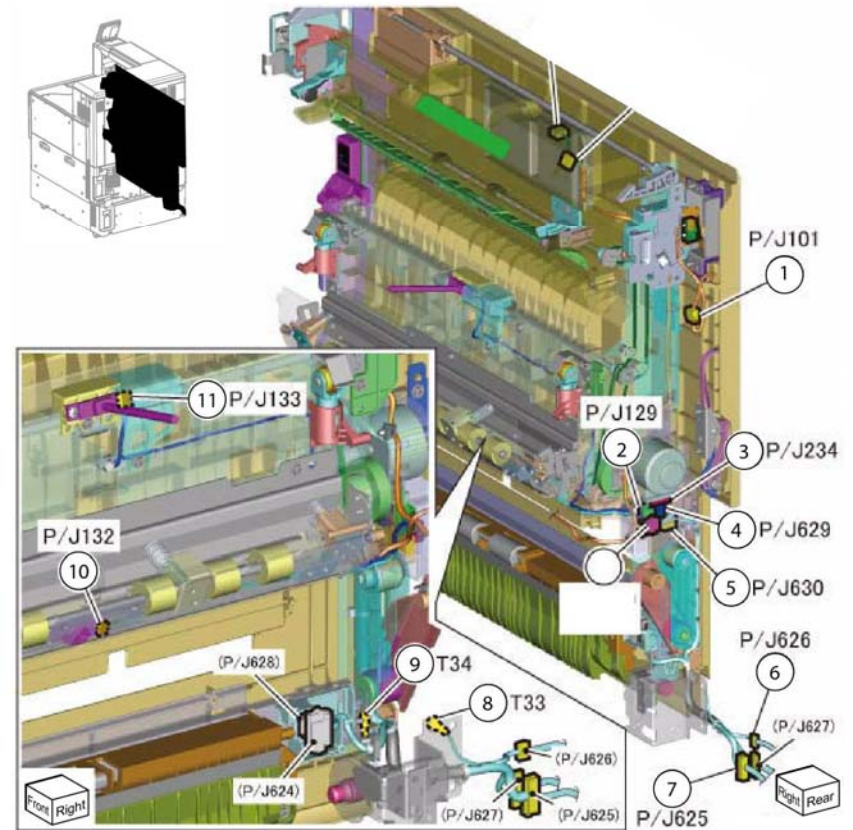
Figure 20 Machine Left Side

Machine Left Side

Location: PL 80.70, PL 80.75, PL 80.80, PL 80.85, PL 80.90

- LPH/toner cartridge CRUM, [Figure 3](#).
- LX finisher horizontal transport, [Figure 26](#).
- Machine left side, [Figure 20](#).
- Main power switch, [Figure 1](#).

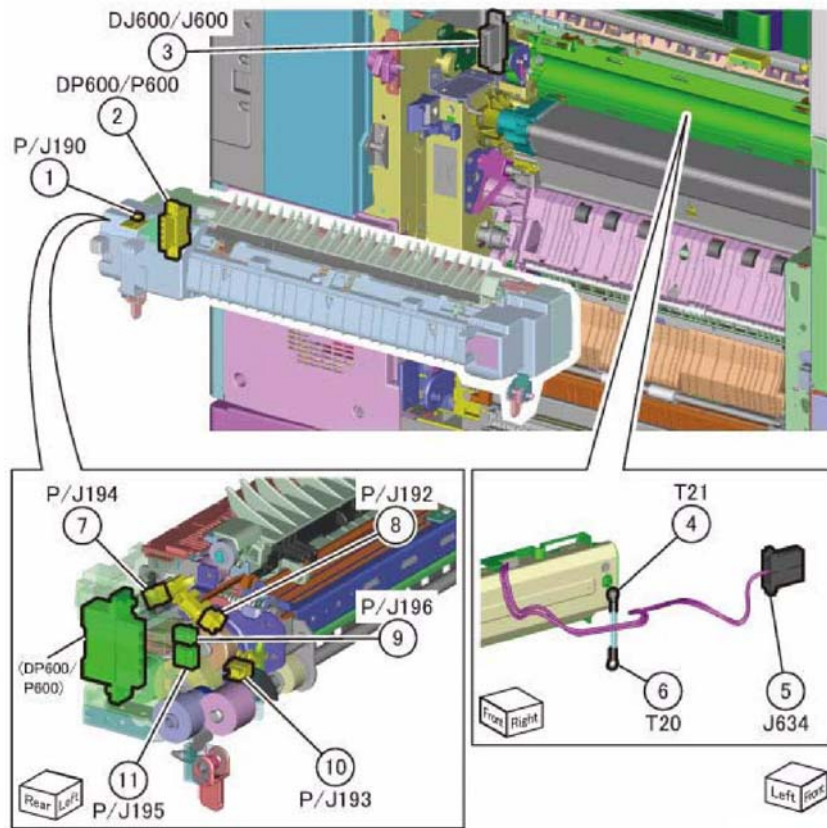
Figure 21 Fuser

Fuser

Location: PL 10.05

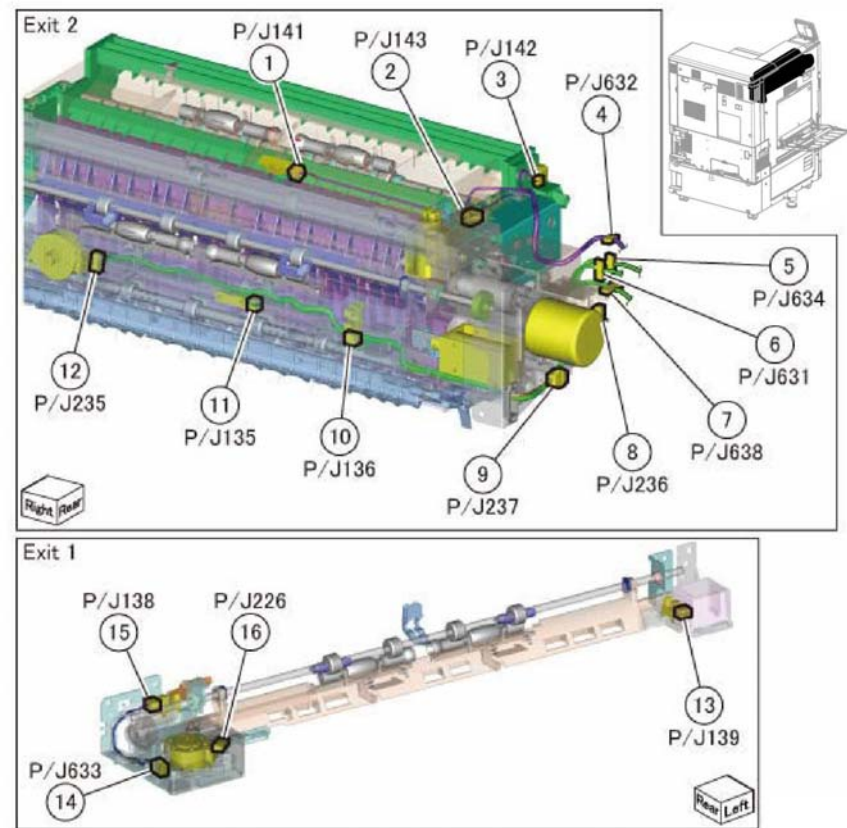
Figure 22 Exit 1 and 2

Exit 1 and 2

Location: PL 10.10, PL 10.15, PL 10.25

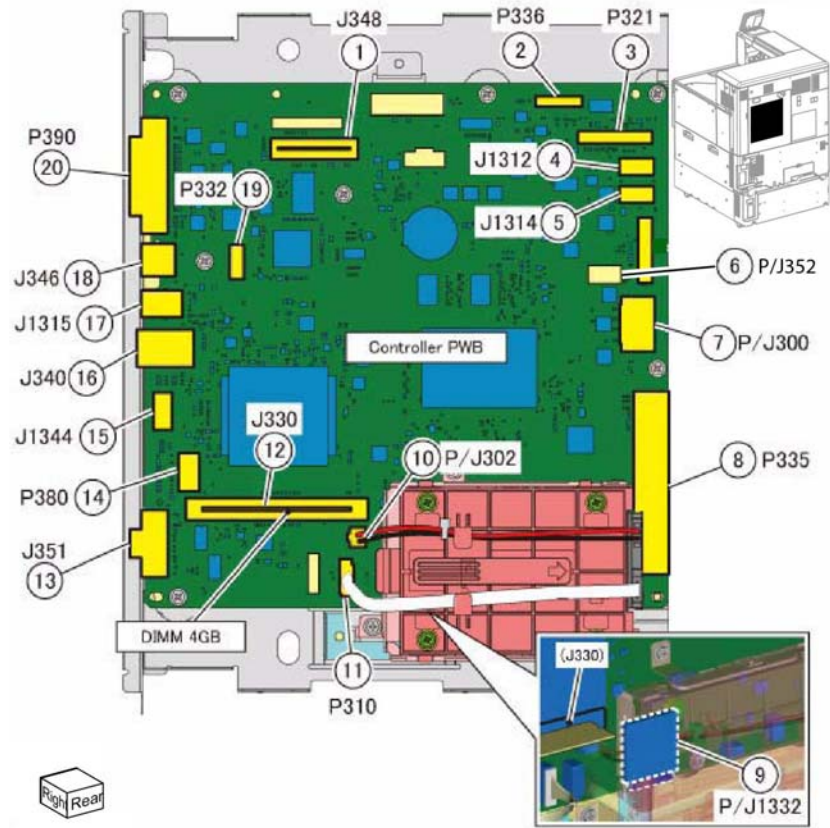
Figure 23 Controller PWB

Controller PWB

Location: PL 3.05

J1314	Figure 23	5	Controller PWB
J1315	Figure 23	17	Controller PWB
P/J1332	Figure 23	9	Controller PWB
P1371/J1341	Figure 25	3	Back plane PWB
J1344	Figure 23	15	Controller PWB
P1353	Figure 25	5	Back plane PWB
P1364	Figure 25	2	Back plane PWB
P1371/J1341	Figure 25	3	Back plane PWB

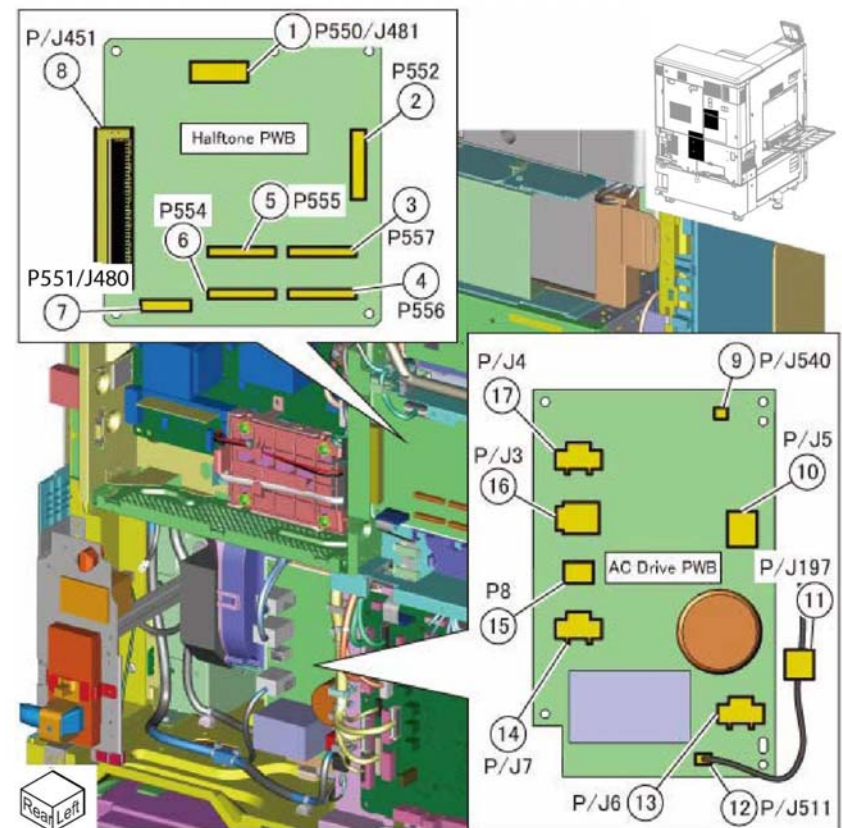
Figure 24 HalfTone PWB/AC Drive PWB

HalfTone PWB/AC Drive PWB

Location: PL 1.15, PL 3.15

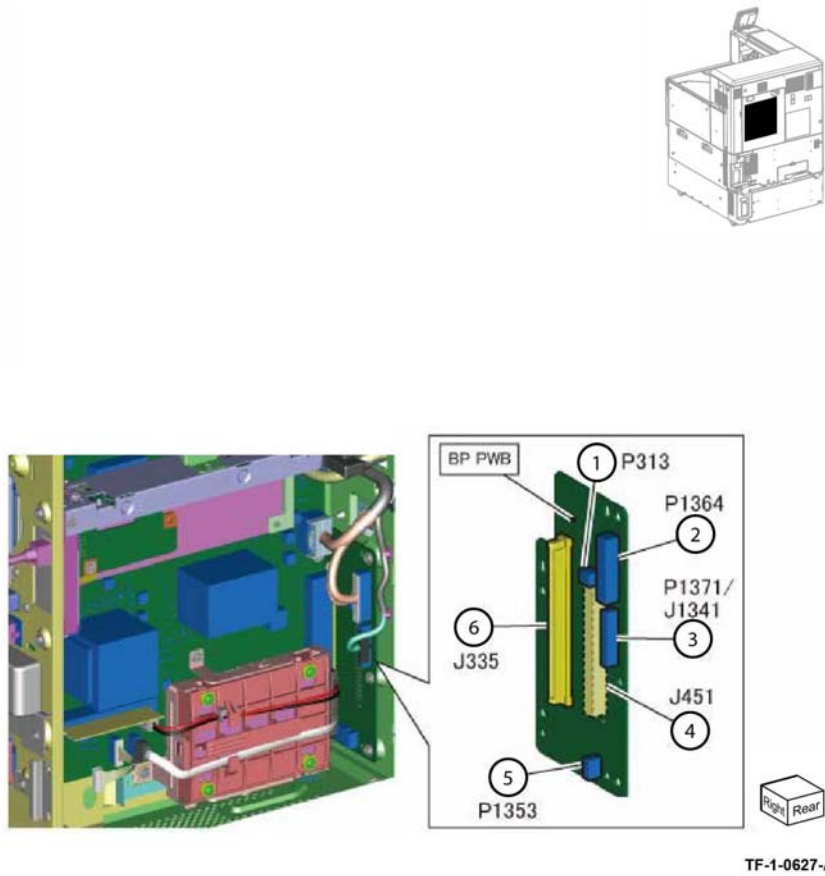
Figure 25 Back Plane PWB

Back Plane PWB

Location: PL 3.15

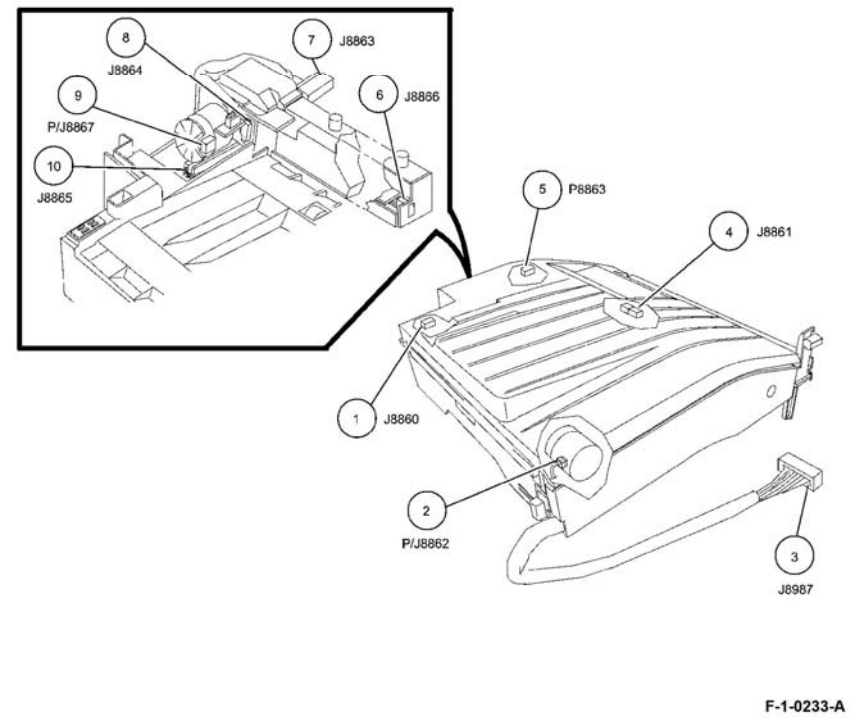
Figure 26 LX Finisher horizontal transport

Office Finisher LX Horizontal Transport

Location: PL 13.06

Connector No.	Figure No.	Item No.	Connector Location
J8860	Figure 26	1	LX finisher horizontal transport
J8861	Figure 26	4	LX finisher horizontal transport
P/J8862	Figure 26	2	LX finisher horizontal transport
J8863	Figure 26	7	LX finisher horizontal transport

Connector No.	Figure No.	Item No.	Connector Location
P8863	Figure 26	5	LX finisher horizontal transport
J8864	Figure 26	8	LX finisher horizontal transport
J8865	Figure 26	10	LX finisher horizontal transport
J8866	Figure 26	6	LX finisher horizontal transport
P/J8867	Figure 26	9	LX finisher horizontal transport
J8868	Figure 29	4	Office finisher LX top
J8869	Figure 29	3	Office finisher LX top
J8870	Figure 28	24	Office finisher LX rear
J8871	Figure 28	23	Office finisher LX rear
J8872	Figure 28	21	Office finisher LX rear
J8873	Figure 28	2	Office finisher LX rear
J8874	Figure 28	1	Office finisher LX rear
J8875	Figure 28	22	Office finisher LX rear
P/J8876	Figure 29	5	Office finisher LX top
P/J8877	Figure 28	20	Office finisher LX rear
P/J8878	Figure 28	6	Office finisher LX rear
P/J8879	Figure 28	5	Office finisher LX rear
J8880	Figure 29	7	Office finisher LX top
J8881	Figure 29	11	Office finisher LX top
J8882	Figure 29	6	Office finisher LX top

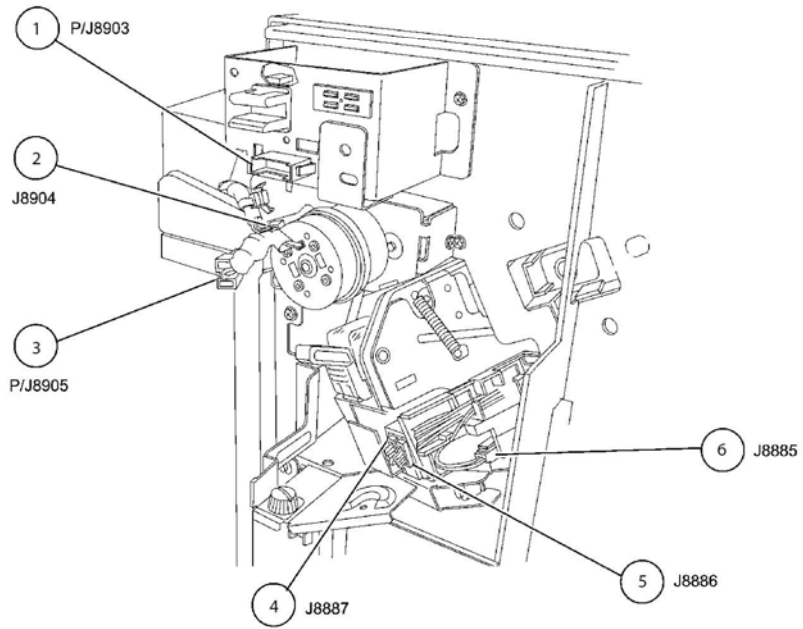
Figure 27 Office finisher LX front

Office Finisher LX Front

Location: PL 13.20

P/J8883	Figure 29	8	Office finisher LX top
P/J8884	Figure 29	10	Office finisher LX top
J8885	Figure 27	6	Office finisher LX front
J8886	Figure 27	5	Office finisher LX front
J8887	Figure 27	4	Office finisher LX front
P/J8888	Figure 29	9	Office finisher LX top
J8889	Figure 28	3	Office finisher LX rear
J8890	Figure 28	4	Office finisher LX rear
J8891	Figure 29	2	Office finisher LX top
P/J8892	Figure 30	1	LX booklet maker top
P/J8893	Figure 30	2	LX booklet maker top
J8894	Figure 31	1	LX booklet maker PWB
J8895	Figure 31	3	LX booklet maker PWB
P/J8896	Figure 30	7	LX booklet maker top
J8897	Figure 30	4	LX booklet maker top
J8898	Figure 30	5	LX booklet maker top
J8899	Figure 30	6	LX booklet maker top
J8900	Figure 30	8	LX booklet maker top
J8901	Figure 30	3	LX booklet maker top
P8903	Figure 29	1	Office finisher LX top
P/J8903	Figure 27	1	Office finisher LX front

Connector No.	Figure No.	Item No.	Connector Location
J8904	Figure 27	2	Office finisher LX front
P/J8905	Figure 27	3	Office finisher LX front
P/J8906	Figure 31	2	LX booklet maker PWB
J8980	Figure 28	19	Office finisher LX rear
P/J8981A/B	Figure 28	10	Office finisher LX rear
J8982	Figure 28	18	Office finisher LX rear
P/J8983	Figure 28	8	Office finisher LX rear
J8984A/B	Figure 28	9	Office finisher LX rear
J8985	Figure 31	4	LX booklet maker PWB
P8985	Figure 28	17	Office finisher LX rear
P/J8986	Figure 28	7	Office finisher LX rear
P8987	Figure 28	16	Office finisher LX rear
P/J8988	Figure 28	11	Office finisher LX rear
J8989	Figure 28	13	Office finisher LX rear
P/J8990	Figure 28	12	Office finisher LX rear
P/J8991	Figure 31	9	LX booklet maker PWB
P/J8992	Figure 31	7	LX booklet maker PWB
P/J8993	Figure 31	6	LX booklet maker PWB
P/J8994	Figure 31	5	LX booklet maker PWB
P/J8995	Figure 31	8	LX booklet maker PWB

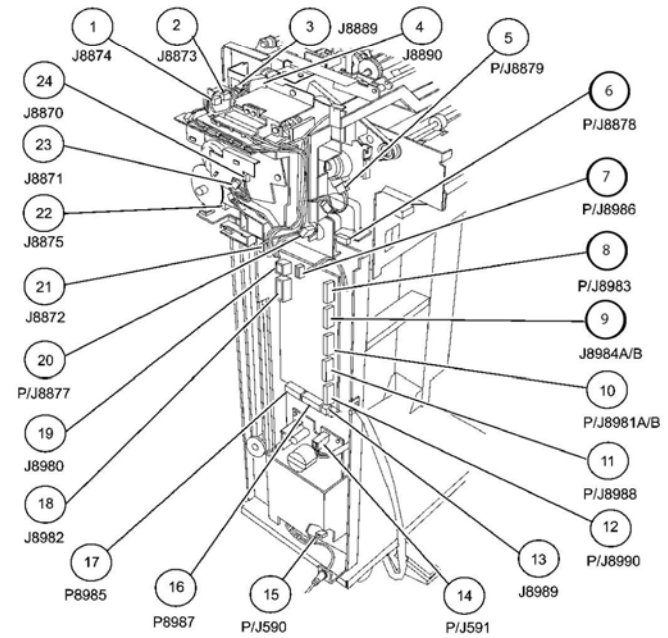
Figure 28 Office finisher LX rear

Office Finisher LX Rear

Location: PL 13.45

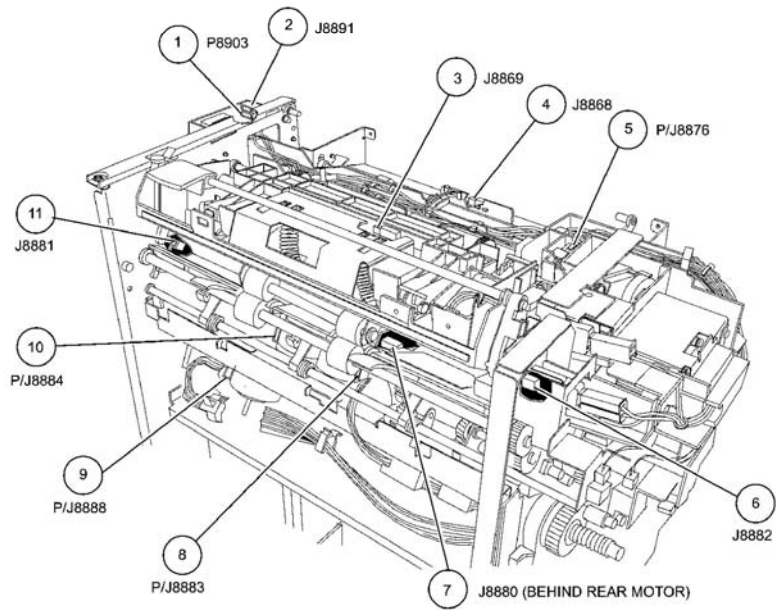
Figure 29 Office finisher LX top

Office Finisher LX Top

Location: PL 13.25

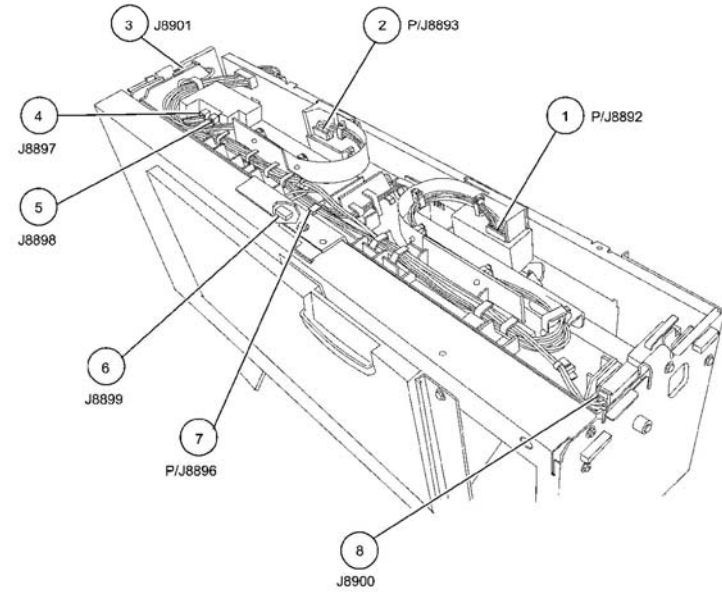
Figure 30 LX Booklet maker top

Office Finisher LX Booklet Maker Top

Location: PL 13.70

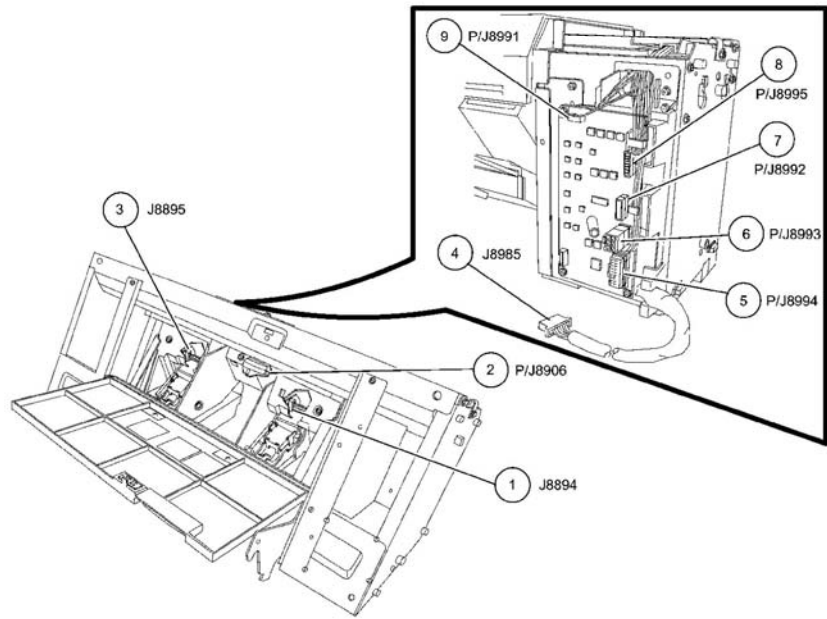
Figure 31 LX Booklet maker PWB

Office Finisher LX Booklet Maker PWB

Location: PL 13.70

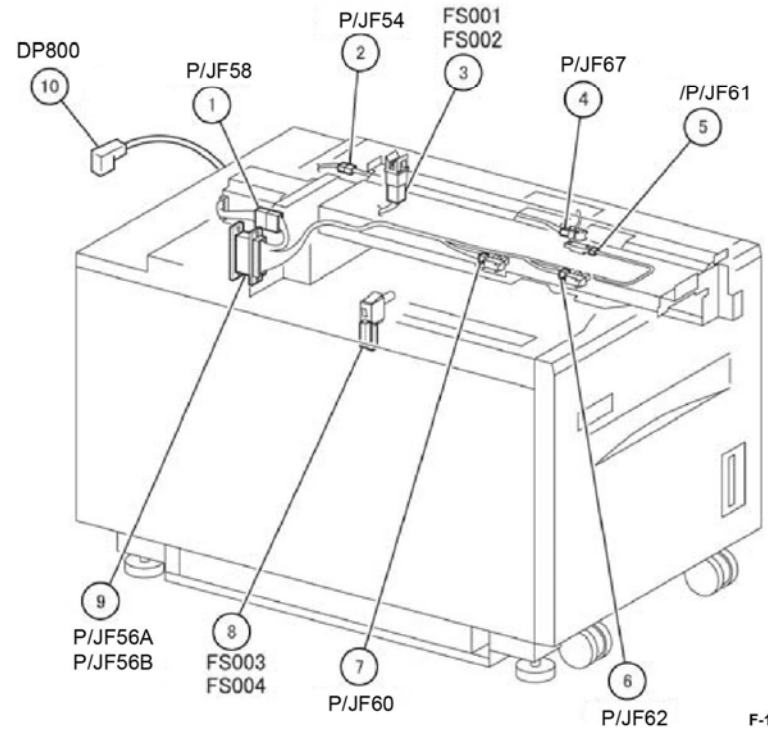
Figure 32 HCF top

HCF Top

Location: PL 70.95

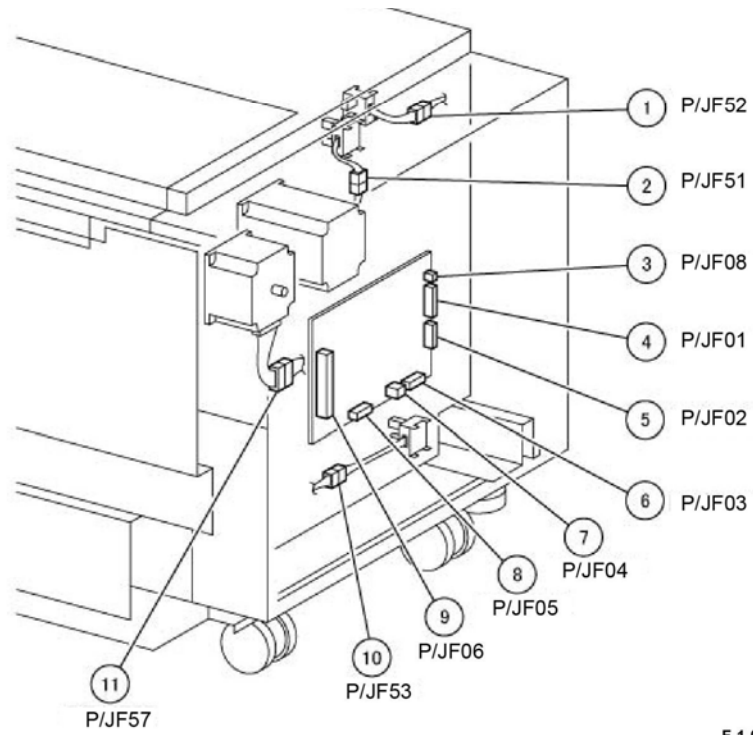
Figure 33 HCF rear

HCF Rear

Location: PL 70.95

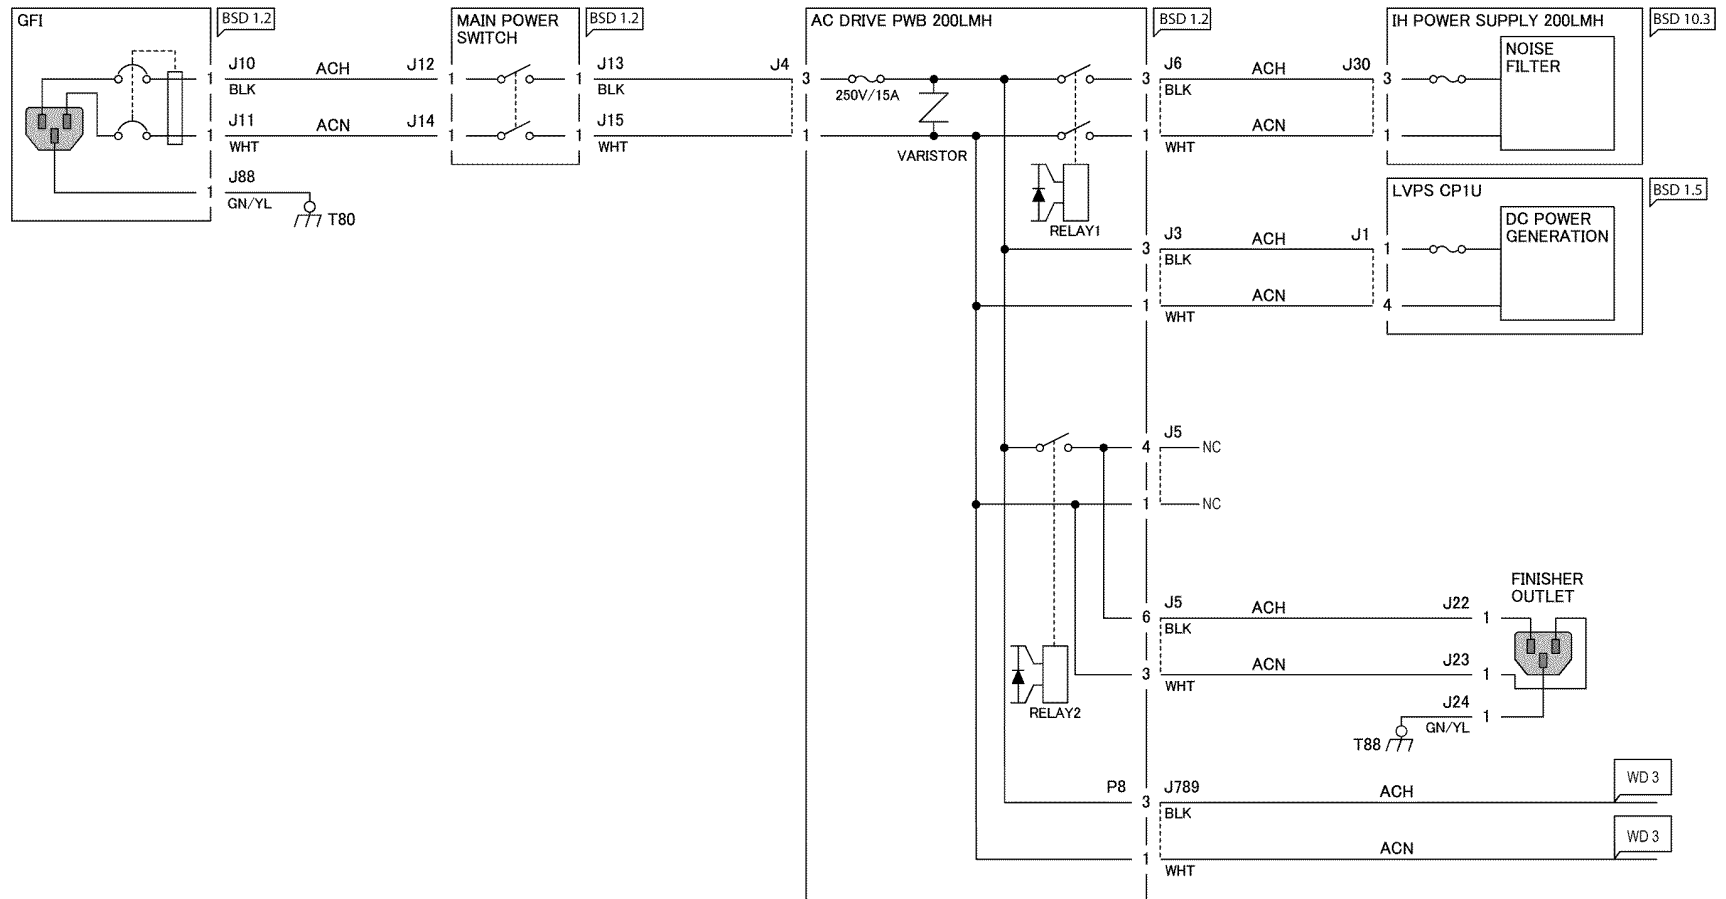
Figure 2 Wiring diagram 2

Wiring Diagram 2 ACH/ACN 220 to 240VAC

WD 2 ACH/ACN 220 to 240VAC

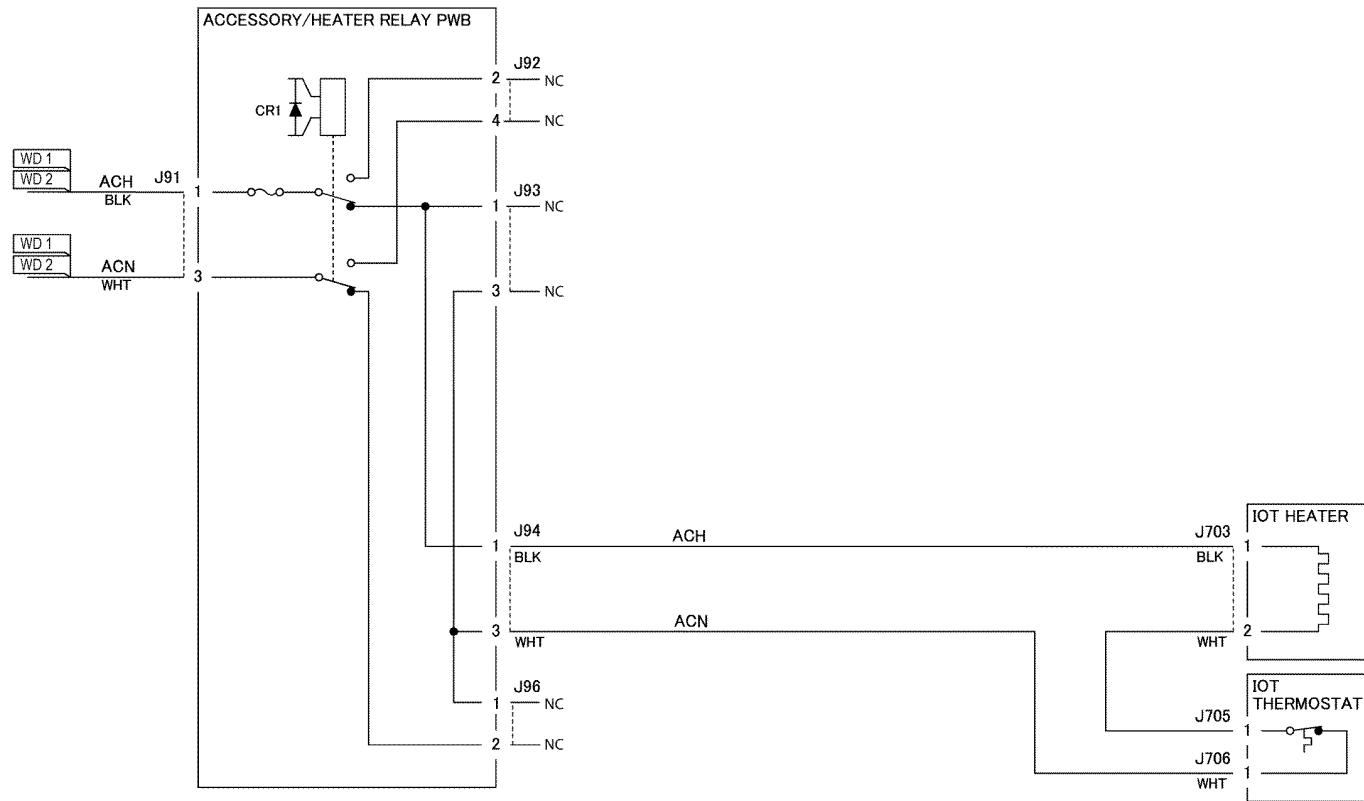
Figure 3 Wiring diagram 3

Wiring Diagram 3 ACH/ACN

WD 3 ACH/ACN

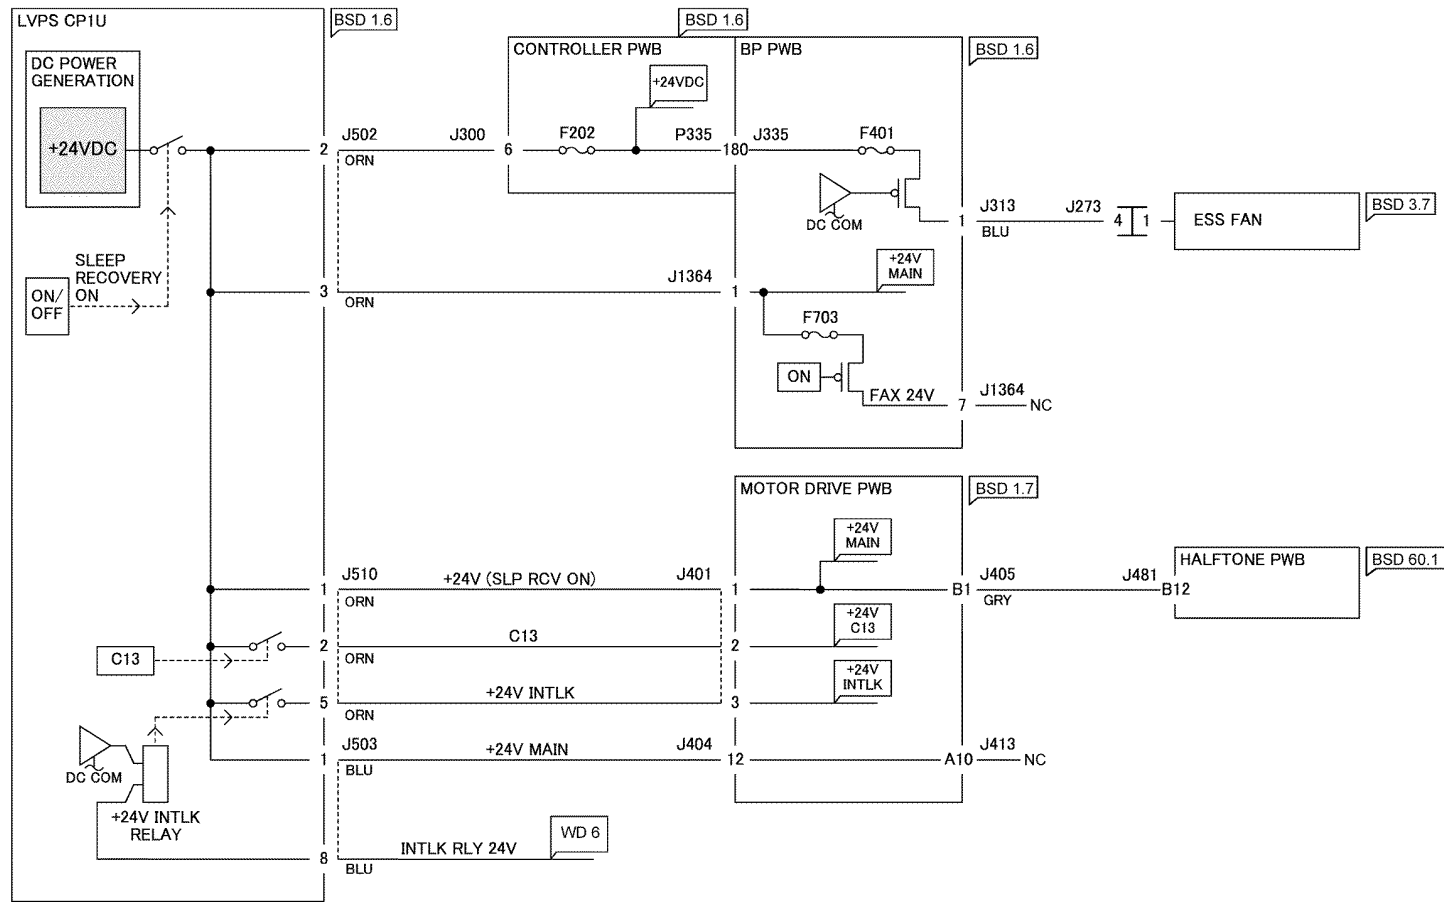
Figure 4 Wiring diagram 4

Wiring Diagram 4 +24VDC (1 of 3)

WD 4 +24VDC

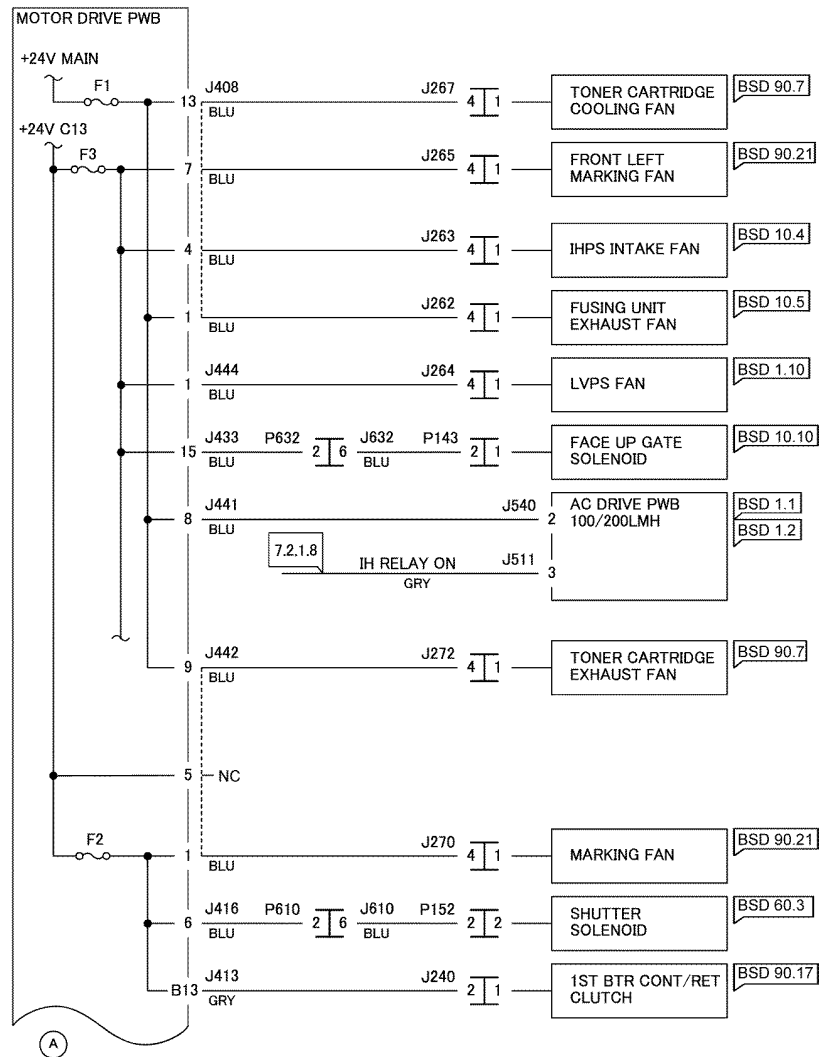
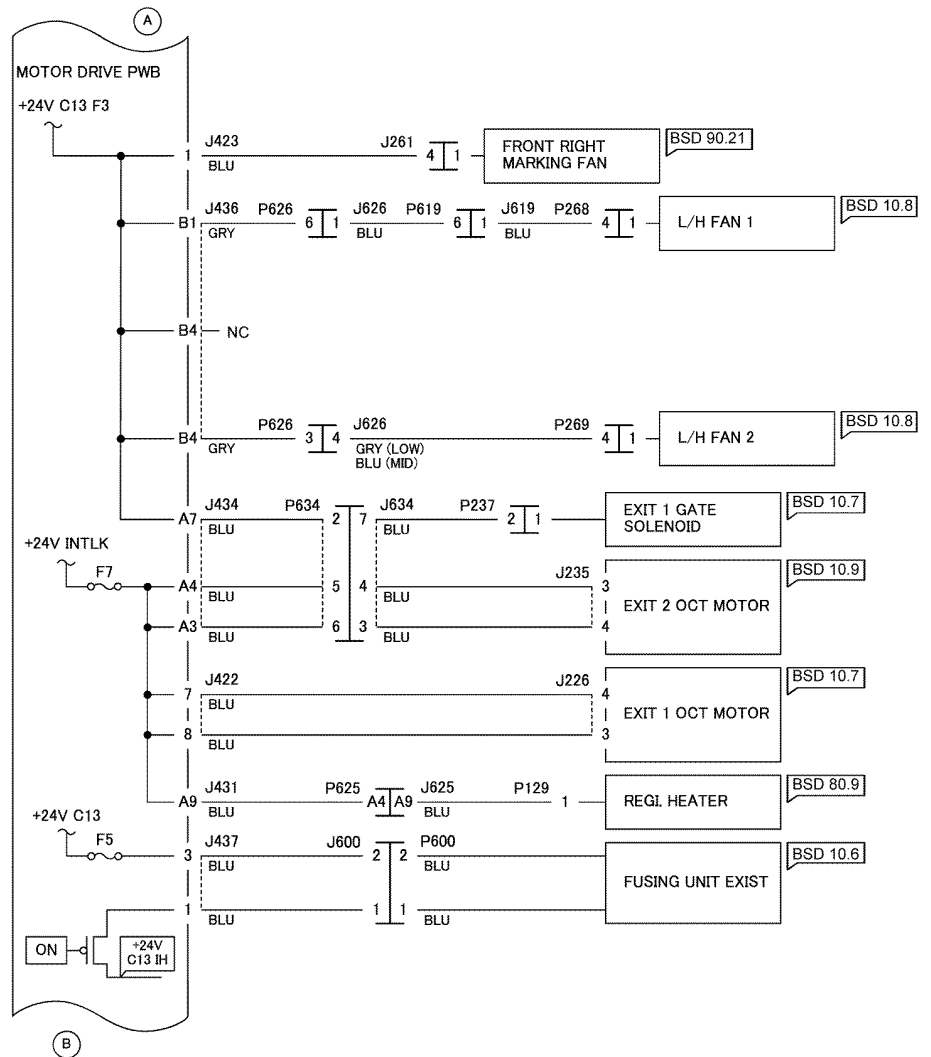
Figure 5 Wiring diagram 5

Wiring Diagram 5 +24VDC (2 of 3)

WD 5 +24VDC (2 of 3)

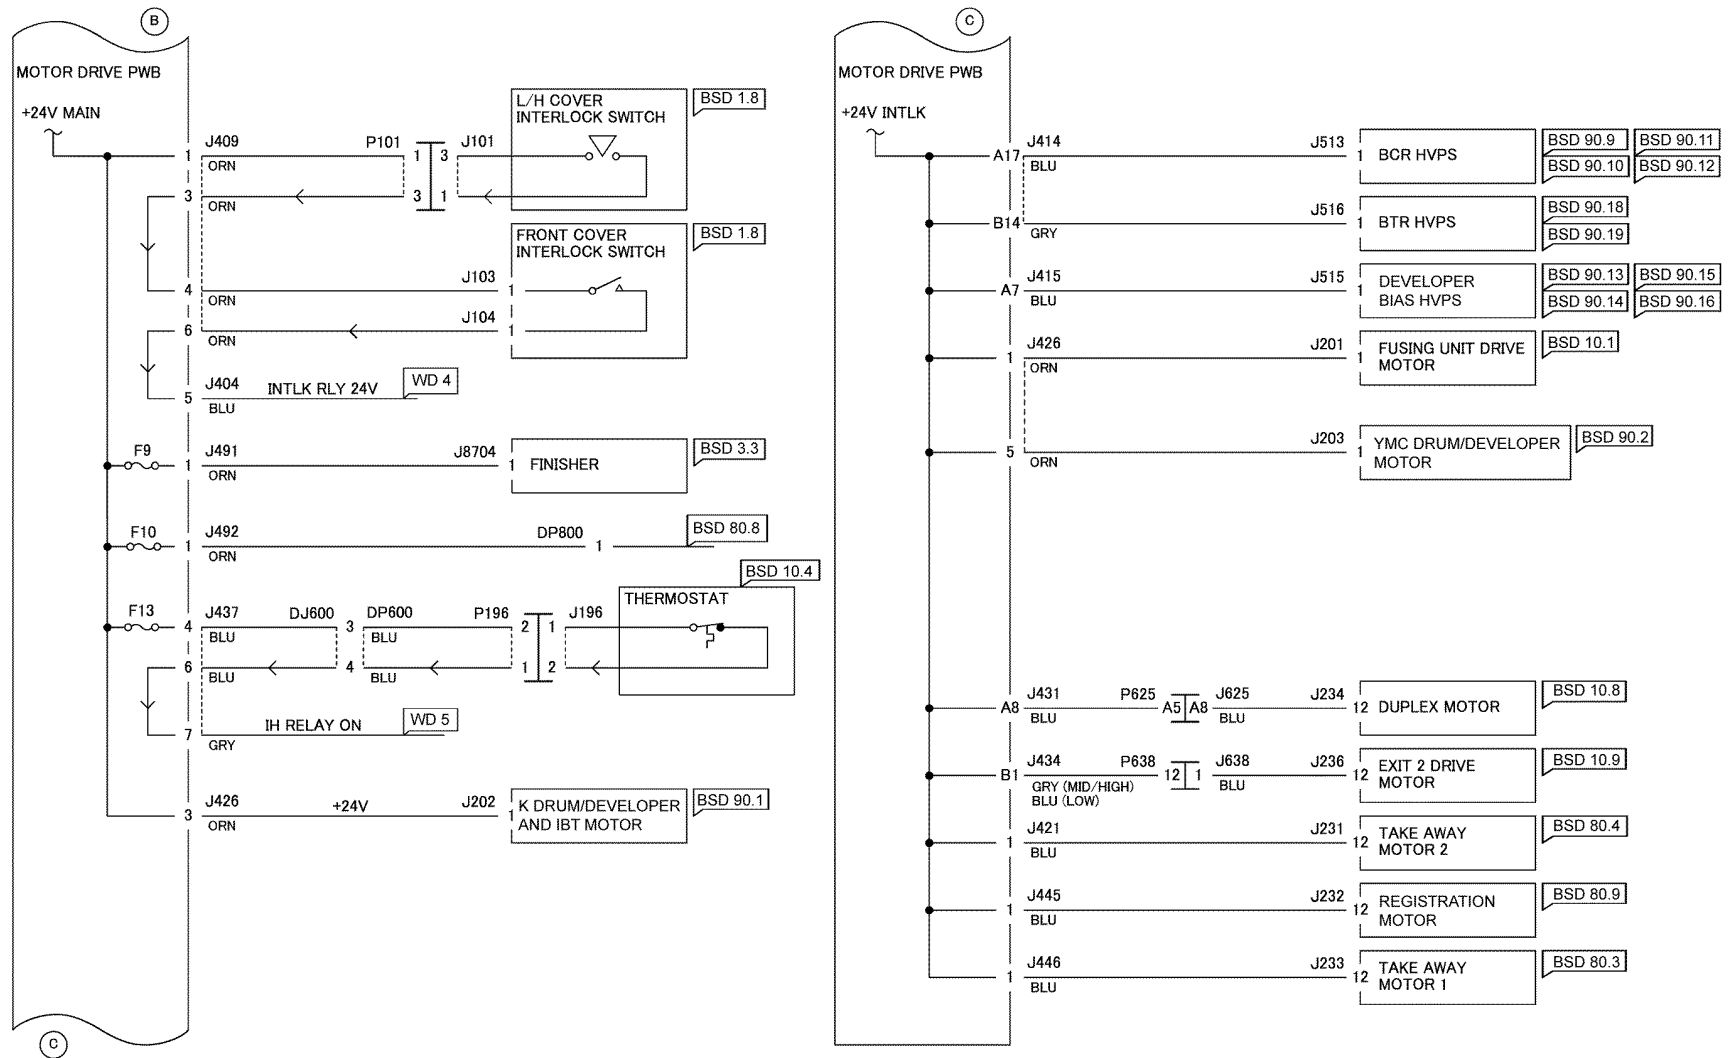
Figure 6 Wiring diagram 6

Wiring Diagram 6 +24VDC (3 of 3)

WD 6 +24VDC (3 of 3)

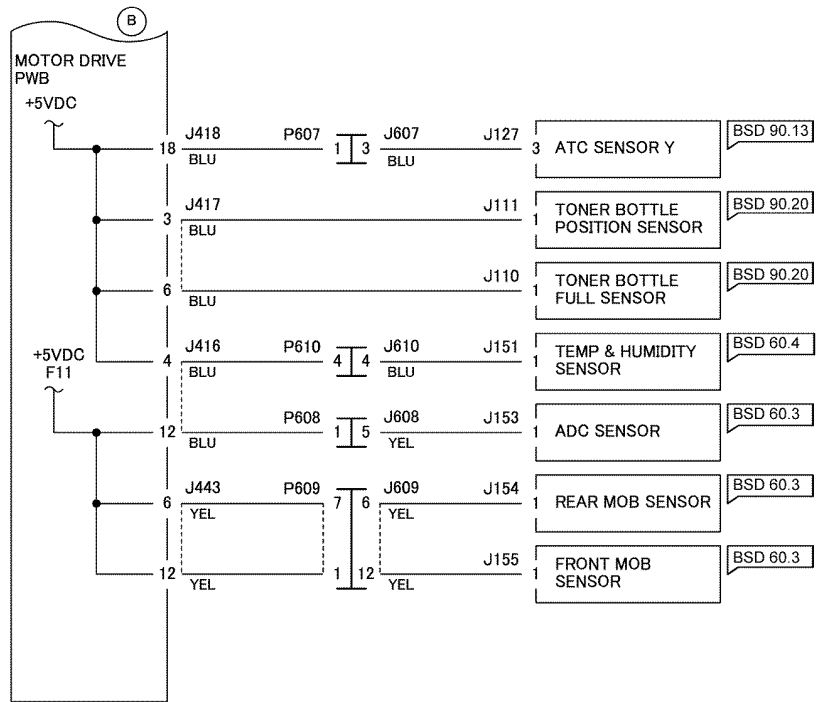
Figure 10 Wiring diagram 10

Wiring Diagram 10 +5VDC (4 of 4)

WD 10 +5VDC (4 of 4)
