VersaLink[®] C8000/C9000 Printer

Service Manual

VersaLink C9000 Family Service Manual

705P01418

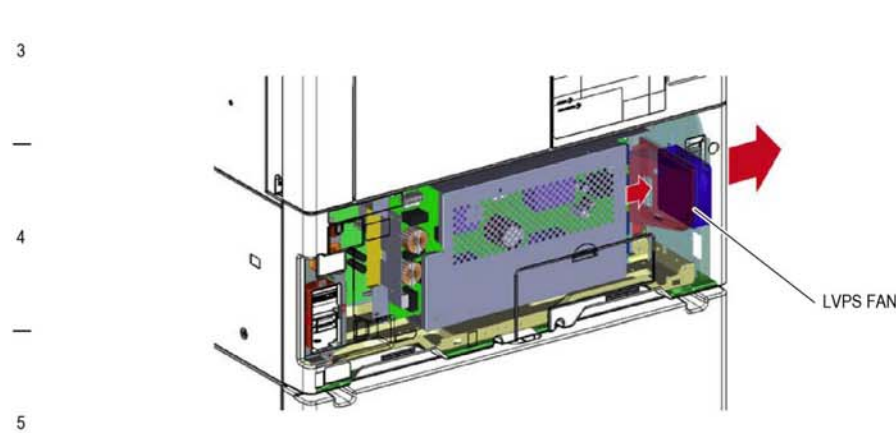
Figure 10 BSD 1.10

BSD 1.10 LVPS Cooling

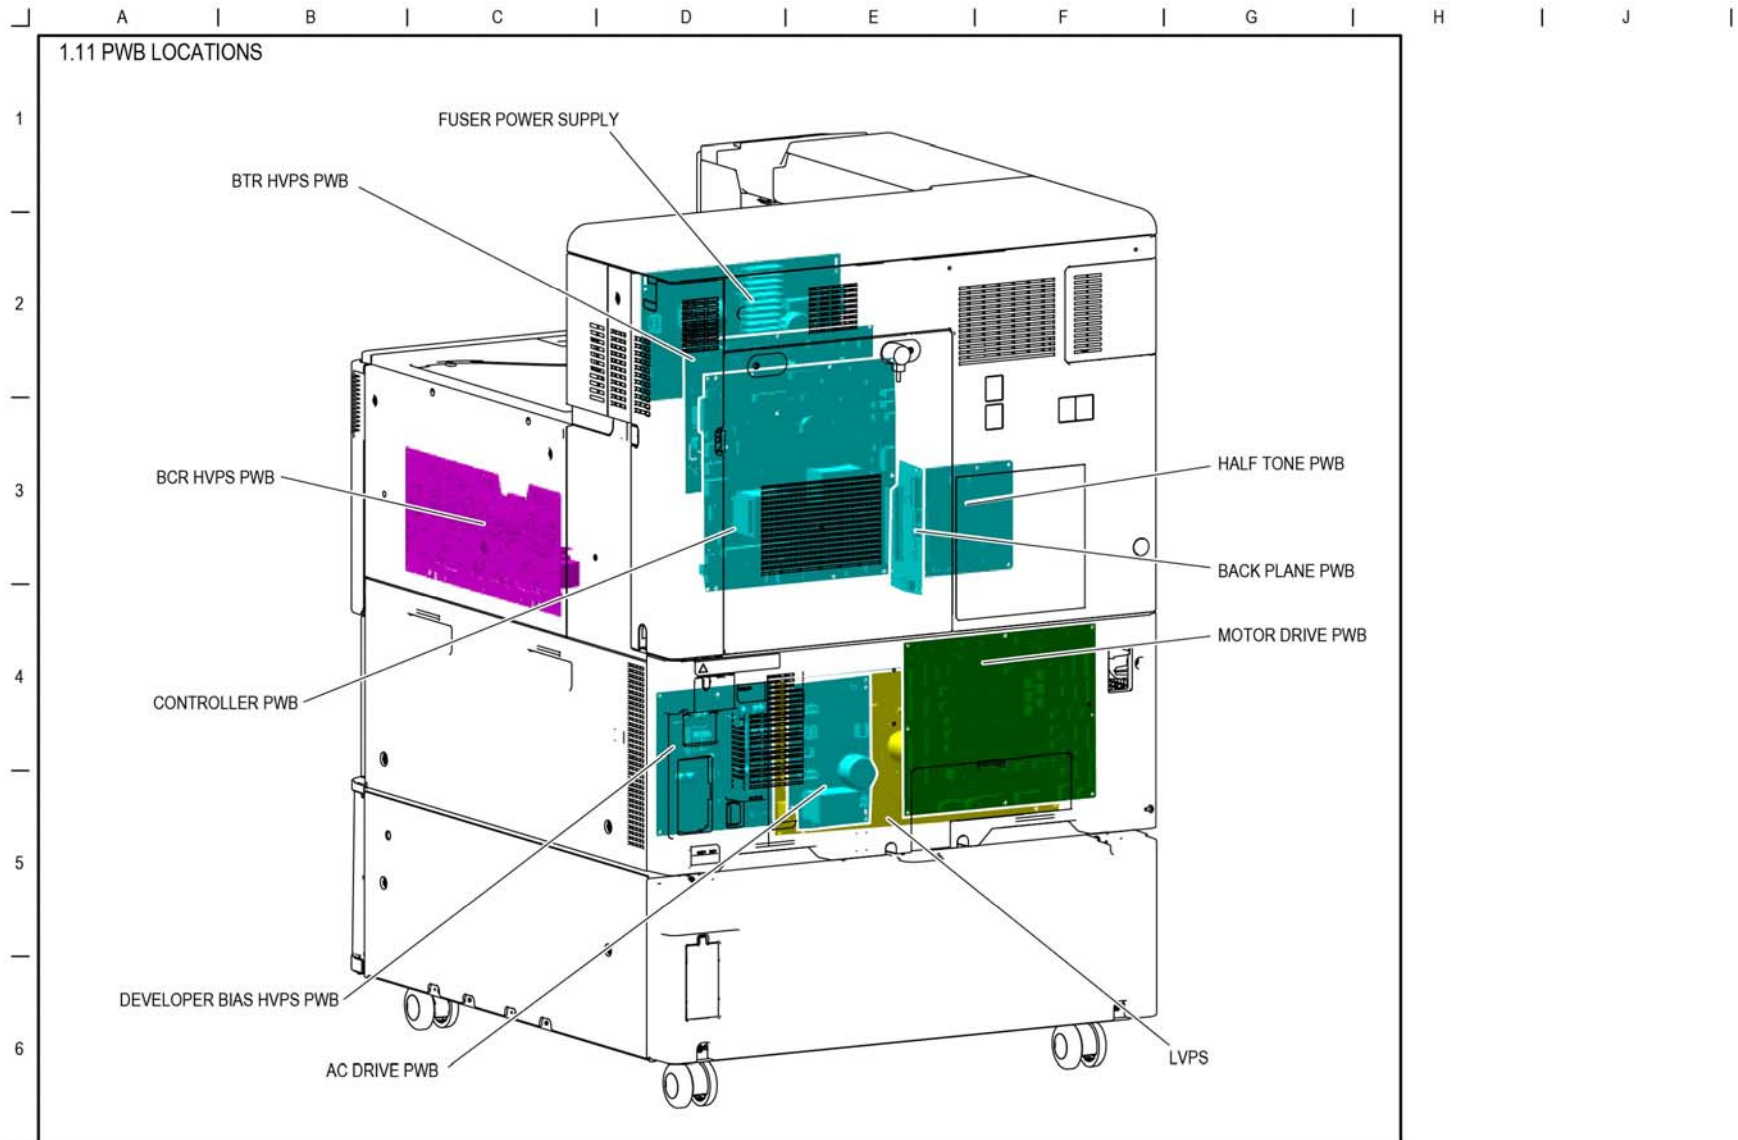
Figure 11 BSD 1.11

BSD 1.11 PWB Locations

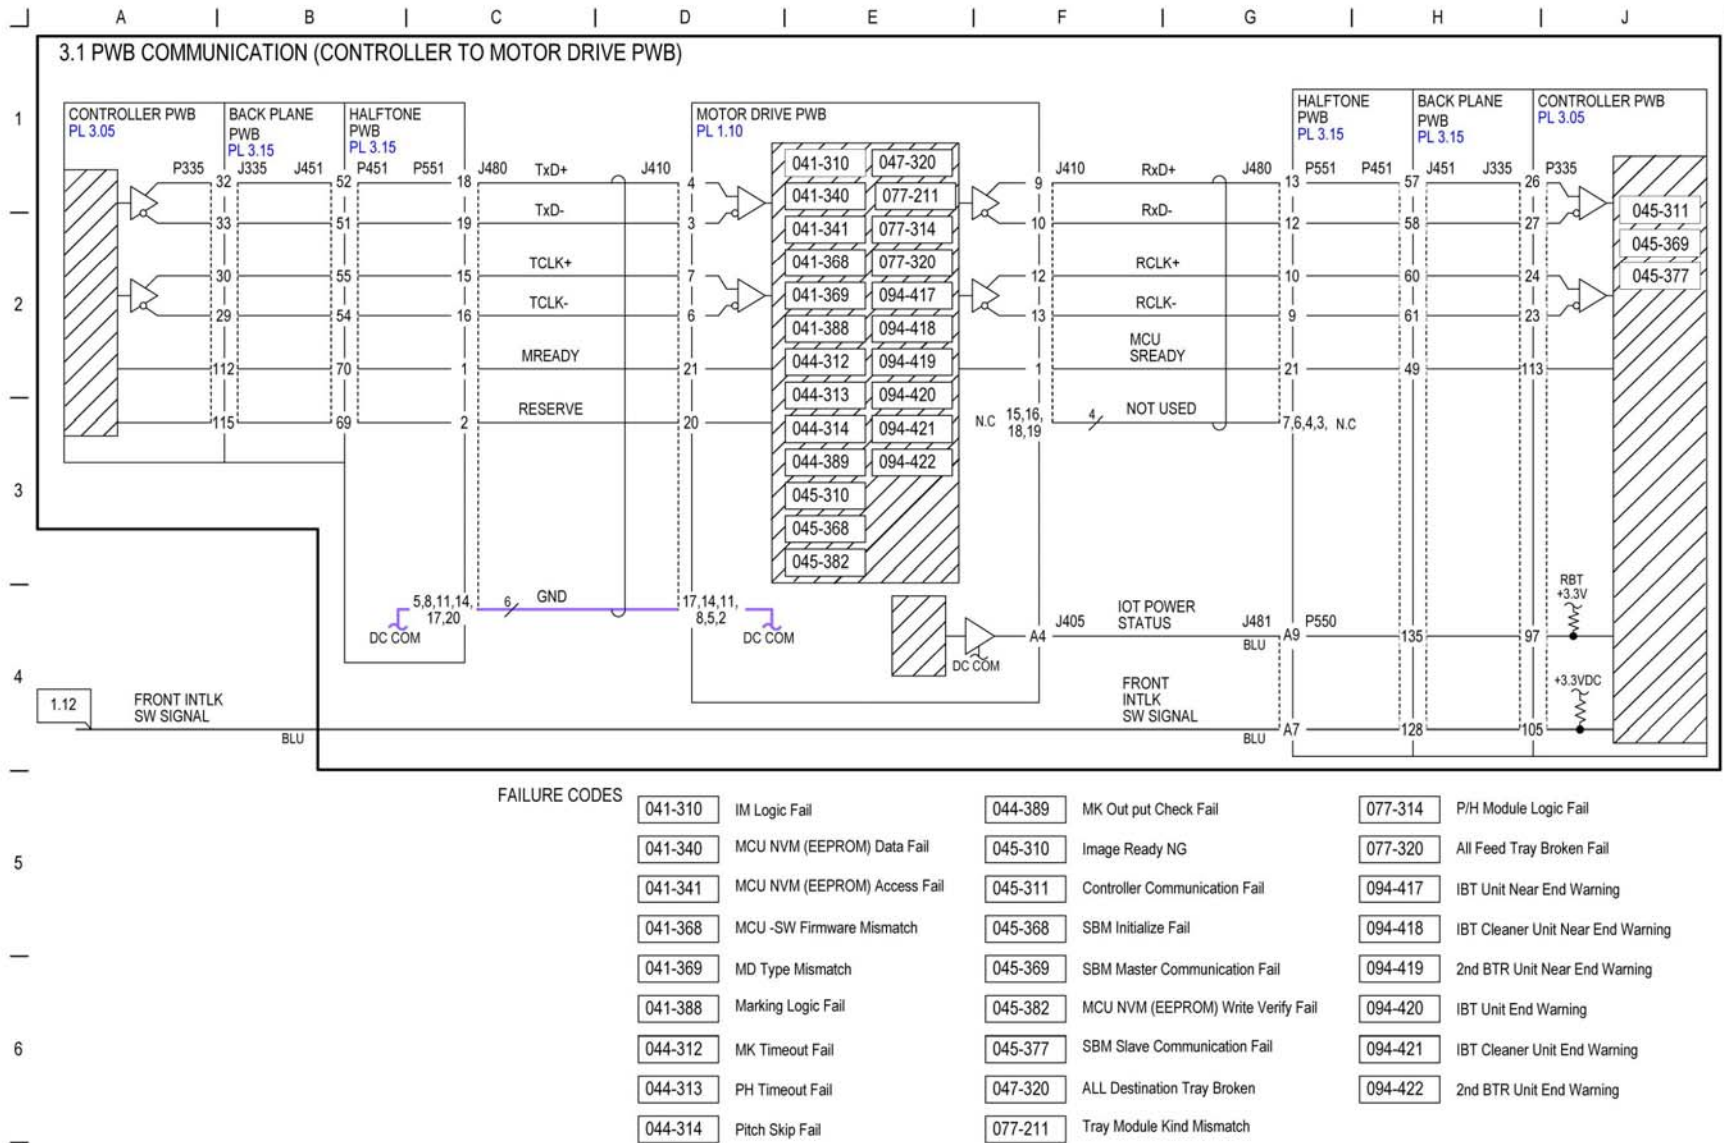
Figure 14 BSD 3.1

BSD 3.1 PWB Communications (Controller to Motor Drive PWB)

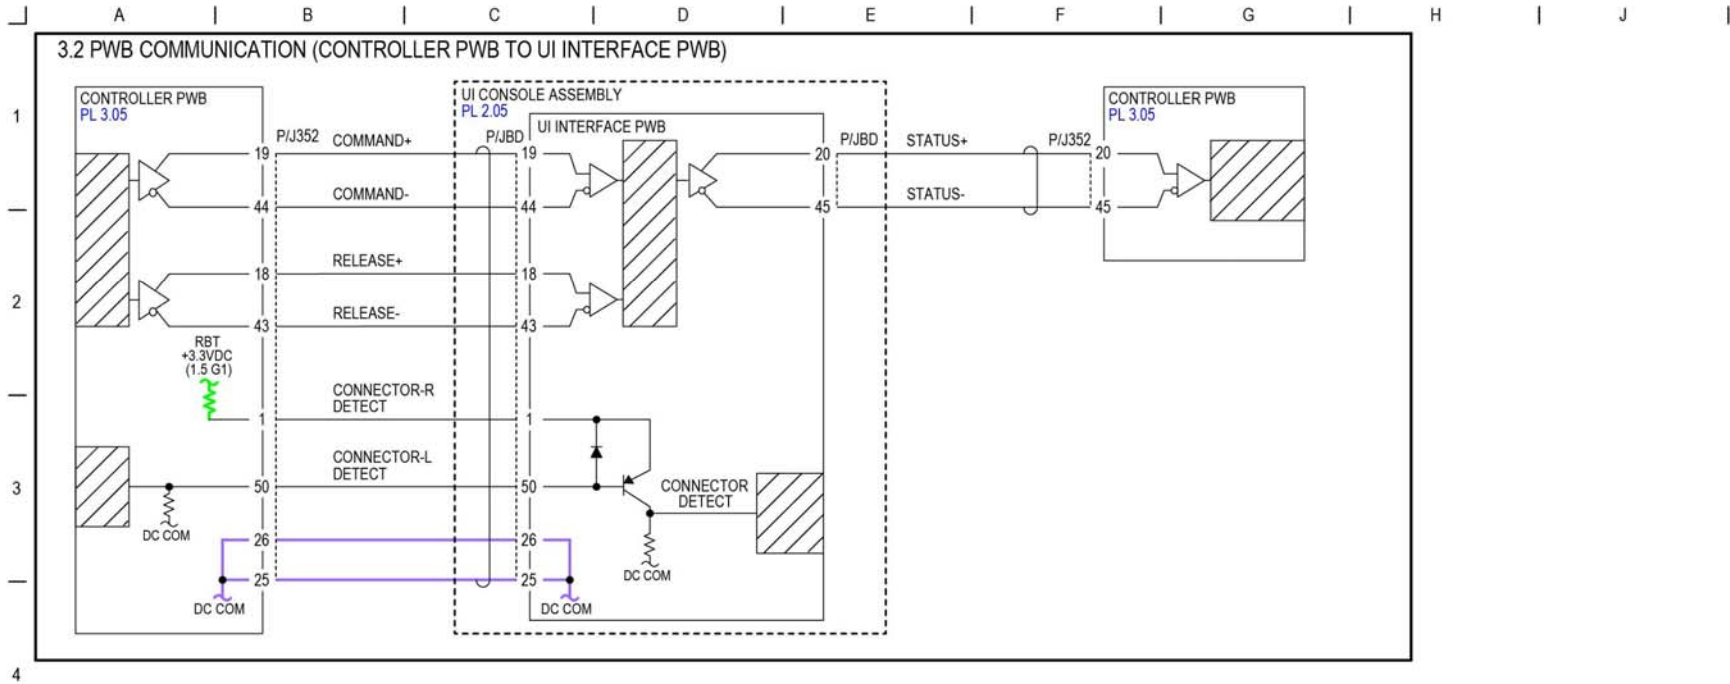
Figure 15 BSD 3.2

BSD 3.2 PWB Communications (Controller to UI PWB)

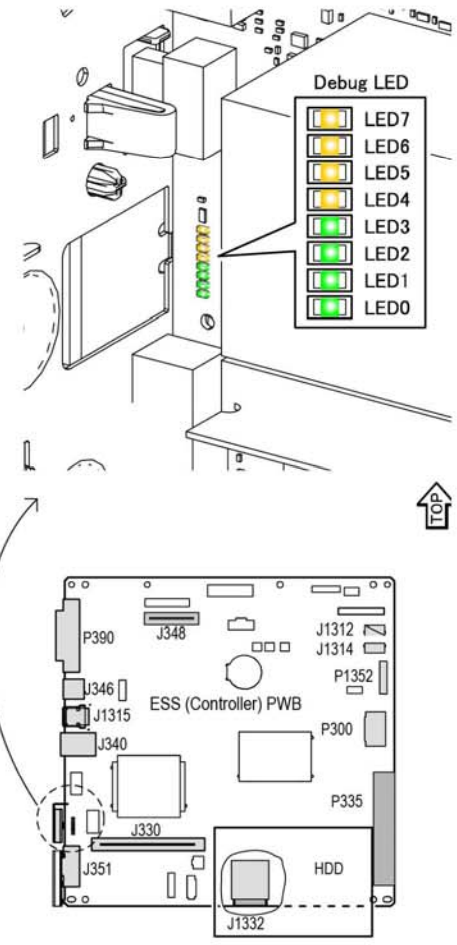
Figure 21 BSD 3.8

BSD 3.8 ESS (Controller) Status LED (1 of 5)

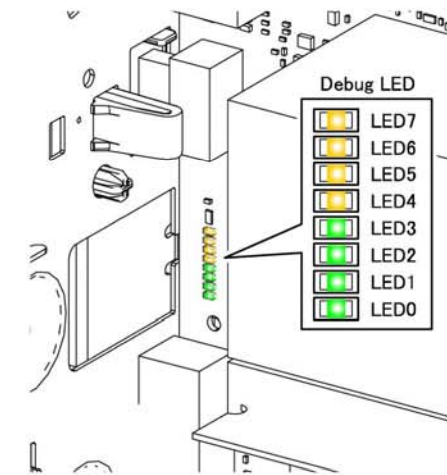
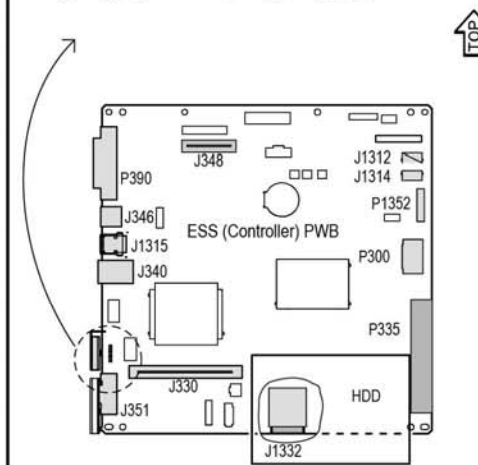
Figure 22 BSD 3.9

3.9 ESS (CONTROLLER) STATUS LED (2 OF 5)		ILLUMINATION STATUS AND DESCRIPTION OF ON-BOARD LEDs										
Number	LED Pattern							Situation	Problem	Normal Diagnosis	LongBoot Diagnosis	Related Fail Code
	LED7	LED6	LED5	LED4	LED3	LED2	LED1					
33	On	On	On	On	On	On	On	0xFF -> 0x00 is repeating alternately. DDR initialization process has failed	Blinking: ESS (Controller) failure	-	-	-
34	On	On	On	On	On	On	On	0xF0 -> 0x0F is repeating alternately. Boot Loader checksum error - L2 Boot has read a Boot Loader checksum error from FCSP1	Blinking: RAM failure	-	-	-
35	On	On	On	On	On	On	On	CA15-0: (0xA0 -> 0x05 is repeating alternately. CPLD is showing an invalid boot mode.	Blinking: ESS (Controller) failure	-	-	-
36	On	On	On	On	On	On	On	LED High Speed Shift ON is operated. Indicates that the Board configuration information is invalid.	Blinking: ESS (Controller) failure	-	-	-
37	On	On	On	On	On	On	On	CA15-0: After the recovery from Switch OFF mode is detected by CPLD flag, before proceeding to read the NVM recovery data	On: ESS (Controller) failure	-	-	-

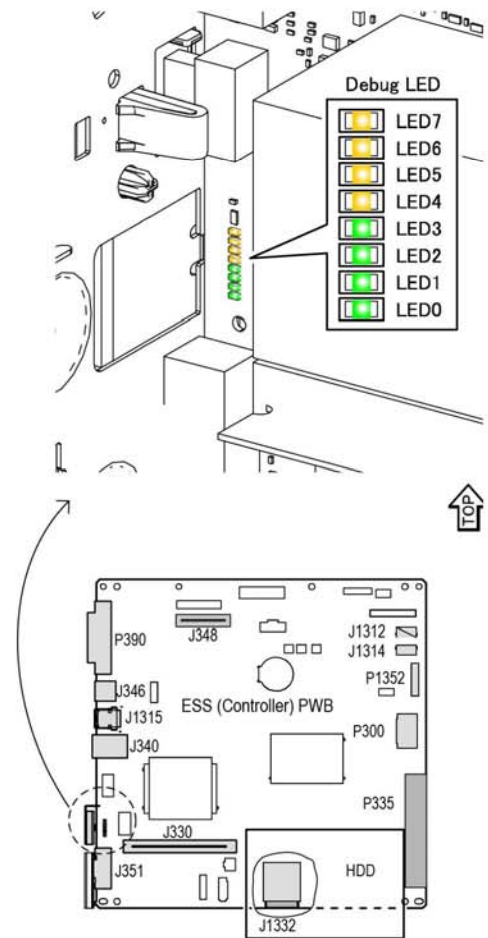
Figure 23 BSD 3.10

84	Off	On	On	On	Off	Off	Off	RTC diagnostics has started	On: RTC failure	-	o	016-342
85	Off	On	On	On	Off	Off	Off	RTC diagnostics has completed	-	-	-	-
86	Off	On	On	On	Off	Off	Off	UI Check has started	On: ESS (Controller)/UI failure	-	o	016-362
87	Off	On	On	On	Off	Off	Off	UI Check has completed	-	-	-	-

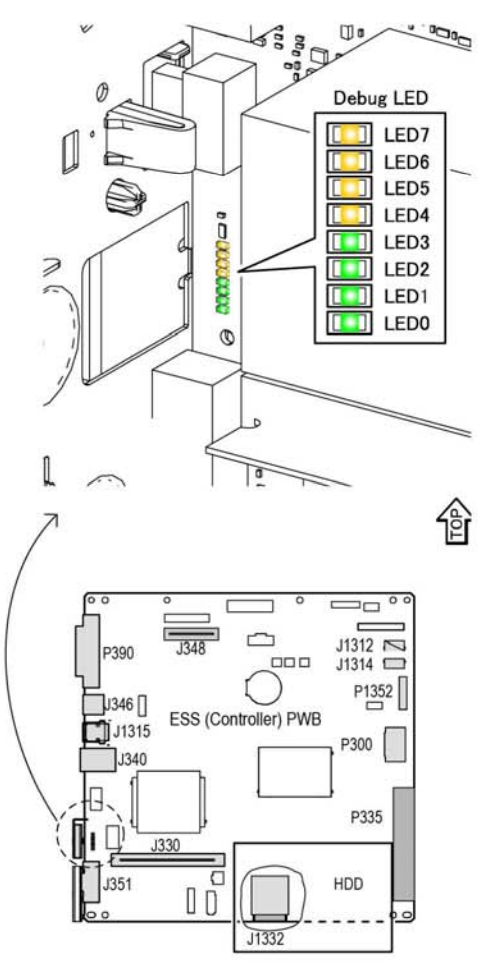
Figure 24 BSD 3.11

BSD 3.11 ESS (Controller) Status LED (4 of 5)

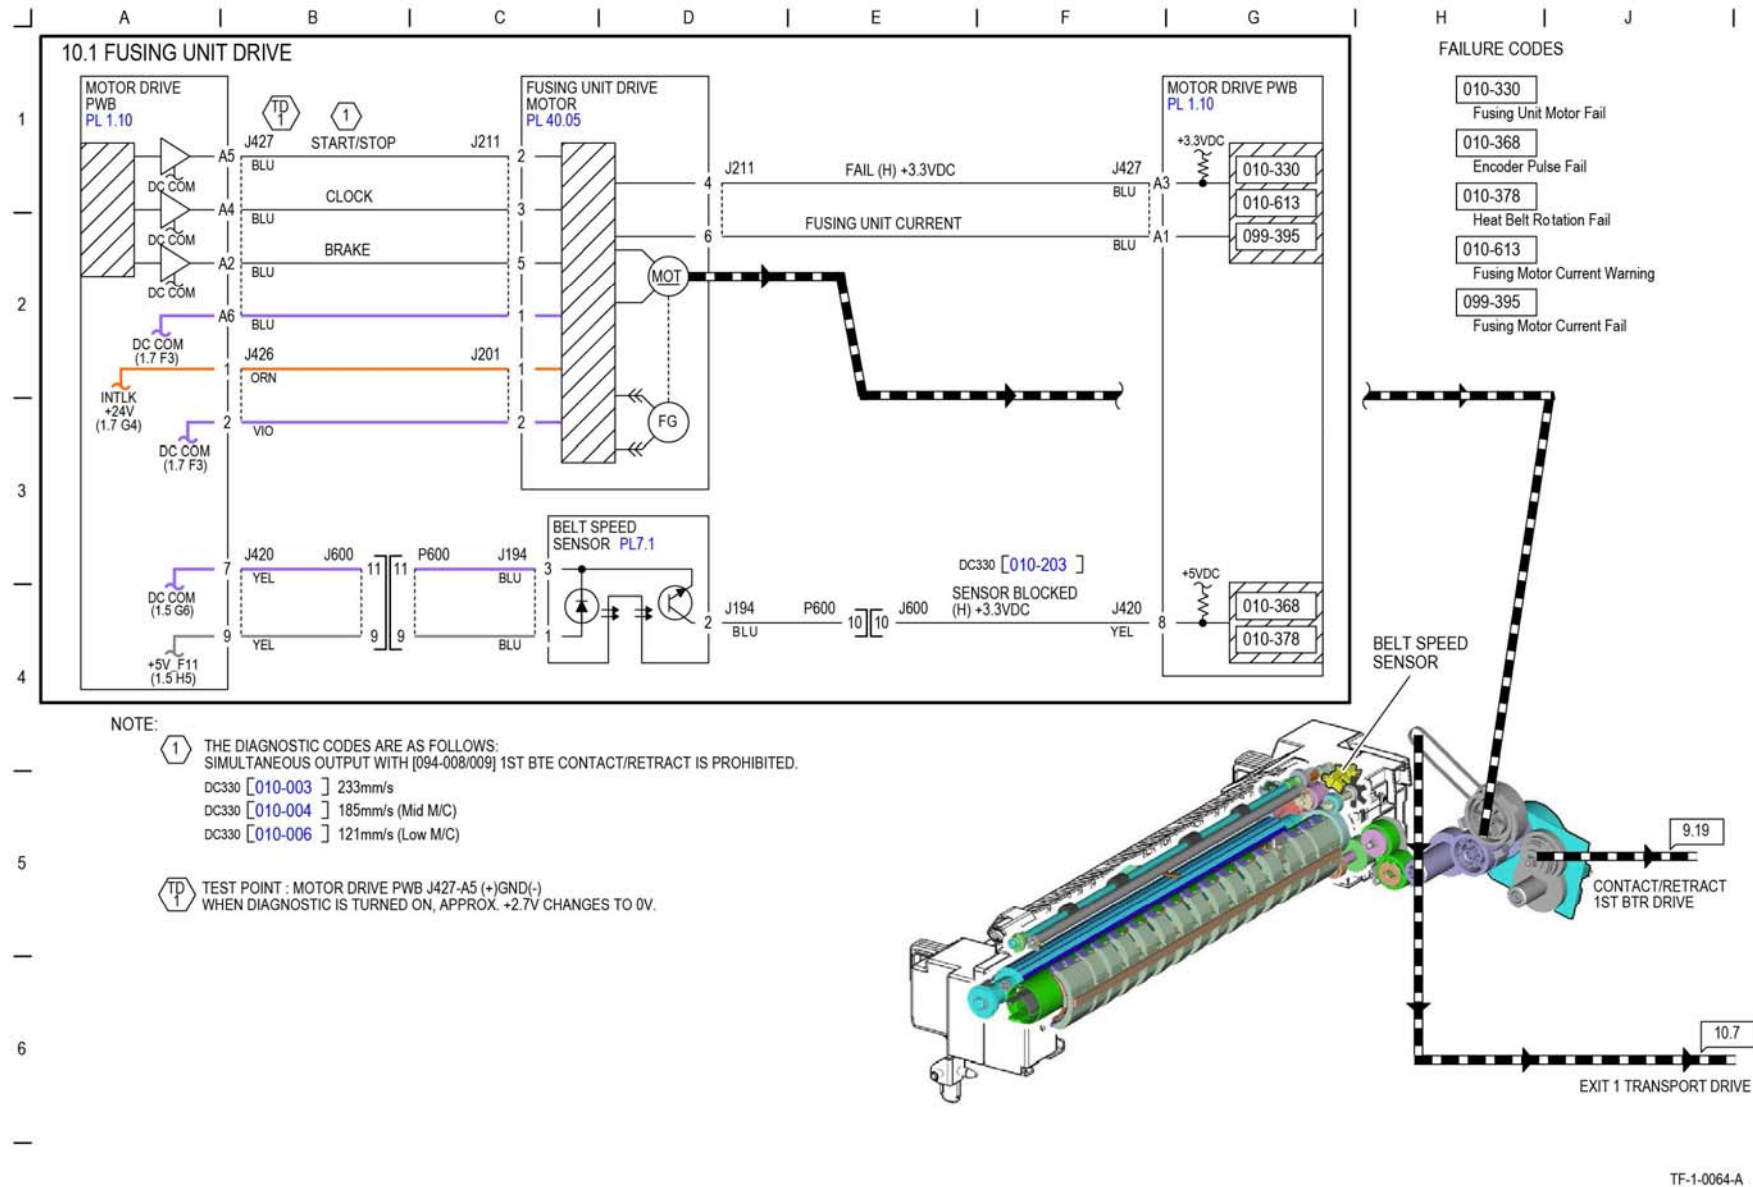
Figure 26 BSD 10.1

BSD 10.1 Fusing Unit Drive

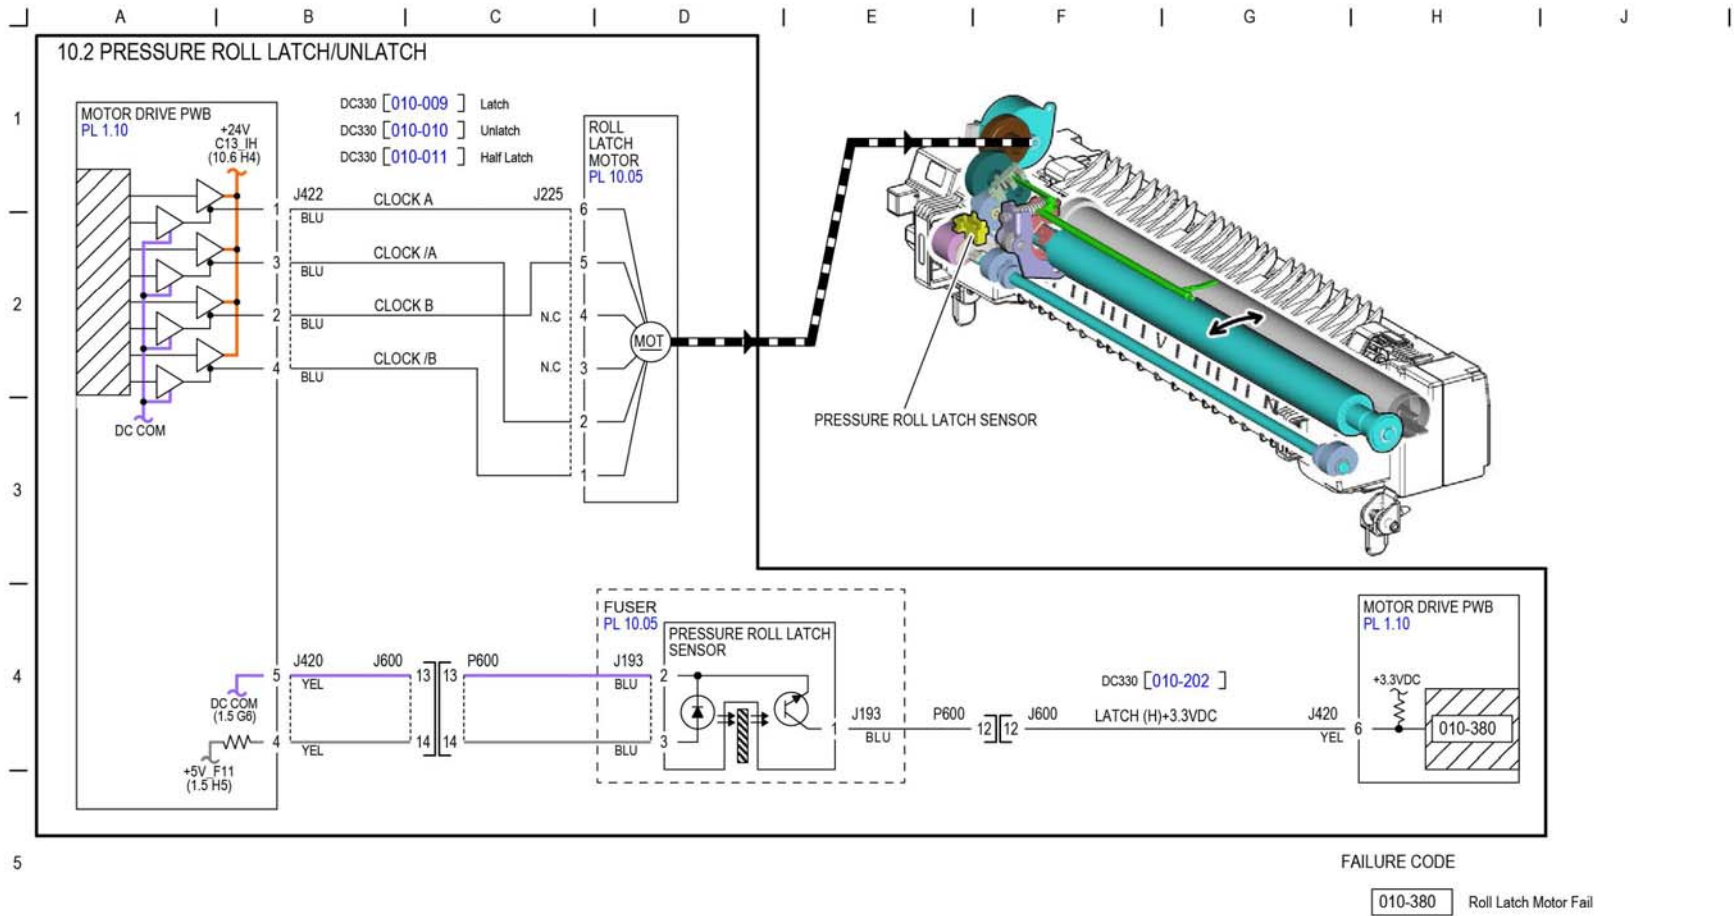
Figure 27 BSD 10.2

BSD 10.2 Pressure Roll Latch/Unlatch

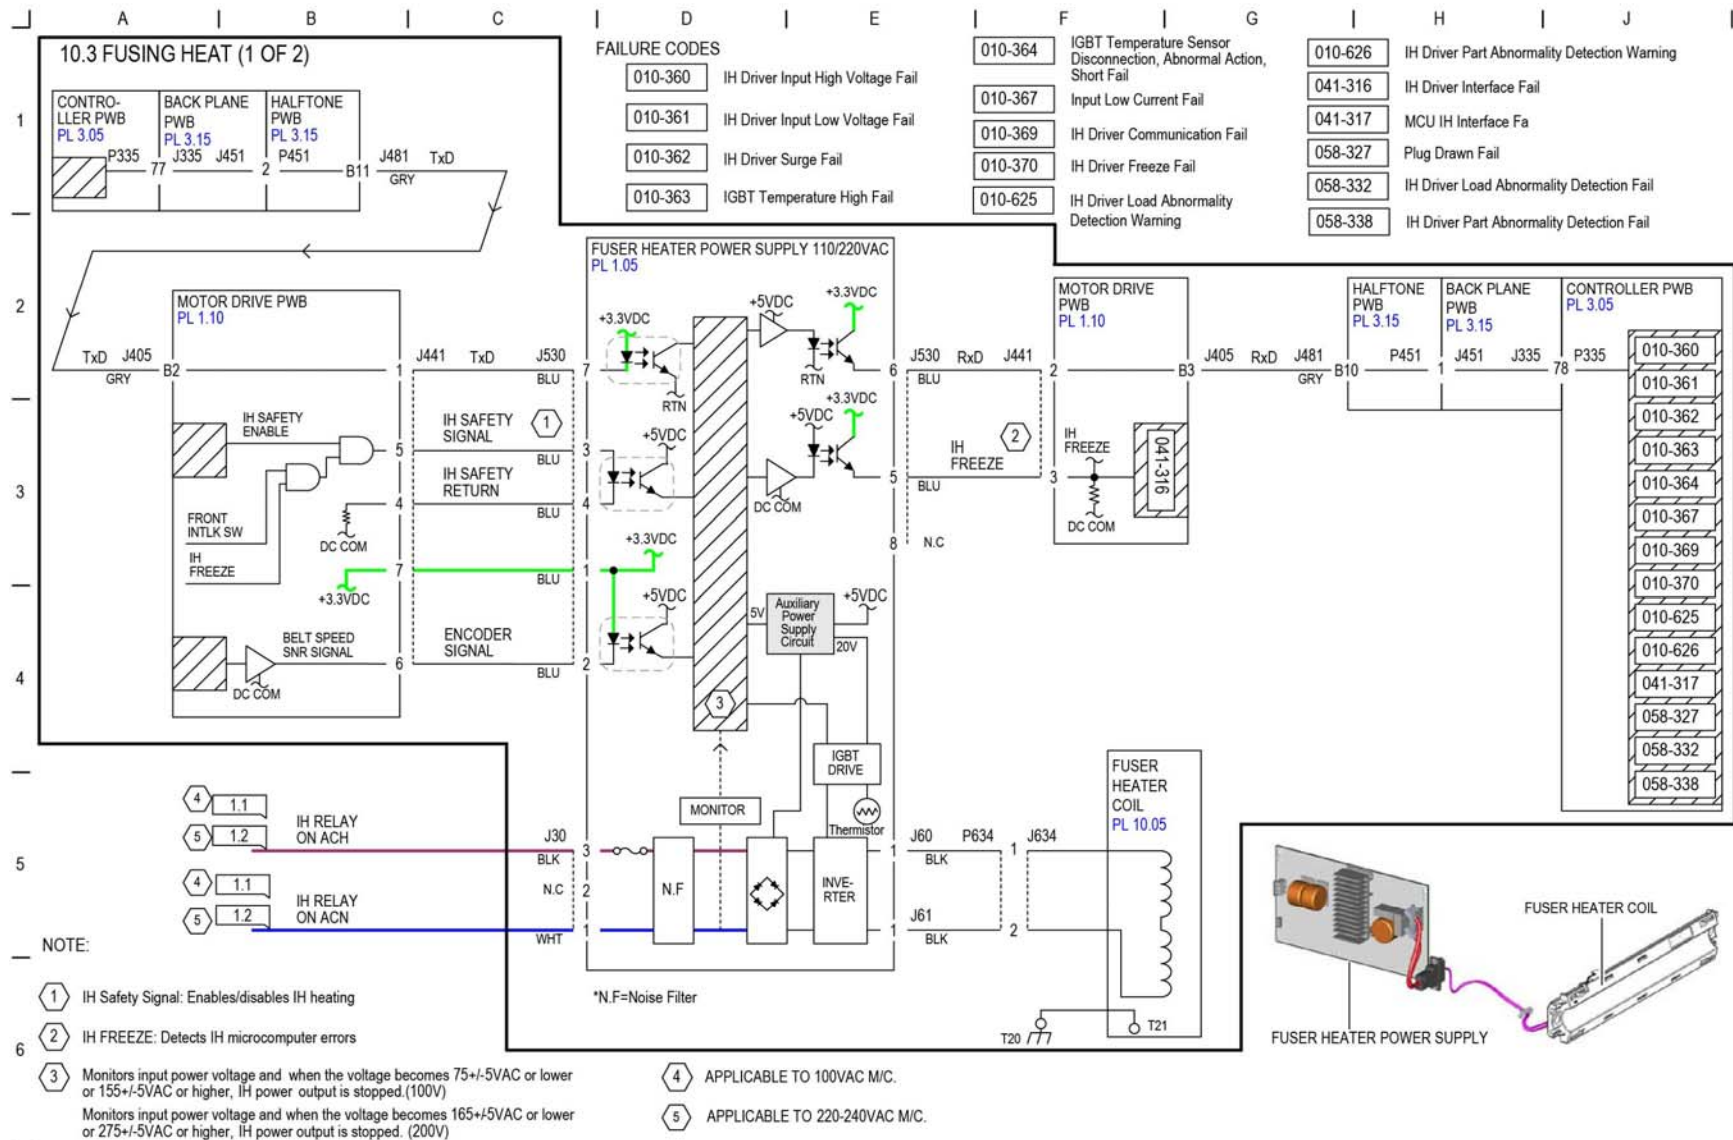
Figure 28 BSD 10.3

BSD 10.3 Fusing Heat (1 of 2)

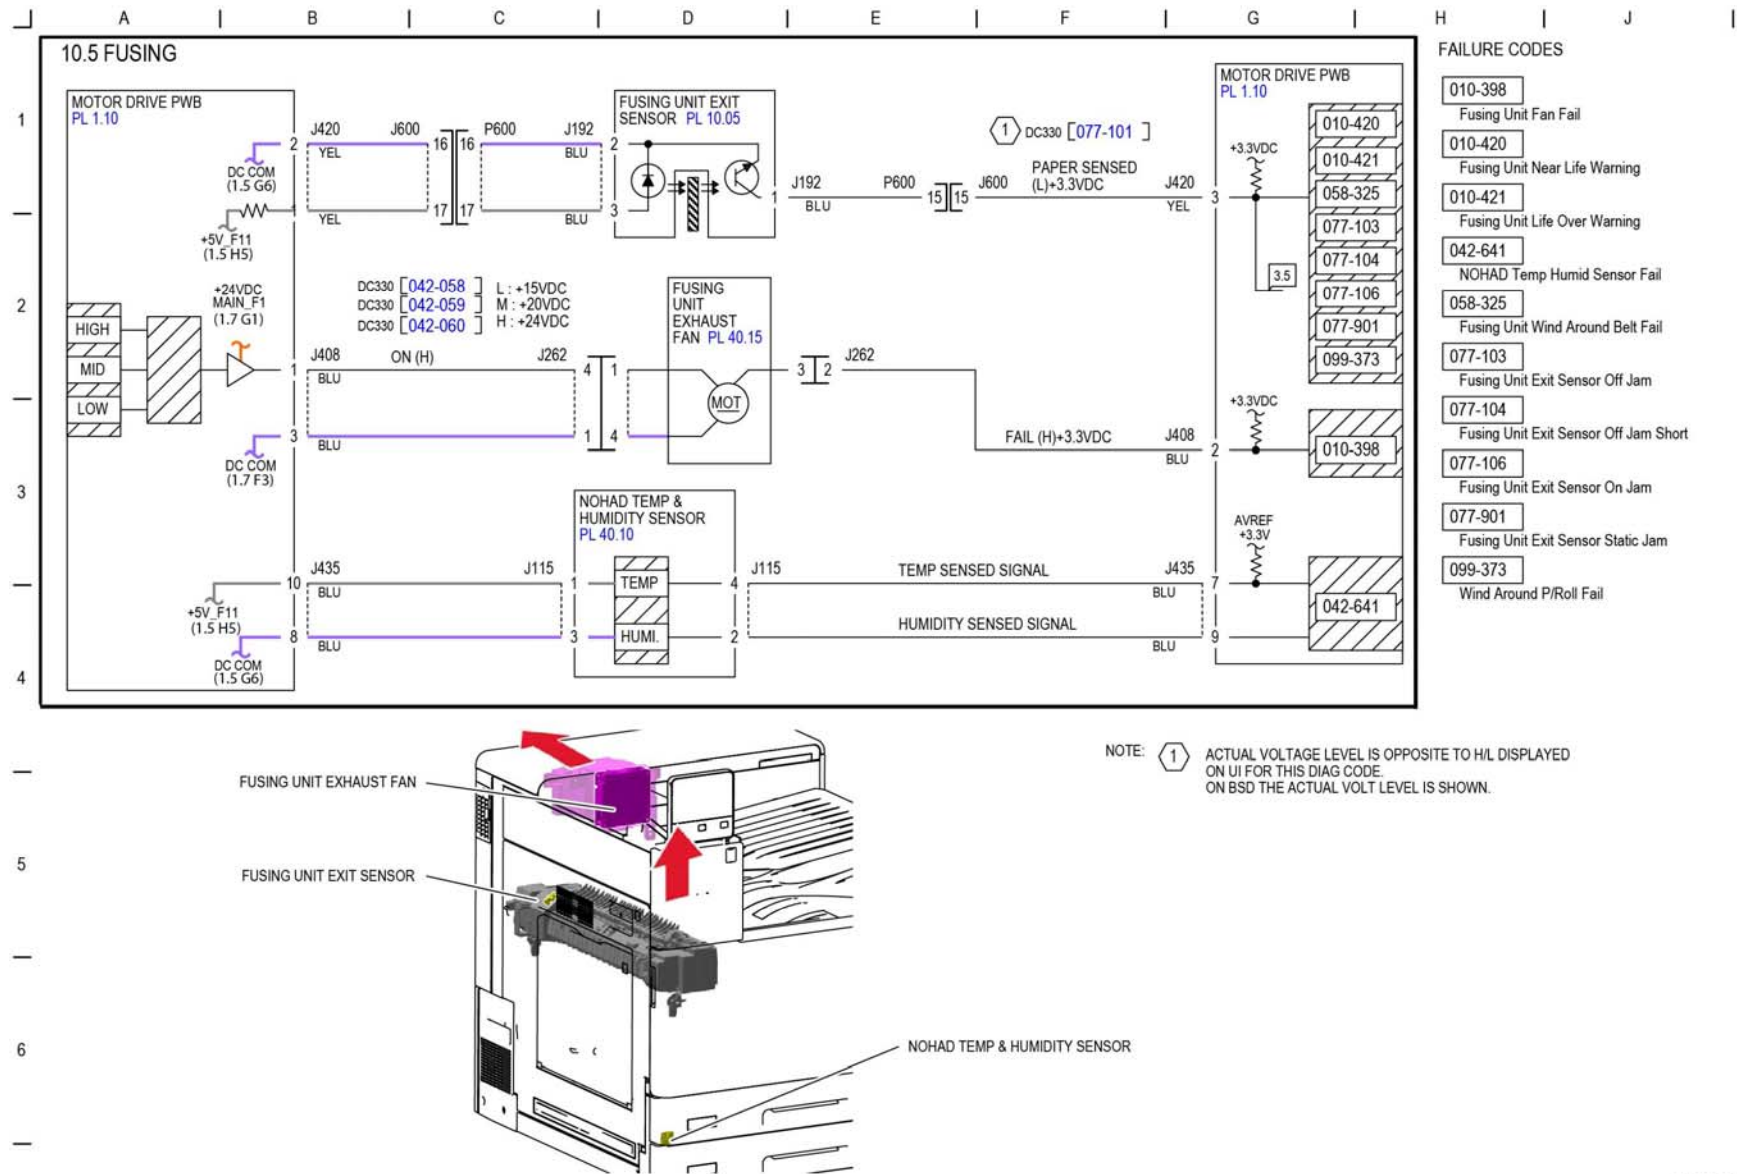
Figure 30 BSD 10.5

BSD 10.5 Fusing

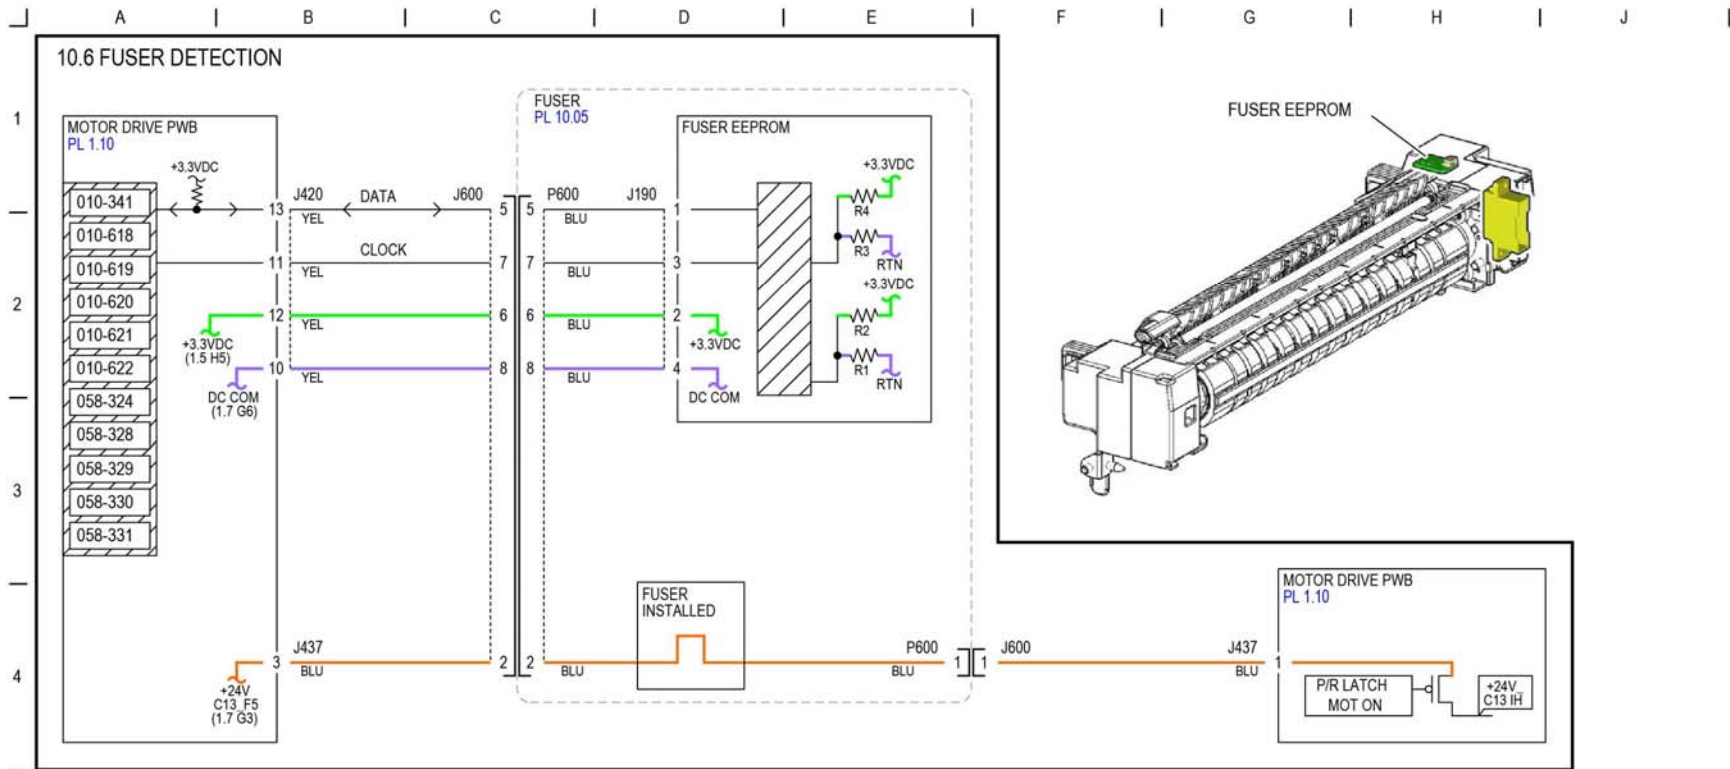
Figure 31 BSD 10.6

BSD 10.6 Fuser Detection

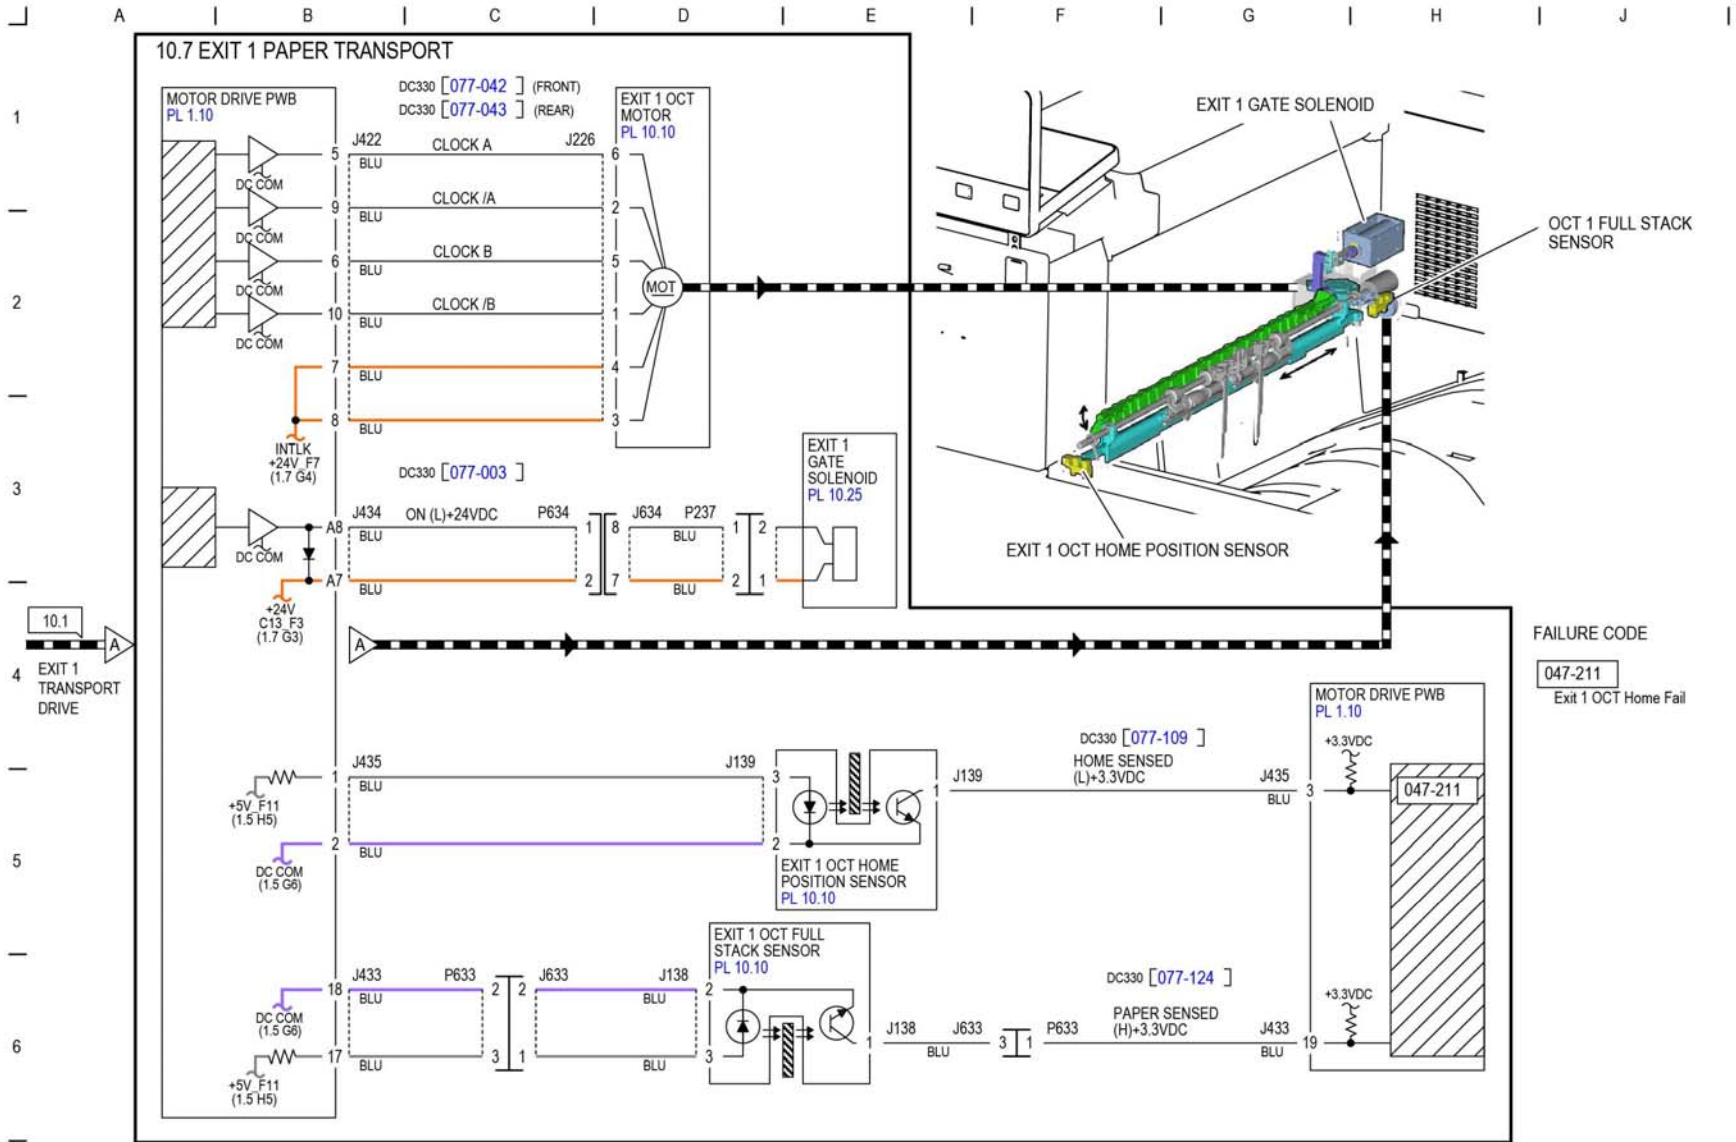
Figure 32 BSD 10.7

BSD 10.7 Exit 1 Paper Transport

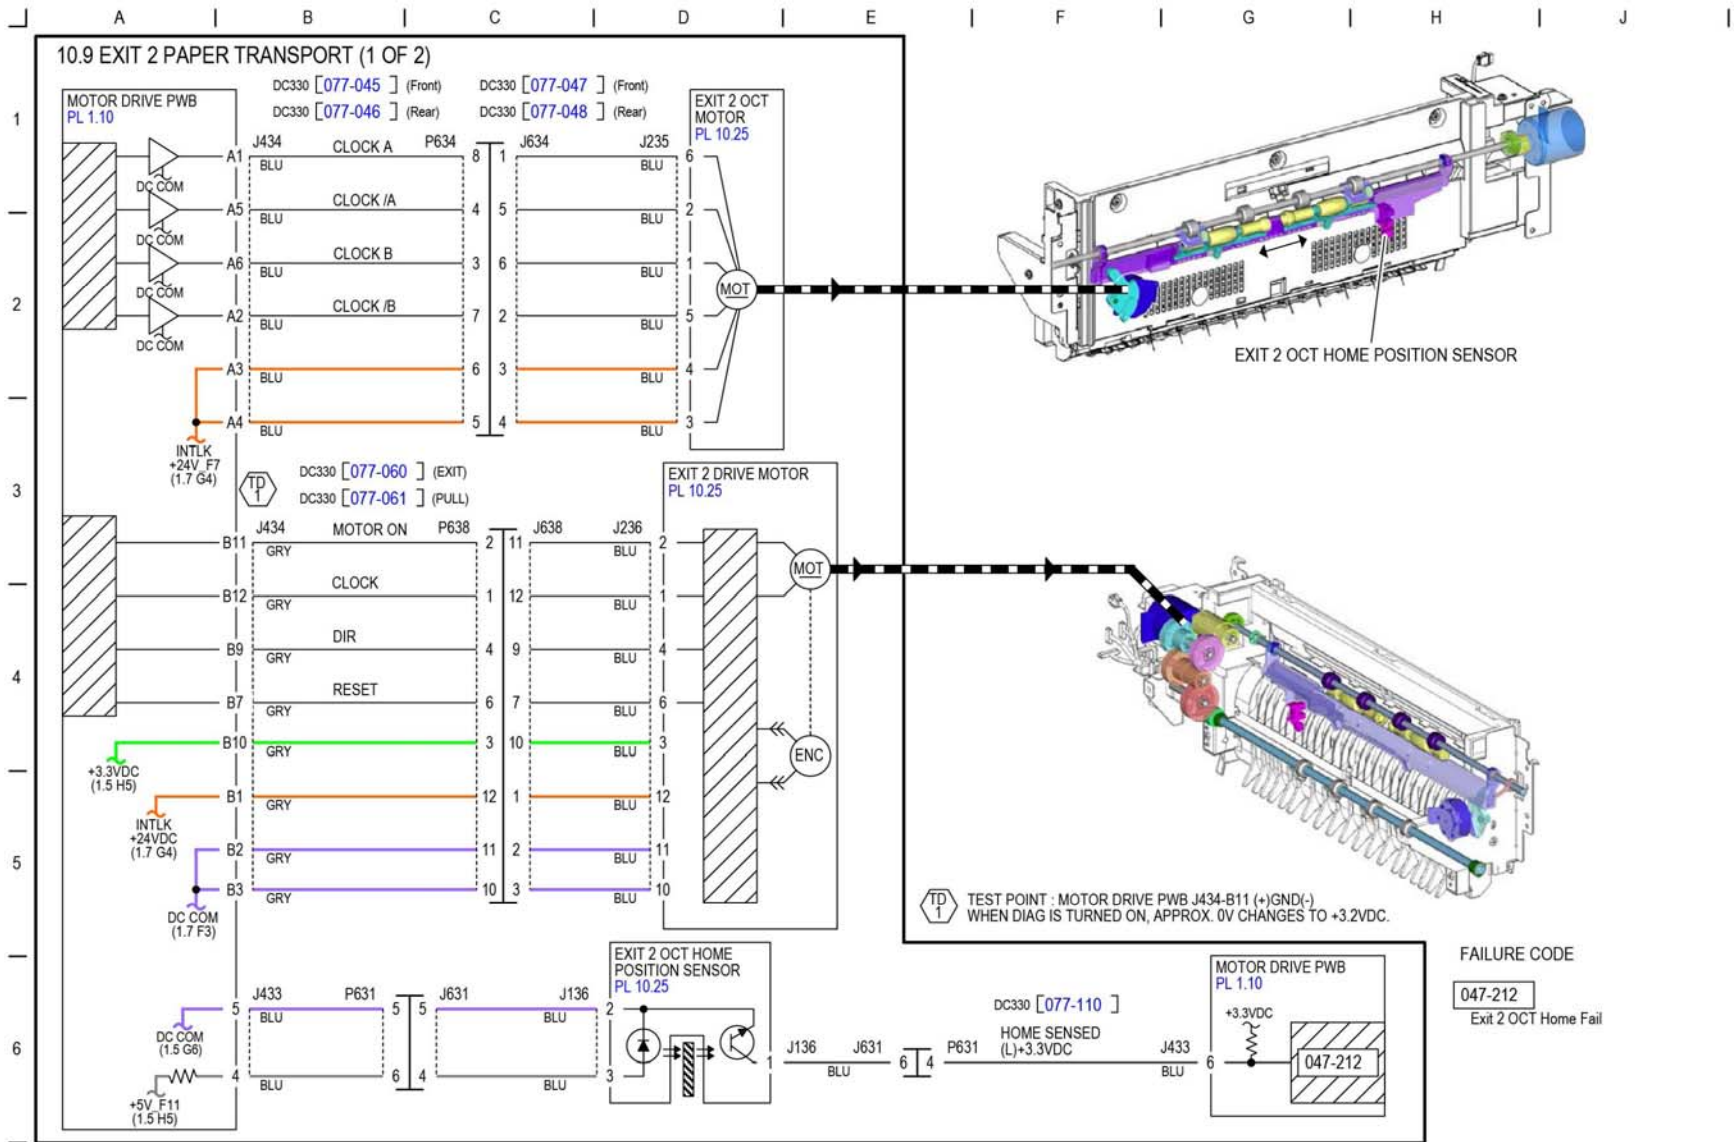
Figure 34 BSD 10.9

BSD 10.9 Exit 2 Paper Transport (1 of 2)

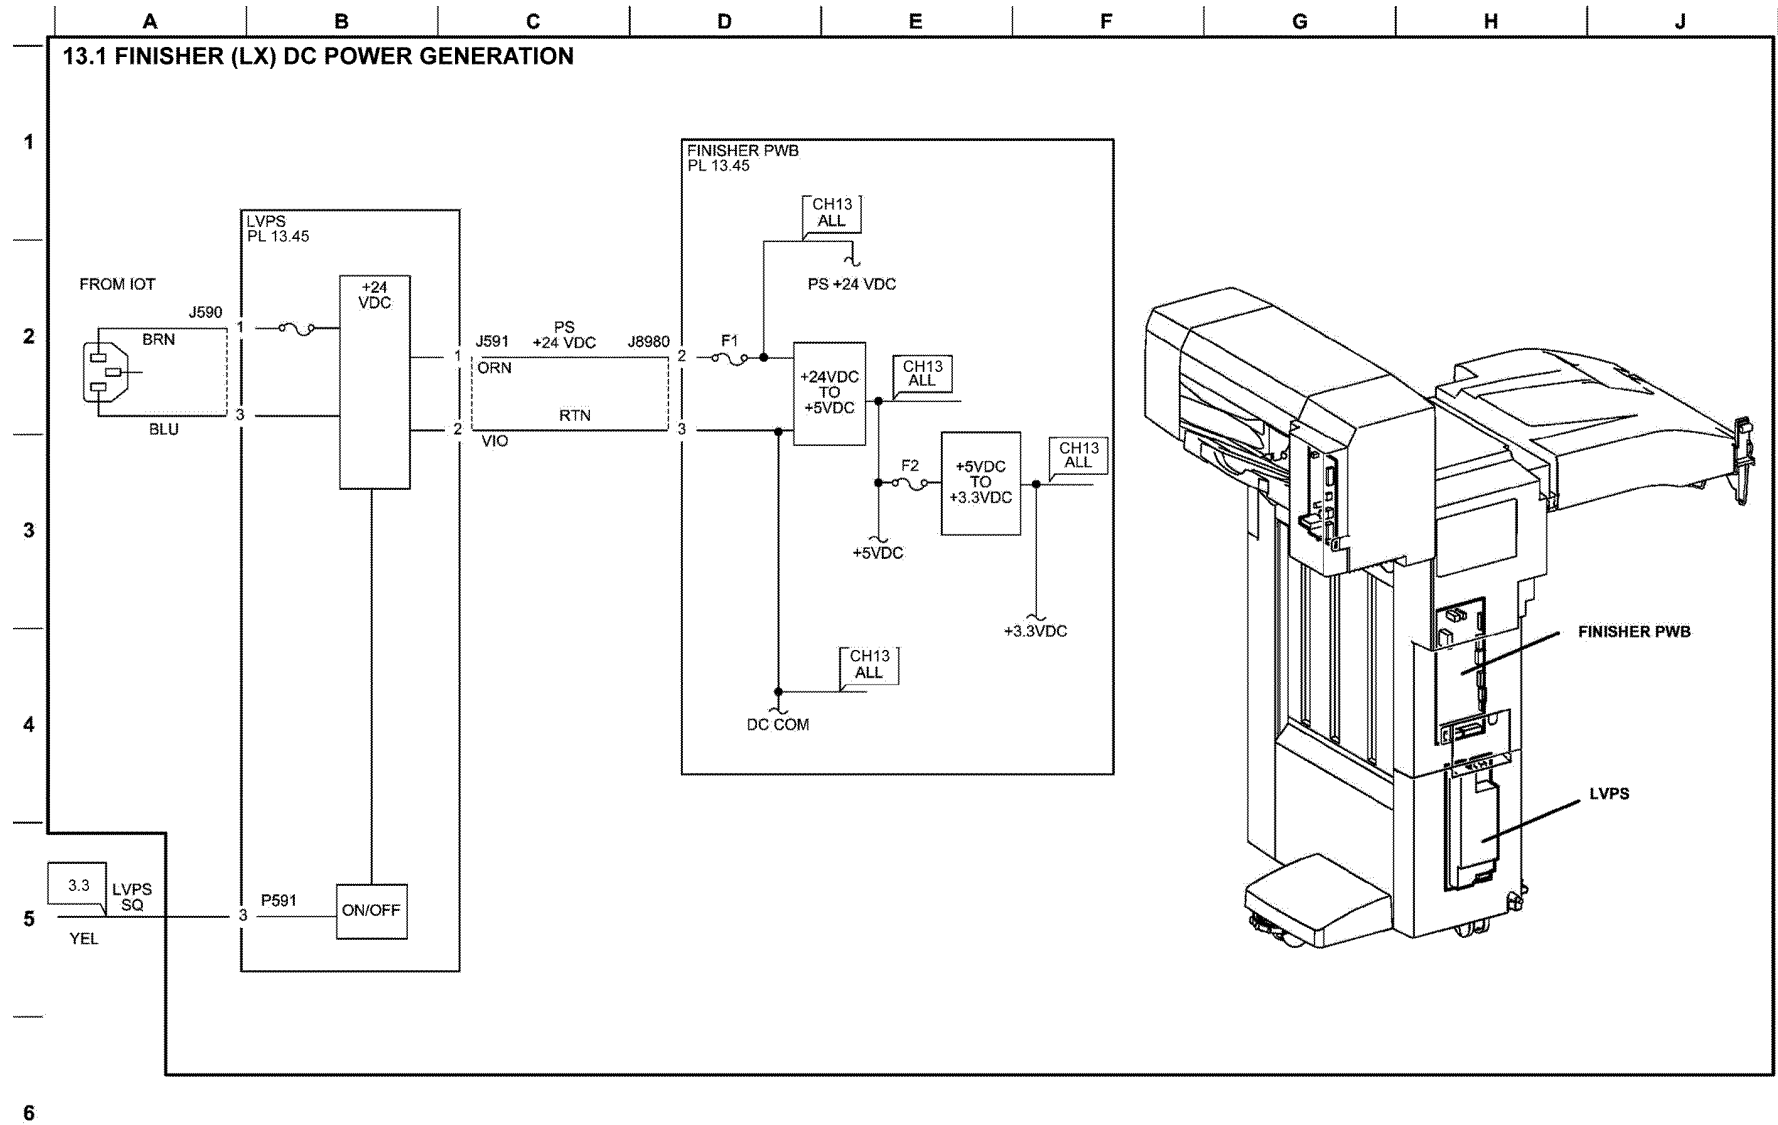
Figure 36 BSD 13.1

BSD 13.1 Office Finisher LX DC Power Generation
