VersaLink[®] C8000/C9000 Printer

Service Manual

VersaLink C9000 Family Service Manual

705P01418

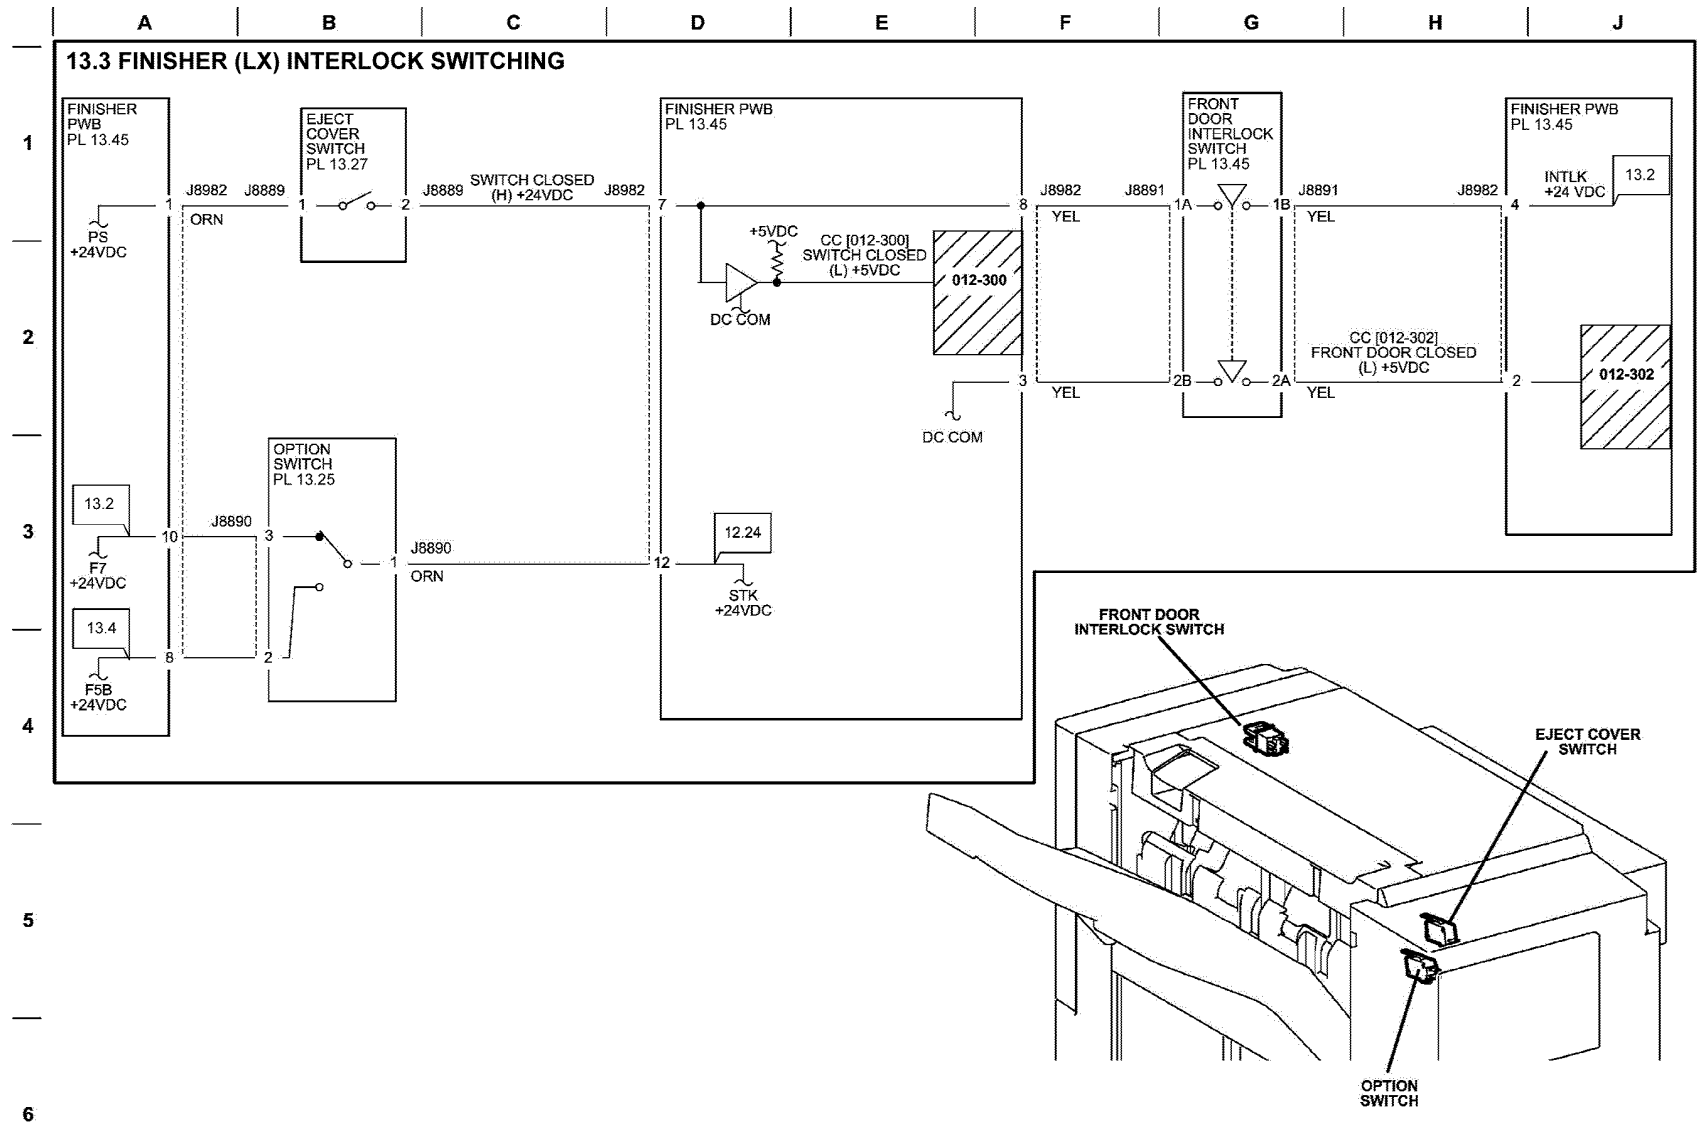
Figure 38 BSD 13.3

BSD 13.3 Office Finisher LX Interlock Switching

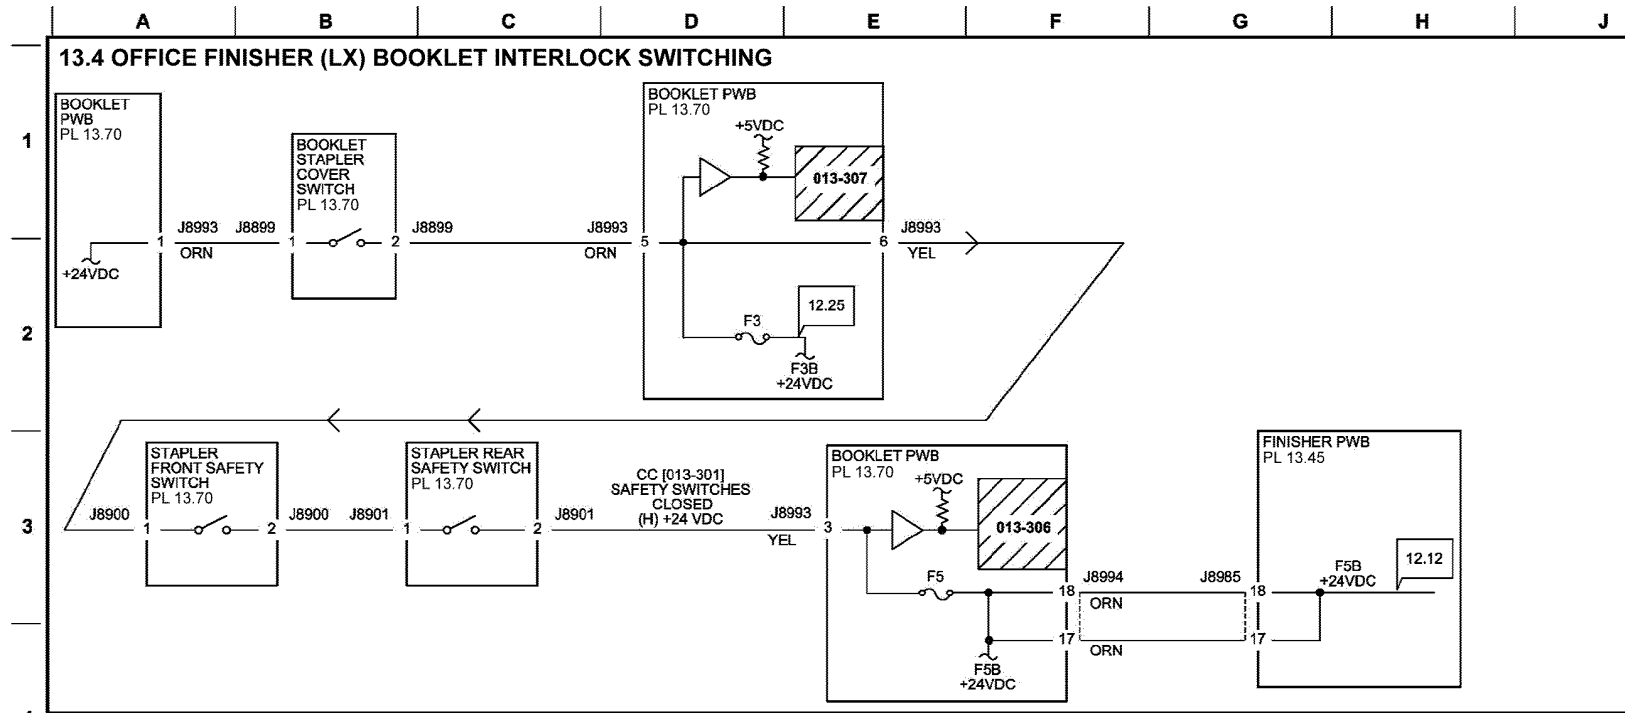
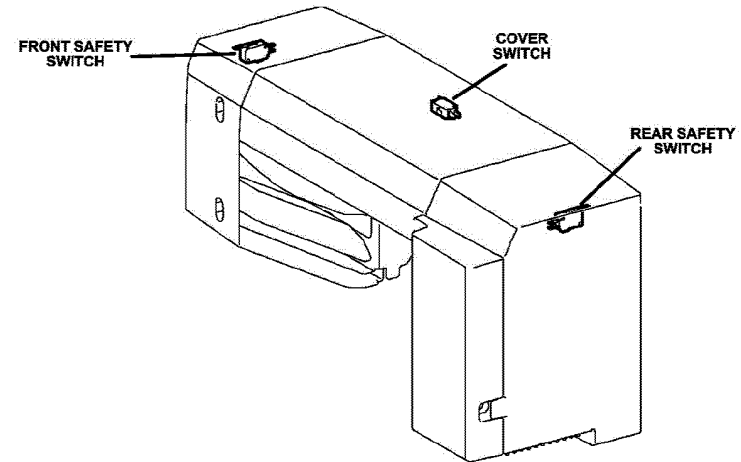
Figure 39 BSD 13.4

BSD 13.4 Office Finisher LX Booklet Interlock Switching

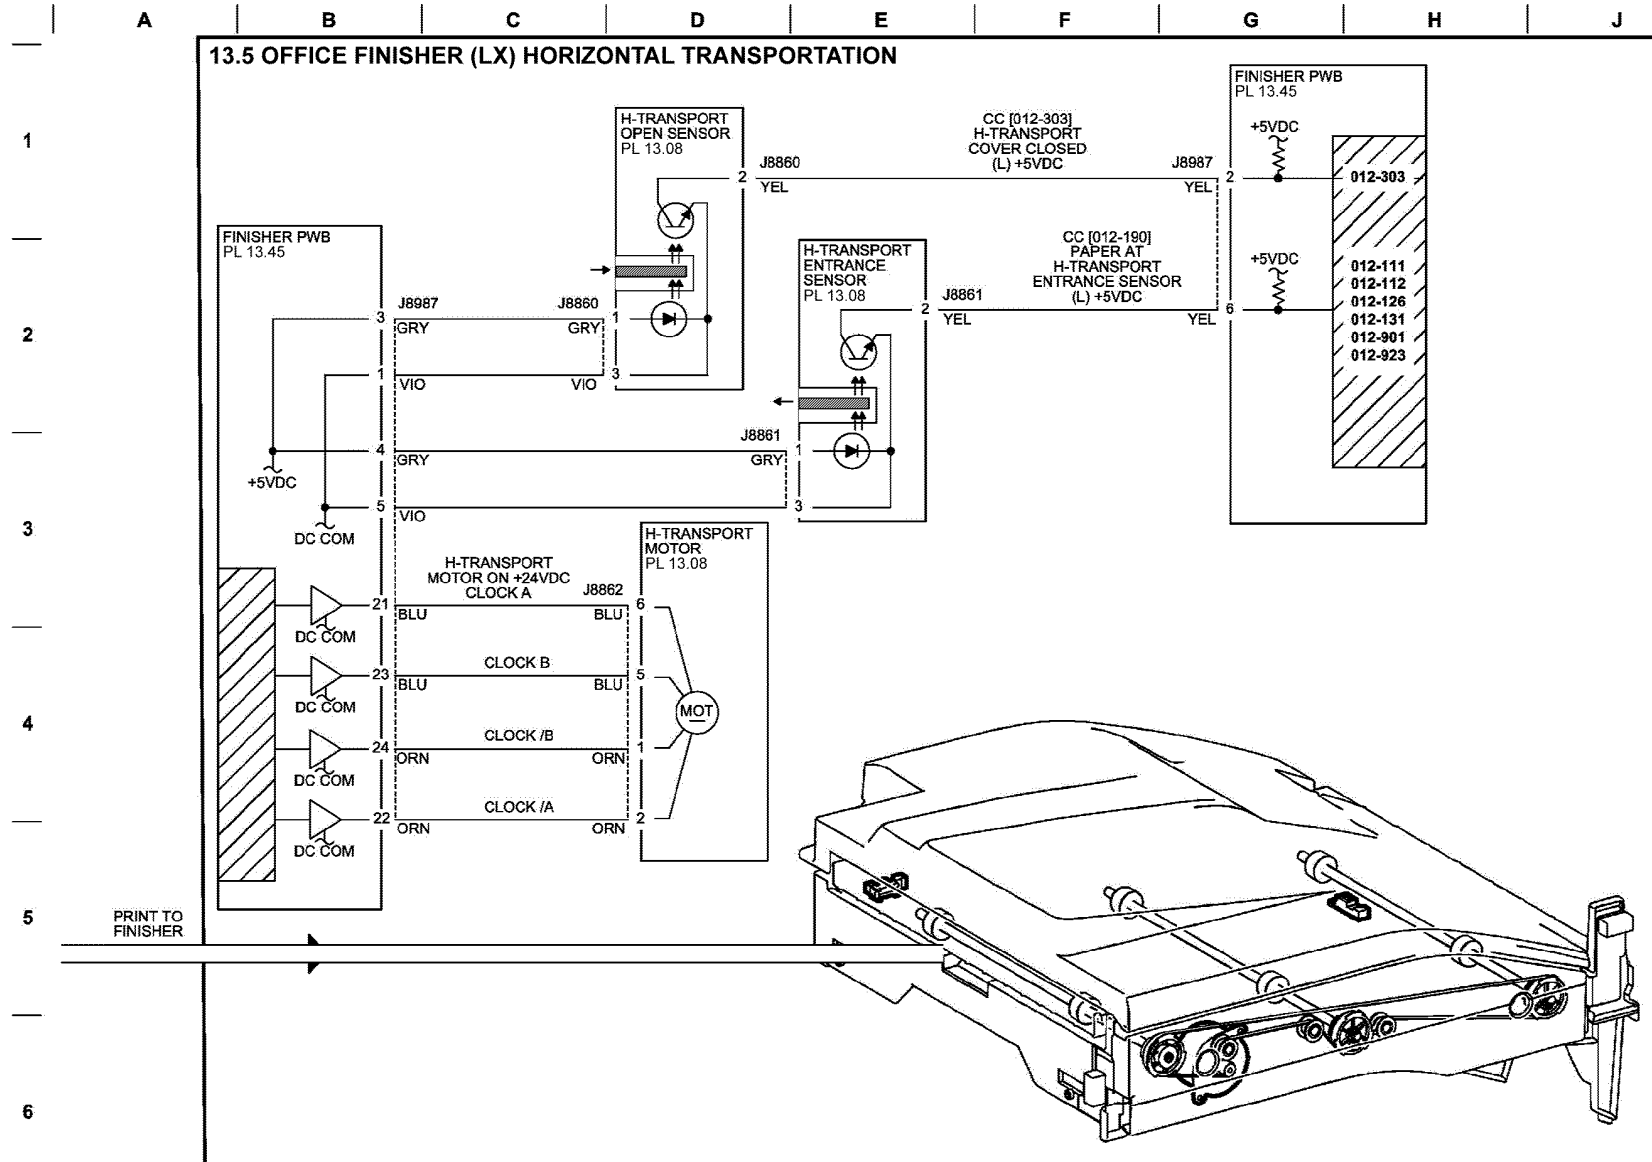
Figure 40 BSD 13.5

BSD 13.5 Office Finisher LX Horizontal Transport

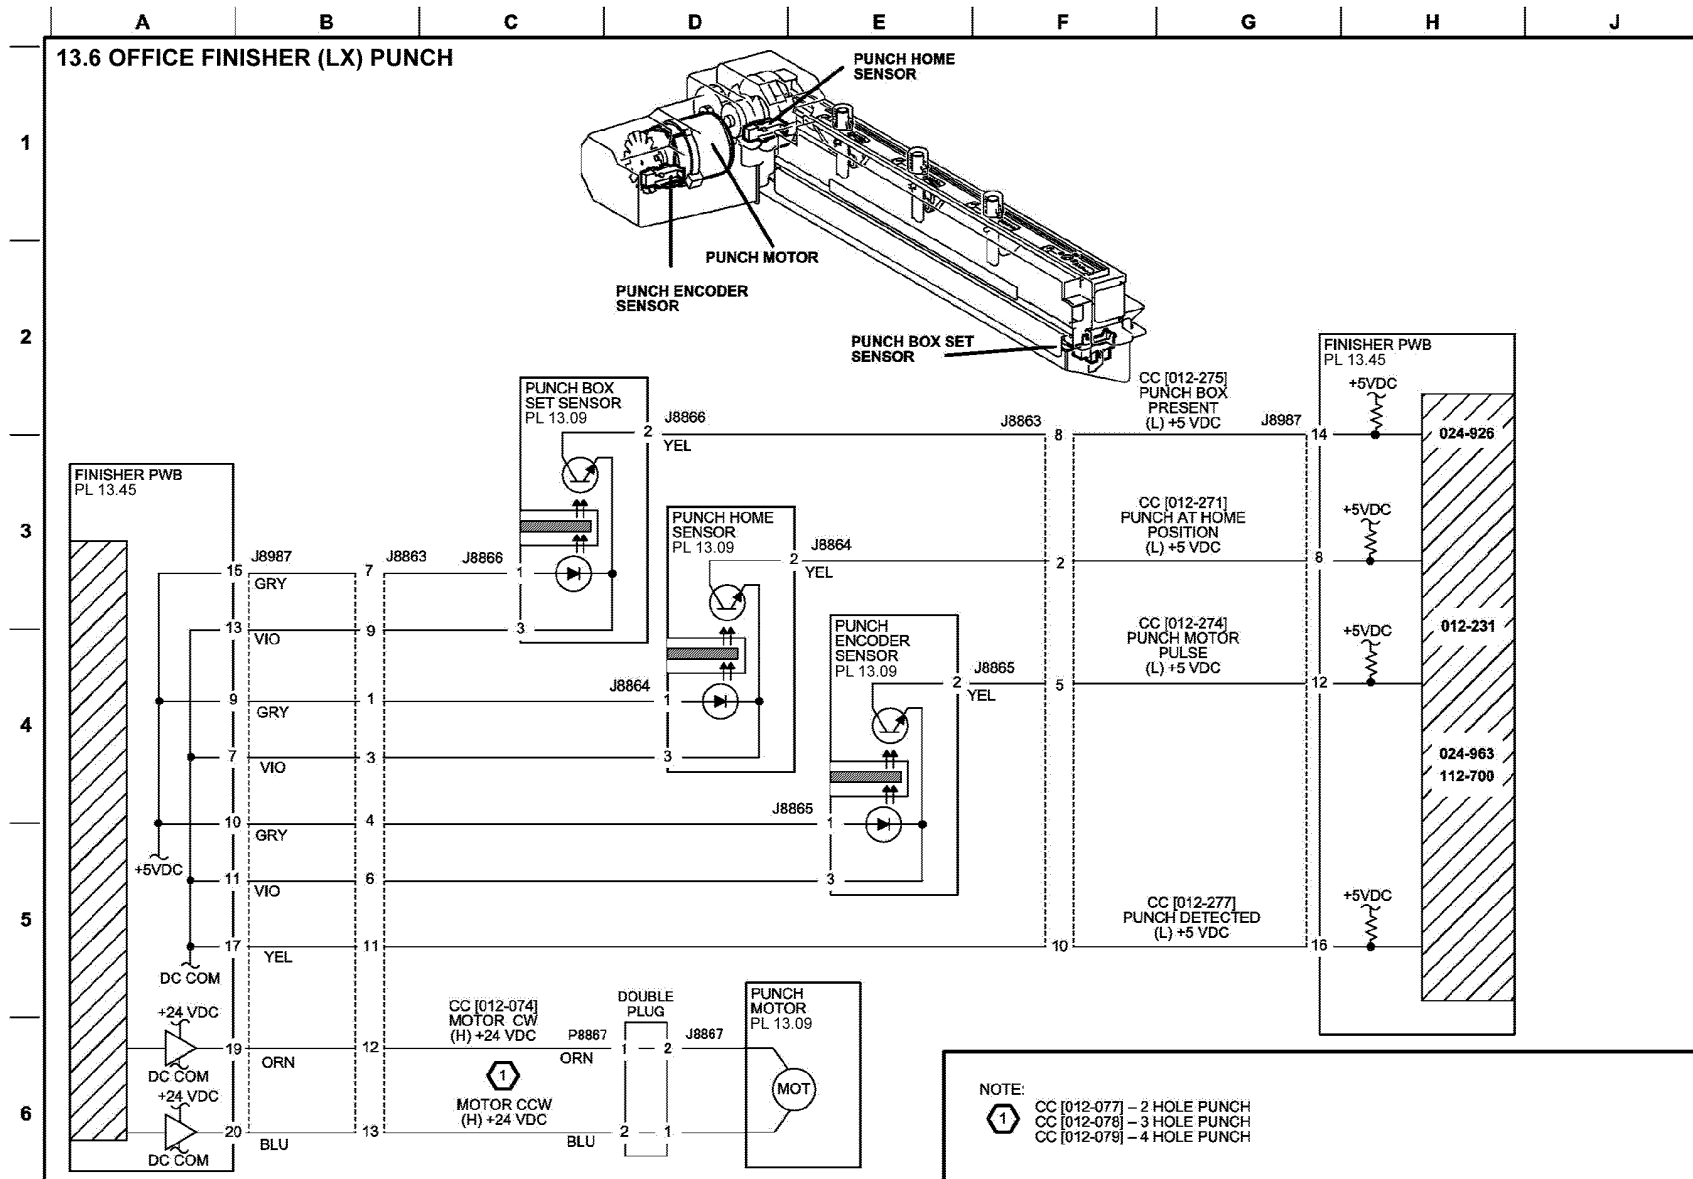
Figure 41 BSD 13.6

BSD 13.6 Office Finisher LX Punch

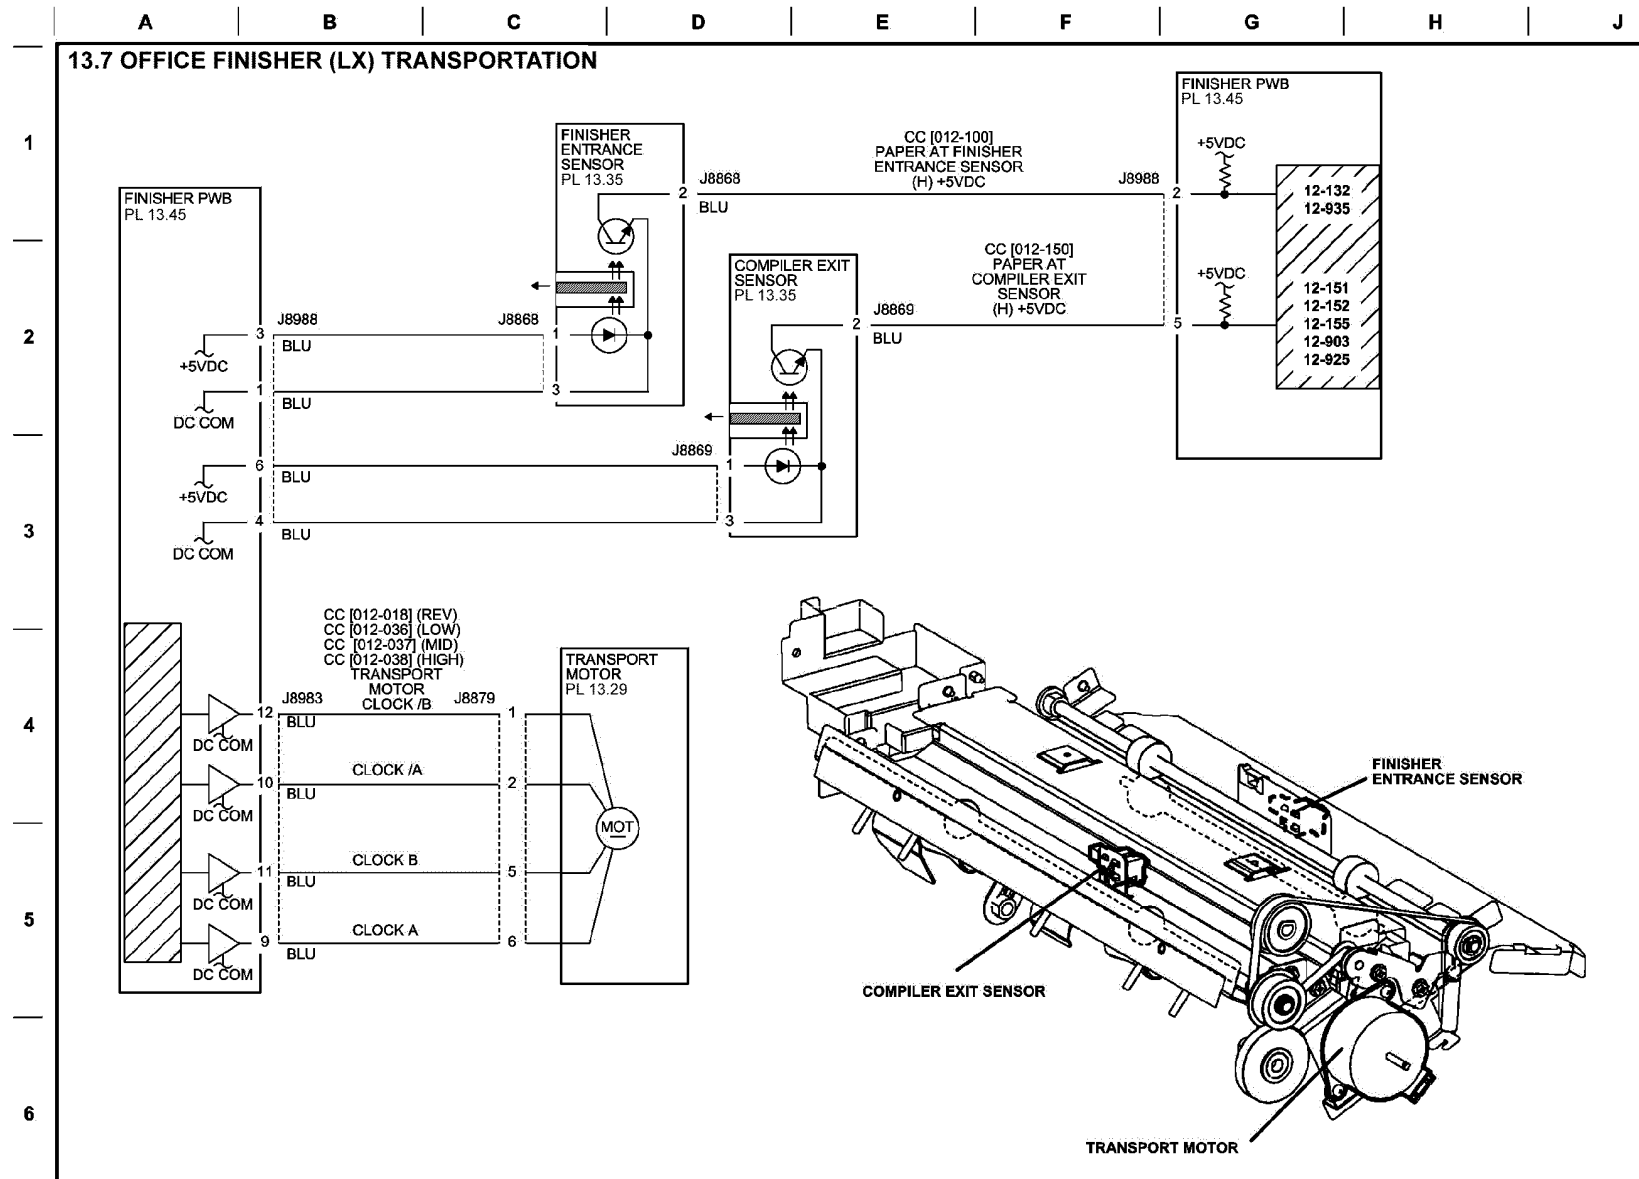
Figure 42 BSD 13.7

BSD 13.7 Office Finisher LX Transportation

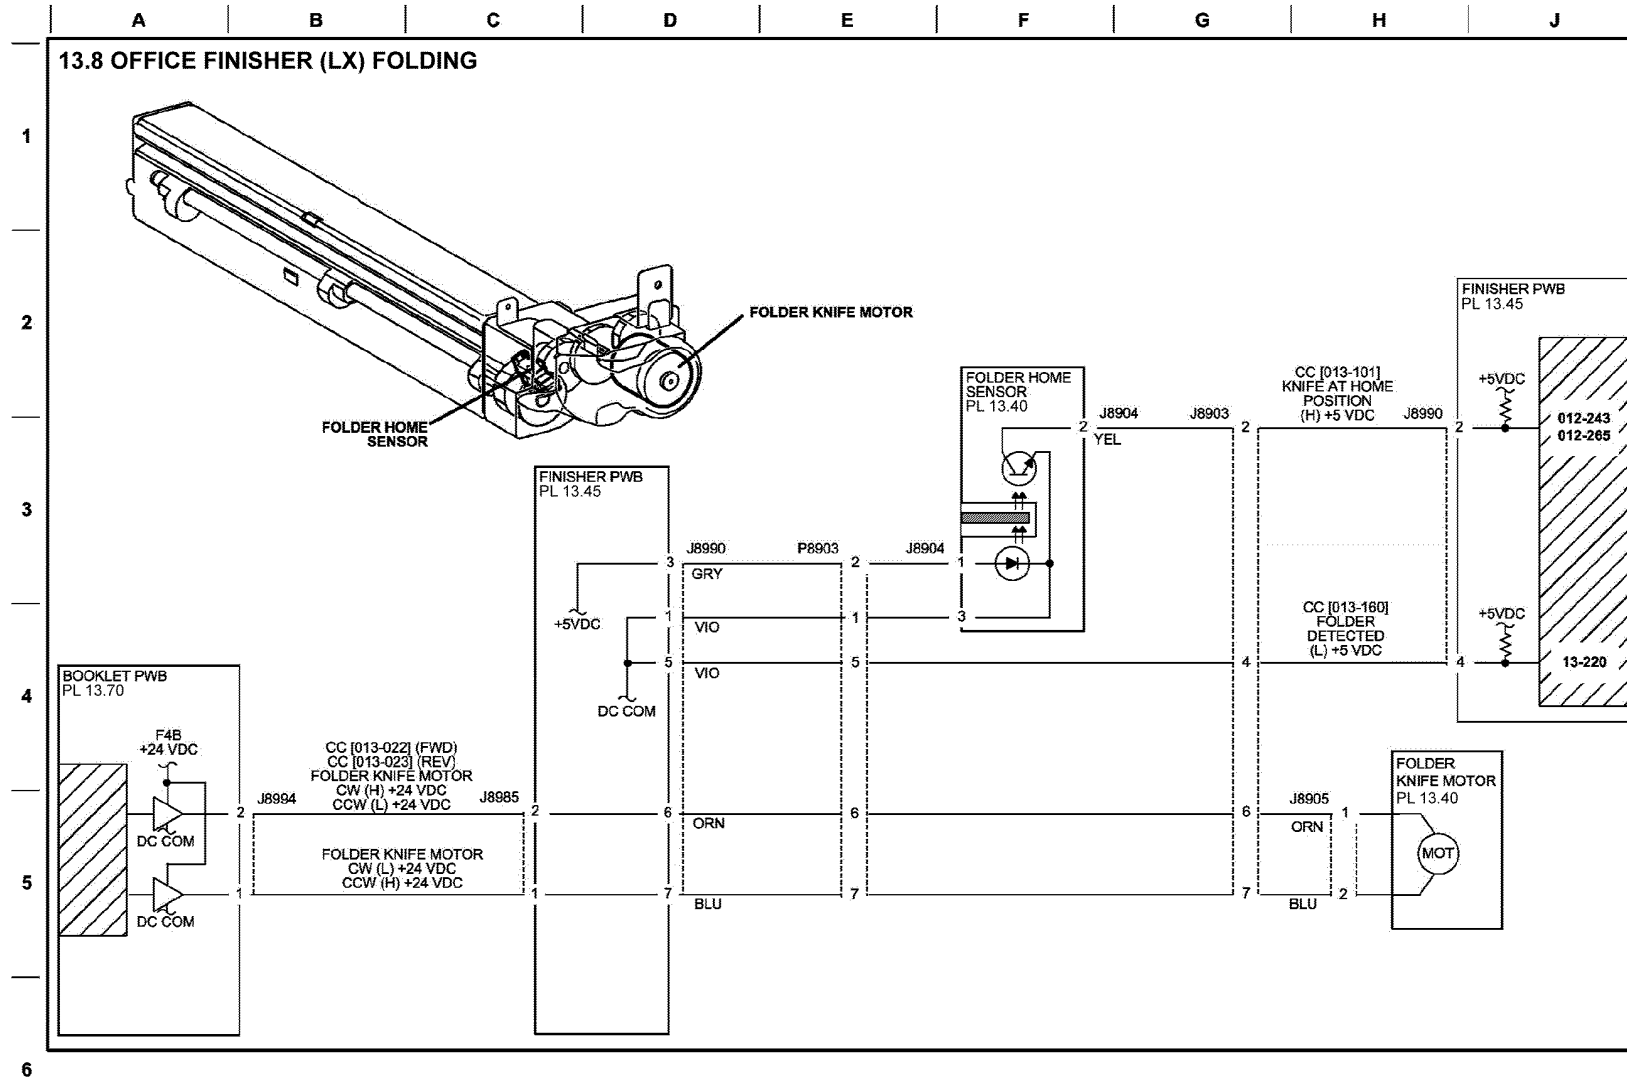
Figure 43 BSD 13.8

BSD 13.8 Office Finisher LX Folding

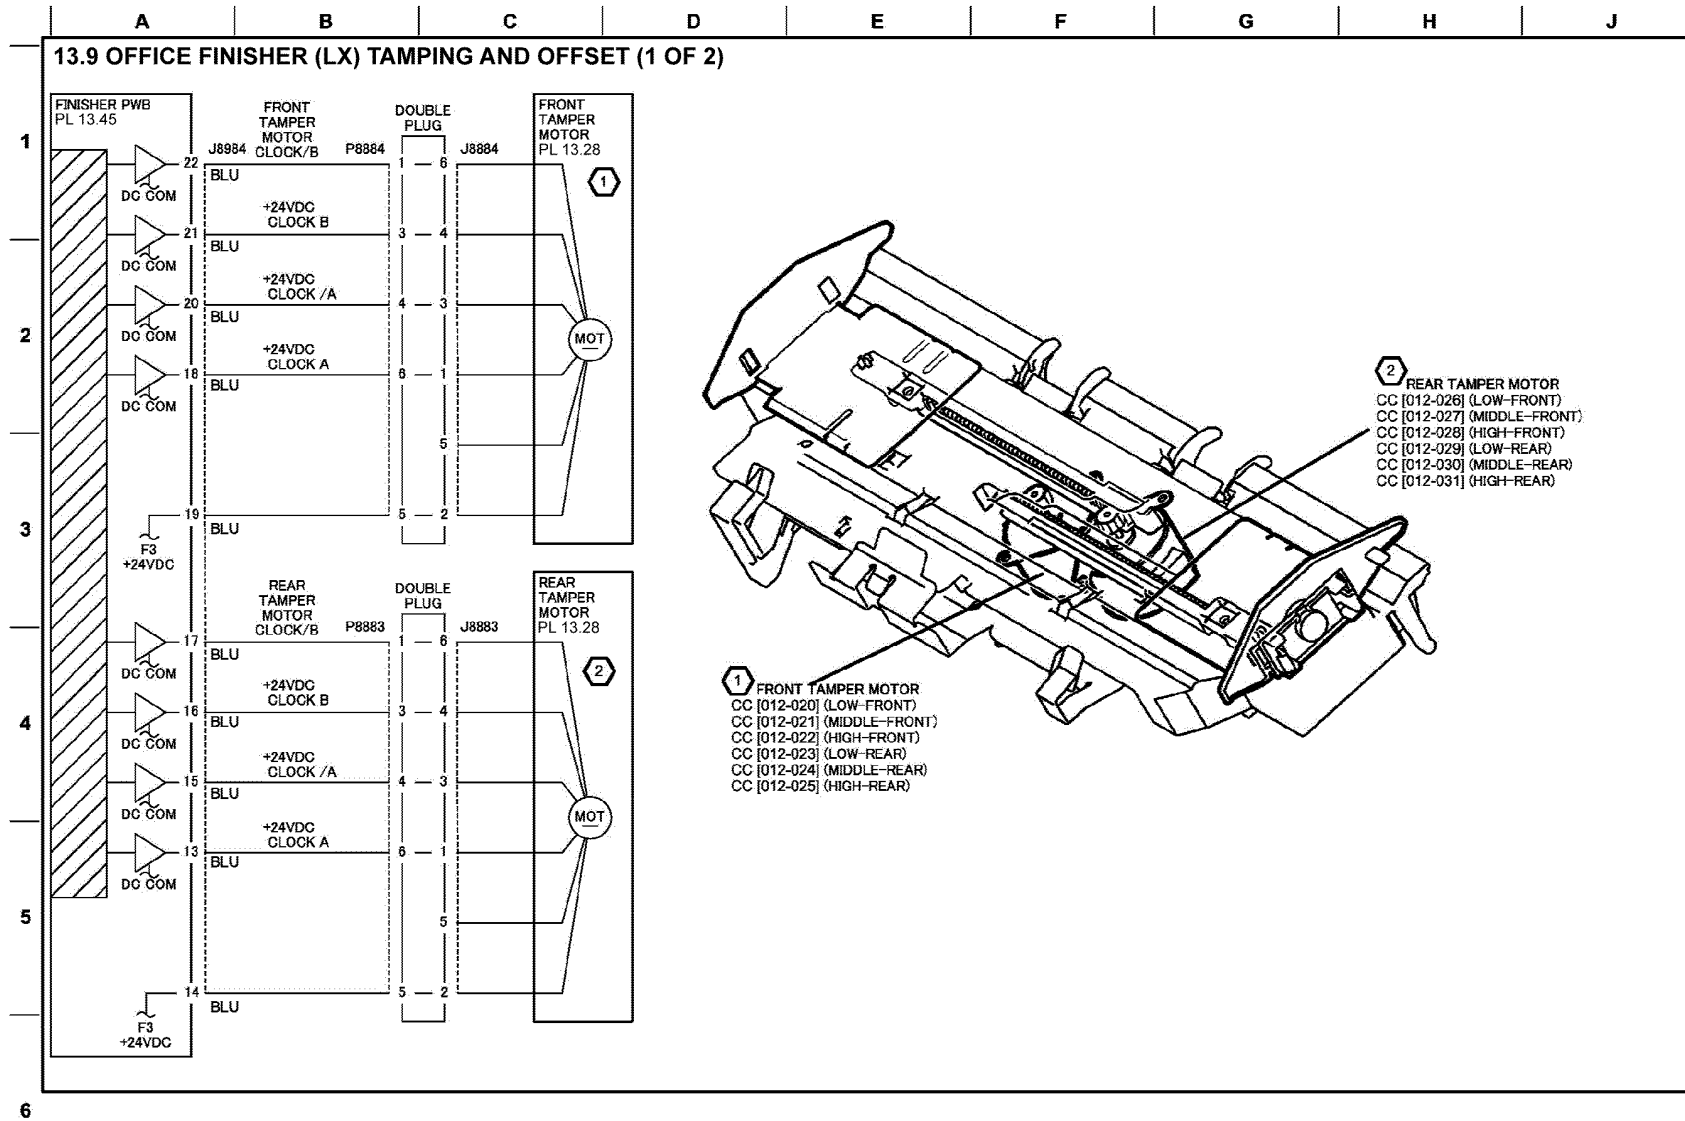
Figure 44 BSD 13.9

BSD 13.9 Office Finisher LX Tamping and Offset (1 of 2)

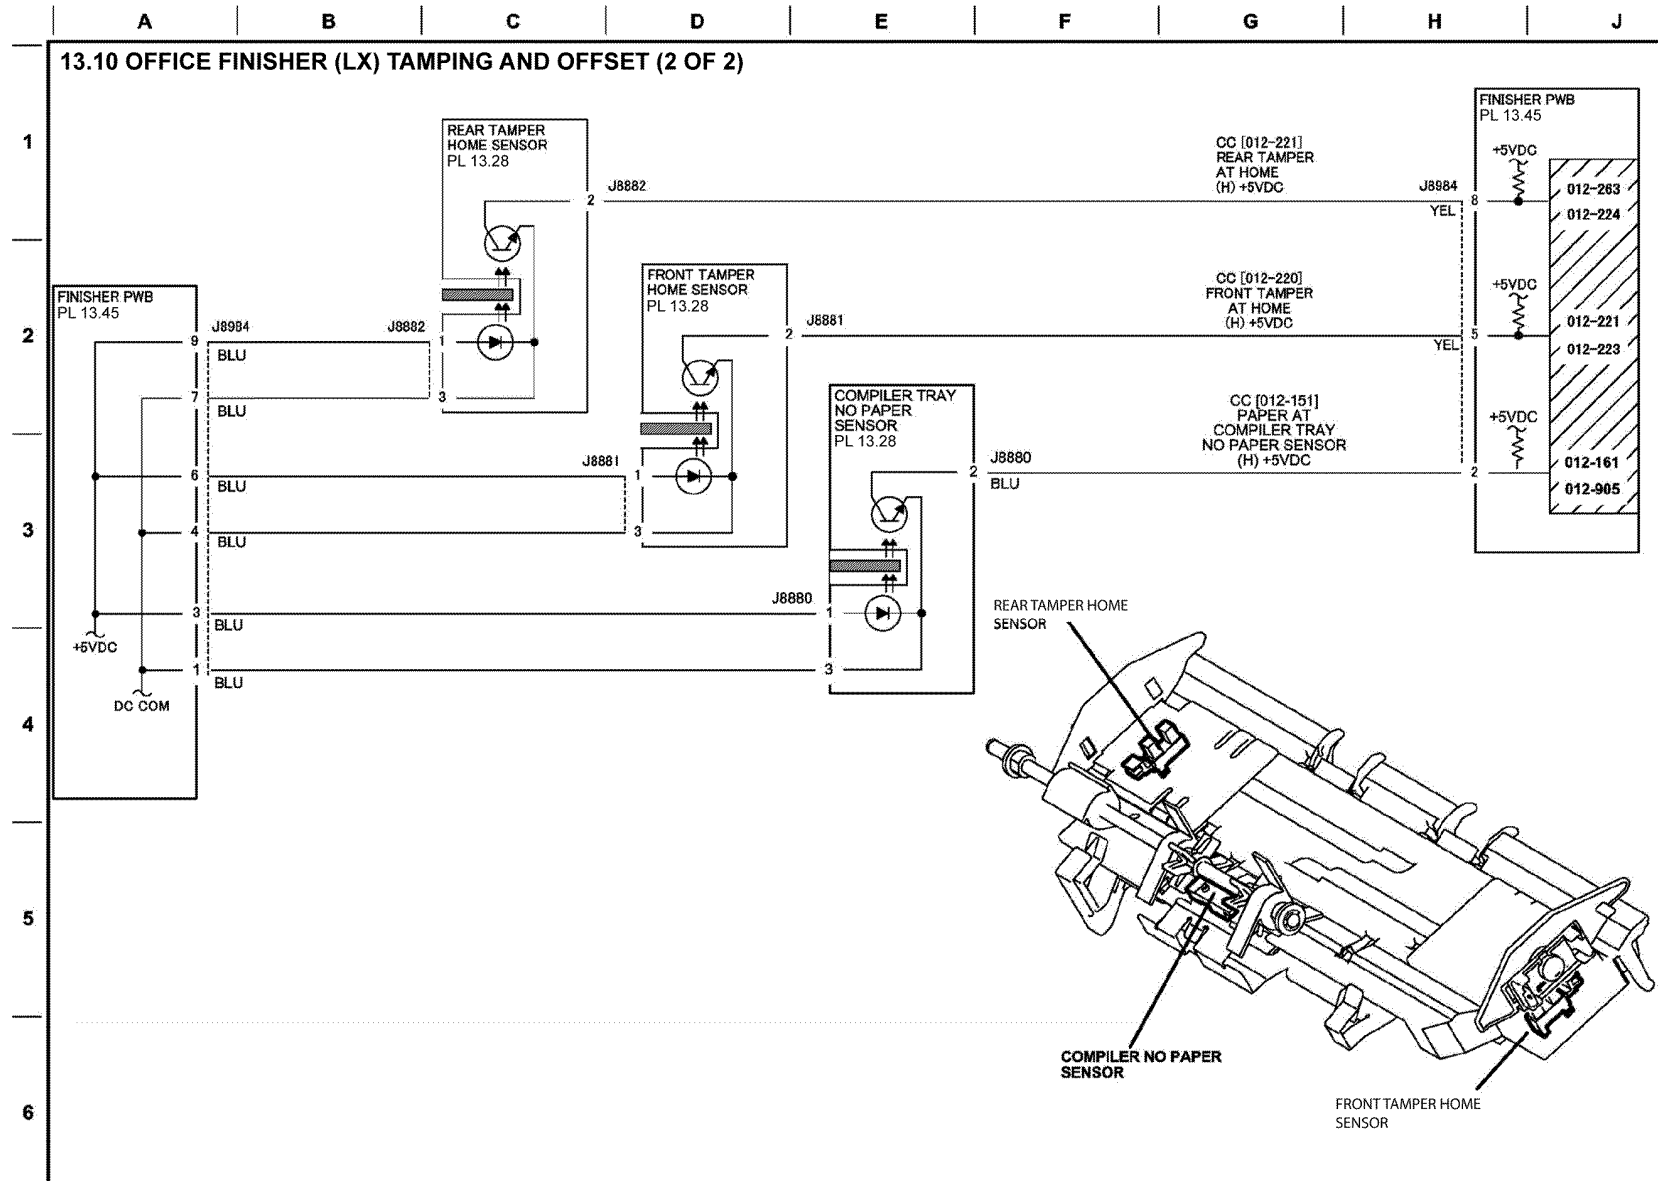
Figure 45 BSD 13.10

BSD 13.10 Office Finisher LX Tamping and Offset (2 of 2)

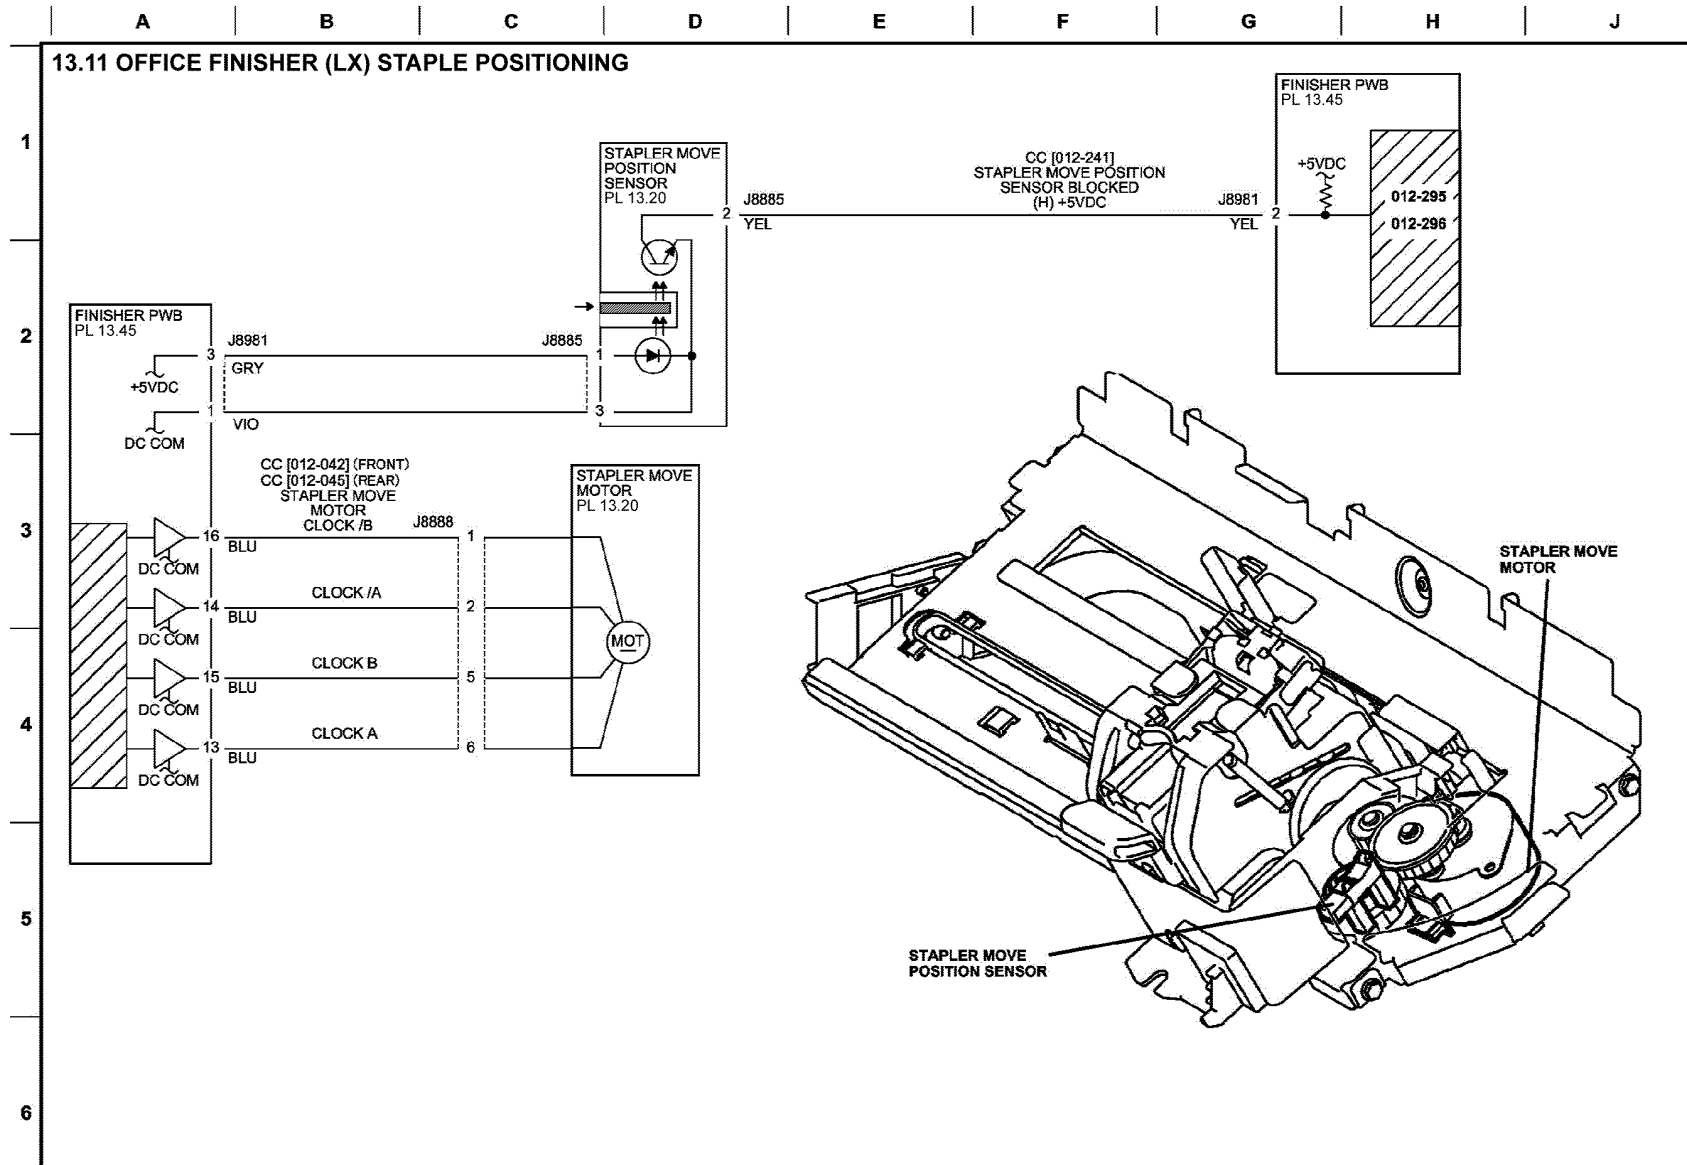
Figure 46 BSD 13.11

BSD 13.11 Office Finisher LX Staple Positioning

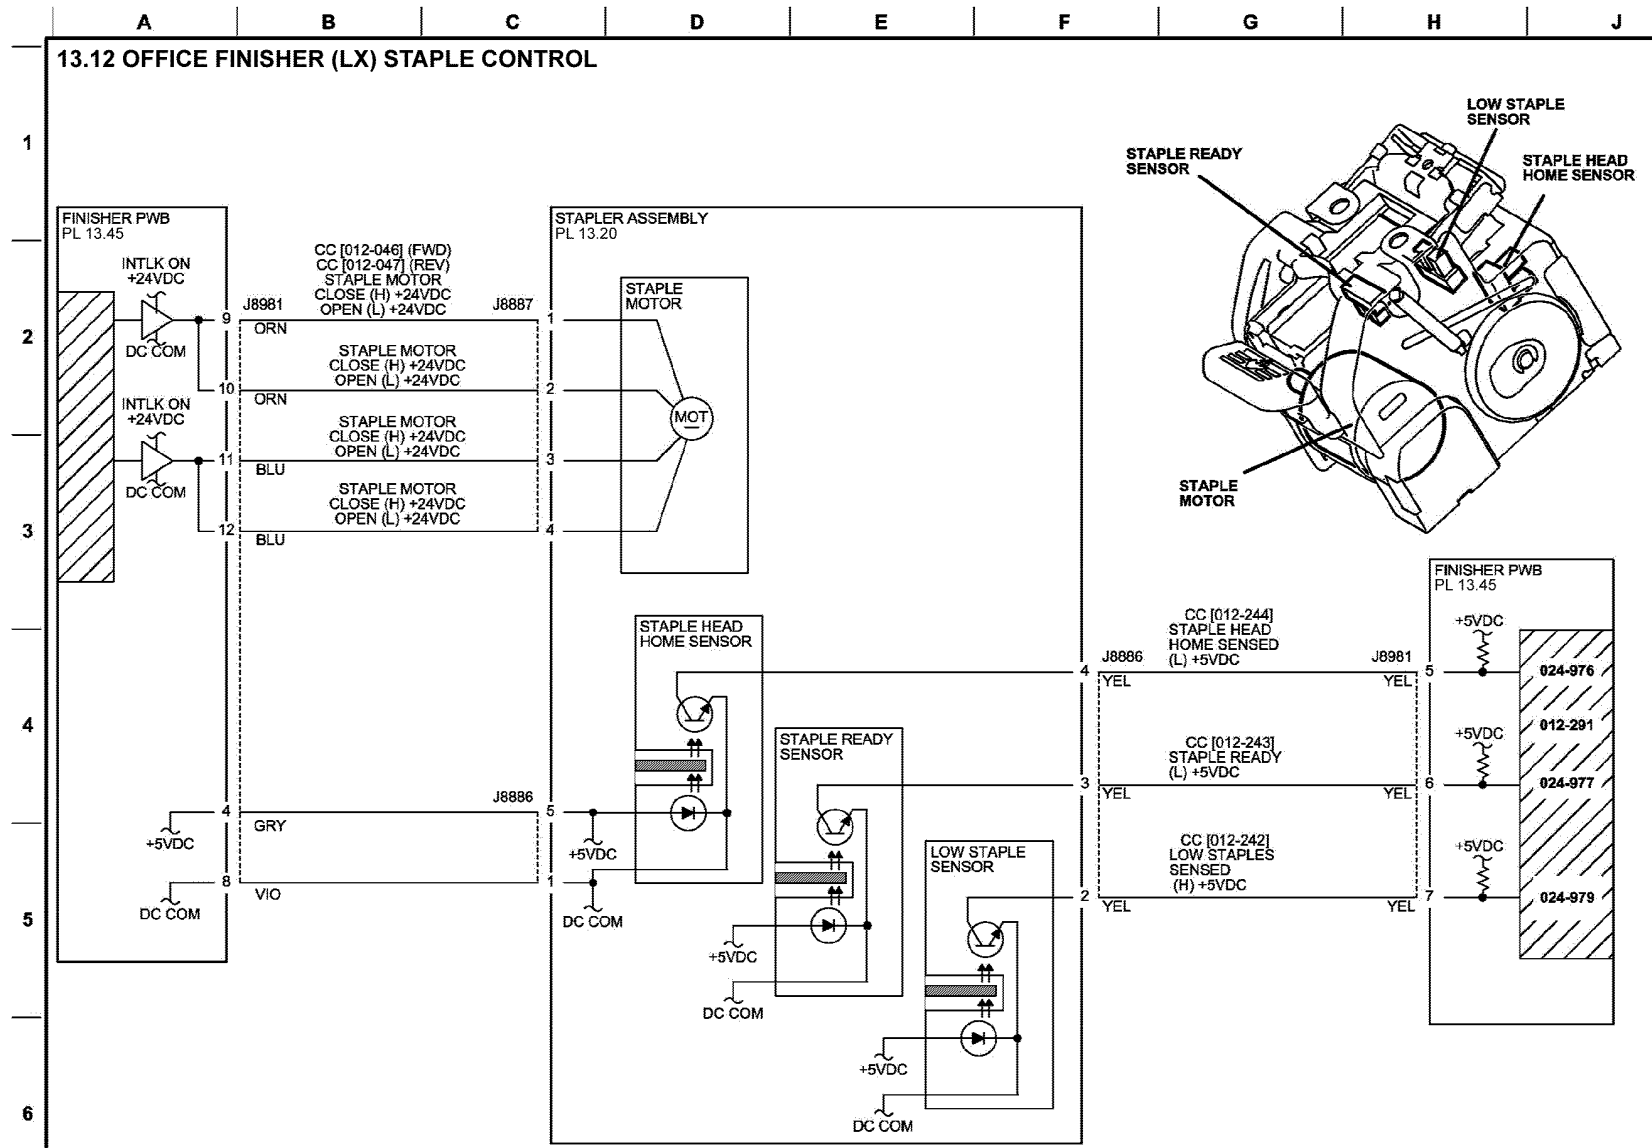
Figure 47 BSD 13.12

BSD 13.12 Office Finisher LX Staple Control

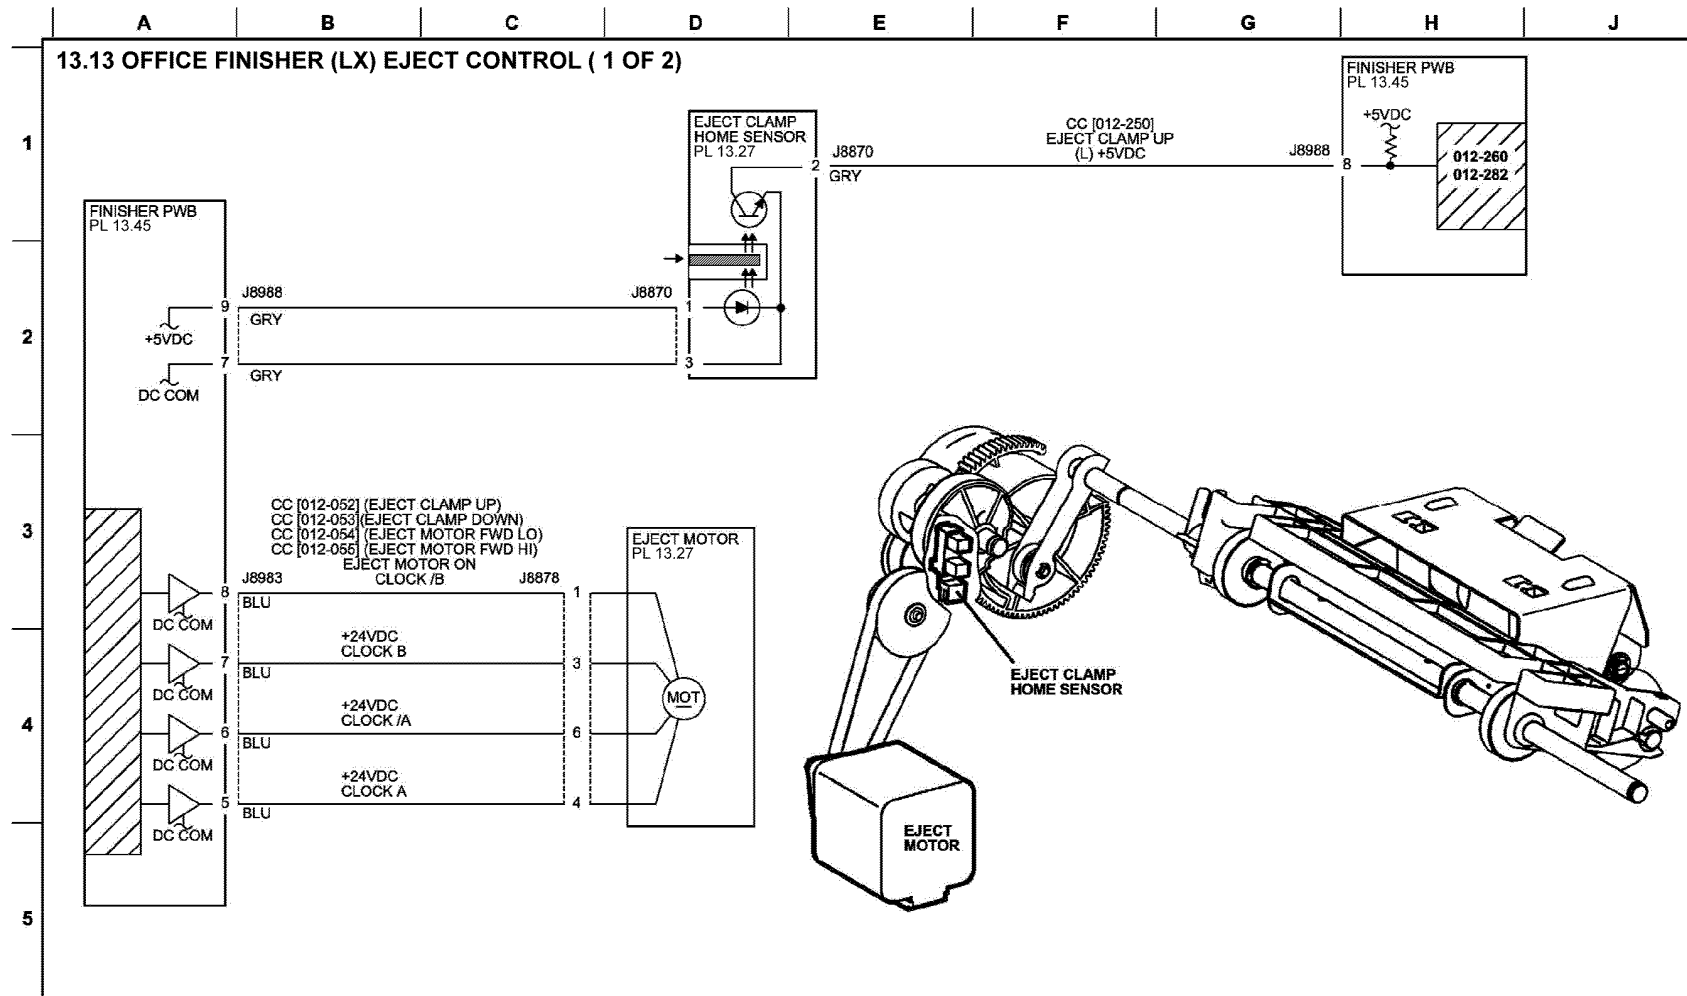
Figure 48 BSD 13.13

BSD 13.13 Office Finisher LX Eject Control (1 of 2)

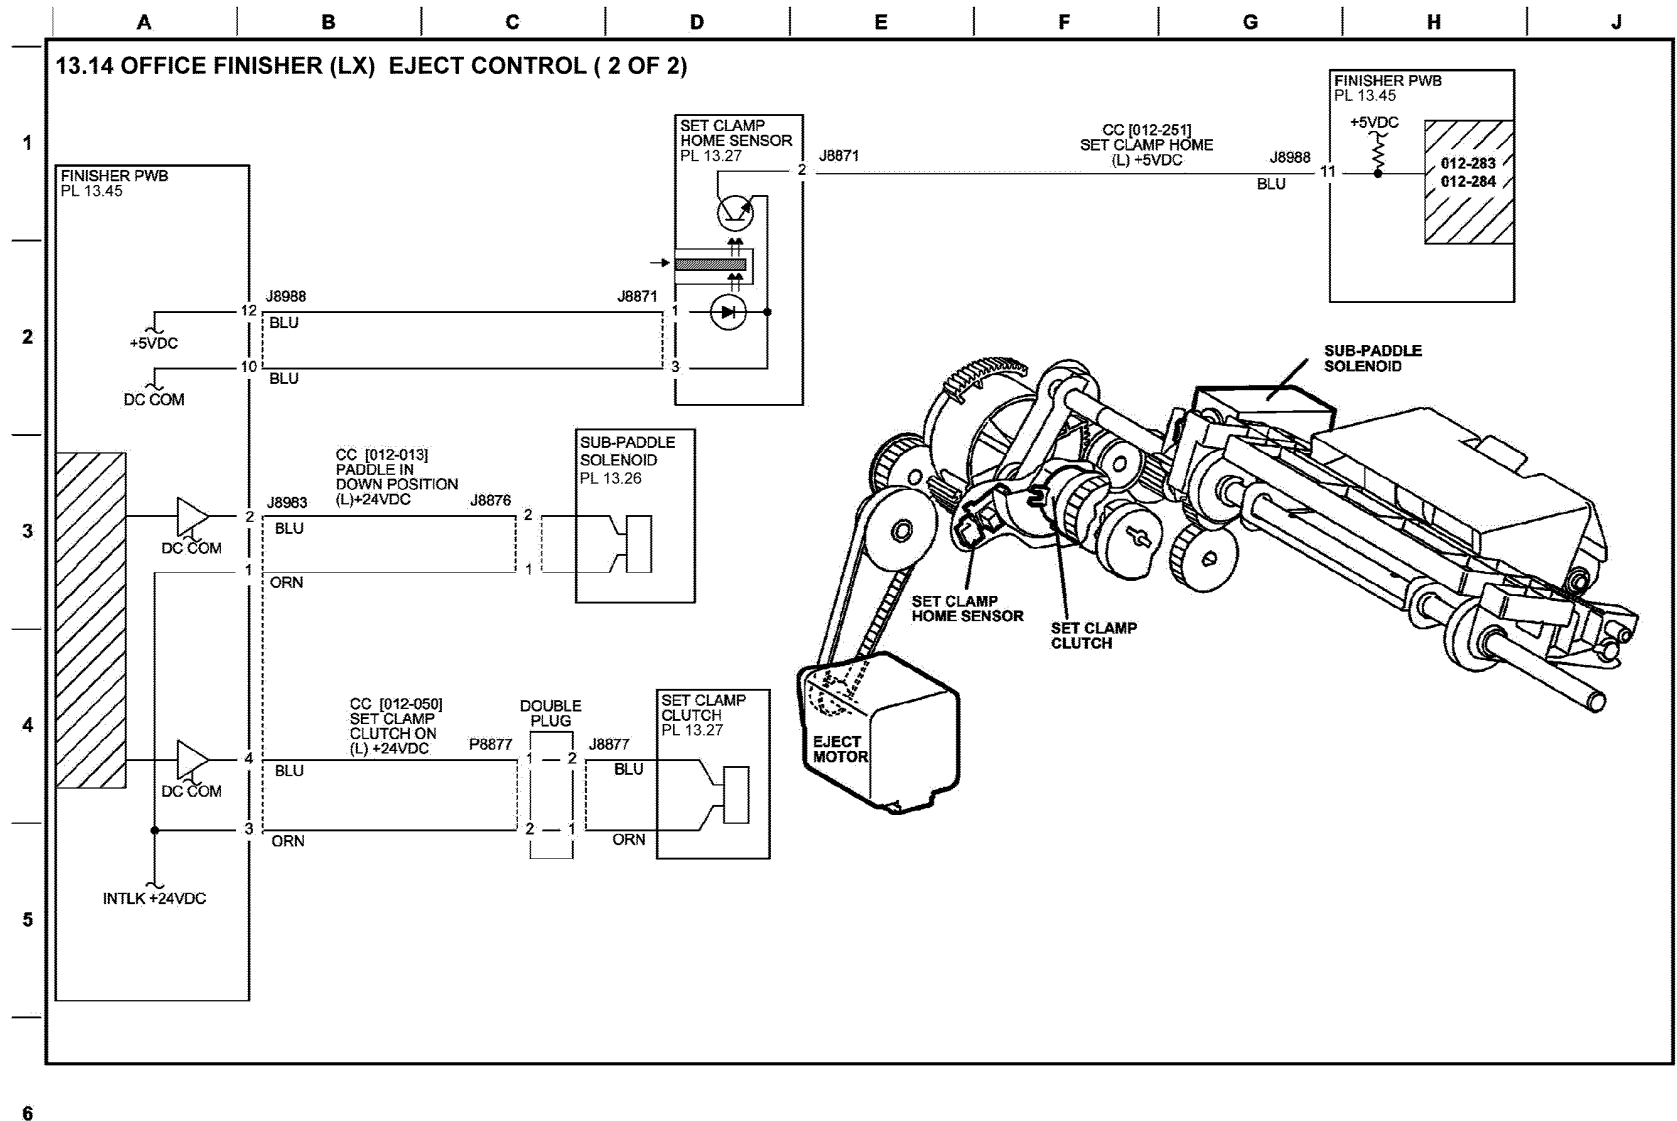
Figure 49 BSD 13.14

BSD 13.14 Office Finisher LX Eject Control (2 of 2)
