VersaLink[®] C8000/C9000 Printer

Service Manual

VersaLink C9000 Family Service Manual

705P01418

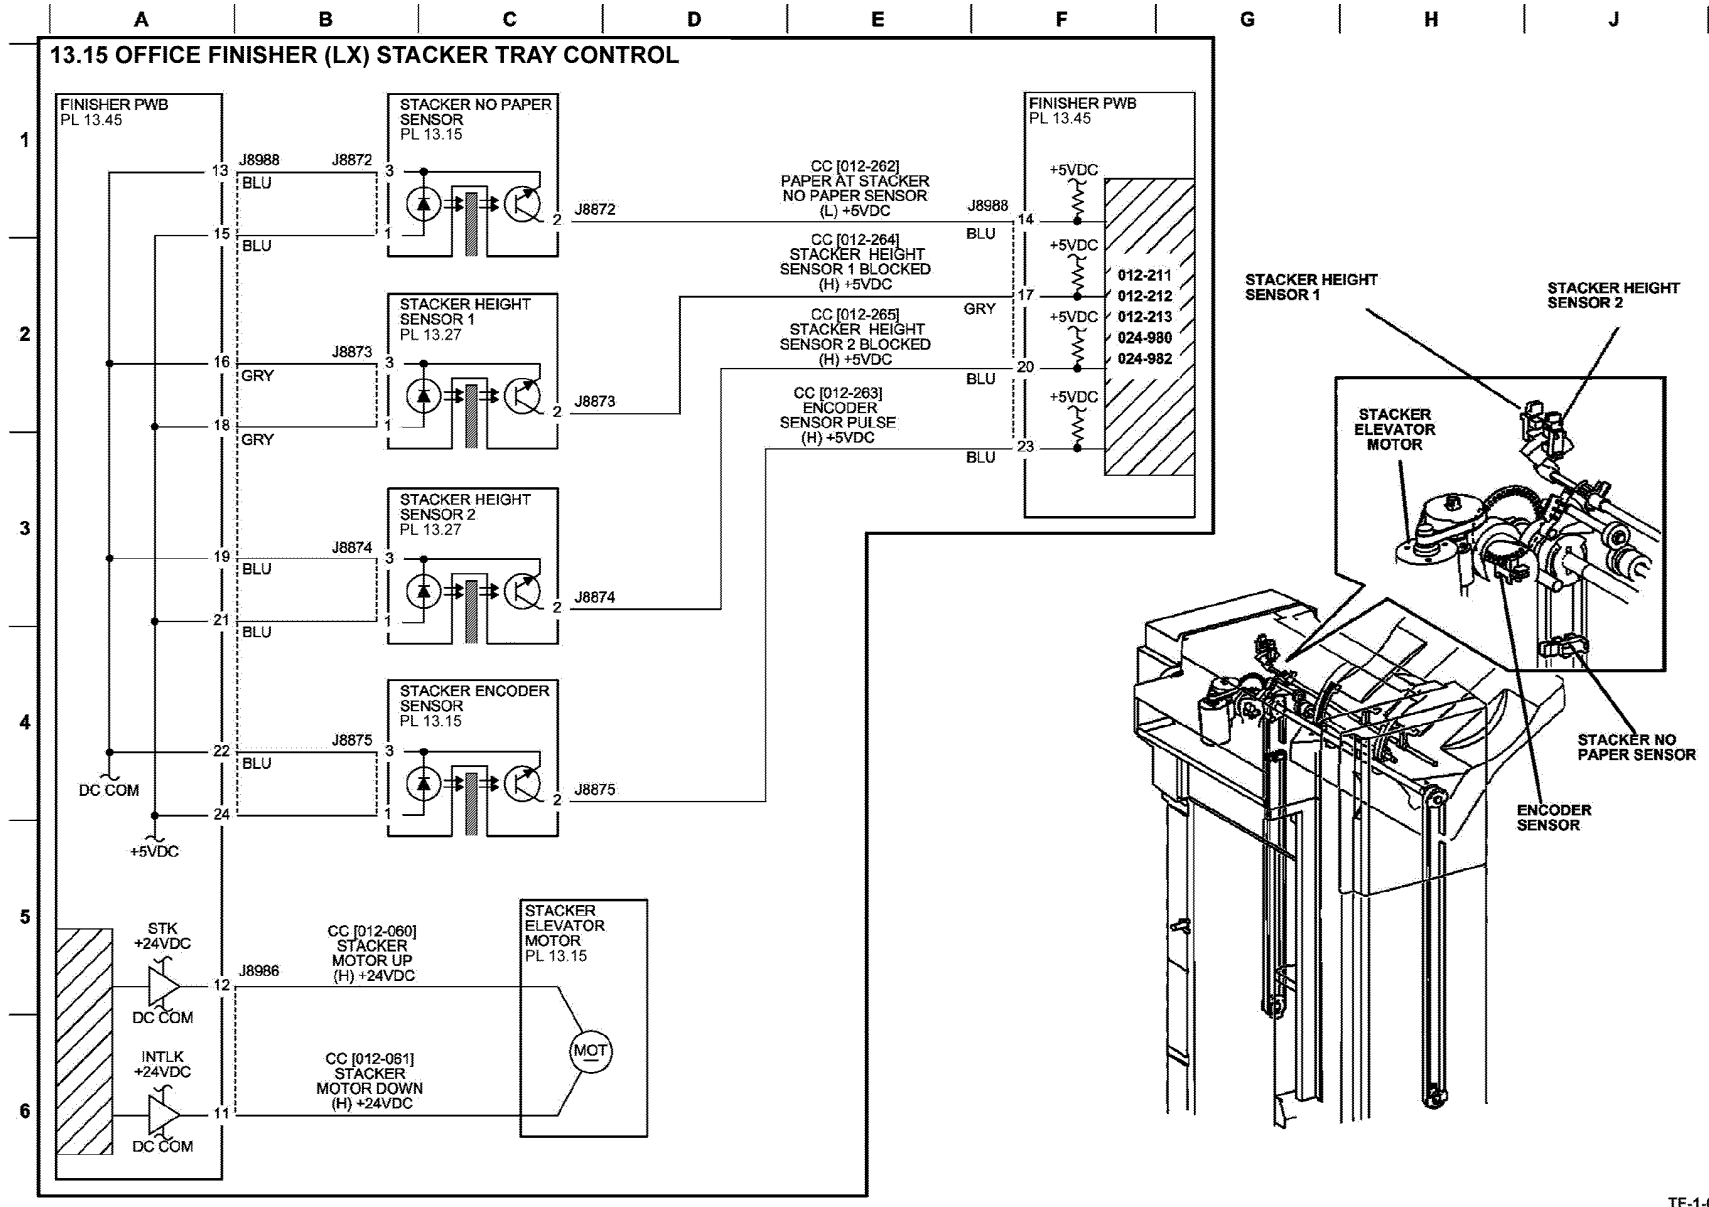
Figure 50 BSD 13.15

BSD 13.15 Office Finisher LX Stacker Tray Control

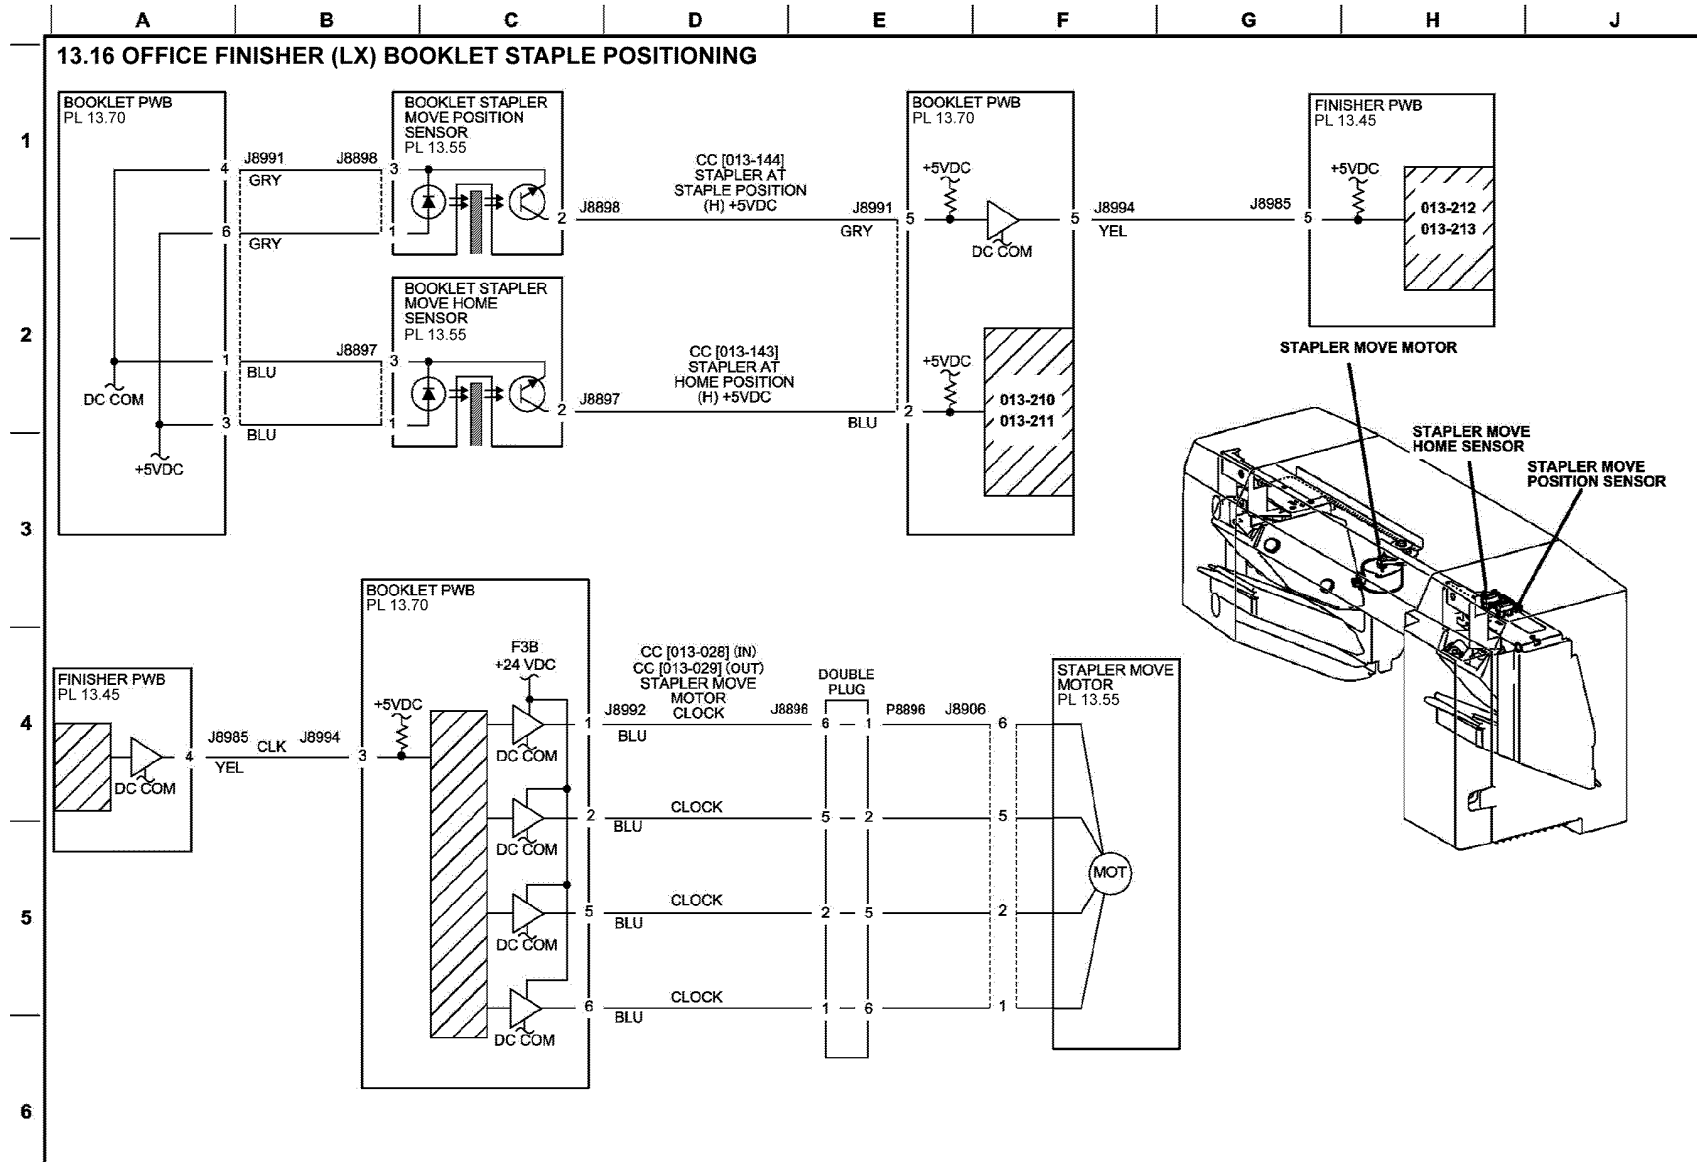
Figure 51 BSD 13.16

BSD 13.16 Office Finisher LX Booklet Staple Positioning

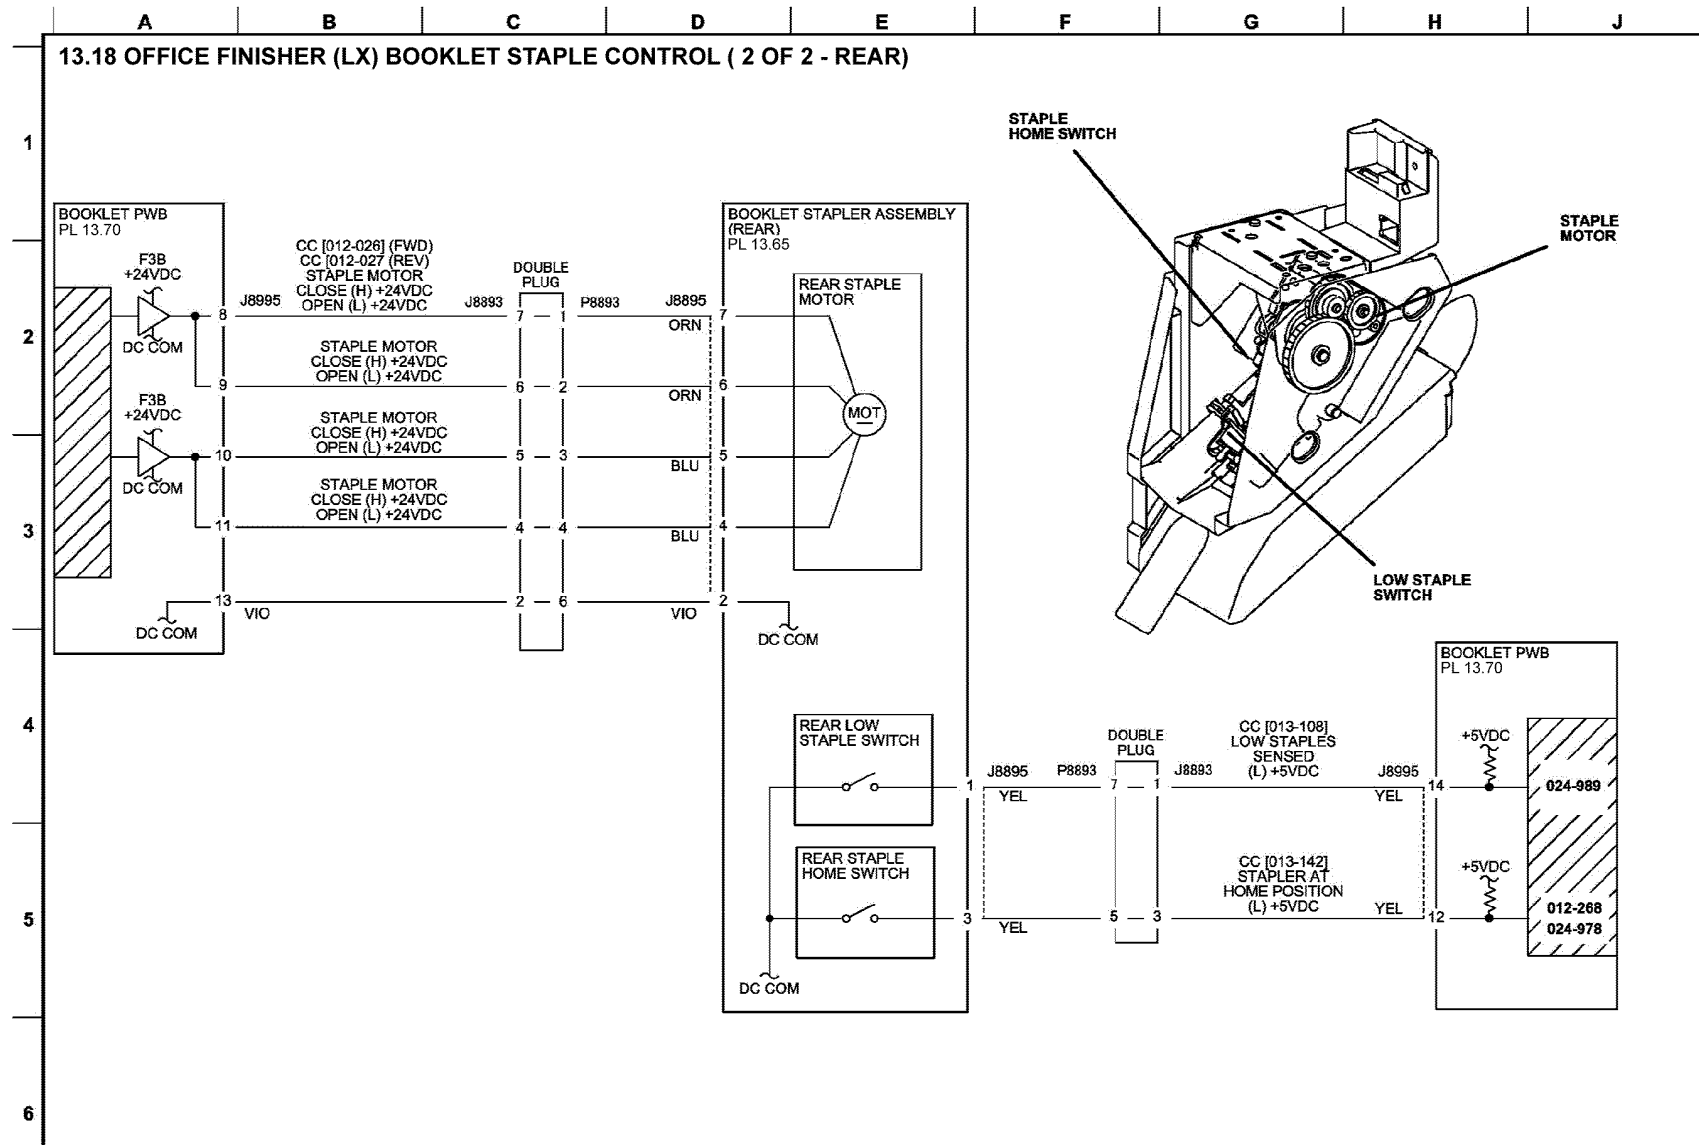
Figure 53 BSD 13.18

BSD 13.18 Office Finisher LX Booklet Staple Control (2 of 2 - Rear)

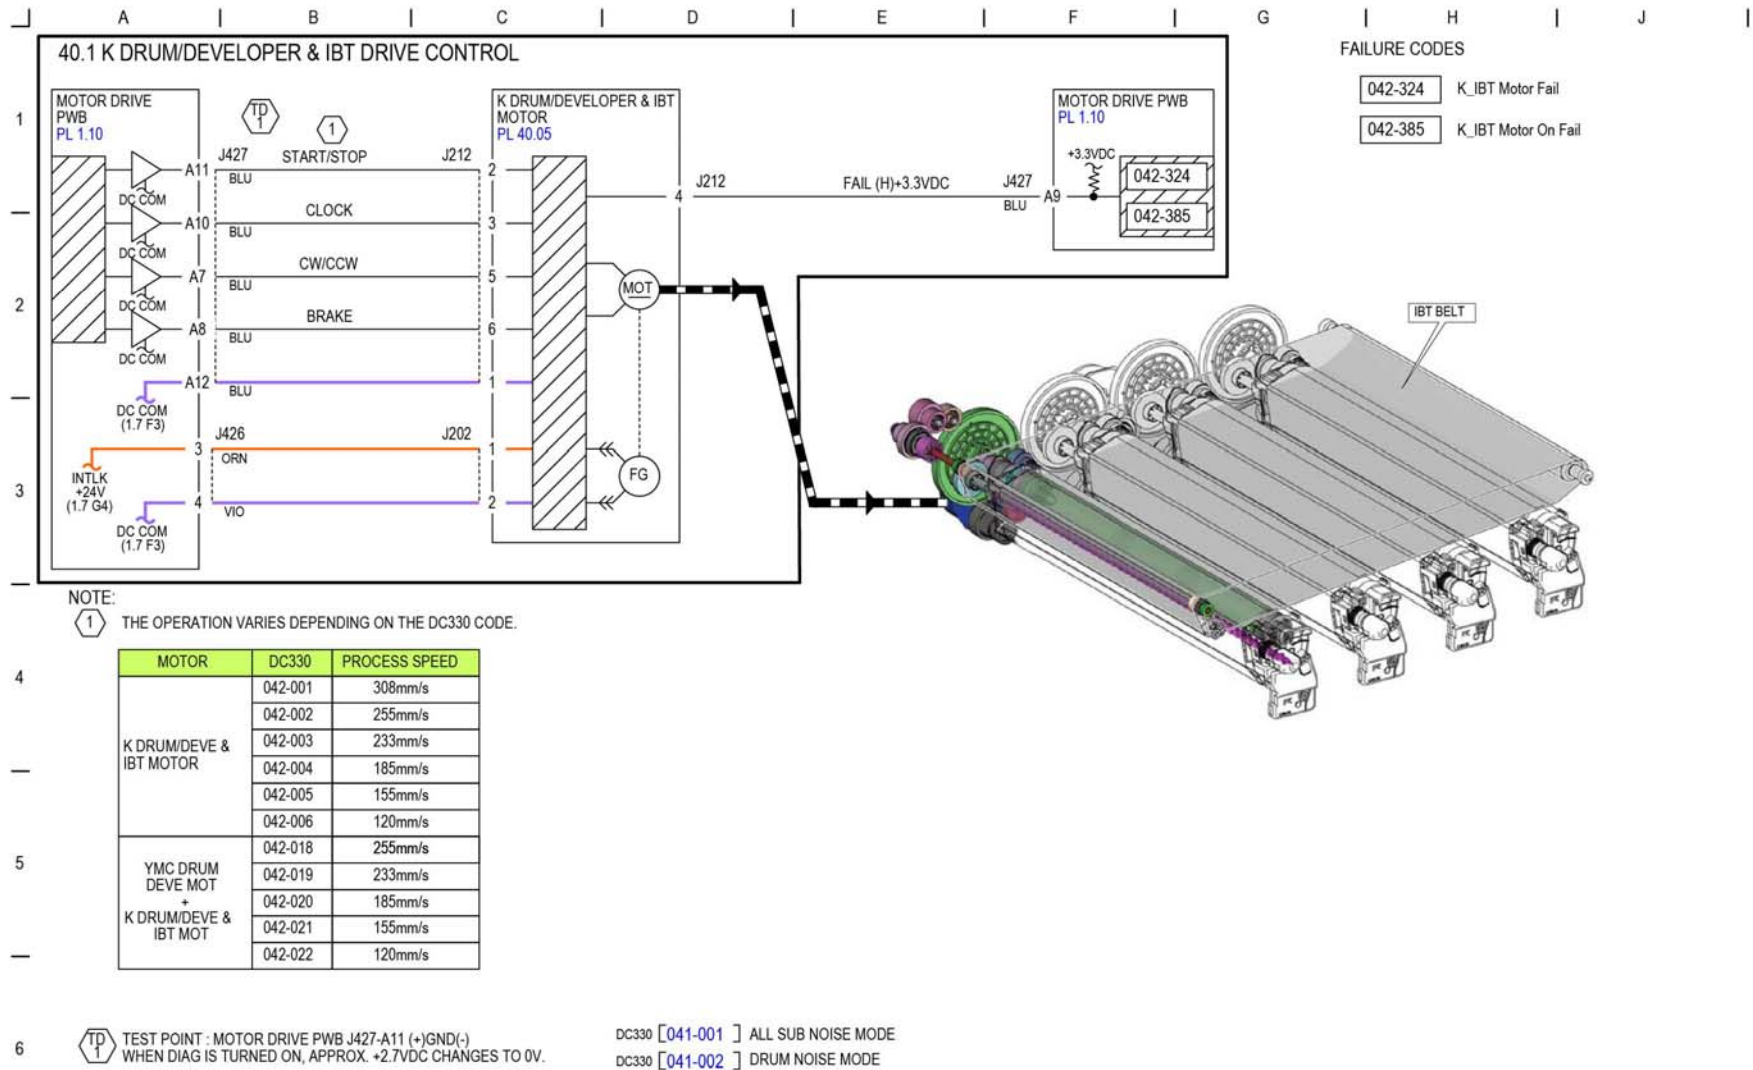
Figure 54 BSD 40.1

BSD 40.1 K Drum/Developer and IBT Drive Control

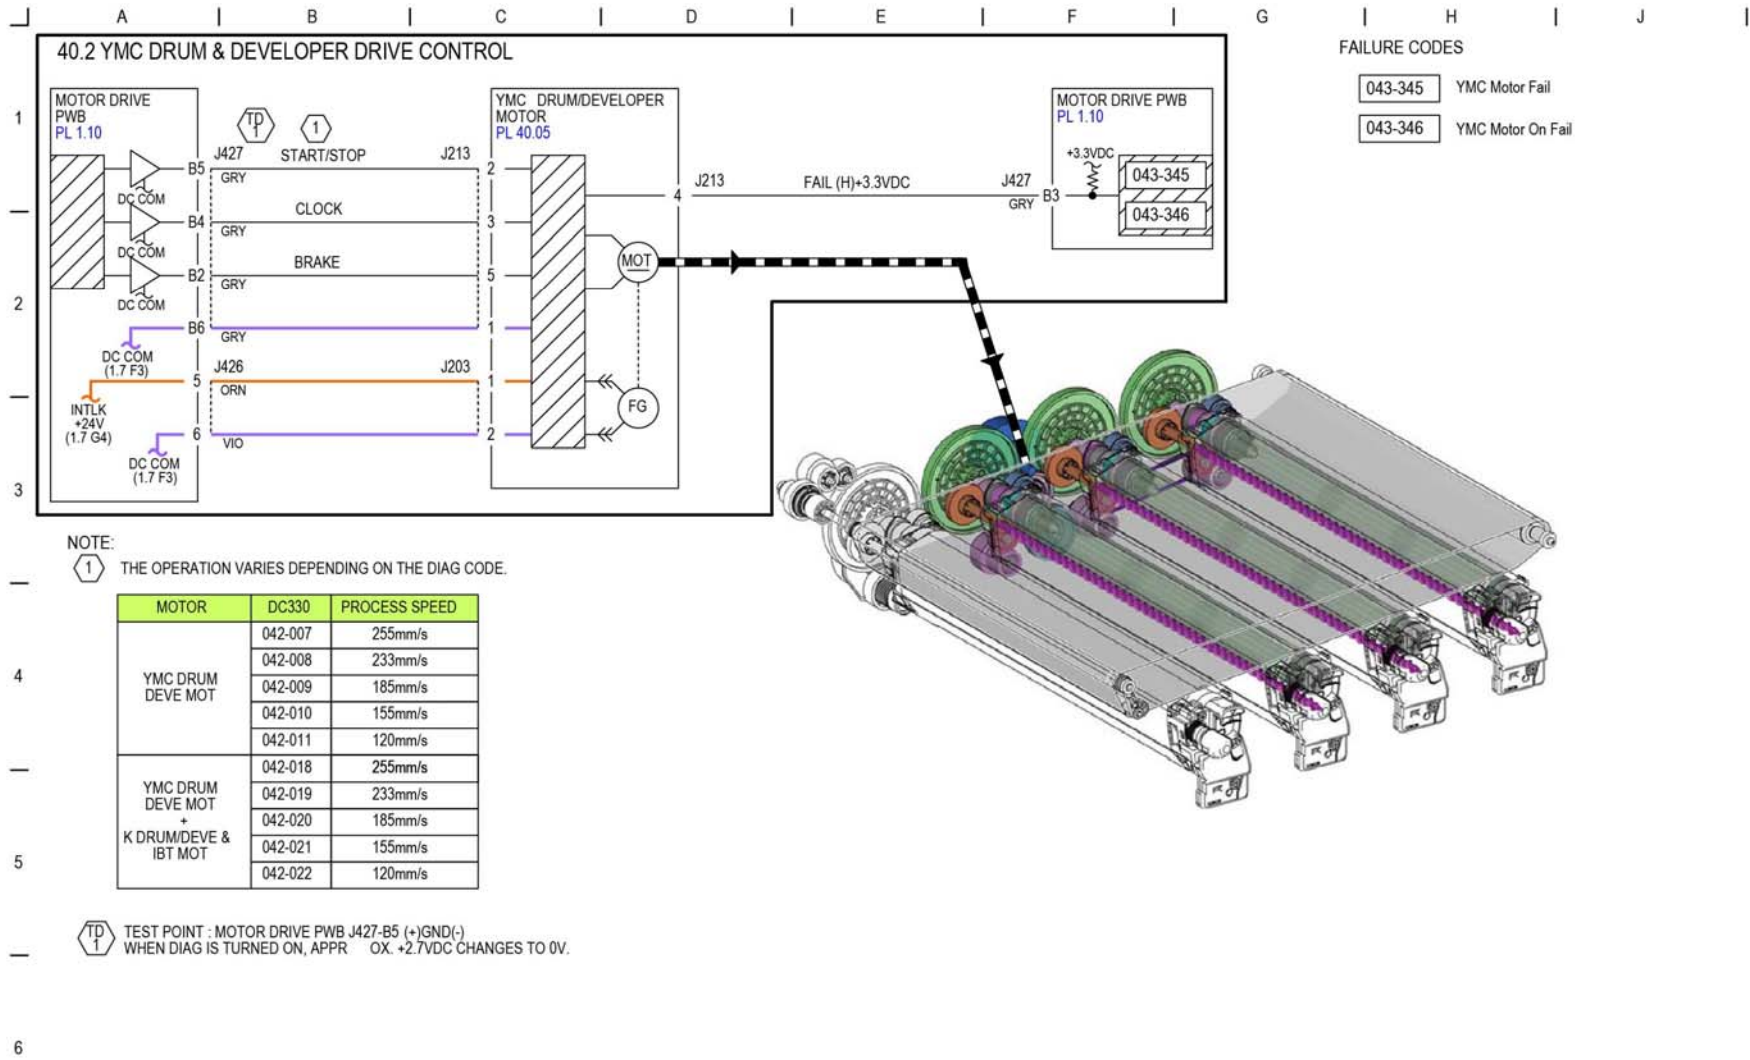
Figure 55 BSD 40.2

BSD 40.2 YMC Drum and Developer Drive Control

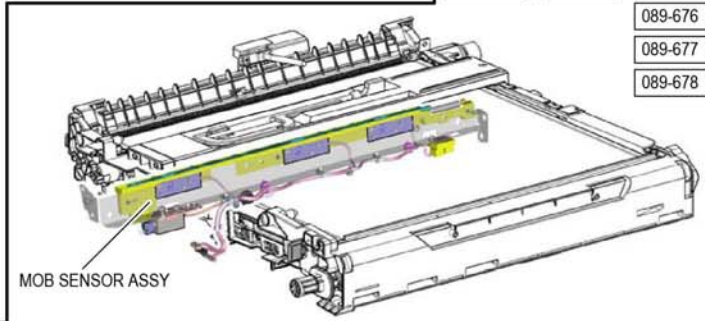
Figure 60 BSD 60.3

BSD 60.3 Color Registration

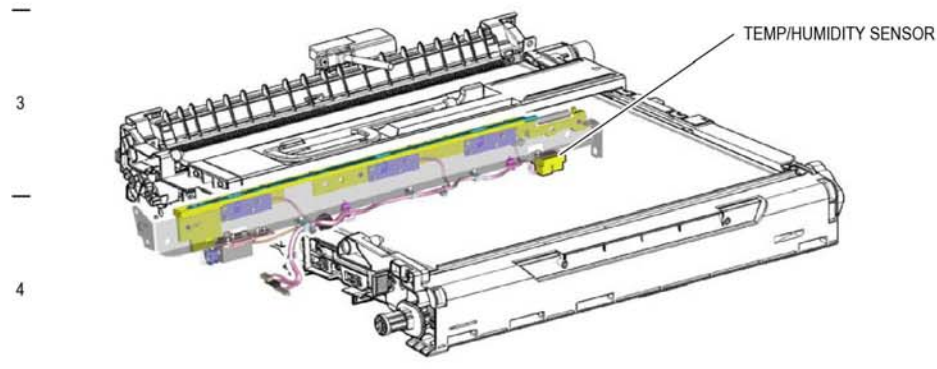
Figure 61 BSD 60.4

BSD 60.4 Temperature and Humidity Sensing

- Monitors the internal temperature and humidity sensors. If a temperature error is detected error code 041-603 is logged. If a humidity error is detected error code 041-604 is logged. Refer to [Temperature and Humidity Detection](#) and [BSD 60.4 Temperature and Humidity Sensing](#).

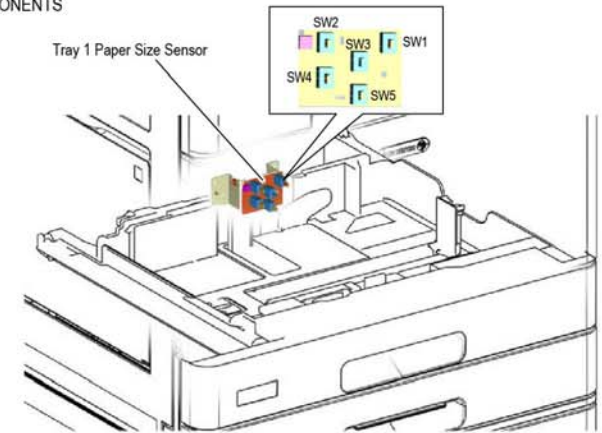
Figure 62 BSD 70.1

BSD 70.1 Tray 1 Paper Size Sensing

FAILURE CODE
071-212
 Tray 1 Paper Size Sensor Broken

② DC140[071-200] displays AD Value from Tray 1 Paper Size Sensor. Normally, the value is in the following output range:
 • Normal output range : 0-989
 • 11"x17" : 0-63
 • A5SEF : 797-857
 • Tray not installed : 922-989

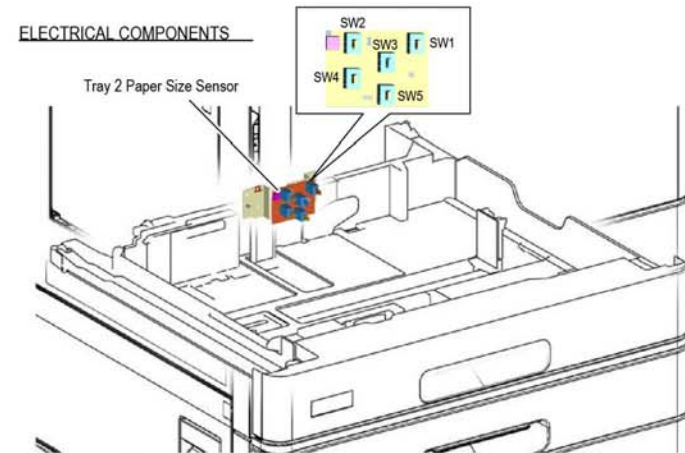
Figure 63 BSD 70.2

BSD 70.2 Tray 2 Paper Size Sensing

FAILURE CODE
072-212
Tray 2 Paper Size
Sensor Broken

NOTE: ¹ Paper size is sensed by voltage corresponding to combined resistance of Paper Size Sensor and SW5 On/Off. The table below shows the relation between paper size and combination of Switch ON/OFF pattern, voltage and AD value. (Any combination other than the ones below results in an undetermined size.)

² DC140[072-200] displays AD Value from Tray 2 Paper Size Sensor. Normally, the value is in the following output range:

- Normal output range : 0-989
- 11"x17" : 0-63
- A5SEF : 797-857
- Tray not installed : 922-989

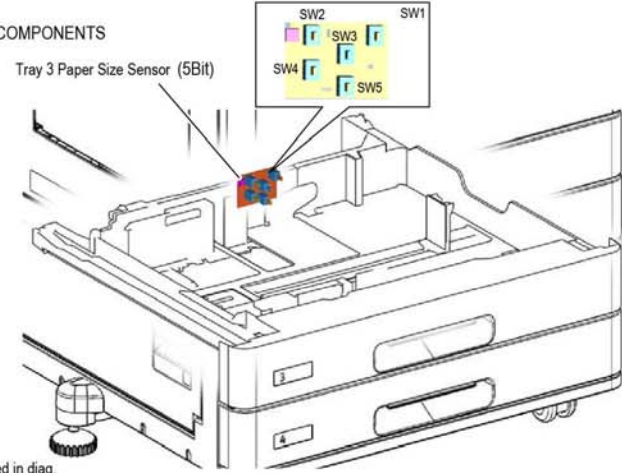
Figure 64 BSD 70.3

BSD 70.3 Tray 3 Paper Size Sensing (2TM)

FAILURE CODE
073-212
 Tray 3 Paper Size Sensor Broken

3 Actual voltage level is opposite to H/L displayed on UI for this diag code. On BSD the actual volt level is shown.

2 DC140[073-200] displays AD Value from Tray 3 Paper Size Sensor. Normally, the value is in the following output range:
 • Normal output range : 0-989
 • 11"x17" : 0-63
 • A5SEF : 797-857
 • Tray not installed : 922-989

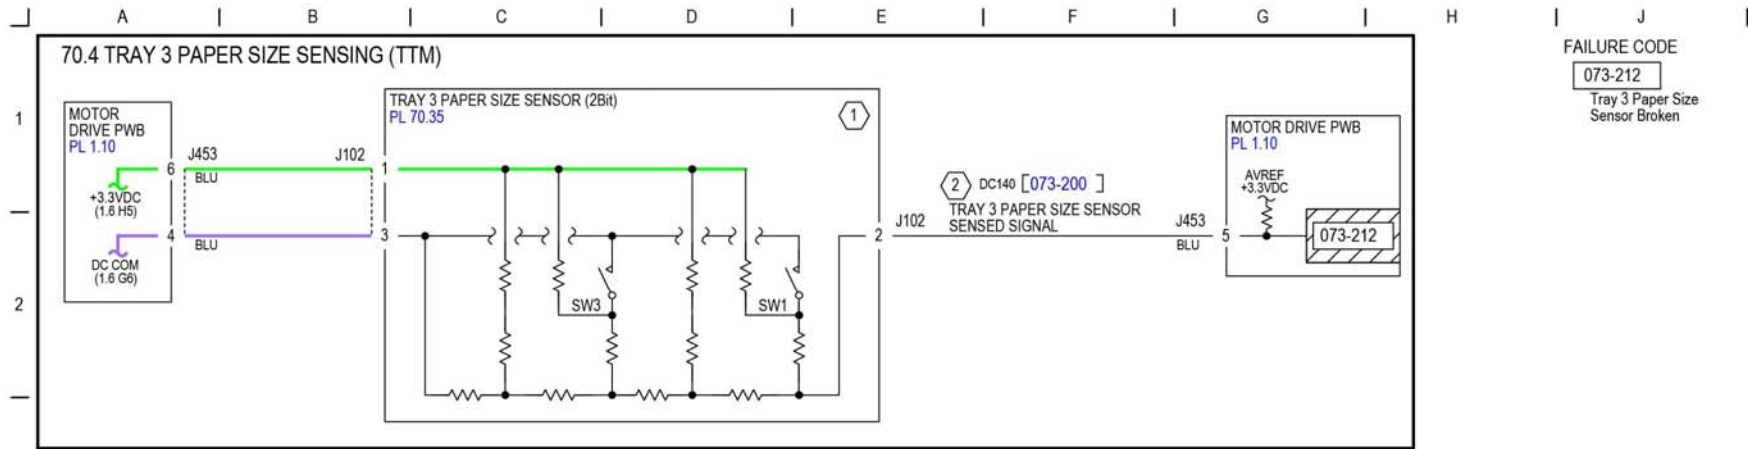
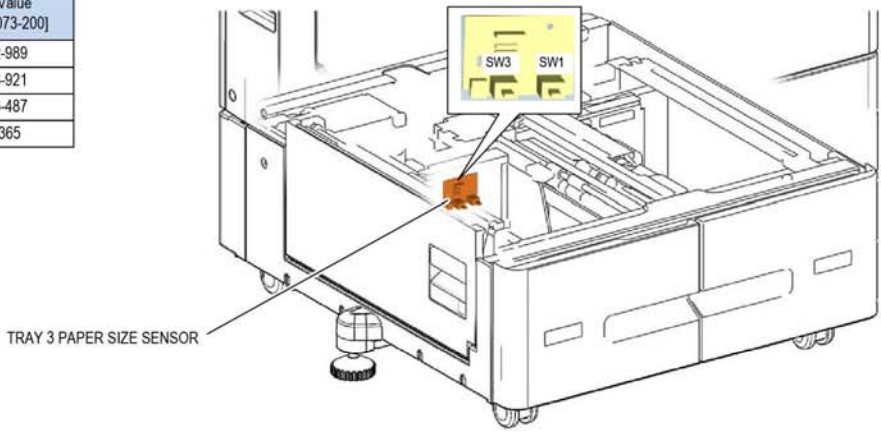
Figure 65 BSD 70.4

BSD 70.4 Tray 3 Paper Size Sensing (TTM)

FAILURE CODE
073-212
 Tray 3 Paper Size
 Sensor Broken

NOTE: ① Paper size is sensed by voltage corresponding to combined resistance of Paper Size Sensor. The table below shows the relation between paper size and combination of Switch ON/OFF pattern, voltage and AD value. (Any combination other than the ones below results in an undetermined size.)

② DC140[073-200] displays AD Value from Tray 3 Paper Size Sensor. Normally, the value is in the following output range.
 • Normal output range : 0-989
 • A4LEF : 0-365
 • 8.5"×11" : 366-487
 • B5LEF : 488-921
 • Tray not installed : 922-989

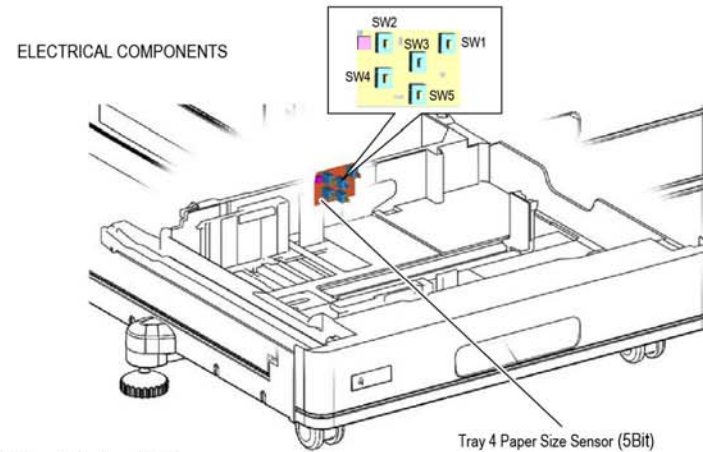
Figure 66 BSD 70.5

BSD 70.5 Tray 4 Paper Size Sensing (2TM)

FAILURE CODE
074-212
 Tray 4 Paper Size Sensor Broken

3 Actual voltage level is opposite to H/L displayed on UI for this diag code. On BSD the actual volt level is shown.

8.5"x11"L	ON	ON	ON	OFF	OFF	0.300±0.066	64-123
16KL(*2)/7.25"x10.5"L(*1)	ON	ON	ON	OFF	ON		
11"x17"S	ON	ON	ON	ON	ON	0.106±0.066	0-63

2 DC140[074-200] displays AD Value from Tray 4 Paper Size Sensor. Normally, the value is in the following output range:
 • Normal output range : 0-989
 • 11"x17" : 0-63
 • A5SEF : 797-857
 • Tray not installed : 922-989

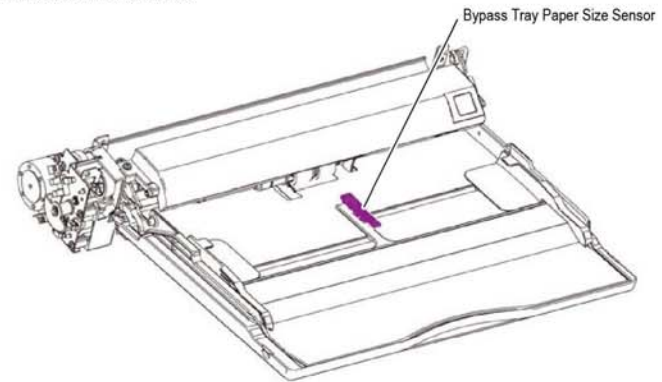
Figure 68 BSD 70.7

BSD 70.7 Bypass Tray Paper Size Sensing

NOTE: ① Paper width (size in fast scan direction) is sensed by voltage corresponding to the Bypass Tray Paper Size Sensor resistance. As to MSI, AD values corresponding to paper sizes (widths) vary depending on the machine because when the Bypass Tray is installed on IOT before shipment, Bypass Tray Size Sensing is adjusted in diagnostics. The values below are for reference.

② DC140[075-200] displays AD Value from Bypass Tray Paper Size Sensor. Normally, the value is in the following output range:
 • Normal output range : 86-966 (Nominal)
 51-1023 (NVM range)
 • Abnormal range : Constant and within the NVN range above.

Ref. Paper length (size in slow scan direction) is sensed by timing how long paper takes to pass the Registration Sensor.

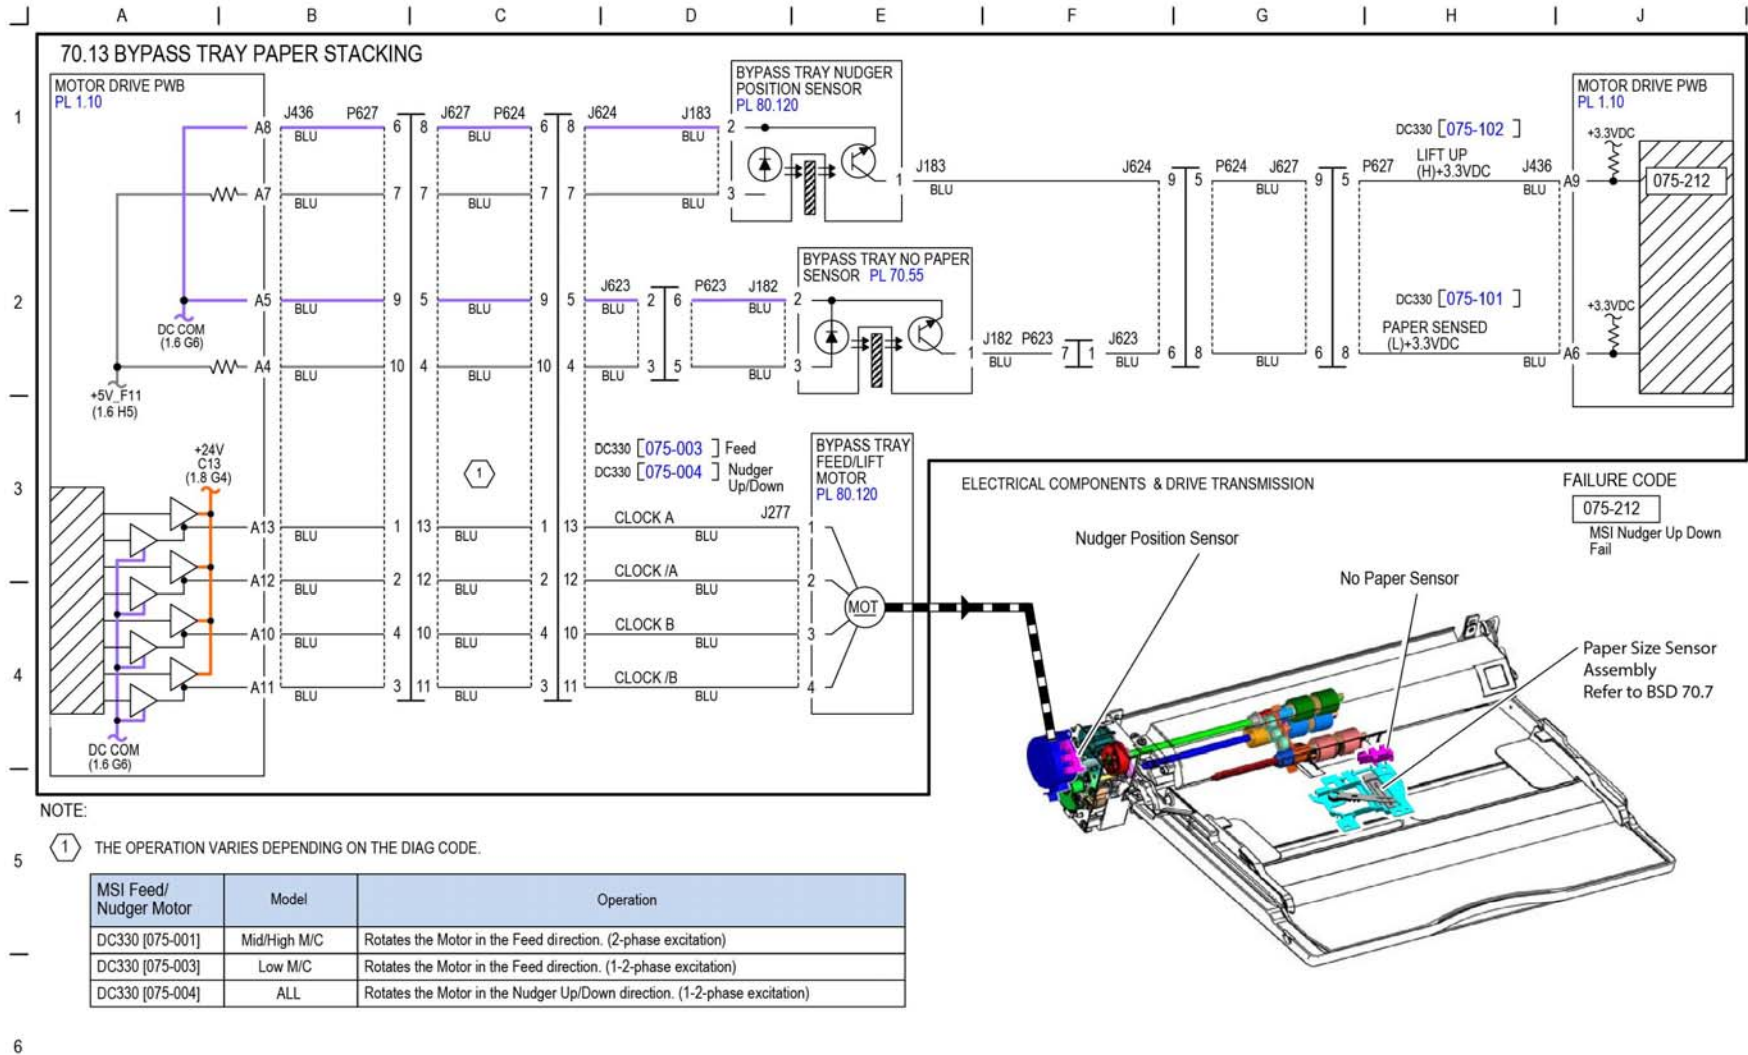
Figure 74 BSD 70.13

BSD 70.13 Bypass Tray Paper Sensing and Stacking

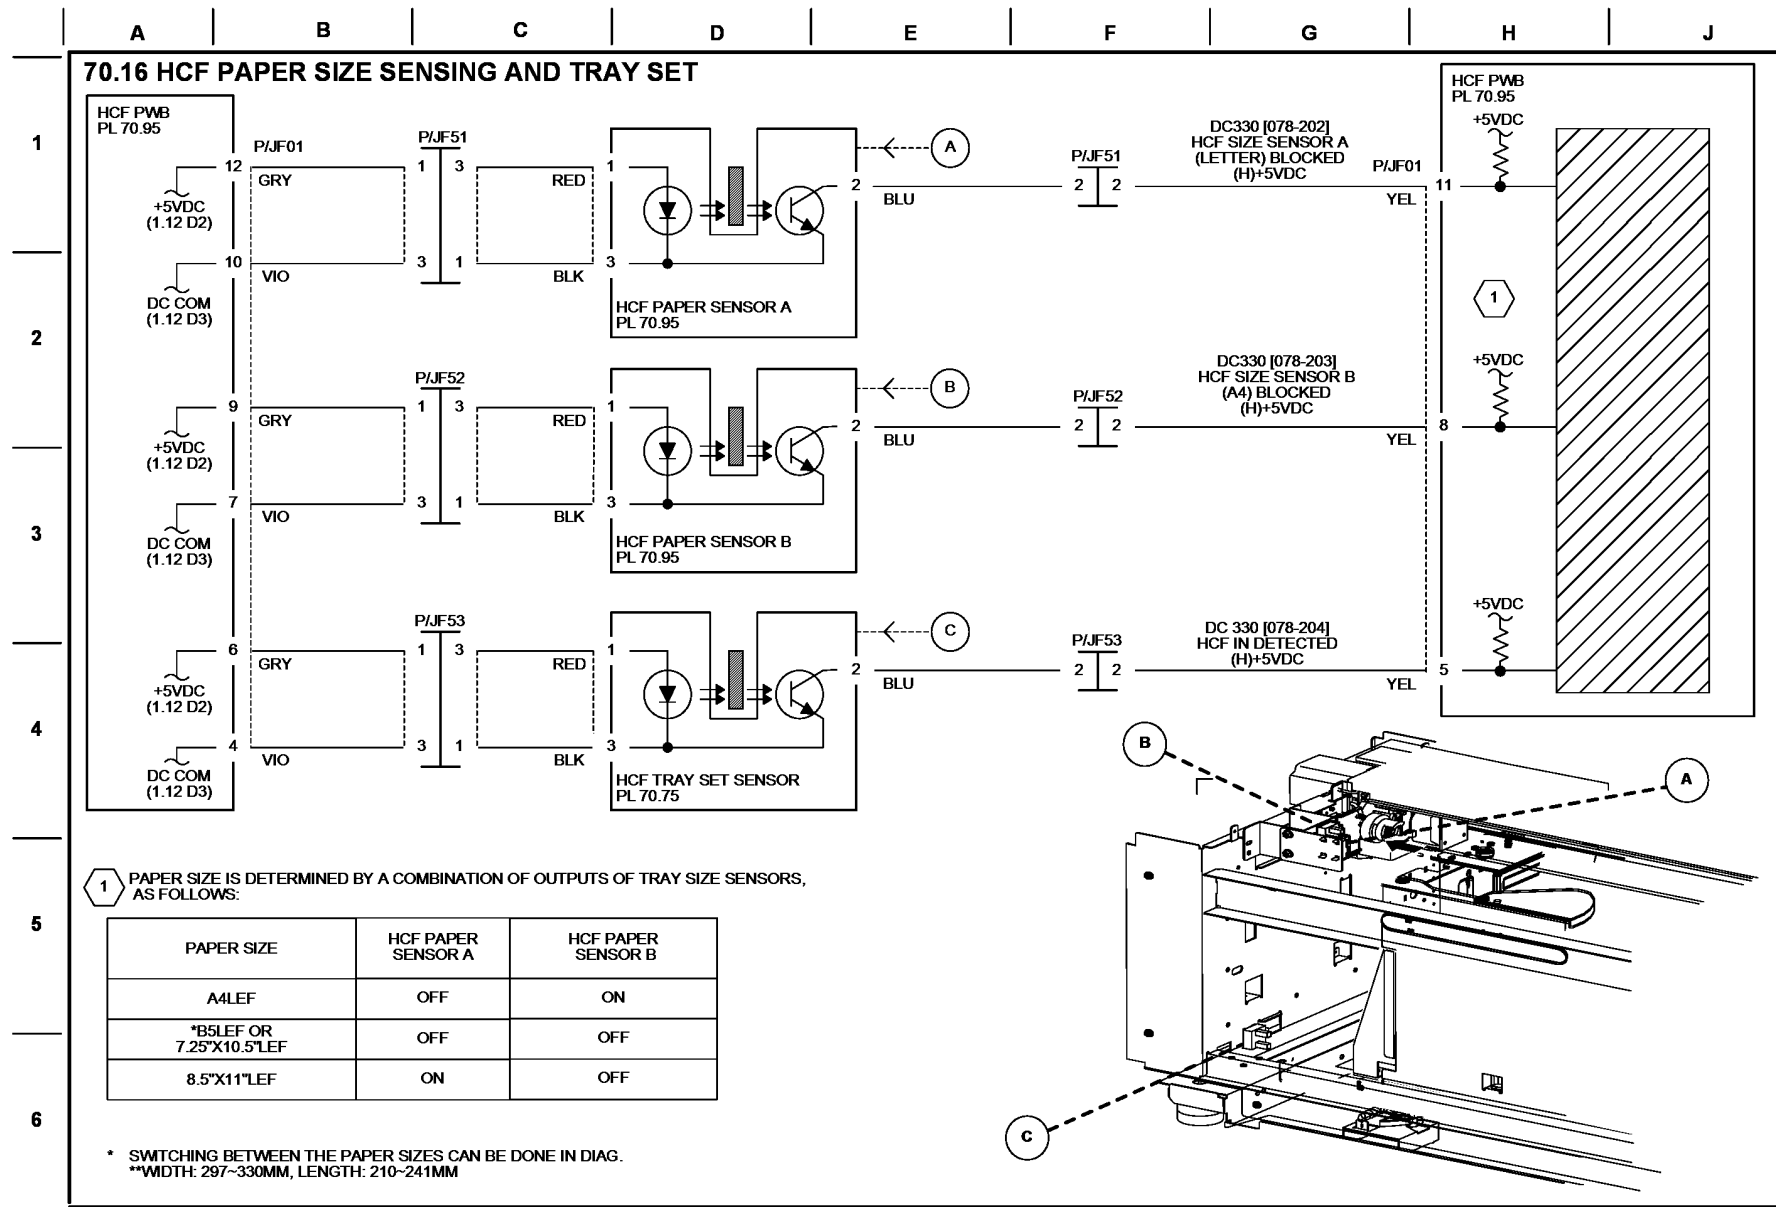
Figure 77 BSD 70.16

BSD 70.16 HCF Paper Size Sensing and Tray Set

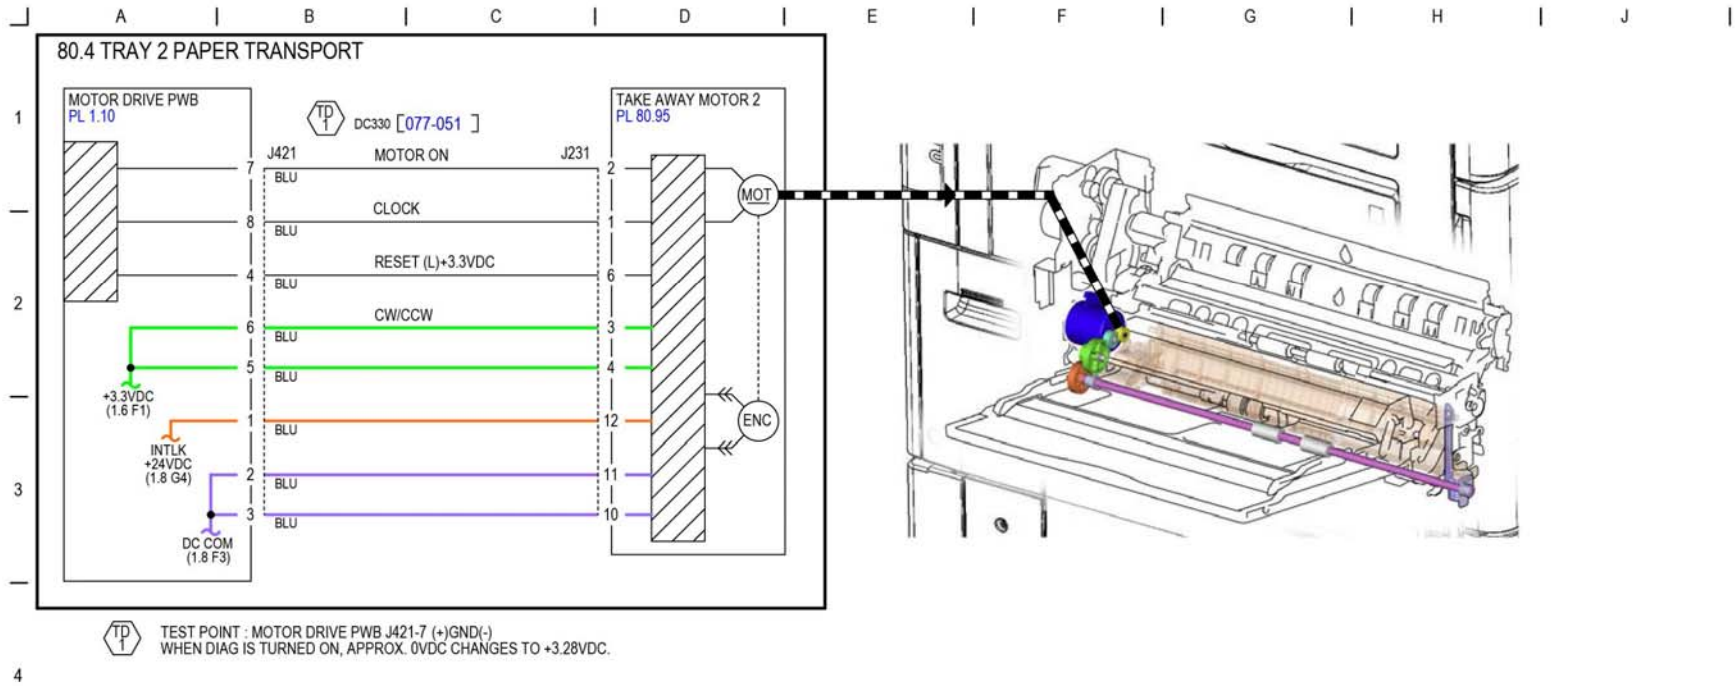
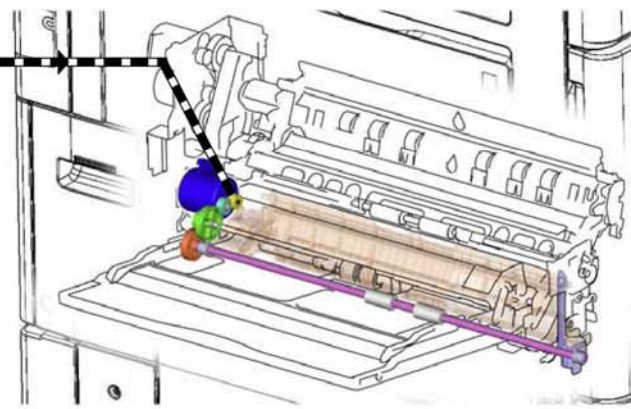
Figure 82 BSD 80.4

BSD 80.4 Tray 2 Paper Transport

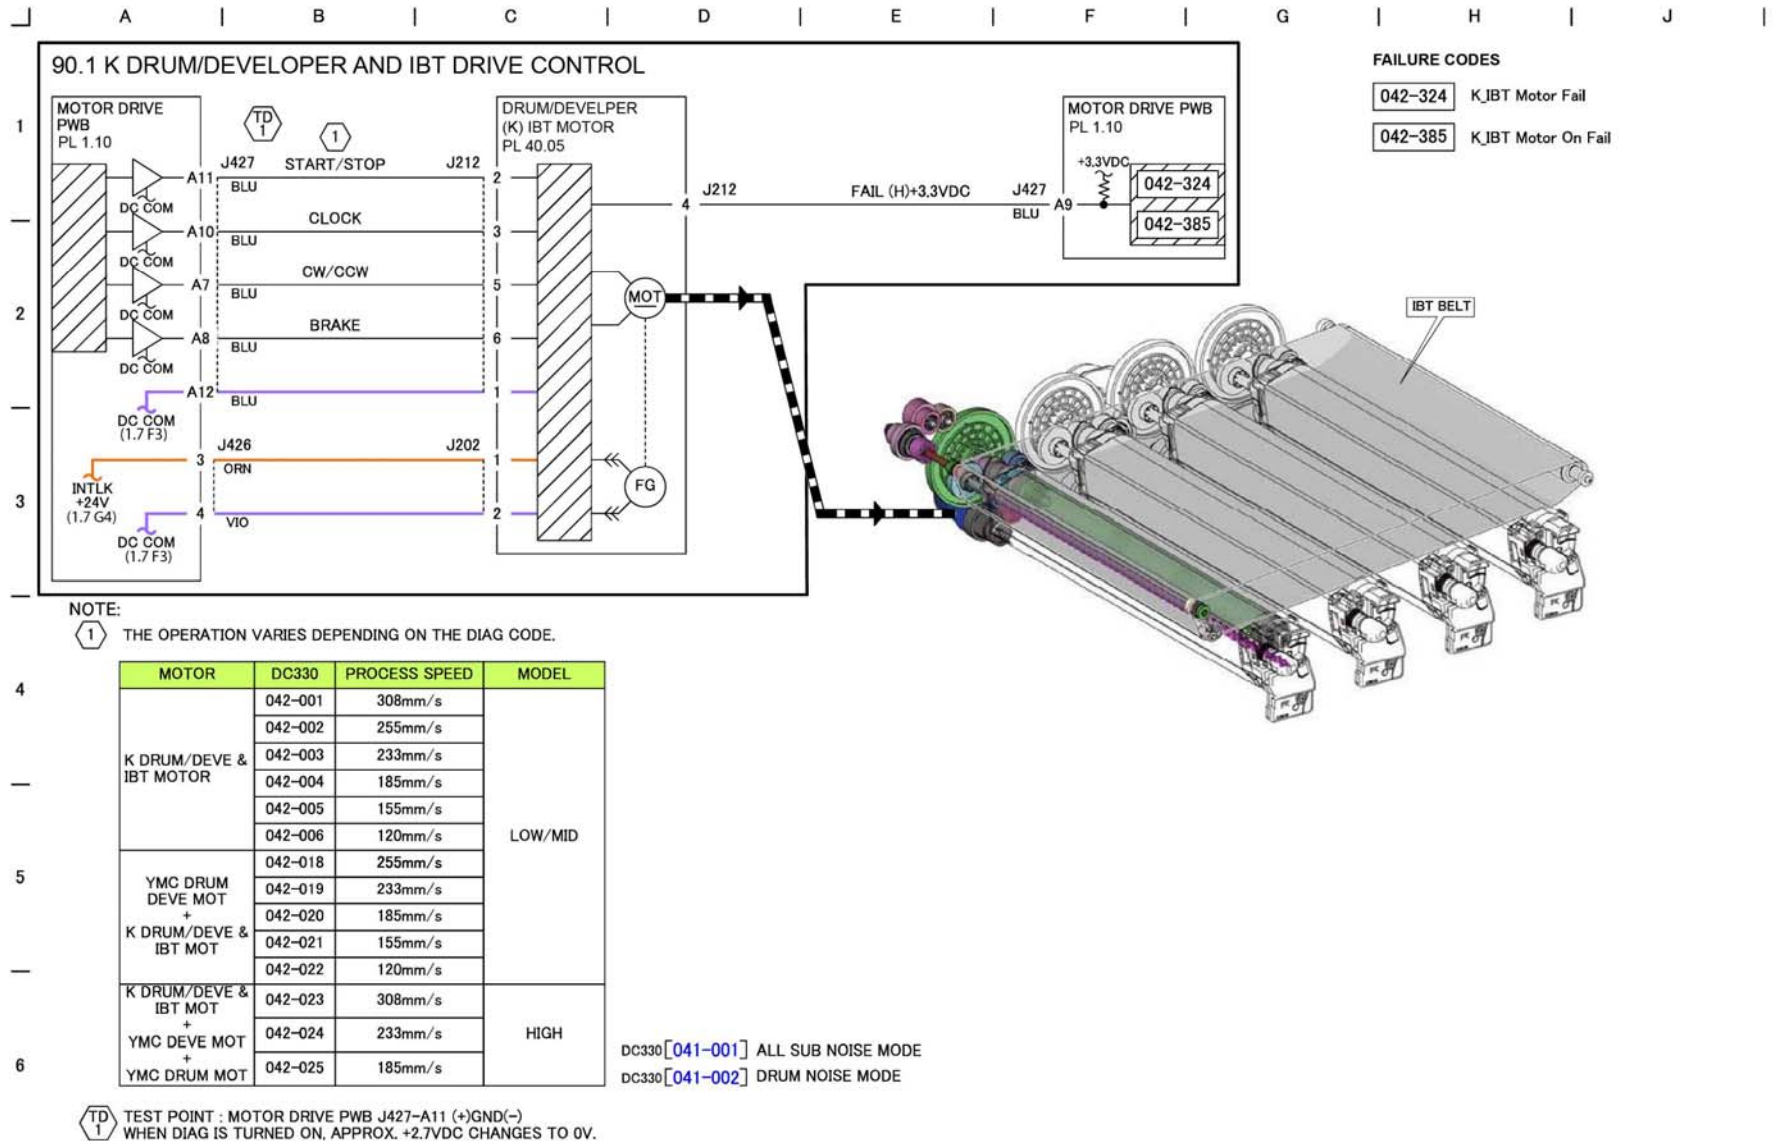
Figure 88 BSD 90.1

BSD 90.1 K Drum/Developer and IBT Drive Control

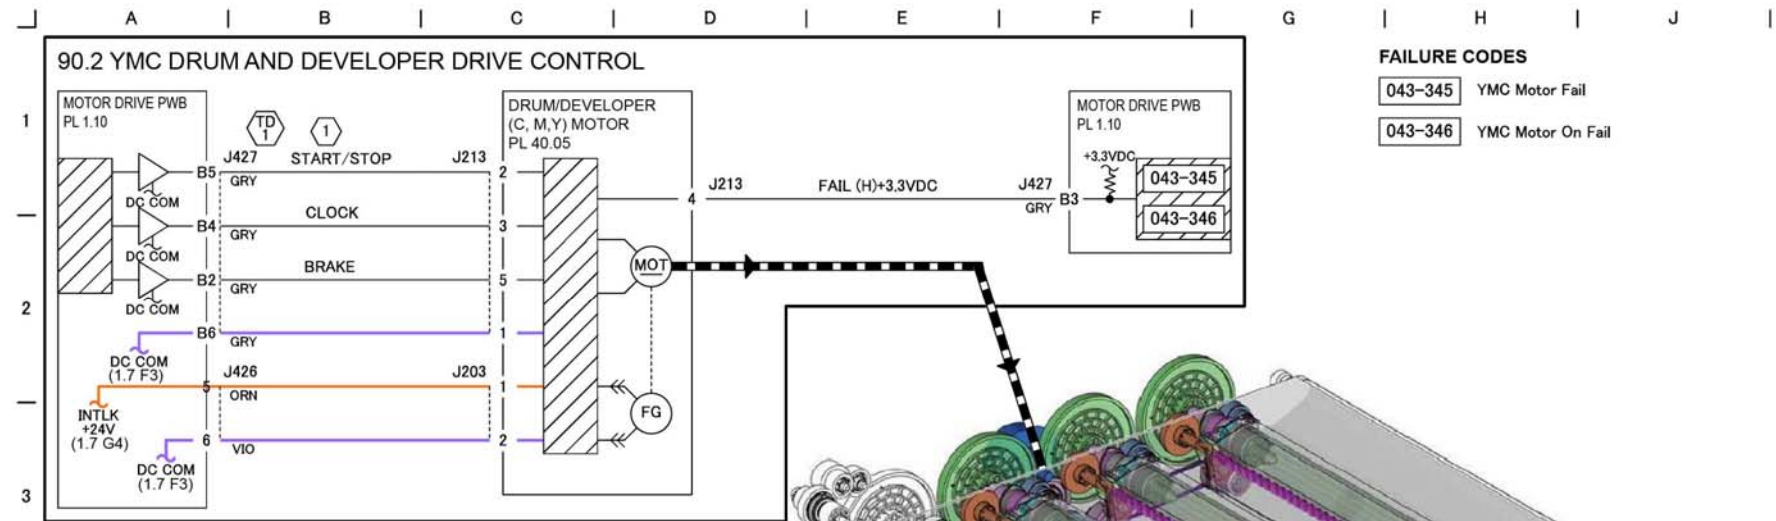
Figure 89 BSD 90.2

BSD 90.2 YMC Drum and Developer Drive Control

FAILURE CODES
 043-345 YMC Motor Fail
 043-346 YMC Motor On Fail

NOTE:
 ① THE OPERATION VARIES DEPENDING ON THE DIAG CODE.
