VersaLink[®] C8000/C9000 Printer

Service Manual

VersaLink C9000 Family Service Manual

705P01418

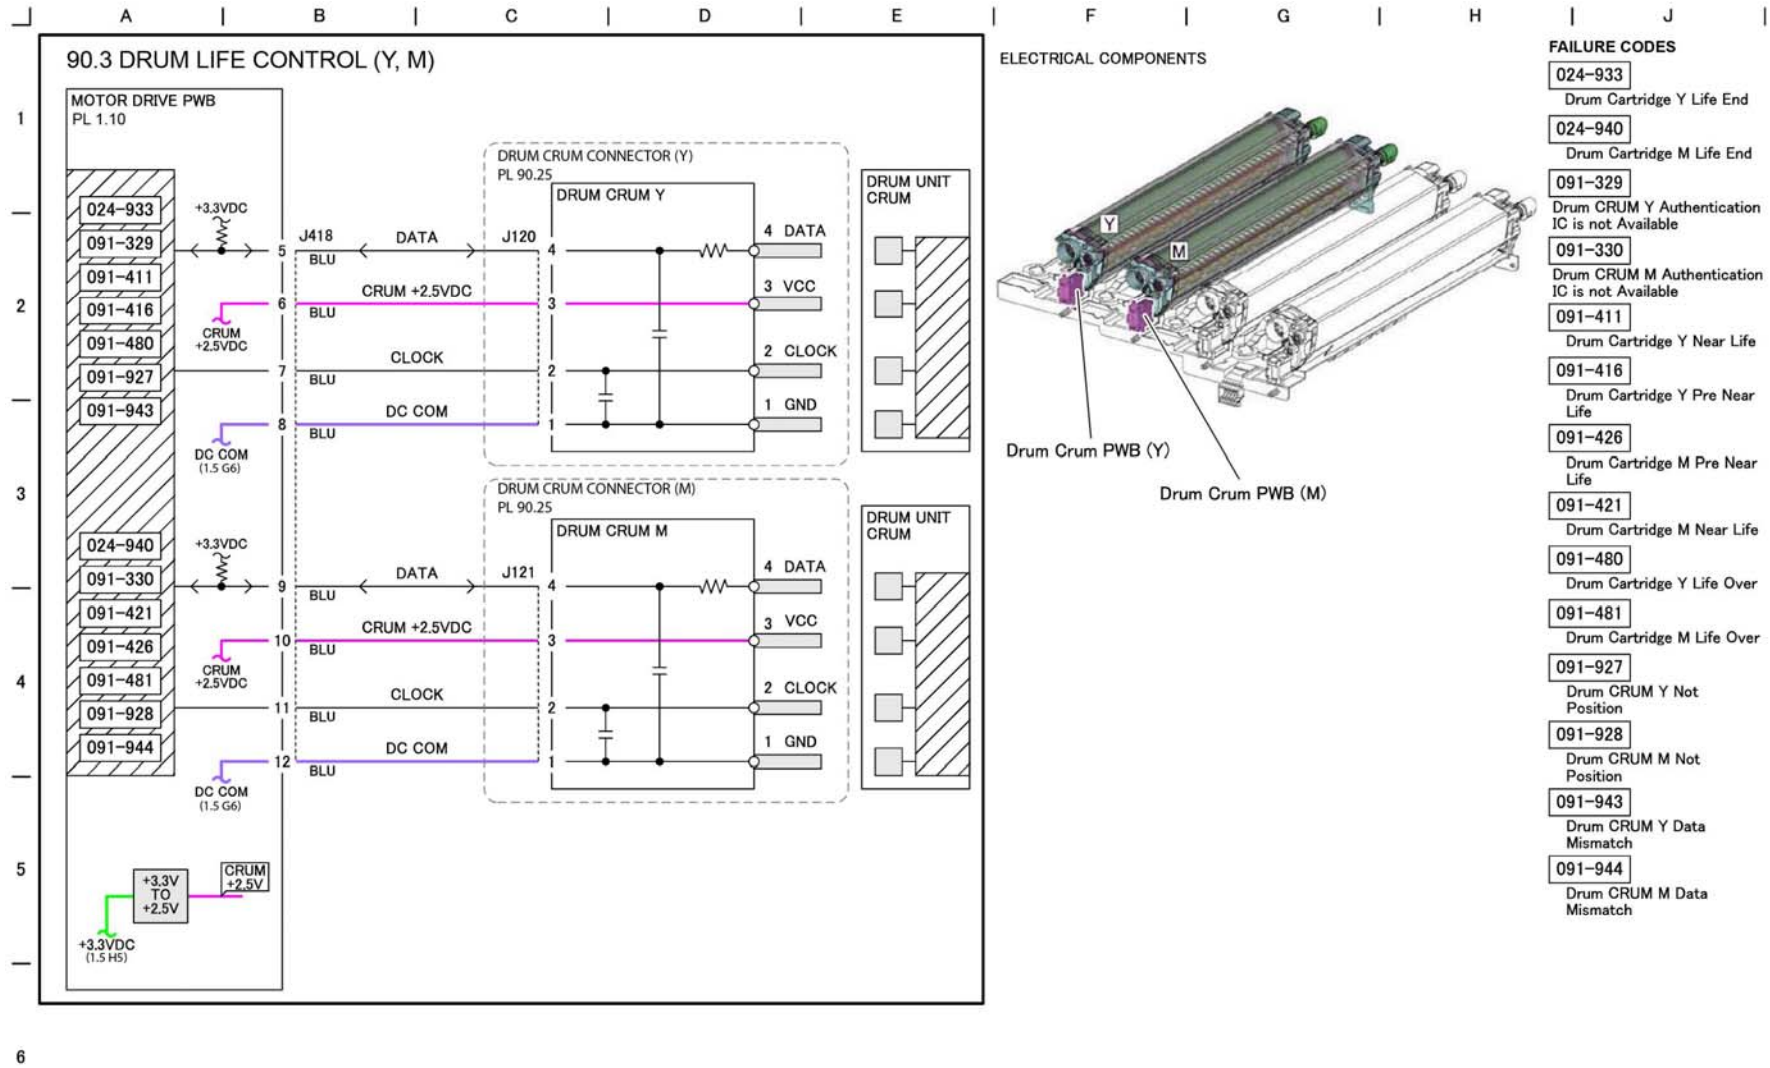
Figure 90 BSD 90.3

BSD 90.3 Drum Life Control (Y, M)

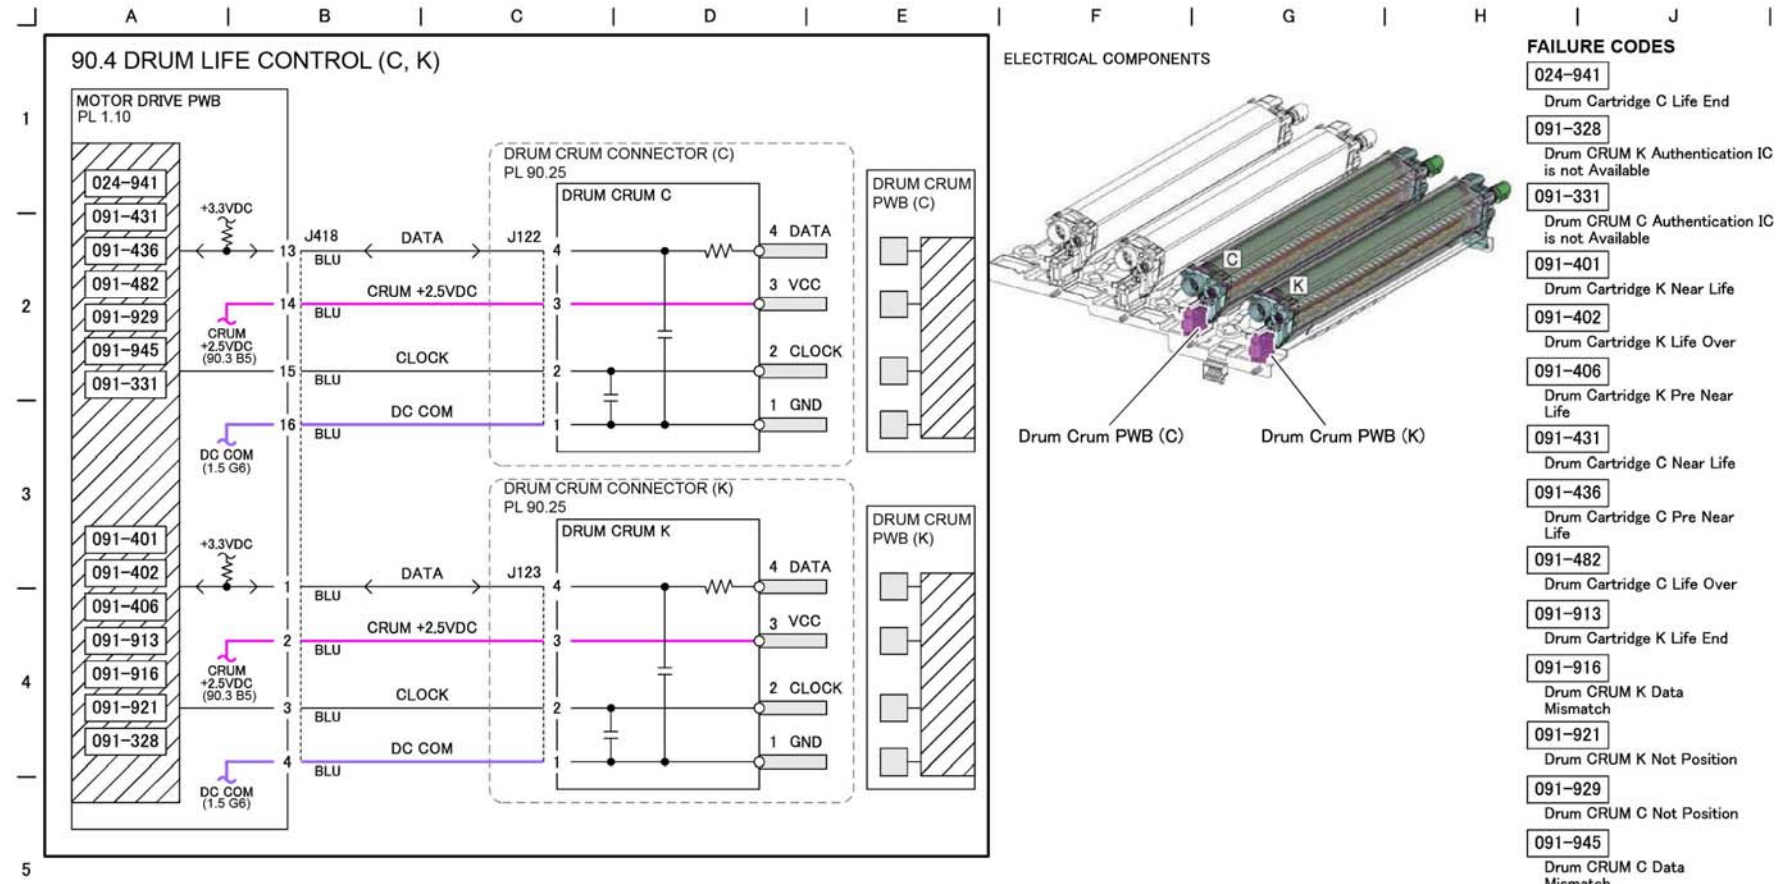
Figure 91 BSD 90.4

BSD 90.4 Drum Life Control (C, K)

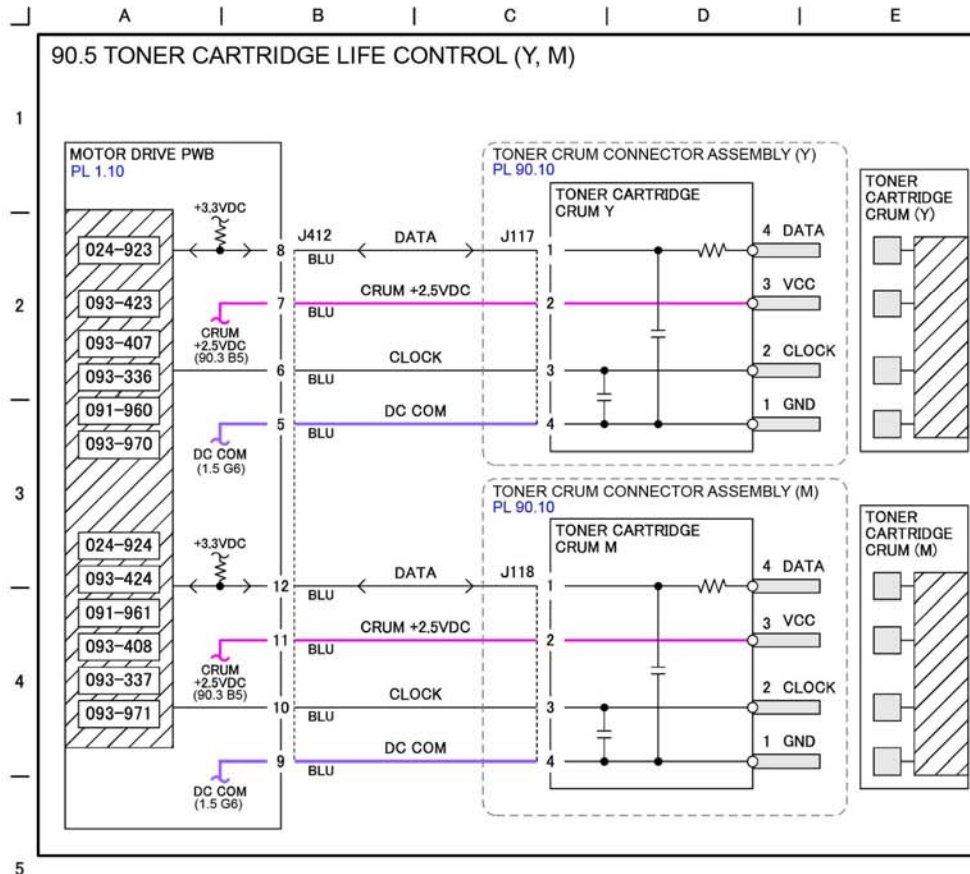
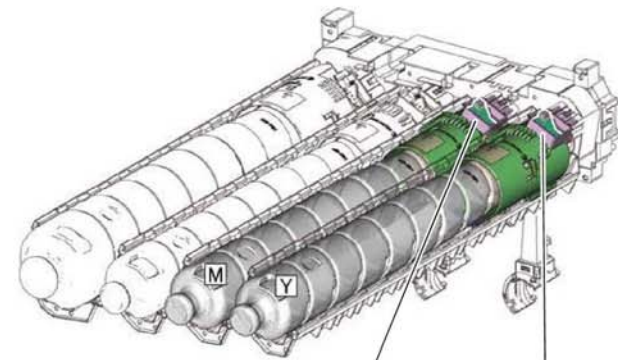
Figure 92 BSD 90.5

BSD 90.5 Toner Cartridge Life Control (Y, M)

Toner Cartridge Crum (M)
Toner Cartridge Crum (Y)

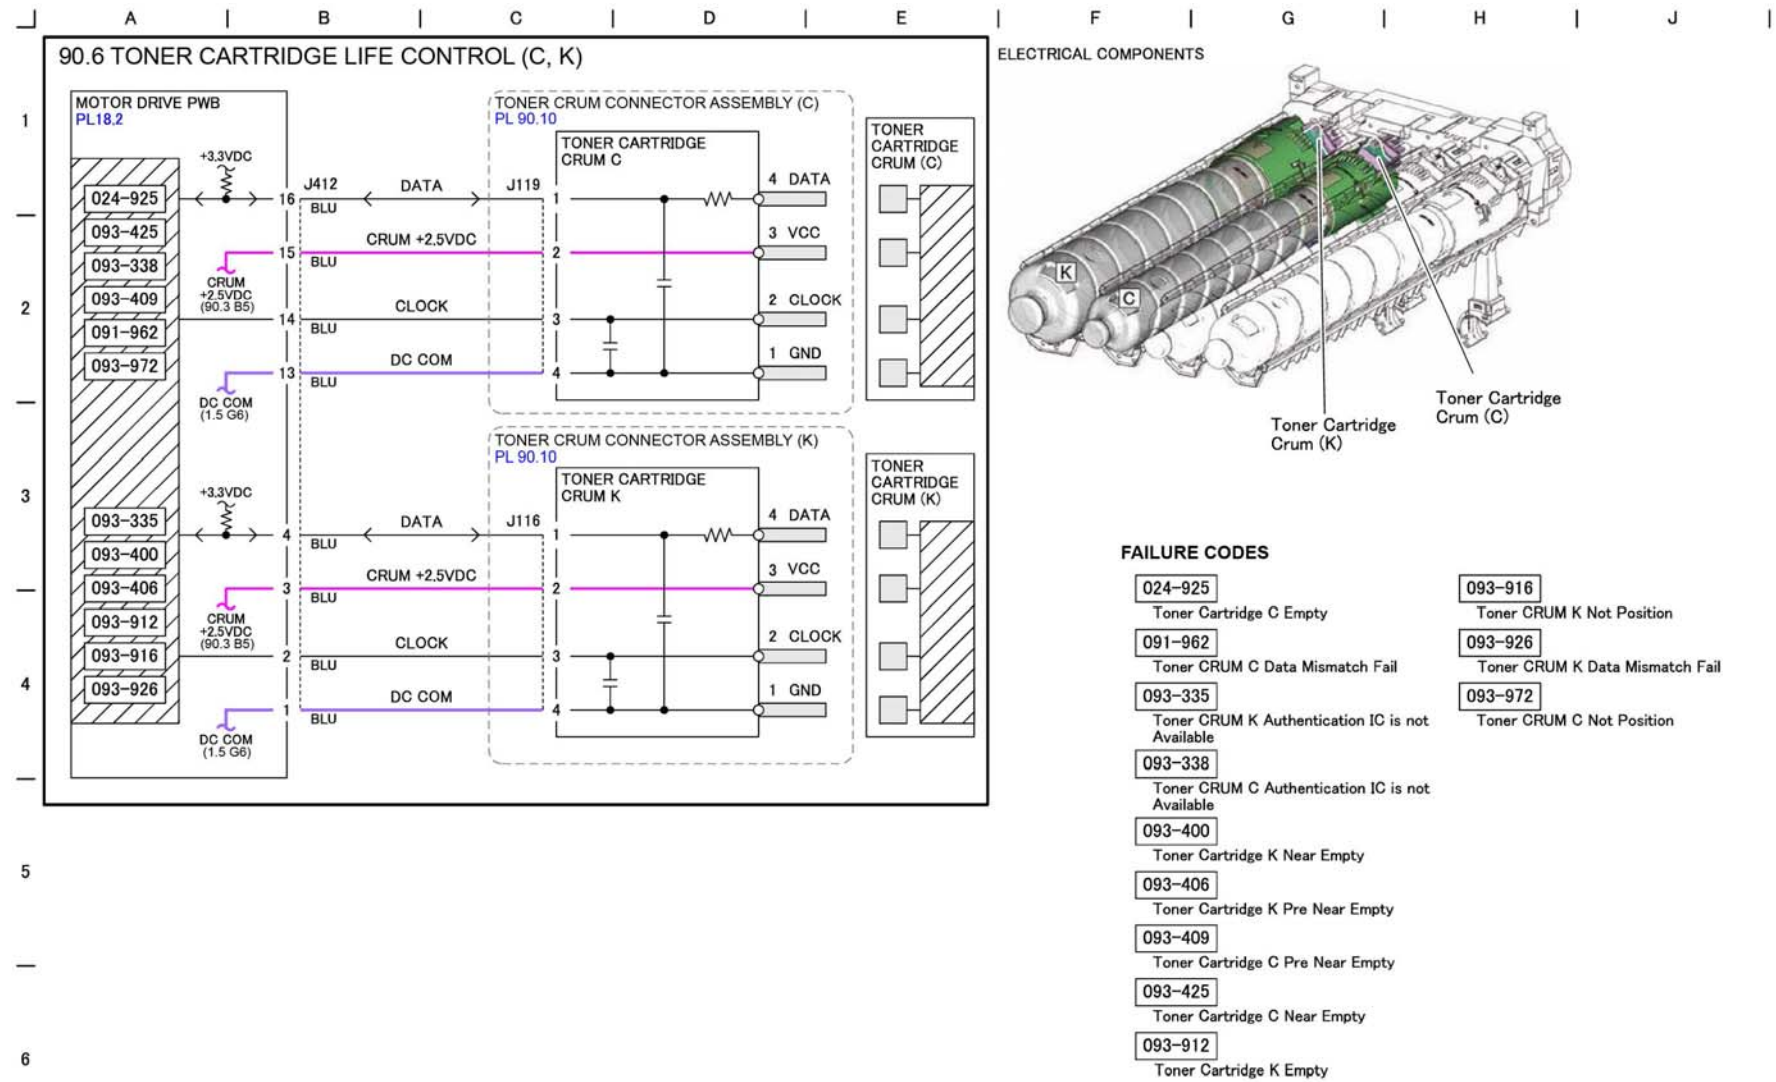
Figure 93 BSD 90.6

BSD 90.6 Toner Cartridge Life Control (C, K)

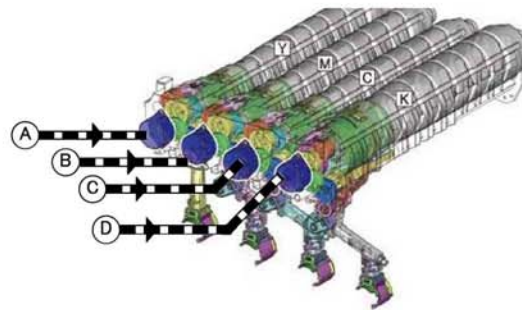
Figure 95 BSD 90.8

BSD 90.8 Toner Dispense Control

DC330[041-003] DISPENSE NOISE MODE

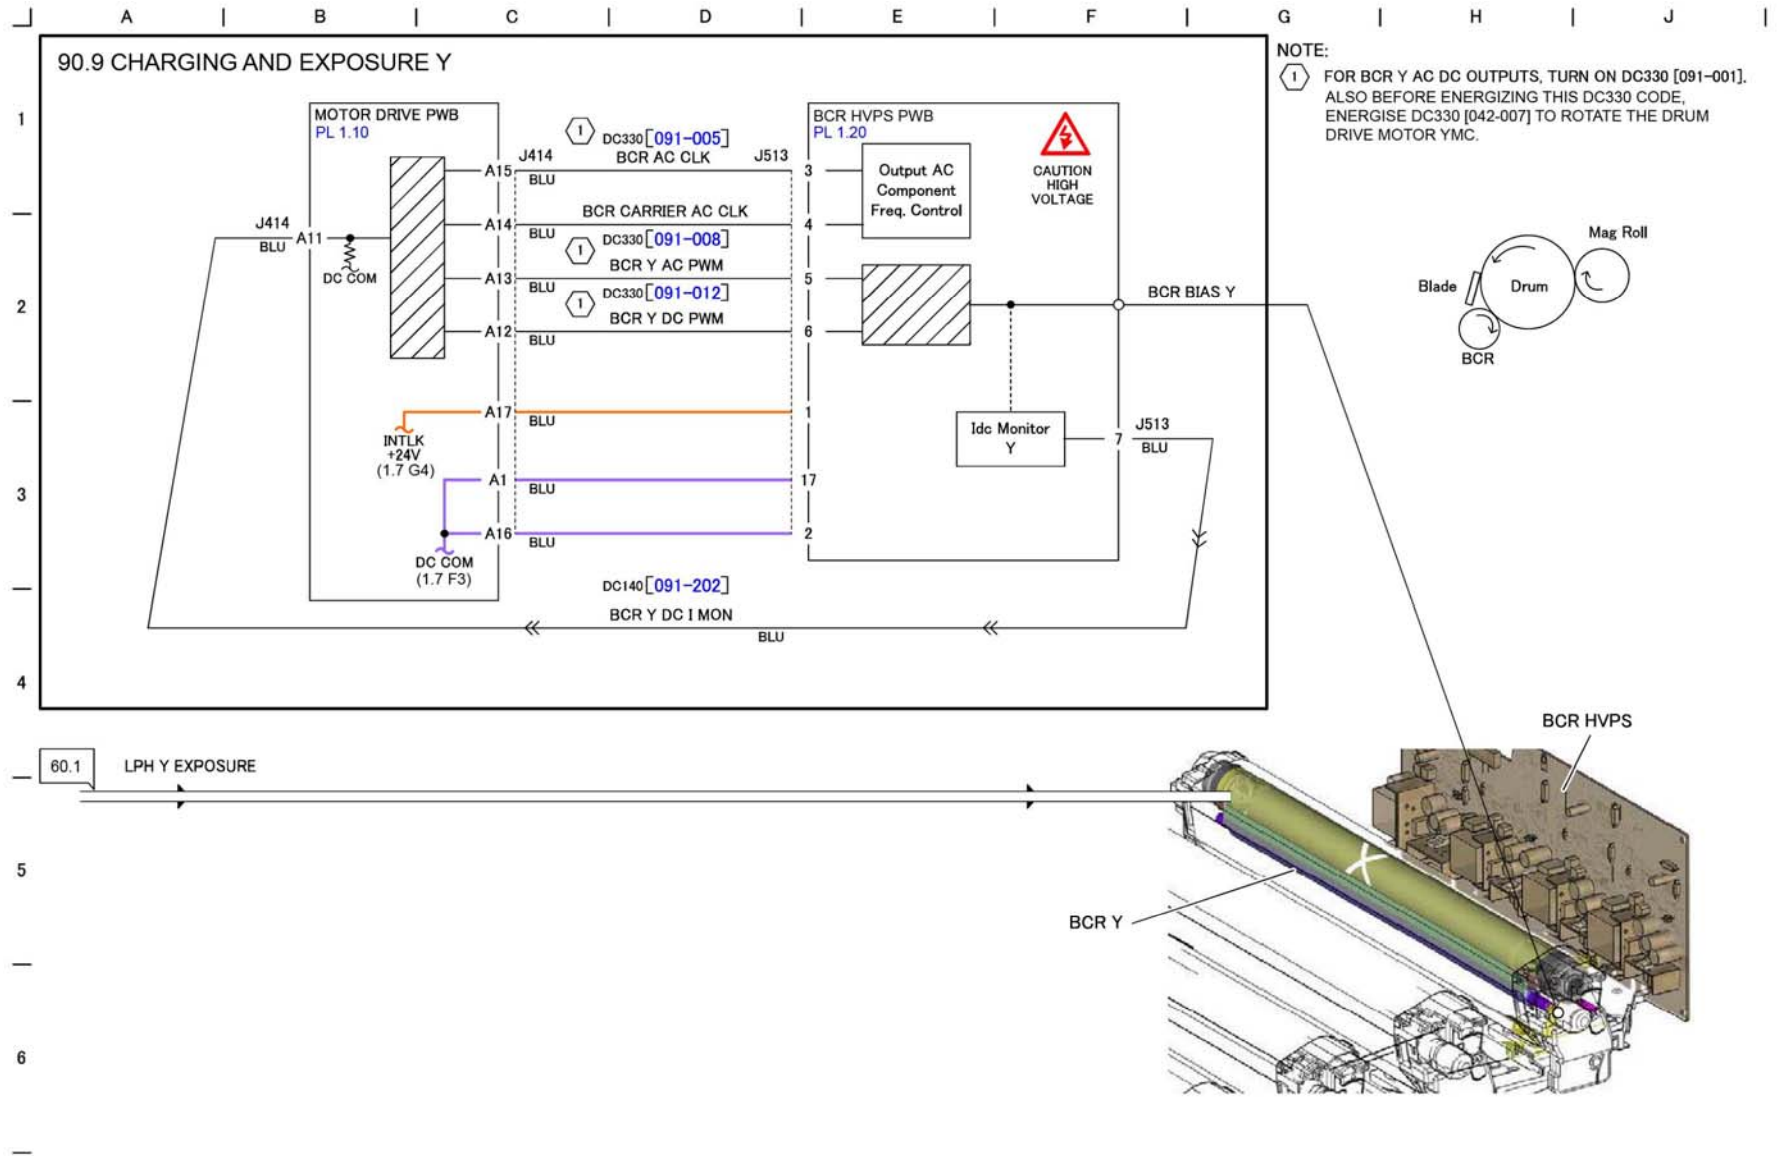
Figure 96 BSD 90.9

BSD 90.9 Charging and Exposure Y

- [BSD 90.9 Charging and Exposure Y](#)
- [BSD 90.10 Charging and Exposure M](#)
- [BSD 90.11 Charging and Exposure C](#)
- [BSD 90.12 Charging and Exposure K](#)

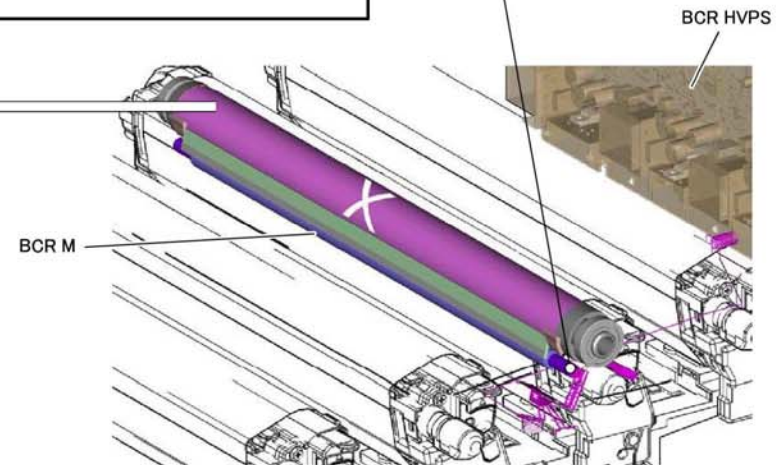
Figure 97 BSD 90.10

BSD 90.10 Charging and Exposure M

60.1 LPH M EXPOSURE

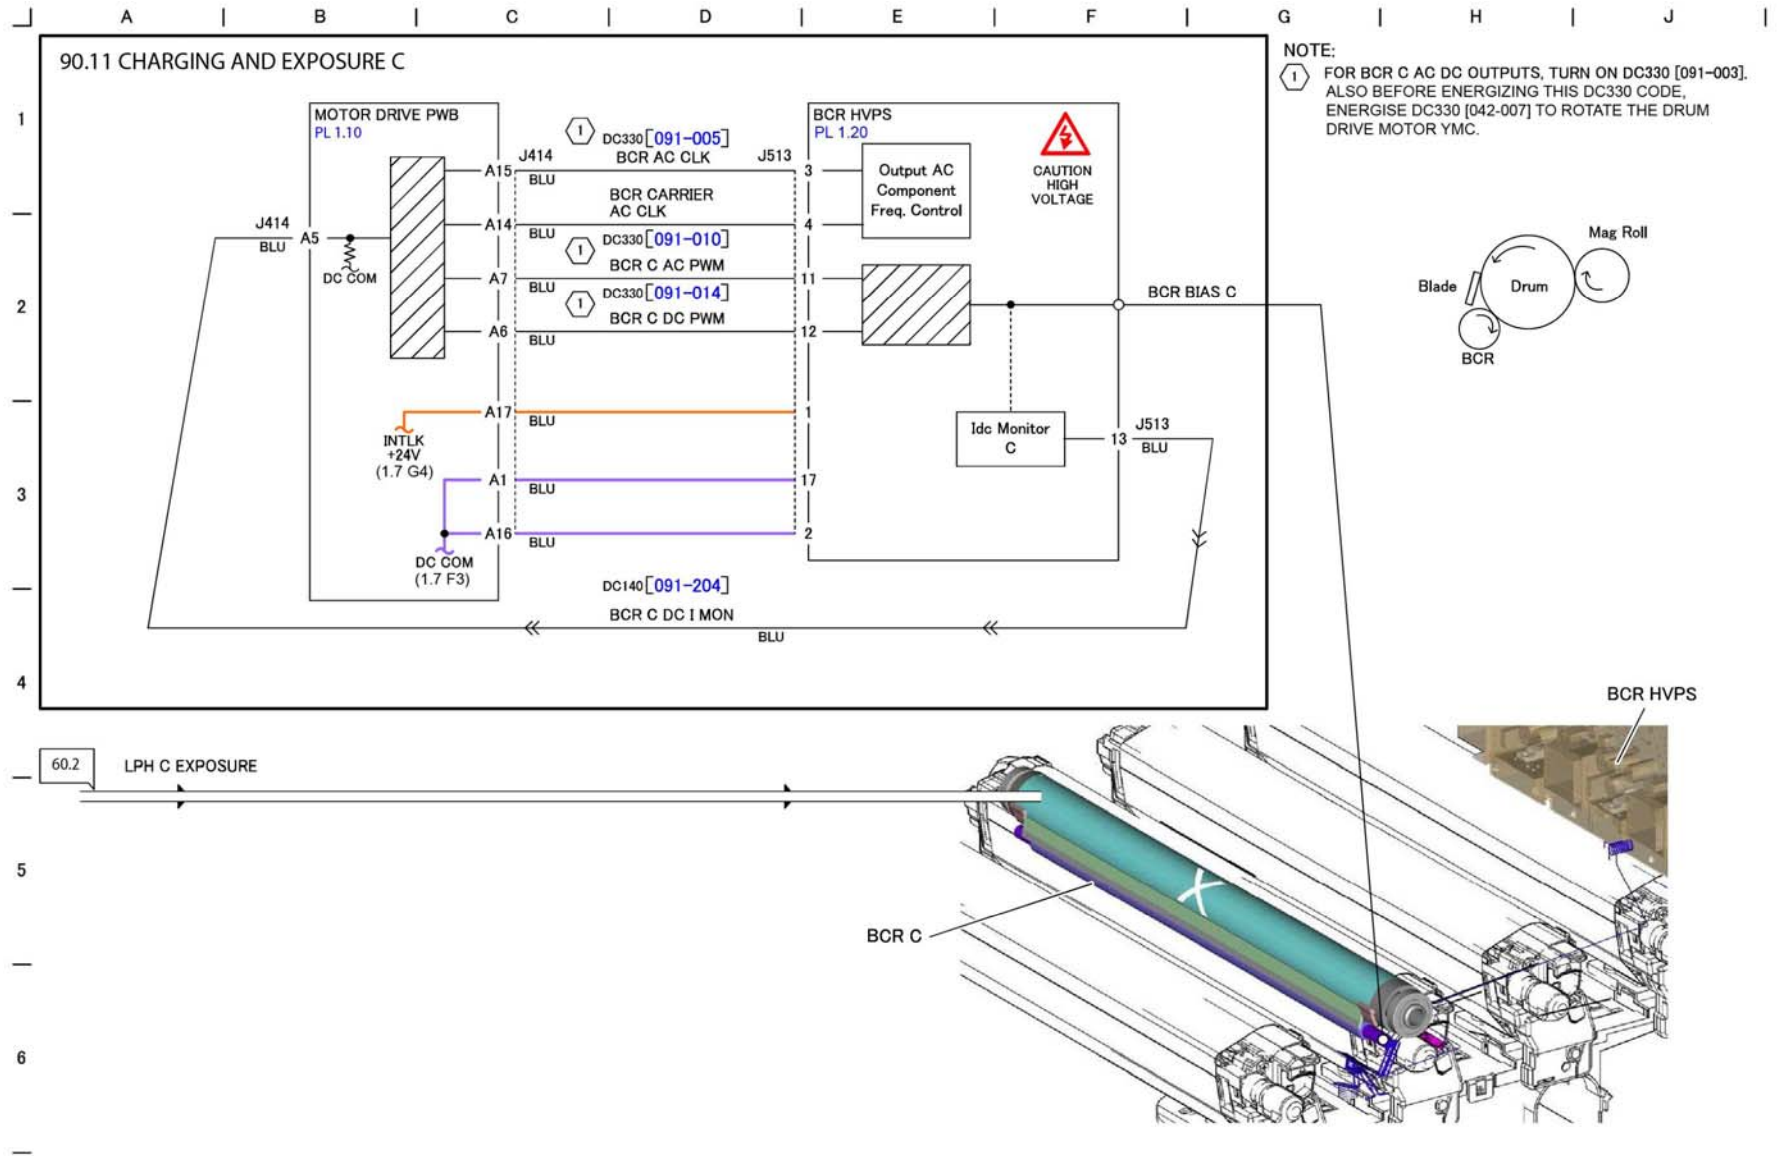
Figure 98 BSD 90.11

BSD 90.11 Charging and Exposure C

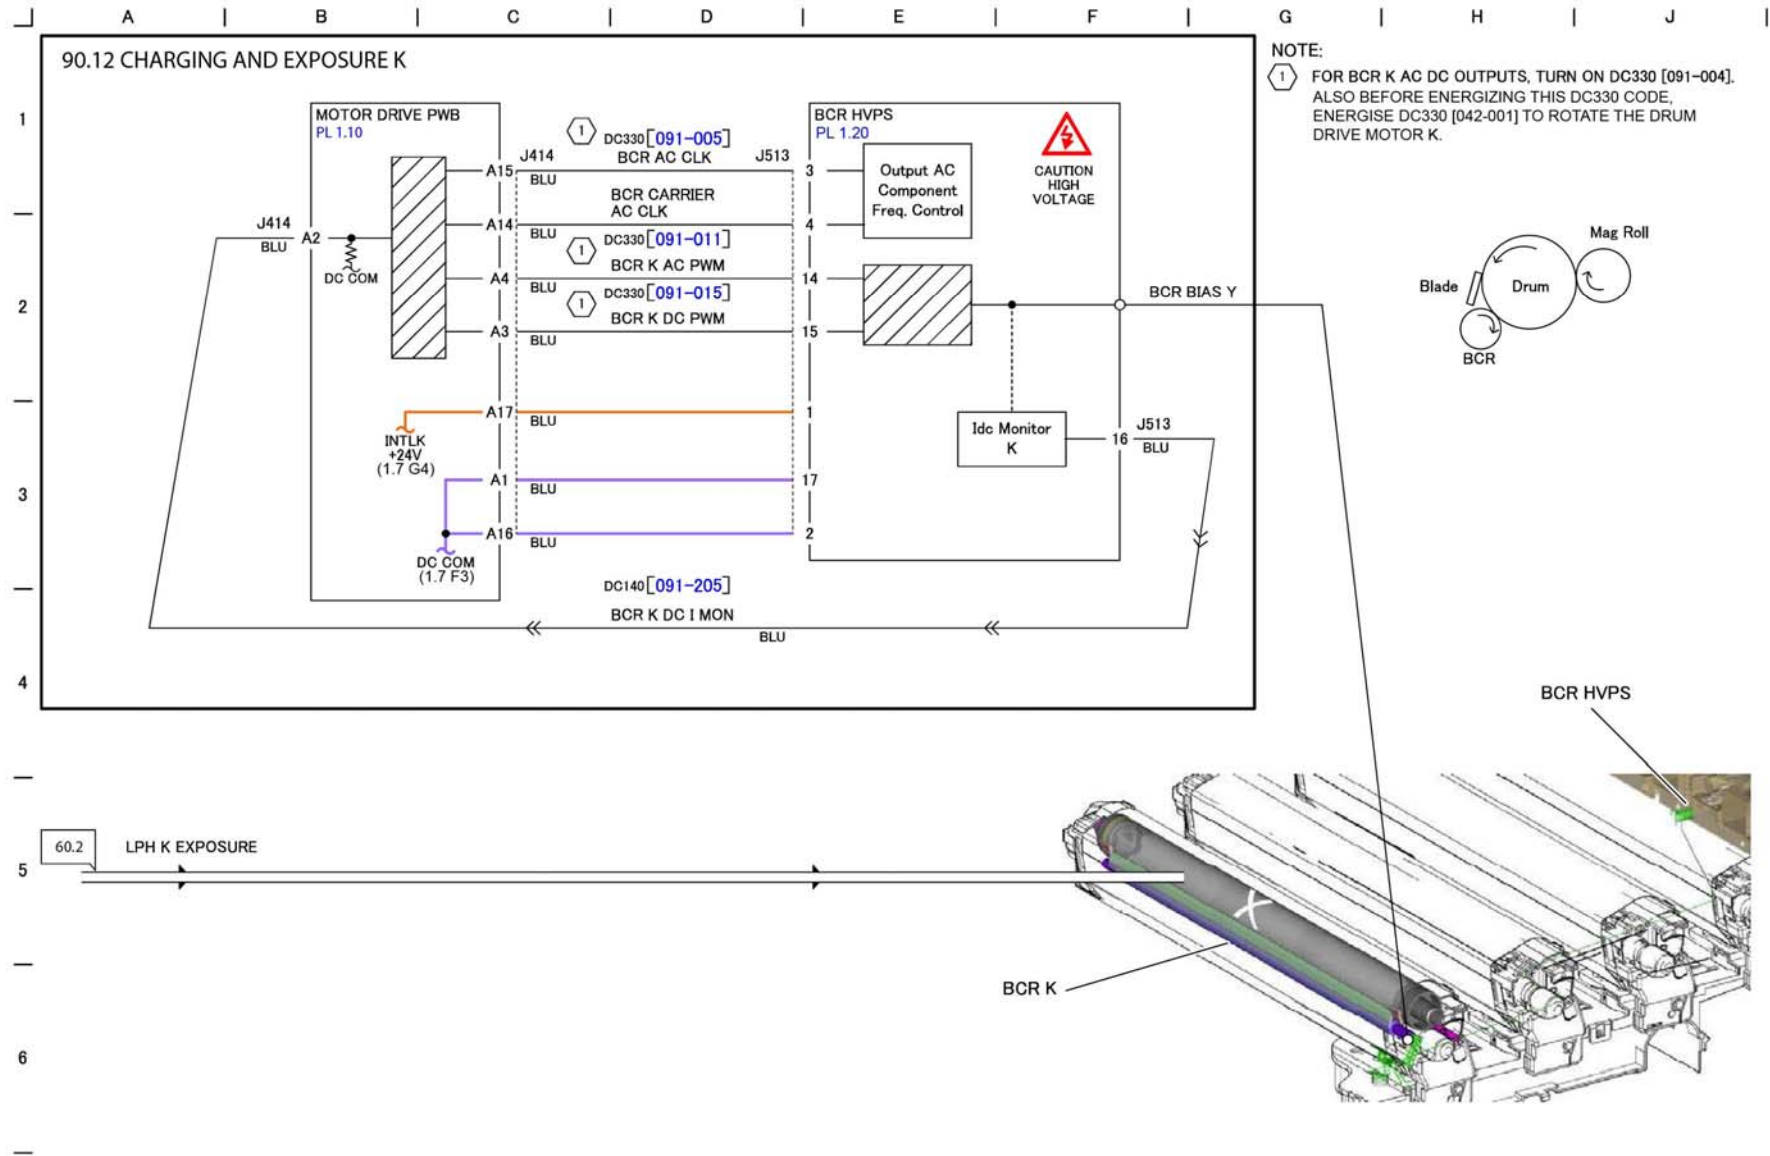
Figure 99 BSD 90.12

BSD 90.12 Charging and Exposure K

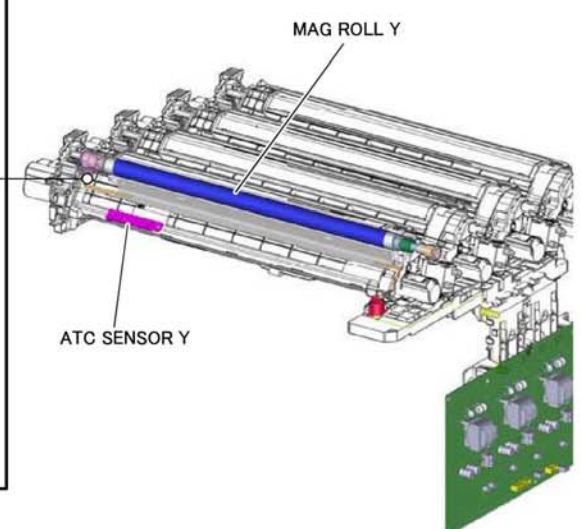
Figure 100 BSD 90.13

BSD 90.13 Development Y

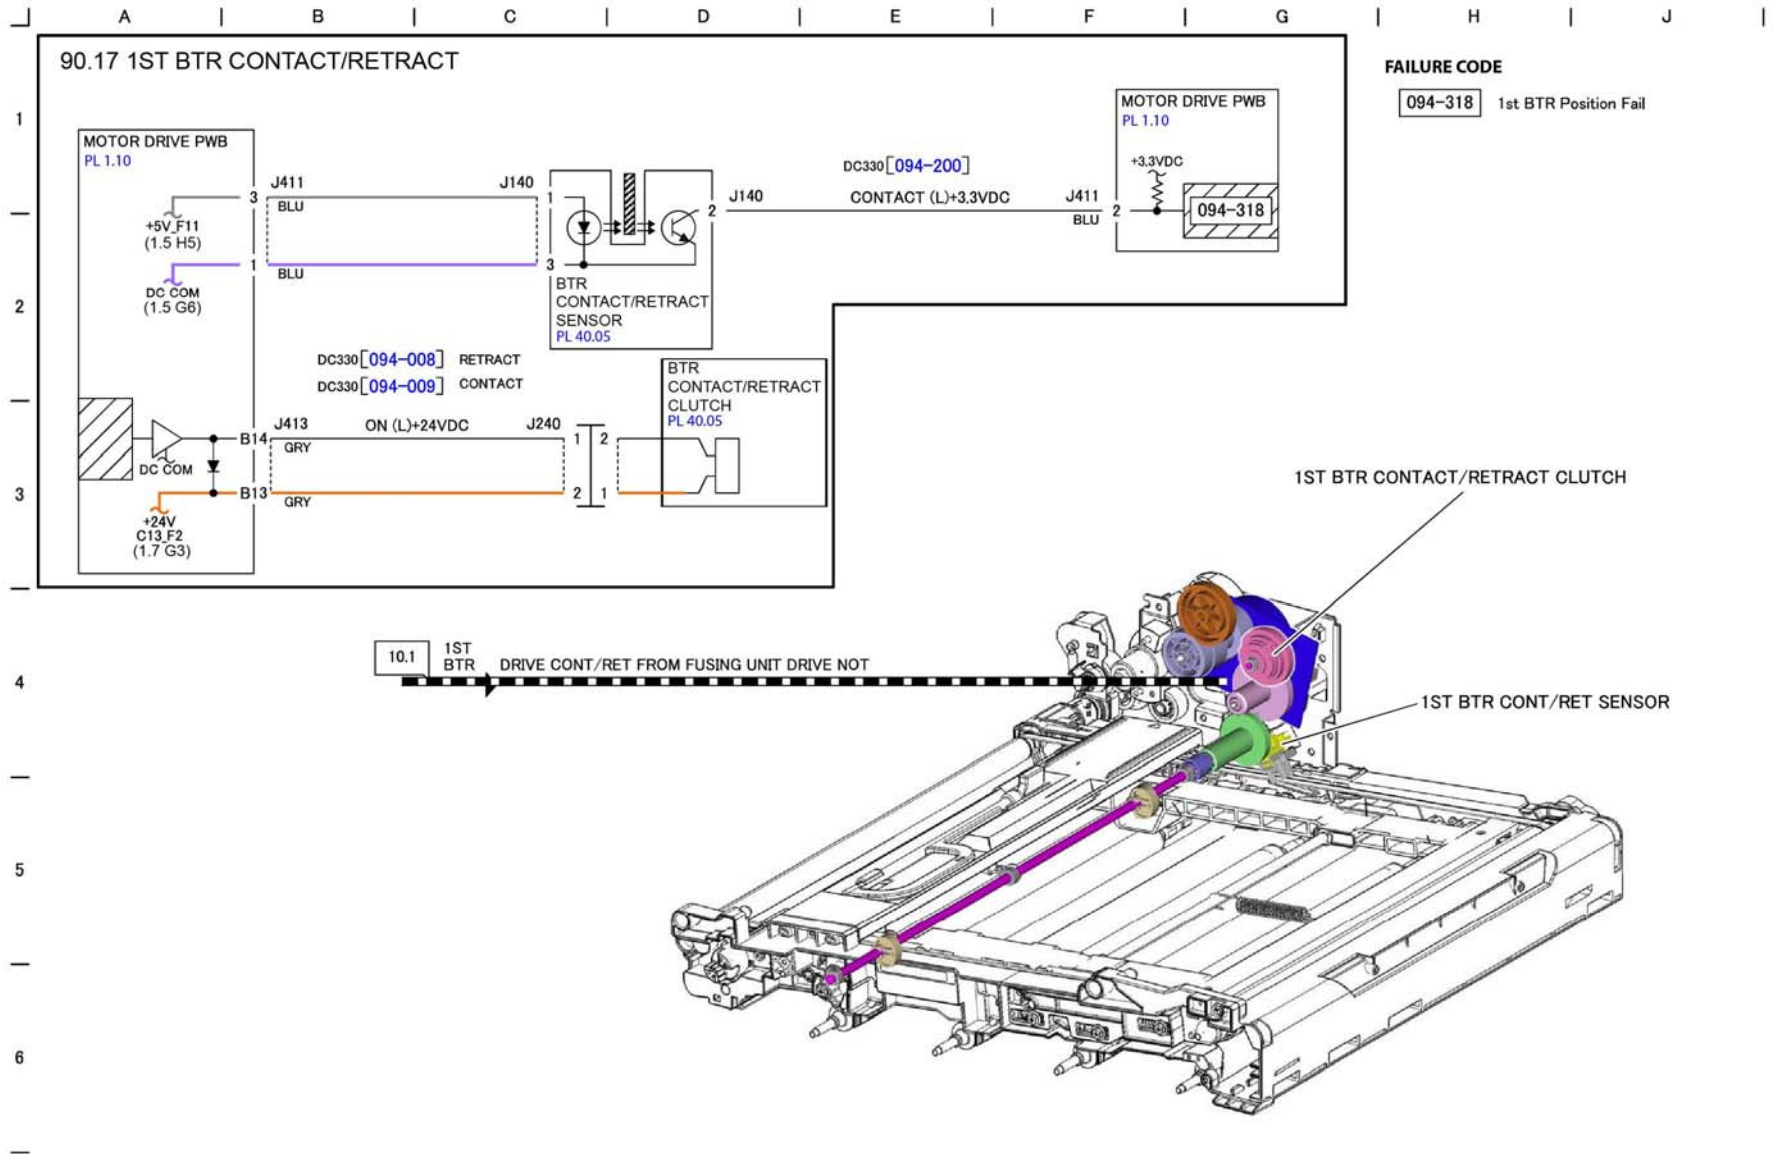
Figure 104 BSD 90.17

BSD 90.17 1st BTR Contact/retract

FAILURE CODE
 094-318 1st BTR Position Fail

10.1 1ST BTR DRIVE CONT/RET FROM FUSING UNIT DRIVE NOT

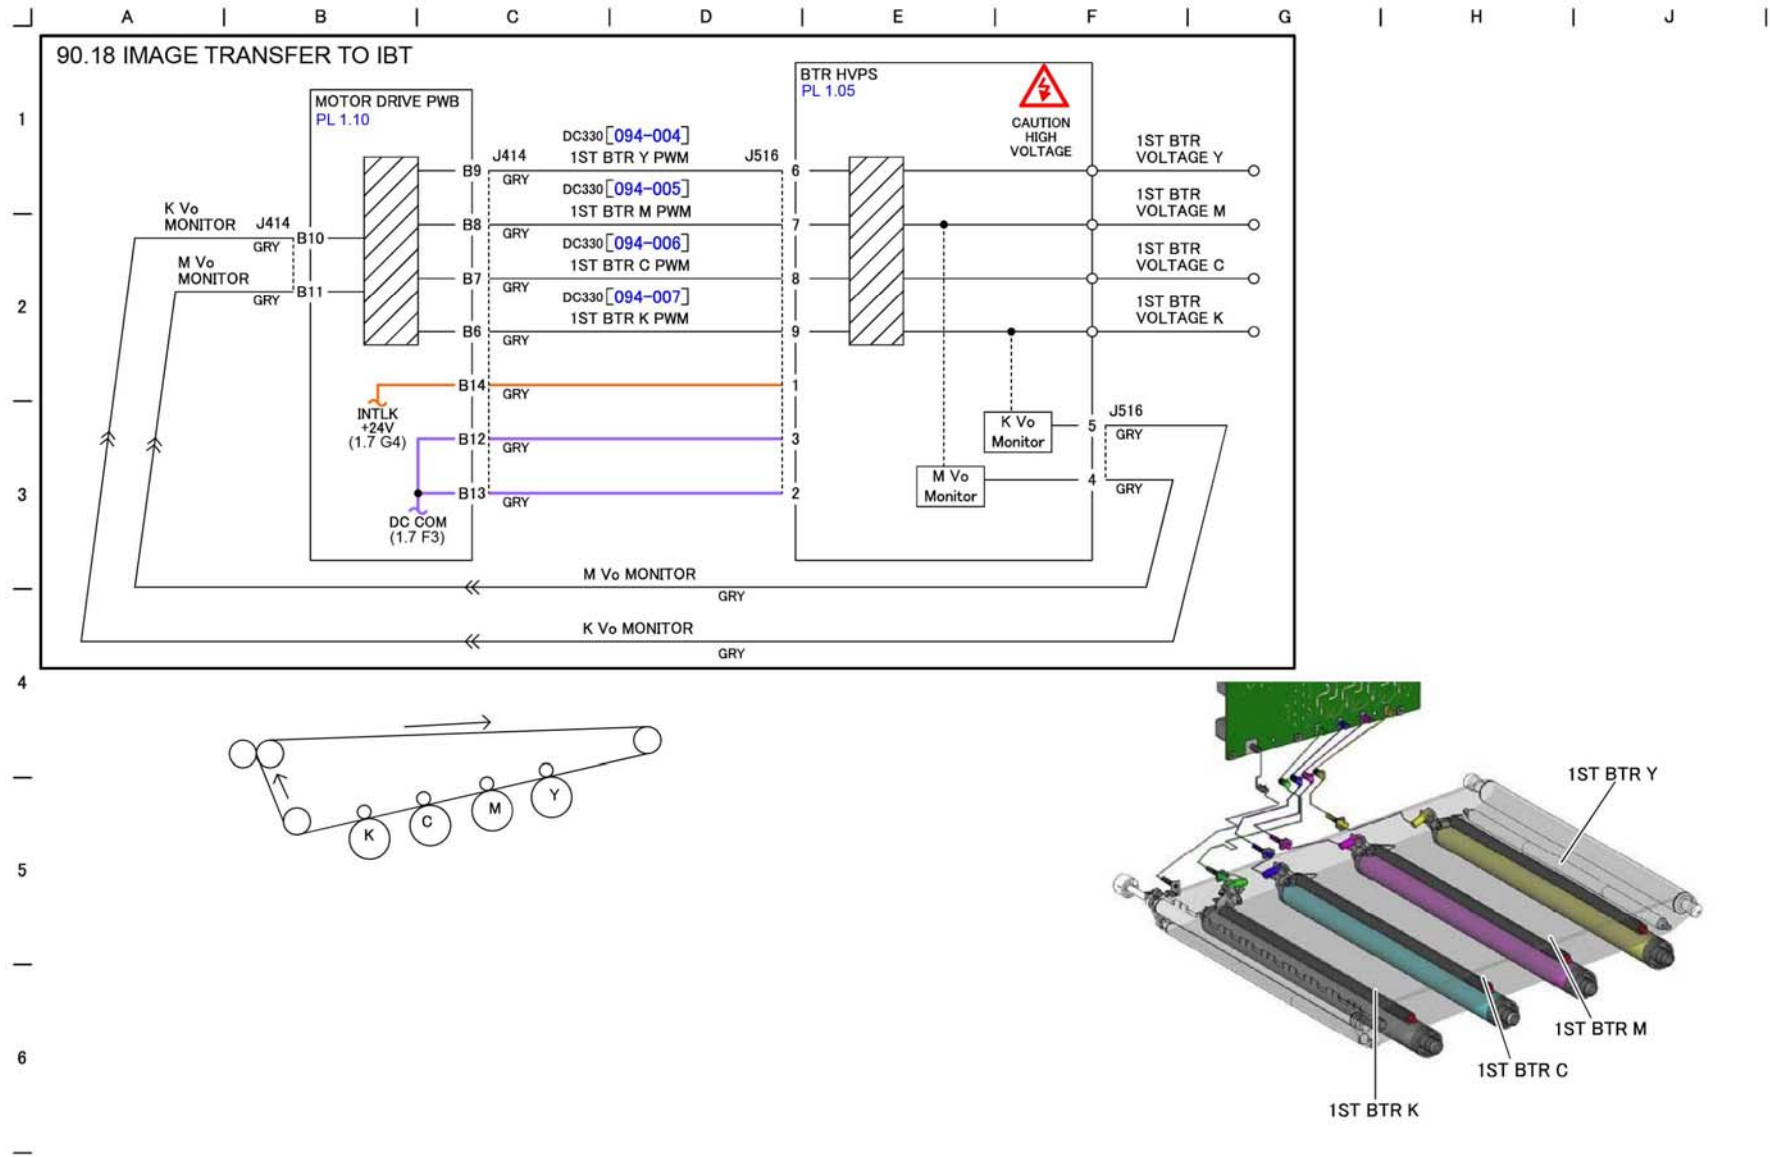
Figure 105 BSD 90.18

BSD 90.18 Image Transfer to IBT

- [BSD 90.18 Image Transfer to IBT](#)
- [BSD 90.19 Image Transfer to Paper](#)

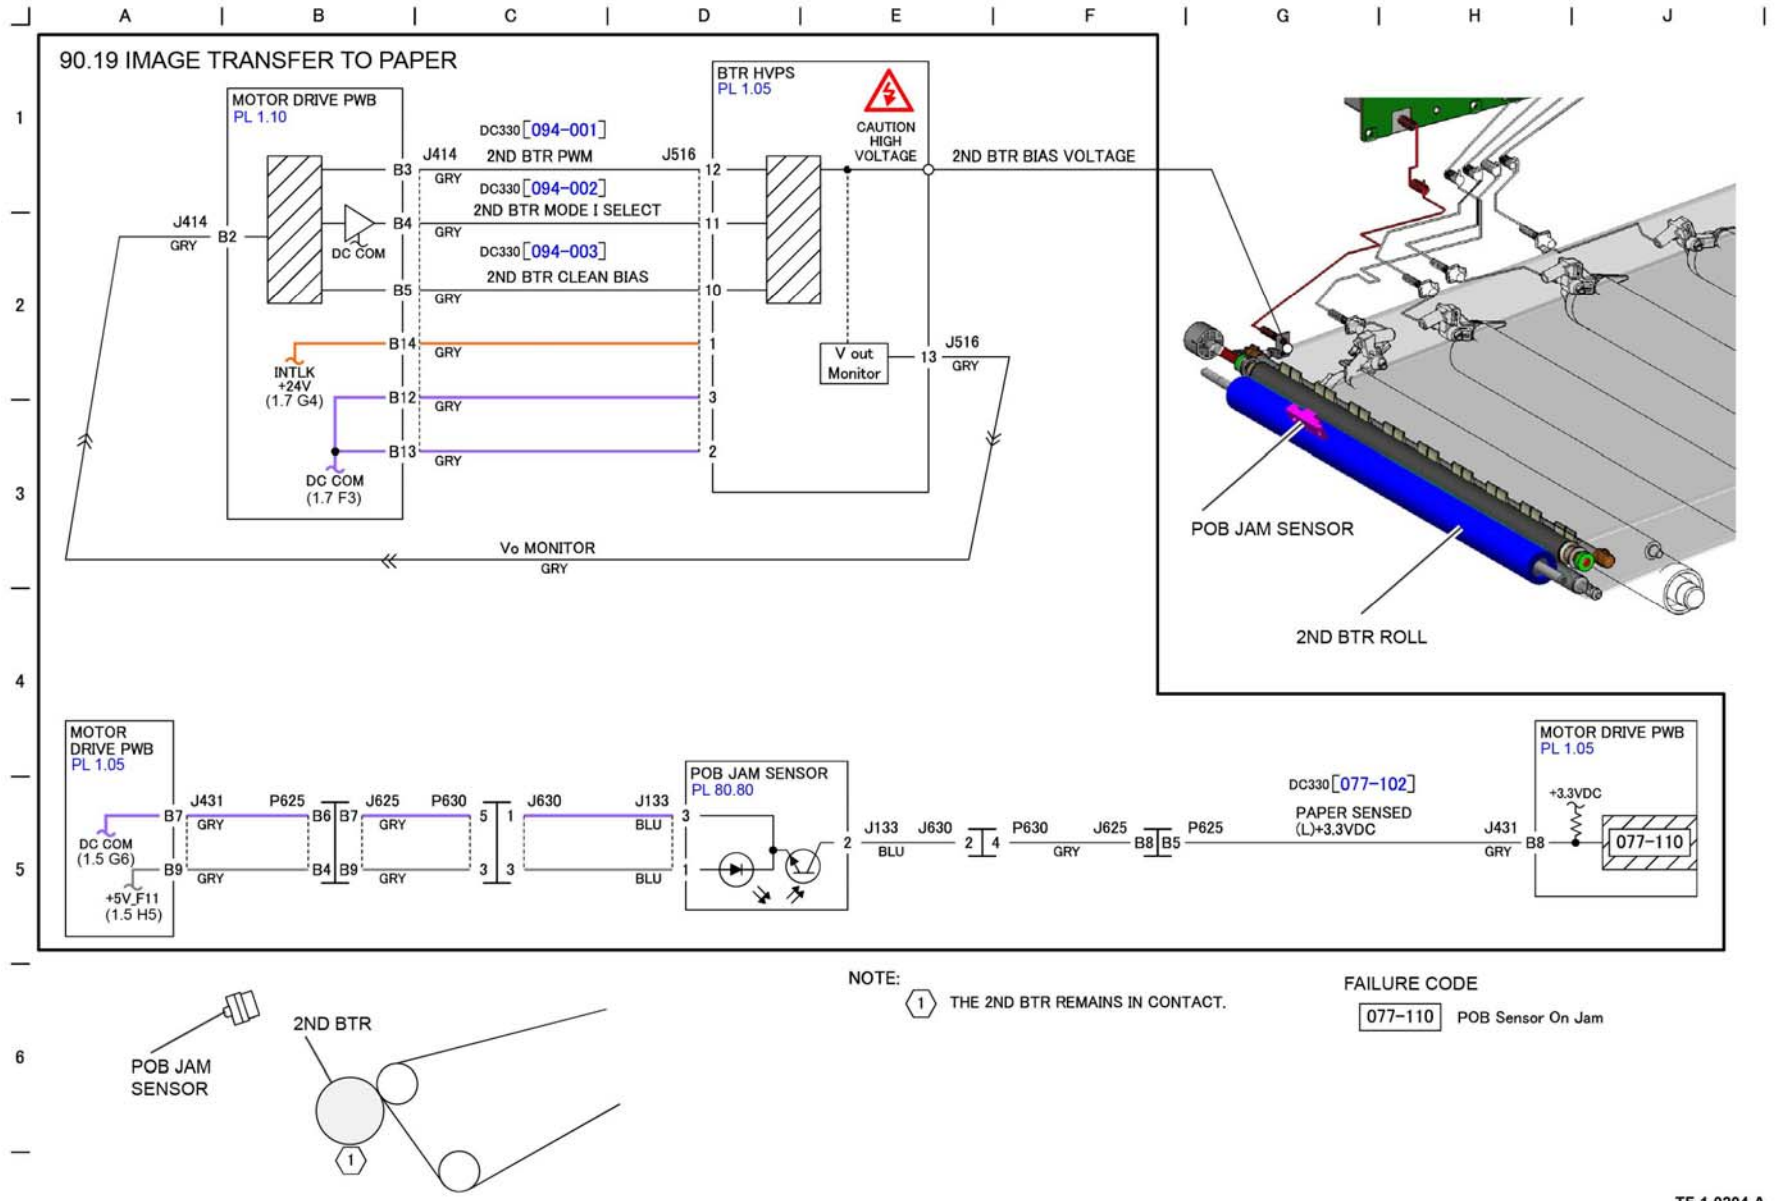
Figure 106 BSD 90.19

BSD 90.19 Image Transfer to Paper

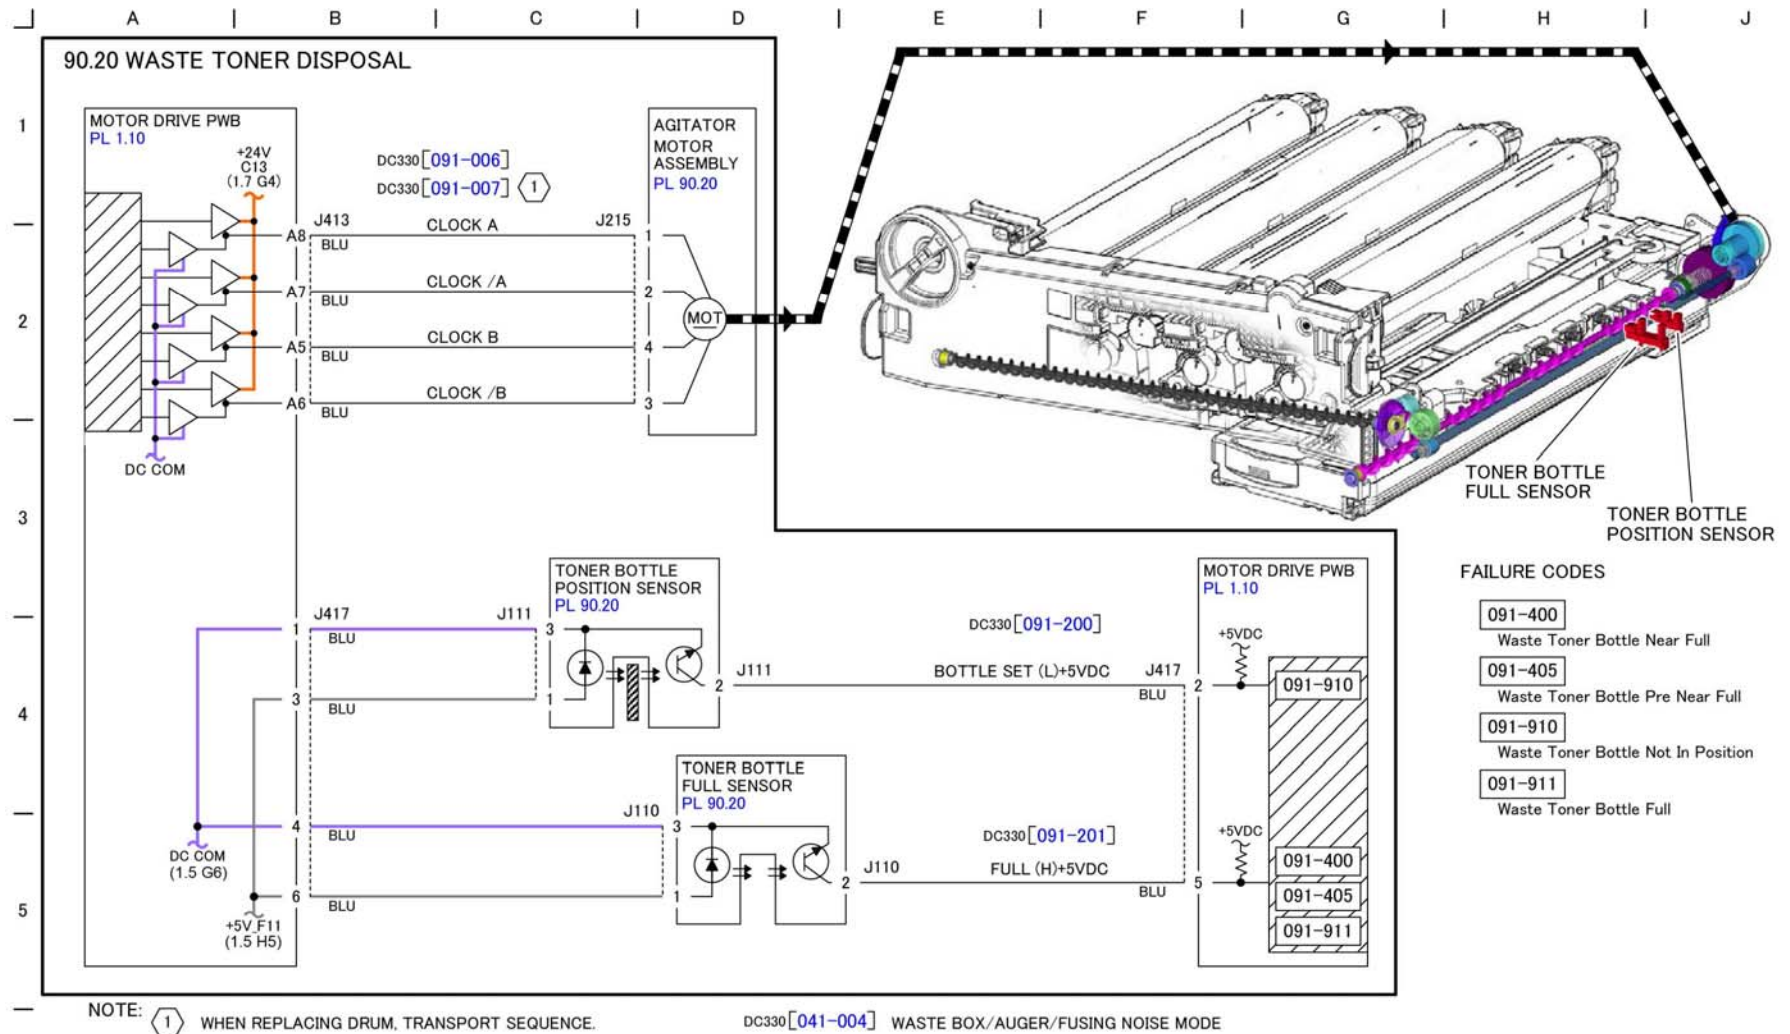
Figure 107 BSD 90.20

BSD 90.20 Waste Toner Disposal
