VersaLink[®] C8000/C9000 Printer

Service Manual

VersaLink C9000 Family Service Manual

705P01418

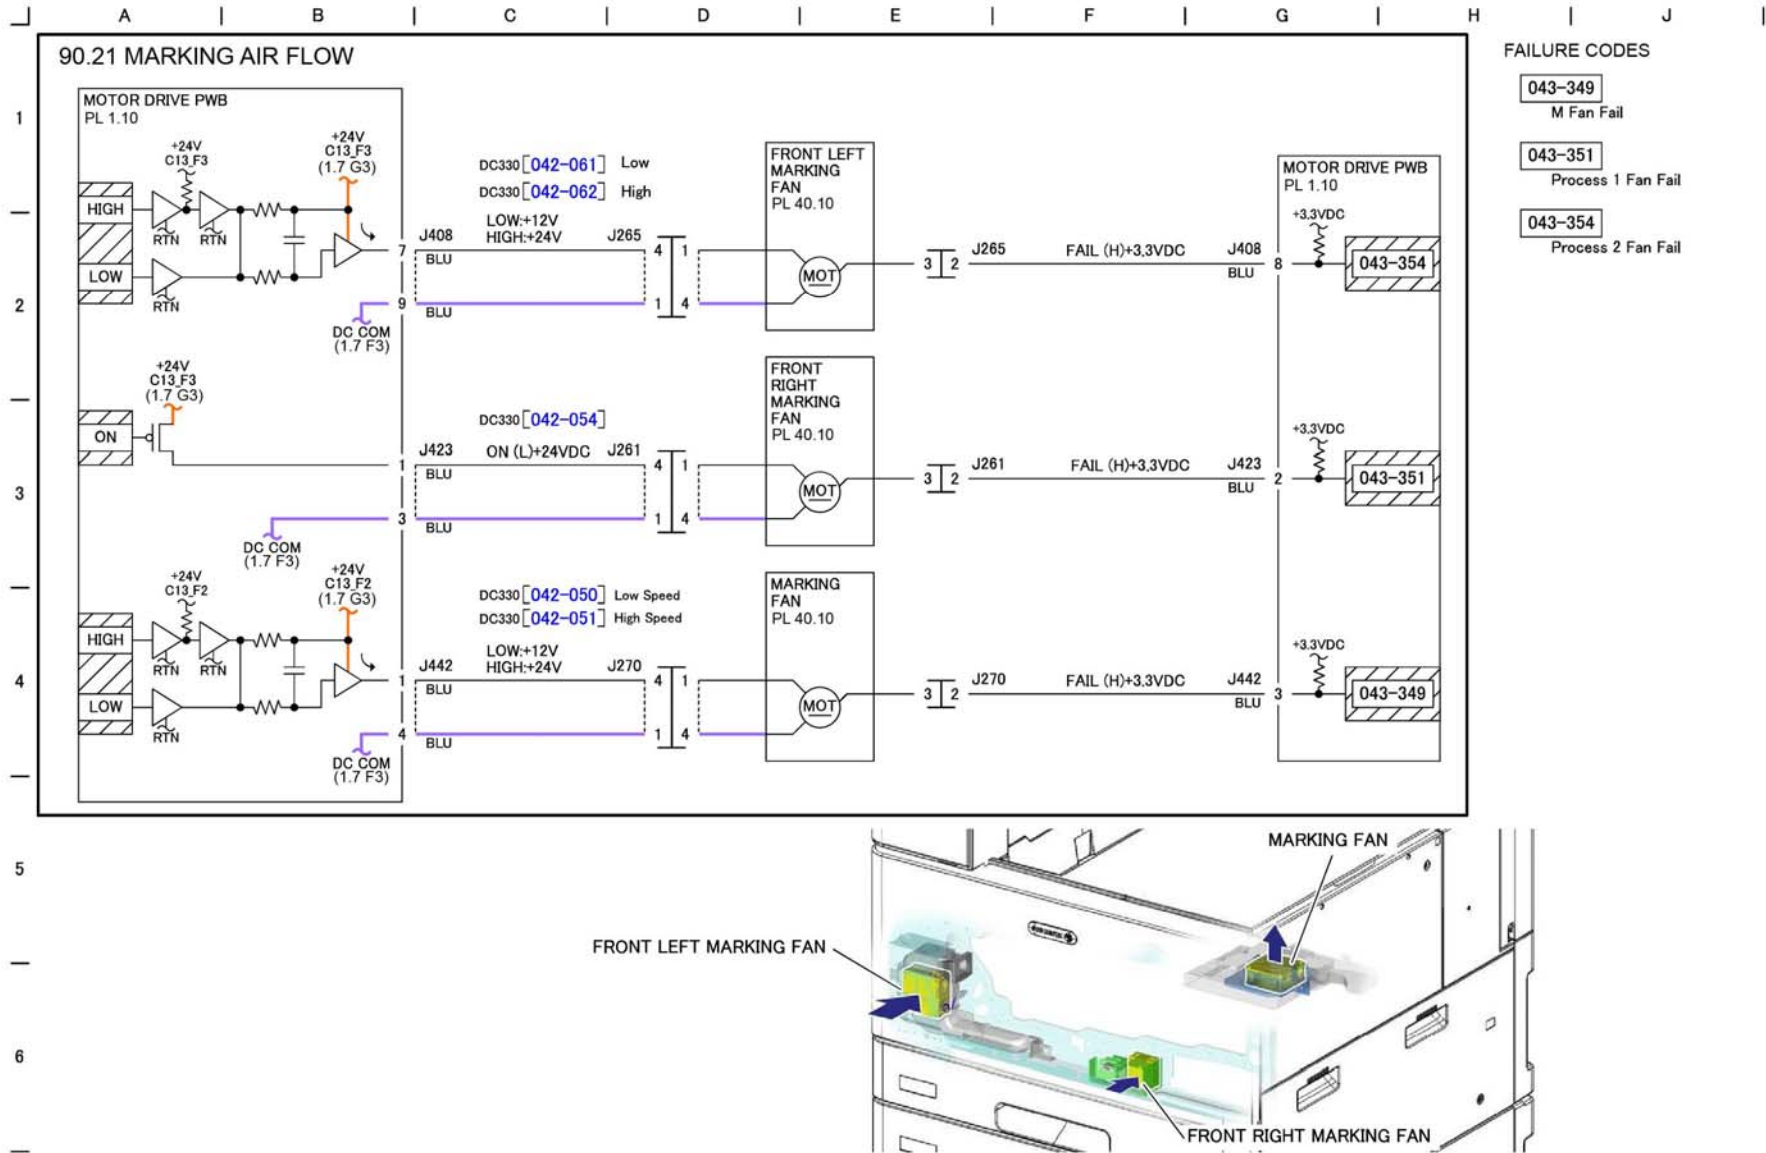
Figure 108 BSD 90.21

BSD 90.21 Marking Air Flow

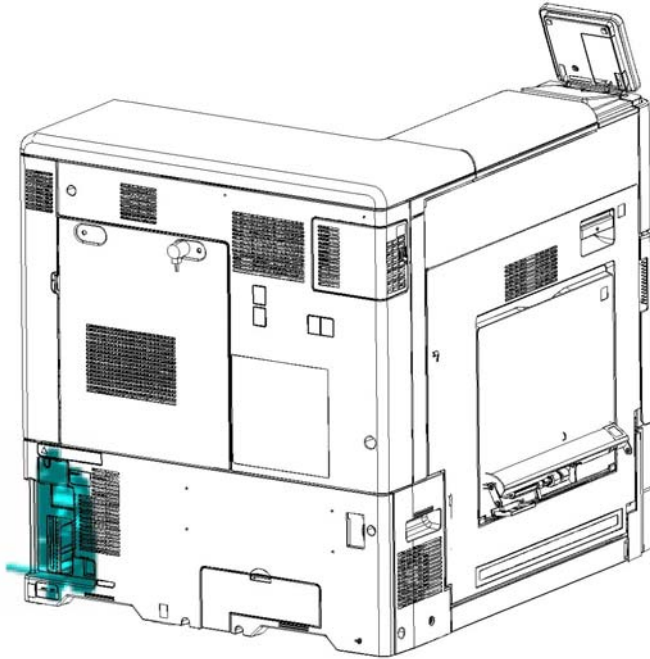
Mains power is supplied via the GFI chassis assembly ([PL 1.10 Item 1](#)) [Figure 1](#), to the main power switch ([PL 1.20 Item 1](#)), [Figure 2](#).

Figure 1 Mains power connector

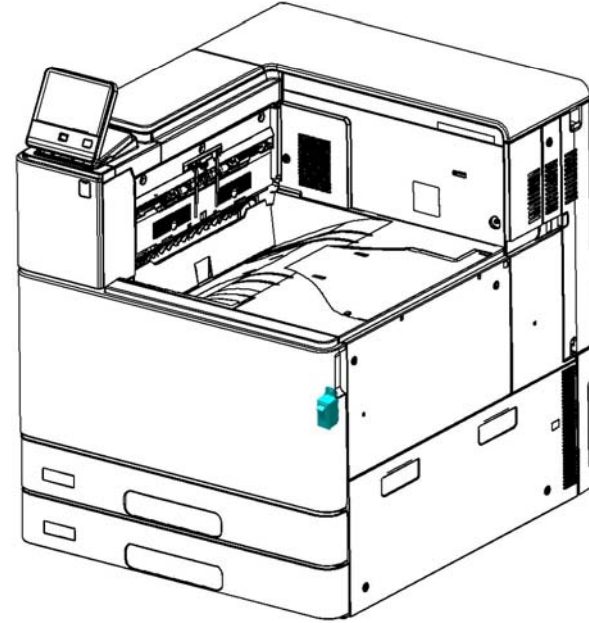
Closing the main power switch, [PL 1.20 Item 1](#), supplies AC power to the [AC Drive PWB, PL 1.15 Item 1](#), from which it is distributed to the [Low Voltage Power Supply](#), the fusing circuit and the finisher power outlet.

Figure 2 Main power switch

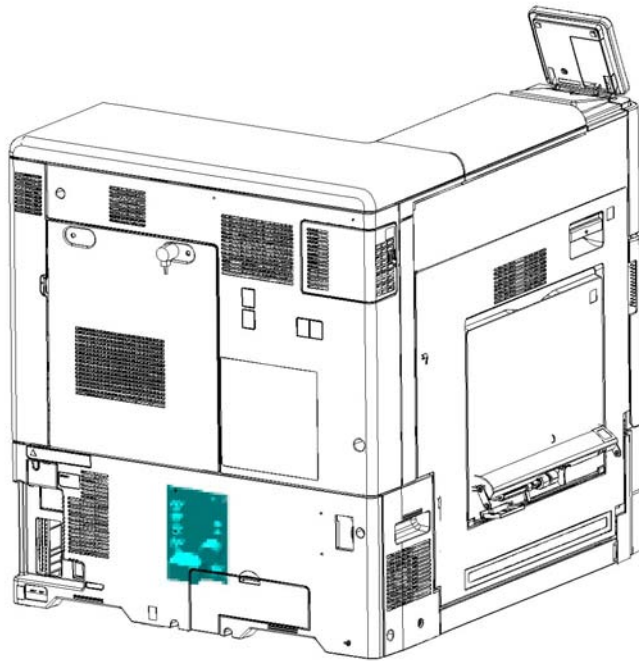
Figure 3 AC Drive PWB

Refer to [Figure 3](#).

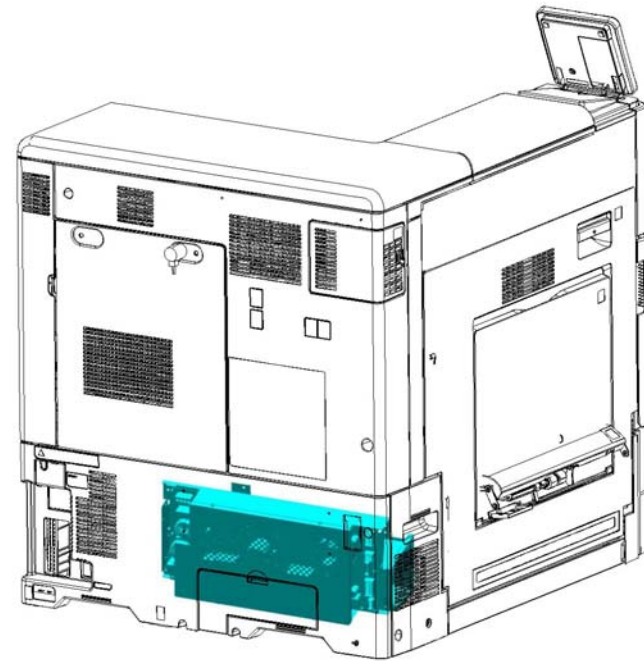
Figure 4 LVPS

Refer to [Figure 4](#).

- [BSD 1.5 DC Power Generation +5V](#)
- [BSD 1.6 DC Power Generation +24V \(1 of 2\)](#)
- [BSD 1.7 DC Power Generation +24V \(2 of 2\)](#)

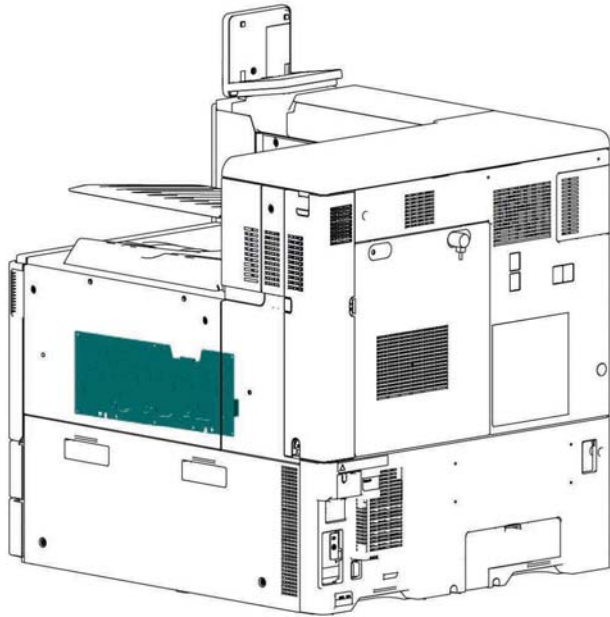
Figure 5 BCR HVPS

Refer to [Figure 5](#).

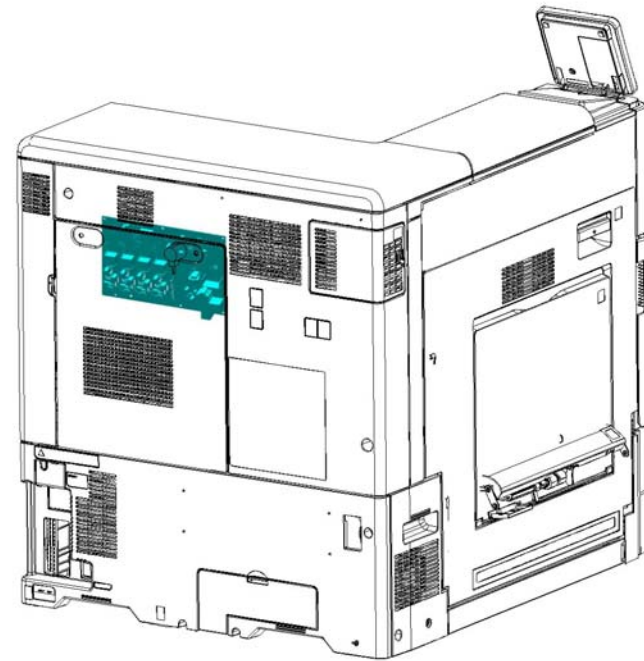
Figure 6 Bias transfer roll HVPS PWB

Refer to [Figure 6](#).

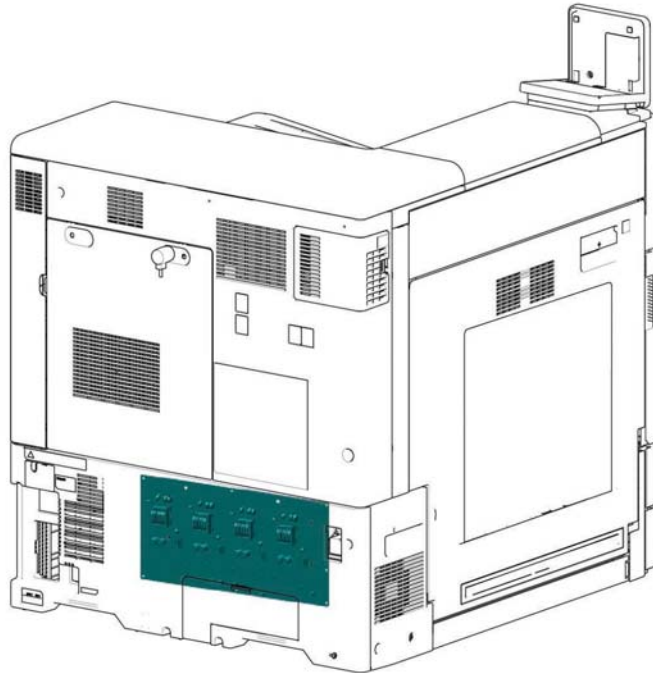
Refer to [Figure 7](#).

Figure 7 Developer bias HVPS

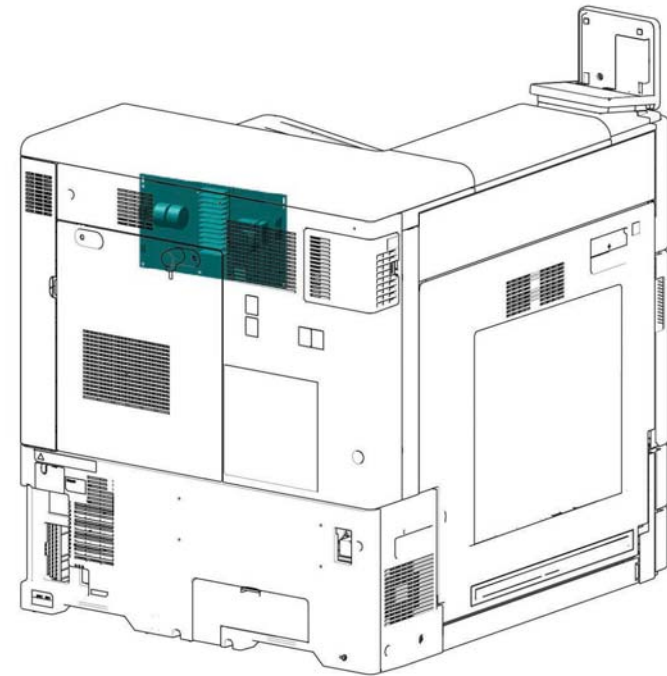
Refer to [Figure 8](#).

Figure 8 Fuser heater power supply

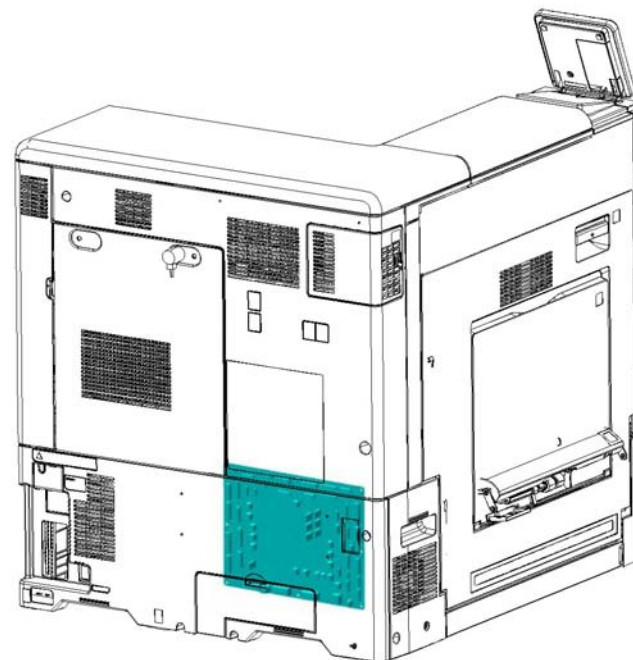
- Monitors the exit 2 sensor and the exit 2 offset catch tray home position sensor. Refer to [Exit 2](#), and [BSD 10.10 Exit 2 Paper Transport \(2 of 2\)](#).

NOTE: The face up sensor is installed but is not used in the C8000 or the C9000 printers.

Figure 9 Motor drive PWB

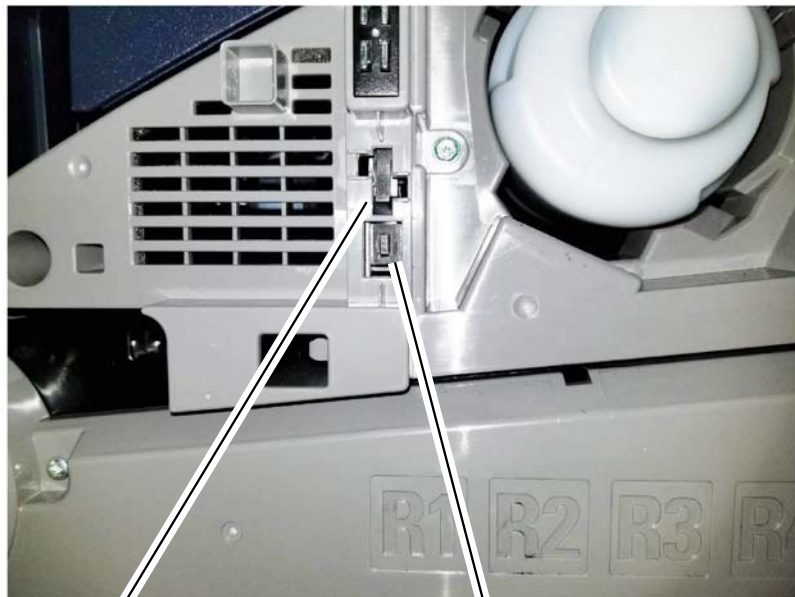
The front cover interlock switch, [PL 28.05 Item 11](#), is wired in series with the left cover interlock switch. It cuts power to the 24V interlocked supply.

Refer to [Figure 10](#) and [BSD 1.8 Interlock Switching](#).

Front cover interlock switch

Front cover open switch

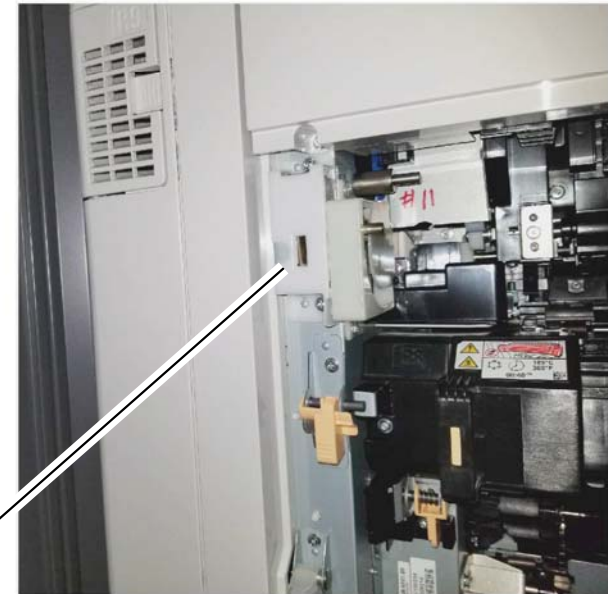
The left cover interlock switch, [PL 80.65 Item 9](#), is monitored by the [Motor Drive PWB](#). When interrupted it logs code 077-301. It is wired in series with the front cover interlock switch so it cuts power to the 24V interlocked supply.

Refer to [Figure 11](#) and [BSD 1.8 Interlock Switching](#).

Left cover interlock switch

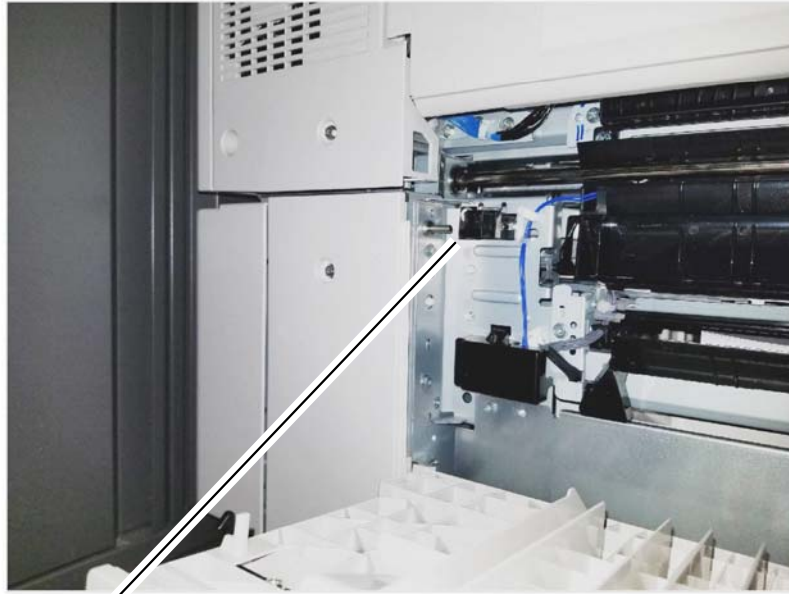
- 2TM - PL 80.20 Item 8, refer to [Figure 12](#).
- TTM - PL 80.40 Item 1, refer to [Figure 13](#).

Two tray module interlock switch

Figure 12 Two tray module interlock switch

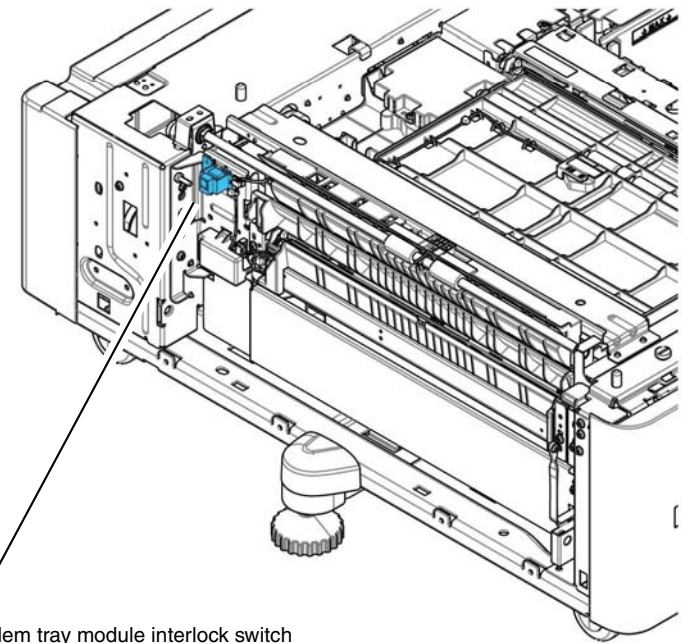
Tandem tray module interlock switch

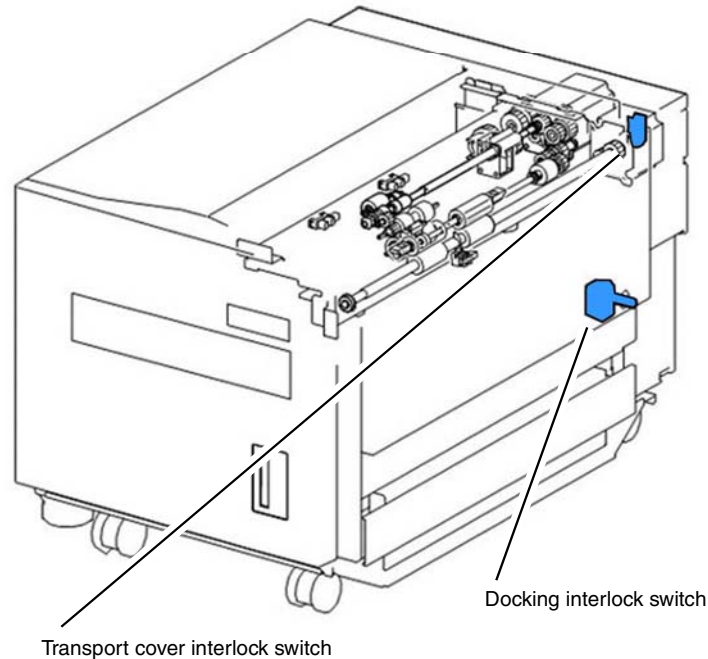
Transport cover interlock switch, [PL 70.90 Item 26](#), cuts +24VDC power to the K1 relay on the HCF PWB, [PL 70.95 Item 9](#), when opened, turning off the HCF feed/lift motor, [PL 80.100 Item 23](#), and the takeaway motor, [PL 70.95 Item 7](#).

Docking interlock switch, [PL 70.95 Item 8](#), The docking interlock switch detects if the HCF is in the home position (against the left side of the machine) following jam clearance.

Figure 14 HCF interlocks

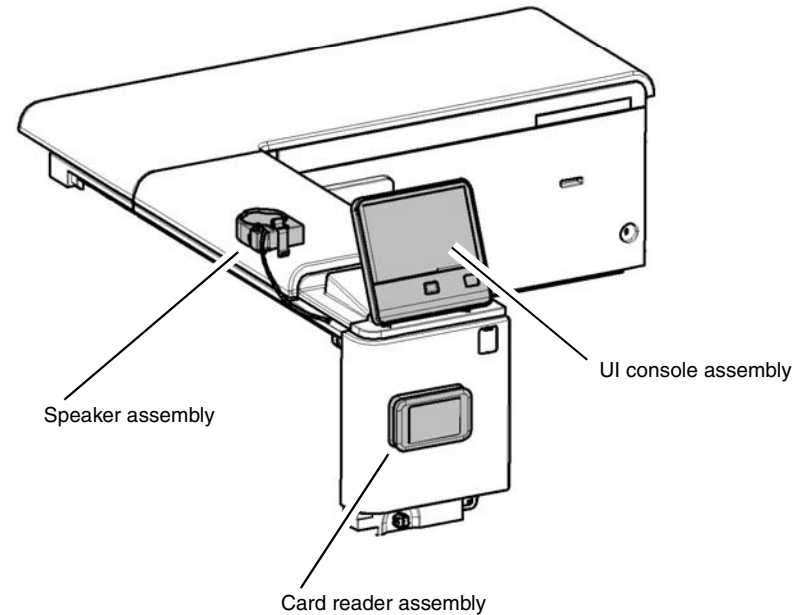
When the UI power button is activated a 3.3V sleep recovery signal is sent via a path through the [Back Plane PWB](#), the [Controller \(ESS\) PWB](#) (waking the controller PWB in the process), the [HalfTone PWB](#) and the [Motor Drive PWB](#). When the sleep recovery signal reaches the [Low Voltage Power Supply](#) 5VDC power is restored. The restoration of 5V power, in turn, restores the 24V DC power.

Refer to [Figure 1](#) and [BSD 2.1 User Interface](#)

Figure 1 User interface

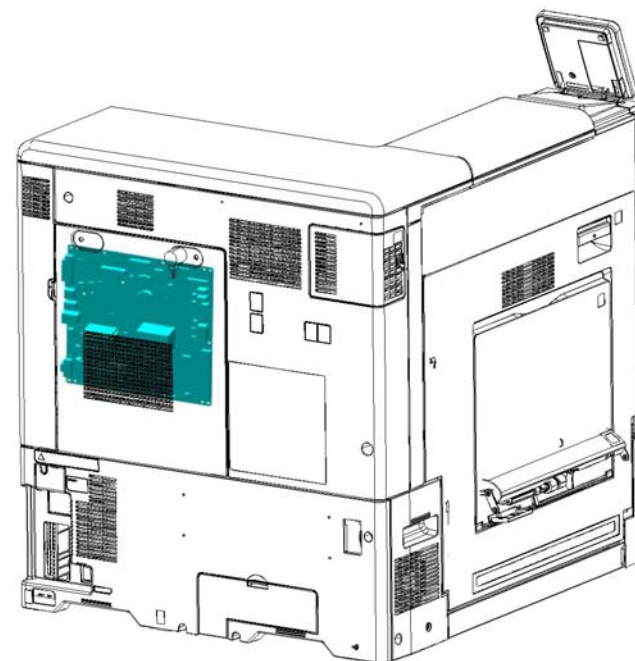
Refer to [Figure 1](#).

Figure 1 Controller PWB

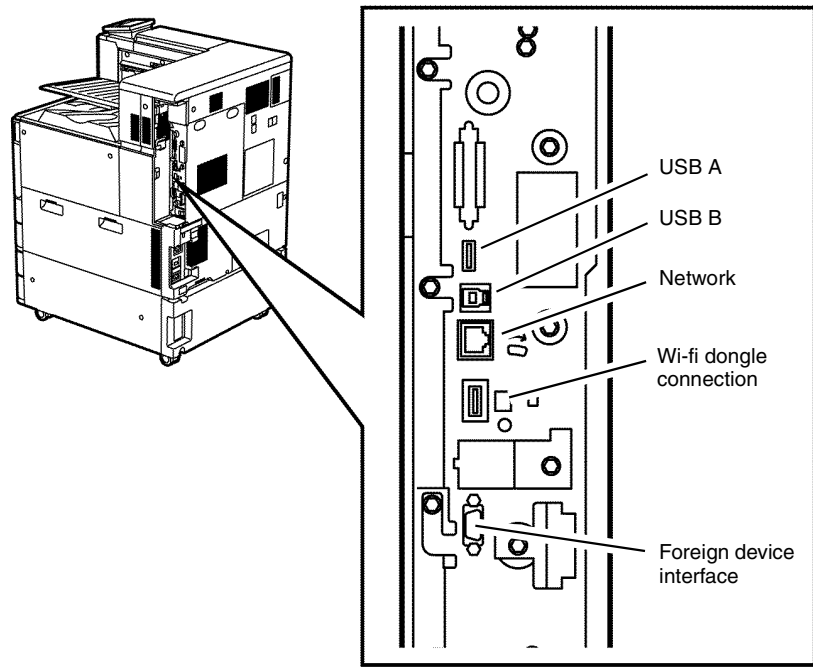
The functions of the connectors along the external edge of the Controller (ESS) PWB are shown in Figure 2.

Figure 2 Controller interface

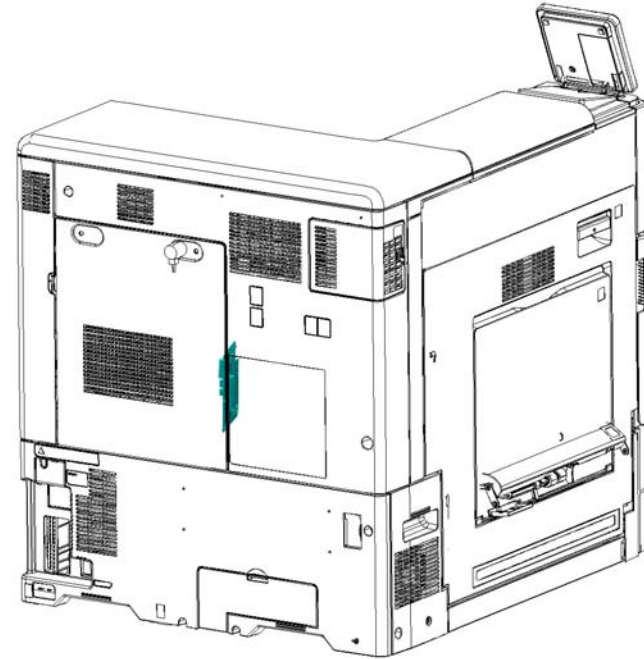
The backplane PWB PL 3.15 Item 2, provides a communication link between the Controller (ESS) PWB and the Halftone PWB. The route through the back plane PWB and the Halftone PWB carries all the communications between the controller PWB and the Motor Drive PWB.

Refer to Figure 3.

Figure 3 Back plane PWB

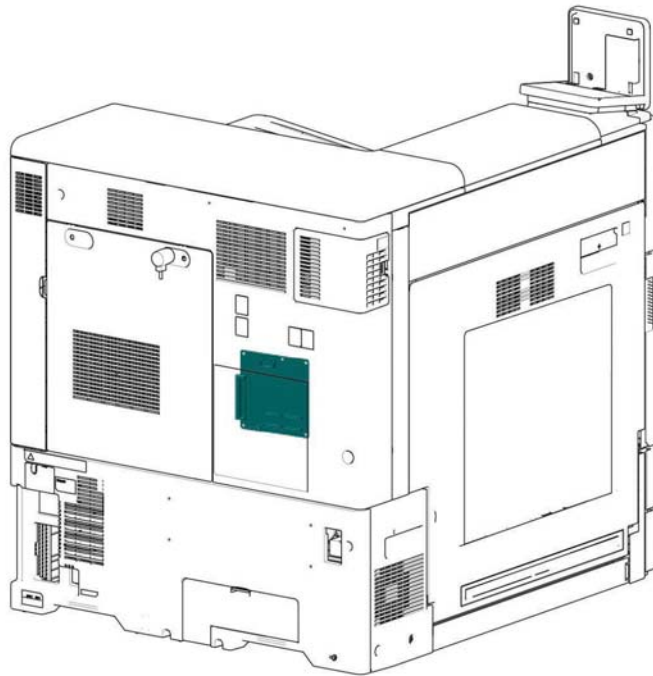
Refer to [Figure 4](#).

Figure 4 Halftone PWB

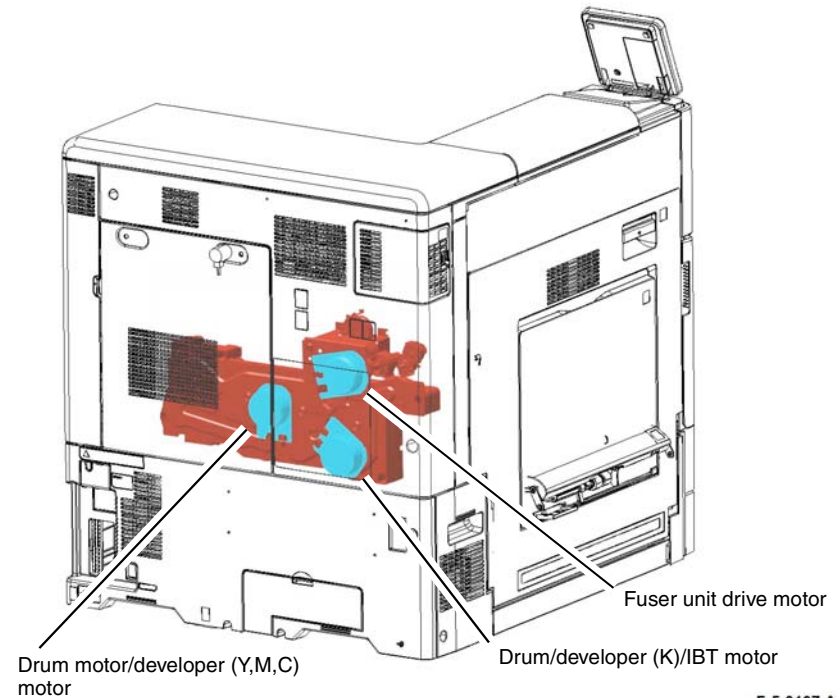
Refer to [Figure 1](#), [Figure 2](#).

Figure 1 Main drive assembly

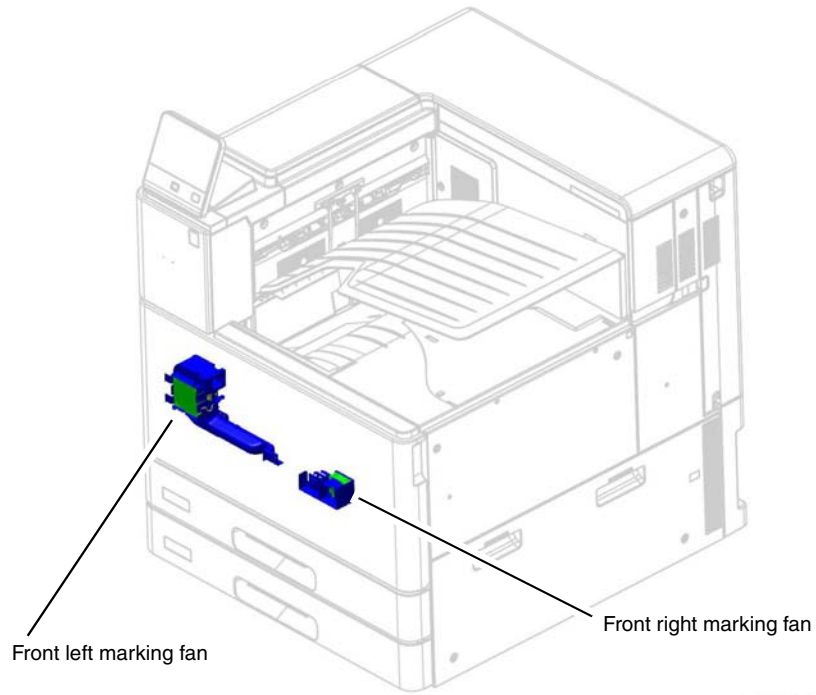
Front left marking fan

Front right marking fan

Figure 3 Front marking fans

- Front/right marking fan (P1), [PL 40.10 Item 9](#), receives 24VDC from the [Motor Drive PWB](#). The motor drive PWB logs code 043-351 if a fan failure is detected, [Figure 3](#).

- Front left marking fan (P2), [PL 40.10 Item 13](#), runs at 2 speeds. The fan receives power from the [Motor Drive PWB](#). At low speed the fan receives 12VDC, at high speed it receives 24VDC. The motor drive PWB logs code 043-354 if a fan failure is detected, [Figure 3](#).

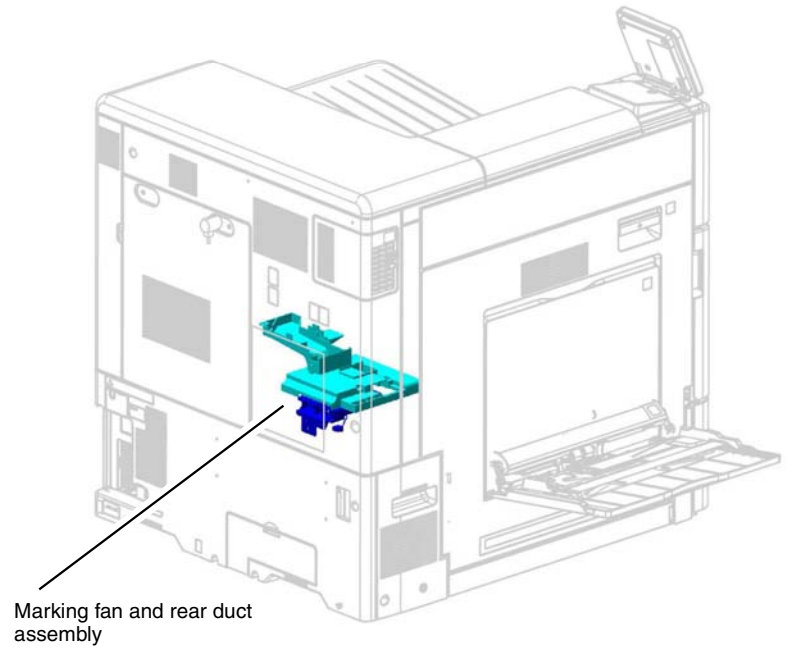
Marking fan and rear duct assembly

Figure 4 Marking fan and rear duct assembly

- Fuser unit exhaust fan, [PL 40.15 Item 2](#), [Figure 5](#).
- Marking fan duct assembly, [PL 40.10 Item 15](#), runs at 2 speeds. The fan receives power from the [Motor Drive PWB](#). At low speed the fan receives 12VDC, at high speed it receives 24VDC. The motor drive PWB logs code 043-349 if a fan failure is detected, [Figure 4](#).

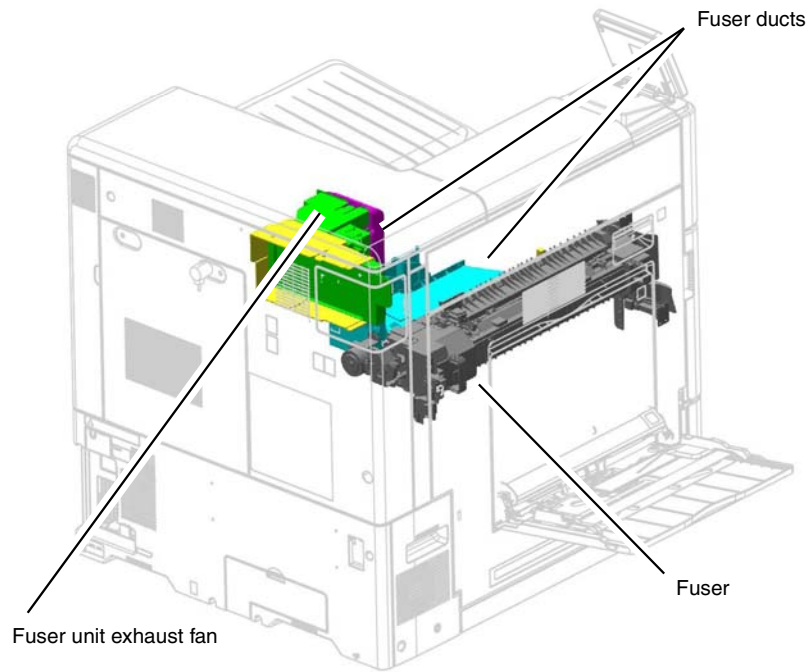
Figure 5 Fuser fan and ducts

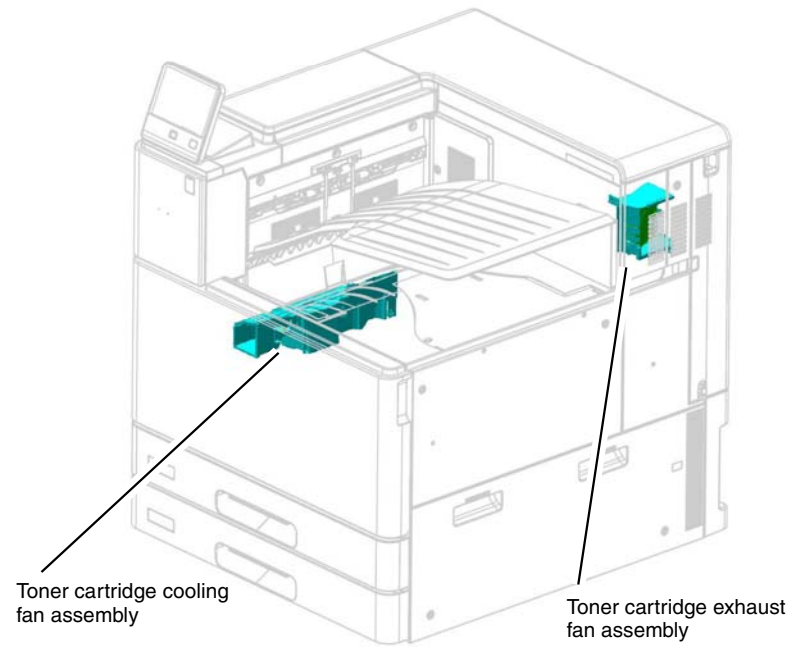
Figure 6 Toner cartridge cooling fan and exhaust fan

- Toner cartridge cooling fan assembly, [PL 40.10 Item 12](#), receives 24VDC from the [Motor Drive PWB](#). The motor drive PWB logs code 043-352 if a fan failure is detected, [Figure 6](#).

- Toner cartridge exhaust fan assembly, [PL 40.15 Item 9](#), receives 24VDC from the [Motor Drive PWB](#). The motor drive PWB logs code 042-344 if a fan failure is detected, [Figure 6](#).

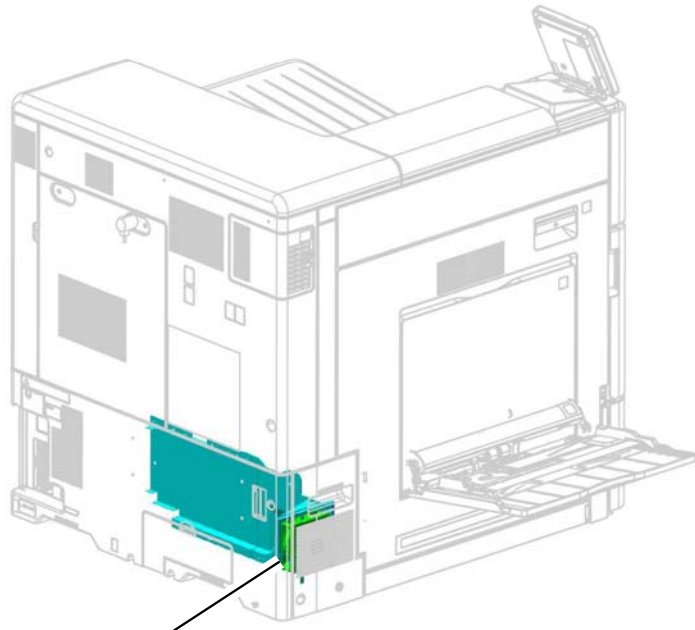
LVPS fan assembly

Figure 7 LVPS fan assembly

- [Low Voltage Power Supply fan](#), PL PL 40.15 Item 4, receives 24VDC from the [Motor Drive PWB](#). The motor drive PWB logs code 043-322 if a fan failure is detected, [Figure 7](#).

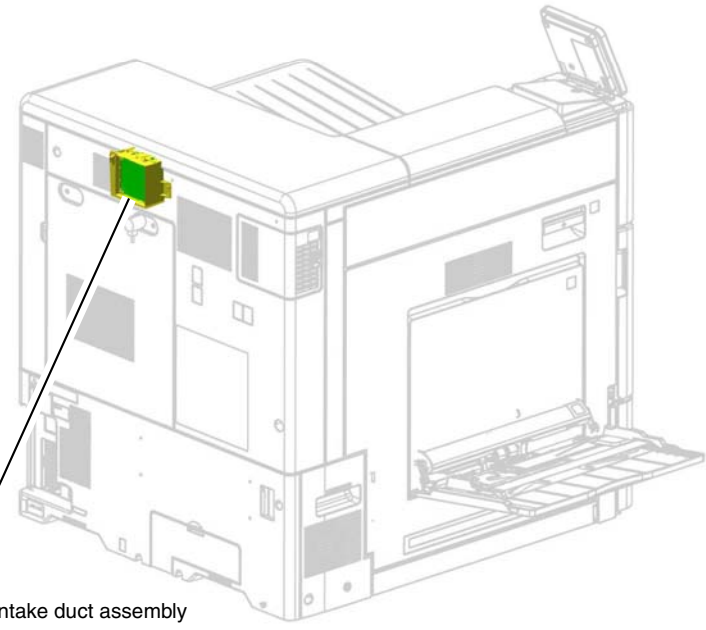
IHPS intake duct assembly

- IHPS intake duct assembly, [PL 40.15 Item 8](#), runs at 2 speeds. The fan receives power from the [Motor Drive PWB](#). At low speed the fan receives 12VDC, at high speed it receives 24VDC. The motor drive PWB logs code 043-356 if a fan failure is detected, [Figure 8](#).

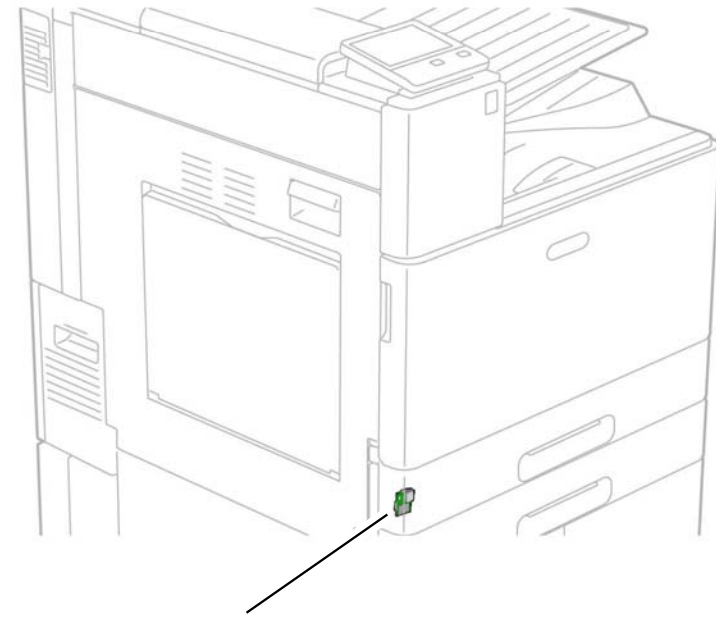
The NOHAD temp & humidity sensor, [PL 40.10 Item 5](#), is monitored by the [Motor Drive PWB](#). The sensor detects changes in external temperature and humidity. The motor drive PWB logs code 042-641 if a value is detected outside of the optimum for the machine. Code 042-641 is categorized as a hidden fail value and does not appear on the UI. [dC120](#) will record 042-641 in the failure code list.

Refer to [Figure 9](#) and [BSD 10.5 Fusing](#).

Temperature and humidity sensor (external)

Figure 9 NOHAD temperature and humidity sensor

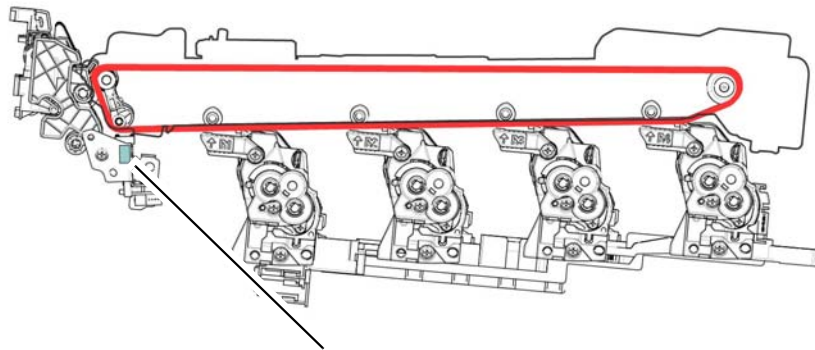
A second temperature and humidity sensor, [PL 90.30 Item 9](#), is installed below the IBT belt assembly. This sensor measures the temperature and humidity inside the machine.

Refer to [Figure 10](#) and [BSD 60.4 Temperature and Humidity Sensing](#).

Location of internal temperature and humidity sensor on bracket below the IBT unit towards the rear of the machine. Refer to [PL 90.30 Item 9](#).

Figure 10 Temperature and humidity sensor (internal)

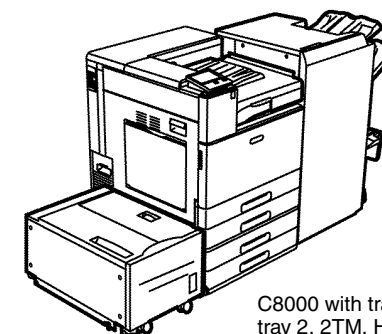
C8000 with tray 1, tray 2, 2TM, HCF and BR finisher

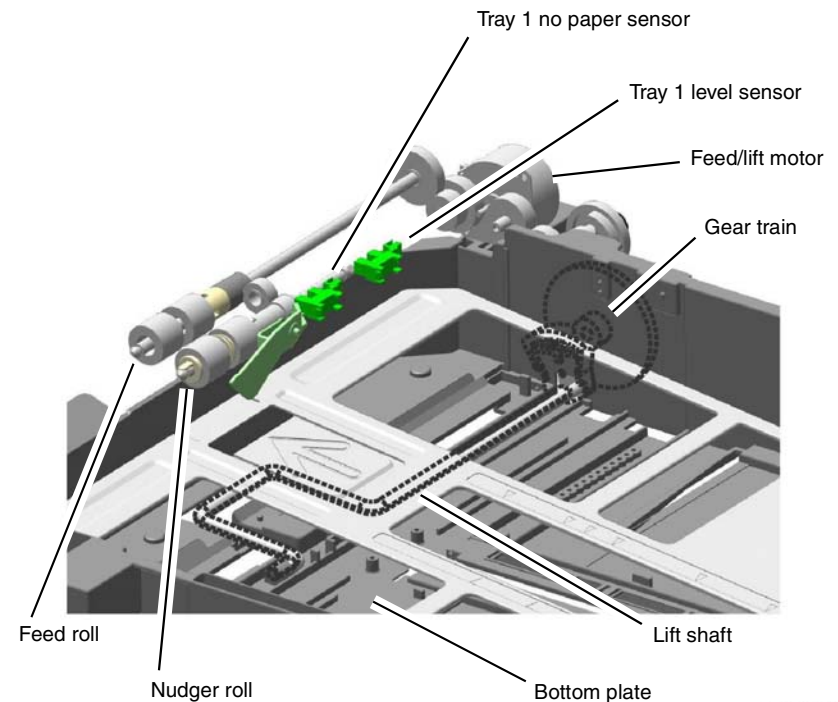
Refer to [Figure 2](#).

Figure 2 Tray 1 components

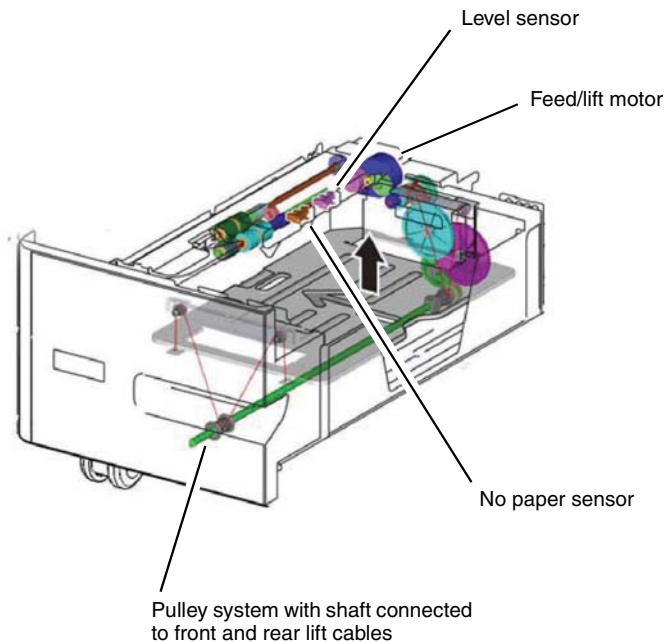
When the tray is loaded and pushed into the machine, thereby actuating the paper size sensor (see [Paper Size Detection](#)), the control logic commands the feed/lift motor to rotate in the lift direction. The motor provides drive to the cable and pulley system raising the stack. When the stack actuates the level sensor to signal Low the motor stops, holding the paper stack in the feed position. The tray level is maintained by a clutch. Refer to [Figure 3](#) and [Figure 4](#).

Figure 3 Tandem tray module tray 3

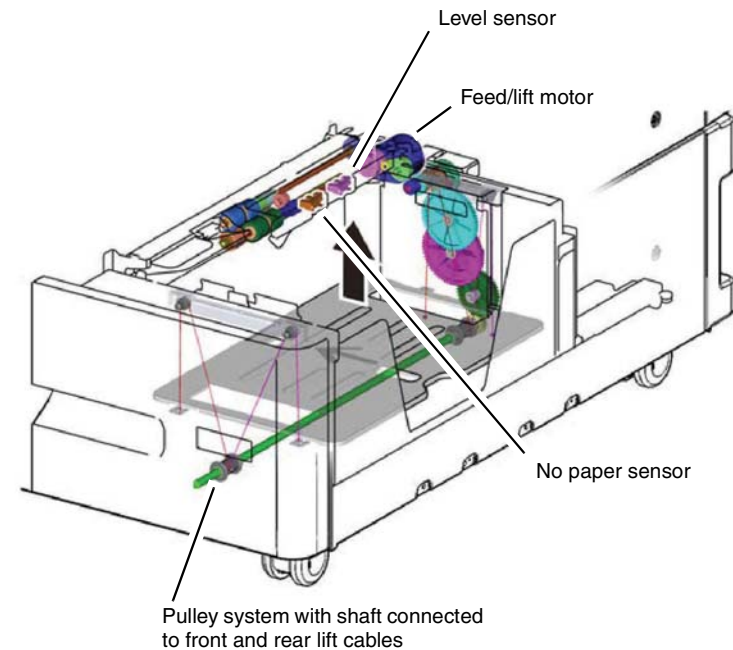
In the feed position the control logic directs the feed/lift motor to rotate in the feed direction. When the height of the paper stack is no longer adequate to actuate the tray level sensor the sensor signals High (3.3VDC) and the control logic directs the feed/lift motor to rotate in the lift direction again.

When the last sheet feeds from the tray the tray no paper sensor actuator drops into an opening in the paper tray elevator unblocking the tray no paper sensor (refer to [Feedhead Components](#)). This signals the control logic that the tray is empty and to display a (tray empty) message on the UI, Refer to [No Paper Detection: Trays 1, 2, 3 and 4](#).

Figure 4 Tandem tray module tray 4

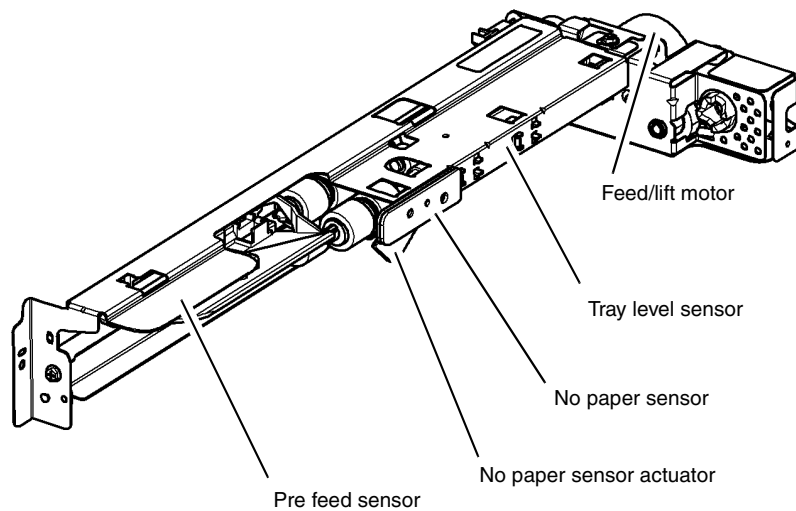
The tray level sensor, no paper sensor and pre feed sensor are all integral to the feeder assembly. The pre feed sensor is used to detect paper mis feeds and paper jams. [Figure 5](#).

Figure 5 Tray 1 feedhead assembly

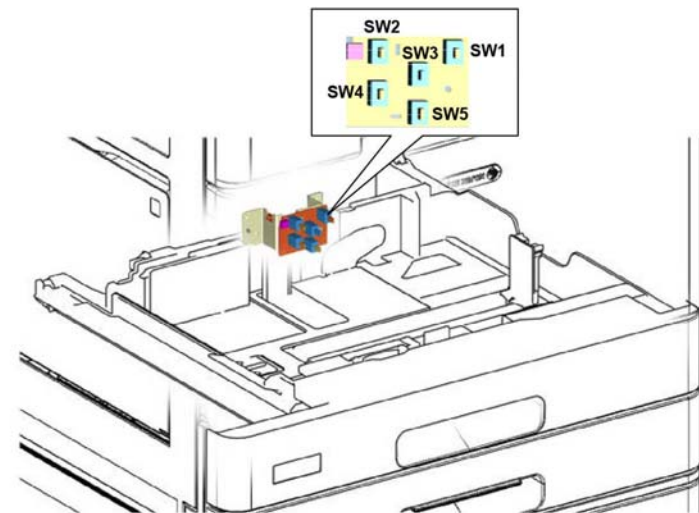
The paper size switches within trays 1 and 2 and trays 3 and 4 of the 2TM operate in a similar way. [Figure 6](#) shows the position of the switch in tray 1 and 2; trays 3 and 4 of the 2TM are in a similar location. The paper size switches in the TTM are different.

Figure 6 Tray 1 paper size switch location

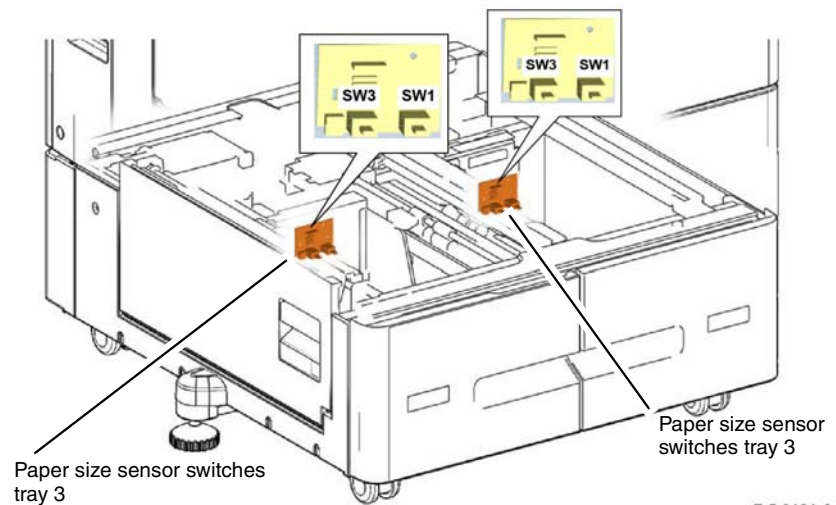
Paper size switch locations in the TTM are shown in [Figure 7](#).

Figure 7 TTM paper size sensors

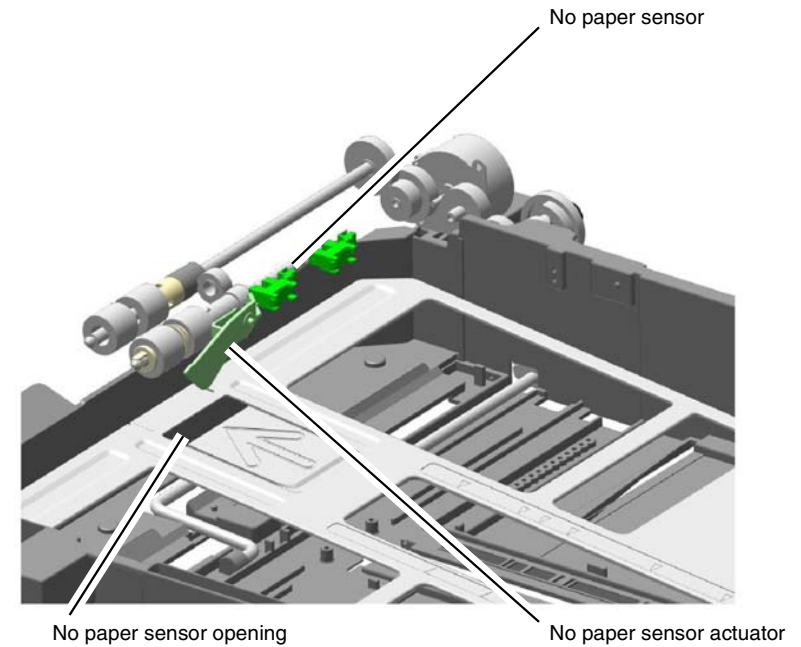
Refer to [Figure 8](#) and [Figure 9](#).

Figure 8 Tray 1 no paper sensor

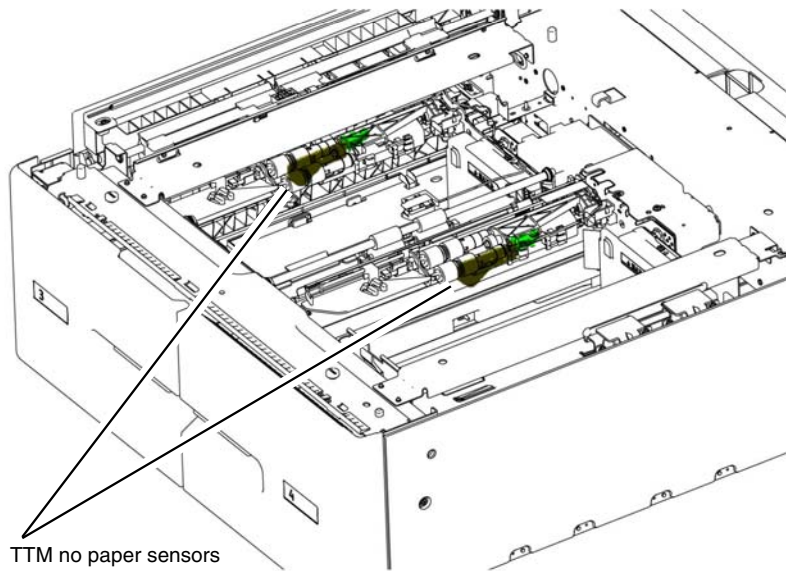
Figure 9 TTM no paper sensor

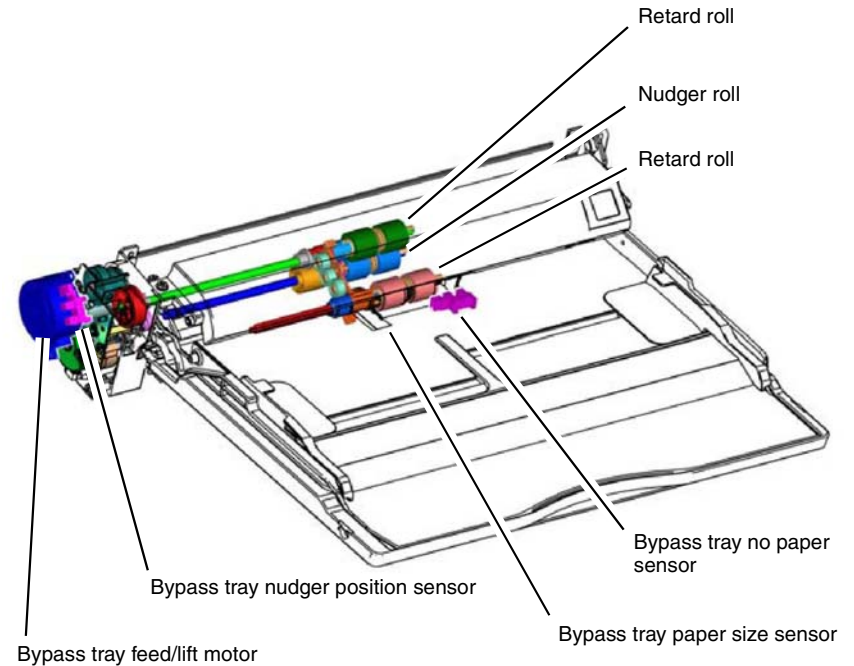
When paper is loaded into the bypass tray the motor drive PWB detects a High signal (3.3VDC) from the bypass tray no paper sensor and the control logic activates the feed/lift motor, [PL 80.120 Item 1](#) to run. The motor elevates the tray (via a gear train and lift shaft) and paper stack acting on a link attached to the base of the tray. When the paper stack actuates the bypass tray nudger position sensor the control logic deactivates the feed/lift motor. When paper is requested from the bypass tray the feed/lift motor operates in the feed direction. If feeding the paper causes the bypass tray nudger position sensor to go High (3.3VDC) the control logic runs the feed/lift motor again in the lift direction until the stack is detected once more.

Figure 10 Bypass tray components

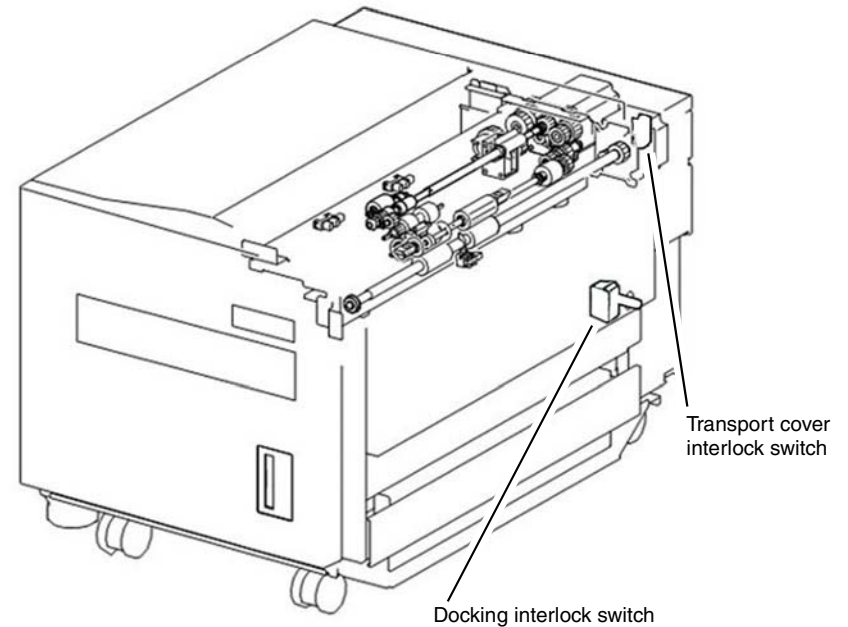
Refer to [Figure 11](#).

Figure 11 HCF interlocks

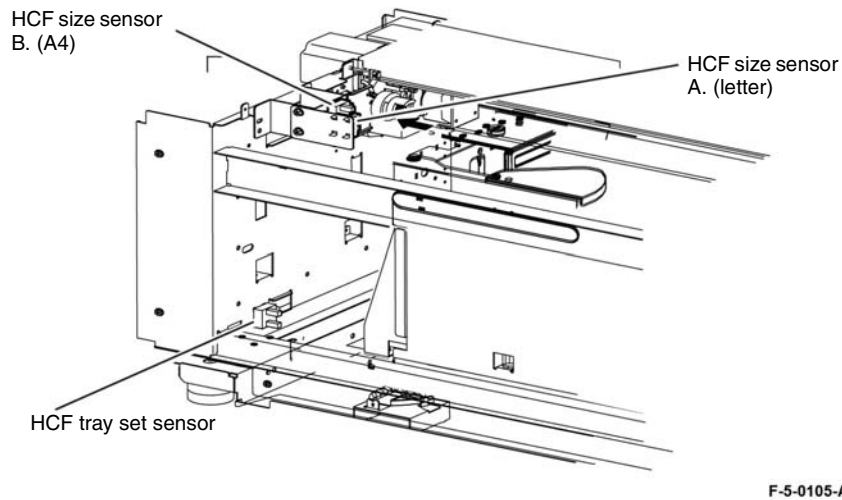
When the HCF tray is pulled out to load paper the lift gear is separated from the drive gear and the tray is free to fall to the bottom position. A torque limiter on the lift shaft slows the fall of the paper tray to prevent damage to feeder components.

Figure 12 HCF tray in and paper size sensors
