VersaLink[®] C8000/C9000 Printer

Service Manual

VersaLink C9000 Family Service Manual

705P01418

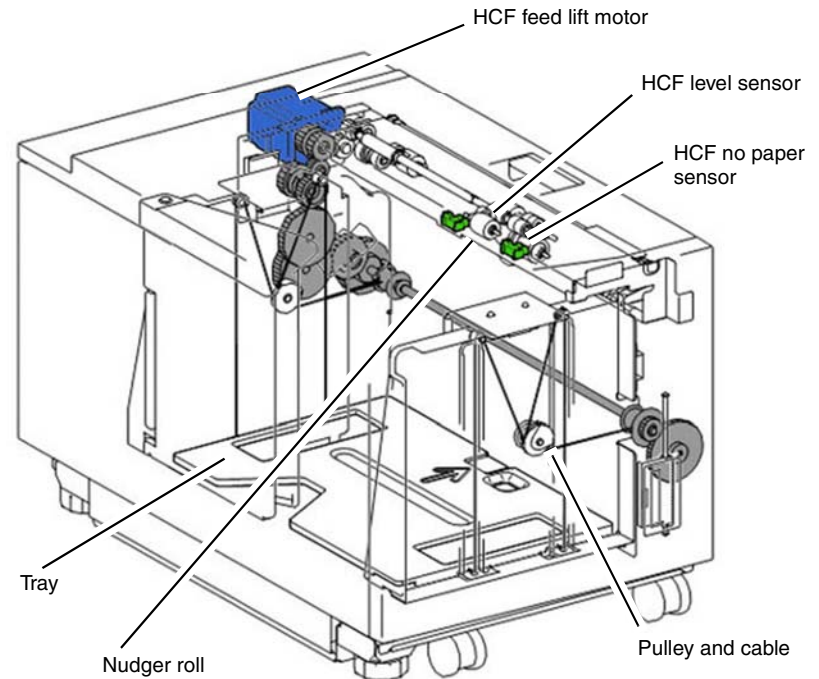
1. The nudger roll, [PL 80.105 Item 23](#), is lowered.
2. The HCF feed/lift motor switches, [PL 80.100 Item 23](#), on and rotates CCW to lift the tray through a pulley and cable arrangement.
3. Lift continues until the paper stack reaches and lifts the nudger roll, deactuating the HCF level sensor, [PL 80.105 Item 19](#).
4. The HCF feed/lift motor switches off.

Refer to [Figure 13](#) and [BSD 70.17 HCF Paper Stacking](#).

Figure 13 HCF level sensor

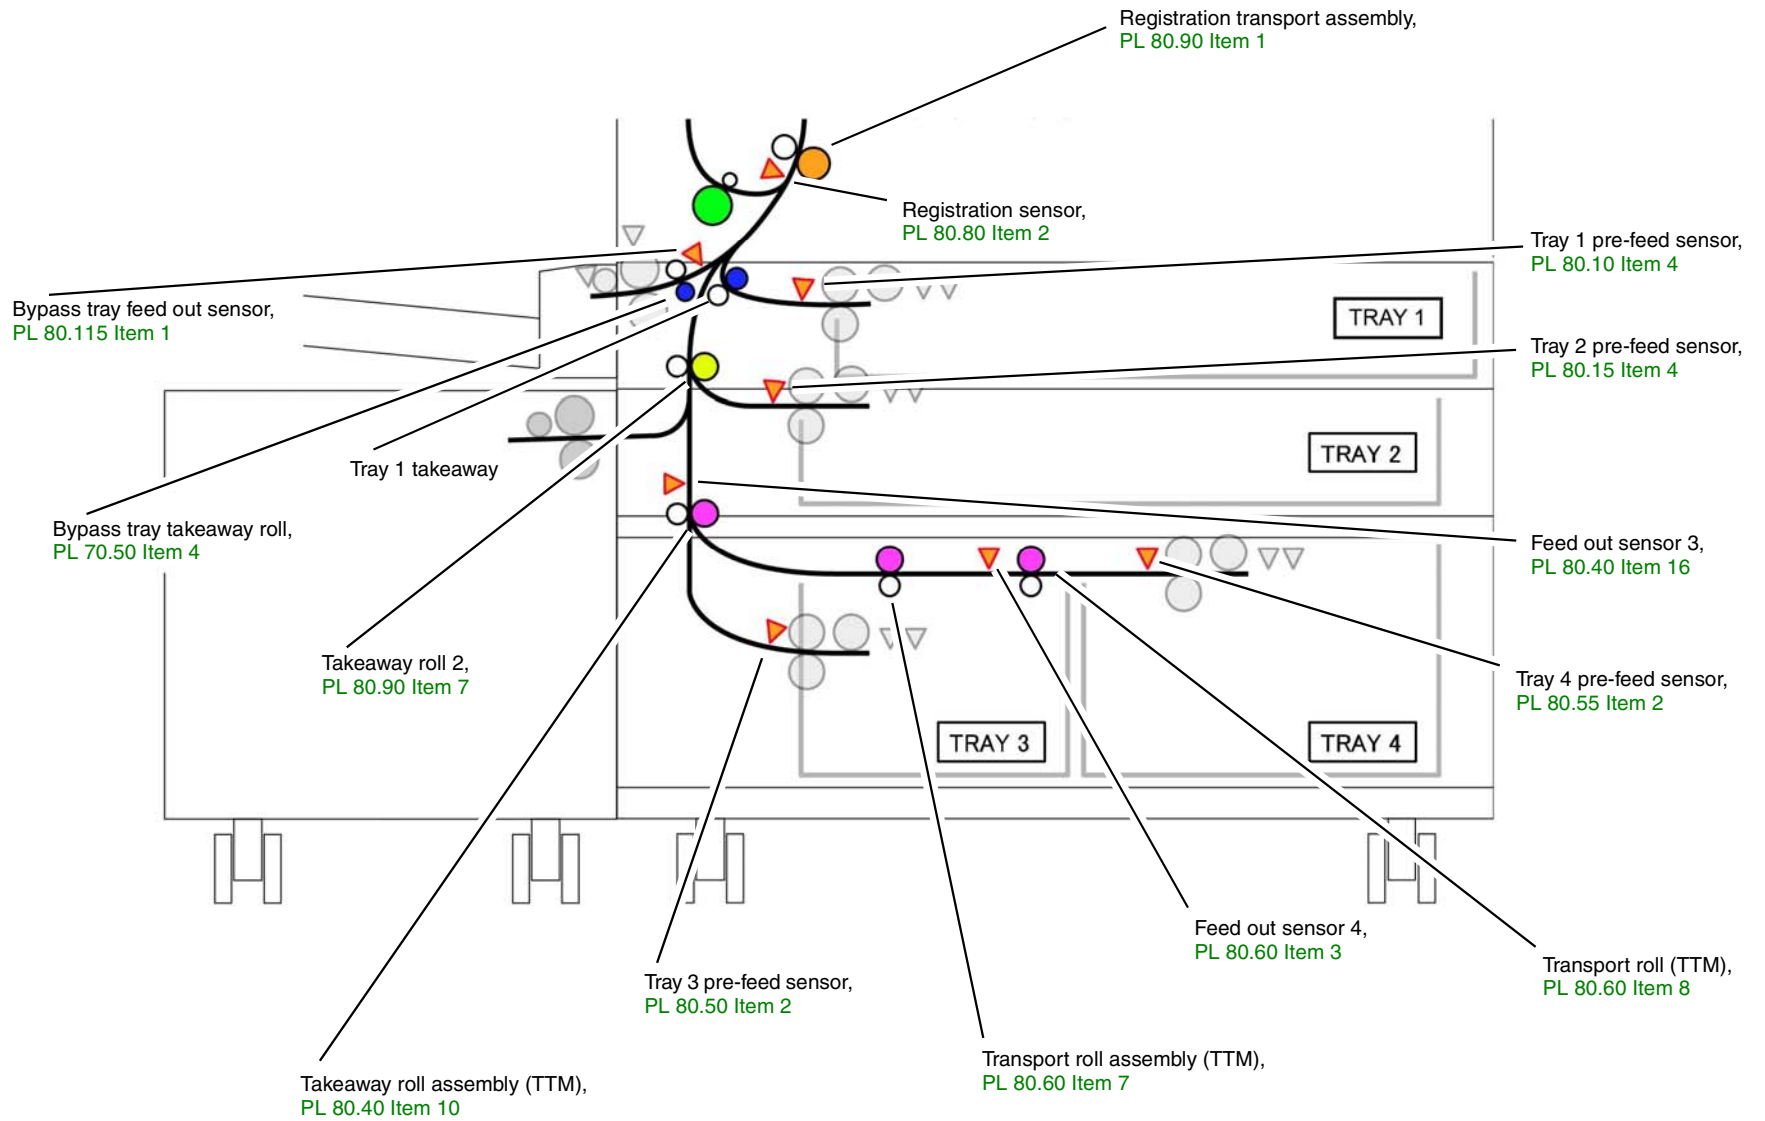
Figure 2 Paper path from TTM configuration

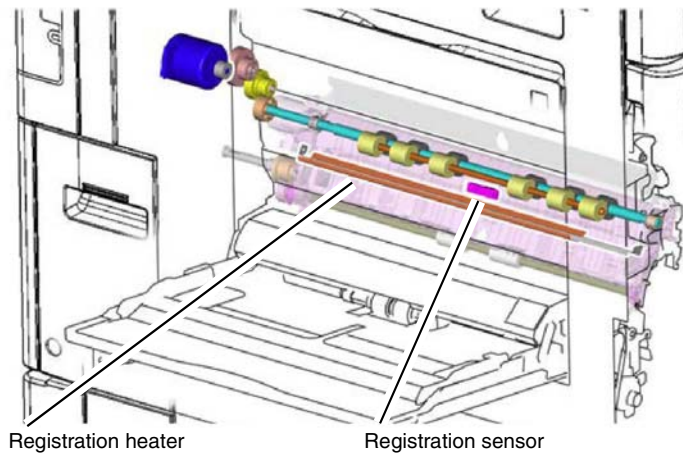
The purpose of the registration heater is to prevent dew condensation inside the printer. ON/OFF control of the registration heater is determined by temperature and humidity values from [Temperature/Humidity \(No.2, Internal\) Sensor](#).

- NVM 741-335 activates the registration heater control based on the temperature inside the printer. Default value 0 = activation disabled. 1 = activation enabled.
- The registration heater starts working when temperature from [Temperature/Humidity \(No.2, Internal\) Sensor](#) is lower than threshold value and stops working when temperature from the internal sensor rises beyond the threshold value.

Figure 3 Registration transport

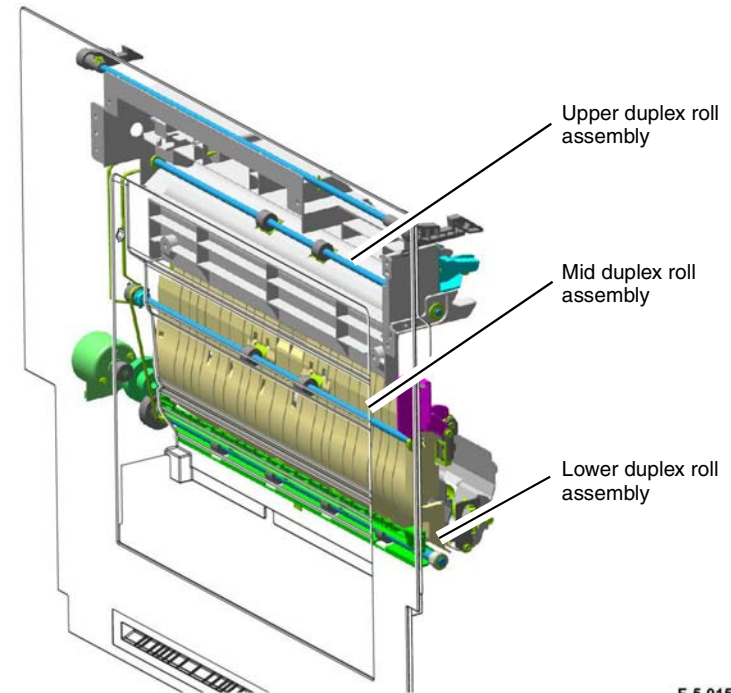
- Upper duplex roll assembly, [PL 80.55 Item 9](#).
- Mid duplex roll assembly, [PL 80.75 Item 22](#).
- Lower duplex roll assembly, [PL 80.75 Item 23](#).

Refer to [Figure 4](#) and [BSD 10.8 Duplex Paper Transport](#).

Figure 4 Duplex transport assembly

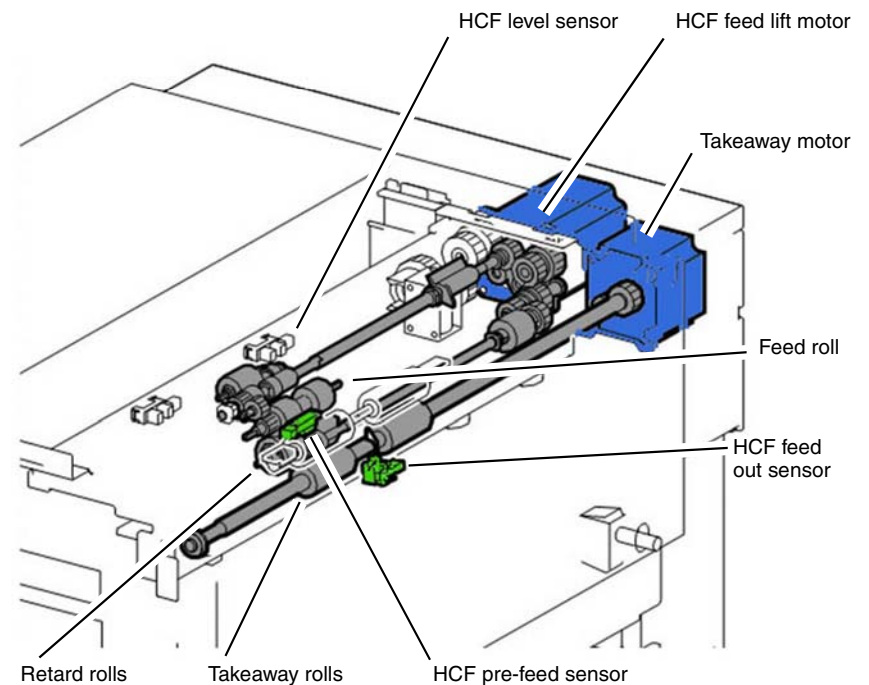
Figure 5 HCF paper feed

Refer to [Figure 5](#).

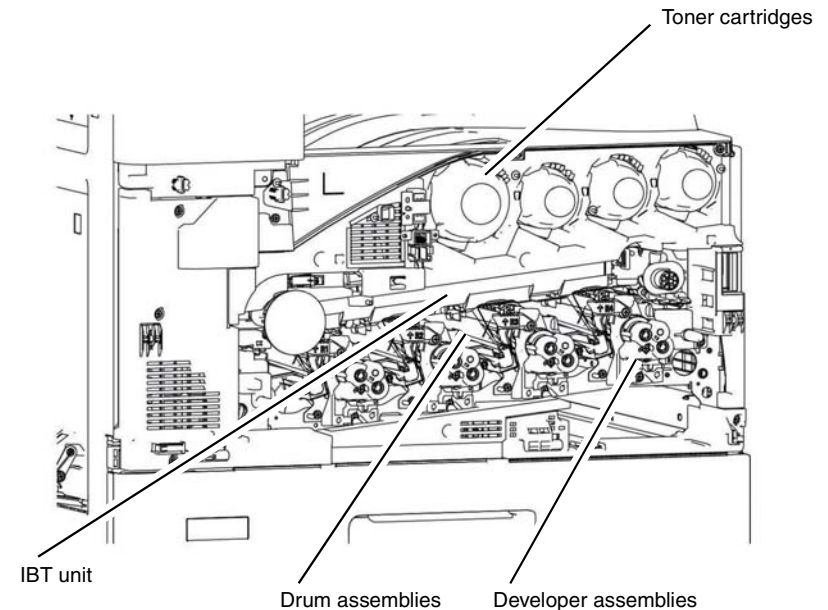
Figure 1 shows the main xerographic components as viewed from the front of the machine, with the waste toner bottle removed.

Figure 1 Main xerographic components

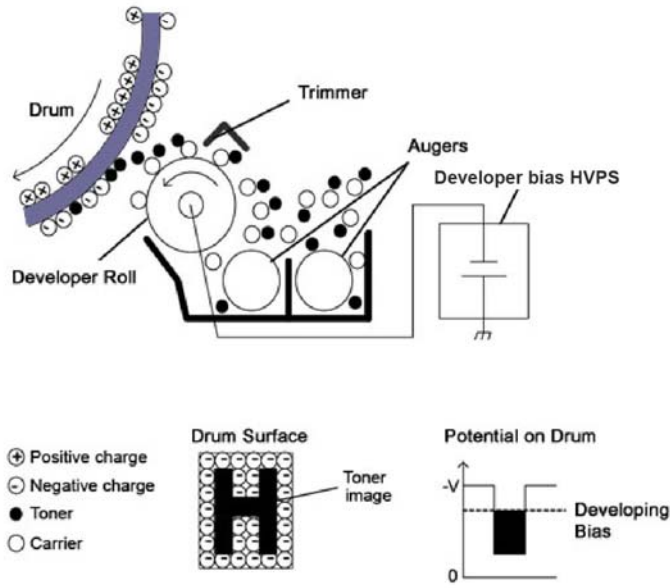
Figure 2 Developer operation

Toner is supplied from each of the toner cartridges to the corresponding photoreceptor drum by the [Toner Dispenser Assemblies](#), the augers and developer rolls. The rotation of the augers mixes the toner and carrier beads which make up the developer mixture. The mixing process produces an electrostatic charge on the toner.

Each developer roll has a magnetic core which causes a brush composed of developer mixture to form at its surface similar to the way iron filings stand up on the surface of a magnet. The height of the brush is controlled by the trimmer blade. The developer brush contacts the photoreceptor drum and the toner is attracted from the brush to the latent image formed by exposure to the LPH, that is, to the areas that have a reduced charge. The carrier material and any excess toner not attracted to the drum falls back into the developer reservoir where it is mixed back into the developer mixture by the continued movement of the augers.

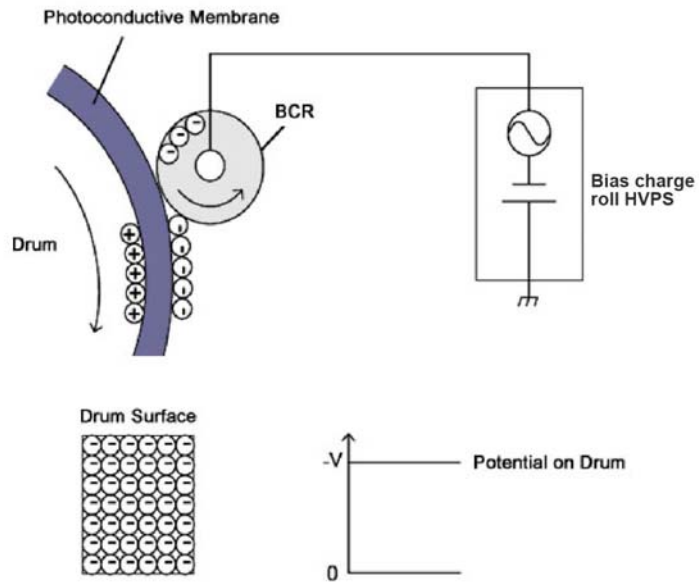
Figure 3 Photoreceptor drum charging

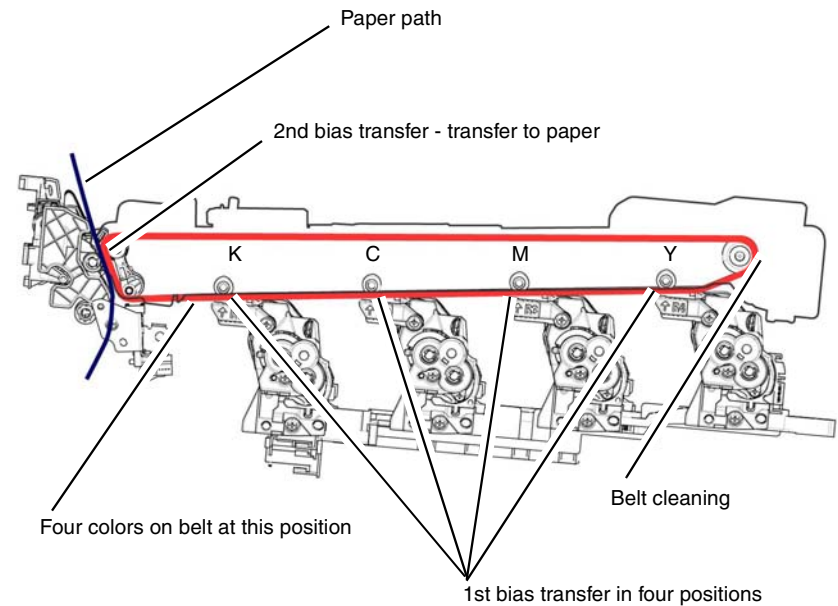
Figure 4 Image transfer process

In the case of 1st bias transfer the bias transfer roller carries a charge that has a greater electrostatic attraction than the charge that is holding the image on the drum. This means that the toner particles are drawn away from the drum to the belt as the belt passes between the BTR and the drum.

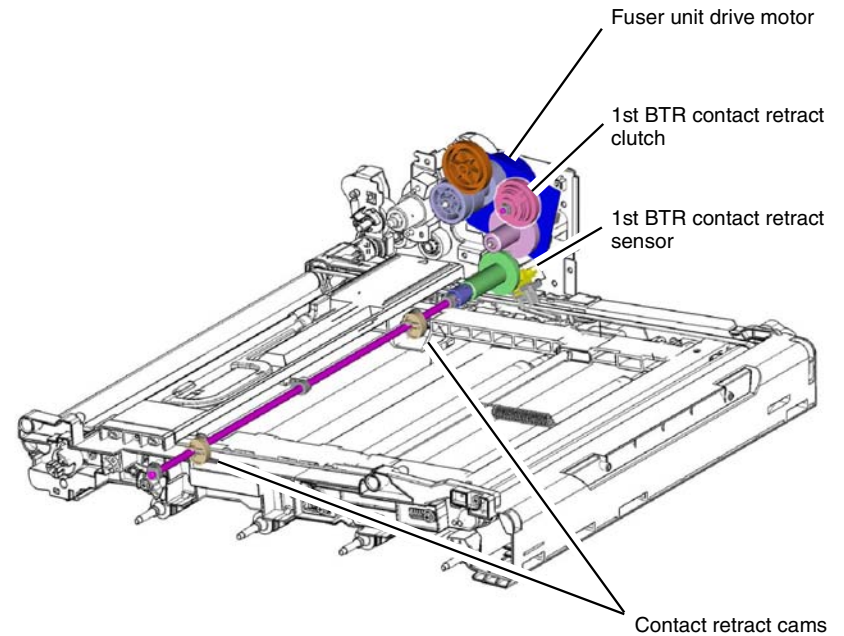
Figure 5 First BTR contact/retract mechanism

In order to reduce wear on the cyan, yellow and magenta photoreceptor drums the 1st BTR rollers are retracted from the C, M and Y drums when operating in greyscale modes. The [Motor Drive PWB](#) operates the 1st BTR contact retract clutch, [PL 40.05 Item 20](#). The clutch allows drive from the fuser unit drive motor, [PL 40.05 Item 19](#), to the 1st BTR contact/retract cam which moves the 1st bias transfer roll (C, M, and Y only) away from the belt. The BTR contact/retract sensor, [PL 40.05 Item 11](#), is monitored by the motor drive PWB to monitor the state of the 1st BTR rolls. The sensor monitors one of the 1st bias transfer rolls and implies the state of the other two.

There is a single drive from the fuser unit drive motor with a signal contact retract clutch. Beyond the clutch the drive splits to drive the individual cams for the C, M and Y bias transfer rollers. Refer to [Main Drive Paths](#).

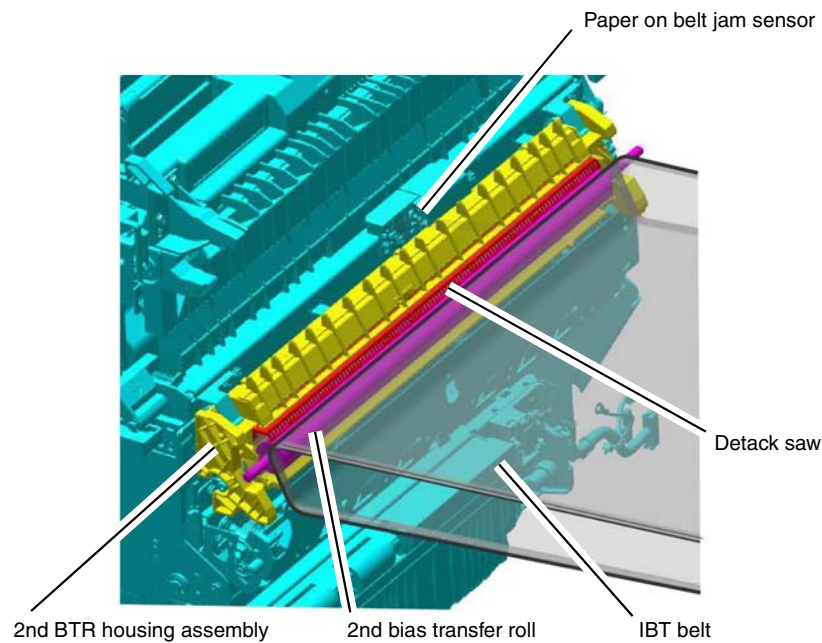
Figure 6 shows the IBT belt and the 2nd bias transfer roll. The tension roll and other IBT components inside the belt have been removed for clarity.

Figure 6 Second transfer

The paper is released from the transfer belt by the detack saw. A voltage is applied to the detack saw to eliminate the charge on the paper and allow it to release from the belt. If the detack saw fails to separate the paper from the belt the **Paper on Belt Jam Sensor** detects the jam.

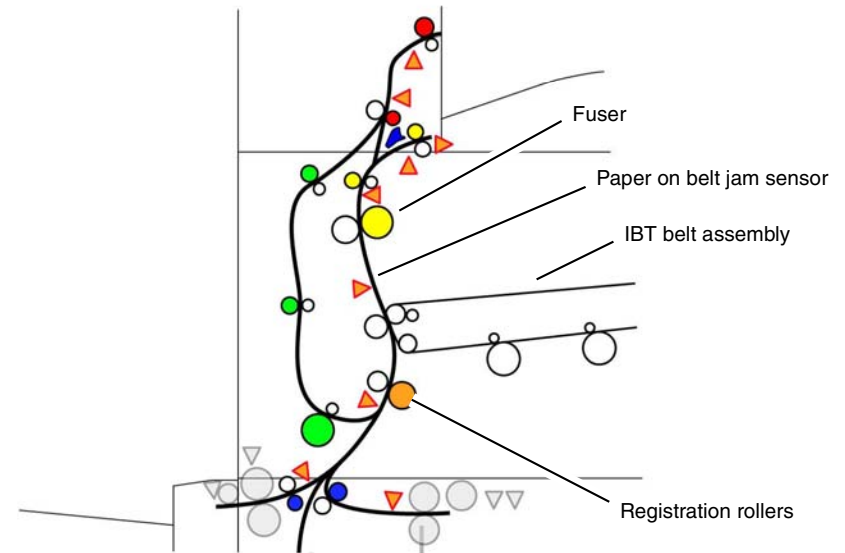
Figure 7 Paper on belt jam sensor

The paper on belt jam sensor, **PL 80.80 Item 9**, detects paper in the path from the **Intermediate Belt Transfer (IBT) Unit** to the fuser (**Fuser Overview**). The sensor is monitored by the **Motor Drive PWB**. When the sensor detects High (3.3VDC) the control logic determines a detack failure. Detack failure indicates that the paper has left the paper path and is jammed on the IBT unit. The IBT unit is stopped and code 077-110 is logged.

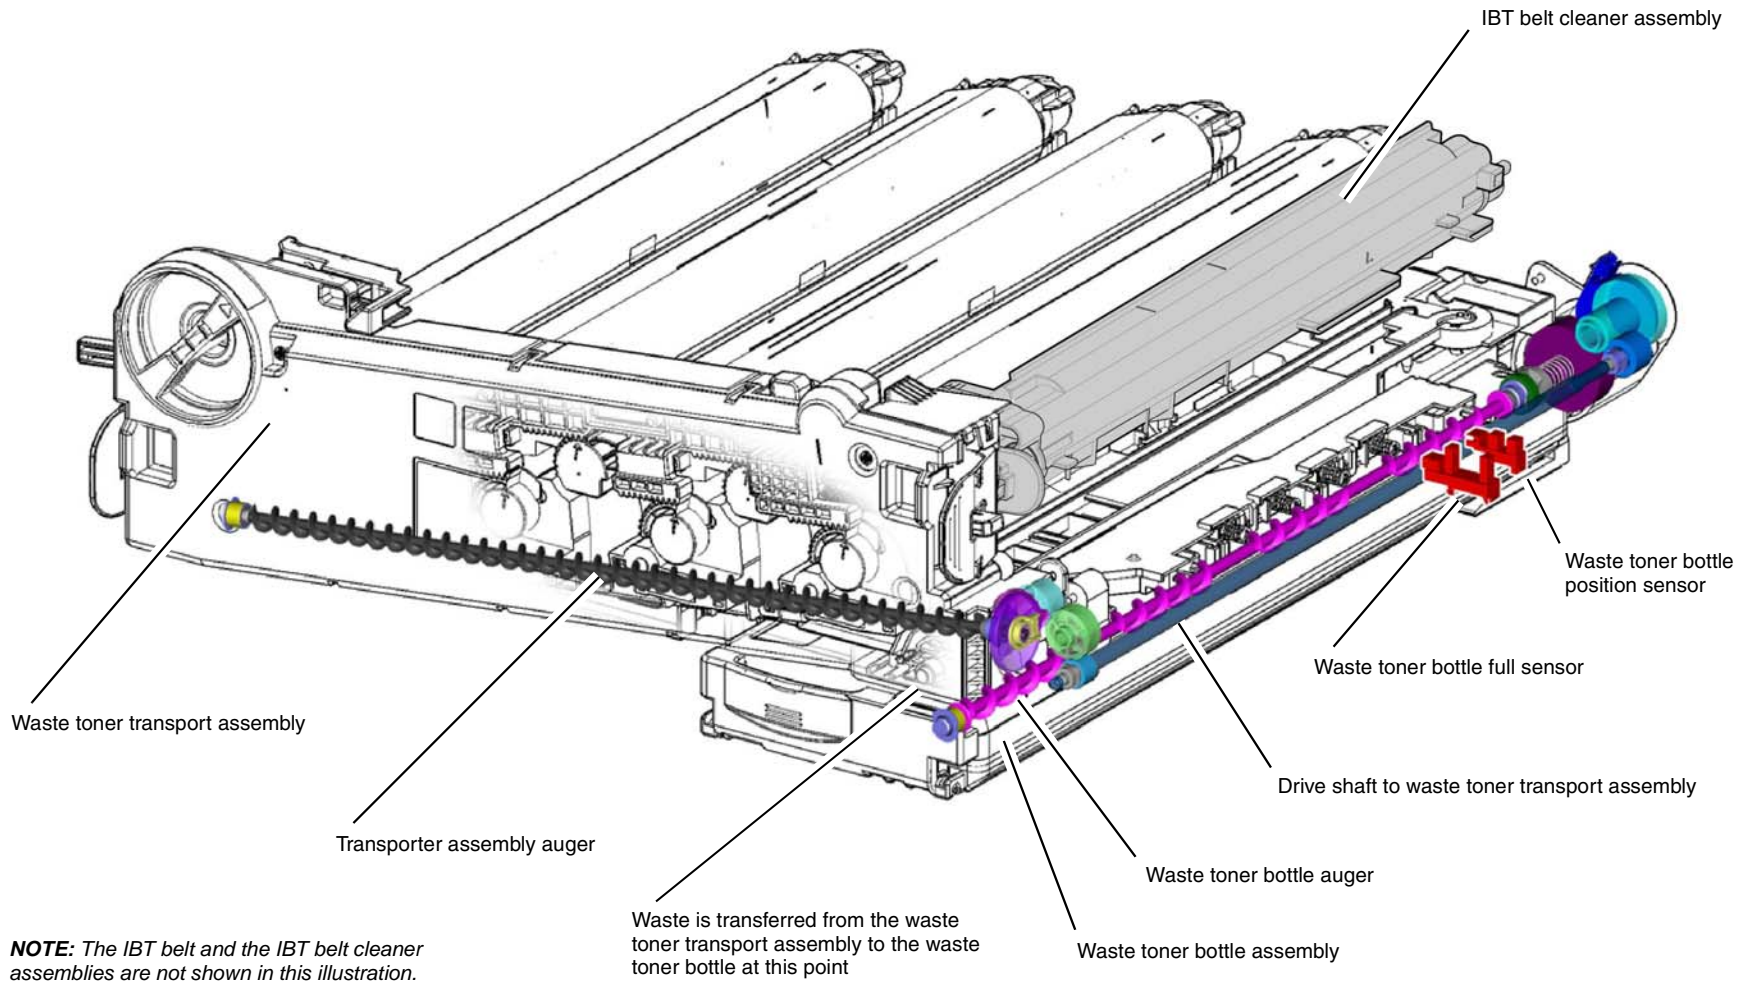
Figure 8 Drum and IBT cleaning

- Waste toner bottle full sensor, [PL 90.20 Item 6](#). This sensor detects the fill level of the waste toner bottle in three levels, full, near full and pre near full.
- Waste toner bottle position sensor, [PL 90.20 Item 7](#). This sensor detects that the waste toner bottle is in position.
- The waste toner bottle sensors are monitored by the [Motor Drive PWB](#).

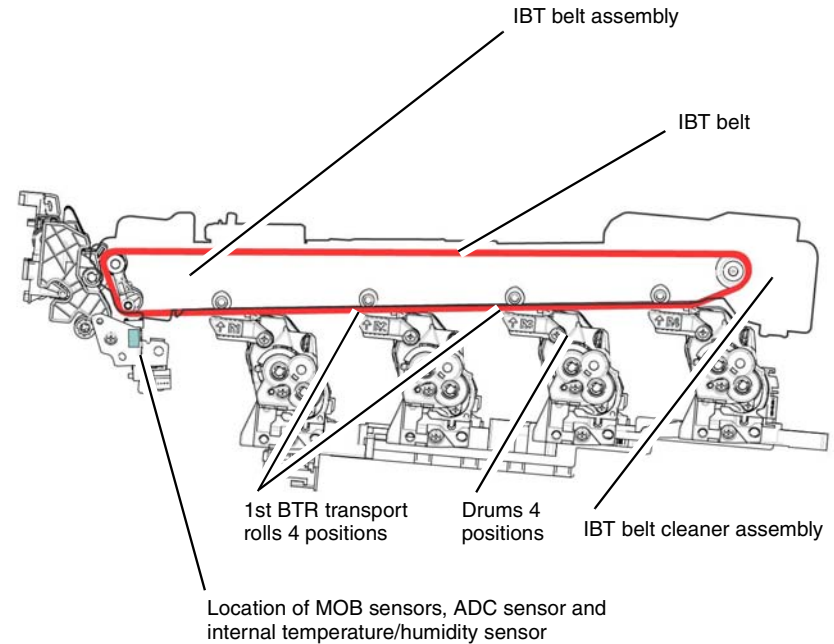
Figure 9 MOB and ADC sensors.

The MOB and ADC sensors monitor the toner concentration on the transfer belt. The sensors are mounted in a row across the belt in a position after the fourth color has been added and before the toner is transferred to the paper, [PL 90.30 Item 8](#) and [Figure 9](#). The MOB and ADC sensors are monitored by the [Motor Drive PWB](#) which feeds data to the [Half-tone PWB](#). Refer to [Automatic Density Control](#).

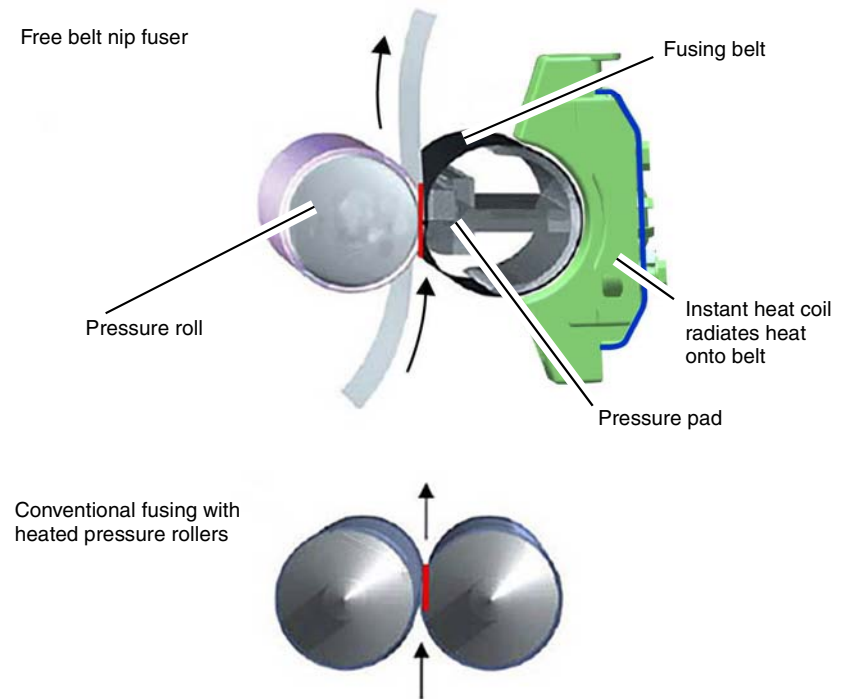
Figure 2 Free belt nip fusing

Fusing works using a free belt nip fusing mechanism consisting of a pressure roll that presses against a heated belt. The belt is held against the pressure roll by a pressure pad inside the belt. The belt is driven by friction applied by the rotation of the pressure roll and the movement of the paper through the fusing nip. The pressure roll is driven by the fuser unit drive motor, [PL 40.05 Item 19](#), (refer also to [Fuser Drive Assembly](#)). A latch mechanism allows for the fusing nip to open for jam clearance when the left cover, [PL 80.70 Item 1](#), is opened. The fuser nip is opened when printing is not in progress to prevent deformation of the pressure roll.

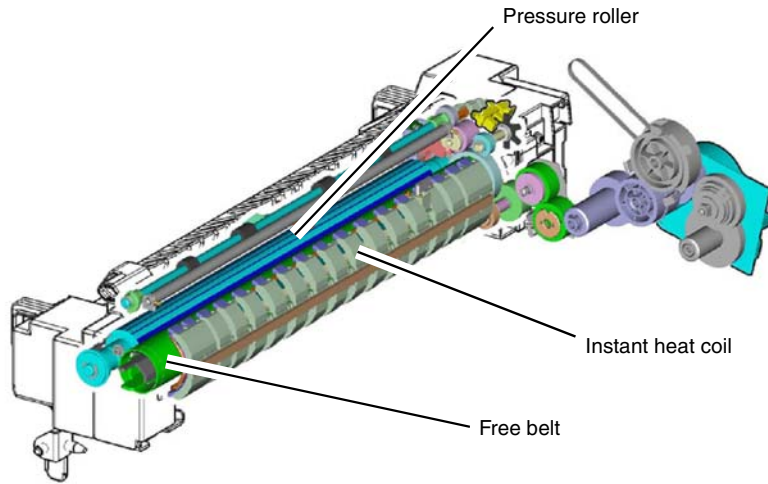
Figure 3 Fuser with IH coil unit

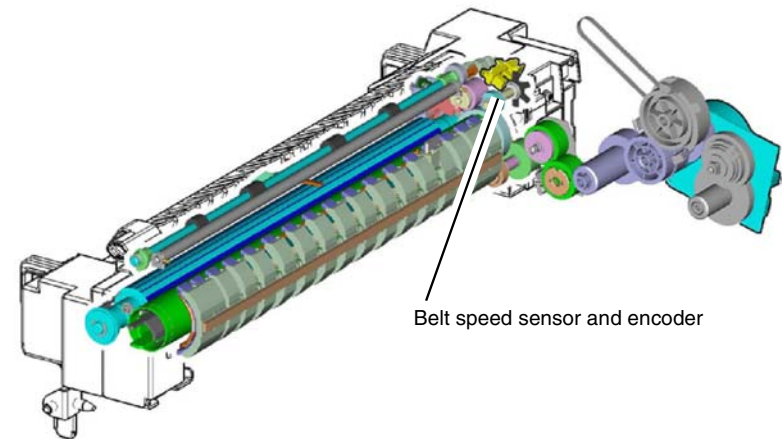
Figure 4 Belt speed sensor

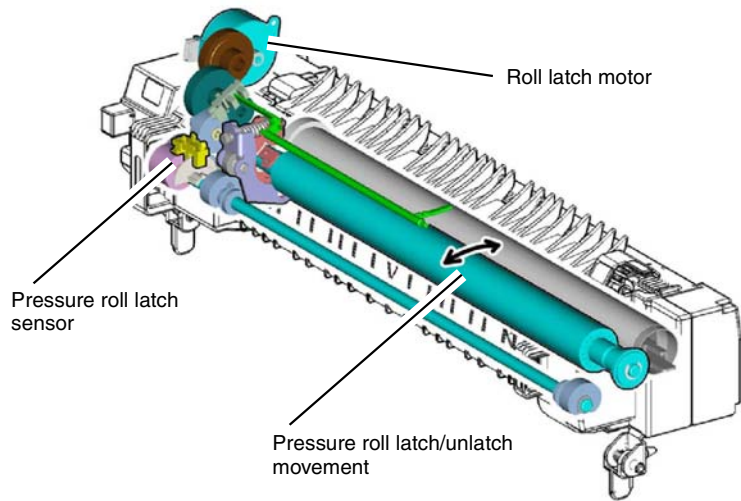
Figure 5 Pressure roll latch mechanism

The **pressure roll latch sensor** is monitored by the **Motor Drive PWB**. It measures the position of a cam attached to the pressure roll mechanism.

The pressure roll latch is driven by the retract motor assembly, **PL 10.05 Item 1**. The pressure roll is unlatched when the fuser is not operational or when the left cover is opened for jam clearance.

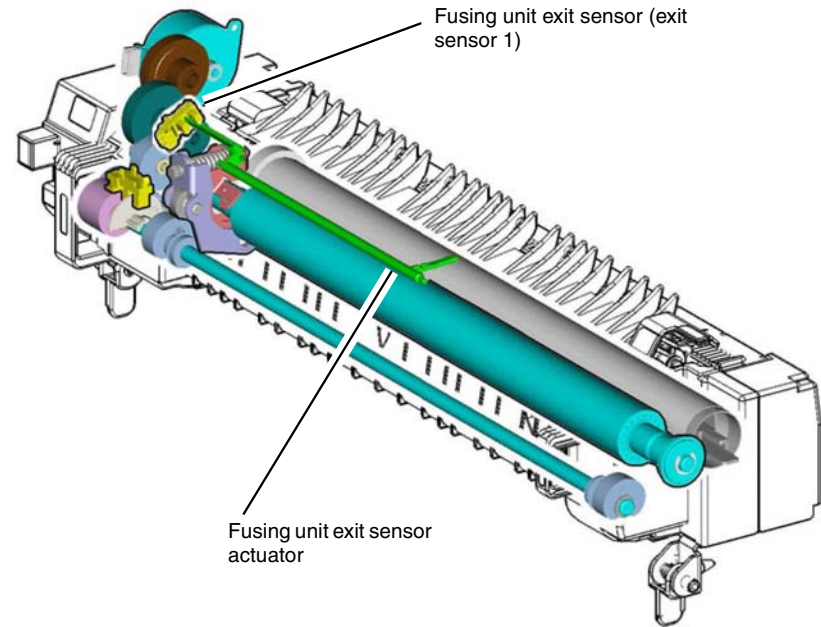
Figure 6 Fusing unit exit sensor

The **fusing unit exit sensor** (exit sensor 1) is monitored by the **Motor Drive PWB**. Paper leaving the fuser lifts an actuator which unblocks the sensor sending a 3.3VDC signal to the motor drive PWB. Once the paper has fully exited the fuser the actuator returns to the default position blocking the sensor.

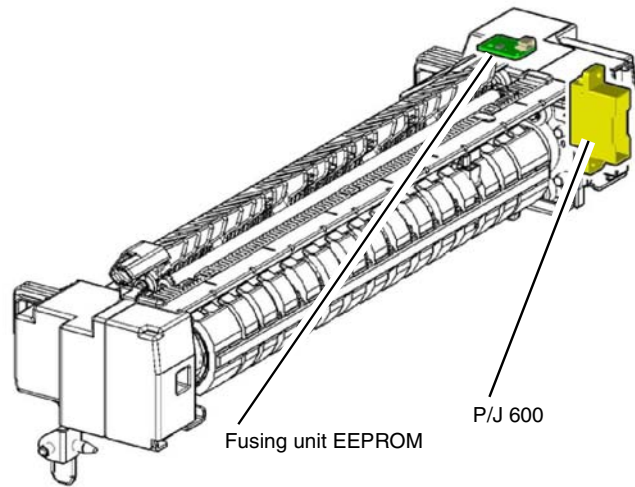
Figure 7 Fuser presence detection

The fusing unit EEPROM contains data about the fuser which is read by the **Motor Drive PWB**. The Motor drive PWB monitors the connection of pin 2 across P/J 600 to verify that the fuser is installed.

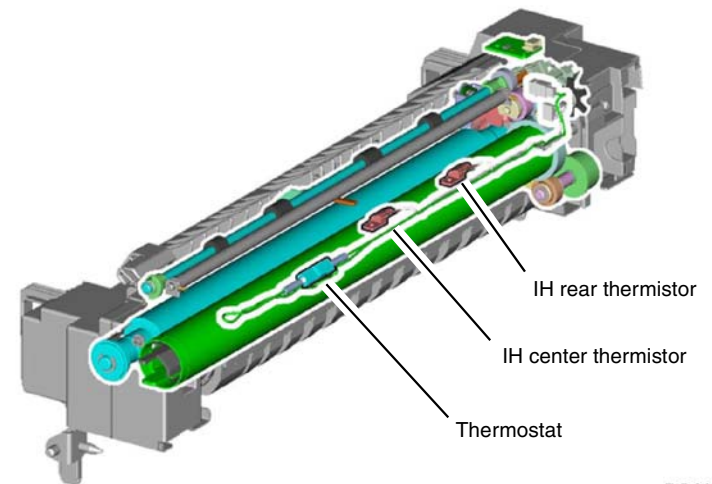
Figure 8 Thermistors and thermostat

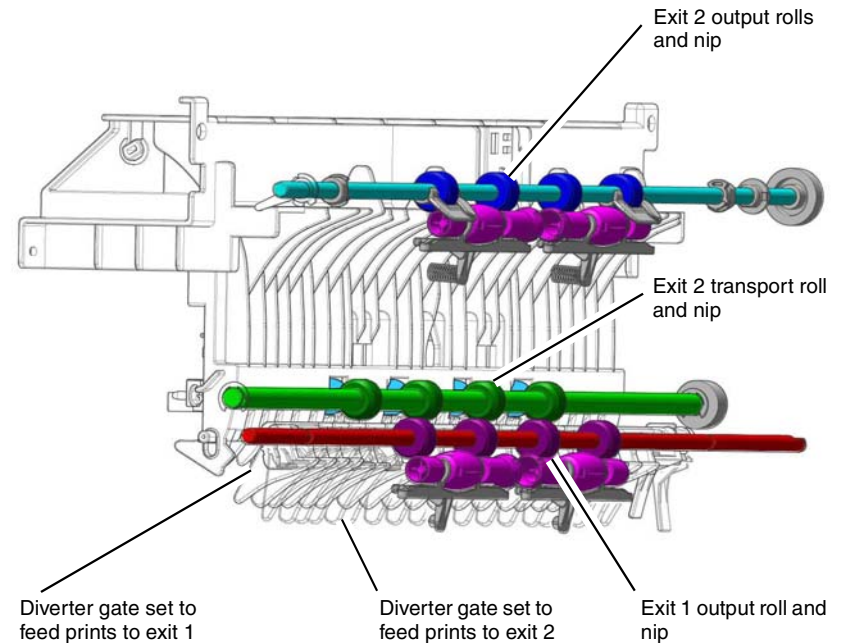
Figure 1 Print transport components

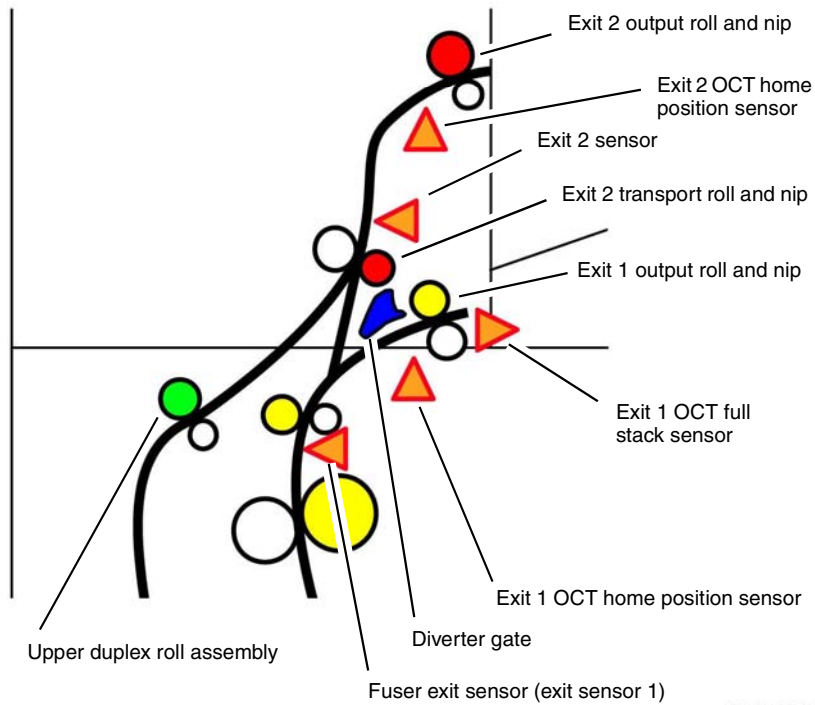
Figure 2 Print transportation sensors and rollers

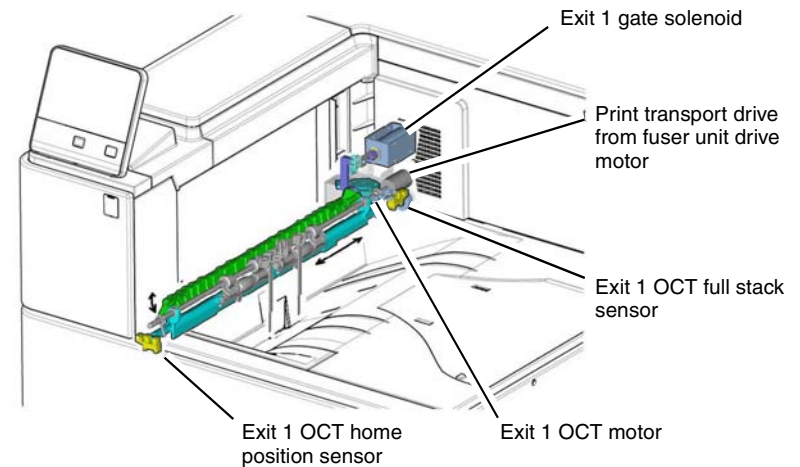
Figure 3 Exit 1

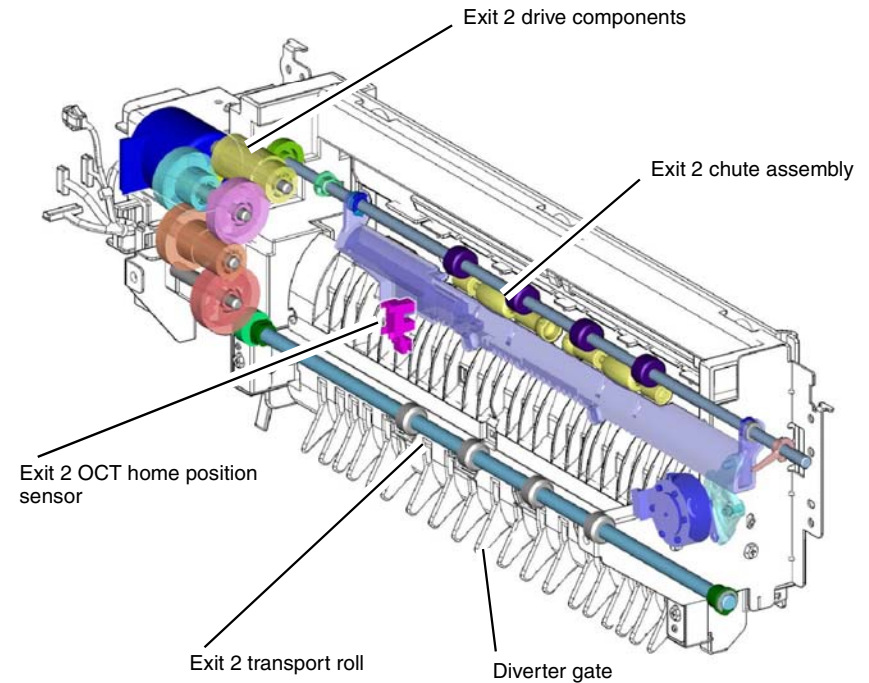
Figure 4 Exit 2 rolls and drives

- Exit 2 chute assembly, [PL 10.25 Item 8](#). Refer to [Figure 4](#) and [Figure 5](#).
- The face up exit sensor is not used on the C8000 or the C9000 printers. The sensor is connected to and monitored by the [Motor Drive PWB](#). In other machines the sensor would be triggered by prints passing in front of the sensor. This part of the print path is not utilized in the C8000 or the C9000. Any codes generated by the sensor are in error. Refer to [Figure 5](#), and [BSD 10.10 Exit 2 Paper Transport \(2 of 2\)](#).

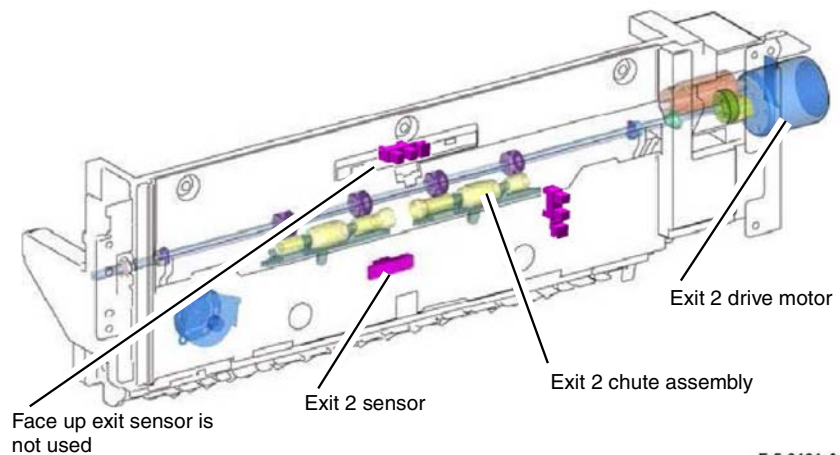
Figure 5 Exit 2 chute assembly

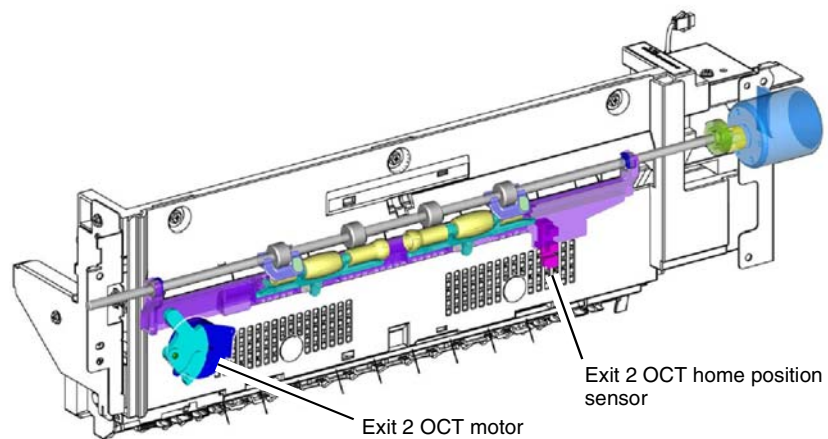
Figure 6 Exit 2 OCT components

- Exit 2 offset catch tray (OCT) motor, [PL 10.25 Item 18](#). The motor is controlled by the [Motor Drive PWB](#) operating a gear and lever that moves the exit 2 chute assembly. Refer to [Figure 6](#) and [BSD 10.9 Exit 2 Paper Transport \(1 of 2\)](#).

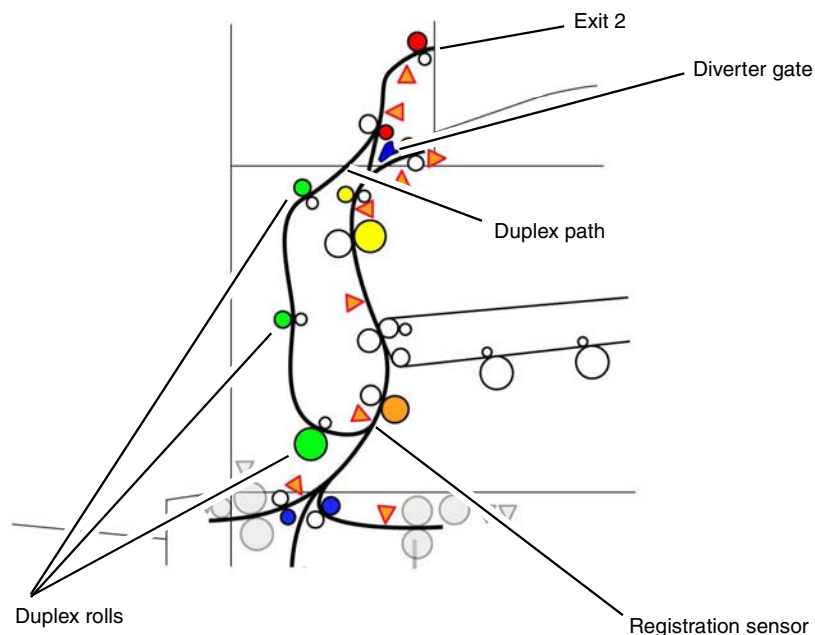
Figure 7 Duplex path

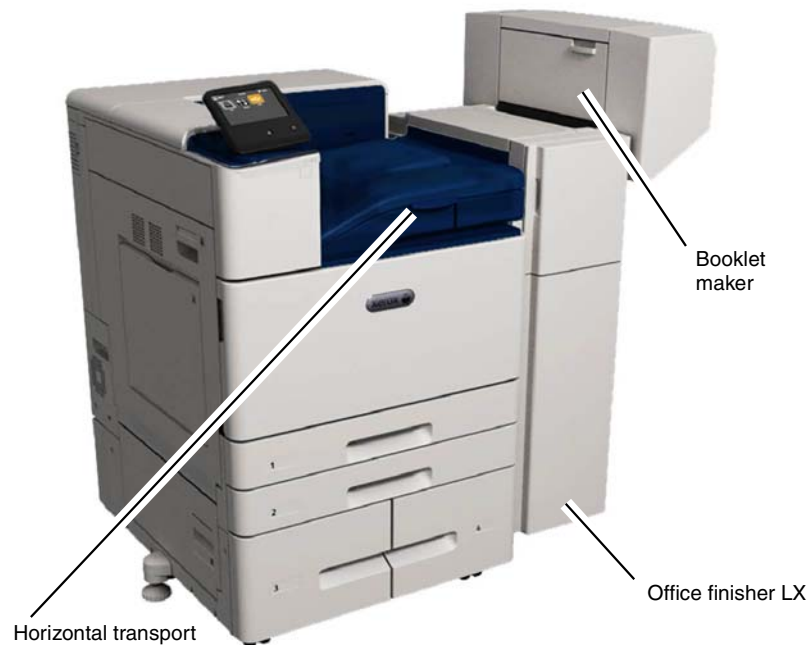
Figure 1 Office finisher LX

- **Horizontal Transport Assembly** - feeds the sheets exiting from the IOT to the finisher.
- **Finisher** - squares up the edges of sheets in the compiler tray to create sets and ejects/offsets the sets into the stacker tray.
- **Compiler Stapler** - Staples sets as specified.
- **Hole Punch Assembly** - Punches 2, 3 or 4 holes depending on the market. If ordered by the customer, the punch unit is in the horizontal transport.
- **Stacker Tray** - Collects the sets ejected from the finisher.
- **Booklet Maker** - (optional) saddle stitches and creases booklets

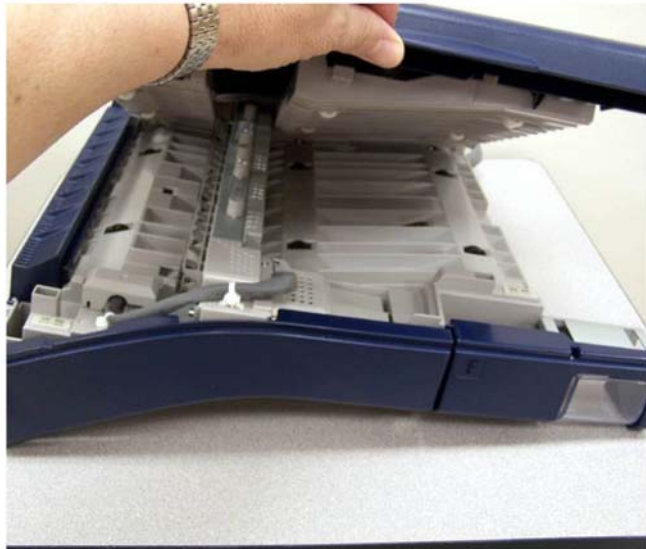
Figure 4 Horizontal transport assembly

The top cover can be opened for jam clearance. Refer to [Figure 4](#).

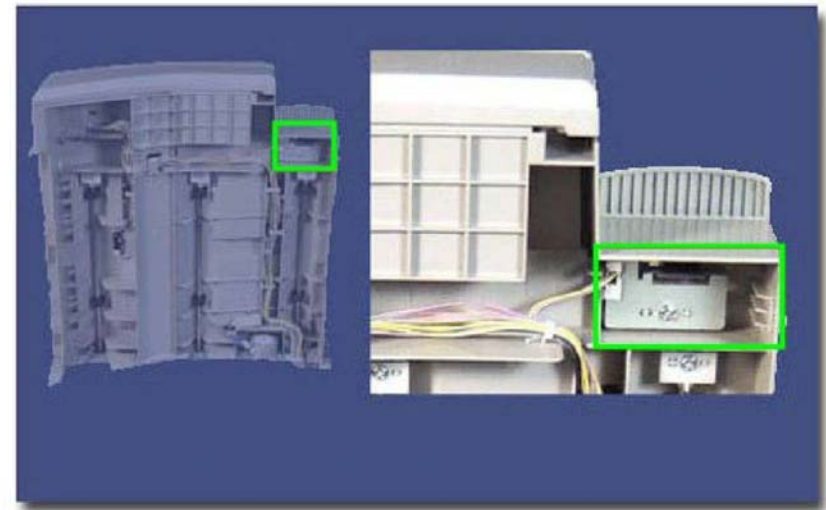
Figure 5 Horizontal transport open sensor

The H-transport open sensor can be viewed from the underside of the horizontal transport. Refer to [Figure 5](#).

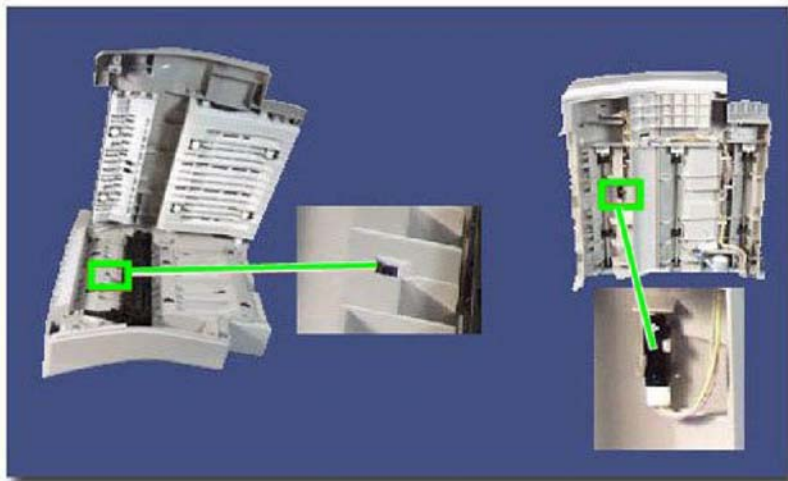
Figure 6 Entrance sensor

If, after a preset amount of time, the entrance sensor does not de-actuate, this indicates a paper jam and an error message is displayed on the UI. Refer to [Figure 6](#).

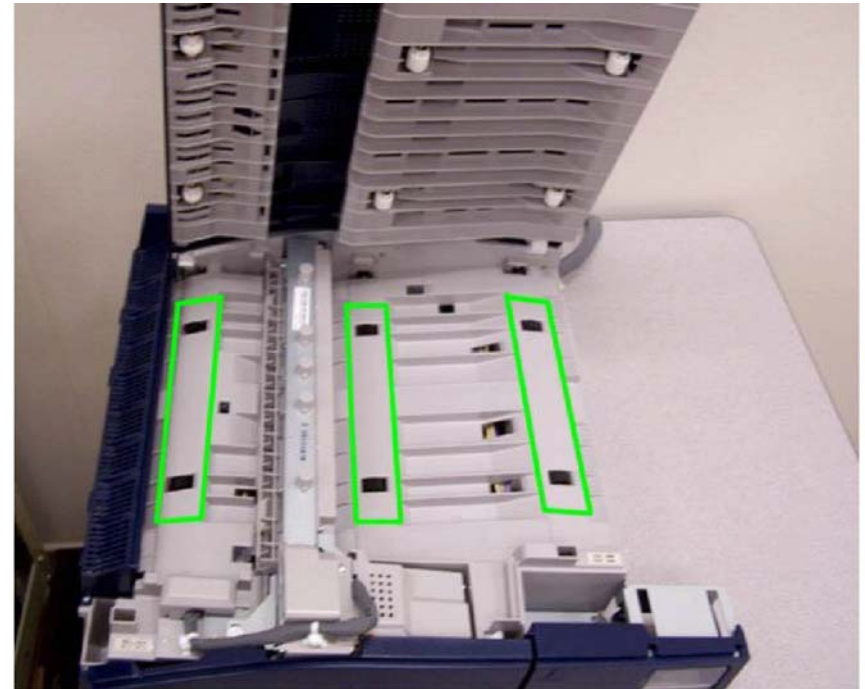
Figure 7 Transport rolls

The paper is moved through the horizontal transport assembly by three sets of transport rolls.

Drive is provided to the transport rolls by the transport motor through a system of gears and belts. Refer to [Figure 7](#).

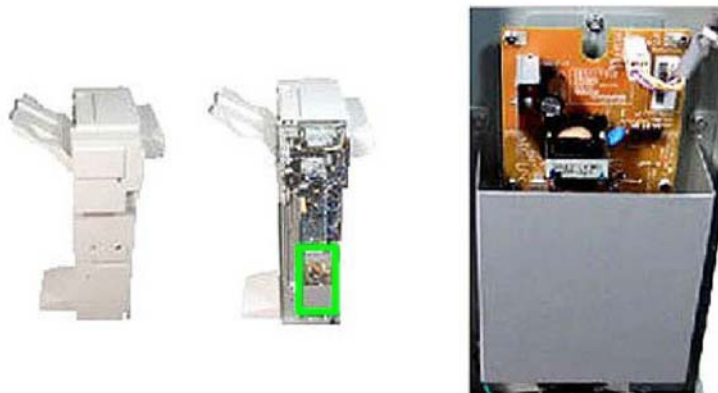
Figure 8 Low voltage power supply

The LVPS receives 110/240VAC supply from the GFI via the power cord and provides +24V to the finisher PWB. Refer to [Figure 8](#).

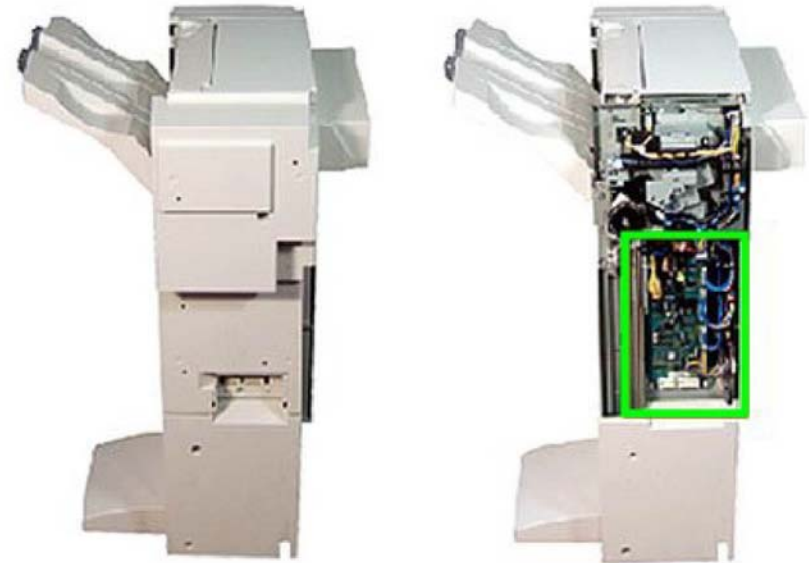
Figure 9 Finisher PWB

In addition to the +24V supplies, the finisher PWB also provides +5V supply for all the sensors and switches. Refer to [Figure 9](#).

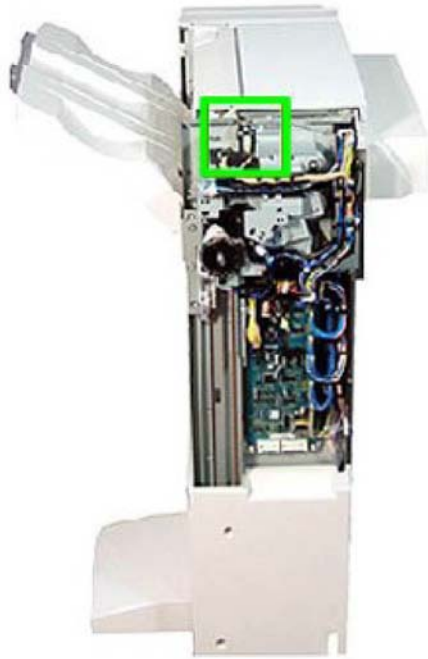
Figure 10 Eject cover switch

- **Eject Cover Switch** - triggered when the eject cover is raised. Refer to [Figure 10](#).
- **Front Door Interlock** - triggered when the front cover is opened. Refer to [Figure 11](#).

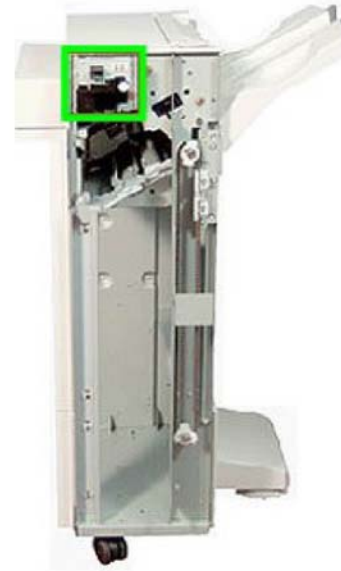
Figure 11 Front door interlock

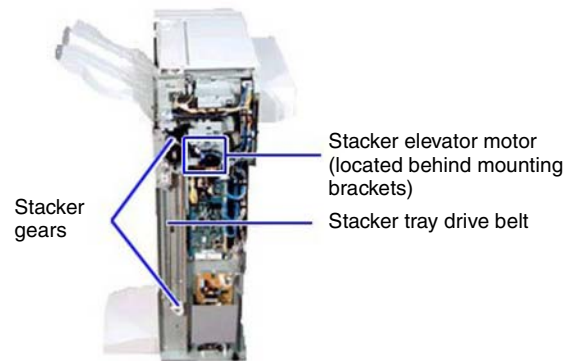
Figure 12 Stacker tray

The stacker tray is raised and lowered by a system of gears and belts. The gears and belts are driven by the stacker elevator motor through a rack gear. Refer to [Figure 12](#).

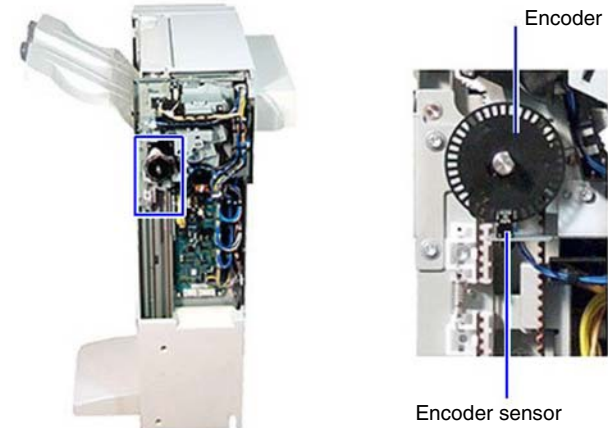
Figure 13 Encoder and sensor

The encoder has a number of apertures cut into it and is connected directly to the main stacker tray drive gear via a shaft.

As the stacker tray drive gear rotates to lower or raise the stacker tray, the encoder also rotates. The rotation of the encoder is monitored by the encoder wheel sensor which is an optical sensor that reflects light onto the encoder. Refer to [Figure 13](#).
