VersaLink[®] C8000/C9000 Printer

Service Manual

VersaLink C9000 Family Service Manual

705P01418

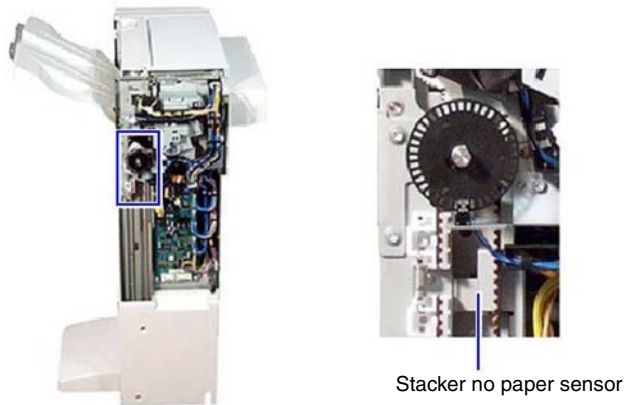
Figure 14 Stacker no paper sensor

The uppermost position of the stacker tray is monitored by the stacker no paper sensor. When actuated, this indicates that the stacker tray is in the uppermost feed position. Refer to [Figure 14](#).

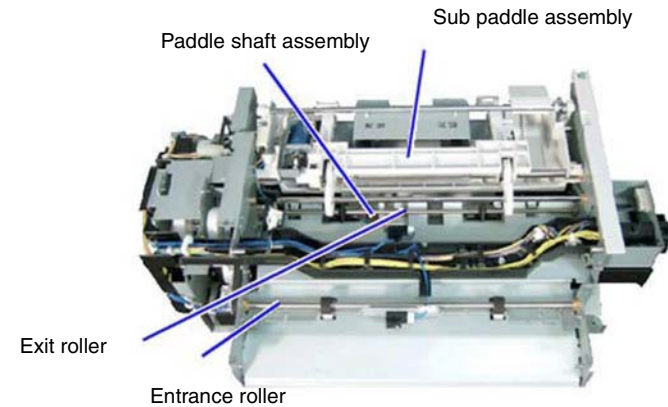
Figure 15 Compiler components

The sheets of paper are moved through the main section of the compiler by the entrance roll, exit roll, paddle shaft assembly and sub-paddle assembly.

Drive is provided to these components by the transport motor and a system of gears and pulleys. Refer to [Figure 15](#) and [Figure 16](#).

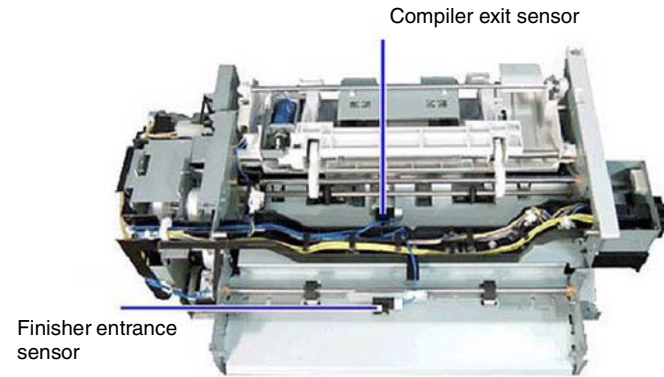
Figure 17 Entrance sensor and compiler exit sensor

The entrance sensor is actuated by the lead edge of the paper entering the finisher from the horizontal transport. This signals the paper feed process to begin.

The compiler exit sensor is used to ensure that paper successfully moves through the paper path. If the compiler exit sensor is not actuated within a pre-set time of the entrance sensor being actuated, a paper jam condition is signalled and an error message appears. Refer to [Figure 17](#).

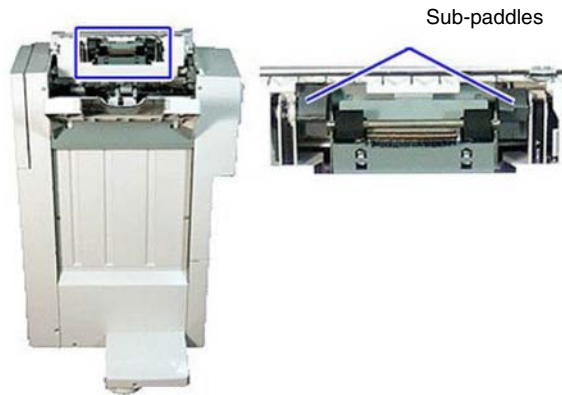
Figure 18 Sub paddle assembly

The sub-paddle assembly actively drives fed paper into the compiler tray when it exits the exit roll.

The sub-paddle assembly consists of a set of sub-paddles, an eject chute, and a solenoid. The rotation of the sub paddles actively drives the paper against the compiler backstops where the paper is tamped, stapled (if required), and ejected. Refer to [Figure 18](#).

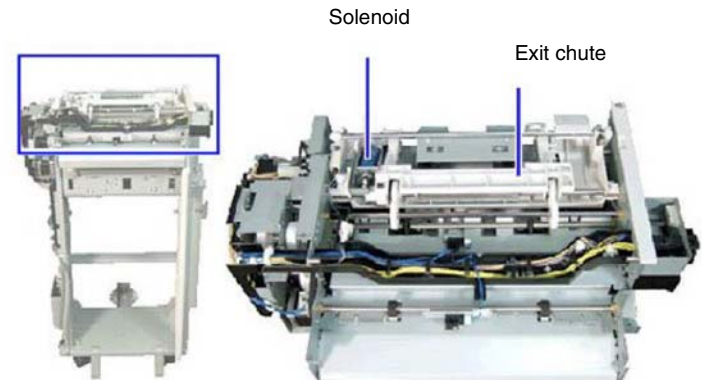
Figure 19 Exit chute

The rotation of the sub paddles actively drives the paper against the compiler backstops where the paper is tamped, stapled (if required), and ejected.

The sub paddles rotate constantly and only come into contact with the paper when the solenoid is actuated. Refer to [Figure 19](#), [Figure 20](#) and [Figure 21](#).

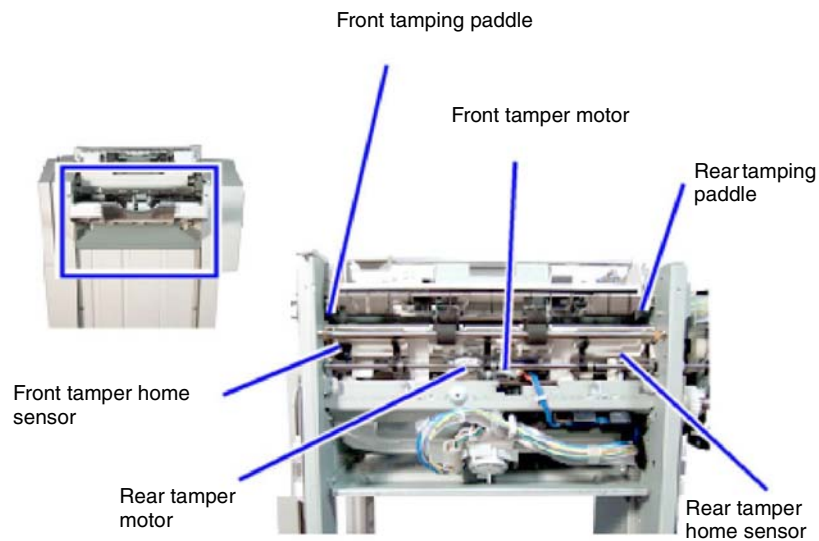
Figure 22 Tamper assemblies

The tamper assemblies are used to compile sets of paper into registered stacks either for stapling or exit to the stacker tray. The tamper assemblies tamp the sets of paper to the front, center, or rear of the compiler, as required.

The Finisher LX has two separate tamper assemblies which operate as a single unit. These are the front and rear tamper assemblies. Each tamper assembly consists of a tamping paddle, tamper paddle motor, and a tamper home sensor. Refer to [Figure 22](#).

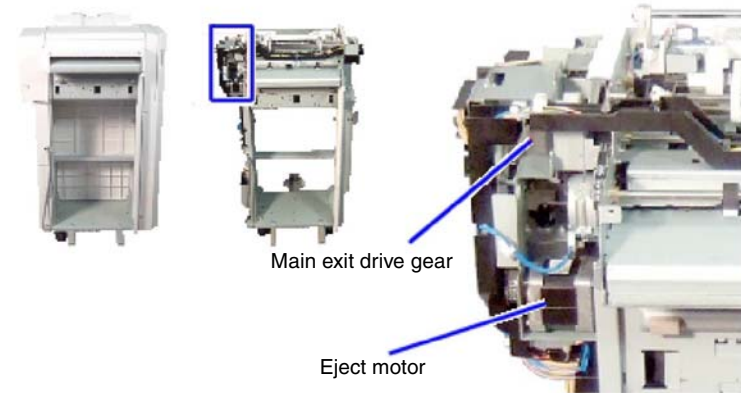
Figure 23 Main exit drive

The exit roll, paper guides, and set clamp assembly all are driven by the eject motor through the main exit drive gear.

Each assembly has a discrete system of gears and quadrant gears which transfer drive from the main exit drive gear to the individual assembly. Refer to [Figure 23](#).

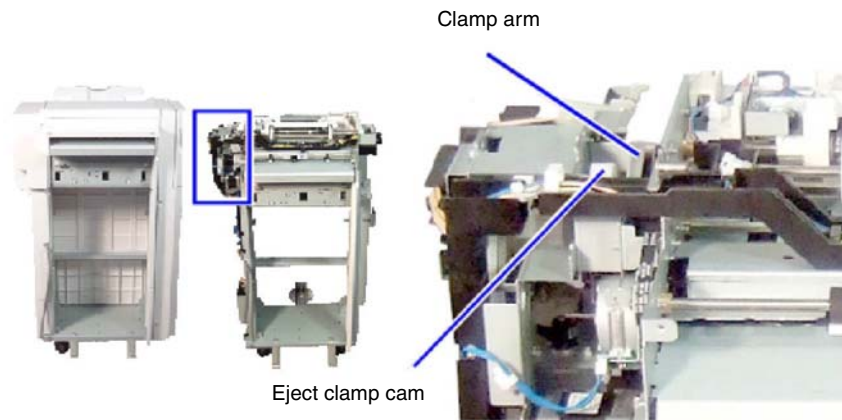
Figure 24 Exit clamp

The exit cam roll, driven by the main exit drive gear, moves the retaining chassis into the raised or lowered position by actuating the retaining chassis lever.

The lower exit roll is driven by the exit roll gears through the main exit drive gear. Paper is moved from the compiler tray to the stacker tray when the upper exit roll is lowered onto the lower exit roll. Refer to [Figure 24](#).

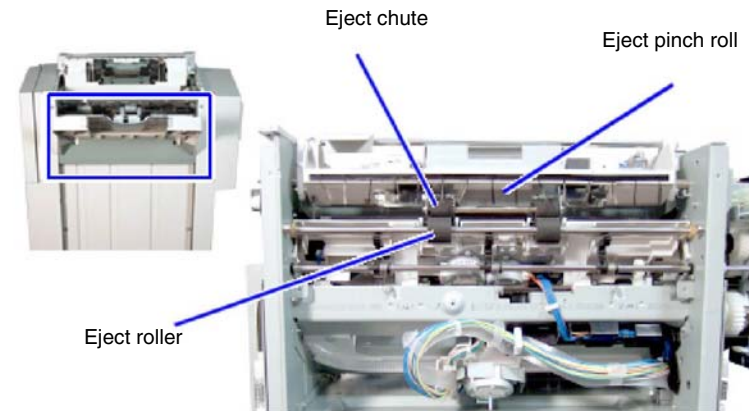
Figure 25 Exit roll assembly

The eject roll is driven by the exit roll gears through the main exit drive gear.

Paper is moved from the compiler tray to the stacker tray when the eject pinch roll is lowered onto the eject roll. Refer to [Figure 25](#).

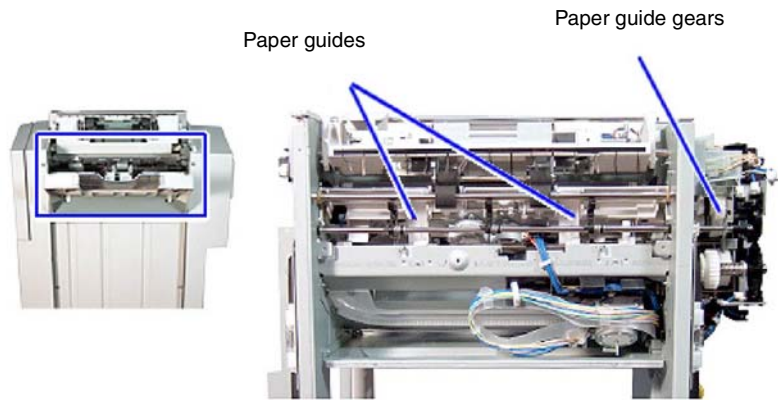
Figure 26 Paper guide

As the main exit drive gear rotates, the eject assembly also rotates, thereby extending or retracting the paper guide.

This action is reversed by a change in direction of the main exit drive gear. Refer to [Figure 26](#).

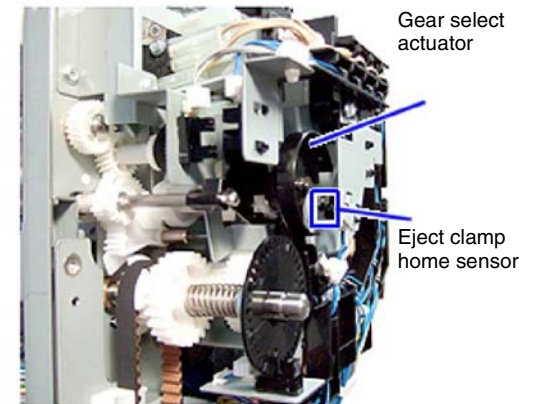
Figure 27 Eject assembly

The gear select actuator is fixed to the end of one of the drive shafts for the eject assembly and rotates to trigger the eject clamp home sensor.

The eject clamp home sensor and gear select actuator are only used to confirm that the support arms are fully extended or retracted. They do not control drive to the main exit drive gear. Refer to [Figure 27](#).

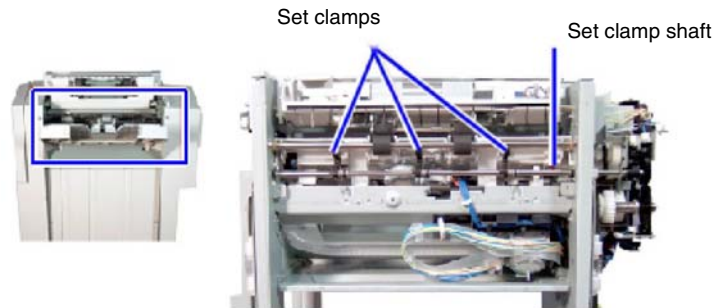
Figure 28 Set clamps

The set clamp assembly uses set clamps to hold sets of paper in position on the stacker tray. The set clamps are fixed to the set clamp shaft which is rotated by the set clamp quadrant gear. Drive is provided by the main exit drive gear. Refer to [Figure 28](#).

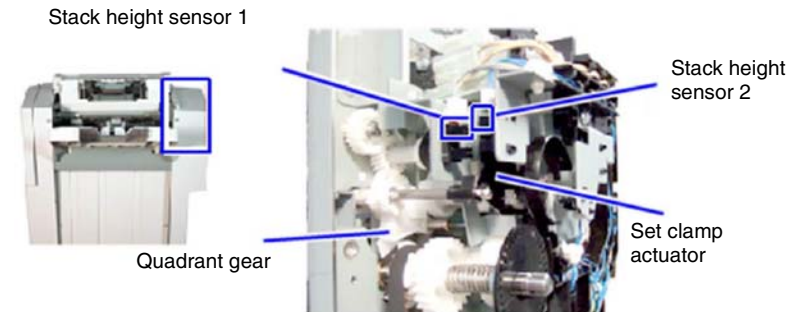
Figure 29 Set clamp position

The position of the set clamps is monitored by two sensors. These are the upper and lower stack height sensors. The set clamp actuator is fixed to the end of the paper clamp shaft and triggers the sensors when the set clamps are in either the upper or lower position. The sensors and actuator are only used to confirm that the set clamps are fully raised or lowered. They do not control drive to the main exit drive gear. Refer to [Figure 29](#).

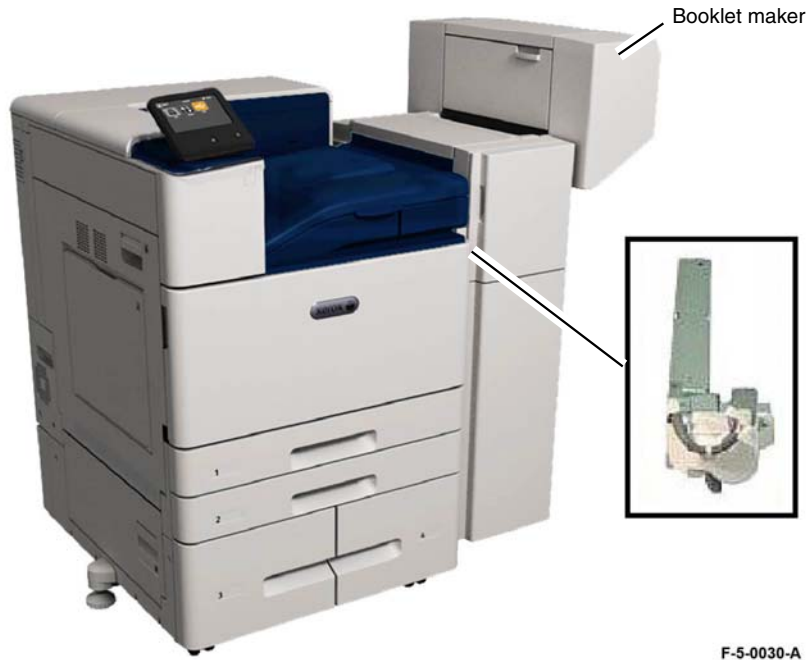
Figure 30 Booklet maker and crease assembly

The optional booklet maker produces pre-creased booklets with either 1 or 2 staples. The booklet maker is supplied with a crease assembly which is installed into the Finisher LX. Refer to [Figure 30](#).

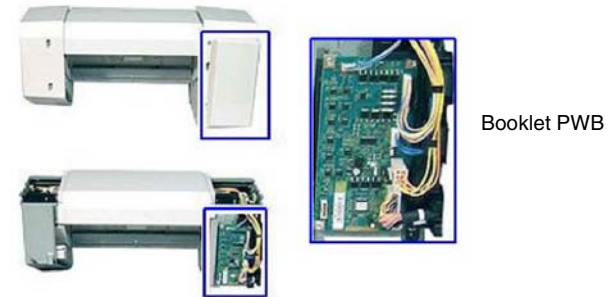
Figure 31 Booklet maker power and control

The booklet PWB controls all the booklet maker components and distributes the + 24V supply to the motors and + 5V to the sensors and interlocks.

The crease assembly is powered and controlled by the finisher PWB. Refer to [Figure 31](#).

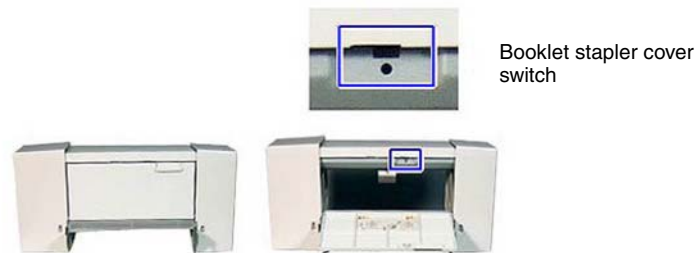
Figure 32 Booklet stapler cover switch

The booklet stapler cover switch is actuated when the side cover is opened. When actuated, all + 24V supplies are removed from the booklet maker. Refer to [Figure 32](#).

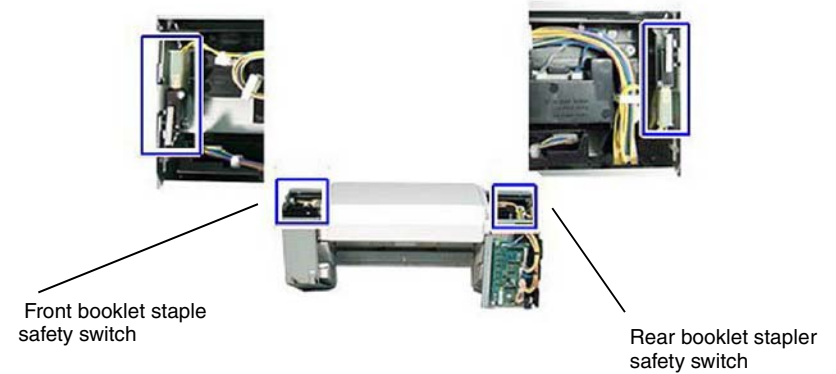
Figure 33 Front and rear safety switches

The front and rear booklet stapler safety switches are actuated when either the front or rear covers are raised.

These Interlocks prevent the booklet maker from operating when either the front or rear covers are obstructed, i.e., raised, or when the booklet maker is incorrectly mounted. Refer to [Figure 33](#).

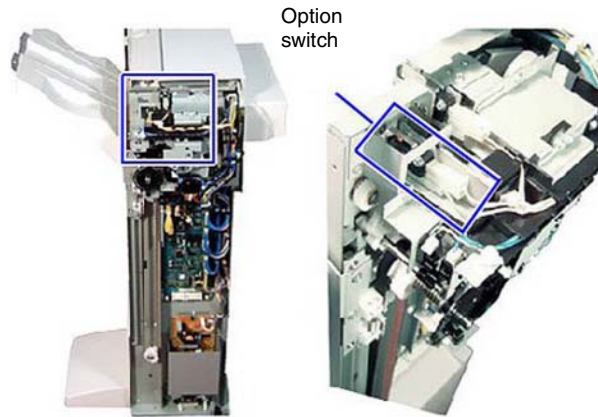
Figure 34 Finisher side interlock

An option switch is used to detect when the booklet maker is installed on the finisher. This Interlock is located on the Finisher LX, not the booklet maker.

When Interlocks are open, power is removed and an error message displays on the UI. Refer to [Figure 34](#).

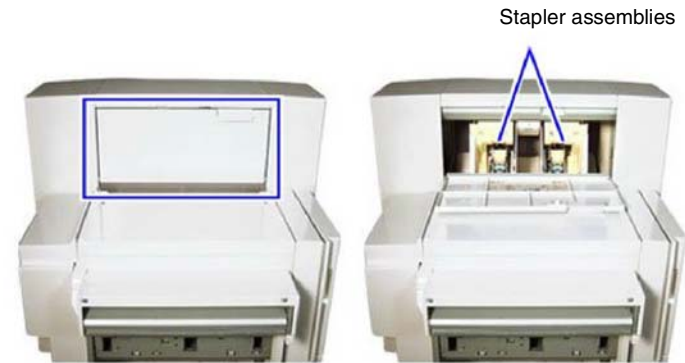
Figure 35 Stapler assemblies

The booklet maker contains two stapler assemblies which support and staple compiled booklets prior to ejecting into the stacker tray.

Each stapler assembly contains a staple module and an exit sub chute. The staple units are mounted on a carriage rail. Refer to [Figure 35](#) and [Figure 36](#).

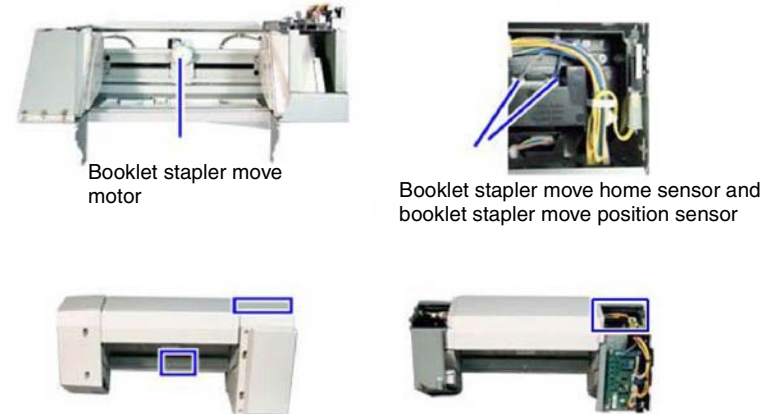
Figure 37 Stapler move motor

The booklet stapler move motor drives two rack gears, one connected to each stapler assembly.

The position of the stapler assemblies is controlled by the booklet stapler move home sensor and booklet stapler move position sensor which monitor the position of the rack gears. Refer to [Figure 37](#).

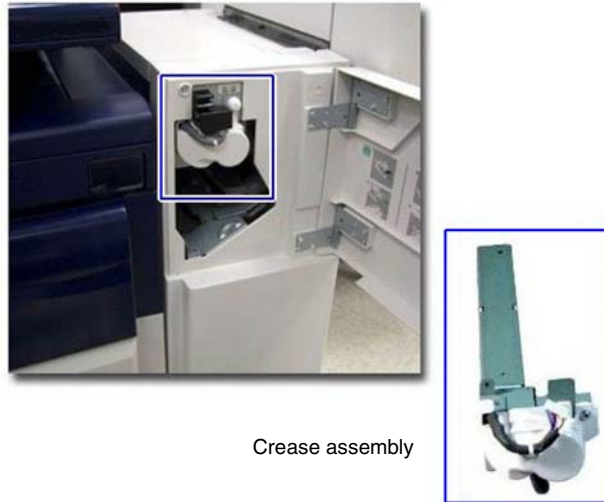
Figure 38 Crease assembly

It is installed behind the compiler within the Finisher LX and is controlled by the finisher PWB.

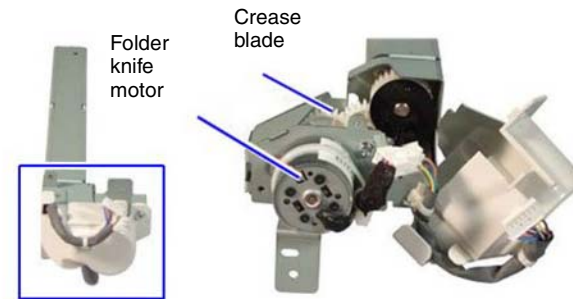
Figure 39 Crease assembly folder and gears

The crease assembly consists of a folder knife motor, gears, crease blade and paper chute.

The folder knife motor raises and lowers the crease blade through one cycle of the gears. Refer to [Figure 39](#).

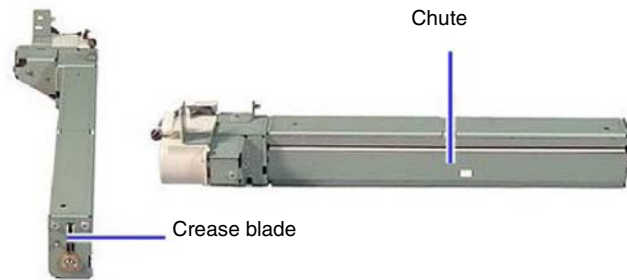
Figure 40 Crease blade and chute

The position of the paper within the crease assembly is monitored by the entrance and compiler exit sensors (part of the finisher LX).

When the paper is in the correct position within the paper chute, the paper momentarily stops feeding and the crease blade is raised and lowered. Paper feed now resumes. Refer to [Figure 40](#).

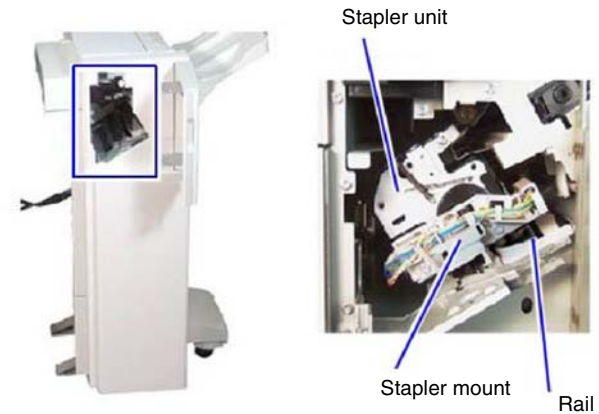
Figure 41 Stapler unit

The compiler stapler has a stapler unit which is installed on a stapler mount. The stapler mount moves the stapler unit to key stapling positions along the rail. Refer to [Figure 41](#).

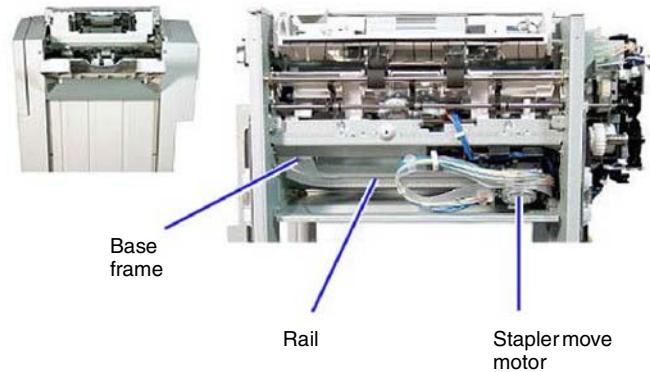
Figure 42 Stapler mount movement

The stapler mount is driven by the stapler move motor which is secured to the bottom of the stapler mount.

A gear fixed to the end of the stapler move motor drives the stapler mount along the rail, which is an integral part of the base frame. Refer to [Figure 42](#).

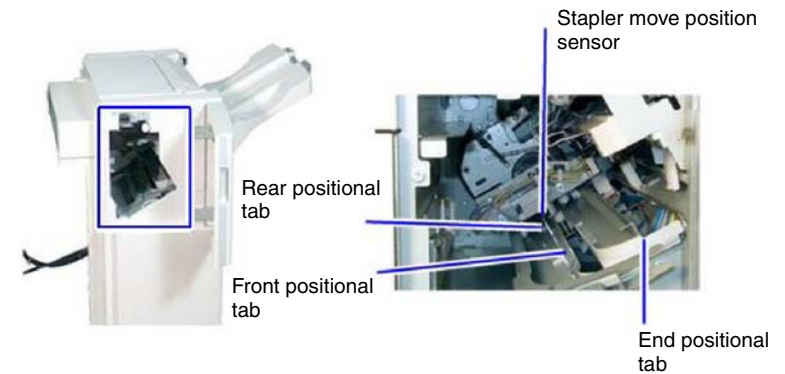
Figure 43 Stapler mount position

The end positional tab is used to indicate the correct position along the base frame for single stapling.

The front and rear positional tabs are used to indicate the correct position along the base frame for double stapling. Refer to [Figure 43](#).

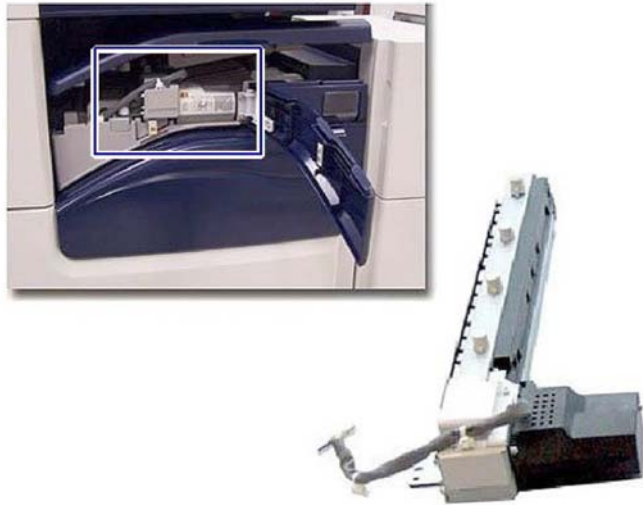
Figure 44 Hole punch assembly

The hole punch assembly punches either 2 or 4 holes in Europe or 2 or 3 holes in North America. The hole punch assembly is installed within the horizontal transport. It is controlled by the finisher PWB. Refer to [Figure 44](#).

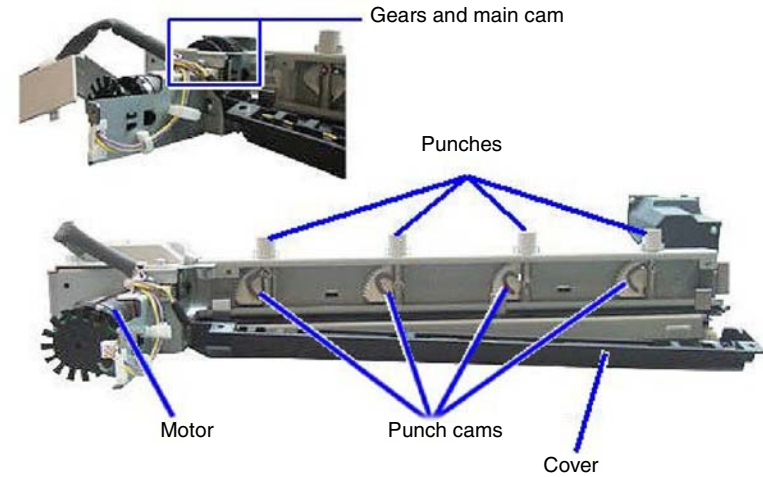
Figure 45 Hole punch components

The motor raises and lowers the punches through one cycle of the gears.

When the motor rotates in a clockwise direction it operates the two inner punch cams and in a counter-clockwise direction it operates all four (XE) or three (USSG, XCL) punch cams. Refer to [Figure 45](#).

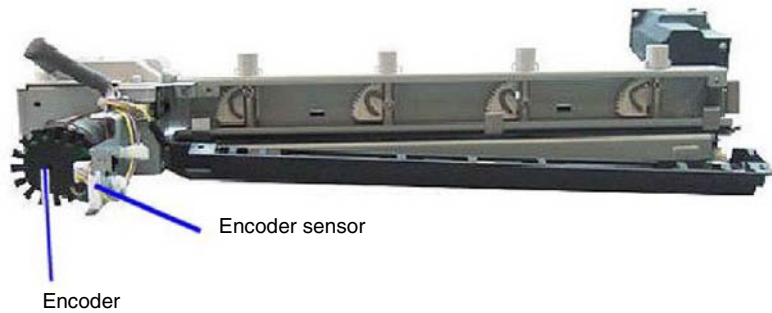
Figure 46 Hole punch encoder

The operation of the hole punch is controlled by an encoder and sensor. The encoder has a number of apertures cut into it and is connected to the motor. As the motor rotates the gears to operate the hole punch, the encoder also rotates.

The rotation of the encoder is monitored by the encoder sensor which is an optical sensor that reflects light onto the encoder. Refer to [Figure 46](#).

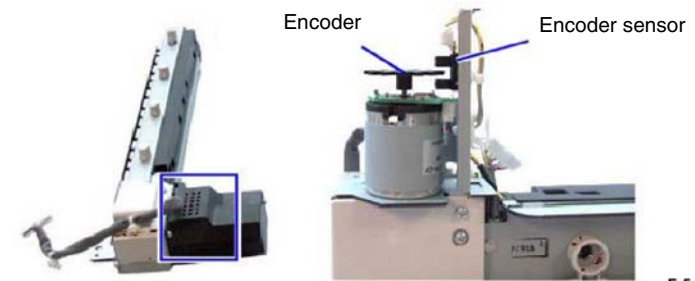
Figure 47 Encoder wheel and sensor

The rotation of the encoder wheel causes the apertures to pass through the encoder sensor wheel, allowing light to pass. This triggers the sensor, which indicates that the hole punch has rotated one cycle. Refer to [Figure 47](#).

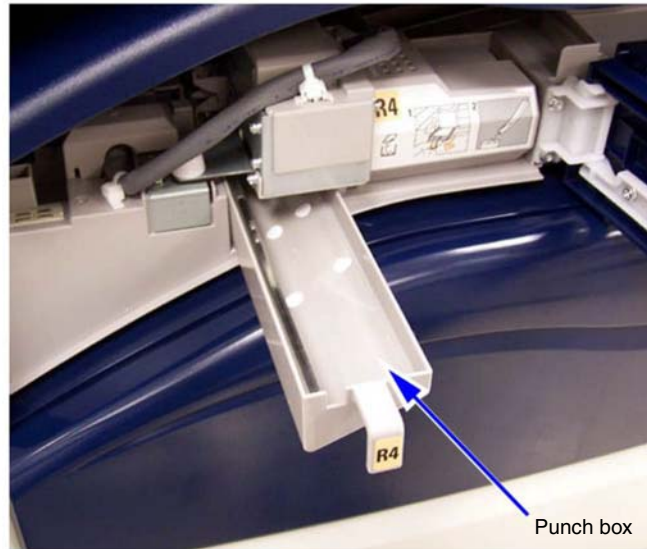
Figure 48 Hole punch box

The punch box is located beneath the hole punch assembly and collects the discarded chads. This will need to be emptied periodically. Refer to [Figure 48](#).

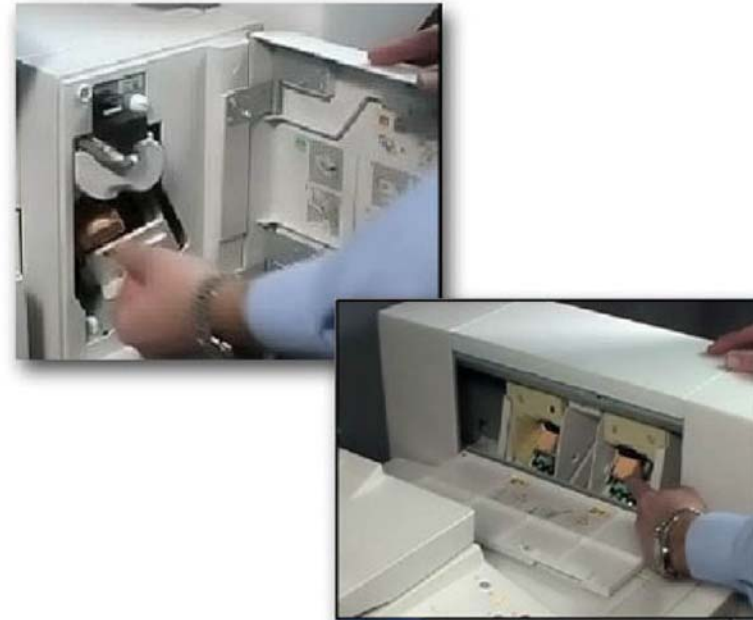
Figure 49 Customer replaceable units

Refer to [Figure 49](#). The only customer replaceable units (CRUs) for the LX finisher are:

- The 5,000 stitch staple cartridge and
- The two staple cassettes for the booklet maker. Each of the staple cassettes holds 2,000 staples.
