708P91010
August 2015

Xerox® WorkCentre® 5890 Family Multifunction Printer Service Manual

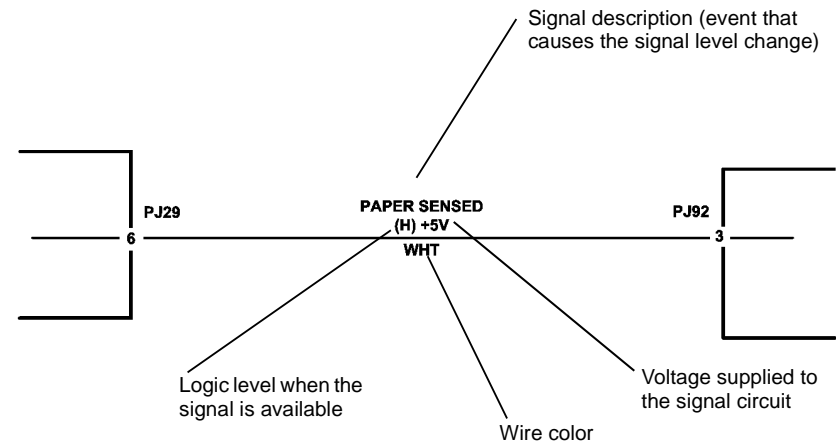
[Figure 1](#) shows the signal nomenclature used in this manual.

Figure 1 Signal Nomenclature

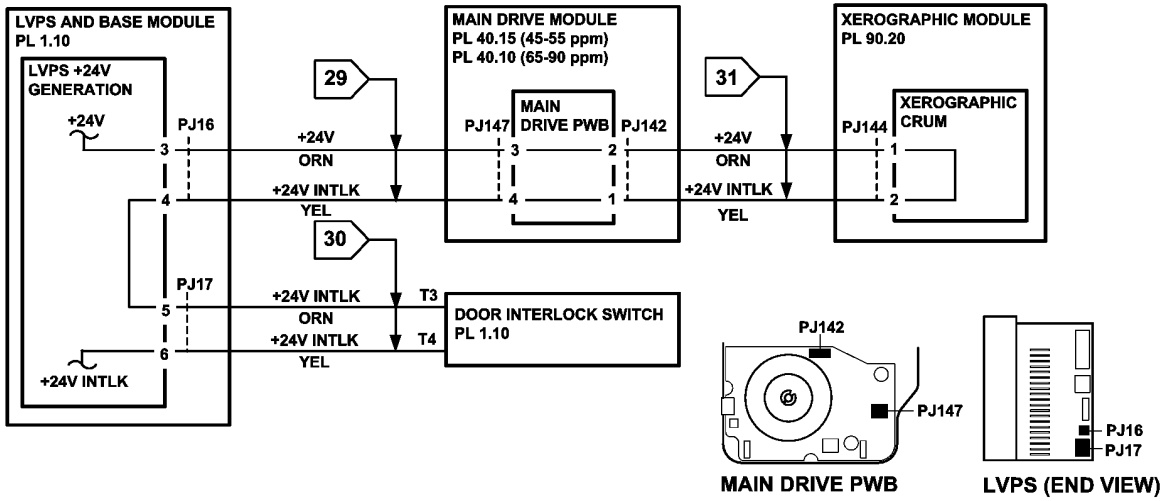
TV-1-0274-A

Figure 4 +24V interlock circuit diagram

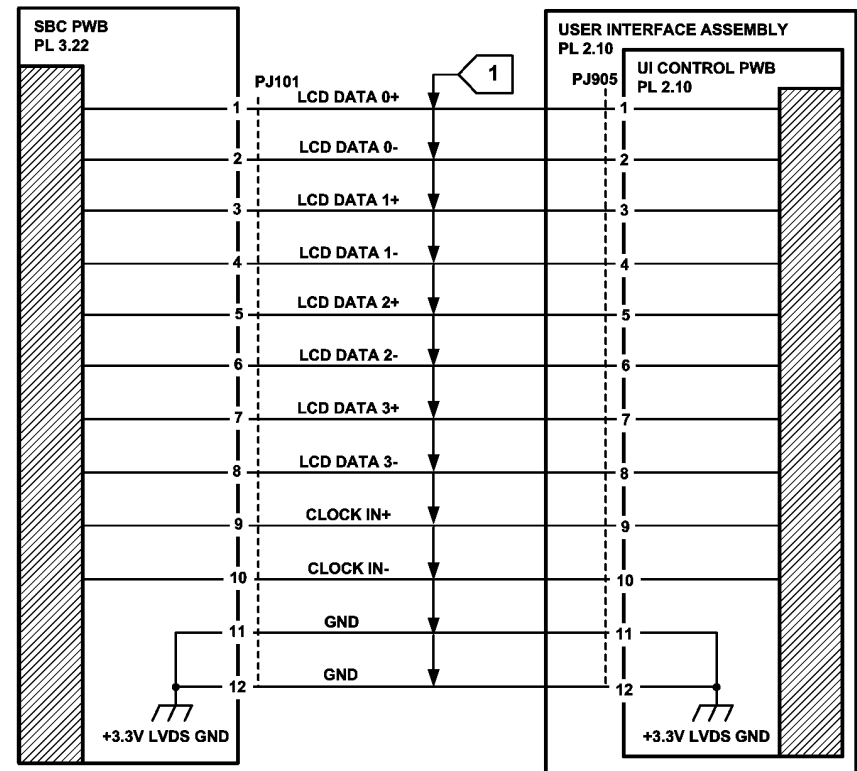
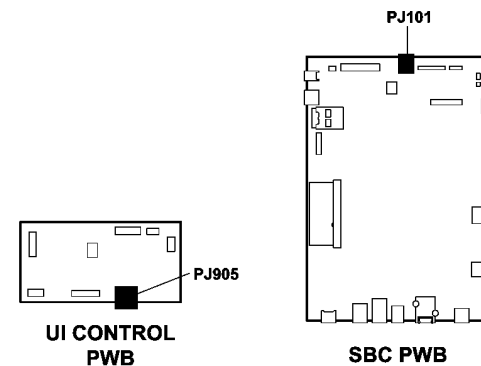
TV-1-0313-A

1. Switch off the machine, then switch on the machine, **GP 14**.
2. Go to **Flag 1**. Check the wiring between **P/J905** on the **UI control PWB** and **P/J101** on the **SBC PWB**. Install new components as necessary:
 - SBC PWB/UI control PWB harness, **PL 3.22 Item 23**.
 - UI control PWB, **PL 2.10 Item 6**.
3. If the fault remains, perform the **303D SBC PWB Diagnostics RAP**.

Figure 1 Circuit Diagram

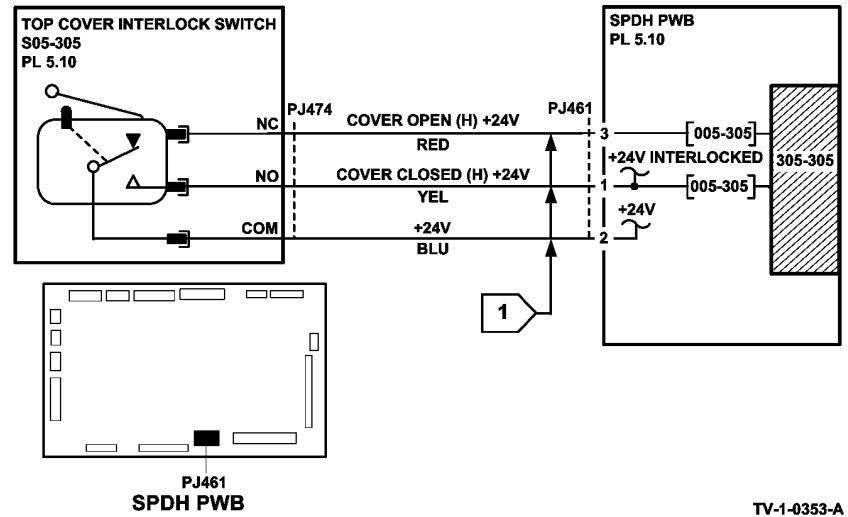
Figure 2 Circuit diagram

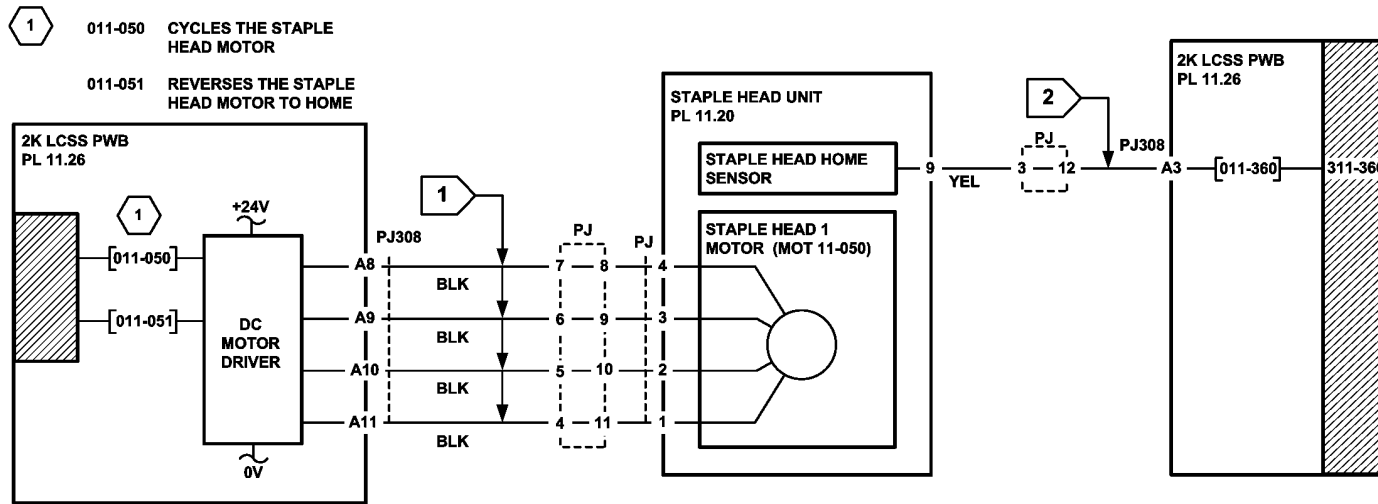
Figure 2 Circuit diagram

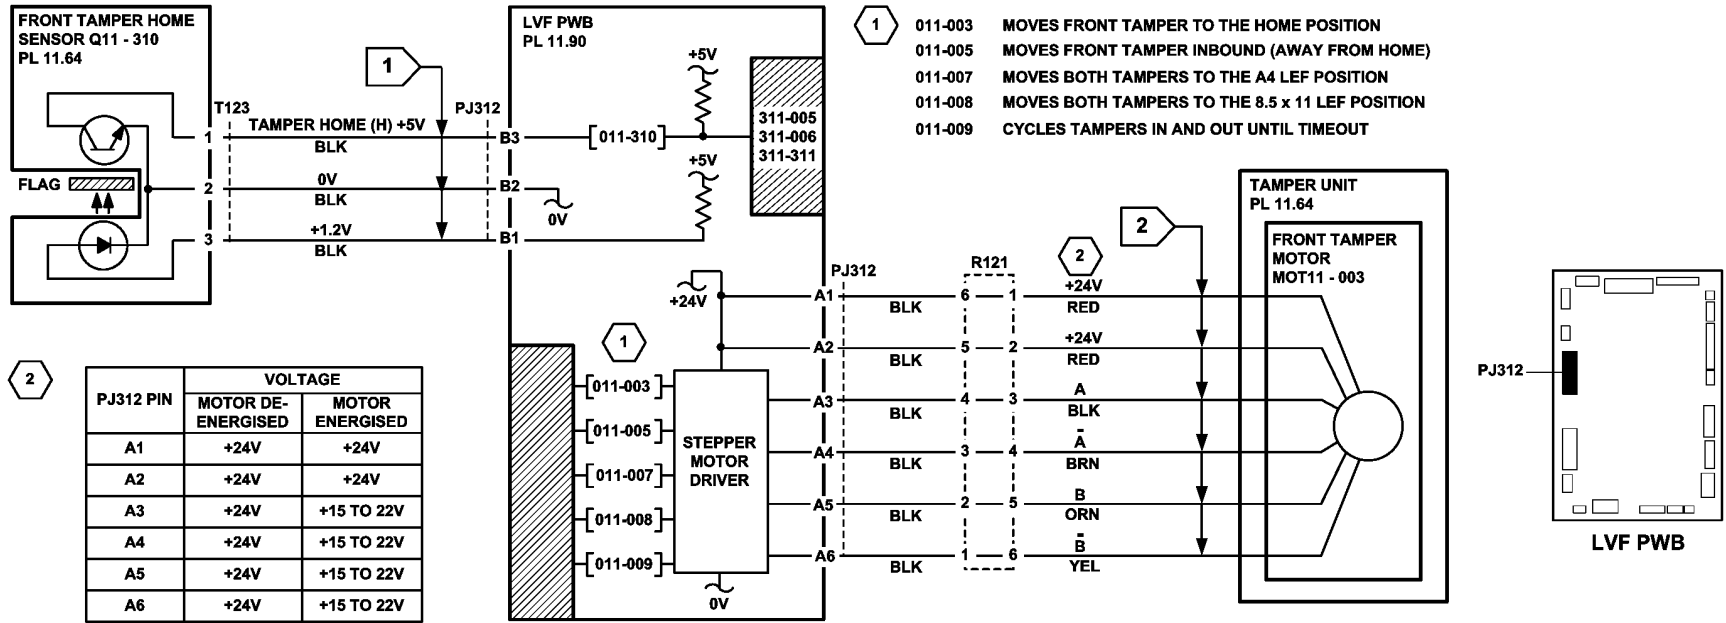
TV-1-0317-A

Figure 2 Circuit diagram

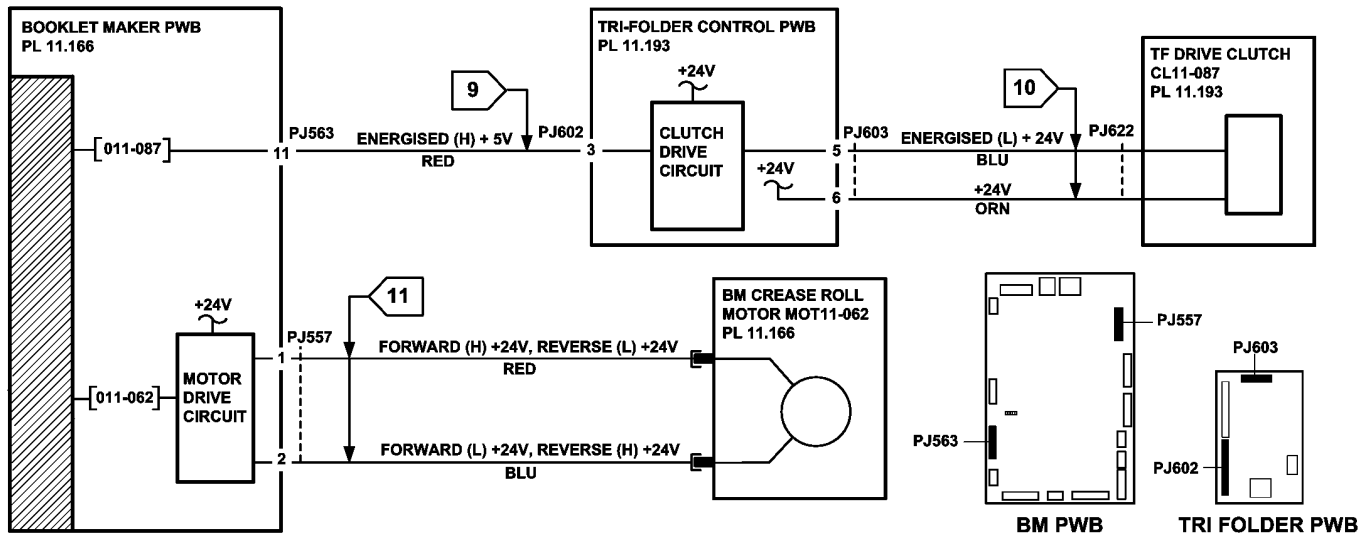
TV-1-0215-A

Figure 5 Circuit diagram

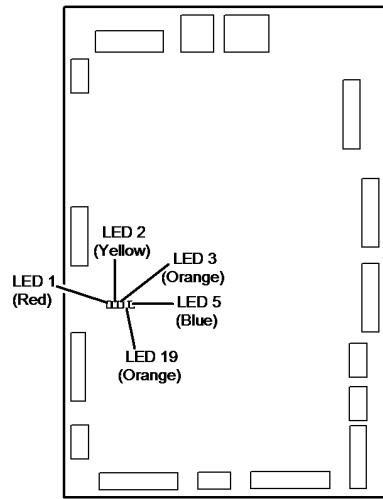
Figure 2 shows the LEDs on the BM PWB. These are:

- LED 1 - red, steady. This indicates a fault or other abnormal status.
- LED 2 - yellow, flashing at about 1Hz. This indicates that the software is operating in normal mode. In other modes, e.g., software downloading, the flashing rate is higher.
- LED 3 - orange, steady. This indicates either:
 - that the tri-folder front door and top cover interlocks are closed, and +24V is available to the BM module or, if the tri-folder is not installed;
 - that the interlock cheater is present in PJ553 on the BM control PWB the logic cheater is present in PJ563 on the BM control PWB.
- LED 19 - orange, steady. This indicates that the +24V supply is within voltage and current limits, and that the power limiting circuit has not been active for over a set time limit.
- LED 5 - blue, steady. This indicates that the +5V supply is present in the BM module.

Figure 2 LEDs on the BM PWB

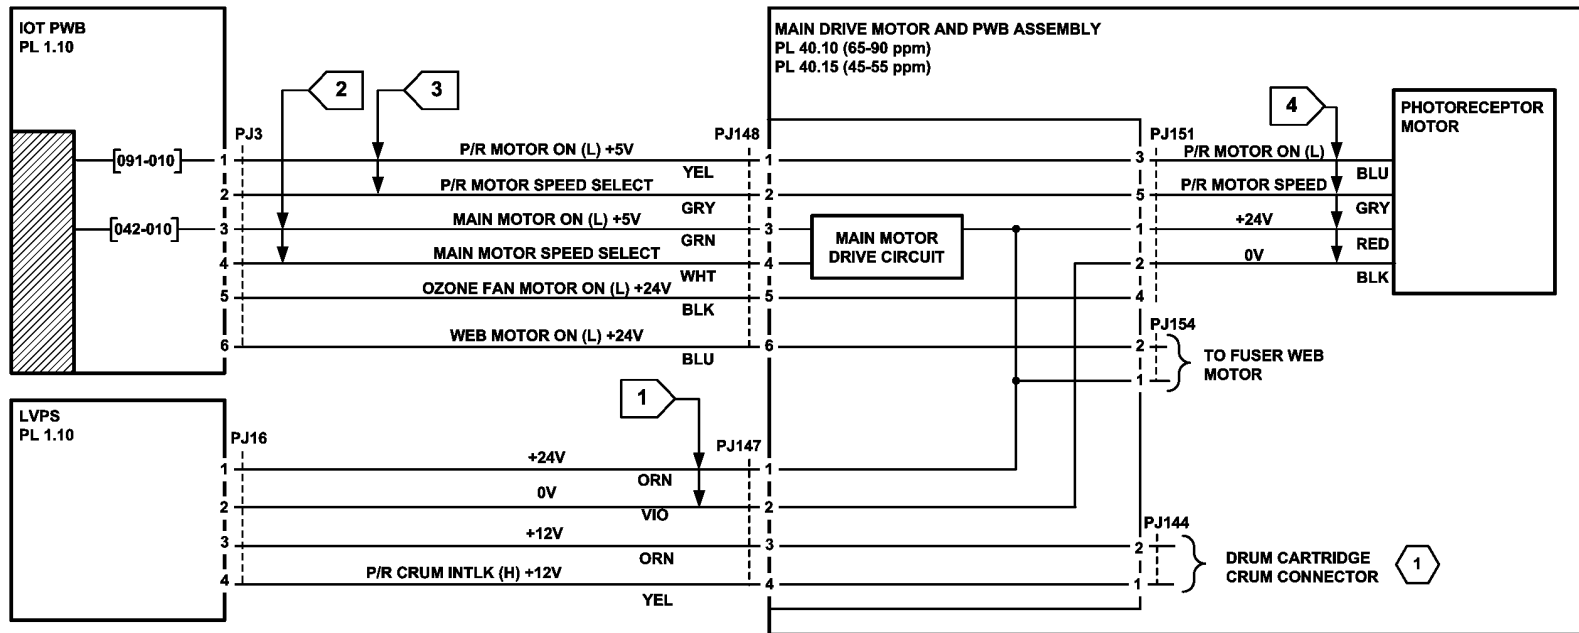
TV-1-0088-A

1 THE +24V AT PJ16 PIN1 WILL NOT BE PRESENT IF THE P/R CRUM INTERLOCK IS (L) +12V

Figure 2 Circuit diagram

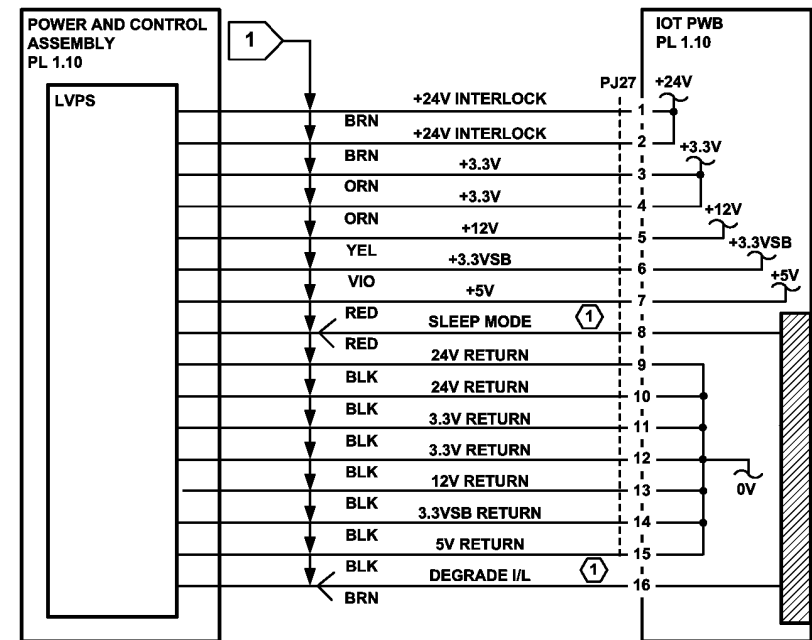
1 THESE LINES ARE HELD LOW DURING NORMAL OPERATION BY WATCHDOG ACTIVITY. FAILURE OF THIS ACTIVITY ALLOWS MACHINE TO ENTER SLEEP OR DEGRADE MODE

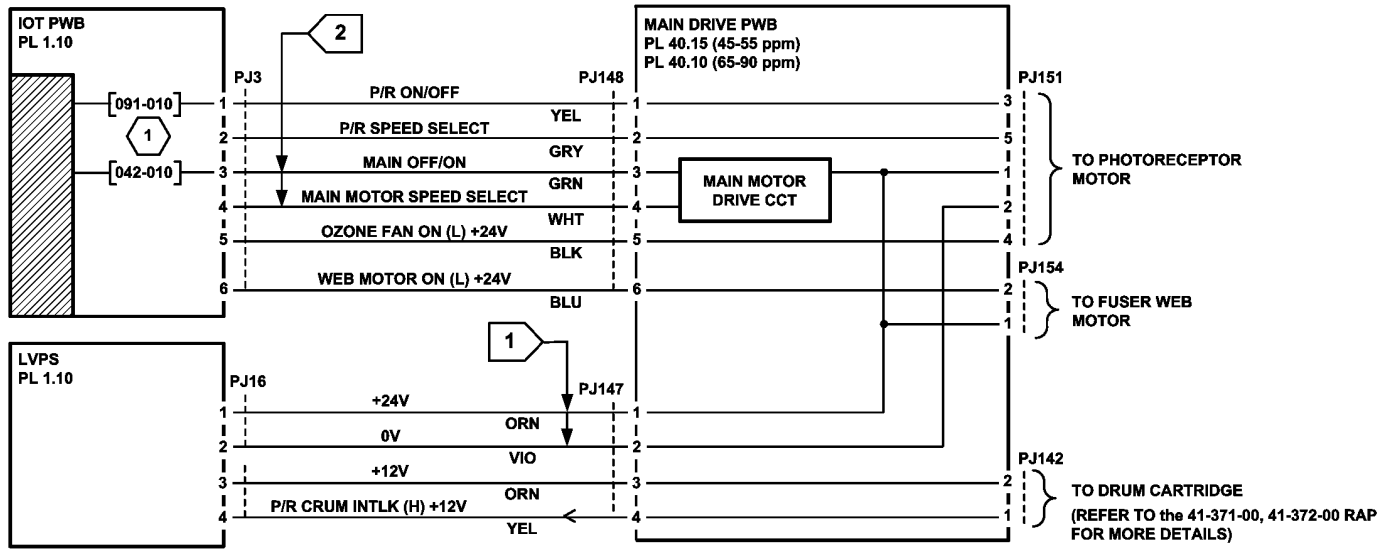
TV-1-0084-A

1 RUN THE CODE 42-010 WITH 91-010, THE P/R MOTOR

Figure 1 Circuit diagram

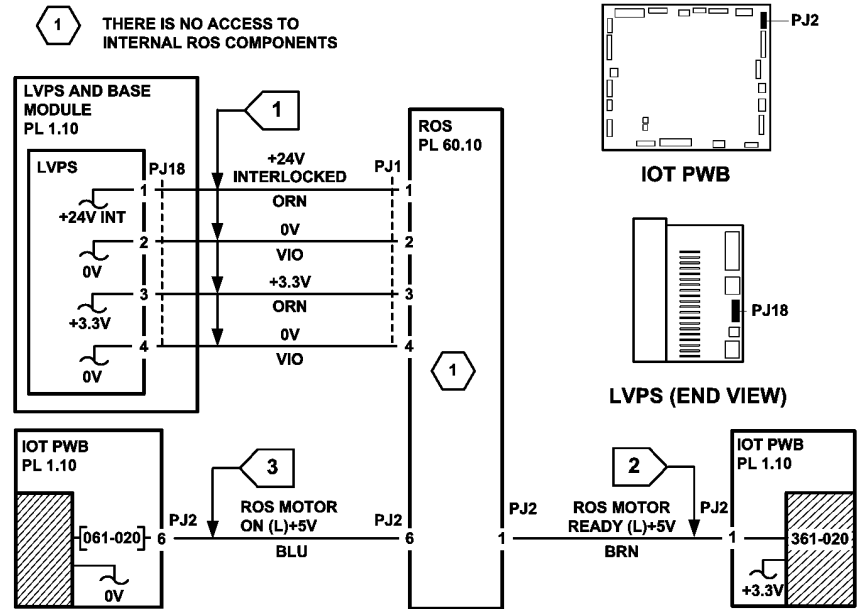
TV-1-0102-B

Figure 4 Circuit diagram

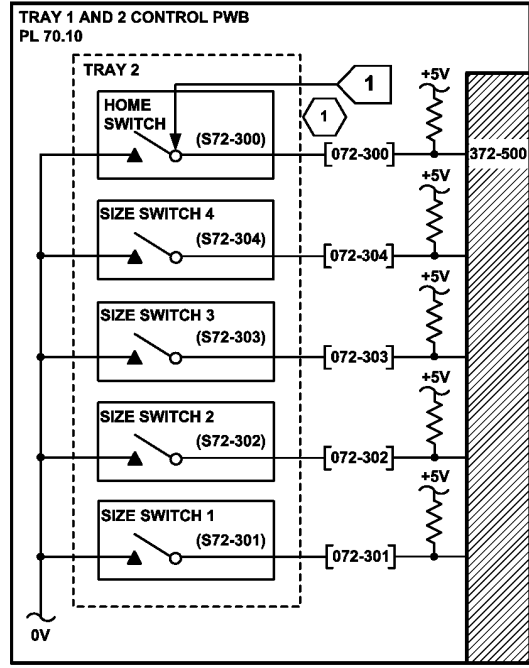
Figure 3 Circuit diagram

1 TRAY HOME (H) +5V (SWITCH NOT ACTUATED) CHECK THE VOLTAGE AT THE SWITCH LEG ON THE PWB

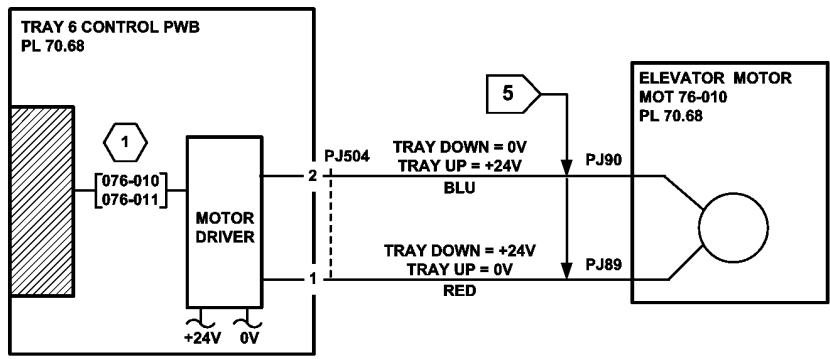
1
 076-010 ENERGISE THE ELEVATOR MOTOR TO DRIVE THE TRAY UP
 076-011 ENERGISE THE ELEVATOR MOTOR TO DRIVE THE TRAY DOWN

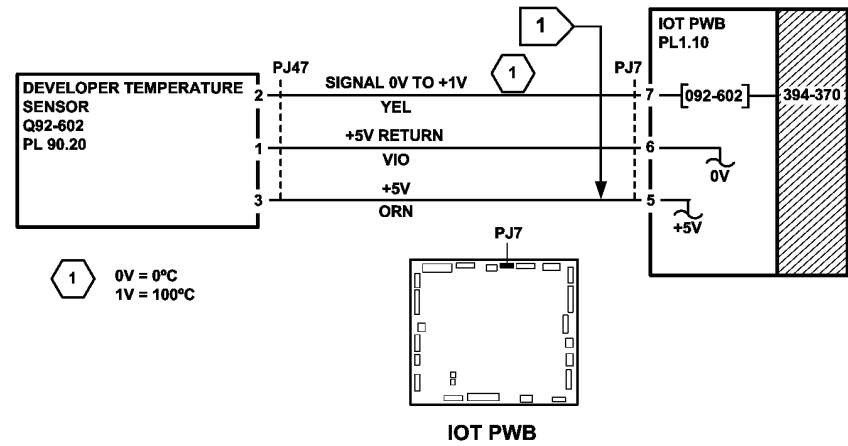
Figure 2 Circuit diagram

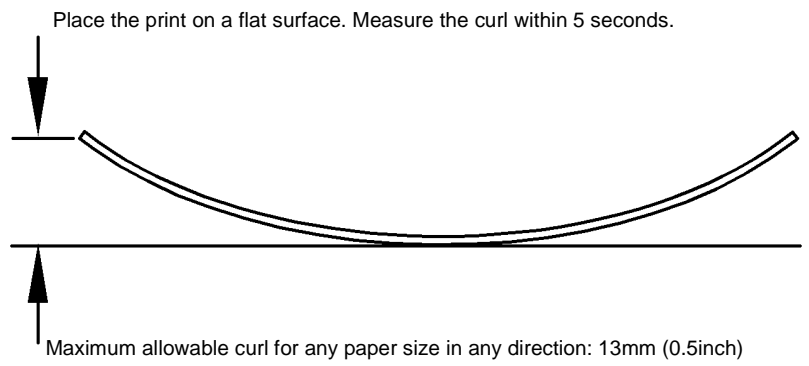
Figure 1 Curl height measurement

Make five simplex prints. Refer to [Figure 1](#). If the curl on the print exceeds 13mm (0.5 inch), perform the following checks:

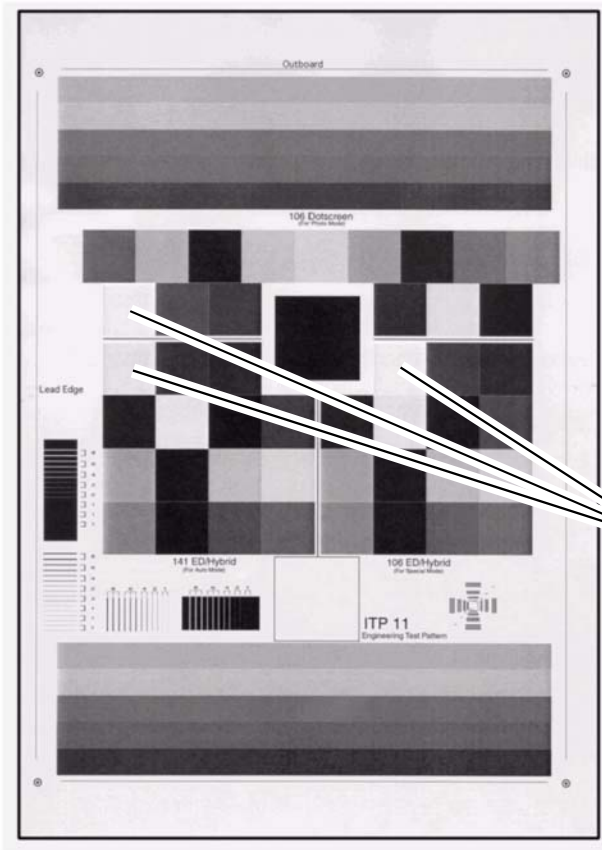
V-1-0310-A

These three areas should be grey. They should not be white.

Figure 4 Internal test print 5

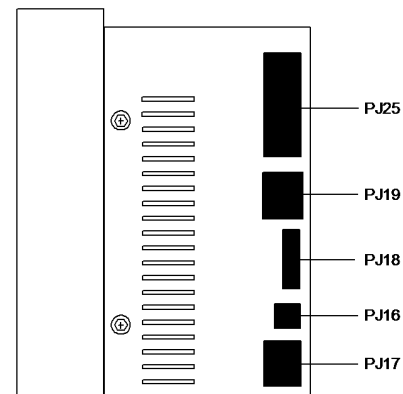
11. **Figure 7.** Disconnect the LVPS wiring.

1
Disconnect all of the PJs from the LVPS

Figure 7 LVPS disconnection

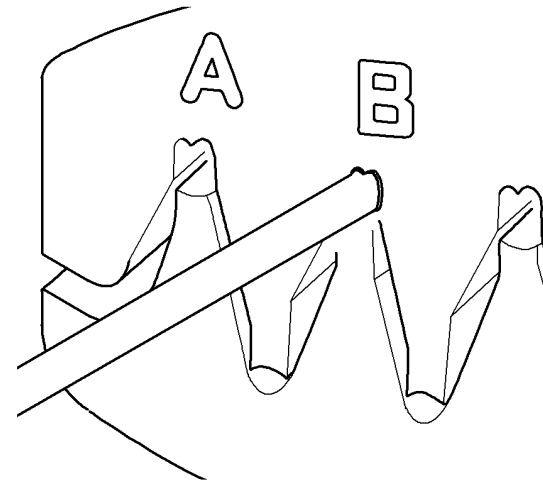
4. **Figure 4.** Insert the crimped terminal into the appropriate position of the crimp tool and close the crimp tool to firmly fasten the insulation of the wire in the cable grip of the terminal.

Figure 4 Crimping the insulated grip.

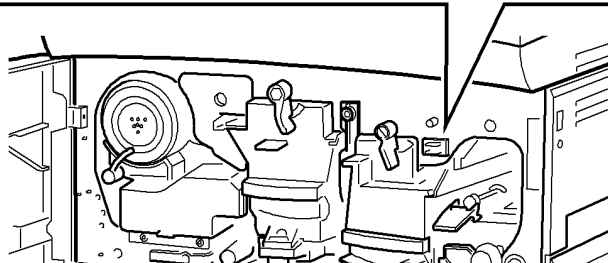
1. Pull the fuser module out a short way.
2. [Figure 1](#). Release the front door interlock switch.

Figure 1 Switch release

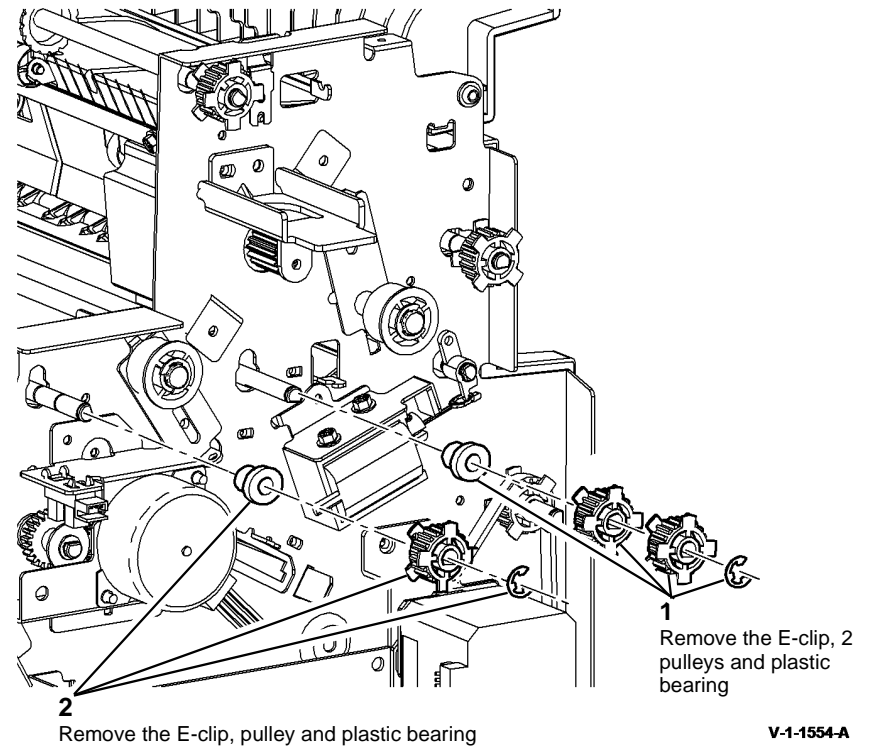
- Remove the 1K LCSS top cover, rear cover and front door cover assembly, [REP 11.1-120](#).
- Remove the tamper assembly, [REP 11.6-120](#).
- Remove the paper output drive belt, [REP 11.4-120](#).
- Prepare to remove the drive shafts [Figure 1](#).

Figure 1 Preparation

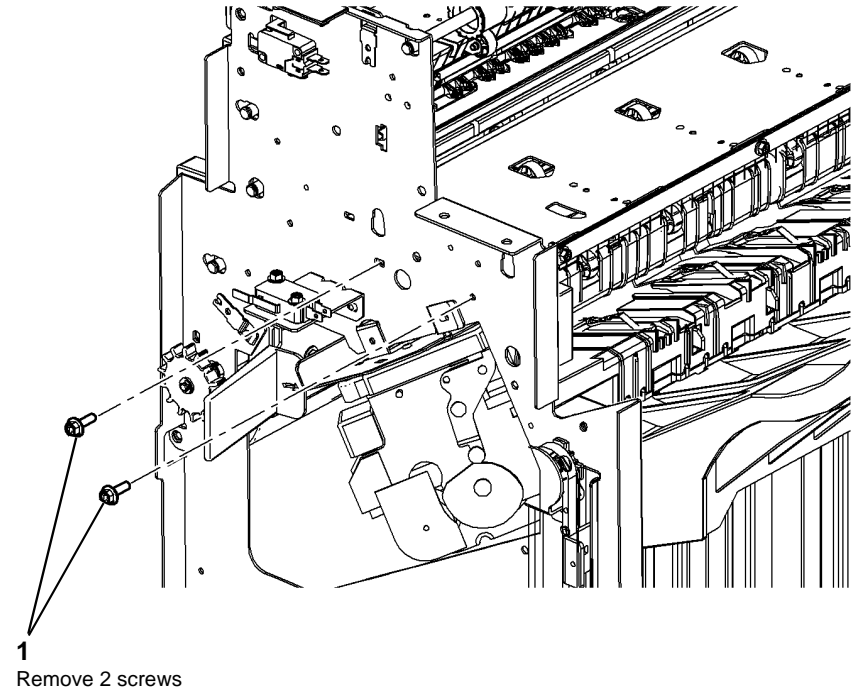
V-1-1558-A

8. Prepare to remove the lower right paper guide, [Figure 5](#).

Figure 5 Preparation

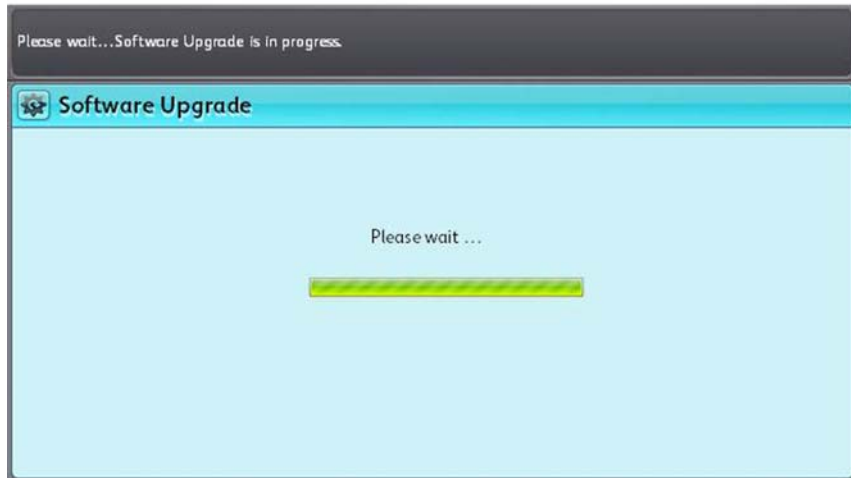
Figure 9 Software upgrade

7. The upgrade start screen is displayed, [Figure 9](#).
8. The upgrade will begin and the progress screen will open, [Figure 10](#).
9. The system upgrade process should complete after approximately 5 minutes, [Figure 11](#), and the machine will come to a ready state.
10. If the system upgrade process fails, perform an Altboot. Refer to [AltBoot Software Loading Procedure](#).
11. The machine will reboot several times before returning to a ready state. The machine may also display the upgrade progress screen, [Figure 10](#). If the power on failure screen is displayed, switch off, then switch on the machine, [GP 14](#).
12. After the software has upgraded, a software upgrade report will be printed.
13. If the USB port security setting was changed at the beginning of this procedure, reset it, then switch off, then switch on the machine, [GP 14](#).

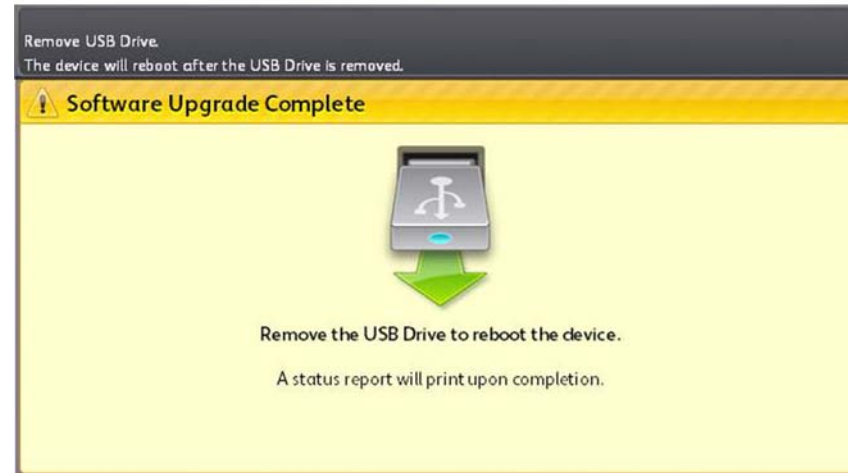
Figure 11 DLM upgrade complete

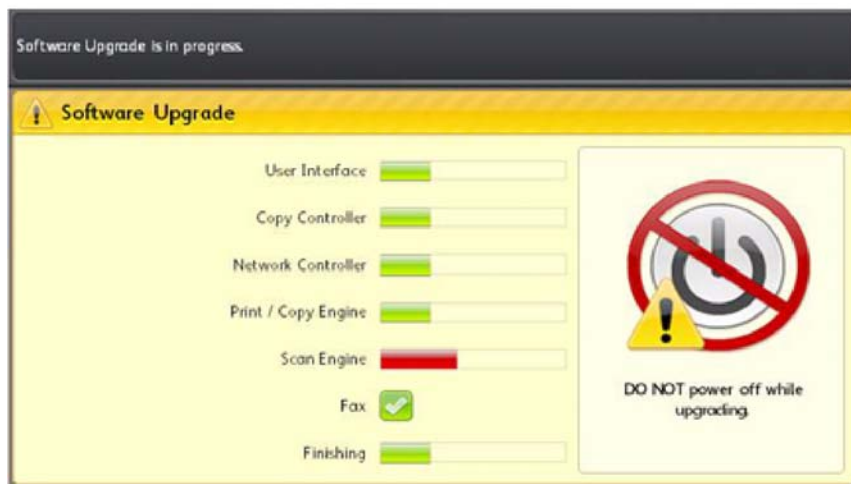
Figure 10 Start of upgrade

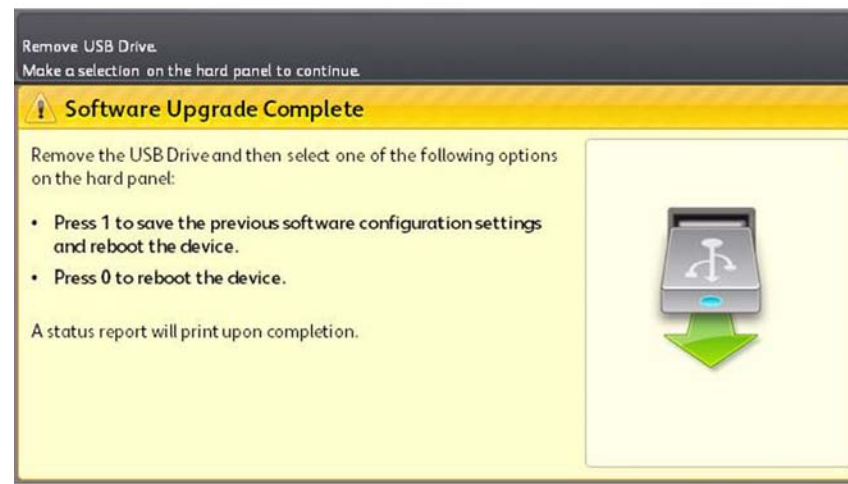
Figure 12 Altboot upgrade complete

9. The AltBoot process should complete after approximately 5 minutes and the AltBoot complete screen will open, [Figure 12](#). Follow the on screen instructions.
10. If the AltBoot process fails, the AltBoot failed screen will open, [Figure 13](#). Follow the on screen instructions. Restart the procedure and refer to [Troubleshooting](#) as necessary.
11. The UI displays the Data Encryption/Decryption in progress screen, [Figure 14](#).

20. The AltBoot process should complete after approximately 5 minutes and the AltBoot complete screen will open, Figure 12. Ignore the instruction to remove the USB flash drive, press 0 to continue.
21. If the AltBoot process fails, the AltBoot failed screen will open, Figure 13. Follow the on screen instructions. Restart the procedure and refer to Troubleshooting as necessary.
22. The UI displays the Data Encryption/Decryption in progress screen, Figure 14.

NOTE: If the upgrade process screen is not displayed after 5 minutes, restart the process.
20. The Forced AltBoot process should complete after approximately 35 minutes and the Alt-Boot complete screen will open, [Figure 12](#). Ignore the instruction to remove the USB flash drive, press 0 to continue.
21. If the Forced AltBoot process fails, the AltBoot failed screen will open, [Figure 13](#). Follow the on screen instructions. Restart the procedure and refer to [Troubleshooting](#) as necessary.

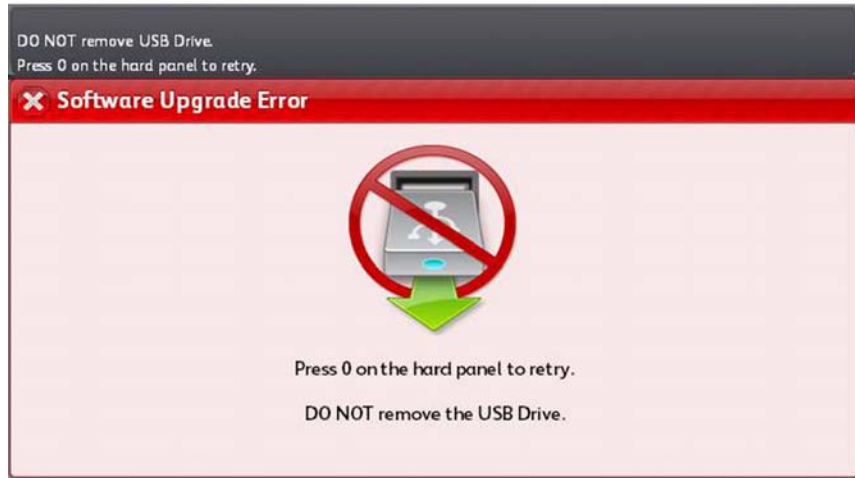
Figure 13 Upgrade failed

NOTE: If the Upgrade Failed screen, [Figure 13](#), displays at this time, it is an indication of hard disk drive failure. Go to the [303C Hard Disk Failure RAP](#).

NOTE: If the Upgrade Failed screen, Figure 13 displays at this time, it is an indication of hard disk failure. Refer to the 303C Hard Disk Failure RAP.

NOTE: If the Upgrade Failed screen, [Figure 13](#) displays at this time, it is an indication of hard disk failure. Refer to the [303C Hard Disk Failure RAP](#).

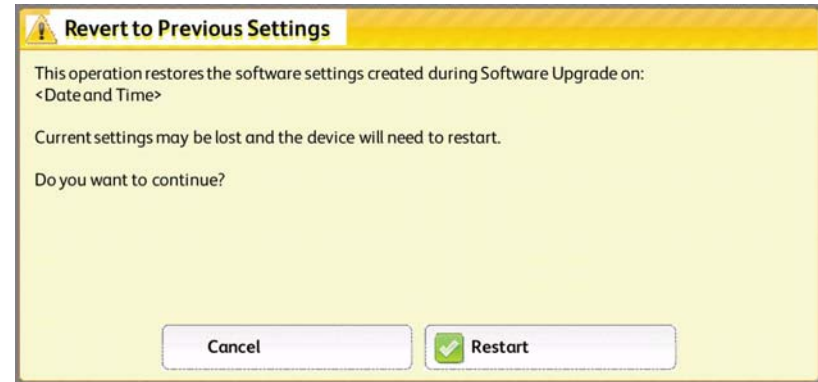
Figure 15 Revert to previous settings

12. Before returning to a ready state, the machine will reboot several times as the previous settings are re-loaded. The previous settings message screen will display, [Figure 15](#). If a power on failure screen appears, switch off, then switch on the machine, [GP 14](#).
13. Check that the software set has been installed. Refer to the printed software upgrade report or by pressing the machine status button.
14. Perform a NVM restore, refer to [dC361 NVM Save and Restore](#).
15. Switch off, then switch on the machine, [GP 14](#).

23. Before returning to a ready state, the machine will reboot several times as the previous settings are re-loaded. The previous settings message screen will display, Figure 15. If a power on failure screen appears, switch off, then switch on the machine, GP 14.
24. Disconnect the data cable and the special crossover ethernet cable from the PWS and the machine.
25. Connect the ethernet cable to the machine.
26. Check that the software set has been installed. Refer to the printed software upgrade report or by pressing the machine status button.
27. If the NVM was saved at the beginning of this procedure, perform a NVM restore, refer to dC361 NVM Save and Restore.

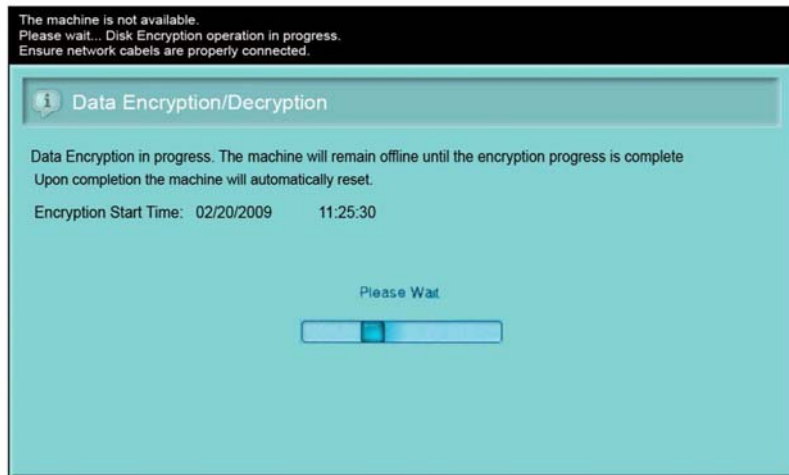
Figure 14 Encryption progress

NOTE: Do not switch off the machine until directed to on the UI. During the reboot, the hard disk drive is encrypted. Switching off the machine can cause only partial encryption of the hard disks partitions. The AltBoot process may need to be re-run if power is removed at this step.

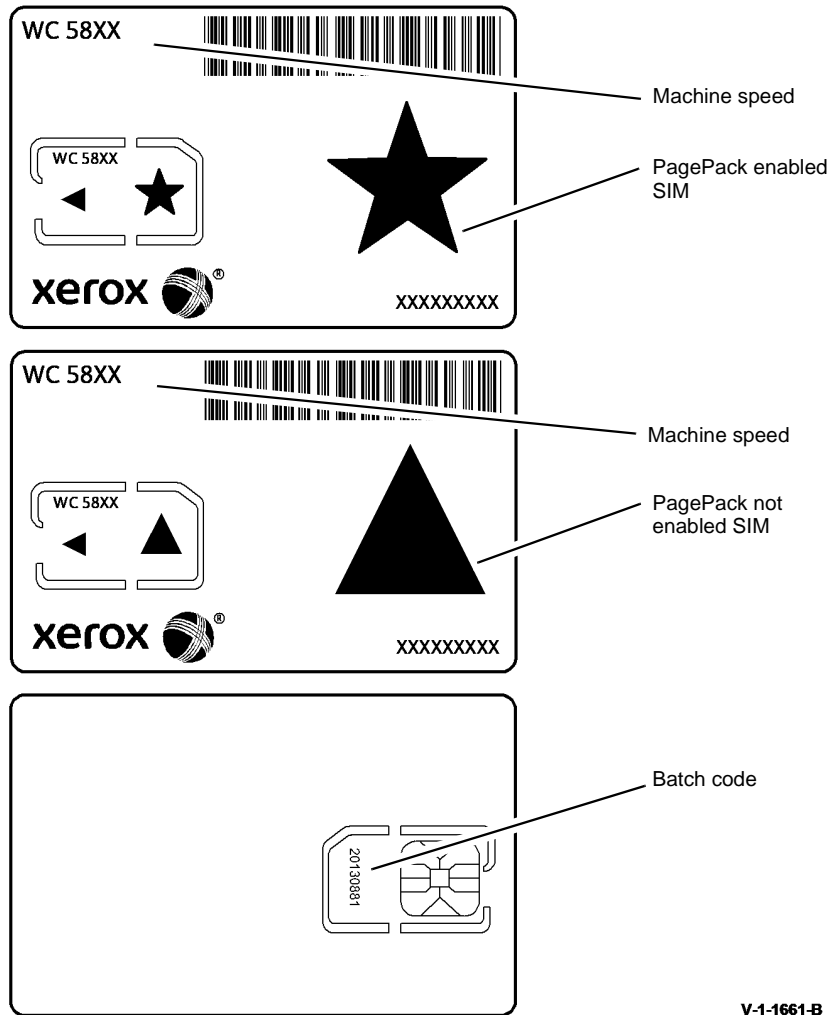
- The PagePack function is enabled in all XE installations. Depending on the customer's full service maintenance agreement, the PagePack function may need to be enabled when a USSG/XCL machine is installed in an XE region.
- A new SIM is pre-programmed with the machine speed and either PagePack enabled or not enabled. When the SIM is installed, the machine serial number is permanently written to the SIM. The SIM can not be reused in another machine.
- On the reverse of each SIM card is printed the batch code.

Figure 1 SIM card matrix

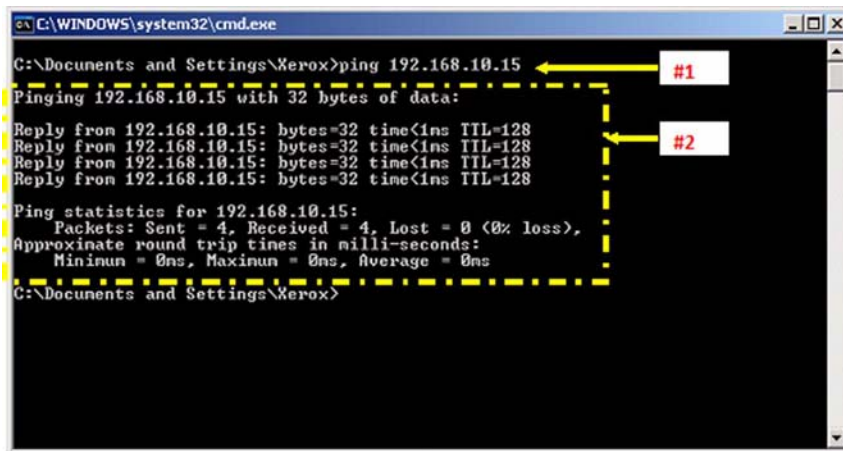
- c. Press return. A command window will open.
6. In the command window, type ping and the address of the device. Refer to number 1 in [Figure 1](#).
7. If the ping command is successful, a reply from the device will be received. Refer to number 2 in [Figure 1](#).

Figure 1 Successful ping command

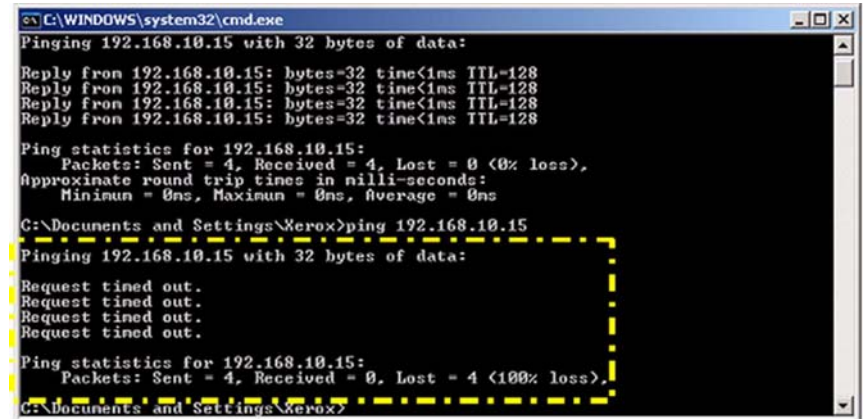
8. If the ping command is unsuccessful, a timed out message will be received, [Figure 2](#).

Figure 2 Unsuccessful ping command

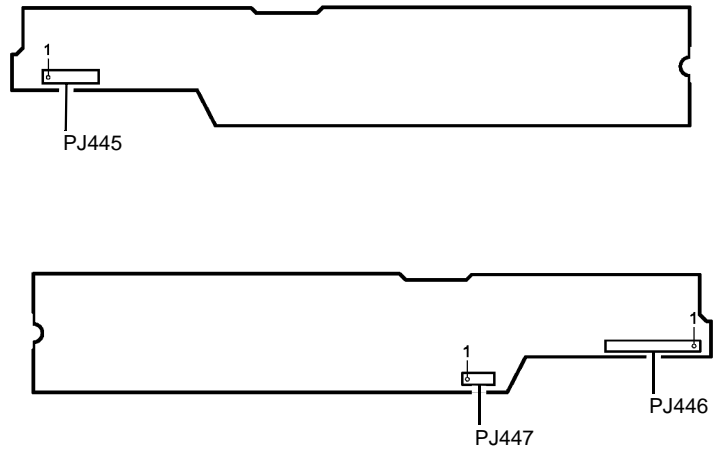
Figure 43 Scanner CCD PWB

Scanner CCD PWB

Location: PL 60.25 Item 4

| PJ number | PJ location figure | PJ location | Wiring diagram |
|---|---|---|---|
| 445 | Figure 43 | Scanner CCD PWB | WD 44 |
| 446 | Figure 43 | Scanner CCD PWB | WD 44 |
| 447 | Figure 43 | Scanner CCD PWB | WD 44 |

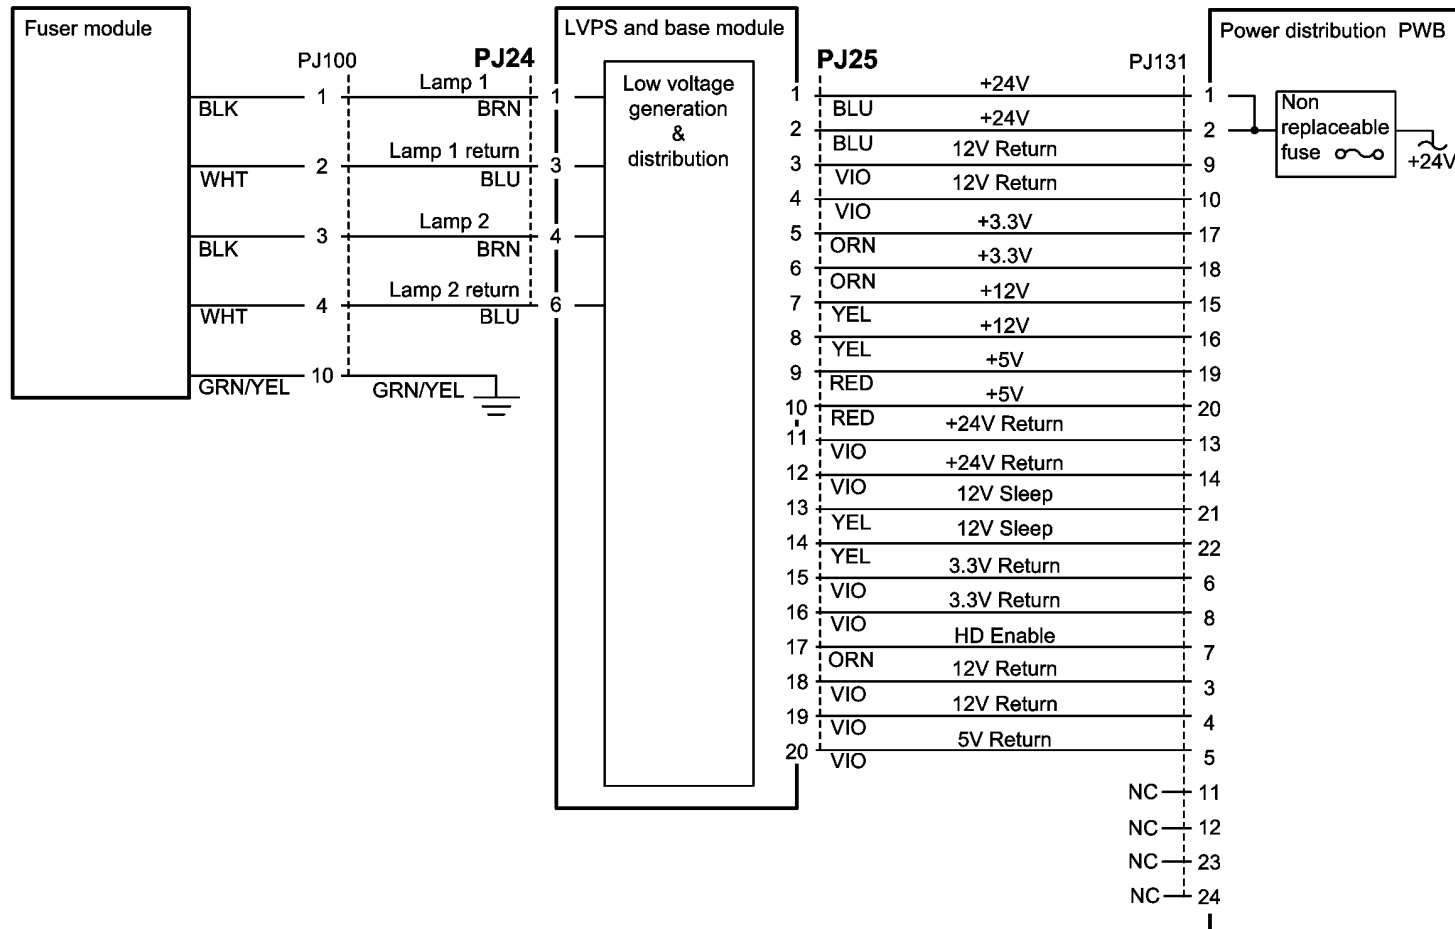
Figure 2 Wiring Diagram 2

Wiring Diagram 2

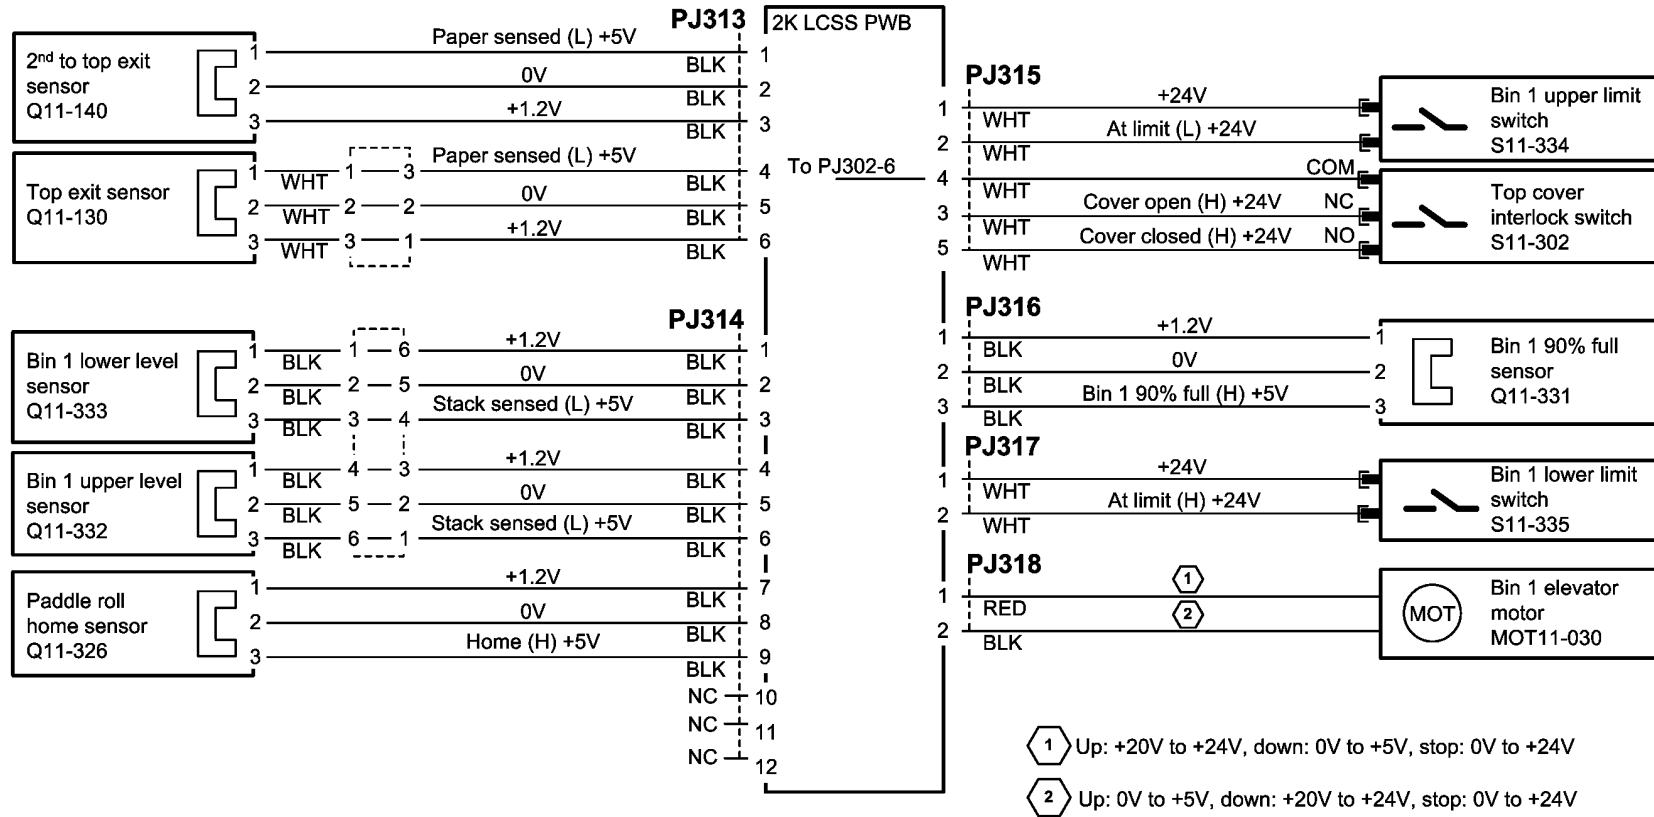
Figure 21 Wiring Diagram 21

Wiring Diagram 21

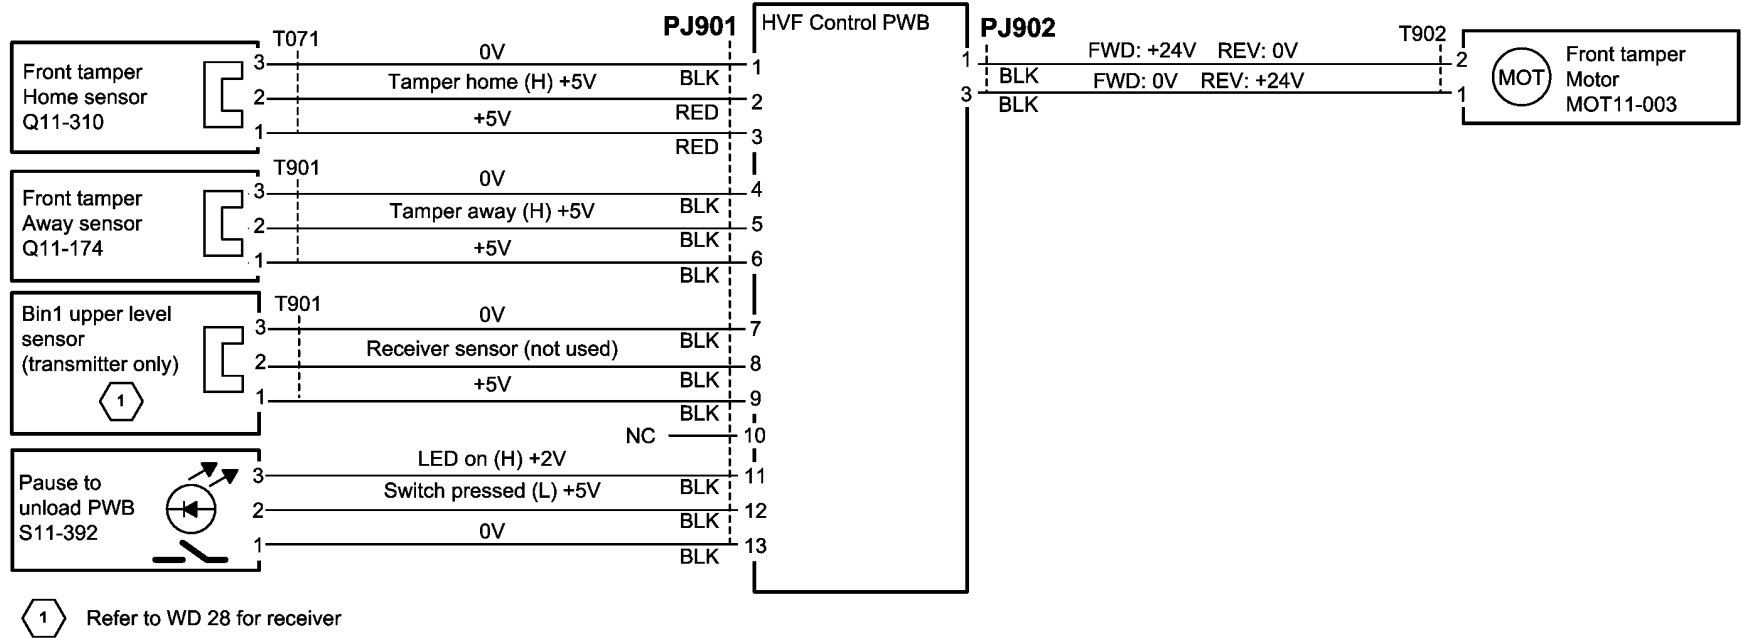
Figure 28 Wiring Diagram 28

Wiring Diagram 28
