708P91010
August 2015

Xerox® WorkCentre® 5890 Family Multifunction Printer Service Manual

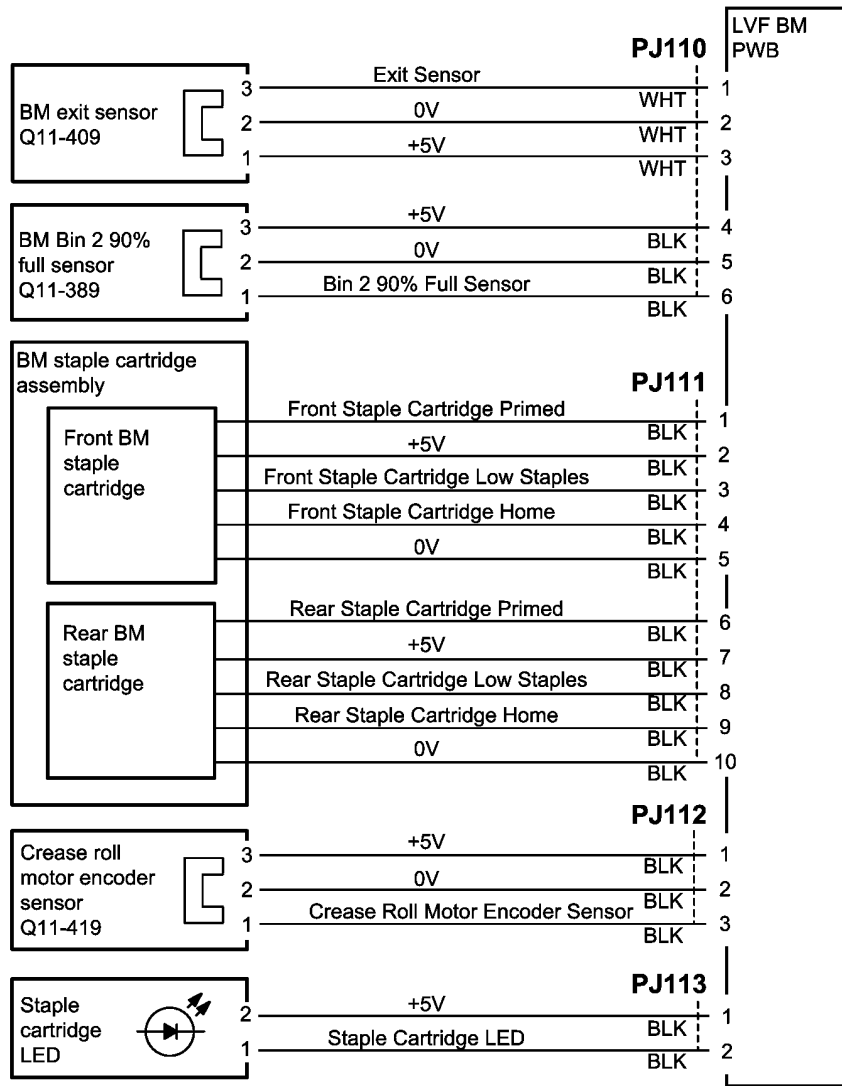
Figure 42 Wiring Diagram 42

Wiring Diagram 42

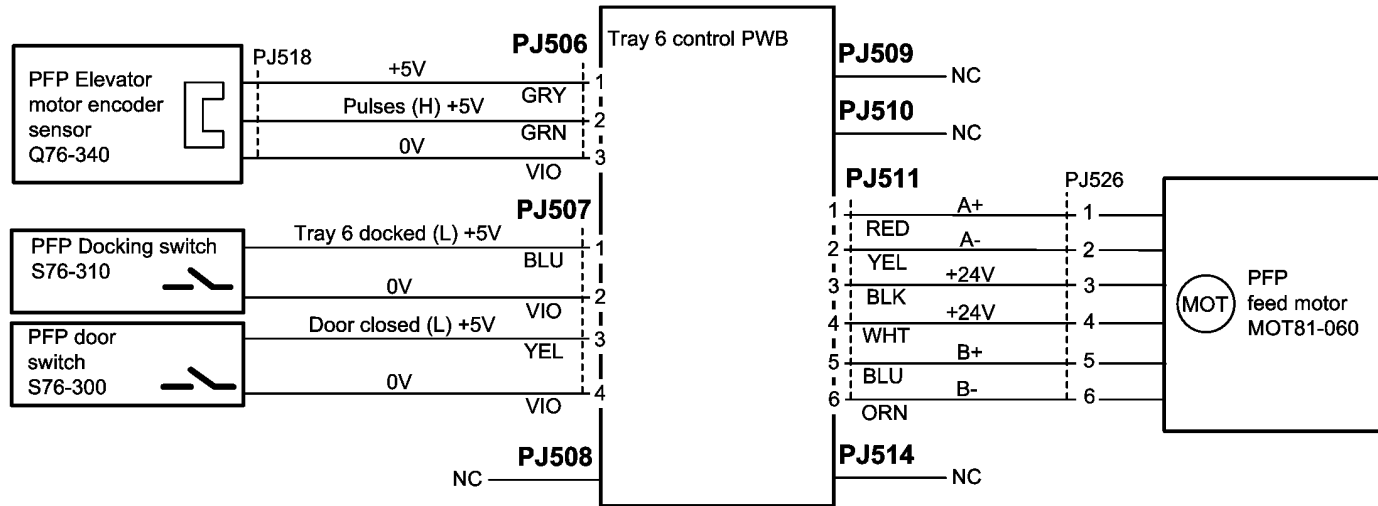
Figure 49 Wiring Diagram 49

Wiring Diagram 49
