Brother Laser Printer SERVICE MANUAL

MODEL: HL-2140/2150N/2170W

Sep 2007 SM-PRN066 84UA0* (5)

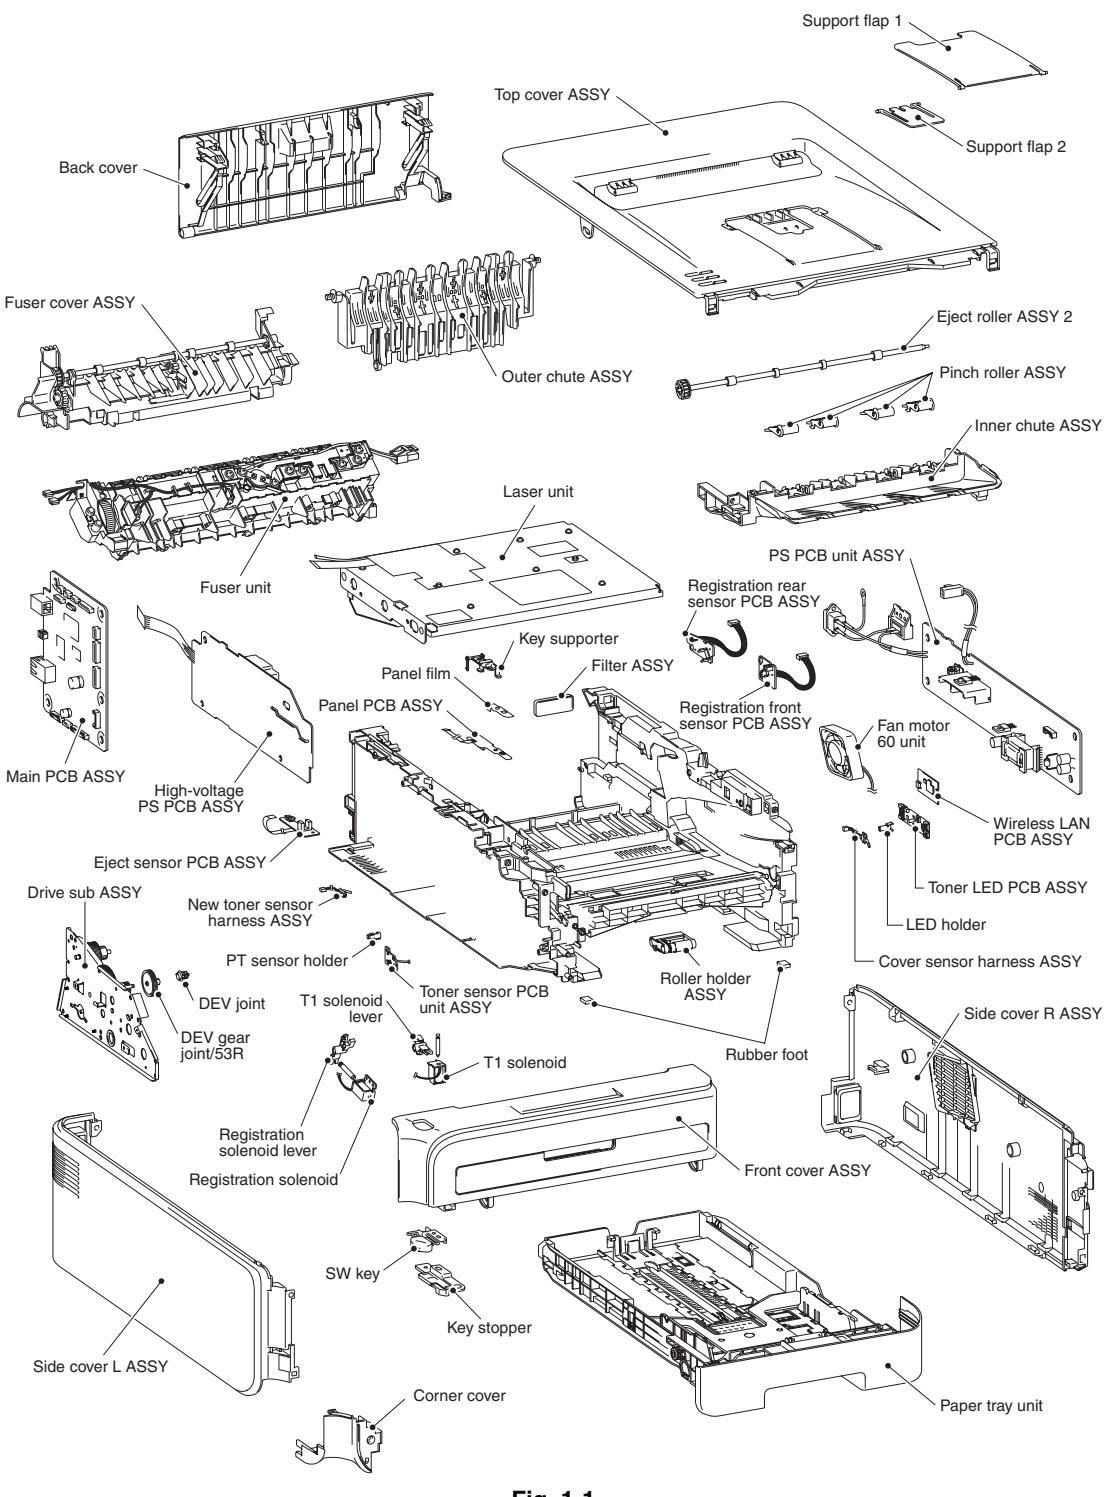
Fig. 1-1

1.2 Part names

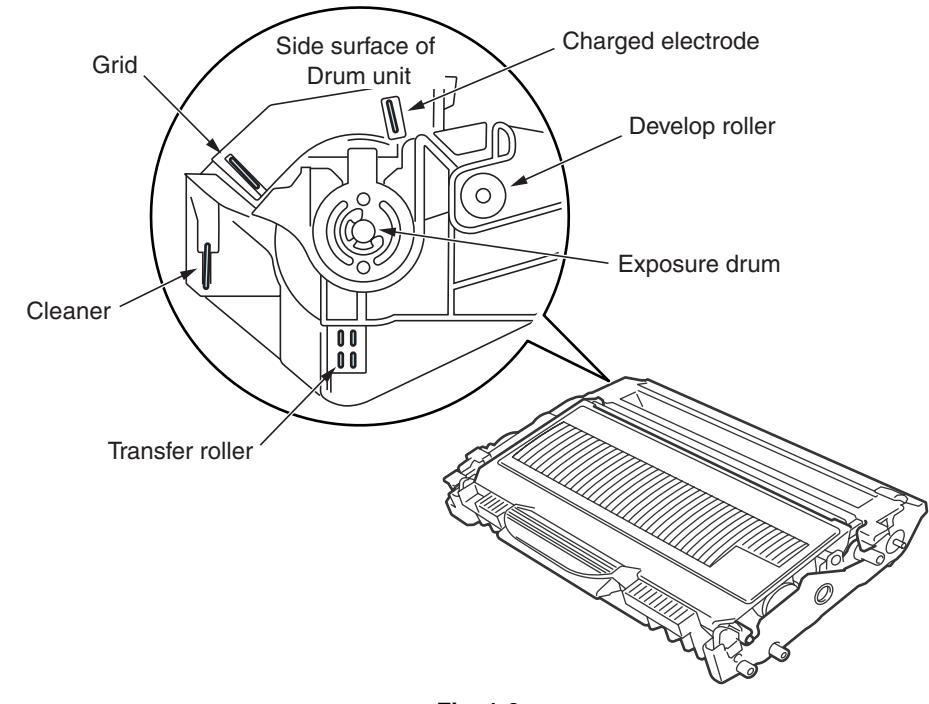
Electrodes location of the drum unit

St	tep	Cause	Remedy
	1	Dirt or dust on drum unit electrodes	Clean the electrodes on the drum unit and the machine body (Refer to Fig. 1-2).
:	2	High-voltage power supply PCB failure	Replace the high-voltage power supply PCB.
;	3	Main PCB ASSY failure	Replace the main PCB ASSY failure.

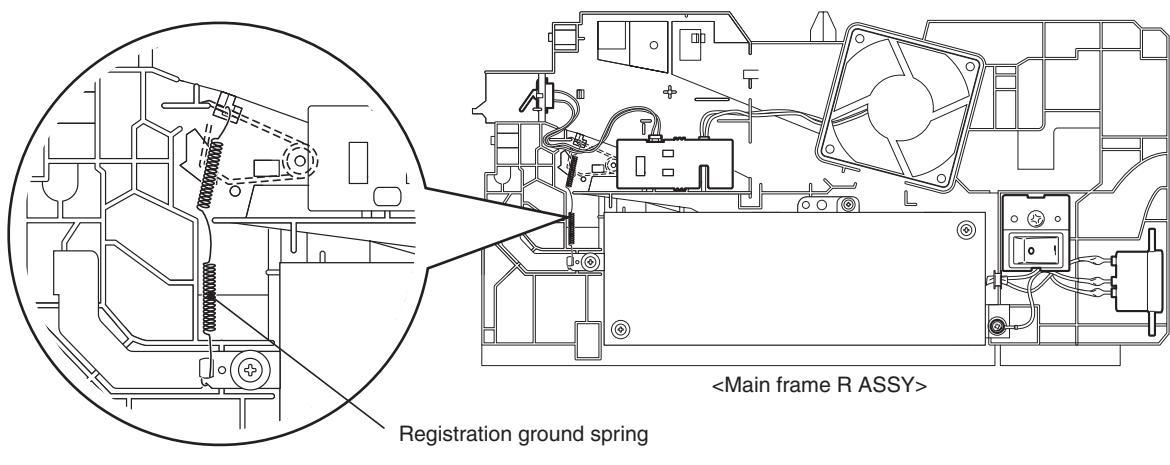
Fig. 1-4

Step	Cause	Remedy
1	Edge actuator or registration front actuator catching on some position	Correct catching of the edge actuator or registration front actuator.
2	Paper feeding kit worn out	Replace the paper feeding kit.
3	Harness connection failure of registration front sensor PCB	Check the harness connections of the registration front sensor PCB, and reconnect it.
4	Registration front sensor PCB failure	Check the edge sensor and registration front sensor performance following the procedure in "Factory Inspection Mode" (Chapter 5). If any problem occurs, replace the registration front sensor PCB ASSY.
5	Toner LED PCB failure	Replace the toner LED PCB ASSY.
6	Registration ground spring loose	Fit the registration ground spring correctly. (Refer to Fig. 1-4.)
7	Main PCB failure	Replace the main PCB ASSY.

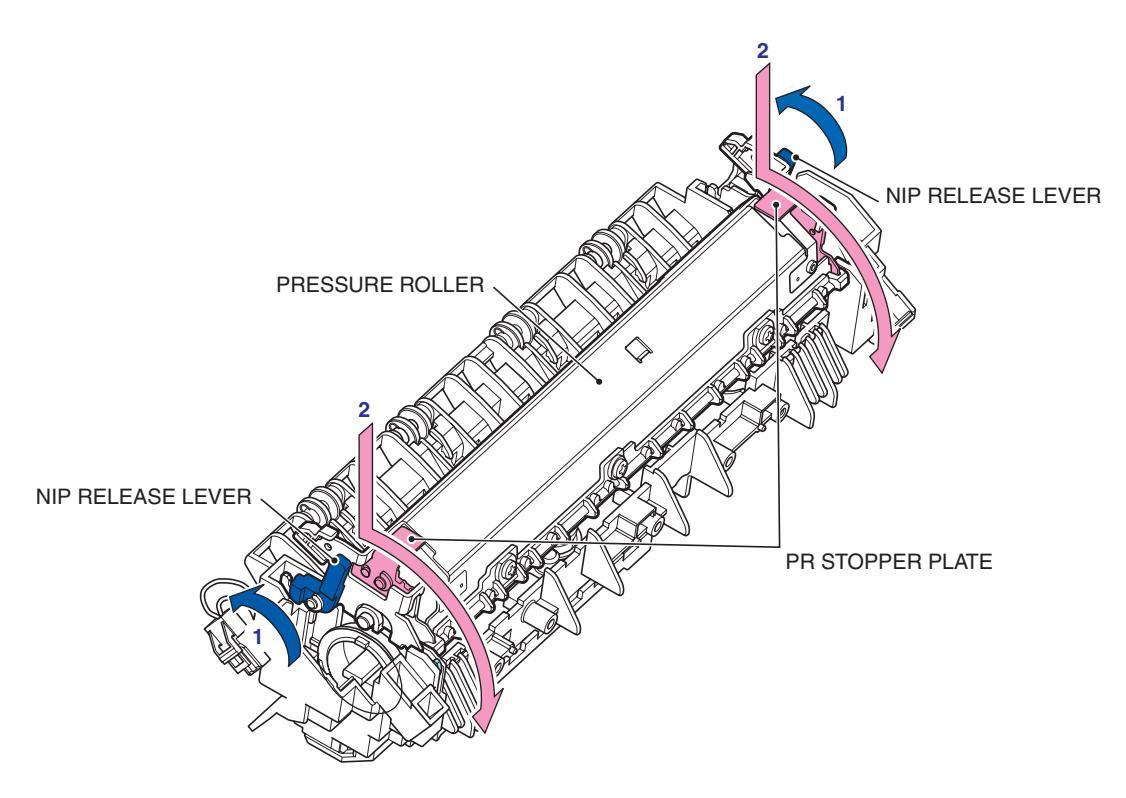
Fig. 1-5
4. **IMAGE DEFECT TROUBLESHOOTING**

- (1) Turn the Nip release lever of right and left to the direction of the arrow.
- (2) Hold and turn the PR stopper plate of right and left.

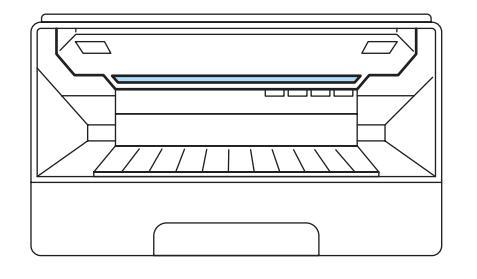
Fig. 1-7

<Location of the leser beam window>

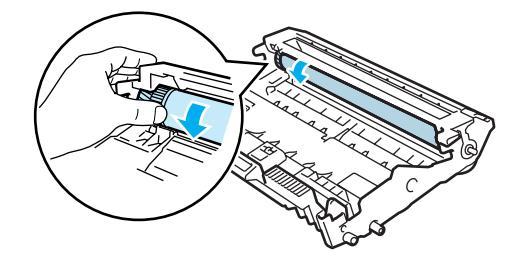
Fig. 1-10

(2) Turn the drum unit gear to the direction of the arrow of the figure by hand while looking at the surface of the exposure drum.

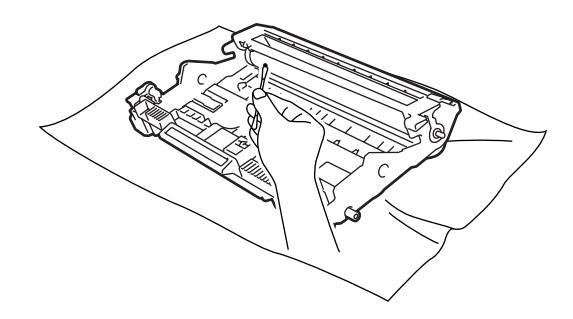
Fig. 1-11

(3) When you have found the mark on the drum that matches the print sample, wipe the surface of the exposure drum with a dry cotton swab until the dust or glue on the surface comes off.

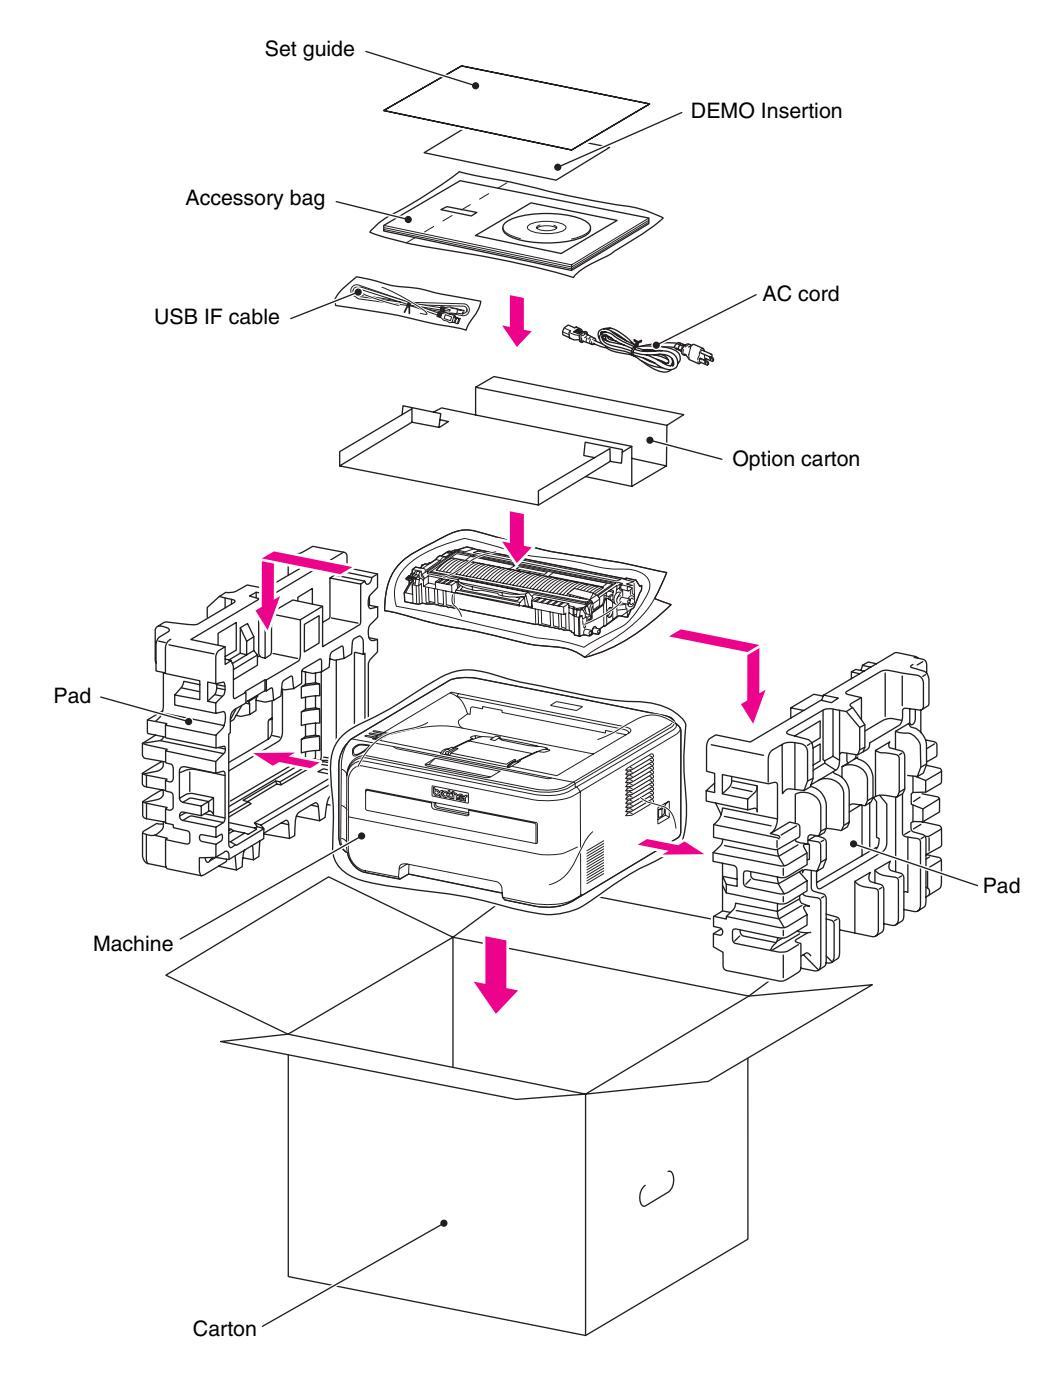
Fig. 3-1

2. PACKING

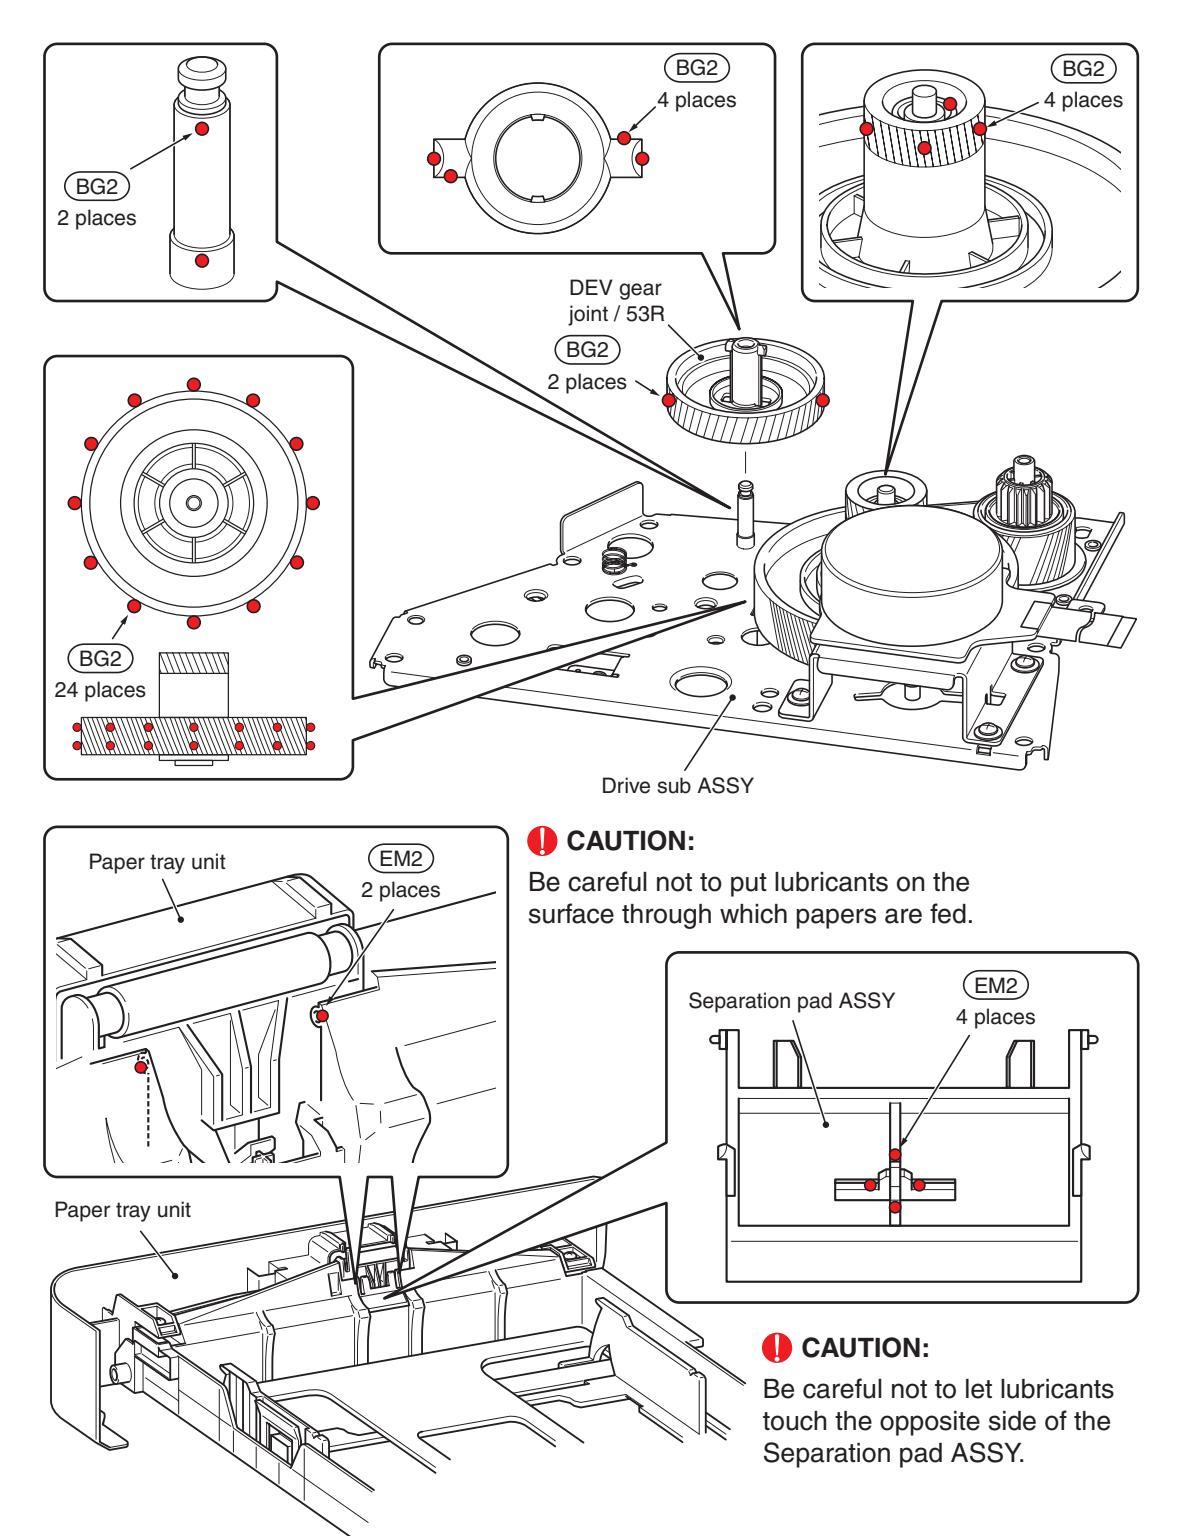
4. LUBRICATION

The kind of the lubricating oil (Maker name)	Lubrication point	Quantity of labrication
BG-MU (Kanto Kasei)	Dev gear joint/53R Drive sub ASSY Drum gear 25L/139L	2mm dia. ball (BG2)
MOLYKOTE EM-D110 (Dow Corning Toray)	Separation pad ASSY	2mm dia. ball

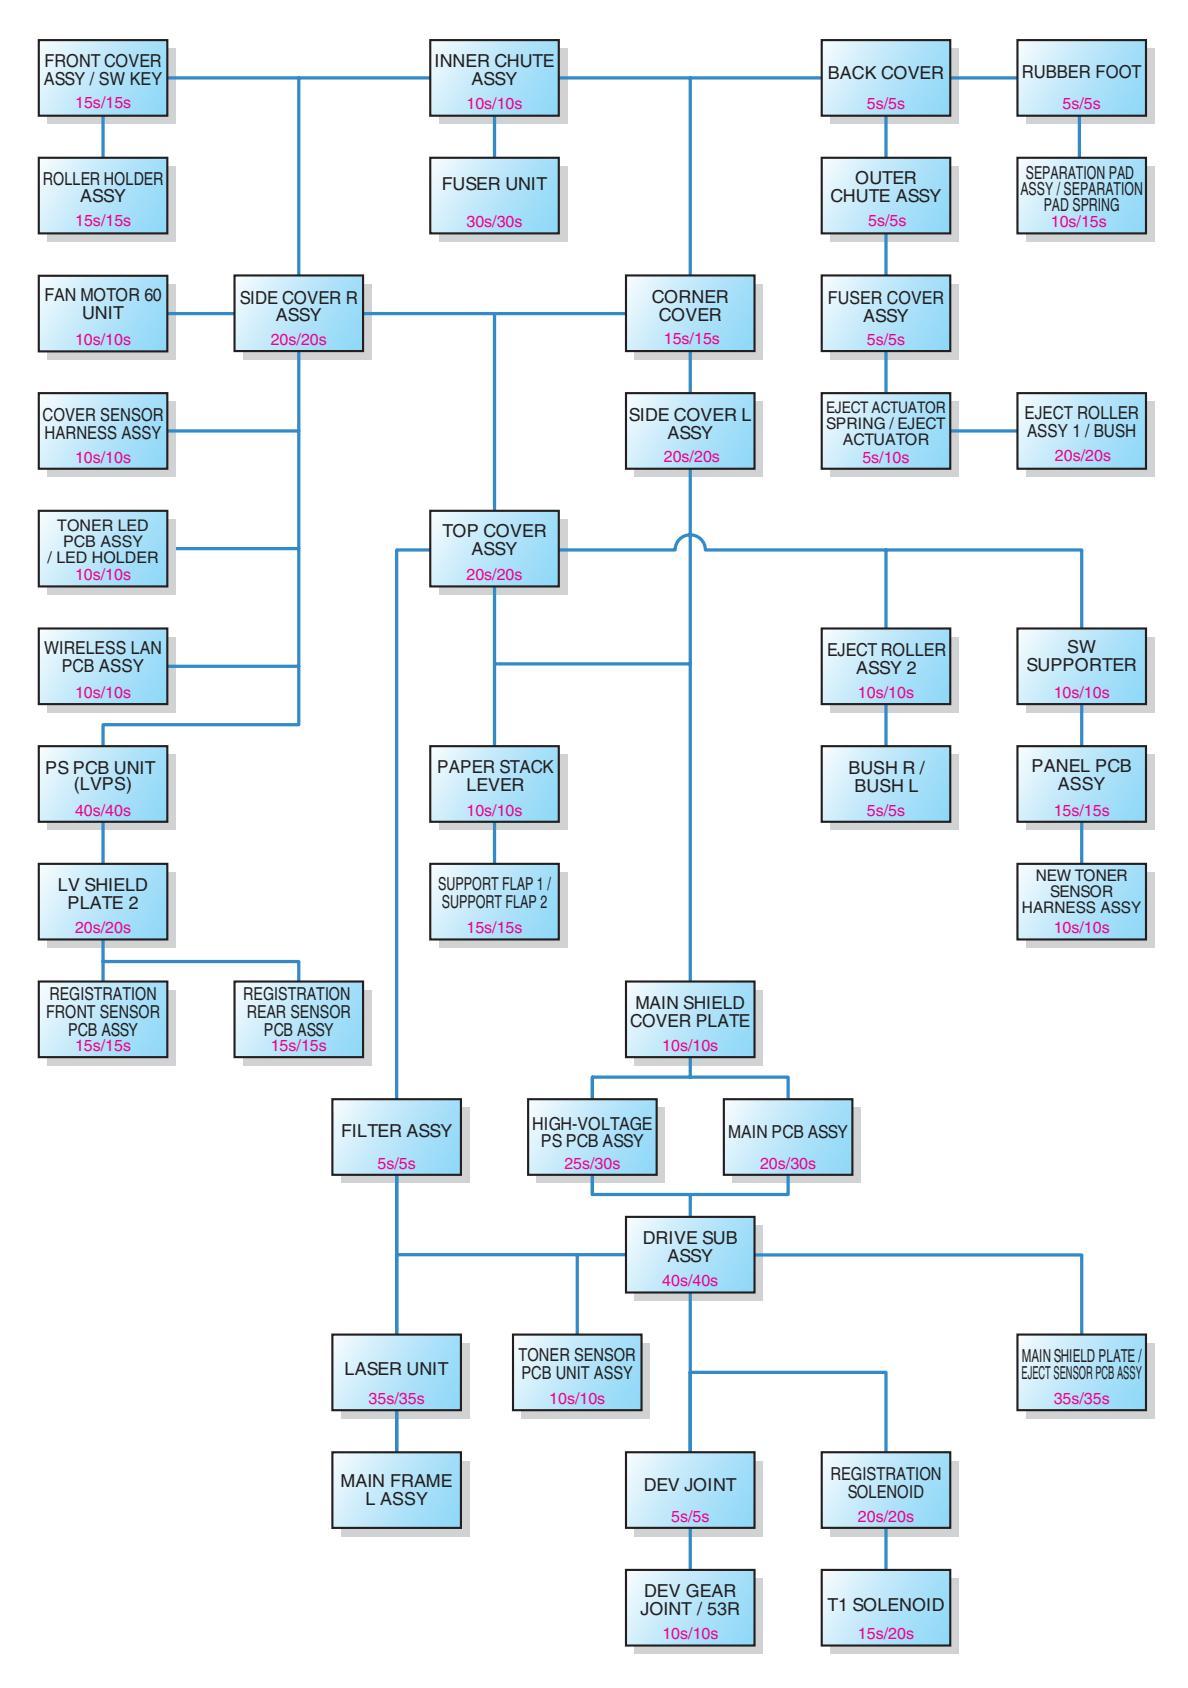
Fig. 3-3

7. DISASSEMBLY FLOW

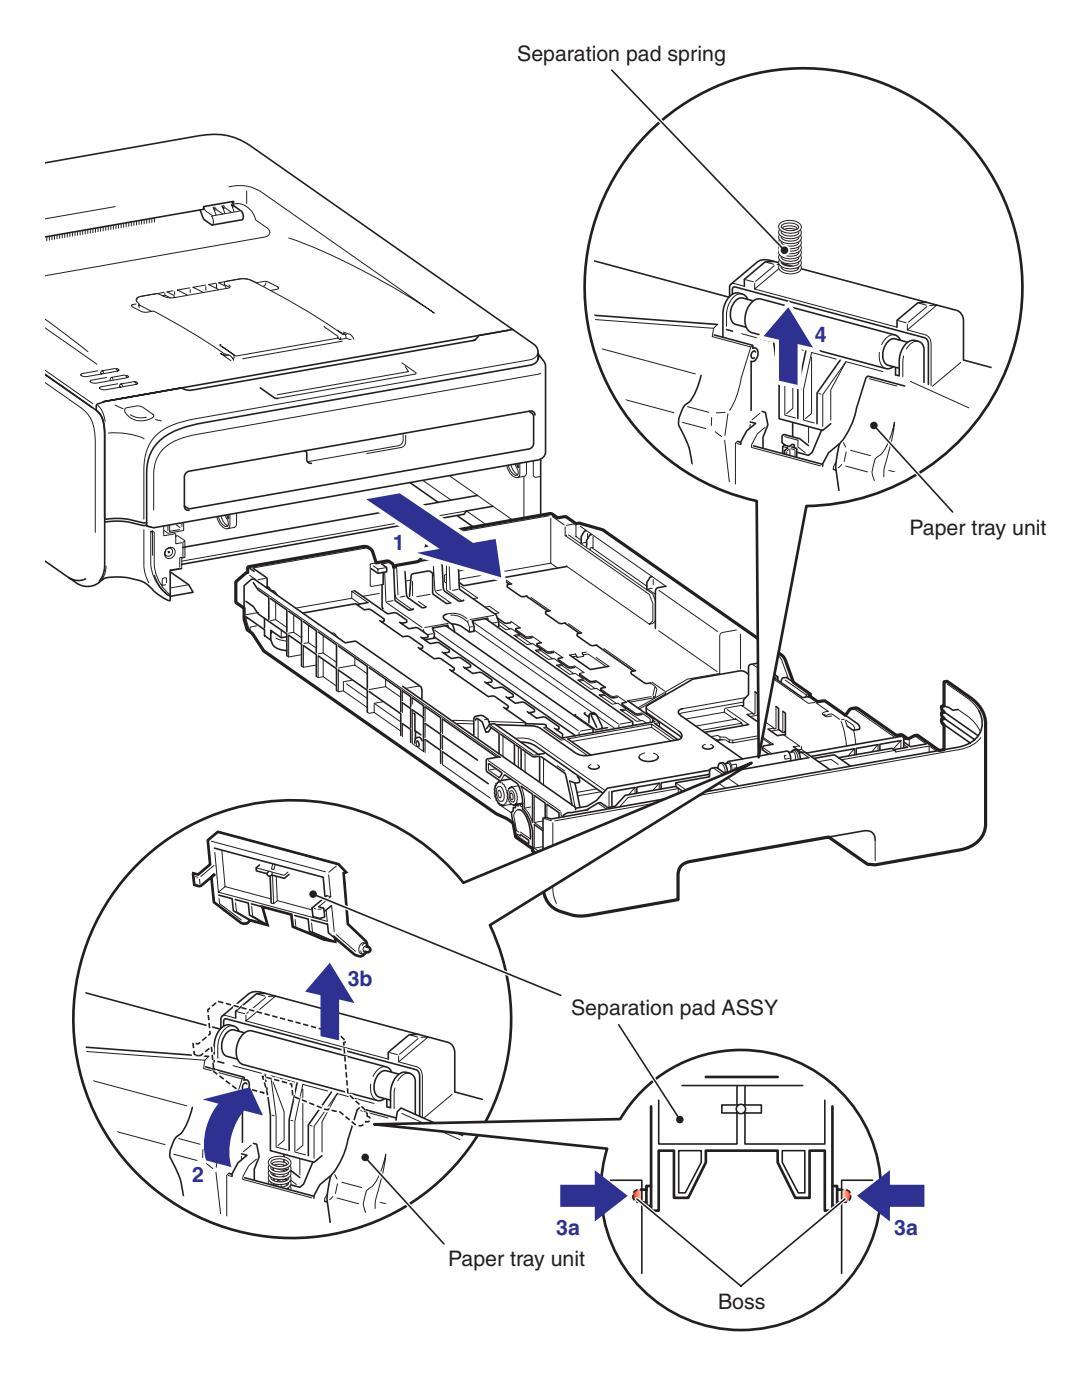
Fig. 3-4

- (1) Pull out the Paper tray unit from the Main body.
- (2) Lift up the Separation pad ASSY.
- (3) Release the Boss to remove the Separation pad ASSY from the Paper tray unit.
- (4) Remove the Separation pad spring from the Paper tray unit.

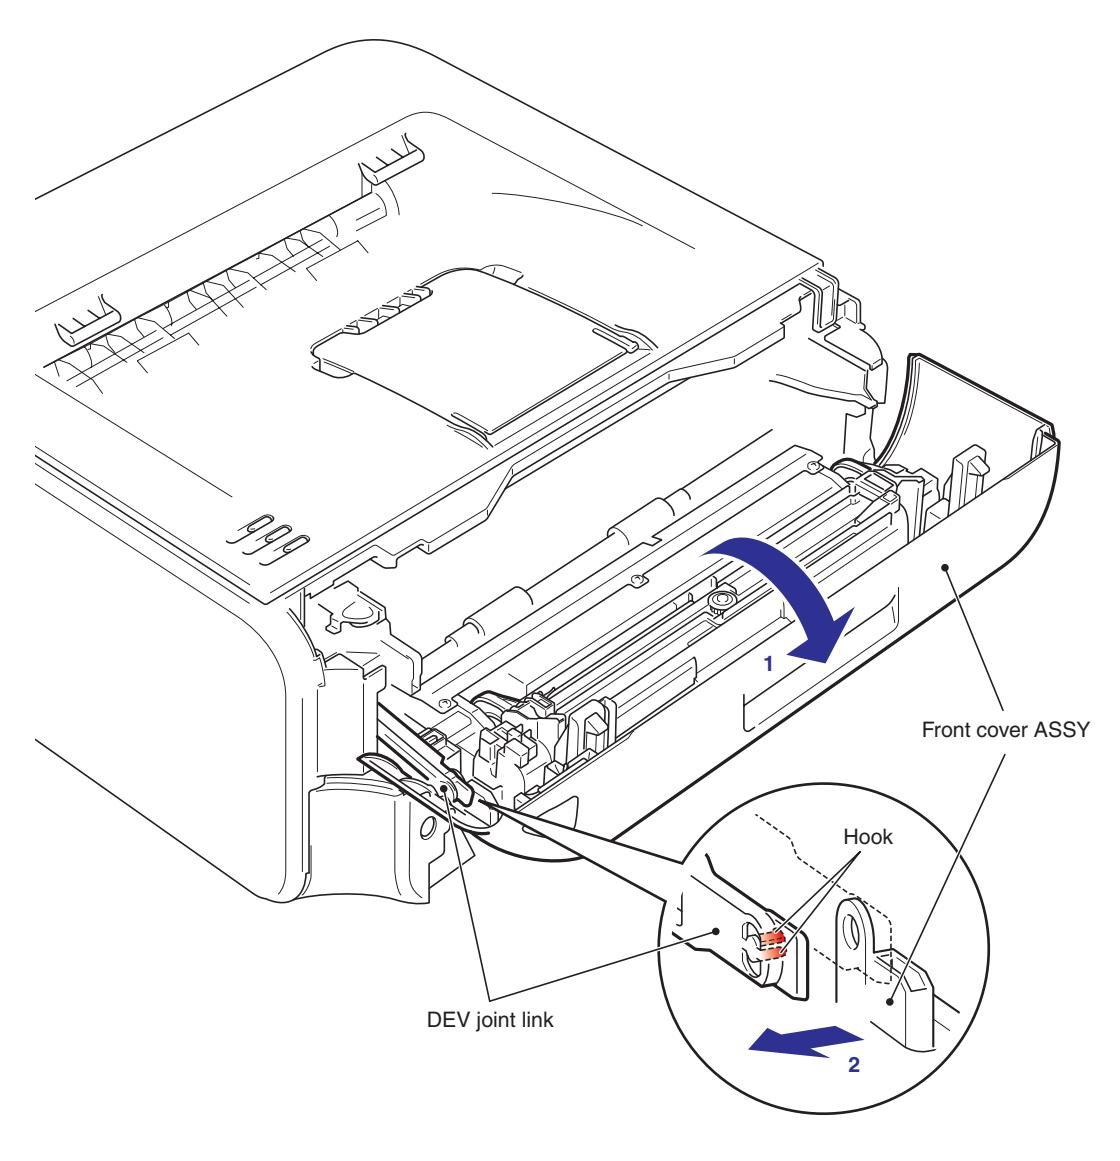
Fig. 3-5

- (1) Open the Front cover ASSY.
- (2) Release the Hook to remove the DEV joint link from the Front cover ASSY.

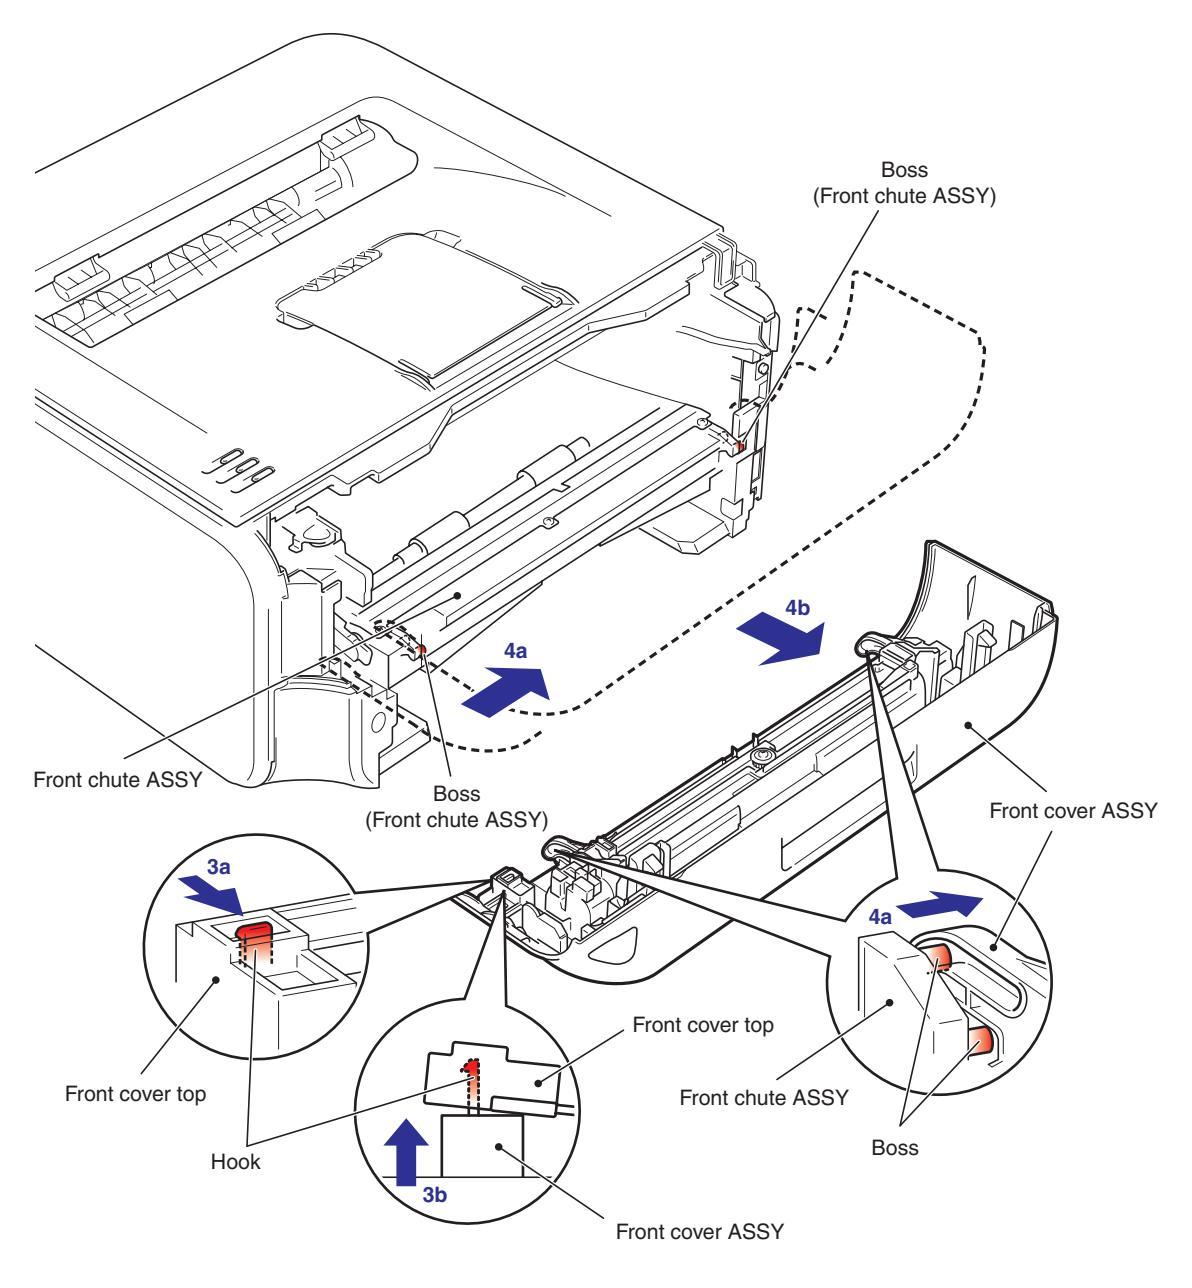
Fig. 3-6

- (3) Release the Hook of the Front cover ASSY from the Front cover top.
- (4) Remove the Boss of the Front chute ASSY, and then remove the Front cover ASSY from the Main body.

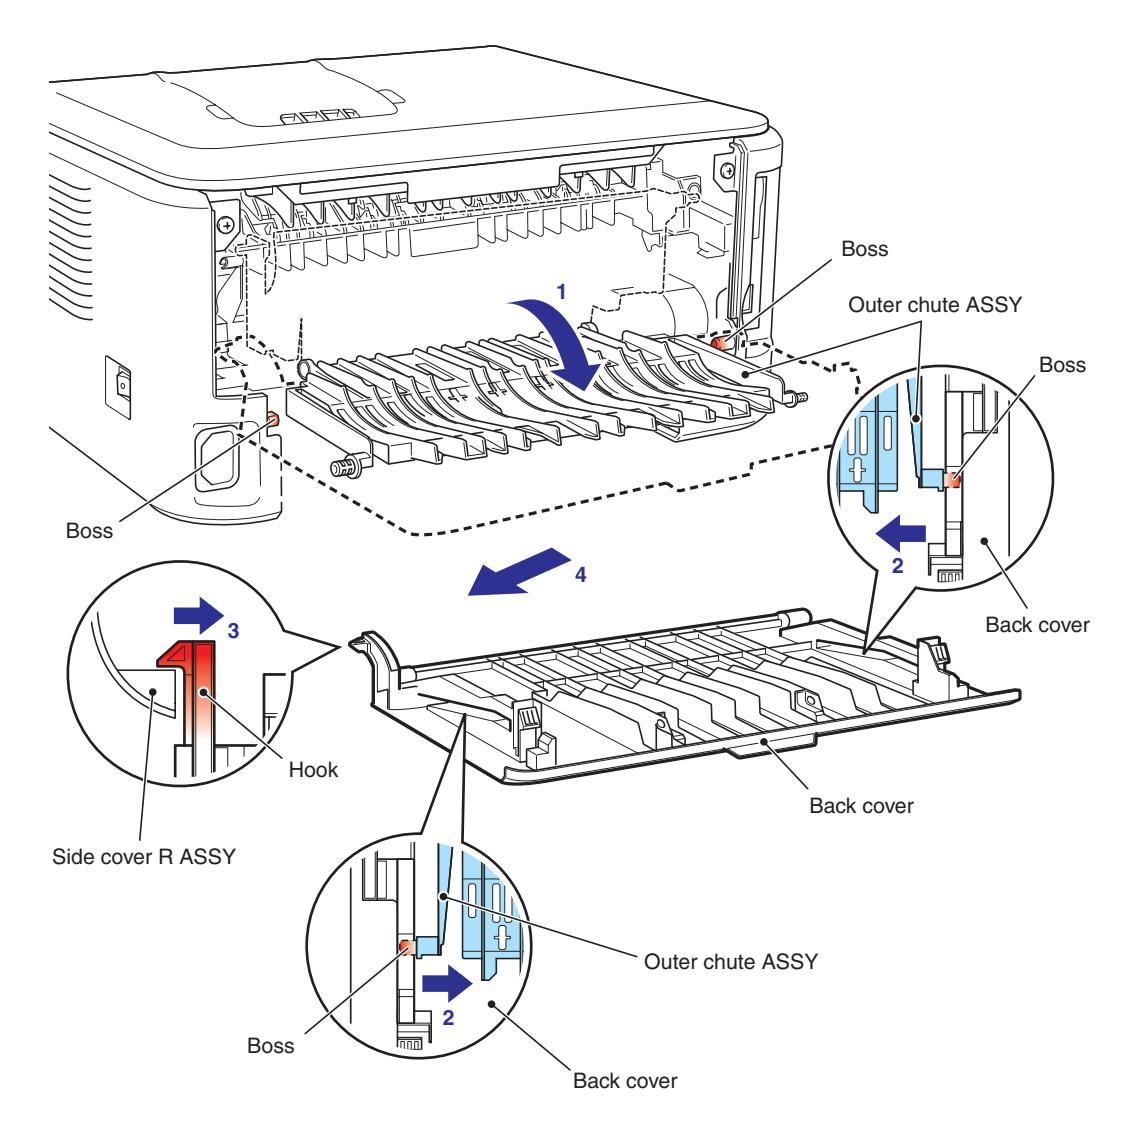
Fig. 3-9

- (1) Open the Back cover.
- (2) Release the Boss of the Outer chute ASSY from the Back cover.
- (3) Release the Hook from the Side cover R ASSY.
- (4) Slide the Back cover from the Main body, and remove it.

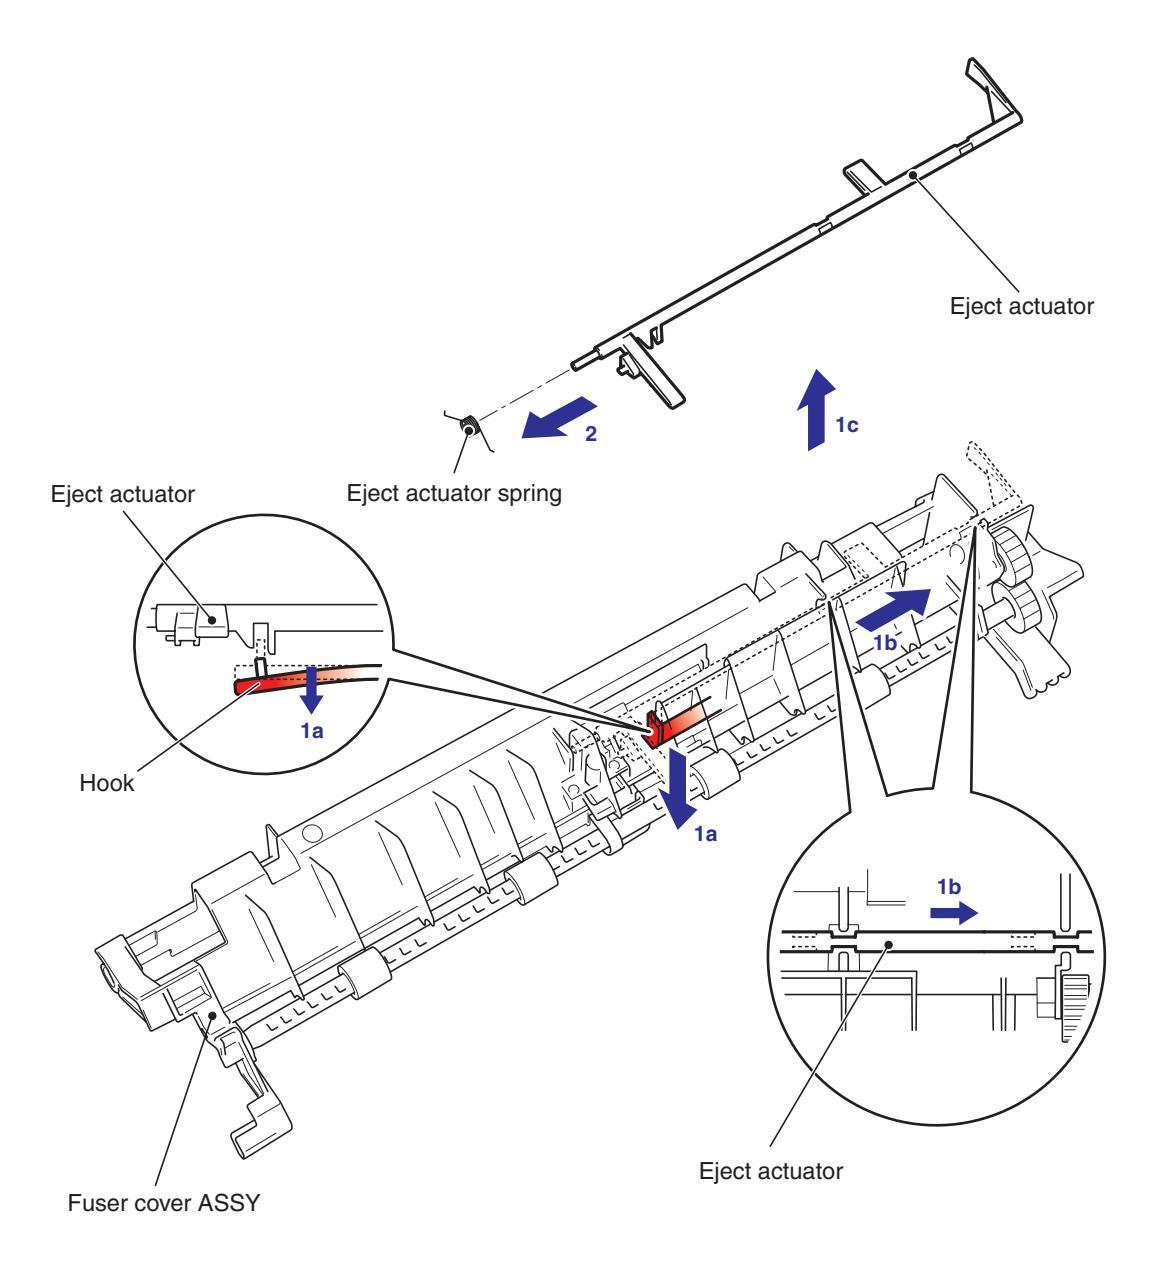
Fig. 3-12

- (1) Release the Hook to slide the Eject actuator, and then remove the Eject actuator from the Fuser cover ASSY.
- (2) Remove the Eject actuator spring from the Eject actuator.

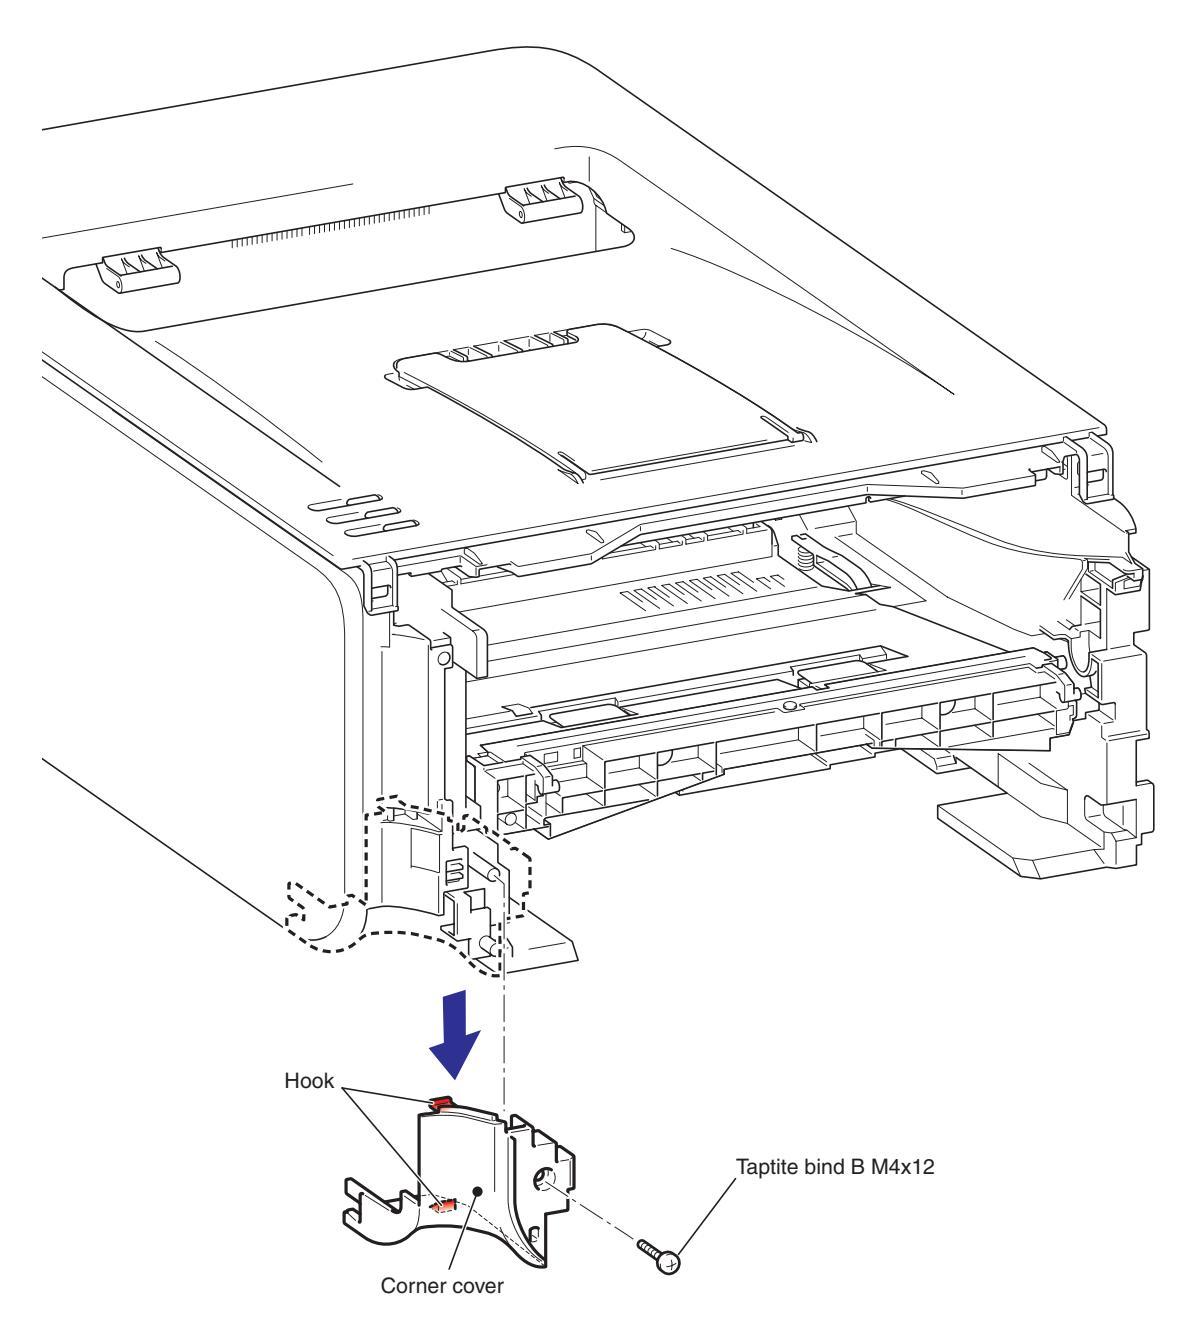
Fig. 3-20

- (1) Remove the Taptite bind B M4x12 screw.
- (2) Release the Hook to remove the Corner cover from the Main body.

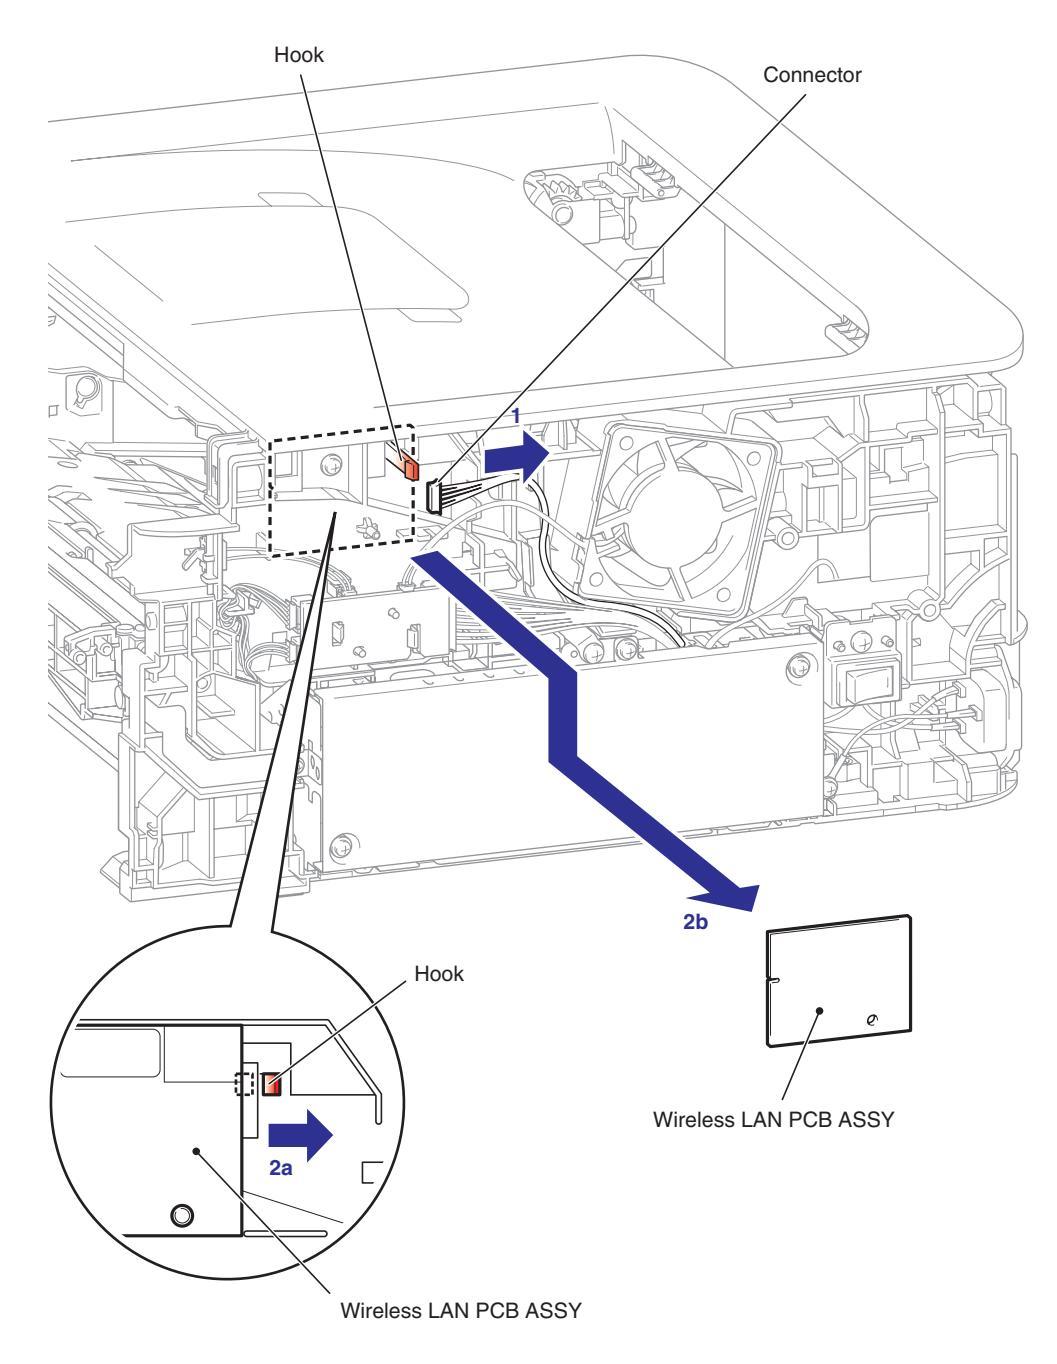
Fig. 3-24

- (1) Disconnect the Connector from the Wireless LAN PCB ASSY.
- (2) Release the Hook to remove the Wireless LAN PCB ASSY from the Main body.

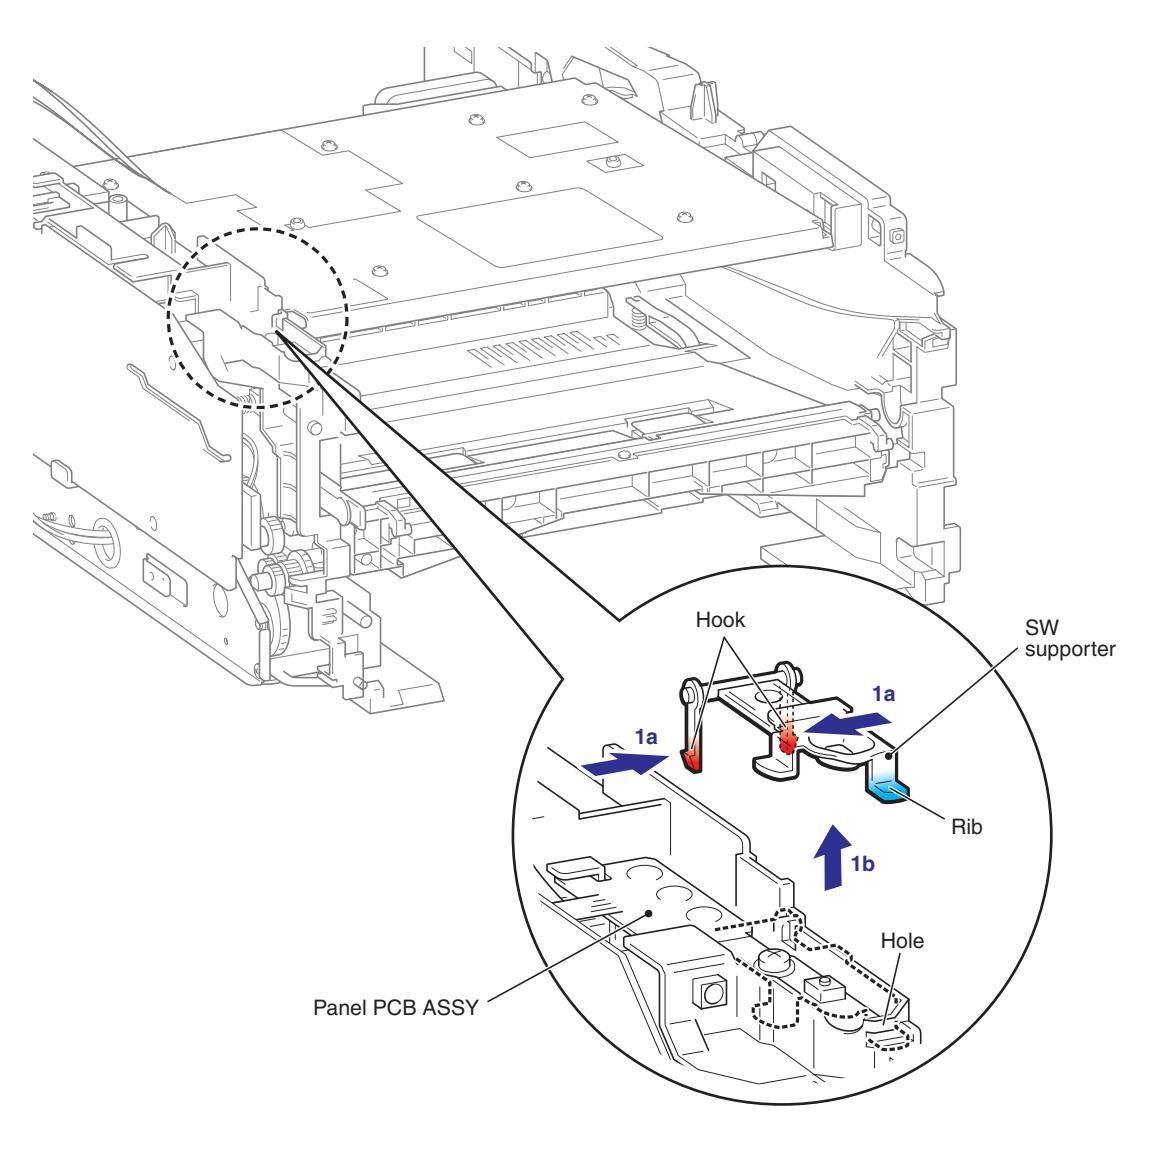
Fig. 3-31

(1) Release the Hook to remove the SW supporter from the Main body.

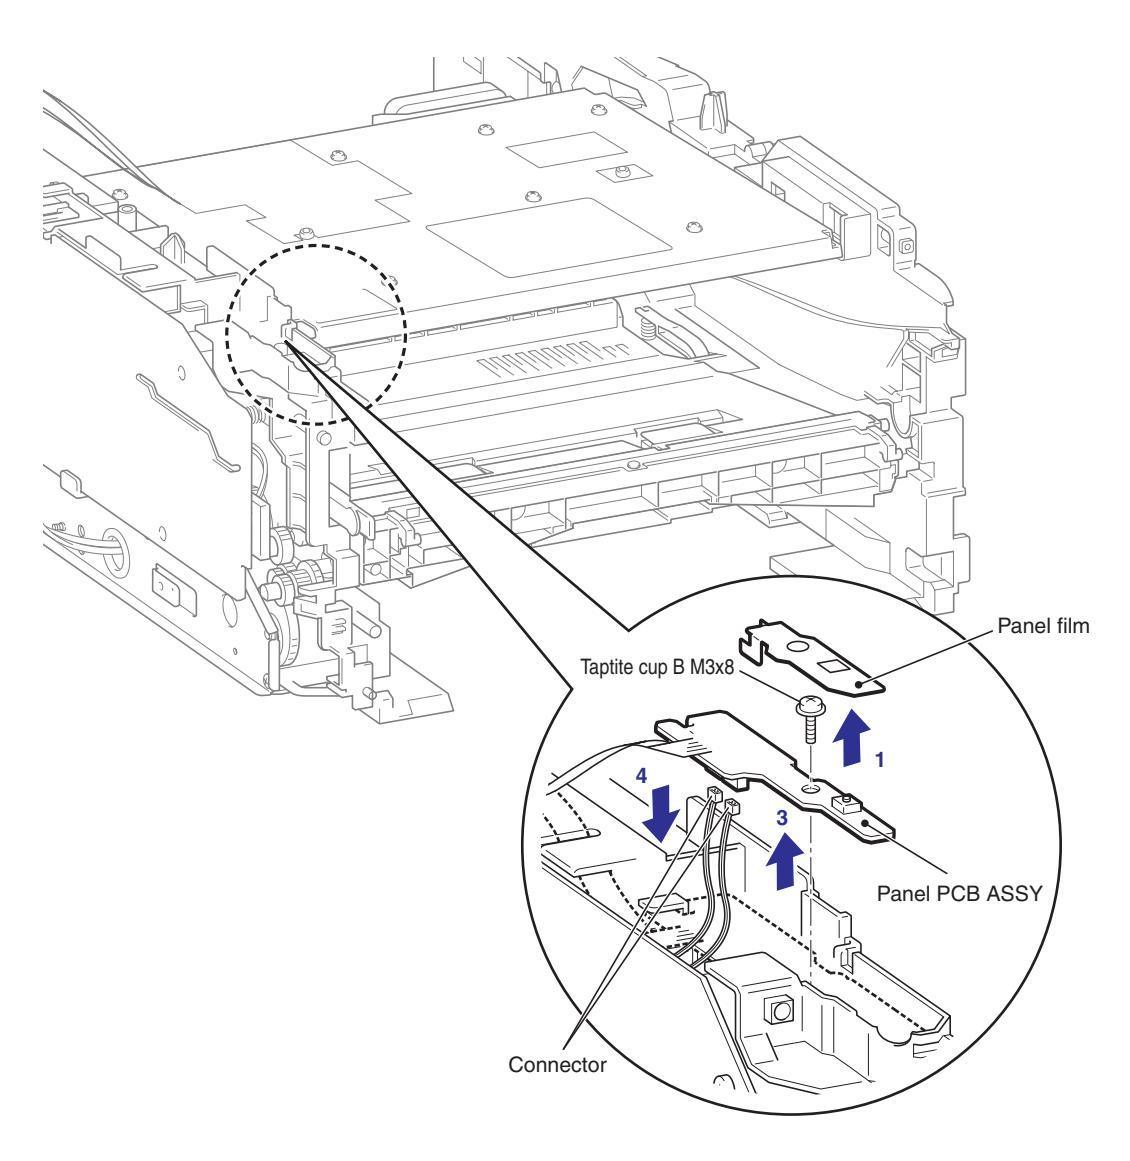
Fig. 3-32

- (1) Remove the Panel film.
- (2) Remove the Taptite cup B M3x8 screw.
- (3) Remove the Panel PCB ASSY from the Main body.
- (4) Disconnect the two connectors from the Panel PCB ASSY.
