Brother Laser Printer SERVICE MANUAL

MODEL: HL-2140/2150N/2170W

Sep 2007 SM-PRN066 84UA0* (5)

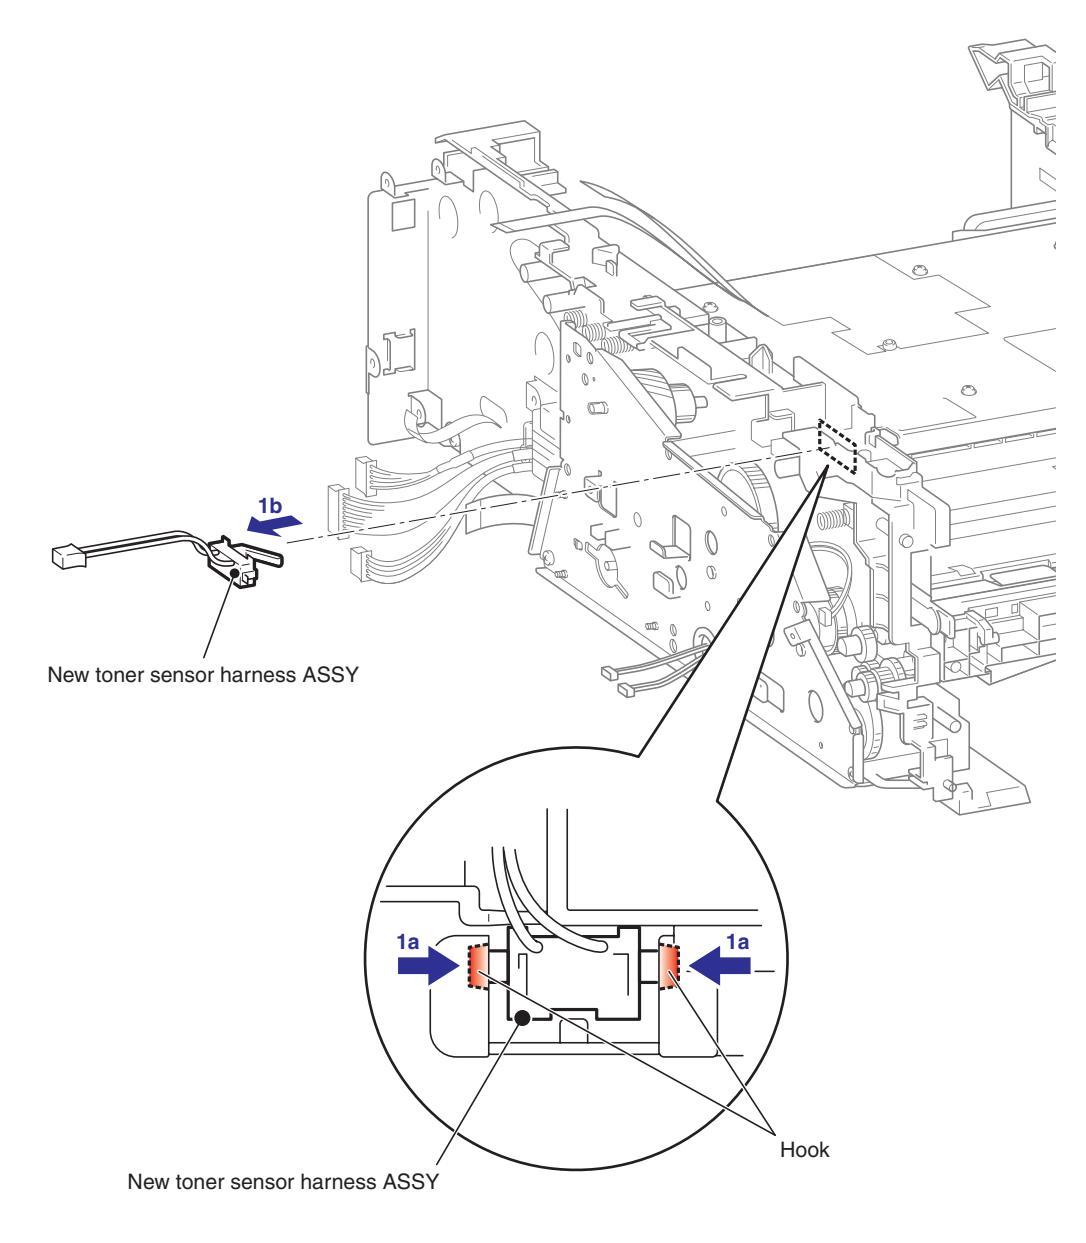
Fig. 3-34

(1) Release the Hook to remove the New toner sensor harness ASSY from the Main body.

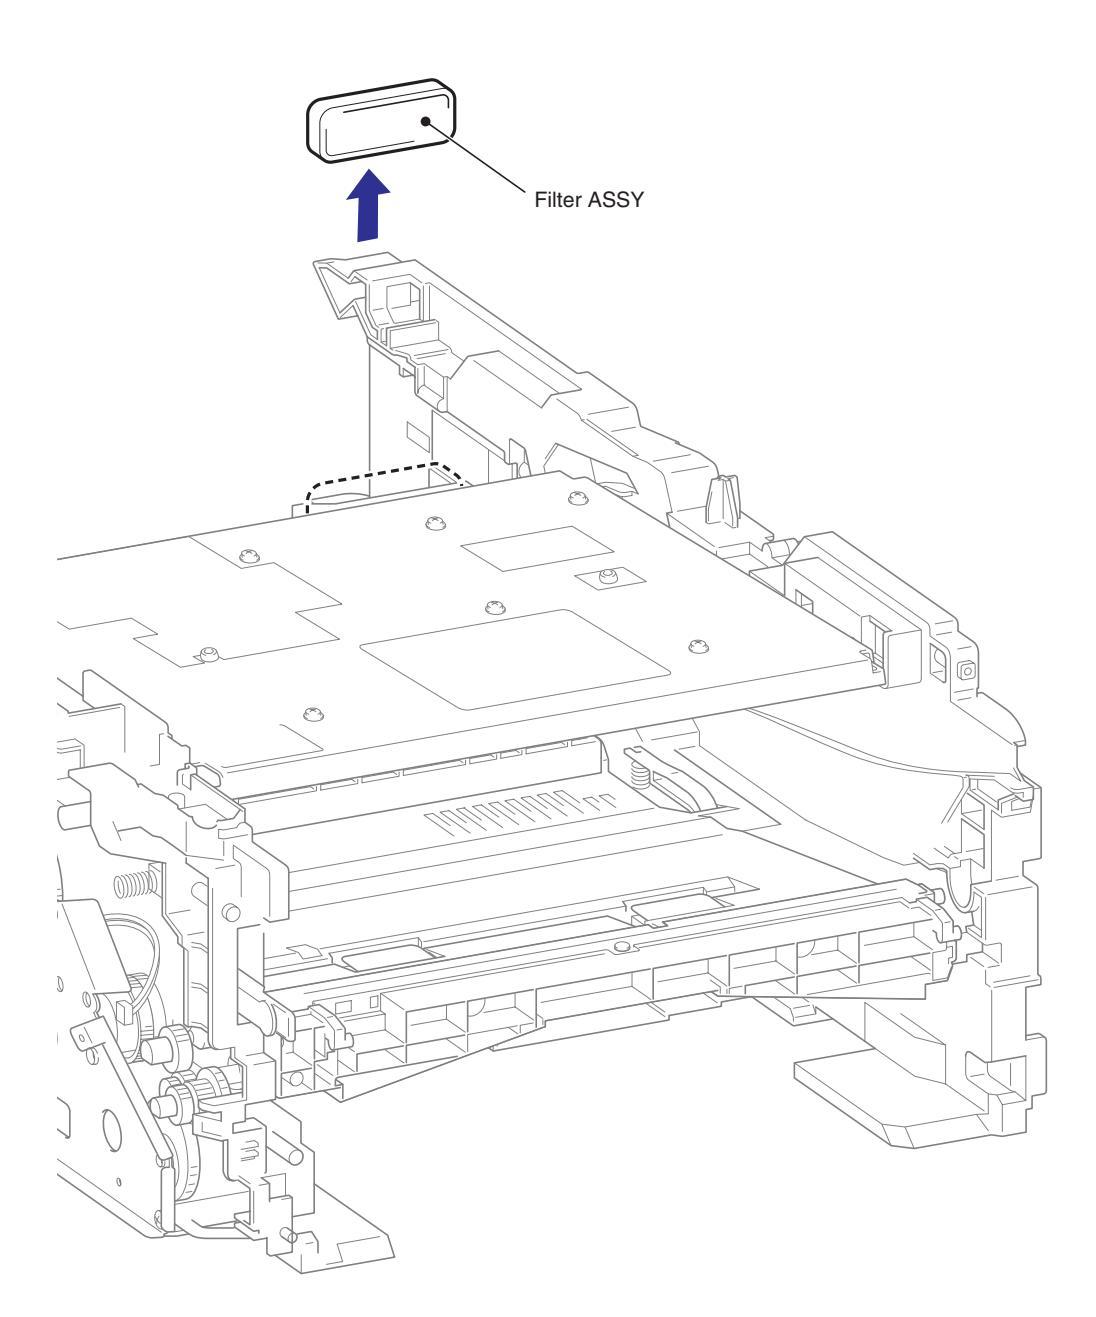
Fig. 3-35

(1) Remove the Filter ASSY from the Main body.

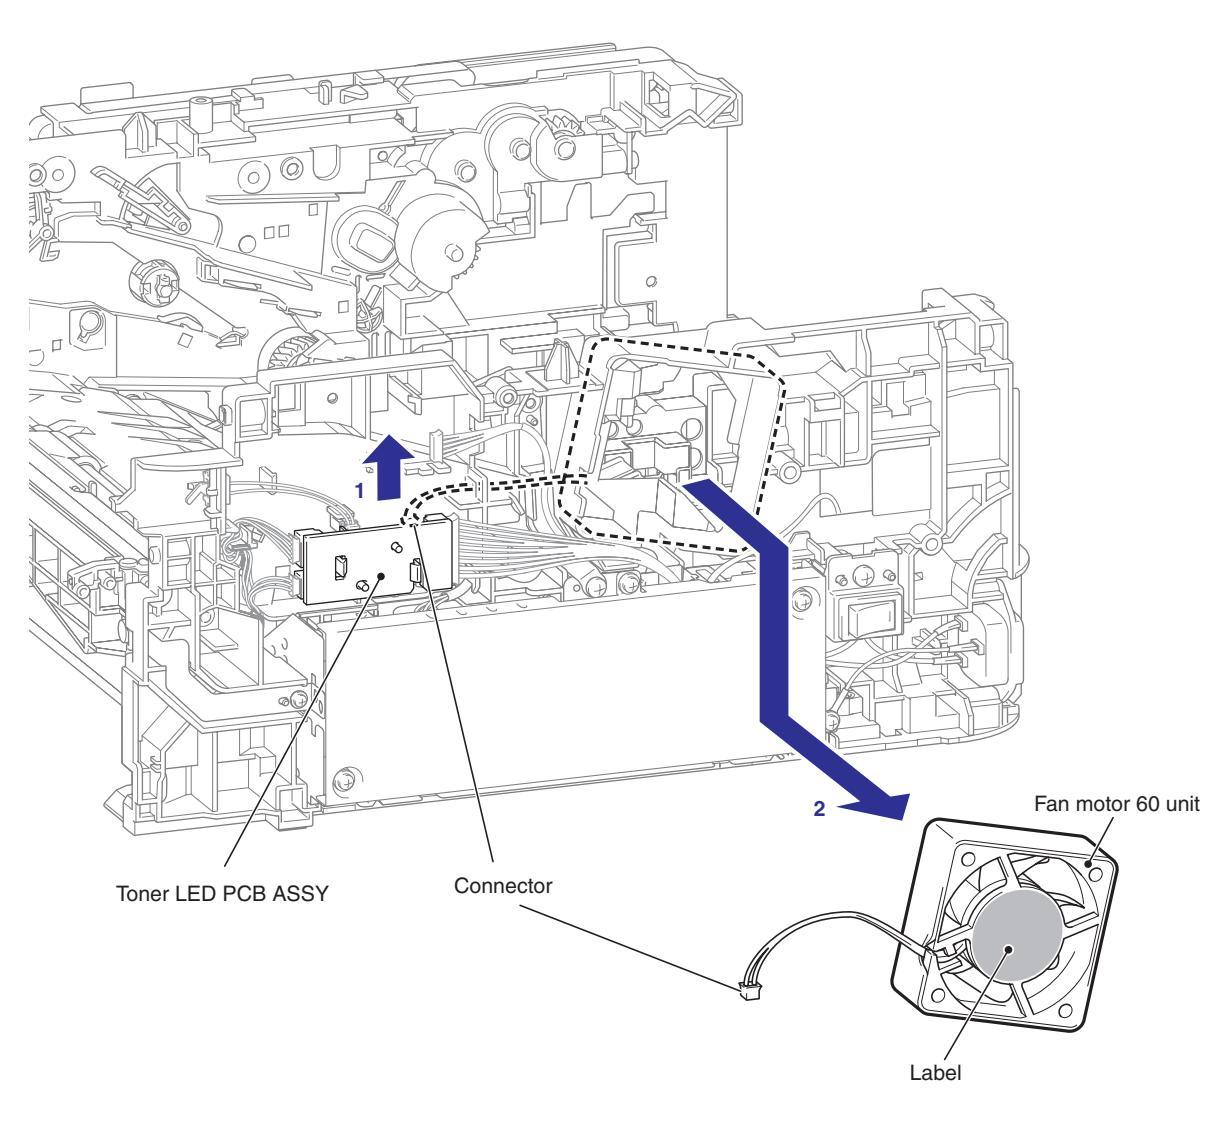
Fig. 3-39

- (1) Disconnect the Connector from the Toner LED PCB ASSY.
- (2) Remove the Fan motor 60 unit from the Main body.

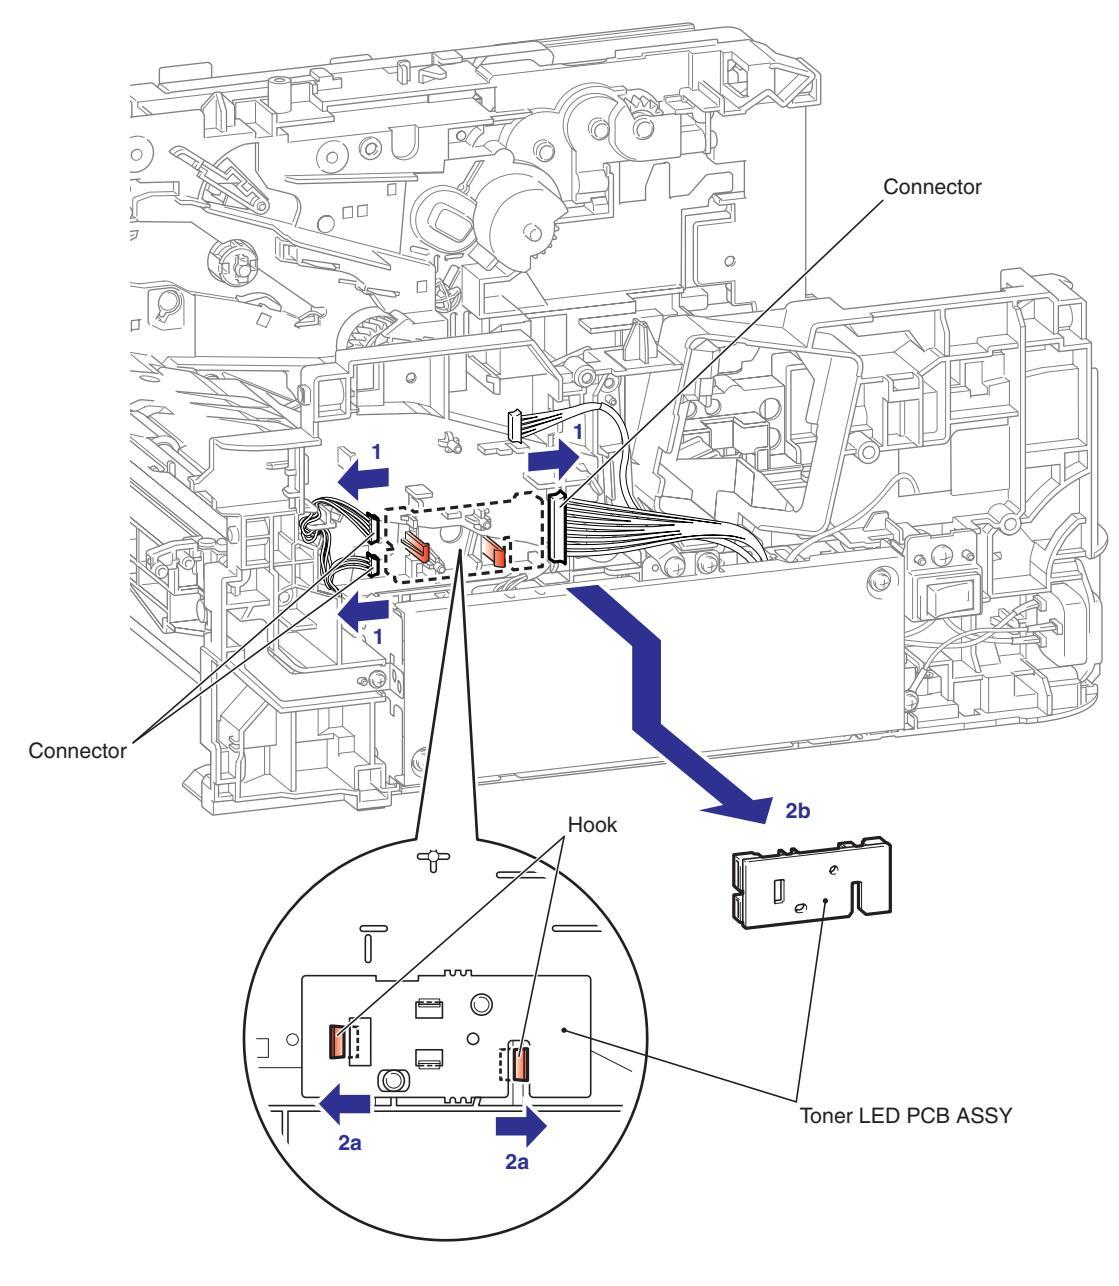
Fig. 3-41

- (1) Disconnect the three connectors from the Toner LED PCB ASSY.
- (2) Release the Hook to remove the Toner LED PCB ASSY from the Main body.

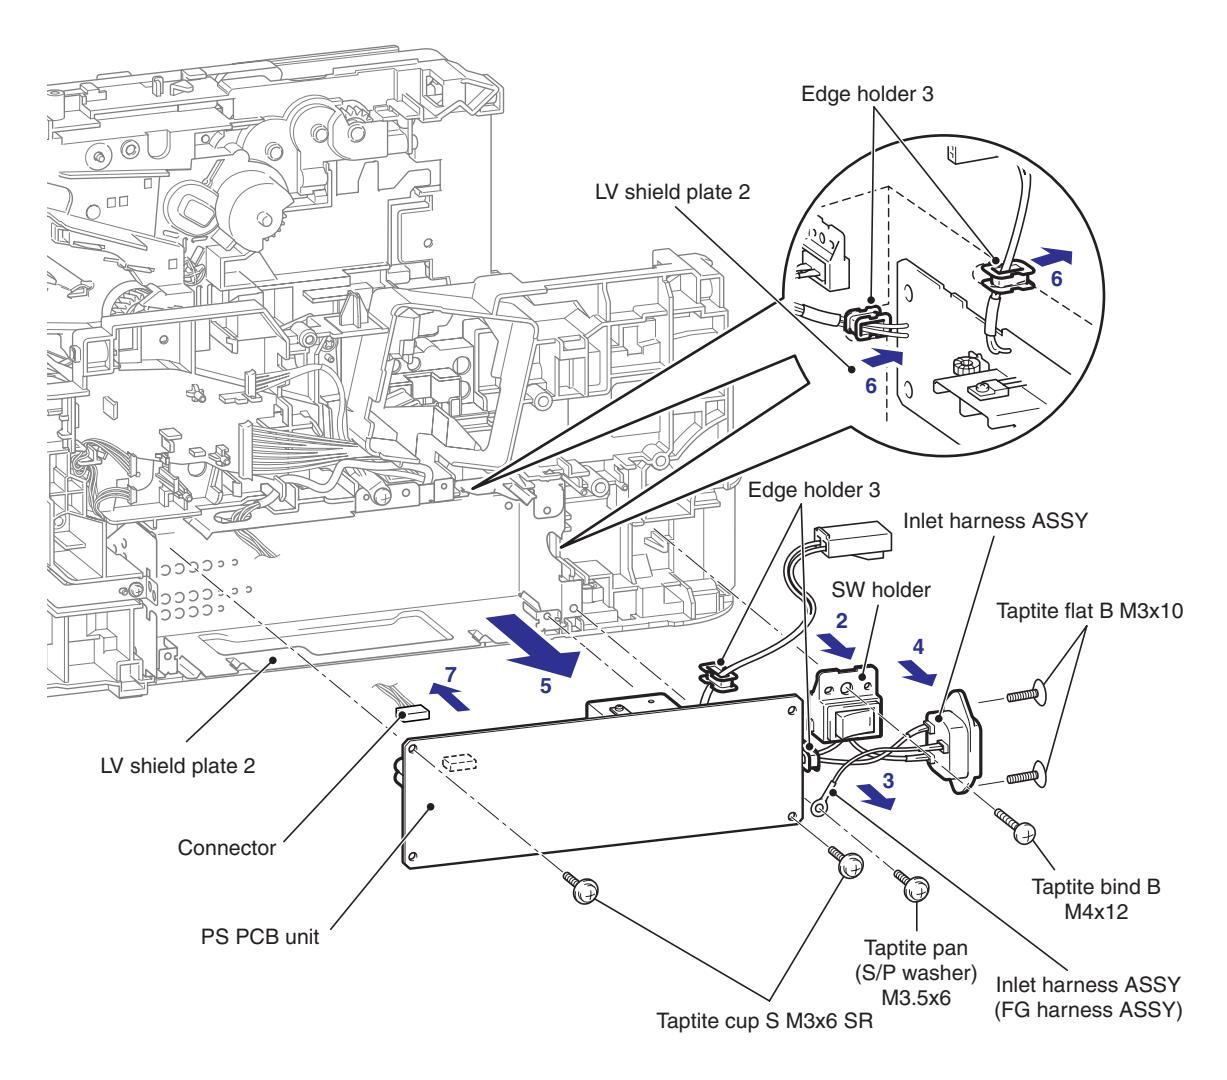
Fig. 3-44

- (2) Remove the Taptite bind B M4x12 screw, and then remove the SW holder from the Main body.
- (3) Remove the Taptite pan (S/P washer) M3.5x6 screw, and then remove the FG harness ASSY of the Inlet harness ASSY from the LV shield plate 2.
- (4) Remove the two Taptite flat B M3x10 screws, and then remove the Inlet harness ASSY from the Main body.
- (5) Remove the two Taptite cup S M3x6 SR screws, and then remove the PS PCB unit from the LV shield plate 2.
- (6) Remove the two Edge holder 3 from the LV shield plate 2.
- (7) Disconnect the Connector from the PS PCB unit.

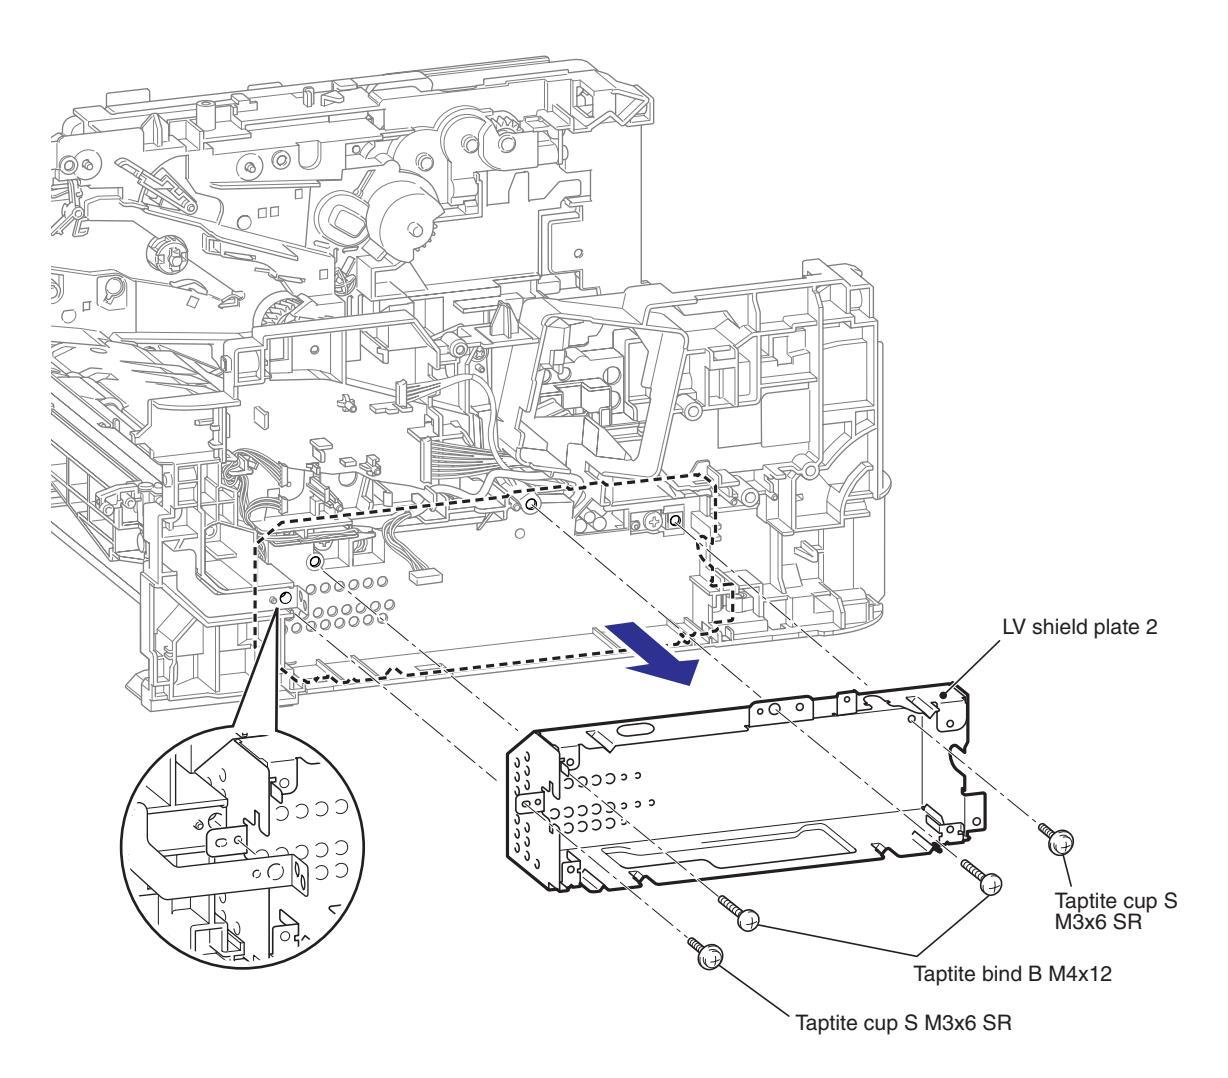
Fig. 3-45

(1) Remove the two Taptite bind B M4x12 screws and the two Taptite cup S M3x6 SR screws, and then remove the LV shield plate 2.

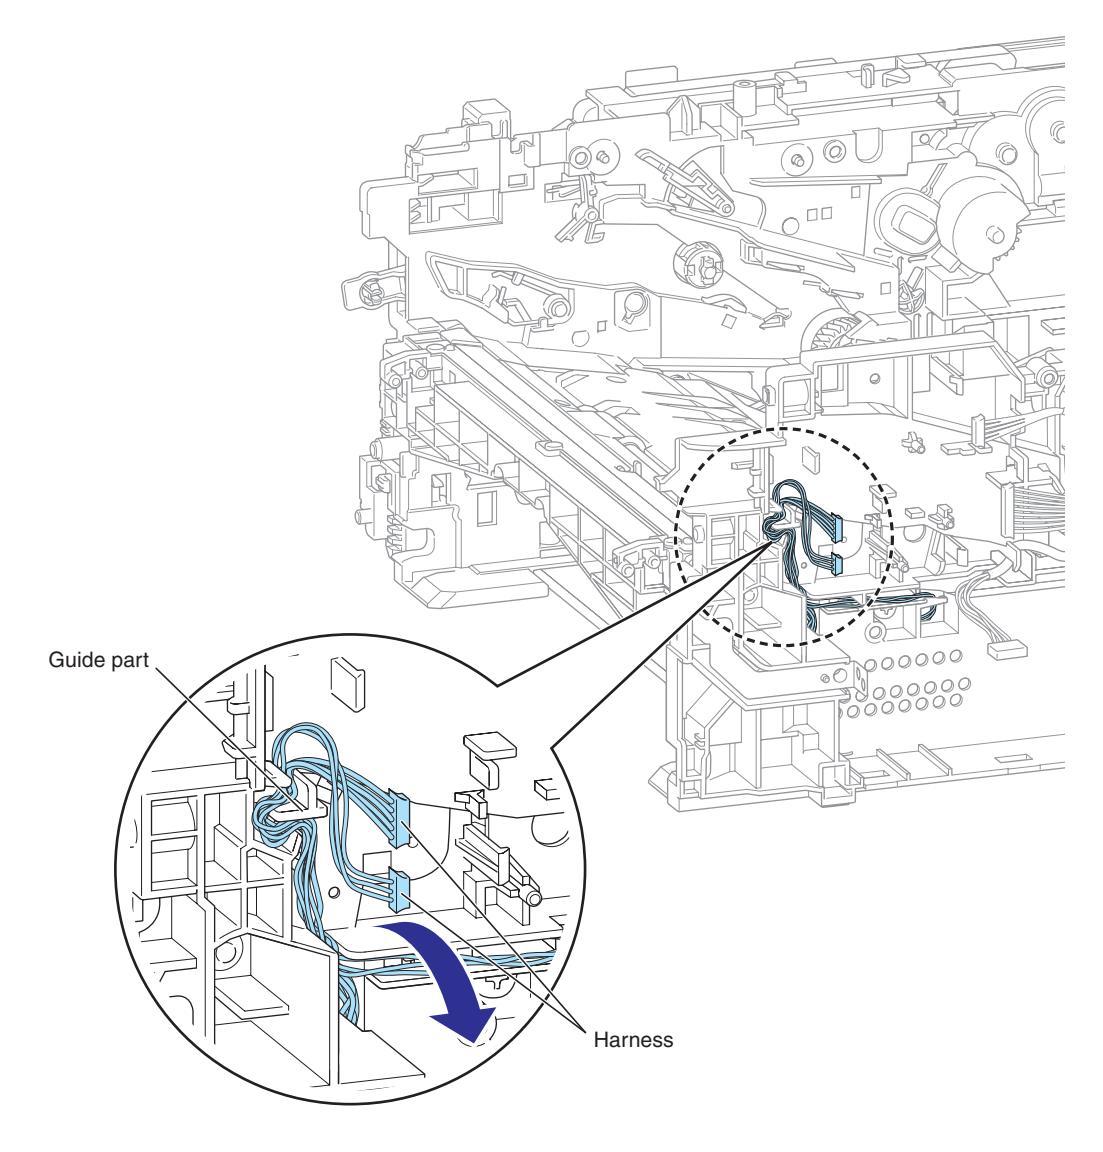
Fig. 3-46

(1) Remove the Harness of the Registration front sensor PCB ASSY and Registration rear sensor PCB ASSY from the Guide part of the Main body.

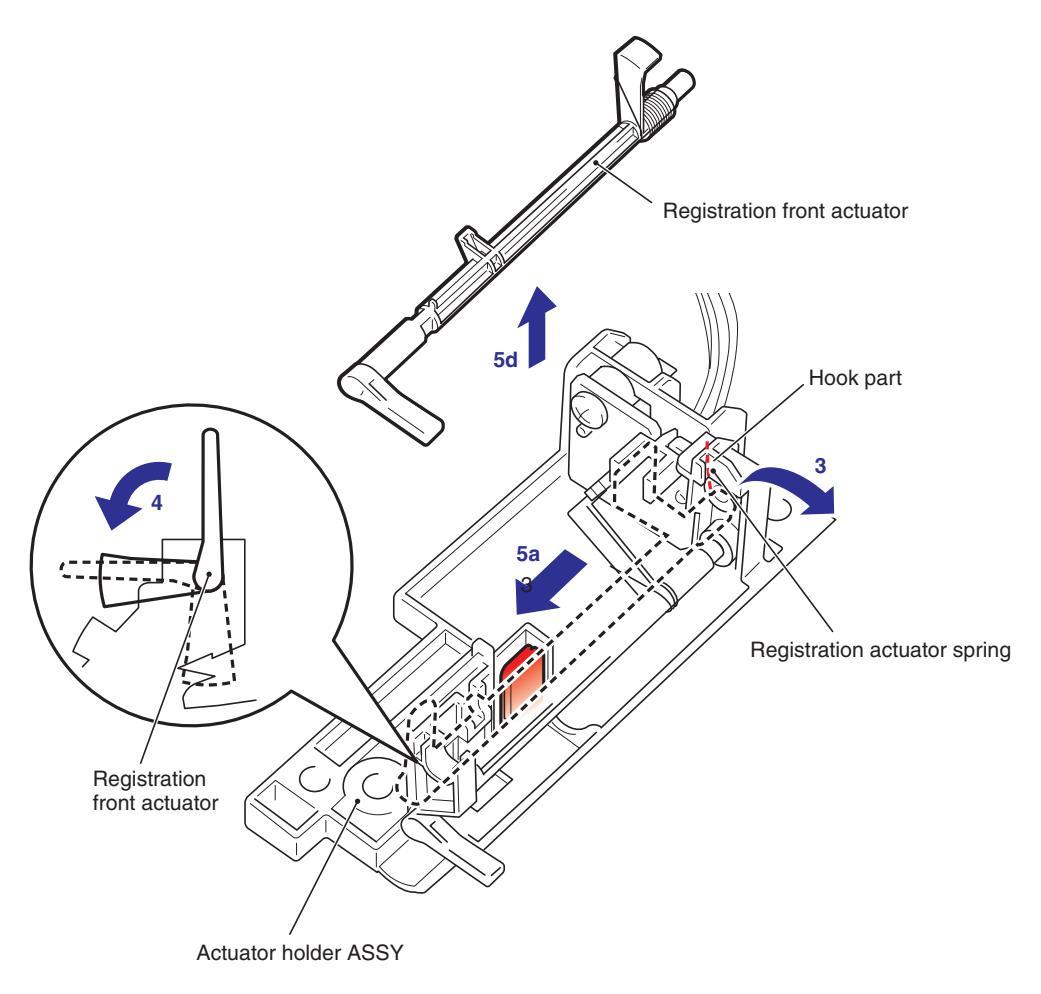
Fig. 3-48

Fig. 3-47
- (3) Remove the Registration actuator spring from the Hook part.
- (4) Turn the Registration front actuator at 90 degrees in the direction of counterclockwise as the arrow 4 shown below.
- (5) Slide the Registration front actuator to remove the Registration front actuator from the Actuator holder ASSY.

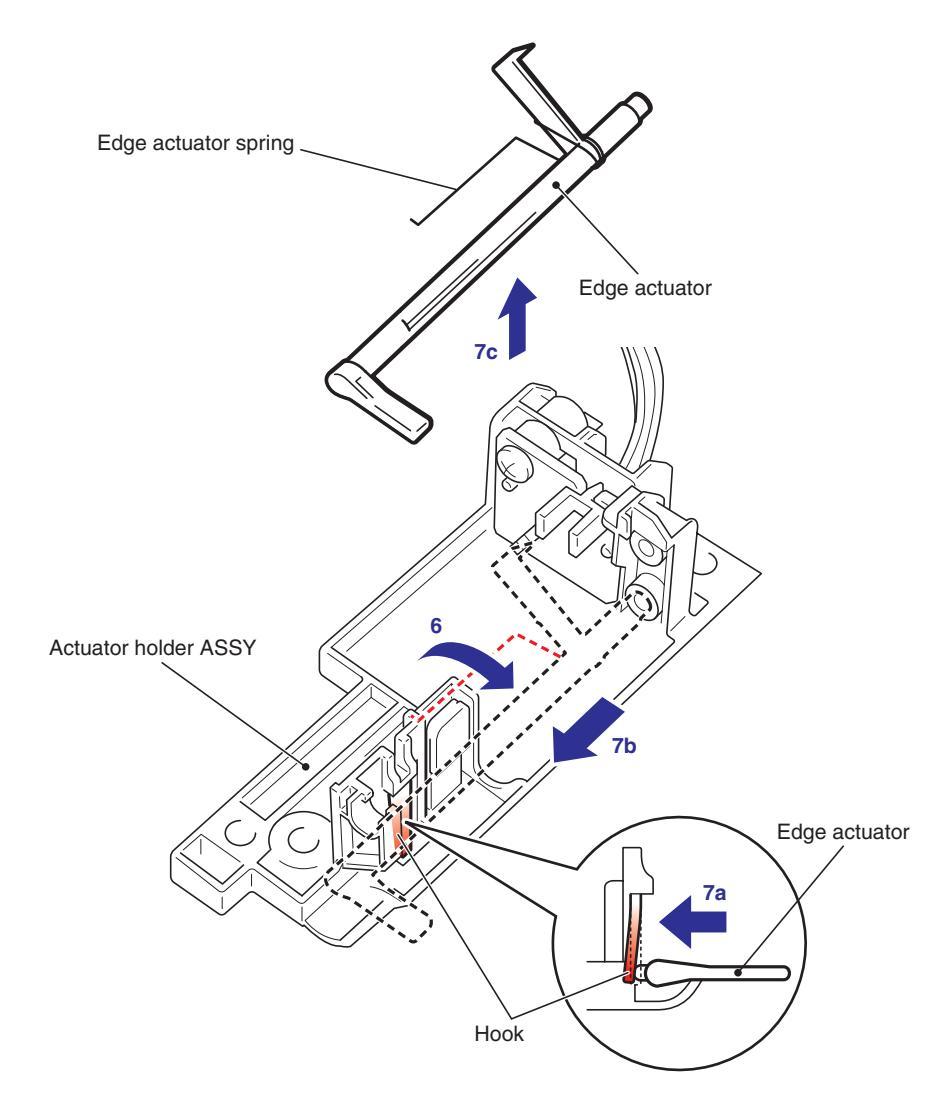
Fig. 3-49

- (6) Loosen the tip of the Edge actuator spring from the Actuator holder ASSY.
- (7) Release the Hook and Slide the Edge actuator to remove the Edge actuator from the Actuator holder ASSY.

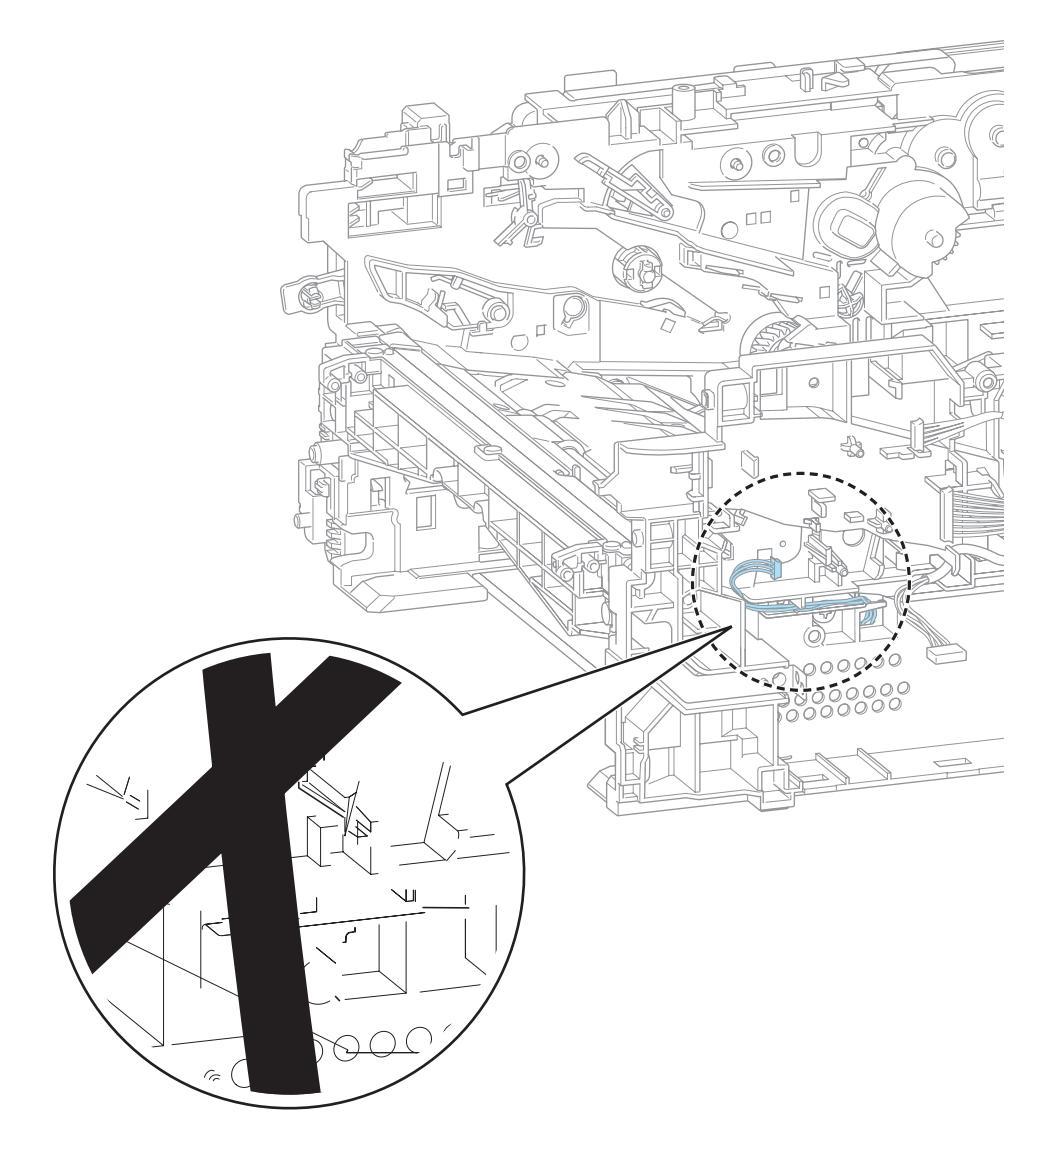
Fig. 3-51

(1) Remove the Harness of the Registration rear sensor PCB ASSY from the Guide part of Main body.

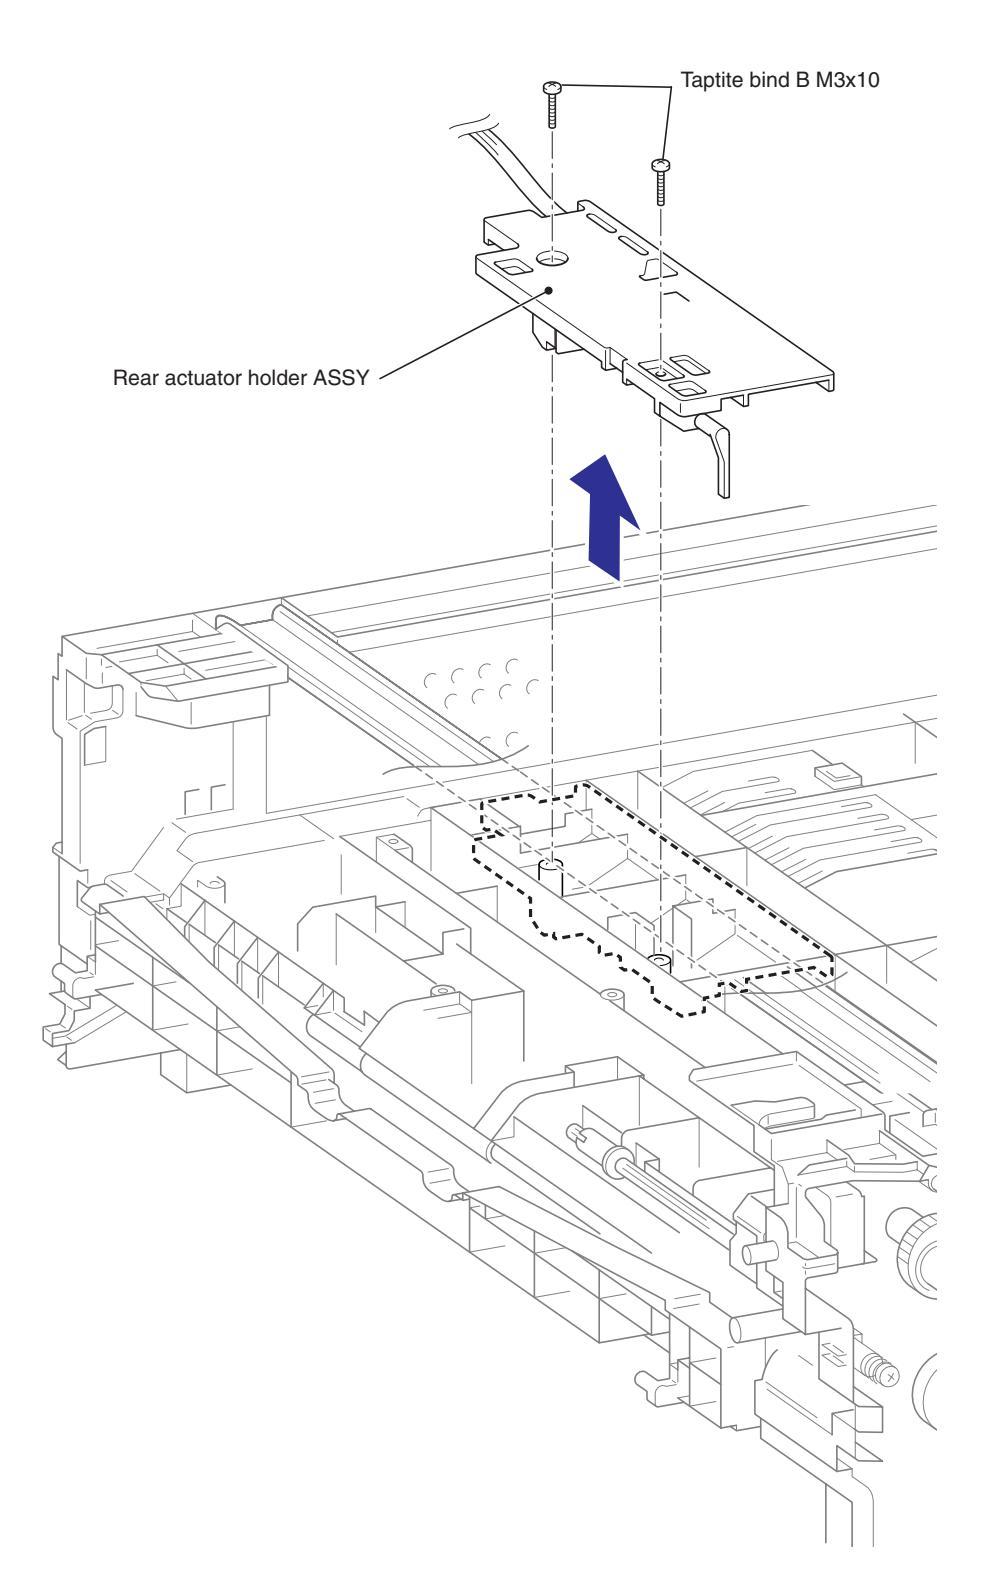
Fig. 3-52

(2) Remove the two Taptite bind B M3x10 screws, and then remove the Rear actuator holder ASSY from the Main body.

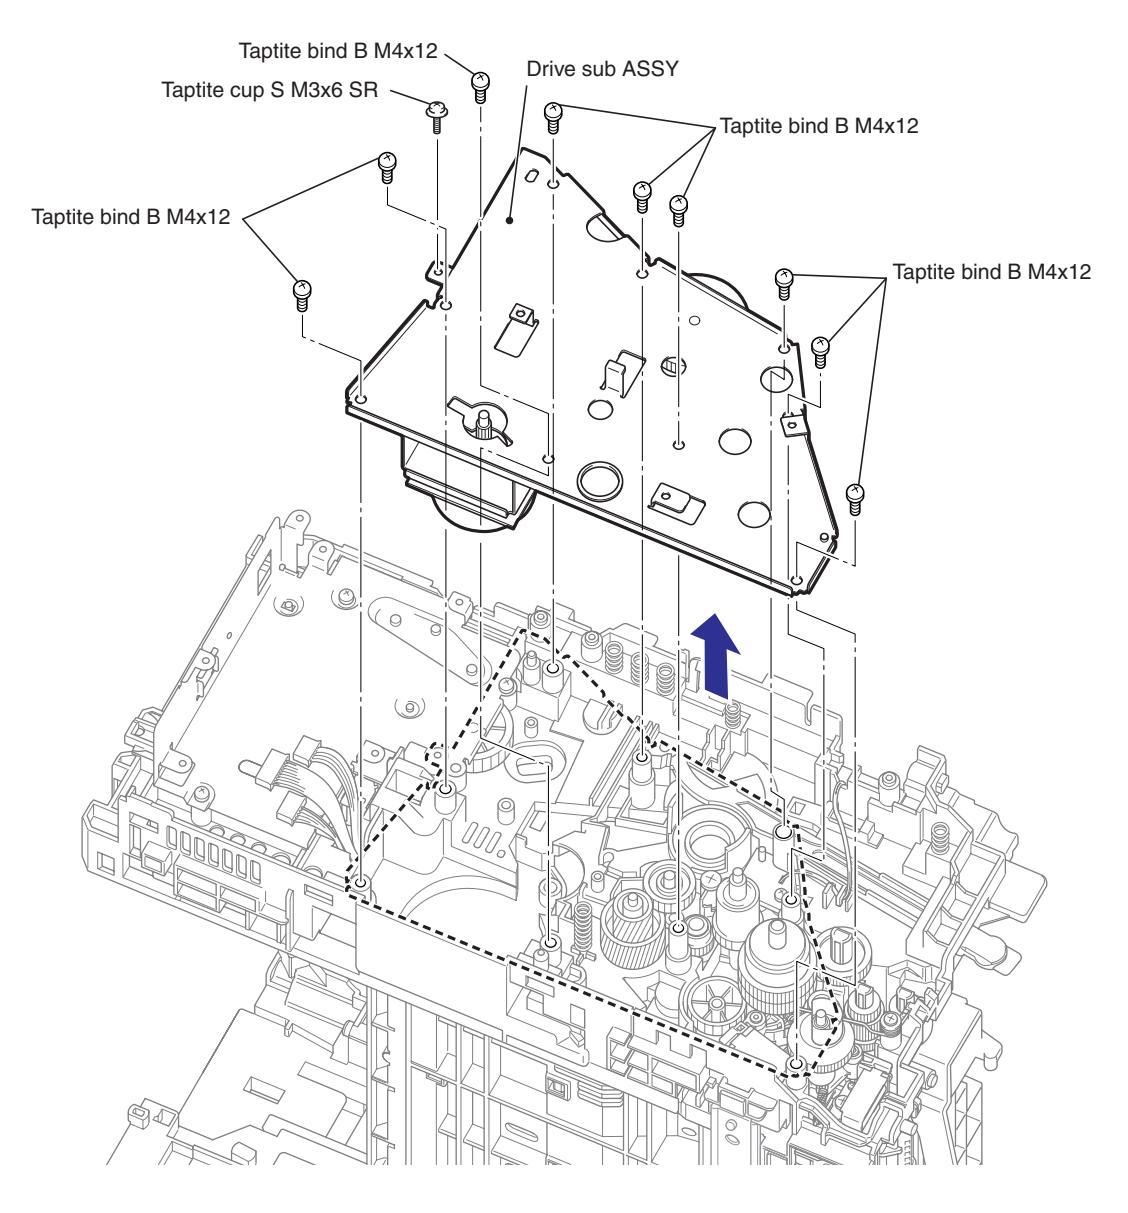
Fig. 3-56

(2) Remove the Taptite cup S M3x6 SR screw and the nine Taptite bind B M4x12 screws, and then remove the Drive sub ASSY from the Main body.

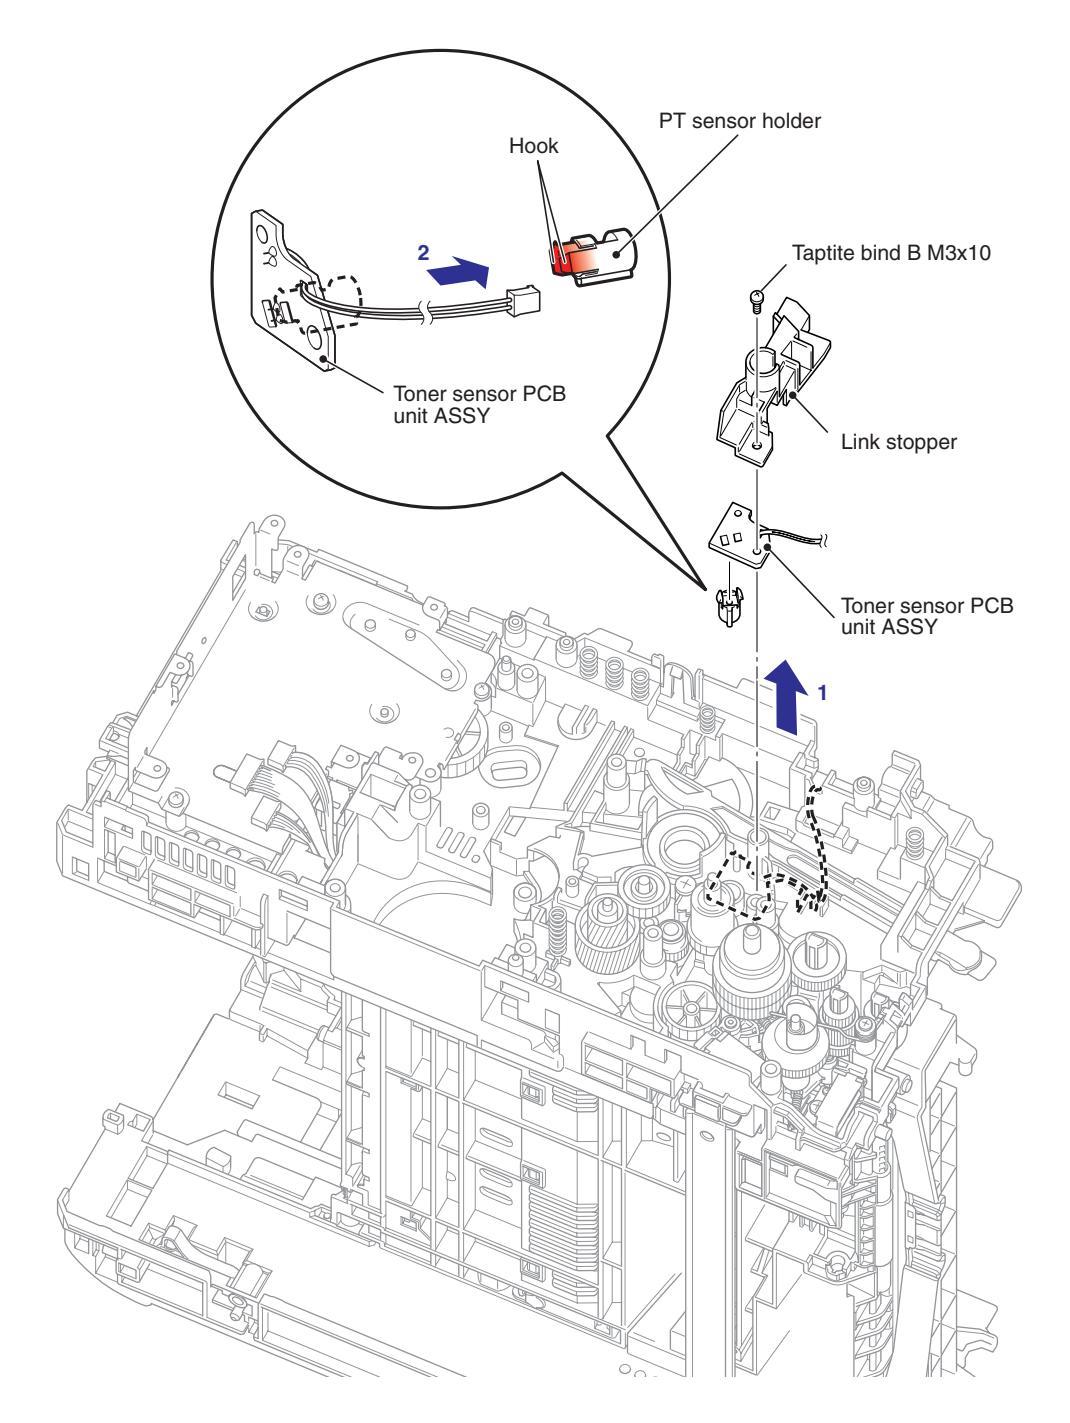
Fig. 3-58

- (1) Remove the Taptite bind B M3x10 screw, and then remove the Link stopper and the Toner sensor PCB unit ASSY from the Main body.
- (2) Remove the PT sensor holder from the Toner sensor PCB unit ASSY.

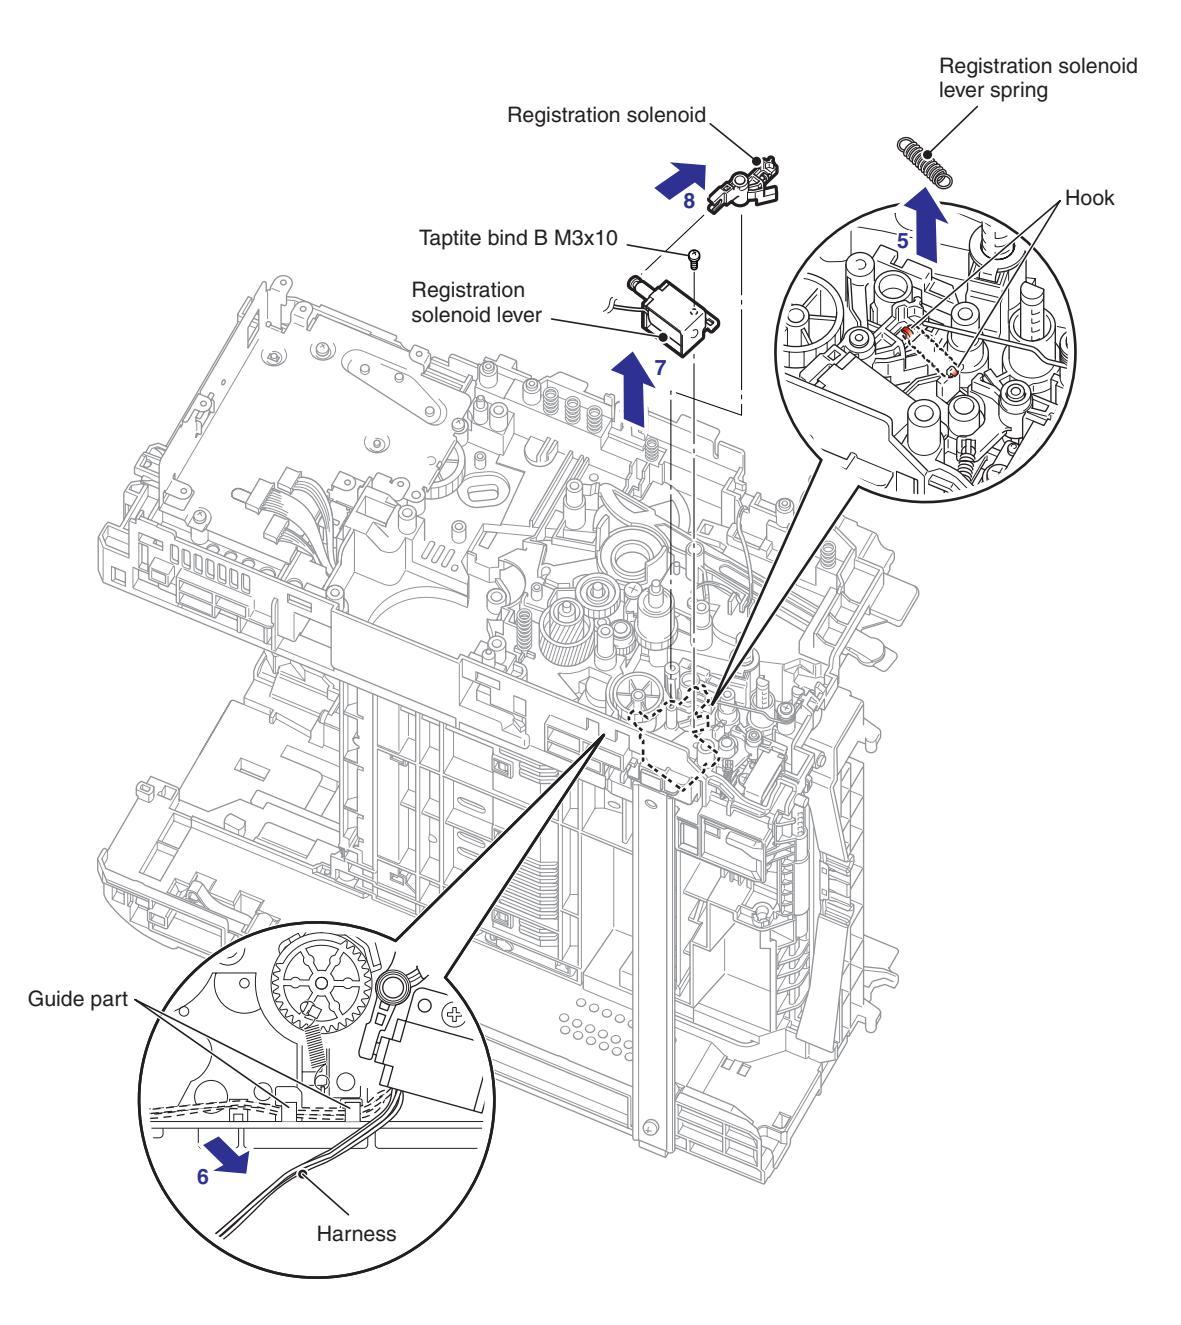
Fig. 3-60

- (5) Remove the Registration solenoid lever spring from the Main body and Registration solenoid lever.
- (6) Remove the Harness from the guide part of Main body.
- (7) Remove the Taptite bind B M3x10 screw, and then remove the Registration solenoid from the Main body.
- (8) Remove the Registration solenoid lever from the Registration solenoid.

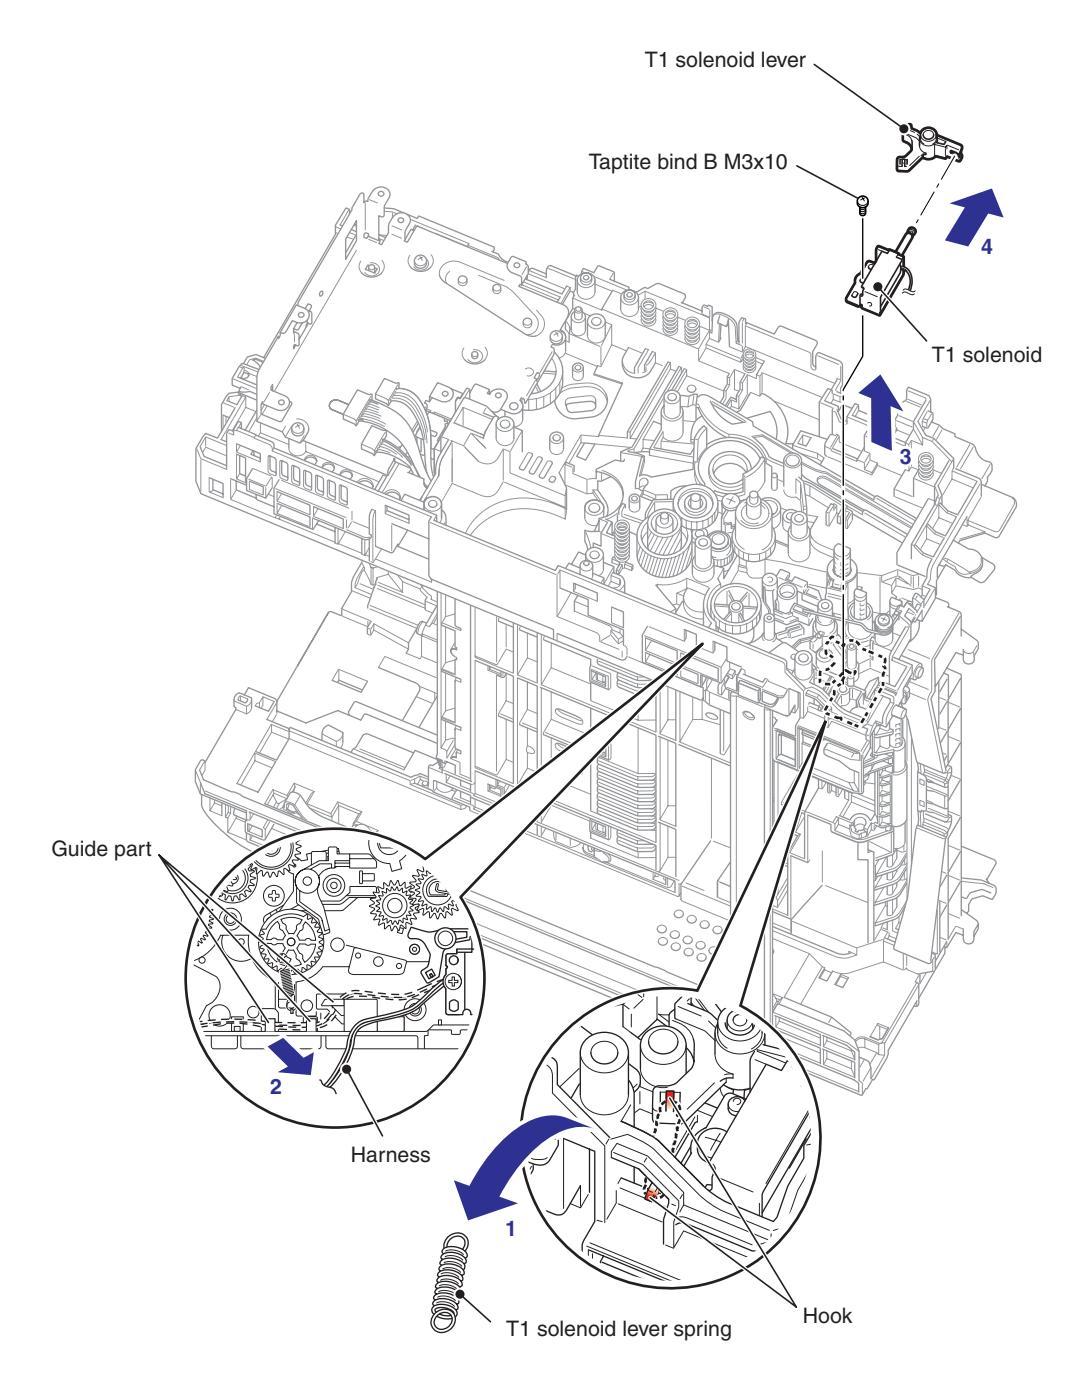
Fig. 3-61

- (1) Remove the T1 solenoid lever spring from the Main body and T1 solenoid lever.
- (2) Remove the Harness from the Guide part of the Main body.
- (3) Remove the Taptite bind B M3x10 screw, and then remove the T1 solenoid from the Main body.
- (4) Remove the T1 solenoid lever from the T1 solenoid.

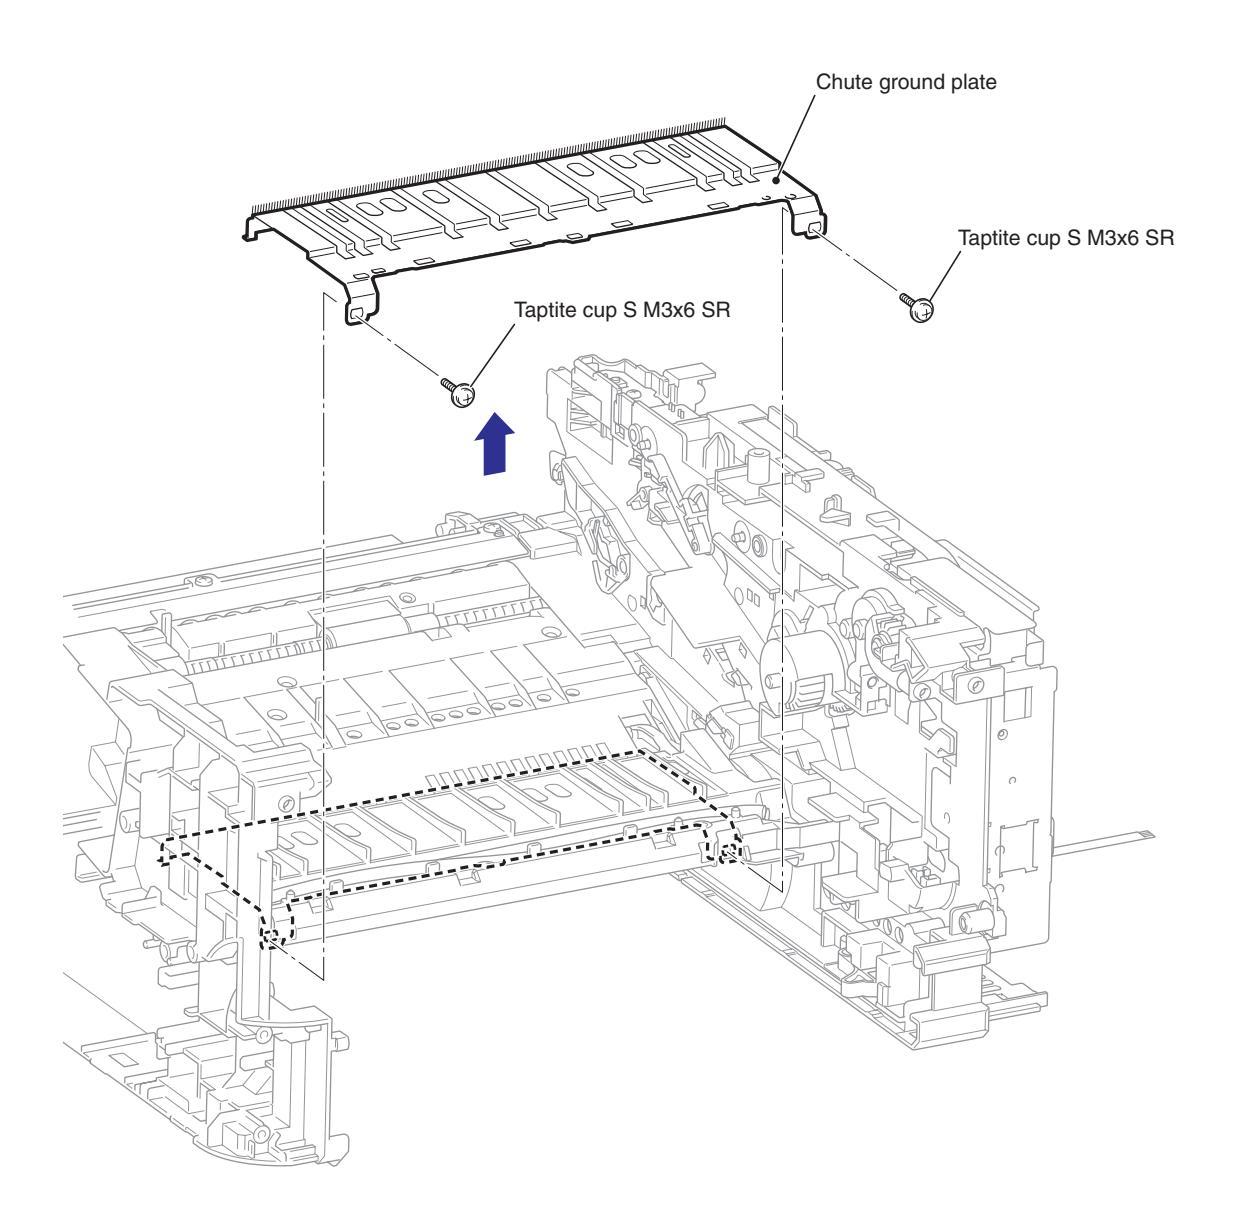
Fig. 3-63

(2) Remove the two Taptite cup S M3x6 SR screws, and then remove the Chute ground plate from the Main body.
