Brother Laser Printer SERVICE MANUAL

MODEL: HL-2140/2150N/2170W

Sep 2007 SM-PRN066 84UA0* (5)

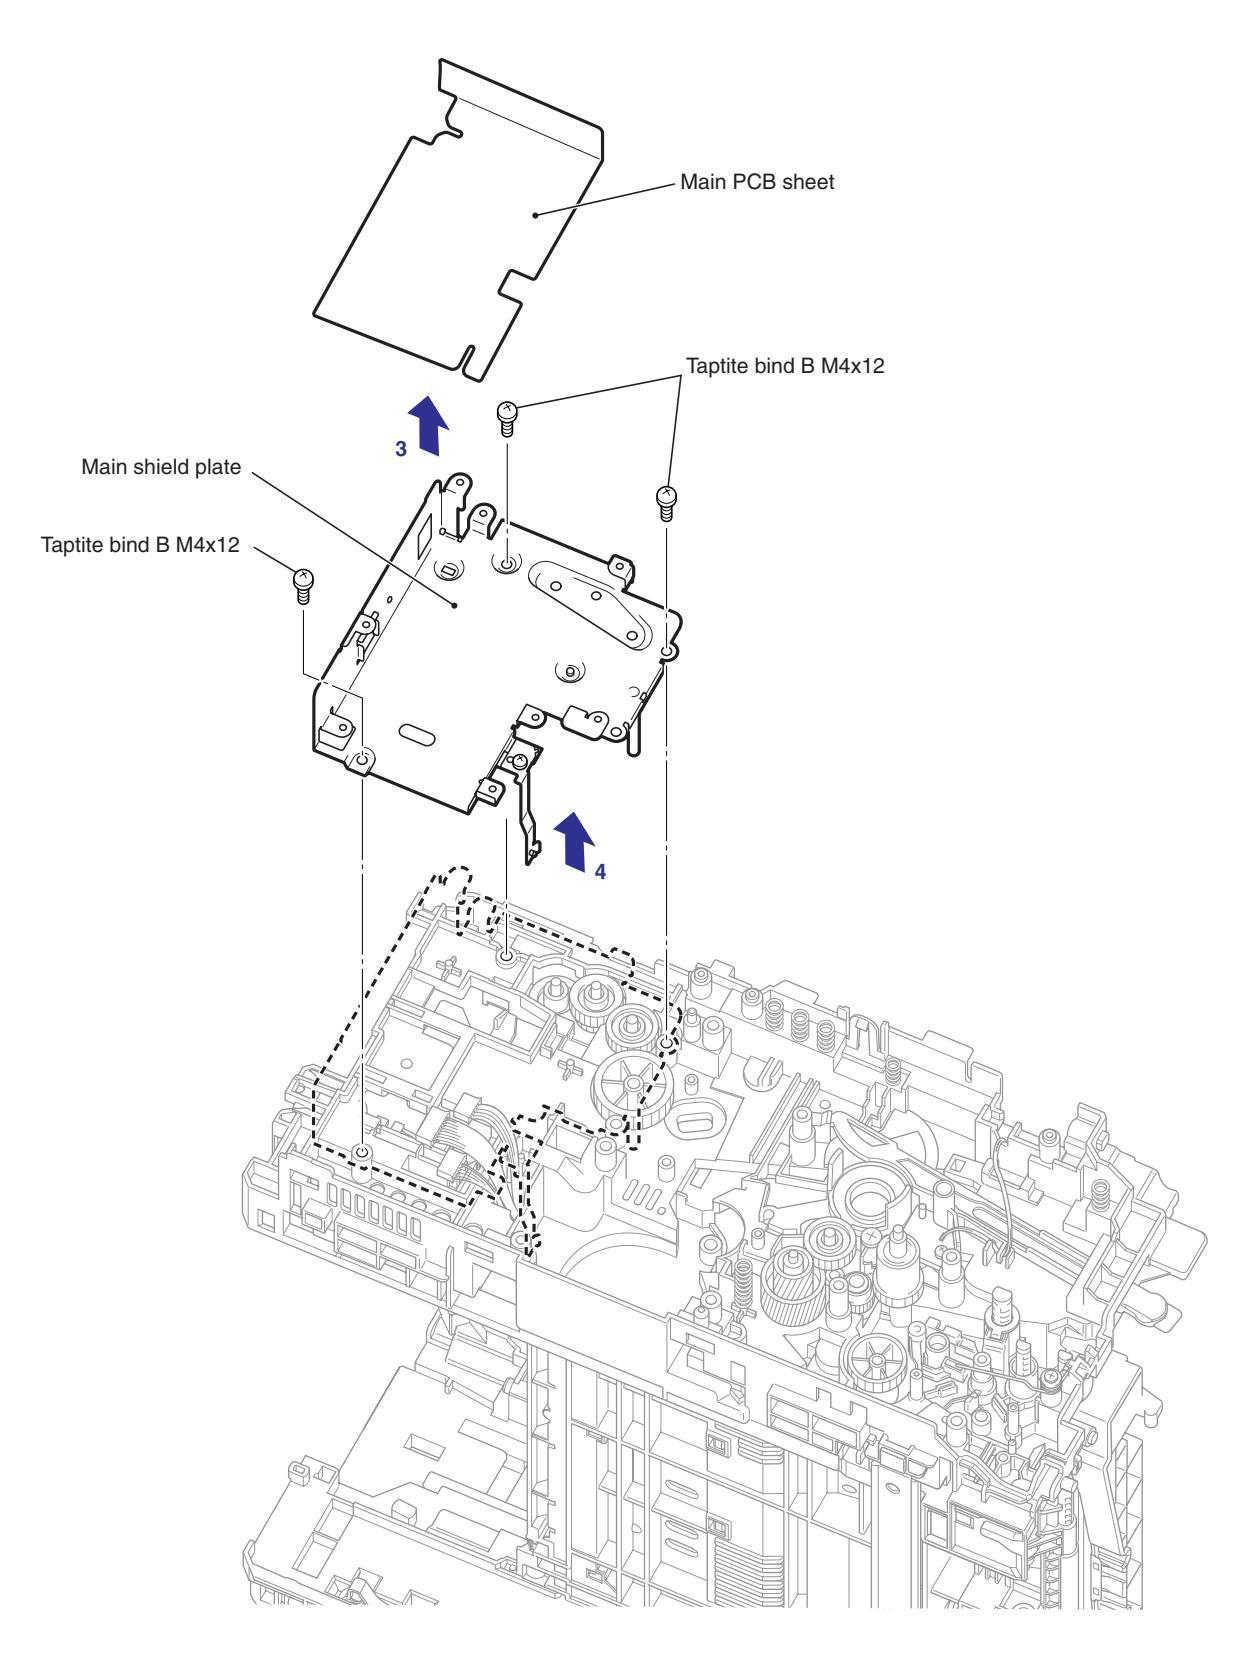
Fig. 3-64

- (3) Remove the Main PCB sheet from the Main shield plate.
- (4) Remove the three Taptite bind B M4x12 screws, and then remove the Main shield plate from the Main body.

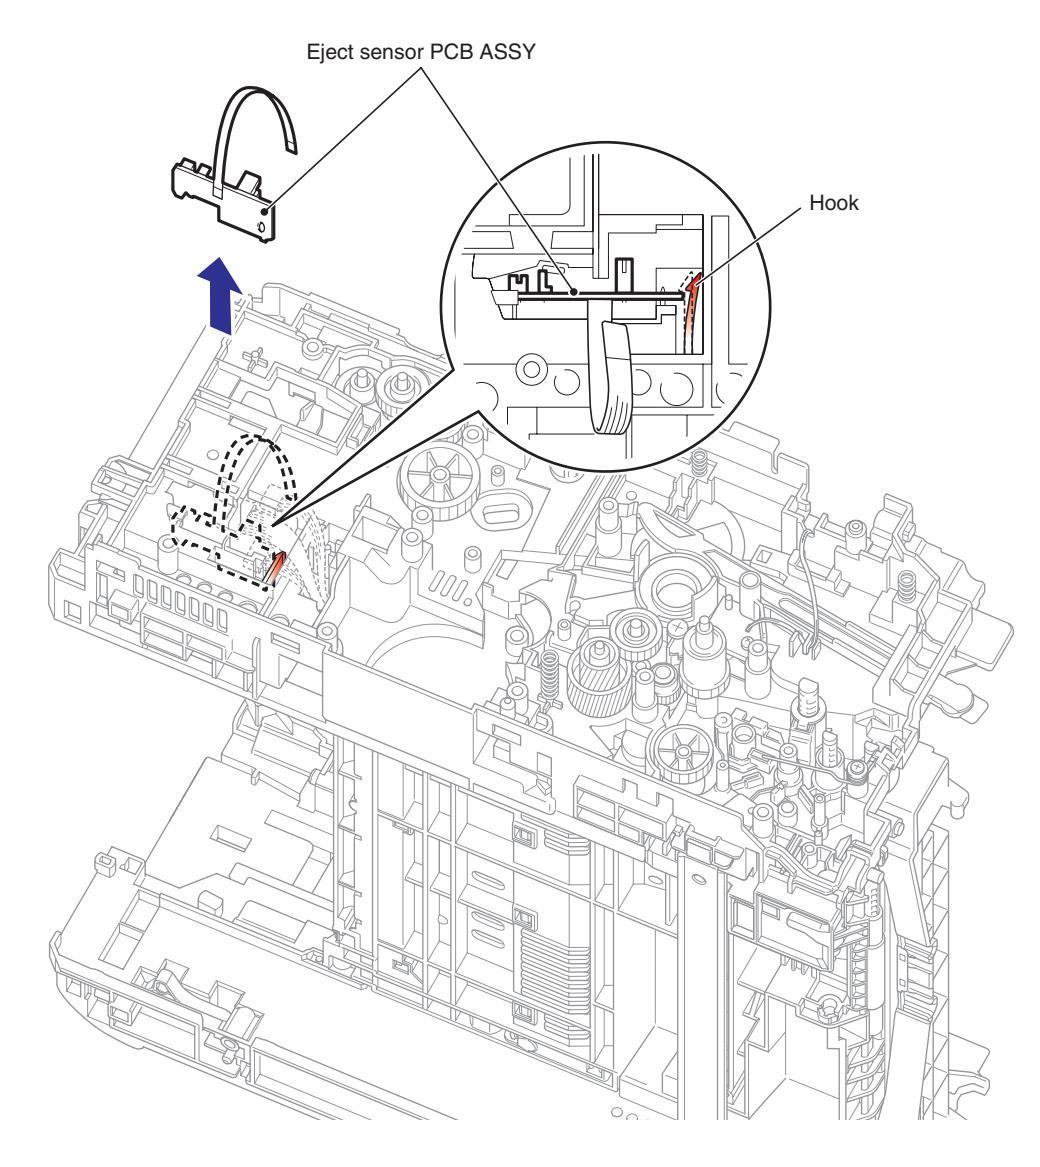
Fig. 3-65

(5) Release the Hook to remove the Eject sensor PCB ASSY from the Main body.

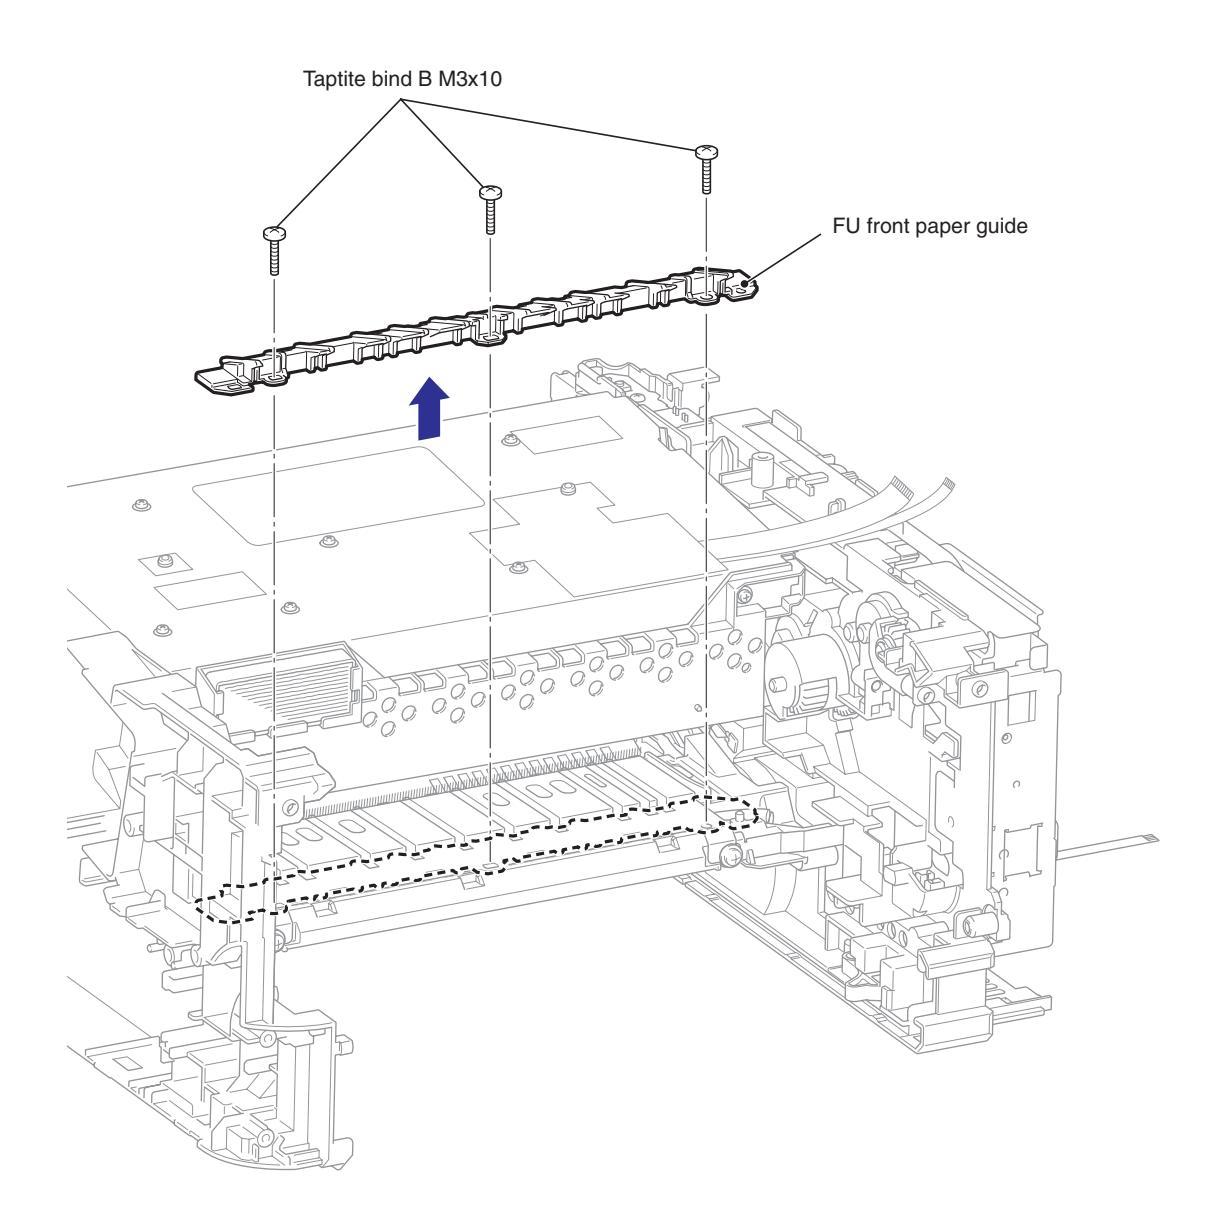
Fig. 3-67

(1) Remove the three Taptite bind B M3x10 screws, and then remove the FU front paper guide from the Main body.
