# Phaser 8560MFP Multifunction Product Service Documentation

Phaser 8560MFP Multifunction Product Service Manual

705P01133

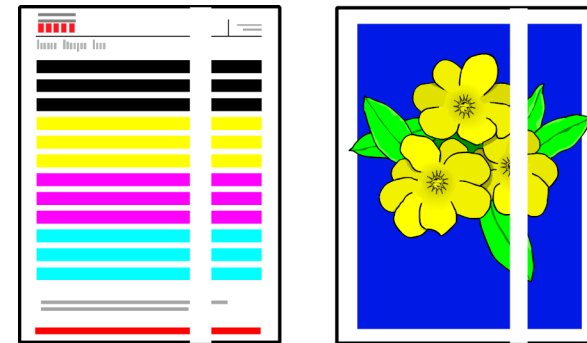
s8560-003

This RAP addresses image quality problems associated with the Print Engine. Predominate light stripes typically result from something scraping the image off the Drum before Transfixing. Indications of a random light stripe condition are all four color bars missing on the test page, or output that appears as follows:

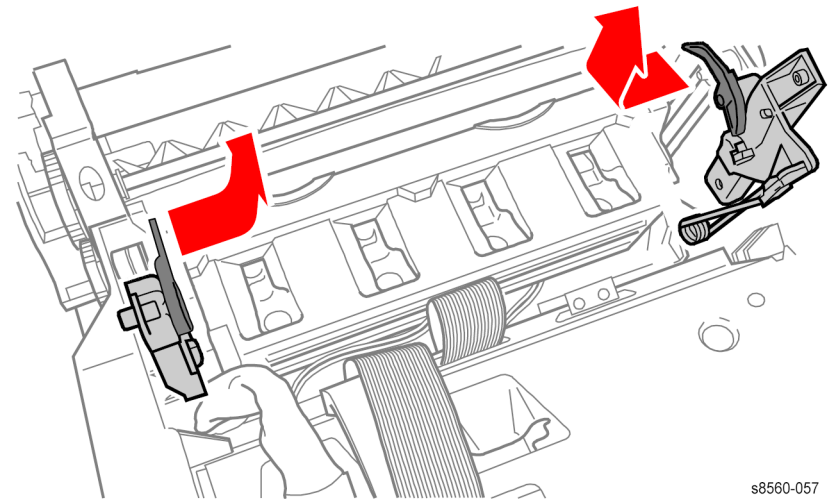
**Figure 6 Removing the Printhead Restraints**

**NOTE:** Use a flat-bladed screwdriver to rotate the X-Axis Motor to adjust the Printhead position as needed to remove the Printhead Restraints.
